Barn at Cooper House
Magson House Road, Luddenden Foot, West Yorkshire:
Historic Building Record

STEPHEN HAIGH

B u i l d i n g s A r c h a e o l o g i s t

OASIS project ID: stephenh1-198738

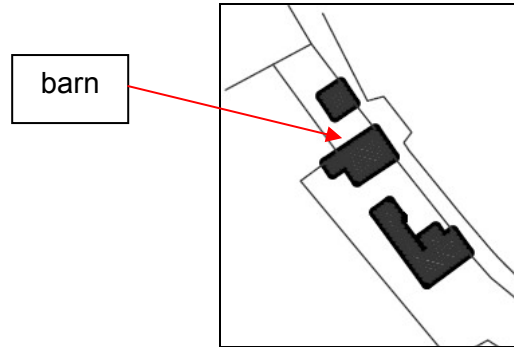
4: Warley township map, 1804

Traced and enlarged from the original: West Yorkshire Archive Service, HXT:675

- 5.6 Cartographic evidence, in the form of the 1804 township map⁹, shows that the barn was certainly extant by that year, and had a small adjoining structure at its western corner (since demolished). The house itself formed a large L-shaped building, and there was another detached building to the north of the barn, which is no longer extant, and may have been a cottage (figure 4).

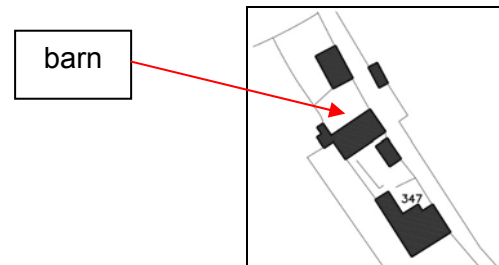
5: Warley township map, 1838

Traced and enlarged from the original: West Yorkshire Archive Service, HXT:676

- 5.7 Another, later source is a survey of the township made in 1838¹⁰, which shows the barn in a generally similar fashion, but with another, detached building to its south-east, next to the road (figure 5); this second outbuilding has not survived either.

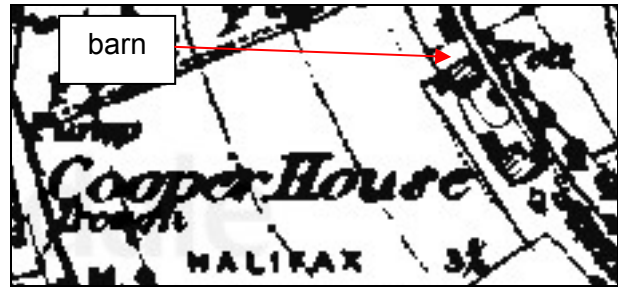
6: OS 1:10560 map, 1854

Surveyed 1848-50; sheet no: Yorkshire, 230

- 5.8 The first edition 1:10560 Ordnance Survey map (figure 6) is likewise at a small scale and does not add significant further information to an understanding of the site, though it appears to show a broadly similar arrangement of buildings as the earlier maps.

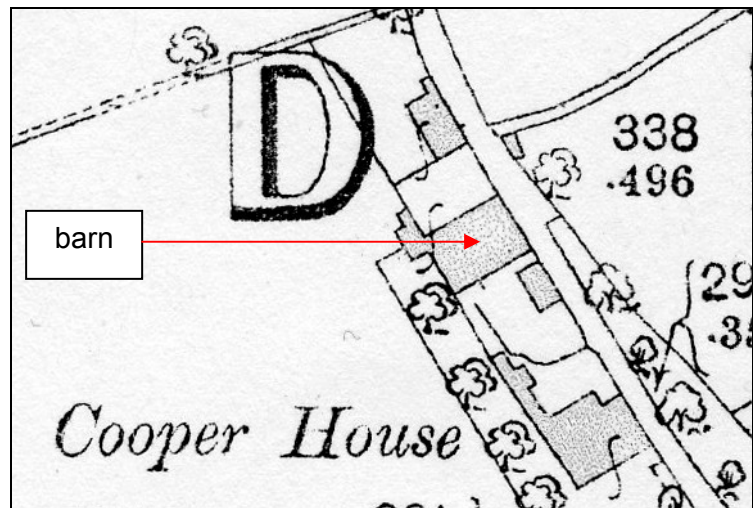
7: OS 1:2500 map, 1894

Surveyed 1888-93; sheet no: Yorkshire, 230.11 (enlarged to 1:1250)

5.9 The more detailed 1:2500 maps show that house, barn and two outbuildings still stood at the site up to the mid twentieth century, but that between 1931 and 1961 the two outbuildings were demolished (figures 7 to 11).

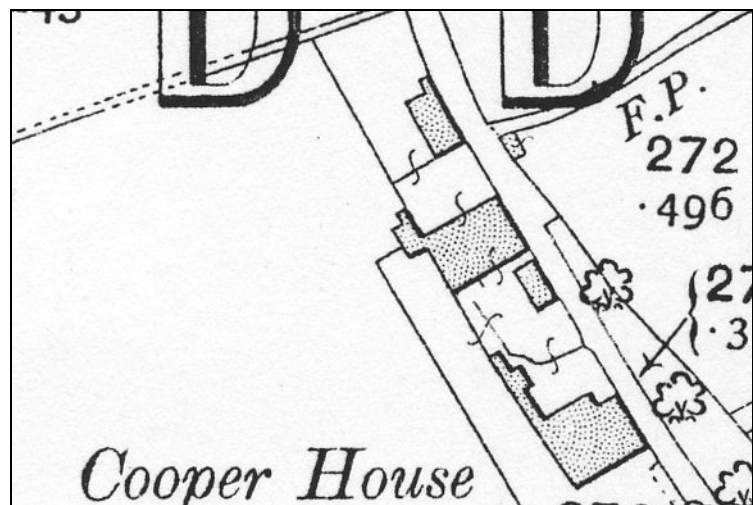
8: OS 1:2500 map, 1907

Revised 1905; sheet no: Yorkshire, 230.11 (enlarged to 1:1250)

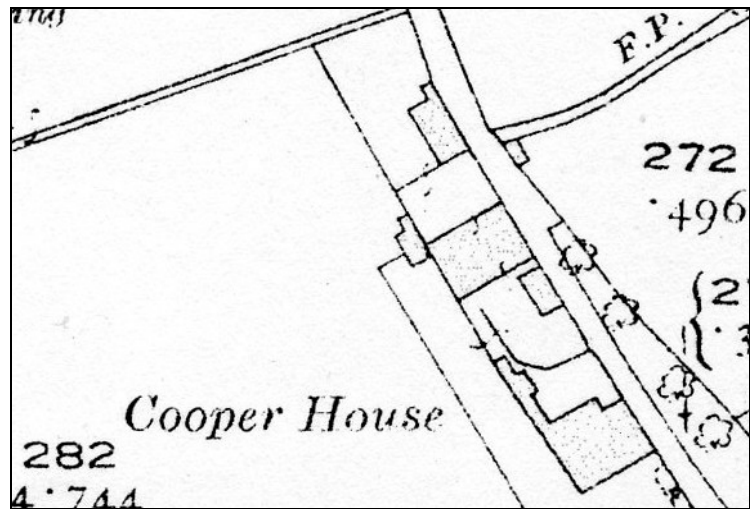
9: OS 1:2500 map, 1919

Revised 1914; sheet no: Yorkshire, 230.11 (enlarged to 1:1250)

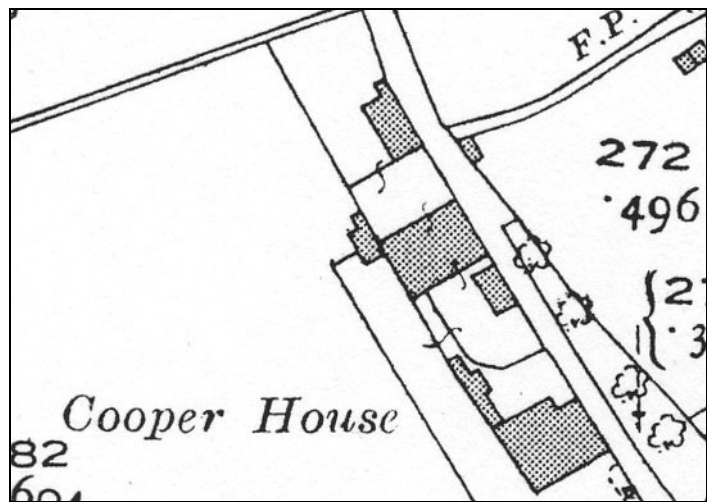
10: OS 1:2500 map, 1933

Revised 1931; sheet no: Yorkshire, 230.11 (enlarged to 1:1250)

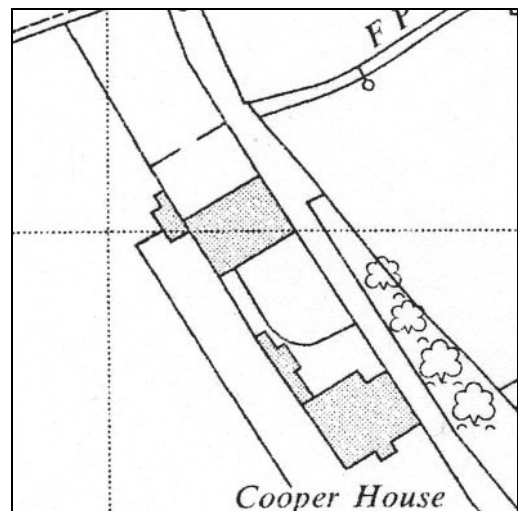
11: OS 1:2500 map, 1964

Revised 1961-2; sheet no: SE 0424/0524 (enlarged to 1:1250)

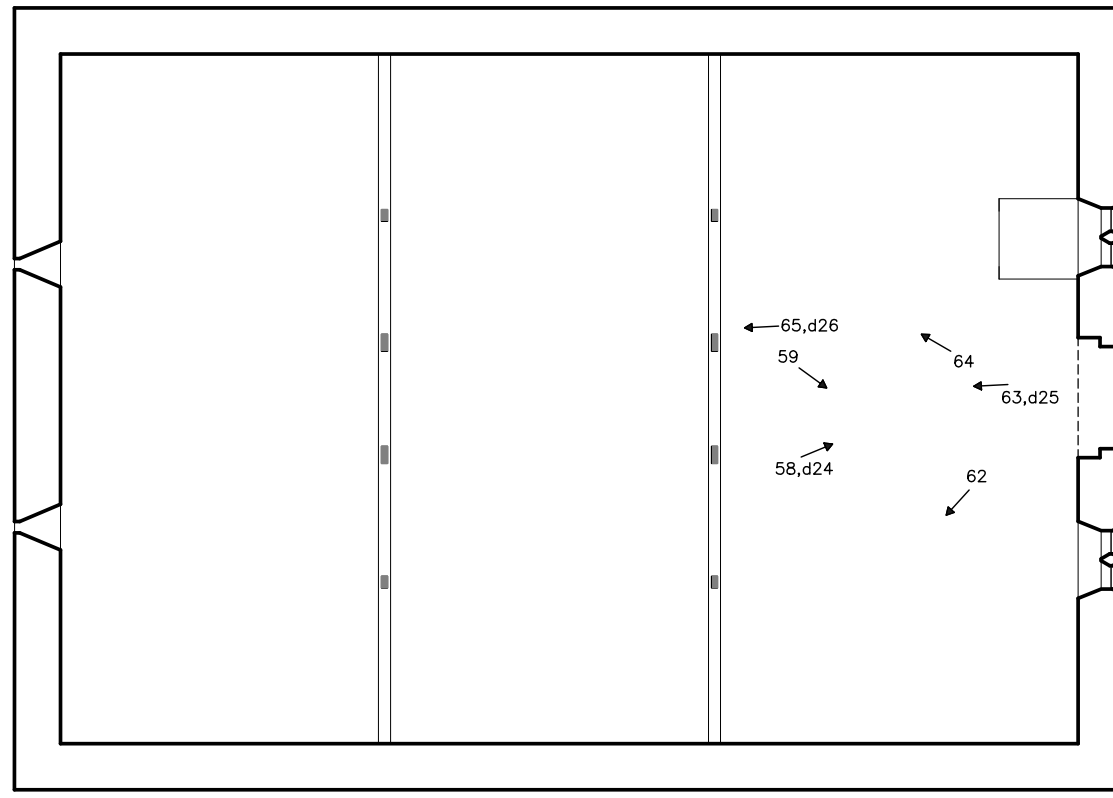
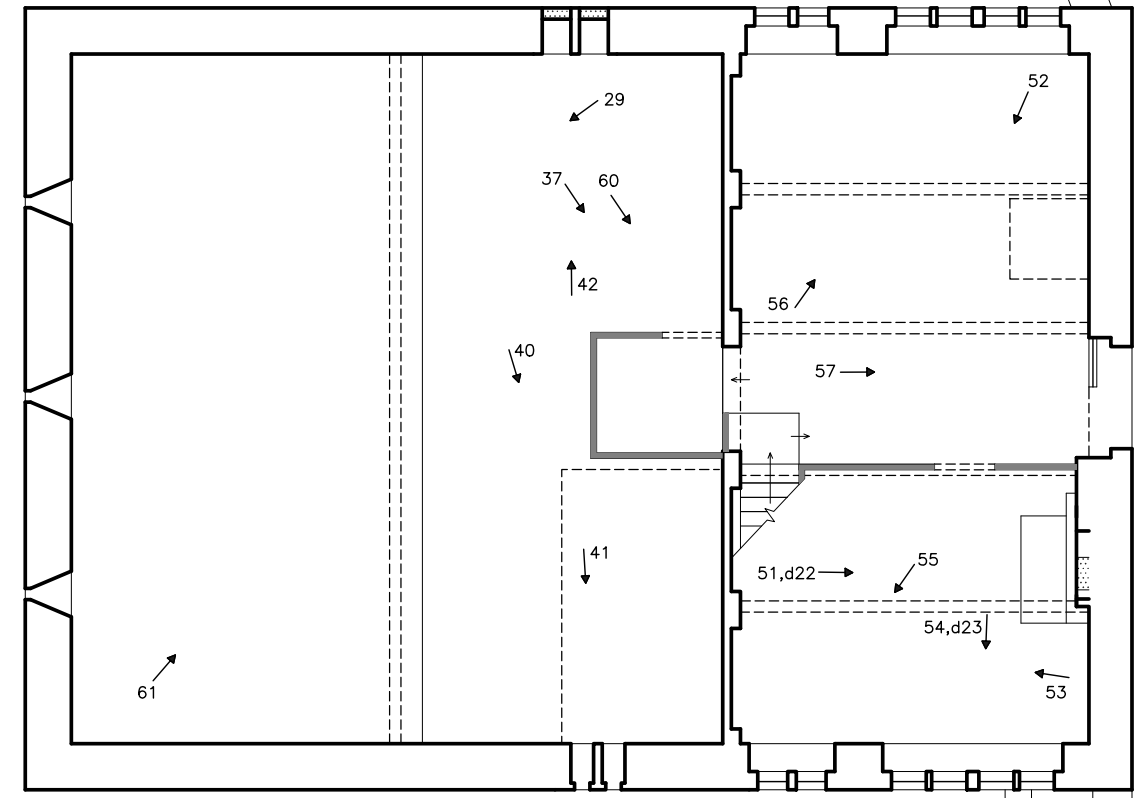
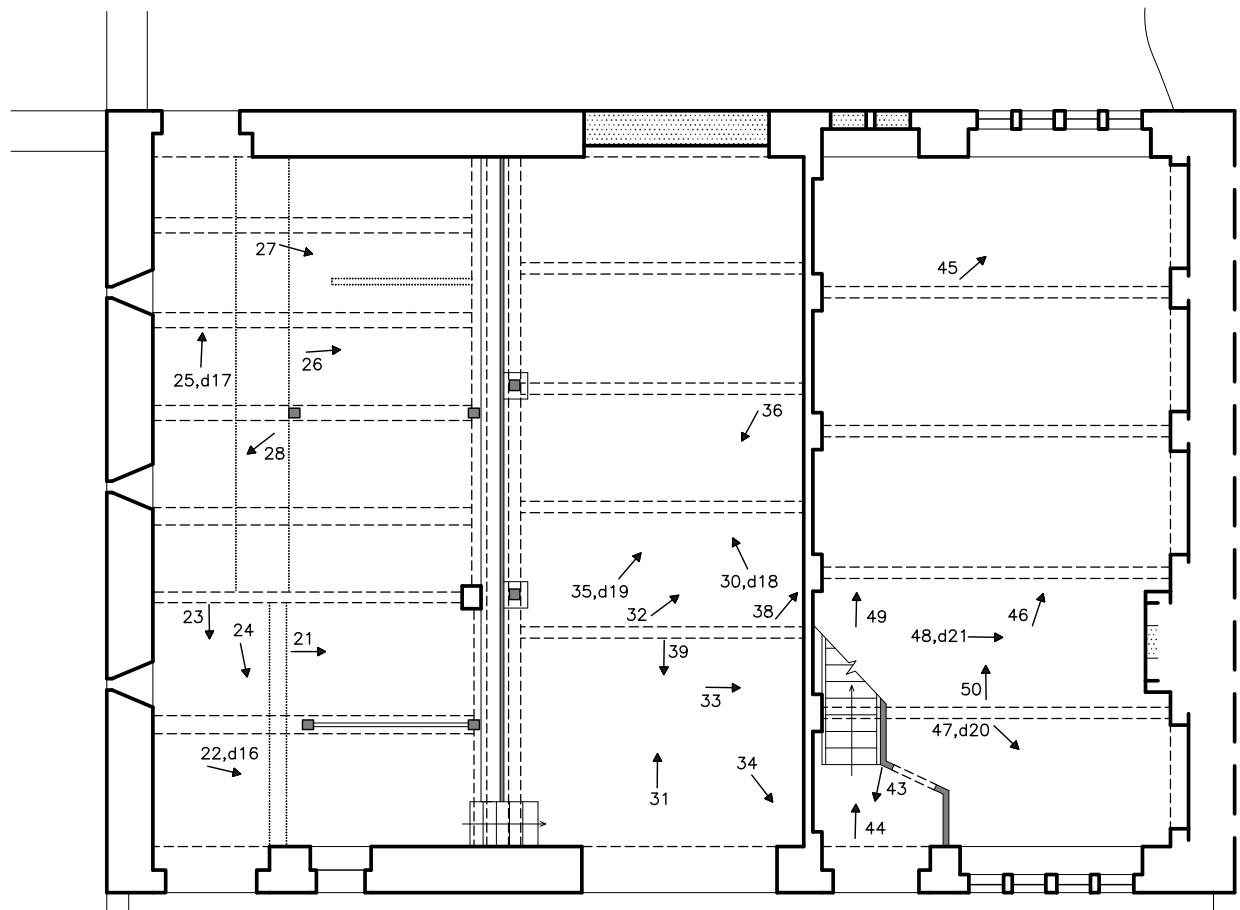
FIGURE 16:
FLOOR PLANS
WITH KEY TO PHOTOGRAPHS

ATTIC LEVEL

FIRST FLOOR

GROUND FLOOR

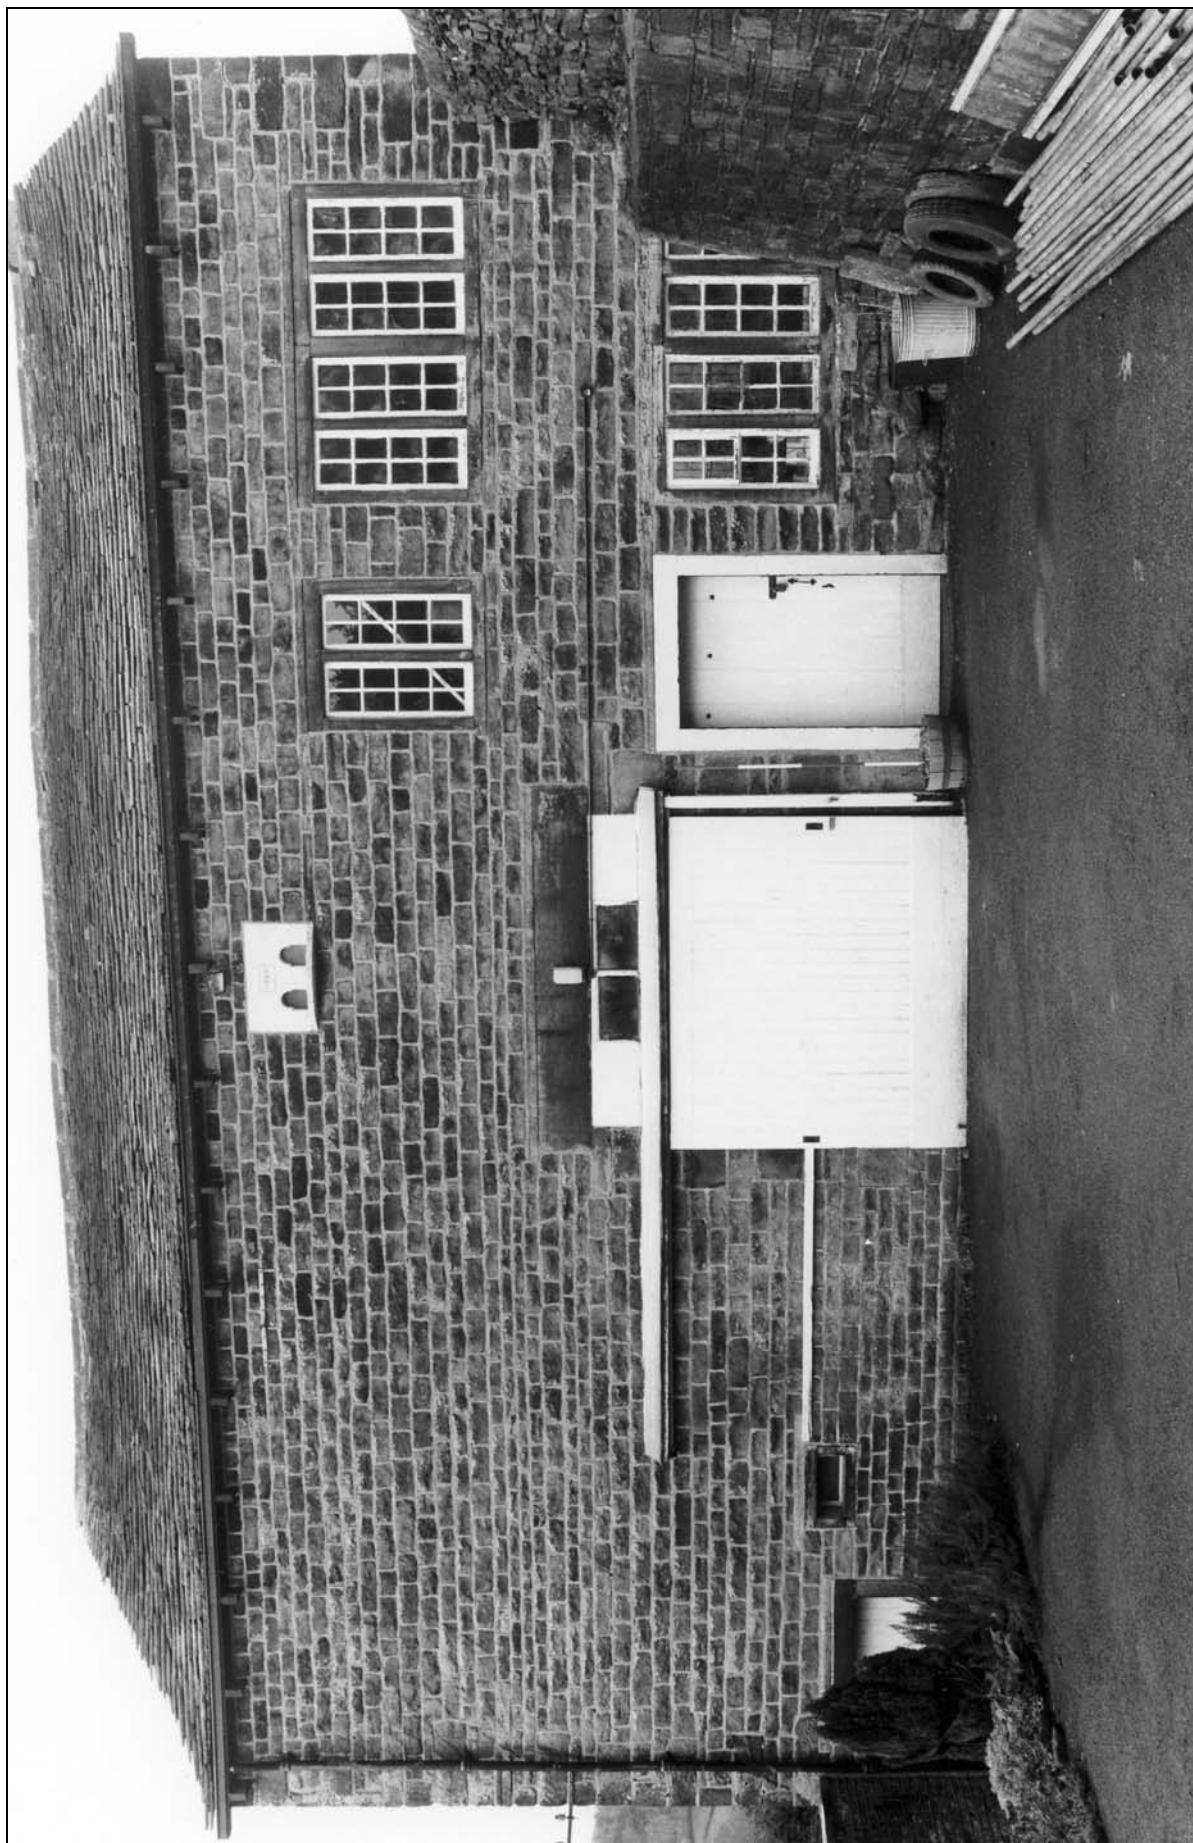
Photo 1: The front (south) elevation (film 1, frame 3)

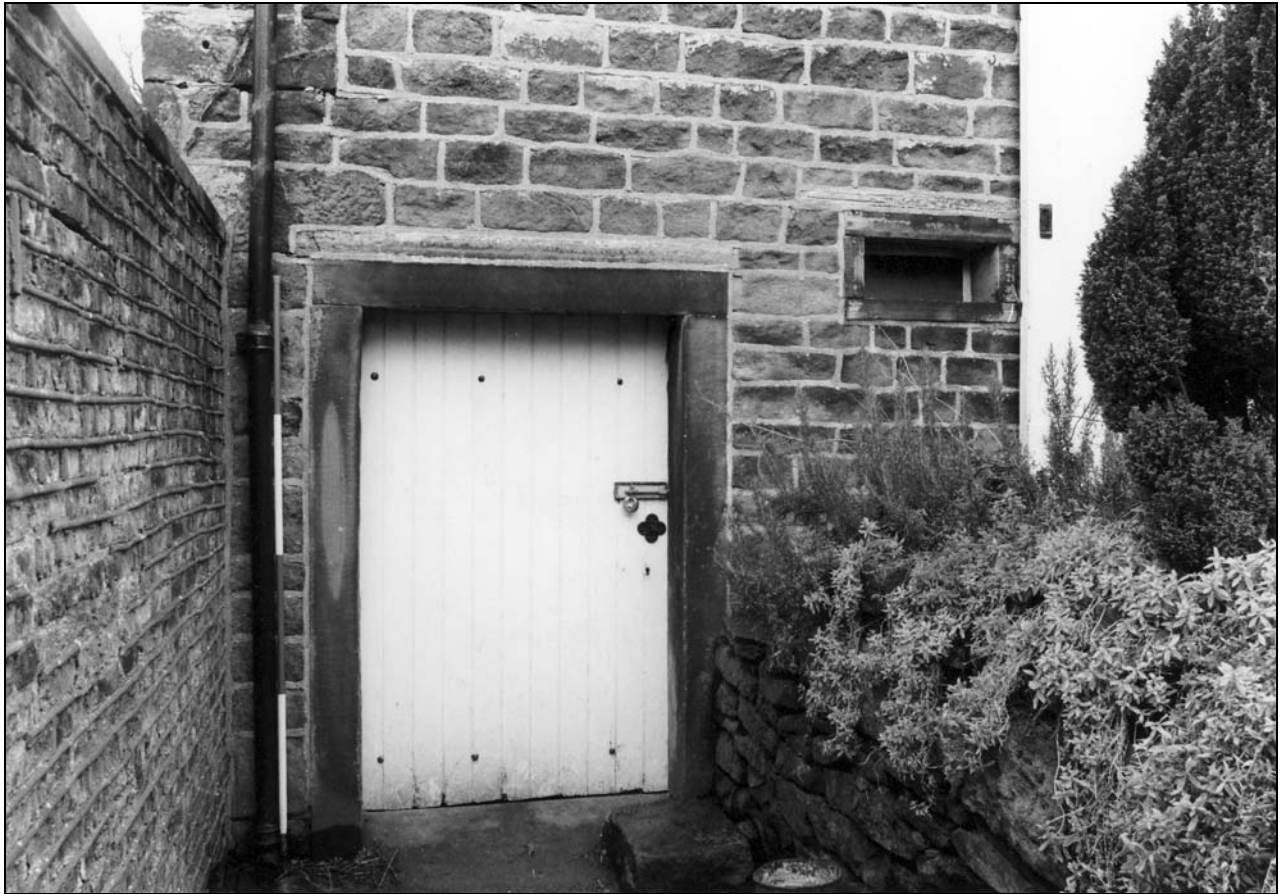
Photo 2: Doorway to stable in west end of front elevation (film 1, frame 8)

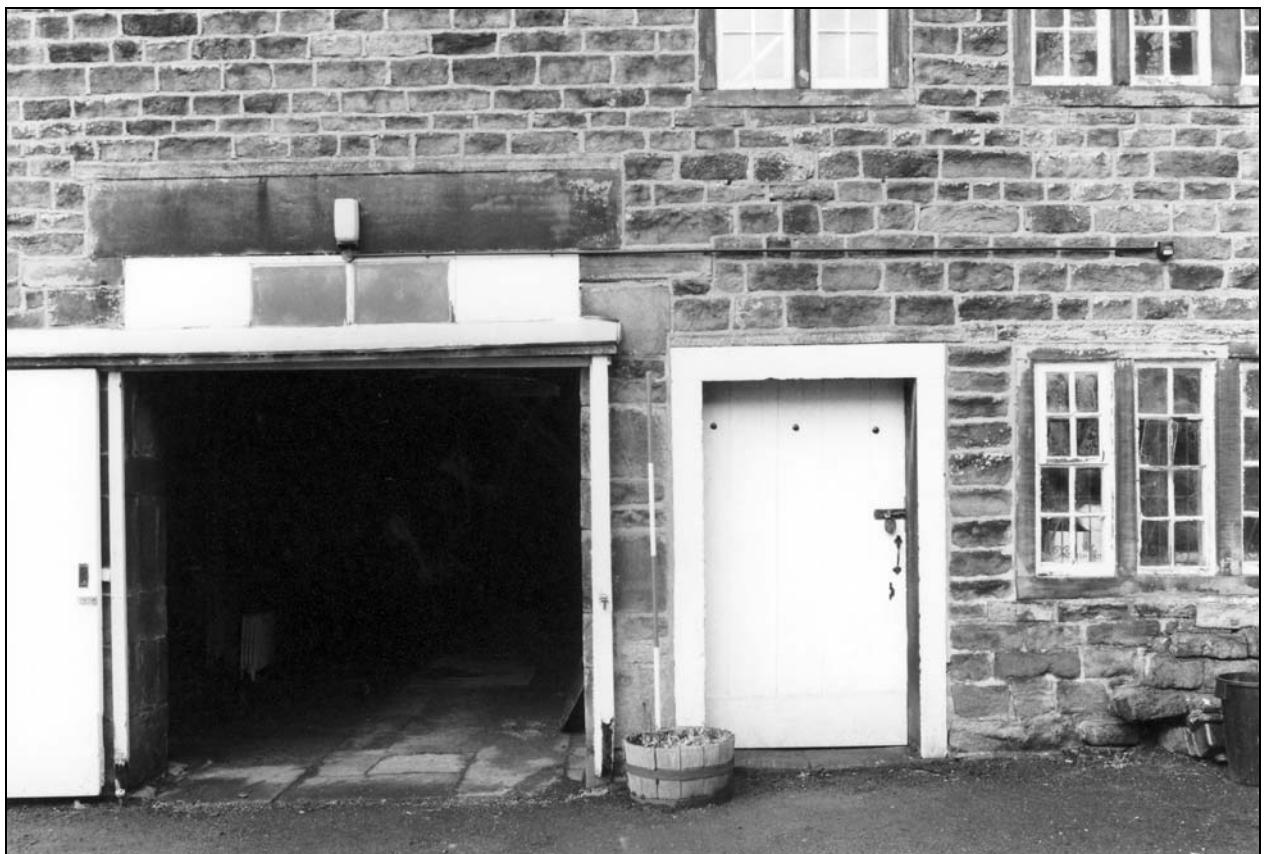
Photo 3: Doorways to central bay and workshop, front elevation (film 1, frame 6)

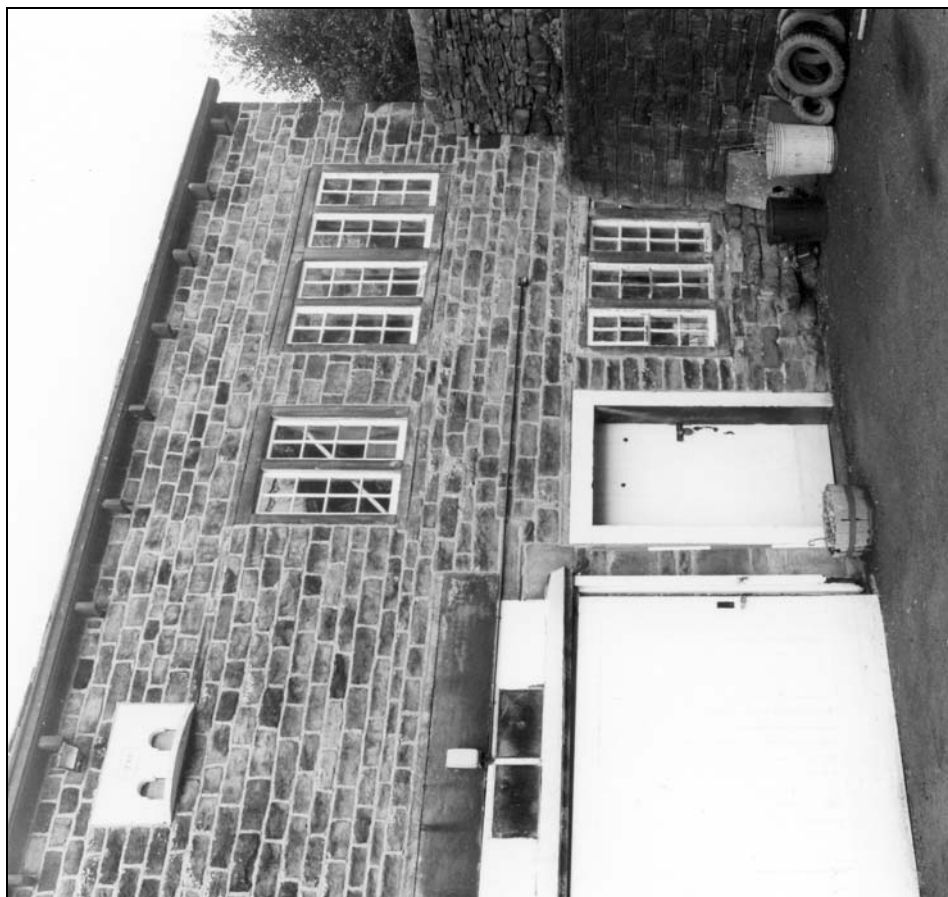
Photo 4: East end of front elevation, containing workshop (film 1, frame 4)

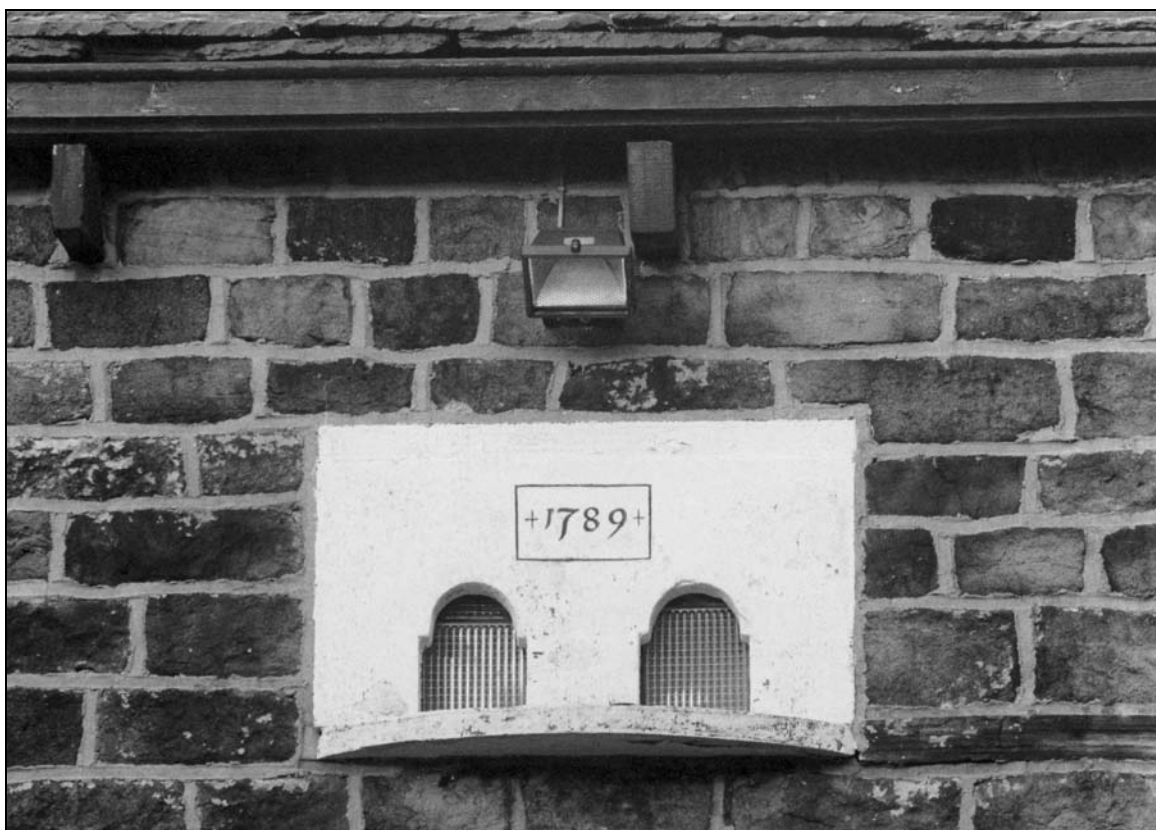
Photo 5: Detail of date-stone and landing ledge to pigeon loft, front elevation (film 1, frame 1)

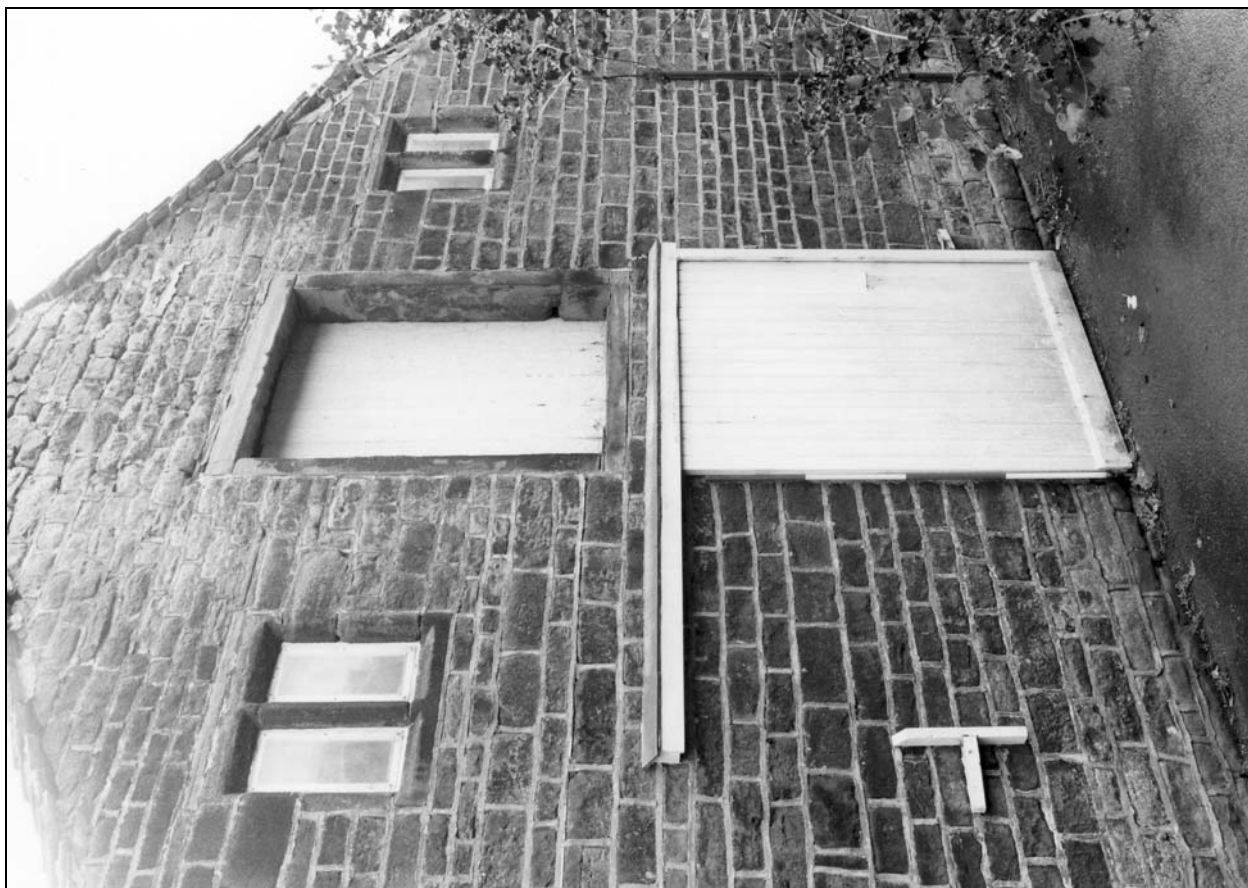
Photo 9: East gable, with doorways to first floor and attic of workshop (film 1, frame 15)

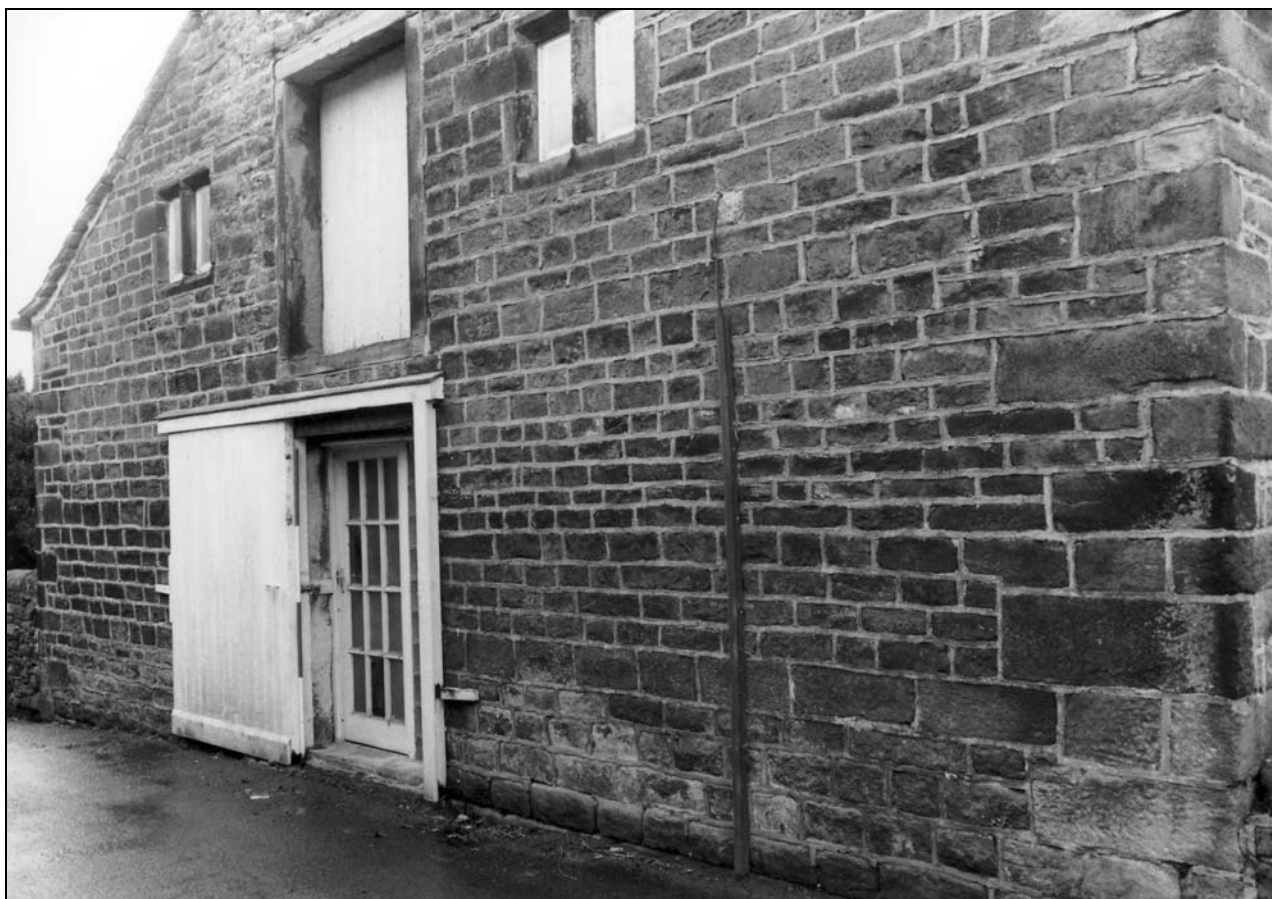
Photo 10: East gable, with doorways to first floor and attic of workshop (film 1, frame 17)

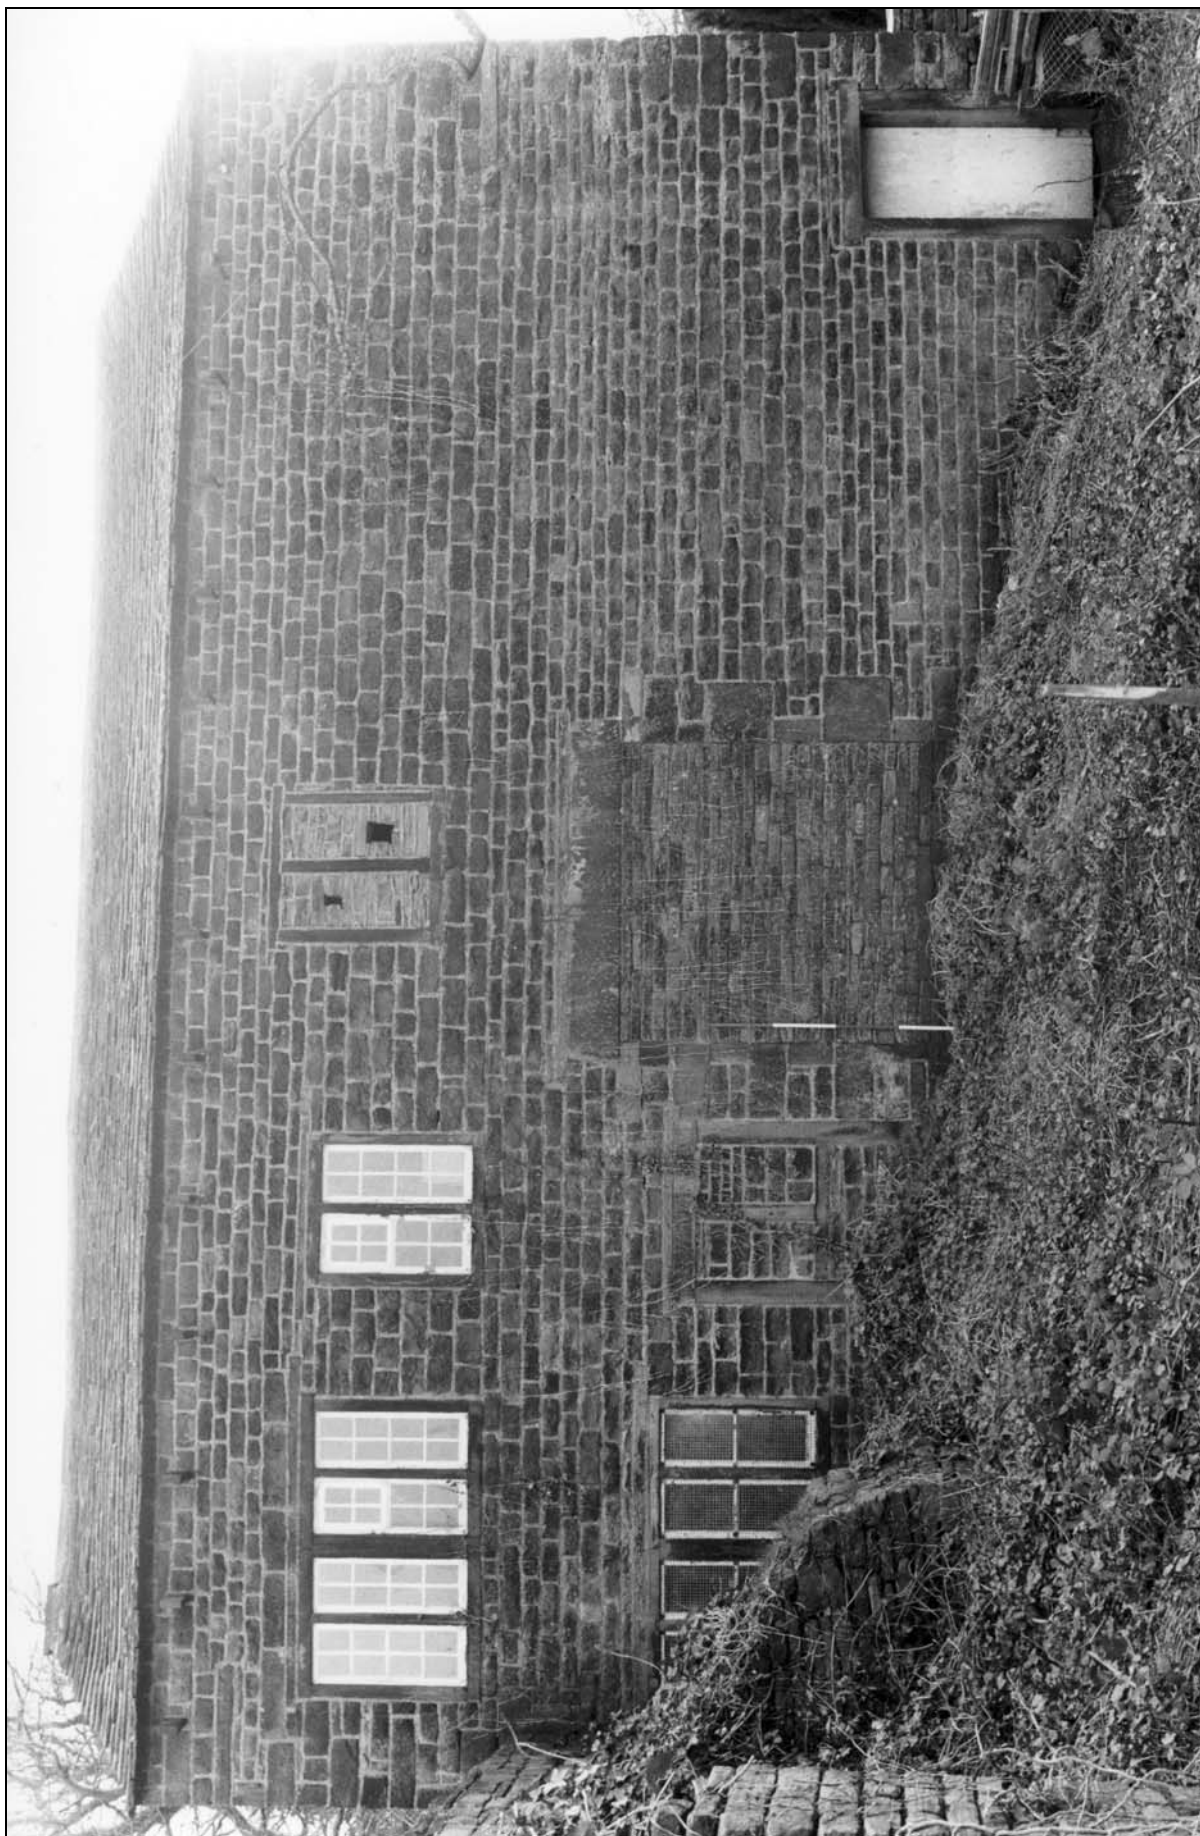
Photo 11: The rear (north) elevation (film 2, frame 2)

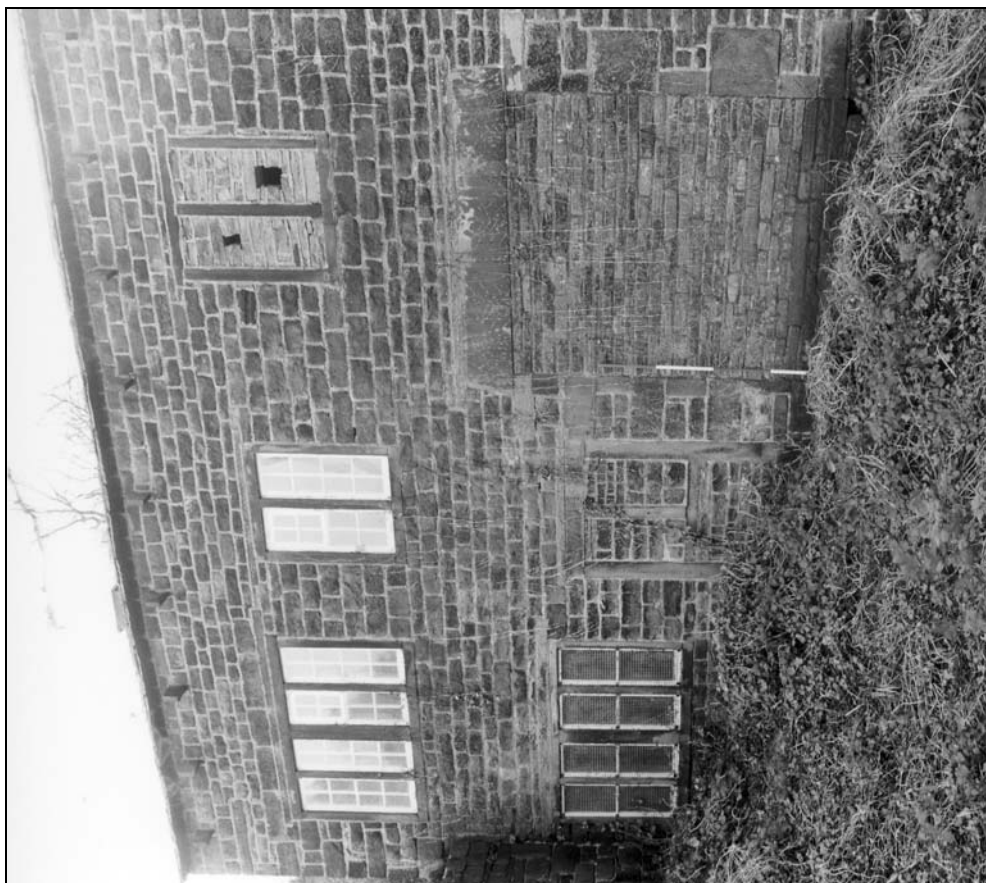
Photo 12: East end of rear (north) elevation (film 2, frame 5)

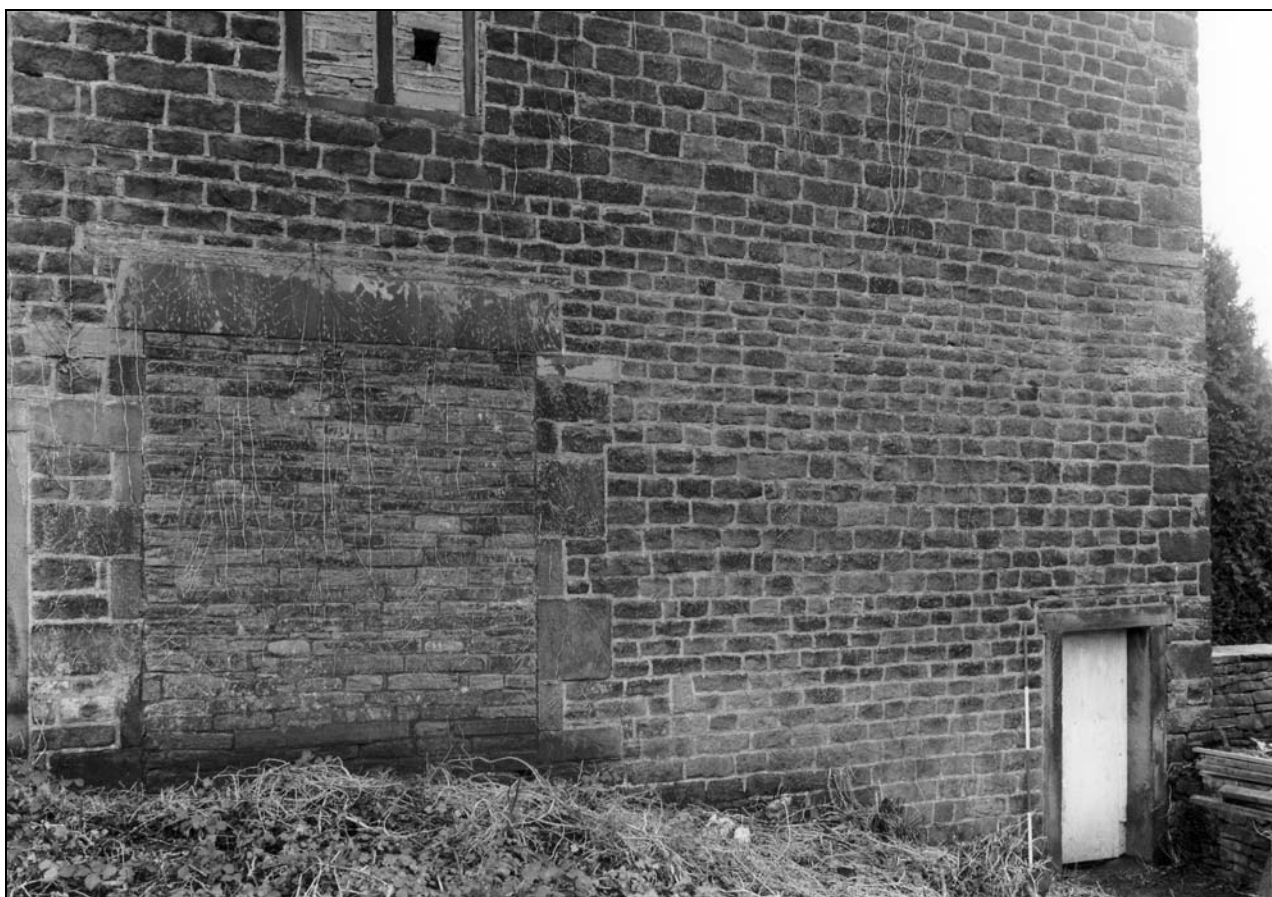
Photo 13: West end of rear (north) elevation (film 2, frame 6)

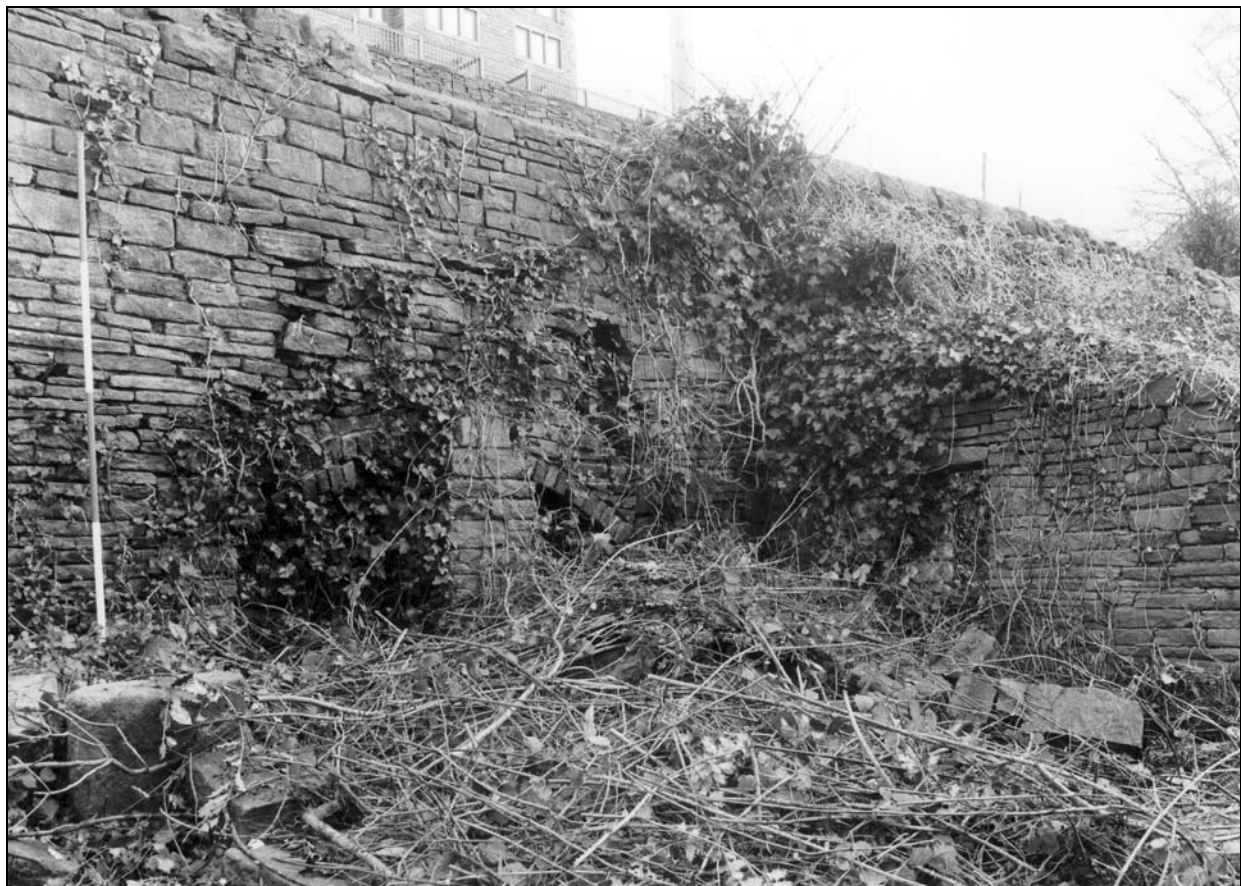
Photo 15: Remains of arch in retaining walls and adjoining buildings, to north of barn (film 2, frame 4)

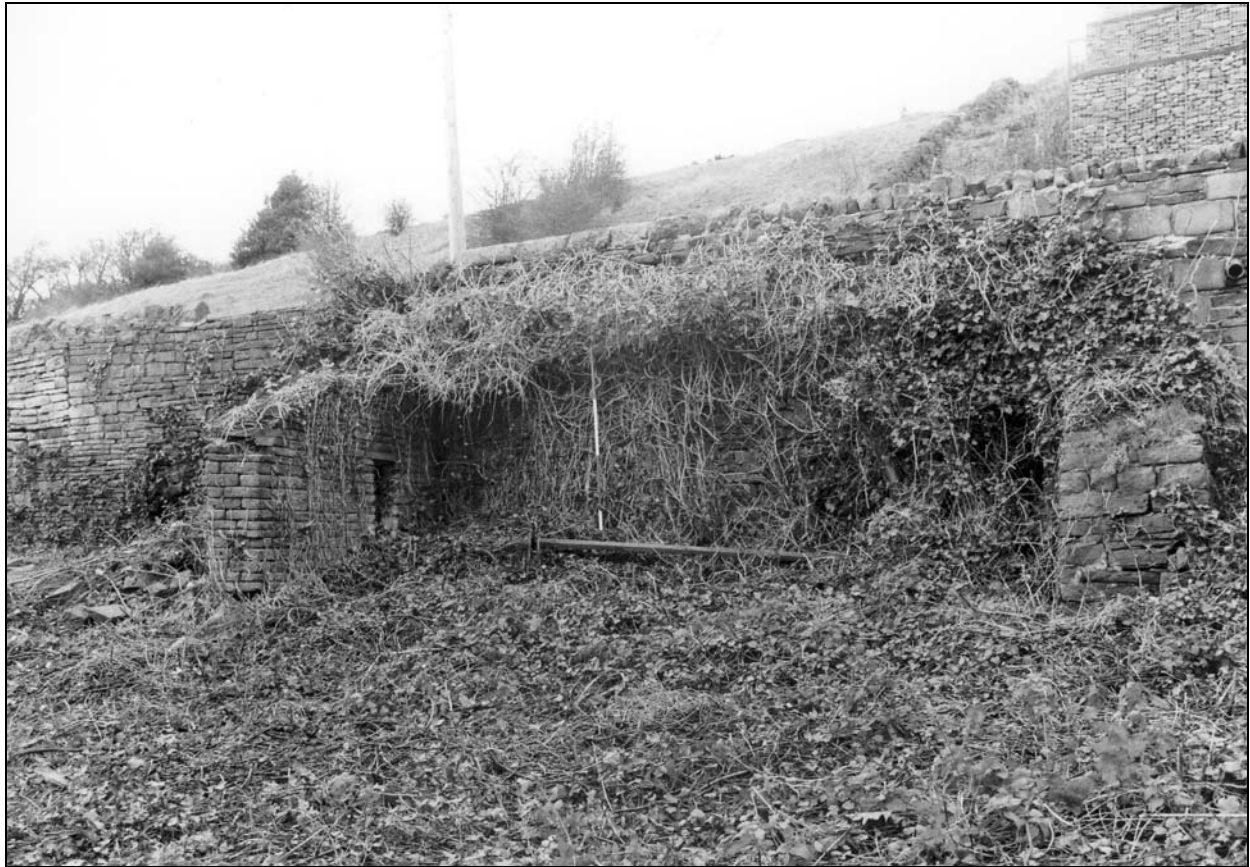
Photo 16: Remains of adjoining buildings, to north of barn (film 2, frame 7)

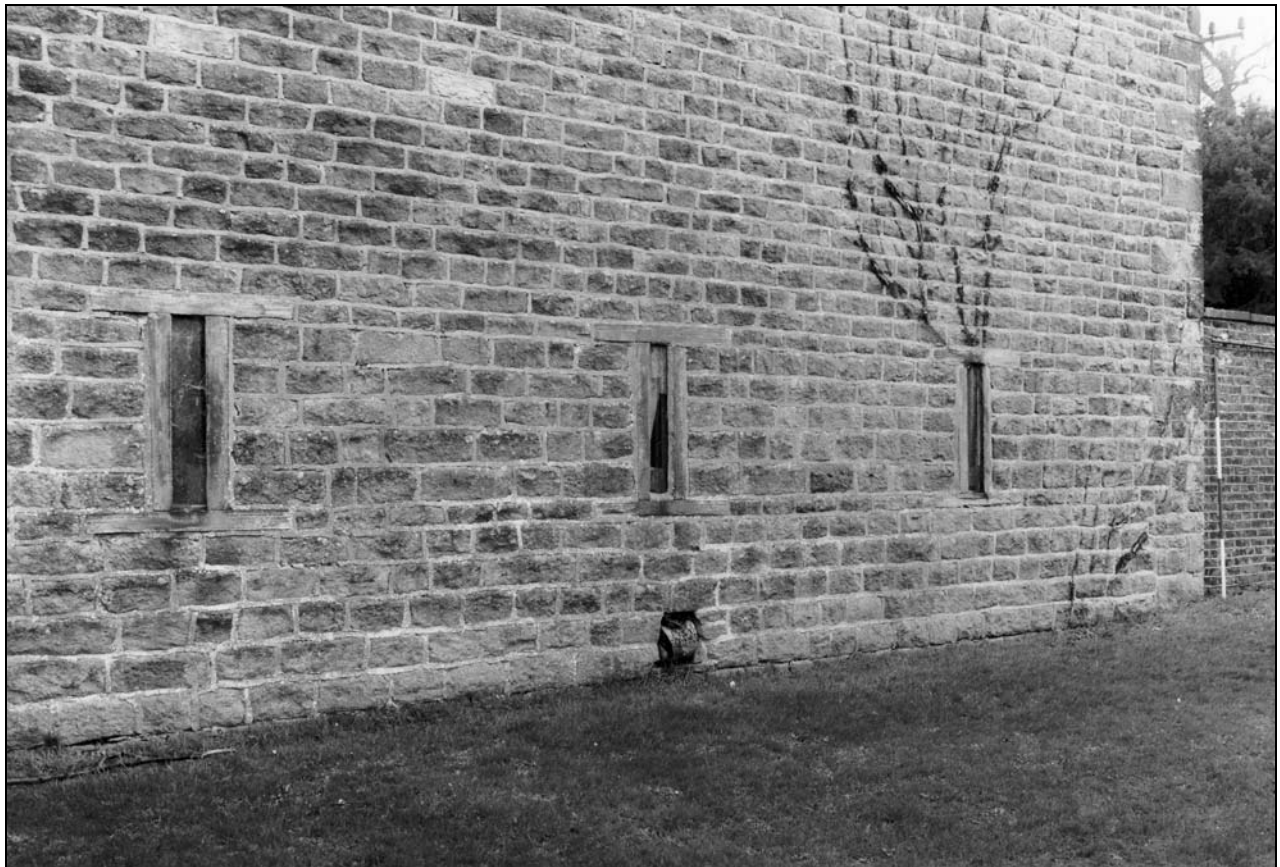
Photo 17: Detail of breathers at foot of west gable (film 1, frame 10)

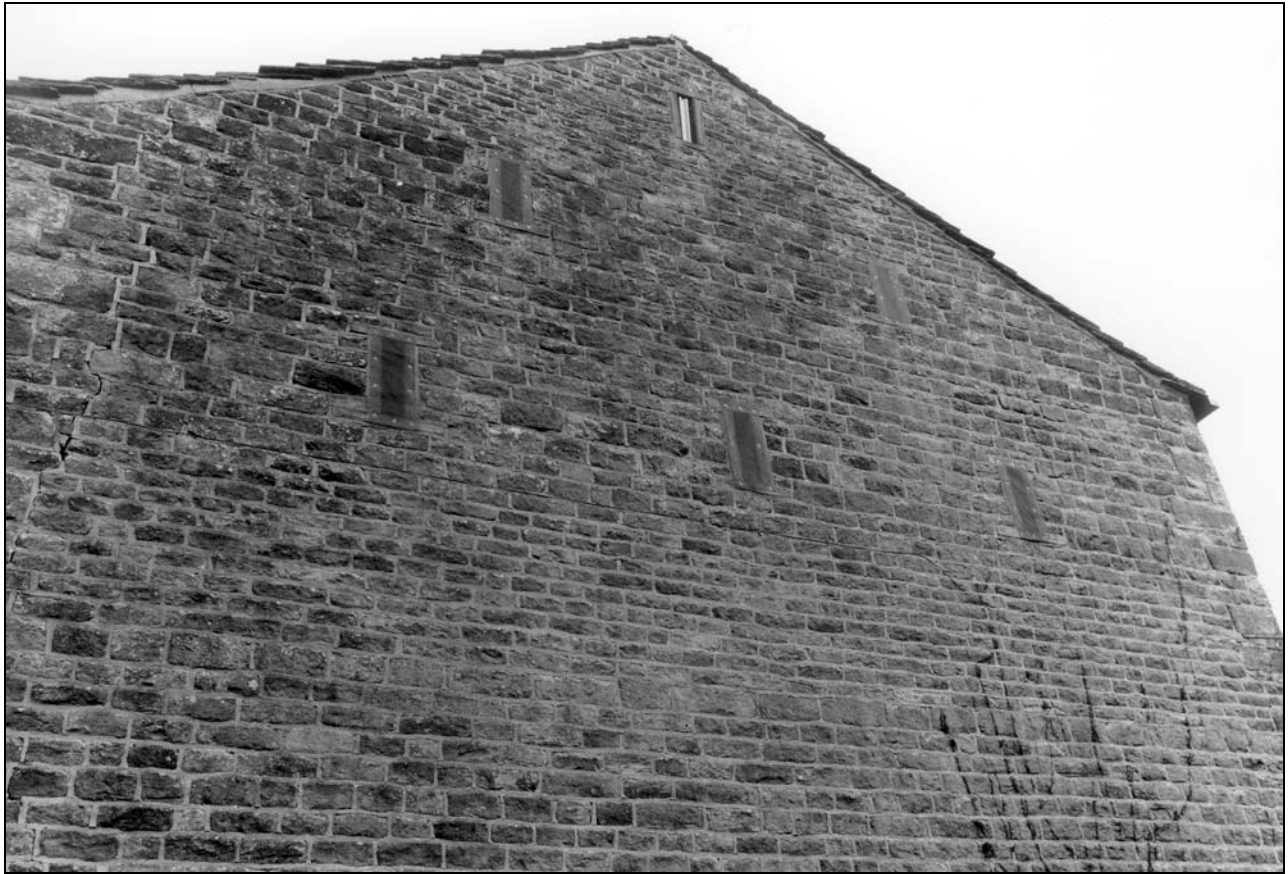
Photo 18: Detail of high level breathers in west gable (film 1, frame 11)
