Barn at Cooper House
Magson House Road, Luddenden Foot, West Yorkshire:
Historic Building Record

STEPHEN HAIGH

B u i l d i n g s A r c h a e o l o g i s t

OASIS project ID: stephenh1-198738

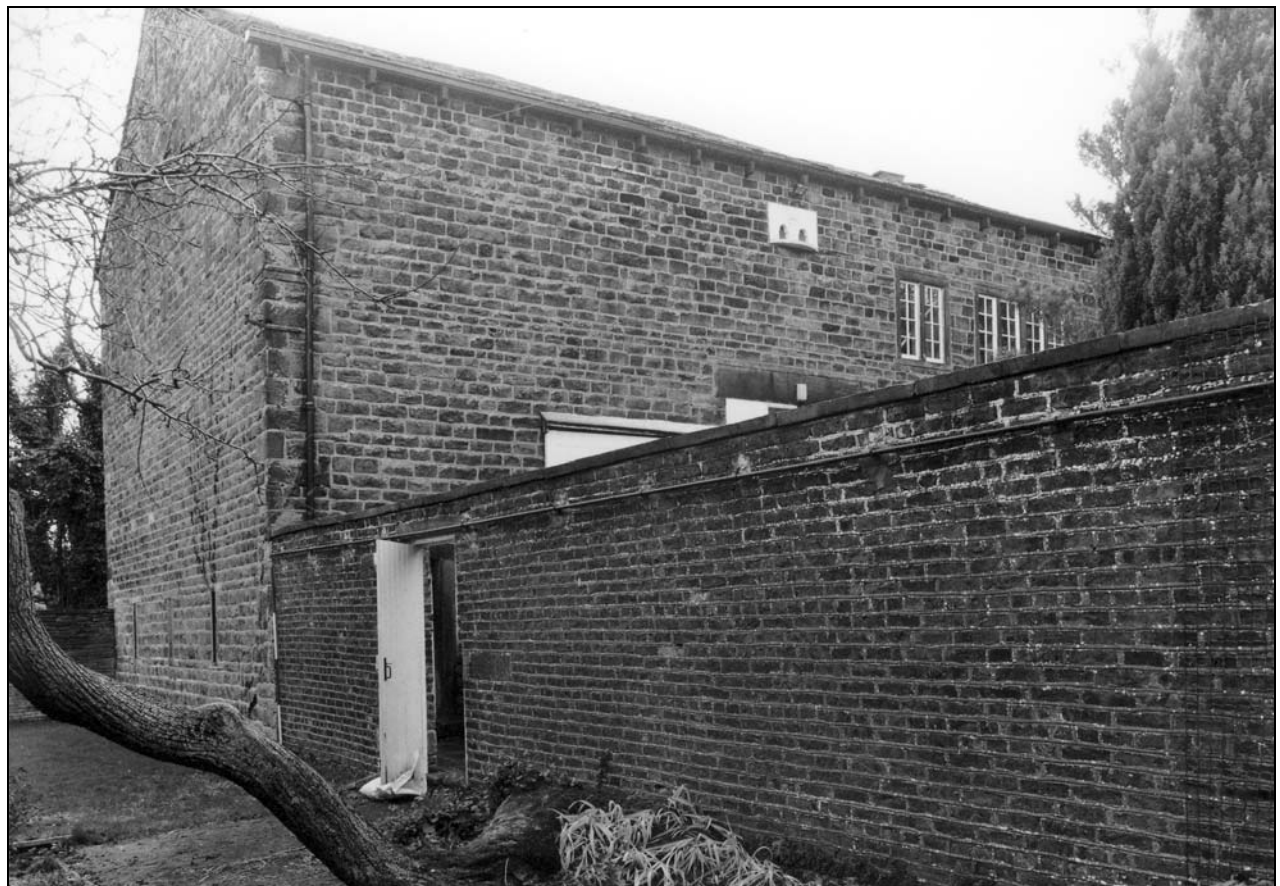
Photo 19: General view from the south-west, showing adjoining garden wall (film 1, frame 9)

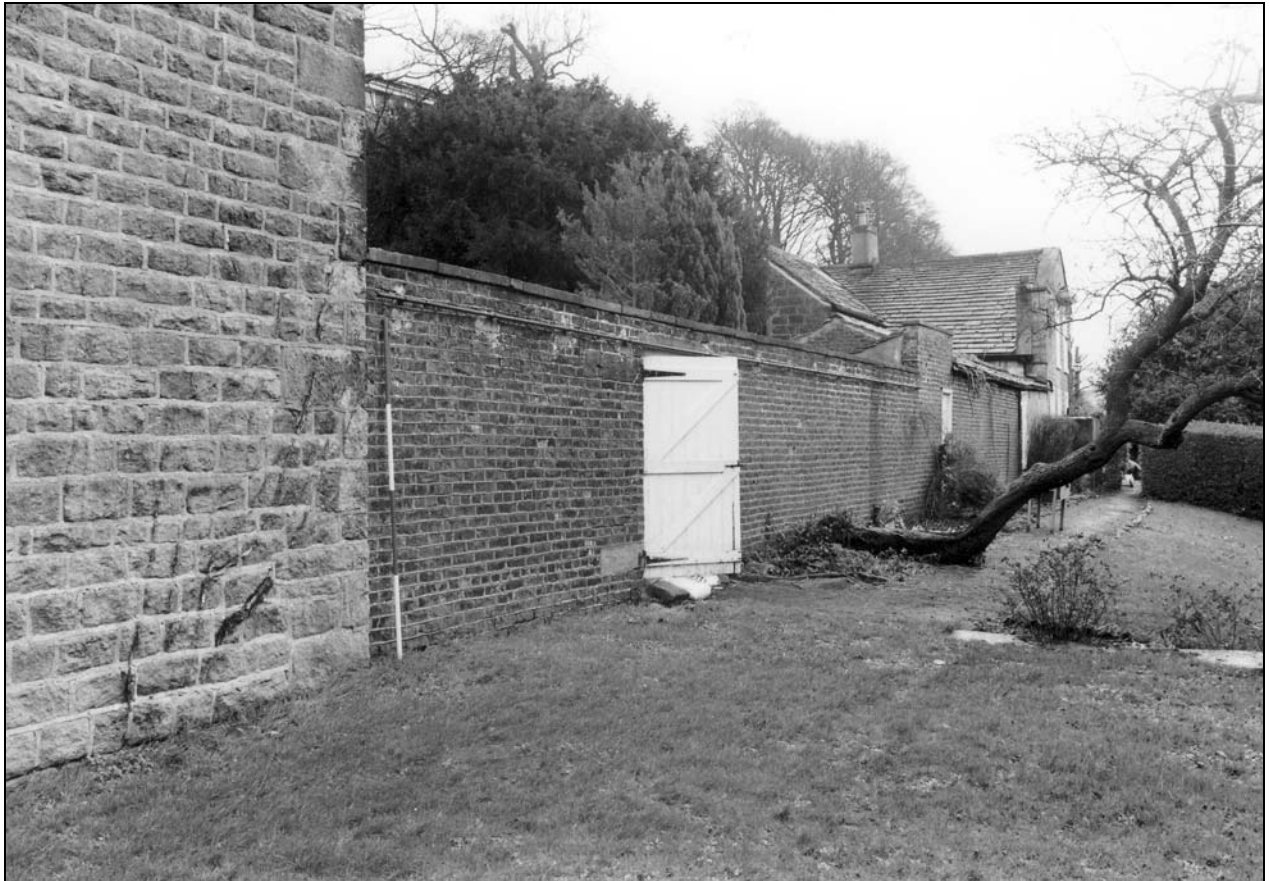
Photo 20: View towards garden wall and Cooper House, from the north-west (film 1, frame 12)

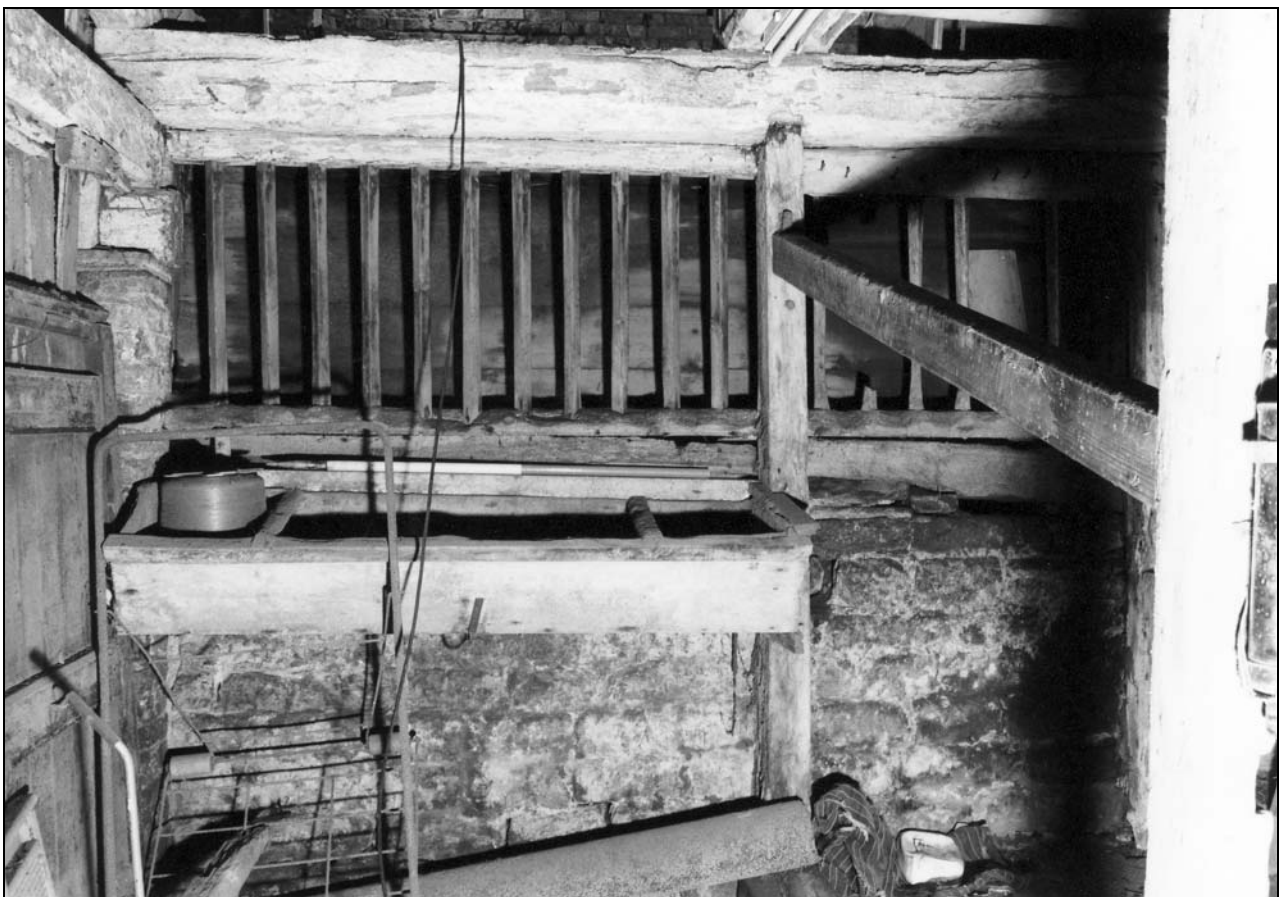
Photo 21: Stable within south-west corner of barn, from the west (film 2, frame 15)

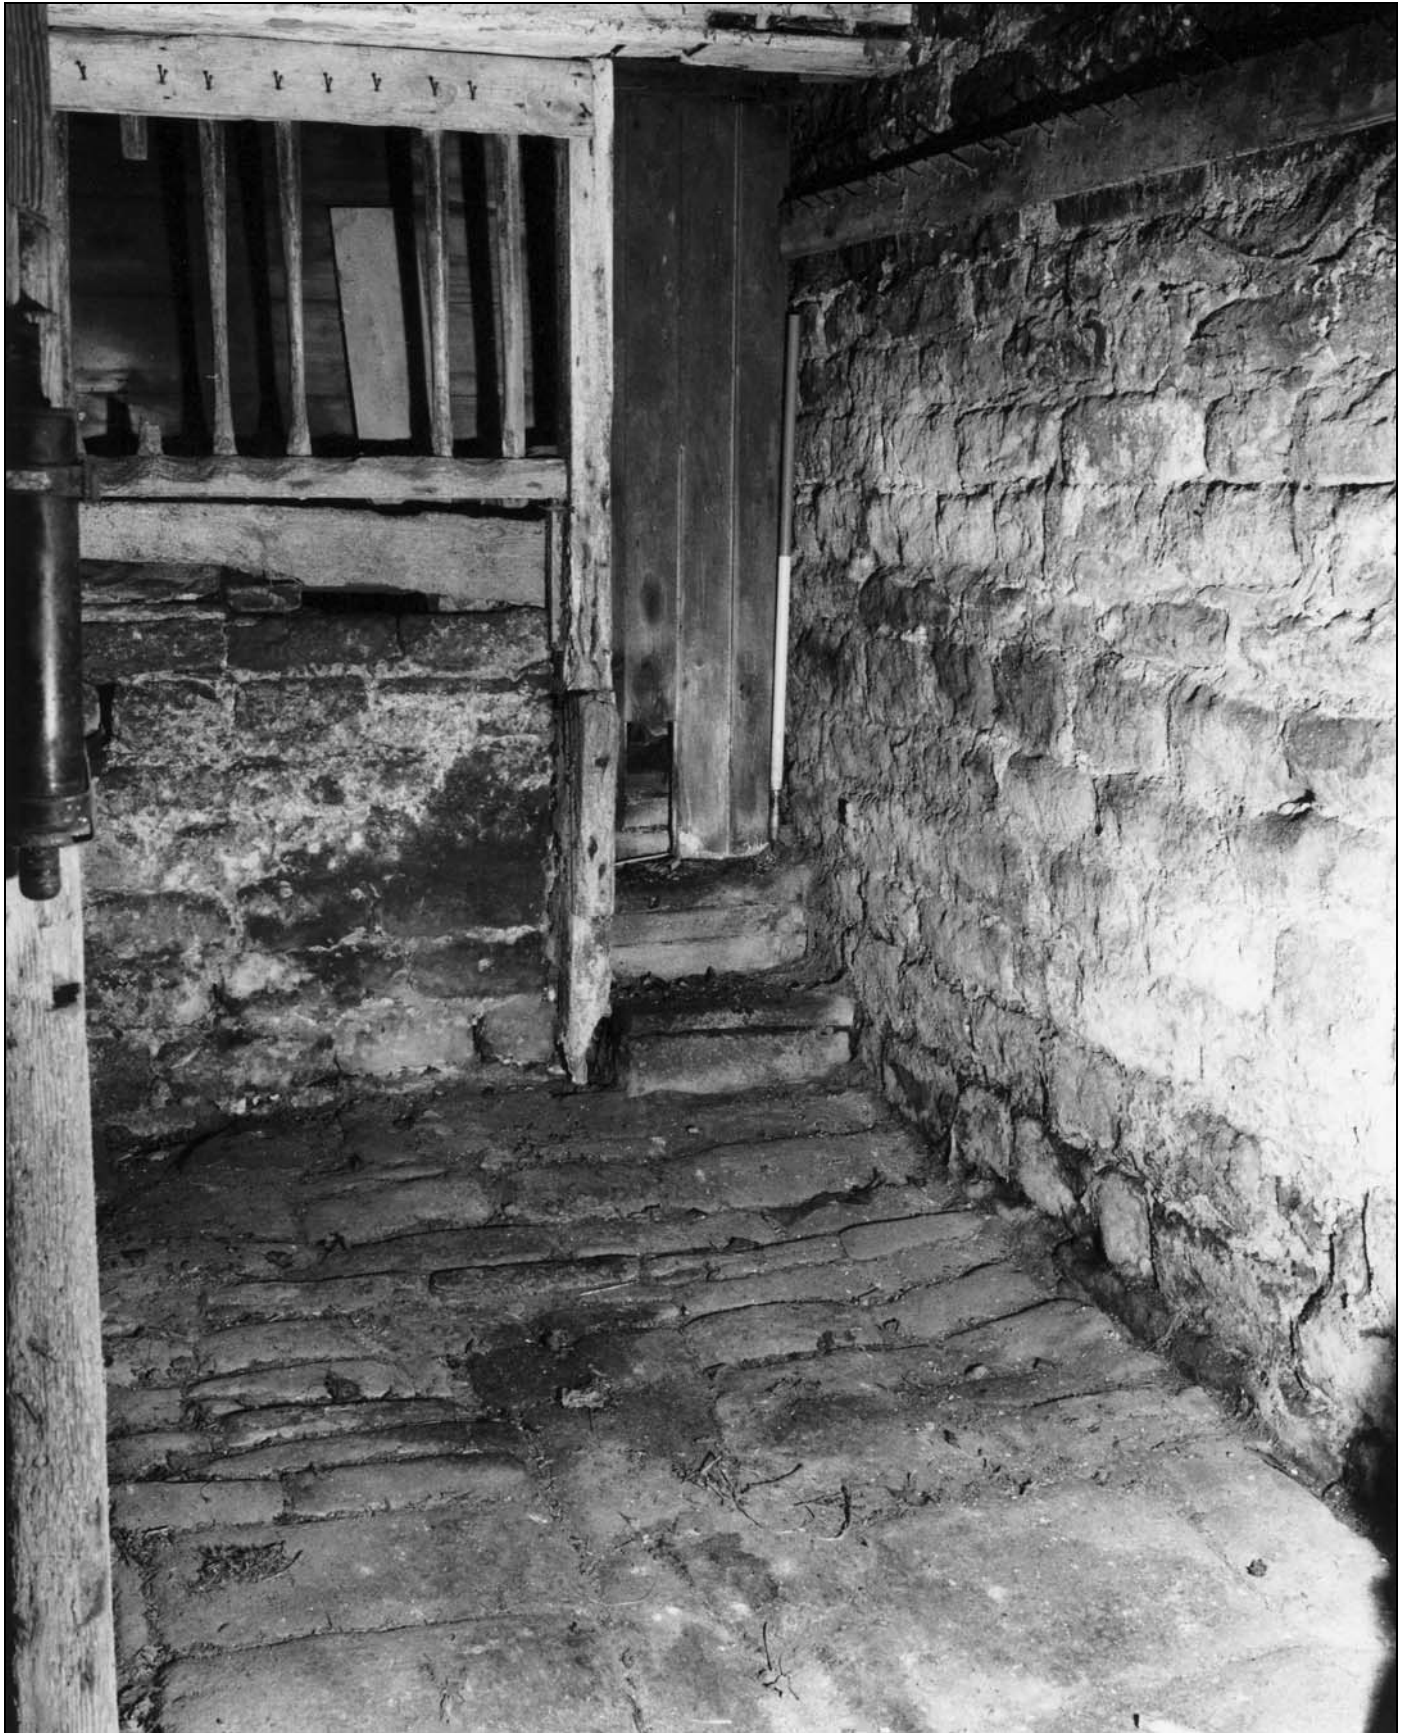
Photo 22: Stable within south-west corner of barn, from the west (film 2, frame 16)

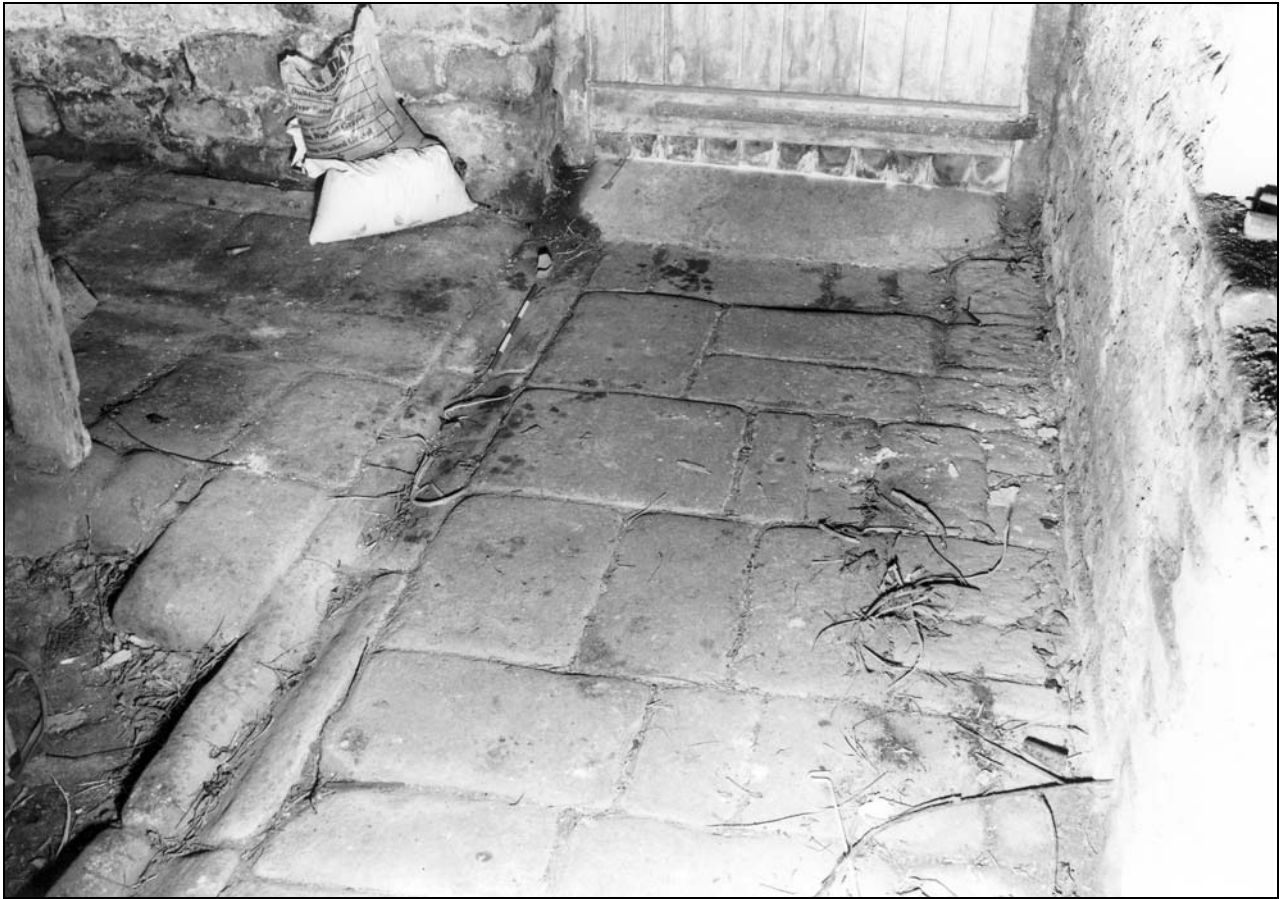
Photo 23: Detail of floor to passage with drain, in stable (film 2, frame 18)

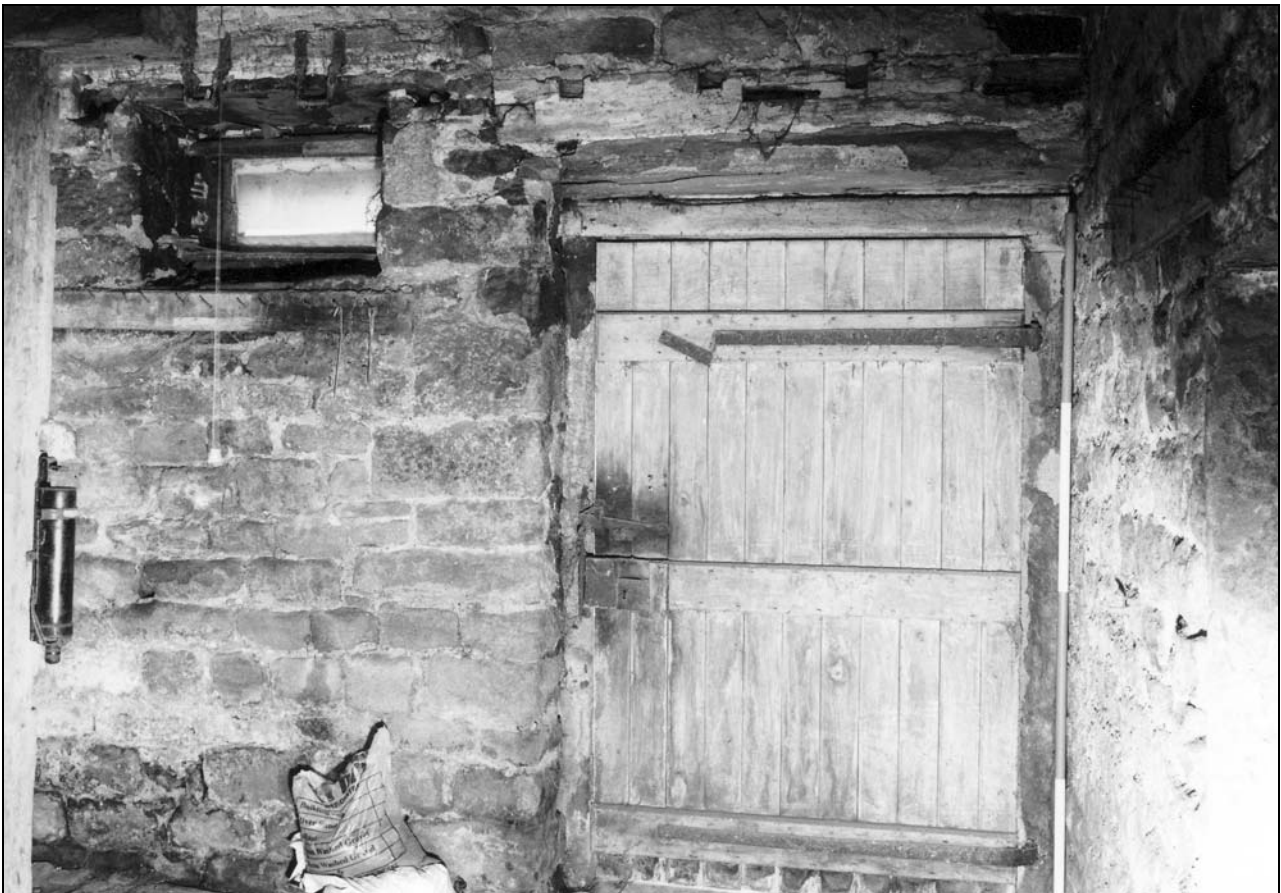
Photo 24: Internal view of doorway and window to stable, from the north (film 2, frame 17)

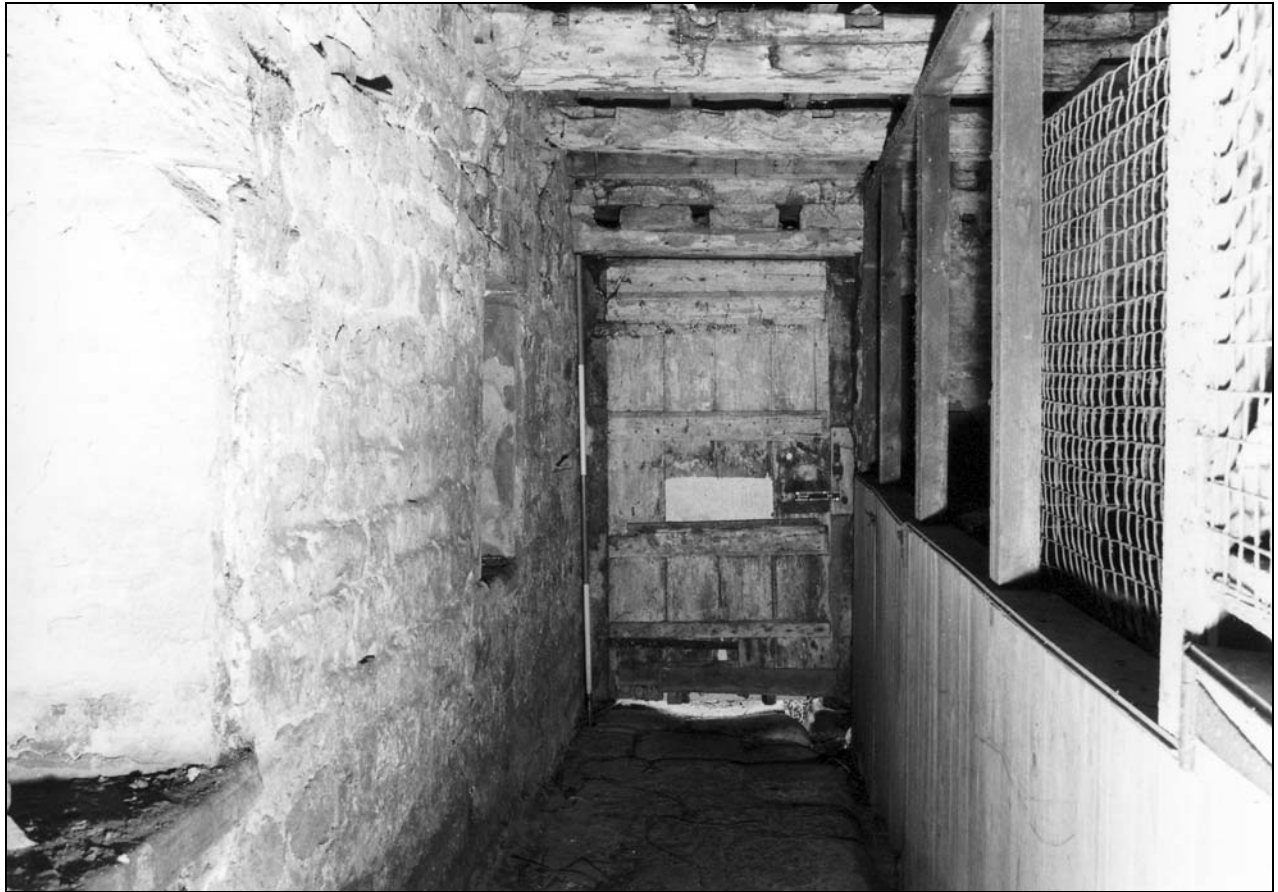
Photo 25: Passage in stable/shippon, from the south (film 2, frame 10)

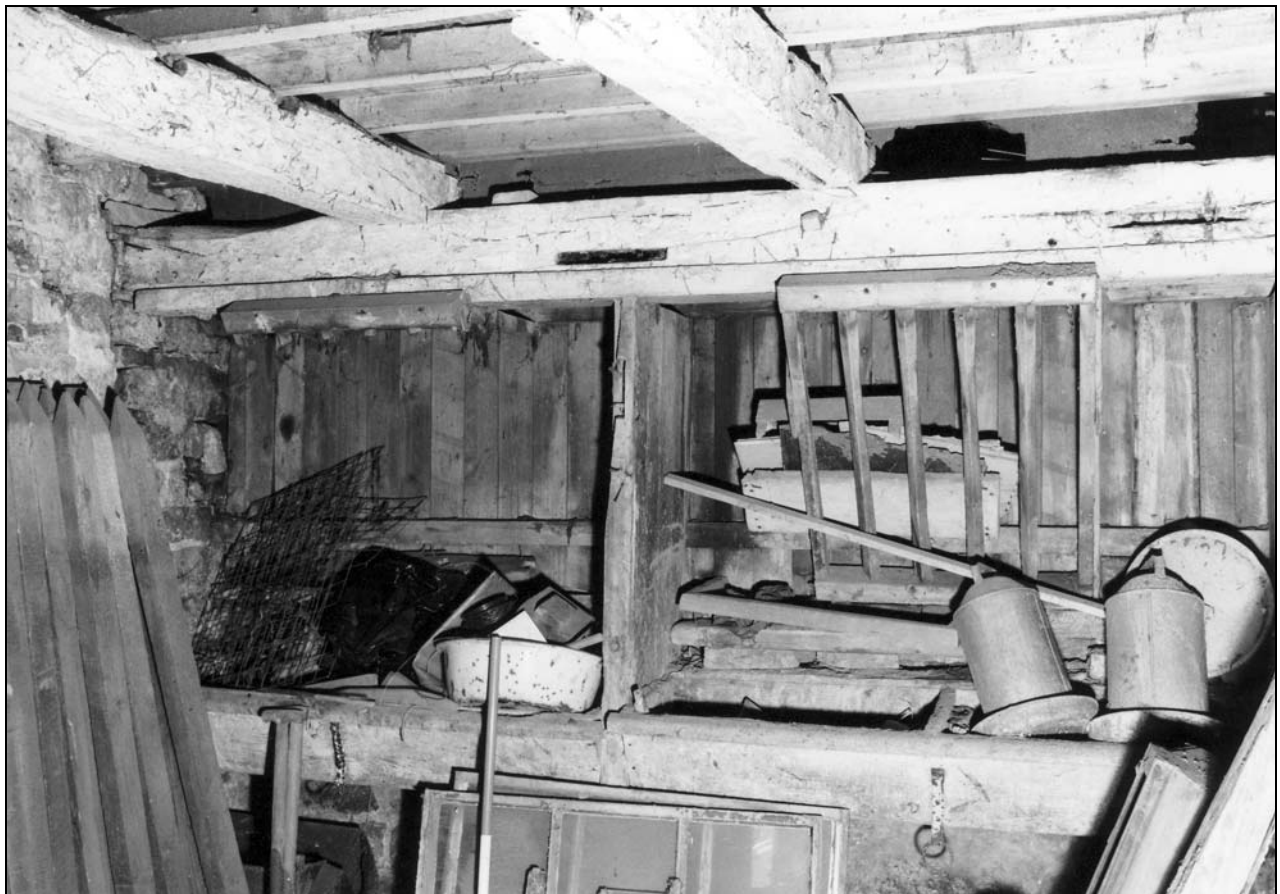
Photo 26: Stable fixtures in former shippon, from the west, with raised loft beams overhead (film 2, frame 11)

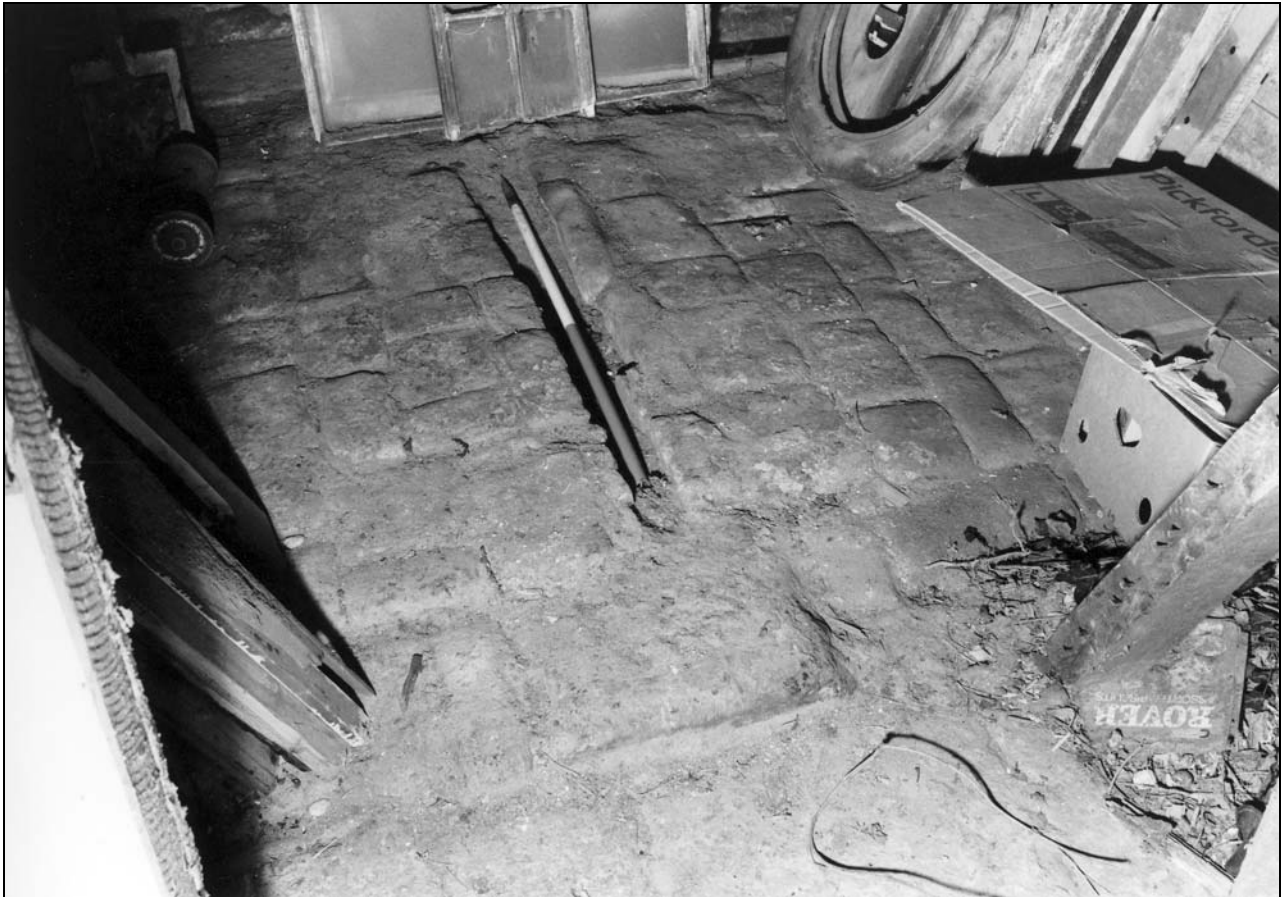
Photo 27: Detail of floor in former shippon, from the west (film 2, frame 13)

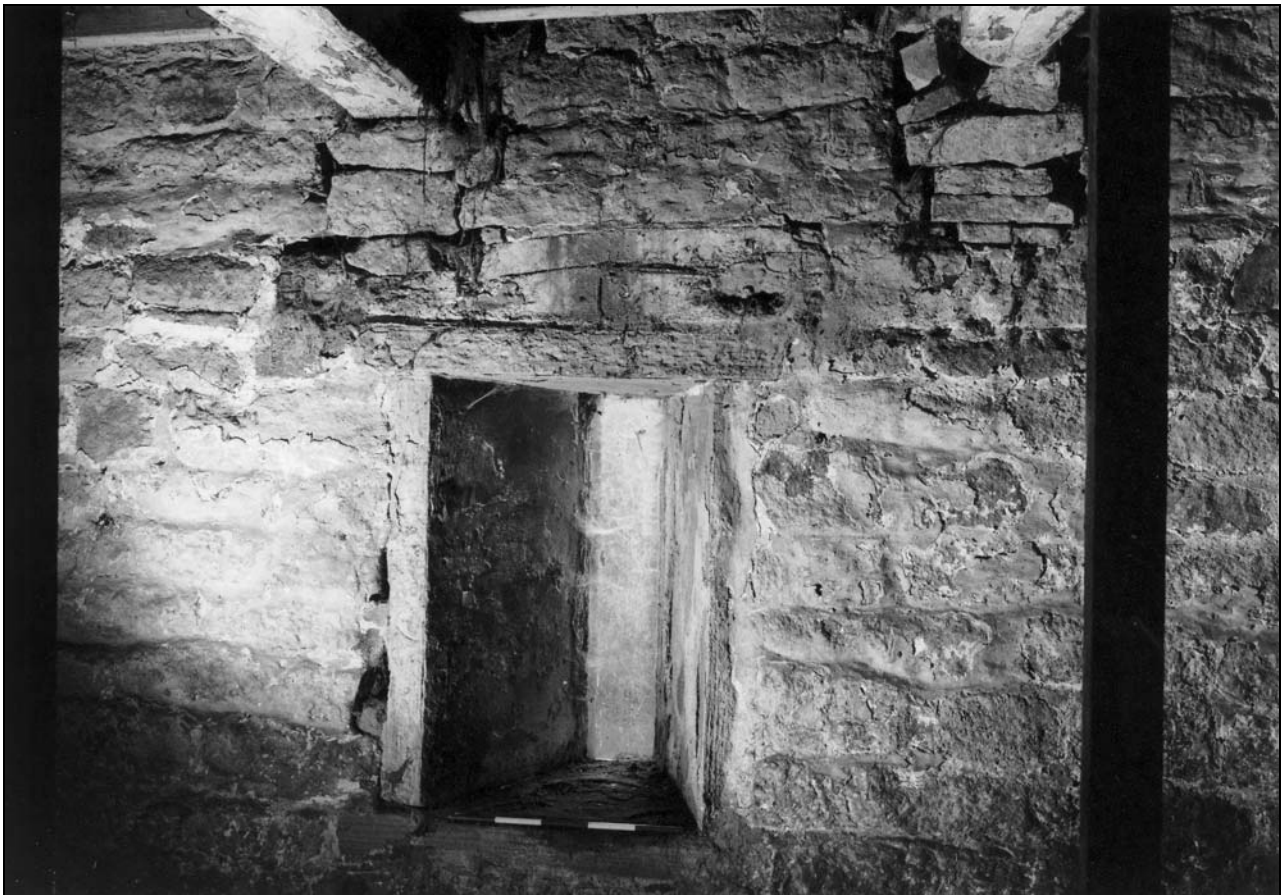
Photo 28: Internal view of breather in west side of stable, with raised loft beams above (film 2, frame 12)

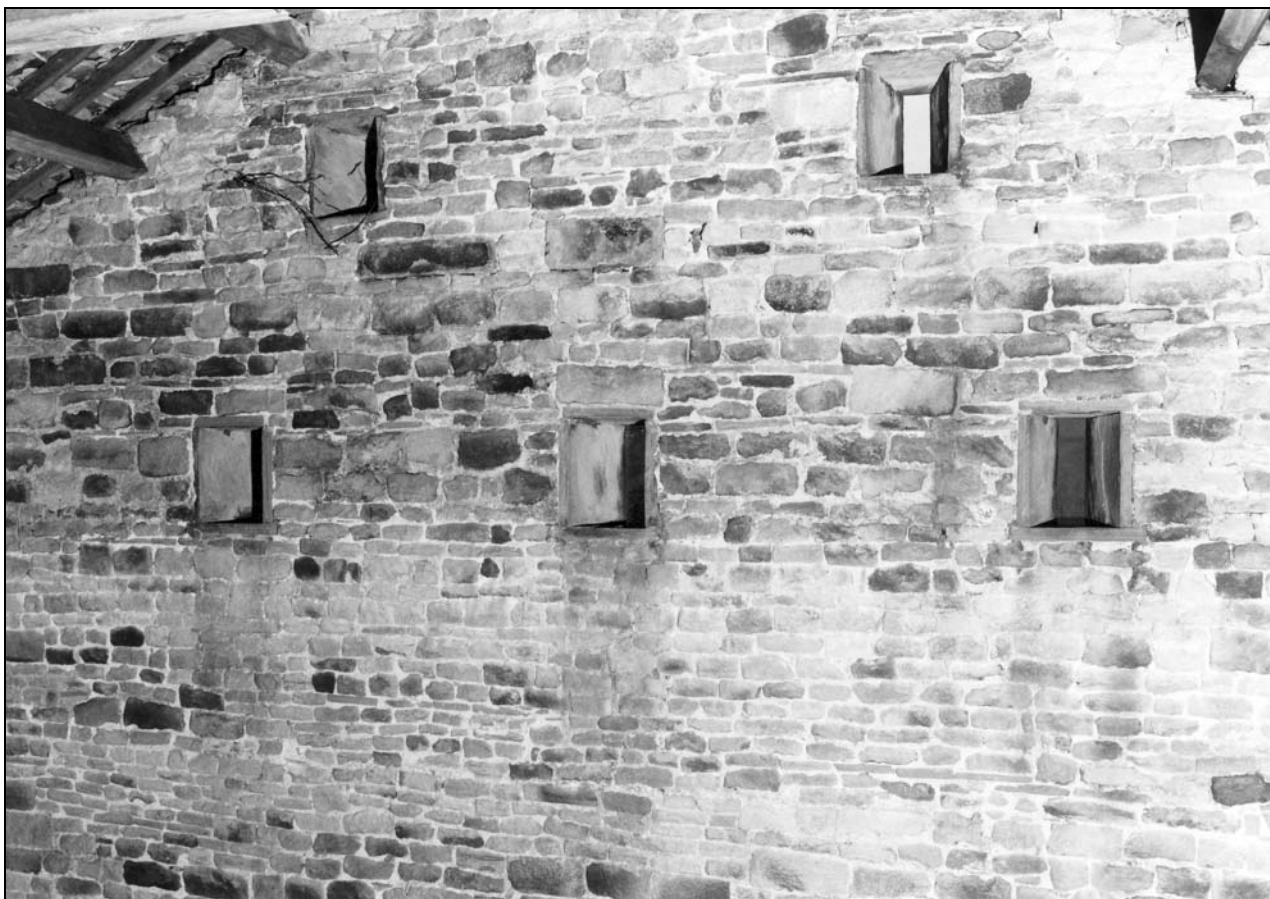
Photo 29: Internal view of west gable at upper level (film 3, frame 13)

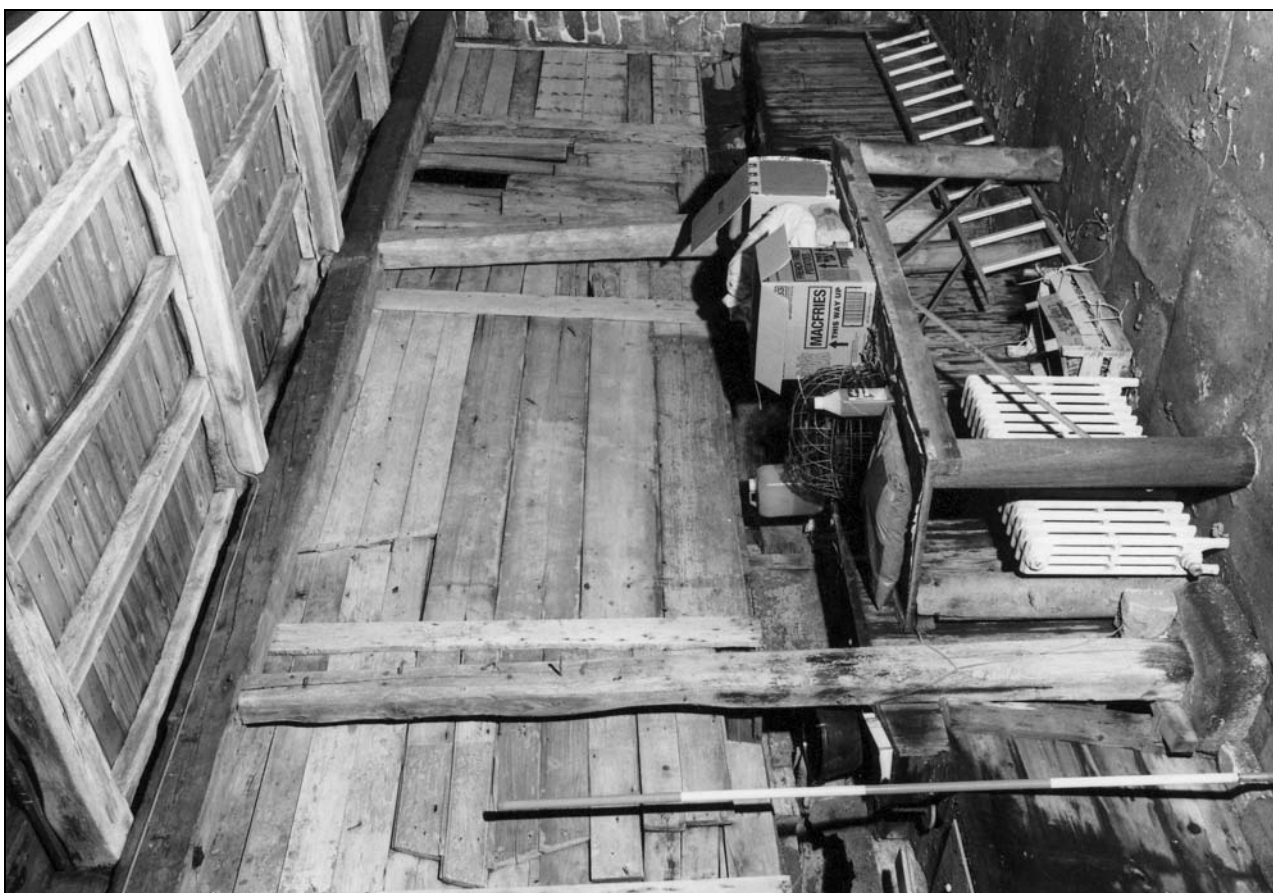
Photo 30: Secondary timber partition between central bay and stable/shippon, from the south-east (film 3, frame 6)

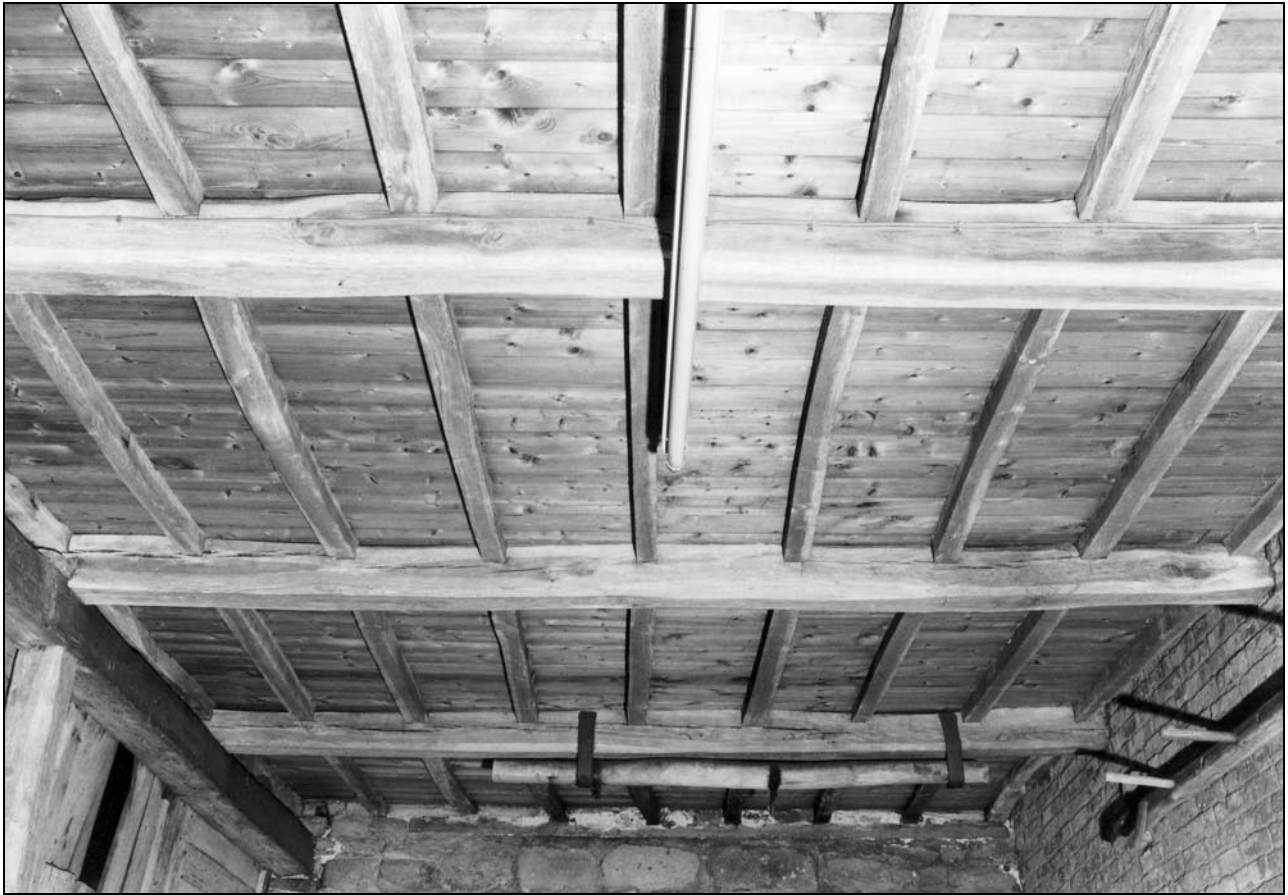
Photo 31: Secondary loft over central bay, from the south (film 3, frame 7)

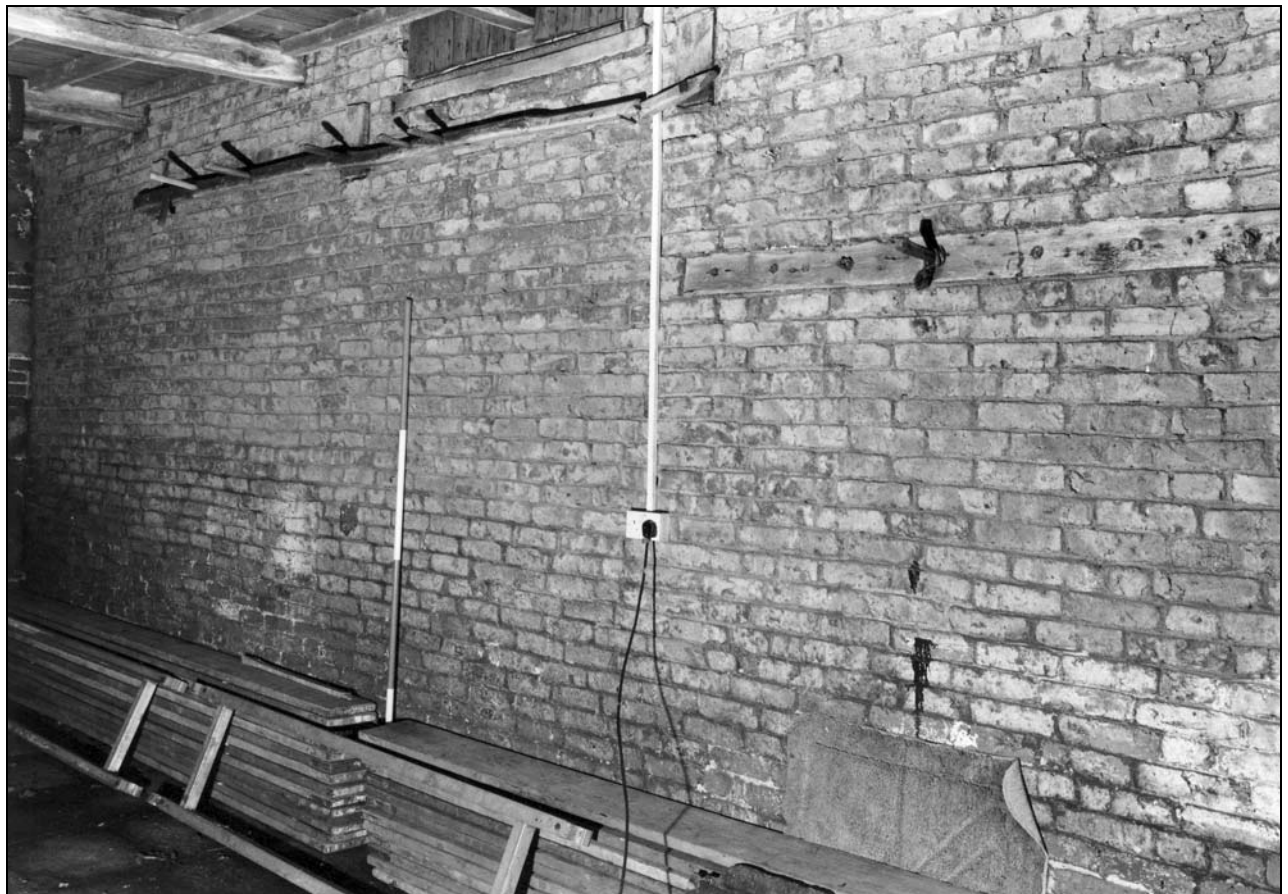
Photo 32: Brick wall on east side of central bay, from the south-west (note harness pegs) (film 3, frame 4)

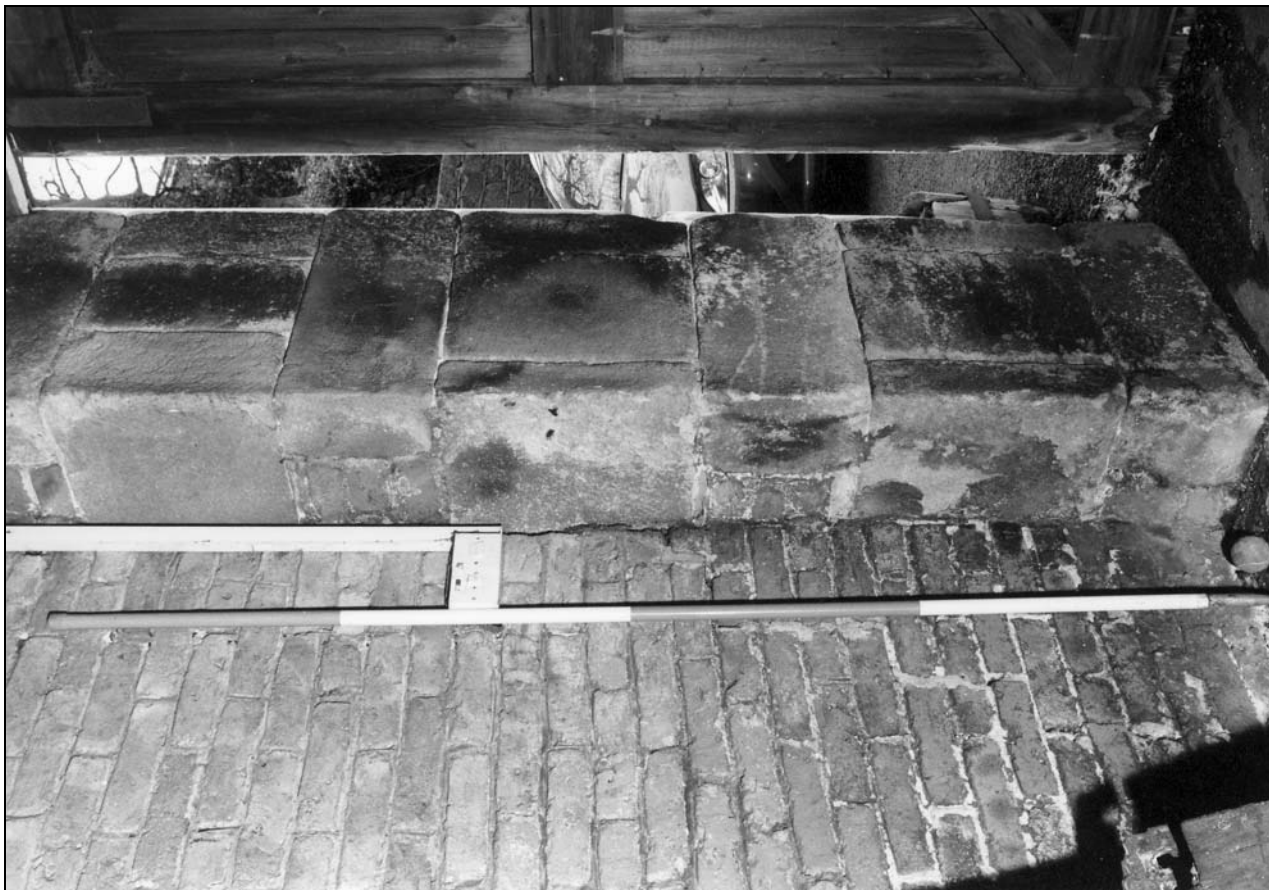
Photo 34: Detail of brickwork within wall on east side of central bay, at junction with front wall (film 3, frame 10)

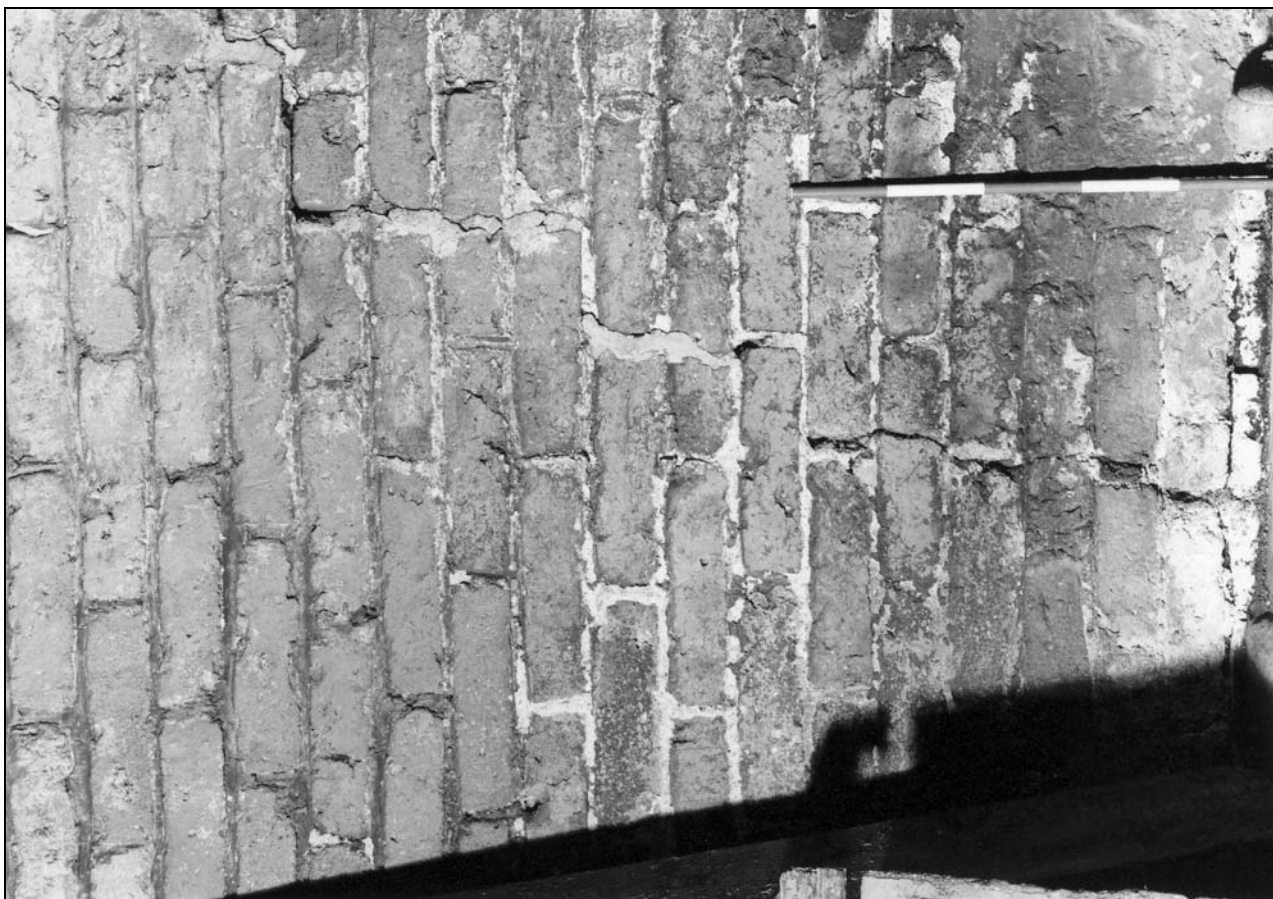
Photo 33: Detail of brickwork within wall on east side of central bay (film 3, frame 12)

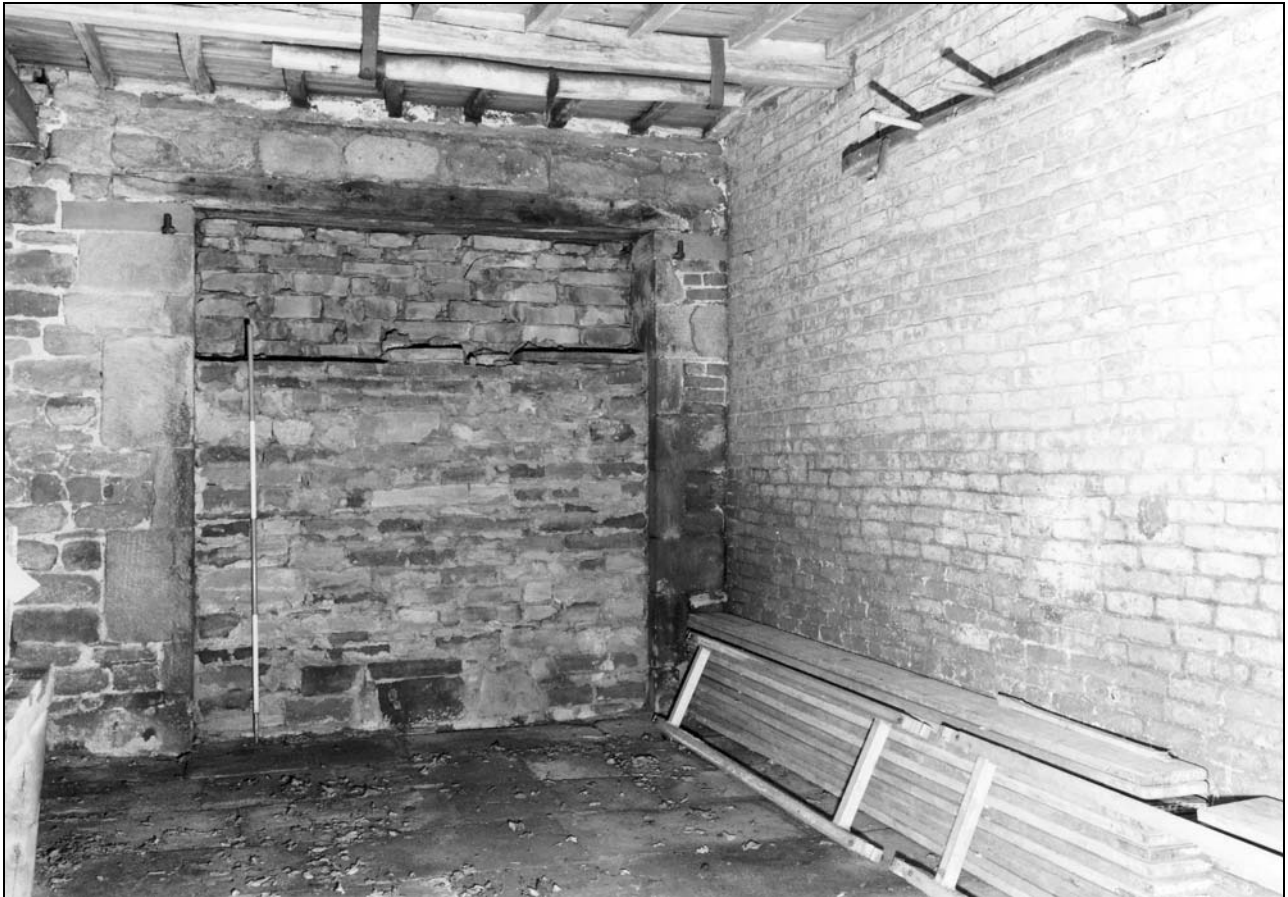
Photo 35: Blocked north doorway to central bay, with later harness pegs to right (film 3, frame 3)

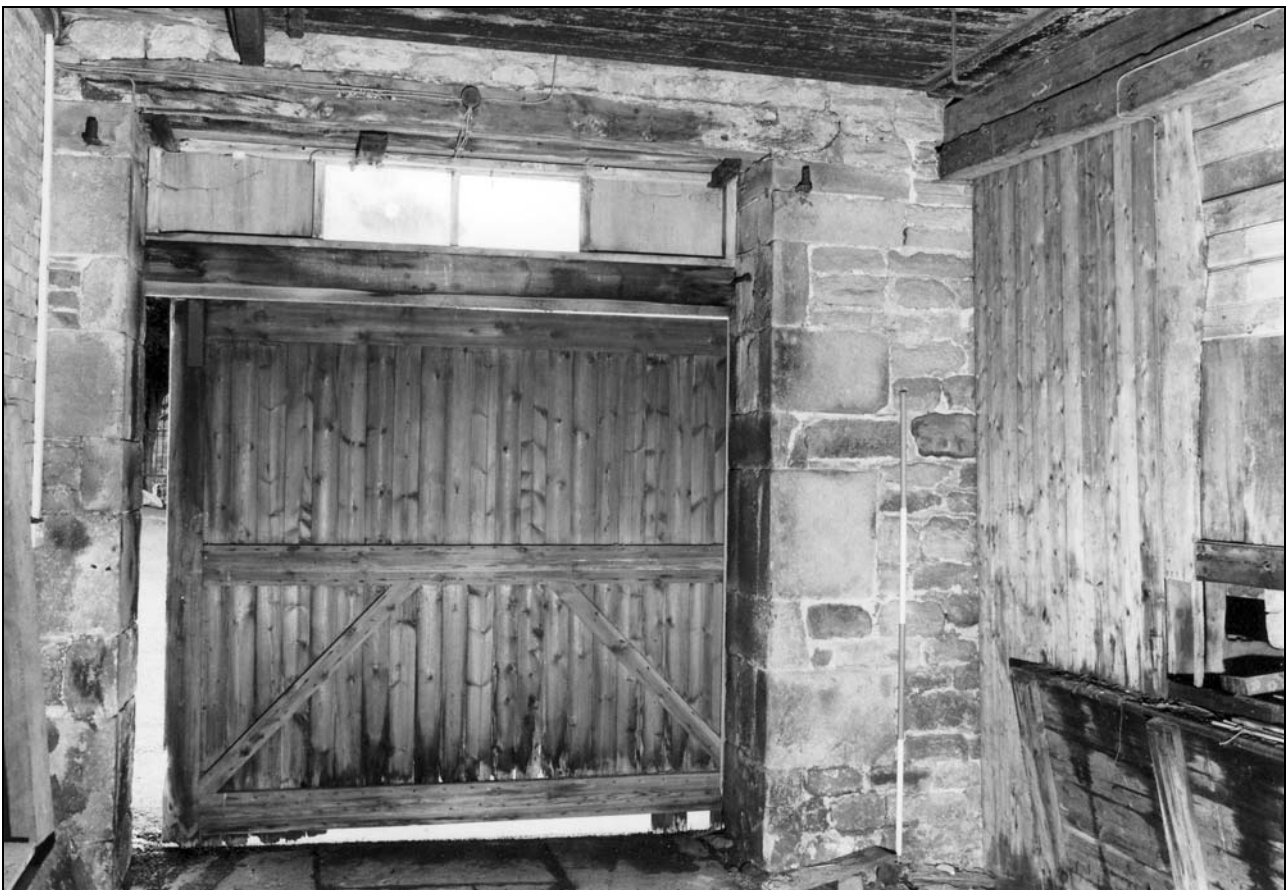
Photo 36: South doorway to central bay, with internal hinges for original doors (film 3, frame 5)
