Barn at Cooper House
Magson House Road, Luddenden Foot, West Yorkshire:
Historic Building Record

STEPHEN HAIGH

B u i l d i n g s A r c h a e o l o g i s t

OASIS project ID: stephenh1-198738

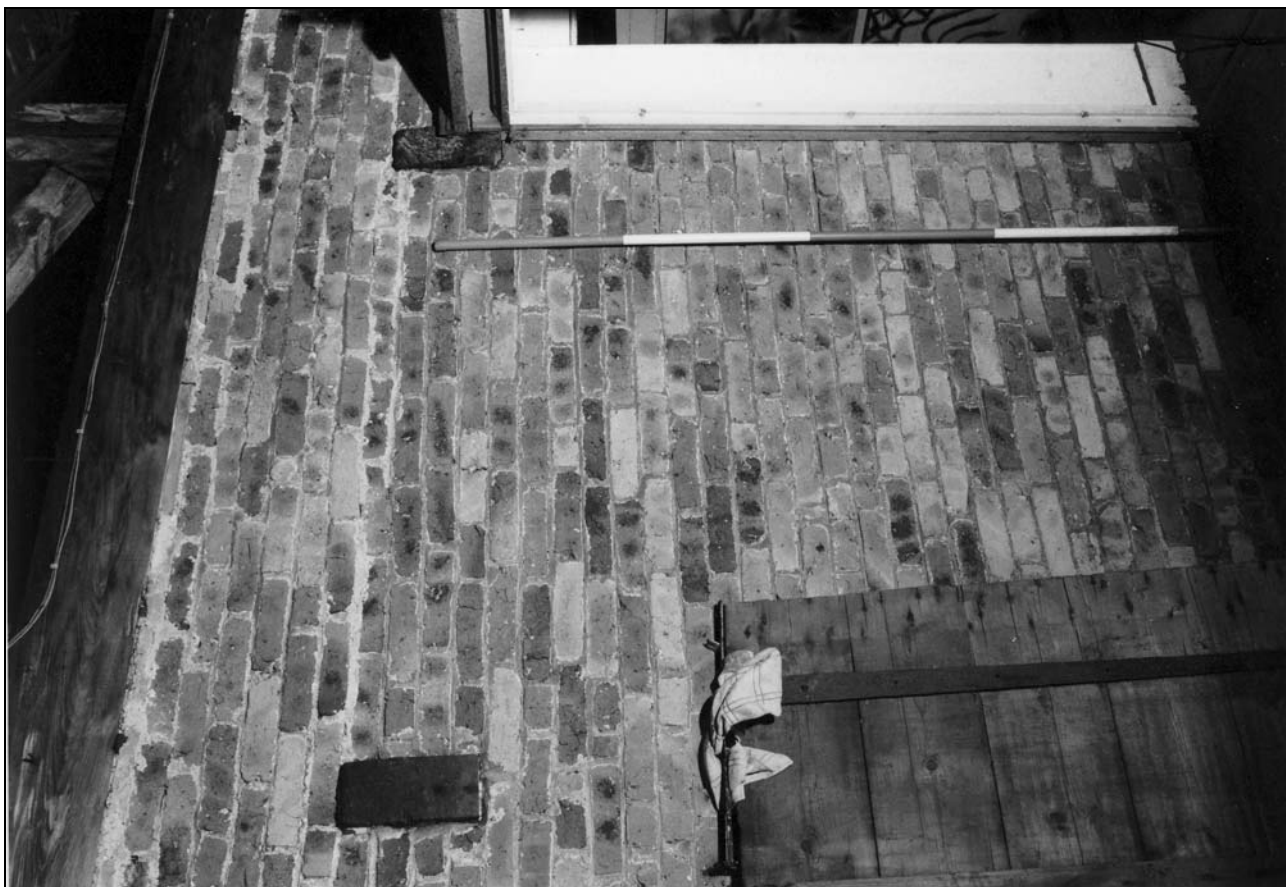
Photo 37: Detail of brick wall to east of central bay, at first floor level (film 3, frame 18)

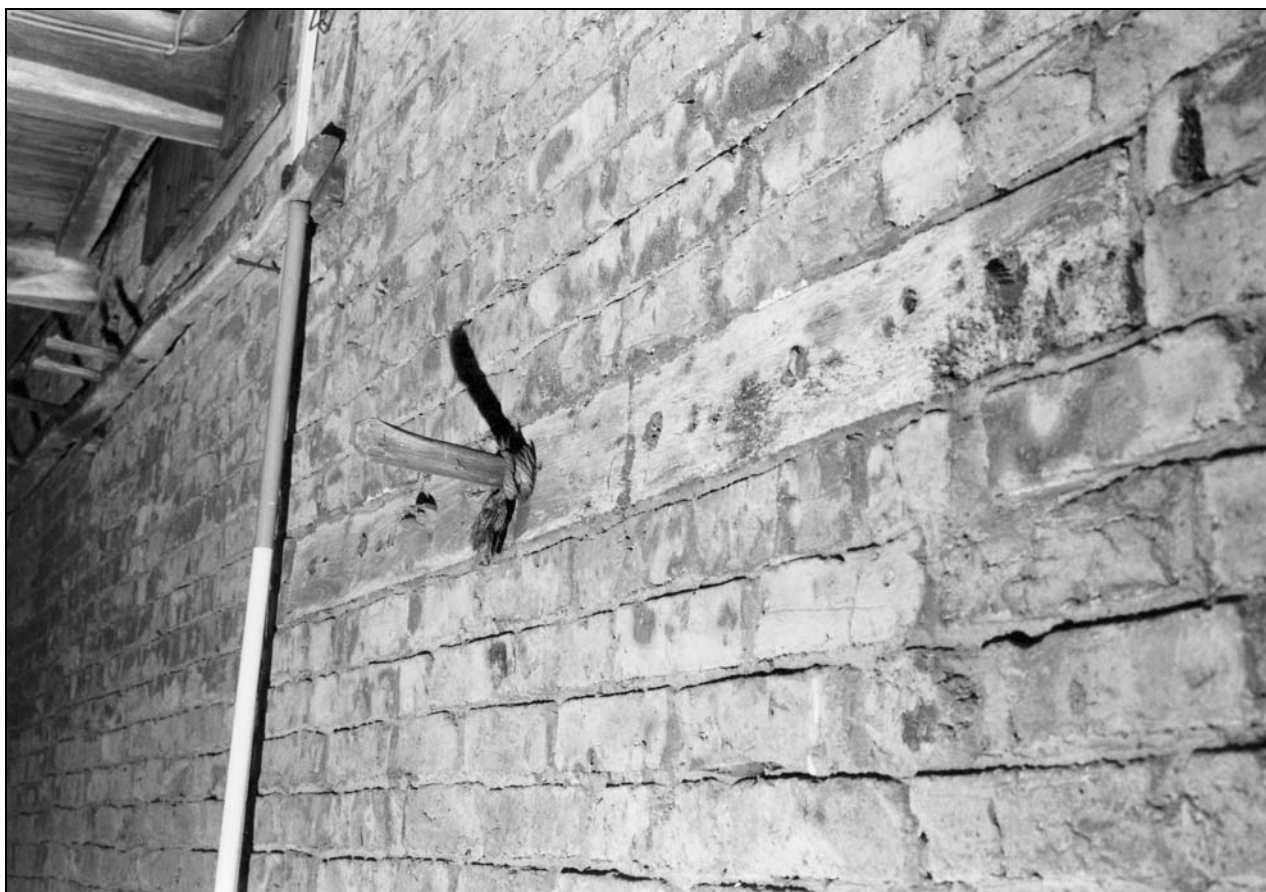
Photo 38: Detail of original timber for harness pegs in east side of central bay (later pegs to top left) (film 3, frame 11)

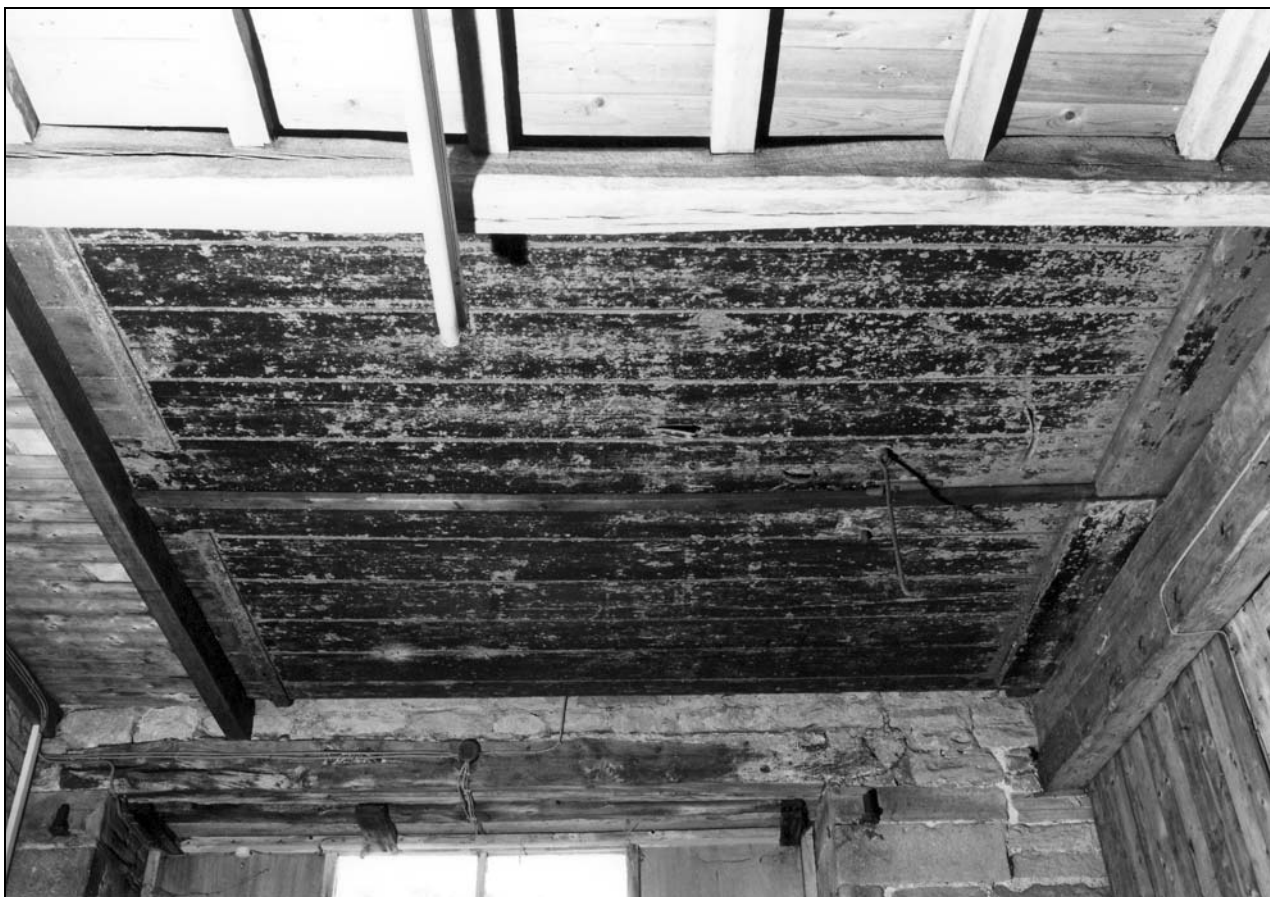
Photo 39: View of original(?) front doors, now serving as loft over south end of central bay (film 3, frame 9)

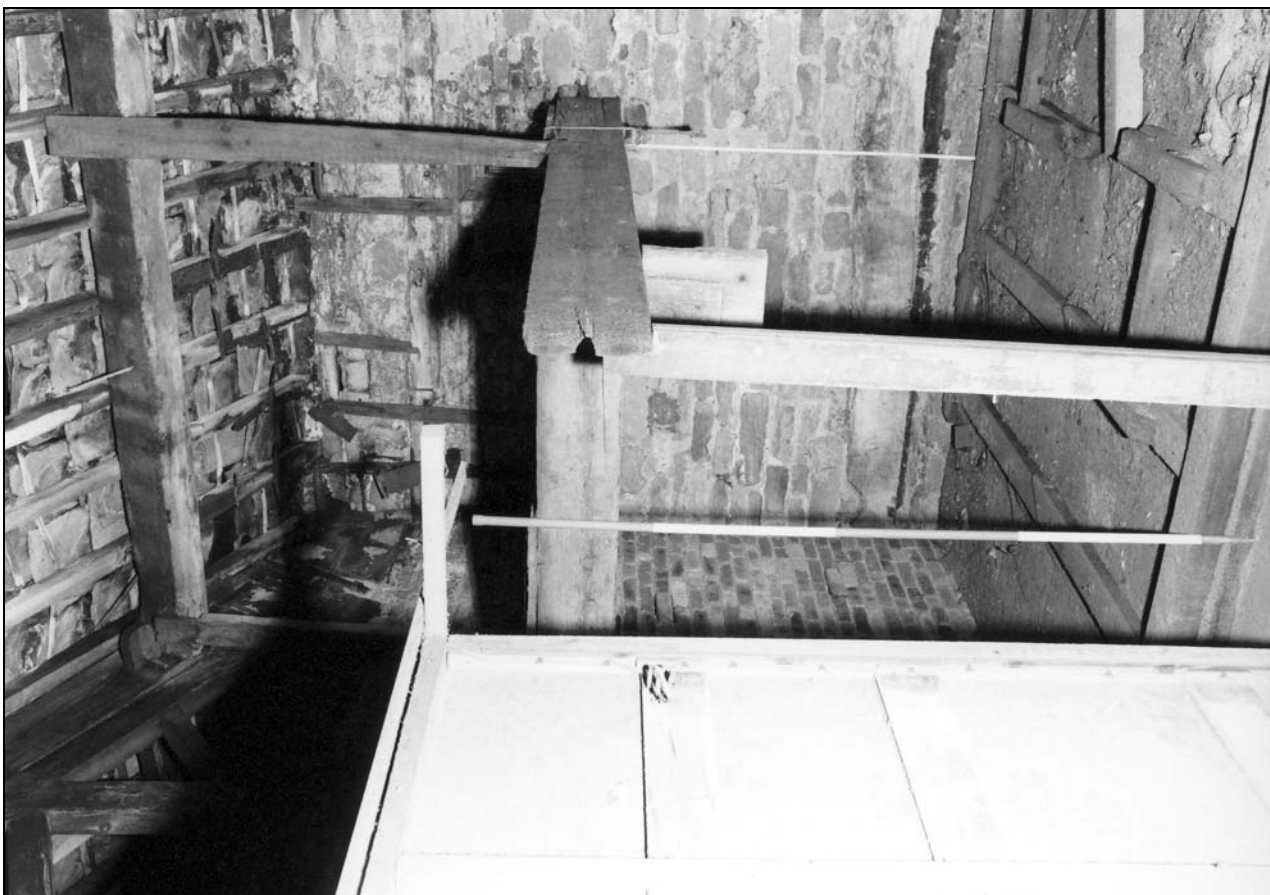
Photo 40: Timber structure at south end of central bay, first floor level – possible remains of pigeon loft (film 3, frame 1)

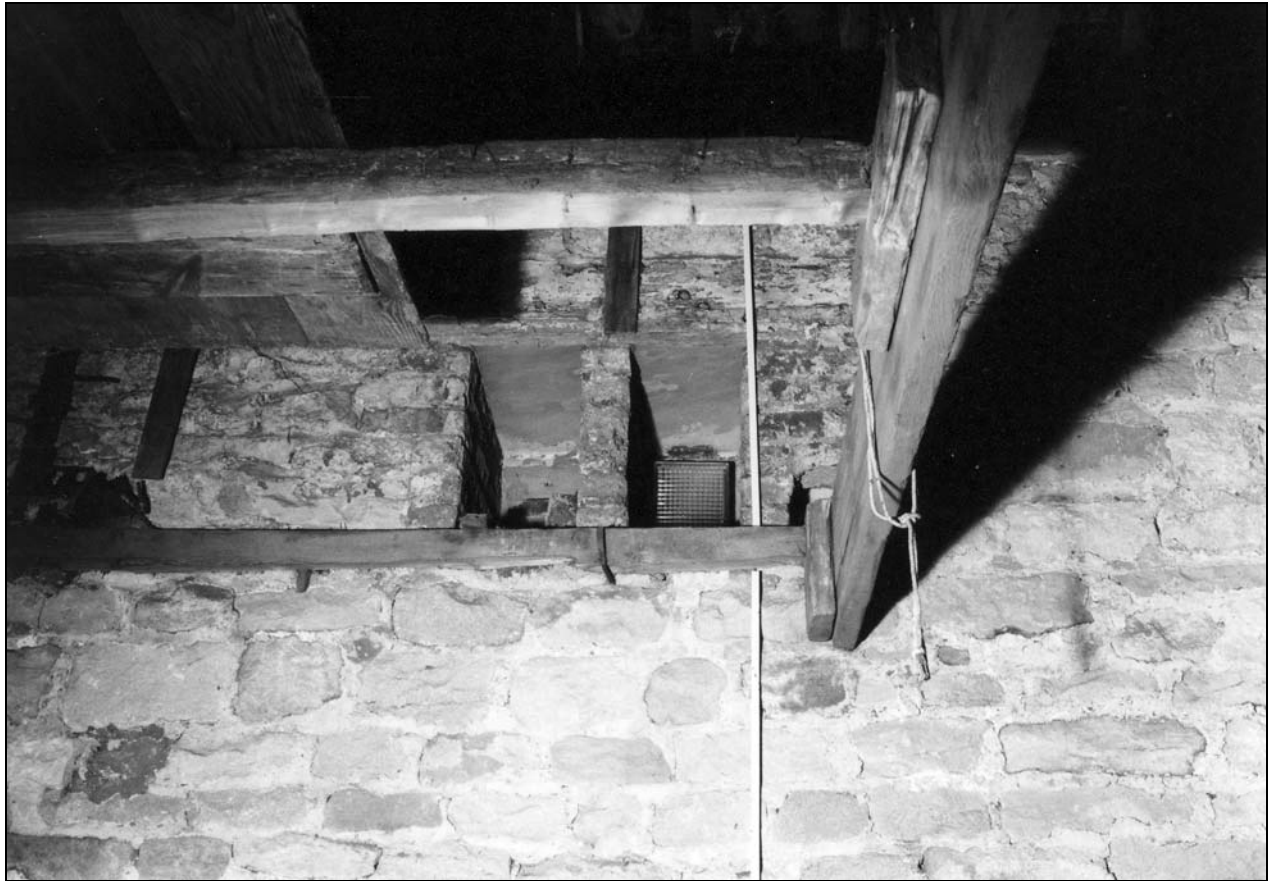
Photo 41: Internal view of entrance to former pigeon loft in central bay, with remains of timber structure (film 3, frame 16)

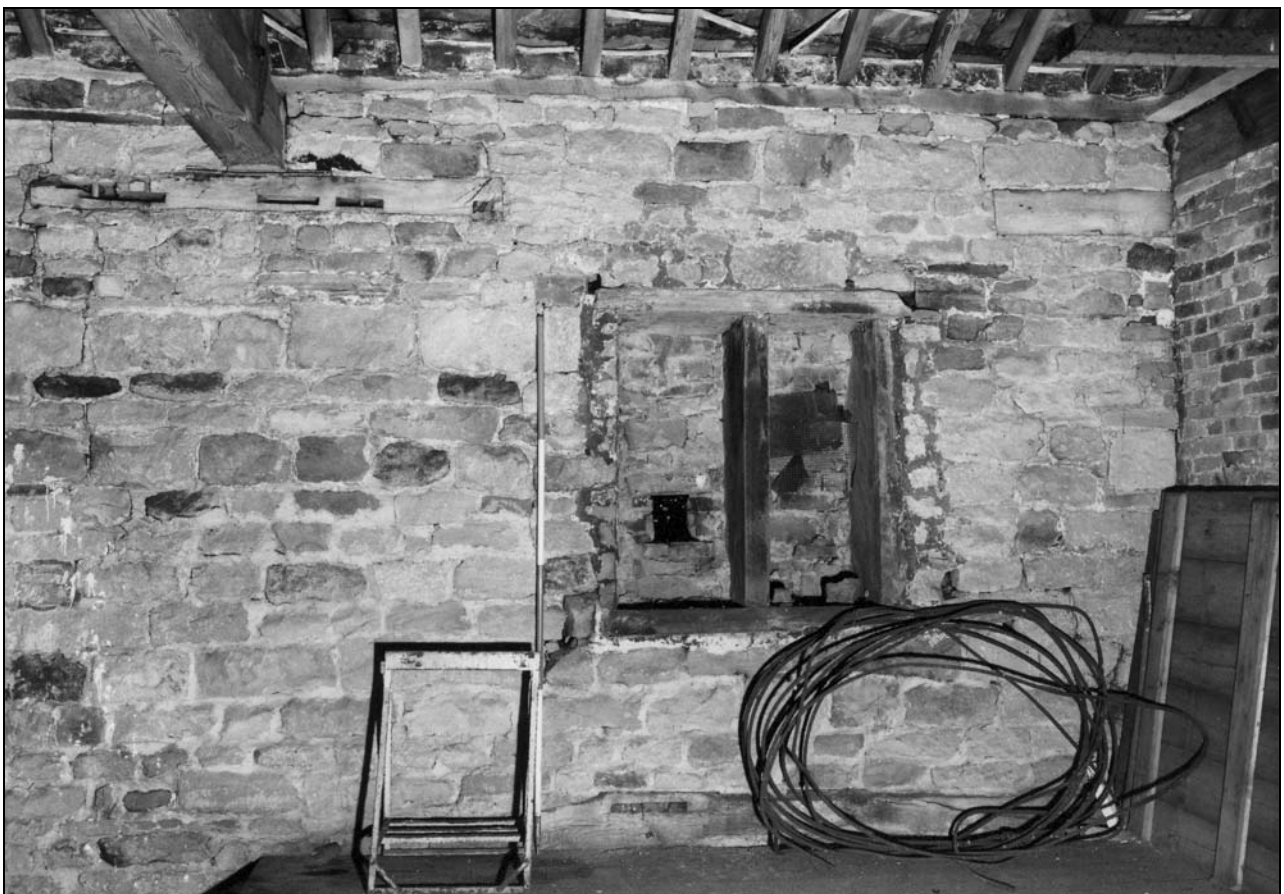
Photo 42: Internal view of inserted and blocked north window to central bay (film 3, frame 17)

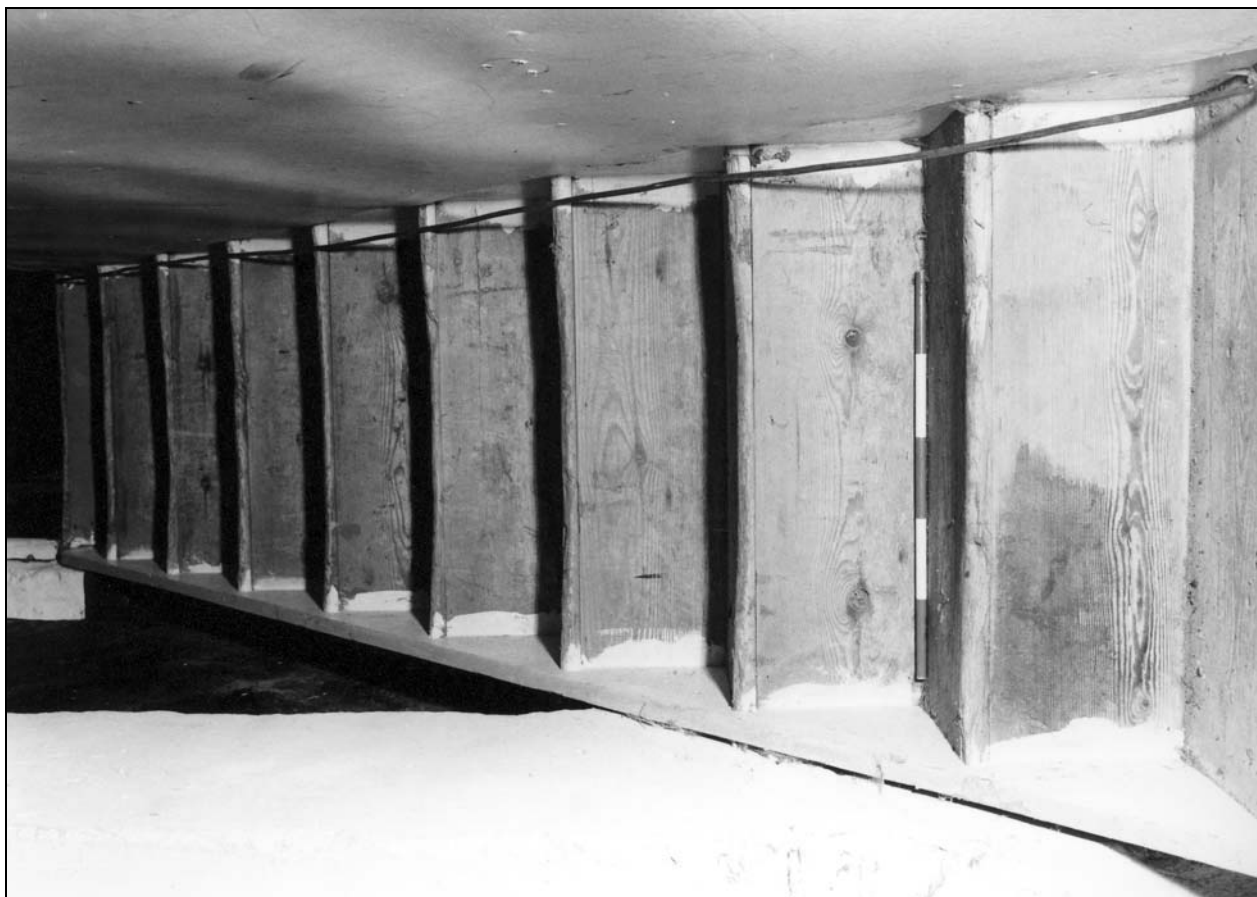
Photo 44: Ground floor staircase in workshop, from the north (film 5, frame 1)

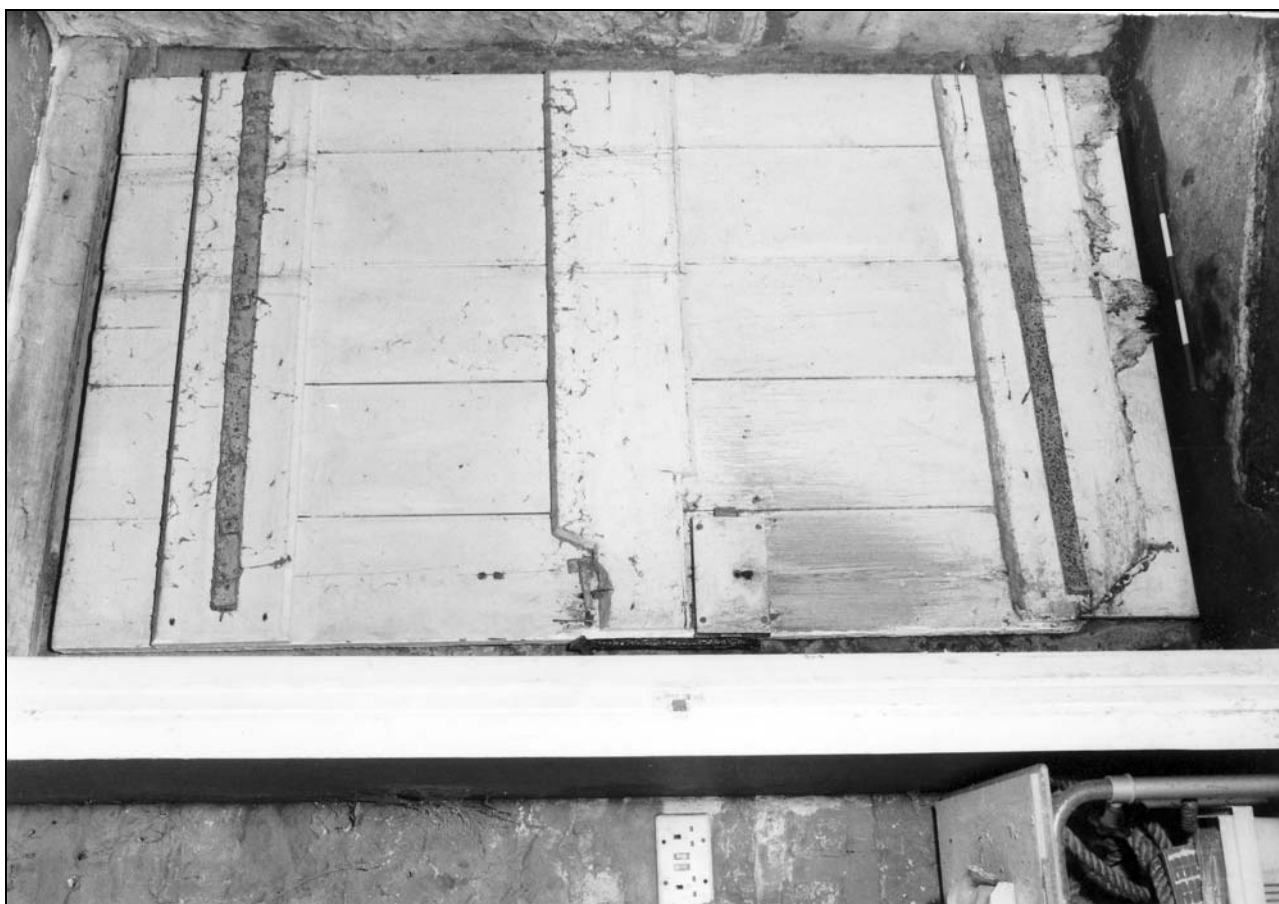
Photo 43: Internal view of north door to workshop (film 4, frame 18)

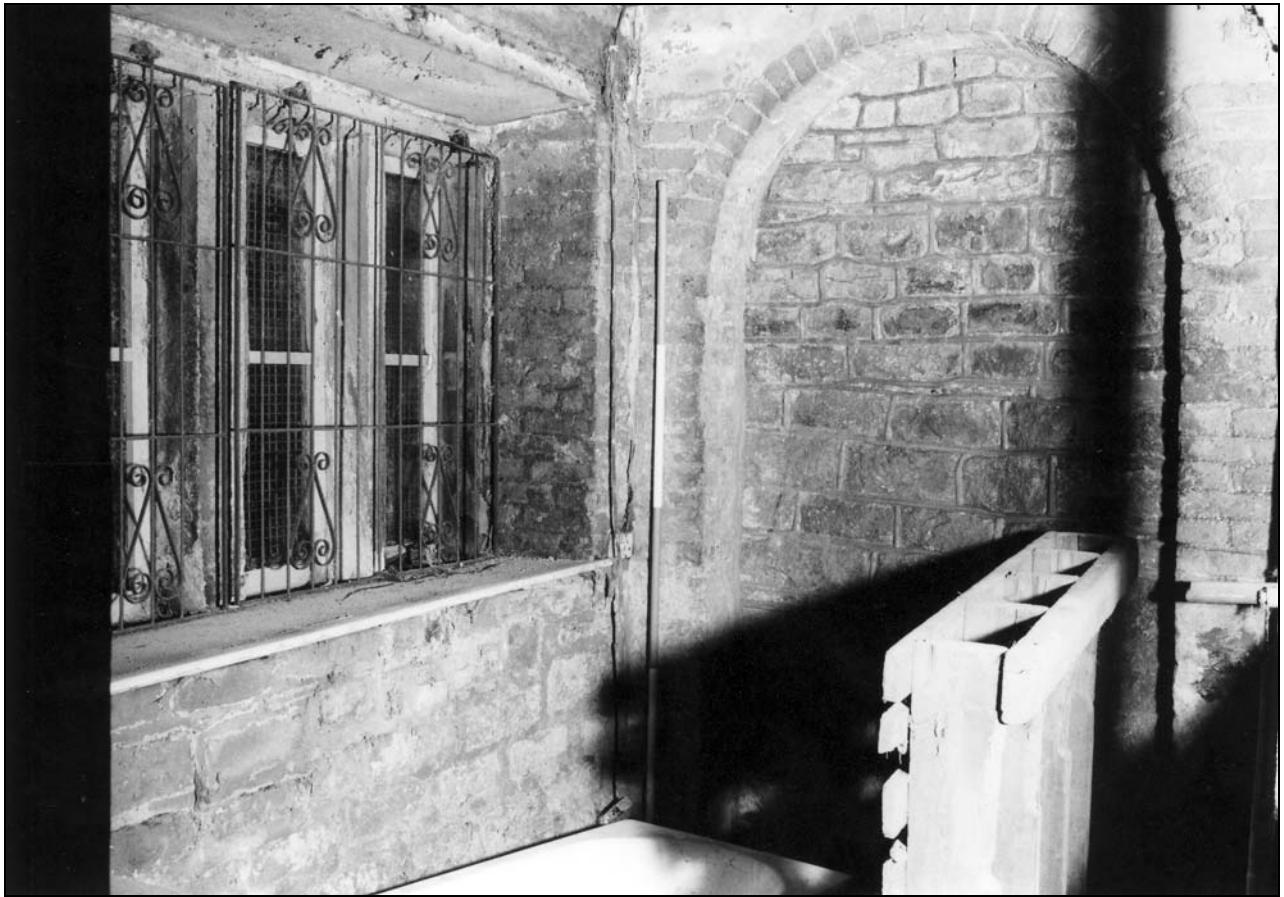
Photo 45: Ground floor of workshop: north-east corner (film 5, frame 4)

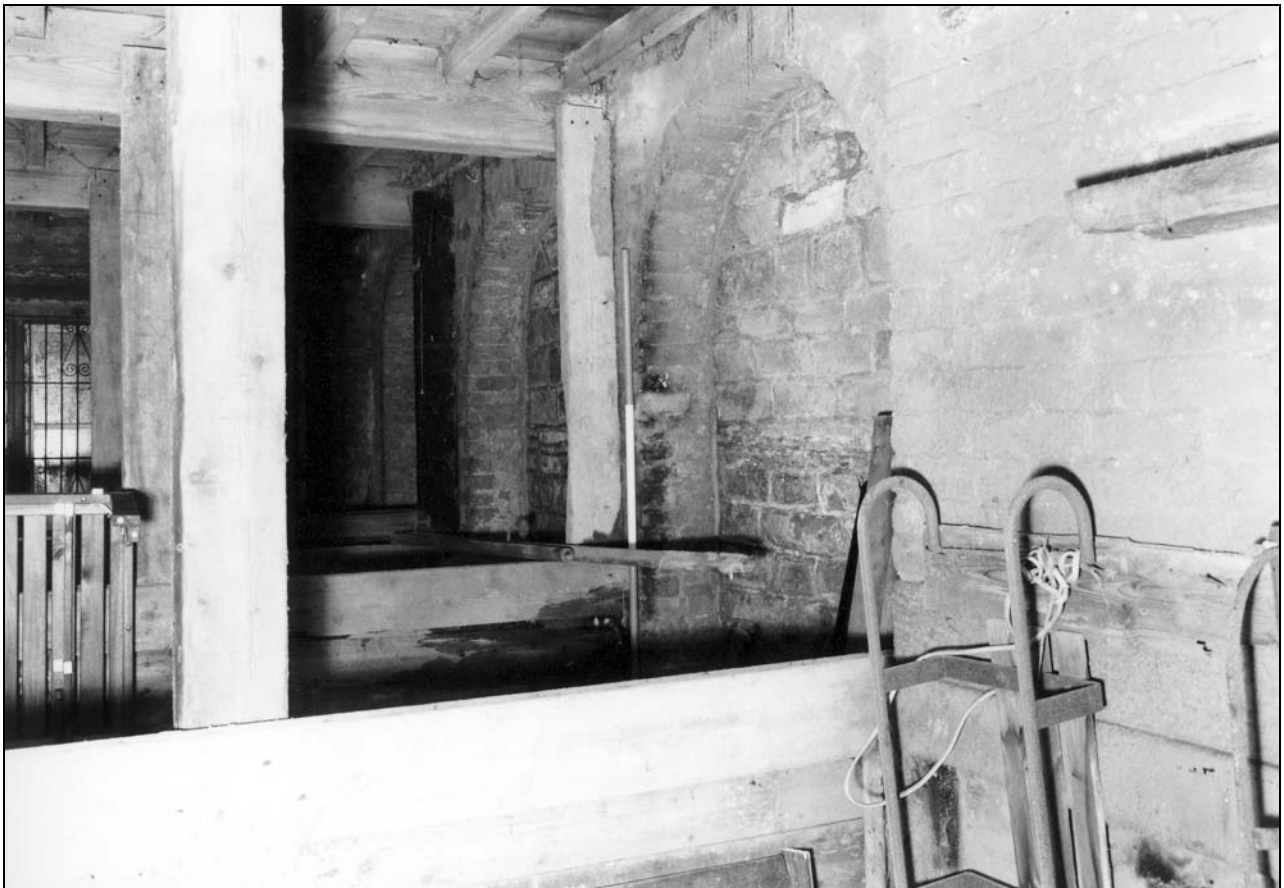
Photo 46: Ground floor of workshop, from the south-west (film 5, frame 5)

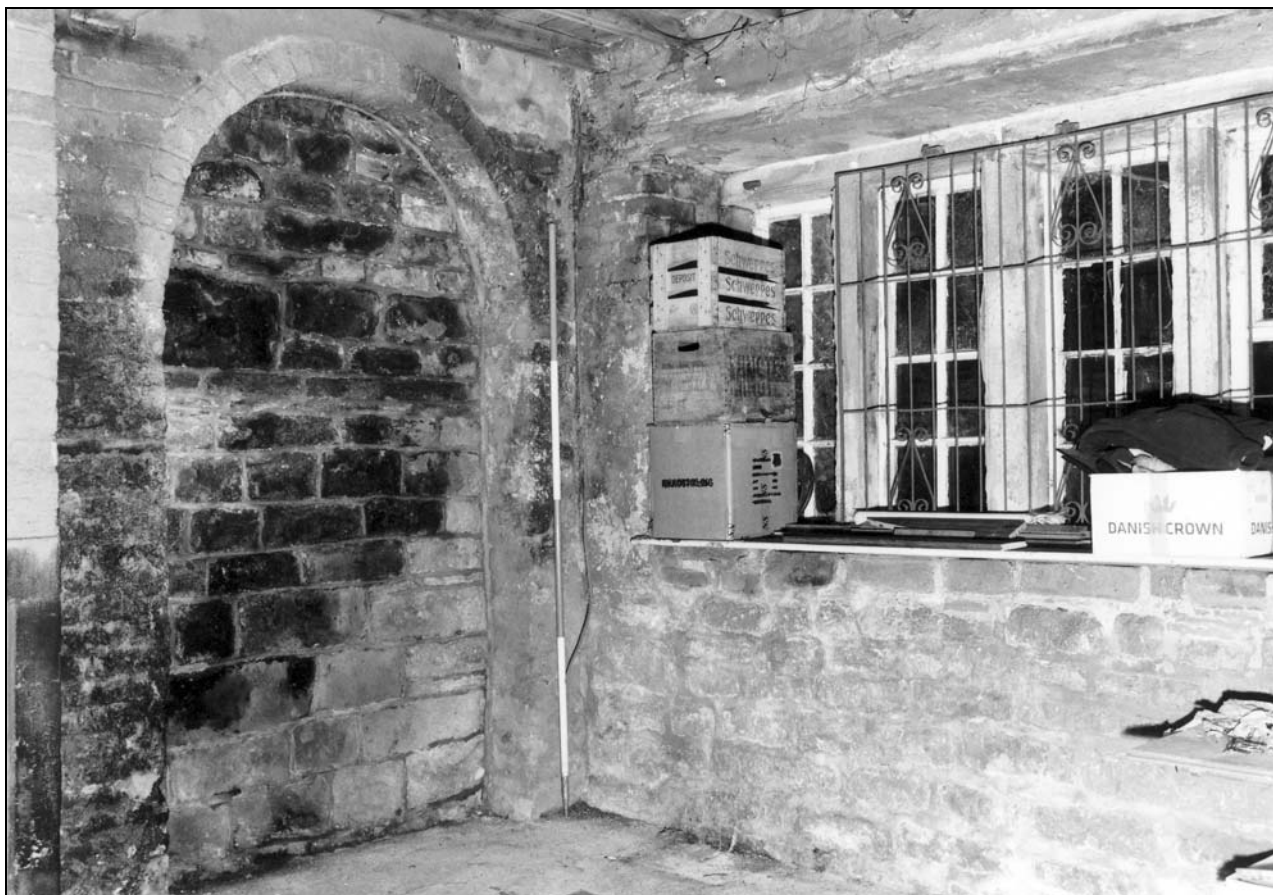
Photo 47: Ground floor of workshop: south-east corner (film 5, frame 7)

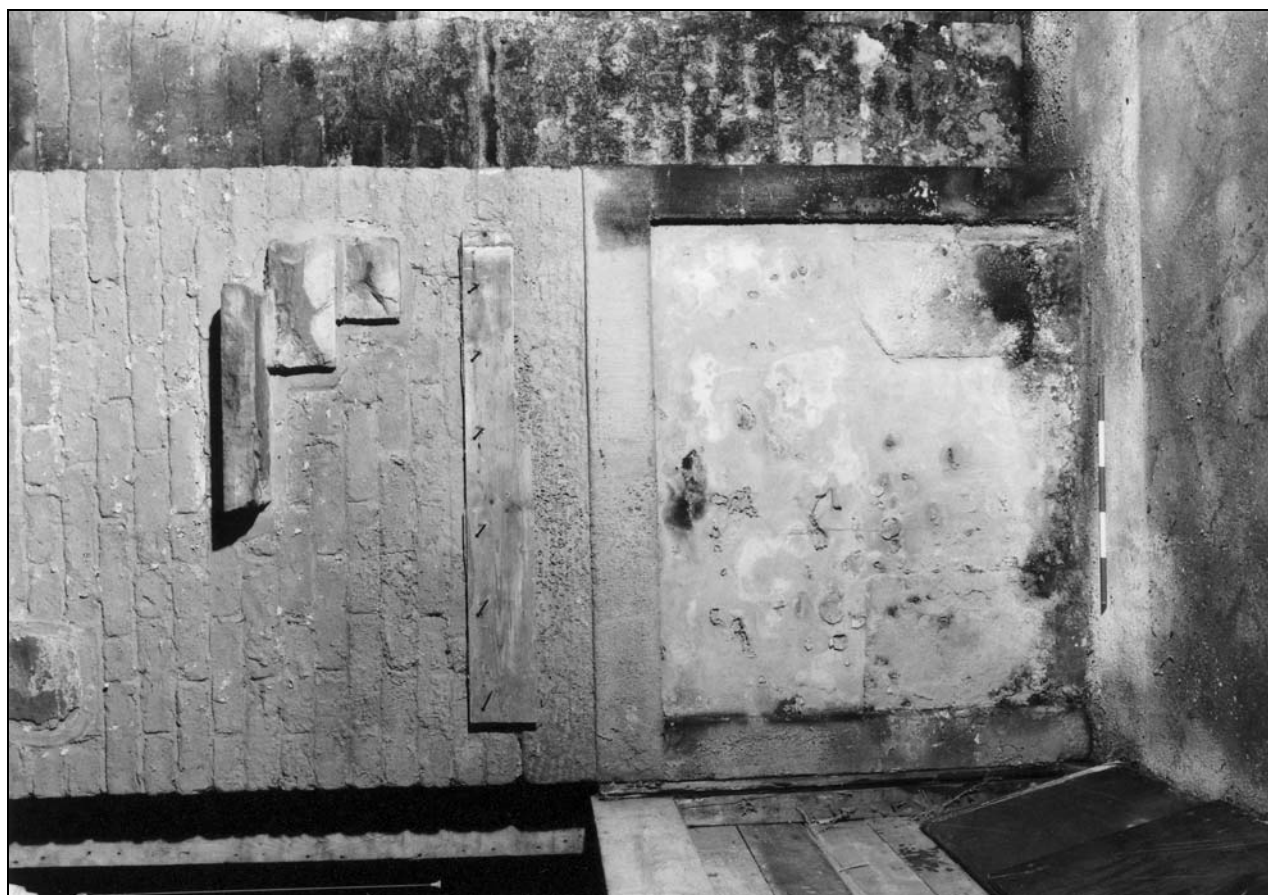
Photo 48: Blocked fireplace on ground floor of workshop, from the west (film 5, frame 6)

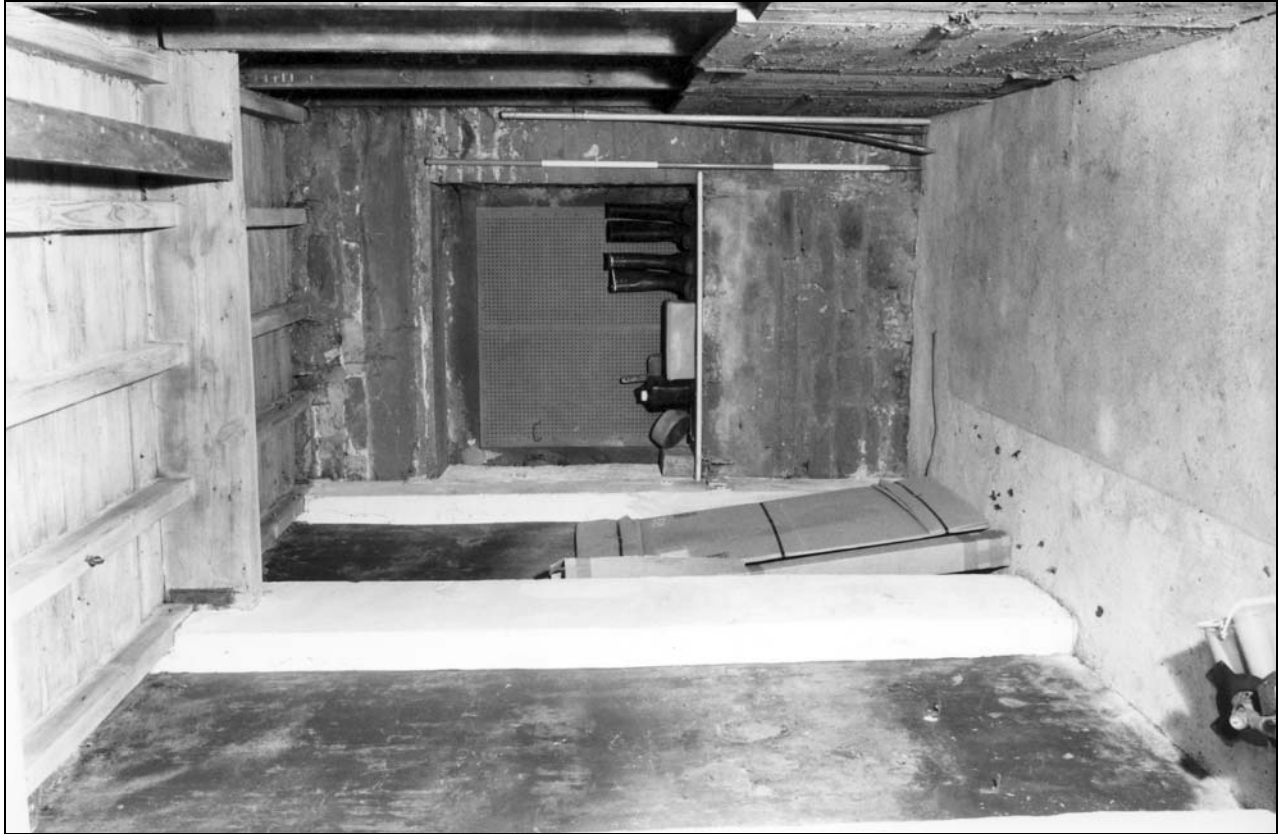
Photo 49: Ground floor of workshop: north-west corner (blocked doorway) (film 5, frame 2)

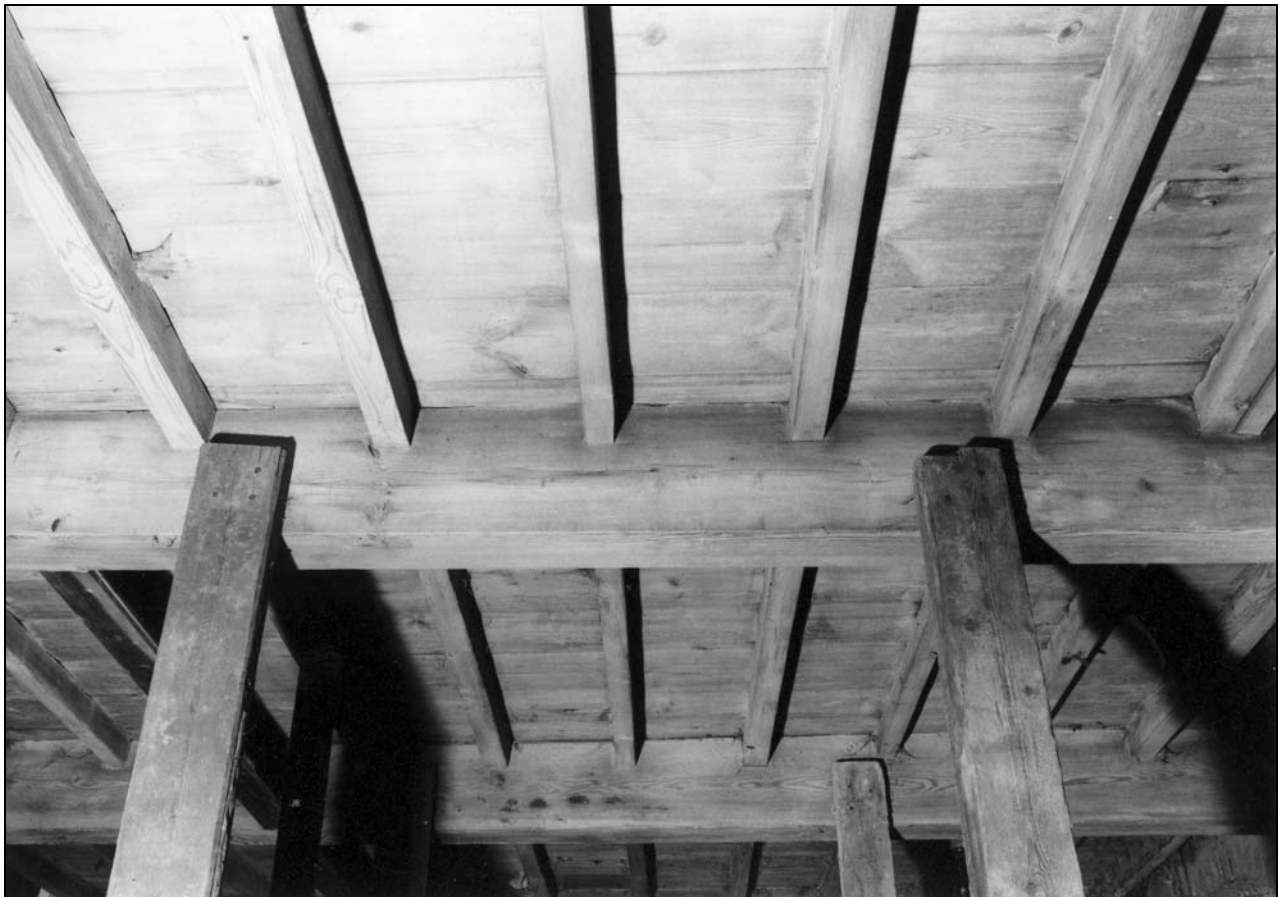
Photo 50: Underside of first floor of workshop, from the south (film 5, frame 9)

- 7.12 Although the internal arrangements within the workshop (occupying the barn's east bay) have been modified in recent years, it is relatively easy to establish which divisions are original, and how this area may have functioned. The front entrance, complete with its original broad plank and batten door, fitted with lock case for security (43), leads to the foot of a staircase to the first floor (44), as well as into a large ground floor room, in which the only partitions now present (including loose boxes for horses) are modern; however there may have been earlier, lightweight divisions, similar to one on the first floor, which have not survived. This room has an unusual form to the east wall, in the presence of four brick arches which support the floor above, together with a brick chimney breast, in which the fireplace has been blocked, while in the west side the brick cross-wall has piers at intervals, also supporting the floor beams overhead (45-49). The first floor itself is of softwood, all members being squarely sawn, and clearly

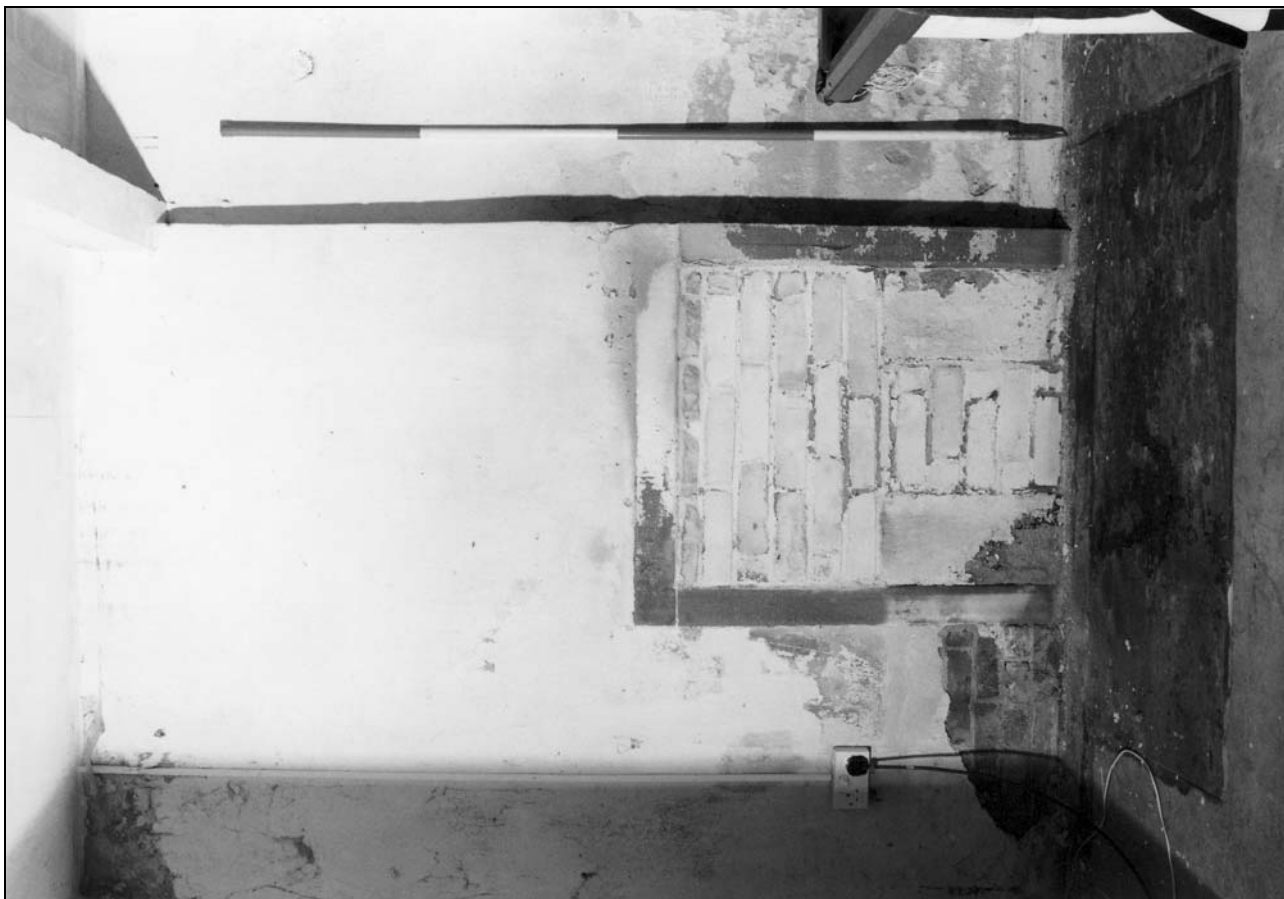
Photo 51: Blocked fireplace on first floor of workshop (south part), from the west (film 4, frame 6)

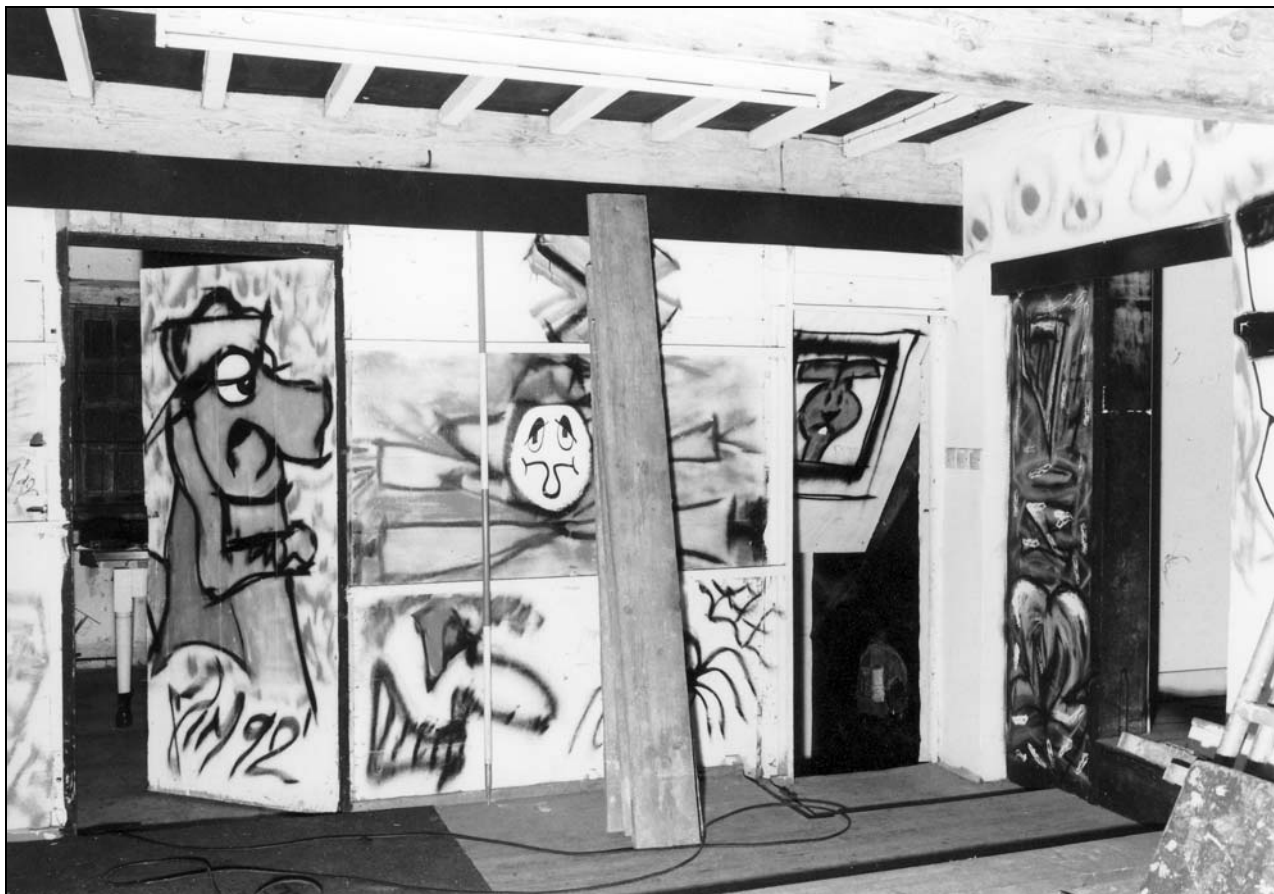
Photo 52: First floor of workshop (north part), from the north-west – the partition with ranging pole appears original (film 4, frame 9)

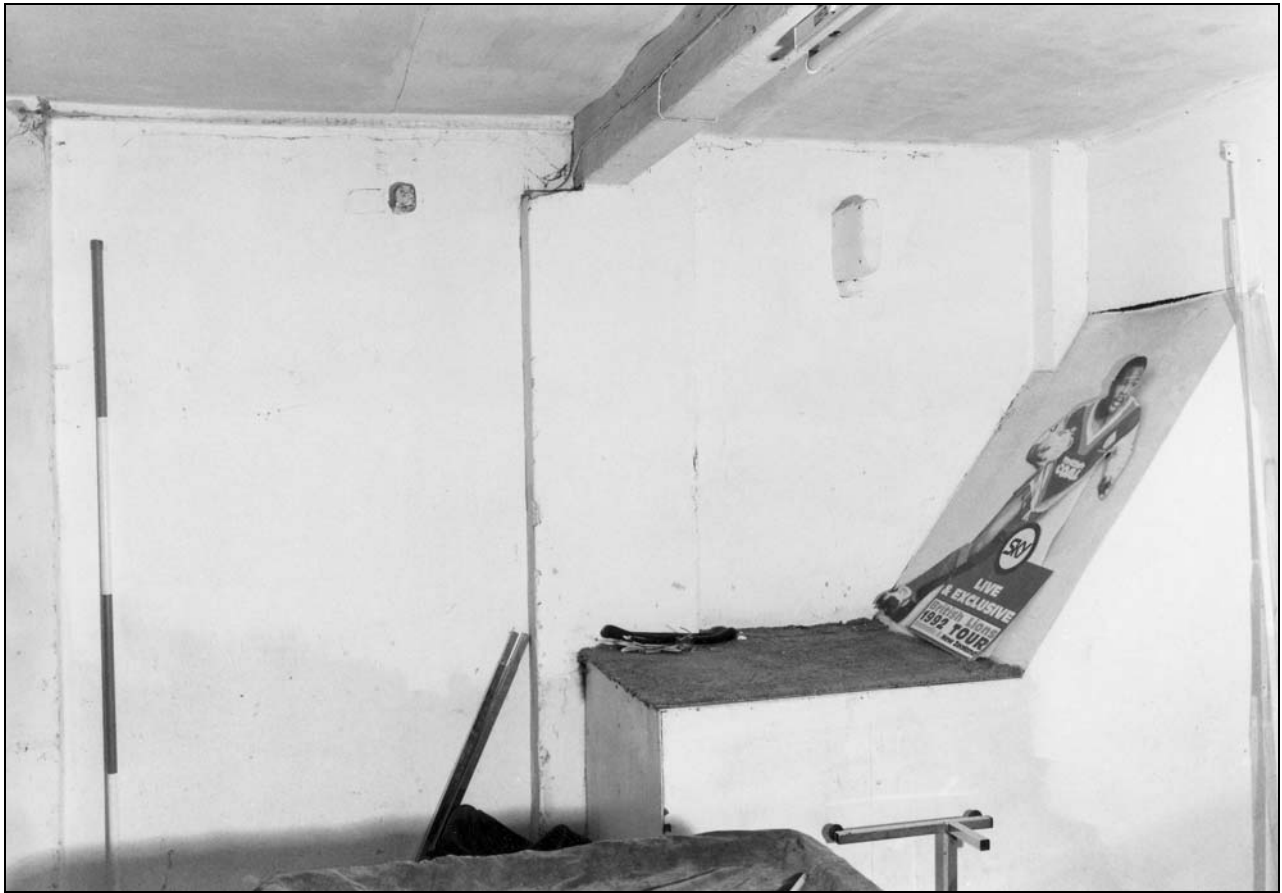
Photo 53: First floor of workshop (south part), from the south-east (film 4, frame 5)

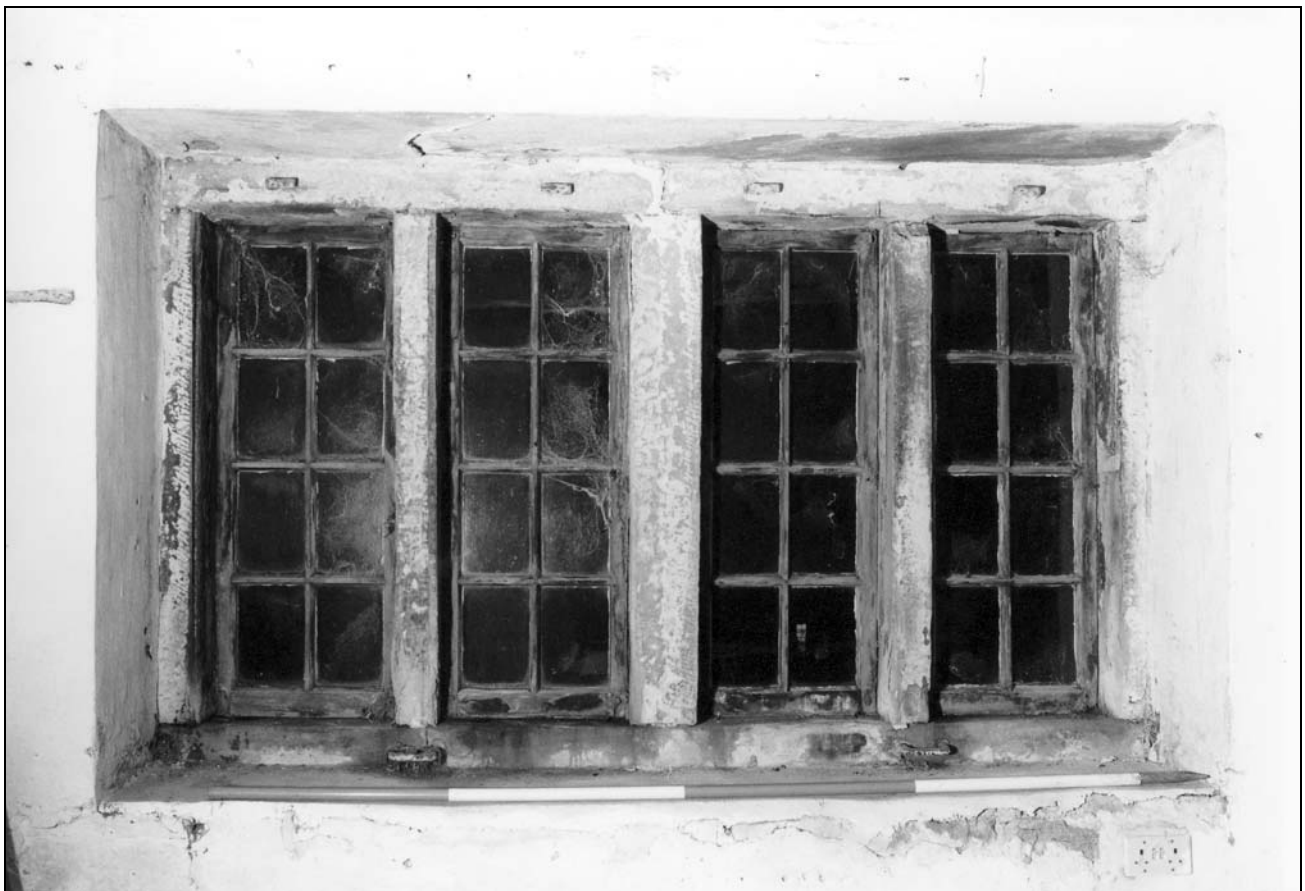
Photo 54: Internal view of first floor window in workshop (south side), showing hinge pintles and barring staples (film 4, frame 4)

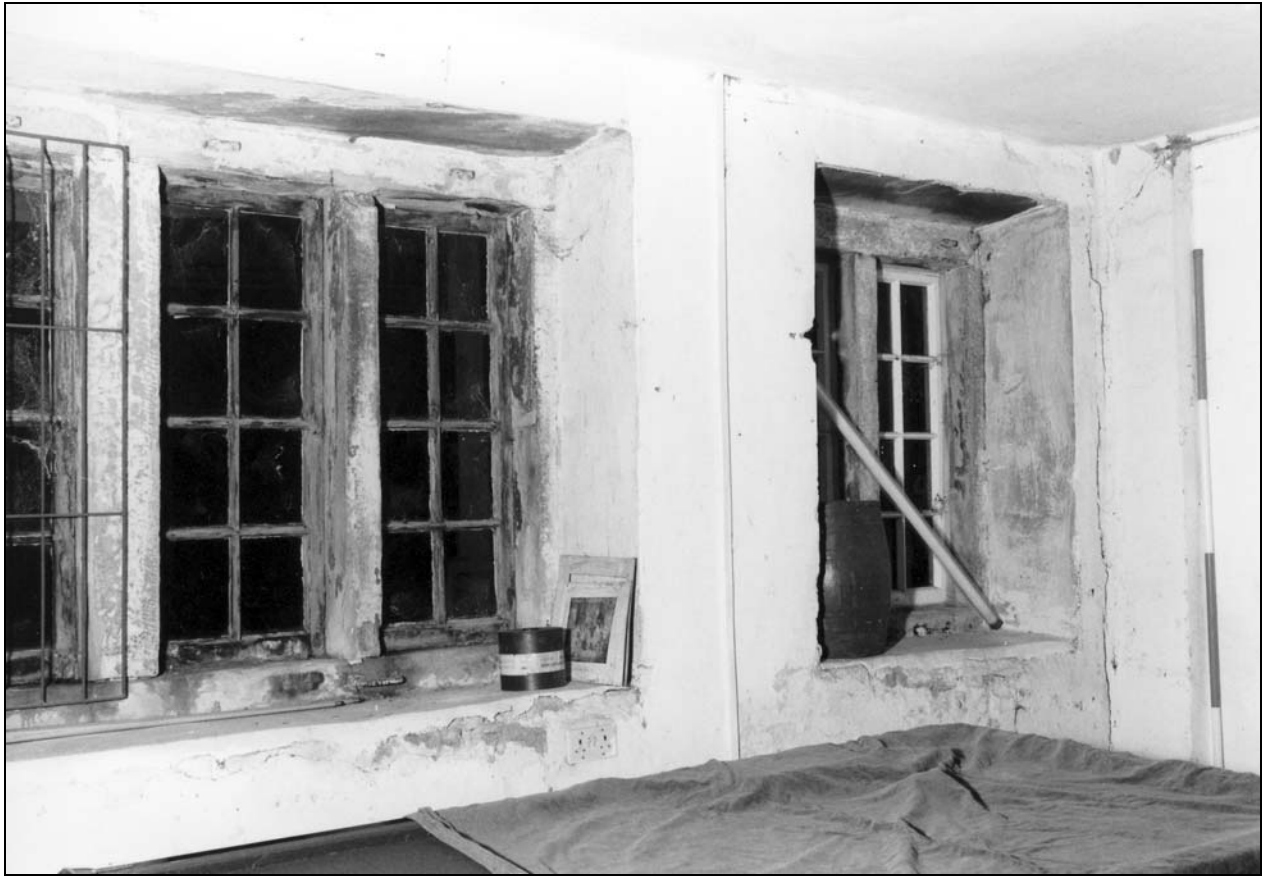
Photo 55: Internal view of first floor windows in workshop, south side (film 4, frame 2)
