Barn at Cooper House
Magson House Road, Luddenden Foot, West Yorkshire:
Historic Building Record

STEPHEN HAIGH

B u i l d i n g s A r c h a e o l o g i s t

OASIS project ID: stephenh1-198738

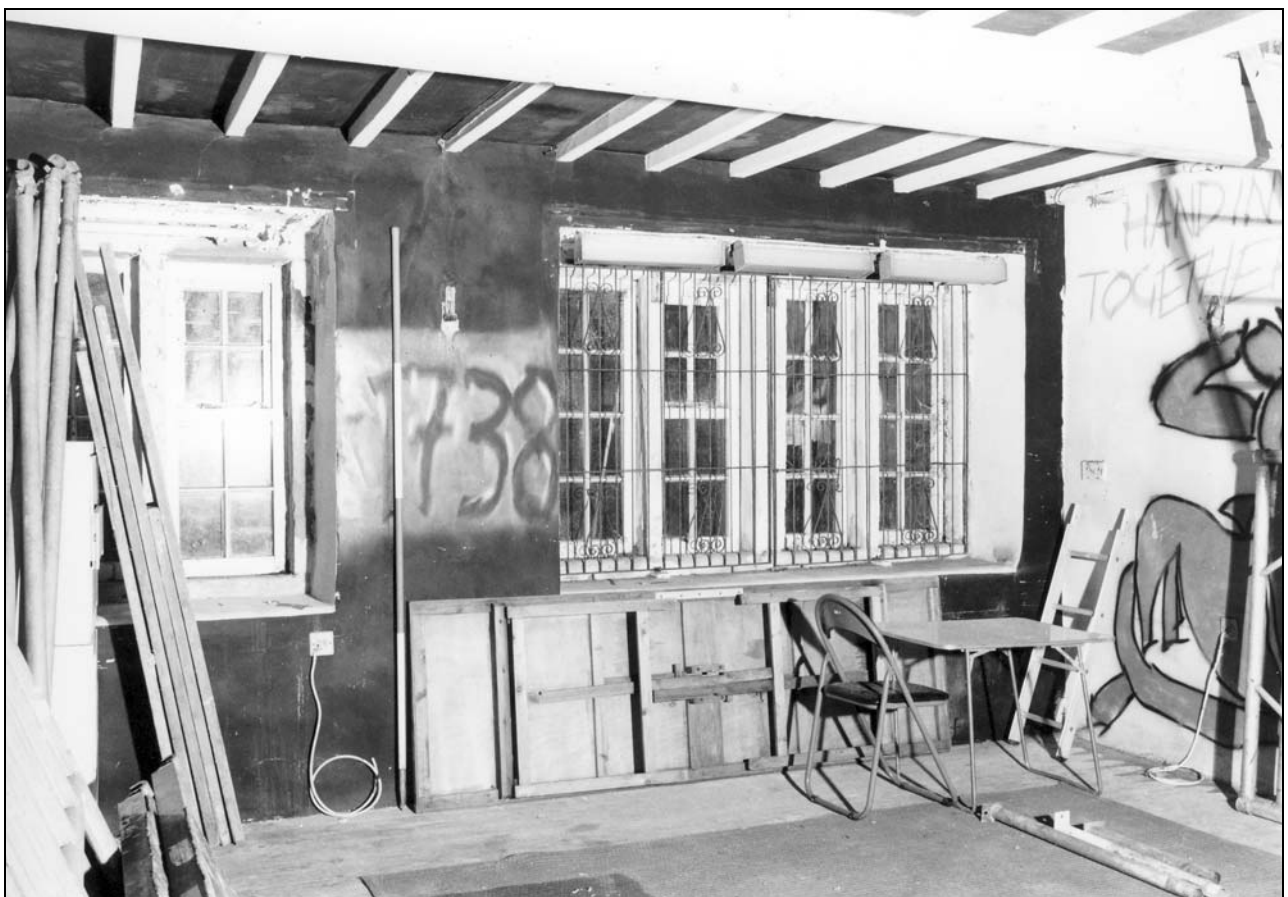
Photo 56: First floor of workshop (north part), from the south-west (film 4, frame 7)

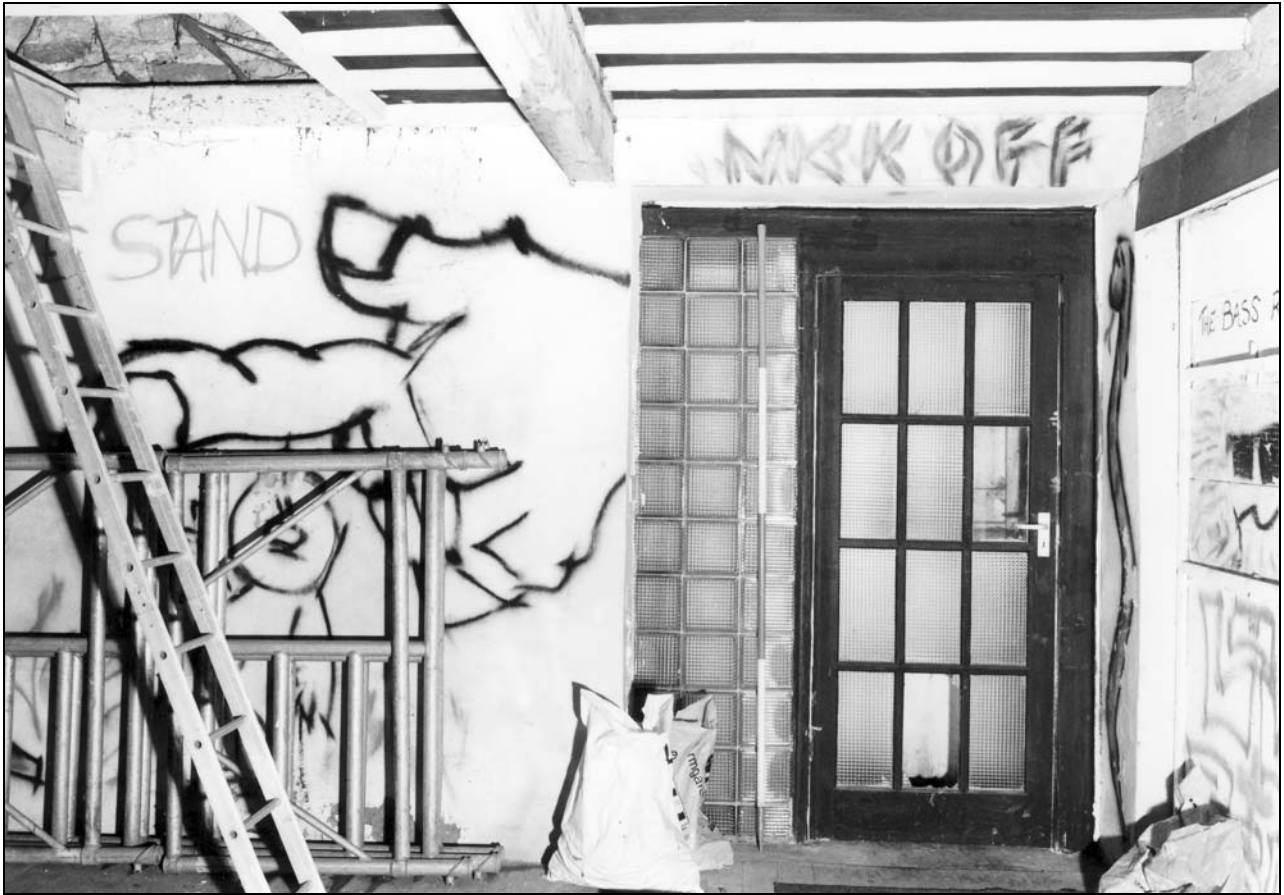
Photo 57: First floor of workshop (north part), with gable doorway to road level (film 4, frame 10)

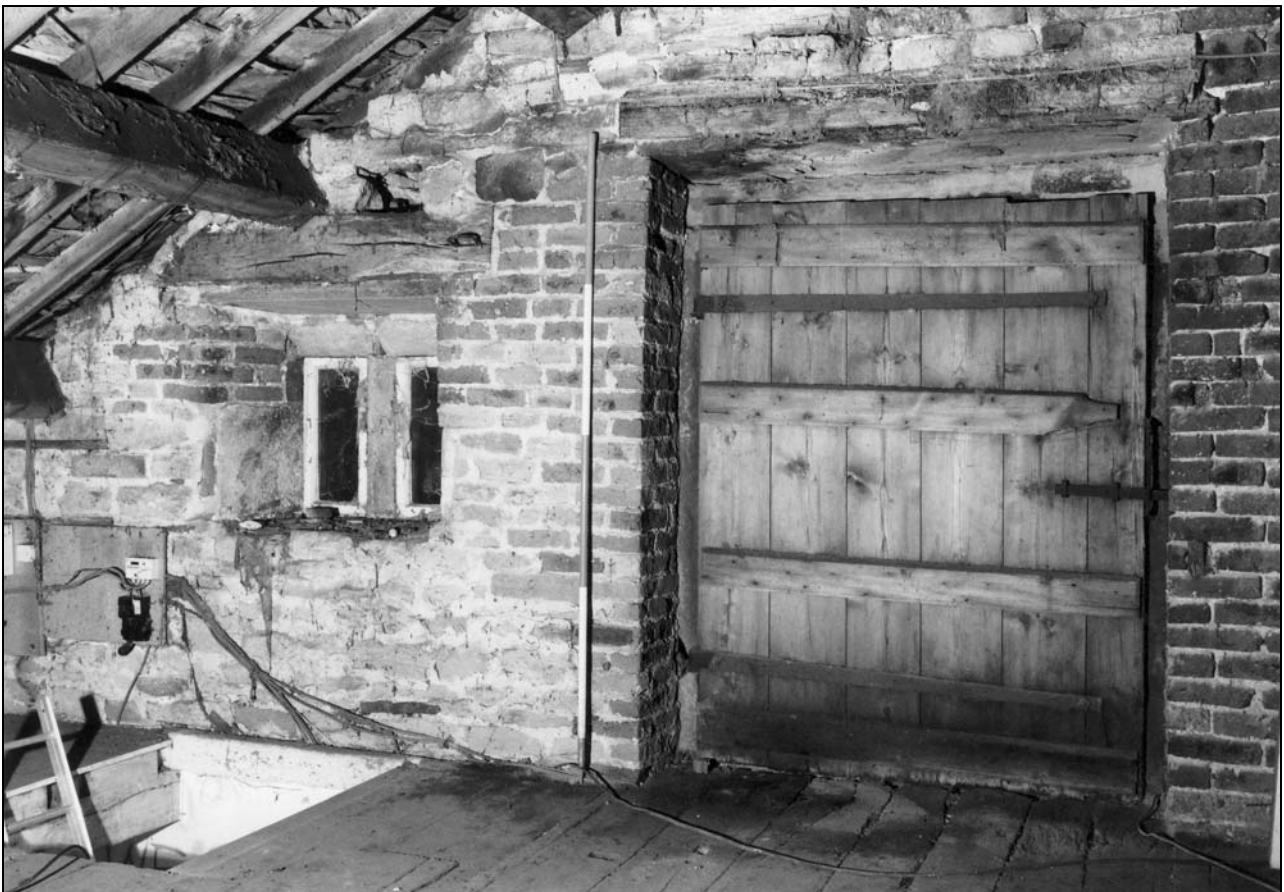
Photo 58: Attic over workshop, with gable taking-in doorway, from the south-west (film 4, frame 11)

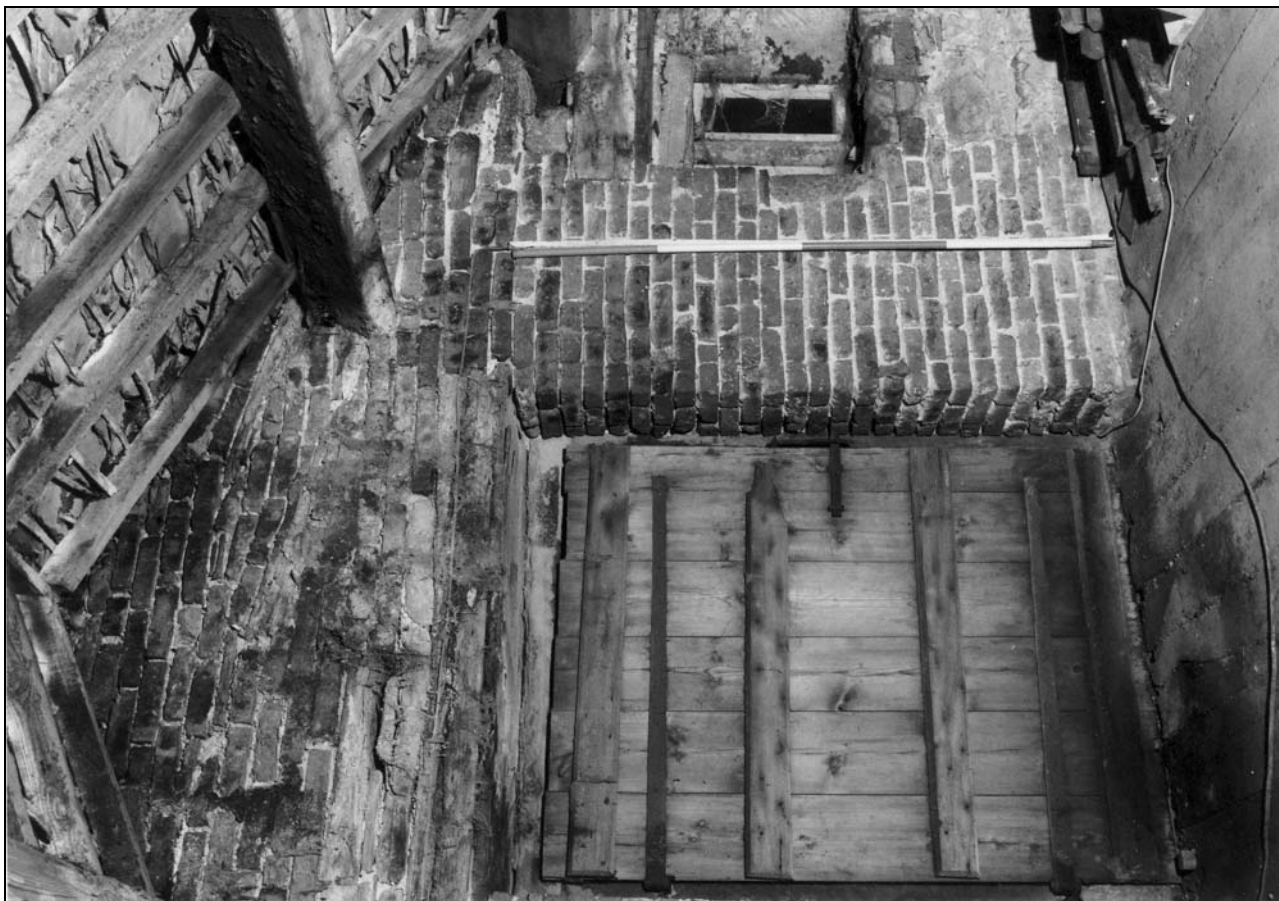
Photo 59: Attic over workshop, with gable taking-in doorway, from the north-west (film 4, frame 12)

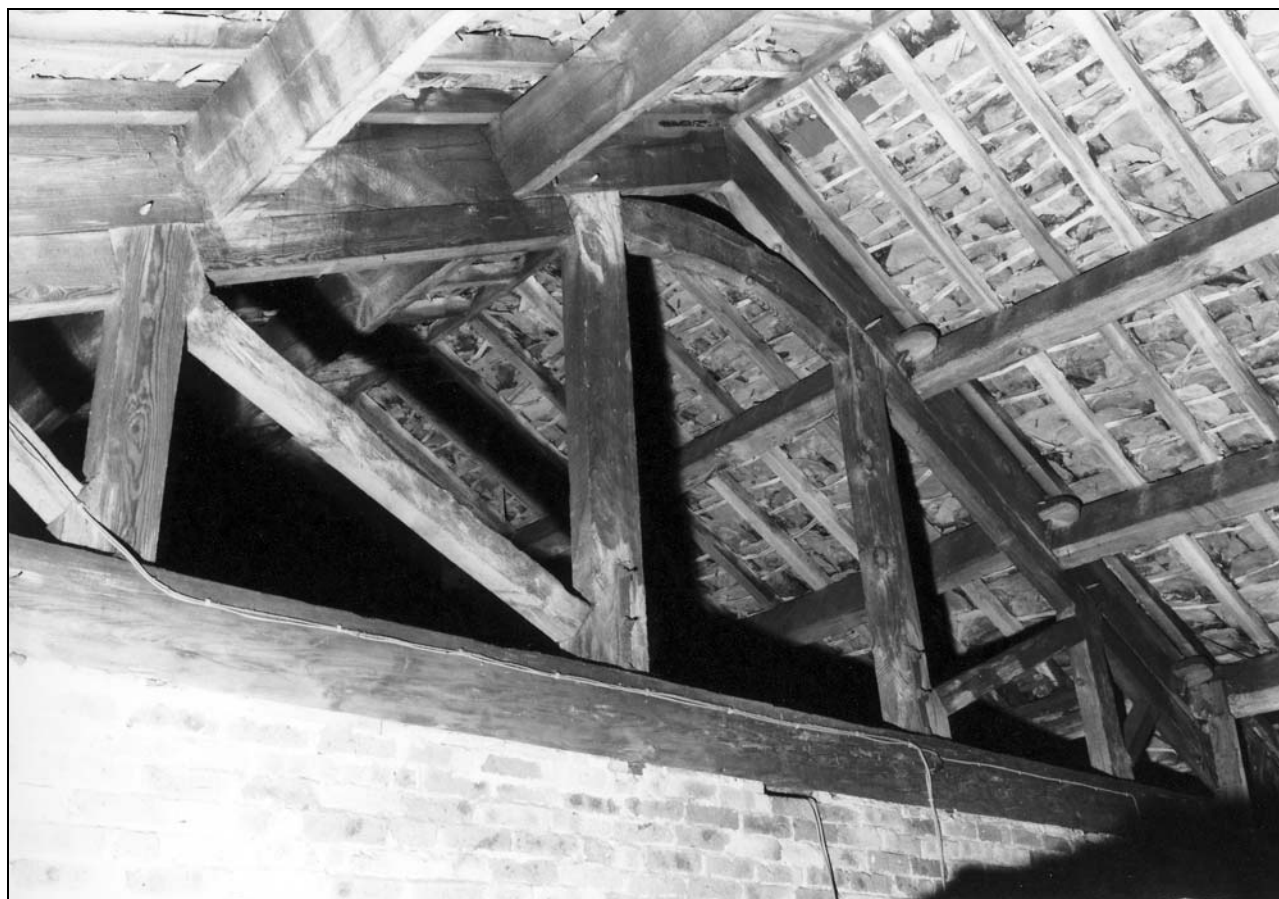
Photo 60: The east roof truss, from the north-west (film 4, frame 1)

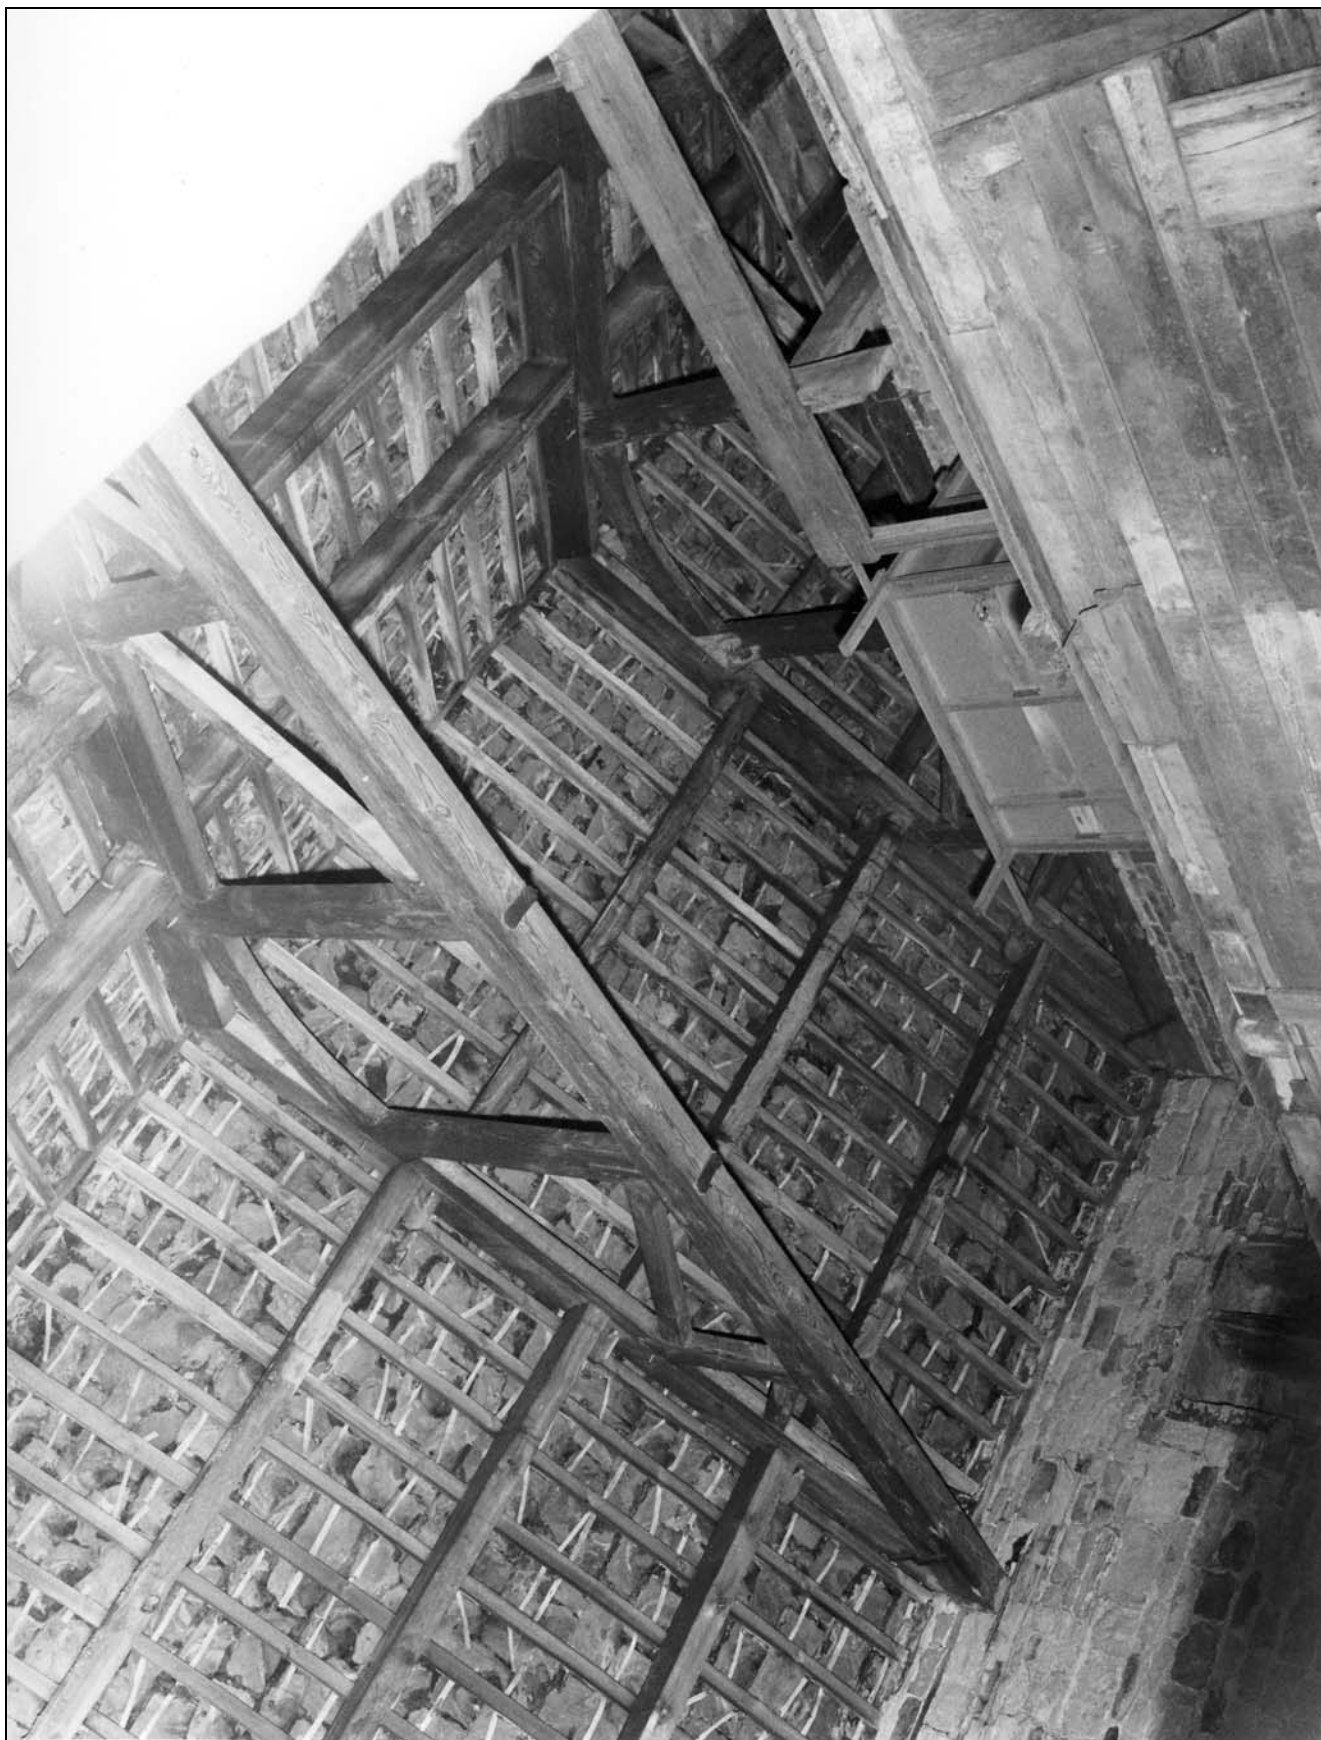
Photo 61: Underside of roof, from the south-west (film 3, frame 1)

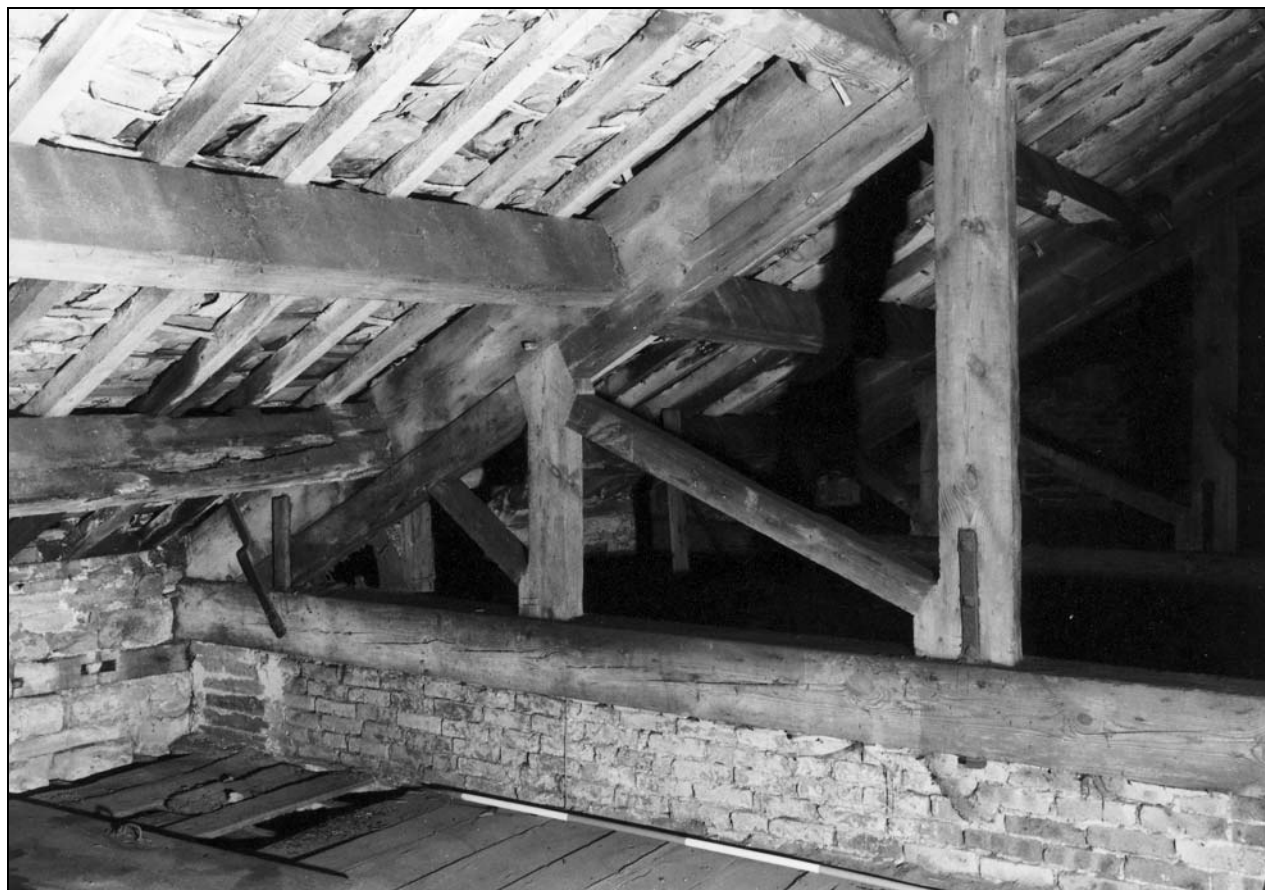
Photo 62: The east roof truss (south end), from the north-east (film 4, frame 13)

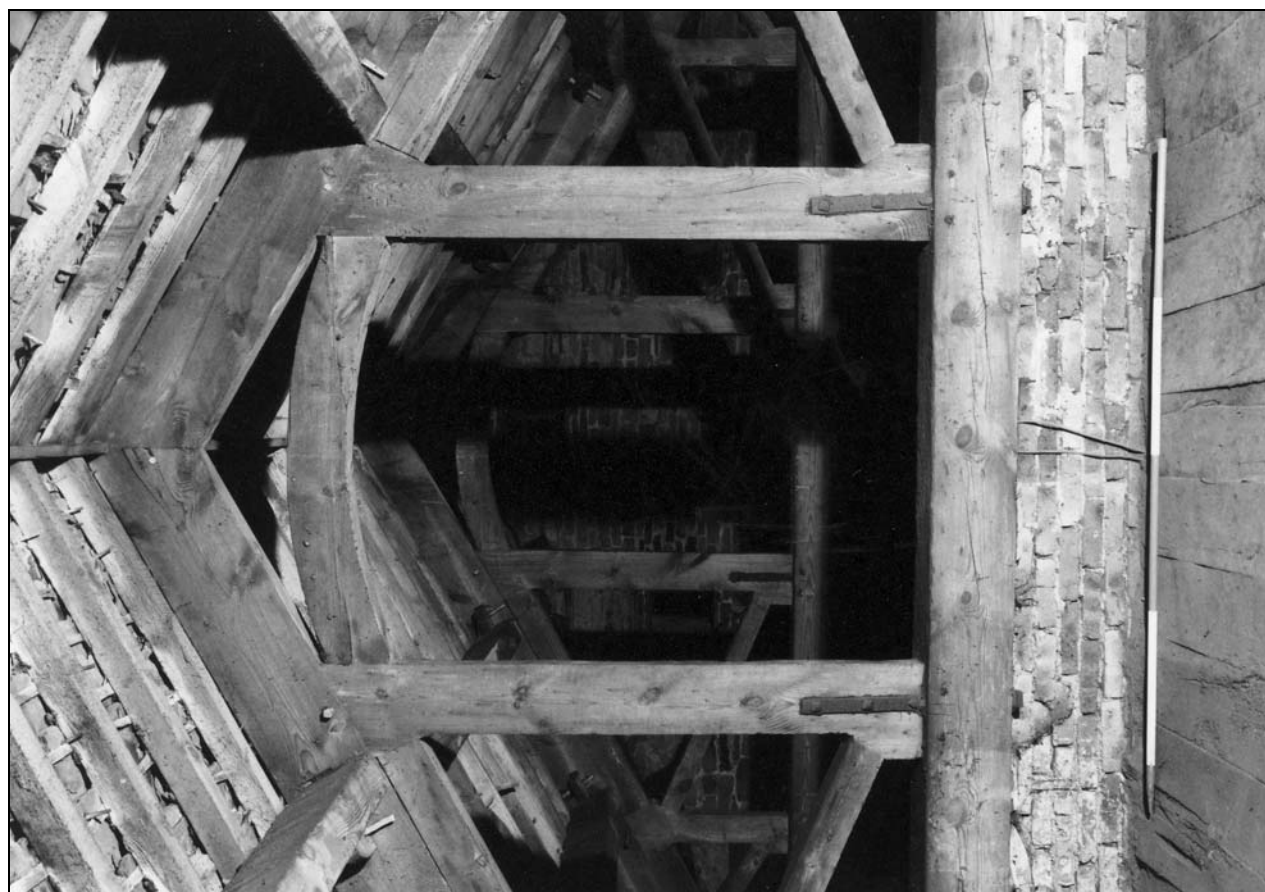
Photo 63: The east roof truss (central part), from the east (film 4, frame 15)

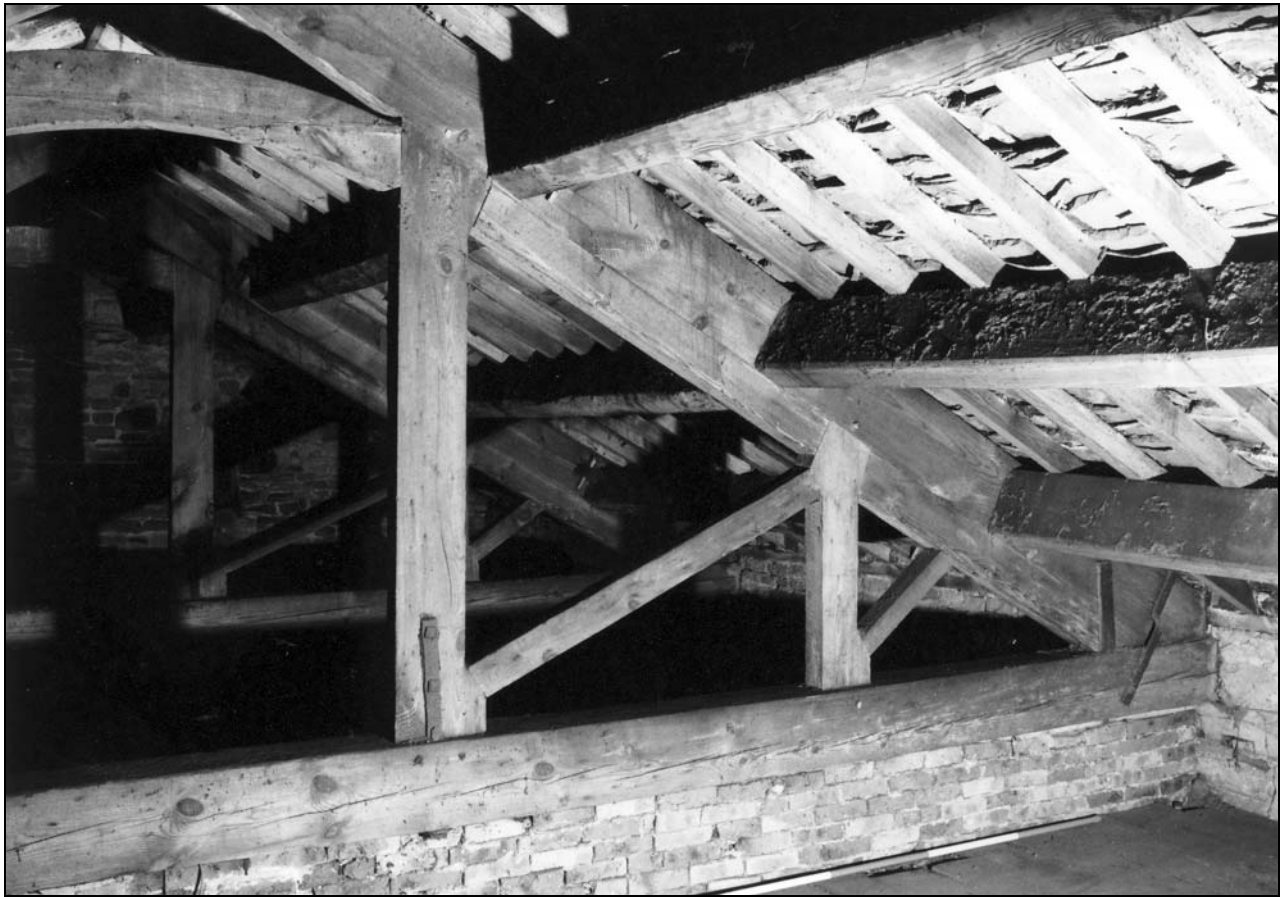
Photo 64: The east roof truss (north part), from the south-east (film 4, frame 16)

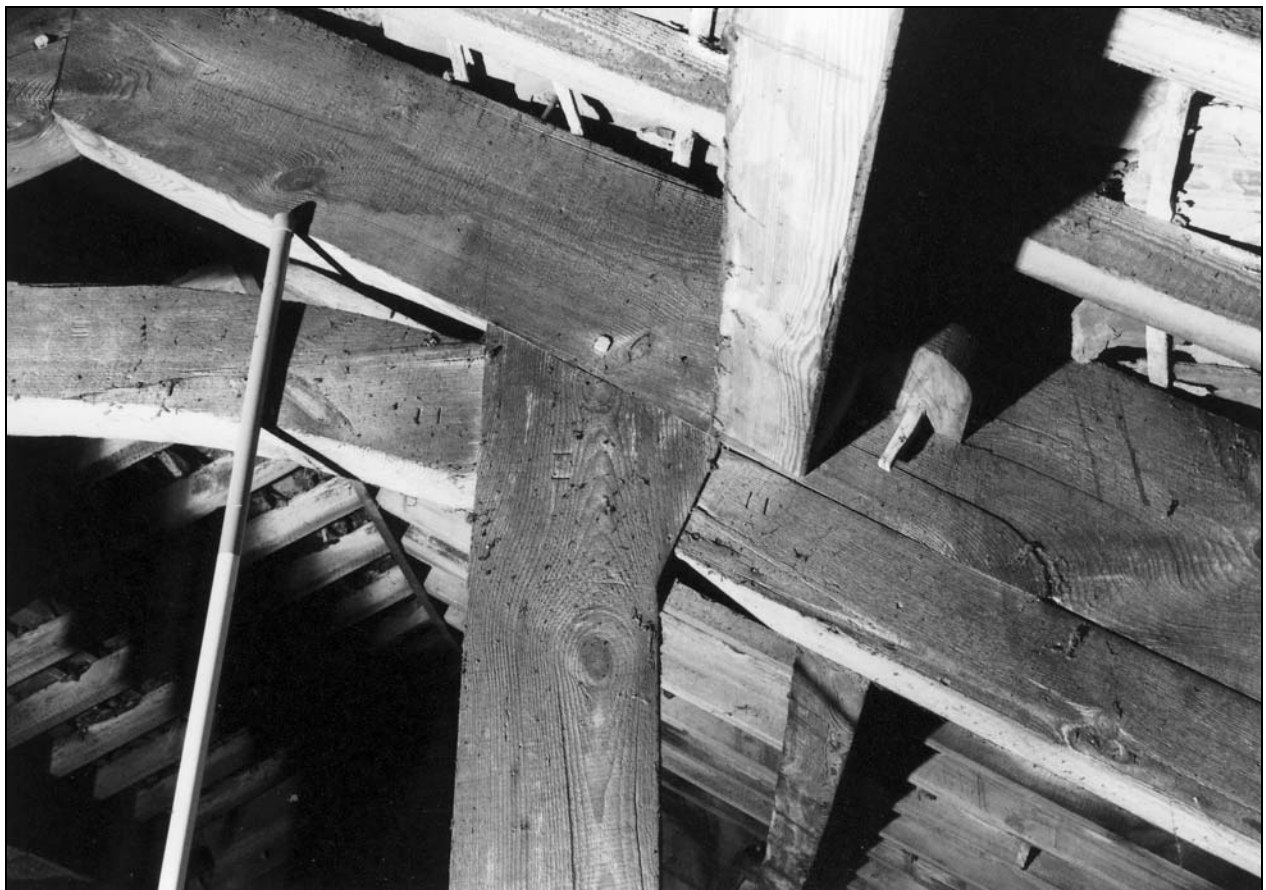
Photo 65: Detail of joints and numbering on east side of east roof truss (film 4, frame 17)
