Former Corn Mill
Mill Lane, Low Bradley, North Yorkshire:
Historic Building Appraisal and Impact Assessment

Historic Building Appraisal and Impact Assessment

SUMMARY

The former corn mill in Low Bradley (NGR: SE 00434871) is largely 18th century with later additions, but contains some earlier building fabric, of unknown but possibly medieval date. Its conversion to a shippon in the early 20th century has left few internal fixtures intact, but these include the hurst, which is 19th century. The wheel-pit, enclosed within a wheel-house, is largely infilled. This report sets out the readily available evidence for the building's history and considers the potential impact of a scheme for the conversion of this grade 2 listed building.

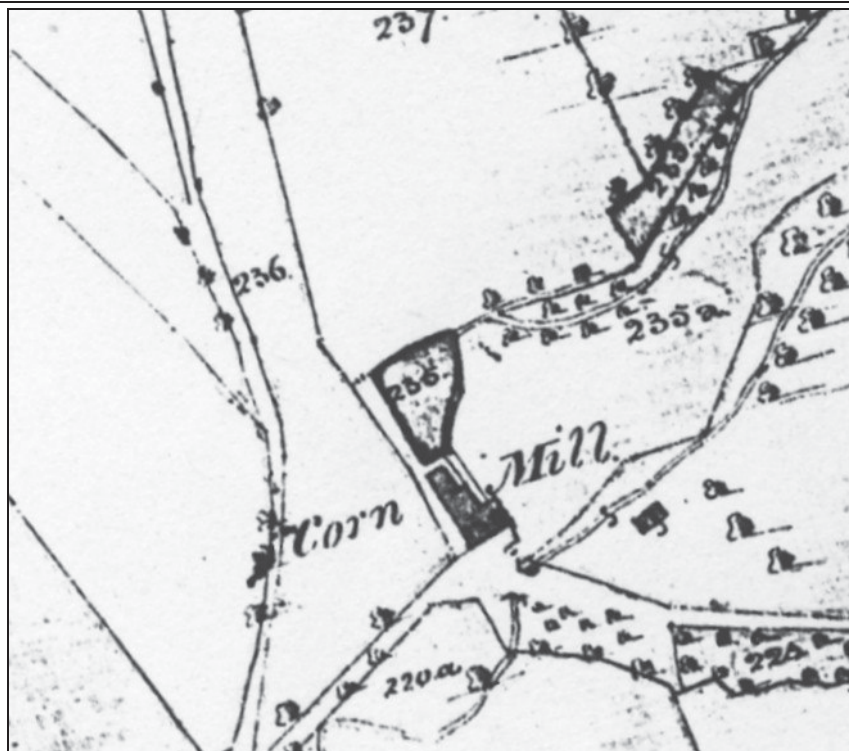
Figure 4: Extract from the 1842 tithe map of Bradleys Both, by Sam Swire (NYCRO MIC 1772/461-467)
Shows a more irregular building, with the head race apparently leading to a shorter wheel-house, and two separate ponds

- 5.3 In the following 50 years, and by 1842 when the tithe map of Bradleys Both was surveyed, the water supply was altered and two separate ponds are evident (Figure 4). The mill building itself (still named "Corn Mill" on the map) was served by a head race running parallel to its north-east side, and appears to comprise three different parts. Its outline differs from the present one in the fact that the wheel-house does not appear to be as long at that time, perhaps suggesting that the wheel may have been centred further to the south-east than at a time later in the 19th century. However, it is possible that the map is schematic to some extent and should not be taken too literally (Figure 5). It is

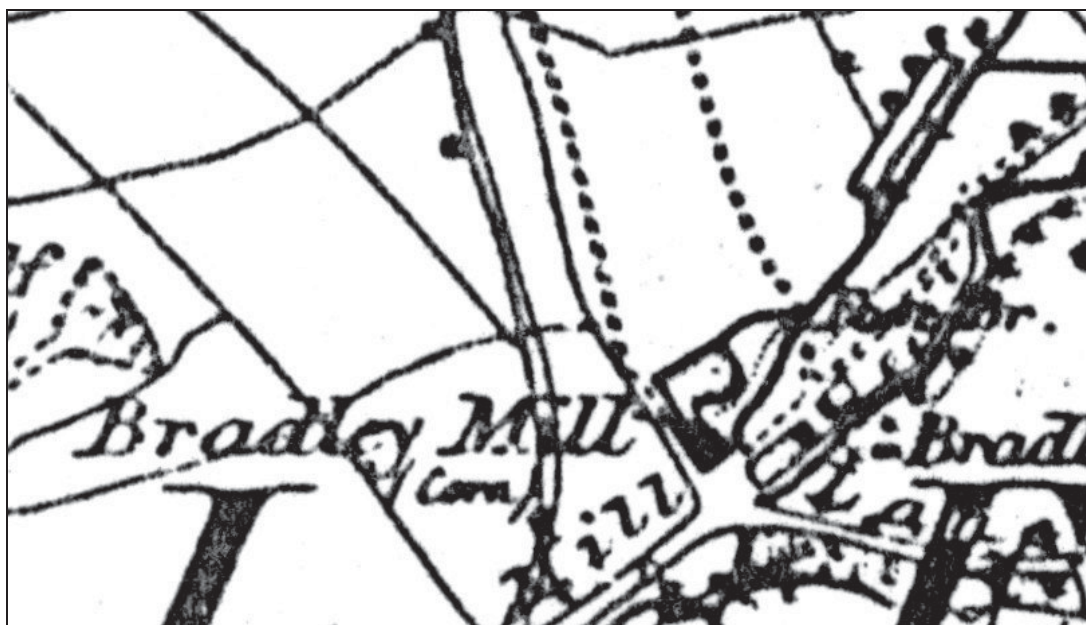
Figure 5: Extract from the Ordnance Survey 1st edition 6" to the mile map, surveyed 1850, published 1854
(Yorkshire, sheet 168) (here enlarged)
Shows essentially the same arrangement, but in less detail than the tithe map
