The Former Fremington Army Camp, Fremington, Devon

Results of an archaeological trench evaluation and
historic building survey

Planning reference: North Devon District Council 53147
(Condition 5)

Document No: ACD754/2/1

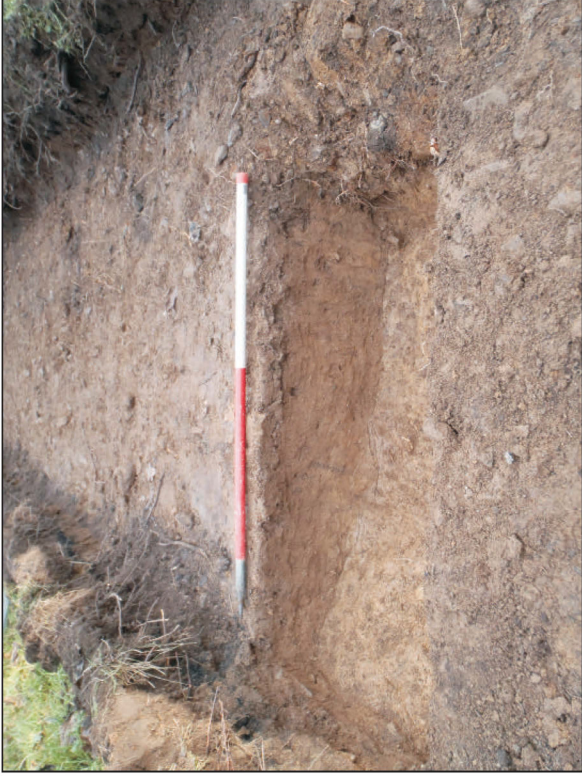
Plate 1: Ditch F1512 viewed from the west. 1m scale

5.2 Trench 15 (Plan and sections Fig. 3a-c; Plate 1)

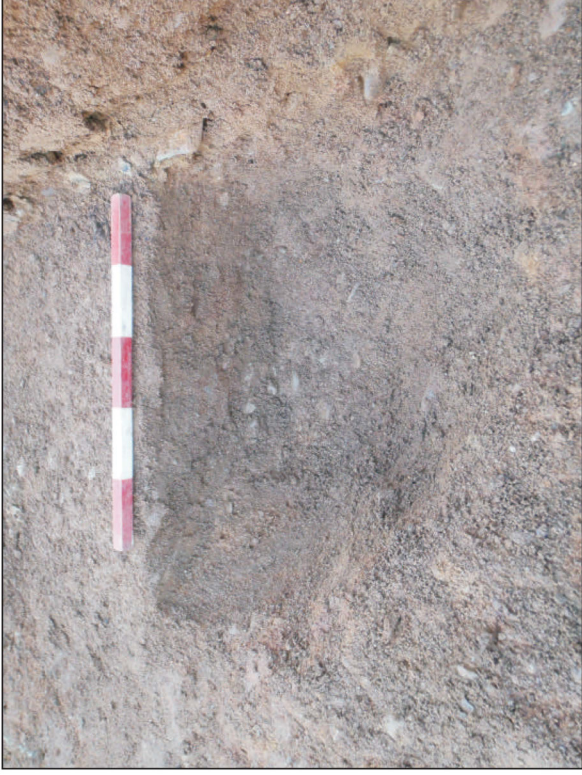
Plate 2: Ditch F2305 viewed from the north. 0.5m scale

5.3 Trench 23 (Plan and sections Fig. 3d-f; Plates 2 and 3)

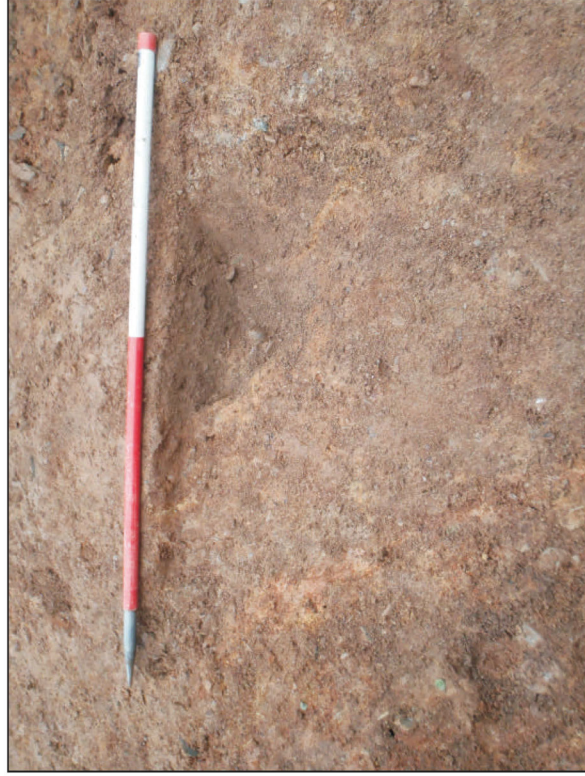
Plate 3: Ditch F2308 viewed from the south. 1m scale

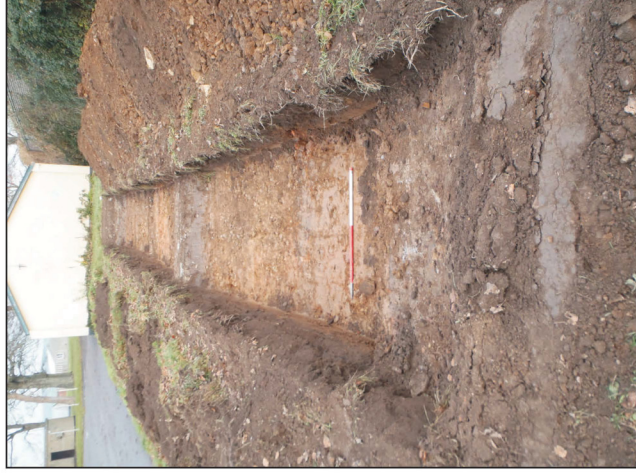
Plate 4: Trench 25 viewed from the south. 1m scale

5.4 Trench 25 (Plan and sections Fig. 4a-c; Plates 4 and 5)

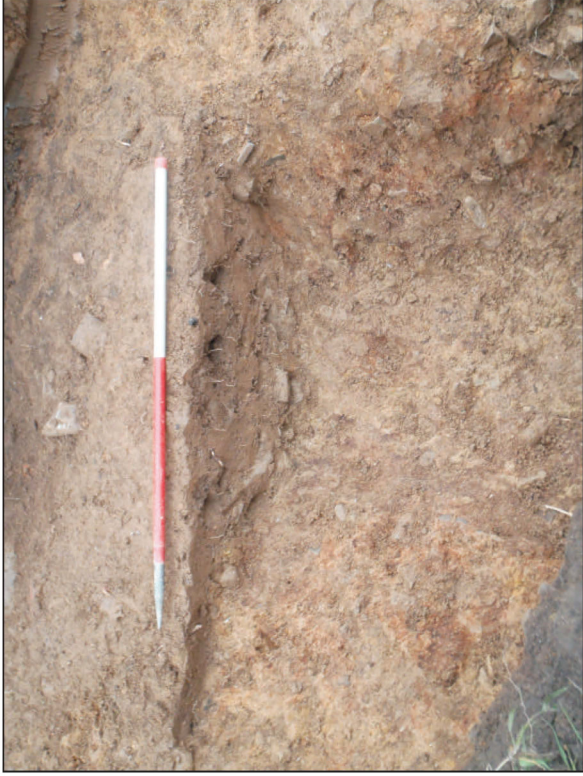
Plate 5: Ditch F2510 viewed from the southwest. 1m scale

The first of the two ditches, F2510, was aligned northeast to southwest and measured 1.90m long by 1.58m wide and 430mm deep. The feature had an asymmetrical profile with gradual to moderately steep edges and a flat base. It contained seven fills. The first (2514) was a 200mm deep, light blue to grey fine sandy clay with a well compacted consistency and inclusions of common well sorted tabular sandstone pebbles. Overlying this were three dumps of material (2515), (2516) and (2517). Context 2515 was a 560mm light brown silty sand clay with a moderate consistency and no inclusions. Context 2516 was 320mm deep and consisted of a light grey brown silty sand clay with moderate compaction and sparse sub-rounded gravels to 25mm in size. Context (2517) was similar in texture and composition to (2515) and (2516) but also contained sparse charcoal inclusions. It was only present in the southeast part of the feature and therefore does not appear on Fig. 4b. The upper most fills of the ditch (2519), (2520), (2521) and (2522) were composed of mid grey brown with red mottling sandy silts and silty clays which contained sparse sub-angular and sub-rounded stone inclusions especially mudstone, slate and sandstone fragments between 25-100mm in size. These contexts also contained frequent mortar, charcoal and CBM and a single sherd of late post-medieval pottery.

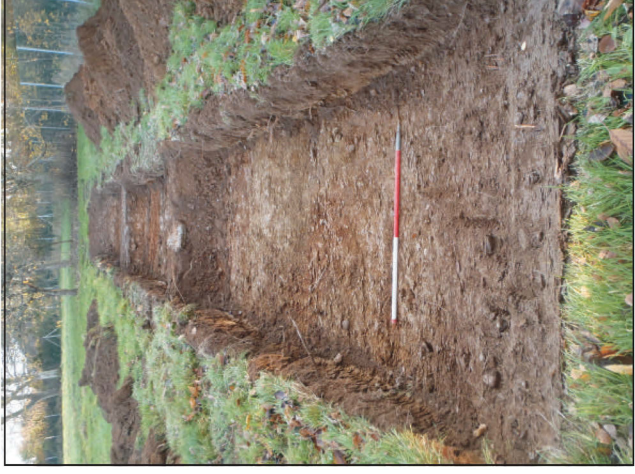
Plate 6: Trench 28 viewed from the west showing footings of demolished buildings. 1m scale

250mm of subsoil (2801) and 200mm of topsoil (2800). Two concrete footings of a demolished Second World War building were noted but not recorded in detail.

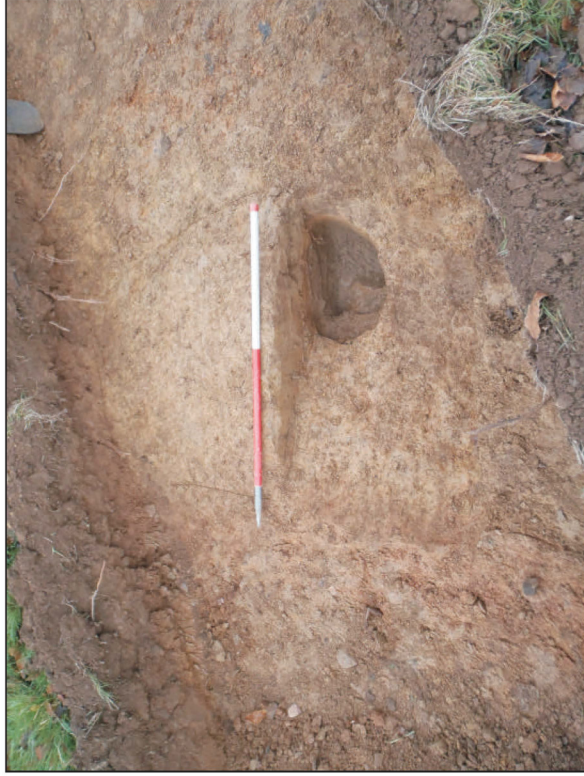
Plate 7: Ditch F2804 and post hole 2806 viewed from the east. 1m scale

5.5 Trench 28 (Plan and sections Fig. 4d-f; Plates 6 and 7)

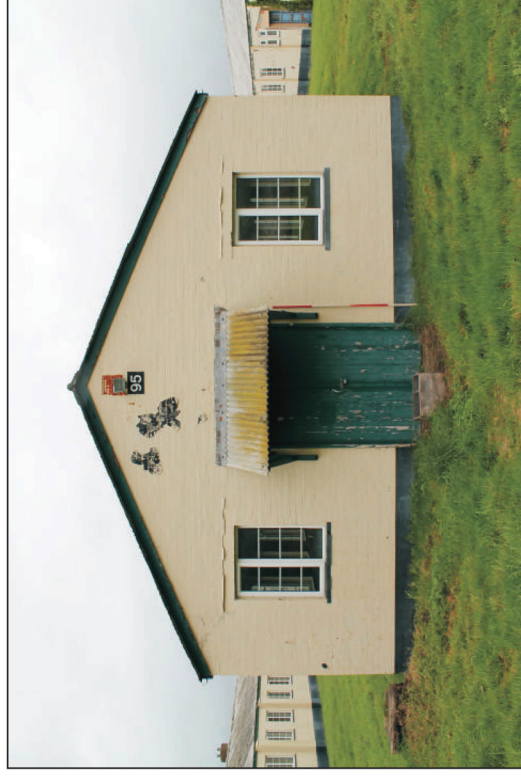
Plate 8: Building 66, gable elevation showing double doors, viewed from the southeast. 1m scale

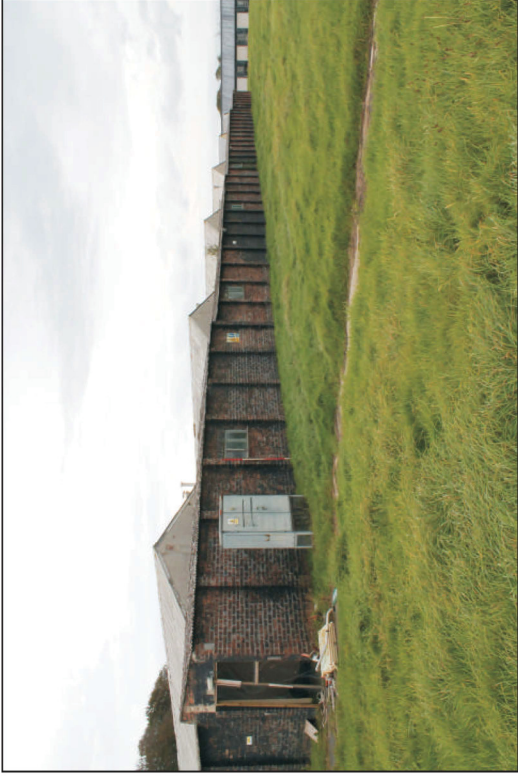
Plate 9: Building 42, walkway, viewed from the northeast.
2m scale

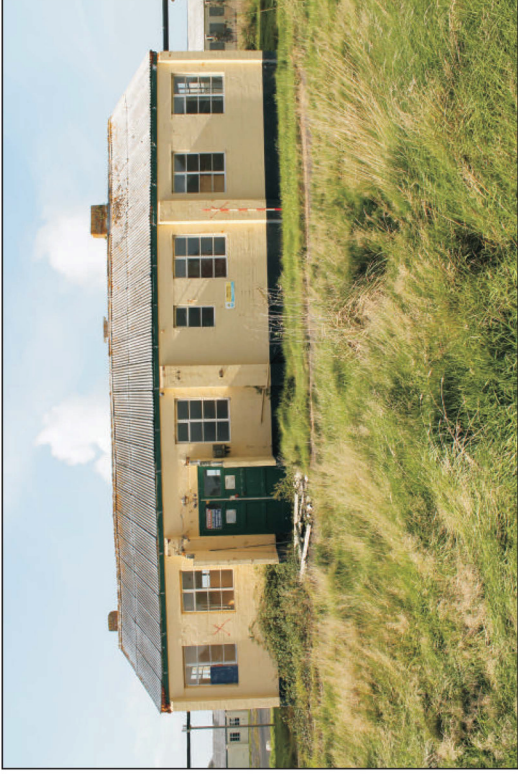
Plate 10: Building 3, east elevation viewed from the east.
2m scale

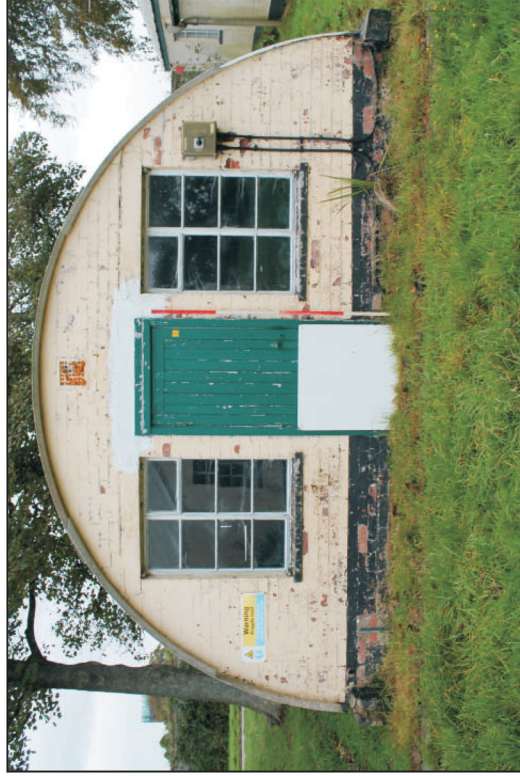
Plate 11: Building 60, curved asbestos hut, viewed from the west. 2m scale

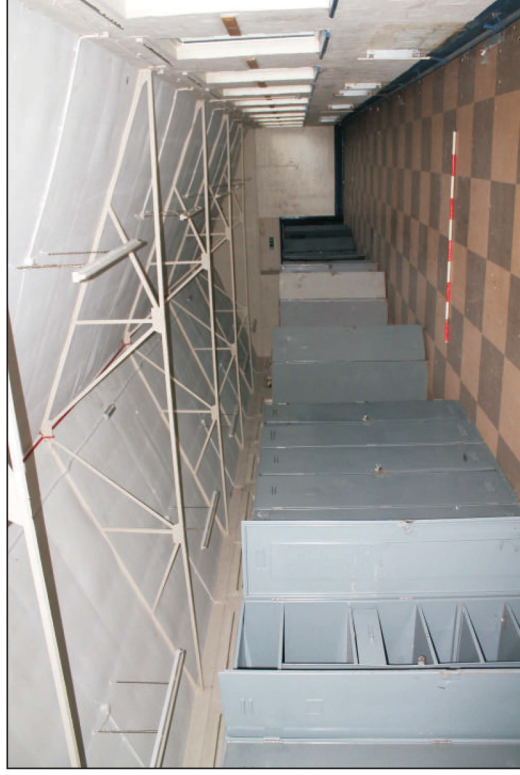
Plate 12: Building 7, ward showing open-plan ward and exposed roof truss viewed from the south. 2m scale

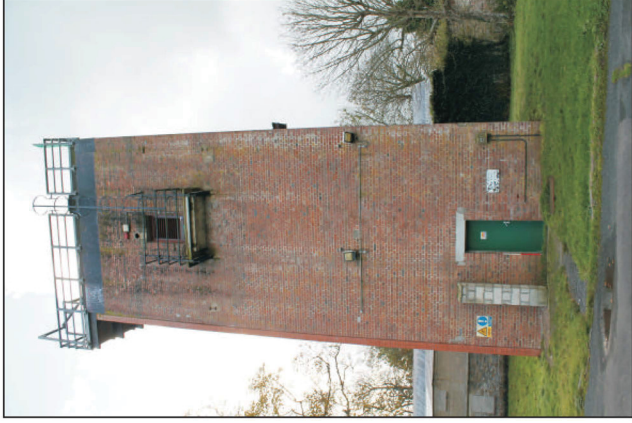
Plate 13: Building 76, water tower, viewed from the north. 1m scale

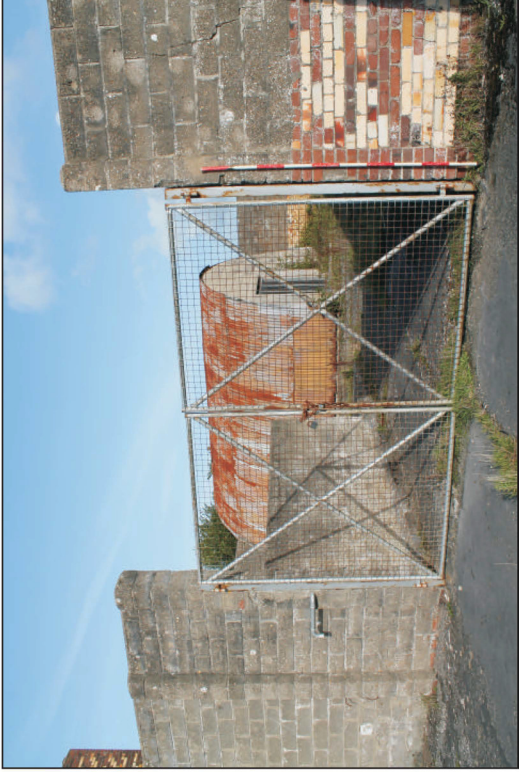
Plate 14: Building 14, store within compound, viewed from the west. 2m scale

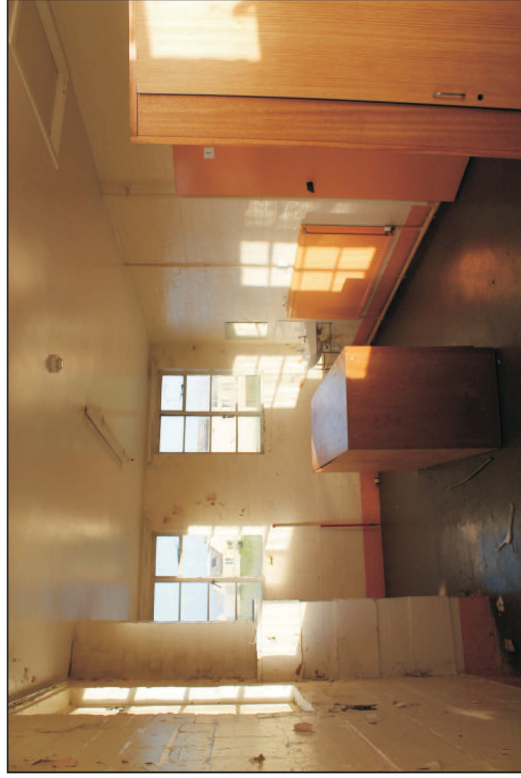
Plate 15: Building 3, accommodation block, interior showing chimney stack, viewed from the east. 1m scale

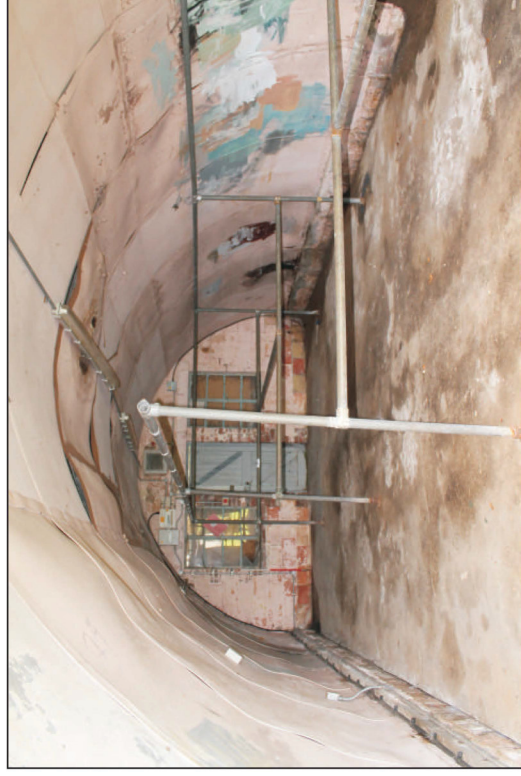
Plate 16: Building 64, interior of a curved asbestos hut, viewed from the west. 1m scale

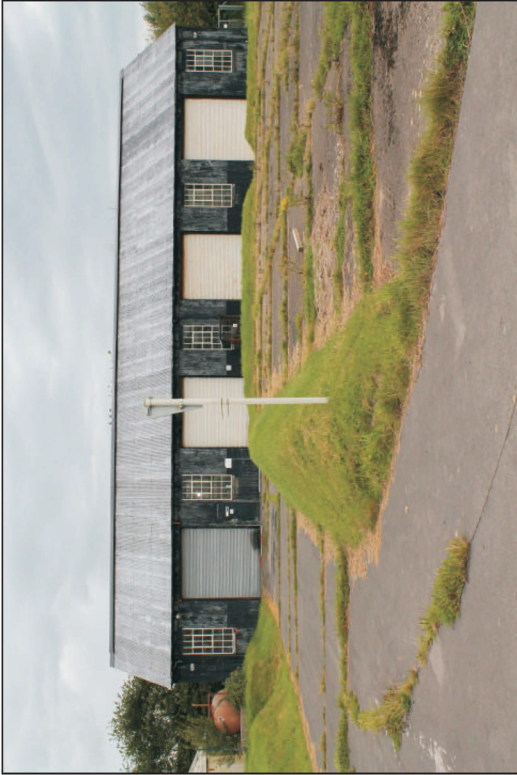
Plate 17: Building 49, post-war garage viewed from the east. 2m scale

There are three post-war buildings positively identified as constructed in 1946. The garage (building 49) has previously been identified as being of all corrugated iron construction, and as such the only one of this construction within the camp (Corcos 2011, plate 13). However, on all

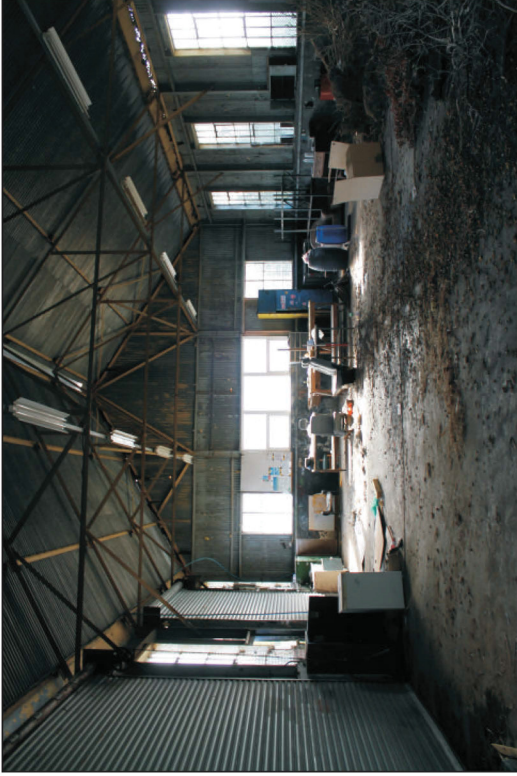
Plate 18: Building 49, post-war garage, interior, viewed from the north. 1m scale

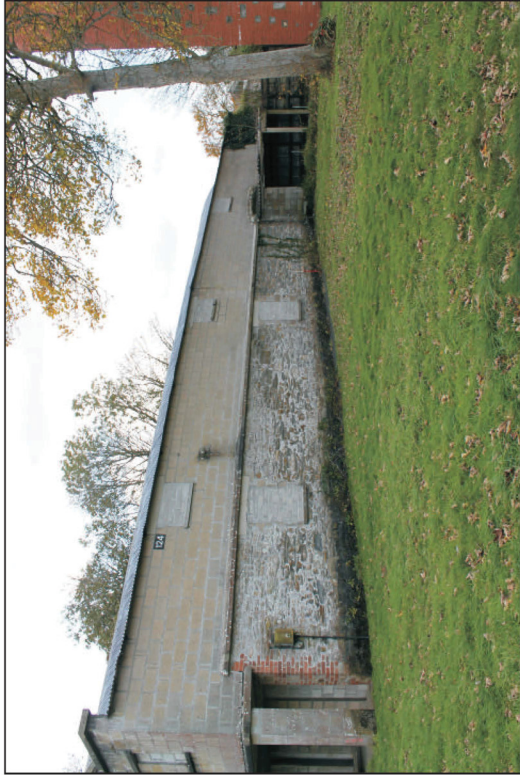
Plate 19: Building 77, The Ship showing the reused stone boundary wall, viewed from the northeast. 1m scale

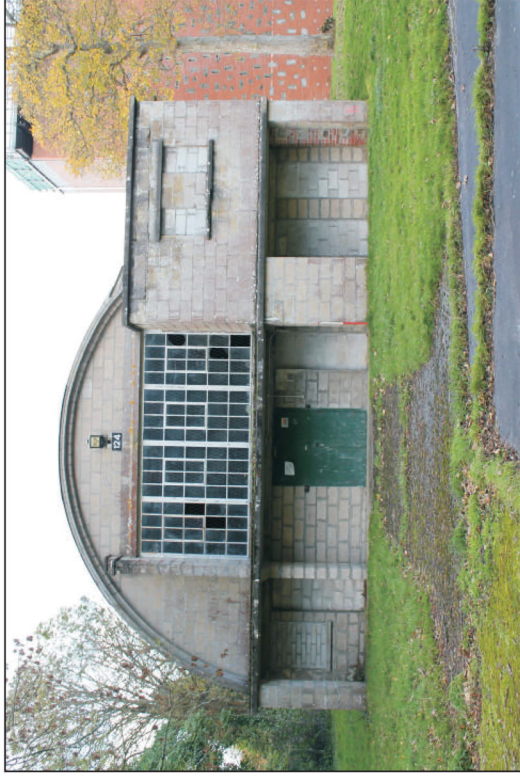
Plate 20: Building 77, The Ship, east elevation viewed from the east. 1m scale

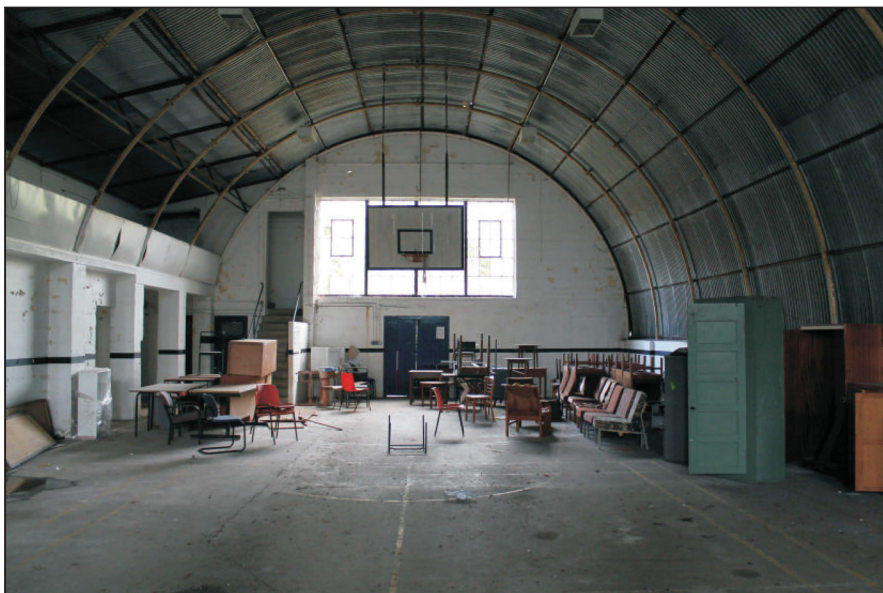
Plate 21: Building 77, The Ship, interior showing raised viewing platform to left, viewed from the west. 1m scale

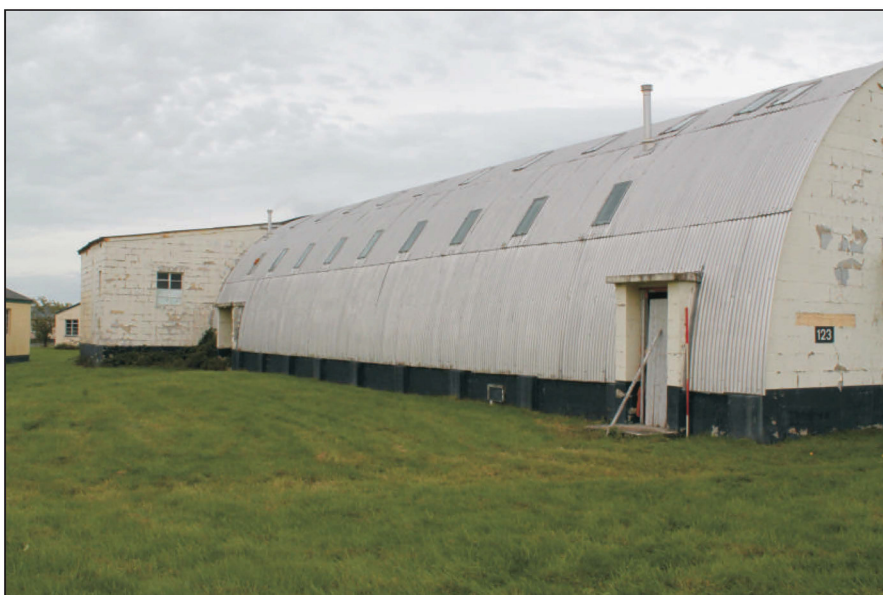
Plate 22: Building 35, Mountbatten Hall, viewed from the southwest. 2m scale

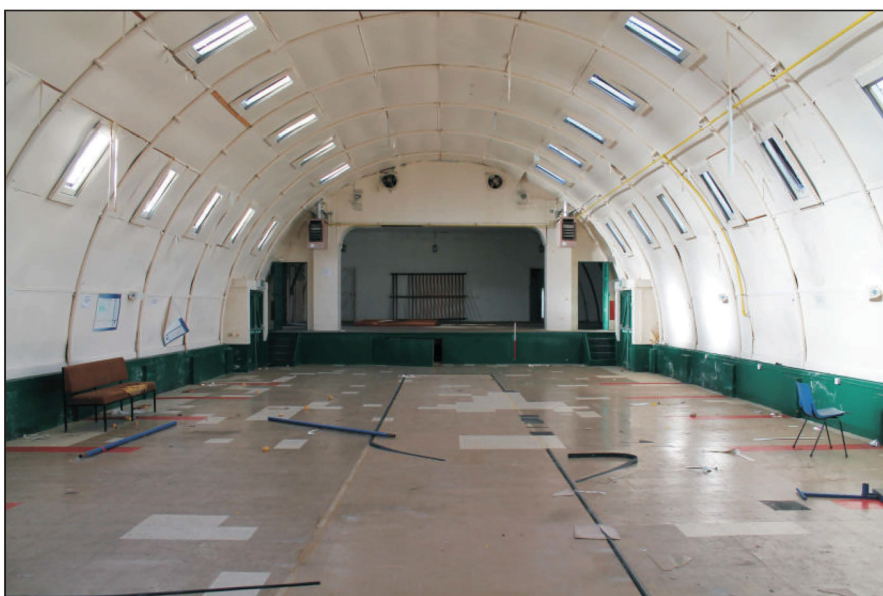
Plate 23: Building 35, Mountbatten Hall, interior viewed from the northwest. 1m scale
