# LAND ADJACENT TO BUCKLAND BREWER PRIMARY SCHOOL, BUCKLAND BREWER, DEVON

Results of an archaeological watching brief

Planning reference: Torridge District Council 1/0716/2012/FULM

Document No: ACD776/2/0

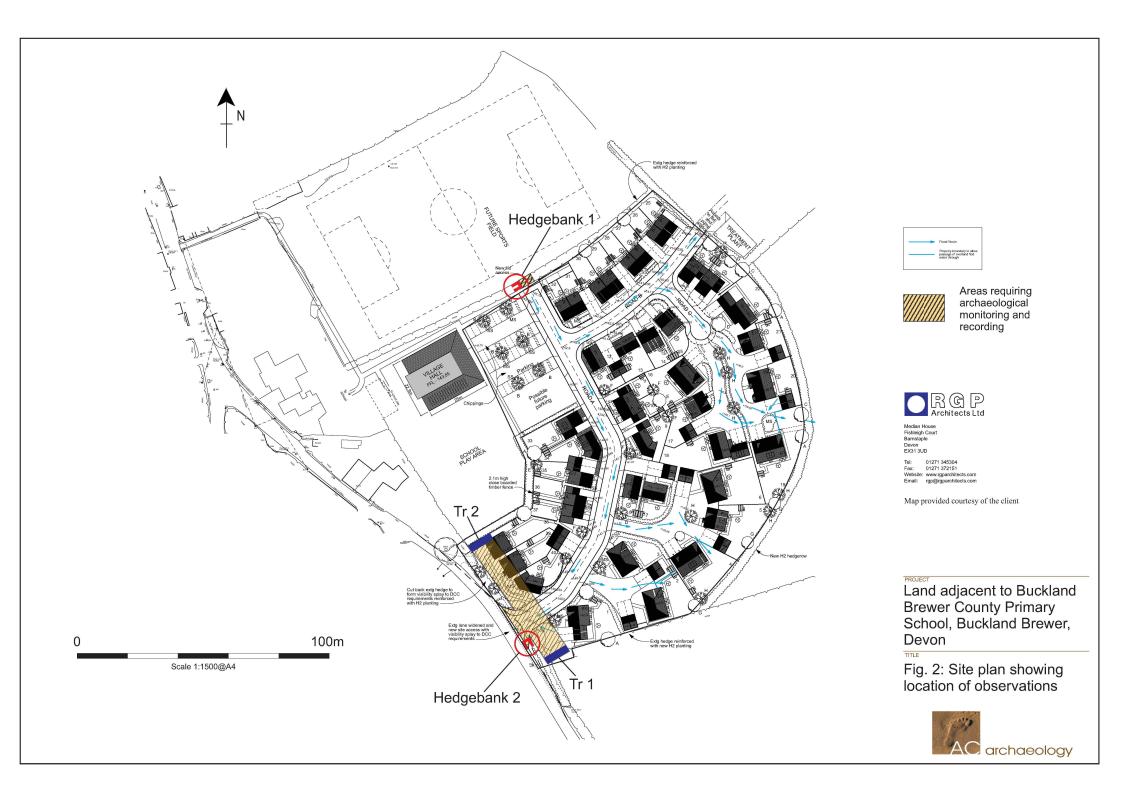
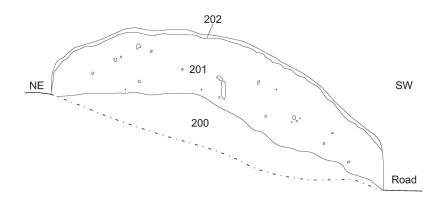
Fig. 3: Hedgebank sections

## a) NE facing section of hedgebank 1

## b) NW facing section of hedgebank 2

### Hedgebanks (Fig. 3; Plates 1-3)

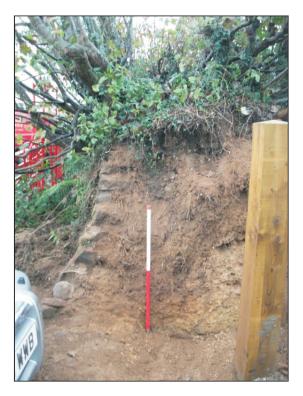
Plate 1: Hedgebank 1, south side, looking west. 1m scale

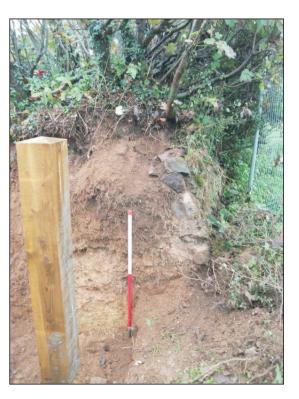
Plate 2: Hedgebank 1, north scale, looking west. 1m scale

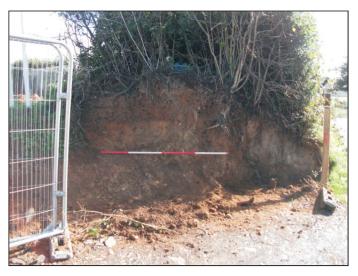
Plate 3: Hedgebank 2, looking southeast. 2m scale

Hedgebank 2 forms the southwest boundary of the site, adjacent to the main road into the village (Plate 3). This hedgebank was in the form of an earthen bank, the bulk of which comprised of a mid brown yellow clay loam (201) with sparse poorly sorted shale and sandstone cobbles and pebbles. This deposit was very mixed in its nature and is likely to derive from up-cast material re-deposited during the course of maintenance of the road. A single sherd of 13th-15th-century coarse-ware pottery was recovered from this fill (not retained). This deposit was sealed by a thin layer of peat-loam (202) derived from partially degraded leaf litter and other organic material. The breaching of the hedgebank cut into the underlying natural subsoil (200). This showed that the level of the natural subsoil in the roadway (observed as dropping away beneath the modern tarmac) had been cut or eroded to a level *c*.1.30m below that in the development site to the northeast, indicating the road way may be of some antiquity.

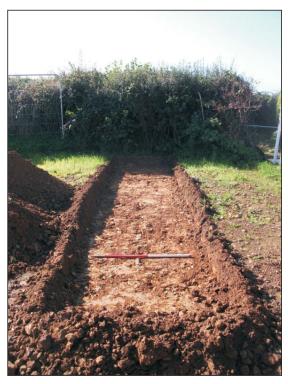
Plate 4: Trench 1, looking southwest. 1m scale

Trenches 1 and 2 were situated at right angles to hedgebank 2 (Figure 2; Plate 4) and were positioned to test the possibility that the road from the southeast into the village had followed a different course in the past. Both trenches were devoid of archaeological features. The exposed soil sequence in both trenches consisted of 0.08m of mid brownish yellow clay loam topsoil which directly overlaid the natural subsoil. The shallow depth of overburden may be due to landscaping of the site during groundworks associated with earlier stages of the development.
