Methodist Church Carne Hill St Dennis Cornwall

A programme of Historic Building Recording

REPORT

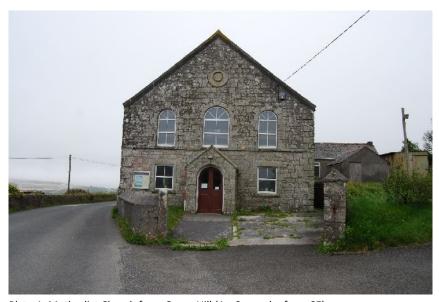
Plate 1. Methodist Church from Carne Hill (1 x 2m scale; from SE)

- 6.3 The imposing façade of the Methodist Church is visible along the south-eastern approach of Carne Hill, the ground in front defined on either side by a rubble wall enclosing hard standing (**Plate 1**). Also visible from this angle is the 20th century extension and detached outbuildings on the north-east side of the main church. The frontage is handsomely constructed and well-proportioned, faced with coursed dressed granite of variable sizes and quoins of large granite side-alternating blocks, standing slightly proud of the main wall and defined by chamfered edges (**Plate 2**). Two rows of windows are separated by a string-course with upper straight chamfer; the two lower windows on either side of the porch are rectangular with monumental granite lintels and sills, while the three upper windows are round-headed with radiating granite voussoirs of alternating larger and smaller sizes, the central window being of grander proportions.

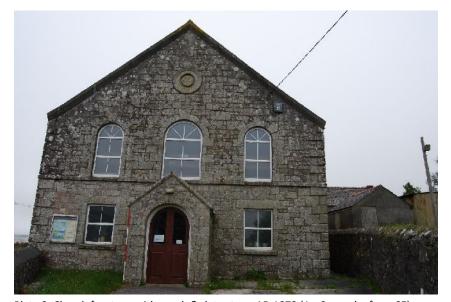
Plate 2. Church frontage with porch & date stone AD 1872 (1 x 2m scale; from SE)

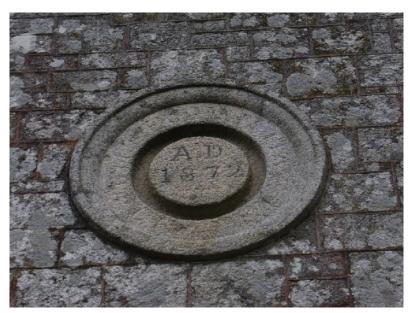
Plate 3. Date stone in gable of church frontage (from SE)

- 6.4 Within the gable apex, directly above the larger central window, is a circular stone comprising a central roundel carved with the date AD 1872, surrounded by three radiating orders comprising a concave recess, then a raised flat surface with traces of eroded letters, and finally a quarter roll mould with billet (**Plate 3**). The small porch emulates the same design as the frontage, with radiating voussoirs of alternating sizes above the round-headed door and gable roof with stone eaves, which also have a straight chamfer identical to those used for the main roof (**Plate 4**). Decorative clay ridge tiles provide additional ornamentation.

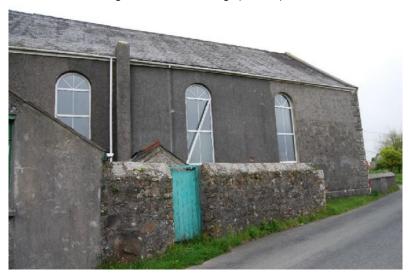
Plate 5. SW side of church from road (1 x 2m scale; from SW)

- 6.5 Each of the long flanks contain three of the round-headed windows (Plates 5 & 6) although the sills of the two north-western windows are higher (making the windows shorter) due to the presence of internal doors below leading to the kitchen on the south-west side (Plate 7) and the north-east extension on the opposing side (Plate 8). The south-west flank is rendered with concrete however the rubble facing of the north-east wall is exposed. The stone surrounds of the windows are visible and are notably simpler than the precisely cut window dressings in the frontage. A change in the render at the southern window of the south-west flank is coterminous with the position of the frontage shown on the 1881 OS map, prior to the church being extended/ re-built to its current length (Plate 5). This also corresponds with the north-east return of the boundary wall constructed of random rubble and depicted on mapping from 1881 (Plate 9). Importantly, a corresponding change in fabric is not evident in the north-easterly wall, where the rubble facing is identical throughout (Plate 6).

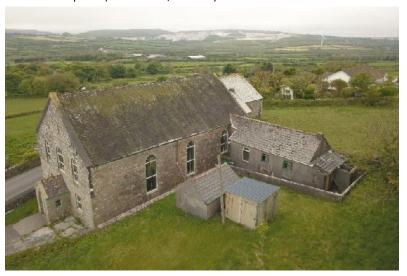
Plate 6. Aerial view showing NE side of church & frontage (from ENE)

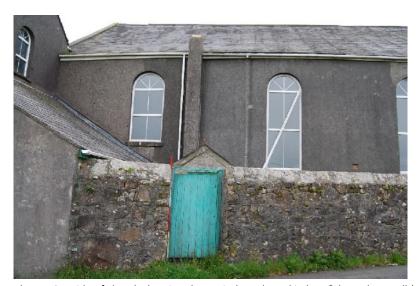
Plate 7. SW side of church showing short window above kitchen & boundary wall (1 x 2m scale; from SW)

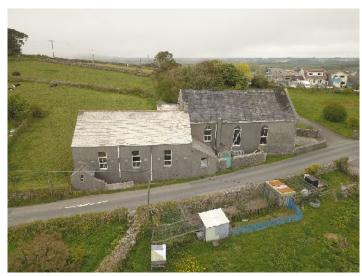
Plate 9. SW side showing rubble wall enclosing attached structure (from SW)

Attached to the south-west flank of the church is a small structure with crested clay ridge tiles; this looks historic from the outside but is actually constructed of concrete blocks (Plate 9). There is no connecting door to the interior. The organ housing is certainly a later addition; externally this is only visible from the field behind the church (Plate 10). Although historic mapping shows it first present by 1907, the same as the Sunday School, the north-east wall of the latter (dated 1893) clasps the north-west corner of the organ loft (Plate 11). Constructed of coursed random rubble with a single hatched window opening with depressed arch, the fabric is notably different from the small rubble and wider mortar joints of the Sunday School building (Plate 12). Inside the organ loft, the original 6-pane vertical sliding sash is extant behind the shutter. The north-east flank of the Sunday School contains two rectangular-headed windows with simple granite surrounds; there are an identical two windows in the north-west end and three further identical windows in the south-west elevation, although the surrounds of the latter are obscured by render (Plate 13). This is also true of the south-east facing wall above the lean-to roof of the kitchen, which contains a single arched window (Plate 9). A series of seven memorial plaques are ranged high-up along the wall; some words and names can be made-out but they are largely illegible (Plate 14). The use of smaller rubble for the porch, as evident in the exposed stone walling of the north-west face, might suggest a slightly later addition that provided the children with a separate entrance, the door facing south-east therefore not leading directly onto the road. Chimneys of grey bricks are present at either end of the Sunday School roof, evidence for the provision of heating within this part of the church.

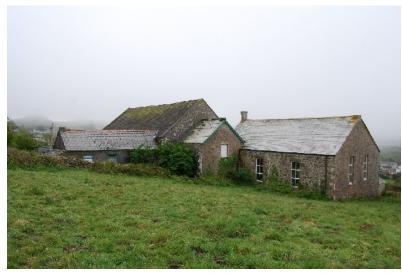
Plate 10. NE side showing organ loft clasped by Sunday School (1 x 2m scale; from NNW)

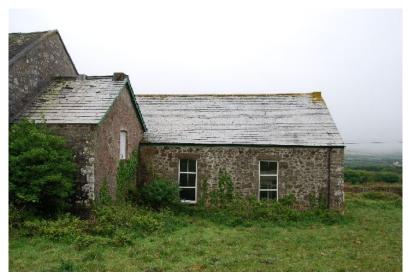
Plate 11. Organ loft & Sunday School (1 x 2m scale; from NE)

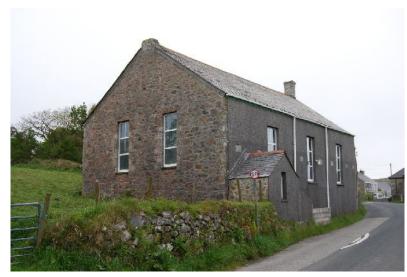
Plate 13. Sunday School (1 x 2m scale; from W)

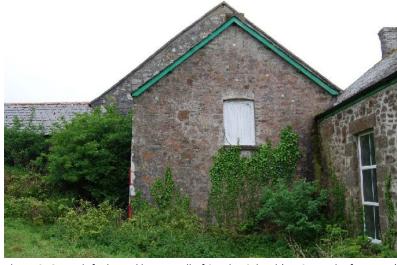
Plate 12. Organ loft clasped by NE wall of Sunday School (1 x 2m scale; from NW)

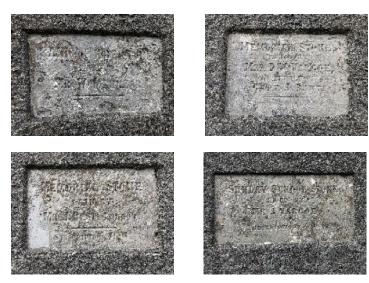
Plate 14. Memorial stones in SW wall of Sunday School (from SW)

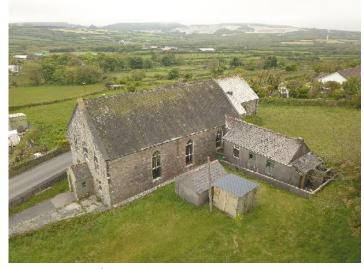
Plate 15. NE side of church showing mid-C20 extension & detached stores in foreground (from NE)

6.7 The 20th century extension to the north-east is terraced into the rising ground towards the east (**Plates 15** & **16**). The gabled roof has a single chimney at the north-east end, and the roof material is slate. There are two wooden double-framed windows with top-openers and one modern UPVC window in the south-east flank (**Plate 17**), and two wooden single-framed windows with top openers in the north-west elevation (**Plate 10**) (dense foliage may obscure a third window, also concealed on the interior by modern cladding). The utilitarian form of the building indicates a 1920's/1930's construction date, although the windows are later; the two wooden frames in the south-east flank sit within openings that have been shortened, with evidence of blocking beneath the sills. An identical window is also present in the south-west wall of the kitchen. The lean-to at the north-east end of the north-east extension, housing an outside W.C. and store, is probably similar in date. Access is via a walkway alongside the north-east flank of the church, with a retaining wall enclosing a grassed area with detached gabled outhouse of similar date to the extension, and a further store constructed of corrugated metal sheets (**Plates 15-17**).

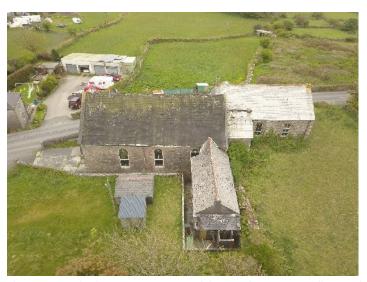
Plate 16. NE side showing extension with lean-to & retaining wall around walkway (from NE)

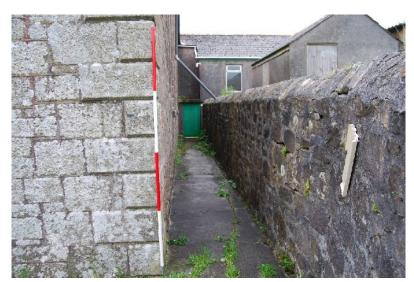
Plate 17. Walkway from front of church to outside w.c. & store (1 x 2m scales; from SE)

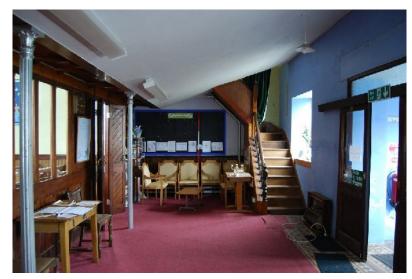
Plate 19. Entrance vestibule (1 x 2m scale; from SW)

- The floor of the front porch is laid with decorated Victorian tiles (**Plate 18**), providing the only access to a handsomely proportioned entrance vestibule floored with the same tile pattern (**Plate 19**). The vestibule is symmetrical with a staircase in each corner leading to the tiered gallery, the sloping underside of which is supported on ornate iron columns. The vestibule is separated from the main body of the church by a decorative timber partition, with two pairs of doors giving access to the two aisles and centrally placed glazing providing a view of proceedings (**Plate 20**).

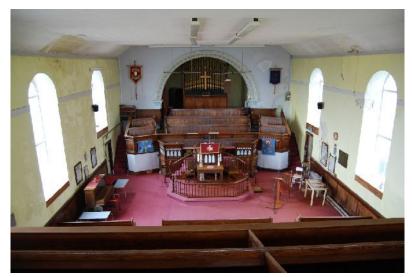
Plate 21. View from gallery to altar, rostrum & choir (1 x 2m scale; from SE)

- 6.9 Looking north-west from the gallery the interior décor is of one period, with no evidence of a building-break adjacent to the southern windows and, similarly, no interruption to the cornicing or string-course (Plate 21). The windows have a continuous single straight splay and a flat sill. The church furniture is predominantly of one period and utilizing pine, stained red; the Victorians used an ochre-based dye to achieve this colour. The panels surrounding the gallery, rostrum and choir stalls are of the same design, as are the bull-nose pew ends for the congregational seating, gallery tiers and choir benches (see Plates 22 & 23), the latter equipped with fold-down seats between the benches. Diagonal panelling in the vestibule partition is also present in the rostrum panelling, however the lighter-coloured pine in the former is replacement timber (Plate 23). The altar table sits on a hexagonal platform with front rail. Decorative foliate plasterwork adorns the inner order of the rounded arch for the organ housing, with a row of acanthus leaves below the imposts (Plate 24). The area beneath the choir stalls and organ loft is accessed from the Sunday School room, and is filled with a robust timber framework to support the weight above; dry rot was observed to be extensive across these timbers. A door is positioned below each of the opposing shorter northern windows, their symmetrical positions and the joinery style perhaps suggesting they formed part of the Victorian design.

- 6.11 The door in the north-east flank of the church leads to the north-east extension (**Plate 21**); it is identical to the opposing door in the south-west flank and is therefore likely to pre-date the 20th century extension. A staircase provides access to the first-floor (the space below was not viewed but may not have a function), which contains a pine-panelled room (**Plate 30**) and more recent partitions to create a W.C. and offices.

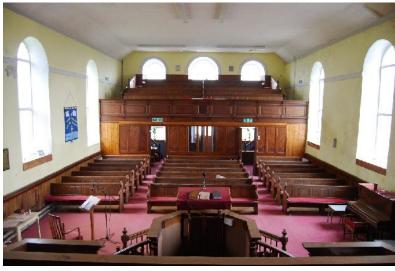
Plate 20. View from choir to gallery above entrance vestibule (1 x 2m scale; from NW)

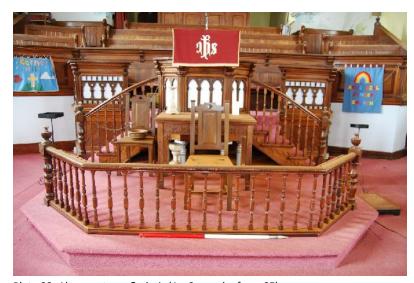
Plate 22. Altar, rostrum & choir (1 x 2m scale; from SE)

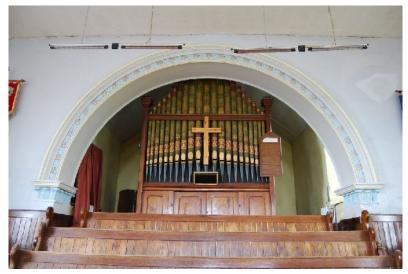
Plate 24. Decorative arch for organ housing, with bullnose choir bench ends (from SE)

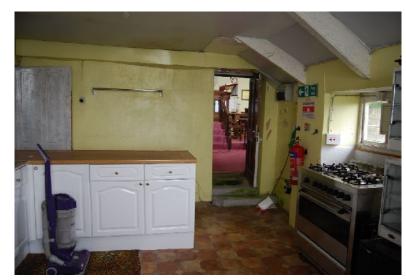
Plate 25. Kitchen (former porch) looking through to church, with Sunday School door on left (from SW)

- 6.10 The door in the south-west flank of the church leads to a kitchen (Plate 25), formerly a porch, and through to the large hall that is the Sunday School room (Plate 26). A further door in the south-east corner provides access to the support structure beneath the organ loft and choir stalls of the church. A gallery is located across the north-west end of the Sunday School hall supported on decorative iron columns (Plate 27); the original panels forming the balcony frontage are extant, although the height has been raised using plywood. The windows have single straight splays to each side and a sloping sill, with a flat lintel above, and the exposed roof structure comprises scissor trusses (Plate 28). A scar in the north-east corner of the building shows the location of the original stairs to the gallery, (Plate 29), now replaced by a wooden staircase on the opposite side. The grey render of the hall is painted with regular black lines to emulate masonry.

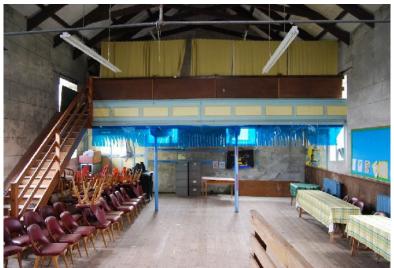
Plate 27. Gallery above Sunday School hall (1 x 2m scale; from SE)

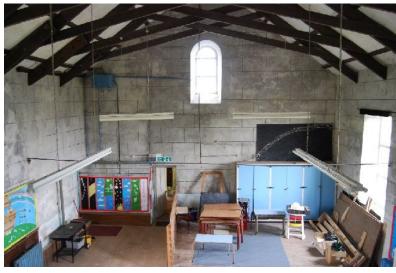
Plate 26. Sunday School hall from gallery, with door to kitchen (1 x 2m scale; from NW)

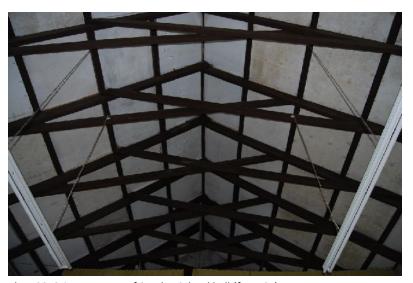
Plate 28. Scissor trusses of Sunday School hall (from SE)

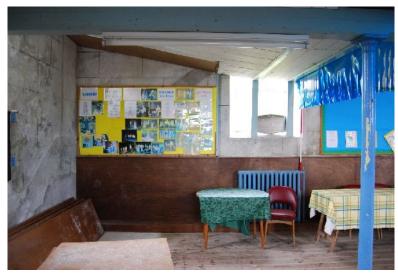
Plate 29. Position of former stairs to gallery of Sunday School hall (1 x 2m scale; from SW)

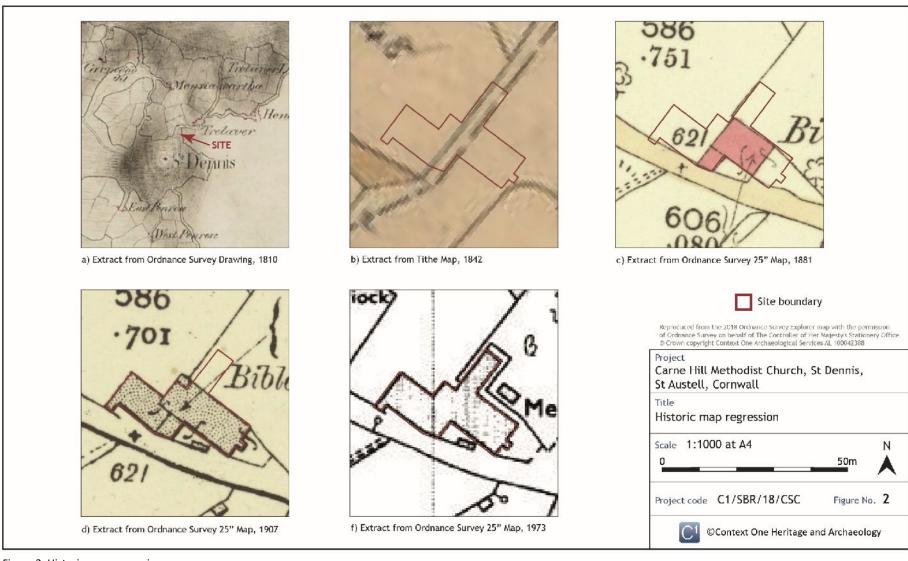
Figure 2. Historic map regression

- The maps referred to in the following account are held at the Cornwall Records Office, or are available in digital format, and are listed in **Appendix 1**. Extracts of selected maps are presented in **Figure 2**. The earliest available map is an Ordnance Survey drawing of 1810 (**Figure 2**, **a**), which is small in scale but shows no buildings. The 1842 St Dennis Tithe Map (**Figure 2**, **b**) shows the Site as part of a large field as opposed to open ground. The current Carne Hill Road, only extended down from the north-west as far as the north-western corner of the current Site, where it met a track which ran north-east to south-west along what is now the north-west boundary of the Site (*ibid*.). The south-west boundary of the Site is similar to the line of the field boundary shown on the Tithe map, and a small building is shown midway along it. The parcel is not numbered and may have represented waste ground.

- 5.6 The 1907 OS map (**Figure 2, d**) reveals that by this time the chapel had either been elongated or re-built on a longer plan with the frontage situated *c.* 5.5m further to the south-west and closer to the road, giving a total length of *c.* 19.5m, although the width remained the same. A porch had been added to the chapel frontage, along with an extension to the north-west end, slightly narrower in width than the main body of the church. Combined this gives a total length of *c.* 25m for the church building with additions. The Sunday School clasped the north-west corner of the church extension, adjoining the original porch or annex at the north end of the south-west elevation. This also had a small porch at the north end of its south-west elevation, again bordering the road. The 1973 OS map (**Figure 2, f**) shows further expansion of the church building, now labelled Carne Hill Methodist Church, with a north-east extension to the northern end. This is bordered by a parallel line representing the retaining wall continuing along the north-east side of the driveway. A small rectangular outbuilding is depicted on the north-east side of this wall.
