THE COACH HOUSE, SANDAL GRANGE FARM,
WALTON LANE, SANDAL MAGNA,
WEST YORKSHIRE

BUILDING RECORDING

Report no: 2012/422.R01
Version: Final
Date: July 2012
Author: Shaun Richardson & Ed Dennison

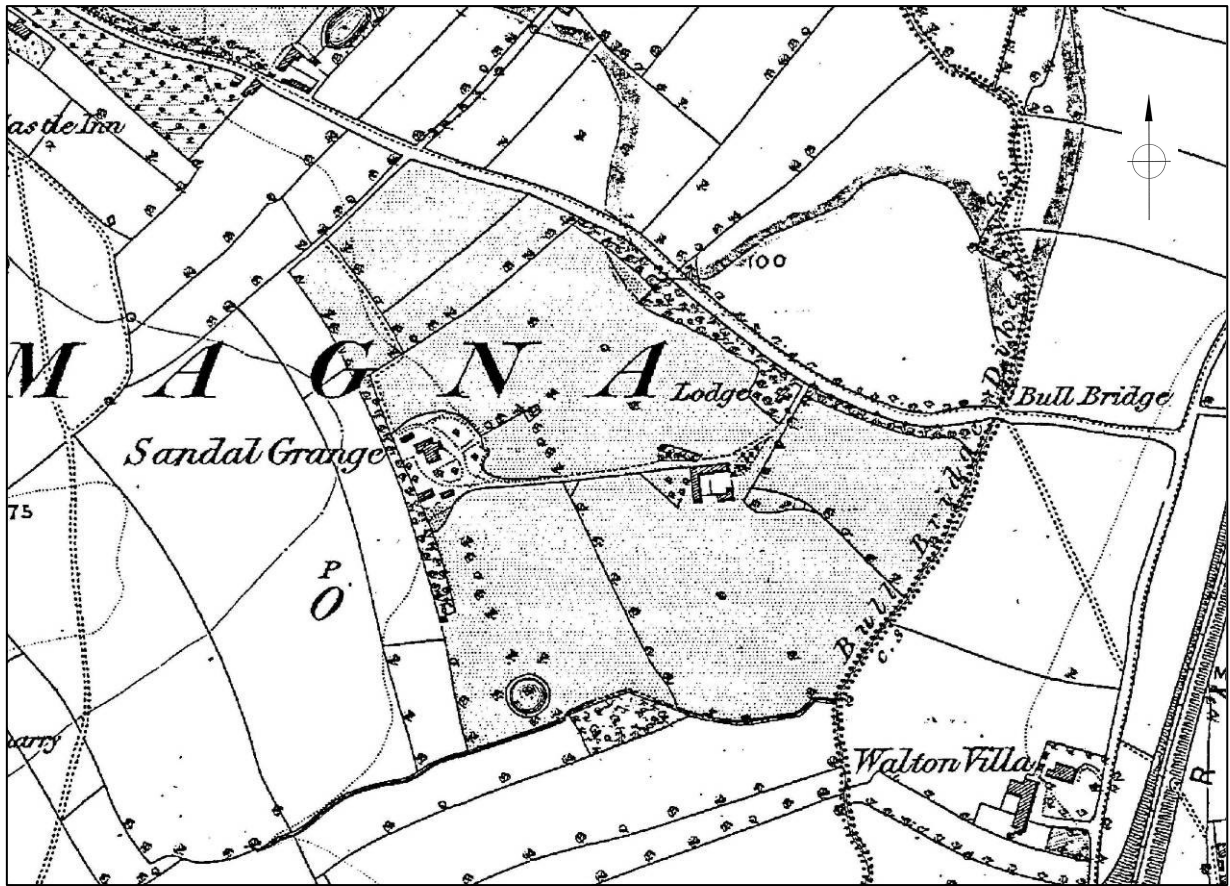
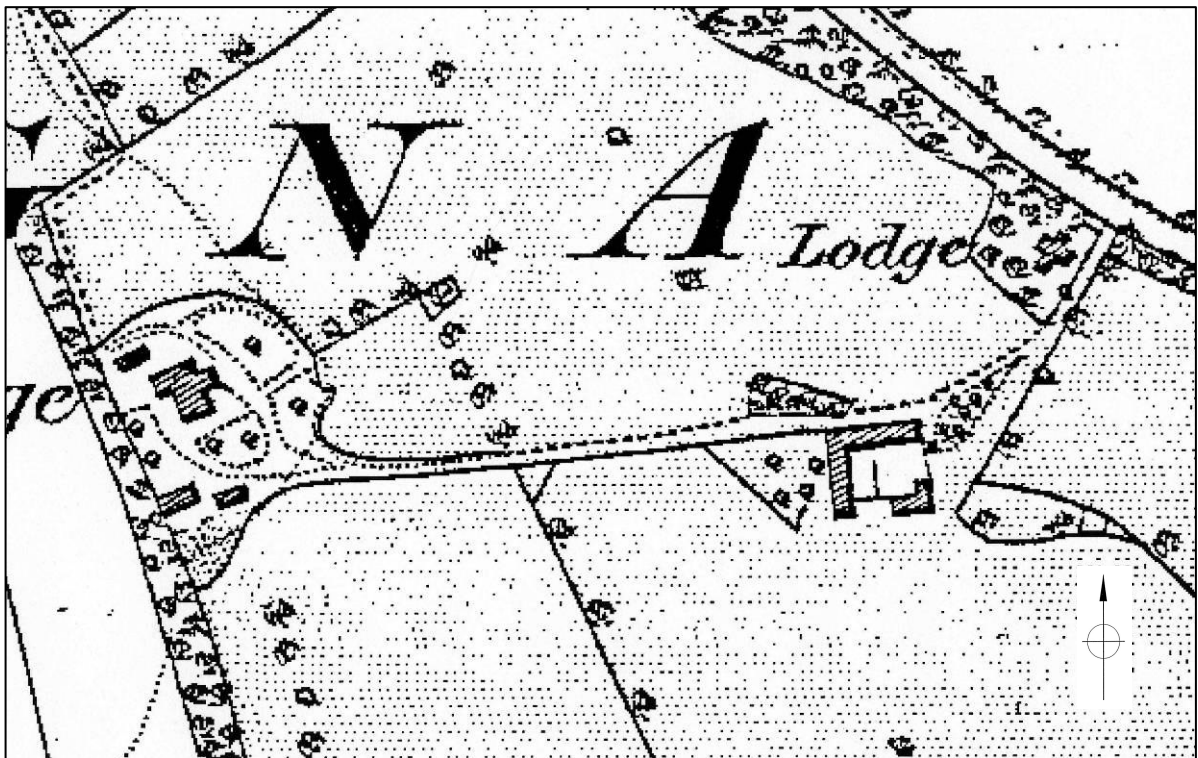
PROJECT		SANDAL GRANGE COACH HOUSE	
TITLE		ORDNANCE SURVEY 1854 MAP	
SCALE	NTS	DATE	JULY 2012
EDAS		FIGURE	3

Source: Ordnance Survey 1854 6" map sheet 248 (surveyed 1849).

- 3.7 As has been described in Chapter 2 above, in 1854 the north range had another conjoined range set at a right angle to the west end (see figure 3). This had been demolished by 1890 (see figure 4), but a sloping scar at the very west end of the south elevation might be a remnant of this; however, a Dutch-barn type structure is known to have been sited in the same position in the second half of the 20th century (Mrs Barrett, *pers. comm.*), and so the scar may relate to this. In the 1970s, the yard area to the south of the north range retained brick paving, crossed by a number of brick drains which converged on a central circular cast-iron drain cover. There was a stone dog kennel on the west side of the yard (also noted in the 1976 Listing Description) (see figure 5), while the south range, shown in 1890, was built of coursed squared stone and of a single storey, with a pitched stone slated roof. The north elevation had a cart or implement opening in the westernmost bay, with a series of paired doorways to the east, most probably representing loose boxes. There was a stone ridge stack placed approximately two-thirds of the way along the roof ridge, while the south elevation contained paired doorways and windows. The building shown to the south of the south range in 1890 was also of stone with a pitched stone slated roof, and appears to have a series of four small stacks rising from the base of the west roof slope.

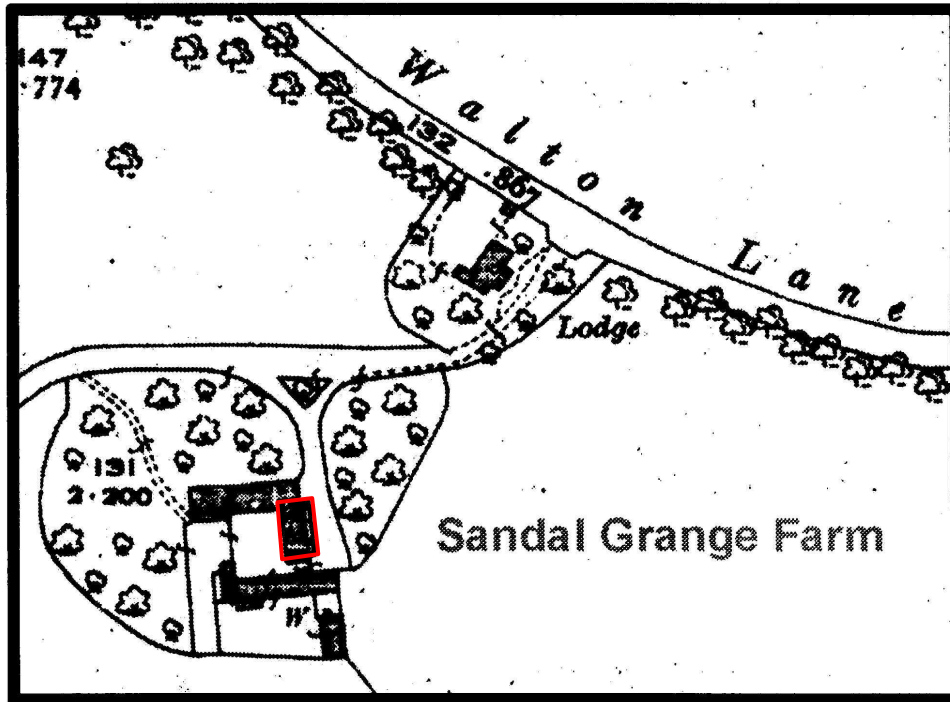
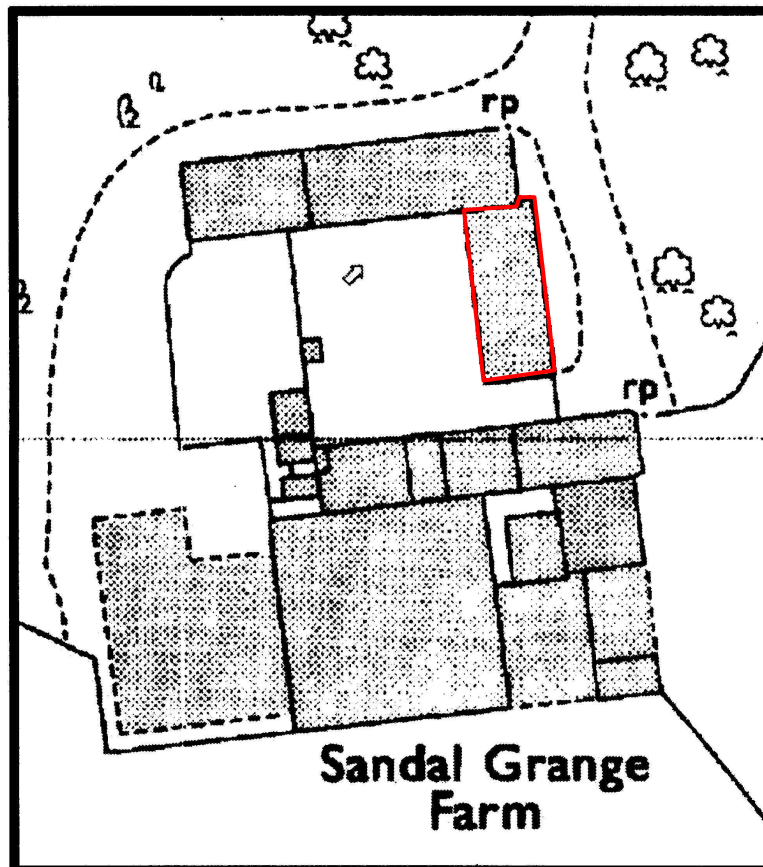
PROJECT		SANDAL GRANGE COACH HOUSE	
TITLE		ORDNANCE SURVEY MAPS	
SCALE	NTS	DATE	JULY 2012
EDAS		FIGURE	4

Top: Ordnance Survey 1890 25" map sheet 248/12.
 Bottom: Ordnance Survey 1967-79 25" map.

Coach house outlined in red.

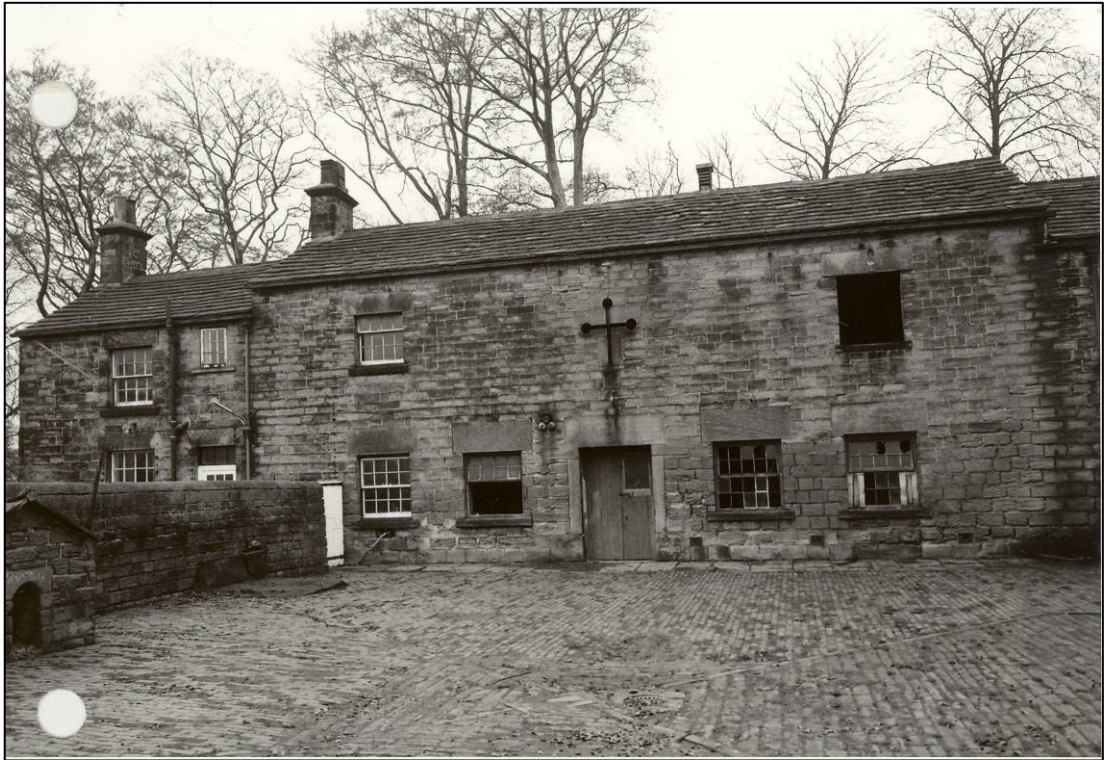
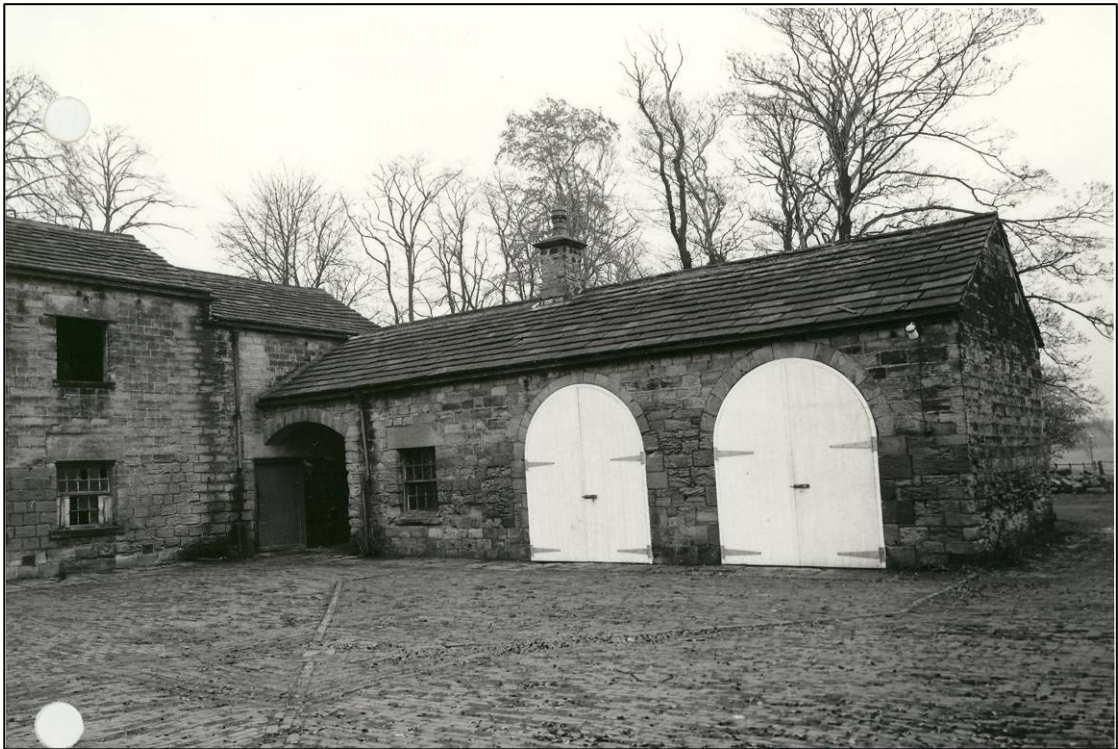
PROJECT		SANDAL GRANGE COACH HOUSE	
TITLE		1970s PHOTOGRAPHS	
SCALE	NTS	DATE	JULY 2012
EDAS		FIGURE	5

Top: South elevation of north range of stable complex, looking N (1970).
 Bottom: West elevation of coach house, looking NE (1970).

the original stable entrance placed to the ground floor of the central bay of the centre block, beneath the date stone (see figure 5). Again all original windows and doorways are beneath deep tooled stone lintels. All windows are now fitted with modern Yorkshire sliding sashes, but in 1976 the listing description noted that the western 2-bay end and the adjacent bay of the centre block, which were then in residential use, retained some sash windows with glazing bars (see Appendix 2); the 1970s photographs show a variety of sash window frames, including decayed 20-pane (10 over 10) vertical timber sashes to the stabling area (see figure 5). The listing description also noted that within the stable, there was a row of cast-iron framed loose boxes manufactured by Hayward Brothers with name plates on the doors, as well as feed bins and an original drained floor.

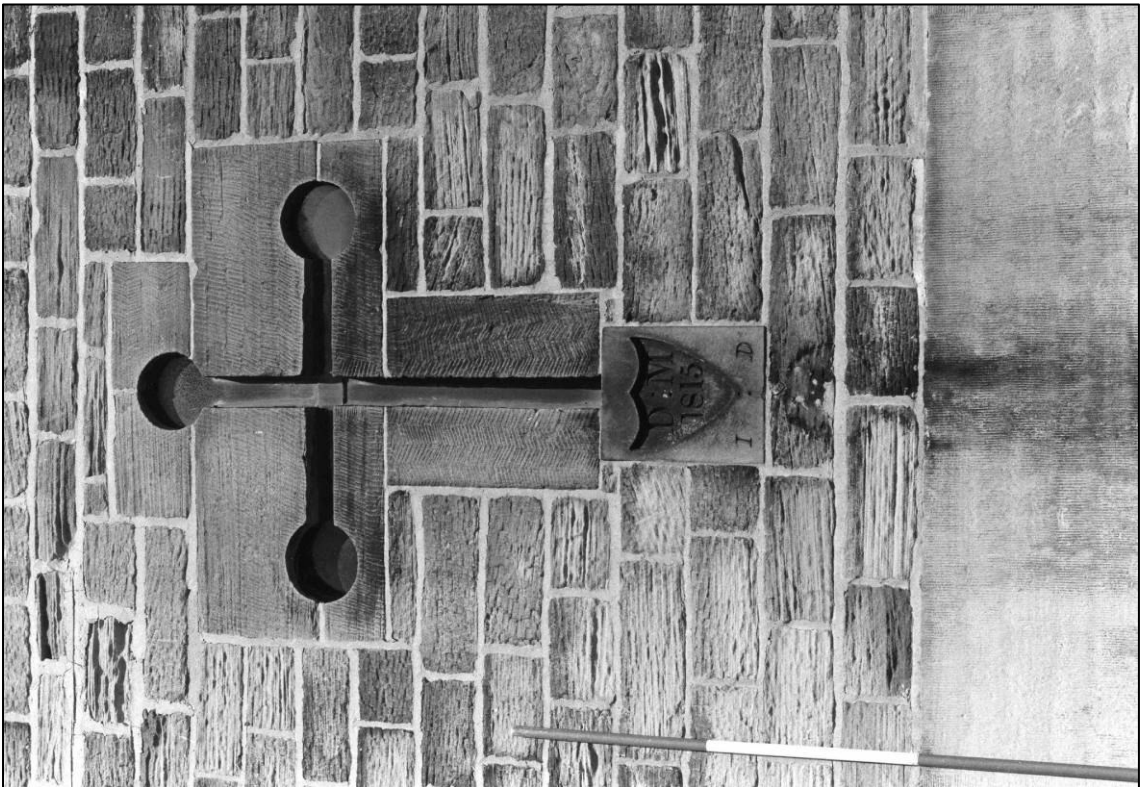
Plate 4: Date stone in south elevation of north range, looking N (photo 3/13) (top to left).

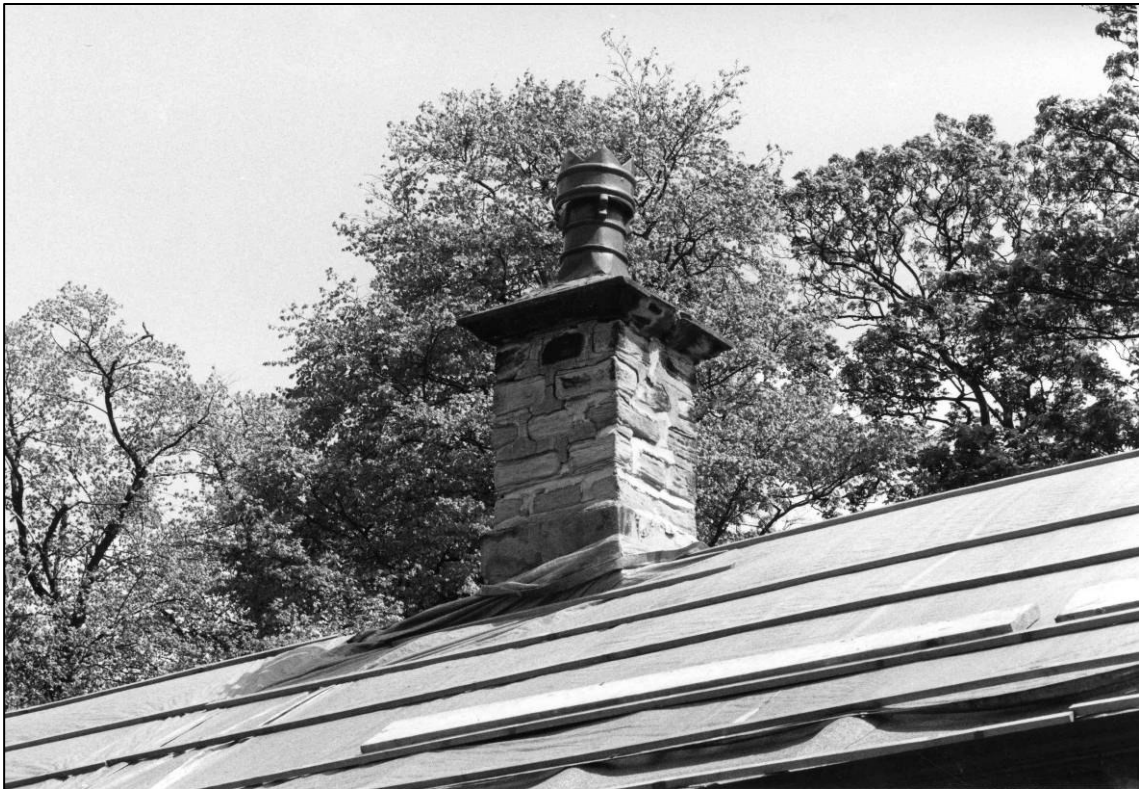
Plate 6: Coach house chimney, looking NE (photo 3/15).

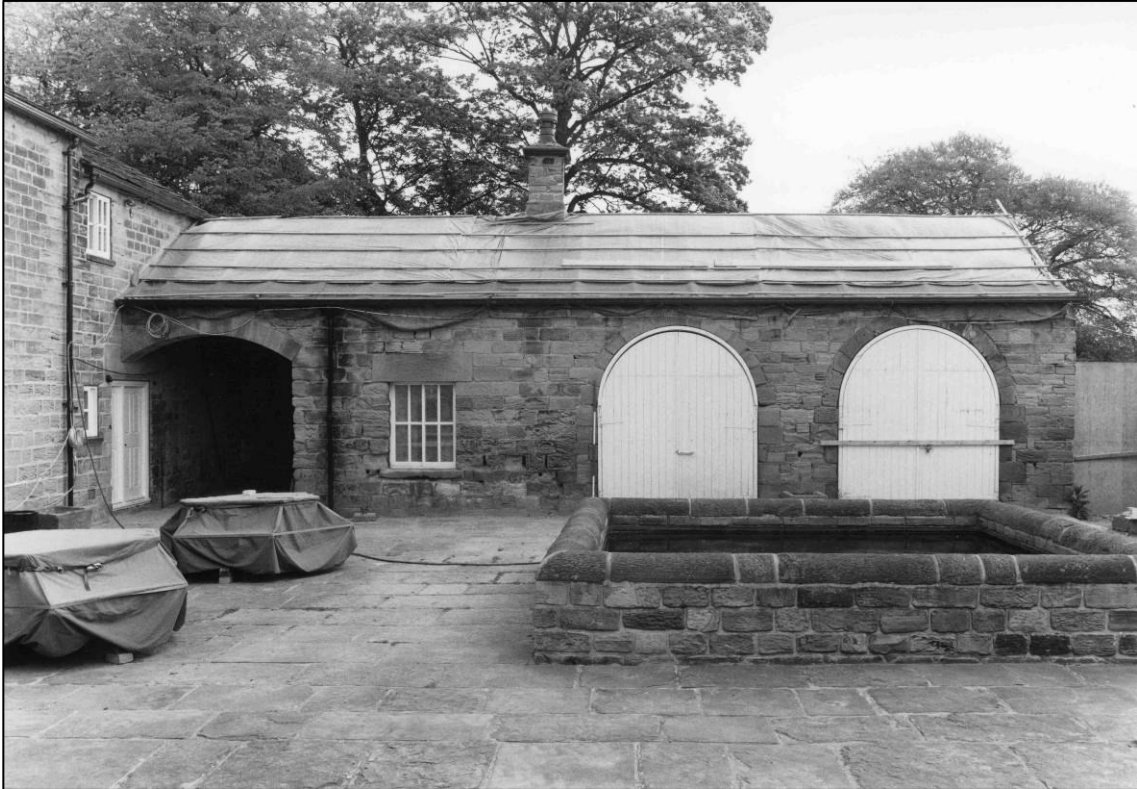
Plate 7: West external elevation, looking E (photo 3/17).

- 3.10 The principal elevation of the coach house faces west onto the yard area to the south of the north range (plates 7 and 8). At the very north end, the northernmost bay is open, with a broad segmental arch of well-cut sandstone voussoirs over the opening; there is no surviving evidence for doors or any other form of partition having been fitted here (plate 9). To the south, the next bay contains a window opening with a deep stone lintel and slightly projecting stone sill. The window is fitted with a modern two-light Yorkshire sliding sash timber frame, each light being of four panes (2 over 2). The window frame is of the same form as those fitted to the north range; it replaced a 16-pane (8 over 8) vertical timber sash shown on the 1970s photographs (see figure 5), of the same form as those once present in the north range. The two southernmost bays are occupied by coach openings, each with semi-circular head of well-cut sandstone voussoirs and quoined jambs (plate 10). The jambs are rebated to the exterior, and each opening was once fitted with a pair of doors, opening outwards; the existing softwood doors are modern, but were in place by the 1970s.

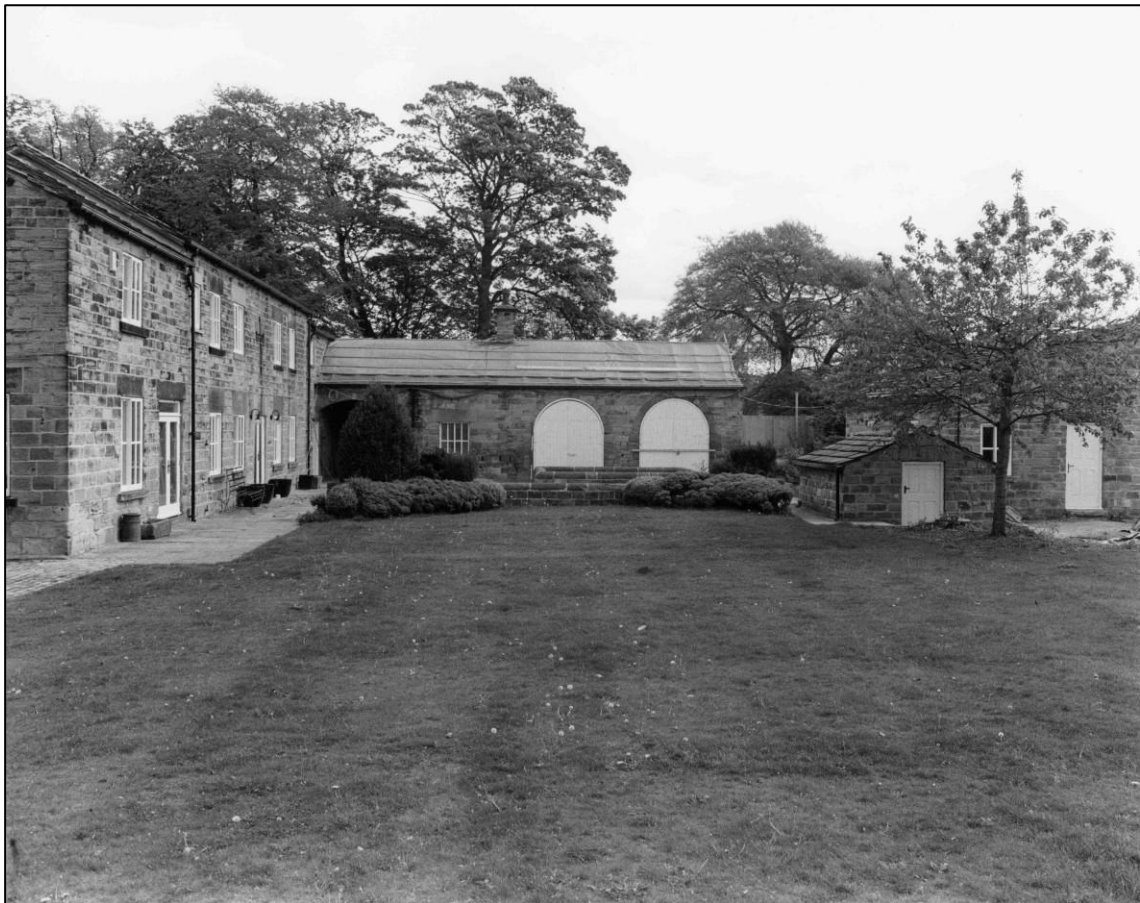
Plate 8: West external elevation, looking E (photo 4/3).

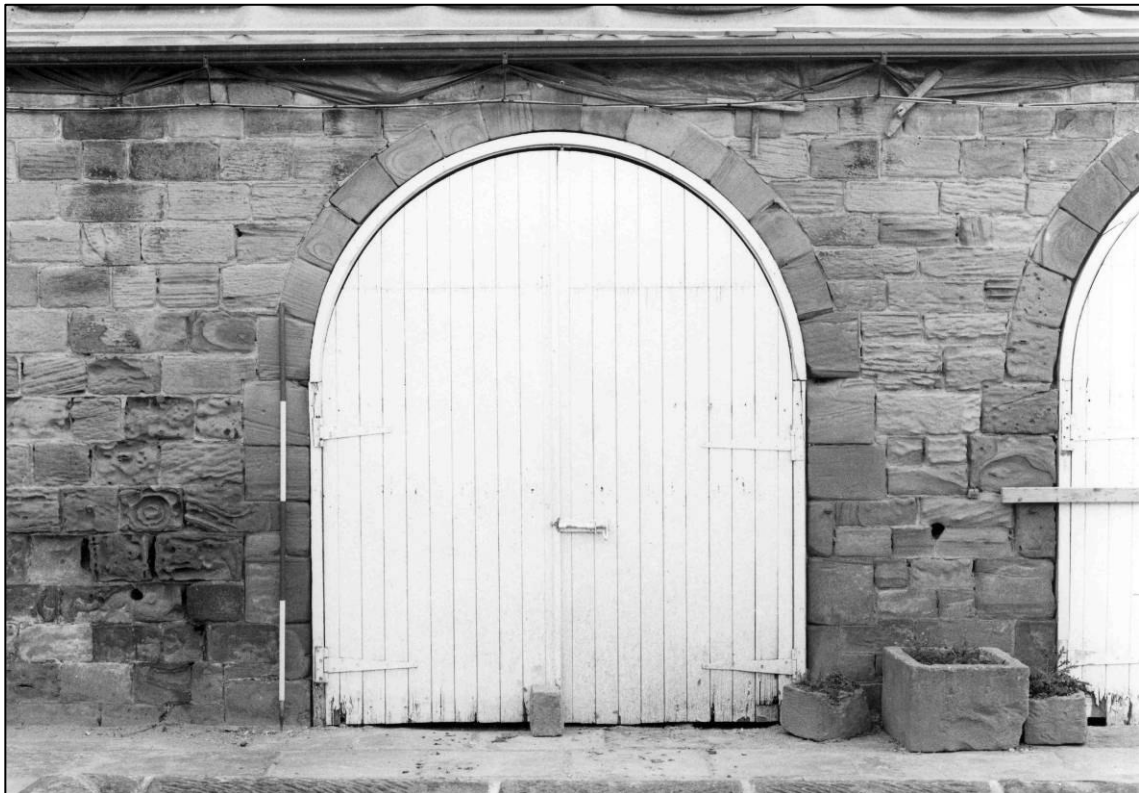
Plate 10: North coach opening, west external elevation, looking E (photo 3/16).

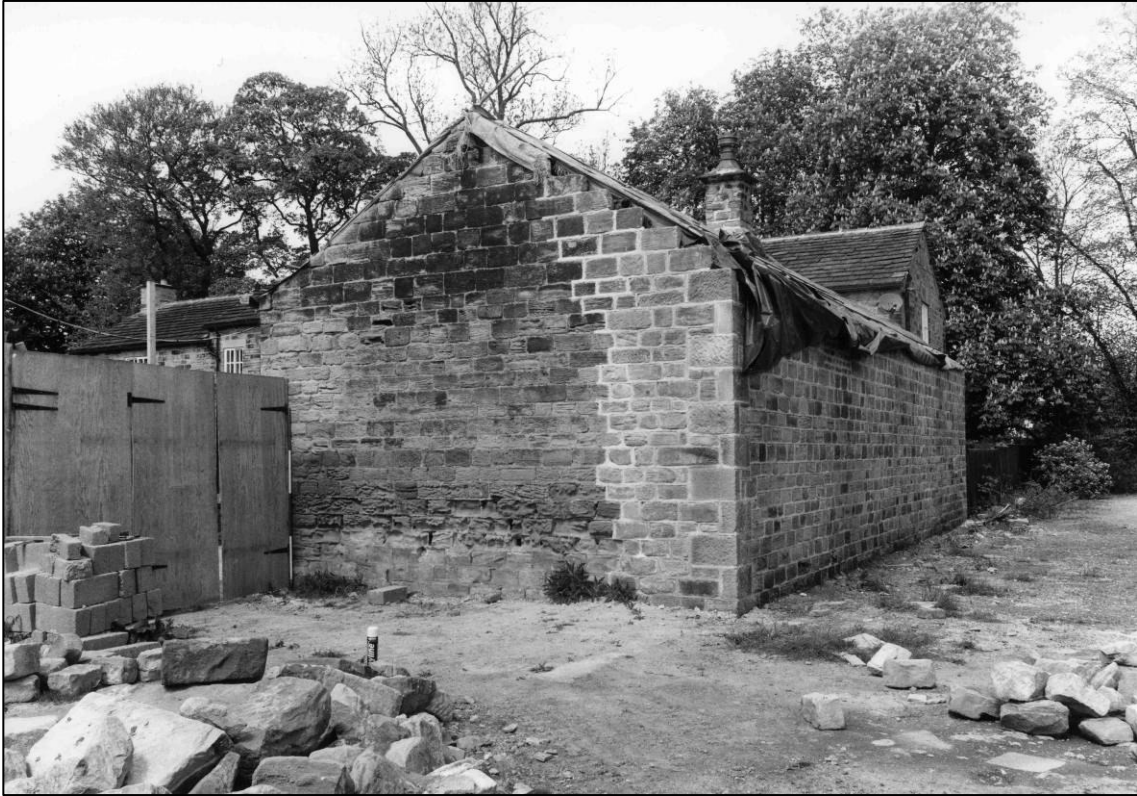
Plate 11: South gable, looking NW (photo 4/5).

- 3.11 The south gable (plate 11) and east elevation (plates 12 and 13) are both completely blank, and both have been partially rebuilt and repointed relatively recently using a lime-based mortar.

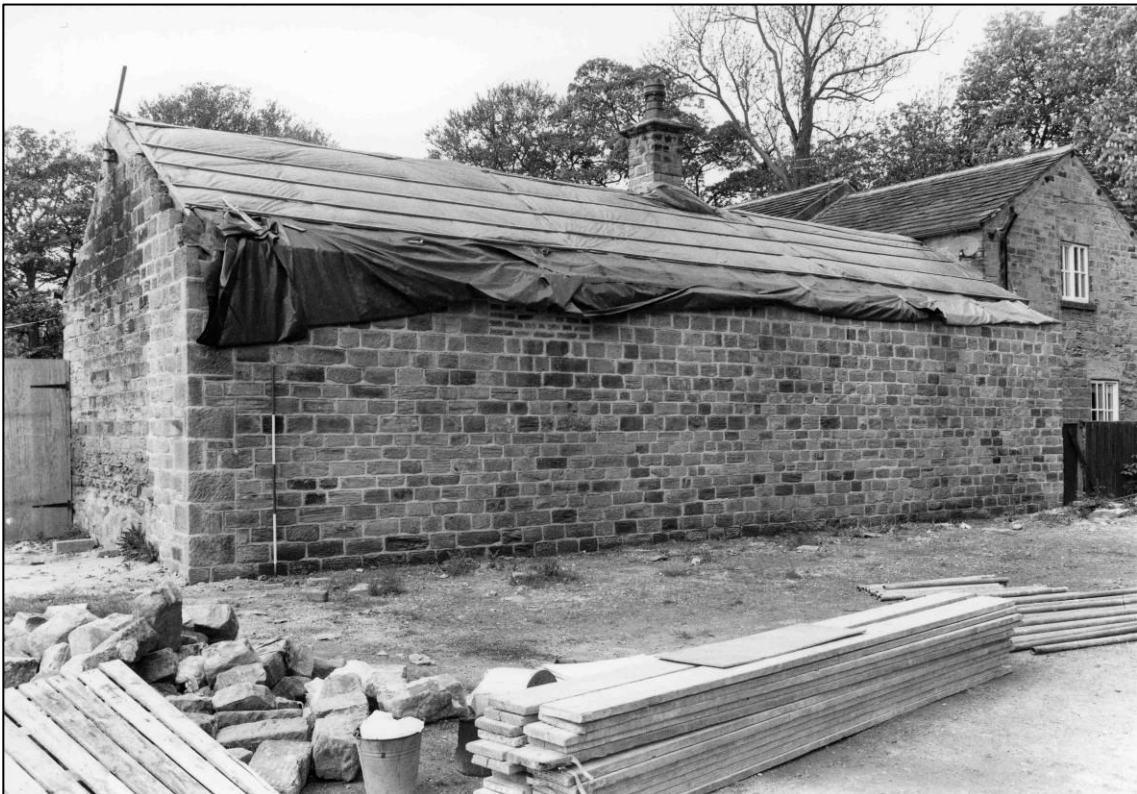
Plate 12: East external elevation, looking NW (photo 4/6).

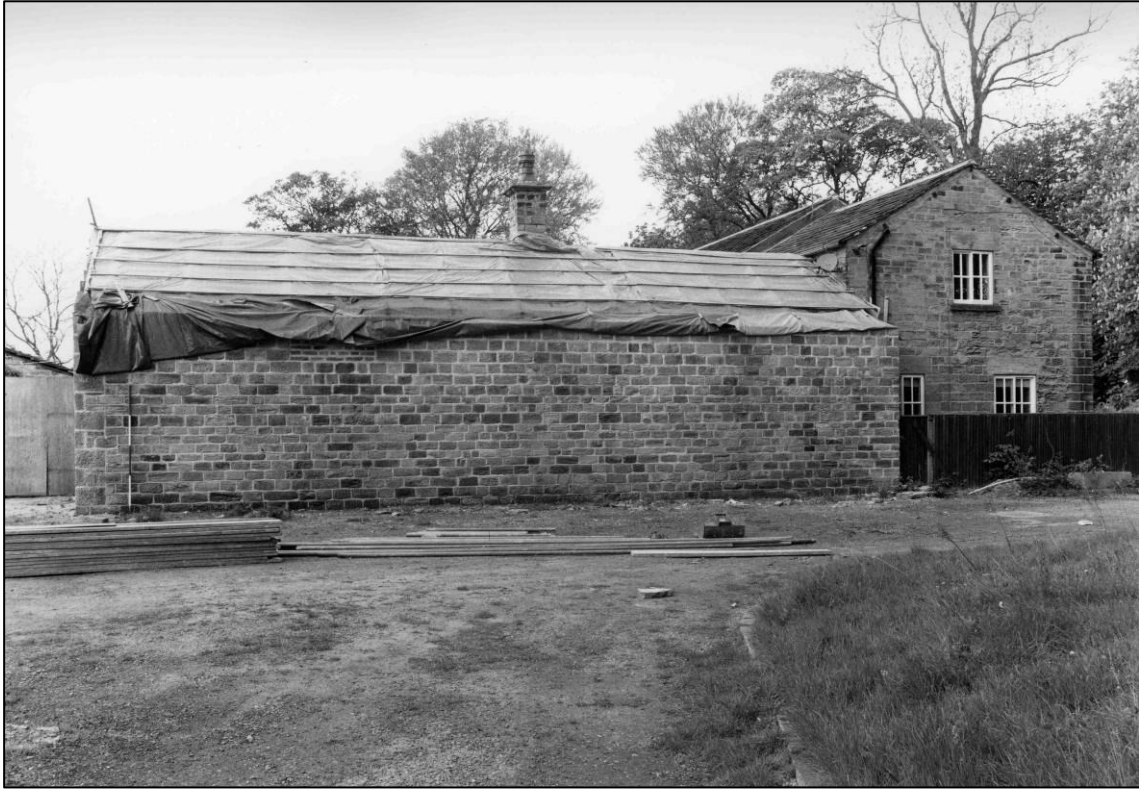
Plate 13: East external elevation, looking W (photo 4/7).

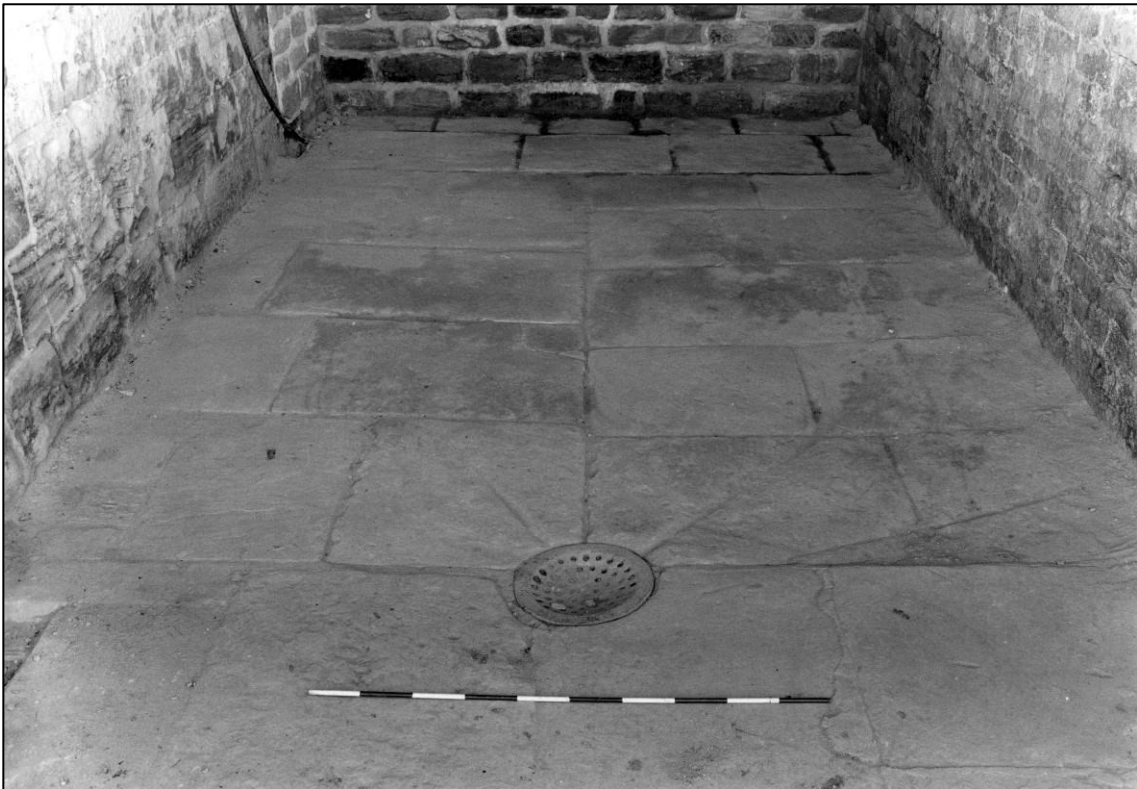
Plate 14: Drain and flagged floor in north room, looking E (photo 3/9).

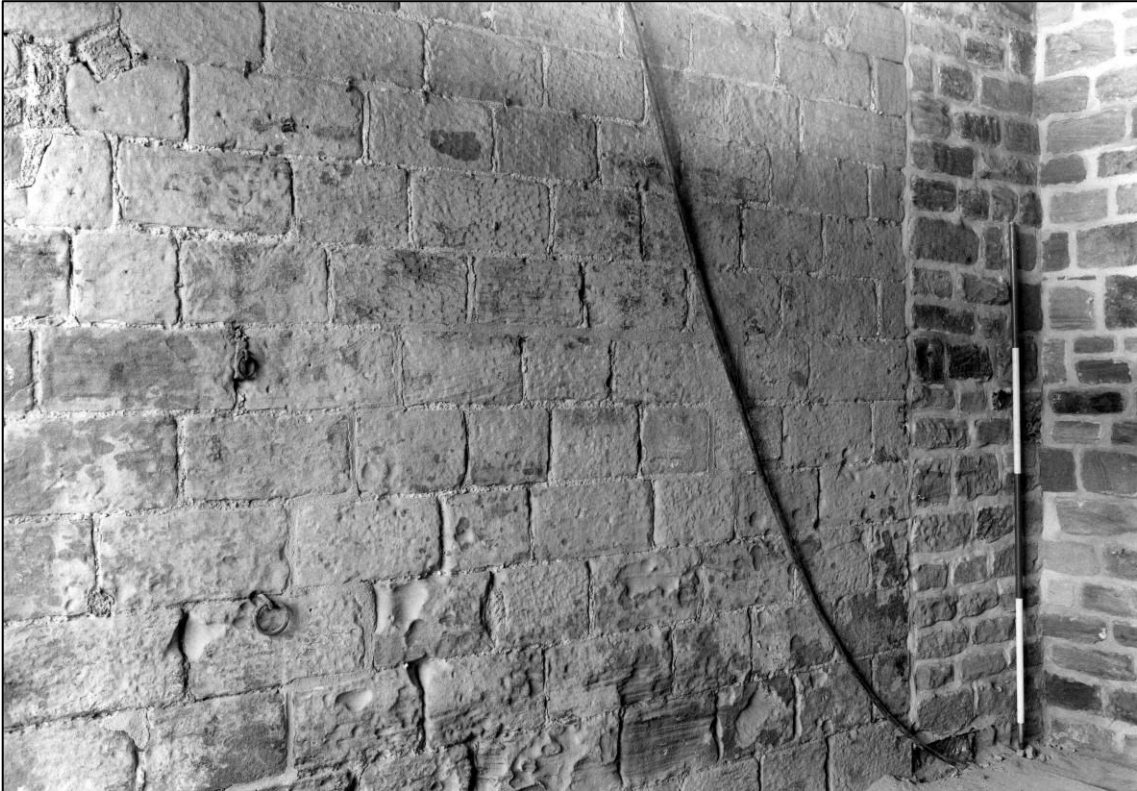
Plate 15: North wall of north room, looking NE (photo 3/3).

- 3.13 The north wall of the room was formerly part of the south elevation of the north range (plate 15). There are two vertically aligned, small diameter, tethering rings fixed to the wall at ground floor level (plate 16), while above, a row of small square holes to the first floor once appear to have held brackets which supported a continuation of the wooden guttering of the north elevation (plate 17). A sawn-off section of the guttering remains visible over the west end of the room, but curiously the brackets seem to have sloped downwards slightly towards a blocked doorway at first floor level (plate 18). This doorway is blocked with brick but would have

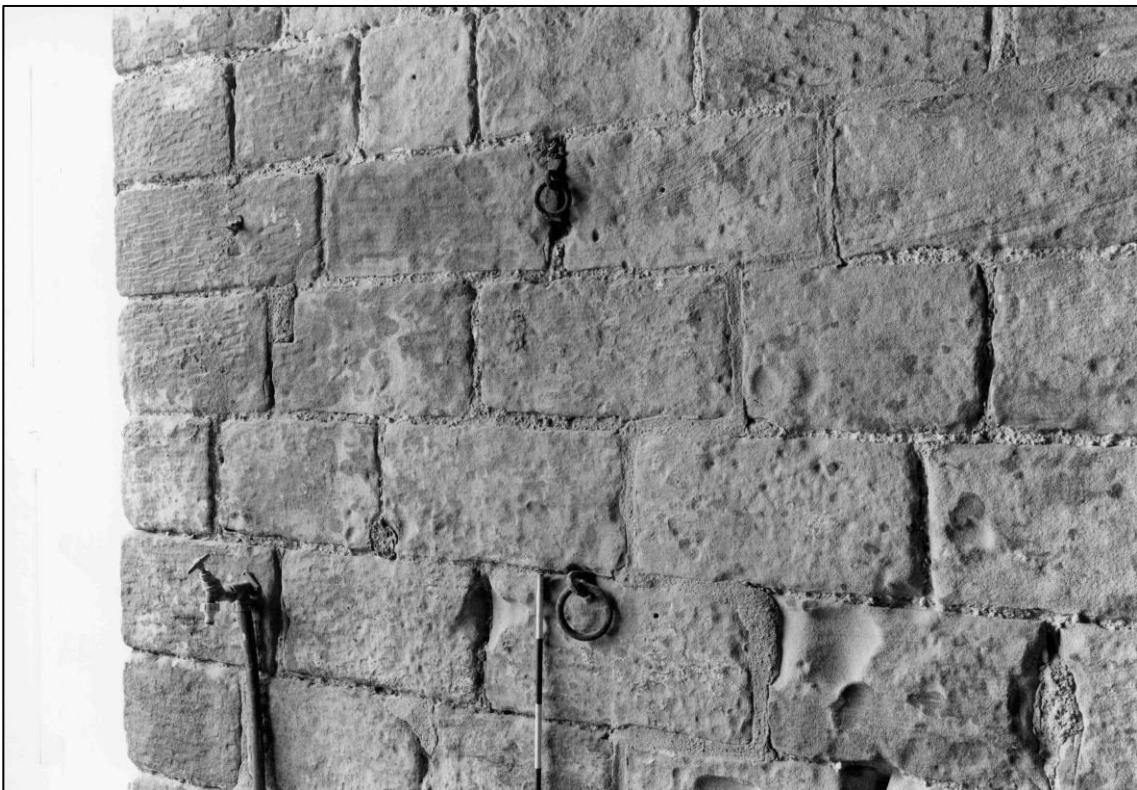
Plate 16: Tethering rings to north wall of north room, looking NW (photo 3/11).

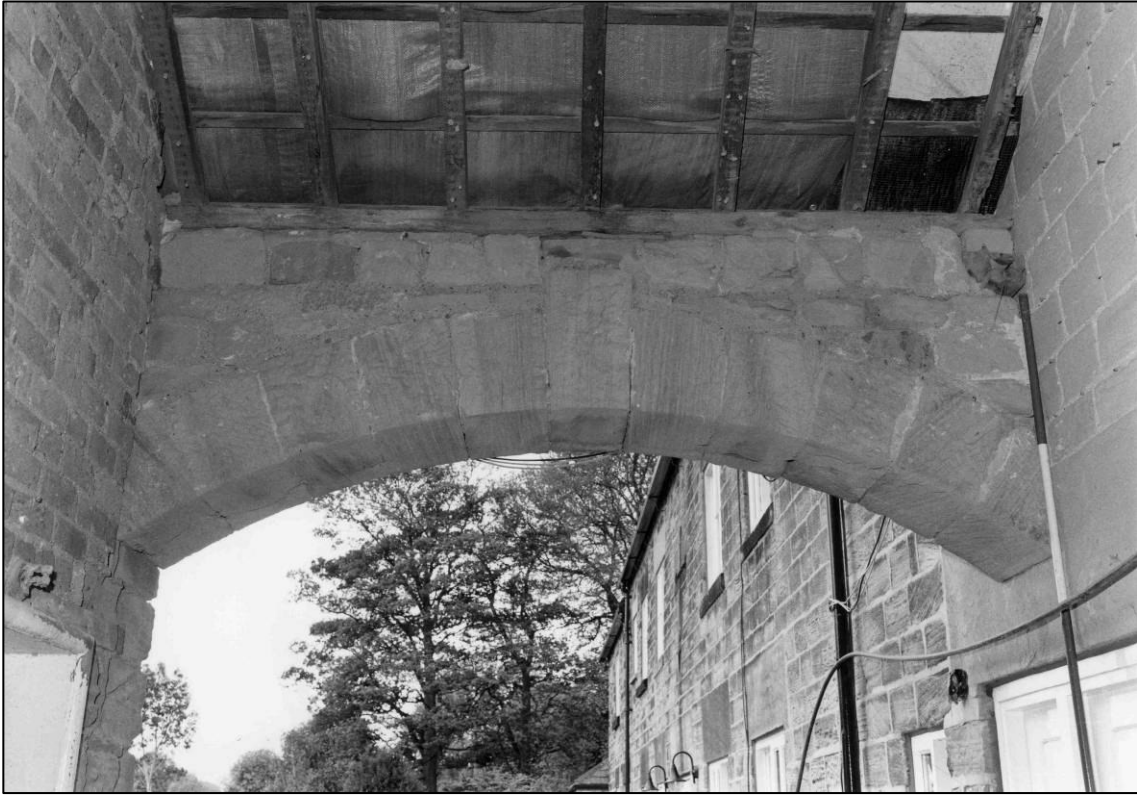
Plate 17: Entrance arch to north room, looking W (photo 3/12).

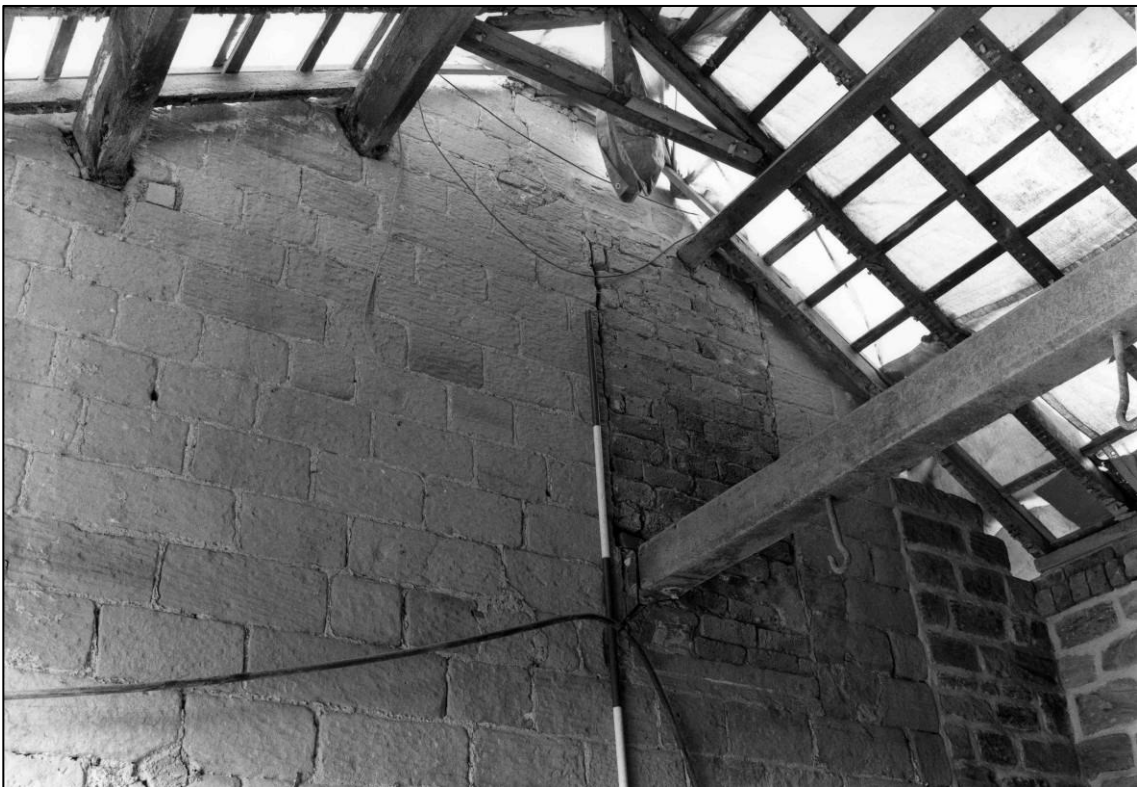
Plate 18: Upper part of north wall of north room, looking NE (photo 3/4).

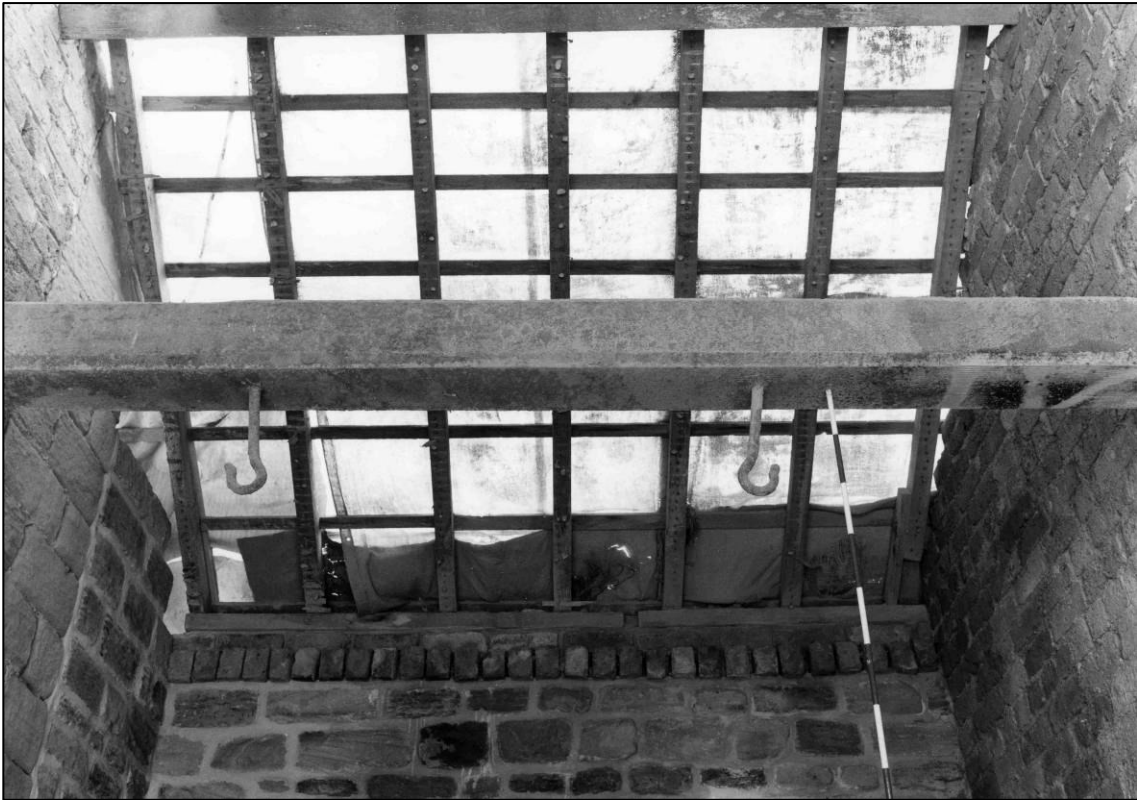
Plate 23: Beam crossing north room, looking E (photo 3/7).

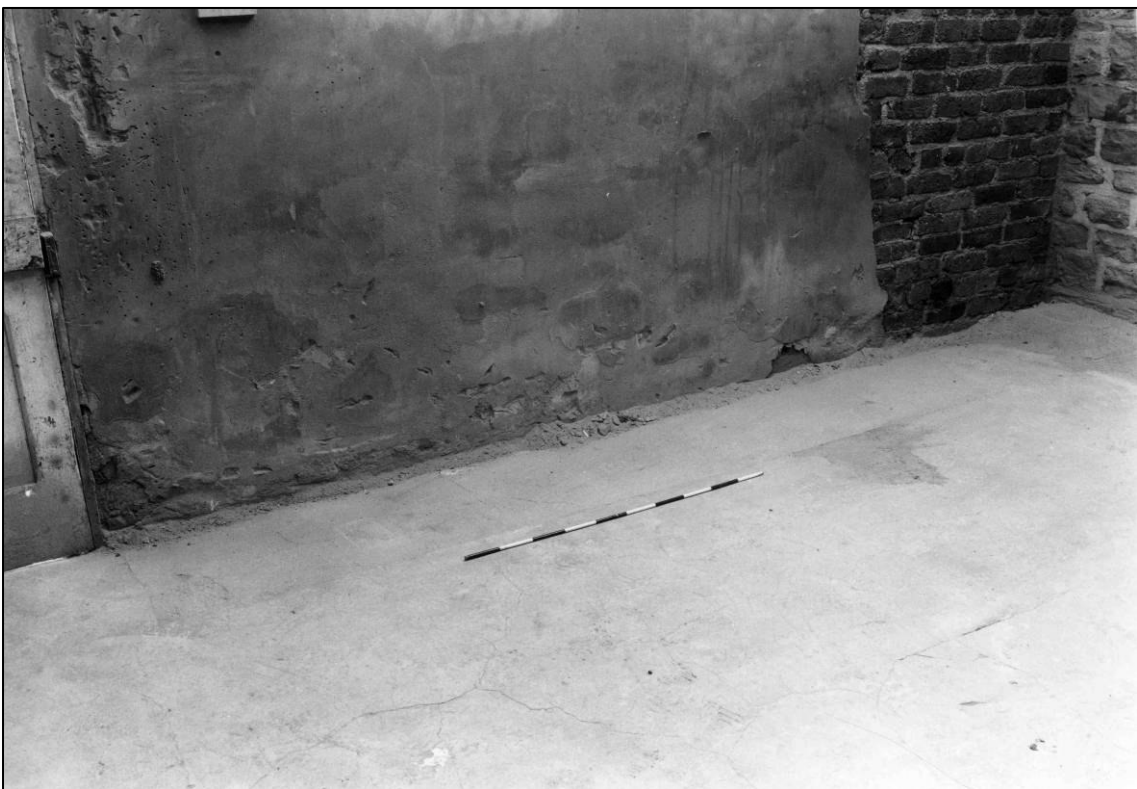
Plate 24: Former fitting position in floor, north wall of central room, looking NE (photo 2/6).

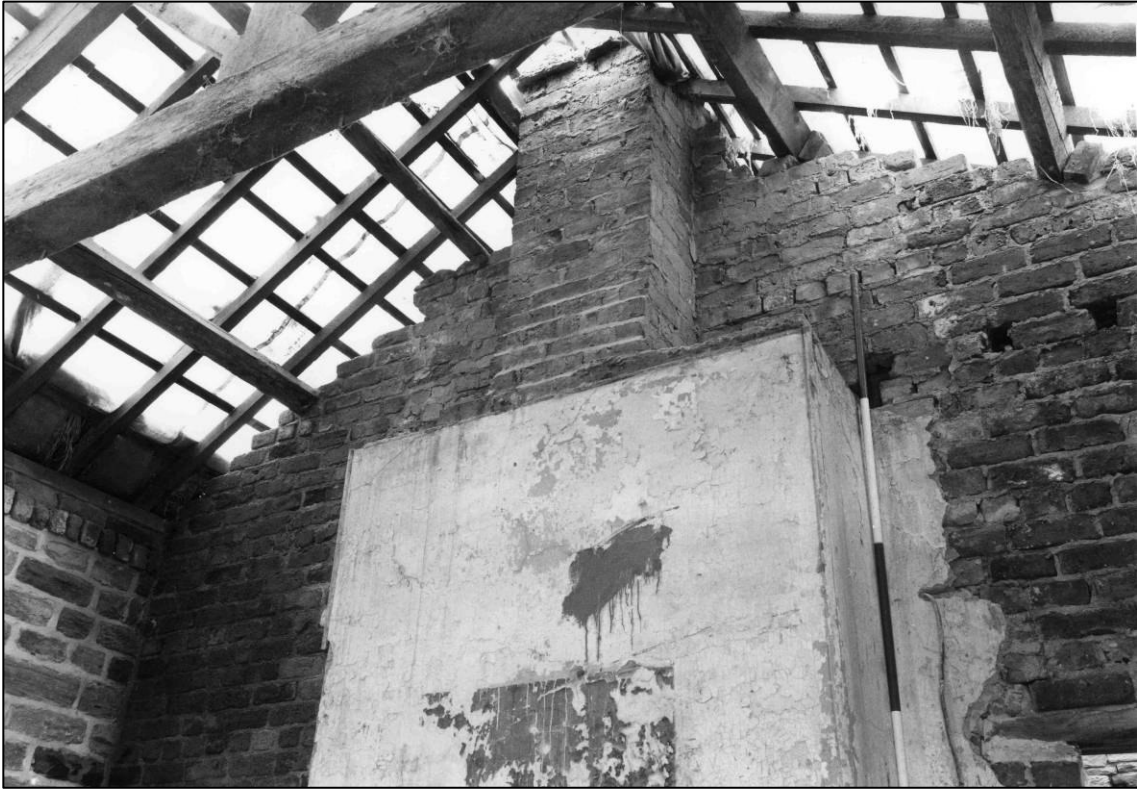
Plate 31: Upper part of south wall of central room, looking S (photo 2/15).

- 3.18 The east (plate 29) and west walls are built of stone, and almost completely blank; the window opening in the west wall has a timber lintel and a brick relieving arch over (plate 30). The south wall, like the north wall, is also of brick (plate 31). The bricks are of very similar appearance and laid in the same bonding pattern, but are slightly deeper (average depth 80mm). The south wall butts the external stone walls of the coach house at either end, although the line of joist holes in the south side (see below) and the positioning of the window in the west wall suggests that the cell has always existed and that the butting is a constructional feature, rather than being from a later alteration. The main feature of the south wall is the projecting chimneybreast (plate 32); again this is built of very slightly different brick to the main body of the wall and is only roughly keyed into it, raising the possibility that it is a later addition (plate 33). There is a rectangular clay tiled hearth to the front of the fireplace opening, which has a flagstone base; the rear appears to have been either rebuilt or subject to significant disturbance. The flat-headed fireplace opening has a substantial tooled stone lintel, and once had a wooden surround fixed to it using wooden dowels (plate 34); in addition, the corners of the chimney breasts were beaded using vertical timber dowels. Above the lintel, the chimney breast is plastered and whitewashed, as is much of the wall to either side. However, there are the remains of a small square panel of dark brown paint immediately over the lintel, which must be relatively old as it runs behind the gas mantle mounted above the fireplace; indeed, the brown may be due to discolouration from the gas mantle itself (plate 35). There is some pencilled graffiti or marking on this darker surface but it is now impossible to read clearly. To the west of the chimney breast, projecting wrought-iron brackets mark the position of a fitting that has since been removed (plate 36); a lead-covered electric cable projects from the wall above the brackets, but it is not clear if it was associated with the fitting. A doorway with a timber lintel at the west end of the south wall leads through into the south room or cell; this was blocked with brickwork in 2011 (Helen Price Associates 2011, 9) but the blocking has subsequently been removed. At the top of the chimney breast, and across the wall to either side, a line of joist holes are visible. As to the north wall, the brickwork above the joist holes is slightly different to that below, perhaps indicating that the upper part of the wall has been rebuilt.

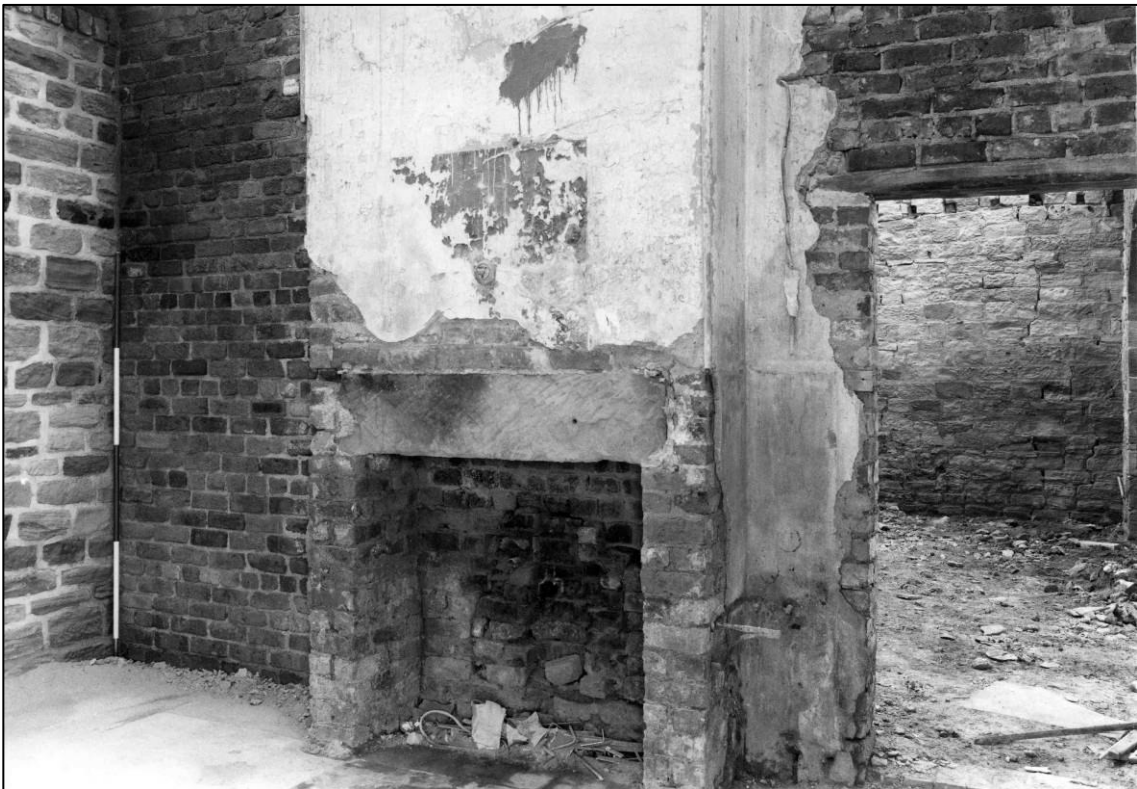
Plate 32: South wall of central room, looking S (photo 2/12).
