THE COACH HOUSE, SANDAL GRANGE FARM,
WALTON LANE, SANDAL MAGNA,
WEST YORKSHIRE

BUILDING RECORDING

Report no: 2012/422.R01
Version: Final
Date: July 2012
Author: Shaun Richardson & Ed Dennison

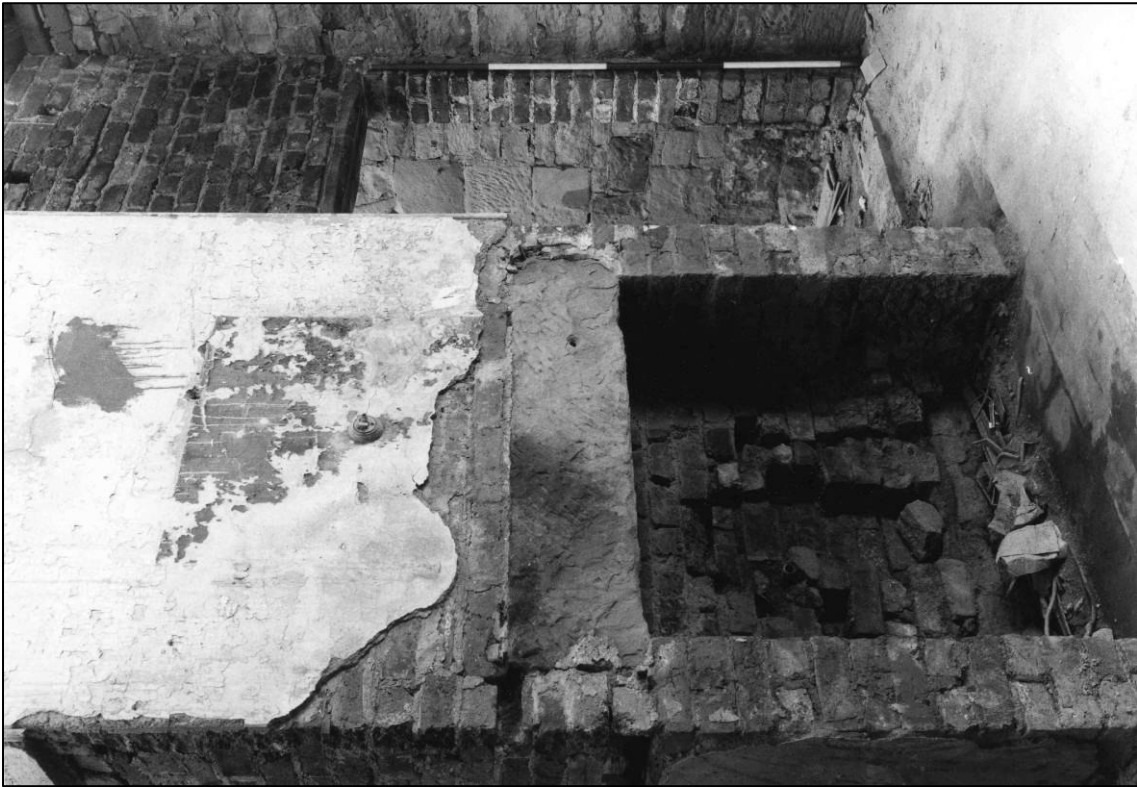
Plate 33: Fireplace in south wall of central room, looking SW (photo 1/18) (top to left).

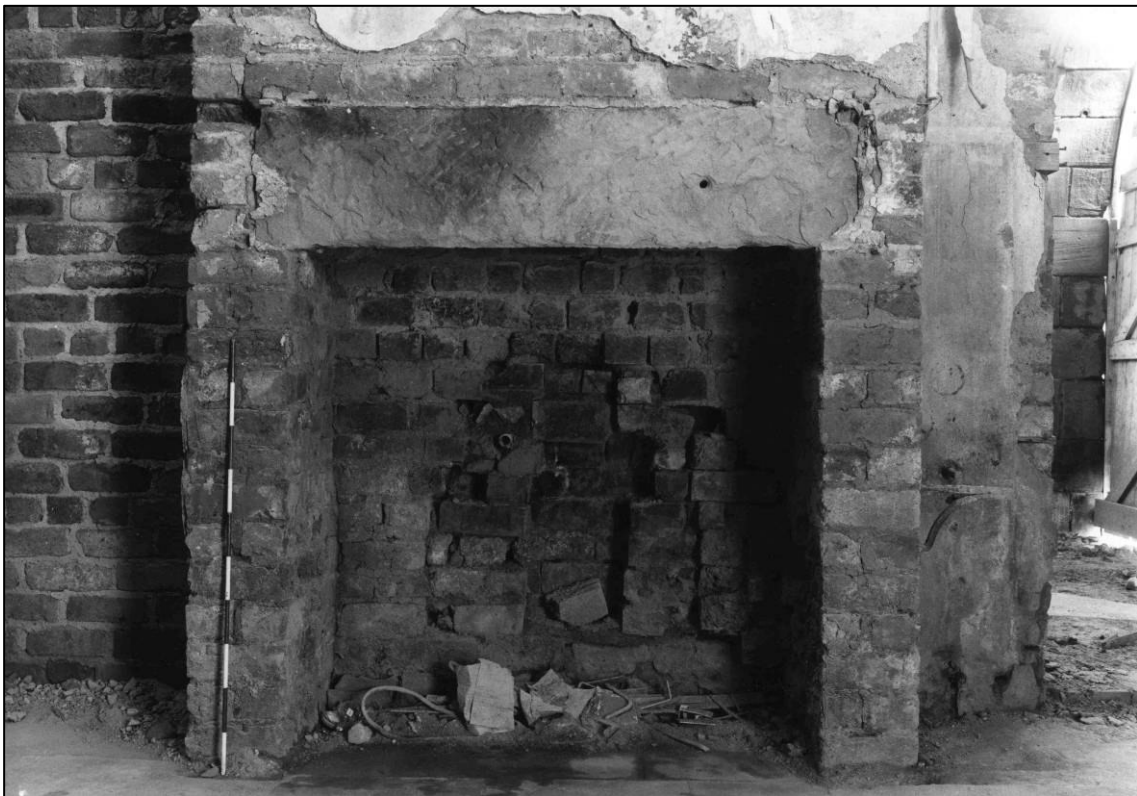
Plate 34: Fireplace in south wall of central room, looking S (photo 2/10).

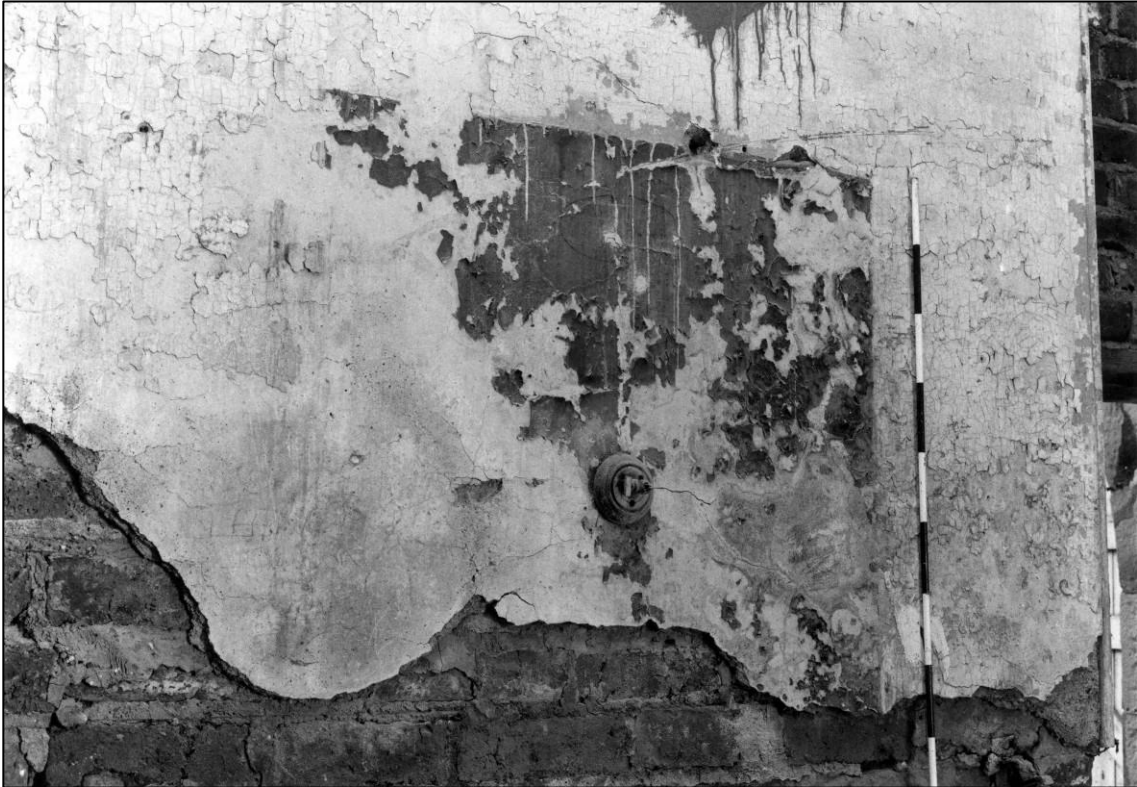
Plate 35: Gas mantle and paint on south wall of central room, looking S (photo 2/17).

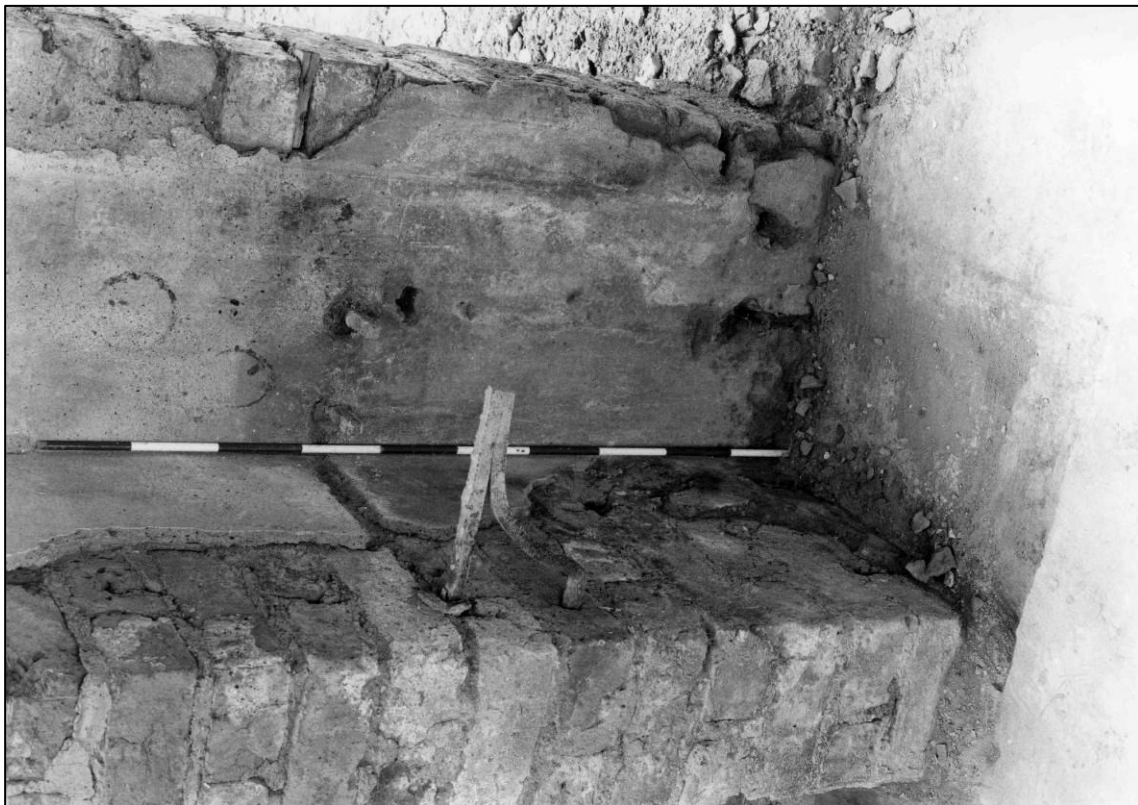
Plate 36: Brackets to west of fireplace, south wall of central room, looking SE (photo 2/18) (top to left).

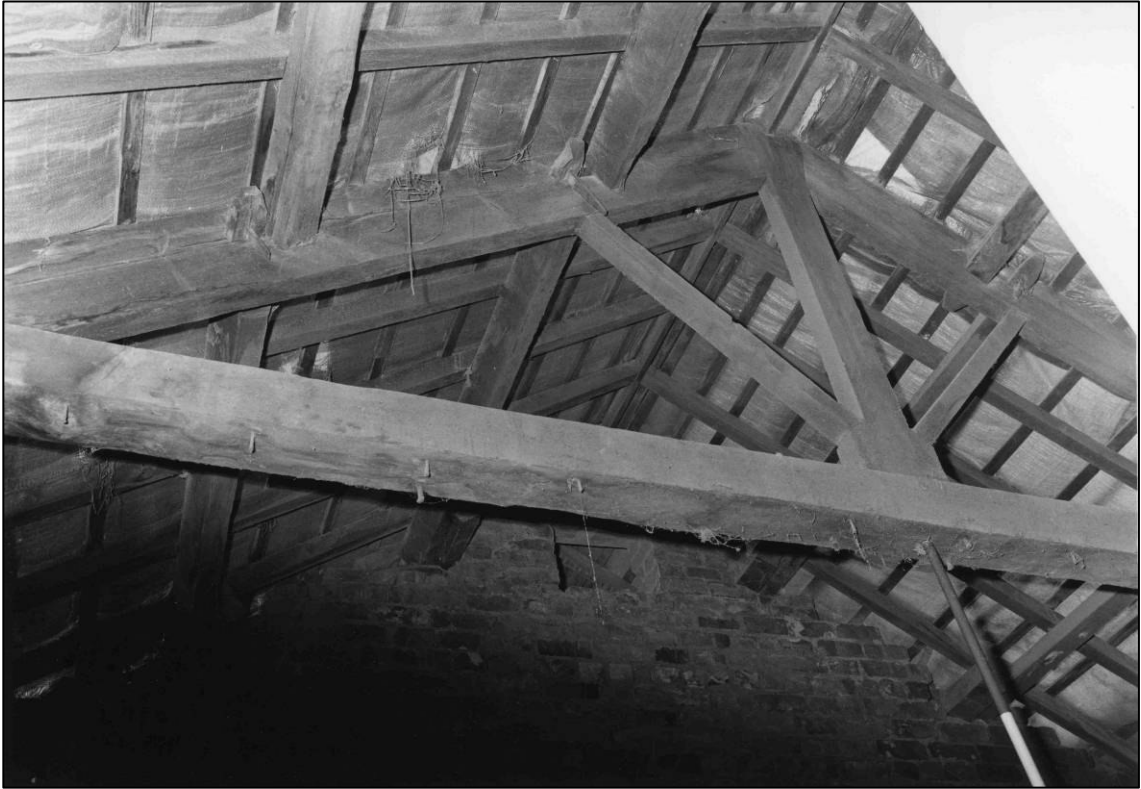
Plate 37: Truss of central room, looking NE (photo 2/9).

- 3.19 The room is crossed by a single east-west aligned softwood roof truss, of bolted construction throughout (plate 37). The truss is of king post form, the king post rising from a tie-beam; either end of the tie-beam rests on a timber bearer set onto the external stone walls. Raking struts rise from the king post to the principal rafters, and the king post has a splayed head, carrying a vertical ridge piece. Each principal supports a pair of staggered purlins with pegged tusked through-tenons, which carry the common rafters. The feet of the common rafters rest on a simple wall plate. In 2011 it was reported that chiselled carpenter's marks were present on the truss (Helen Price Associates 2011, 7) - no numbering was visible at the time of the EDAS survey, but there are some laying out marks.

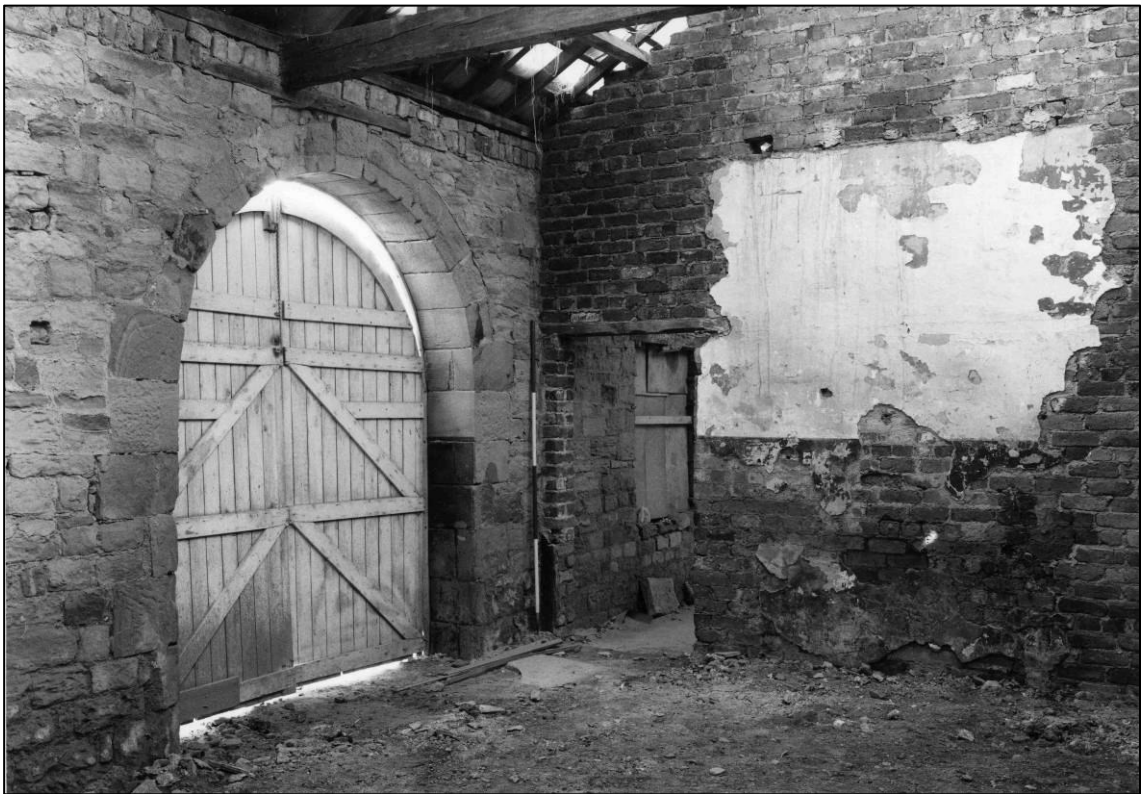
Plate 38: North-west corner of south room, looking NW (photo 1/2).

- 3.20 Apart from the two large openings in the west elevation (see below), another access to the interior of the south room or cell was through the previously blocked doorway at the west end of the central room's south wall (plate 38). The central room is of two bays. At the time of the EDAS survey, the floor was a disturbed mixture of soil and brick rubble. The north wall is of the same brickwork as

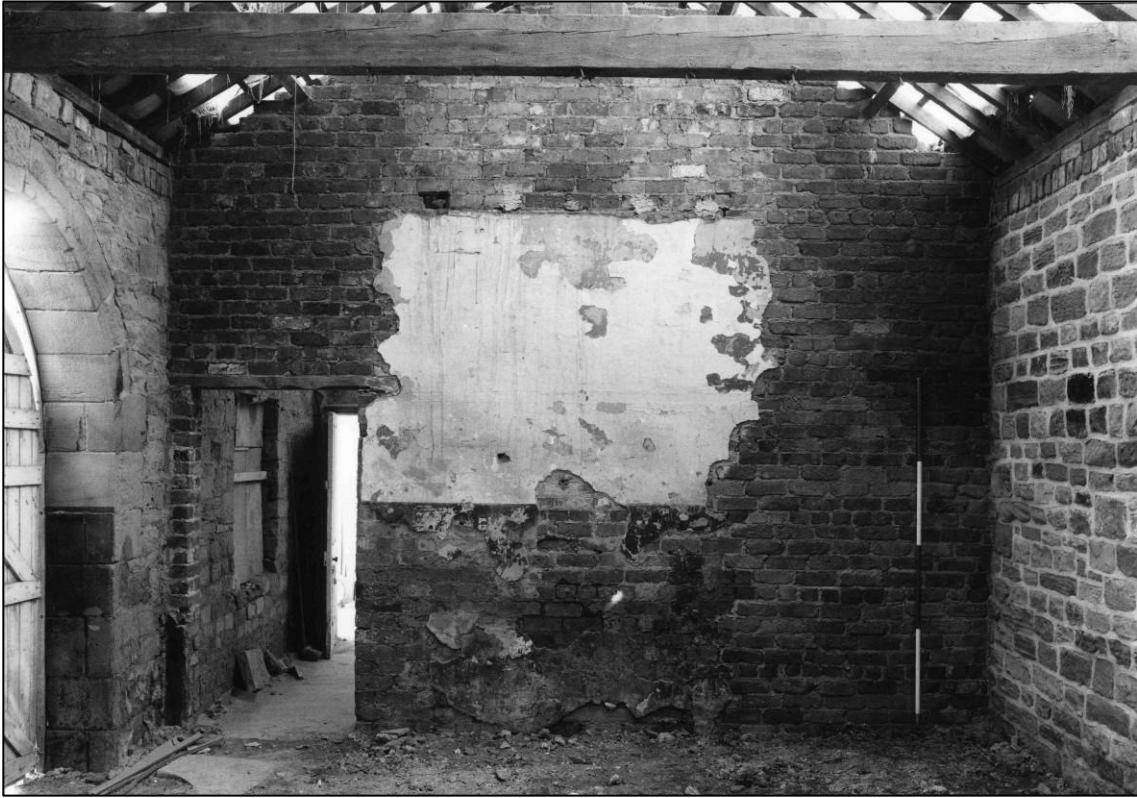
Plate 39: North wall of south room, looking N (photo 1/4).

described for the north and central rooms above, and has been plastered and painted, although much had recently been removed (plate 39). The wall is painted black to 1.40m above the internal floor level, and then whitewashed above this; between 2.02m and 2.08m above the internal floor level, a line in the whitewash indicates the former presence of a rail. In 2011, the lower line of black paint curved upwards at the east end, and there was a metal tethering pole fixed to the wall to take a sliding tethering ring (Helen Price Associates 2011, 9), indicating that stalls were formerly laid out along the east side of the room. At the same date, the previously blocked doorway at the west end of the north wall was also whitewashed. A row of now mostly blocked joist holes set at c.3m above the internal floor level indicates that the room was formerly ceiled; above the joist holes, the brickwork is bare and of slightly different appearance, suggesting that the upper part may have been rebuilt.

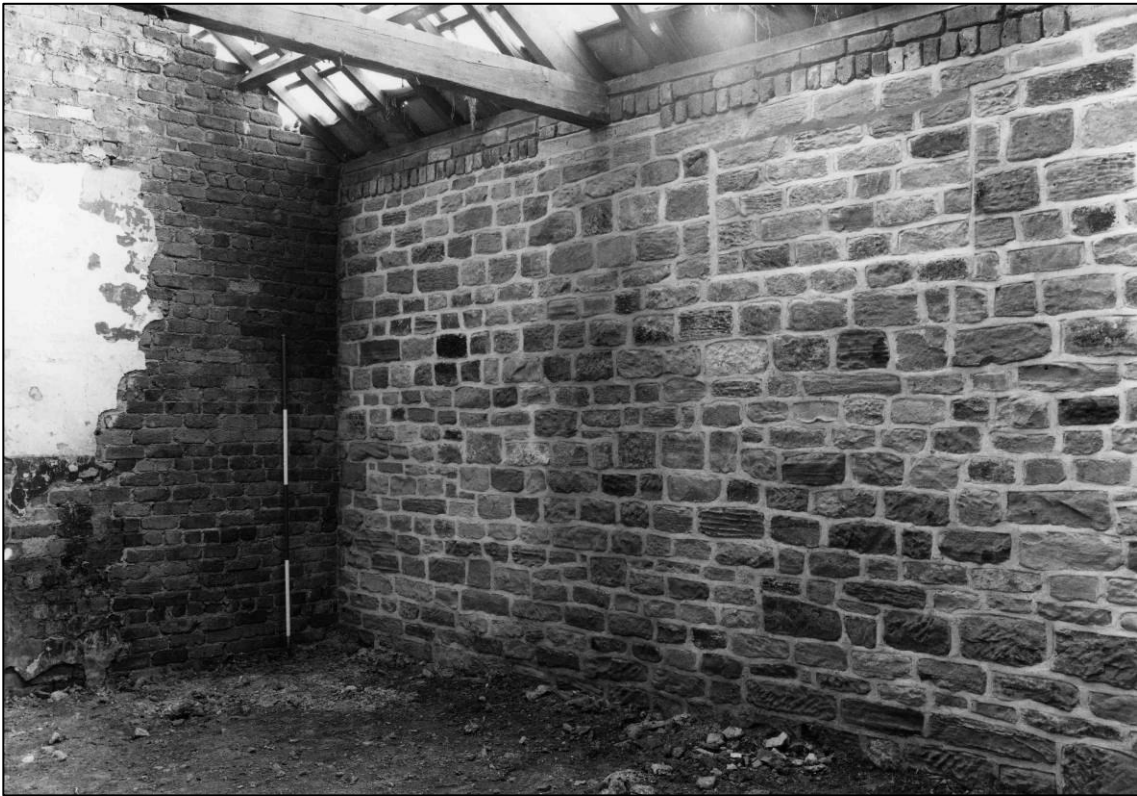
Plate 40: North end of east wall of south room, looking NE (photo 1/5).

- 3.21 The east wall is built of stone, and is almost completely blank (plates 40 and 41), with the exception of a low rectangular blocked window opening, centrally placed at a high level; there is a metal catch or pintle to the south side (plate 42). The previous 2011 shows that this opening formerly extended through the wall (Helen Price Associates 2011, 7). There are one and occasionally two courses of brickwork surmounting the wall. The south wall is also of stone and again almost completely blank (plate 43); a row of joist holes set at c.3m above the internal floor level corresponds to those seen in the north wall and a small number of timber inserts to support panelling or boarding survive towards the west end. In 2011, at the east end, there was formerly a tethering point of the same form as that described for the north wall (Helen Price Associates 2011, 7).

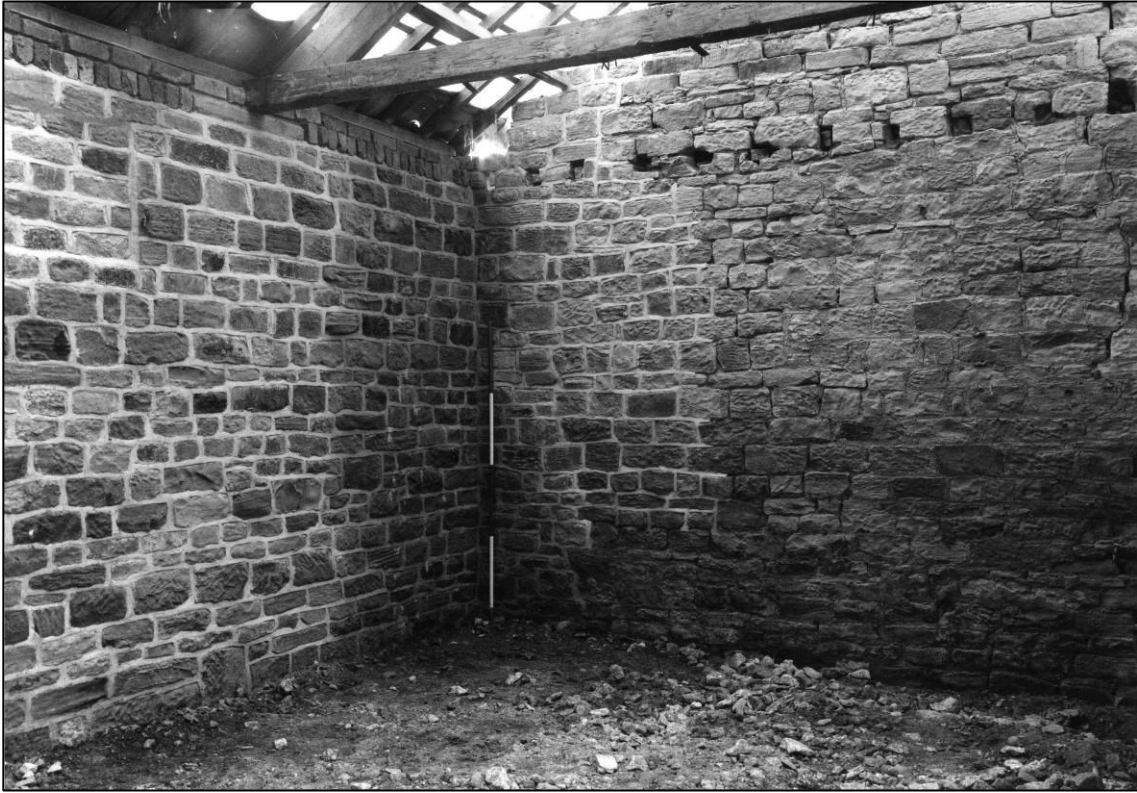
Plate 41: South-east corner of south room, looking SE (photo 1/6).

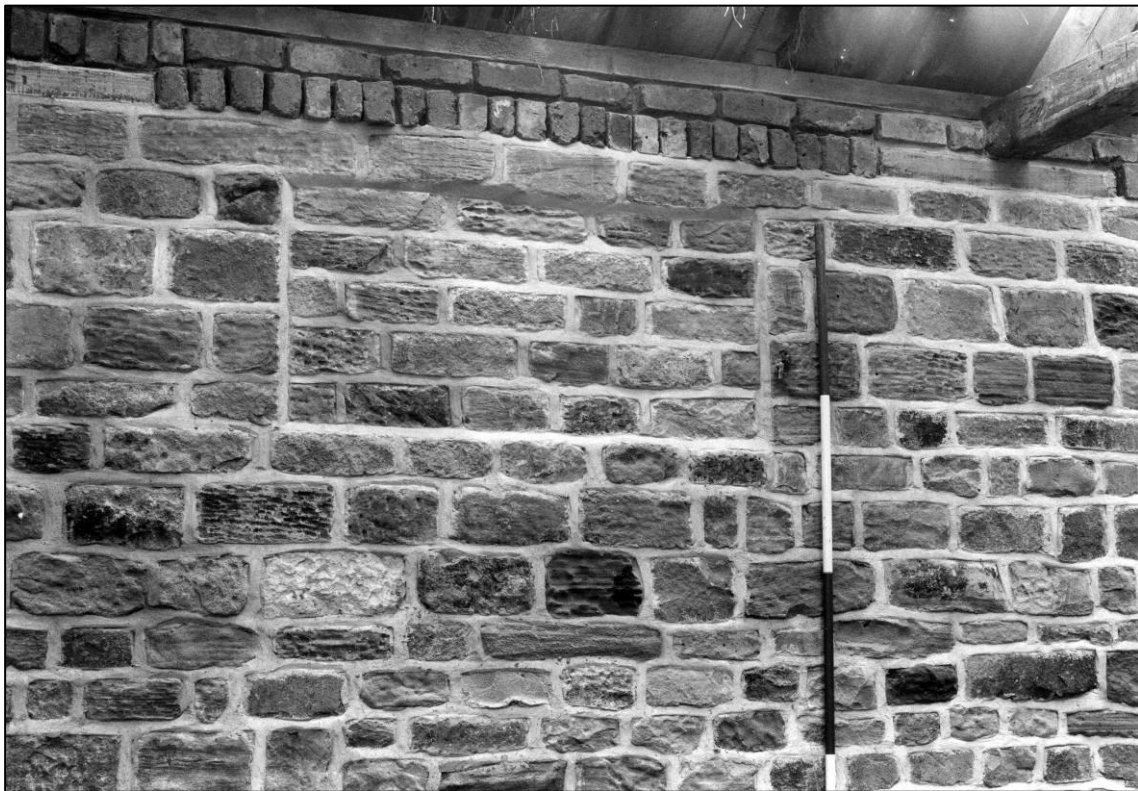
Plate 42: Blocked window in east wall of south room, looking E (photo 1/16).

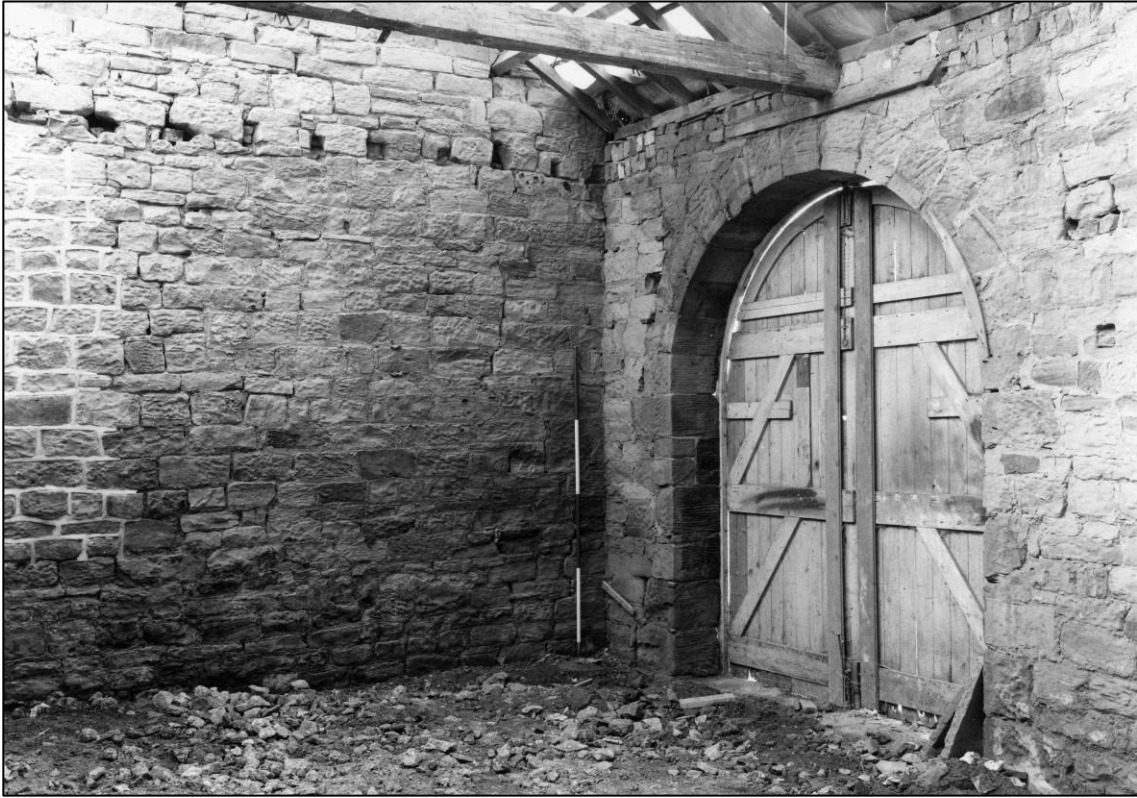
Plate 43: South-east corner of south room, looking SW (photo 1/1).

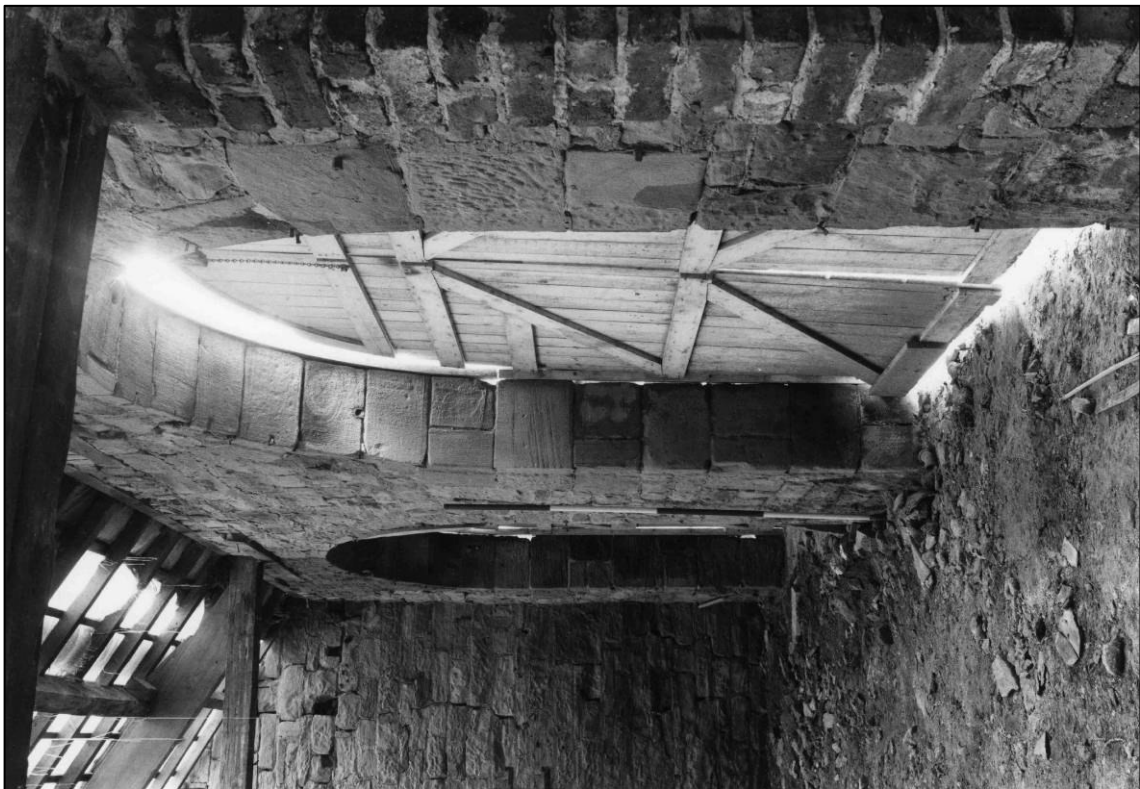
Plate 44: West wall of south room, looking S (photo 1/17) (top to left).

- 3.22 The stone west wall is largely occupied by the two coach openings (plate 44). An interesting feature of these is a very shallow recess around the jambs and head of the openings to their inner faces (plate 45). This recess is c.0.10m wide, and once housed a softwood timber board mirroring the shape of the openings; a very small piece of this survives to the south opening (plate 46). This timber may have continued around to the inner face of the openings, and was designed to stop coaches rubbing against the stonework as they were moved in and out, and so damaging their woodwork/paintwork. A small blocked recess is placed midway between the openings in the west wall, with a possible slightly larger recess, more crudely blocked, above. As with the east wall, there are two courses of brickwork surmounting the wall.

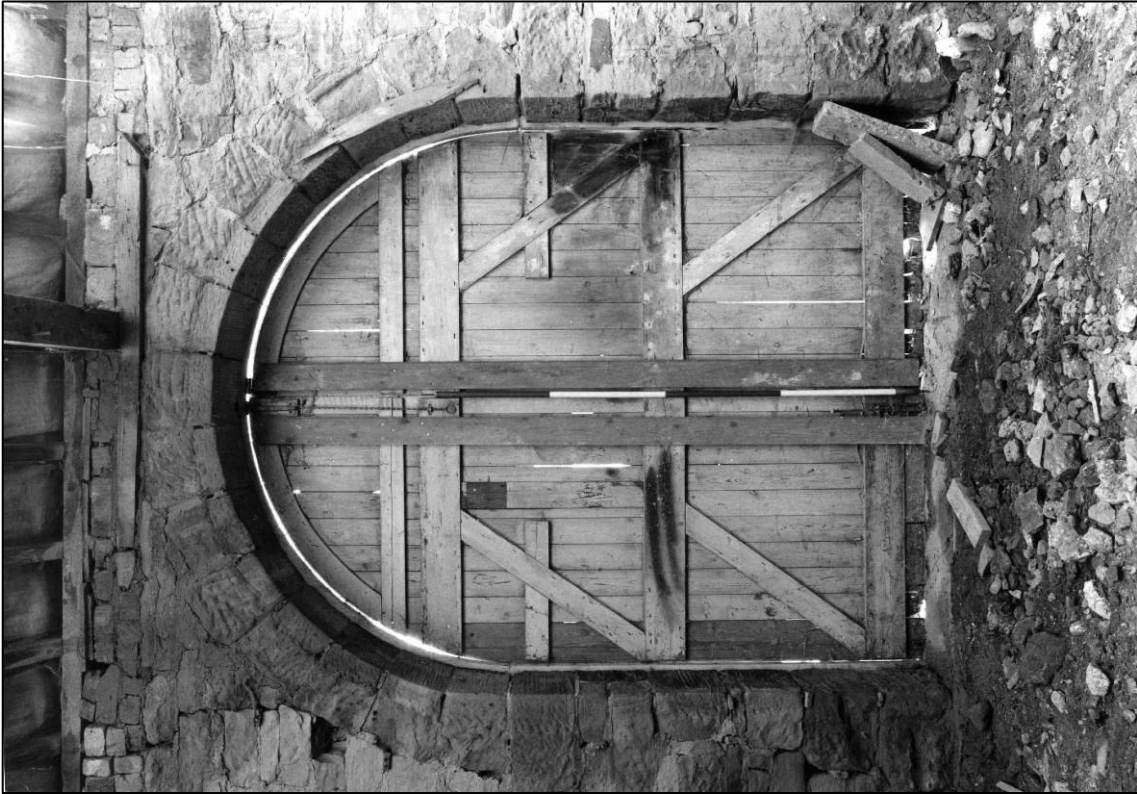
Plate 45: South coach opening in west wall of south room, looking W
(photo 1/12) (top to left).

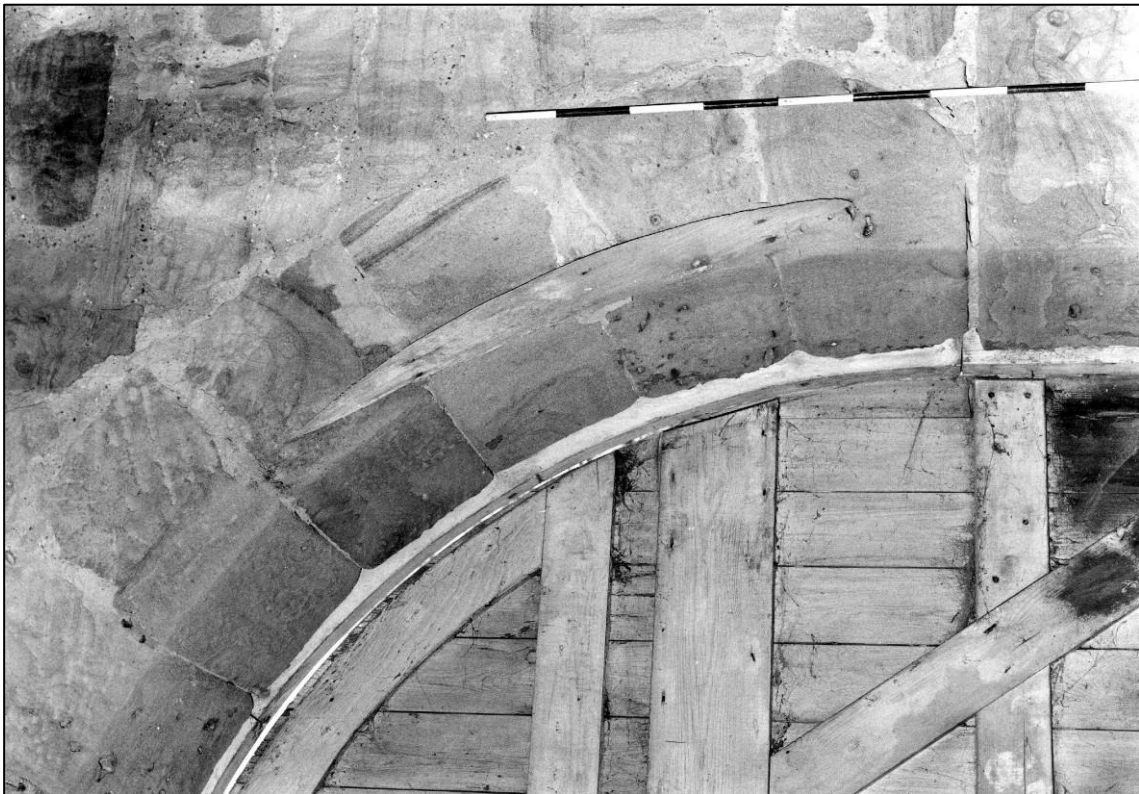
Plate 46: Former timber lining of south coach opening, west wall of south room, looking W
(photo 1/15) (top to left).

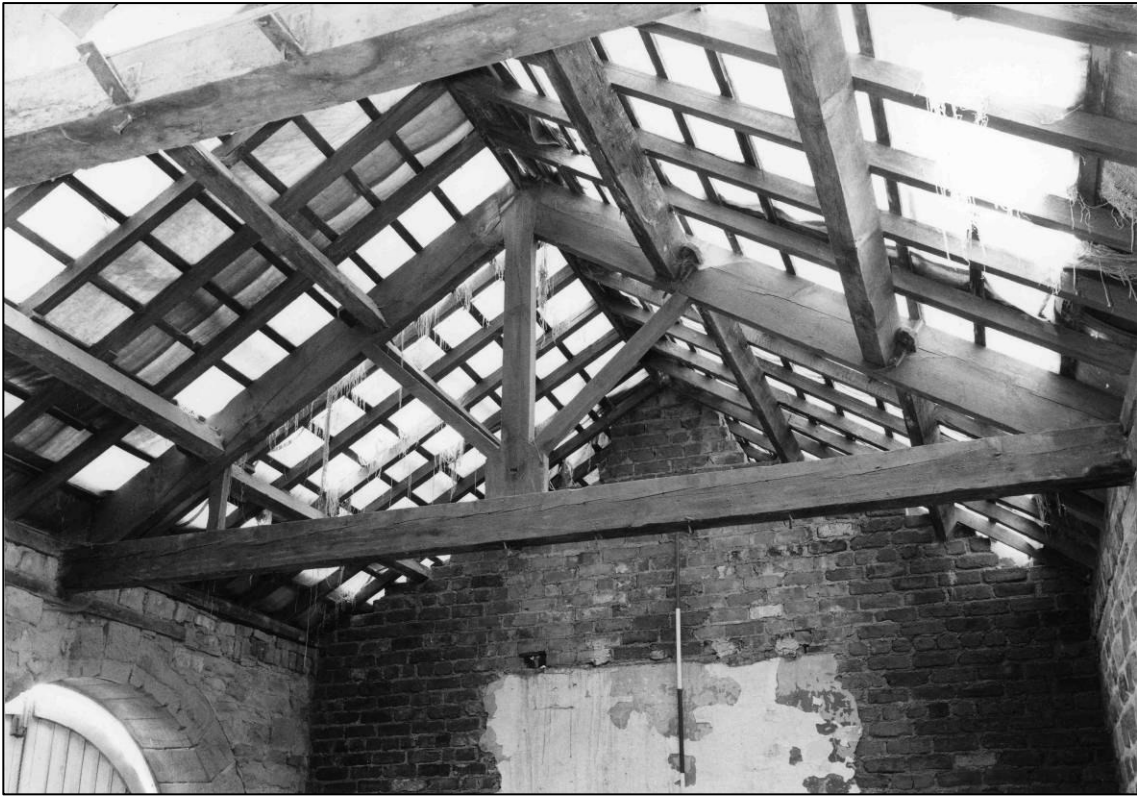
Plate 47: North truss of south room, looking NW (photo 1/9).

- 3.23 The room is crossed by two east-west aligned roof trusses. The north truss is of very similar form to that described above over the central room (plate 47). Again, in 2011, it was reported that chiselled carpenter's marks were present on the truss (Helen Price Associates 2011, 7). No numbering was visible at the time of the EDAS survey, but there are some laying out marks, and also possibly the numerals '87' very crudely scratched into the west end of the tie beam's south face, although these may be no more than a pattern to the wood's surface. The south truss is somewhat different, in that rather than having pegged tusked through-tenons, the purlins are supported by cleats. The head of the king-post is also of slightly different form (plate 48). It has previously been suggested that this truss is a later replacement (Helen Price Associates 2011, 8), and this seems likely, at least above tie-beam level.

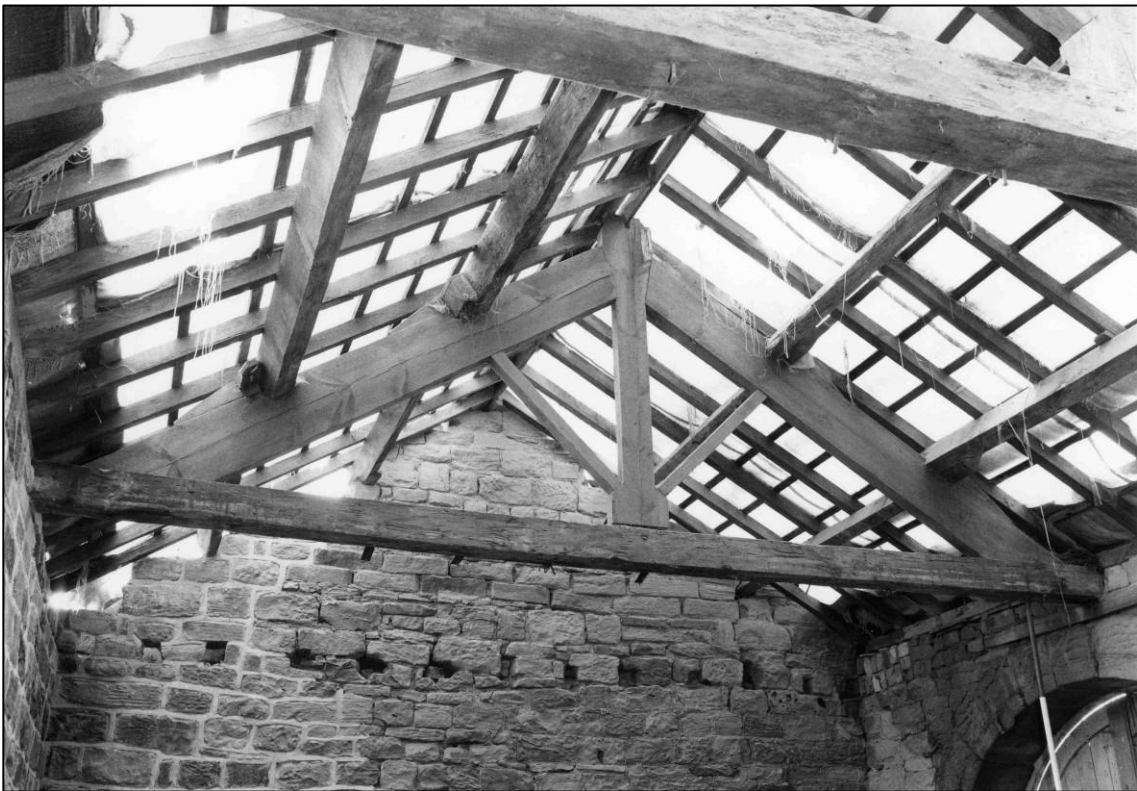
Plate 48: South truss of south room, looking SE (photo 1/11).
