DEMOLITION OF FORMER WHITE HOUSE UNIT (PREVIOUSLY SUTTON COUNCIL SCHOOL AND SUTTON SCHOOL FOR THE DEAF), 262 SALTSHOUSE ROAD, KINGSTON UPON HULL, HU8 9HJ

LEVEL 2 HISTORIC BUILDING RECORDING

Report no: 2020/611.R01

Author: Ed Dennison & Shaun Richardson

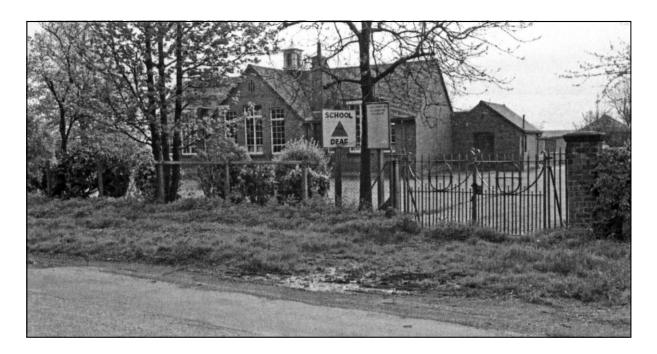
View of Sutton School for the Deaf, showing front elevation and entrance gates, looking NE from Saltshouse Road, c.1964.

- 3.5 Originally, the principal entrance to the school appears to have been at the southeast corner of the site, off Saltshouse Road, although the 1945 plan (see figure 4) might suggest that this later became the girls' entrance; the c.1964 photograph shows that this was closed with decorative wrought-iron gates of early 20th century appearance, which were fitted in 1911 (see figure 8 top). This photograph also shows that the Saltshouse and Dunvegan Road boundaries were post and wire fencing at this date, with 'School Deaf' signs prominently displayed. However, a concrete kerb survives along the former fence line with evidence for the former railings [1/206]. At a later date (and by at least 1945), two additional entrances

with modern UPVC units. However, the c.1964 photographs (see figure 8) show that the window openings were once fitted with wooden-framed windows, of either two or four lights, the lights to the larger windows having up to 15 panes. These windows were presumably wartime replacements of the originals, which had been bomb damaged in 1941, and had themselves been replaced by 1983 when the complex became the White House Unit - all the windows were boarded up externally at the time of the EDAS survey, although a number of photographs show the previous arrangement (see figures 9 top and 10).

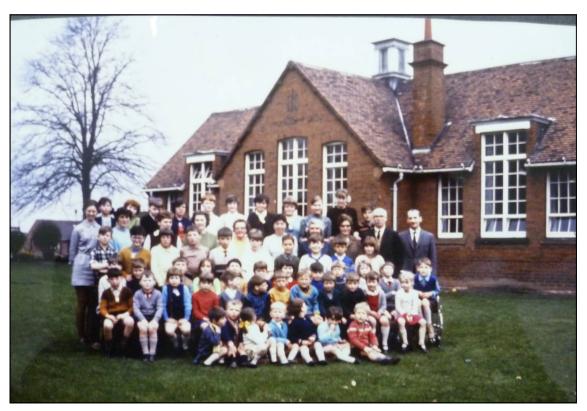
Staff and pupils of Sutton School for the Deaf, in front of the main school building (Block 1), late 1960s.

- 3.11 The school is of a tall single storey, with pitched roofs covered in modern interlocking concrete tiles. A tall brick chimney with a moulded collar rises from the base of the southern roof slope of the building's east range. There is also a squat vent covered in modern cladding at the point over the centre of the building where the roofs meet; in c.1964, a small cupola was present here, probably forming part of a ventilation system but possibly originally comprising a bell cote (see figure 8 top and figure 9 top).

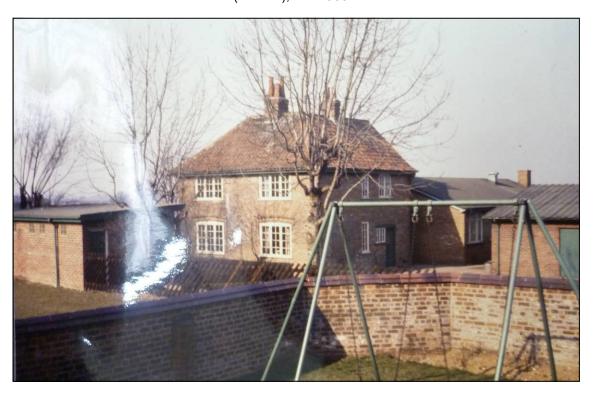
View towards former headmaster's house (Block 3), with Block 2 in foreground and Blocks 4 and 5 in background, and former wall of girls' playground, looking N, late 1970s.

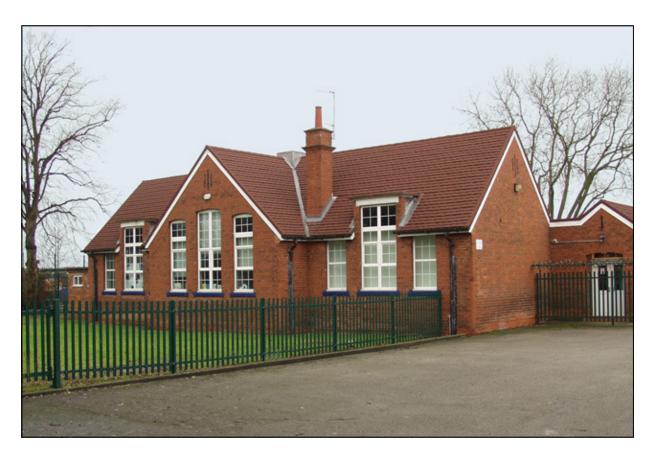
FORMER WHITE HOUSE UNIT, HULL		
2008 PHOTOGRAPH		
SCALE NTS	OCT 2020	
EDAS	figure 10

Colour photograph of White House Unit by Paul Harrop (available at https://commons.wikimedia.org/wiki/File:The_White_House_Unit,_Hull_-_geograph.org.uk_-_657011.jpg)

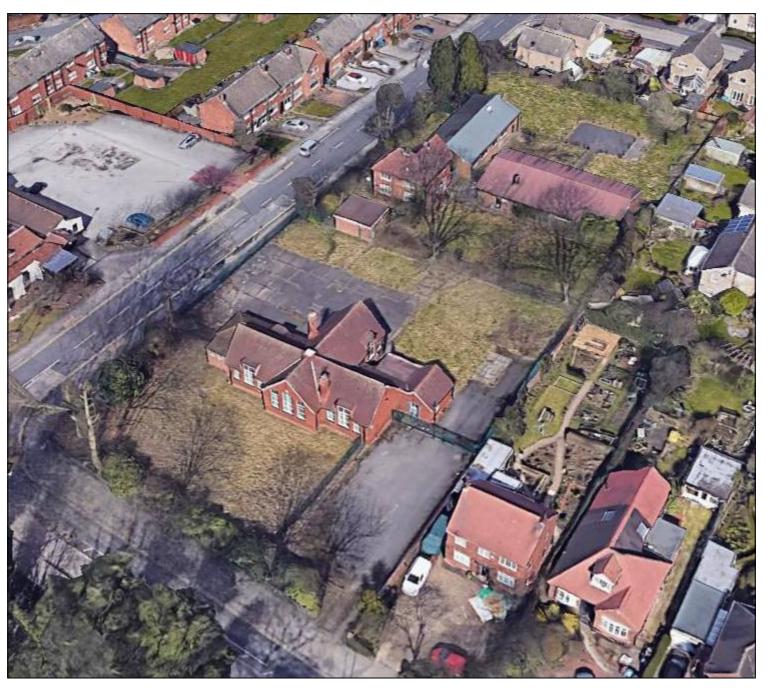
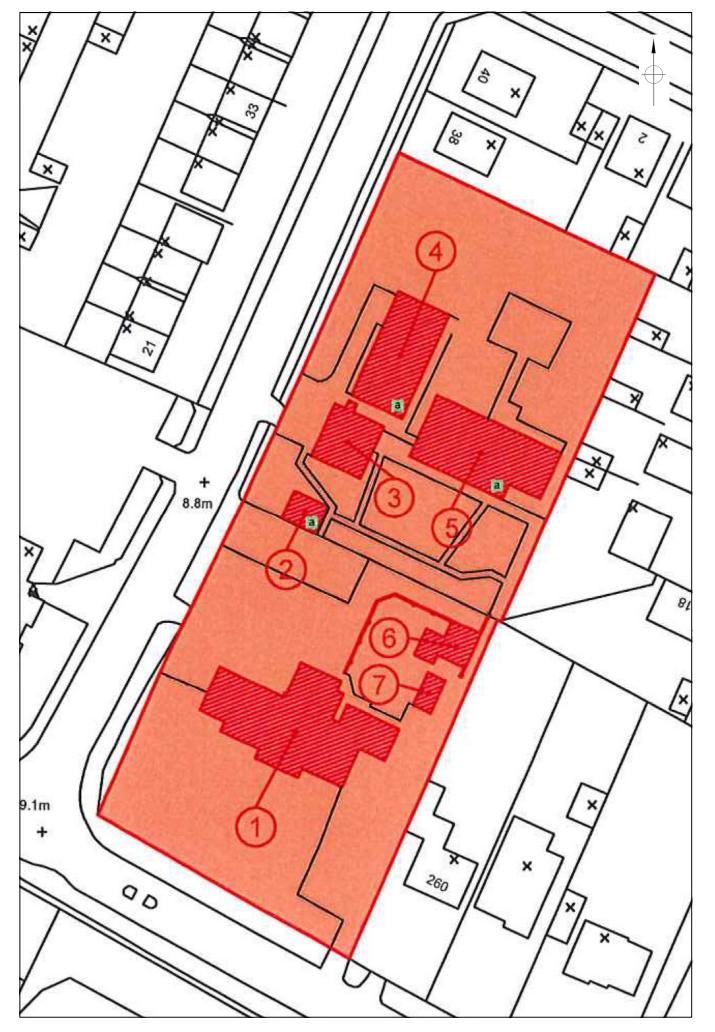
FORMER WHITE HOUSE UNIT, HULL		
2020 SITE PLAN & AERIAL PHOTO		
SCALE NTS	OCT 2020	
EDAS	FIGURE 11

Aerial view of the former White House Unit (Google Earth 2020 accessed image).

Detailed site plan, showing block numbers. Plan provided by Interserve Construction Ltd, reproduced with permission.

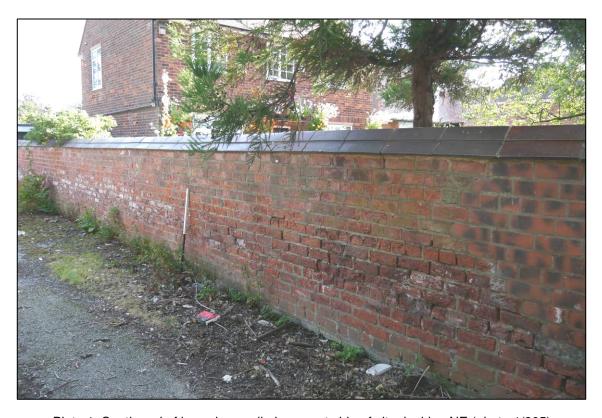
Plate 1: South end of boundary wall along east side of site, looking NE (photo 1/205).

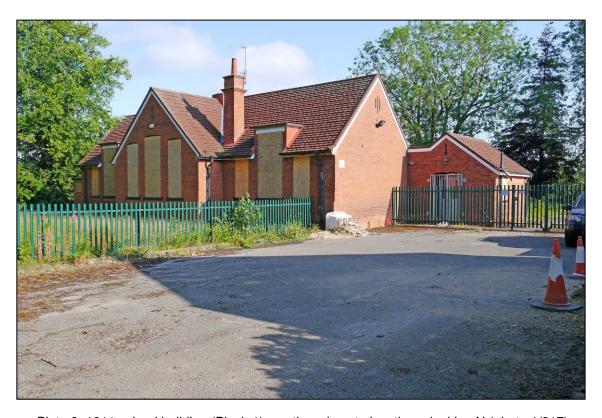
Plate 2: 1911 school building (Block 1), south and east elevations, looking N (photo 1/217).

- 3.6 Entering the site off Saltshouse Road, there is an area of tarmaced car parking to the west of the original boundary wall [1/217] (see plate 2). The area to the south of the main school building (Block 1), shown as divided into two parts in 1928 and 1945, was a single grassed space at the time of the EDAS survey [1/210]. To the north-west of the main school building, there is a rectangular area measuring 25m by 16.5m, paved with large, rectangular concrete slabs, now slightly overgrown [1/201, 1/207] (see plate 3). This is named as the 'boys' playground' in 1945 (see figure 4A), and was used for impromptu football, cricket and other games (Sheila Harness and Mary Hayes, pers. comm.). The rest of this part of the site was rough grass at the time of the survey apart from a number of concrete paths leading to and around the more modern buildings in the northern part of the site; photographs held by the Hull Deaf Centre suggest that the grounds were kept in good order. The boundary shown running north from the main school building in 1928 and angling to the former toilet block has recently been demolished, although it was previously a tall brick wall built in the same style as that which remains on the east side of the site (see figure 9 bottom). The area to the east of this wall, and including the present tarmac car park, is named as the 'girls' playground' in 1945, and a late 1970s photograph shows swings in the northern part (see figure 9 bottom). The building at the north-east corner (the former Block 6) formed lavatories, which in 1928 and 1945 were divided into two parts internally with separate entrances from each playground. Both the wall and the lavatory block are shown on the c.2018 ground plans provided to EDAS, but they had been demolished by the time of the EDAS survey.

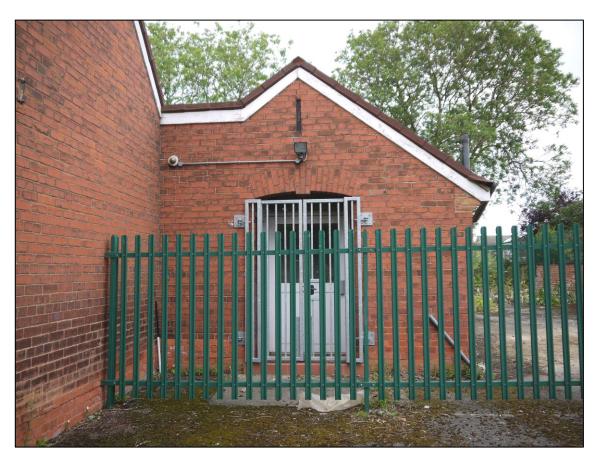
Plate 5: 1911 school building (Block 1), former girls' entrance in south elevation, looking NE (photo 1/151).

- 3.15 The south external elevation is described from east to west. At the extreme east end, a small projection here is gabled, with a tile kneeler to the east side and a narrow slit to the apex under wooden barge boards [1/147, 1/151] (see plates 5 and 6). To the centre, there is a doorway opening with a tiled step and a segmental head with a lowered brick key [1/148-1/150]; the 1945 plan suggests this was originally the girls' entrance. The east gable end of the main body of the building is largely blank, with a tile kneeler to the south end [1/147]. It is noticeable that, to the lower c.1.50m of brickwork, there is a large amount of scratched graffiti. Some is obviously very recent, but the style of lettering or numbering of much of the graffiti suggests that it is earlier - some is repeated several times, for example 'PLAIN', 'RICH', '23', 'ES23', 'ES13' and 'ES55'. Approximately 2.50m above ground level to the centre of the gable, there are two metal rings projecting from the brickwork, possibly once supporting a light fitting. Above and to the south of these, there is evidence for another older fitting having been removed, possibly an old hoop for a ball game. To the apex of the gable, there are three narrow slits, fitted with metal gauze, and wooden barge boards [1/146].

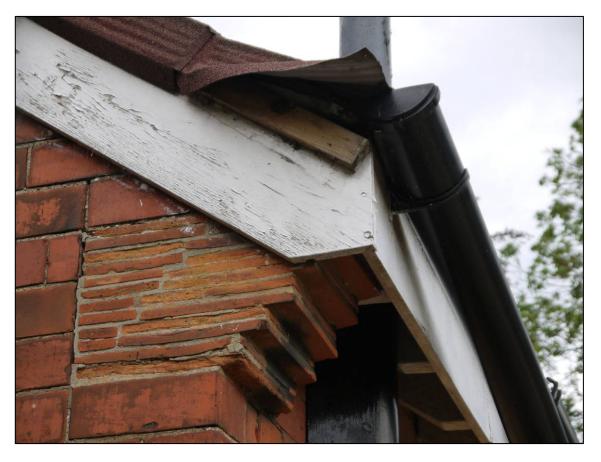
Plate 6: 1911 school building (Block 1), detail of tiled kneeler on south elevation, looking NW (photo 1/147).

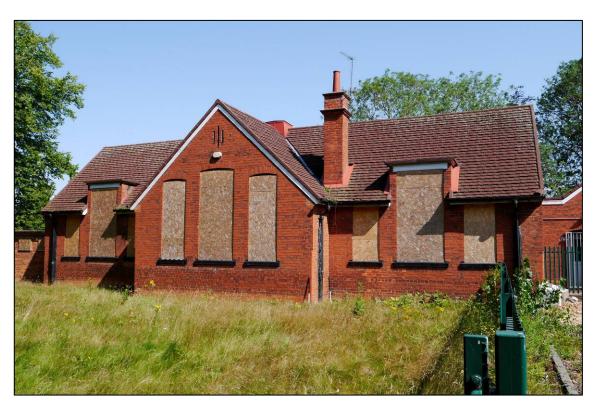
Plate 7: 1911 school building (Block 1), south elevation, looking N (photo 1/154).

- 3.16 The south elevation of the main body of the building is nine bays in length, the central three bays breaking forward as a gabled projection with tile kneelers [1/142, 1/153, 1/154] (see plate 7). The two outer three bay blocks flanking the central projection have a window to each bay, all flat-headed and with slightly projecting stone sills. The central window is taller and projects above the eaves line as a flat dormer; these taller windows have stone lintels and a moulded wooden cornice over [1/135, 1/143] (see plate 8). The central projection has three tall windows, the central one slightly taller and wider than those to either side, each with a slightly projecting stone sill and shallow segmental head [1/136, 1/138, 1/139] (see plate 9). A recent photograph shows the fenestration, all of modern UVPC casements (see figure 10). There is an old metal fitting between the central and west window, and three narrow slits to the apex fitted with metal gauze. The lower c.1.50m of the central projection's brickwork again has much scratched graffiti, including 'Betty

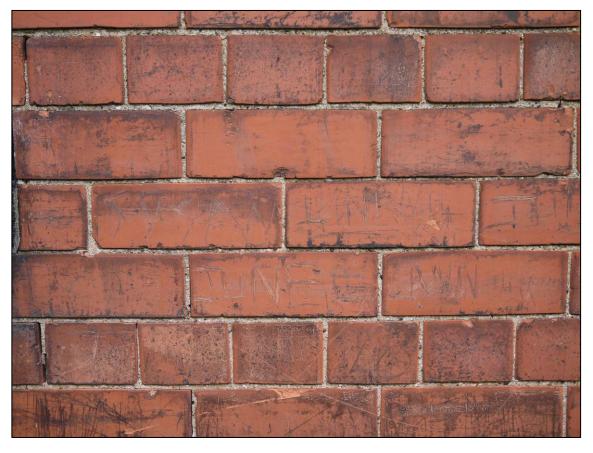
Plate 10: 1911 school building (Block 1), detail of graffiti on gable of central projection to south elevation, looking NE (photo 1/140).

Norman', 'LINDA 14 Year Old', 'JUNE 12 Year Old', 'JUNE PAL 15 YR' and 'ANN 14 year old' [1/137, 1/140, 1/141] (see plate 10). The short returns to either end of the central projection are blank [1/144].

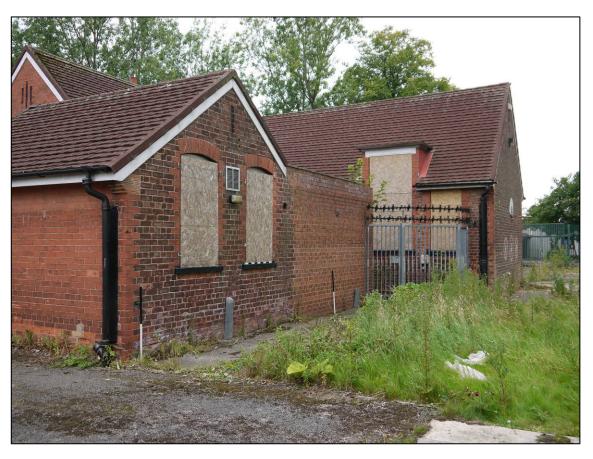
Plate 11: 1911 school building (Block 1), east end of north elevation, looking W (photo 1/132).

- 3.19 This elevation is described from east to west. The gabled projection at the northeast corner of the school has a tile kneeler, and two windows with slightly projecting stone sills and segmental heads; there is also an original glazed ceramic vent and a slit to the apex beneath wooden barge boards [1/112, 1/131, 1/132] (see plate 11). To the west, a modern (post-1974), single storey flat roofed addition has blank walls built of machine-made brick (average dimensions 210mm by 110mm by 70mm) set with cement mortar [1/113]; the junction between the two phases is clearly evident in the brickwork, and the later extension does not have bull-nosed bricks to the north-west corner. Only a small part of the original north elevation remains visible here, and this has a single window, detailed as the others to the east [1/114].

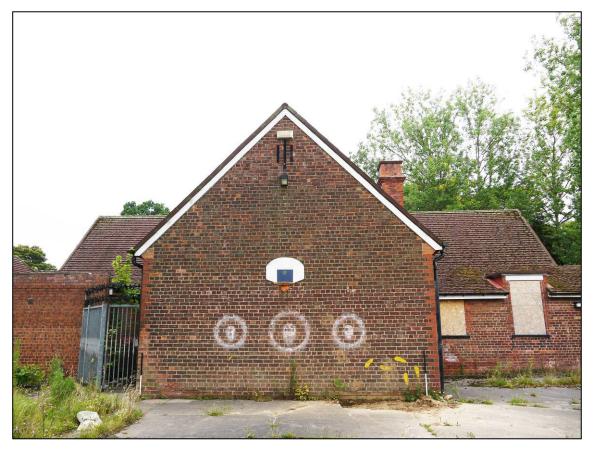
Plate 12: 1911 school building (Block 1), central projection to north elevation, looking SW (photo 1/125).

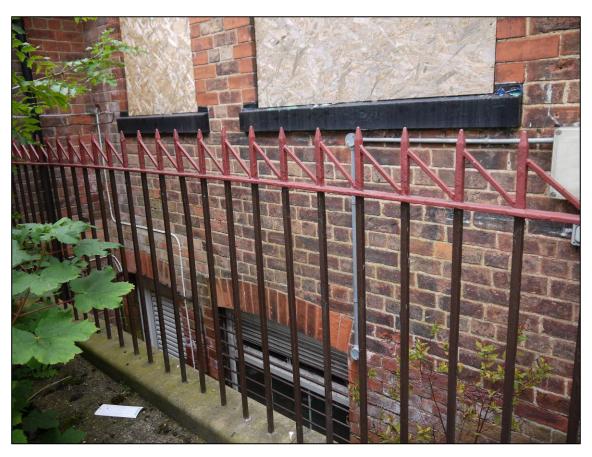
Plate 13: 1911 school building (Block 1), north elevation, detail of railings to boiler house steps, looking SW (photo 1/130).

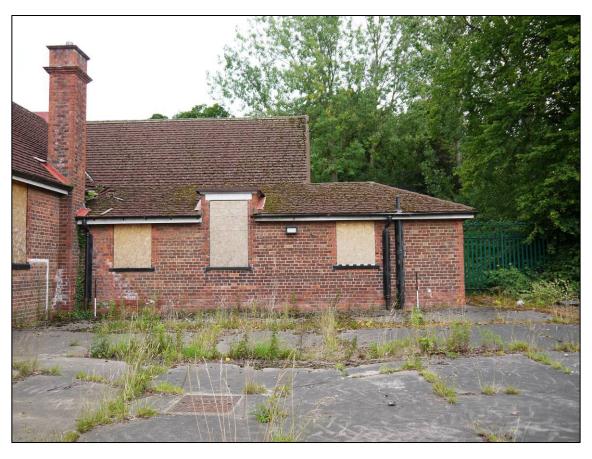
Plate 14: 1911 school building (Block 1), north elevation, west side of central projection, looking SE (photo 1/123).

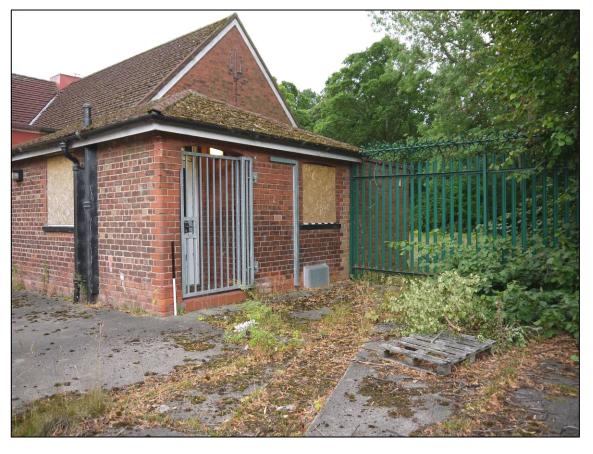
Plate 15: 1911 school building (Block 1), west end of north elevation, looking SW (photo 1/122).

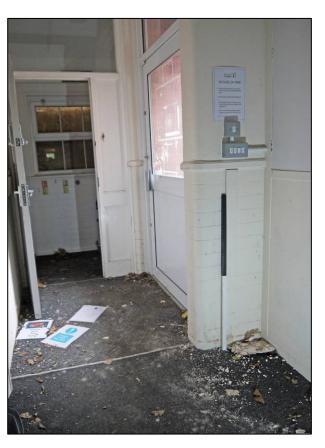
Plate 17: 1911 school building (Block 1), east end of internal corridor (G/001), looking SE (photo 1/001).

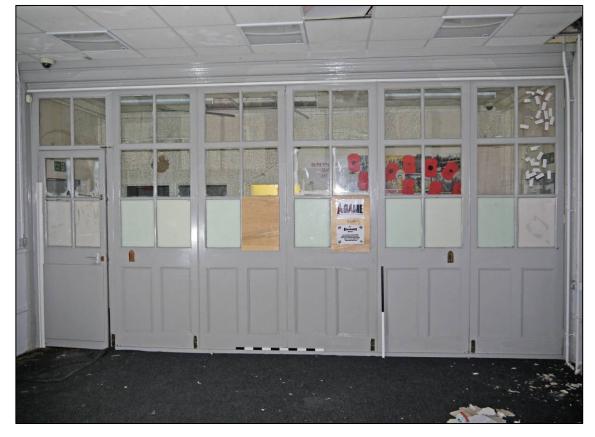
Plate 21: 1911 school building (Block 1), classroom (G/005), handle on folding screen, looking SW (photo 1/022).

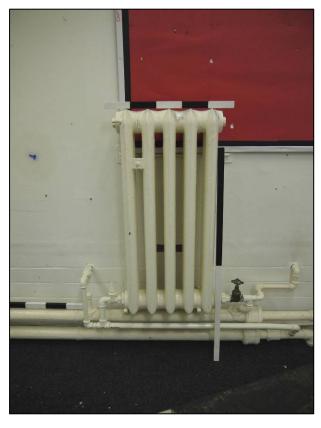
Plate 23: 1911 school building (Block 1), classroom (G/005), windows and rib-type radiator to east wall, looking E (photo 1/019).

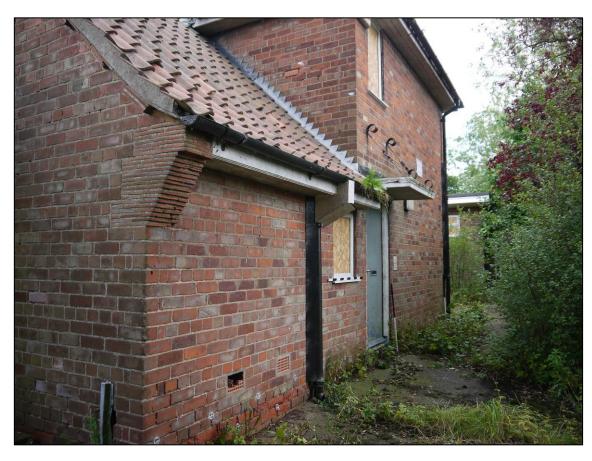
Plate 33: 1923 house (Block 3), east elevation, looking NW (photo 1/169).

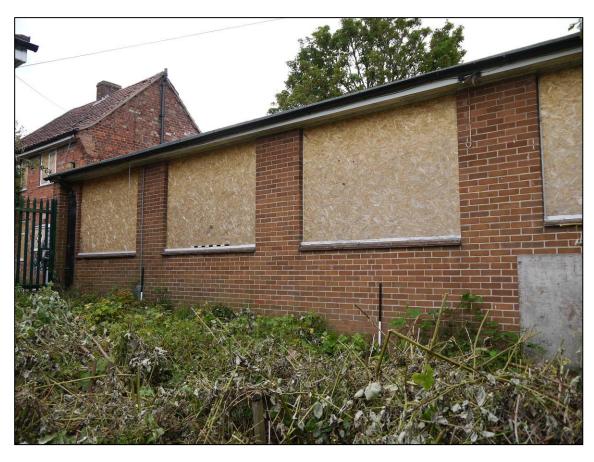
Plate 42: 1960 kitchen and dining block (Block 4), west elevation, looking S (photo 1/175).

3.47 The entrance to the dining hall was in the south gable, through a central two-leaf part glazed doorway with splayed jambs and recessed brick detailing, and a concrete canopy over [1/178] (see plate 40). The west elevation is of five bays (see plate 42). The north bay breaks forward slightly, and has a recessed two-leaf doorway with a raised concrete step, flanked by a small flat-headed window to the north [1/177]. The four bays to the south each contain a large window with a projecting tiled sill; the sill of the northernmost window is set at a slightly higher level than the other three [1/175, 1/176]. The east elevation is of very similar form, although the north bay does not break forward and contains only a single leaf doorway [1/179, 1/180, 1/185] (see plate 43). The north gable has three small flatheaded windows and a number of vents [1/181, 1/182] (see plate 44).

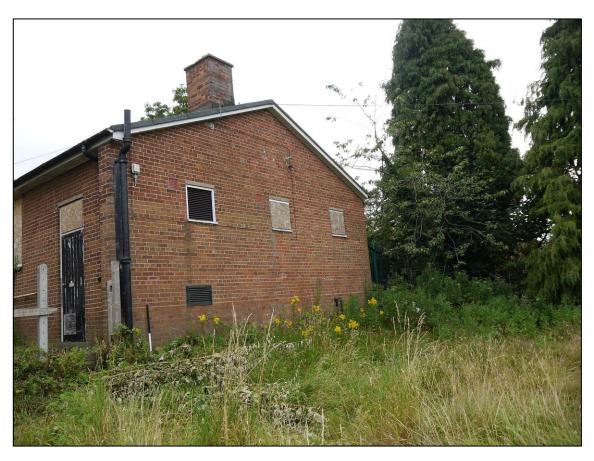
Plate 43: 1960 kitchen and dining block (Block 4), east elevation, looking SW (photo 1/179).

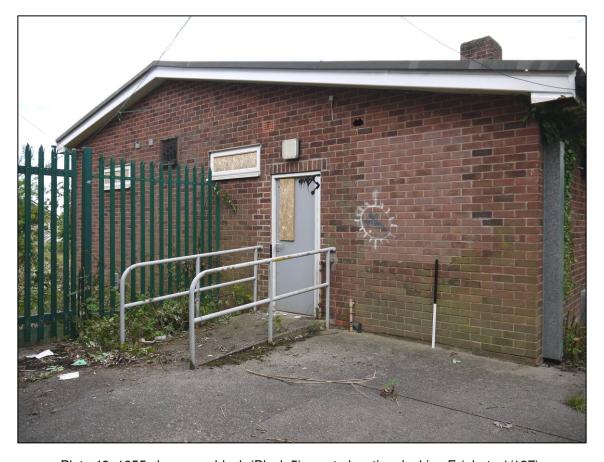
Plate 48: 1955 classroom block (Block 5), west end of south elevation, looking E (photo 1/188).

3.51 The classroom block is rectangular in plan, aligned east-west, and measures 21.00m east-west by 10.30m north-south (see plate 48). It is of a single storey, with a pitched roof; internally, the roof can be seen to be made of overlapping, corrugated steel sheets, covered with felt. There is a tall brick stack to the west of centre of the south roof slope. The block is built of brown machine-made bricks (average dimensions 210mm by 105mm by 70mm) laid in Stretcher bond and set with a cement mortar. No original windows survive, all having been replaced with UPVC units. Internally, there are a small number of probable 1970s doors and radiators but, as would be expected, the building has clearly been refurbished a number of times during its lifetime.

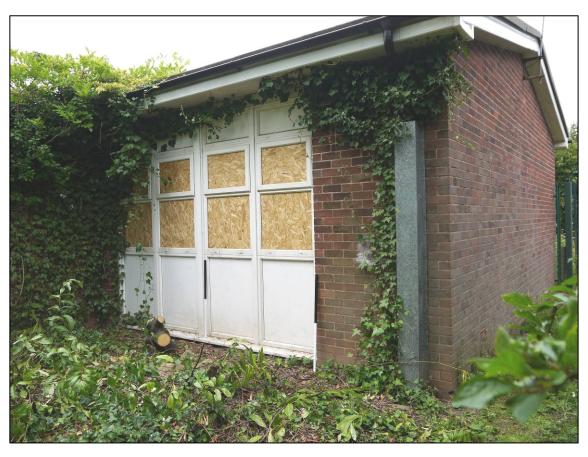
Plate 49: 1955 classroom block (Block 5), west elevation, looking E (photo 1/187).

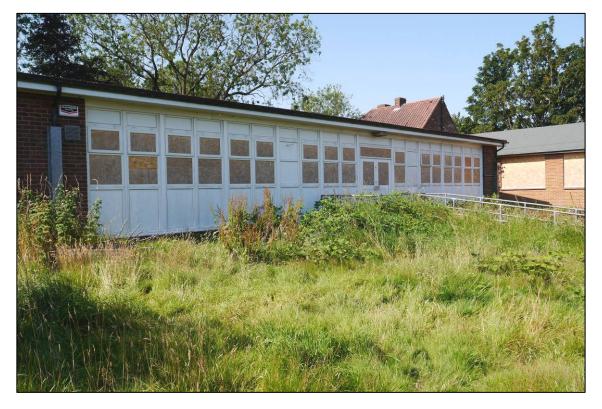
Plate 50: 1955 classroom block (Block 5), east end of south elevation, looking N (photo 1/192).

- 3.52 The west elevation or gable has a doorway to the south of centre with an access ramp leading up to it, and two low single-light windows placed at a high level to the north, with a larger blocked window to the south; the brickwork around the doorway suggests that it was inserted, presumably to create a disabled access [1/186, 1/187] (see plate 49). The south elevation has a doorway with an adjacent window (now blocked but with a ventilator) at the west end, which leads into two plant rooms (G/009 and G/010) [1/189] (see plate 48). Further to the east is a recessed doorway forming the principal entrance, flanked by long low three light windows set at a high level [1/188, 1/190, 1/191, 1/197]. The elevation then steps back, with the recessed portion largely taken up by modern glazing, formed by two modern UPVC units; these units are formed by four rows which increase in height from top to bottom, with only the central two rows being glazed and the others closed with panels [1/192] (see plate 50). The east gable is blank [1/193, 1/194].

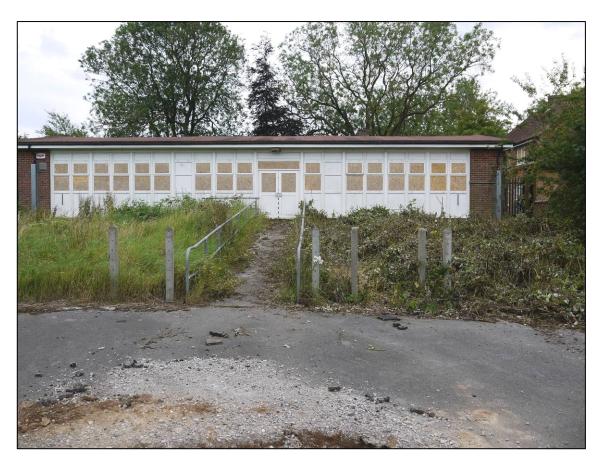
Plate 51: 1955 classroom block (Block 5), north elevation, looking S (photo 1/198).

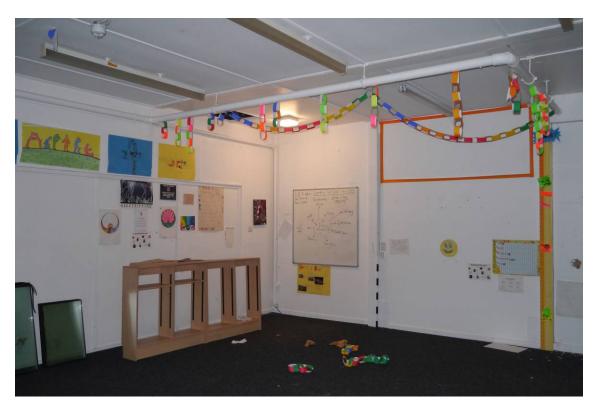
Plate 53: 1955 classroom block (Block 5), classroom (G/002), looking E (photo 1/088).

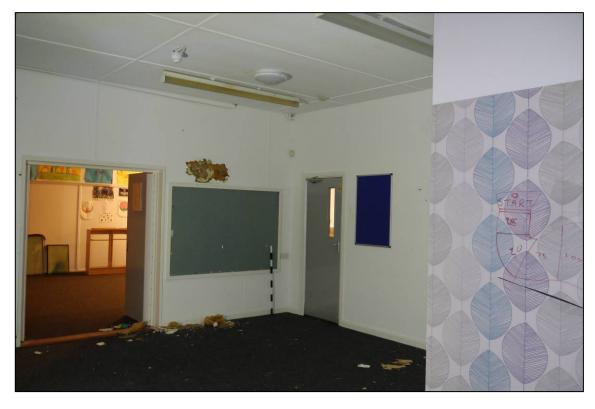
Plate 55: 1955 classroom block (Block 5), classroom (G/008), looking S (photo 1/098).

- 3.56 A doorway at the west end of the north wall of the corridor (G/001) opens into a small circulation space (G/012) [1/106]. A door in its north wall gives access into the western classroom (G/008), assumed to be the former combined domestic science, housewifery and dressmaking room. The south-west corner of this room has been truncated by adjacent WC facilities, but it contains little of interest, apart from a rib-type radiator placed against the north wall [1/096-1/099] (see plate 55). A large cupboard indicated on the supplied floor plan in the north-west corner has since been removed.

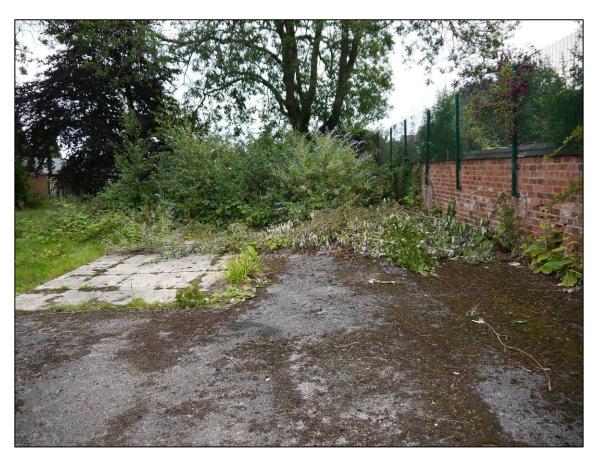
Plate 56: Sites of 1911 lavatories (Block 6) and later building (Block 7), looking NE (photo 1/202).

- 3.60 Both blocks are shown on the c.2018 floor plans provided to EDAS, but both had been demolished prior to the EDAS survey taking place, leaving an overgrown area marking the site of the lavatories and a hard standing for the other structure [1/202] (see plate 56).

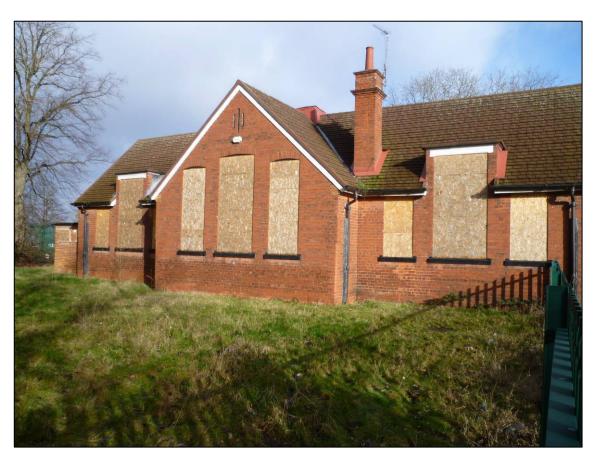
Plate 1: Main School Building (Block 1), front elevation, looking NW.

- 2.3 All the buildings are brick-built and of a single storey with a combination of flat and pitched roofs, apart from Block 3 which is a two storey house. Block 1 is the main school building (see plates 1 and 2), Block 2 is possibly an infants classroom, Block 3 is presumably the former Head Teacher's house (see plate 3), and Blocks 4 and 5 are additional classroom blocks (see plates 3 and 4). The architectural detailing on Blocks 1 and 3 suggests that they date from the 1920s, while the other structures are more recent. In all cases, all external openings have been boarded up for security, making the interiors very dark without artificial illumination. Internally, there are few historic features remaining and, although many wall faces are boarded out with modern panels etc, there is some evidence for original construction, fixtures and fittings (e.g. windows, radiators, doors and door furniture etc). There are a number of large trees around the periphery of the site, and some areas of scrub and high vegetation obscuring some building elevations and views. The site as a whole is surrounded by a high security fence.

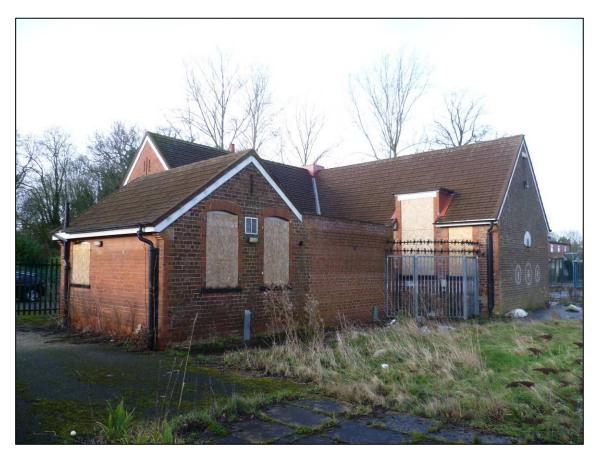
Plate 2: Main School Building (Block 1), rear elevations, looking SW.

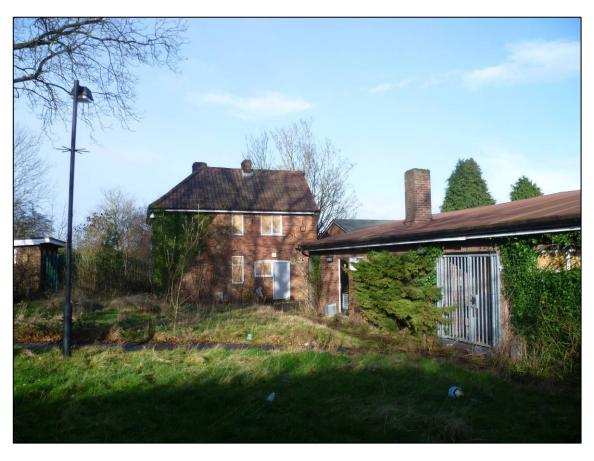
Plate 3: Head Teacher's House (Block 3) with classroom block (Block 5) to right, looking W.

5.10 There is some minor vegetation encroachment around some of the disused buildings, specifically localised growths of shrubby bushes (see plate 3). Although in general this should not hinder the on-site survey work (depending on the timing of the project), some vegetation will need to be cut down to ensure that there are clear slight lines around and to the various buildings. The Archaeological Contractor should therefore allow for two days site clearance, with the arisings moved away from the buildings so as not to obscure subsequent recording.

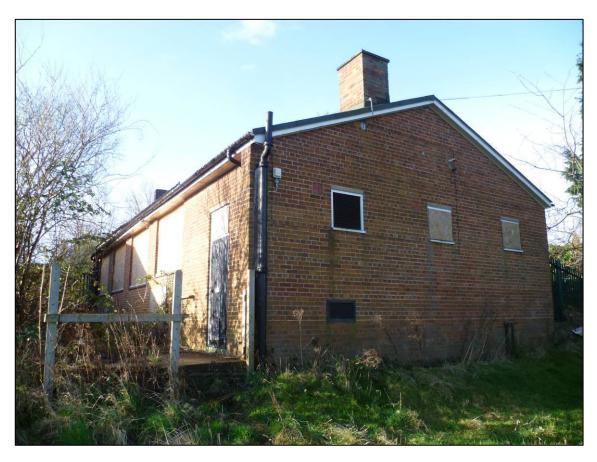
Plate 4: Classroom block (Block 4), looking SE.
