FORMER ENTRANCE BLOCK TO BRAMLEY UNION  
WORKHOUSE (ST MARY'S HOSPITAL),  
ARMLEY, LEEDS LS12 3QE

ARCHAEOLOGICAL AND ARCHITECTURAL  
PHOTOGRAPHIC RECORD

Report no: 2020/609.R01  
Version: Final  
Date: May 2020  
Author: Shaun Richardson & Ed Dennison

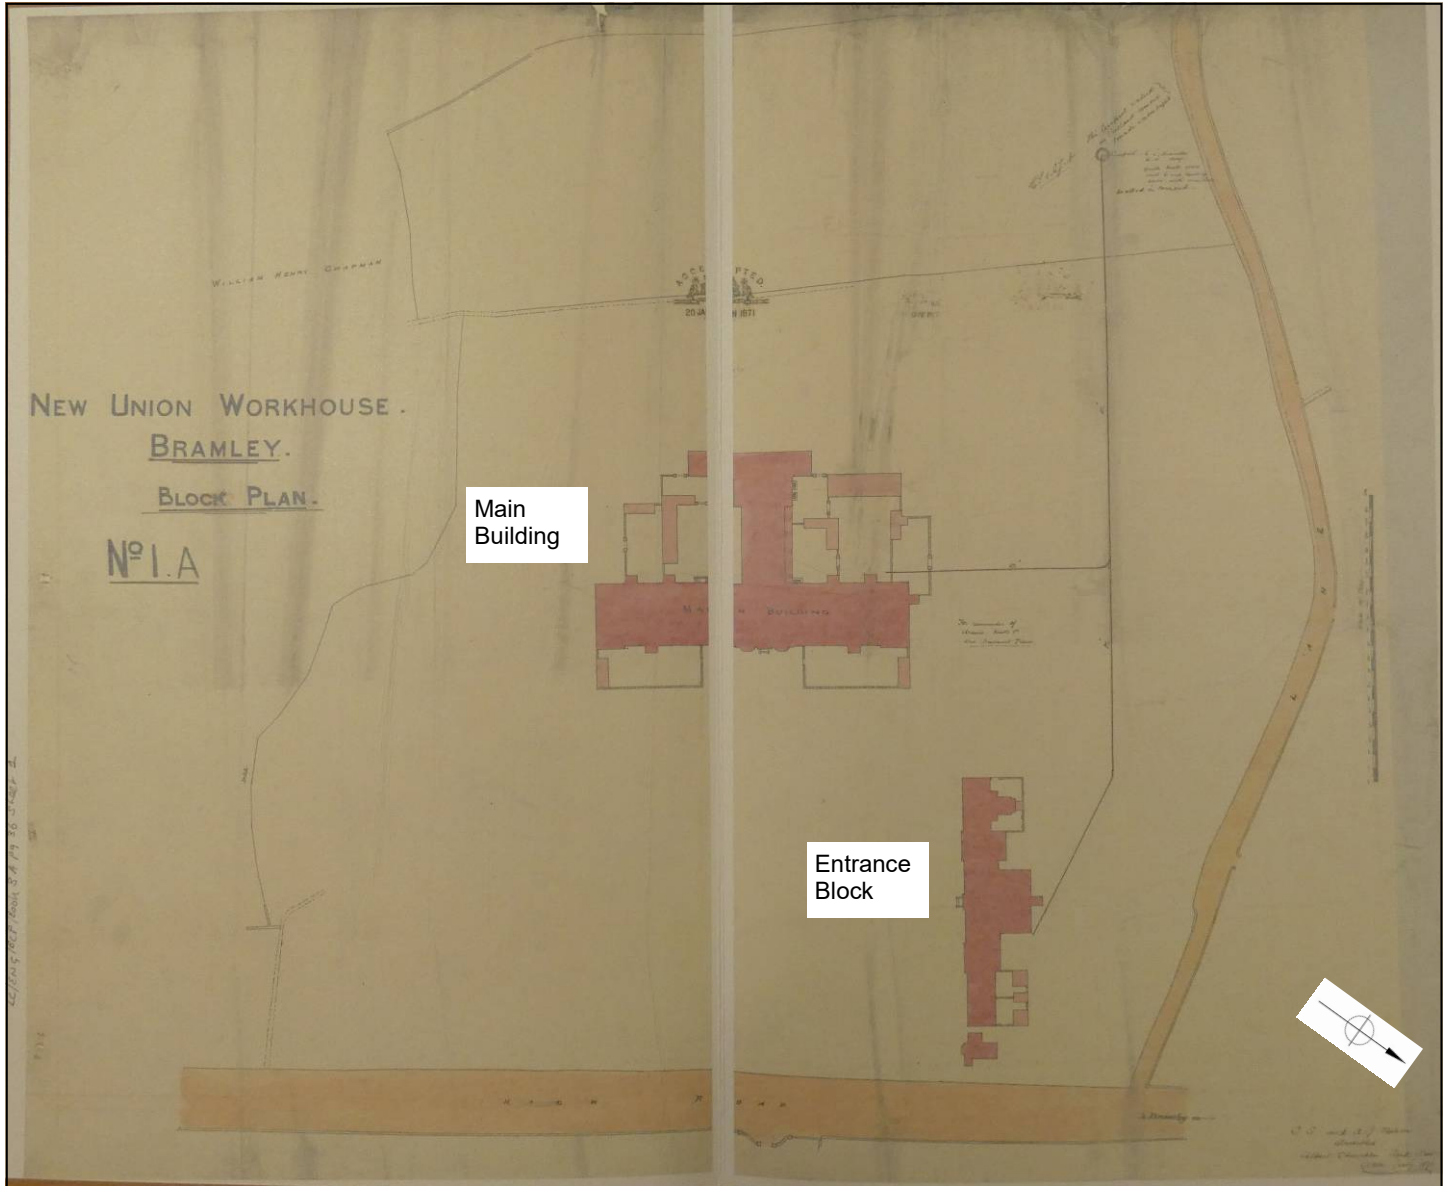
PROJECT BRAMLEY UNION WORKHOUSE, ENTRANCE BLOCK	
TITLE 1870-71 BLOCK PLAN	
SCALE AS SHOWN	DATE MAY 2020
EDAS	FIGURE 3

New Workhouse at Armley for the Bramley Union, Block Plan (Source: WYAS Leeds LC/ENG/BCP/Book 3A, p36, sheet 1).

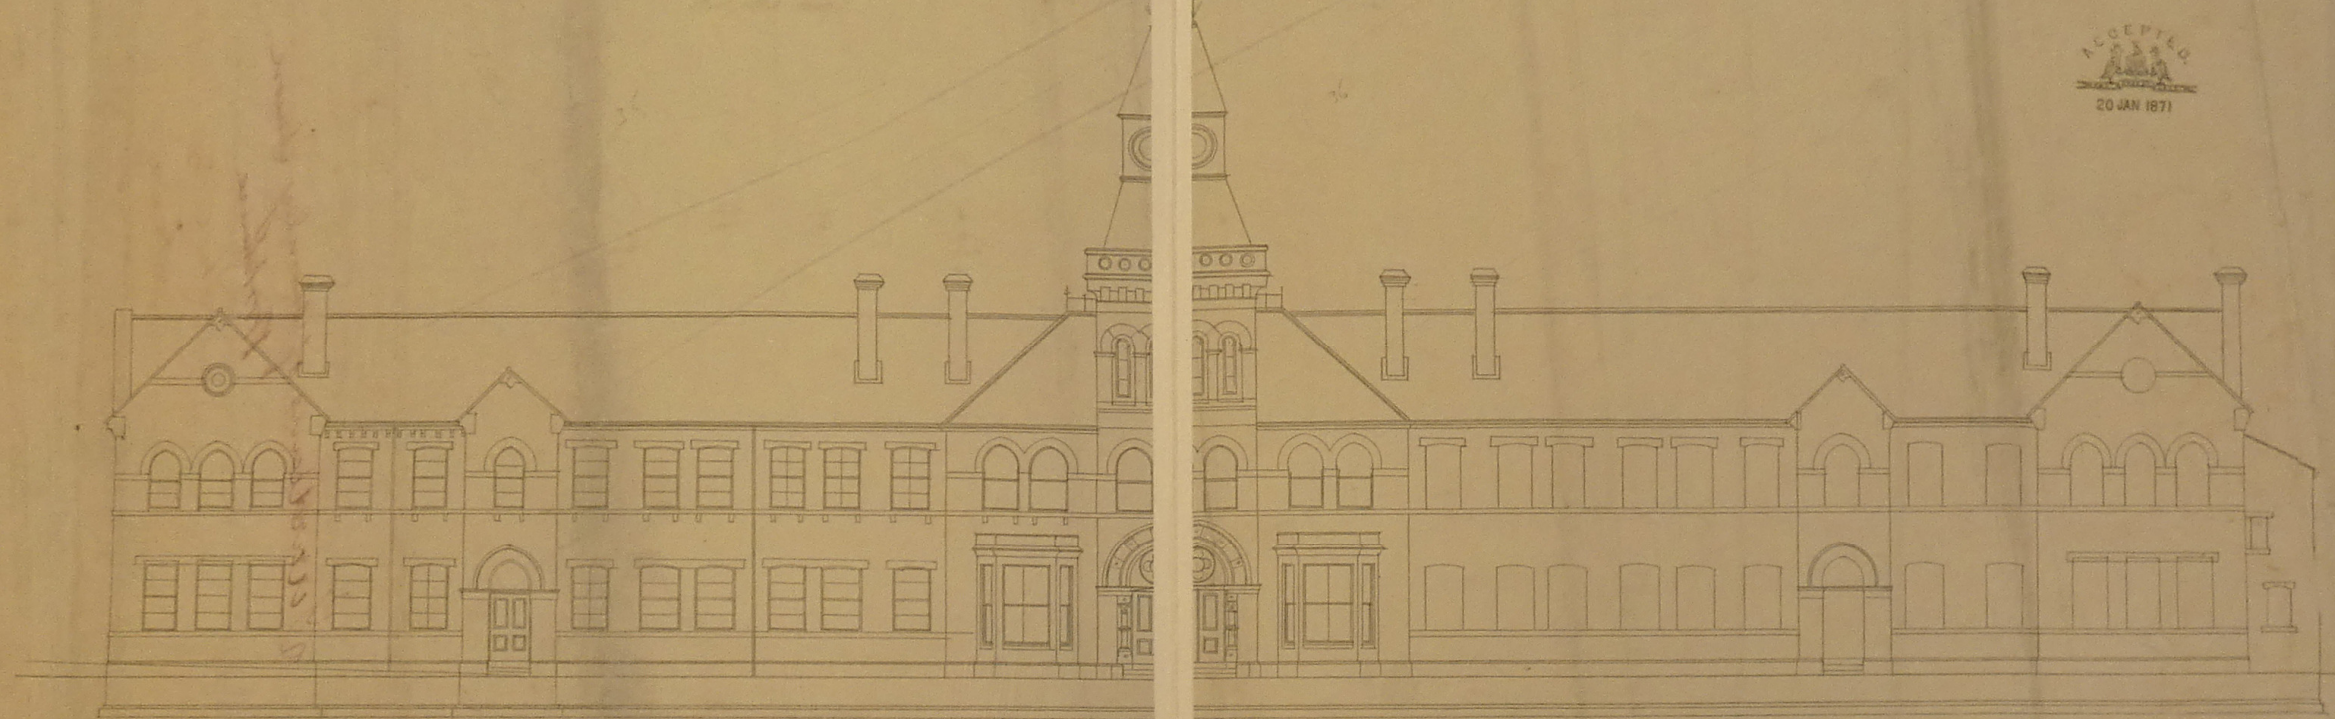
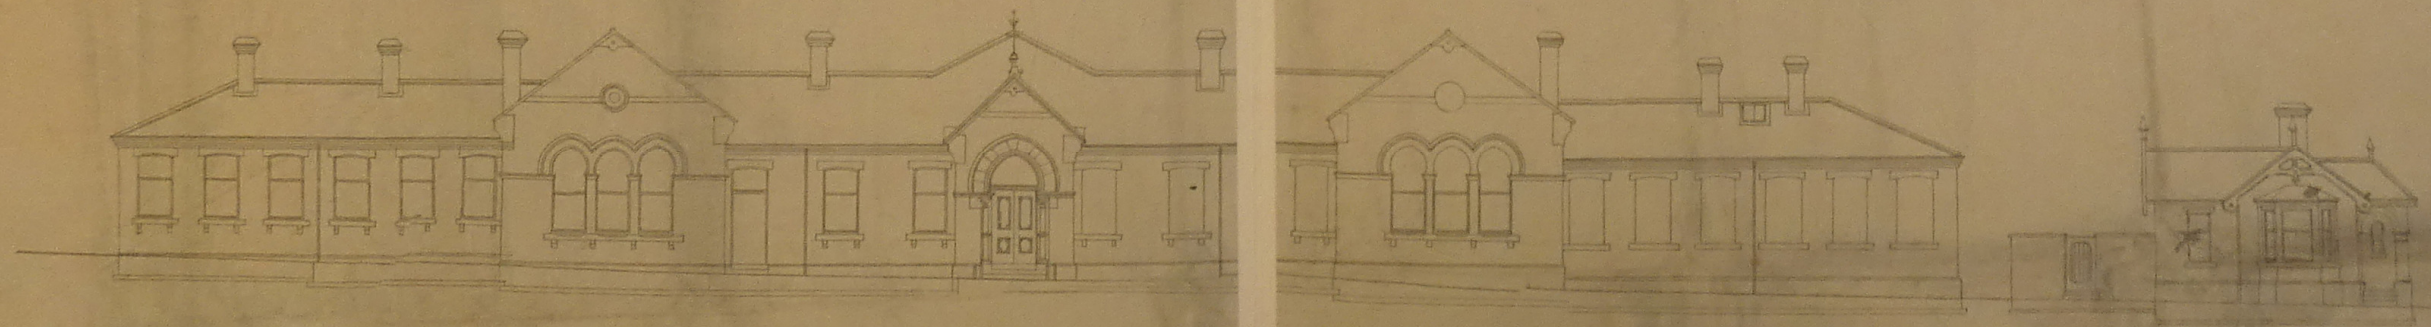
PROJECT		BRAMLEY UNION WORKHOUSE, ENTRANCE BLOCK	
TITLE		1870-71 ELEVATIONS	
SCALE	AS SHOWN	DATE	MAY 2020
EDAS		FIGURE	4

FRONT ELEVATION.  
(Main Building)

FRONT ELEVATION.  
(Entrance Block)

- 3.9 The Porter's Lodge forms an original part of the 1872 workhouse complex. It is shown on the 1870-71 drawings as essentially a small single storey cottage, with a gable facing the entrance drive, decorated with barge boards and containing a canted bay window (see figures 4 and 5). The main entrance was through an external porch at the south-east corner. This led into a living room to the south and a bedroom to the north, both heated by fireplaces. To the west was a scullery with a large sink, and then an attached yard with an ash house, earth closet and coal house arranged along the north side (see figure 6).

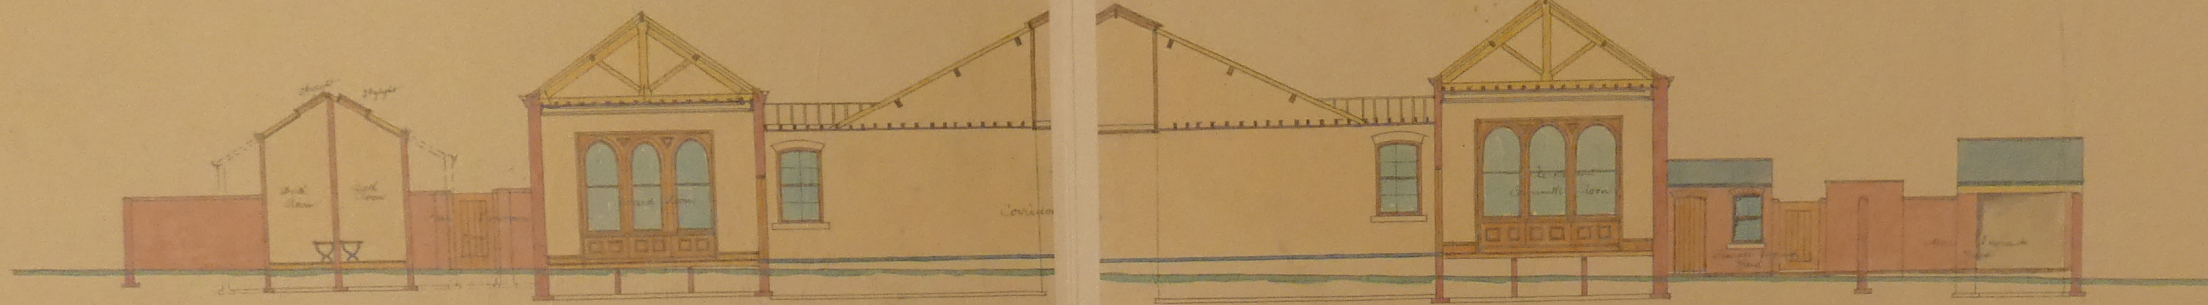
PROJECT	
BRAMLEY UNION WORKHOUSE, ENTRANCE BLOCK	
TITLE	
1870-71 SECTION AND GROUND PLAN	
SCALE	DATE
AS SHOWN	MAY 2020
EDAS	FIGURE
	5

LONGITUDINAL SECTION  
AT AA

GROUND PLAN

- 3.2 Given the degree of modern alteration to the entrance block buildings, the 1870-71 architects' drawings are extremely important in trying to understand their original layout (see figures 5 and 6); they are the only known detailed 19th century depictions of the buildings, and without them it would be difficult to accurately attribute functions to many of the spaces which now exist. Therefore, throughout the description, frequent but limited references are made to the drawings where it is relevant to the surviving fabric being described.

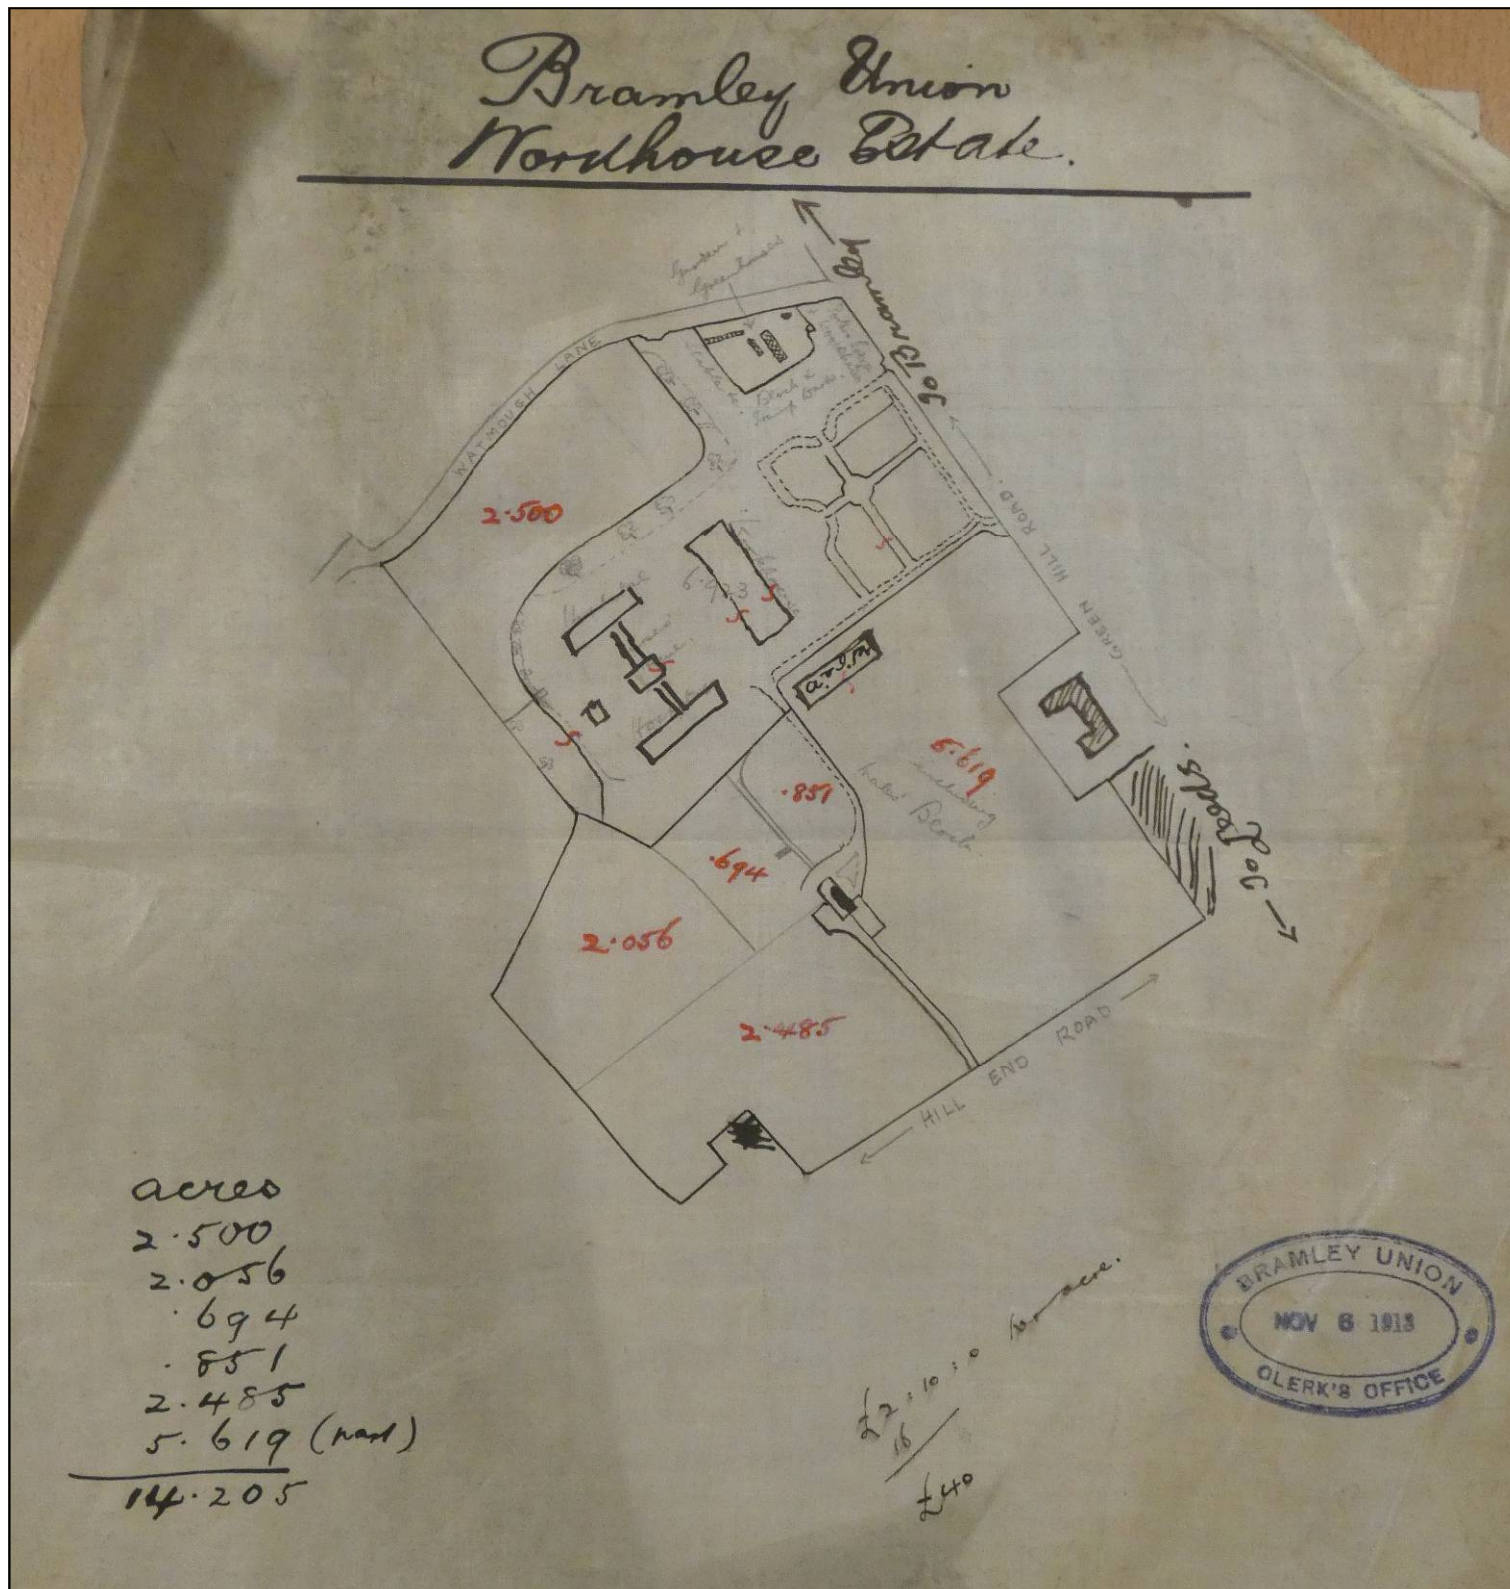
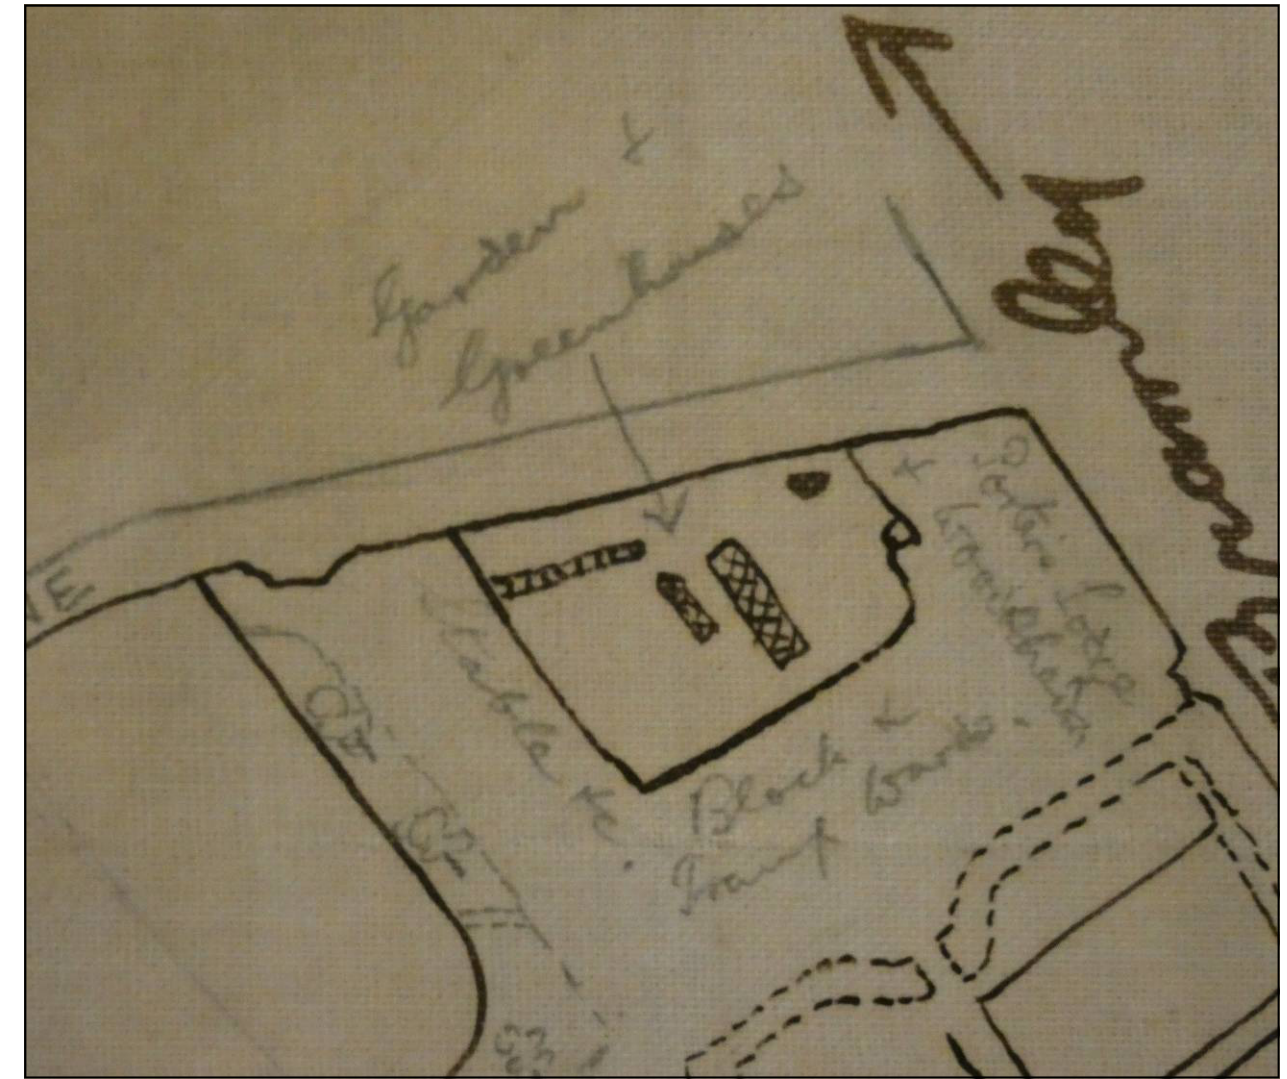
PROJECT BRAMLEY UNION WORKHOUSE, ENTRANCE BLOCK	
TITLE 1913 SKETCH PLAN	
SCALE NTS	DATE MAY 2020
EDAS	FIGURE 8

1913 Bramley Union Workhouse Estate (Source: WYAS Leeds PL/P/181).

- 2.18 By the time that the 1908 Ordnance Survey 25" map had been published, there had been only minor changes to the buildings under consideration. Some minor alterations had been made to the rear of the entrance block, whilst several further glazed structures had been built in the area between the east and west ranges (see figure 7B). A sketch plan of the Bramley Union workhouse estate made in 1913 (WYAS Leeds PL/P/181) and apparently issuing from the Clerk's Office, provides some additional detail (see figure 8). Although the entrance block and ranges are not shown, pencil annotations in their positions describe the entrance block as 'Block & Tramp Wards', the west range as 'Stable &c' and the east range as 'Porter's Lodge & Woodsheds'. The space between the ranges has the same arrangement of glazed structures as shown in 1908, and was described as 'Garden & Greenhouses'. This sketch plan shows that the estate stopped at Watmough's Lane and did not extend beyond it.

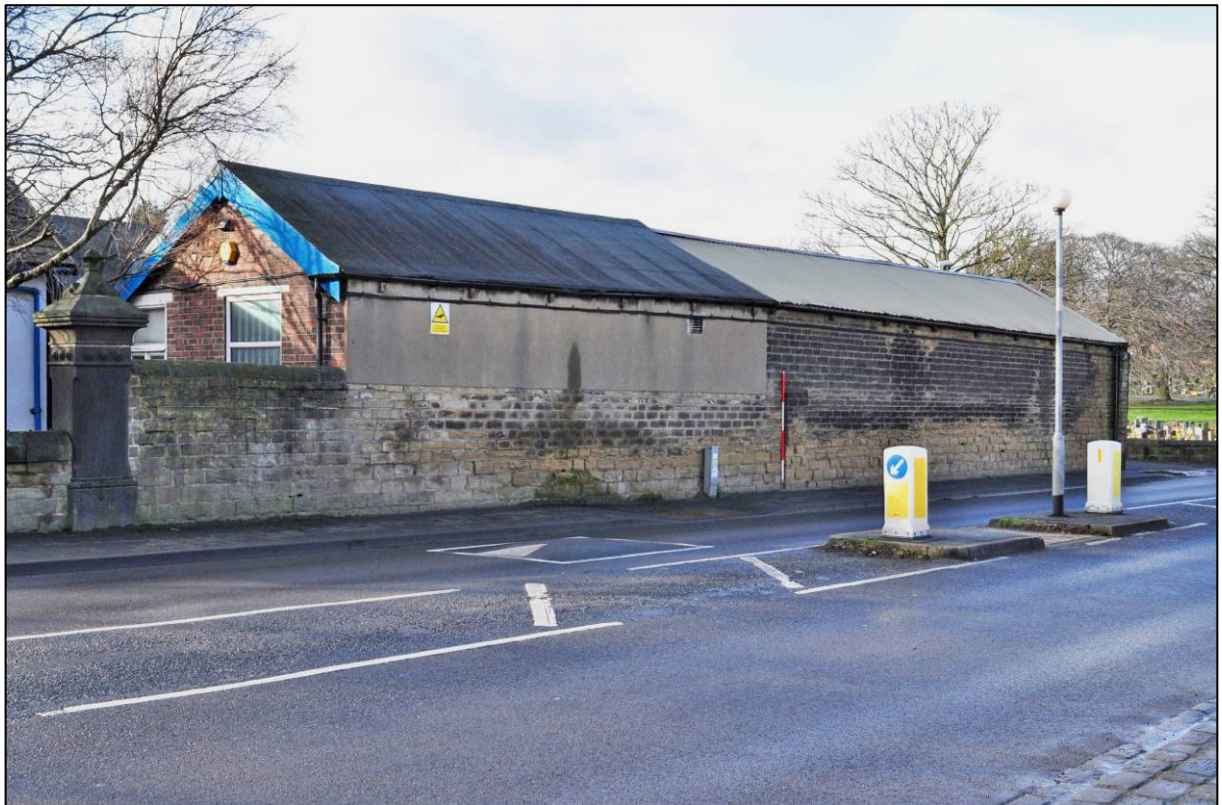
Plate 2: East range, south gable and east elevation, showing earlier boundary wall, looking NW (photo 1/2918).

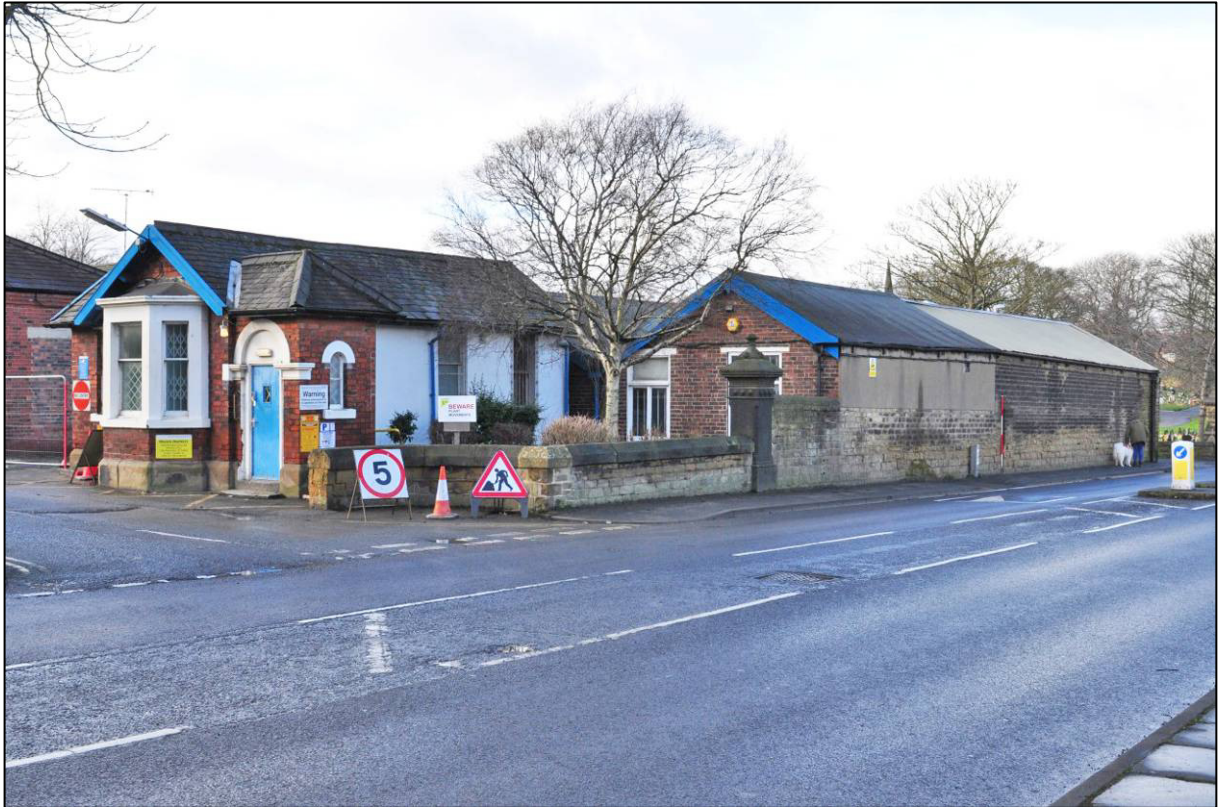
Plate 3: East range, south gable and east elevation, with Porter's Lodge, looking NW (photo 1/2921).

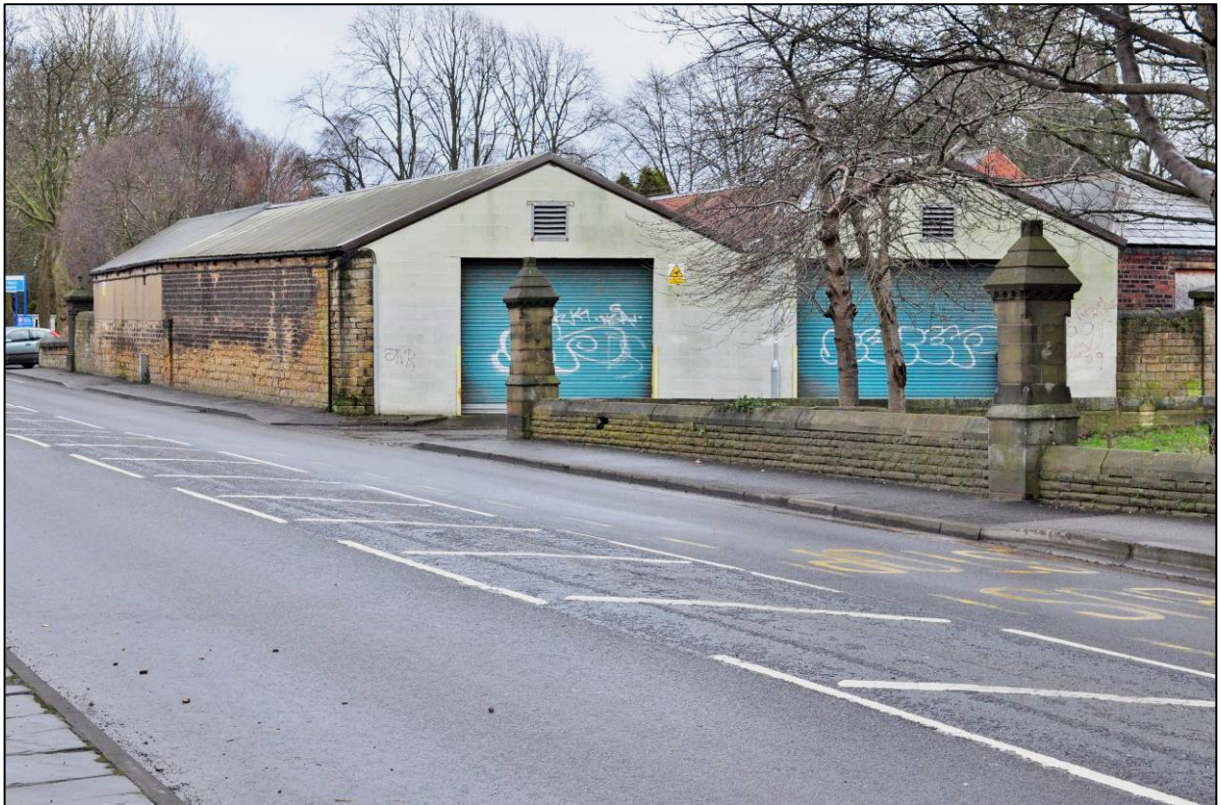
Plate 4: East range, western extension, north gable, and cemetery boundary wall to Green Hill Road, looking S (photo 1/3036).

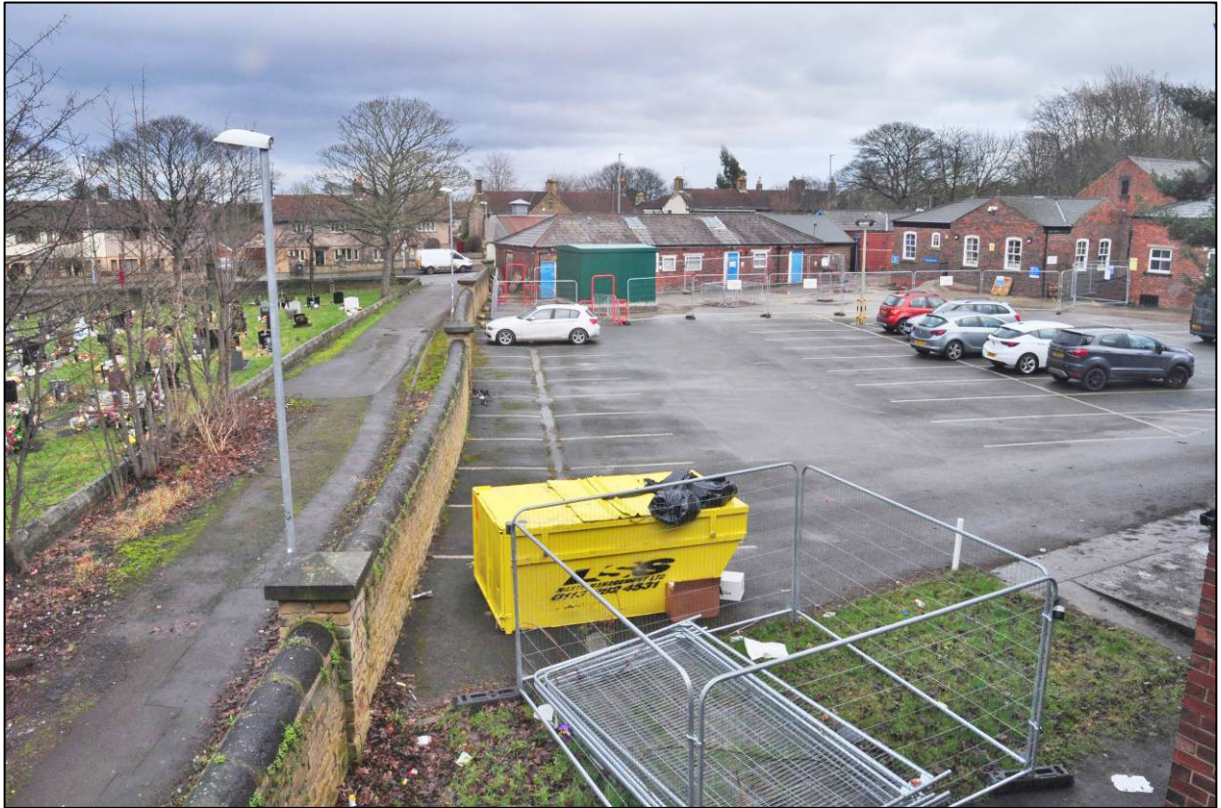
Plate 5: Boundary wall along Mortuary Lane, looking E (photo 1/3000).

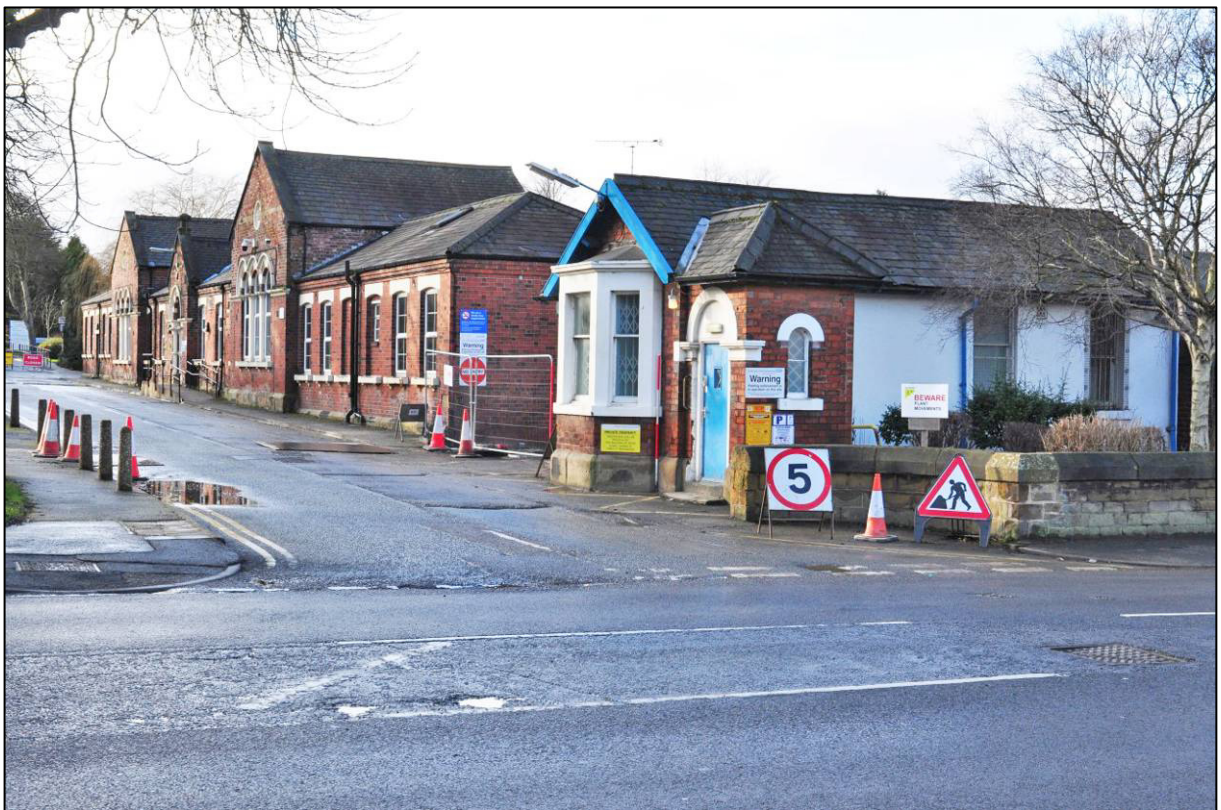
Plate 6: Porter's Lodge and Entrance Block, looking W (photo 1/2924).

- 3.10 The Porter's Lodge was built closely to the design shown on the 1870-71 drawings. It comprises a single storey cottage, with a sub-rectangular plan form, set where the entrance drive met Green Hill Road (plate 6). The ridge of the main pitched roof runs north-south. A small projection to the west, originally housing the scullery, also has a pitched roof, and a small projection to the east a hipped roof over the porch. All parts of the roof are slated, and there are no surviving chimney stacks. The walls of the lodge rise from a chamfered stone plinth, and are built of neat mid-red handmade bricks (average dimensions 220mm by 110mm by 80mm) laid in Flemish Bond and set with a lime mortar. All window and door fittings are modern replacements of the originals.

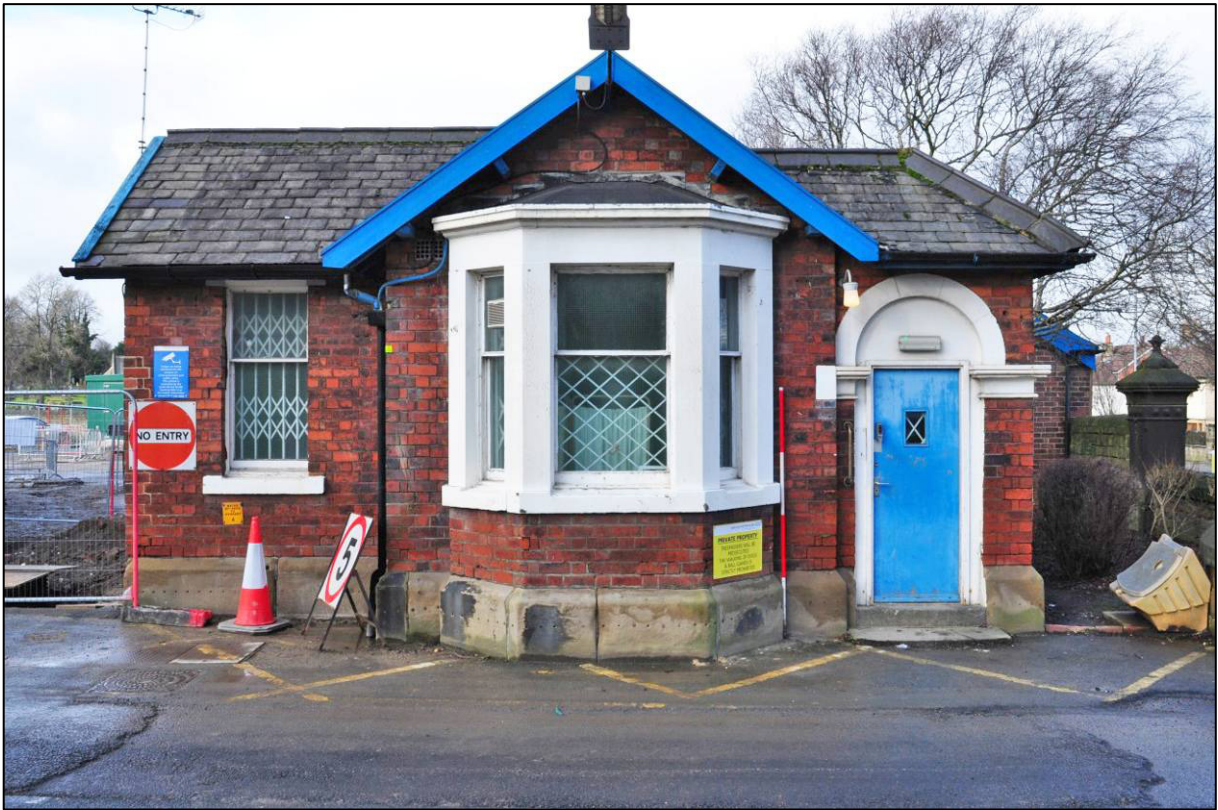
Plate 7: Porter's Lodge, south elevation, looking N (photo 1/2929).

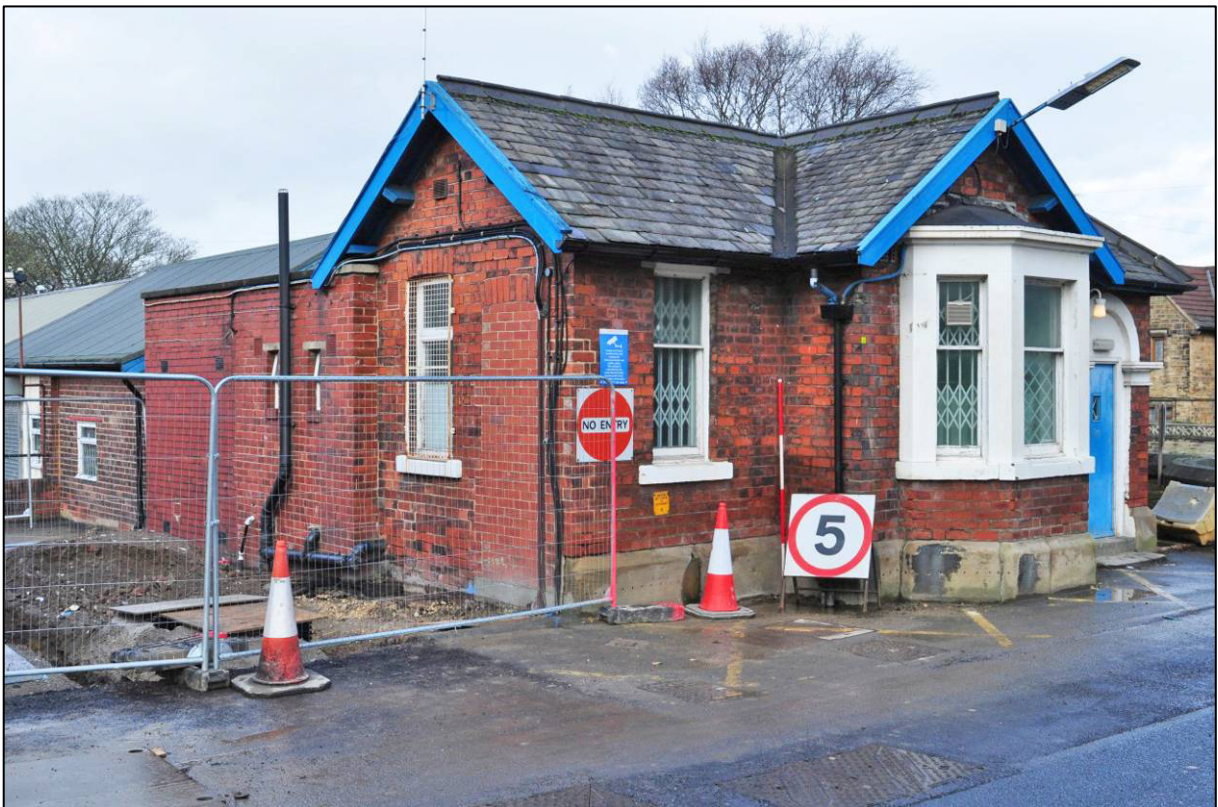
Plate 8: Porter's Lodge, west and south elevations, looking NE (photo 1/2931).

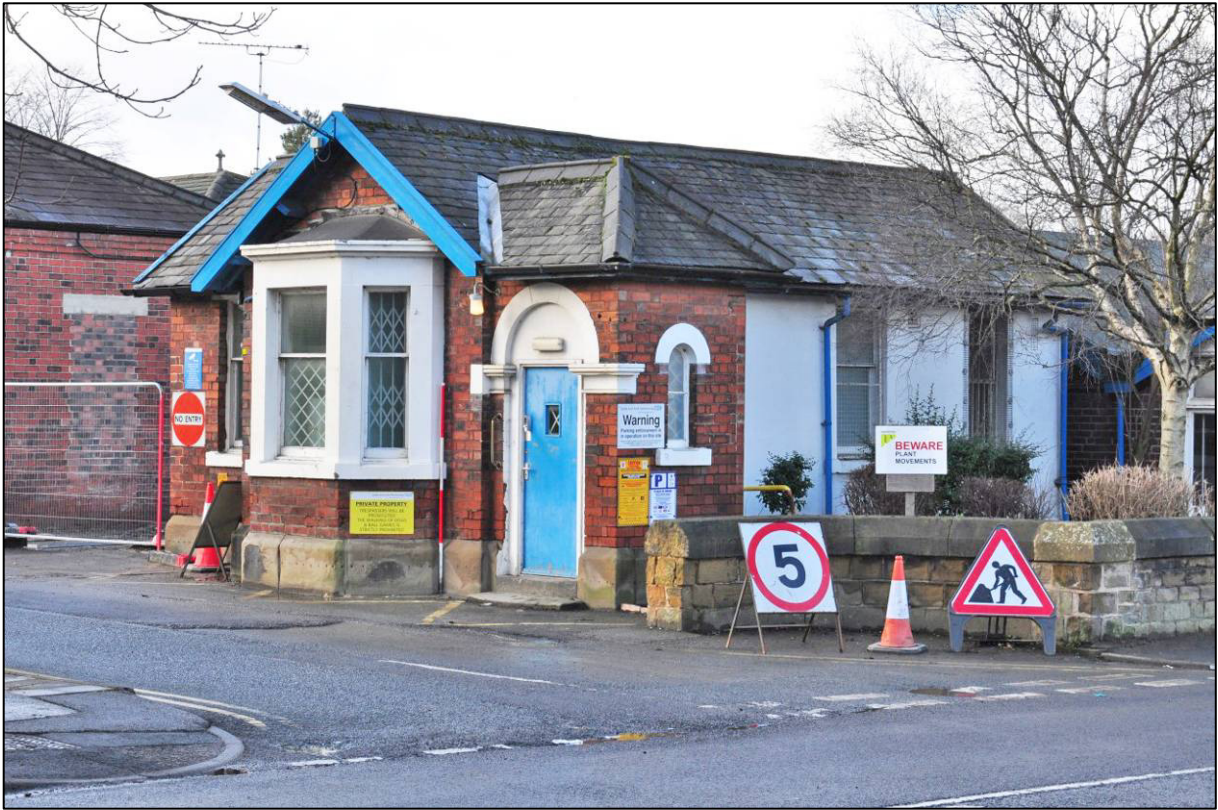
Plate 9: Porter's Lodge, east and south elevations, looking NW (photo 1/2923).

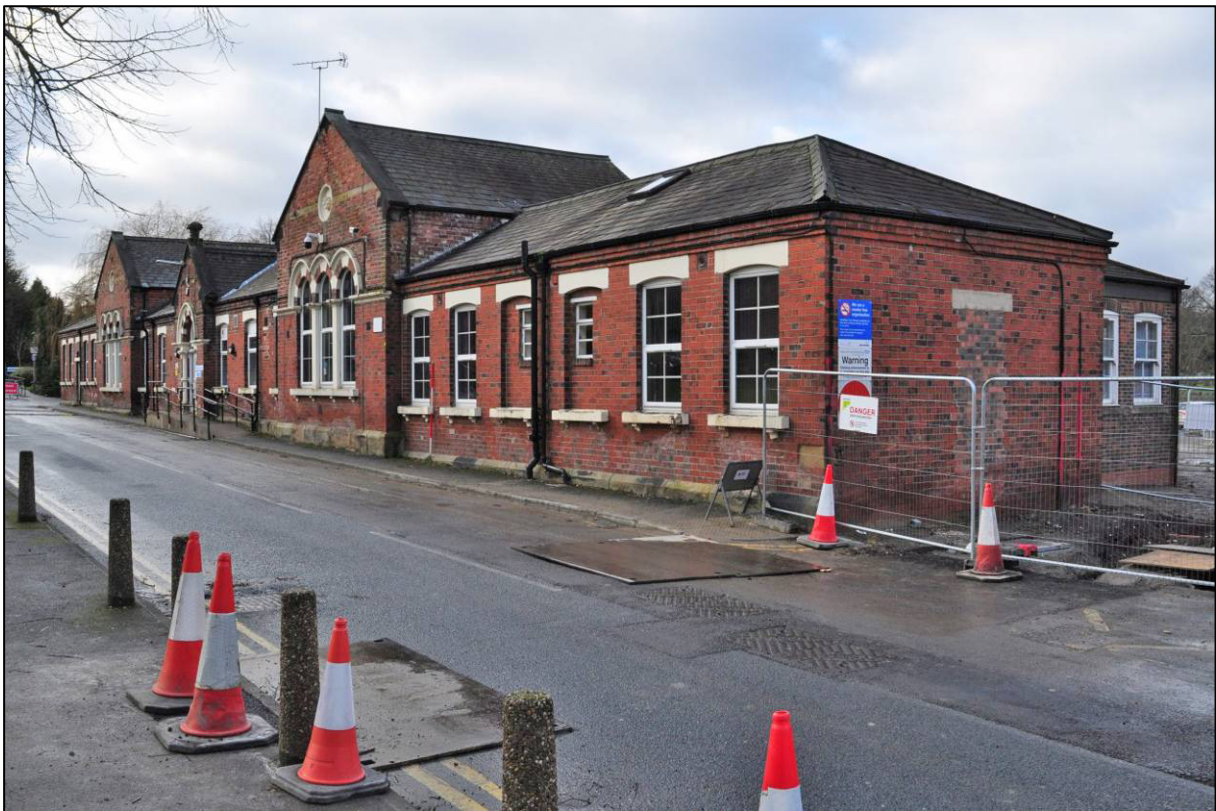
Plate 12: Entrance Block, south elevation, looking NW (photo 1/2934).

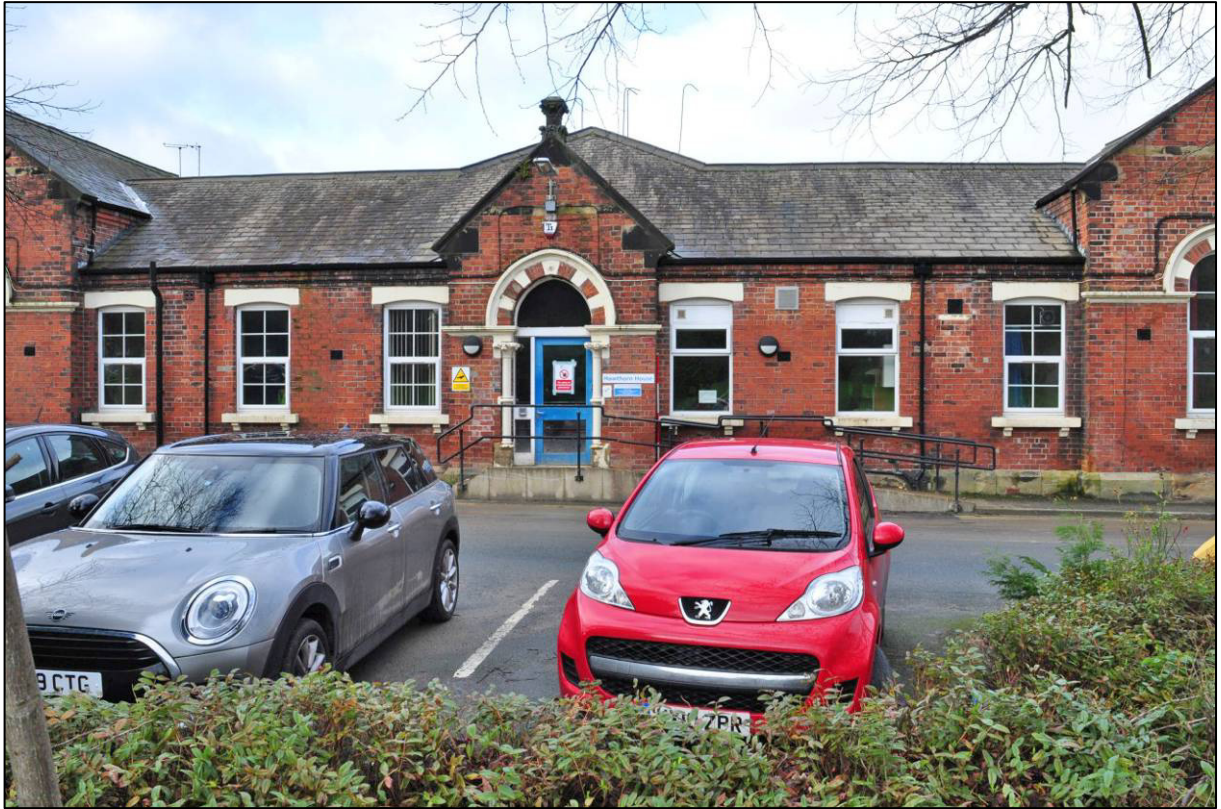
Plate 13: Entrance Block, central part of south elevation, looking N (photo 1/2942).

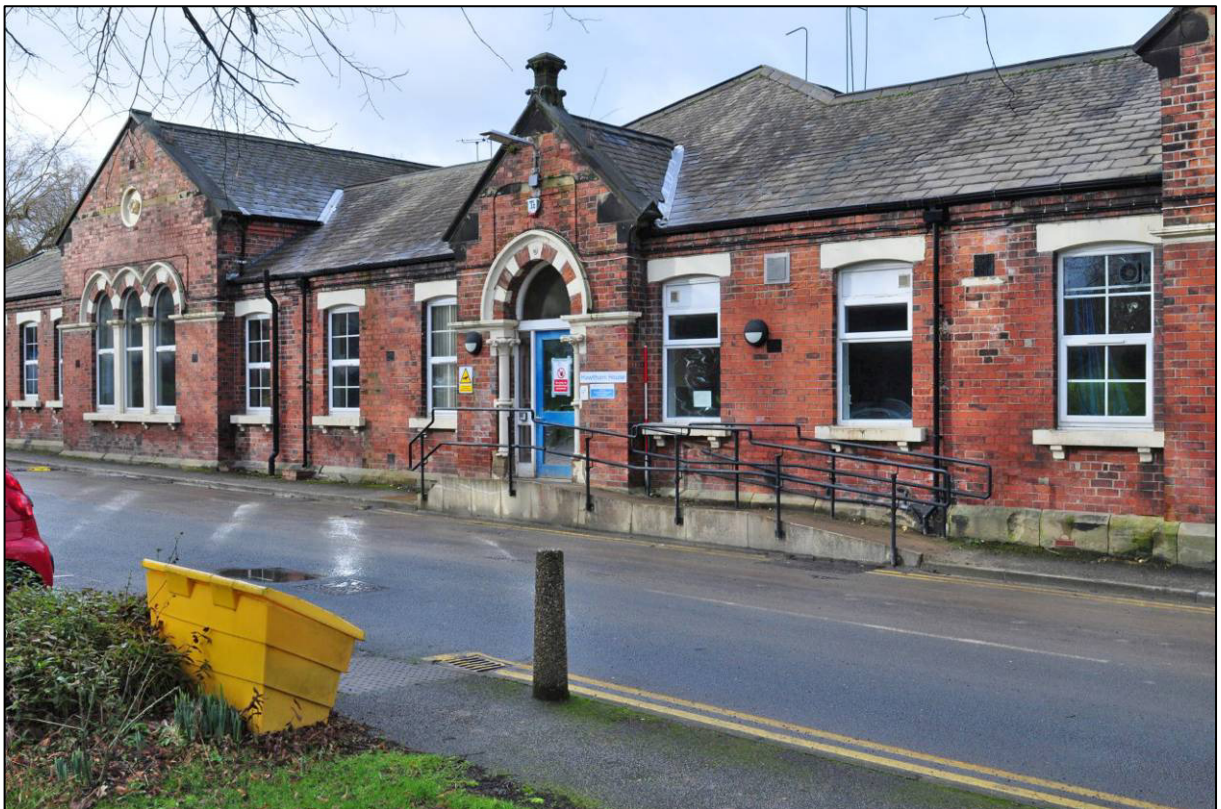
Plate 14: Entrance Block, central part of south elevation, looking NW (photo 1/2947).

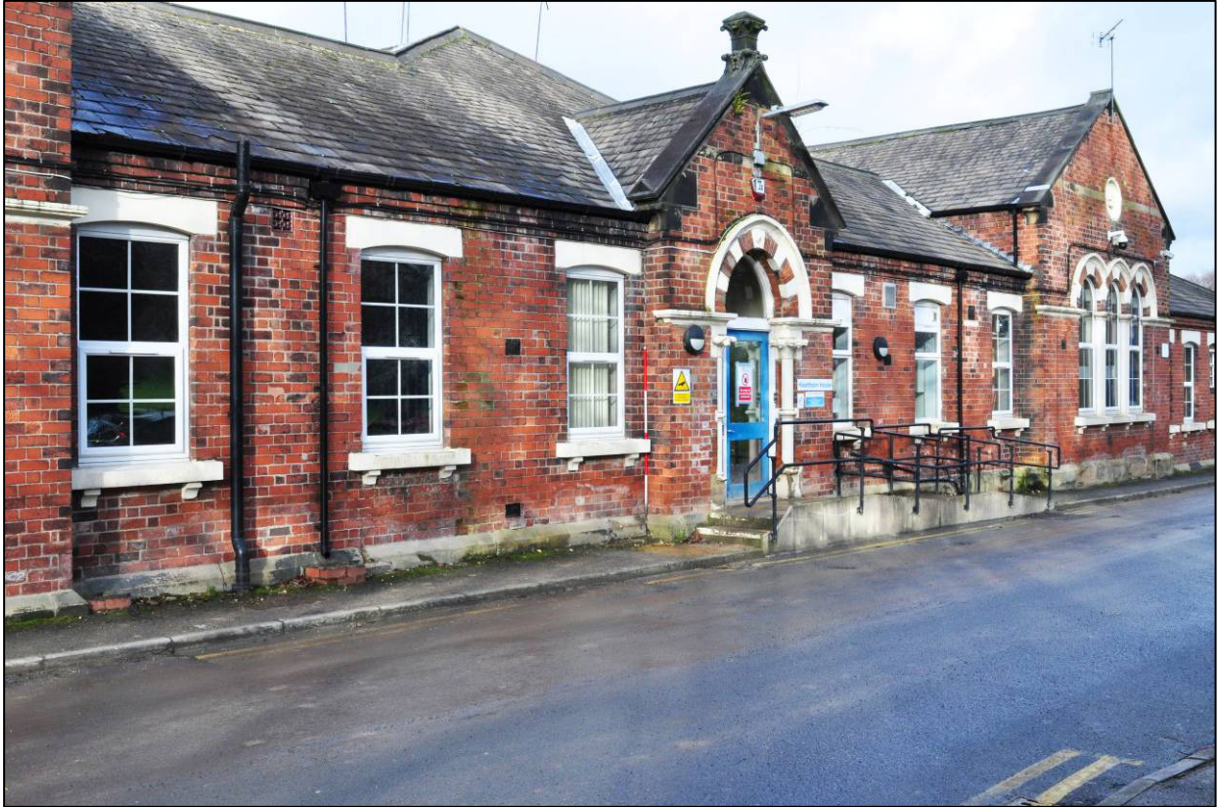
Plate 15: Entrance Block, central part of south elevation, looking NE (photo 1/2953).

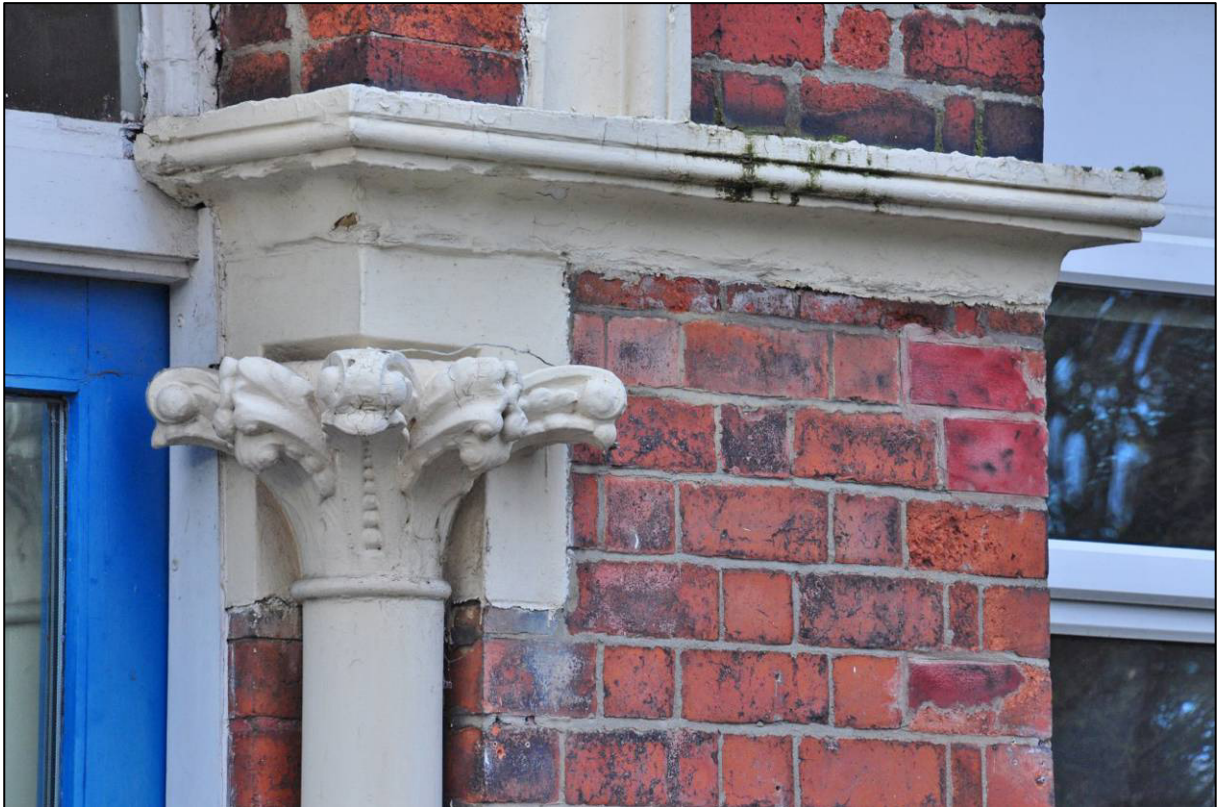
Plate 16: Entrance Block, south elevation, entrance capital detail, looking NE (photo 1/3032).
