FORMER ENTRANCE BLOCK TO BRAMLEY UNION  
WORKHOUSE (ST MARY'S HOSPITAL),  
ARMLEY, LEEDS LS12 3QE

ARCHAEOLOGICAL AND ARCHITECTURAL  
PHOTOGRAPHIC RECORD

Report no: 2020/609.R01  
Version: Final  
Date: May 2020  
Author: Shaun Richardson & Ed Dennison

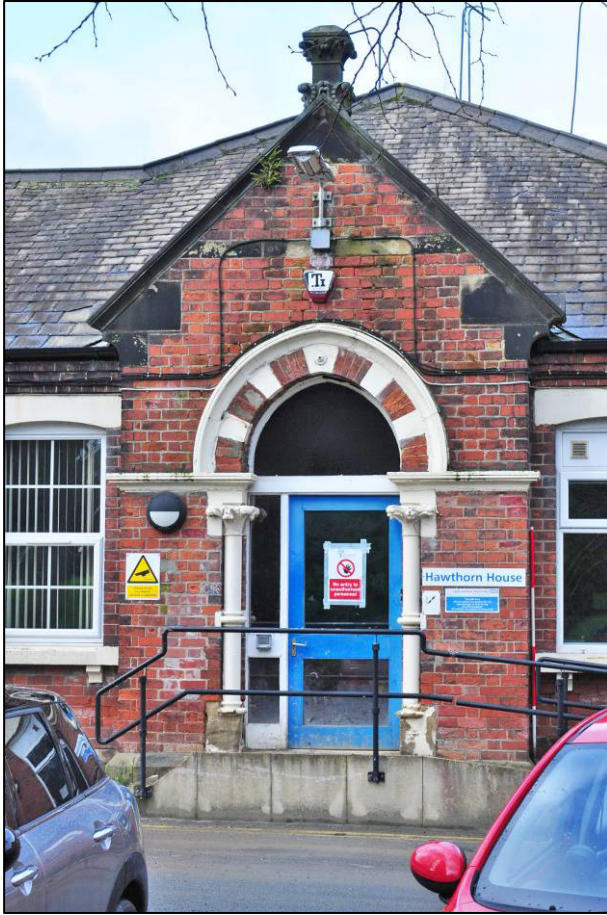
Plate 17: Entrance Block, central part of south elevation, entrance detail, looking N (photo 1/2945).

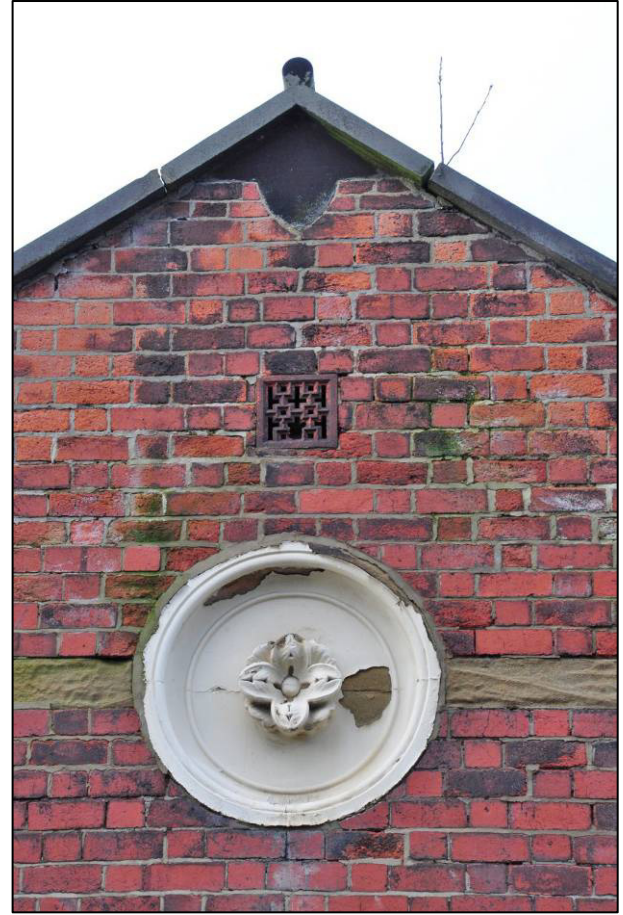
Plate 18: Entrance Block, south elevation, medallion and vent to western gable, looking N (photo 1/3028).

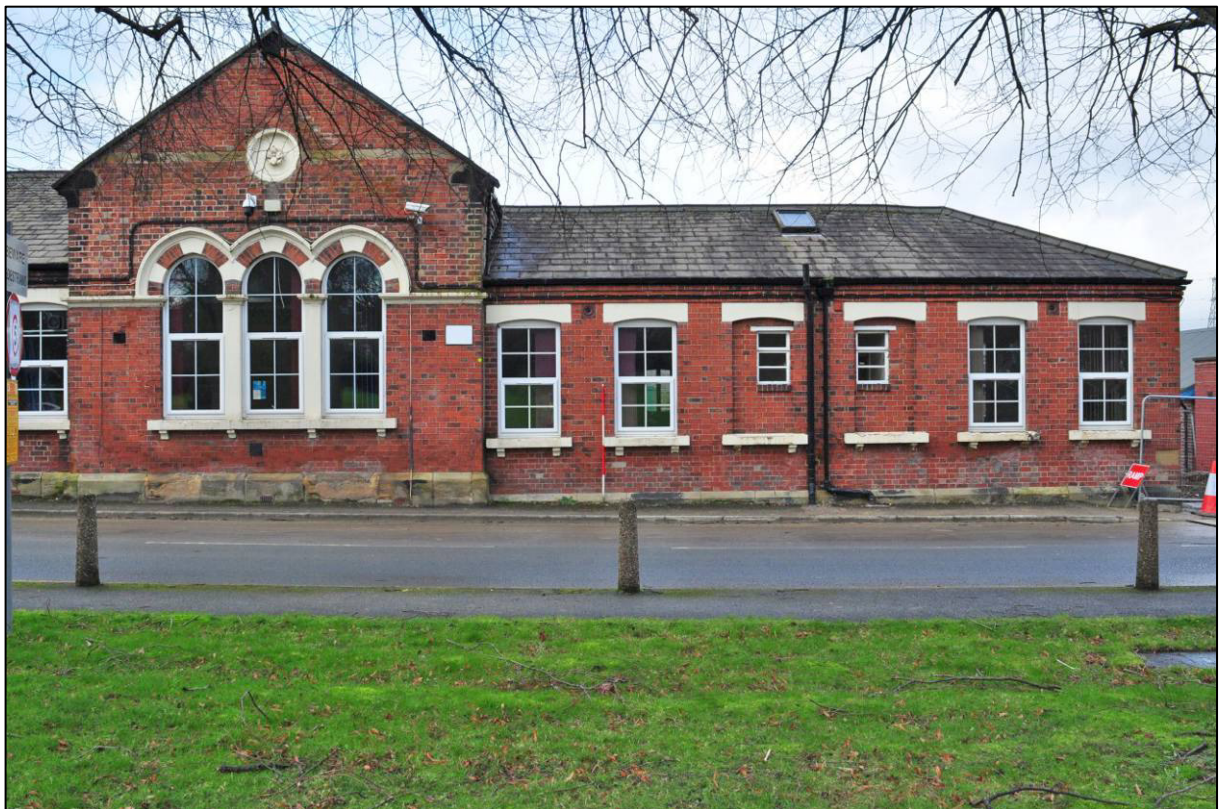
Plate 19: Entrance Block, east end of south elevation, looking N (photo 1/2938).

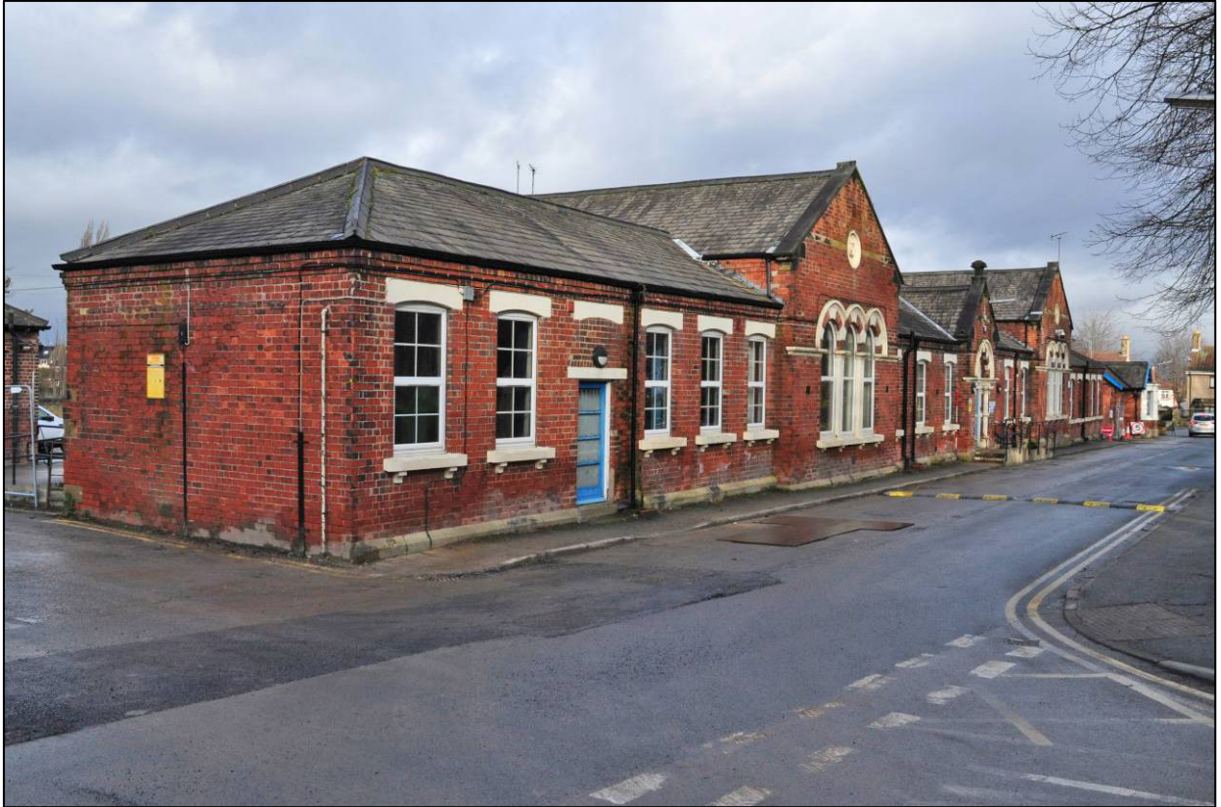
Plate 20: Entrance Block, south elevation, looking NE (photo 1/2948).

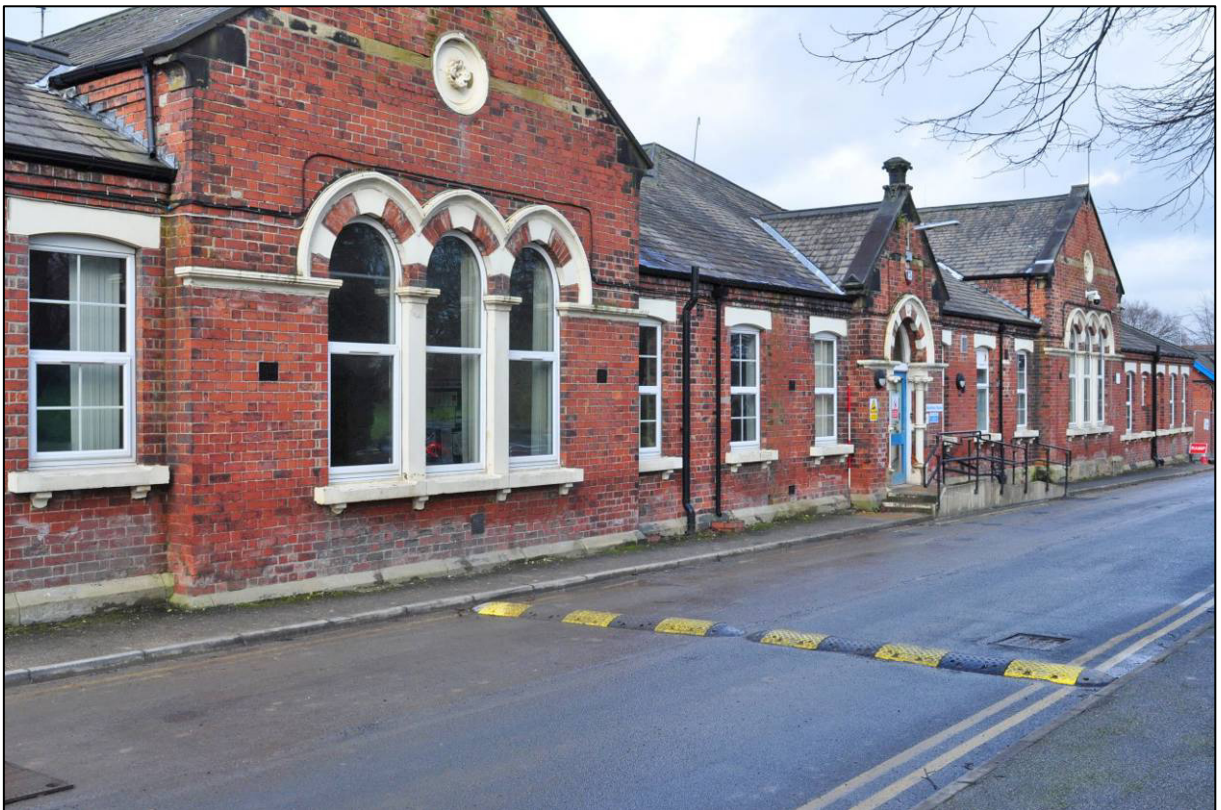
Plate 21: Entrance Block, central part of south elevation, looking NE (photo 1/2952).

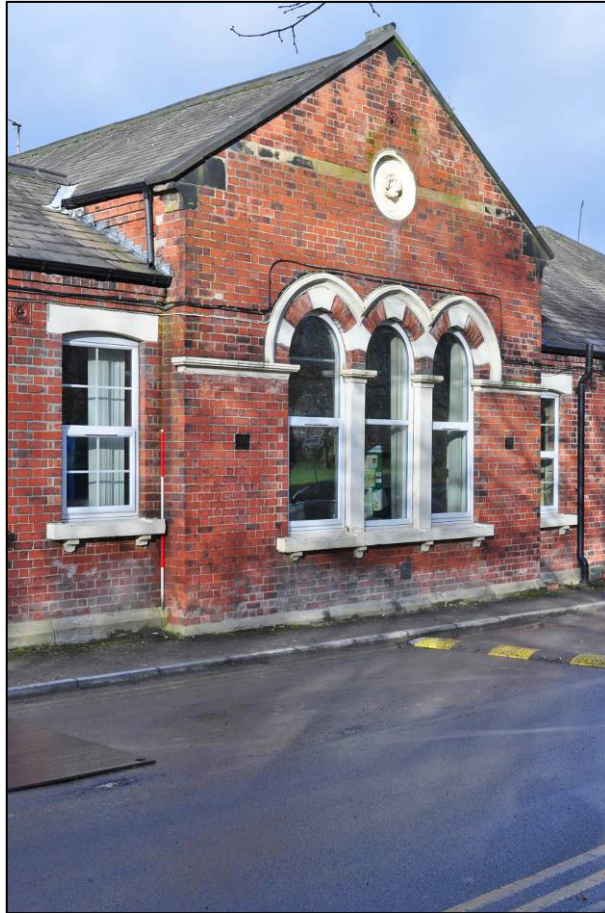
Plate 22: Entrance Block, west part of south elevation, gable detail, looking NE (photo 1/2956).

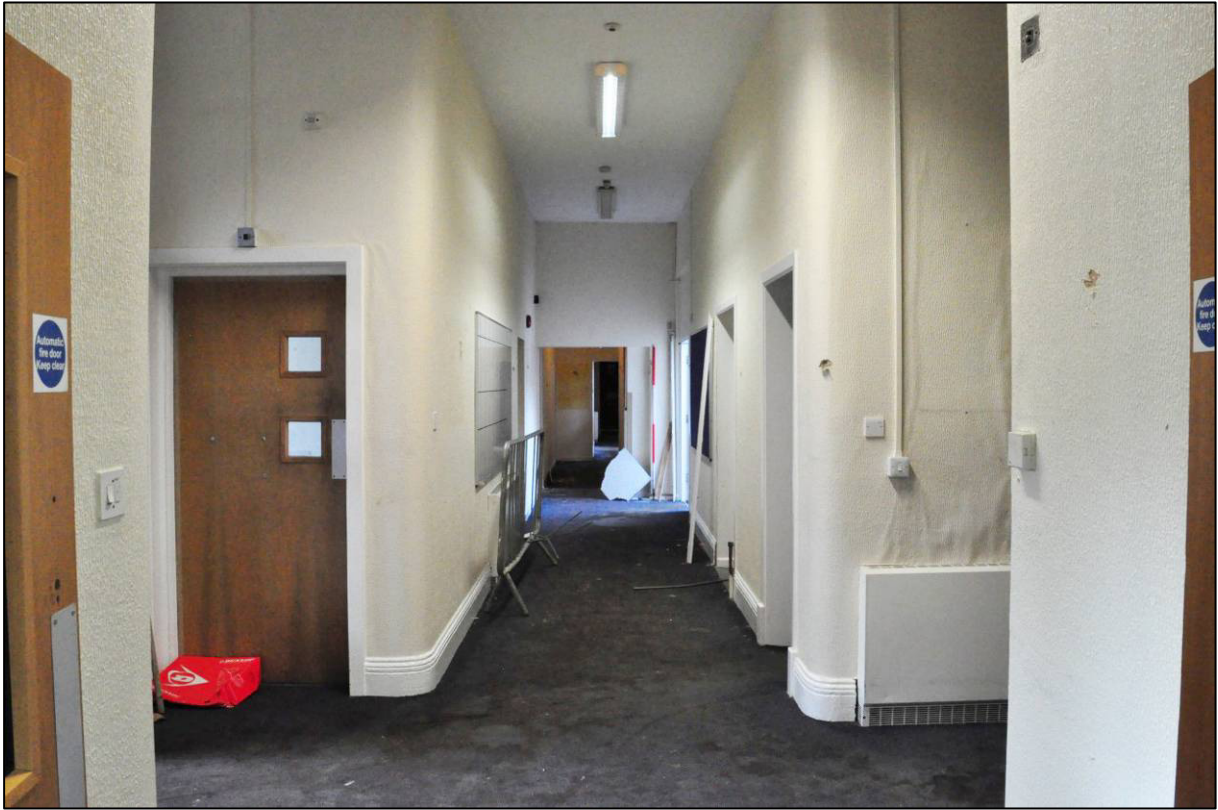
Plate 33: Entrance Block, room G3 (Principal Entrance lobby), looking S (photo 1/2837).

- 3.21 At the time of survey, the main access to the interior of the entrance block was through the original gabled entrance bay in the centre of the south elevation. This led into the Principal Entrance Lobby (**G3**) (plate 33), although this has now been sub-divided and given modern fixtures and furnishings. The lobby lay on the south side of the Main Corridor (**G4**), which formerly ran east-west between the Board Room (**G14**) to the west and the Clerks and Committee Room (**G7**) to the east, but was subsequently extended through them to reach the other areas at either end that had originally been kept separate. The corridor is a tall space, that was once lit by a large skylight where it met the lobby (plates 34 and 35). It has since been decorated with modern finishes, and the only original feature to survive is the tall skirting board (plate 36). The corners between the entrance lobby, its extension to the north and the Main Corridor have been rounded with bull-nosed bricks, the curve of which is maintained by the skirting. Towards the east end of the corridor, the removal of wall lining around a window in the north wall had exposed the original brickwork and cill (plate 37). The entrance lobby extends to the north, beyond the main corridor, to the separate former heated Male and Female Waiting Rooms. The Female Waiting Room to the east has been sub-divided into modern toilets, and no historic fixtures remain, including the original entrance. The Male Waiting Room (**G12**) remains more open, but is still sub-divided by modern partitions and again contains no surviving historic fixtures (plate 38).

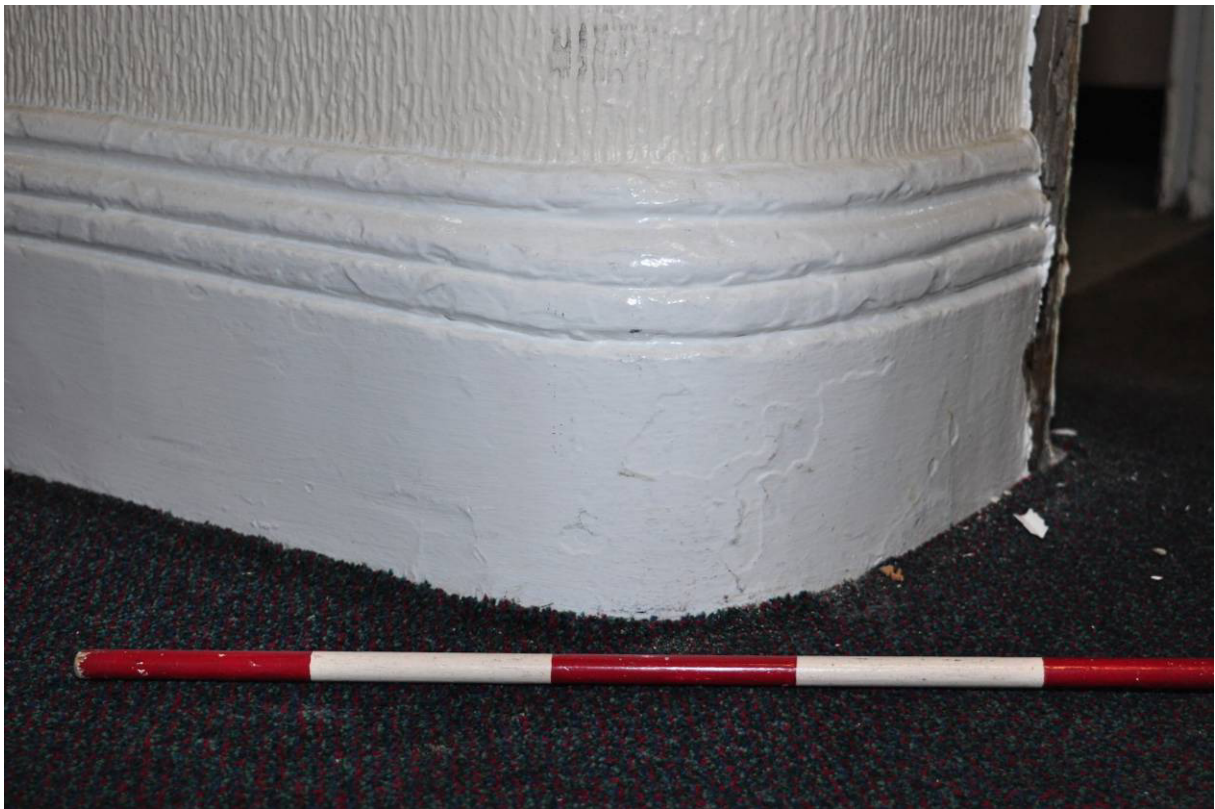
Plate 35: Entrance Block, main corridor G4, looking E (photo 1/2843).

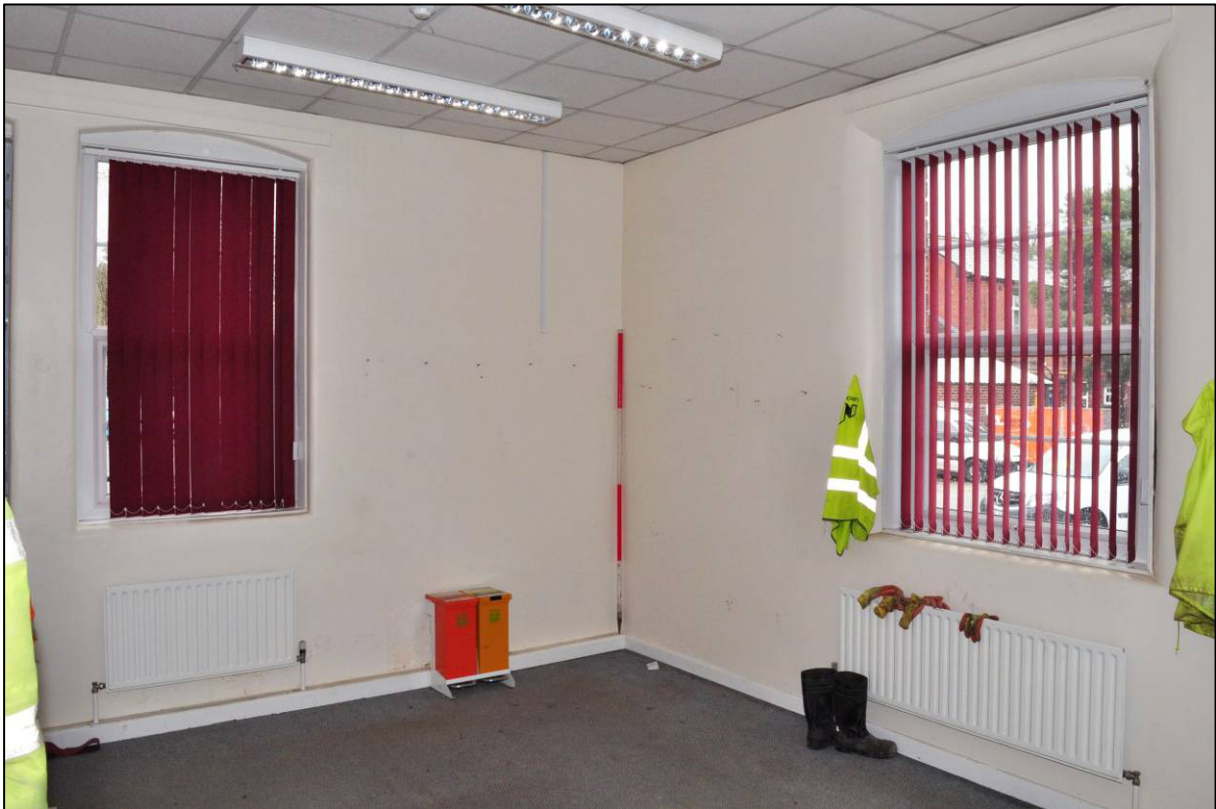
Plate 37: Entrance Block, main corridor G4, window detail, looking NW (photo 1/2854).

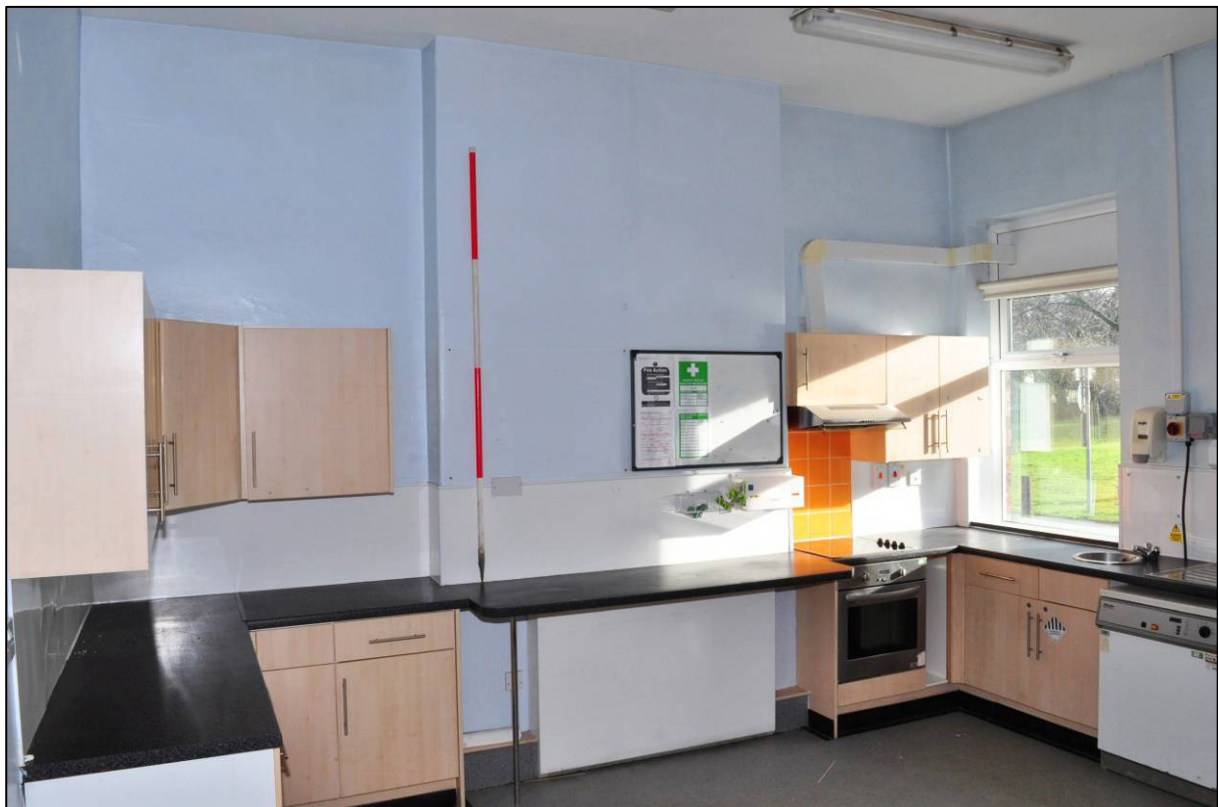
Plate 38: Entrance Block, room G12 (former Male Waiting Room), looking NW (photo 1/2856).

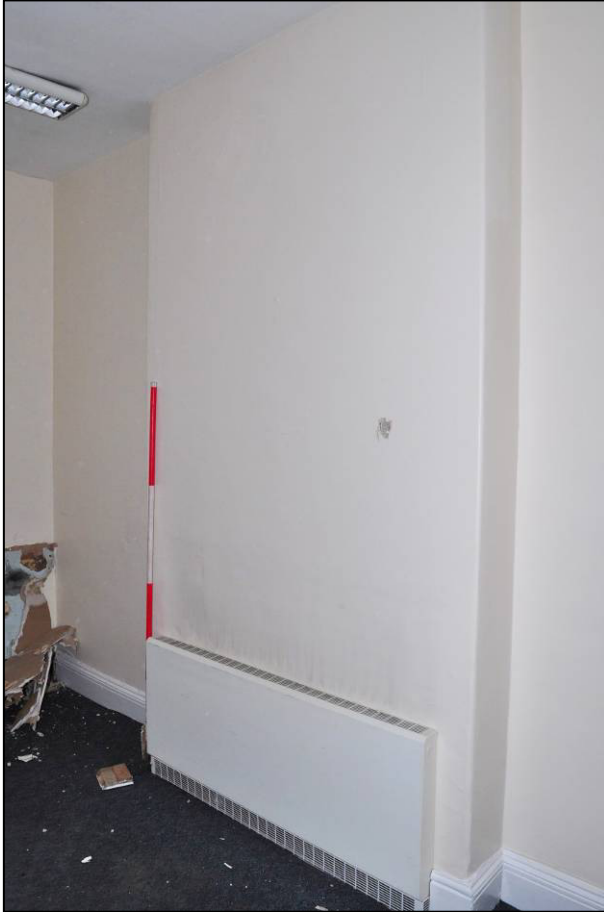
Plate 39: Entrance Block, room G5, (former Receiving Officer's room), chimney breast, looking SE (photo 1/2855).

- 3.22 To the immediate east of the entrance lobby was the Relieving Officer's Room (**G5**), heated by a fireplace in the east wall; it is now used as a kitchen, although the chimney breast remains visible (plate 39). This had a separate Waiting Room (**G6**) to the immediate east, and again the chimney breast is the only historic feature to survive (plate 40). Moving east, the former Clerks and Committee Room (**G7**) has been sub-divided into three modern spaces; the northern of these forms the continuation of the Main Corridor (**G4**). Historical documentation indicates that the arcaded windows in the north and south walls once had oak-panelling around them, but this has all been removed although parts of the windows themselves remain visible (plates 41 and 42).

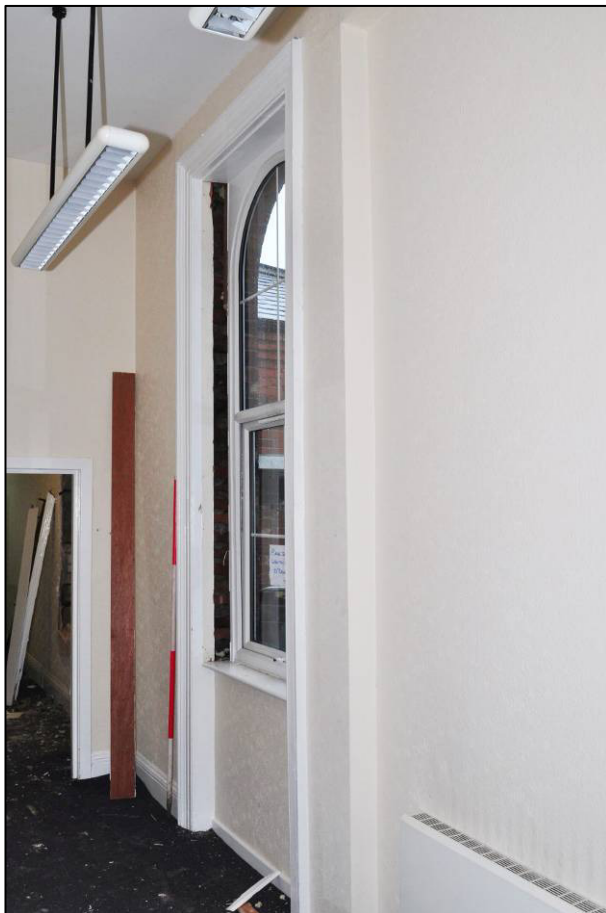
Plate 41: Entrance Block, room G7 (former Clerks and Committee room), windows to south side, looking S (photo 1/2850).

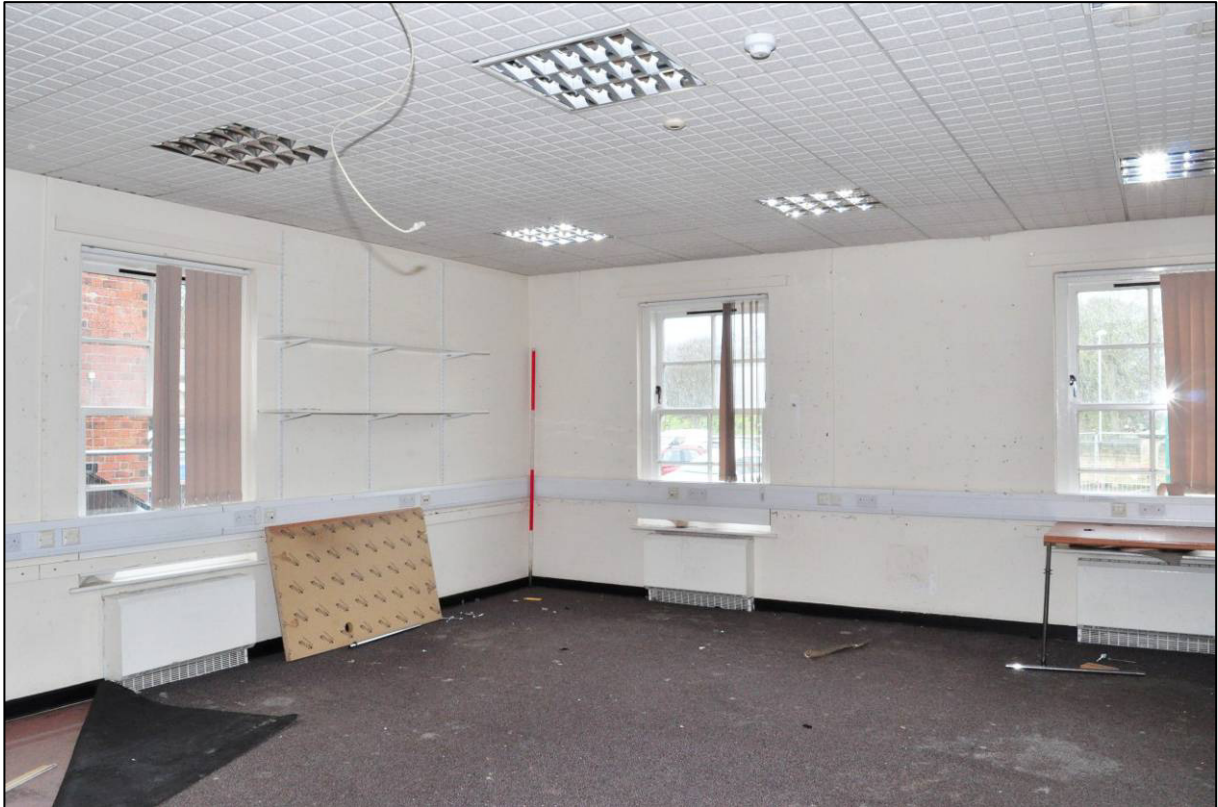
Plate 42: Entrance Block, main corridor G4, window to N side, looking NW (photo 1/2851).

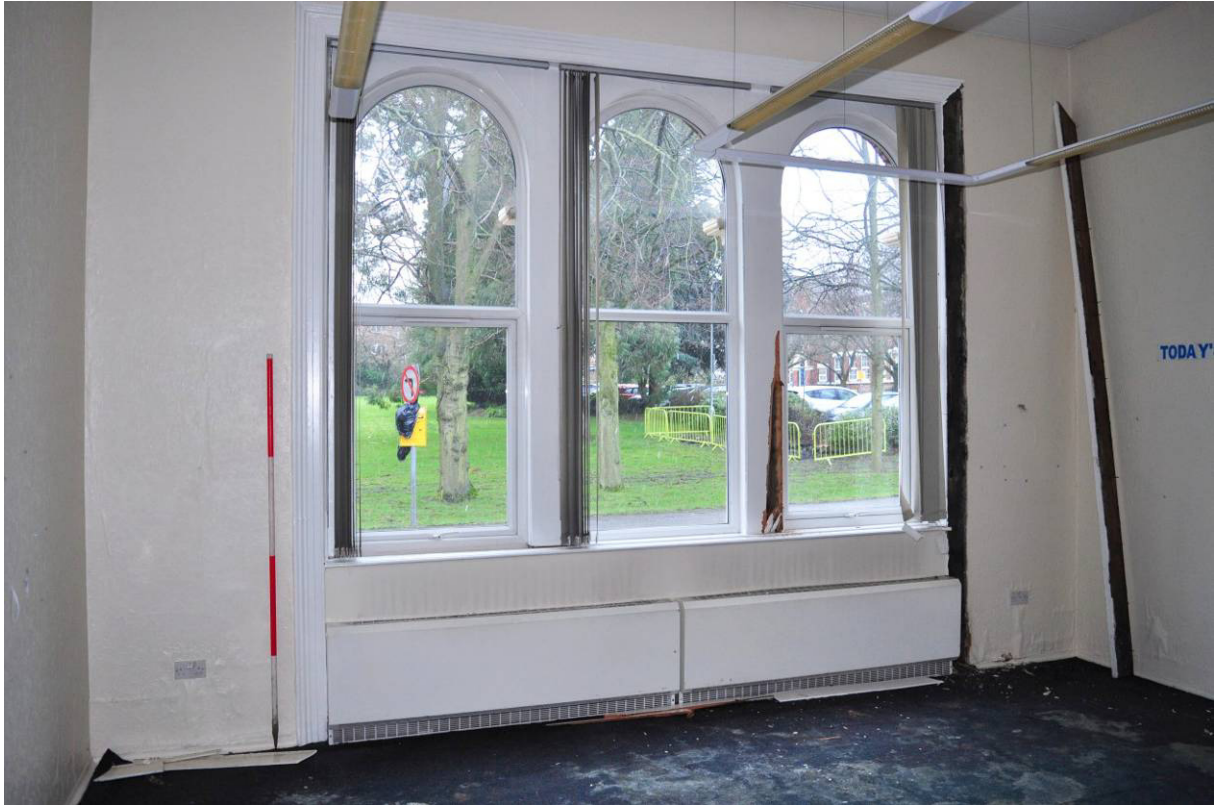
Plate 48: Entrance Block, room G13, looking SW (photo 1/2857).

- 3.24 To the west of the entrance lobby (**G3**), there was a second Relieving Officer's room and a Lavatory with an earth closet (**G13**). These spaces have both been radically altered and sub-divided; a feature in the west wall of the Lavatory resembles a fireplace (plate 48), although none is shown here on the 1870-71 drawings. Further west, the Board Room (**G14**) has been sub-divided into three modern spaces, the central one of which represents the western continuation of the main corridor (**G4**). Historical documentation indicates that the arcaded windows in the north and south walls once had oak-panelling around them, but this has all been removed, although the windows themselves, with mostly modern fittings, remain visible (plates 49 and 50). Interestingly, where parts of the modern suspended ceiling had either been removed or fallen, the original deep moulded ceiling cornice of the Board Room was revealed, with foliate plaster decoration to the corners (plates 51 and 52). In the western part of the building, the Board Room once marked the western terminus of the main corridor, with the Probationers' areas in the west part of the entrance block being completely separate. However, these spaces have again been subsequently radically altered internally. The associated yards to the north were demolished, leaving only the former Bath Rooms (**G17**) (plate 53), although no historic features remain. The former Male Probationers' Ward and Male Clothes Store (**G15**) have been knocked through to create a single space (plate 54), as have the former Female Probationers' Ward and Clothes Store (**G16**) (plate 55).

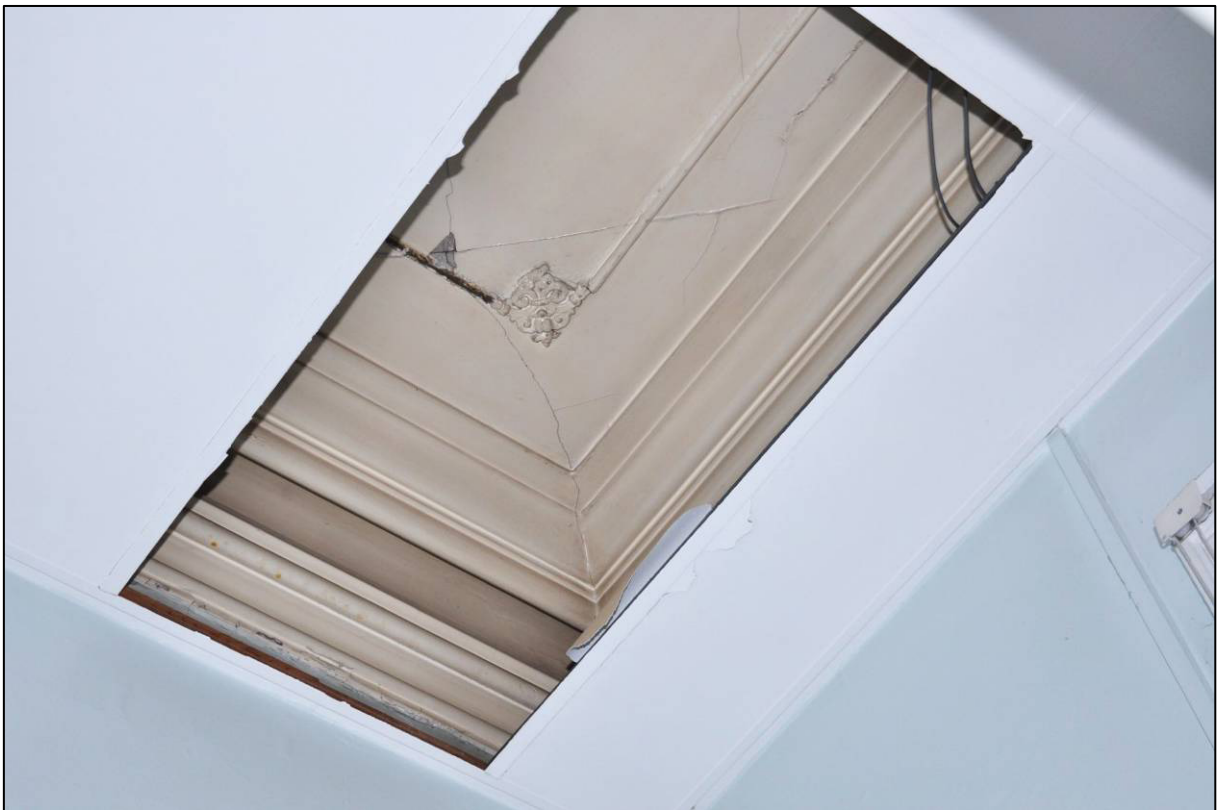
Plate 51: Entrance Block, room G14 (former Board Room), ceiling cornice, looking E (photo 1/2859).

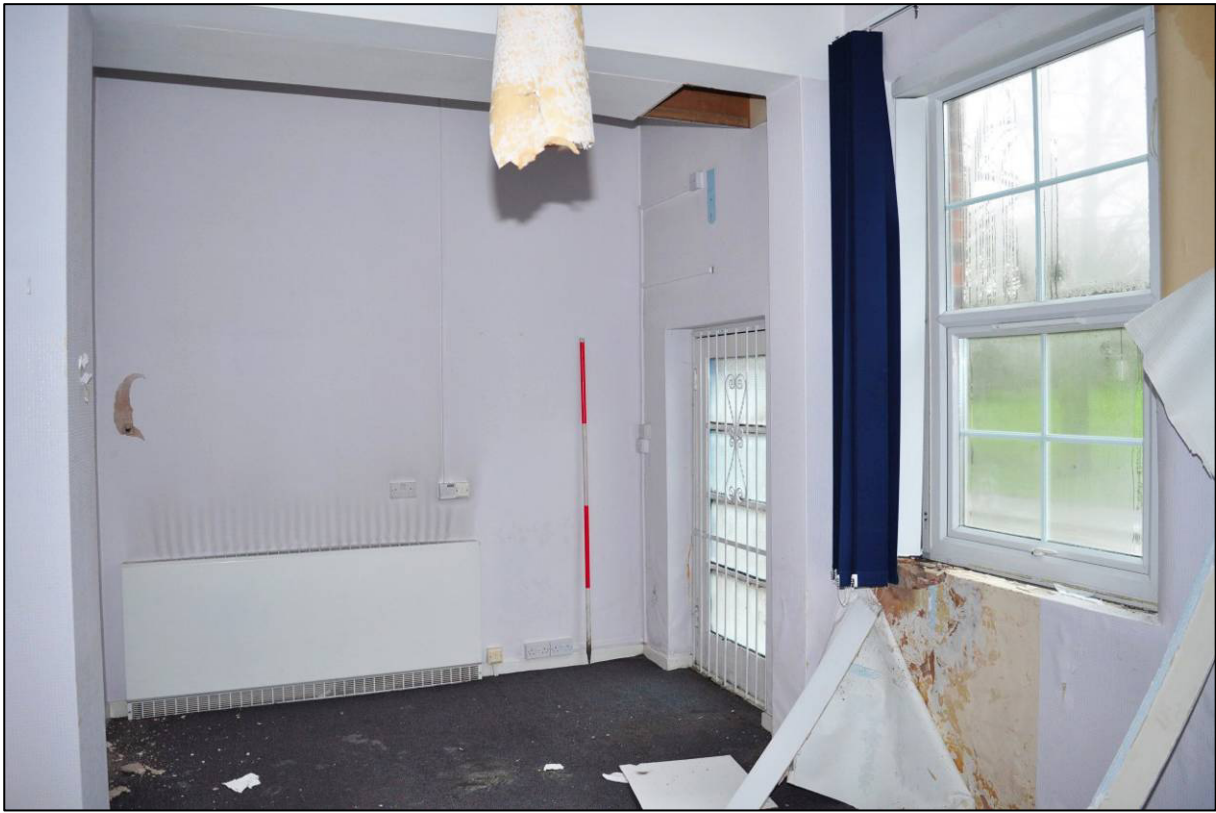
Plate 54: Entrance Block, room G15 (former Male Probationers' Ward), looking SE (photo 1/2865).

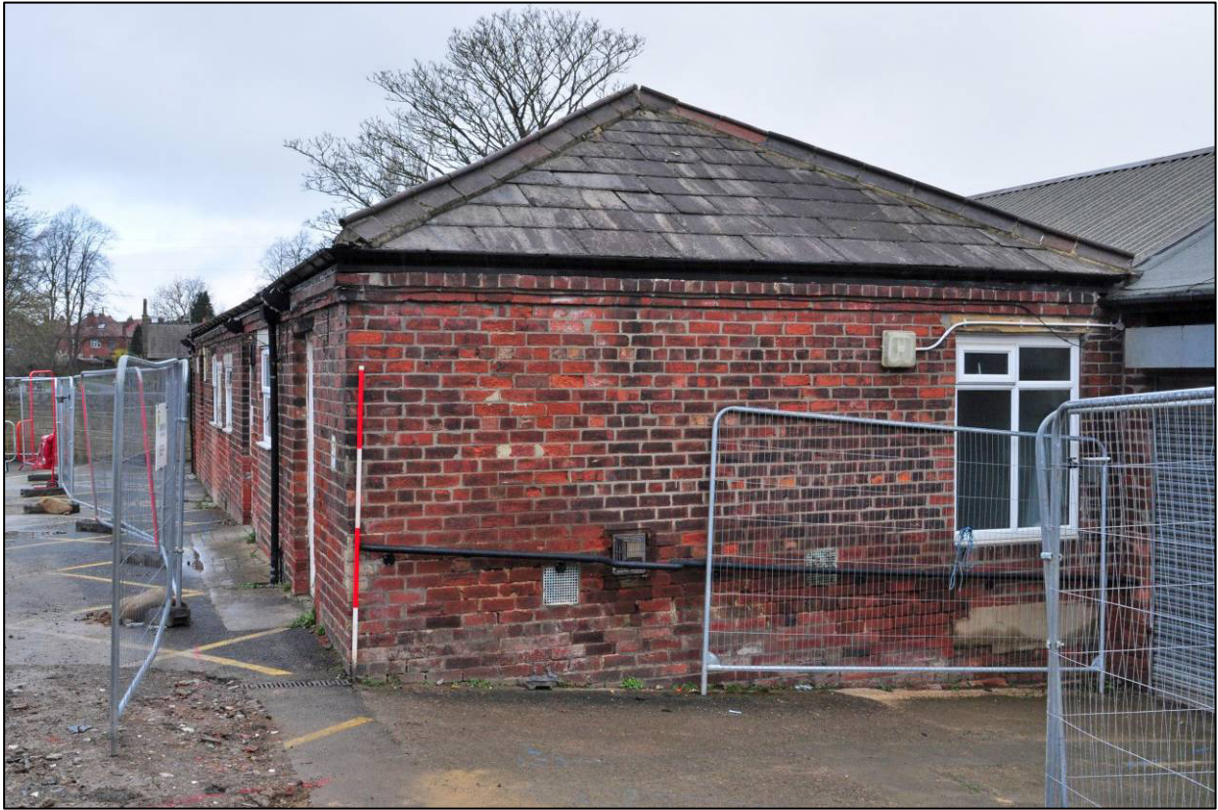
Plate 56: East range, original part, west elevation, looking E (photo 1/2979).

lintels indicate that there may have been four windows, perhaps with a doorway at the north end only, although this is not certain; the northernmost window is the only example which seems to retain its early form (plate 56). The narrow south elevation is plain, with an inserted window towards the east end (plate 57). The north elevation is also plain; the original east elevation is now concealed within the later extension to the east, and so is described under the interior below.

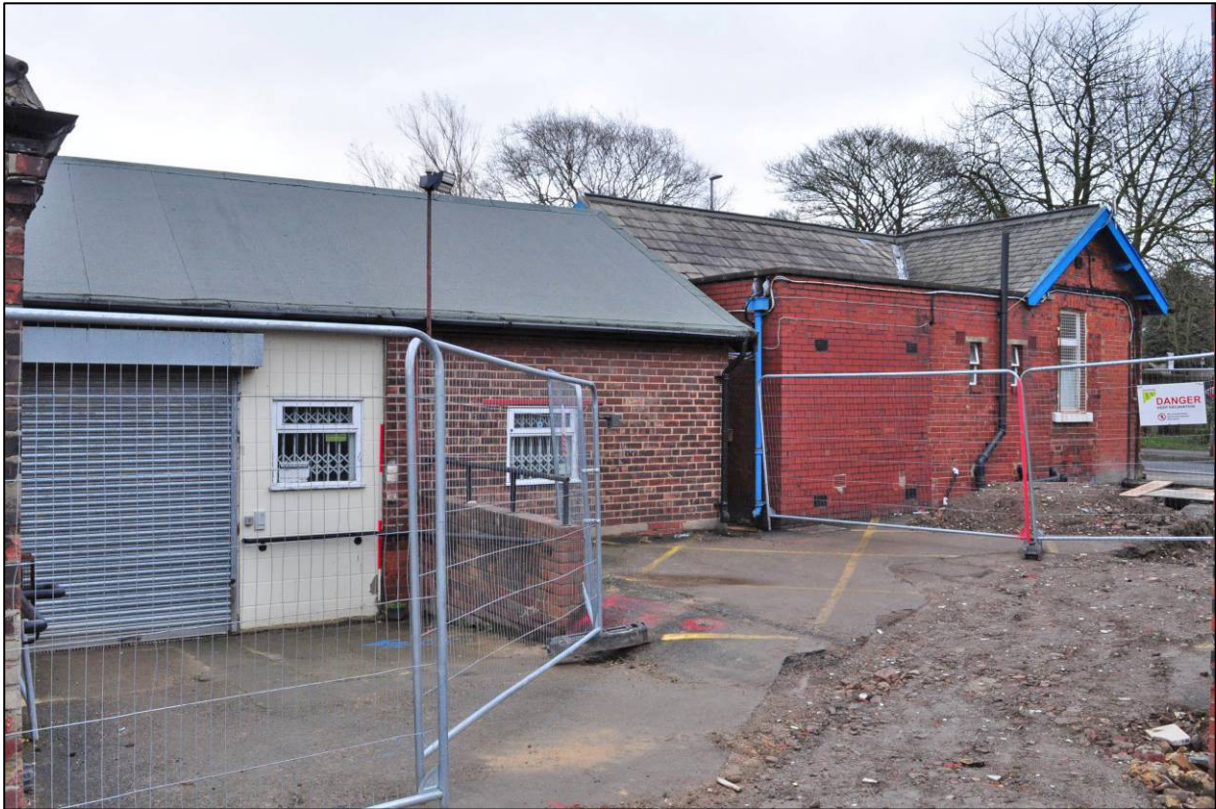
Plate 58: East range, north gable and east elevation, showing earlier boundary wall, looking SW (photo 1/2917).

- 3.27 The later extension to the east range, built before 1893, is a sub-rectangular building of a tall single storey, covered by two parallel, pitched, corrugated sheet roofs. A tall metal vent emerges from the north end of the east slope of the west roof. The east elevation is built of coursed and squared gritstone, and incorporates the earlier boundary wall of the workhouse complex to Green Hill Road (plate 58 and also plate 2). The twin north gables have been rebuilt in modern blockwork, and each has a large entrance doorway fitted with a metal roller shutter (see plates 4 and 58).

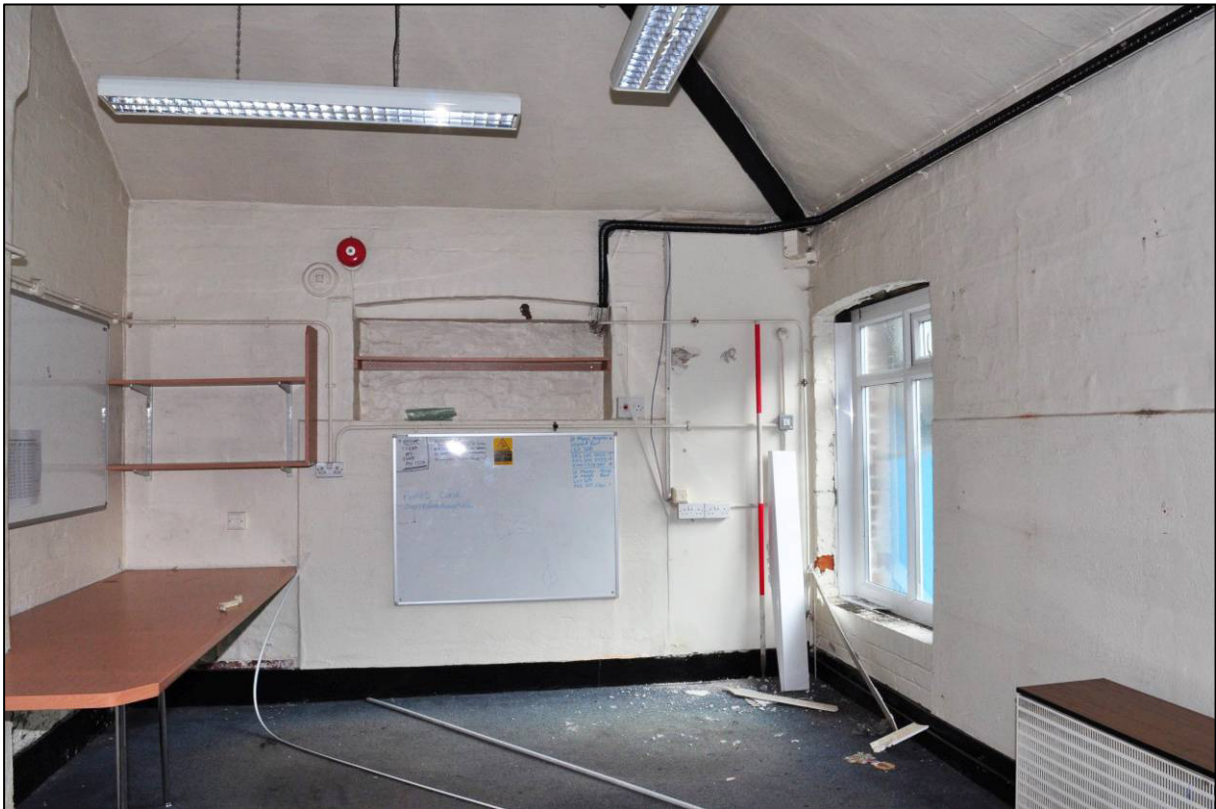
Plate 60: East range, original part, room G18, chimney breast to north wall, looking NW (photo 1/2899).

- 3.29 At the time of the EDAS survey, the earliest part of the east range (i.e. the west part) was accessed through the doorways in the west elevation. The interior is now divided into four cells; the southern three are interconnected, but the north cell remains separate. The southernmost cell (**G18**) has a large chimney breast to the north wall with bull-nosed bricks to its corners (plate 60); the north wall is built of brick and rises to the apex of the roof. The inserted window to the south wall may once have been a doorway (although there is nothing to indicate this externally), whilst there is a large blocked original window with a segmental head to the east wall (plate 61). A doorway at the west end of the north wall leads through to the cell to the north (**G19**). Where the modern suspended ceiling has been pulled down, a roof truss is visible, set towards the south of centre. The softwood king-post truss is of bolted construction throughout, comprising tie-beam with raking struts from the king-post to the principal rafters (plates 62 and 63). Each principal rafter carries a single trenched purlin. A wide opening in the north wall connects the cell to that to the north. The east wall of this cell (**G20**) has a blocked cart entrance with bull-nosed jambs and a stop-chamfered timber lintel, and a small blocked window or other opening with a segmental head at the east end of the south wall (plate 64). To the north wall of the cell, there are two further blocked openings (plate 65). The east opening has an inverted horseshoe shape, and is at least 1.5m tall, while the west opening has a semi-circular head and is much lower; both are blocked with blockwork. These blocked features are also visible from within the north cell (**G21**) (plate 66); from this space, it can be seen that the east opening is oval and c.2m in height, whilst the west opening is actually sub-circular. The blocked sub-circular opening appears to be set within a larger opening, perhaps a doorway, that was itself blocked with brick. There are no openings, blocked or otherwise, in the north wall. The cell is crossed by a roof truss of the same form as described above (plate 67).

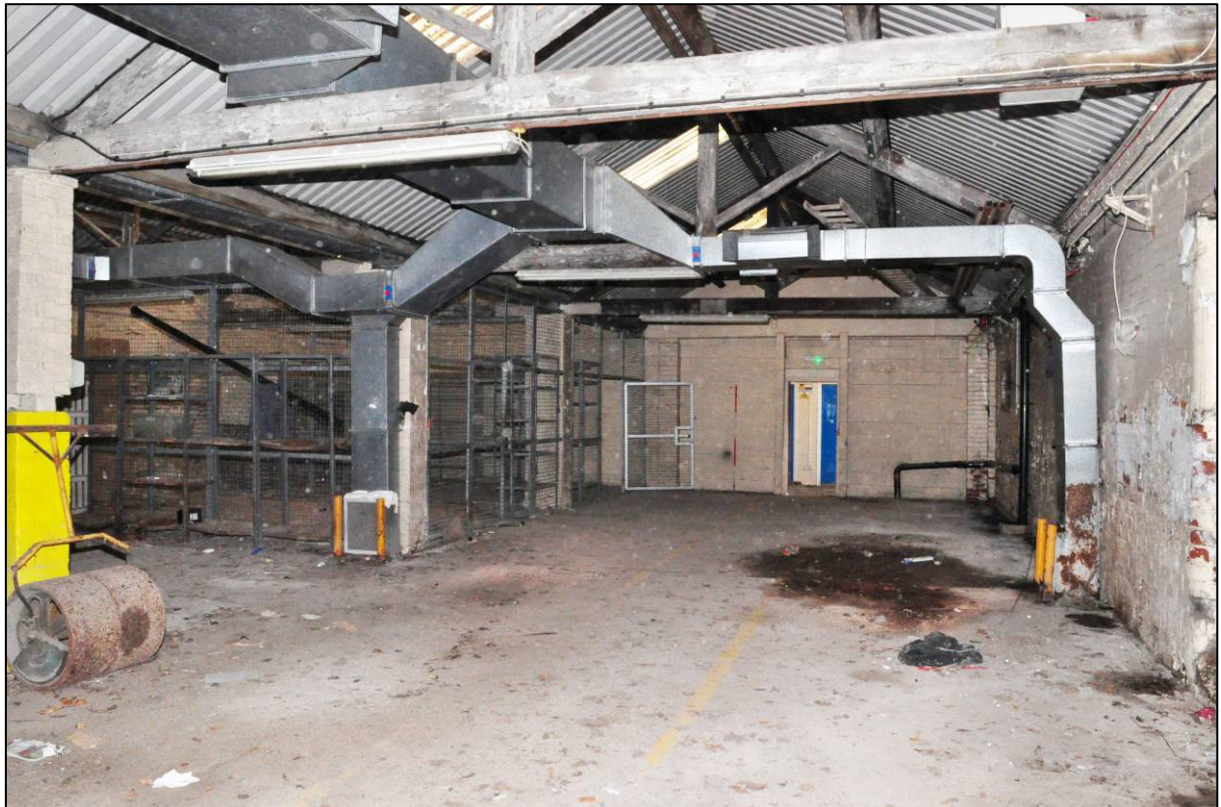
Plate 67: East range, original part, room G21, roof truss, looking S (photo 1/2912).

cages. A north-south aligned row of three brick piers supports the end of the paired roof trusses of the parallel roof ranges (plate 68). Each truss is of bolted, softwood, king-post form, with incised carpenters' marks numbering them from 'I' to 'III' from south to north (plates 69 and 70). The west wall plate is supported on a number of cast-iron brackets (plate 71). The west wall of the space is formed by the original external east elevation of the earliest part of the east range. This was of four bays. The southern two bays each contain a large blocked window with a segmental head, whilst the northernmost bays each have a blocked cart entrance with bull-nosed jambs and a stop-chamfered timber lintel (plate 72). The east wall incorporates the remains of the earlier boundary wall of the workhouse complex (plate 73), whilst there was once a tall and wide opening which occupied the eastern half of the south wall.

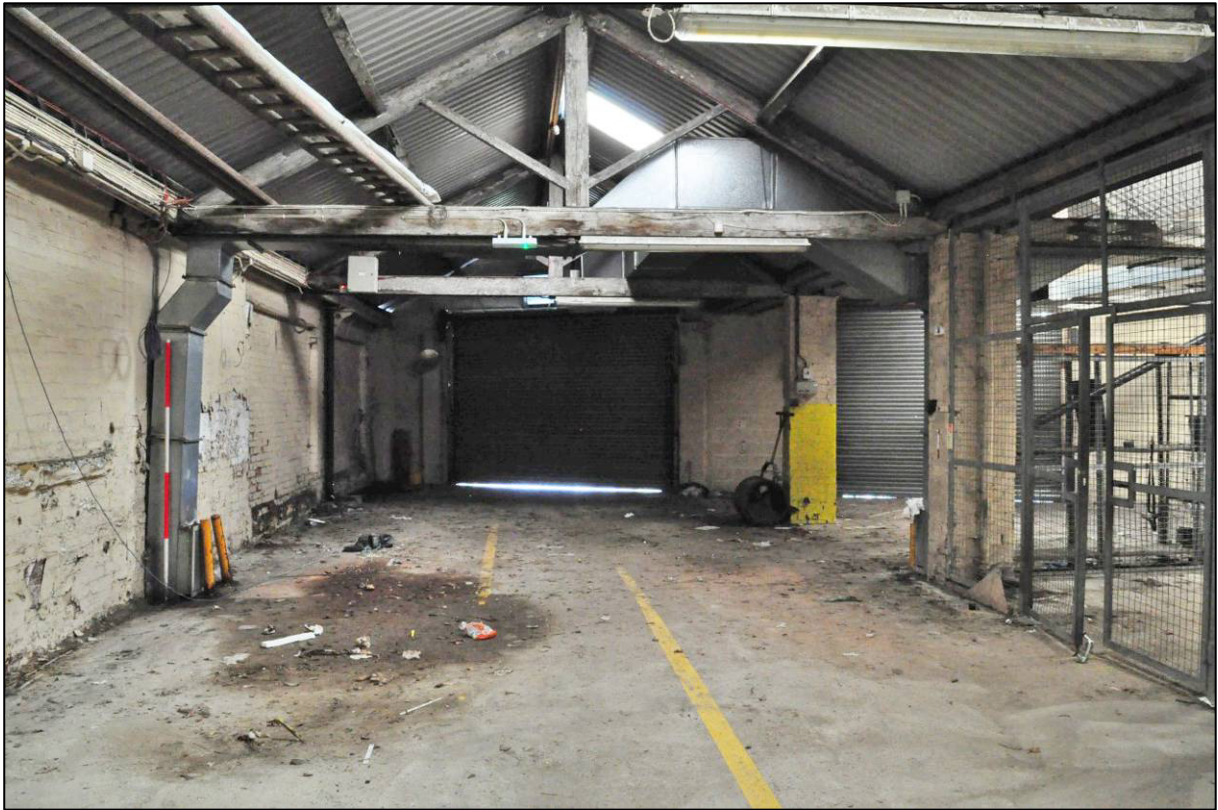
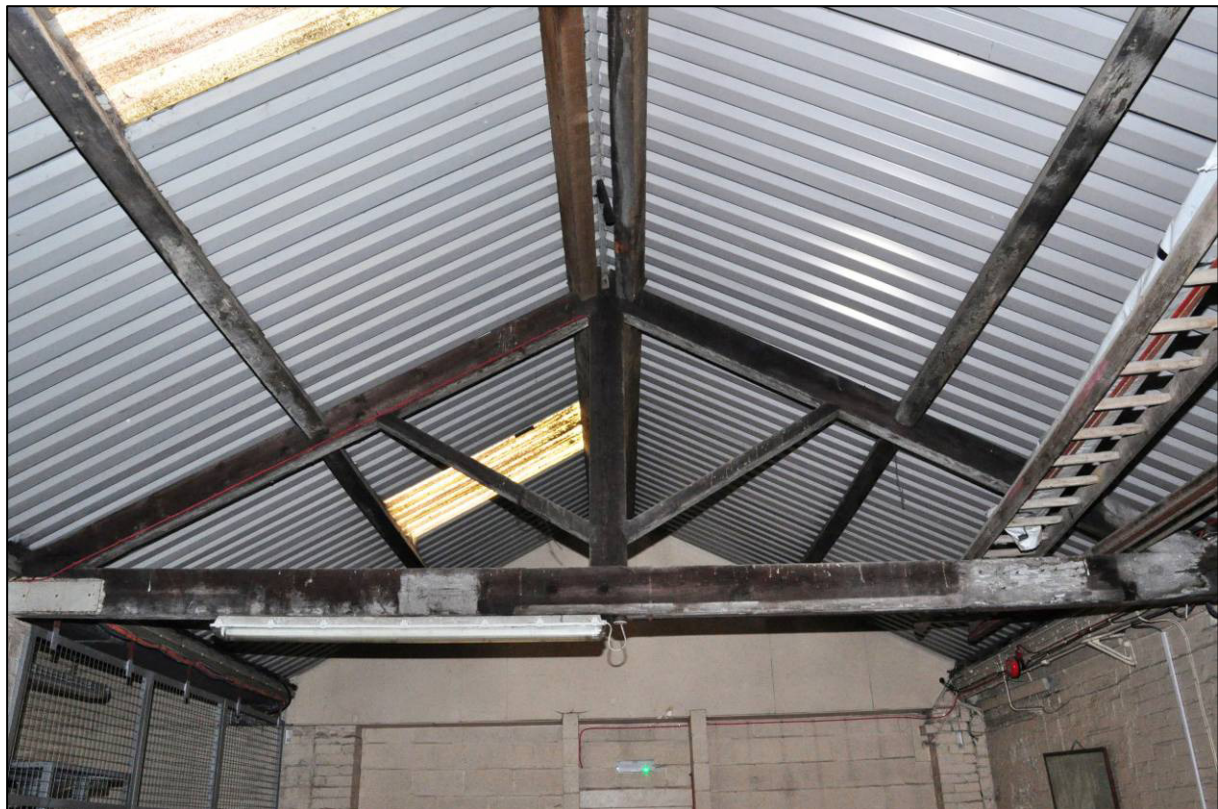
Plate 68: East range, eastern extension, room G22, looking SE (photo 1/2887).

Plate 69: East range, eastern extension, room G22, looking N (photo 1/2885).

Plate 70: East range, eastern extension, room G22, roof truss, looking S (photo 1/2891).
