FORMER ENTRANCE BLOCK TO BRAMLEY UNION  
WORKHOUSE (ST MARY'S HOSPITAL),  
ARMLEY, LEEDS LS12 3QE

ARCHAEOLOGICAL AND ARCHITECTURAL  
PHOTOGRAPHIC RECORD

Report no: 2020/609.R01  
Version: Final  
Date: May 2020  
Author: Shaun Richardson & Ed Dennison

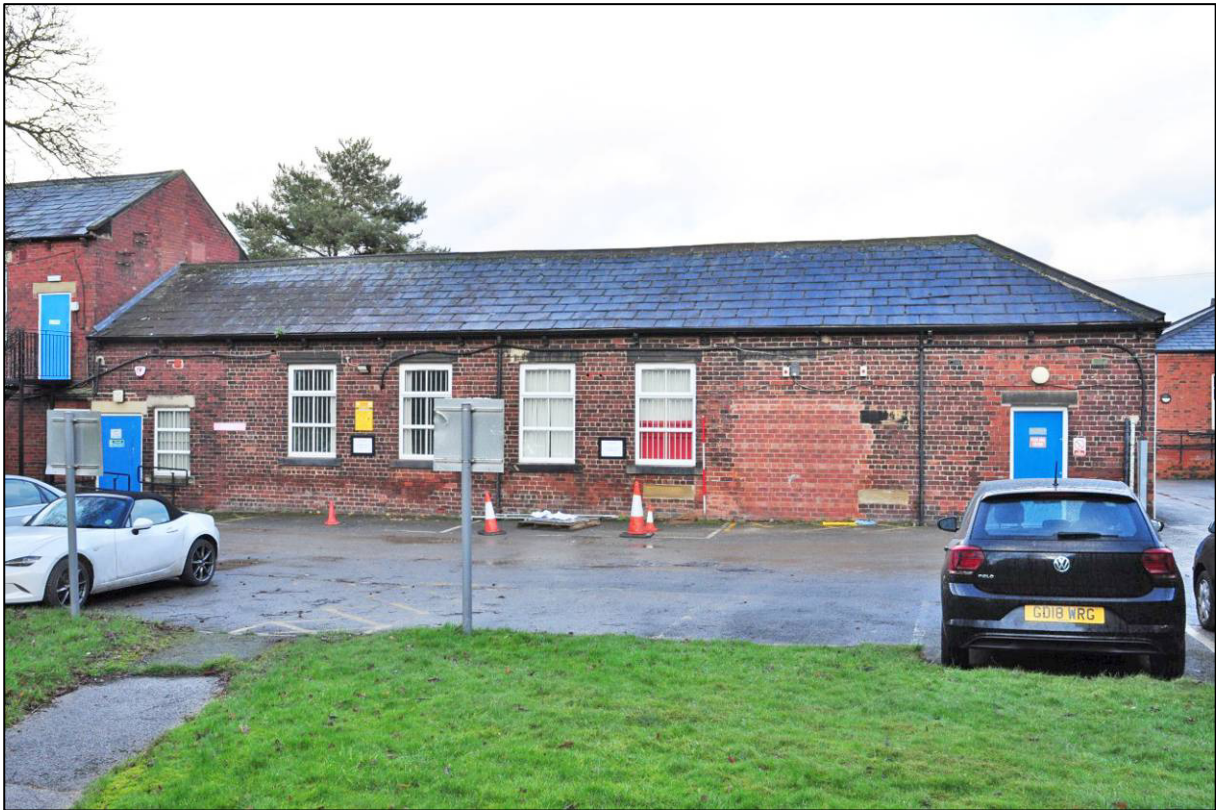
Pate 79: West range, original part, west elevation, looking E (photo 1/3007).

- 3.33 The earlier, southern half of the west range is of similar form and appearance to the earliest part of the east range. It was a rectangular, single storey building, with a hipped, slated roof; there are no surviving chimney stacks. All walls are built of neat mid-red handmade bricks (average dimensions 220mm by 110mm by 70mm) laid in English Garden Wall bond (three stretcher courses to each header course) and set with a lime mortar. The majority of window and door fittings are modern replacements of the originals. Bracketed eaves are carried around the building's exterior. The west elevation has been subject to much alteration (plate 78). There may have once been a tall doorway to the south end, and there was definitely a cart entrance to the north of this; the stone blocks which once supported the door pintles remain *in situ*. At a later date, probably when the northern half of the range was built between 1908 and 1921, at least five large windows with stone lintels and sills were inserted into the elevation, together with doorways at either end; some of these features were themselves subsequently blocked (plate 79). The south elevation has a single central window which is probably also inserted. The east

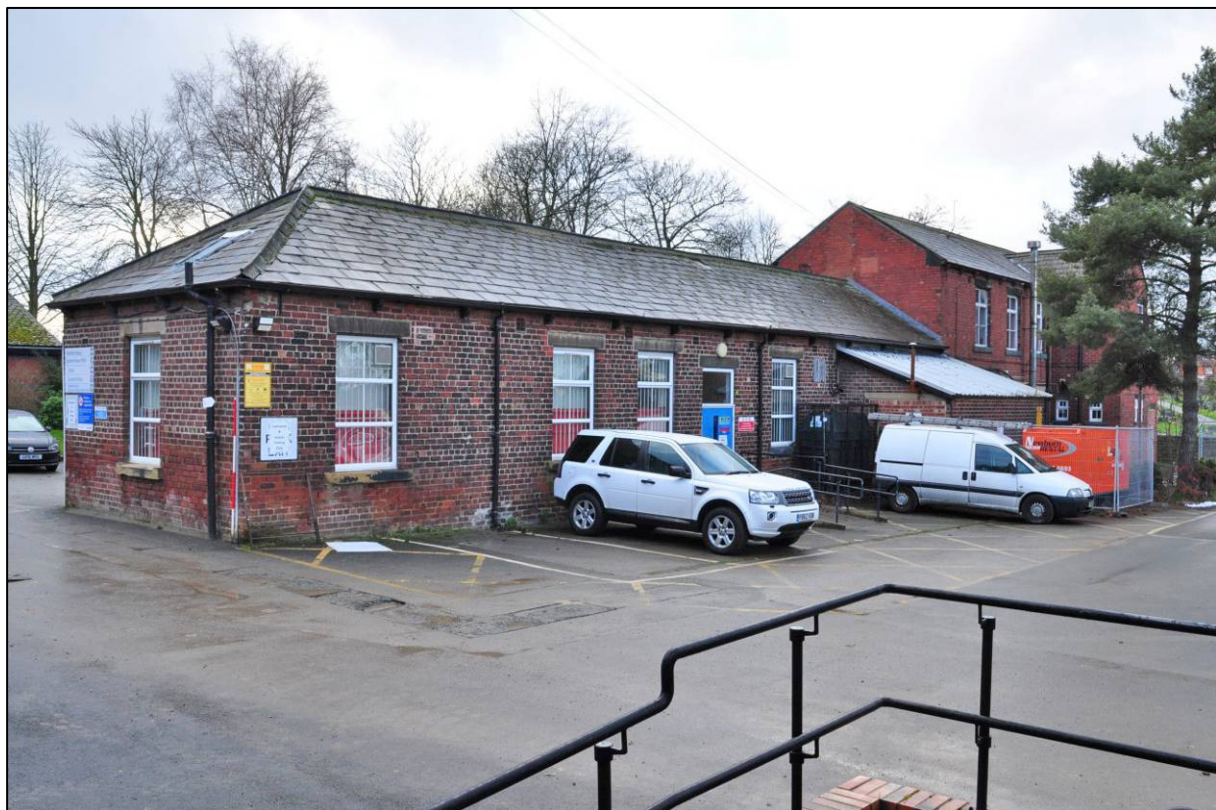
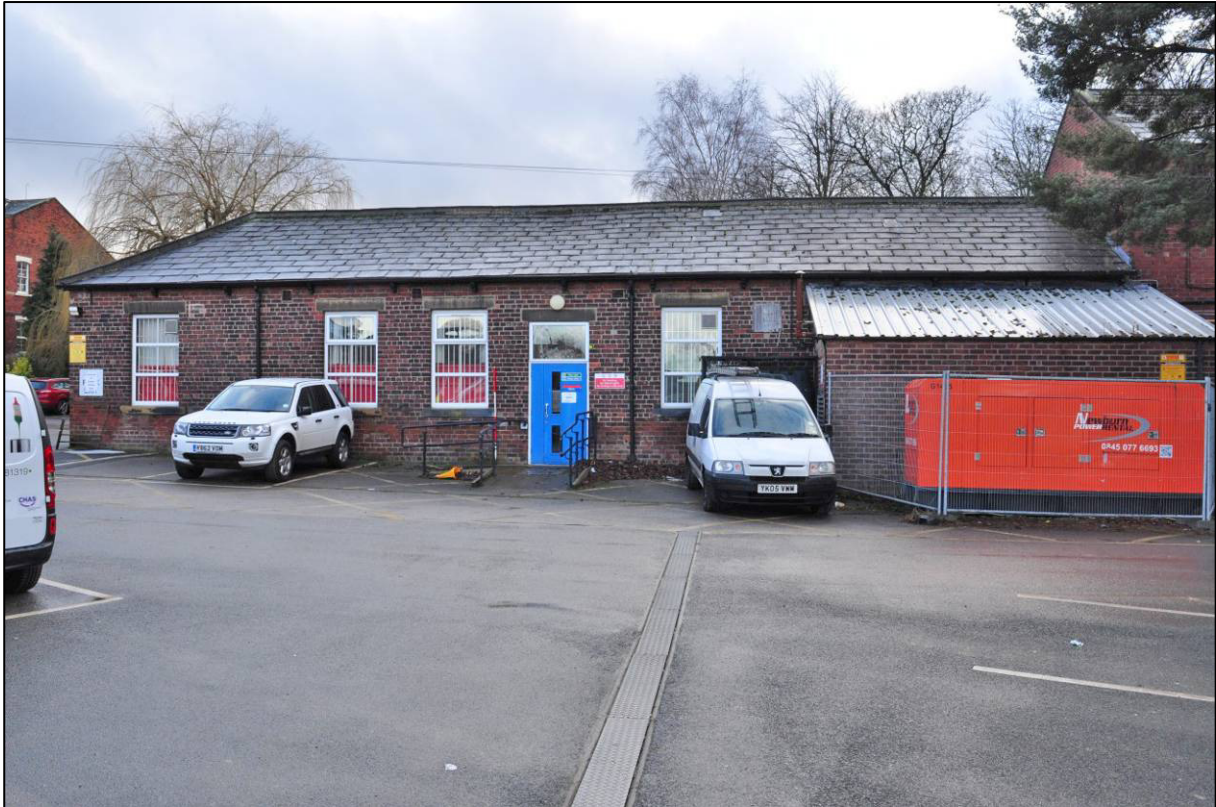
Plate 80: West range, original part, east elevation, looking NW (photo 1/3023).

Plate 81: West range, original part, east elevation, looking W (photo 1/3021).

elevation contains a doorway and four windows, of the same form as those to the west and south elevations (plate 80). The northernmost part is obscured by the single storey brick extension built by the 1960s (plate 81).

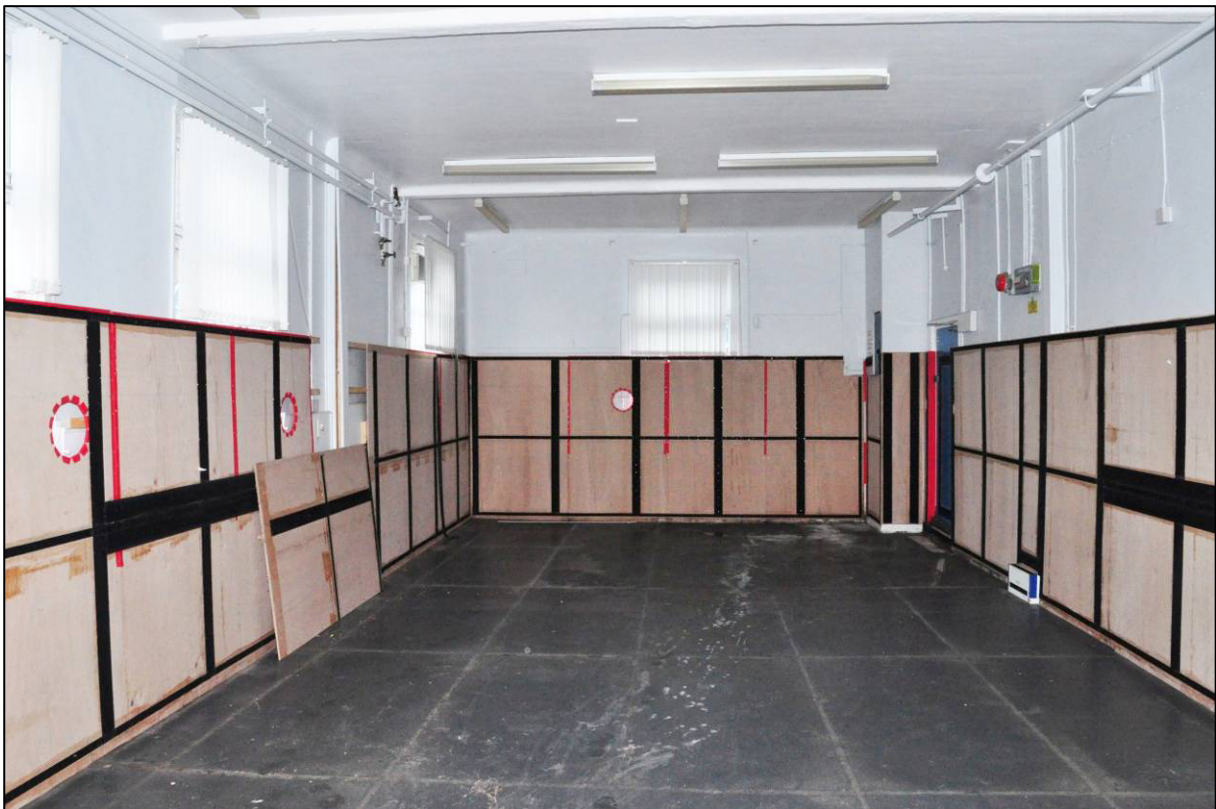
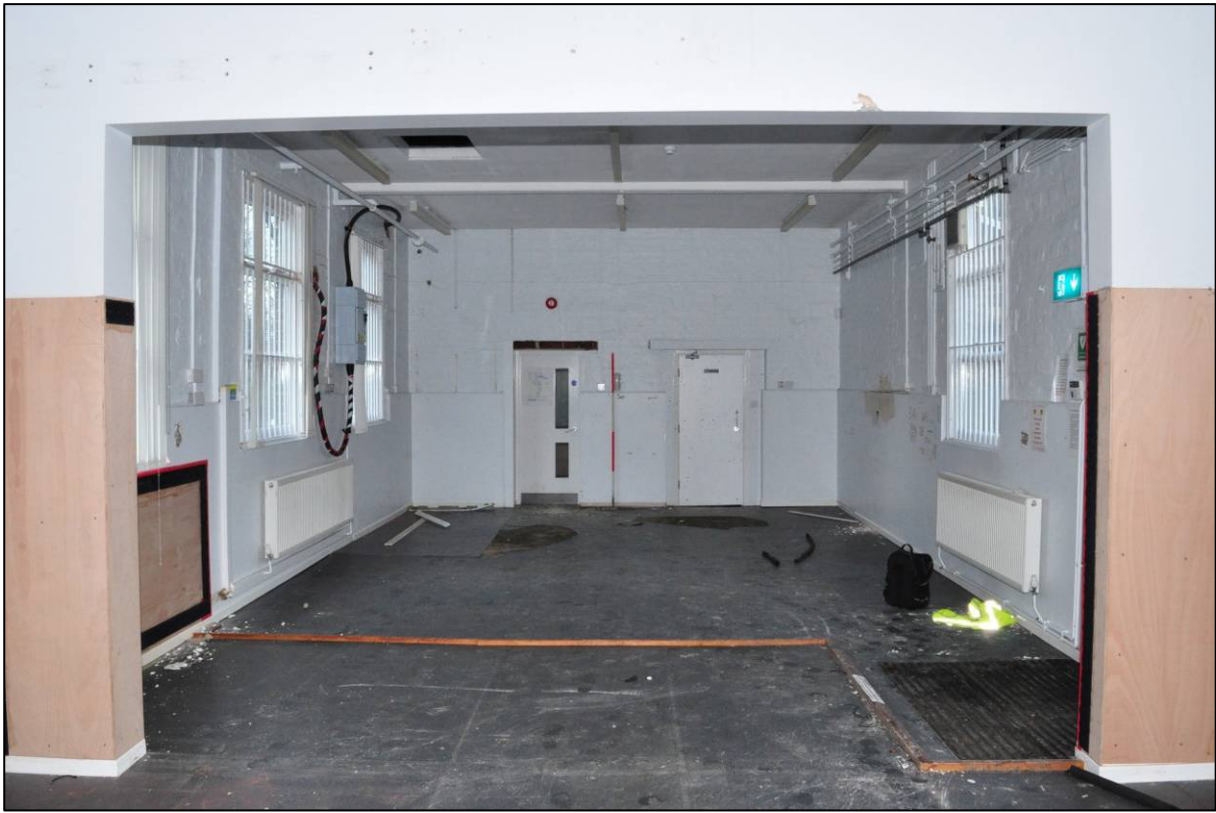
Plate 86: West range, original part, room G24, looking S (photo 1/2984).

Plate 87: West range, original part, room G24, looking N (photo 1/2986).

- 3.36 At the time of the EDAS survey, the southern half of the west range was accessed through a doorway in the east elevation. The interior has been completely opened out to a single space (**G24**) and partly lined for PMVA (Prevention Management of Violence and Aggression) usage (plates 86 and 87). At the north end, there are two small cells forming a kitchen and toilets. Partial stripping out in the toilets (**G25**) revealed early white-glazed brick wall surfaces (plate 88).

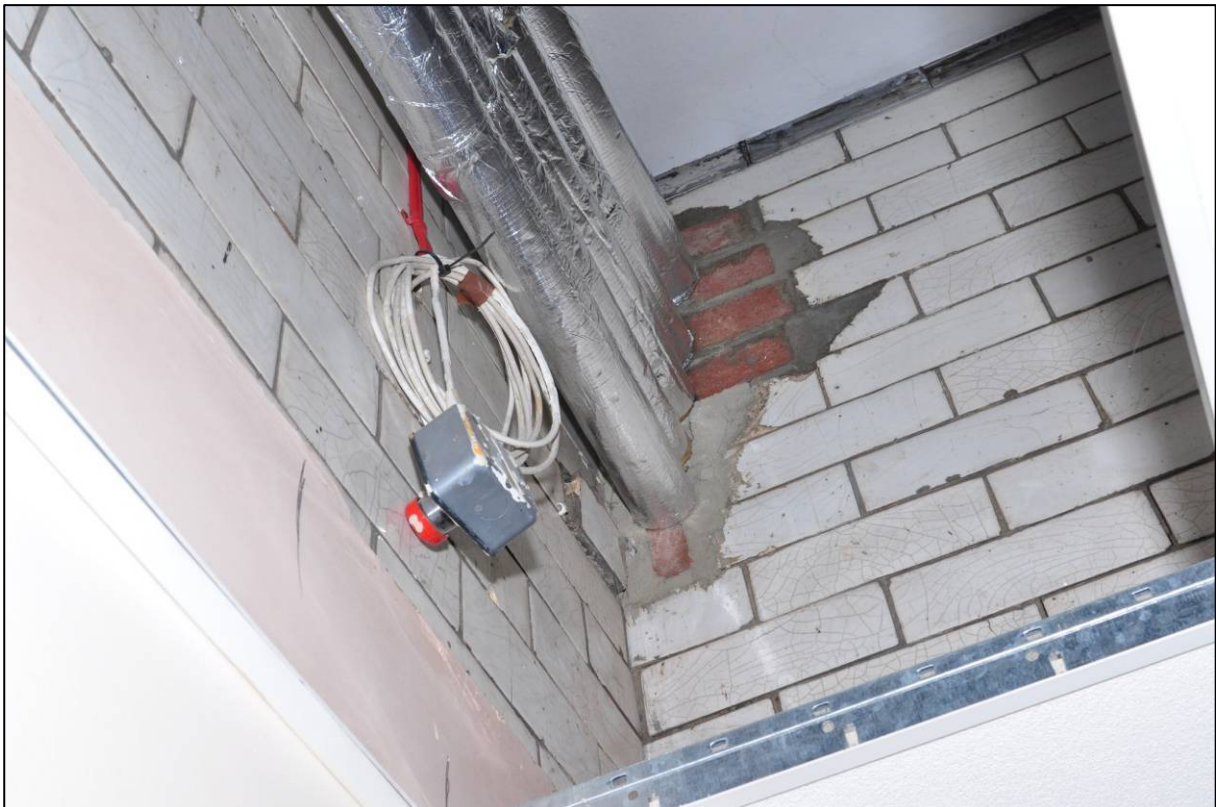
Plate 88: West range, original part, room G25, glazed tiles, looking NE (photo 1/2988).

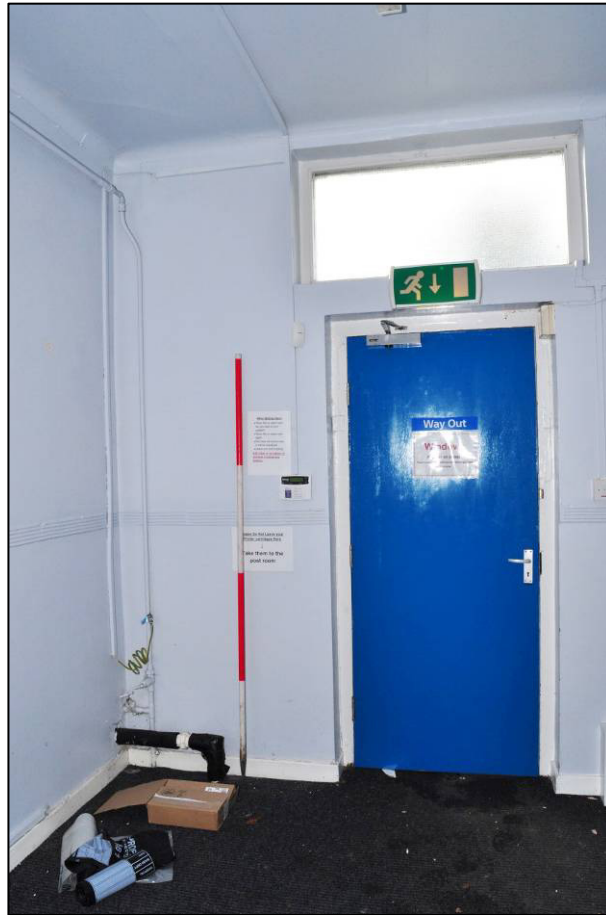
Plate 89: West range, later part, room G28 (lobby), looking W (photo 1/2989).

- 3.37 The northern half of the west range was accessed through a doorway in the west elevation. This opens into a lobby (**G28**) with a tiled dado and plain skirting boards, both of which occur throughout the interior (plate 89). The ground floor rooms to the north (**G29**) (plate 90) and to the south (**G26**) (plate 91) are very plain; there is a recess in the south wall of G26 which may be a former doorway. To the immediate south of the entrance lobby (**G28**), the main internal staircase (**G27**) rises to the first floor. The staircase is of dog-leg, open-string form, with a flat metal handrail and stick balusters (plates 92 and 93). It cuts rather awkwardly across a window in the west wall (plate 94), perhaps suggesting that the original main staircase may have been located elsewhere.

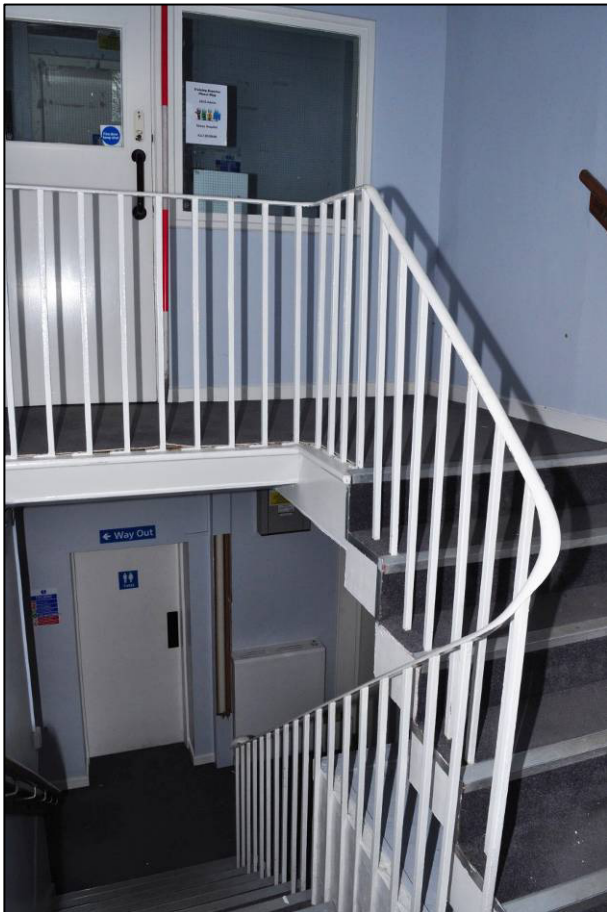
Plate 95: West range, later part, room 1F1 (landing), looking E (photo 1/2996).

- 3.38 The staircase rises to a first floor landing (**1F1**) (plate 95). Opposite the landing, the toilet block (**1F2**) retains four-panel doors which may be original to the building (plate 96). As on the ground floor, the rooms to the north (**1F3**) (plate 97) and south (**1F4**) (plate 98) are very plain with no features of interest.

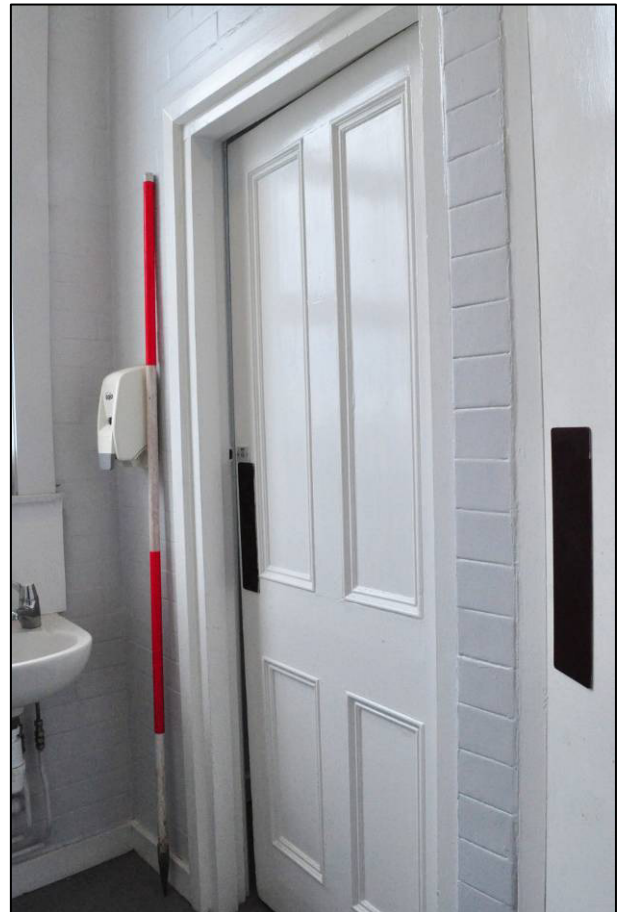
Plate 96: West range, later part, room 1F2 (toilets), door detail, looking SE (photo 1/3001).

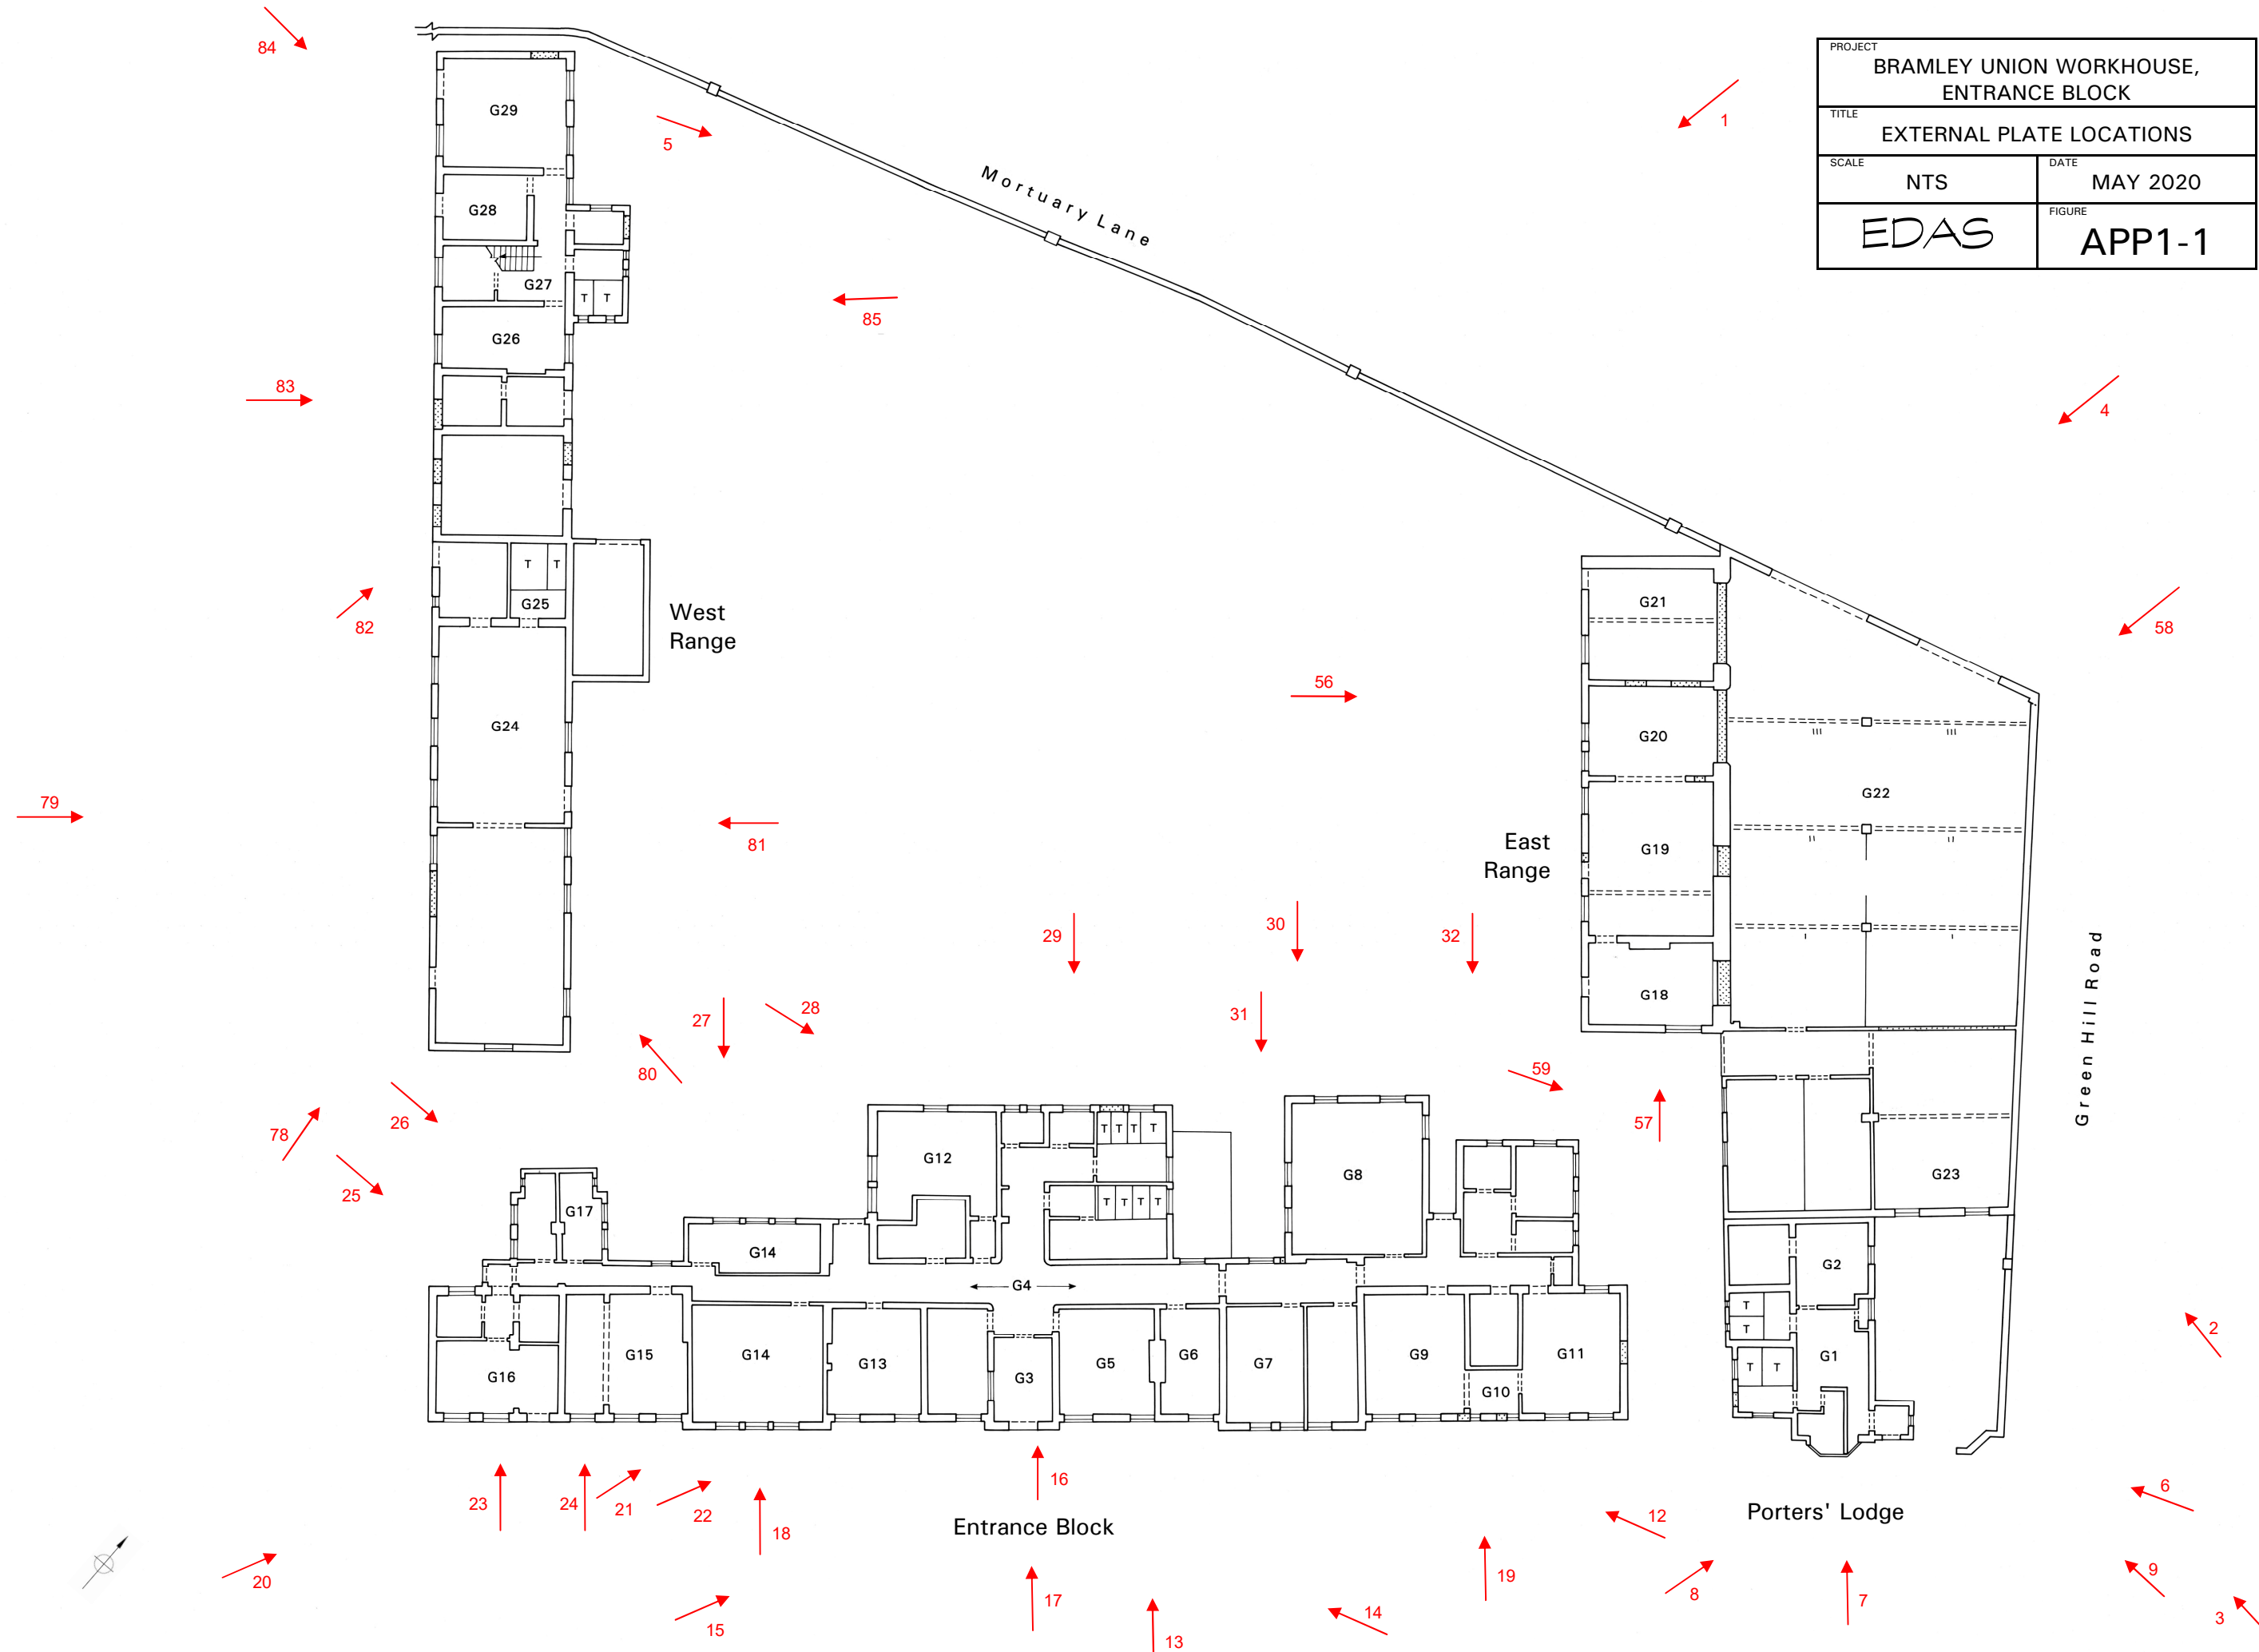
PROJECT		BRAMLEY UNION WORKHOUSE, ENTRANCE BLOCK	
TITLE			
EXTERNAL PLATE LOCATIONS			
SCALE	NTS	DATE	MAY 2020
EDAS		FIGURE	APP1-1

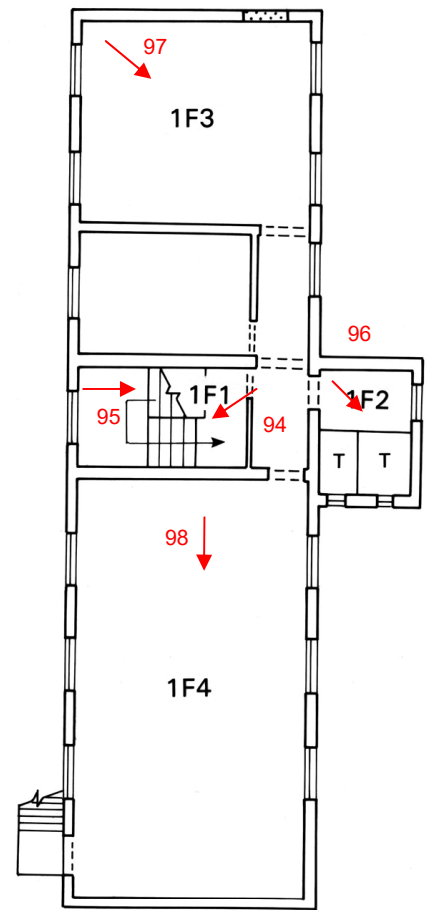
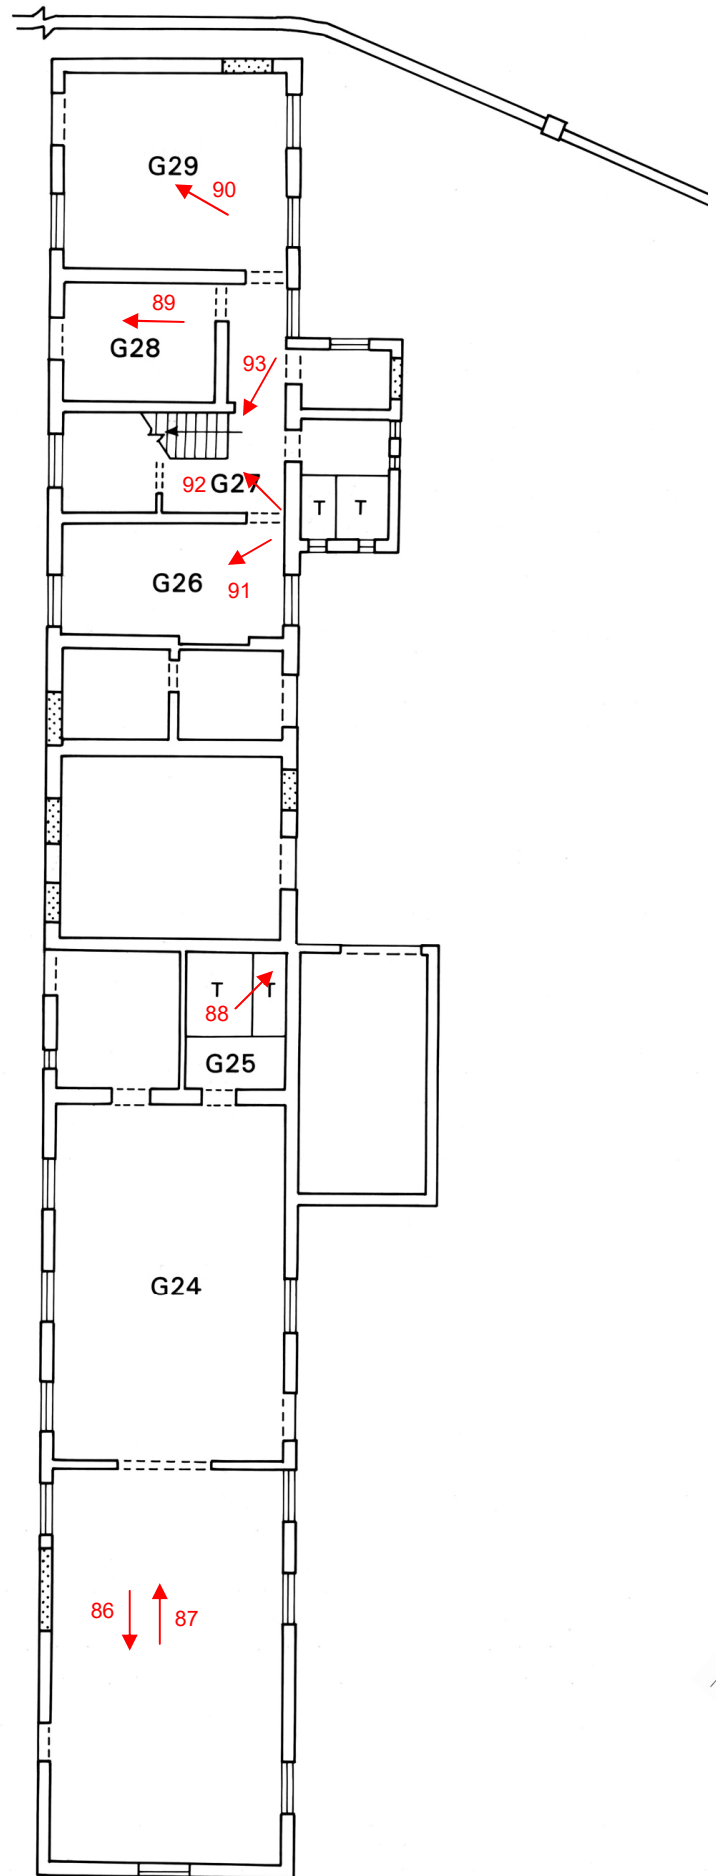
PROJECT BRAMLEY UNION WORKHOUSE, ENTRANCE BLOCK	
TITLE INTERNAL PLATE LOCATIONS	
SCALE NTS	DATE MAY 2020
EDAS	FIGURE APP1-3

First floor

Ground floor
