## **Hallin Hall SRE, Hebden Bridge**

Historic Building Recording

ARCUS report 1275.1(1)

# Hallin Hall SRE, Hebden Bridge, West Yorkshire

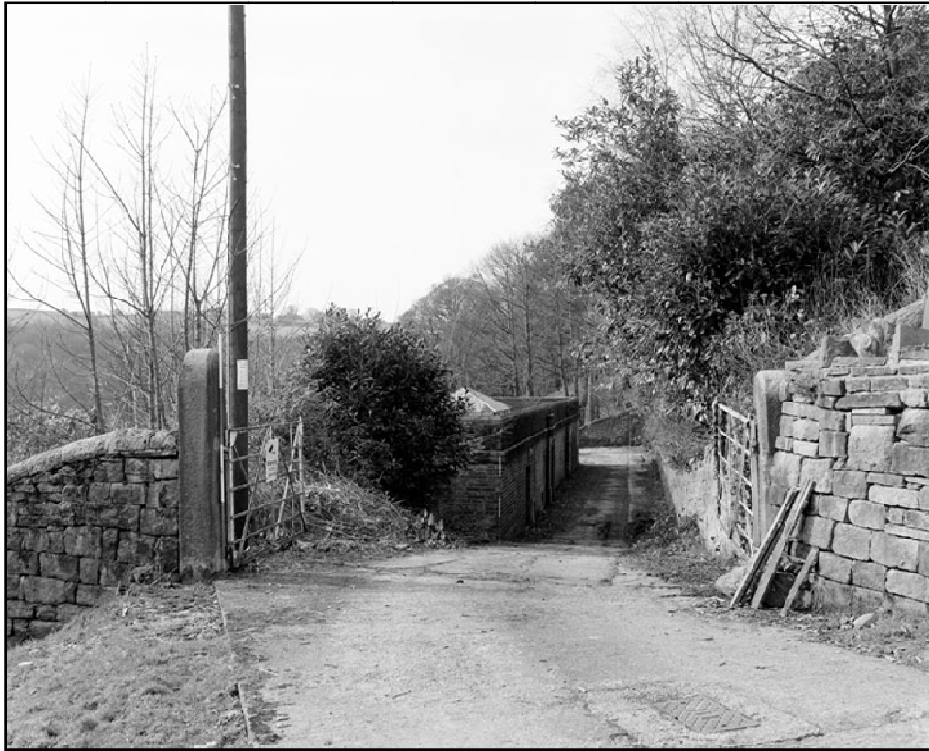
**Plate 1:** General view down track from Midgehole Road (film 2.03)

Access to the site (**Illustration 5**) was down a track from Midgehole Road to the northeast (**Plate 1**), which continued along the northern elevation of the filter house, bounded to the north by a dry stone retaining wall, and opening out to form a concrete covered yard to the west of the filter house. The water filter house lay at a northeast-southwest alignment to the north of the survey area (**Plate 2**). Immediately to the south was a large concrete subterranean reservoir (**Plate 3**), which occupied the largest portion of the site. Located a small distance down the hill to the southwest of the reservoir were two open shuttered concrete tanks (**Plate 4**) with intake pipes entering from the northeast.

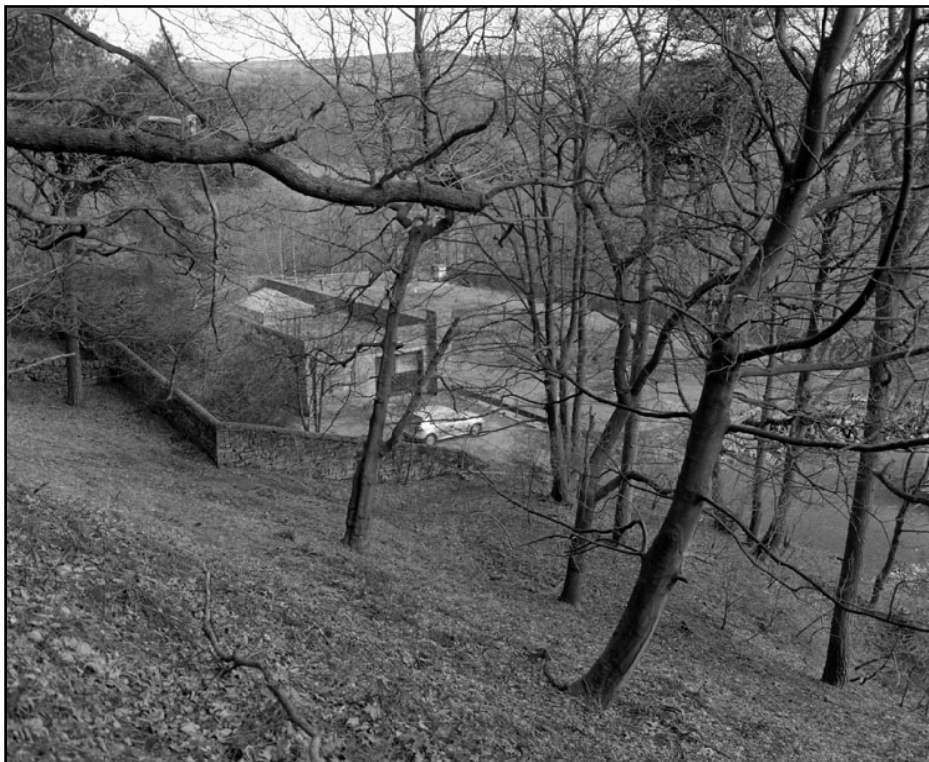
**Plate 2:** General view of filter house and reservoir looking southeast (film 7.01)

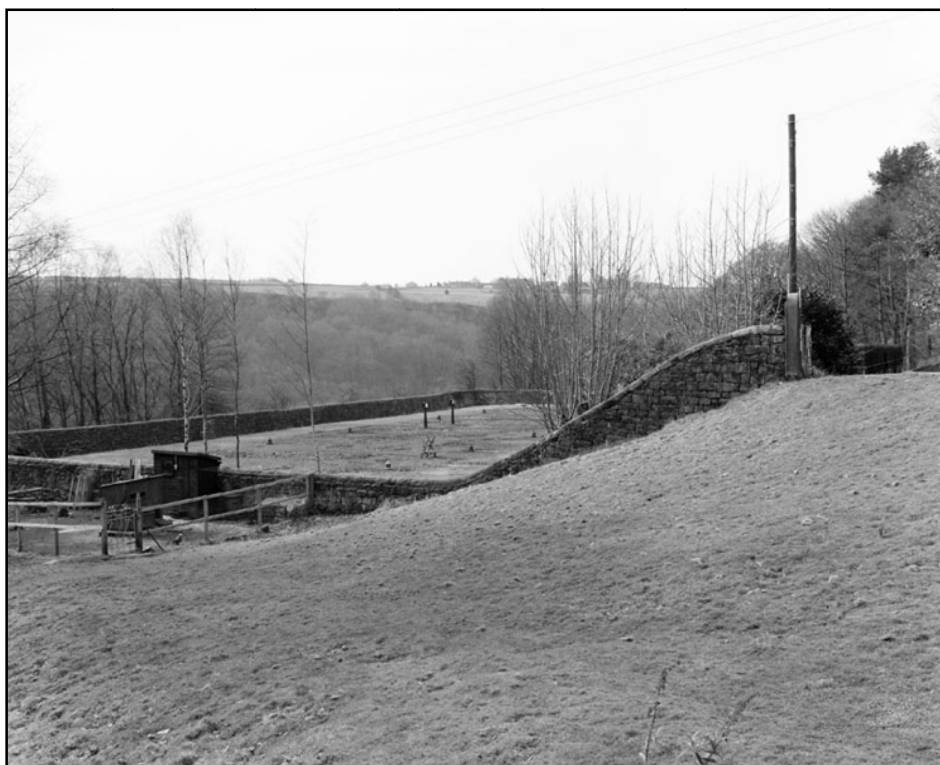
**Plate 3:** General view of covered reservoir from track (film 2.01)

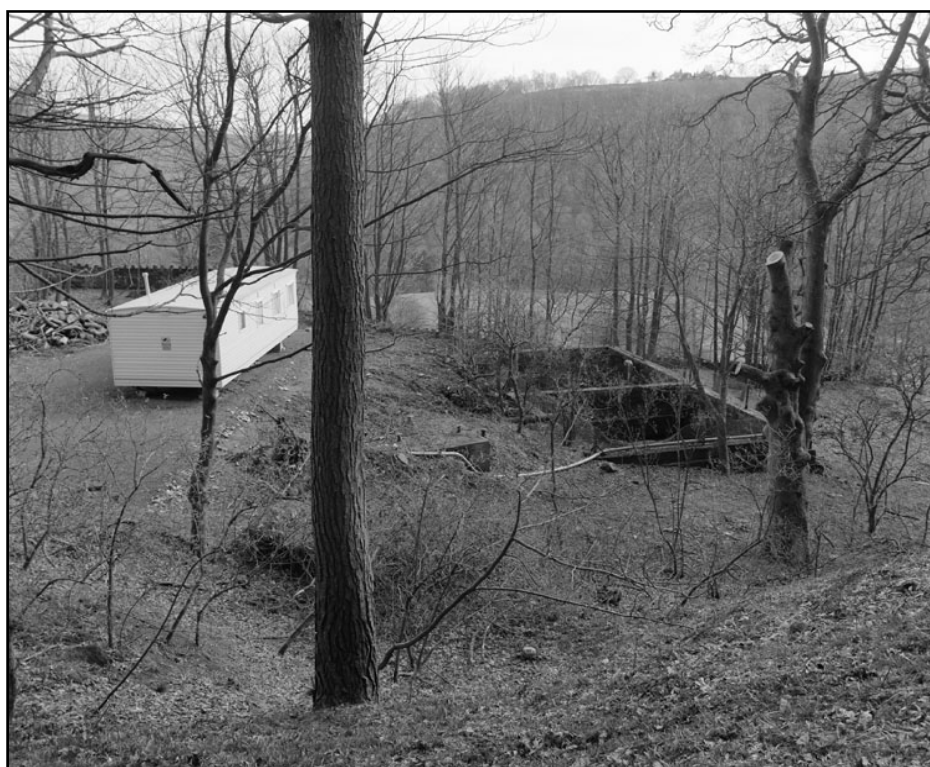
**Plate 4:** General view of settling tanks to west of reservoir, looking south (film 7.03)

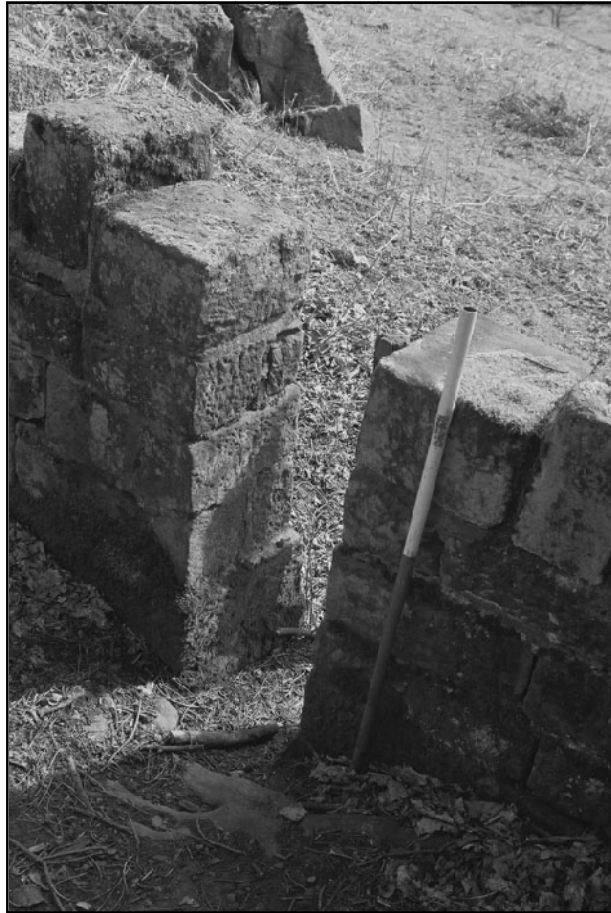
**Plate 5:** General view of stile in southern boundary wall (film 1.21)

horizontal stones). Set into the southwest boundary wall, in proximity to the settling tanks, was a stile (**Plate 5**). A roughly inscribed date stone within the northern retaining wall bore the initials F.C., the date 14.9.81, and a mason's mark of a cross, presumably indicating work on the site in the latter half of 1981 (**Plate 6**). The existence of both walls on the 1894 OS suggests that they were contemporary despite their different constructions.

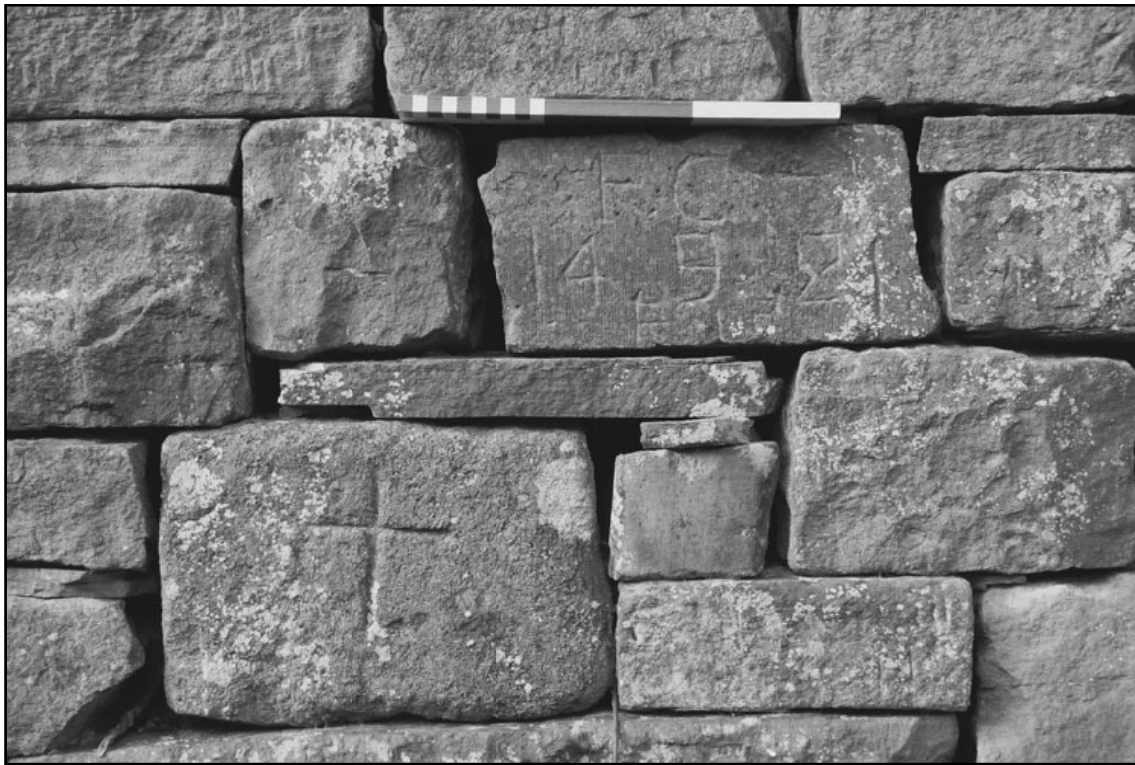
**Plate 6:** Detail of date stone and mason's mark in retaining wall north of track (film 6.36)

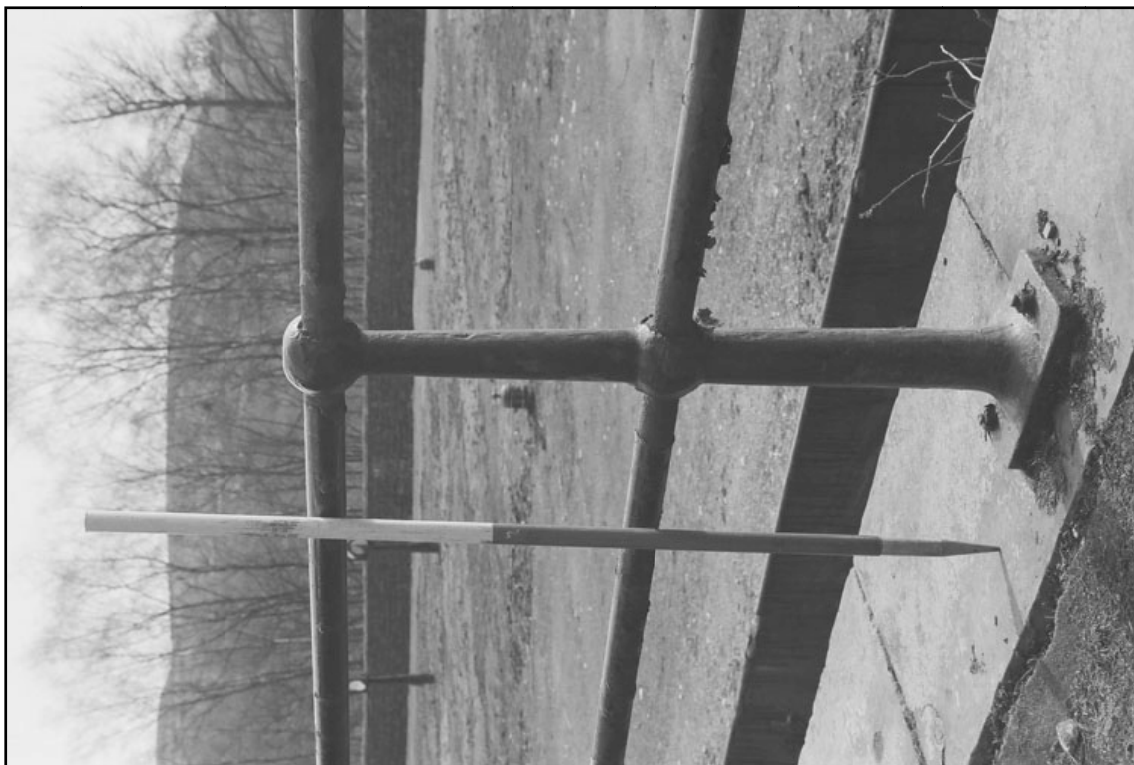
**Plate 7:** Detail of cast iron balustrade to west of filter house (film 1.28)

The yard to the west of the filter house was paved in concrete and bounded to the south by a cast iron balustrade (**Plate 7**). To the northwest corner of the yard, abutting the dry stone walls was a small stone built outbuilding with a flat roof, measuring 1.10 x 1.20m (3'6" x 4') (**Plate 8**). There was a timber panelled door in the southern elevation, and a small blocked window in the eastern elevation. Internally the outbuilding had been recently panelled in wood obscuring evidence for former use, although it is likely to have been a shed or toilet. Beneath the yard to the southeast was a brick built chamber with a RSJ reinforced concrete ceiling abutting the west elevation of the filter house. Entry into the chamber was through a doorway in the retaining wall separating the lower level of the reservoir from the yard. A flue on the southwest corner of the filter house extended into this chamber where there were two openings for a removed exhaust duct (**Plate 9**). A manhole from the yard above acted as a coal chute, corresponding to a pile of coal and ash in the western half of the chamber (**Plate 10**). It is believed that the room housed a generator, possibly a backup power supply to power water pumps in the case of a power cut.

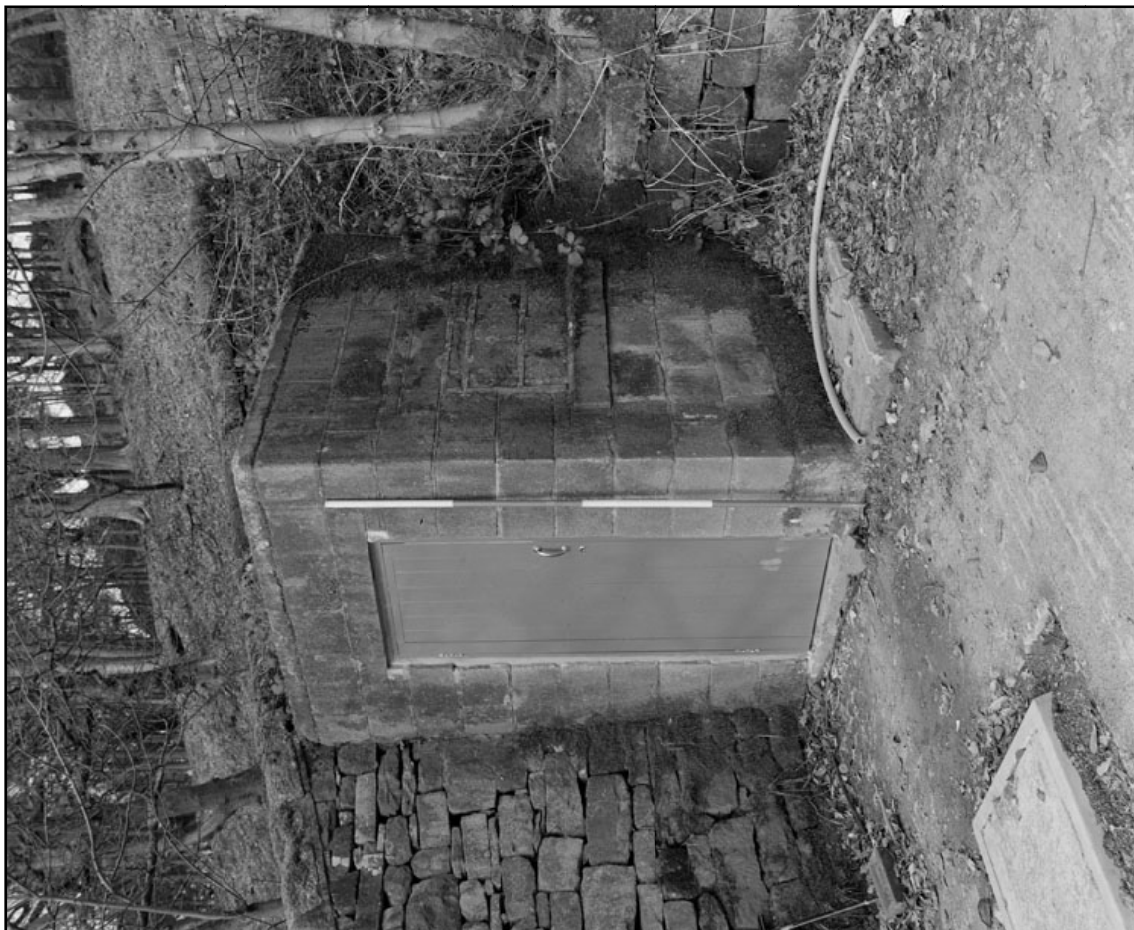
**Plate 8:** General view of outhouse to west of filter house (film 3.06)

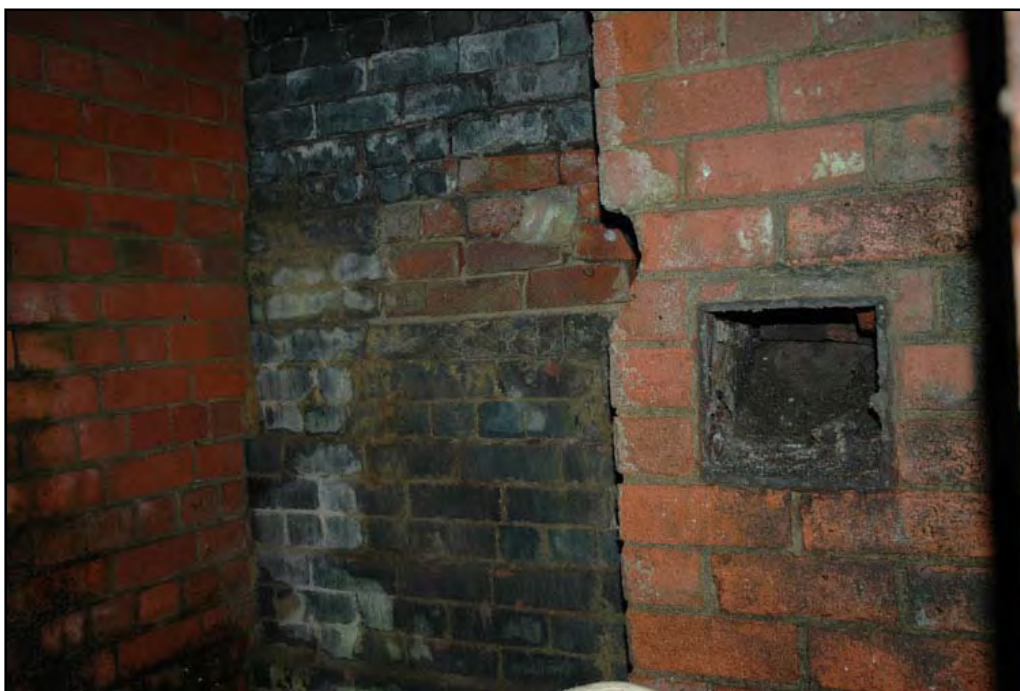
**Plate 9:** Detail of flue in southeast corner of generator chamber beneath yard

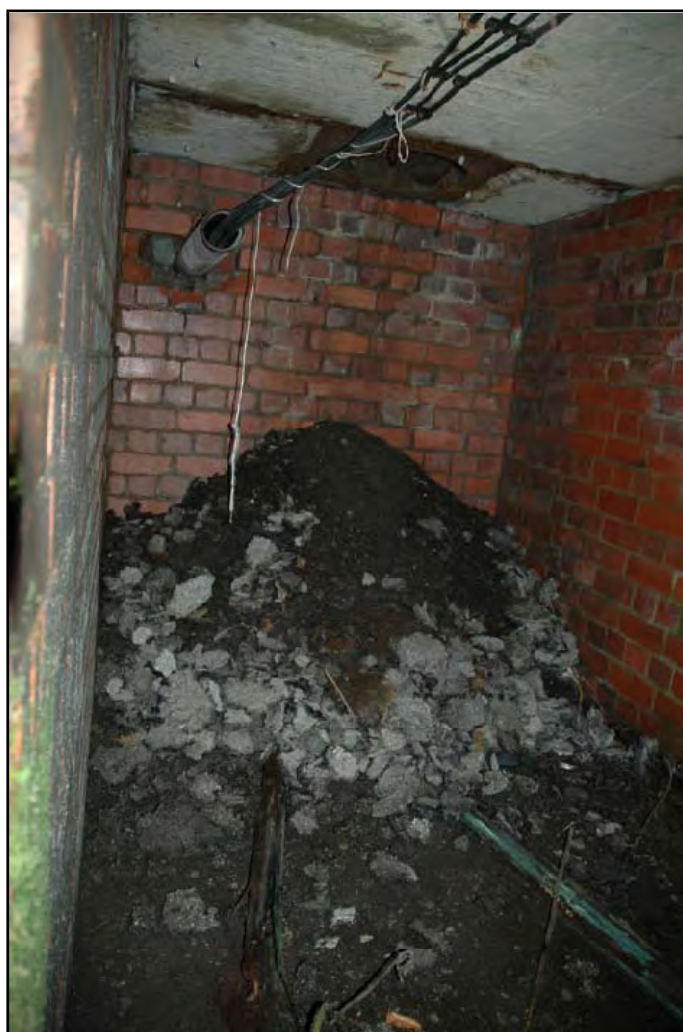
**Plate 10:** Detail of coal pile in western half of generator chamber; note manhole above

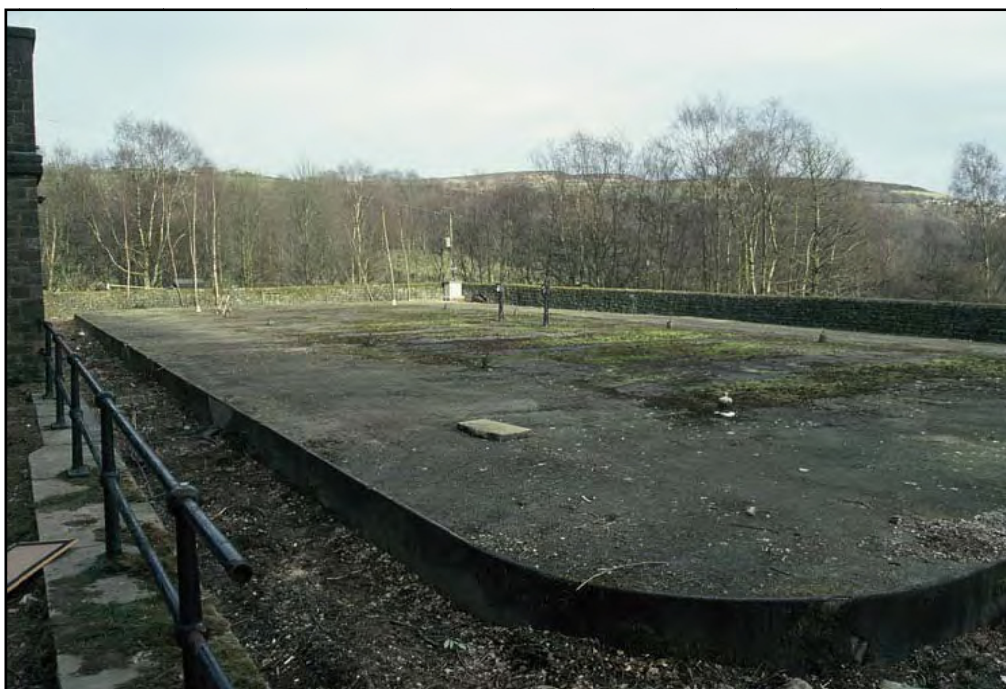
**Plate 11:** General view across covered reservoir, looking southeast (slide 21)

The reservoir measured 54 x 24.5m (177' x 80'6"), with a concrete roof/cover rising 80cm above ground level (**Plate 11**). Spaced at regular intervals across the top of the reservoir were 12 small iron vents with ornate finials (**Plate 12**), for the venting of gases that could build up within the reservoir. Towards the centre of the reservoir were two depth gauges for measuring the level of the water inside the reservoir that were manufactured by The LEA Recorder Co. Ltd., Manchester (**Plate 13-17**). In addition there was also cluster of inspection covers (**Plate 18**) towards the centre of the reservoir, with two manholes possessing fixed ladders to allow access into the interior of the reservoir (**Plate 19**). Internally the reservoir was 3.66m (12') deep, had slopping slides, concrete lining, frequent square concrete columns supporting the cap, and pipes running east west across the base of the reservoir (**Plate 20**). A manhole to the north of the reservoir, against the southern elevation of the filter house, showed that water from the filter house could be diverted to the west away from the reservoir, presumably during cleaning of the filters (**Plate 21**). To the east of the reservoir was a deep shaft with an iron cover and cast iron stench pipe over the location where water was drawn from the reservoir down to a meter house by Midgehole Road where there was a water main into Hebden Bridge (**Plate 22**).

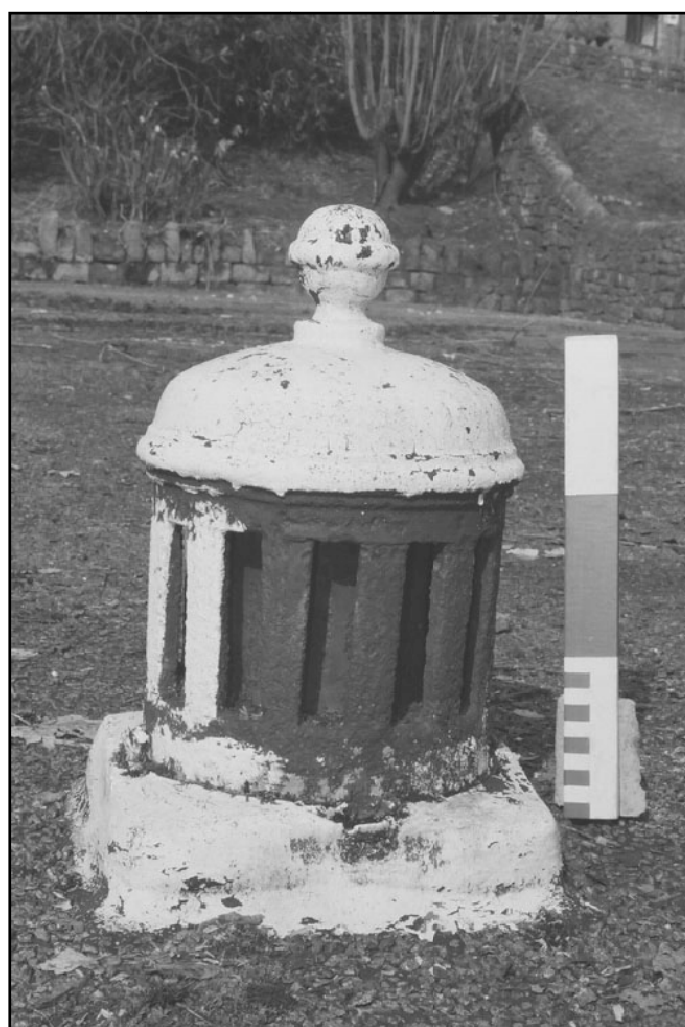
**Plate 12:** Detail of ornate cast iron vent above reservoir (film 1.16)

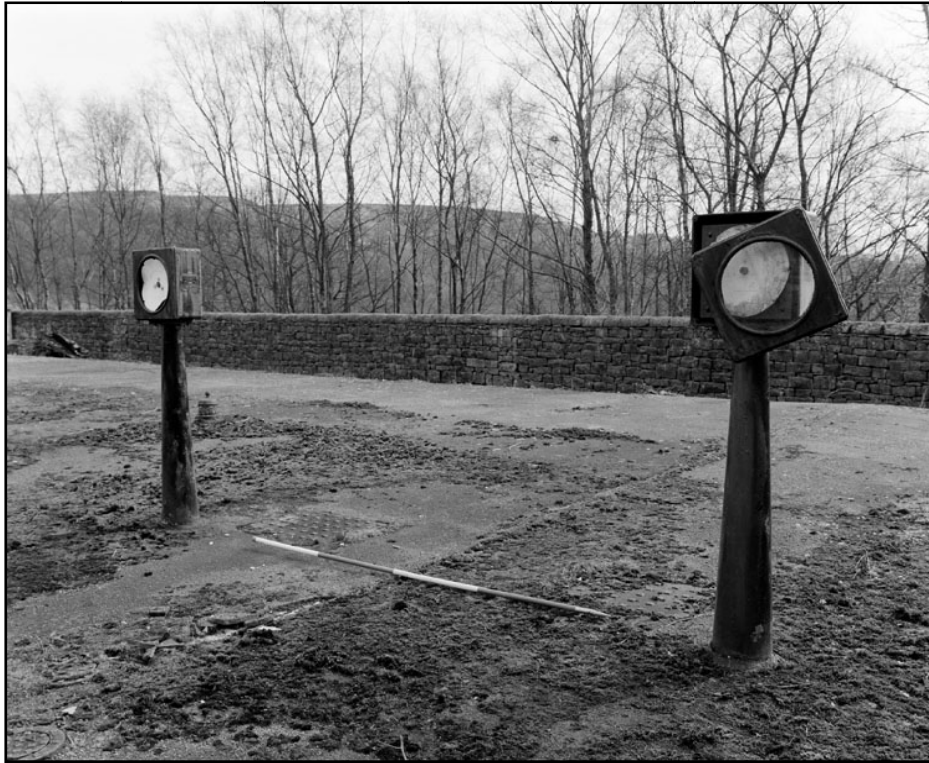
**Plate 13:** General view of depth gauges above reservoir, looking southeast (film 5.07)

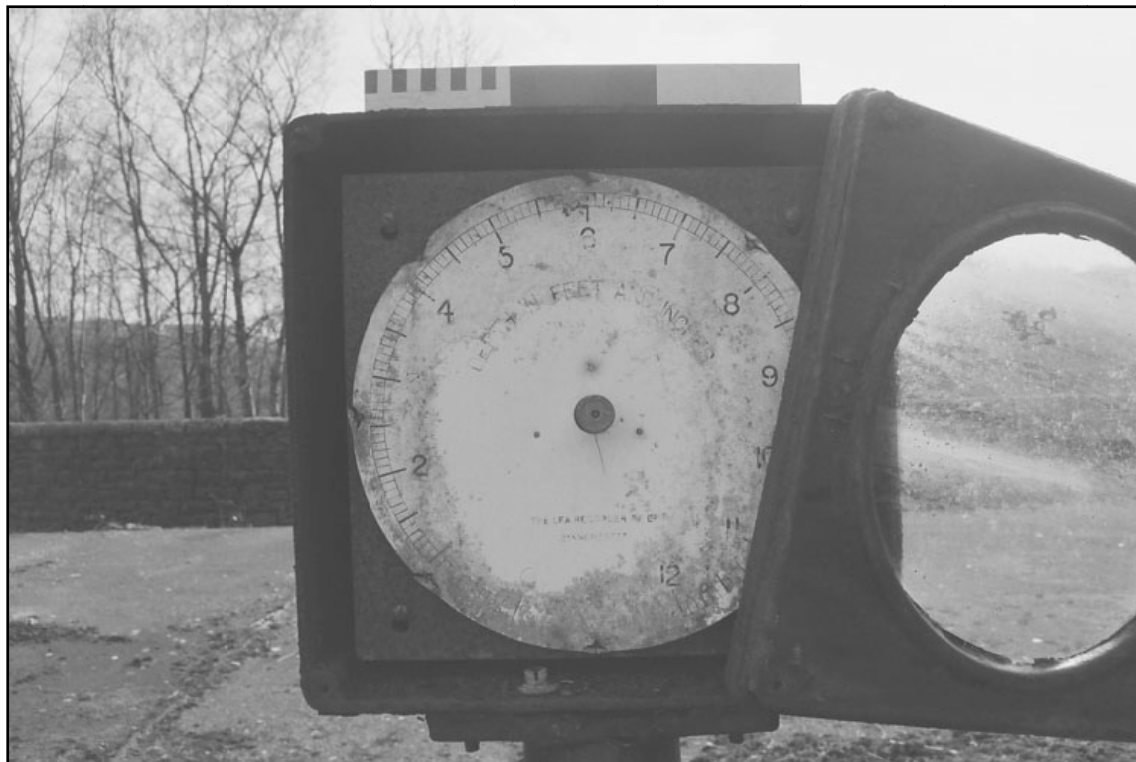
**Plate 14:** Detail of western depth gauge; note depth registers up to 12ft (film 1.08)

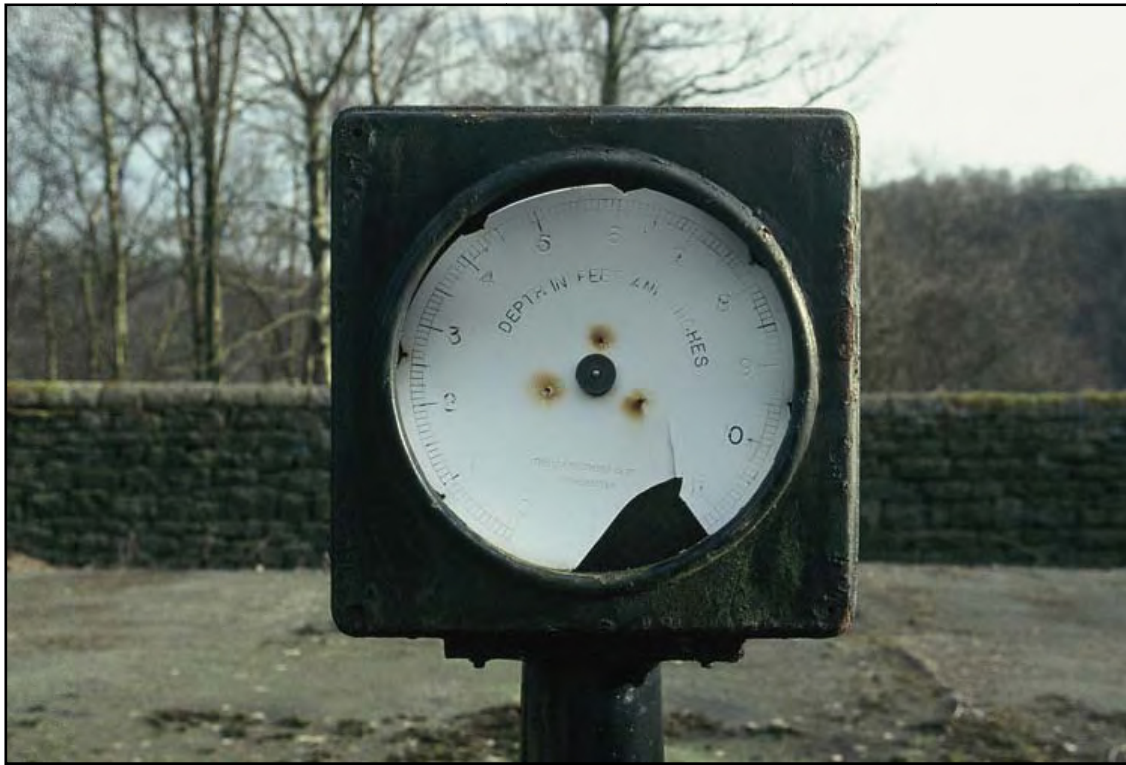
**Plate 15:** Detail of eastern depth gauge (slide 19)

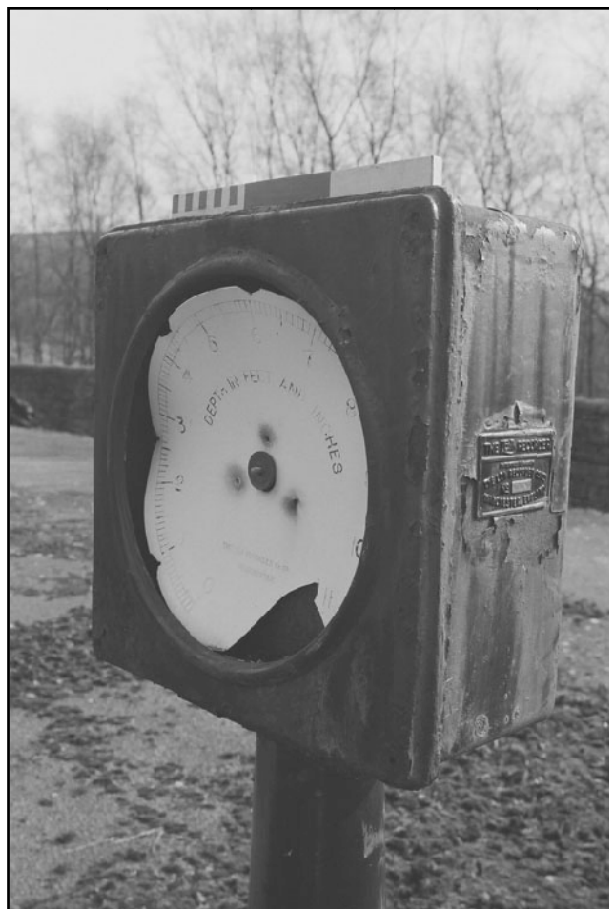
**Plate 16:** General view of eastern depth gauge (film 1.11)

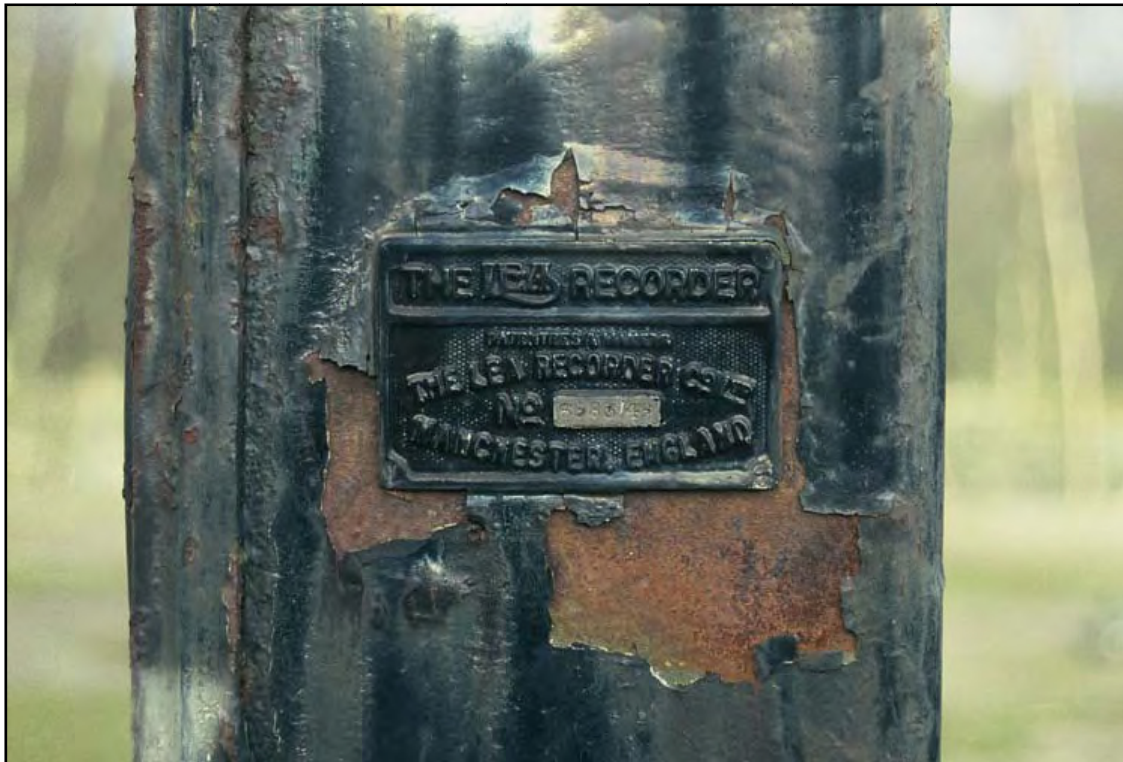
**Plate 17:** Detail of maker's plate on side of eastern gauge (slide 17)

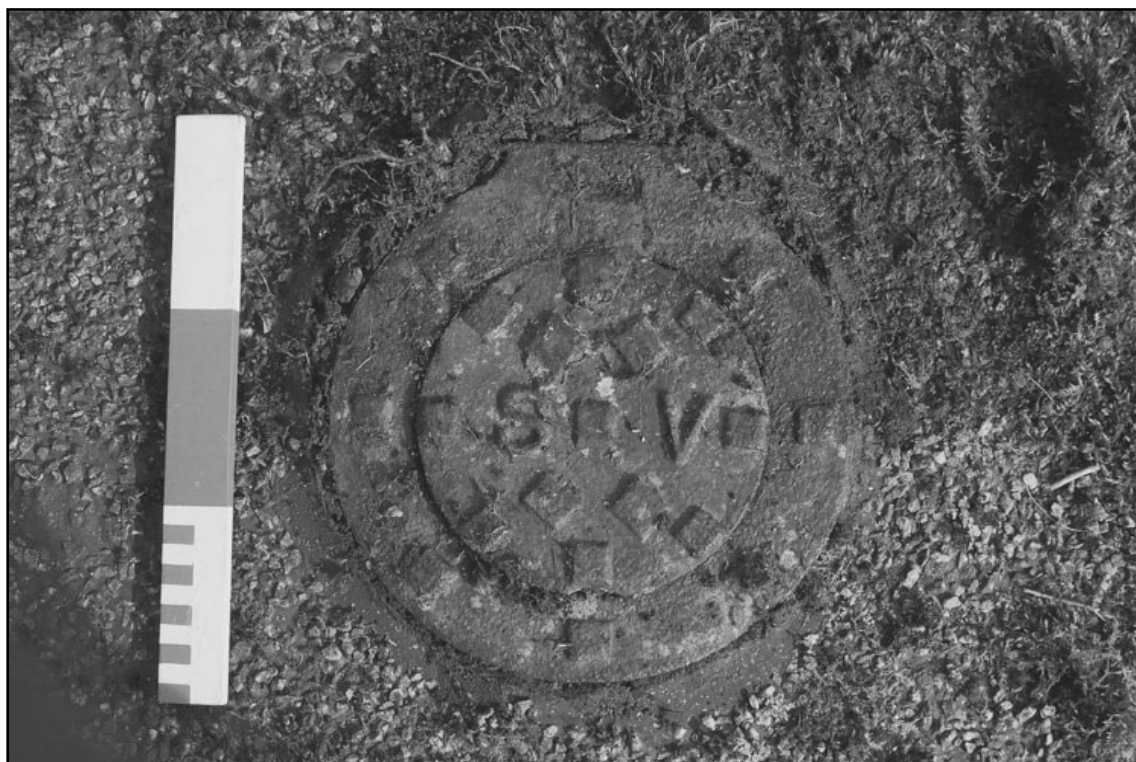
**Plate 18:** Detail of circular inspection cover above reservoir (film 1.04)

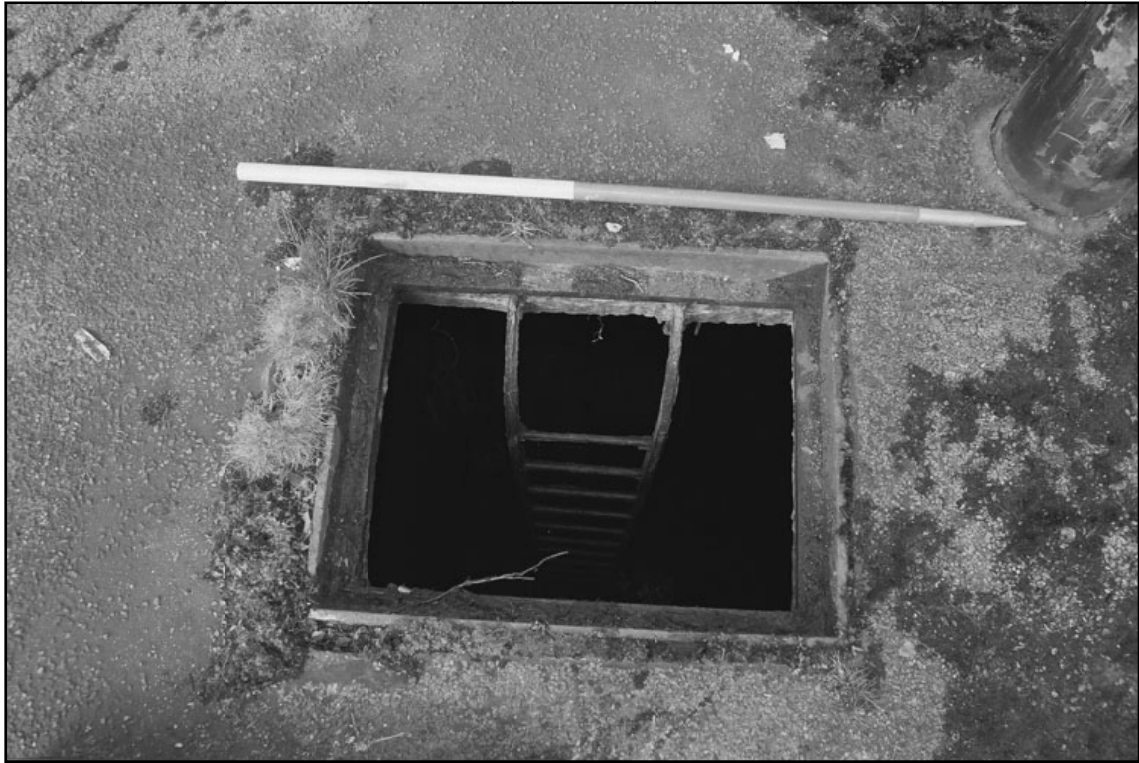
**Plate 19:** Detail of manhole with ladder into reservoir (film 1.07)

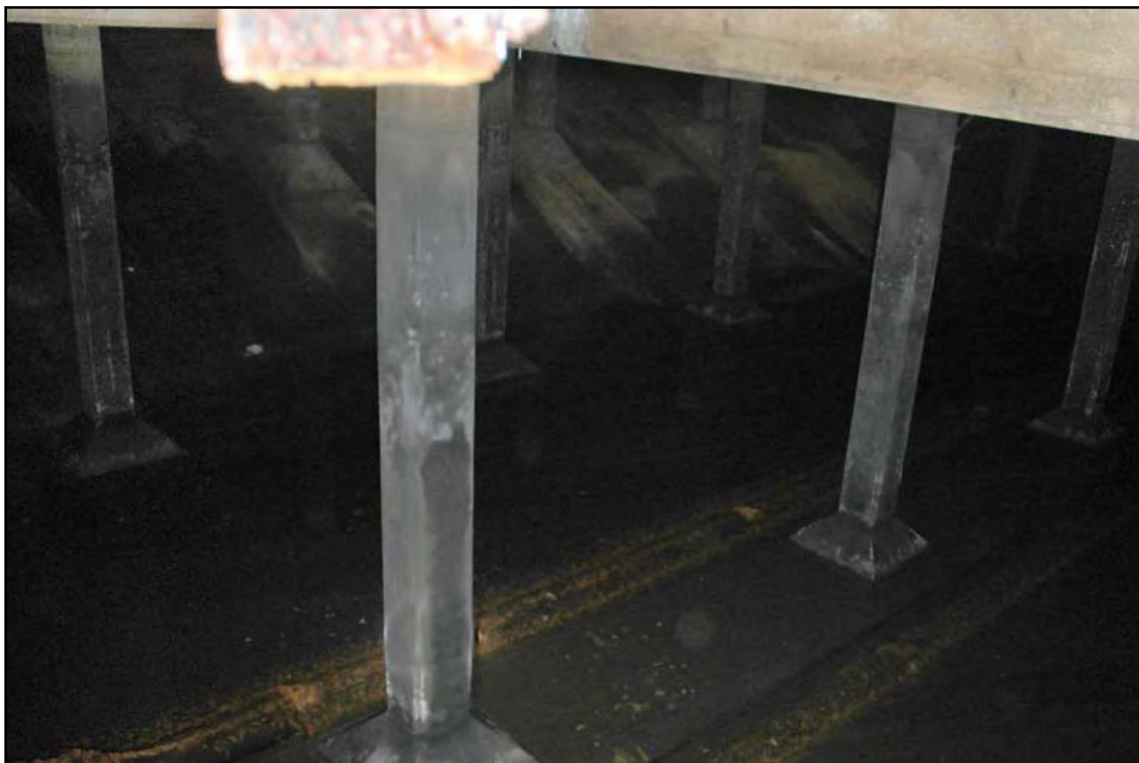
**Plate 20:** General view into reservoir, looking northeast

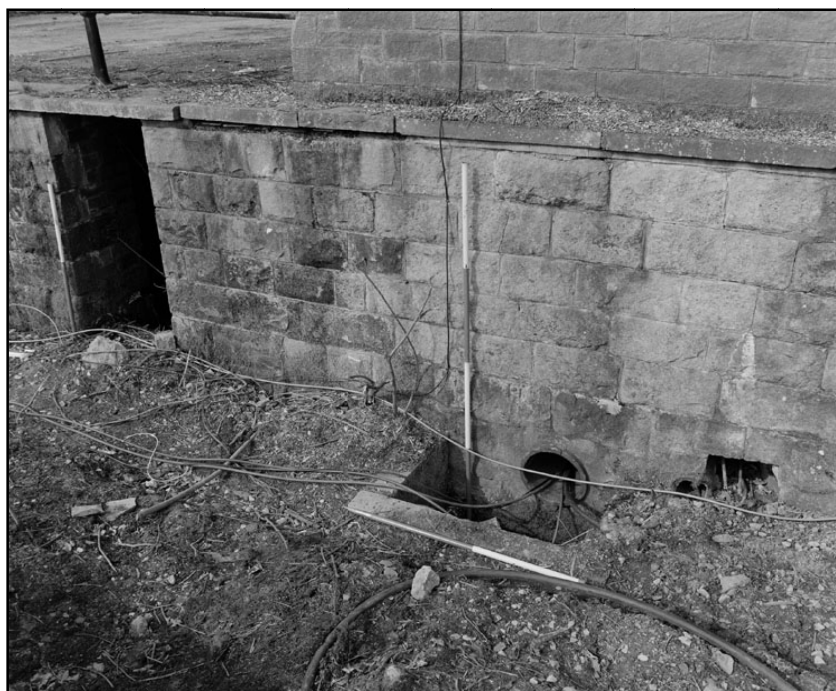
**Plate 21:** Detail of wash-out outlet from filter house; note entrance into generator chamber to left (film 5.09)

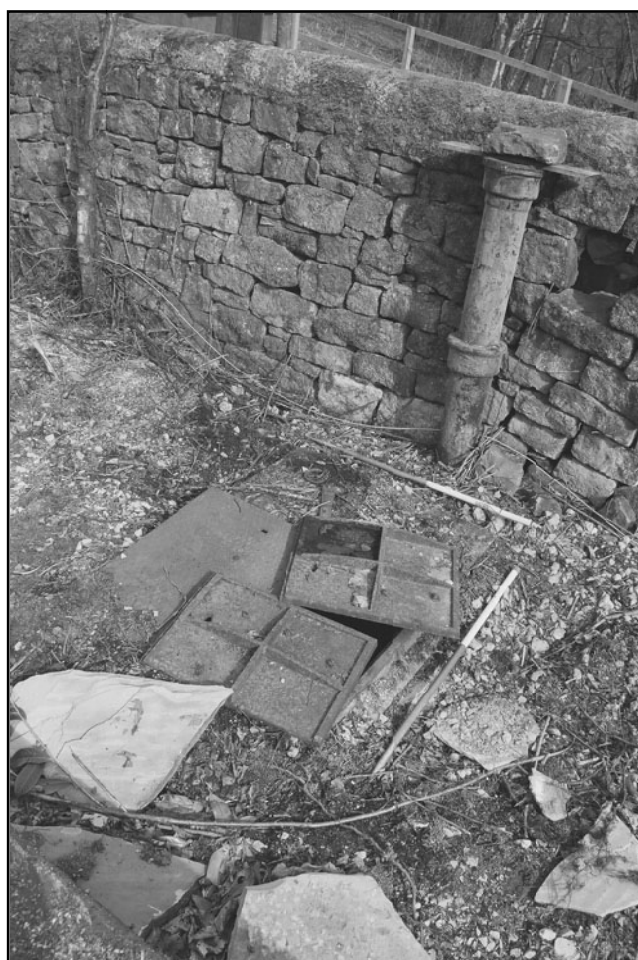
**Plate 22:** Detail of manhole above reservoir outlet to east (film 1.18)

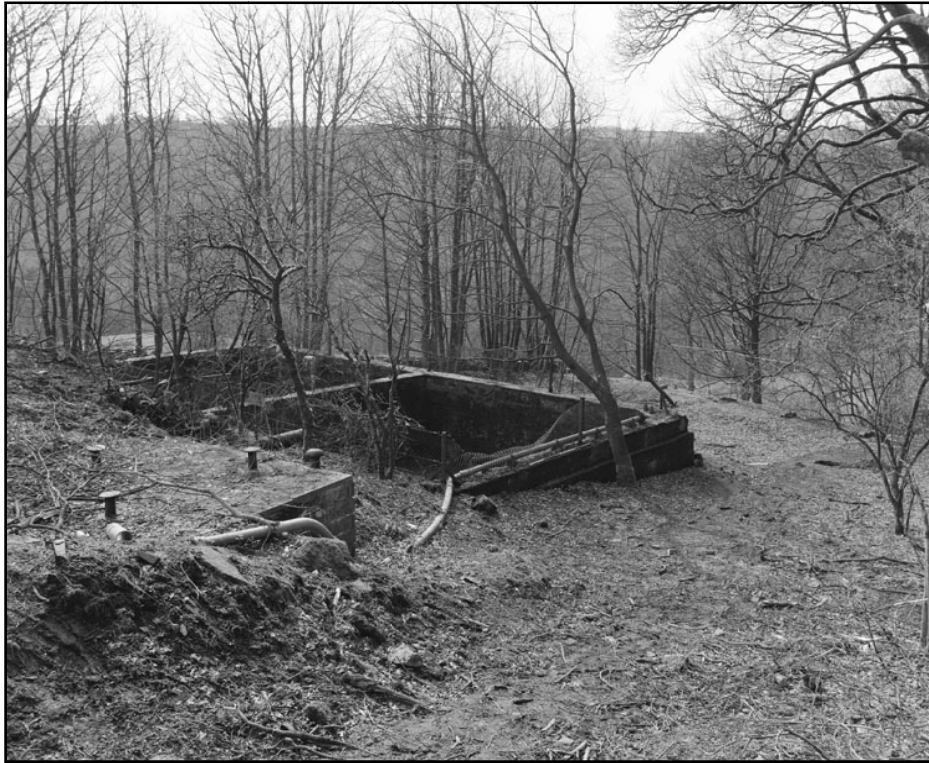
**Plate 23:** General view of concrete settling tanks, looking southwest (film 4.01)

Located west of the reservoir, down the hill, were two open shuttered concrete tanks (**Plate 23-24**). On the eastern side of each tank was a cast iron inlet pipe (**Plates 25-26**), ladder, and a modern plastic stench pipe (**Plate 27**). To the southern side of the tanks was a concrete inspection shaft with iron cover (**Plate 28**). Between the two concrete tanks and the reservoir was a concrete structure, probably a water tank, of unknown function (**Plate 29**). Situated to the south of the concrete tanks was a depression was a large rectilinear earthwork feature of unknown function (**Plate 30**).

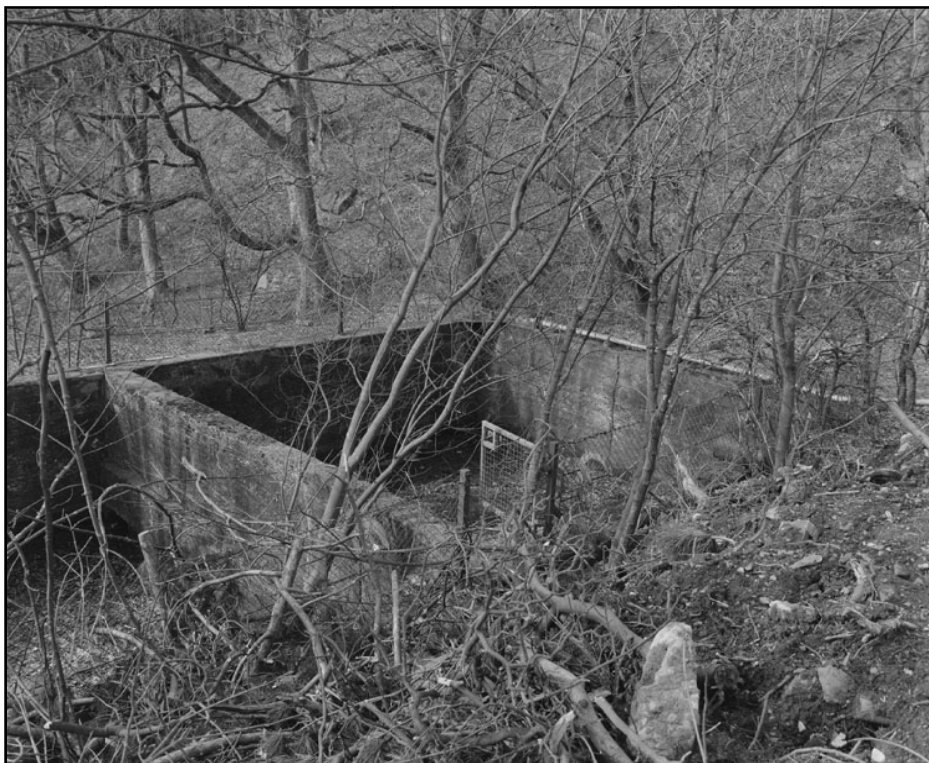
**Plate 24:** General view of concrete settling tanks, looking west (film 4.03)

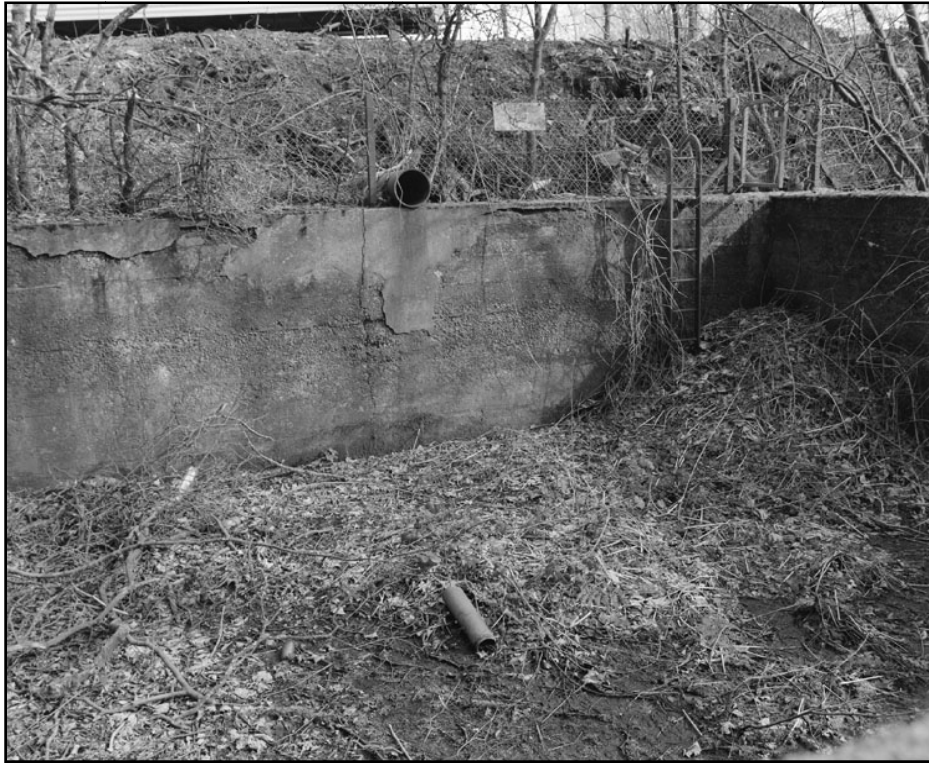
**Plate 25:** General view of inlet pipe and ladder on east wall of north tank (film 4.07)

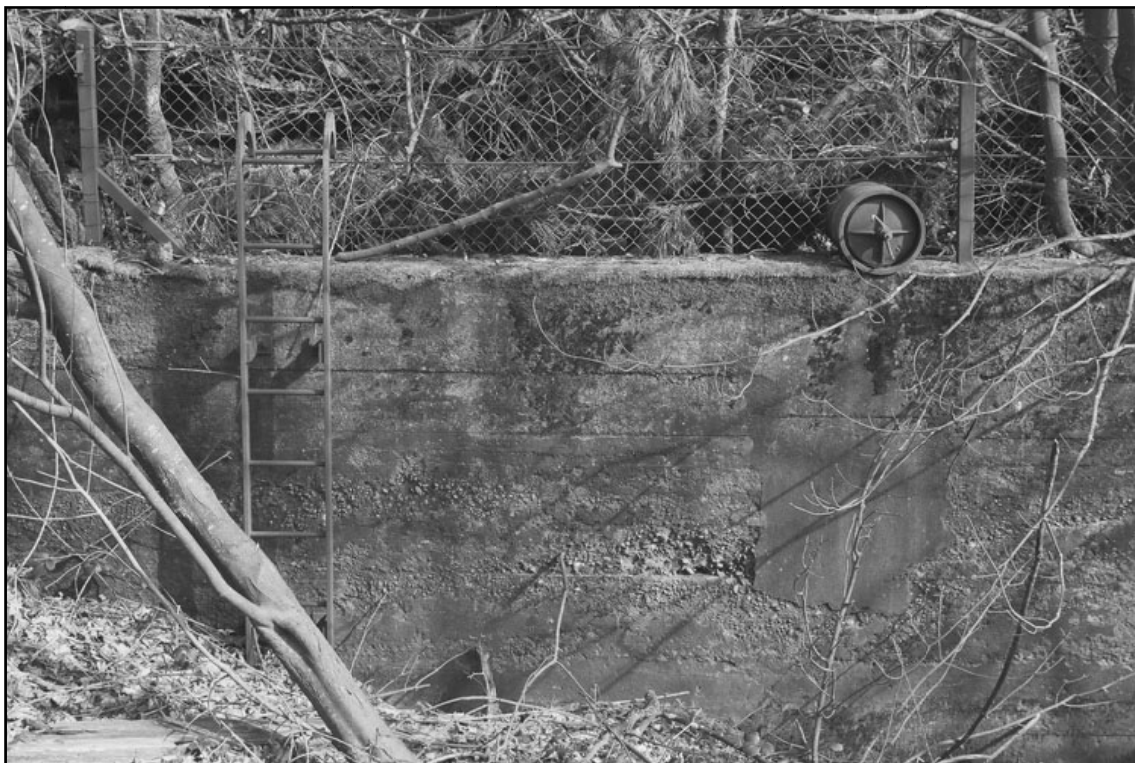
**Plate 26:** Detail of inlet pipe and ladder on east wall of south tank (film 1.23)

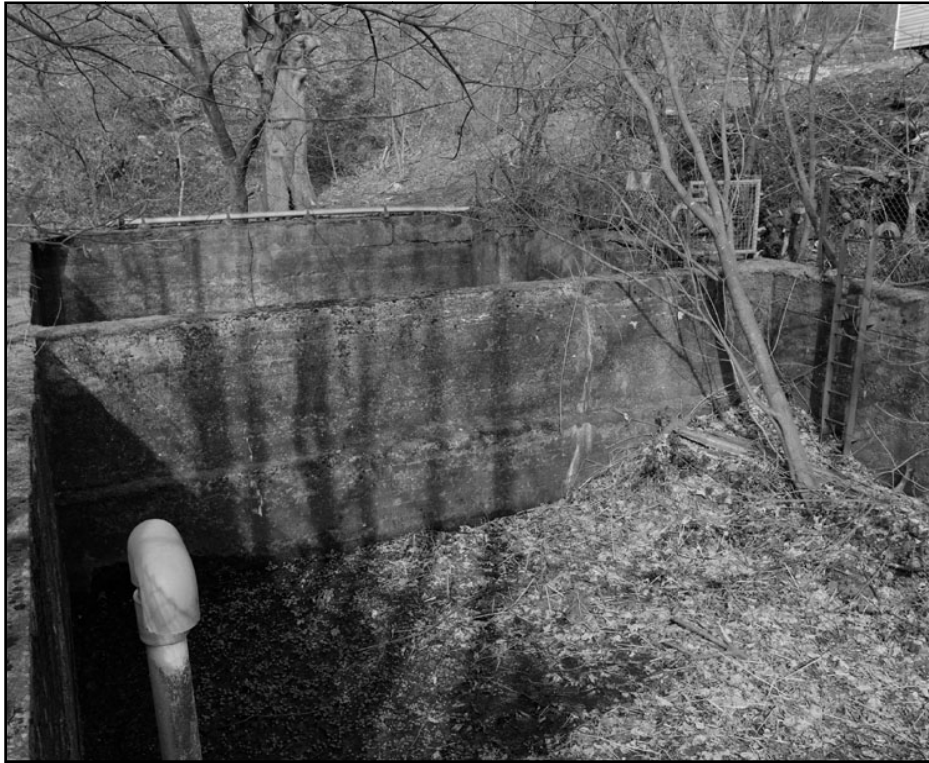
**Plate 27:** General view of settling tanks looking north; note pipe in left corner (film 4.05)

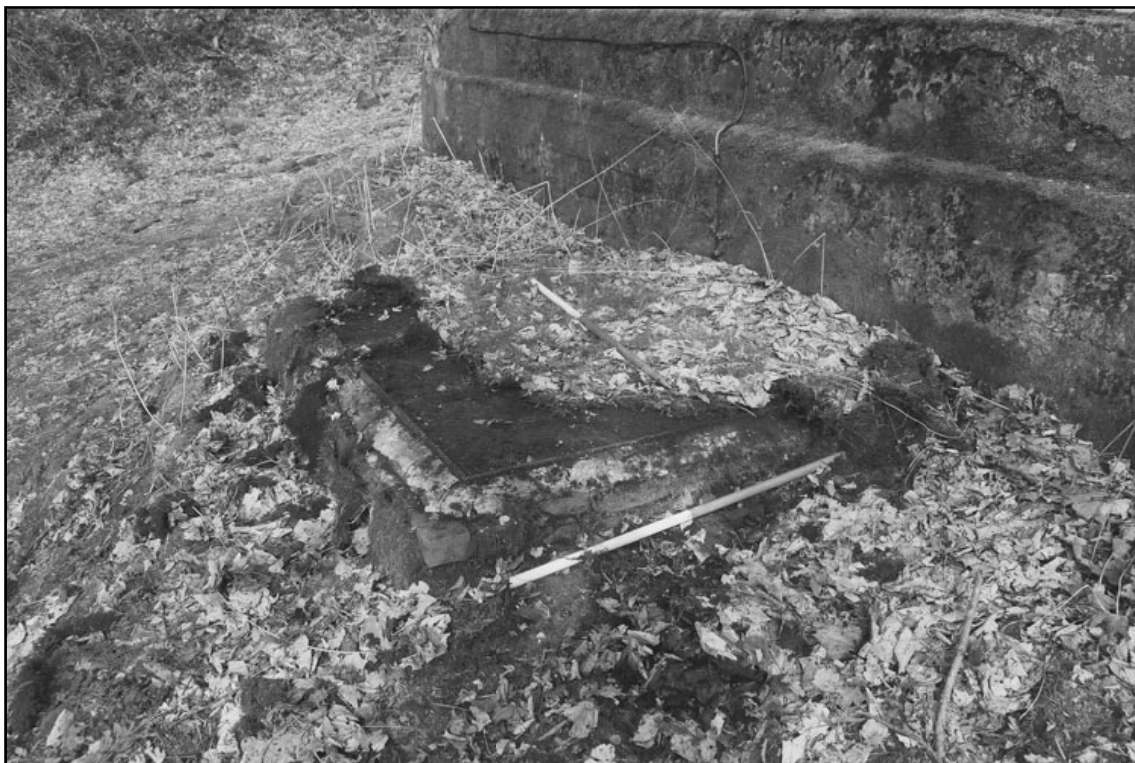
**Plate 28:** Detail of manhole to west of settling tanks (film 1.25)
