## **Hallin Hall SRE, Hebden Bridge**

Historic Building Recording

ARCUS report 1275.1(1)

# Hallin Hall SRE, Hebden Bridge, West Yorkshire

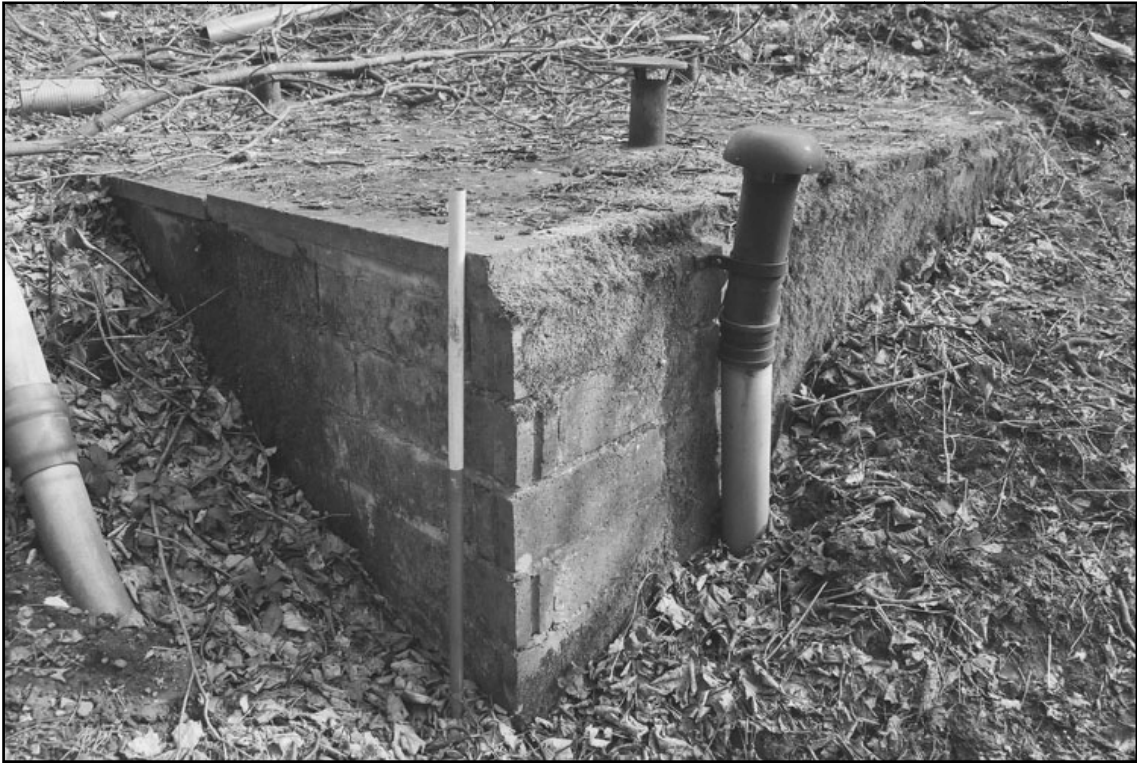
**Plate 29:** Detail of concrete structure northeast of settling tanks (film 1.26)

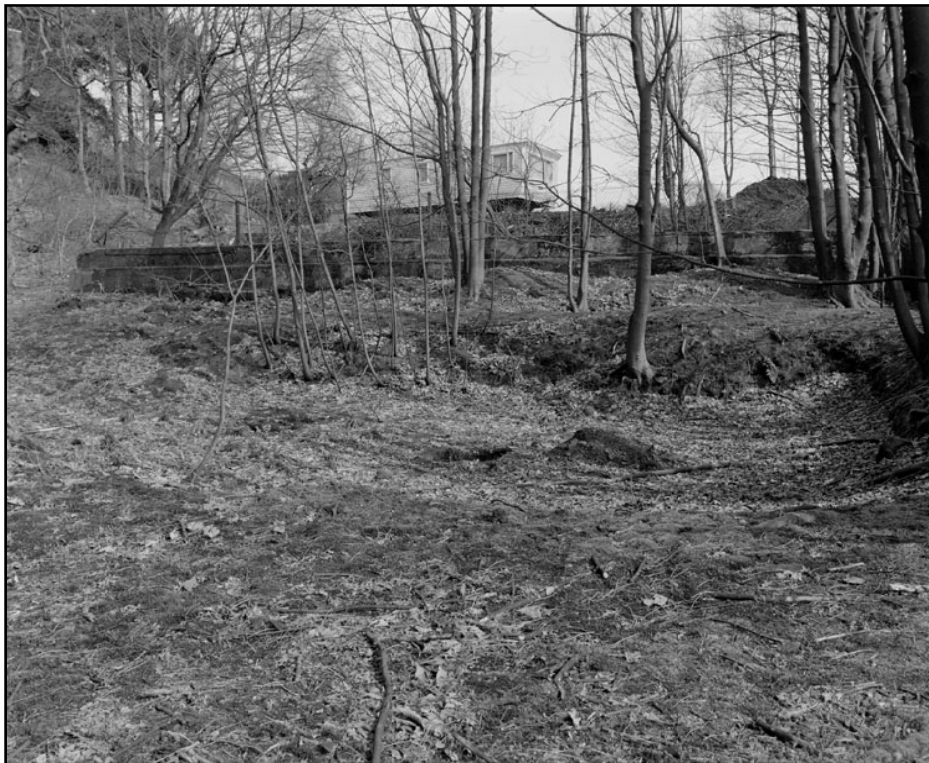
**Plate 30:** General view of depression to west of settling tanks (film 4.09)

Located west of the reservoir, down the hill, were two open shuttered concrete tanks (**Plate 23-24**). On the eastern side of each tank was a cast iron inlet pipe (**Plates 25-26**), ladder, and a modern plastic stench pipe (**Plate 27**). To the southern side of the tanks was a concrete inspection shaft with iron cover (**Plate 28**). Between the two concrete tanks and the reservoir was a concrete structure, probably a water tank, of unknown function (**Plate 29**). Situated to the south of the concrete tanks was a depression was a large rectilinear earthwork feature of unknown function (**Plate 30**).

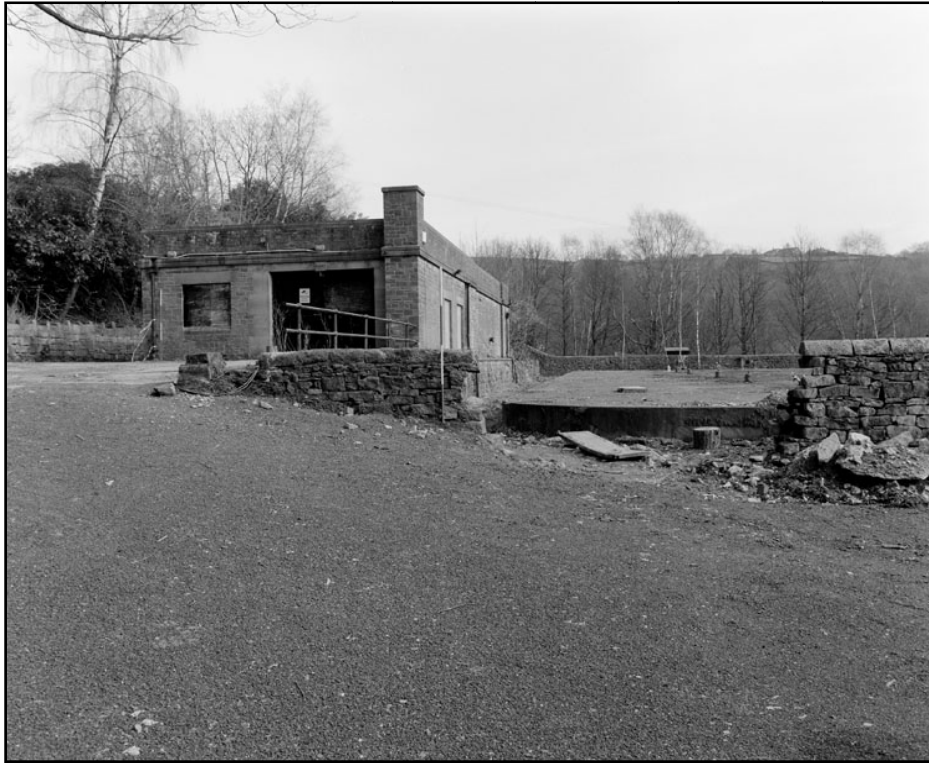
**Plate 31:** General view of filter house to north of reservoir, looking northeast (film 3.09)

The water treatment works was a stone clad single storey rectangular structure, measuring 24.2 x 8.9 (79'6" x 29'), with a flat roof surrounded by a parapet (**Plate 31**)

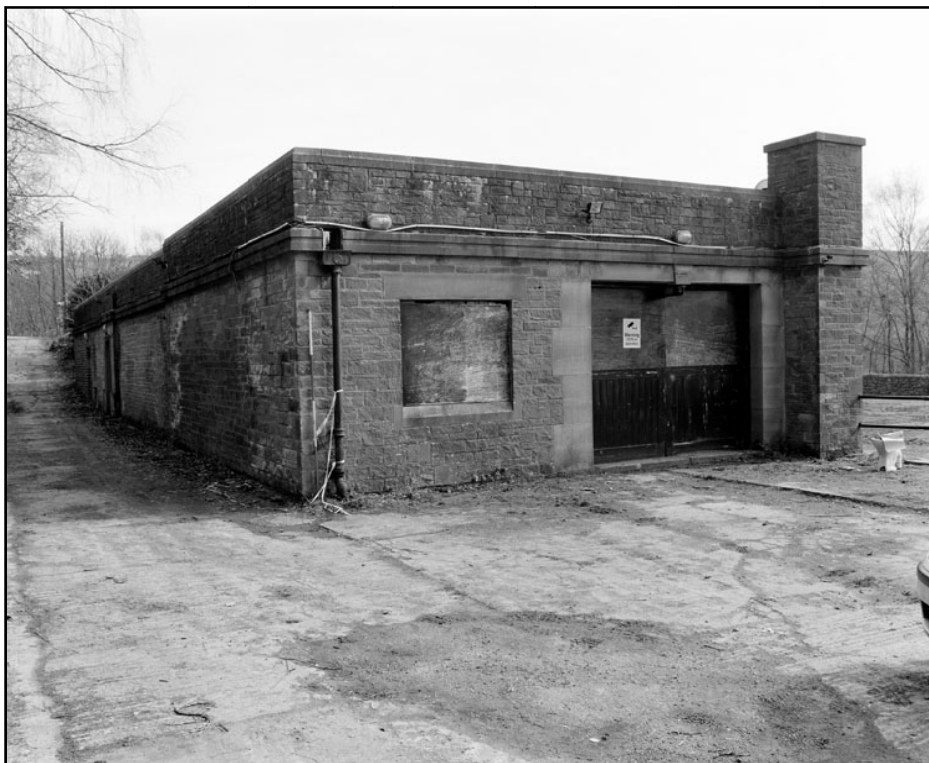
**Plate 32:** General view of north and west elevations of filter house; note continuous string course (film 3.03)

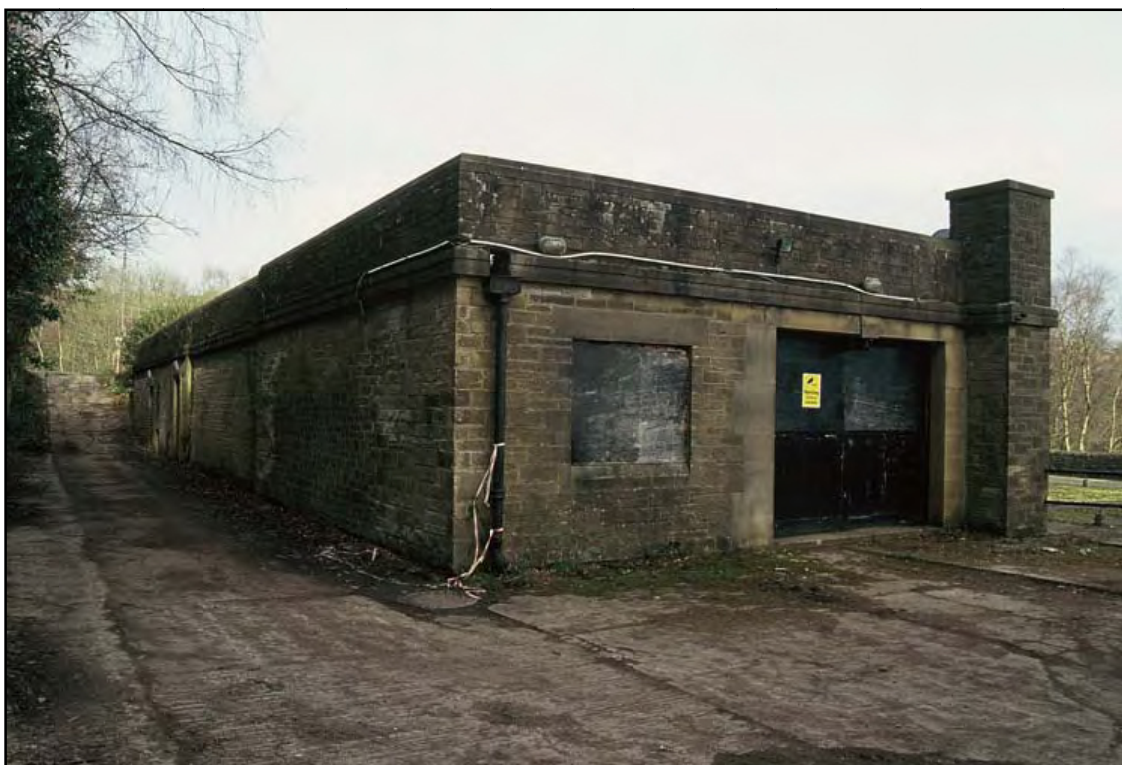
**Plate 33:** General view of north and west elevations of filter house (slide 23)

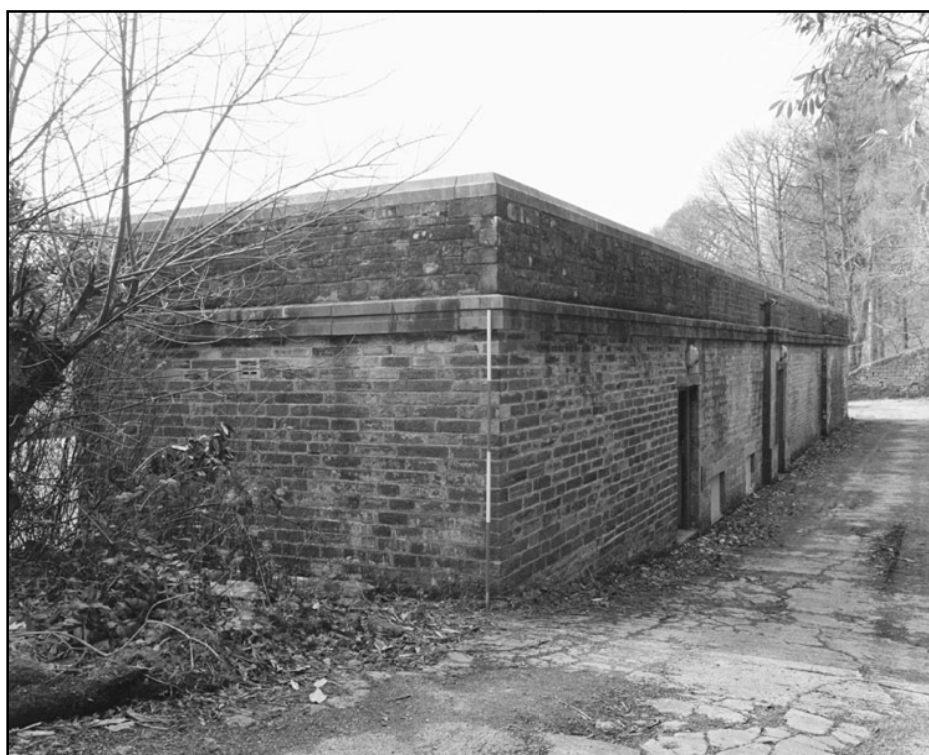
**Plate 34:** General view of north elevation and eastern elevation of extension (film 2.05)

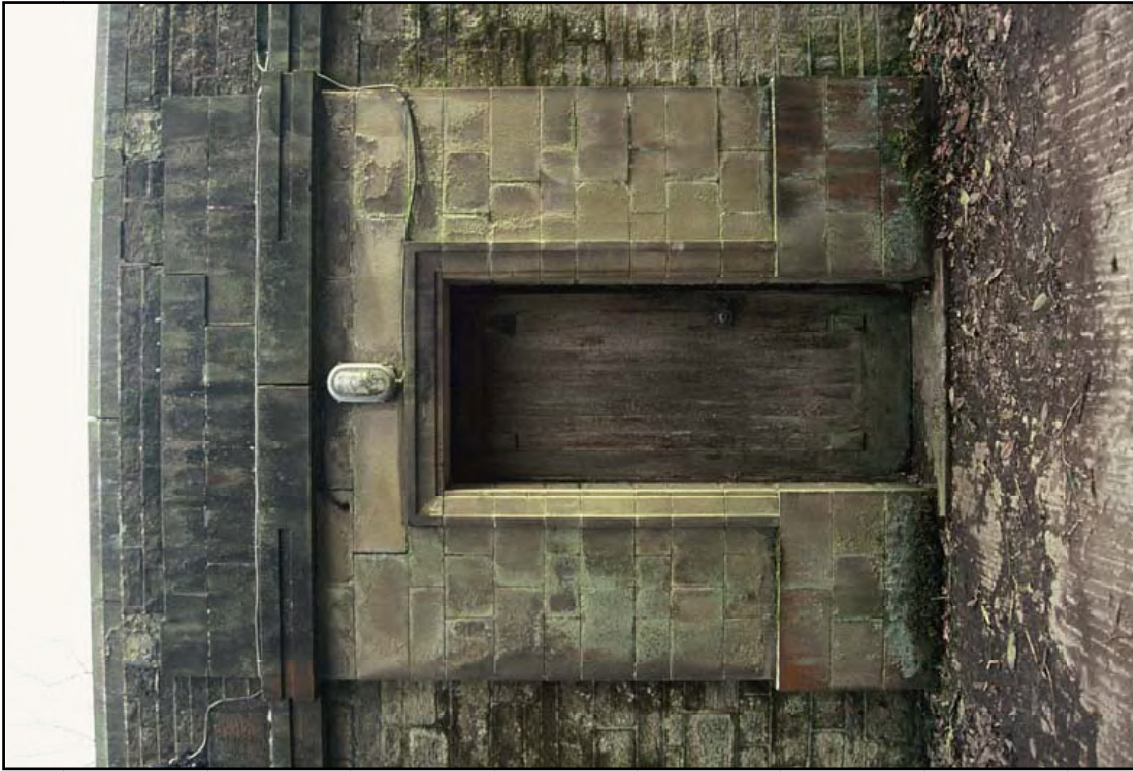
**Plate 35:** Detail of main entrance in north elevation  
(slide 25)

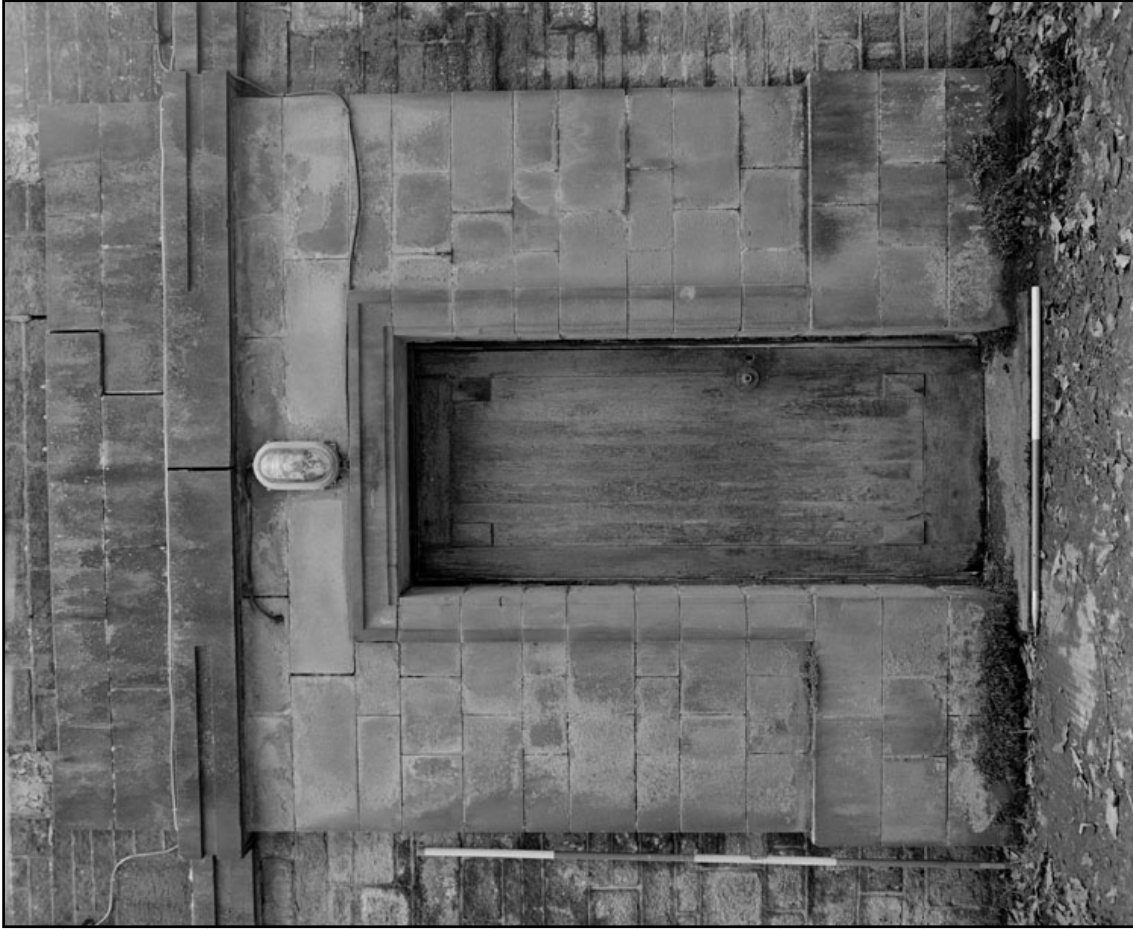
**Plate 36:** Detail of main entrance in north elevation (film 3.02)

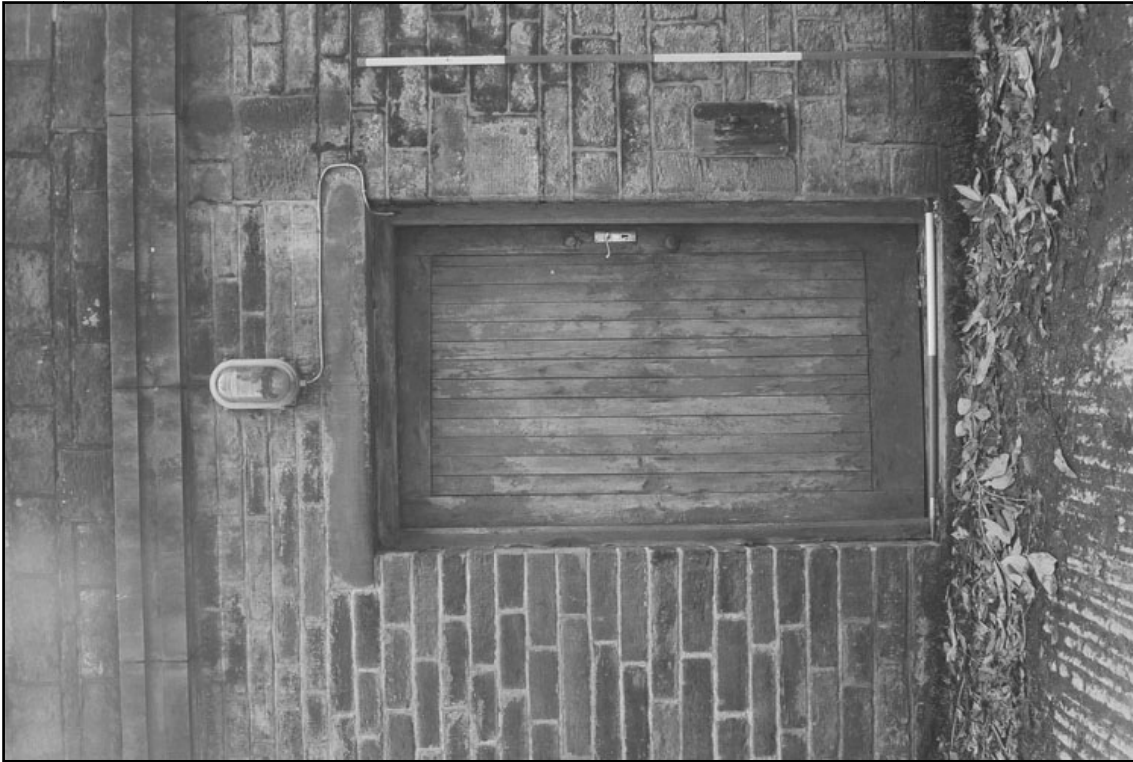
**Plate 37:** Detail of door in northern wall of east extension (film 1.32)

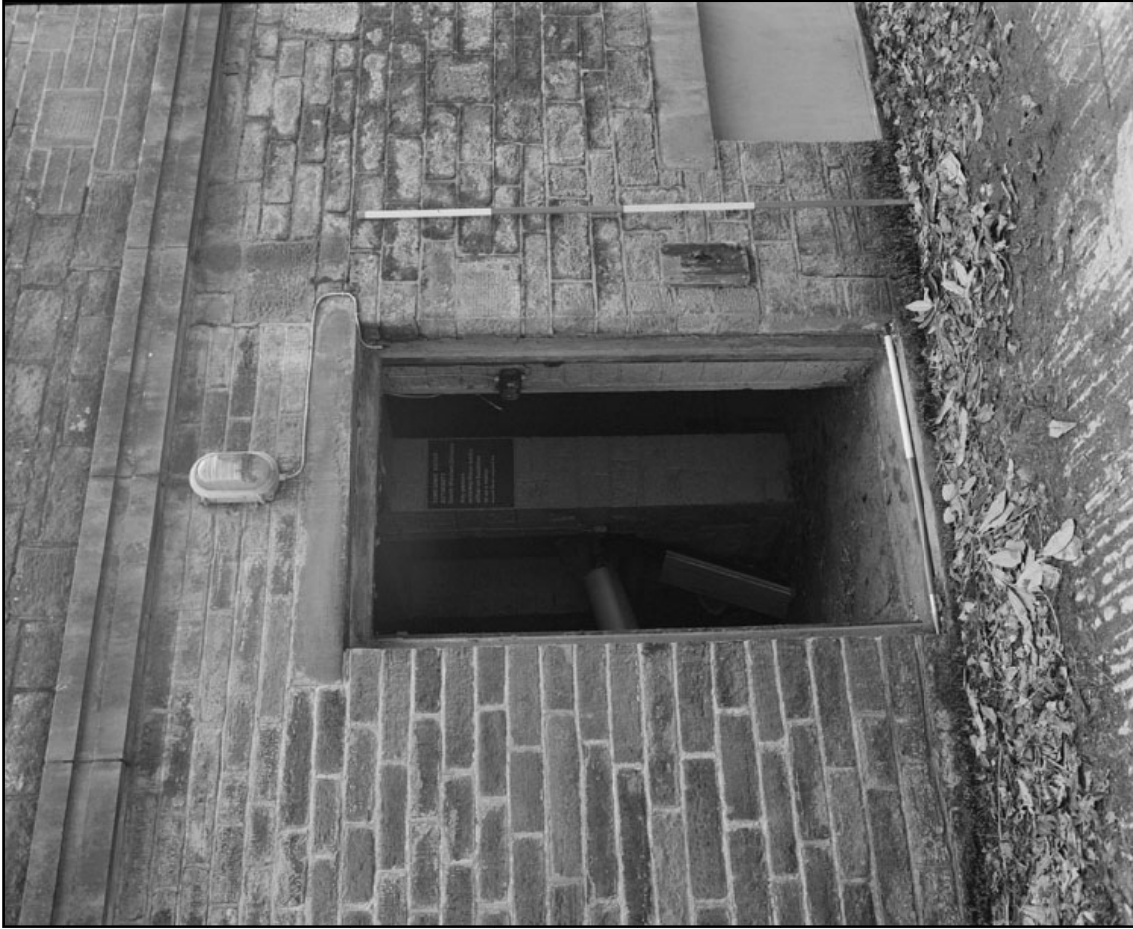
**Plate 38:** Detail of doorway in northern wall of east extension (film 2.09)

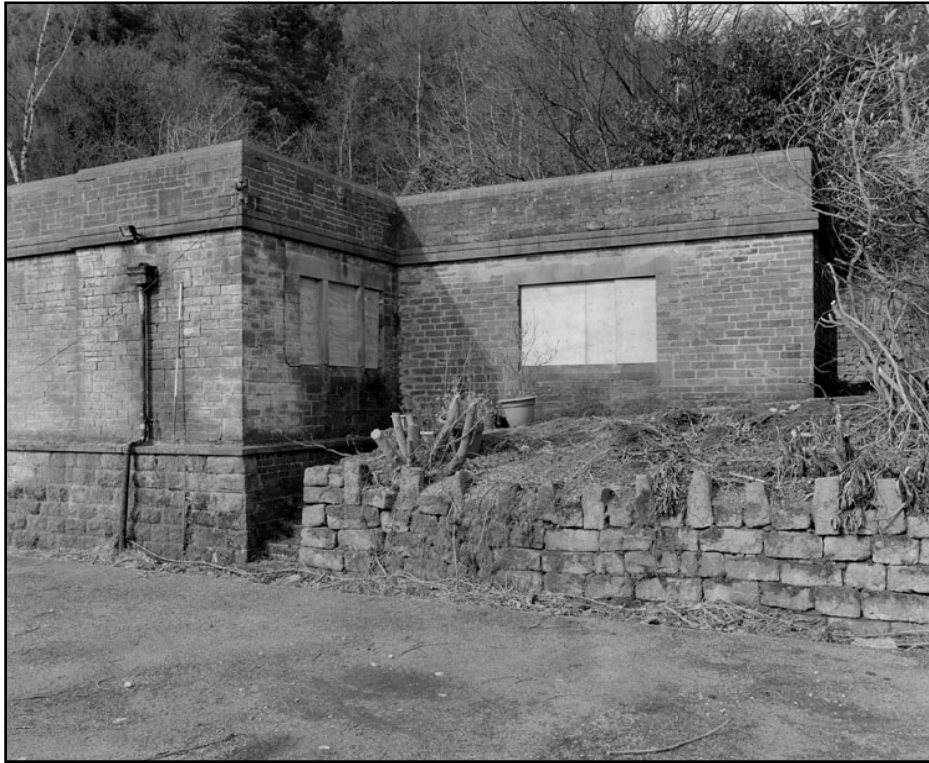
**Plate 39:** General view of east elevation; note window in south elevation of extension (film 5.05)

Extending from the east elevation was a later offshoot extension running adjacent to the track, with a wide rectangular timber framed window with chamfered stone sill and lintel in its southern elevation (**Plate 39**). Within the southern half of the original elevation, still visible from the exterior, was a wide rectangular window with two stone mullions, a stone lintel, and a chamfered stone sill (**Plate 40**). Running down this elevation from the track to the reservoir was a footpath, with stone steps along its southern extent (**Plate 41**).

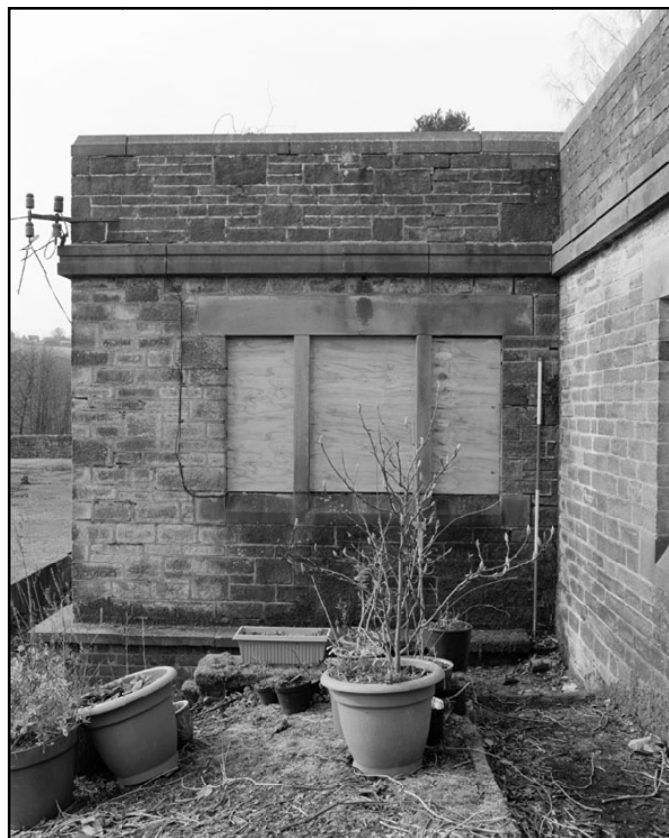
**Plate 40:** Detail of window in east elevation of filter house (film 2.07)

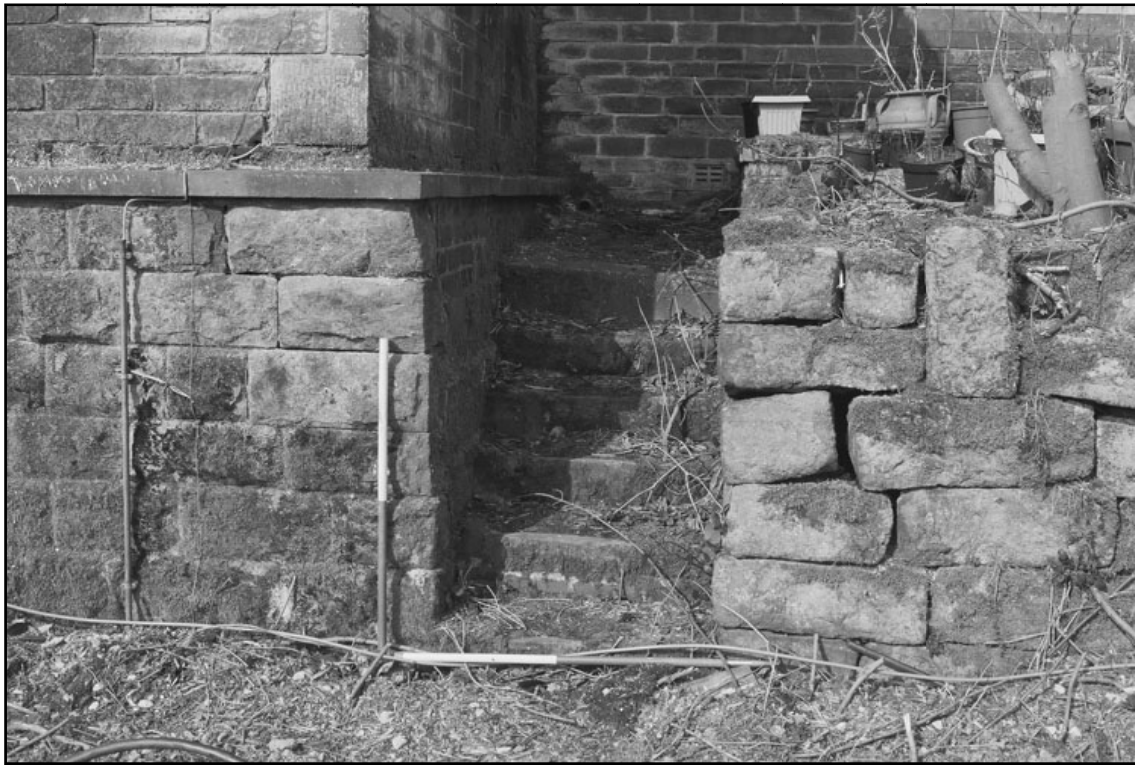
**Plate 41:** Detail of stone staircase adjacent to east elevation of filter house (film 1.14)

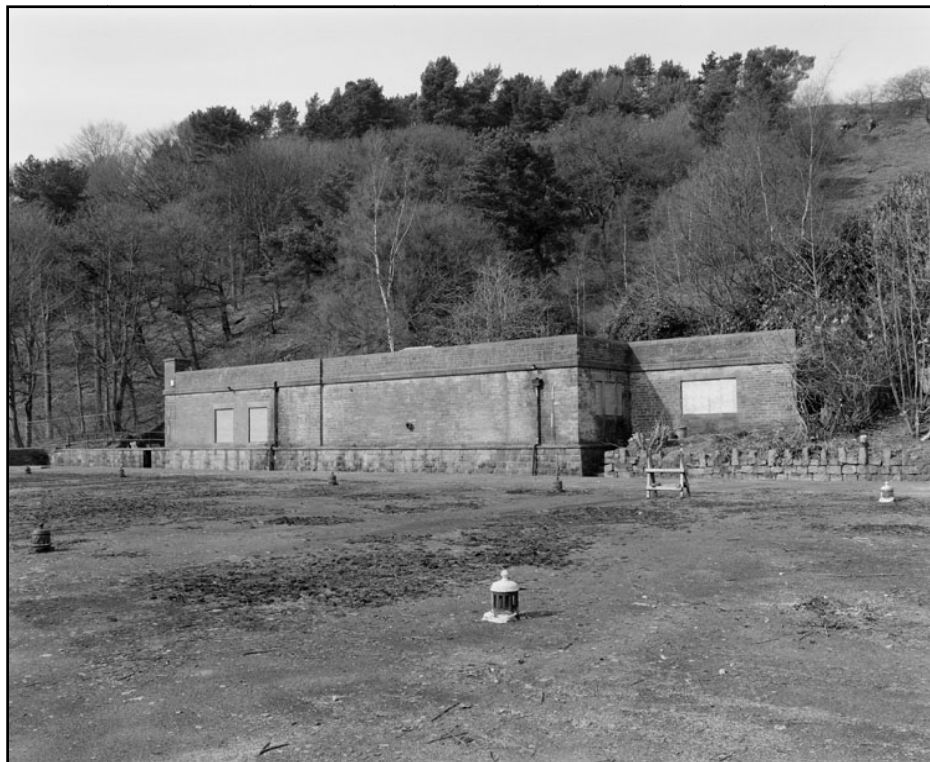
**Plate 42:** General view of south elevation of filter house (film 5.03)

The southern elevation had few features beside two windows towards the western end of the elevation (**Plates 42-43**) and a truncated pipe in the centre (**Plate 44**). Abutting the bottom of the wall was a stone wall built of a rougher stone with level coping.

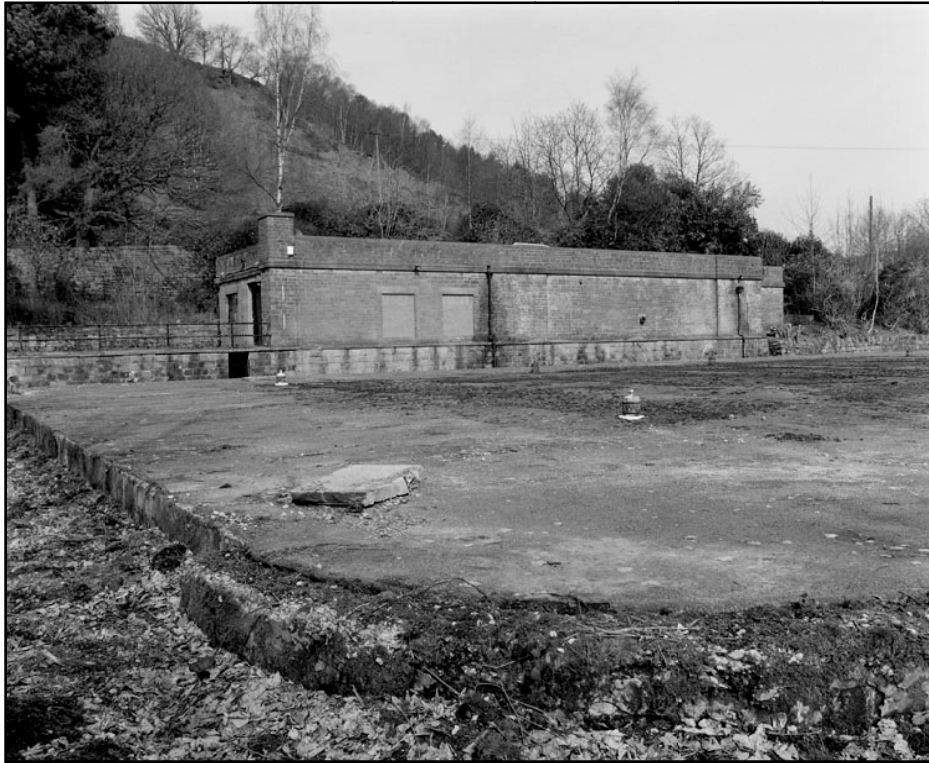
**Plate 43:** General view of south elevation of filter house (film 5.01)

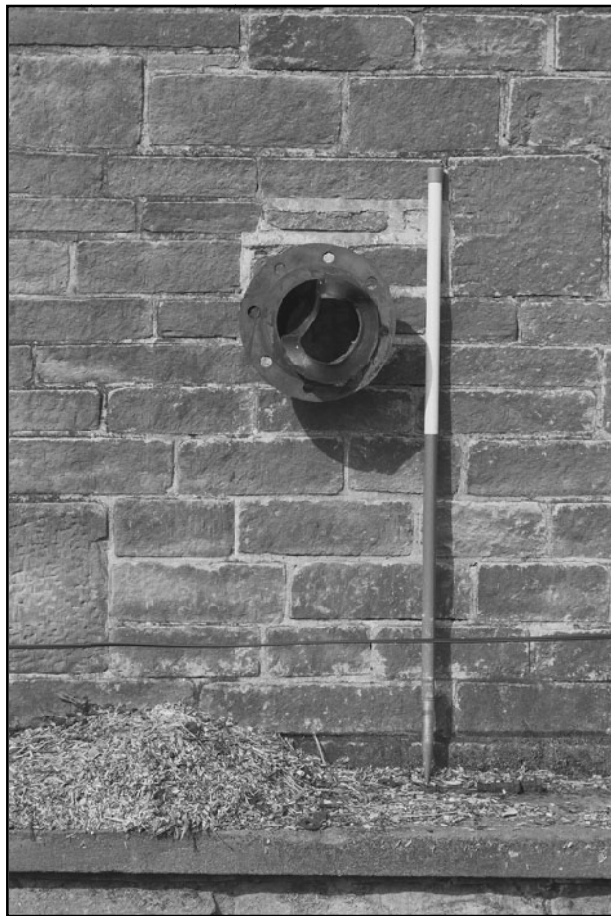
**Plate 44:** Detail of truncated pipe within south elevation of filter house (film 1.12)

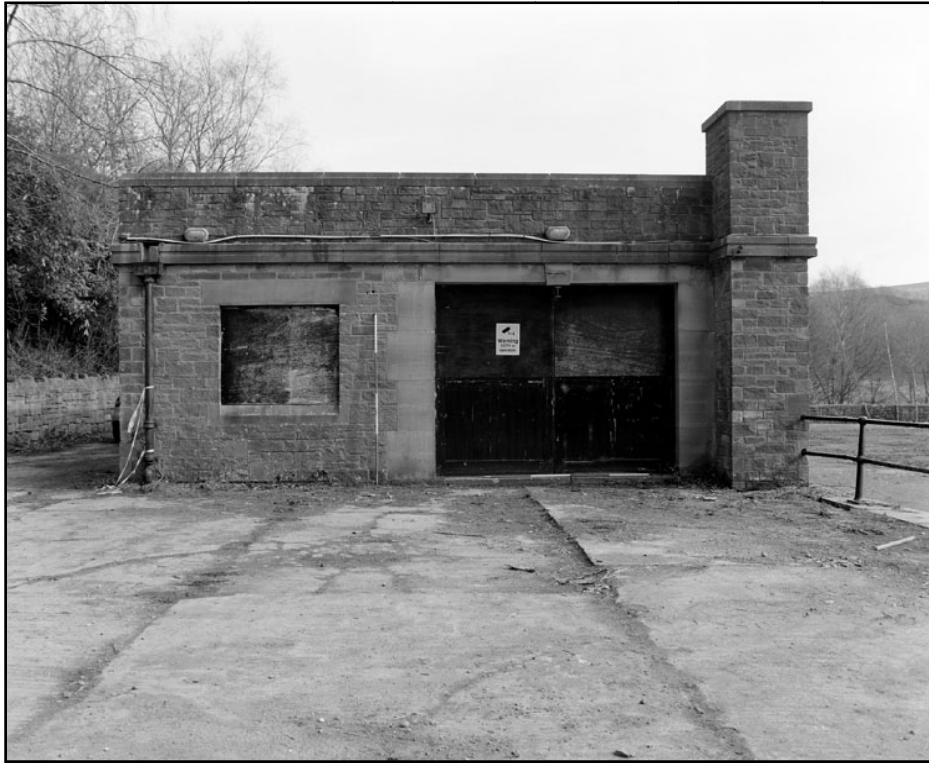
**Plate 45:** Detail of west elevation of filter house (film 3.08)

The west elevation faced onto a concrete paved yard (**Plate 45**). On the southern end of the elevation was a large chimney stack matching the architectural style of the rest of the structure, to the northern end there was a window with stone lintel and chamfered stone sill, and between them there was a double timber door with sandstone jambs and lintel with prominent imitation voussoir. To the north of the window was a cast iron downpipe with a hopper ornamented with a rose emblem (**Plate 46**).

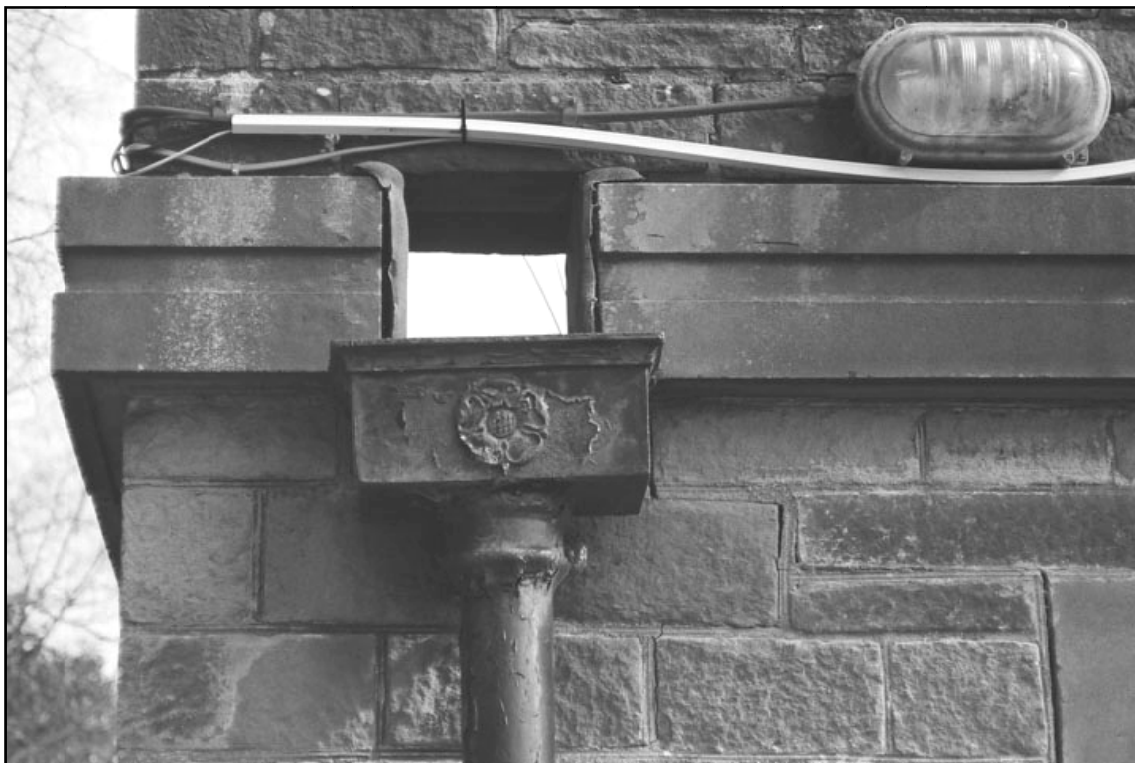
**Plate 46:** Detail of cast iron hopper on west elevation of filter house (film 1.30)

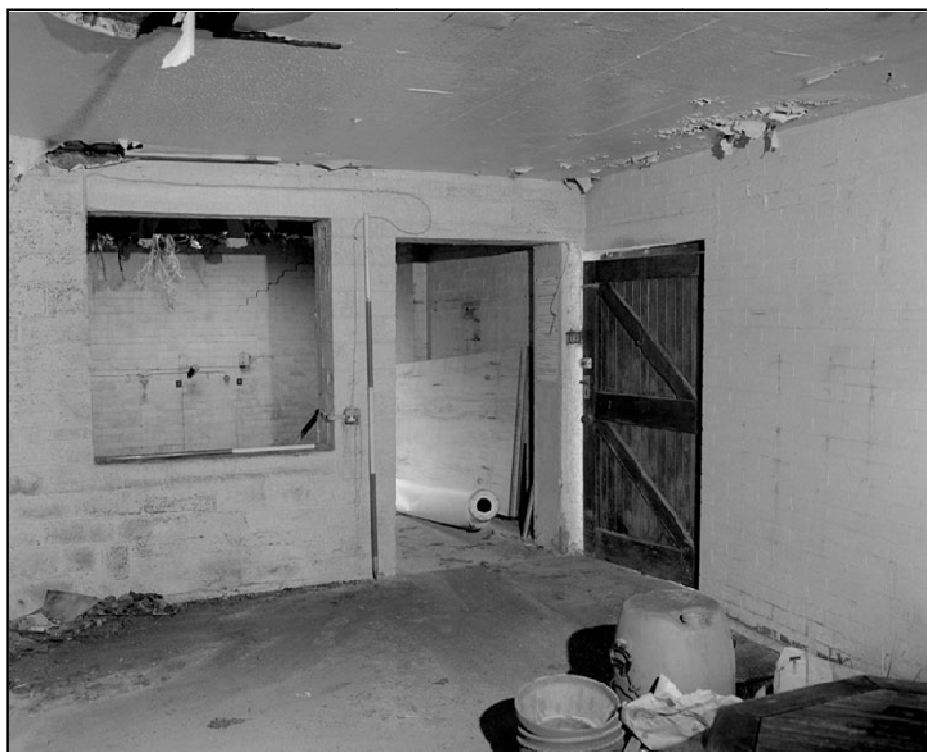
**Plate 47:** General view of room 1 looking west; note inserted doorway in stone faced wall (film 7.06)

Room 1 was a rectangular extension at the east of end of the original building, measuring 5.95 x 3.7m (19'6" x 12') (**Plates 47-48**). The internal walls consisted of brick to the north, south and east and the stone facing of the former eastern elevation of the filter house to the west. A door and window had been inserted within the western wall (**Plate 47**), divided by a brick pier, and replacing an original window that had been similar to that in the eastern wall of room 3, for which a rubbed brick lintel was still visible above the inserted openings. Fixed to either jamb of the inserted door were two recent (c1980s) perspex signs indicating that access was at the bequest of Yorkshire Water Authority (**Plate 49**), and detailing safety procedures in the event of leakages (**Plate 50**). Within the southern wall was a timber framed

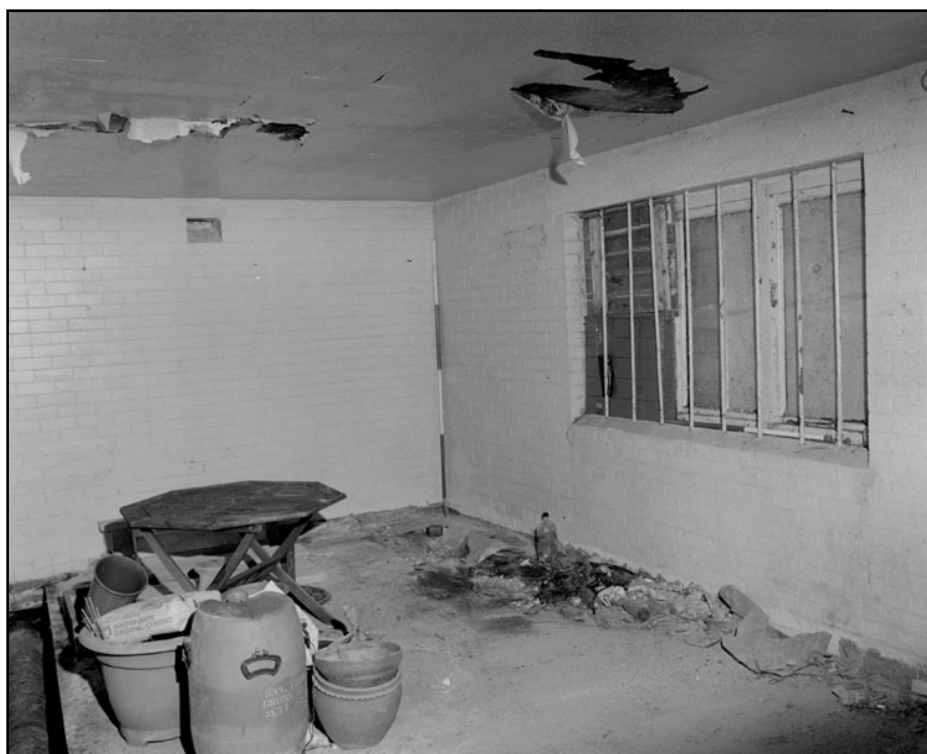
**Plate 48:** General view of room 1 looking east (film 7.07)

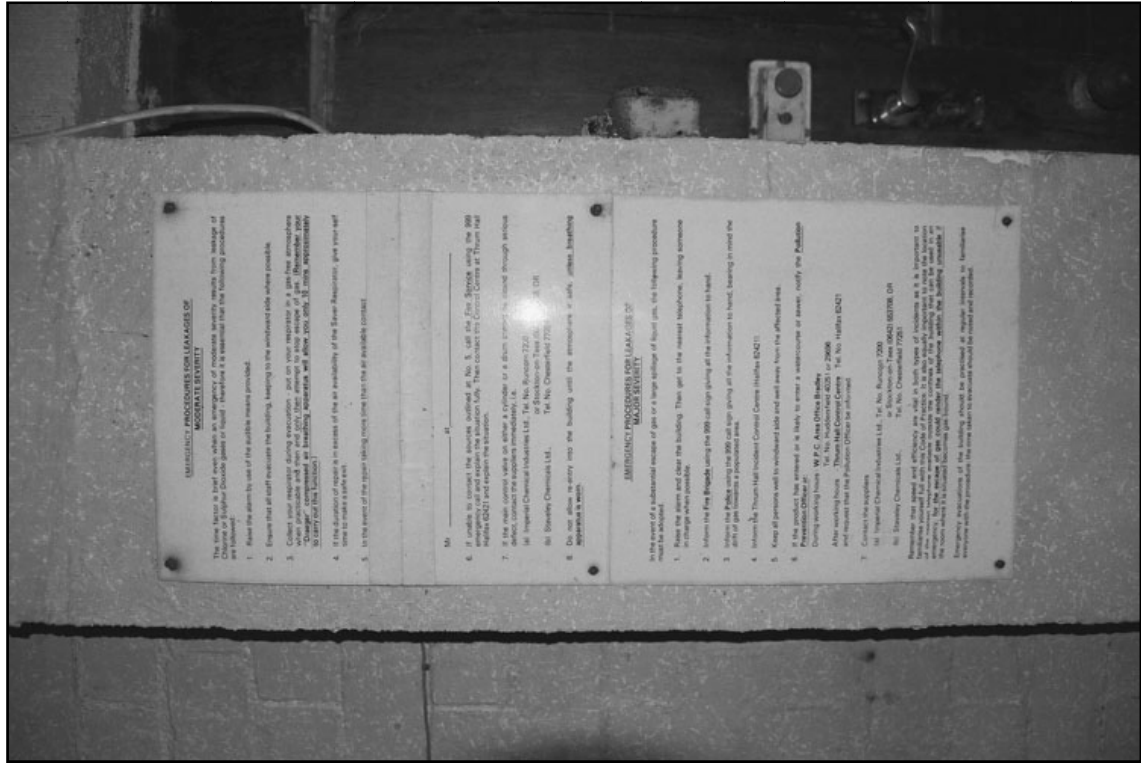
**Plate 50:** Detail of sign on north jamb of inserted door in room 1 (film 6.27)

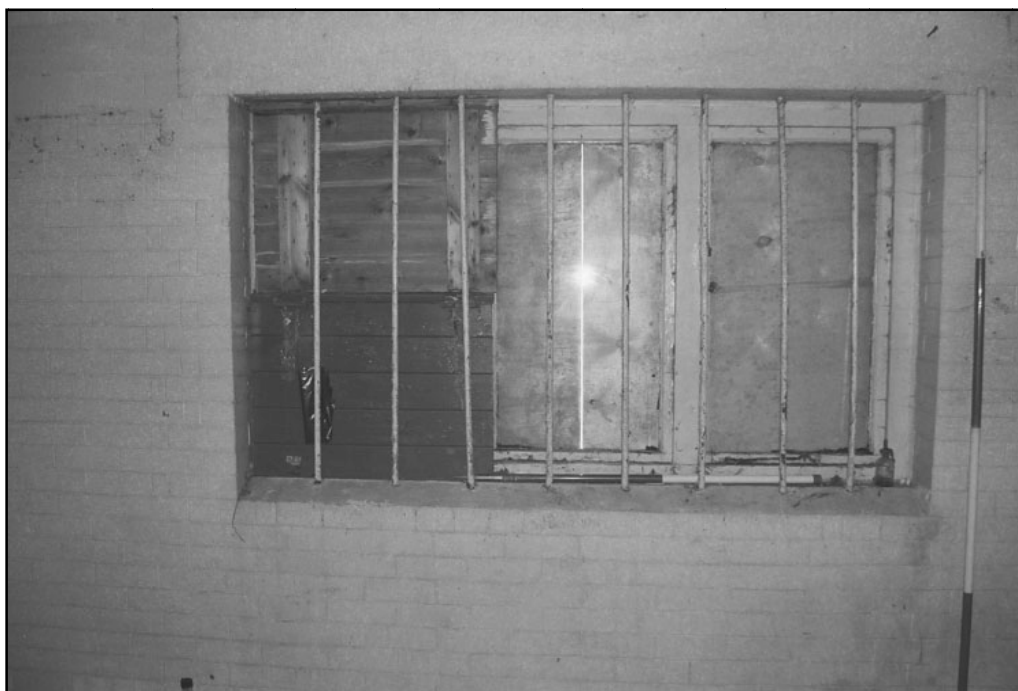
**Plate 51:** Detail of window in south wall of room 1 (film 6.34)

window with concrete lintel and sill divided horizontally into three timber casements (**Plate 51**). The casements were hinged to open outward and secured with iron monkey-tail catches. Steel security bars had been inserted on the inside of the window. There were also small high level vents within the north and east walls. The walls were painted white with blue flecks. The concrete floor was elevated compared to the original building where the rooms were built into the slope of the hill rather than on it, as in room 1. Within the floor was a c30cm deep floor duct along the northern edge of the room with recesses along each side to support a cast iron cover, of which two sections remained to the west (**Plate 52**). Within the duct was a 0.20m (8") cast iron water pipe with bolted flanges, representing the inlet pipe to the filter house from the meter house to the northeast. The ceiling was of shuttered concrete.

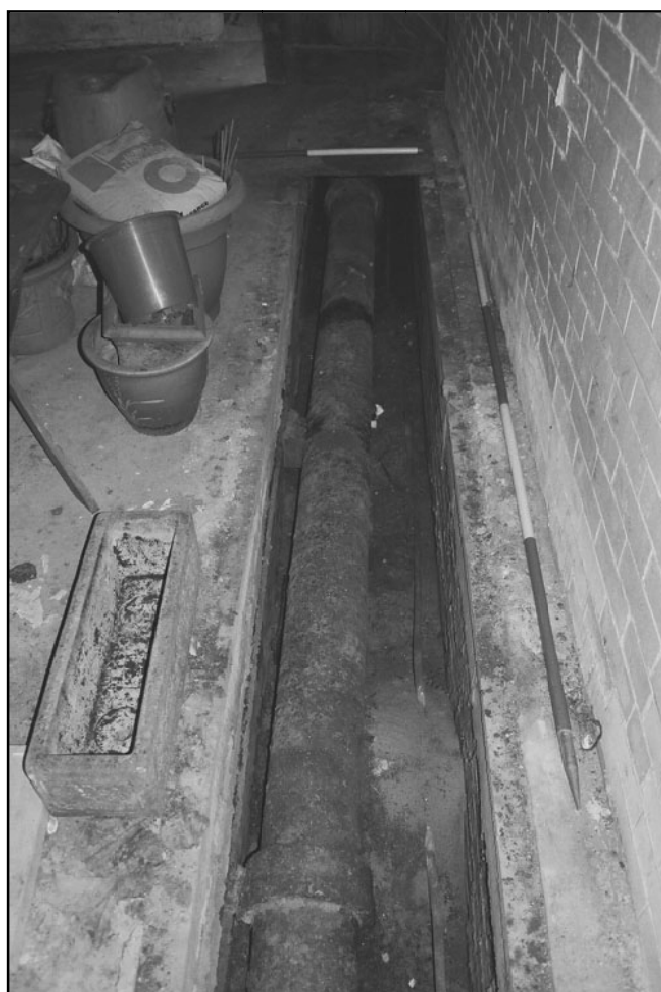
**Plate 52:** Detail of 8" water main inlet within floor of room 1 (film 6.32)

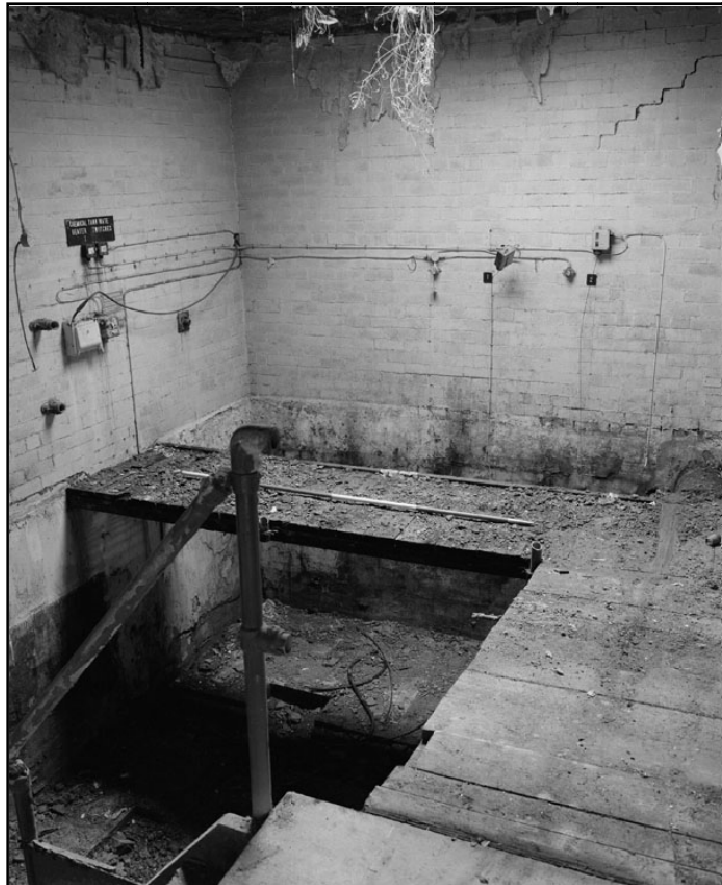
**Plate 53:** General view of room 2 (film 7.09)

Room 2 was within the northeast corner of the original filter house building, measuring 5.50 x 3.95m (18' x 13') (**Plate 53-55**). The walls of the room were brick, thickening by an extra course within the lower 0.91m (3') along the northern and eastern walls. There were two small timber framed two paned fixed windows in the northern wall (**Plate 56**), possessing brick sills and arched brick lintels, and a timber battened door in the southern wall. In the eastern wall the original rubbed brick arch was visible above the later opening (**Plate 57**). A scar in the paintwork adjacent to the door on the southern wall indicated that there had most likely been a cabinet against it (**Plate 58**). The upper walls were painted white with blue flecks, whereas the lower projecting wall was plastered and painted off-white. Due to the elevated level of room 1 a metal staircase and concrete platform supported on a brick pier had been inserted within the northeast corner of room 2 (**Plate 55**). The staircase also provided access to a timber gantry running along the north wall and across the centre of the room supported on a metal frame set into the walls (**Plates 53-54**). Signs and switches on the west and south walls at gantry level indicated that there had been two chemical tanks in the room with electric water heaters (**Plates 59-60**). Within the concrete floor was a duct running north-south beneath the gantry (**Plate 61**) with recessed edges to take a cover, aligned with a valve in the 0.20m (8") cast iron water pipe that continued along the north wall, from room 1, supported on a brick pier (**Plate 62**). The ducting continued beneath the southern wall into room 3. The ceiling was of shuttered reinforced concrete, with a reinforced concrete joist crossing the room from north to south, and a glass block skylight to the west.

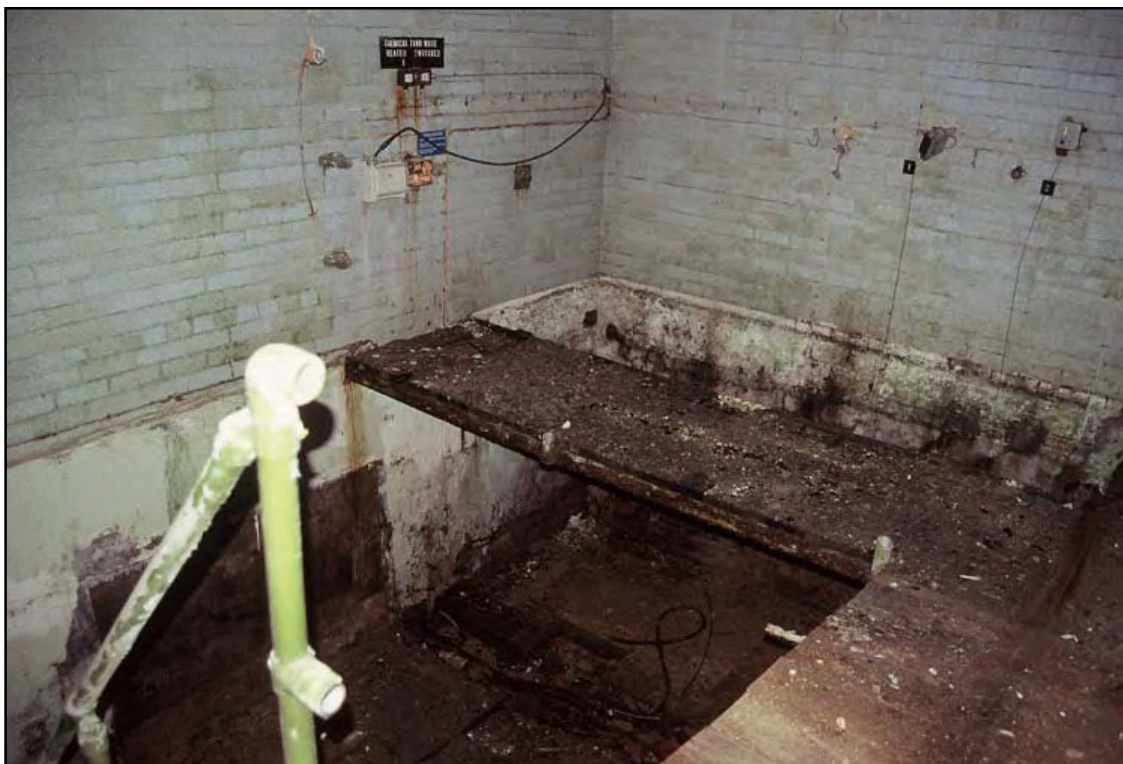
**Plate 54:** General view of room 2 (slide 16)

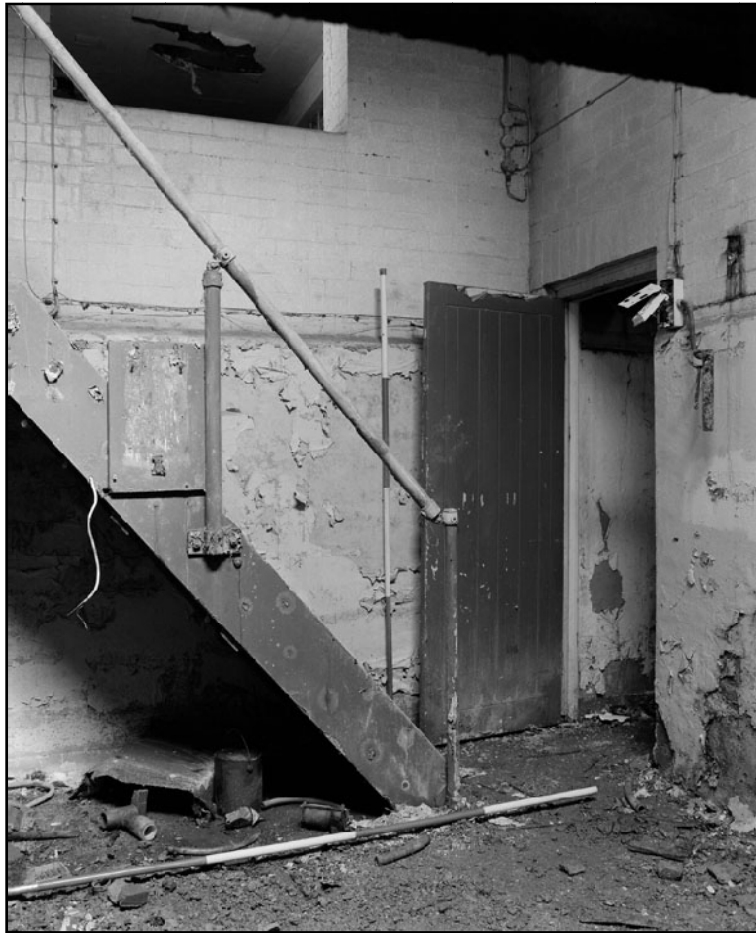
**Plate 55:** General view of room 2; note timber battened door in south wall (film 8.03)

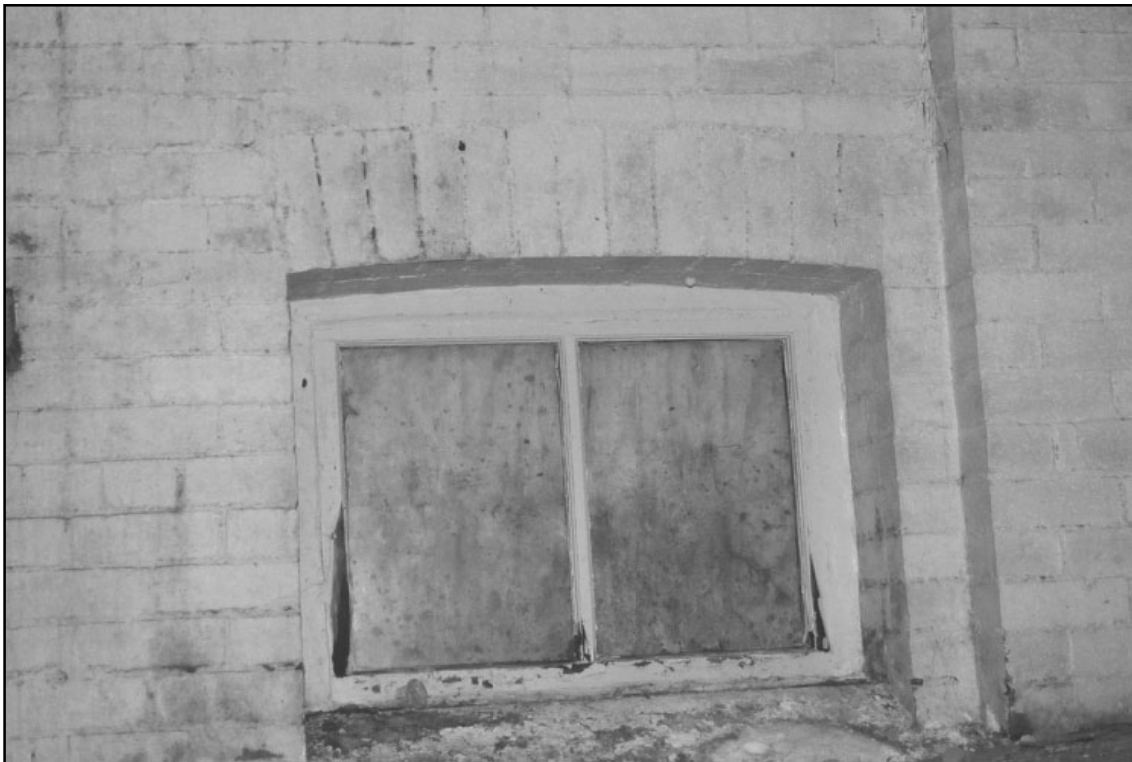
**Plate 56:** Detail of small timber framed window in north wall of room 2 (film 6.24)
