## **Hallin Hall SRE, Hebden Bridge**

Historic Building Recording

ARCUS report 1275.1(1)

# Hallin Hall SRE, Hebden Bridge, West Yorkshire

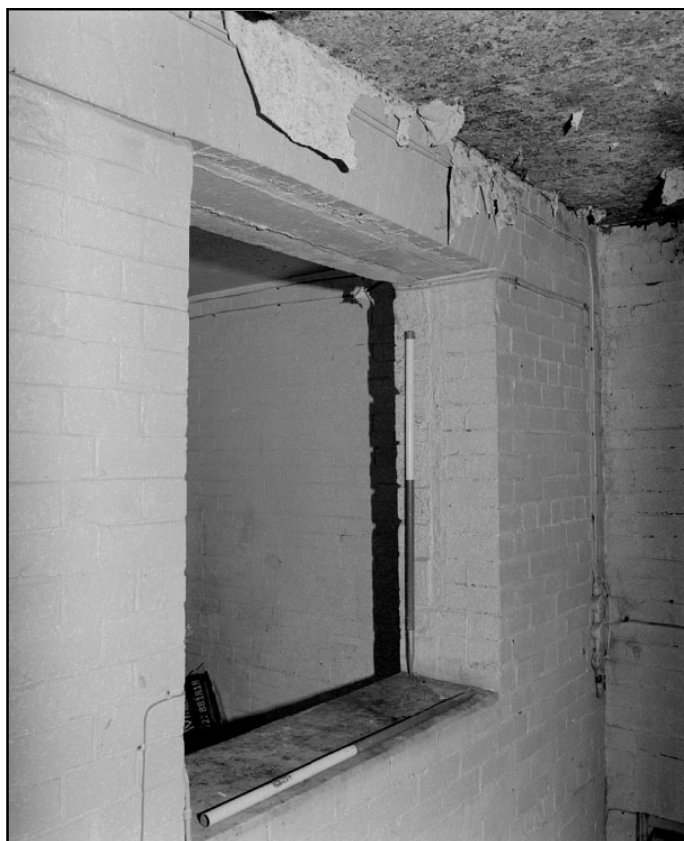
**Plate 57:** General view of window in east wall of room 2; note rubbed brick arch above from original larger window (film 8.02)

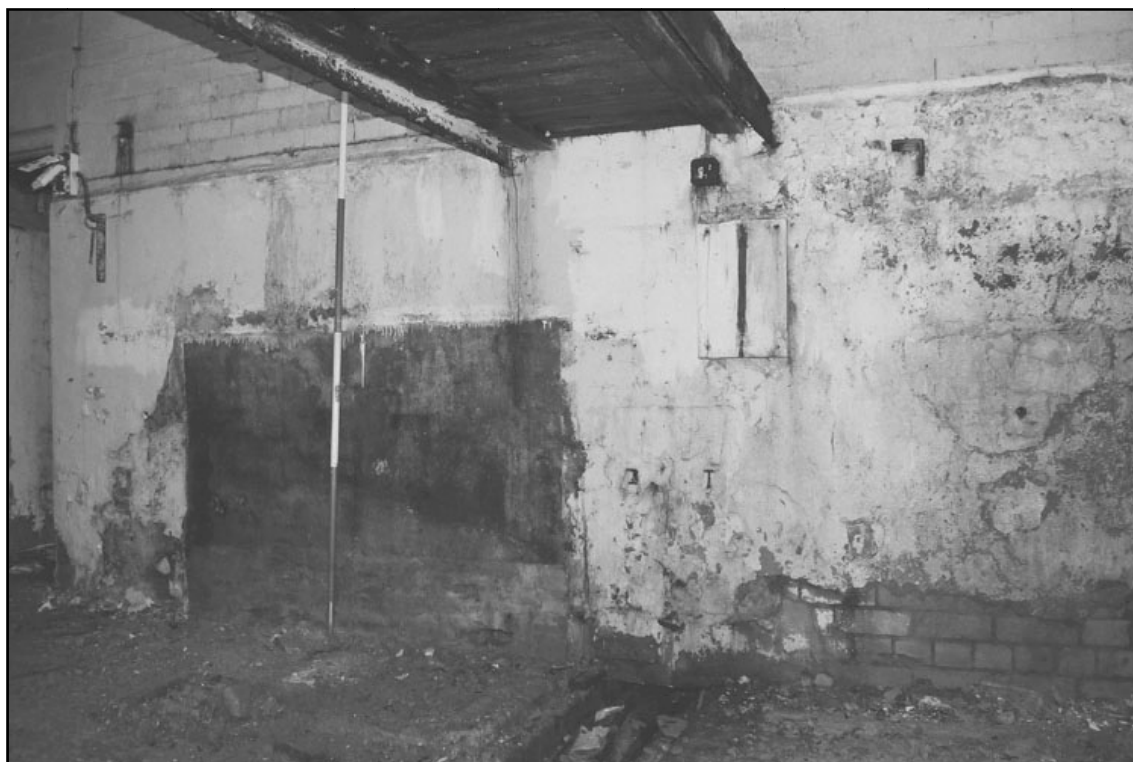
**Plate 58:** General view of south wall of room 2; note scar from removed cabinet (film 6.20)

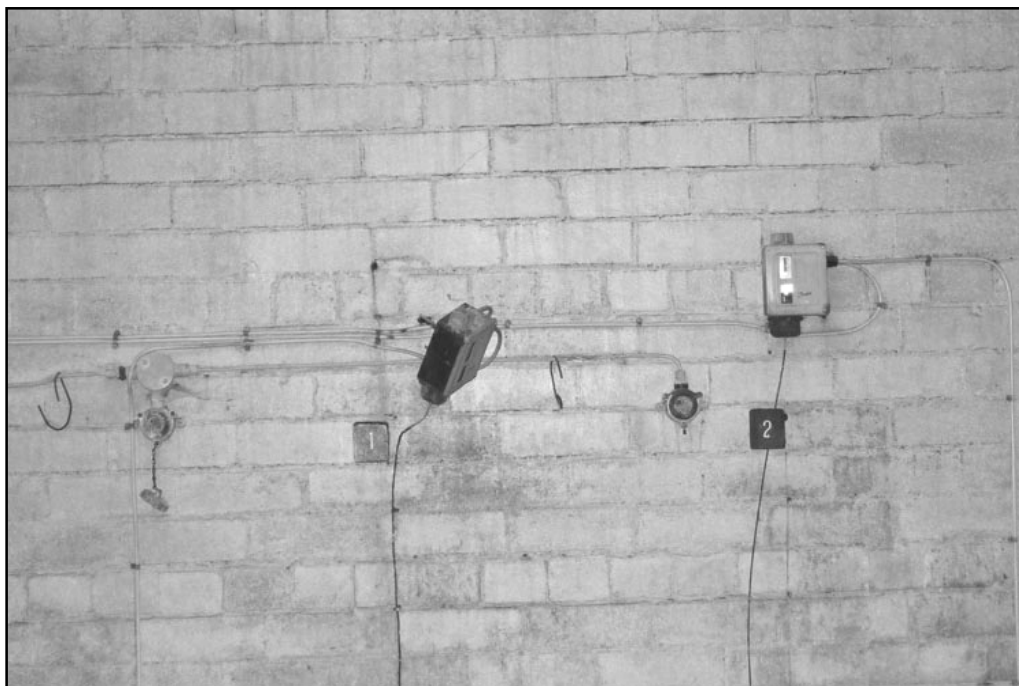
**Plate 60:** Detail of numbered switches on west wall of room 2 (film 6.21)

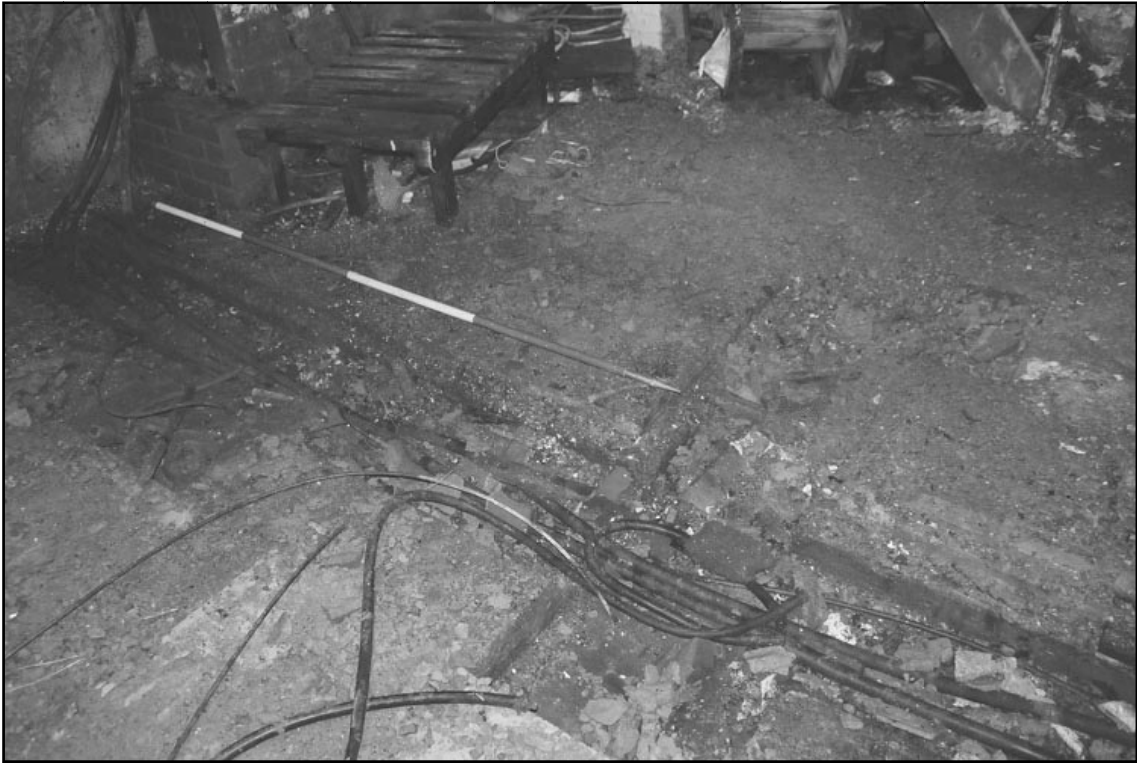
**Plate 61:** Detail of floor ducts within room 2 (film 6.18)

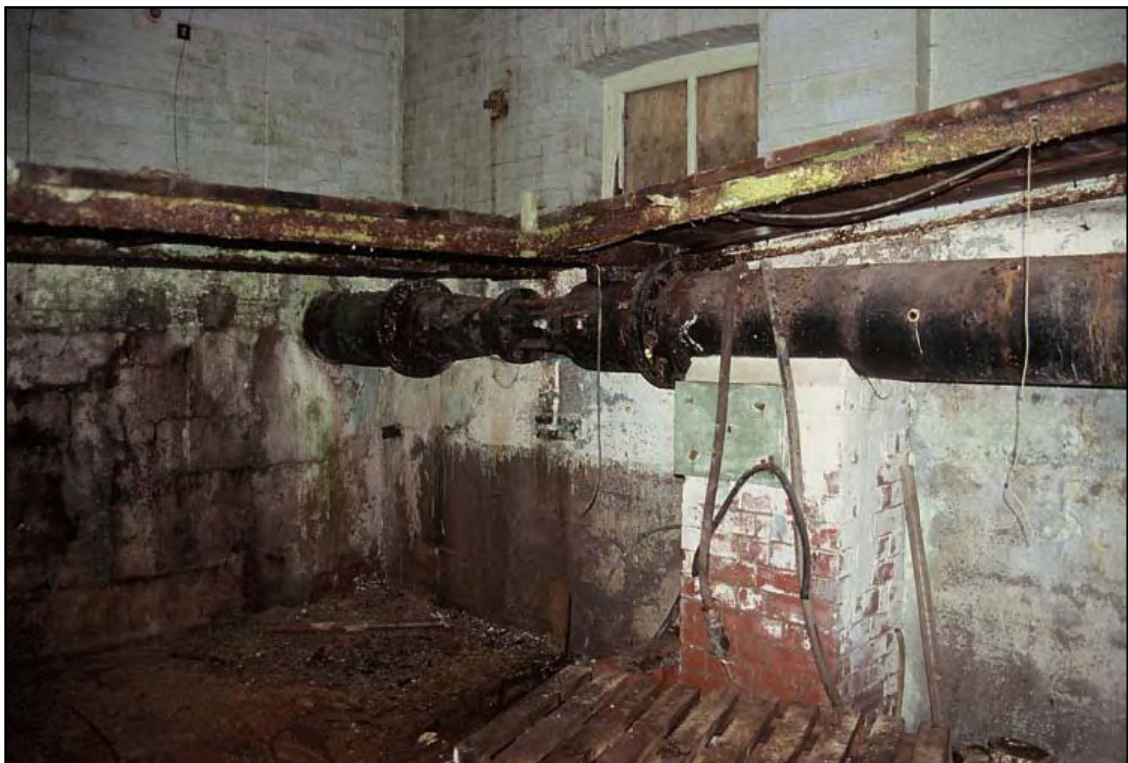
**Plate 62:** Detail of 8" water main in room 2, noting valve (slide 14)

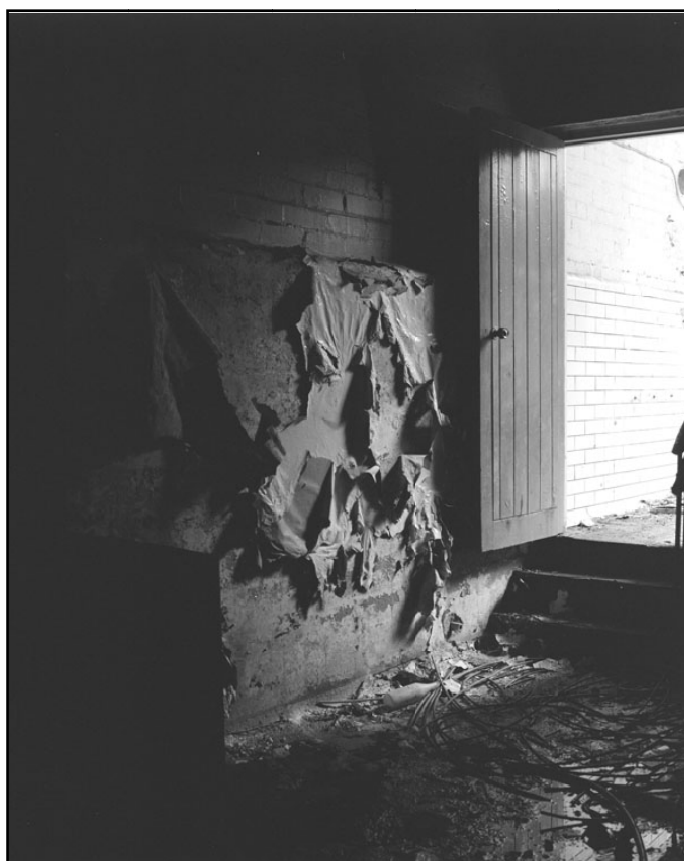
**Plate 63:** General view of door and protruding lower wall in room 3 (film 8.08)

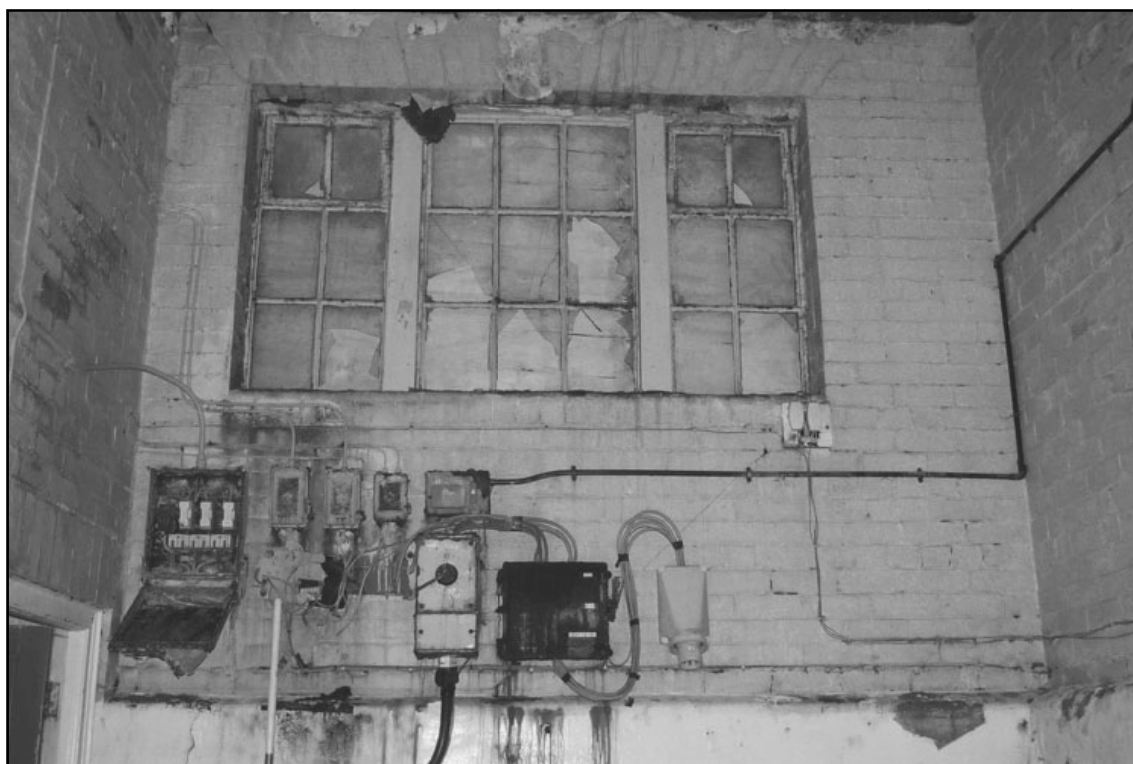
**Plate 64:** Detail of iron framed window and electrical junction boxes on east wall of room 3 (film 6.16)

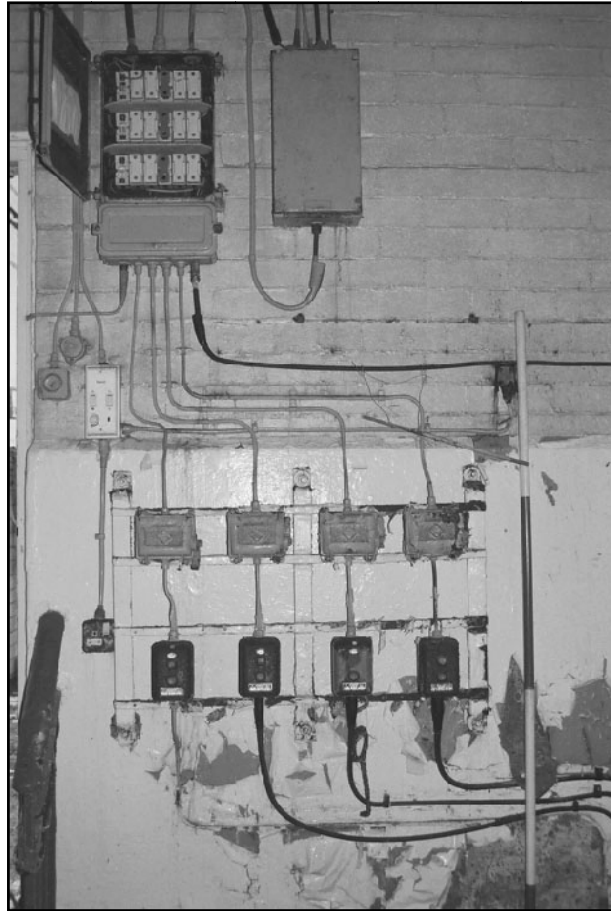
**Plate 65:** Detail of electrical switches on west wall of room 3 (film 6.09)

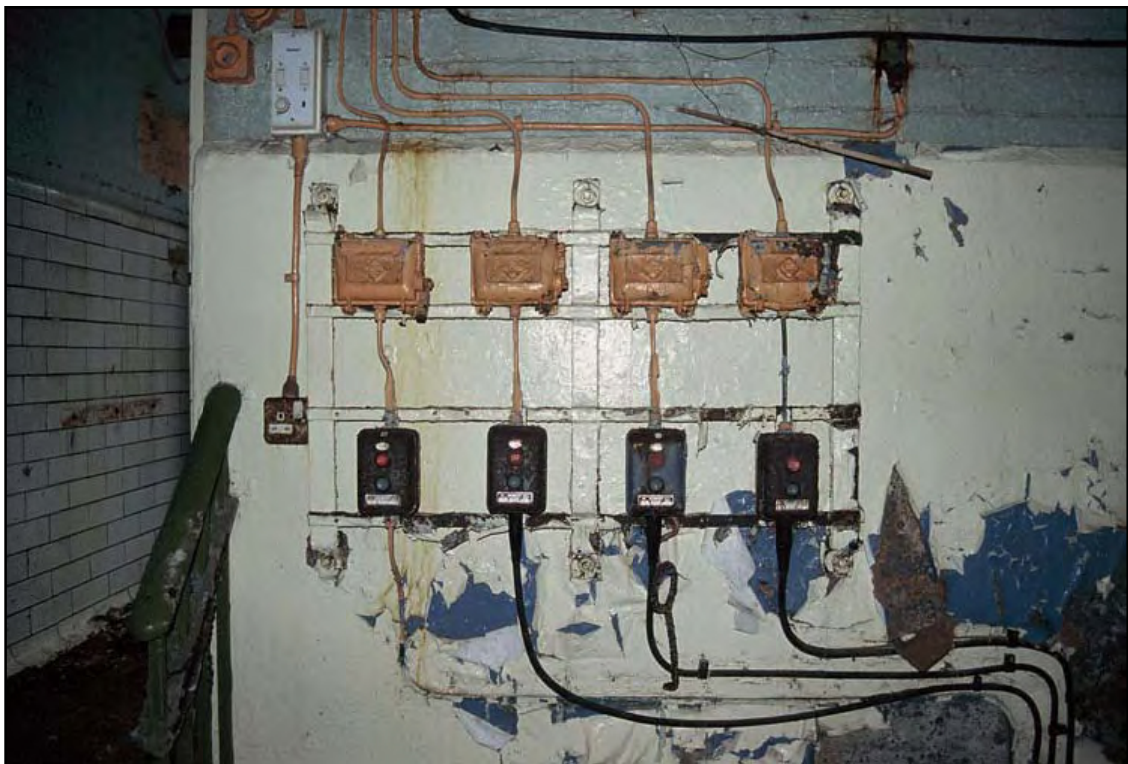
**Plate 66:** Detail electrical switches on west wall of room 3; note banister to left (slide 11)

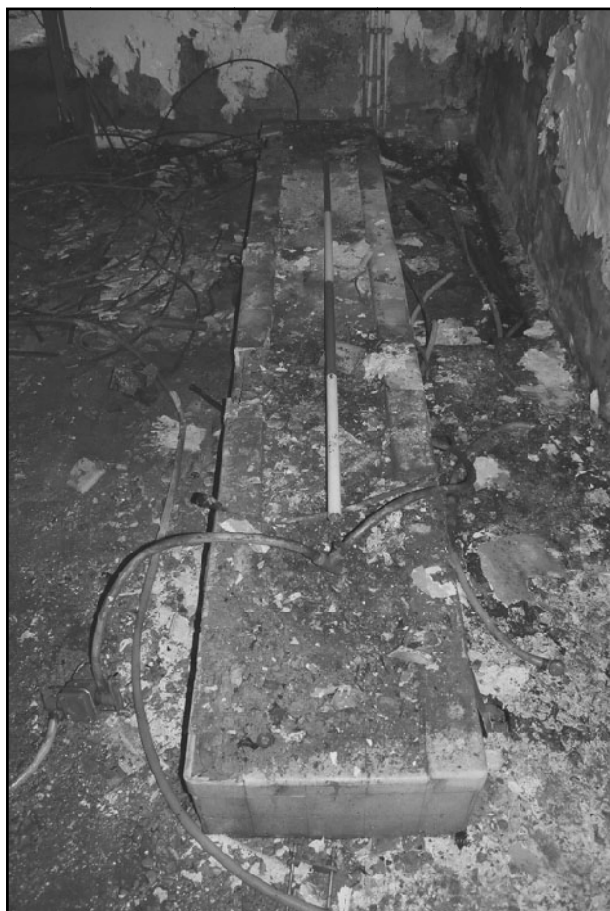
**Plate 67:** Detail of tiled concrete base in northwest corner of room 3 (film 6.11)

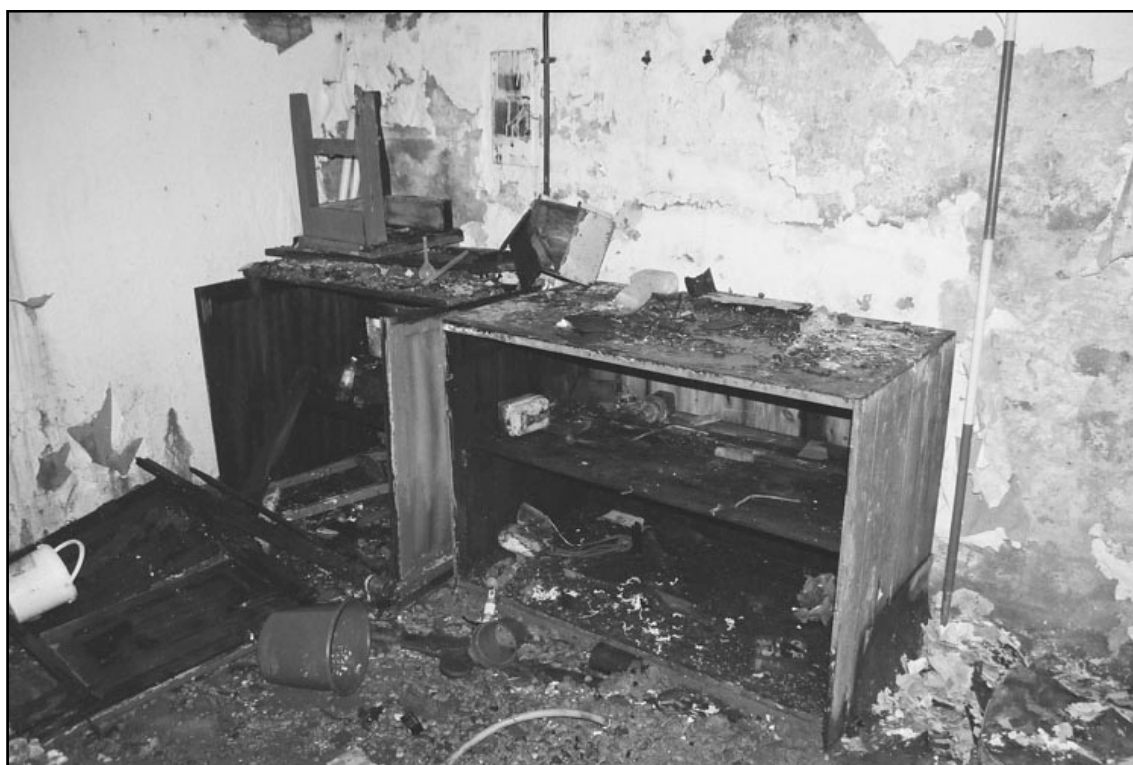
**Plate 68:** Detail of cabinets in southeast corner of room 3 (film 6.14)

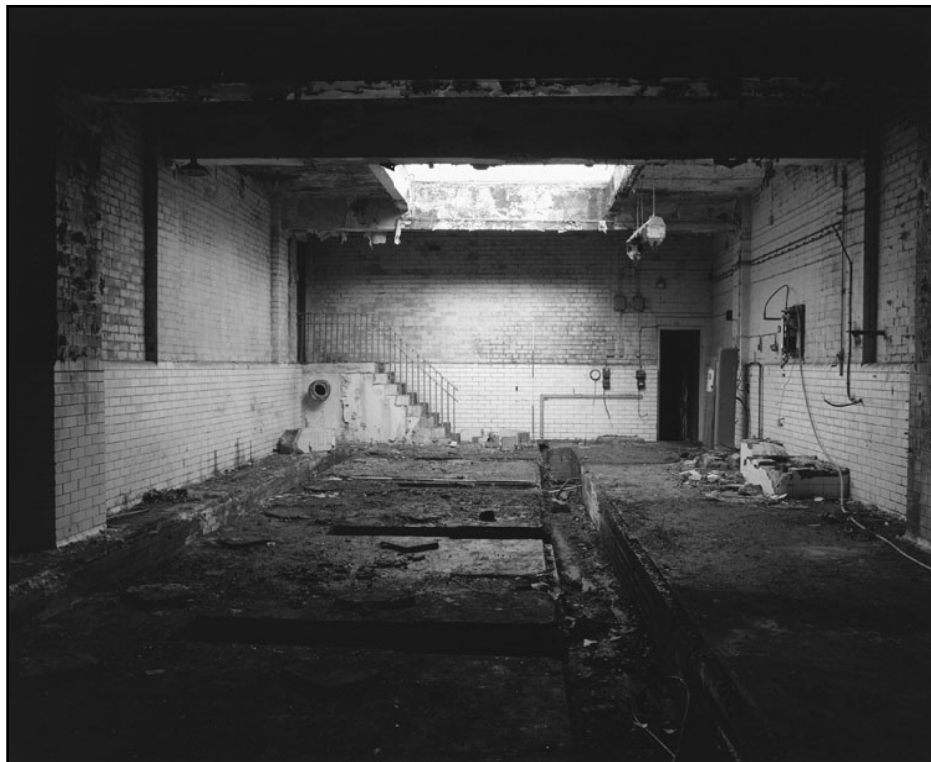
**Plate 70:** General view of room 4 looking east (film 9.02)

Room 4 was within the western two-thirds of the filter house, measuring 17.80 x 7.10m (58'4" x 23'6") (**Plates 70-72**). The walls were of brick, thickening by an extra course of white glazed brick within the lower 0.91m (3') of all walls. Above the glazed brick on the north and south elevations were five brick piers supporting reinforced concrete joists. The central piers on each wall were thicker and wider than the others, protruding into the room, with the projecting glazed brick dado continuing around. These piers mark the position of the former western wall of the filter house as illustrated by H. L. Bottomley in 1940 in the site plan held in WYAS: Calderdale (ref: CMT 8 HEB: 192). Beyond this point there had originally been a settling tank, which room 4 was evidently expanded into incorporating some original material probably c1950. Located in the east end of the north wall was a timber battened door at external ground level height preceded by a flight of concrete steps along the east wall with a cast iron banister identical in design to that within room 3 (**Plates 73-74**), as well as a metal light switch beside the door (**Plate 75**). The 8" cast iron pipe from rooms 1 and 2 passed beneath the concrete steps, and although it had been truncated, two brick piers suggest there had been a junction that turned ninety degrees toward the south. In the south end of the east wall was a timber battened door into room 3, with two concrete machine bases situated to the north of the door that were associated with two electrical boxes and a pressure gauge (**Plate 76**). Two chamfered timber framed windows were situated in the western half of the southern wall with stone lintels and brick jambs (**Plate 77**), and a truncated section of iron pipe to the exterior within the eastern half of the southern wall. In addition against the southern wall were a glazed brick floor basin with two associated hydraulic pressure gauges (**Plates 78-79**), and a raised glazed tiled concrete machine base with associated water and gas pressure gauge (**Plate 80**). Within the western wall was a timber double taking-in door at external ground level with a RSJ beam for a hoist centred above (**Plate 81**), and a window to the north of it in the west wall with a modern replacement frame, stone lintel, and brick sill.

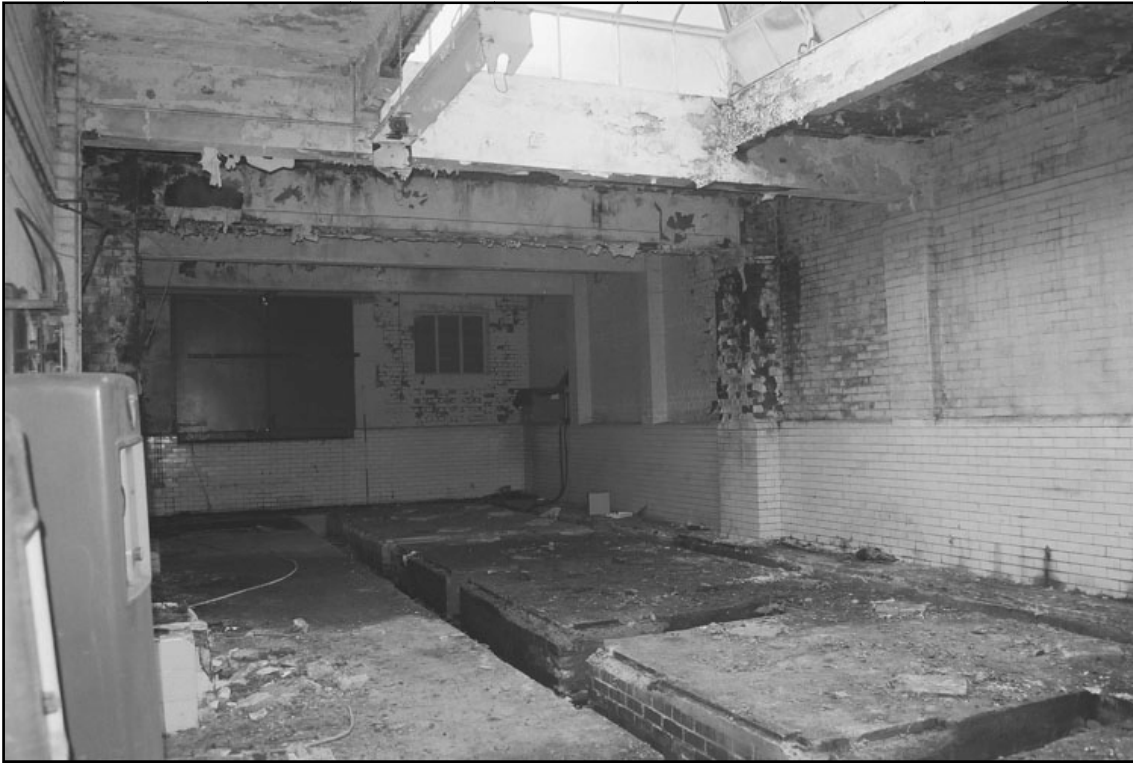
**Plate 71:** General view of room 4 looking northwest (film 10.24)

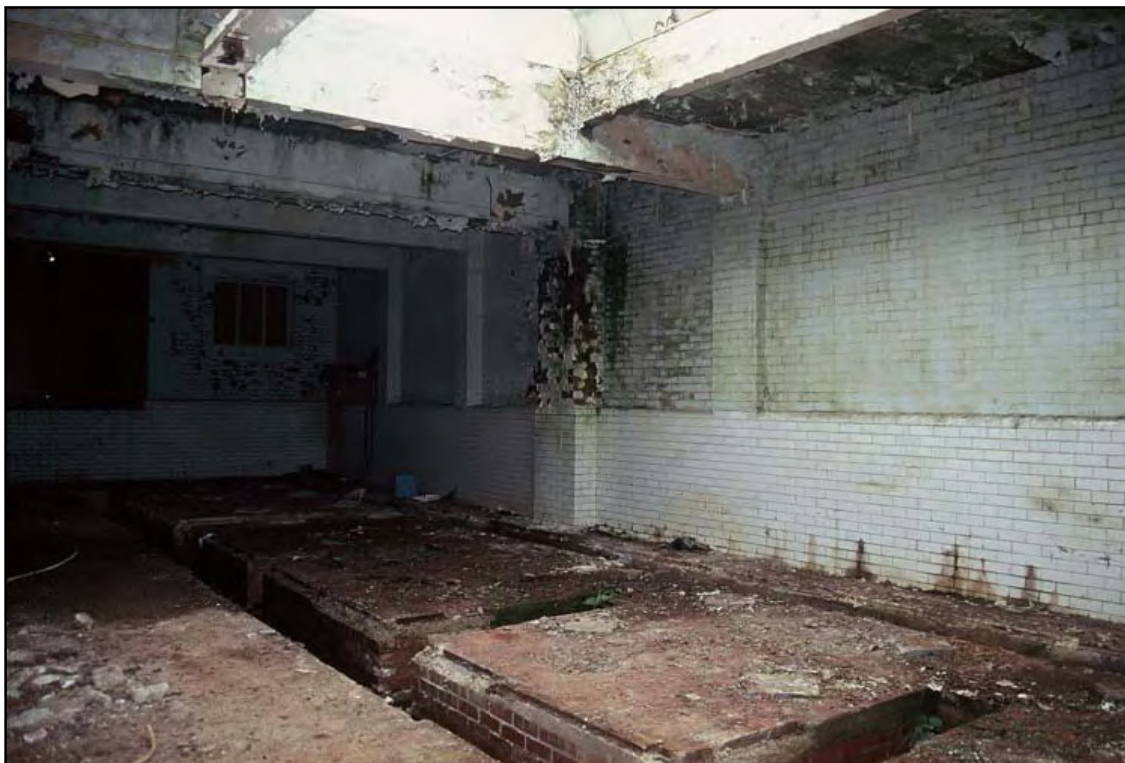
**Plate 72:** General view of room 4 looking northwest (slide 7)

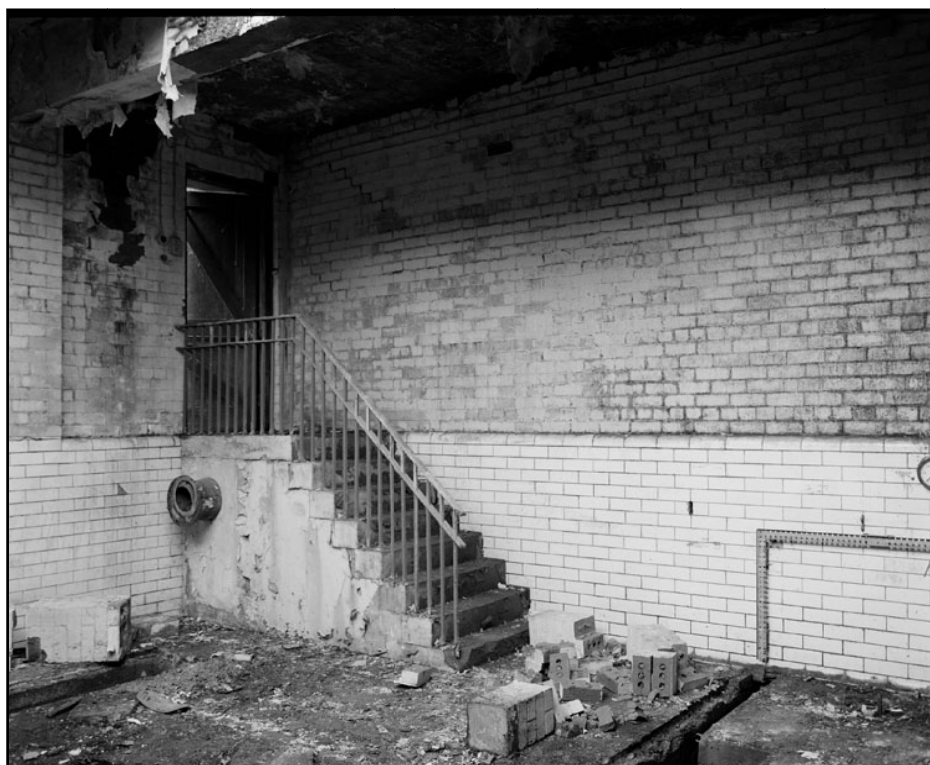
**Plate 73:** General view of staircase in northeast corner of room 4 (film 9.08)

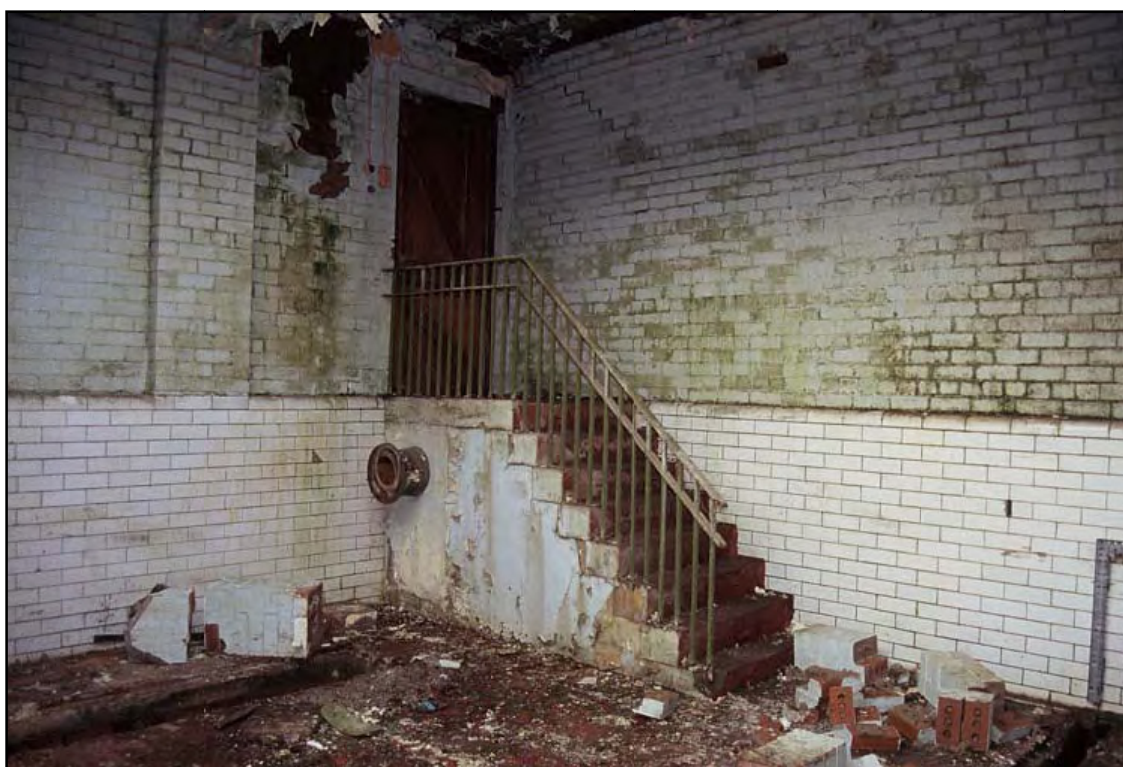
**Plate 74:** General view of staircase in northeast corner of room 4; note truncated 8" water main beneath (slide 3)

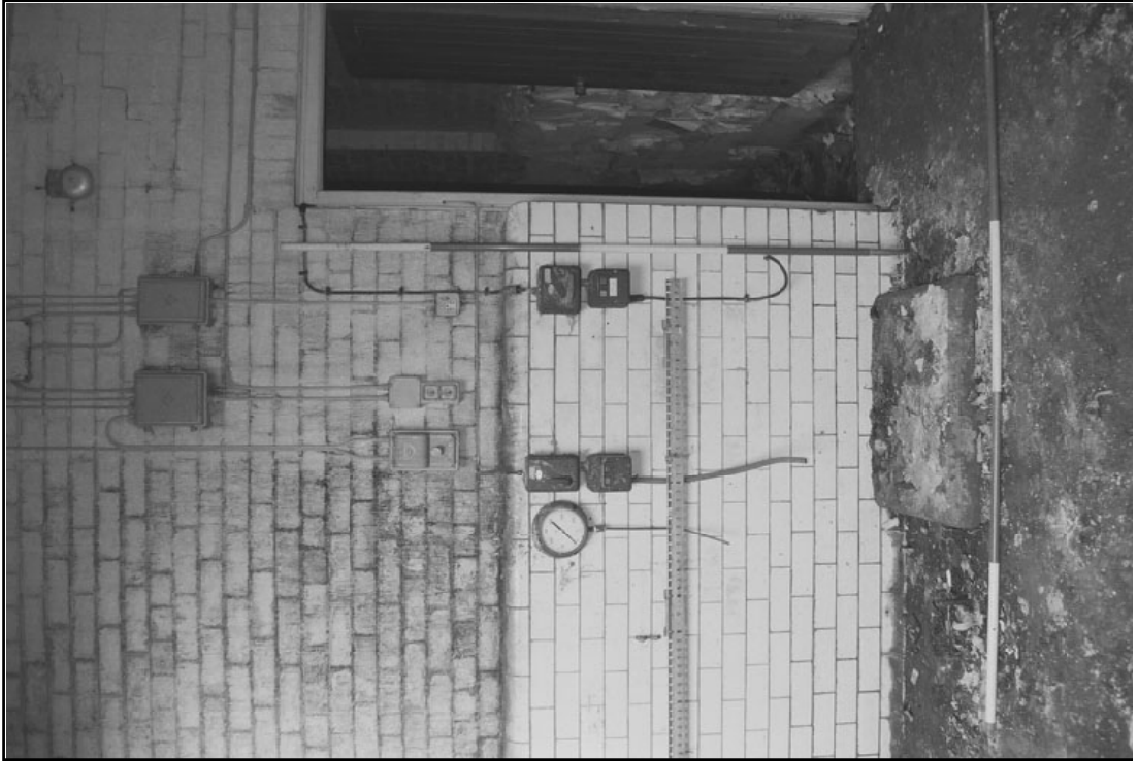
**Plate 76:** Detail of machine base, dials and switched adjacent to door in east wall of room 4 (film 6.07)

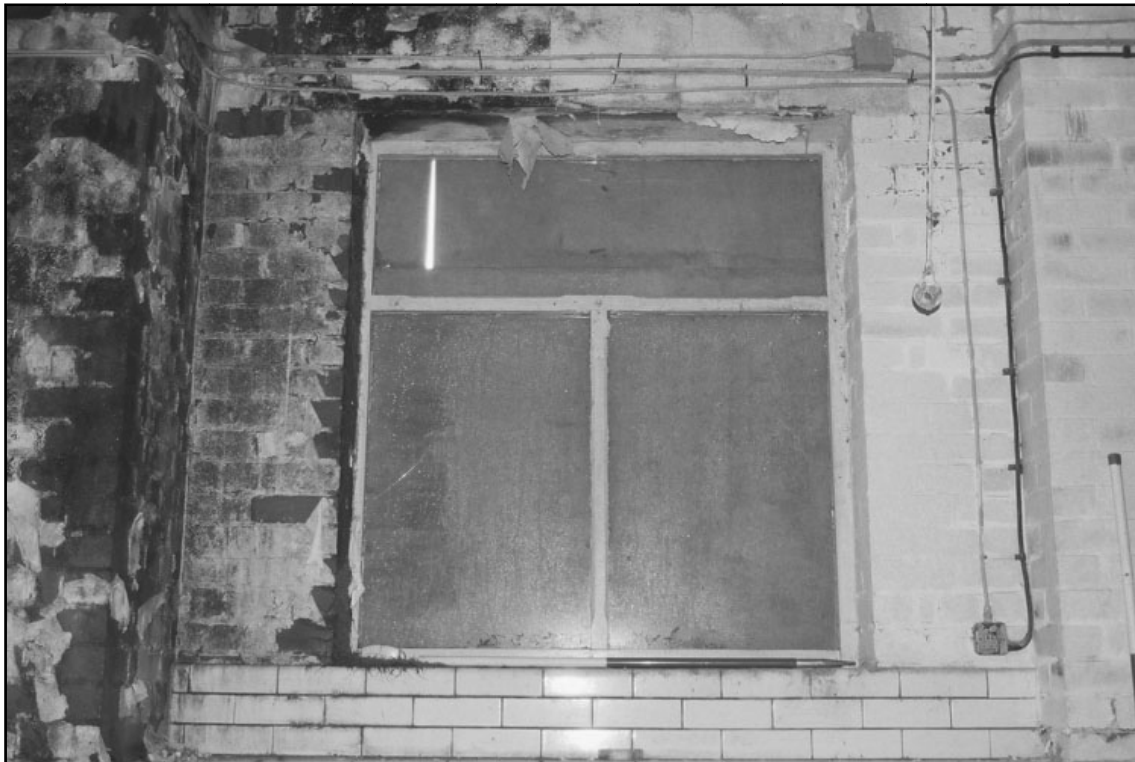
**Plate 77:** Detail of chamfered timber framed window in south wall of room 4 (film 10.32)

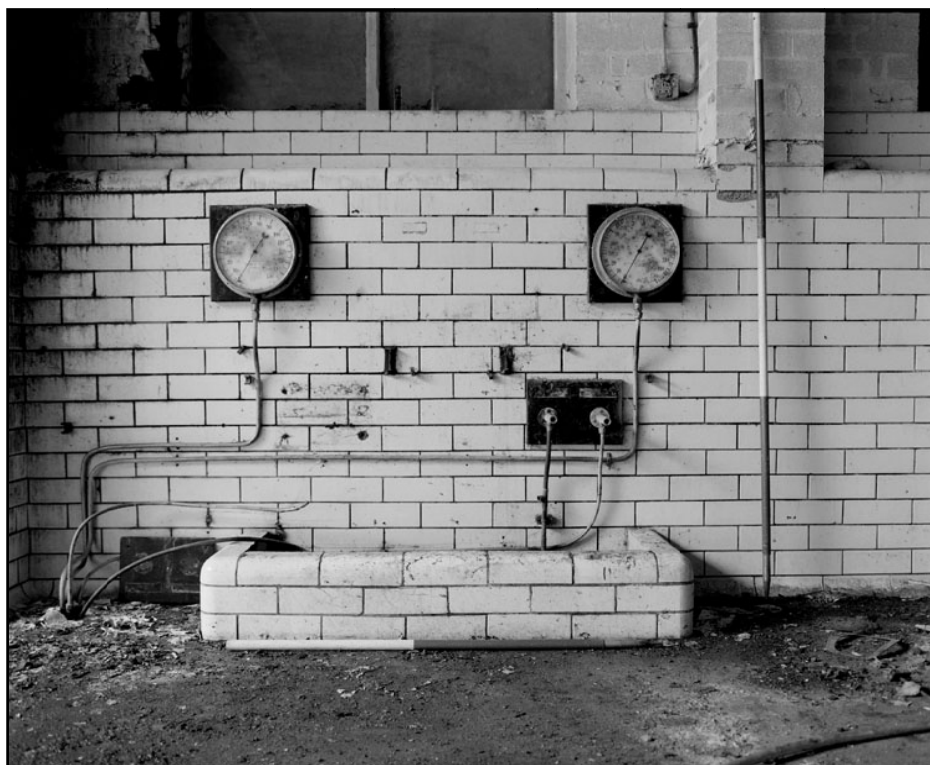
**Plate 78:** Detail of glazed brick floor basin against south wall of room 4 (film 9.03)

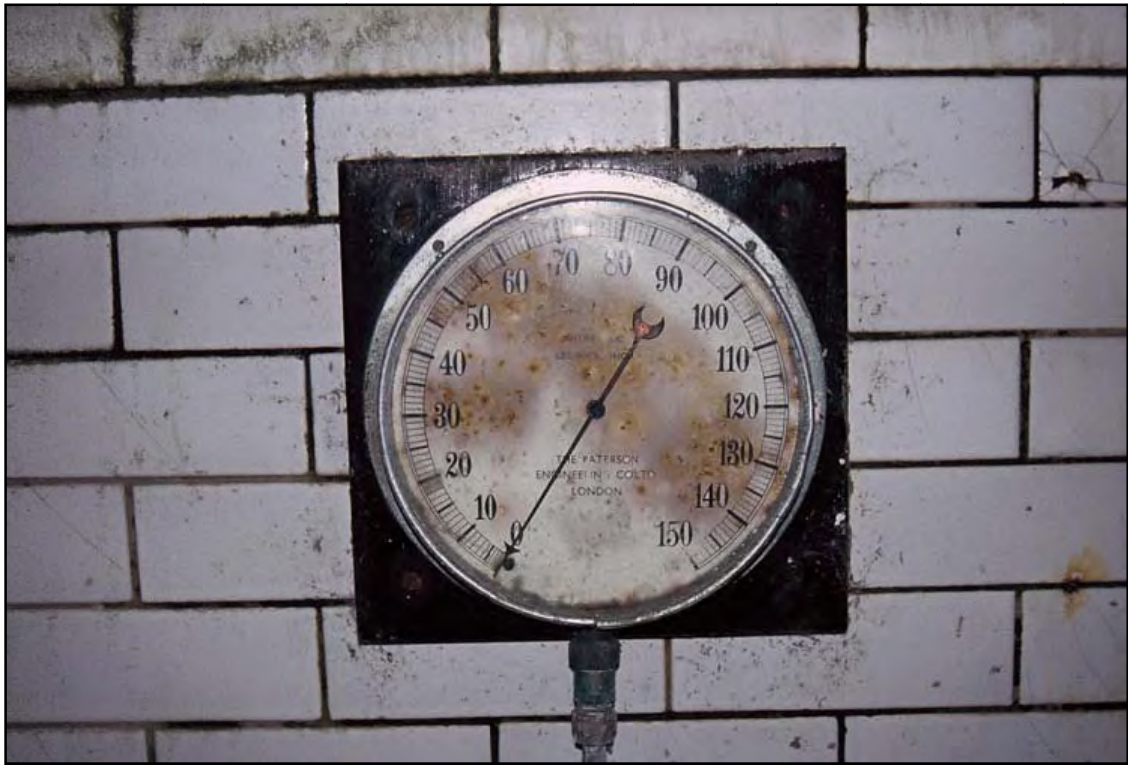
**Plate 79:** Detail of pressure gauge above glazed basin on south wall of room 4 (slide 1)

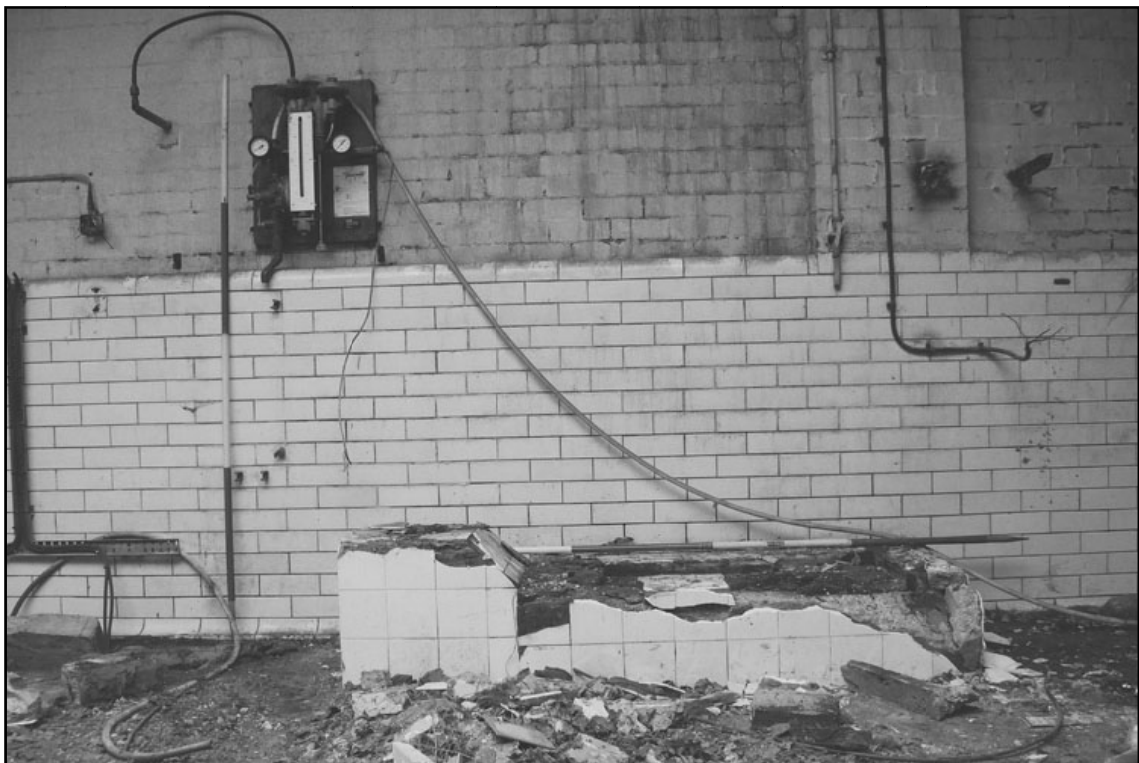
**Plate 80:** Detail of tiled concrete machine base against southern wall of room 4 (film 6.03)

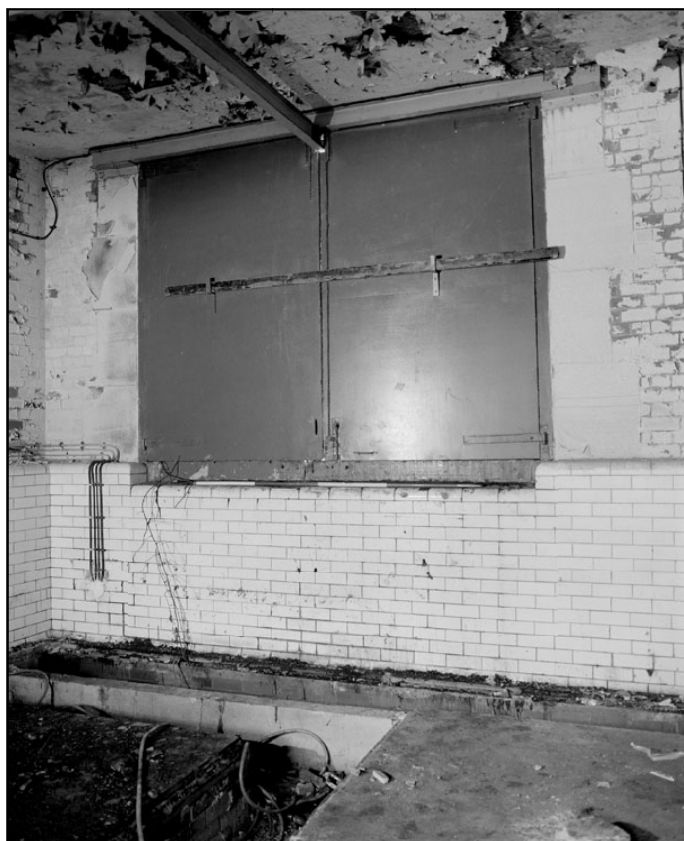
**Plate 81:** Detail of taking in door in west wall of room 4 (film 9.10)

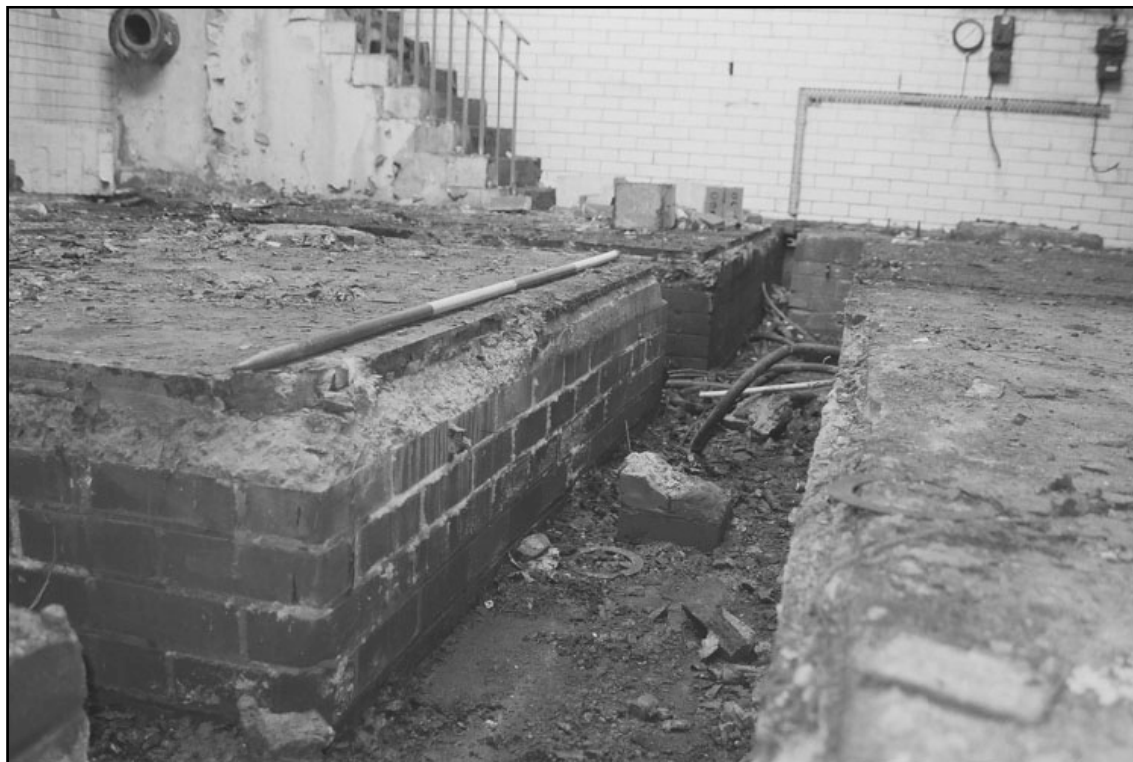
**Plate 82:** Detail of southern main floor duct, looking east (film 6.01)

The floor of room 4 was laid in brick with concrete over, and cut by numerous interconnected ducts shaped on the upper edges to take covers. There were two main ducts within the floor; one circumventing the room along the north and west walls and exiting through the southern wall; and another running just south of centre across the room (**Plate 82**) turning to the south alongside the first duct and with five short branches projecting at even intervals to the north. Located around each of these branches were four square concrete pads indicating plant had been positioned above them (**Plate 83**). In addition there were square scars in the floor to the east of each branch duct indicating additional associated structures, possibly short brick piers supporting elements of the plant. A further narrow branch duct from the southern main duct extended to the south where there had been a stone base set over it with two gas pressure column gauges in grey plastic cabinets (**Plates 84-85**). Above where the two main ducts exited beneath the southern wall was a wooden board that had previously taken a gauge (**Plate 86**). The ceiling of room 4 was of shuttered reinforced concrete with a cast iron framed hipped lantern skylight with reinforced glass above the eastern half of the room (**Plate 87**). In addition there were a number of additional light fittings including a halogen strip light and a lamp with metal shade (**Plate 88**).

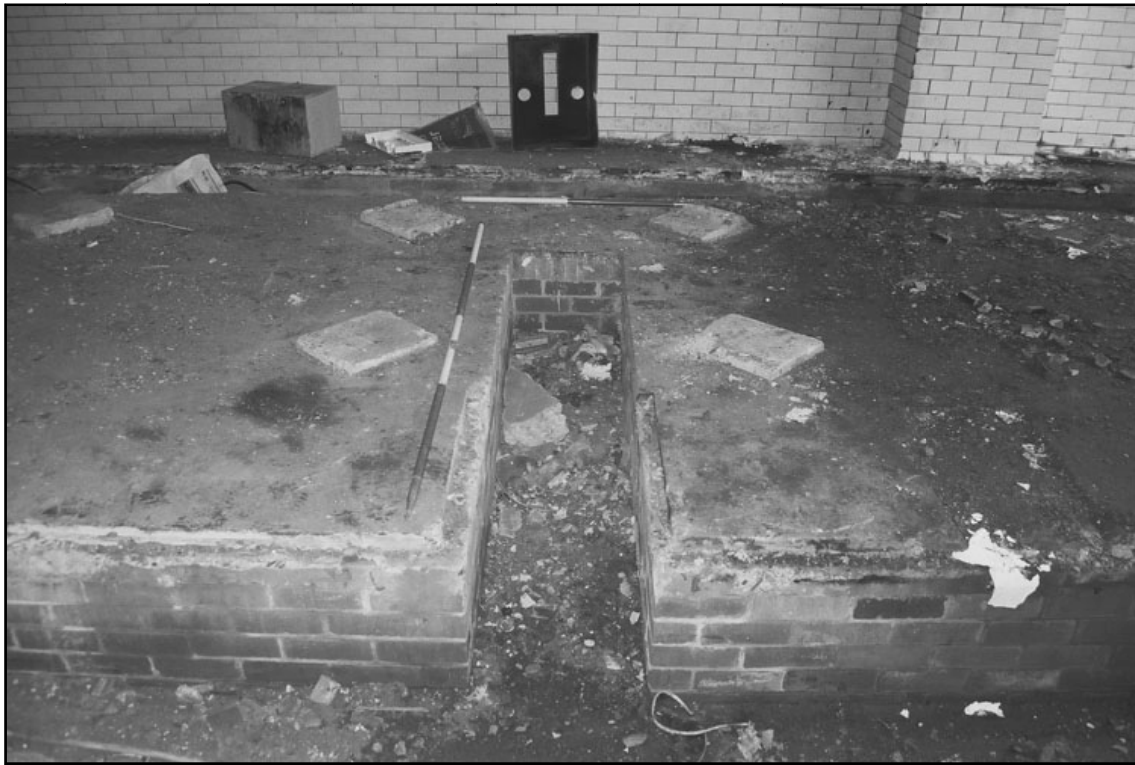
**Plate 83:** Detail of concrete pads around branch duct in room 4 (film 10.31)

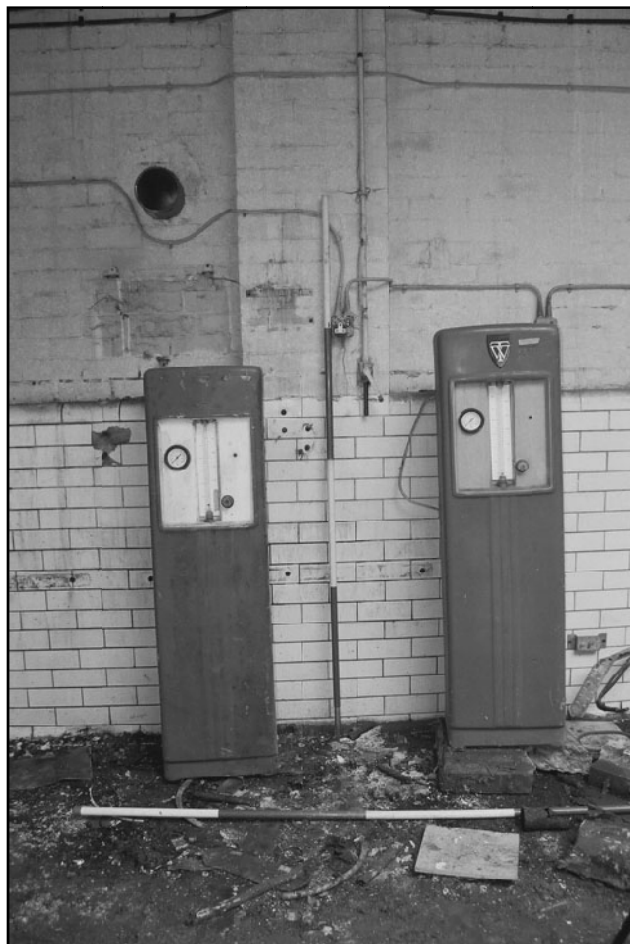
**Plate 84:** Detail of pressure gauges (not *in situ*) from southern wall of room 4 (film 6.05)

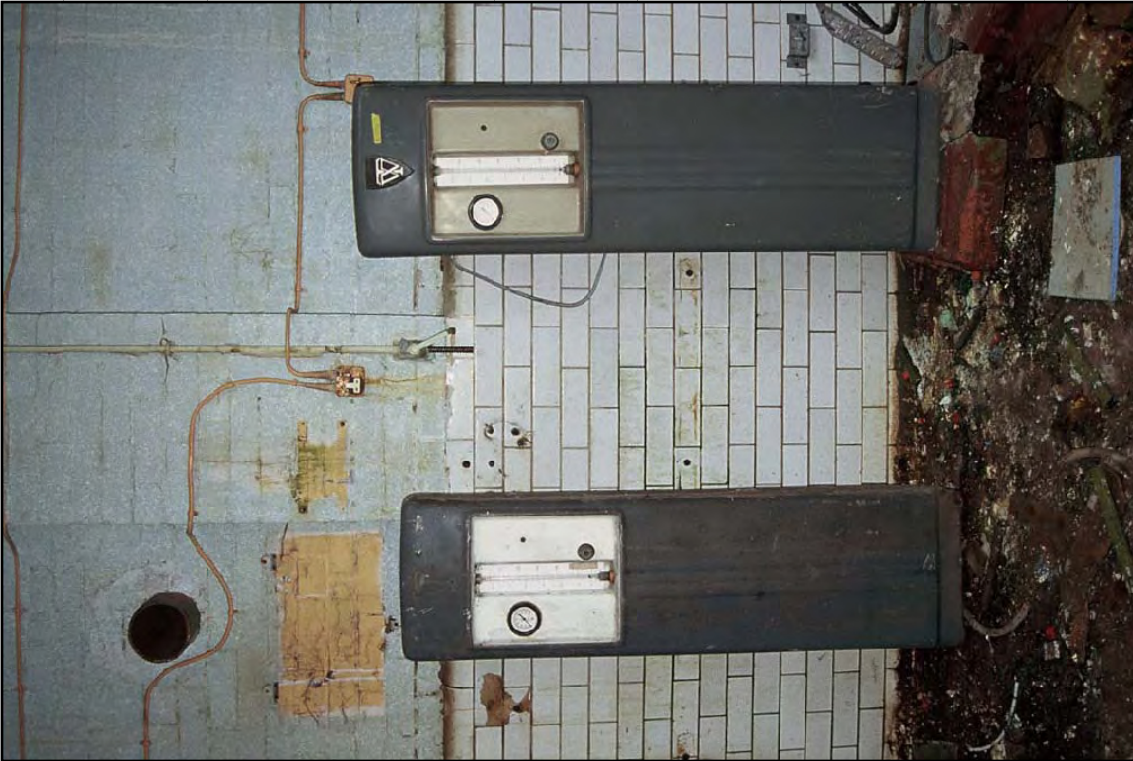
**Plate 85:** Detail of pressure gauges (not *in situ*) from southern wall of room 4 (slide 5)

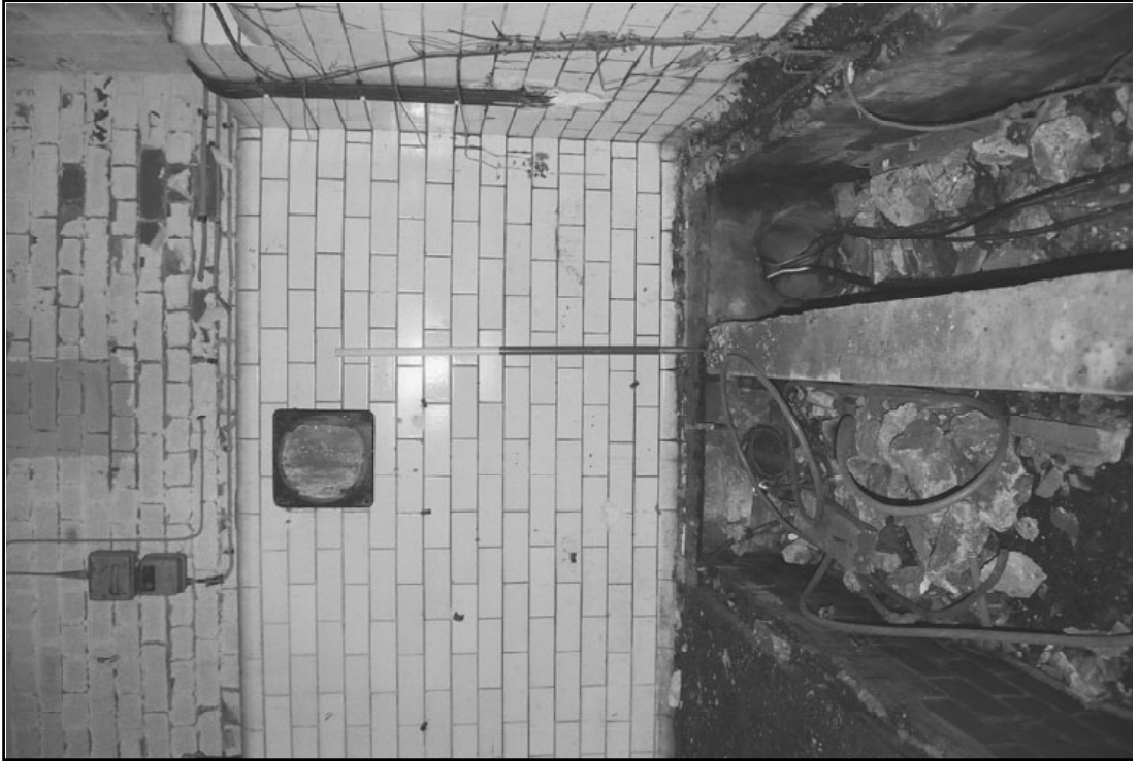
**Plate 86:** Detail of ducts and board for gauge against southern wall of room 4 (film 10.34)
