## **Hallin Hall SRE, Hebden Bridge**

Historic Building Recording

ARCUS report 1275.1(1)

# Hallin Hall SRE, Hebden Bridge, West Yorkshire

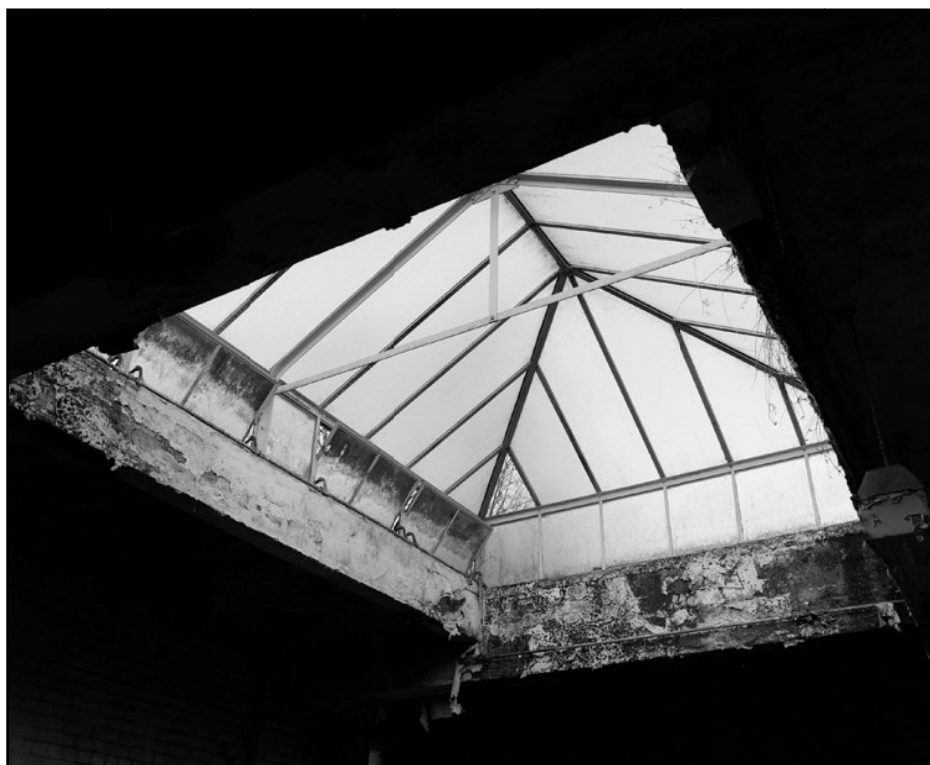
**Plate 87:** Detail of reinforced glass lantern skylight above room 4, looking northeast (film 9.05)

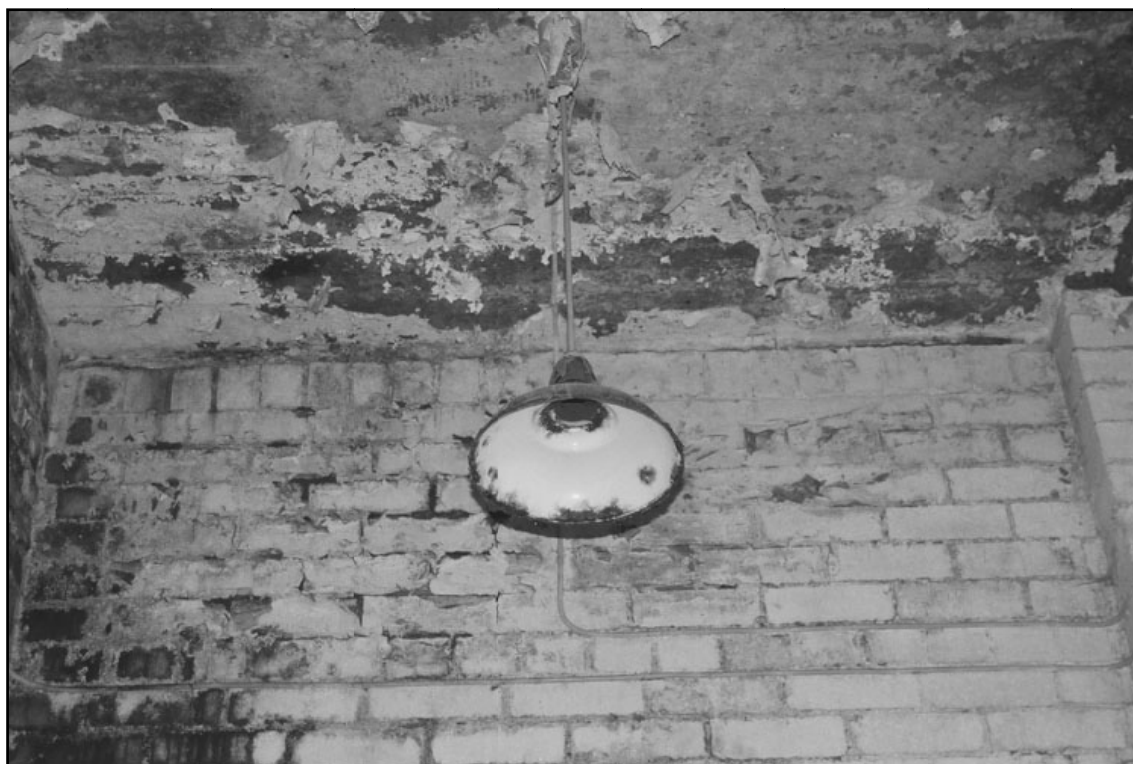
**Plate 88:** Detail of metal light shade and fitting within room 4 (film 10.28)

The floor of room 4 was laid in brick with concrete over, and cut by numerous interconnected ducts shaped on the upper edges to take covers. There were two main ducts within the floor; one circumventing the room along the north and west walls and exiting through the southern wall; and another running just south of centre across the room (**Plate 82**) turning to the south alongside the first duct and with five short branches projecting at even intervals to the north. Located around each of these branches were four square concrete pads indicating plant had been positioned above them (**Plate 83**). In addition there were square scars in the floor to the east of each branch duct indicating additional associated structures, possibly short brick piers supporting elements of the plant. A further narrow branch duct from the southern main duct extended to the south where there had been a stone base set over it with two gas pressure column gauges in grey plastic cabinets (**Plates 84-85**). Above where the two main ducts exited beneath the southern wall was a wooden board that had previously taken a gauge (**Plate 86**). The ceiling of room 4 was of shuttered reinforced concrete with a cast iron framed hipped lantern skylight with reinforced glass above the eastern half of the room (**Plate 87**). In addition there were a number of additional light fittings including a halogen strip light and a lamp with metal shade (**Plate 88**).
