DUNTHWAITE, COCKERMOUTH, CUMBRIA

Historic Building Recording (Volume 1 – Text and Figures)

Matrix Archaeology

Report No. 2016-02
(Project Code: MA610)

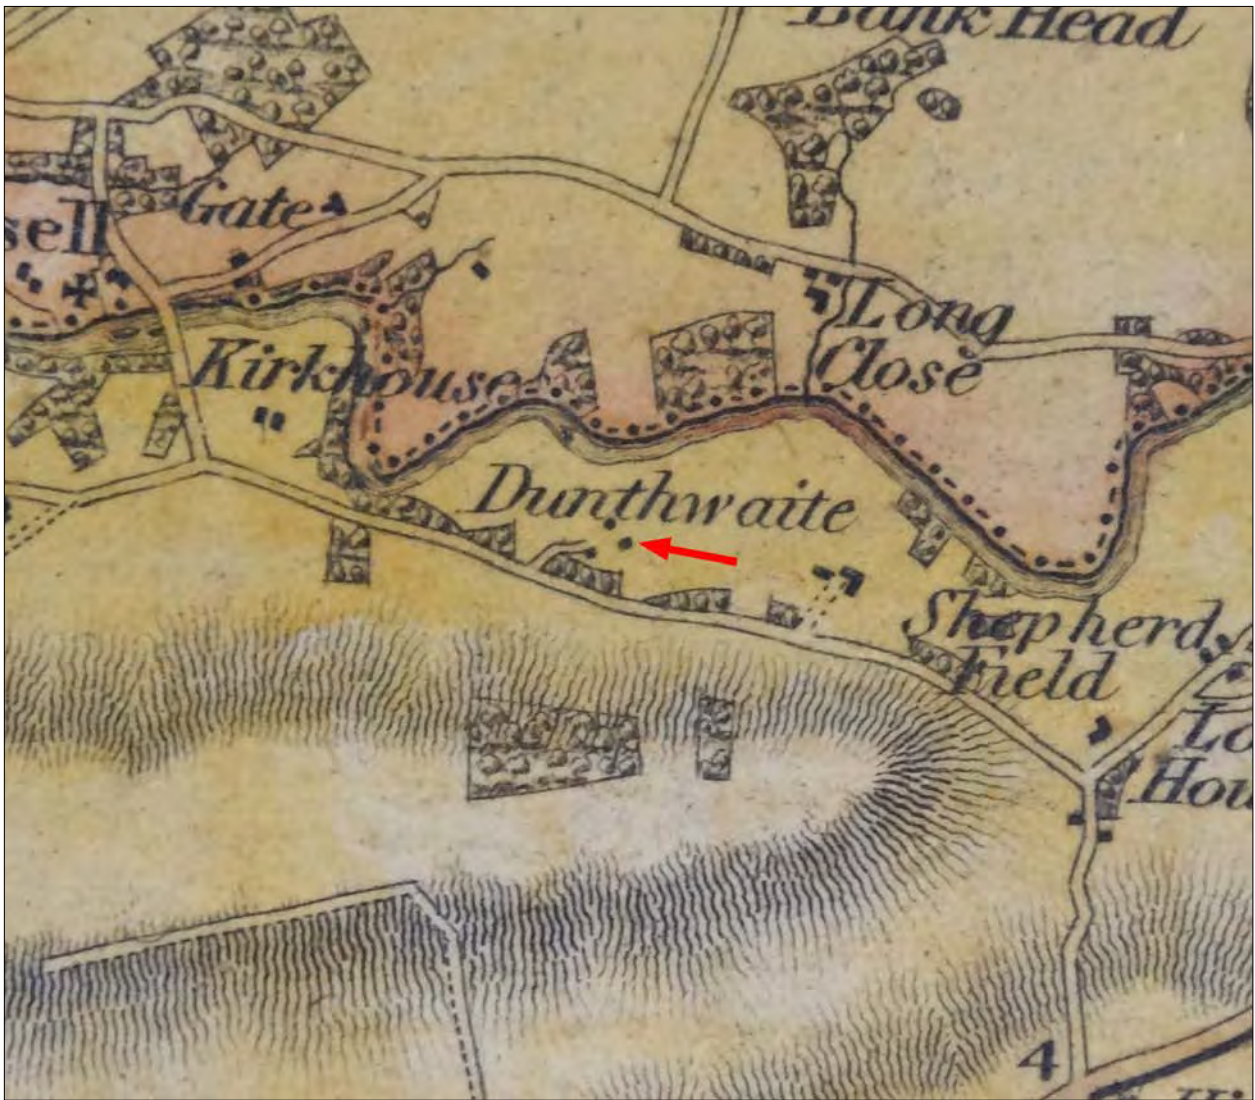
Figure 4: Dunthwaite (arrowed) on 'Map of the County of Cumberland', surveyed in 1821-2 by C & E Greenwood, published 1823 (CALSCW D/WM/1/11).

Three buildings are also indicated at Dunthwaite on the Greenwoods' county map surveyed in 1821-2 (Figure 4), and on the plan accompanying the

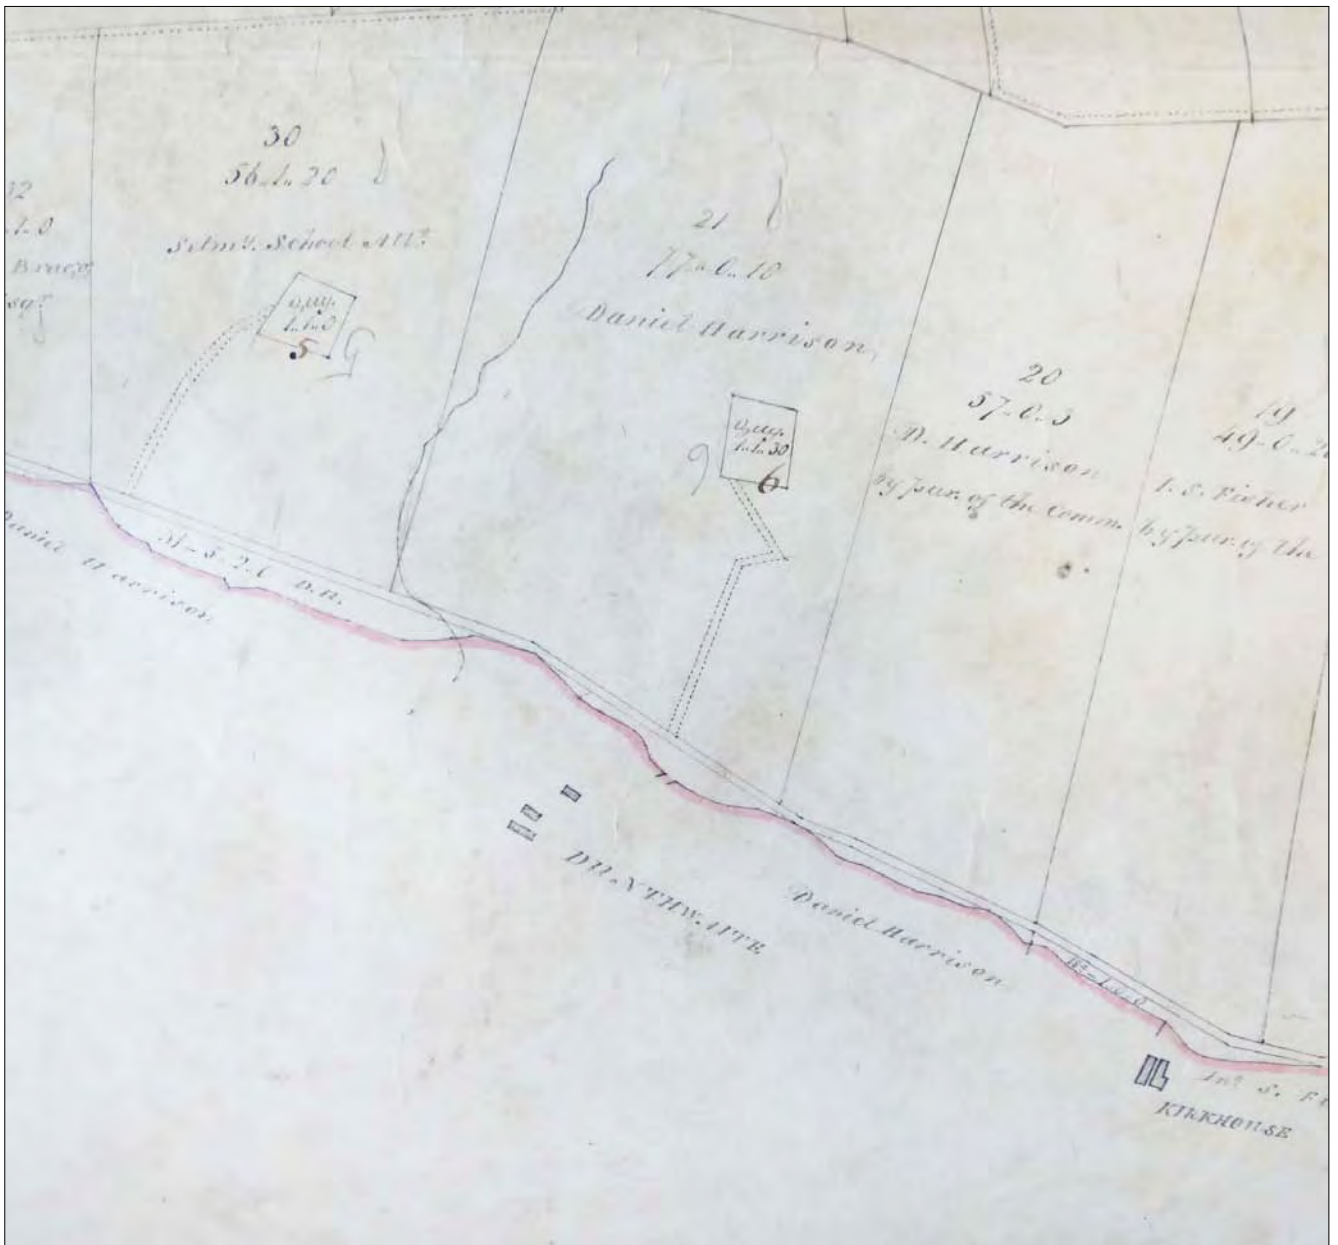
Figure 5: Dunthwaite on plan accompanying the Embleton and Setmurthy enclosure award, 1824 (CACC QRE/1/37). North is at the top.

Setmurthy enclosure award (Figure 5). These buildings are presumed to be the same as those on the tracing.

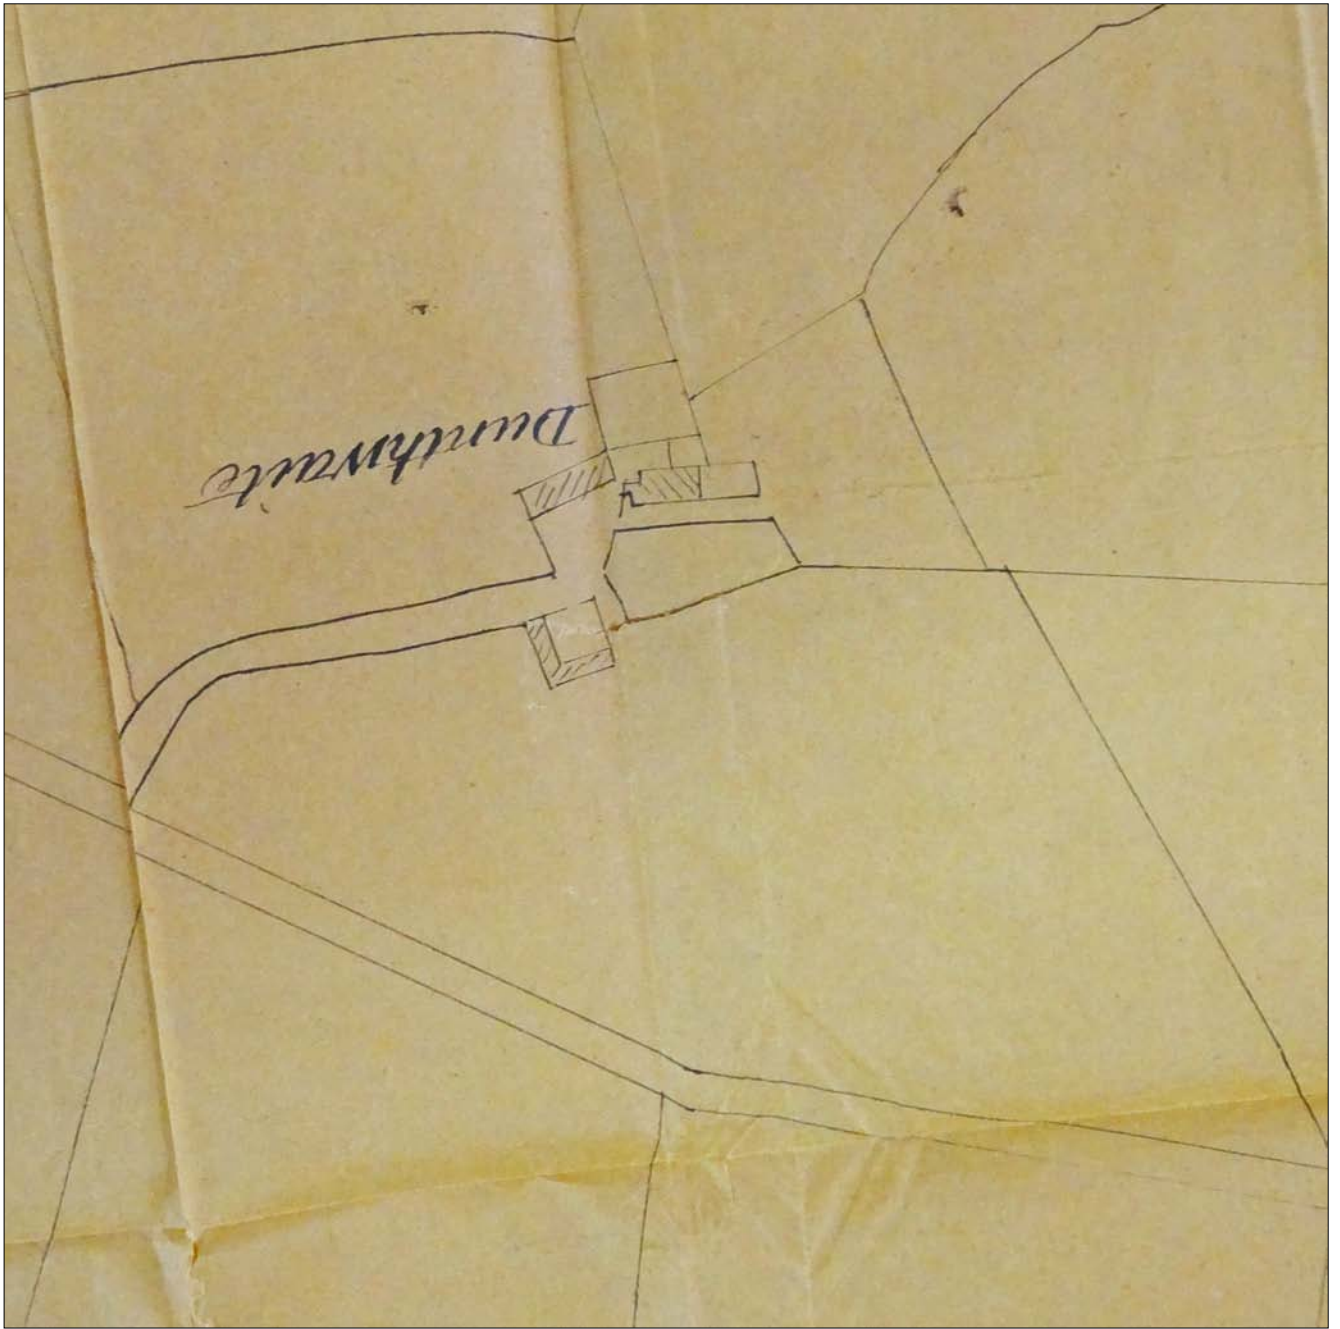
Figure 6: Dunthwaite on tracing of Low Field and Dunthwaite, nd (CALSCW D/WM/2/72).
Reproduced at 1:2000.

The earliest known detailed mapping of Dunthwaite is found on a plan of land at Setmurthy (Figure 6), which survives as a tracing in the Whitehaven archives. The plan is undated but is evidently of the early 19th century. On the south side of the Cockermouth-Bassenthwaite road it shows several fields created as part of the enclosure of the Setmurthy common authorised by Act of Parliament in 1813. However, at Dunthwaite the tracing does not include the barn (Building 3), known from the datestone to have been built in 1823.

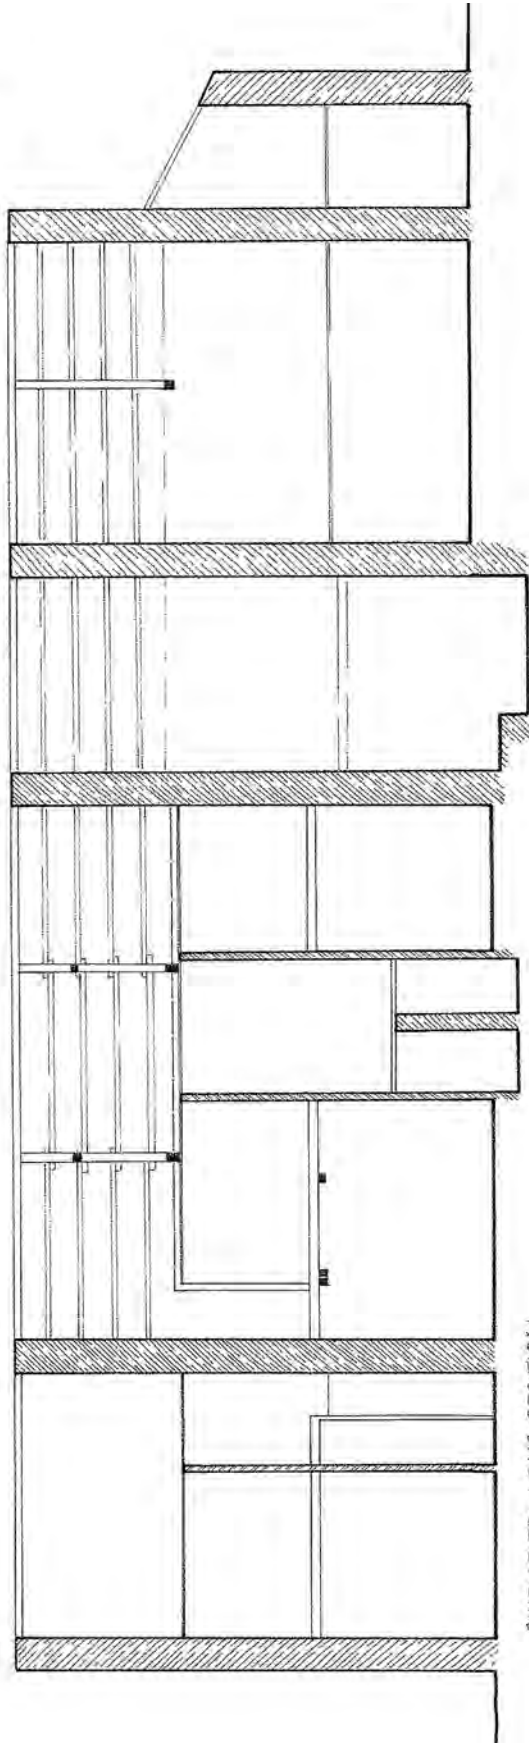
DUNTHWAITE HOUSE, BUILDING 1A+B

SIMPLIFIED LONG SECTION

ATTIC STOREY

Figure 14: 1986 survey, Building 1 longitudinal section and attic plan (Higgins 1986).

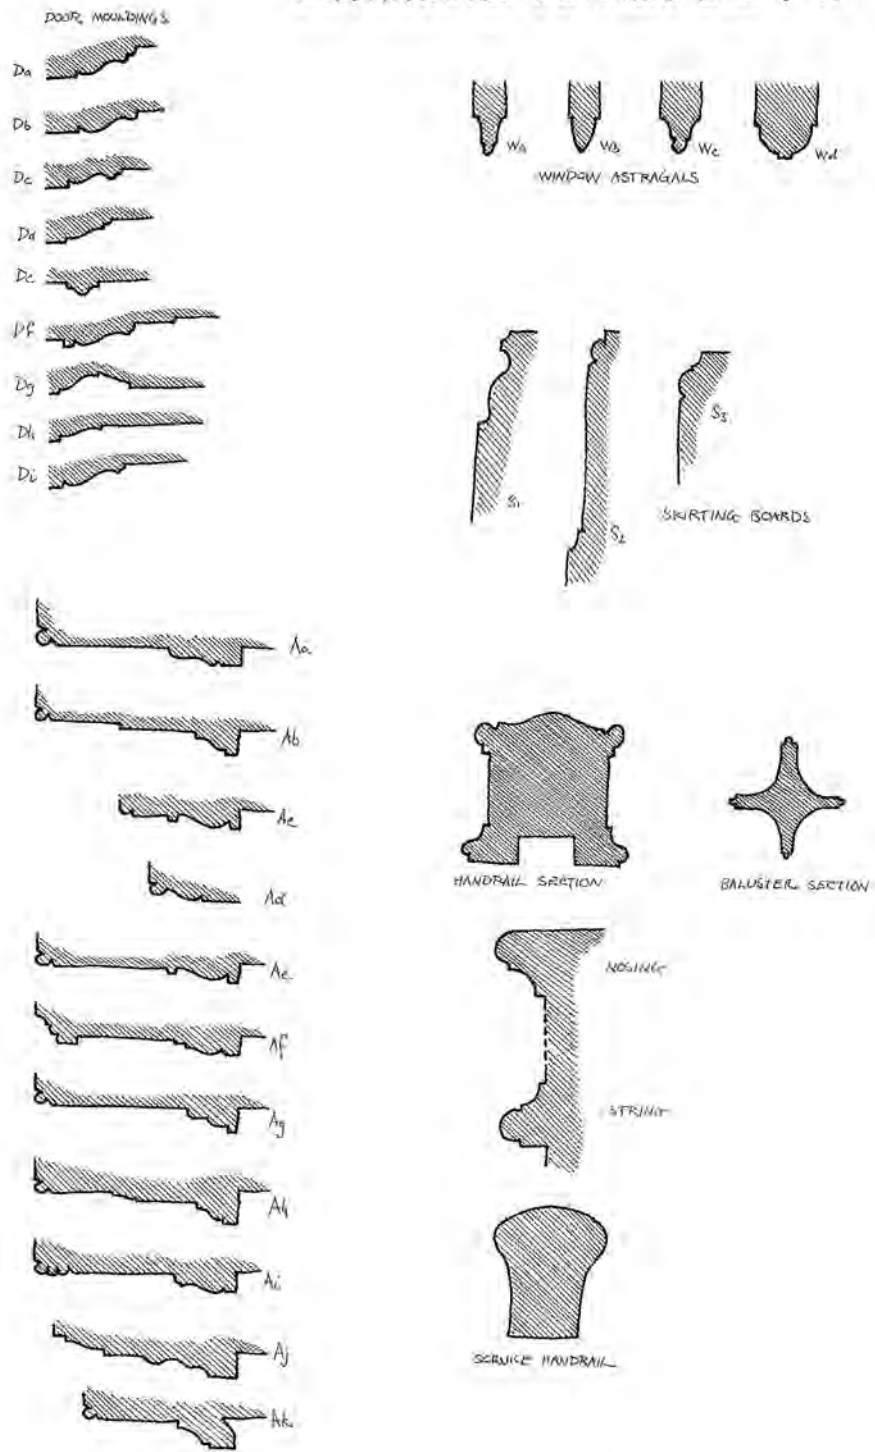
DUNTHWAITE DETAILS BLDG 1.

Figure 15: 1986 survey, Building 1 details (Higgins 1986).

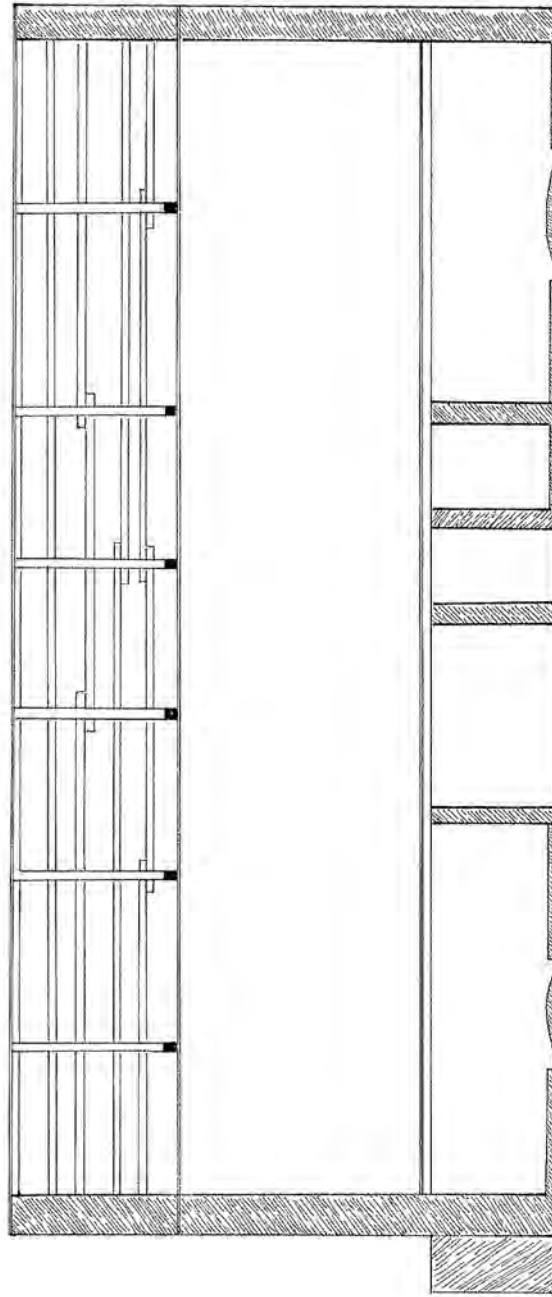
DUNTHWAITE - BUILDING 3

LONGITUDINAL SECTION E-W

Figure 19: 1986 survey, Building 3 longitudinal section (Higgins 1986).

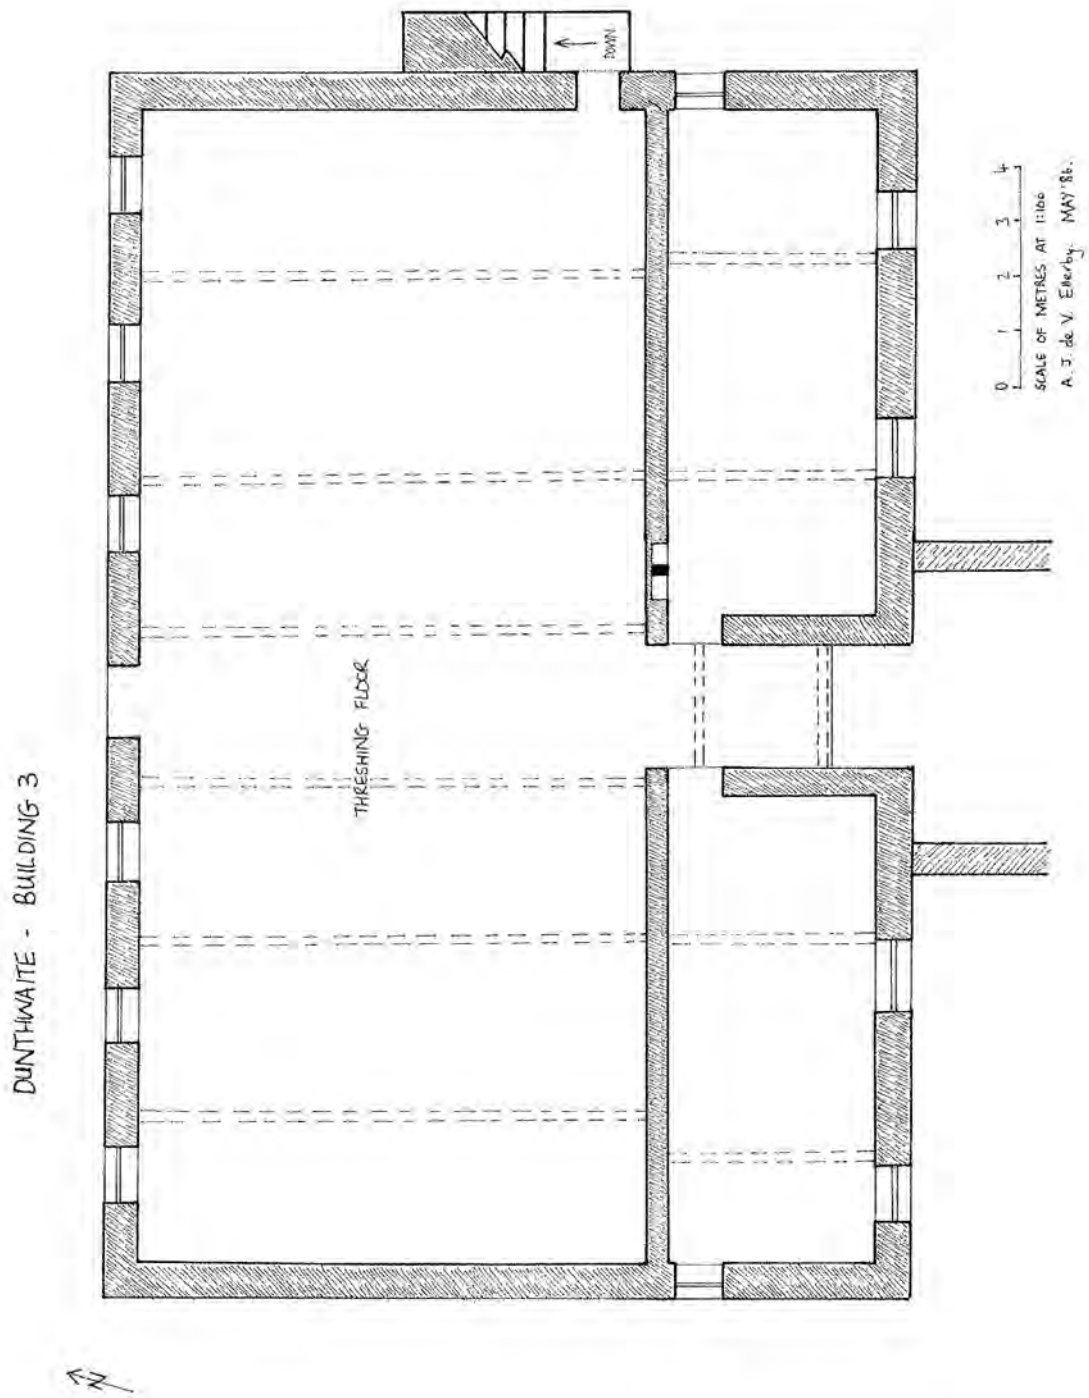
Figure 20: 1986 survey, Building 3 upper floor plan (Higgins 1986).

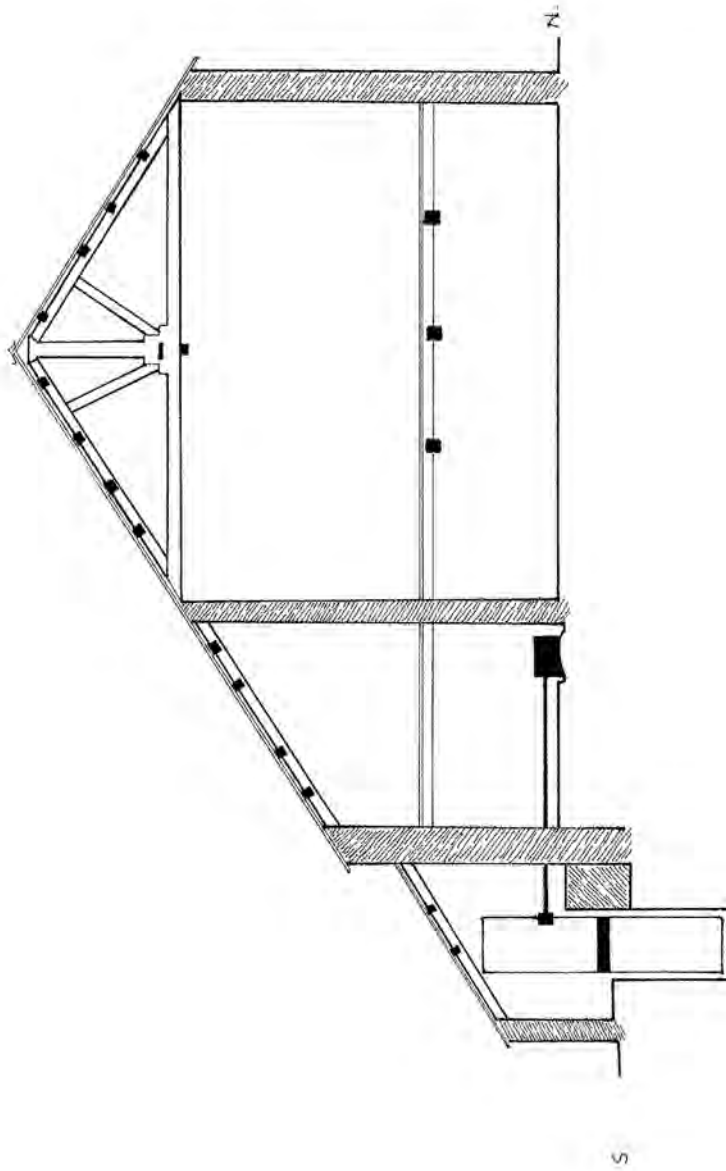
DUNTHWAITE - BUILDING 3

GABLE SECTION S-N

Figure 21: 1986 survey, Building 3 cross section (Higgins 1986).

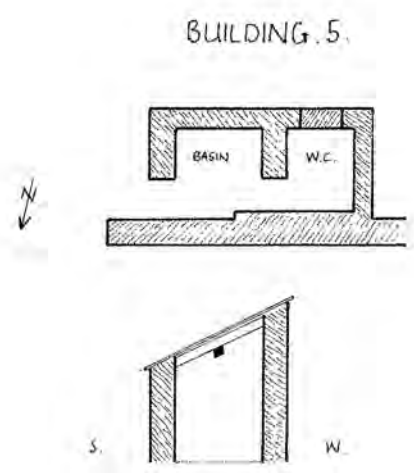
BUILDING . 6 .

Figure 23: 1986 survey, Buildings 5 and 6 (now 4) plans and sections (Higgins 1986).

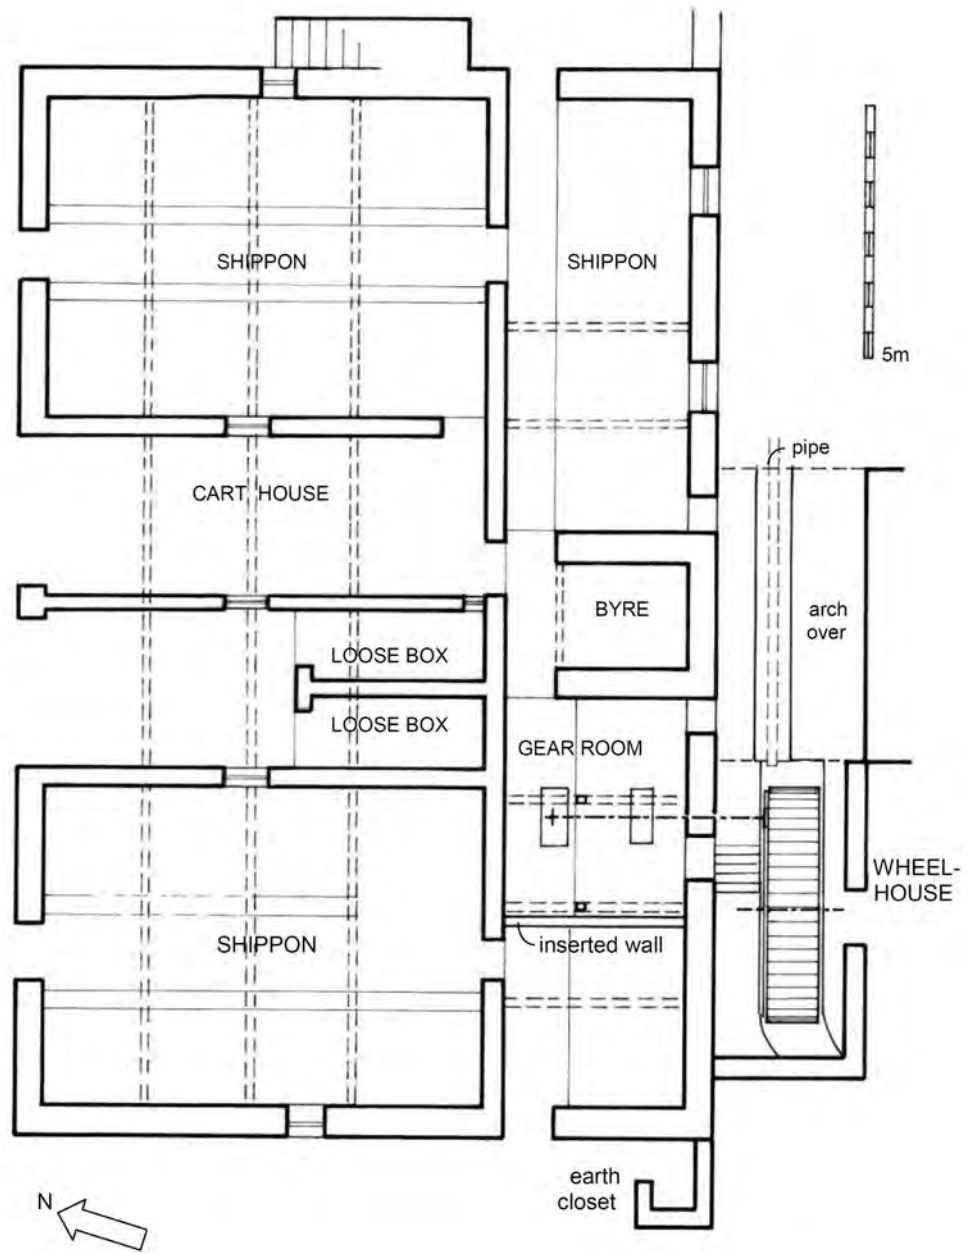
Figure 24: Building 3 ground floor plan (Watts 2013).

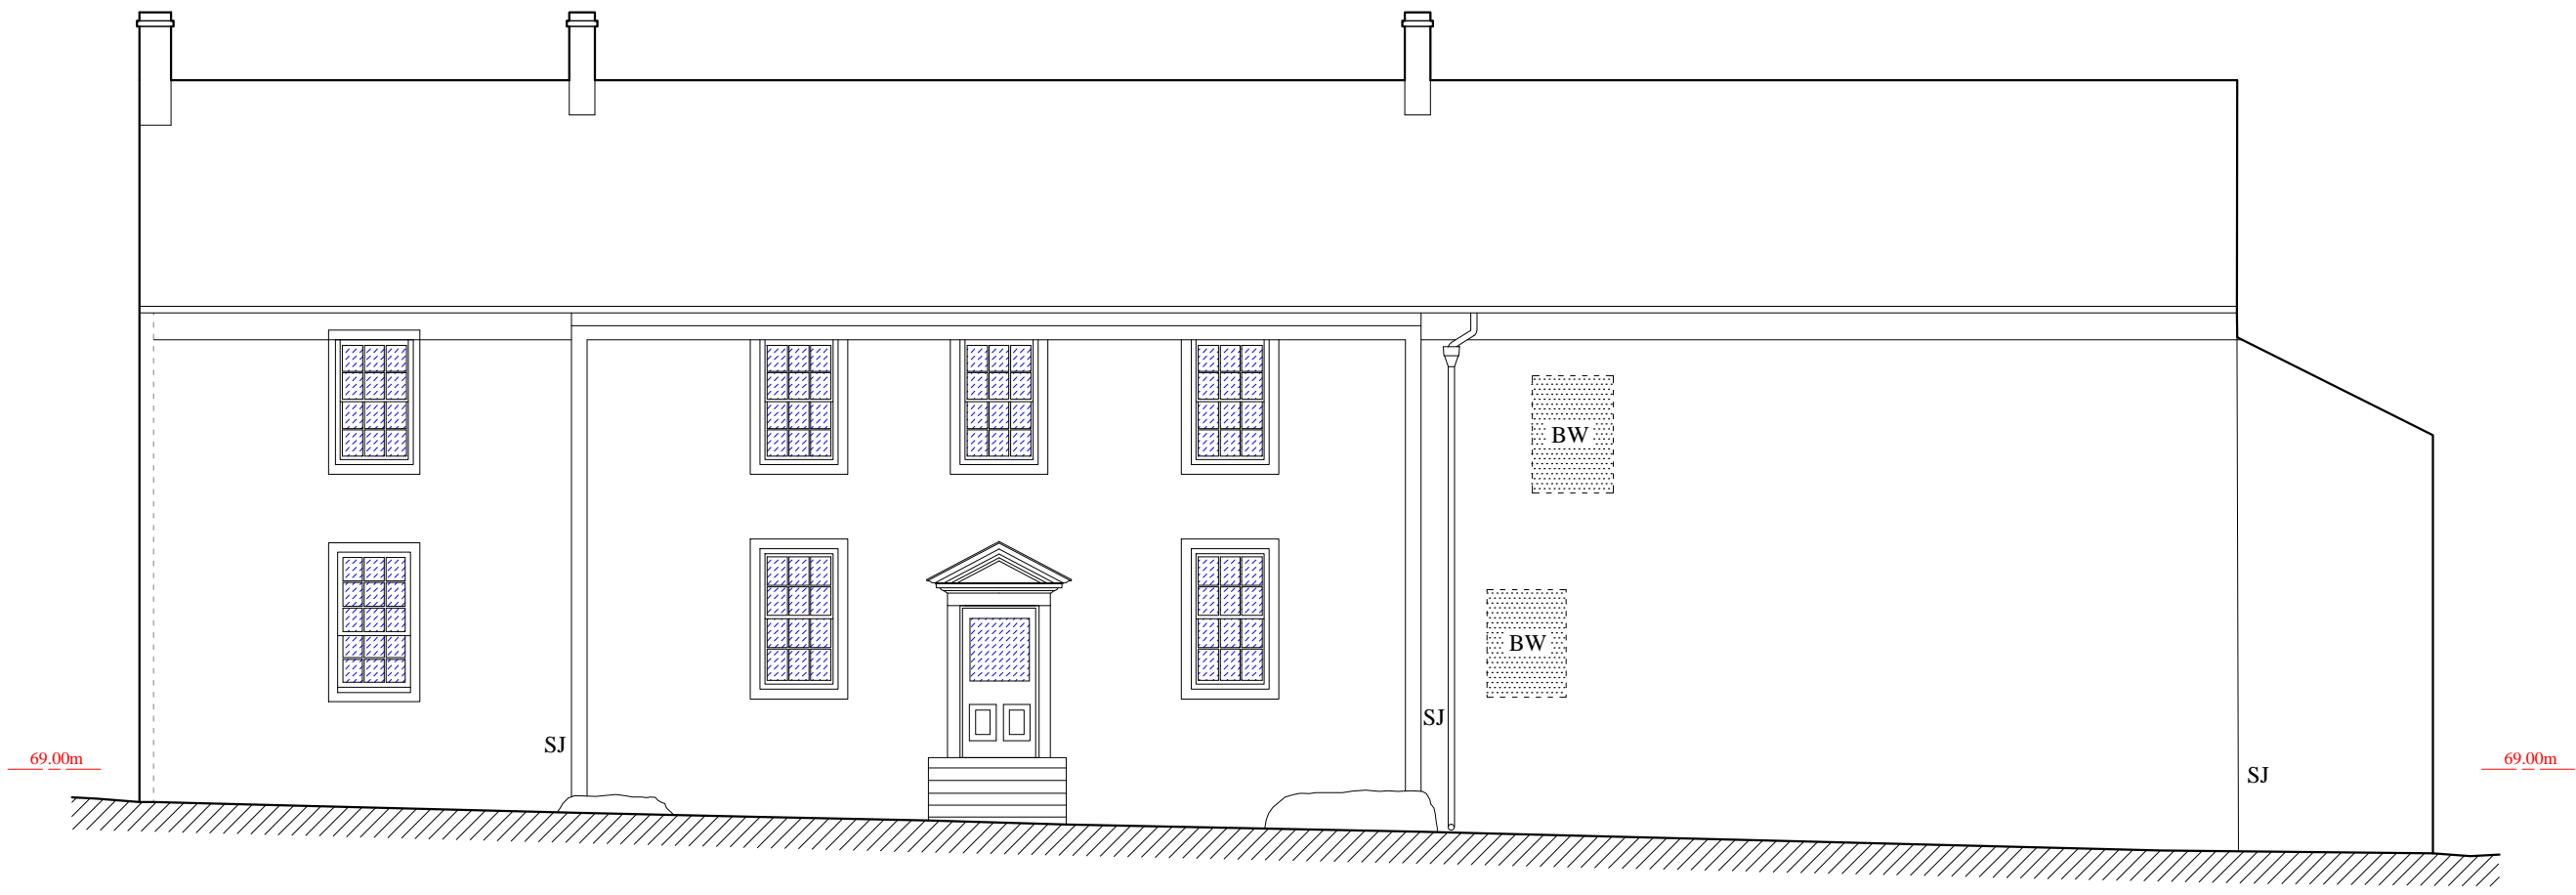
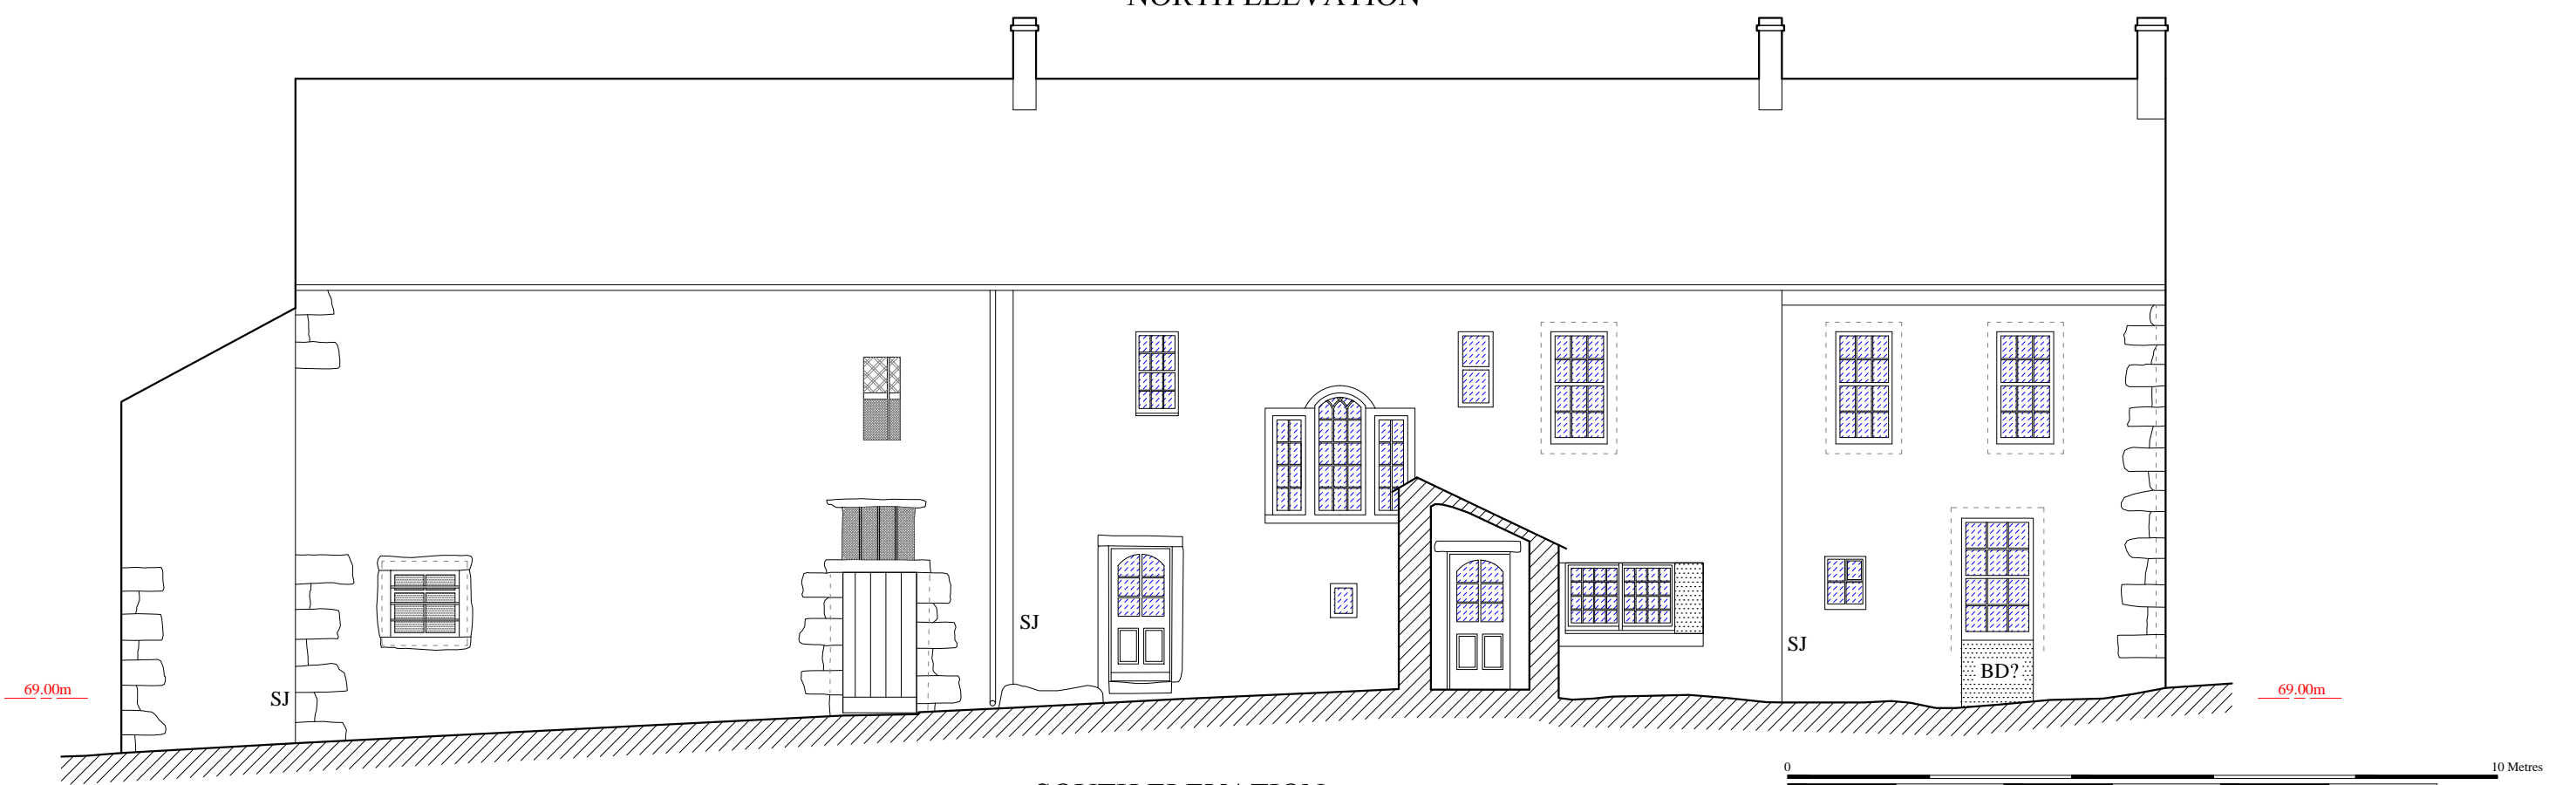
Sheet 3 of
 9 Sheets
Figure 39

Figure 39: House north and south elevations.

WEST ELEVATION

NORTH ELEVATION

SOUTH ELEVATION

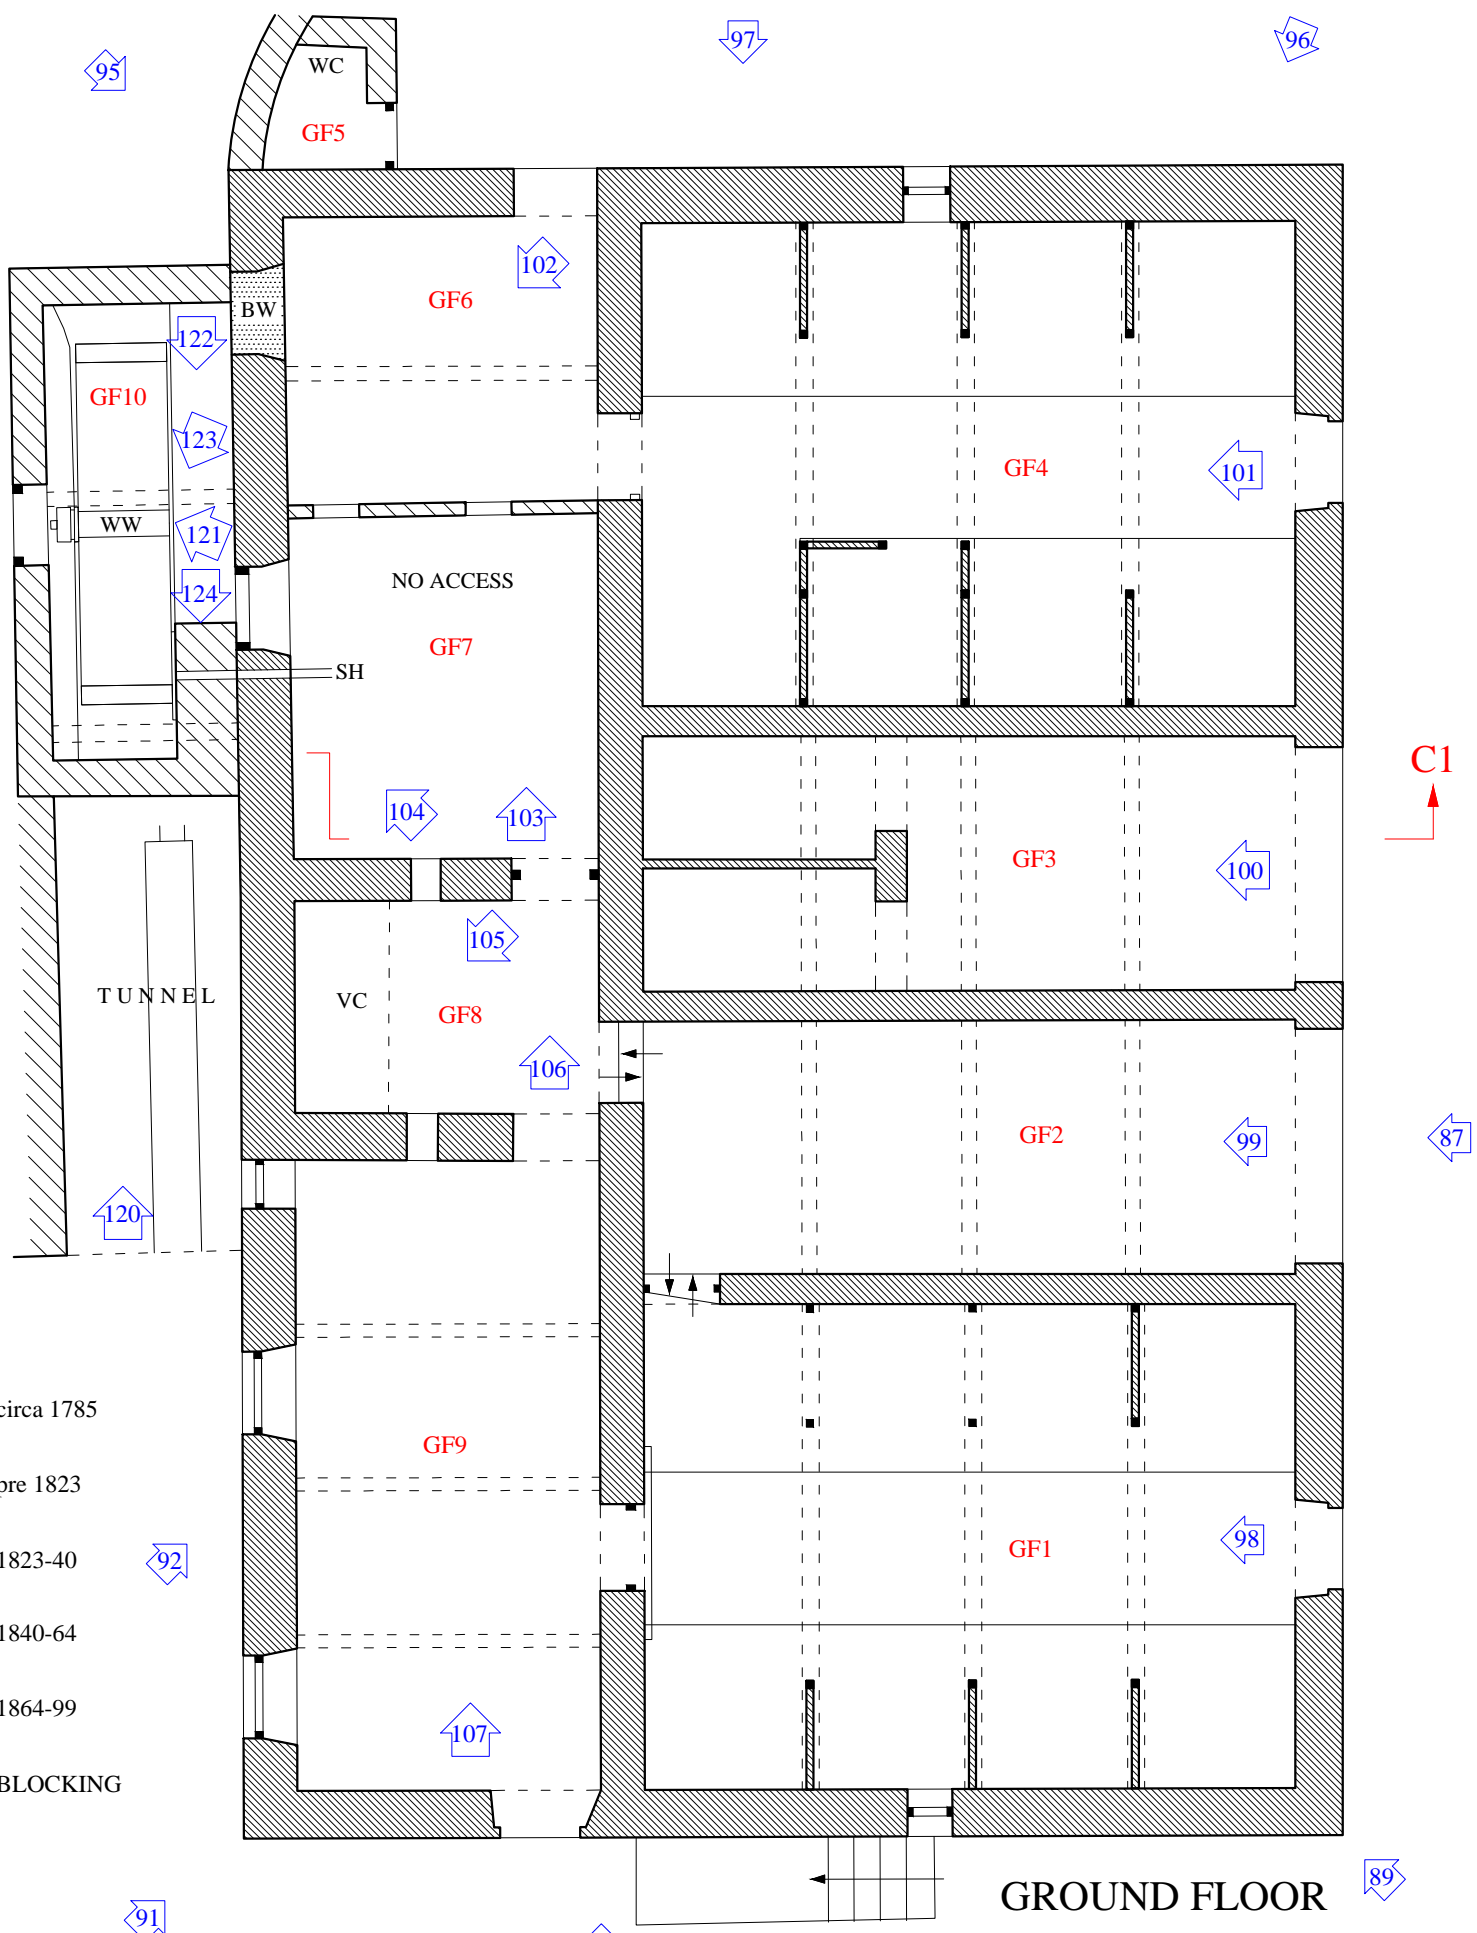
GROUND FLOOR

- circa 1785
- pre 1823
- 1823-40
- 1840-64
- 1864-99
- BLOCKING
