**GLEBE FARM AND BREWHOUSE,  
BRODSWORTH ESTATE, SOUTH YORKSHIRE**

**BUILDING RECORDING REPORT**

**REPORT NUMBER 2010/114**

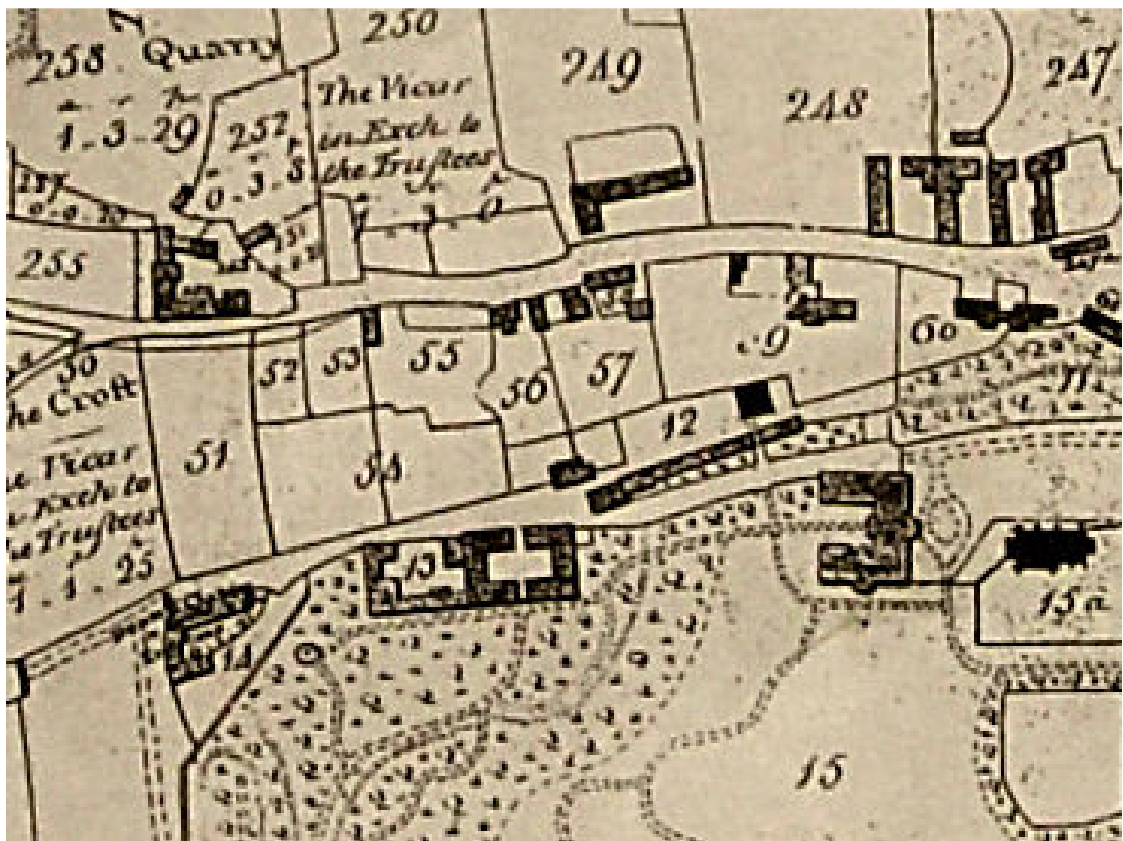
*Figure 2 Enclosure map of 1815-30. Glebe Farm is to upper left, Brewhouse immediately below number 9. Old Hall lies SE of Brewhouse and stables with enclosed yard to the SW*

The enclosure map of 1815-30 (Figure 2) shows west and south ranges at the farm and it is almost certain that this includes the existing barn. The south range is shown with a number of projections to its northern side and the western of these may even represent a walled area rather than a building. To the immediate north of the barn a wide building is present and this may be a predecessor to the extant single storey building in this location. An eastwards

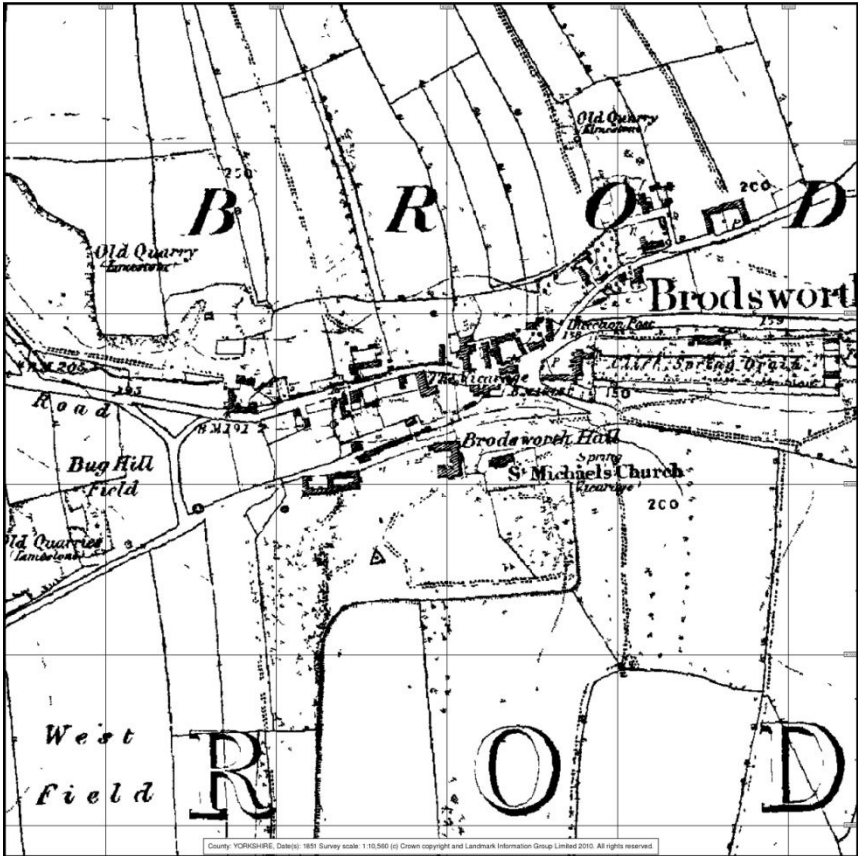
Figure 3 First edition O.S. map of 1851. Glebe Farm is to centre left, Brewhouse the small detached building immediately NW of the old Brodsworth Hall

A broadly similar picture is presented by the O.S. map of 1851 (Figure 3) though structures to the east side of the cart shed are shown whilst the east – west arm of buildings at the northern end of the western range had been removed by this date. There are also hints of a structure to the west side of the southern end of the barn. The O.S. map of 1906 (Figure 4) shows the farm with greater clarity. The western and southern ranges appear much as they are today although an apsidal structure is depicted butting up to the west side of the southern end of the barn, as is a rectangular structure immediately to the north of this. These structures are depicted with an outline of a broken line and appear likely to have been open-sided. On morphological grounds, the apsidal ended structure was almost certainly a horse engine. Buildings are still seen to be present to the eastern side of the cart shed as is the building to the south-east of this. The southern range is still shown with a northerly projection at its eastern end.

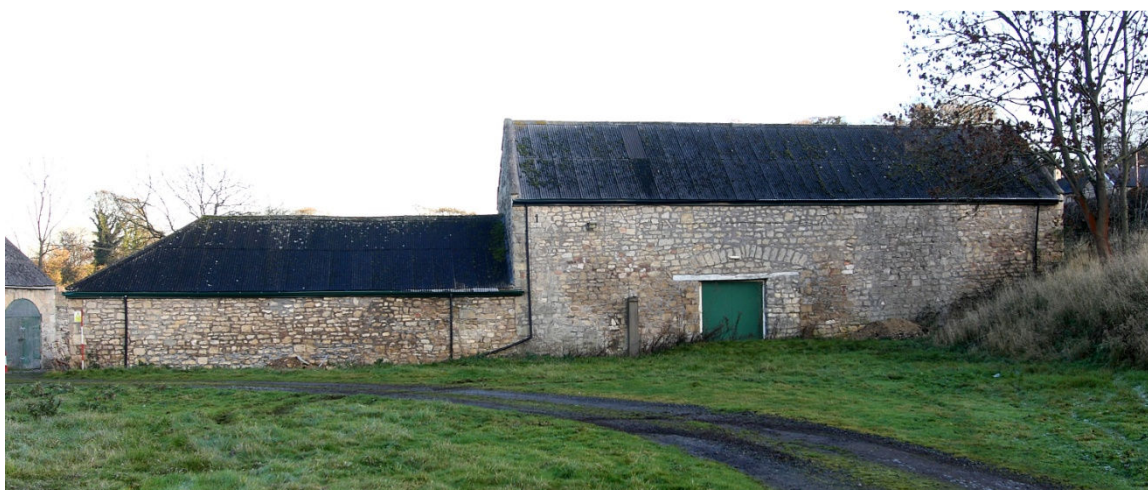
*Plate 1 Barn and extension of west range, looking E*

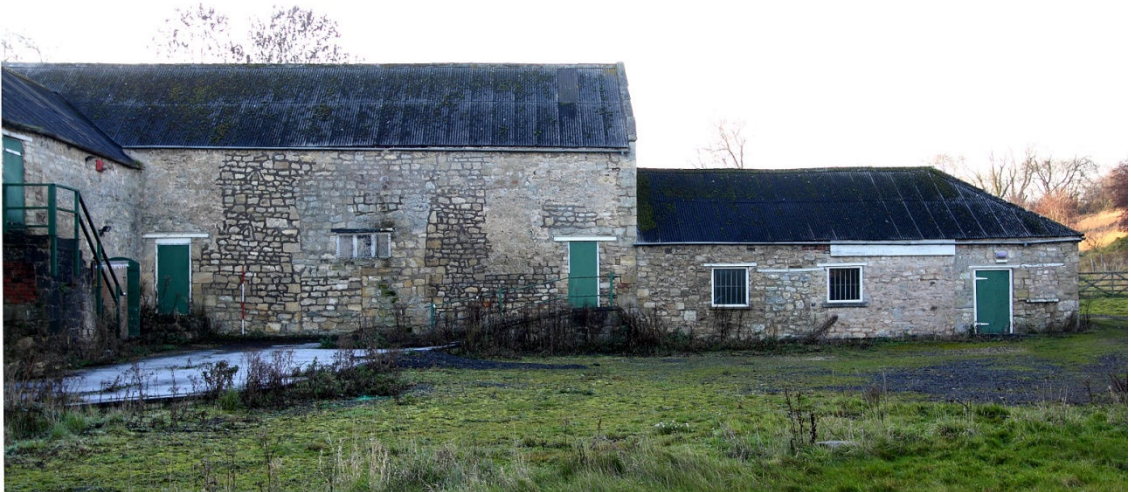
*Plate 2 Barn and extension of west range, looking W*

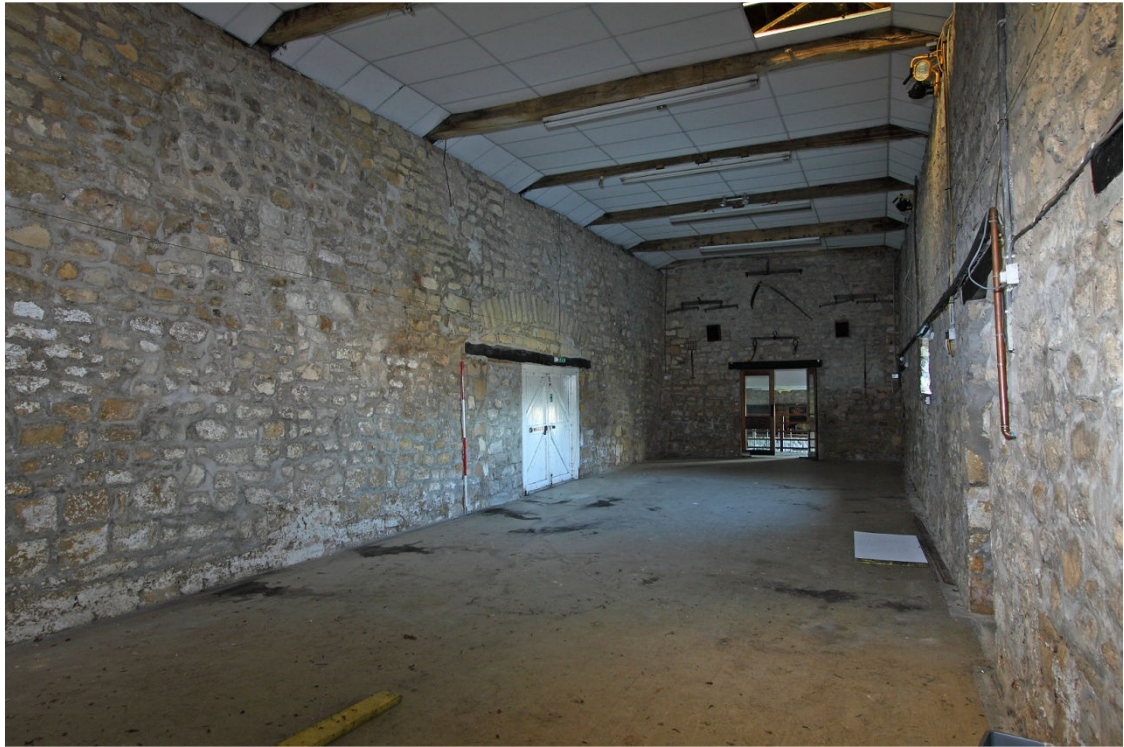
*Plate 3 Interior of barn, looking N*

The present floor of the barn is of concrete and there is a suspended ceiling of light metal framework and white fibreboard inserted at the basal level of the six roof trusses. Through small gaps in the suspended ceiling it was possible to gain glimpses of the gabled timber roof structure. The trusses were seen to be of king post type with angled side, or raking, struts. Two sets of butt-purlins, each staggered in relation to its neighbour, were present to each side of the roof. Each bore a tenon at either end which extended through the principal rafters and was secured by pegs. It was noted that there were four common rafters between each principal rafter. A ridge plank could be seen to be present in places, though not at the extreme southern end where the apex of the roof is supported by a pair of relatively light timbers secured to the upper side of the truss at high level. With the possible exception of these light timbers none of the visible roof timbers appeared to be machine cut. Some plastic guttering and downpipes are present to the east and west sides of the barn.

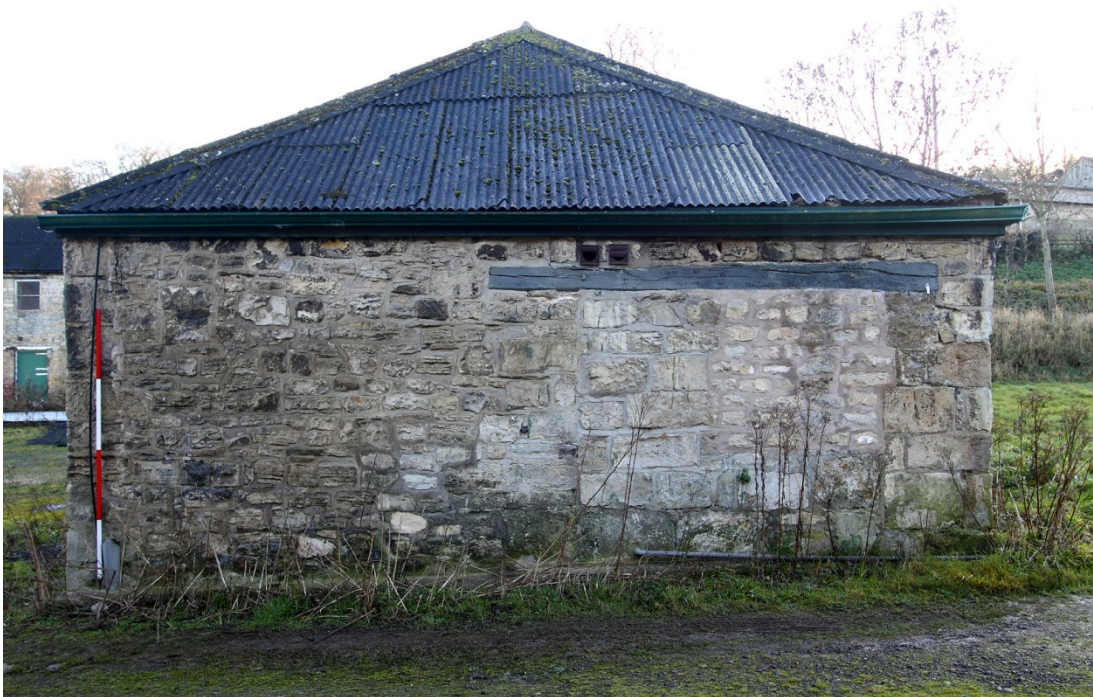
*Plate 4 North end of extension to west range, looking S*

the stonework in this building these walls at the northern end are heavily re-pointed in cement and it is difficult to form a judgement as to their age. These walls would not appear likely to form part of the original form of the building as they would have prevented the functioning of the wide doorway visible in the north elevation. They could however, relate to any point in time after this date and even be contemporary with the window that was inserted into the blocked up doorway. Immediately to the south of the two northern rooms is a modern bar servery.

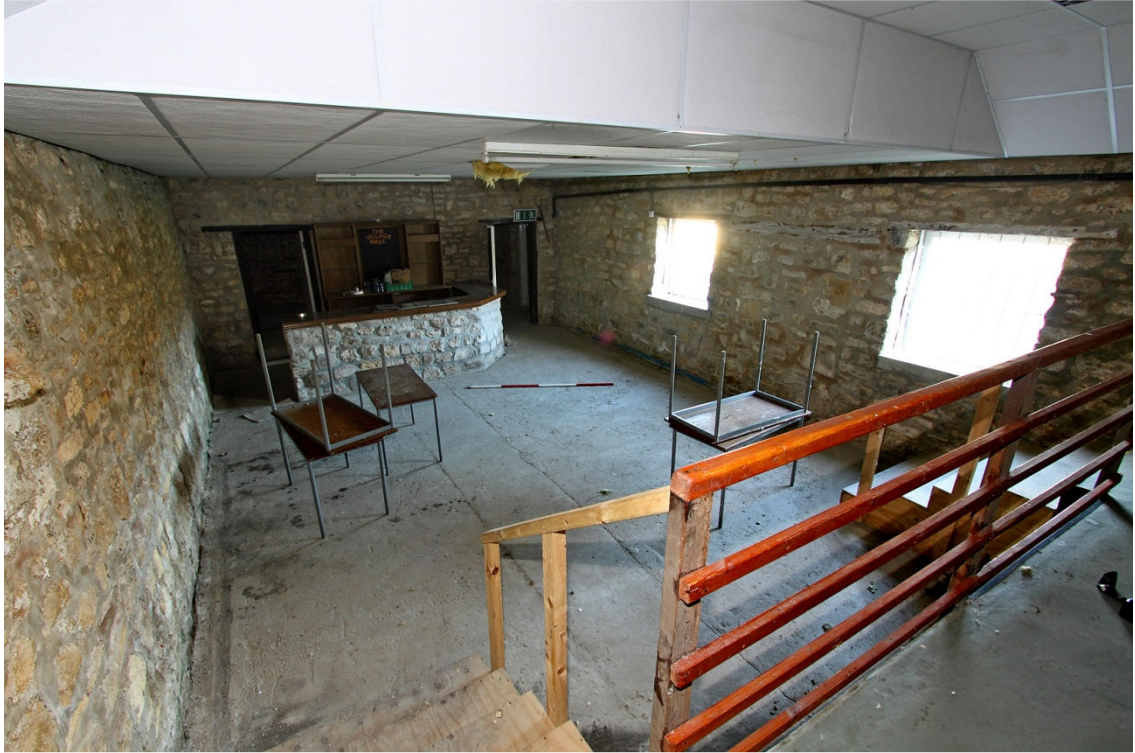
Plate 5 Interior of extension to west range, looking N

The function of this building is open to some uncertainty and interpretation is hampered by the removal of all original internal fixtures and fittings and the heavy re-pointing of the walls which may have obscured evidence for former sub-divisions. The large doorway on the eastern side suggests a cart shed/implement store rather than, for example, a cow shed. Glebe Farm was in all probability a mixed farm and may well have possessed a cow shed/s. Although none are now obviously present at the farm it is clear from the historic mapping that a number of the farm buildings no longer survive and one or more of these may have served as such.

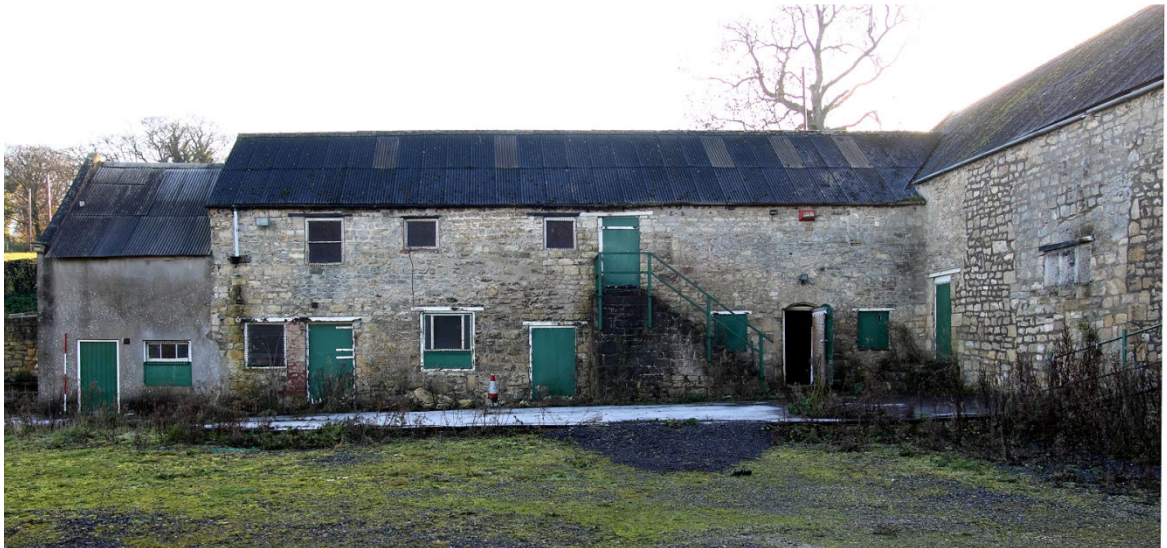
*Plate 6 South range, looking E. (infill building is immediately to left of taller barn)*

The earliest part of the existing south range is the two storey part whose western side lies in the vicinity of the external stone staircase and is here externally marked by quoining. A substantially rebuilt single storey block lies to the eastern end of this building and this was very likely constructed as part of the same building, albeit to a lower level. Although the lower eastern part of the building has a replaced gable end of brick and the north elevation is almost completely obscured by 20<sup>th</sup> century cement render it can be seen that the walling above the eaves is finished with quoins whilst that part below the eaves is not. Were the lower eastern part to be of a separate build such an arrangement would not be anticipated. The southern side of the building is built into the ground-slope and no windows or doorways are present to this elevation. Three doors and three windows are present to the ground floor of the north elevation and above this, three windows and a door (accessed via an external staircase of stone) to the first floor. A single doorway is present to the lower, eastern, elevation whilst internally there is a doorway leading from the western end into the later 'infill building'. Some guttering still survives to the north elevation, none is present to the south elevation. This building has been subject to considerable alteration and adaptation over the years and so its present appearance and arrangements are firstly described. This is followed by a consideration of the sequence of alterations that have produced its present form.

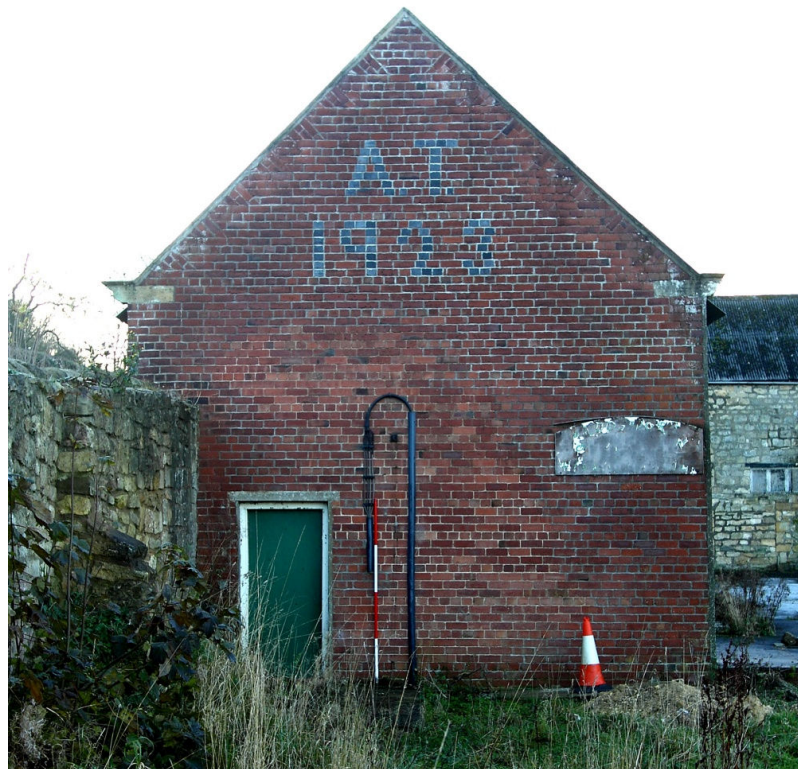
Plate 7 Rebuilt gable end of south range, note reuse of kneelers and coping, looking W

Although the lower eastern end of the building, with its brick gable end bearing the date 1923 (curiously with re-used kneelers, simple tumbling and stone gable coping) and cement rendering presents an appearance quite marked to that of the remainder of the building, it is almost certain that the two are contemporary. As has been noted above, this is pointed to by the use of quoins above the eaves level of the lower eastern end and the apparent continuation of the north and south walling between the lower and higher parts of the building. The first floor windows appear to be original features though they were probably once of greater height. Also part of the original layout was the high level doorway, now blocked up, at the west end of the building. This must have been accessed via an external staircase, presumably of stone. Given the width of the building such a staircase is likely to have descended down in a northerly direction and to have reached ground level a short distance beyond the building itself. Also part of the original arrangement of this building was a hipped roof at its west end. The evidence for this is provided by the addition of a thin walling of brick at, and above, eaves level atop the thicker wall of stone below. Originally then, the roof at this west end will have sloped down from the western truss to the top of the stone walling. The brickwork suggests that this may have happened in the later 18<sup>th</sup> century and presumably coincided with the infilling of the gap between this building and the barn. The rationale for this alteration to the roof will have been the requirement for a roof to run continuously up to the barn. This arrangement then, argues for the existing exterior staircase and the first floor doorway at the head of the stairs, being a later arrangement. At ground

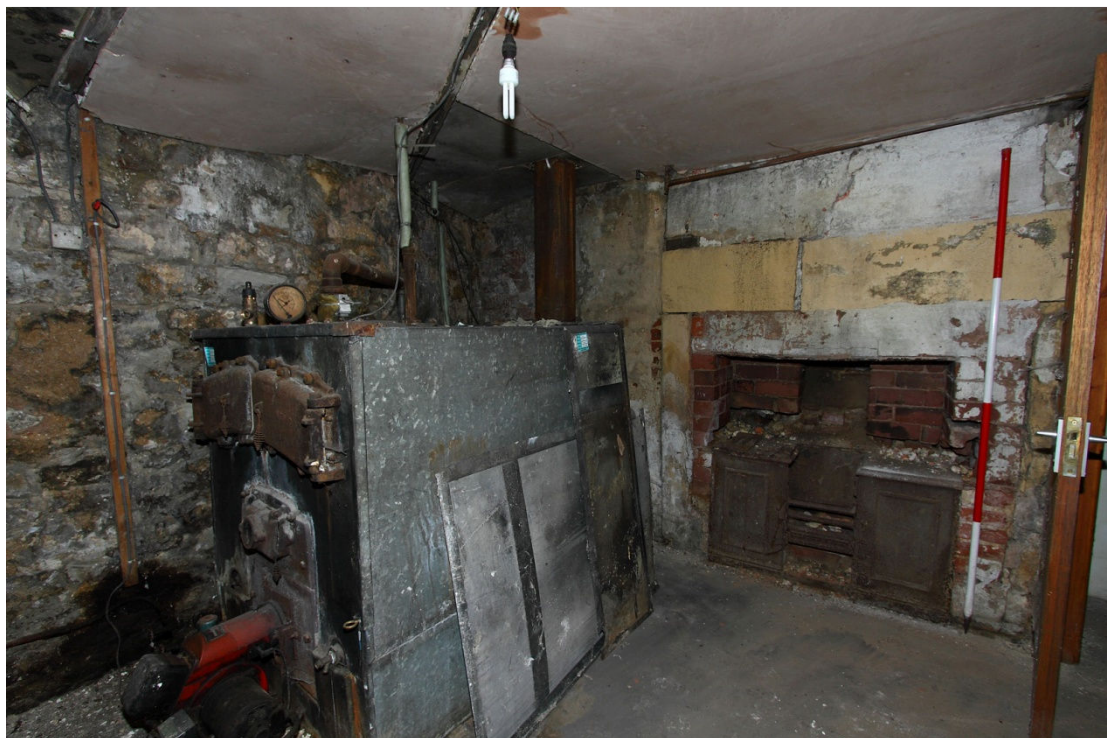
Plate 8 Boiler room of early building of south range, note succession of fireplaces, looking E

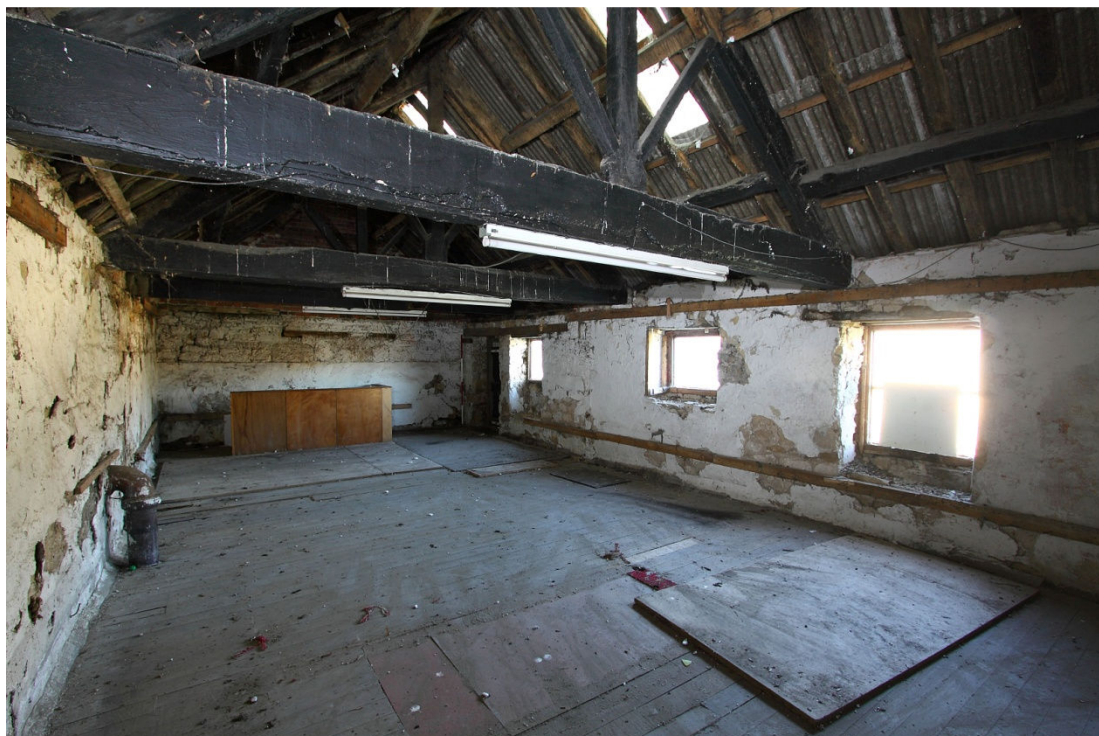
Plate 9 First floor of original building of south range, looking W

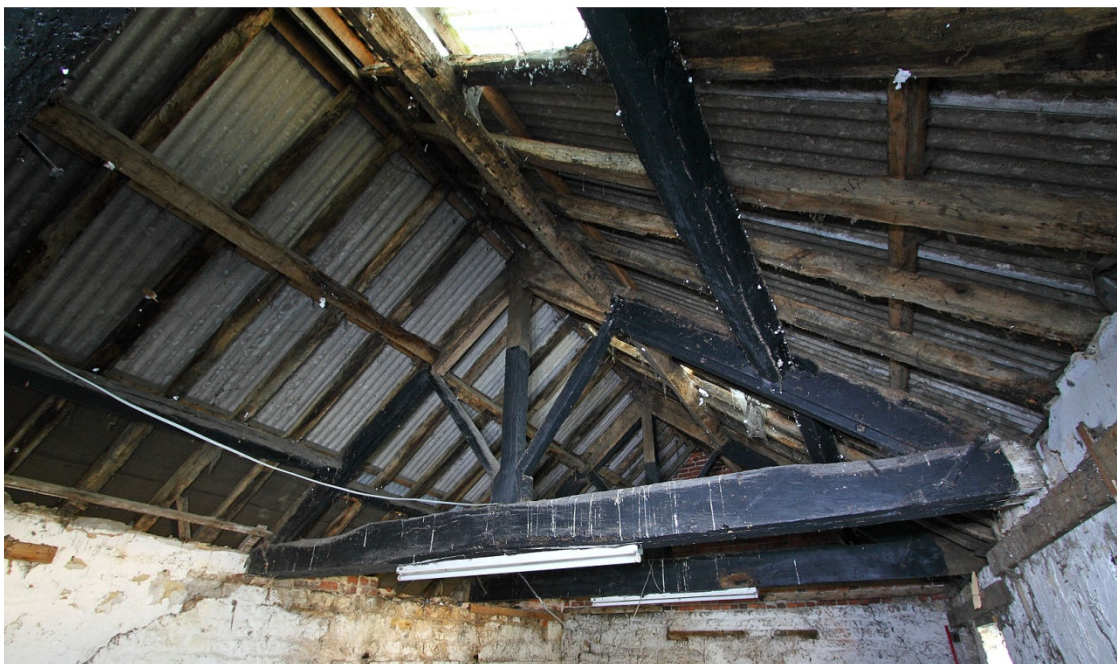
Plate 11 Painted roof truss of original building of south range, looking W

The roof of the large space is formed of three trusses of king post type with raking side struts. All three trusses have iron strap-work at the point of junction between the tie-beam and king post. It was noted that some of the principal rafters have chamfers on one side and a rebate on the opposite side. This may be evidence for re-use of materials rather than some in-situ arrangement to the roof. There are two, staggered sets of butt-purlins to each side of the roof and a central ridge plank. At least four of the purlins bore various notches indicative of re-use. There are five common rafters to each side of the roof between each truss. None of the roof timbers appeared to be machine sawn, excepting the roofing battens seated directly above the rafters. It could be seen in a few places that the trusses were seated on a

timber wall plate atop the walls. In most places the wall plate was obscured by three courses of later brickwork that had been added to the top of the inner face of the walls – possibly as an attempt at draught minimisation? It was noted that the roof timbers had been painted black up to the point of the tops of the raking struts and left unpainted above this level. Traces of white polystyrene tiles were also apparent at the interface of the painted and unpainted areas. This would seem to indicate that a modern ceiling with polystyrene tile finish had been inserted that coincides with these levels. The only visible assembly marks were Roman numerals to the lower end of a principle rafter and tie-beam. That none could be discerned elsewhere is likely to relate to the later painting of the trusses and an accumulation of grime.

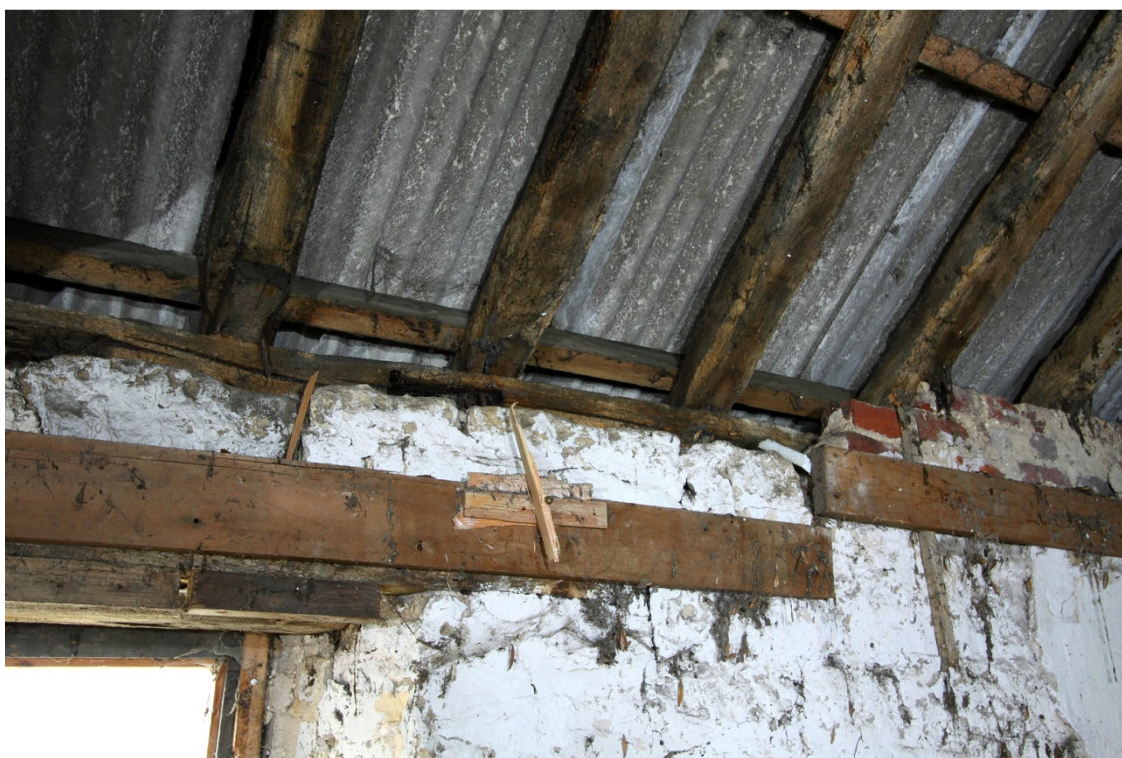
Plate 12 Rafters of original building of south range resting on wall plate, looking N

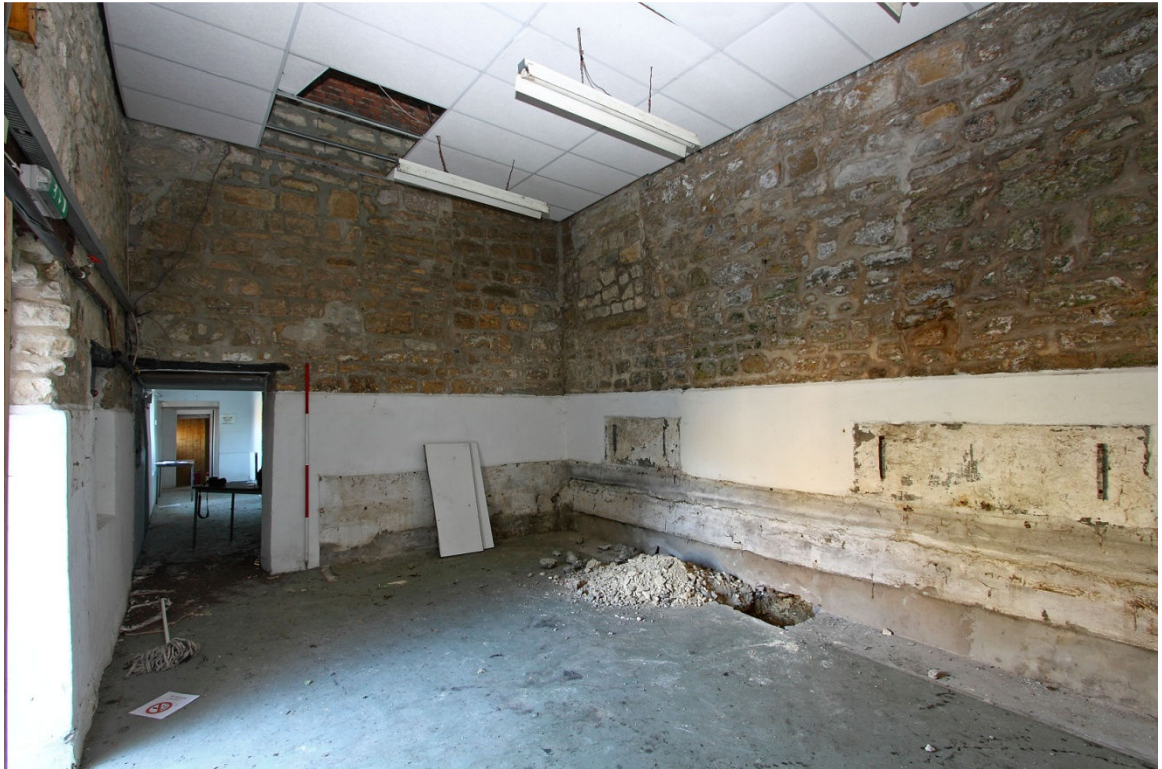
*Plate 13 Infill building of south range, looking E. (Note blocked openings to right)*

This infill building is roofed at the same height and pitch as the original south range building. This was accomplished simply by the removal of the former hipped end and the extension of the roof to that of the barn (whose roof is at a slightly higher level) where carpentry of somewhat greater complication will have been required. Only a very restricted part of the roof structure was visible in a gap in the suspended ceiling, though enough to see that the roof trusses and purlins were of the same, or very similar, pattern to those of the original south range building. It is thought that there are probably two trusses spanning this infill building. There is no evidence, in the form of scars or other indicators in the fabric, to suggest that this building ever possessed a first floor, indeed the height of the openings in the south wall would also argue against this.

Interpretation of this building is again hindered by the absence of internal features and fittings. The absence of a raised floor, or indeed a first floor, would argue against storage of grain, and probably even hay given the relative absence of ventilation. It is most likely that the building housed either horses or cattle.

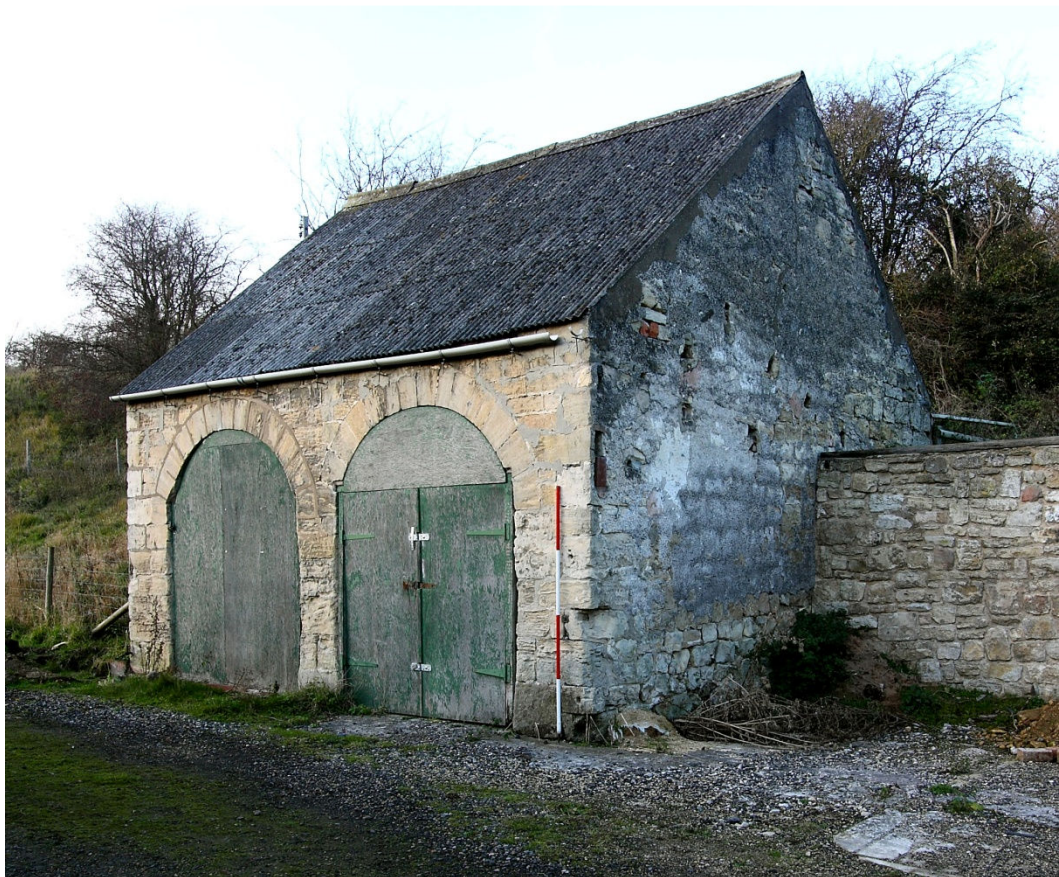
*Plate 14 Cart shed with dovecote over, looking NW. (Note roofline of former structures in gable end to right)*

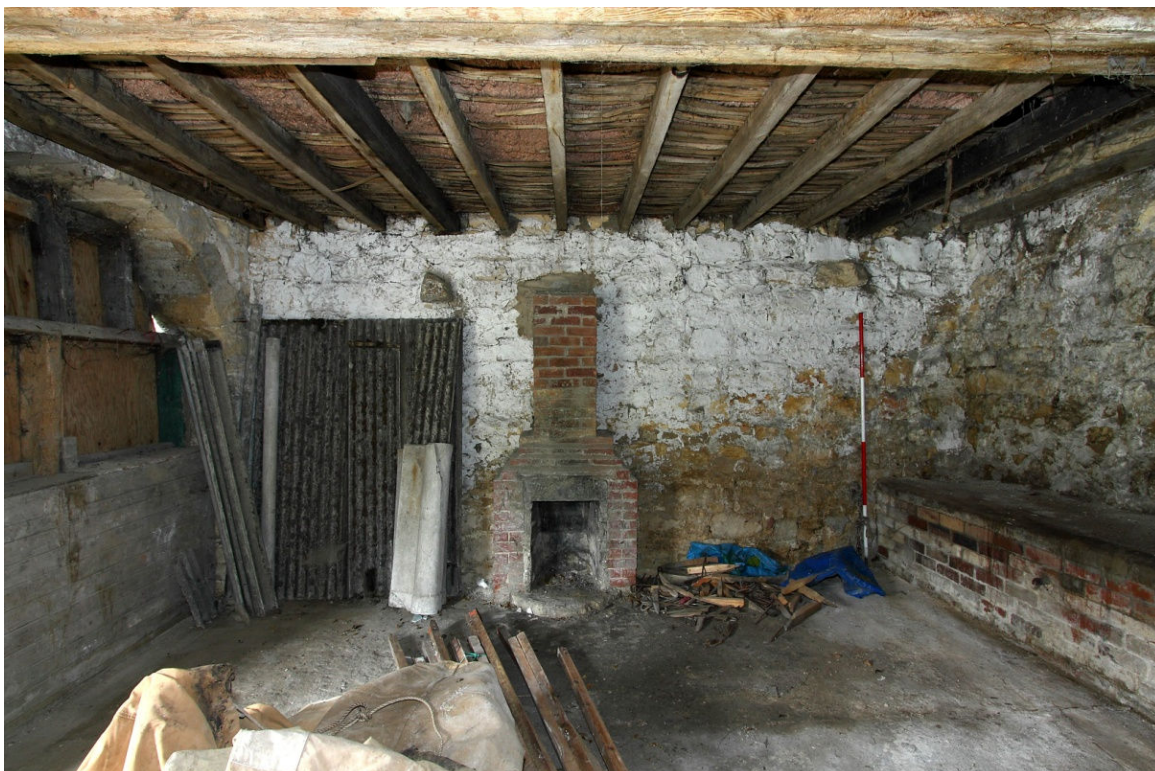
Plate 15 Interior of cart shed with inserted fireplace and plinth, looking W

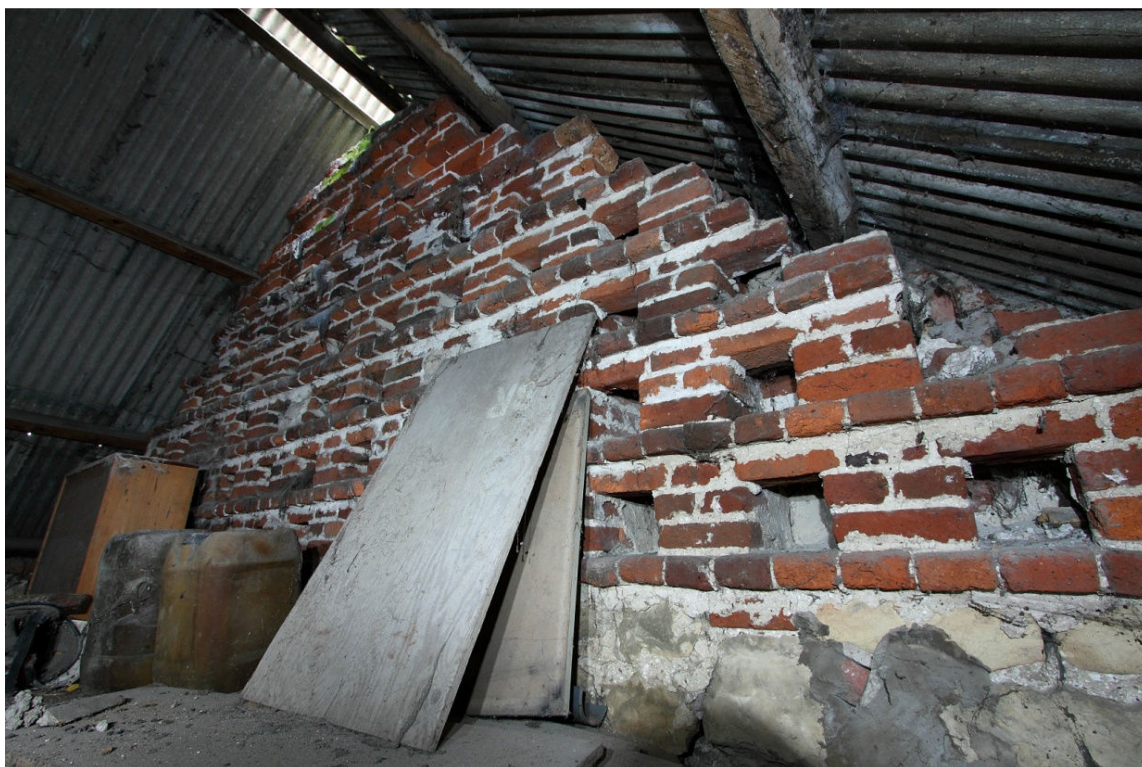
Plate 16 Nesting boxes of dovecote in west gable wall, looking SW

The roof of the cart shed/dovecote had a single truss of king post type with raking side struts, the timbers of which all appeared to be machine sawn. Two purlins, of back purlin type secured by cleats, were present to either side of the roof. No common rafters were present. The northern principal rafter bore two mortises, presumably originally for butt purlins, though the southern principal rafter bore none. These irregularities suggest the likelihood that some of the roof timbers are reused, and that the roofing arrangement, as it presently exists, is

likely to be a 19<sup>th</sup> or 20<sup>th</sup> century replacement cobbled together from pieces of earlier roof timbers. The existing roof structure would not permit ingress or egress of doves and clearly there must have originally been some arrangement for this. Most commonly this access was achieved via the use of a 'glover', an open sided structure on the ridge, or by a dormer.

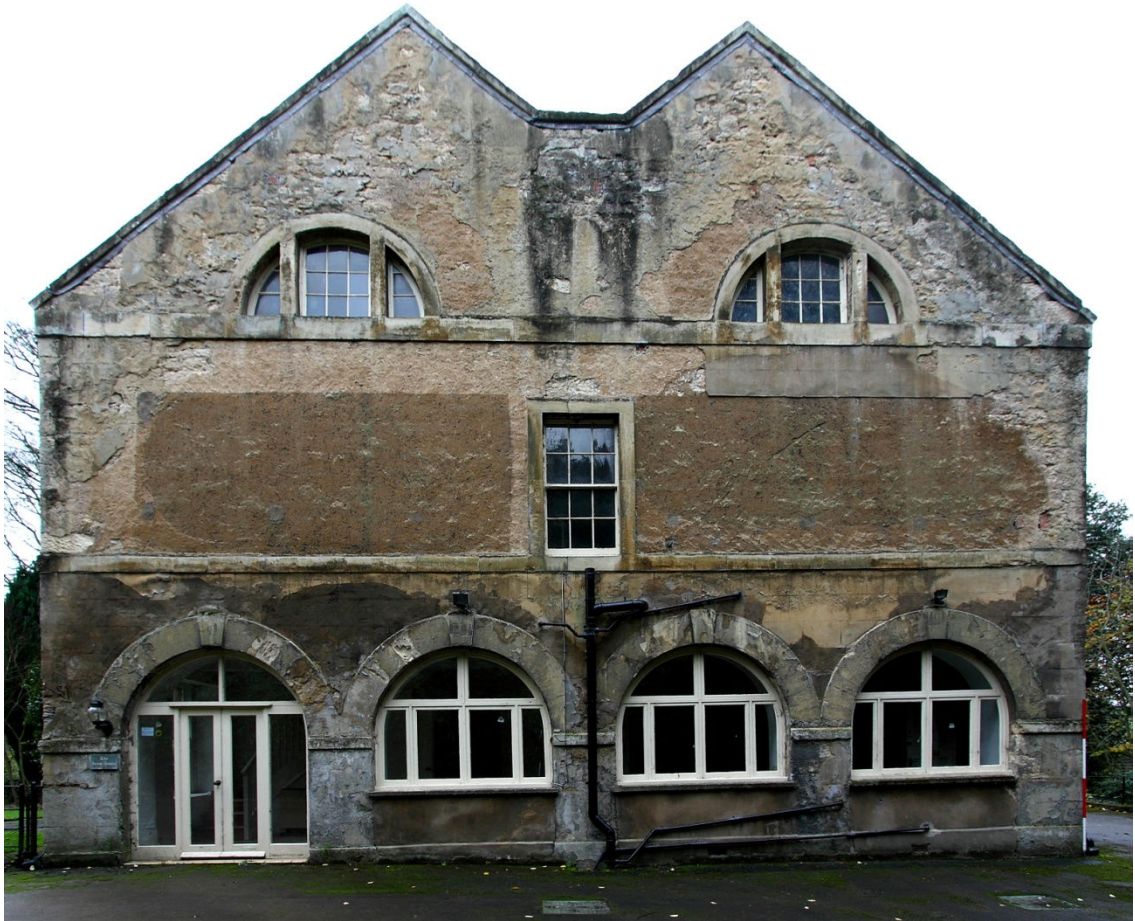
*Plate 17 S elevation of Brewhouse, looking N*

Facing directly onto the estate road, this elevation forms the main, or front, façade of the building. The exterior is mortar rendered with some much more recent cement render with incised lines in places. In a few small areas the render has fallen away and the coursed limestone is exposed. The ground floor is occupied by four round arches with an impost band and projecting keystones. The western of these archways contains a 20<sup>th</sup> century door with glazing above and to the sides. The remaining arches have been infilled in their lower parts whilst the upper parts are occupied by 20<sup>th</sup> century casements with concrete sills. There are

two further projecting bands, or string courses, one at first floor level, the other at attic/eaves level. The first floor has one centrally placed twelve pane sash window with projecting surround. To the attic are two Diocletian windows. There is lead sheathing to the roof coping and a variety of black plastic plumbing pipes to the lower eastern part of the elevation. There are two chimney stacks of mortar rendered brick. One of these, with four pots, is located in the roof valley, the other, with one pot, to the eastern ridge of the roof.

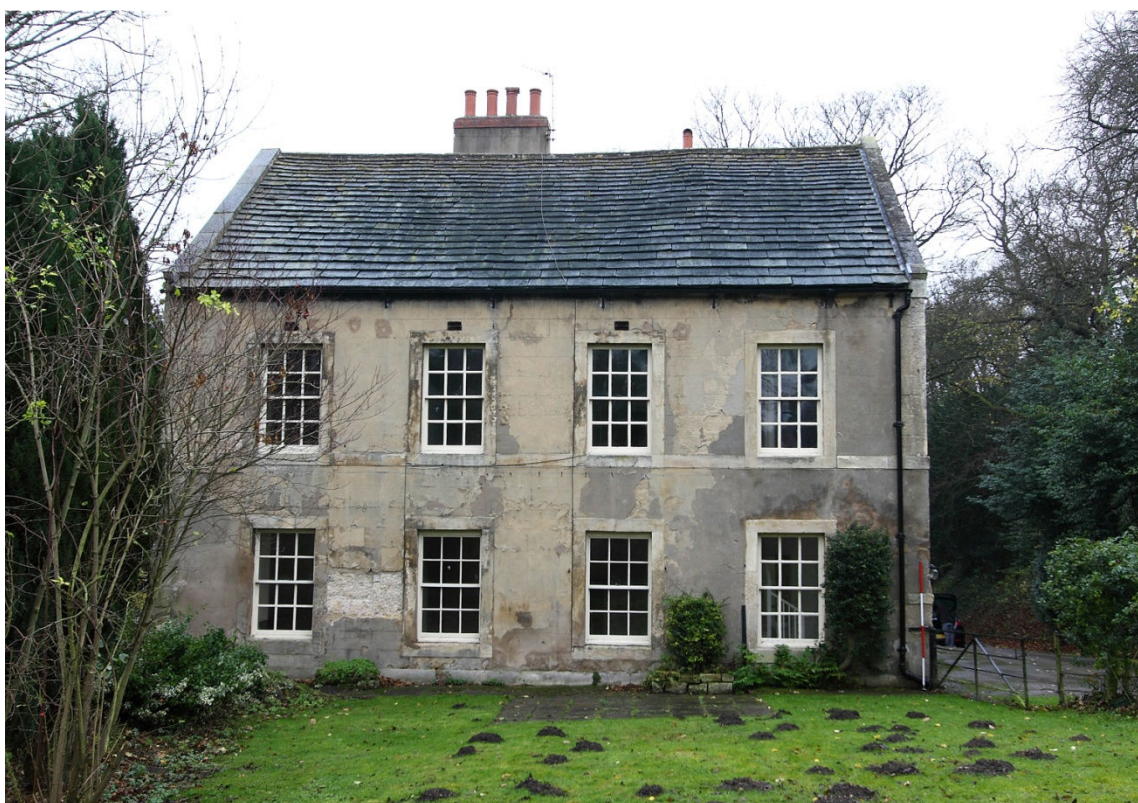
*Plate 18 W elevation of Brewhouse, looking E*

This mortar rendered symmetrical elevation faces directly into a small garden area on the west side of the Brewhouse and the only openings are windows. Four large twelve pane sash windows are present to the ground floor with a further four, of identical pattern, directly over to the first floor. All windows have a projecting surround. Three iron vents sit directly over the northern three windows of the first floor. Also to first floor level is a band, or string course; this being a continuation of that to the south elevation. At eaves level there is a cast iron rainwater gutter which feeds into a downpipe at the south side of the elevation.

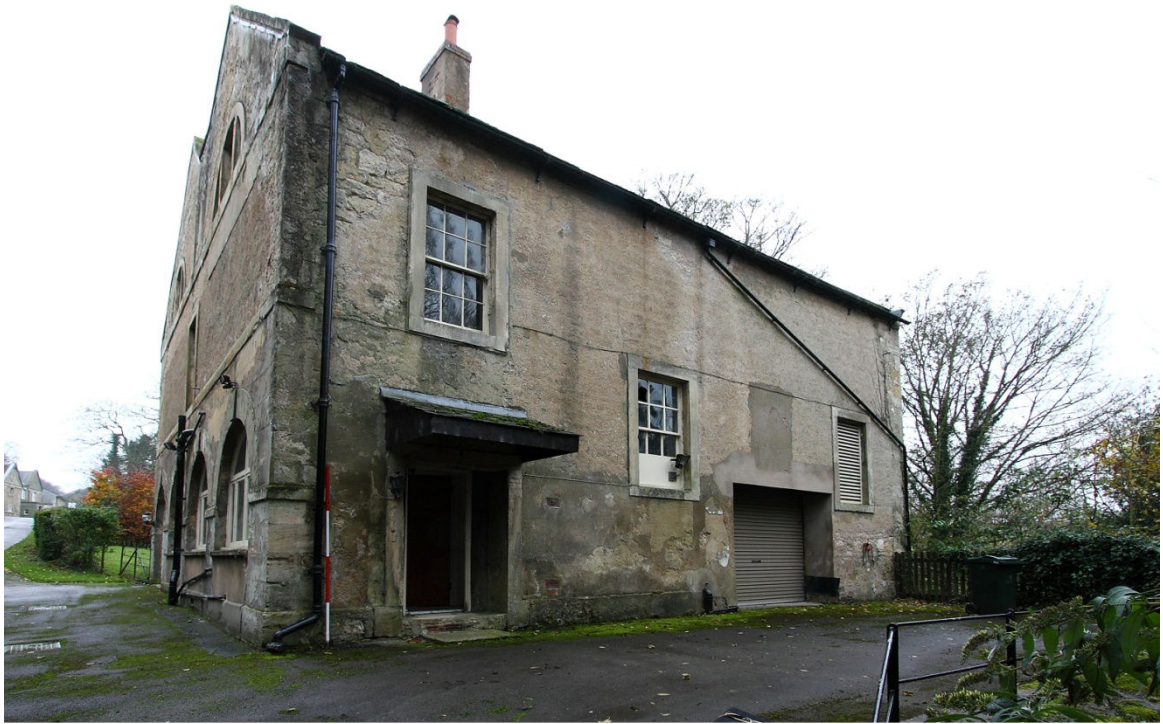
*Plate 19 E elevation of Brewhouse, looking WNW*

Perhaps more than any of the other elevations the east elevation highlights the working character of this building. To the ground floor, towards the south of the elevation, there is a doorway with stone surround. The wooden panel door is of 20<sup>th</sup> century date, as is the wooden framed hood with slate covering over the doorway. Behind this elevation the northern portion is occupied by a large room that extends fully from the ground floor up to first floor ceiling level. As a result of this arrangement, there are three windows were set at an intermediate height. The southern of these still contains its vertical sash window. The northern window has been replaced by a wooden louvre whilst the middle example has been completely blocked up. The southern and northern windows still retain their stone surrounds. A similar surround is likely to have been present to the central window though this is no longer extant. A large modern roller door of later 20<sup>th</sup> century date has been inserted in the area of the blocked middle window and provides vehicular access to the large full height room. A first floor window with stone surround is present above the doorway. Like the other vertical sash windows in the Brewhouse this is of twelve panes. External plumbing to this elevation is a combination of cast iron and black plastic pieces.

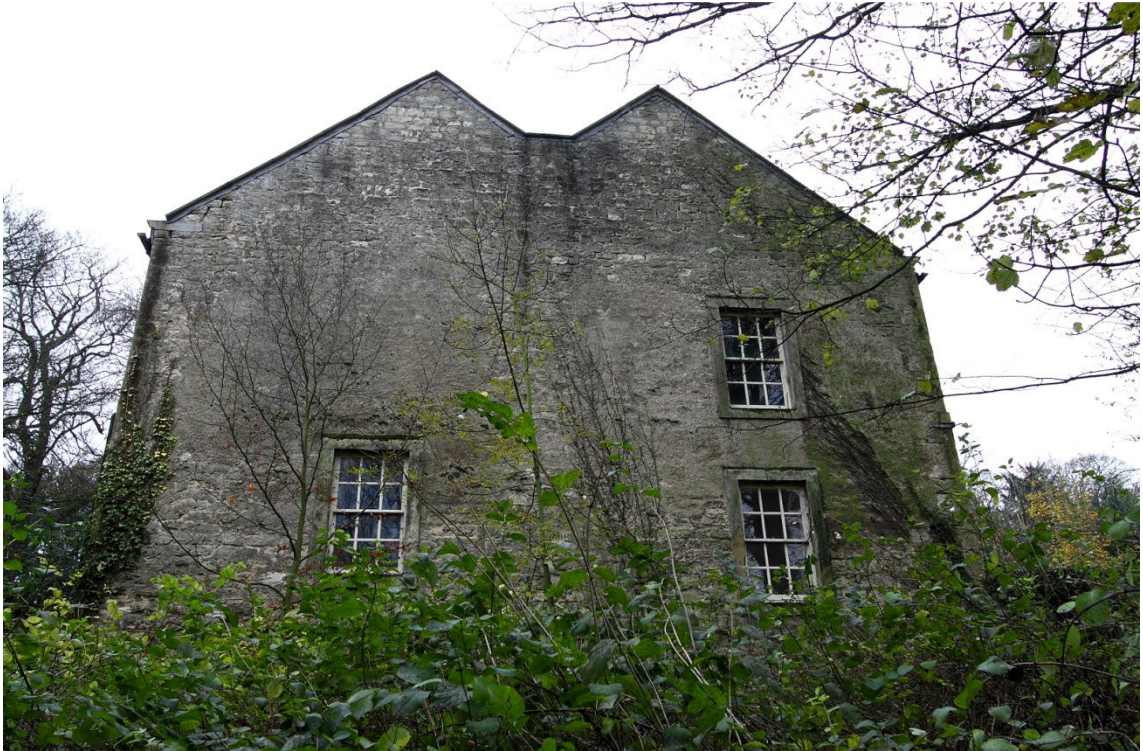
*Plate 20 N elevation of Brewhouse, looking S*

This is the plainest of all the elevations. There is a twelve pane vertical sash window with stone surround to the western side of the elevation at ground floor level, with an identical example directly above at first floor level. A further identical window is also present at an intermediate height in the eastern part of the elevation. This intermediate height window is located in the tall 'full-height' room. There is a projecting horizontal string course at a height immediately below the level of the ground floor window. Kneelers are present to both sides at eaves level – but only to this elevation.

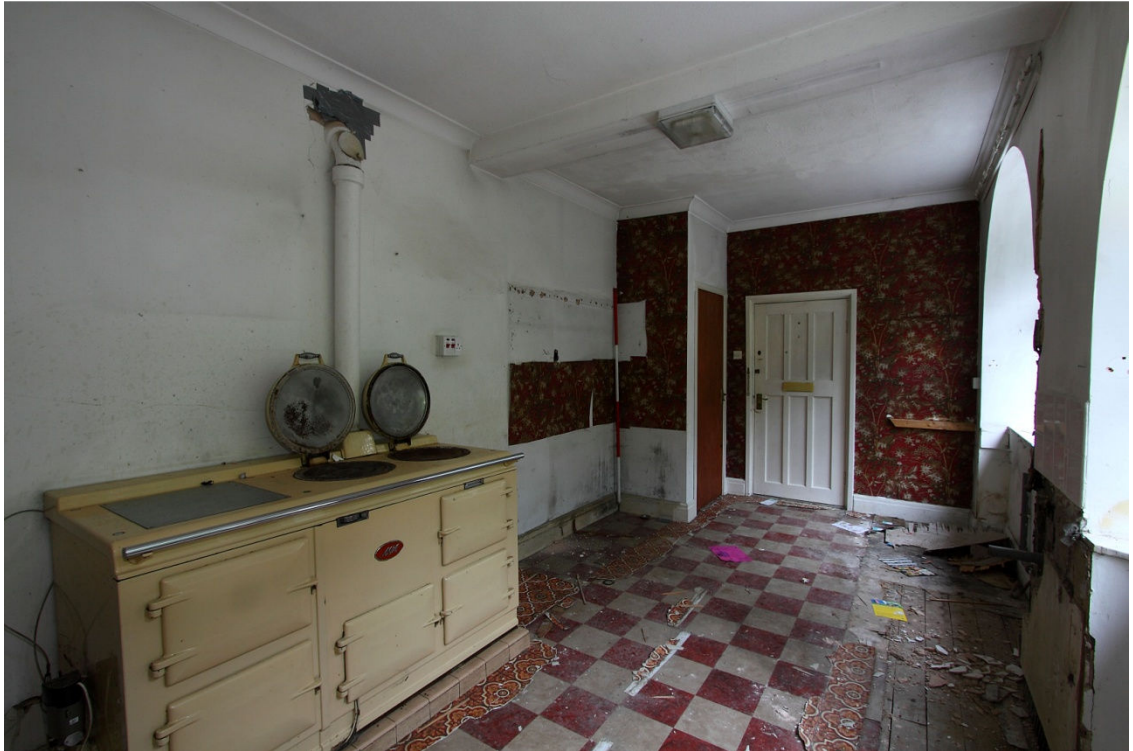
*Plate 21 Brewhouse kitchen, looking E*

The doorway to the east elevation leads into what is now a kitchen. Nearly all kitchen fittings, save for an Aga cooker against the north wall, have been removed. All lighting is provided by windows to the two arches of the south wall. The pine floor boards have been covered with linoleum like materials. To the west side of the kitchen a timber stud wall with central doorway leads to a hallway.
