**GLEBE FARM AND BREWHOUSE,  
BRODSWORTH ESTATE, SOUTH YORKSHIRE**

**BUILDING RECORDING REPORT**

**REPORT NUMBER 2010/114**

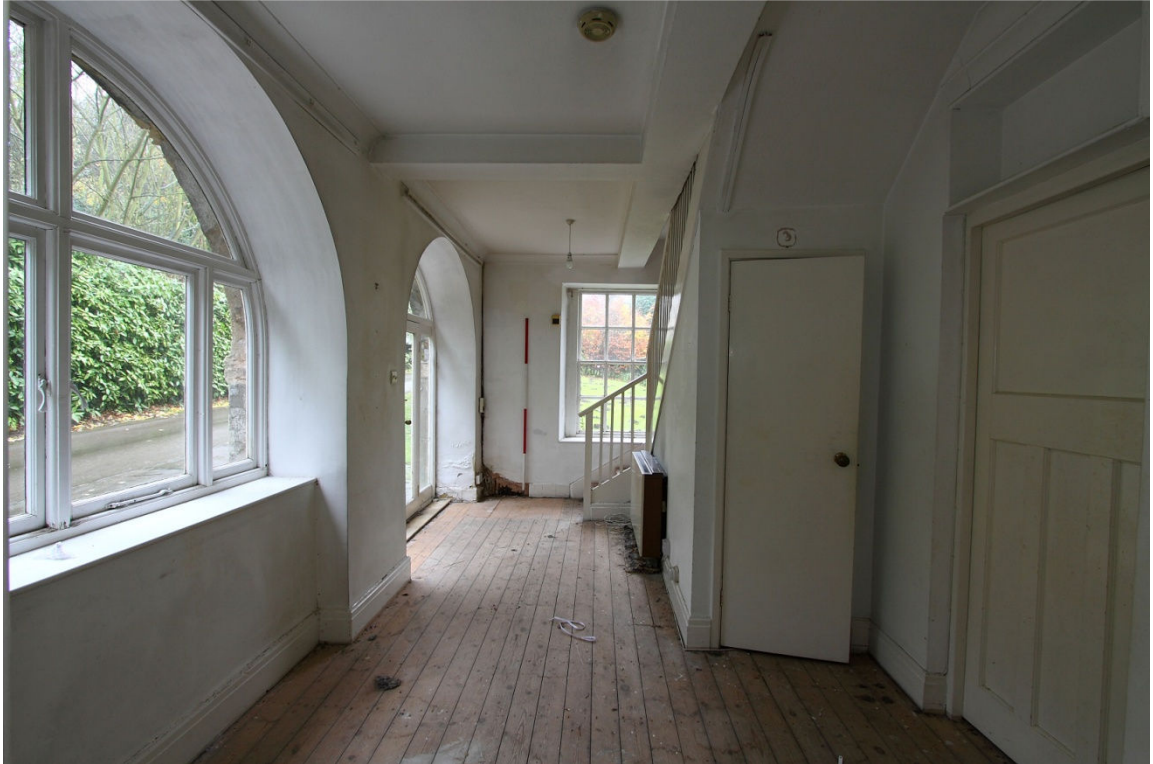
*Plate 22 Brewhouse hallway, looking W*

Access into the hallway internally is via the kitchen and externally via a doorway in the western arch of the south wall. The room is lit with two windows to the arches of the south wall and with a window to the west wall close to the foot of the staircase. The plain wooden staircase with simple square section newels and spindles has three steps leading to a half landing with a straight flight of twelve further steps to the first floor. This staircase, which has under-stair storage accessed by a door to the east side, is of 20<sup>th</sup> century date and probably replaces an earlier example in the same location. A doorway through the eastern end the north wall of the hallway leads to the large living room.

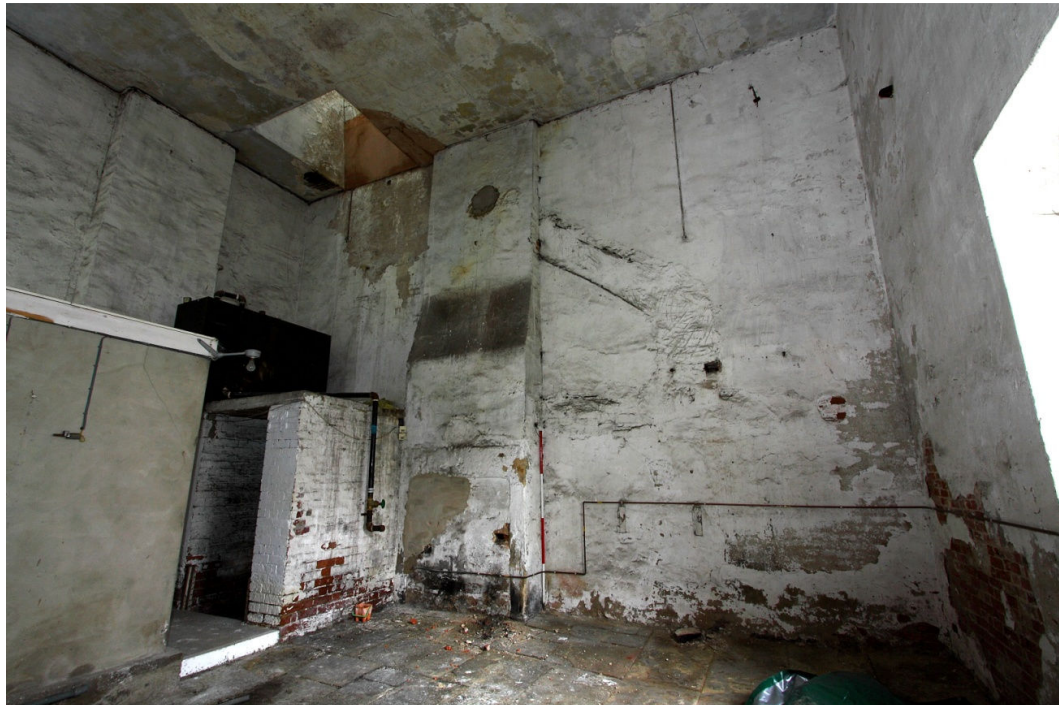
*Plate 24 W wall of Brewhouse interior, looking W. Note tapering hood to upper left, blocked up fireplace and scar of old flue to right of extant flue. Small pulley wheel is present to upper walling to right and to left of this a high level iron fitting.*

room where a flue, smaller than that of the large flue to the west wall, is evident. If this was so then the brick blocking up and successive layers of whitewash have masked its recognition. Until recently the Aga in the kitchen utilised this flue.

The blocking up and removal of fireplaces, insertion of solid fuel stores, a bathroom and garage door together with the apparent stripping out of other early features has resulted in much of the original arrangements of the brewhouse, and later still, the laundry, being lost. Nonetheless, a few small parts of items of earlier arrangements are evident. To the upper eastern part of the south wall a square section wooden feed pipe can be seen to enter the room from the area of what is now bedroom 1 of the first floor. Below this truncated feed pipe three iron mountings are evident to the wall. These suggest that after this square section feed pipe entered the room it led downwards into the working area of this space. Affixed at a high level to the southern end of the eastern wall is a single, isolated iron hook, whilst to a high level in the northern part of the west wall is a bent iron rod. A small pulley wheel held by an iron mounting is also evident at a high level towards the western side of the north wall. Finally there is also a small network of small diameter metal piping at a high level to south, west and east walls. It was not possible to gain direct access to these pipes which appear likely to have fed water rather than gas.

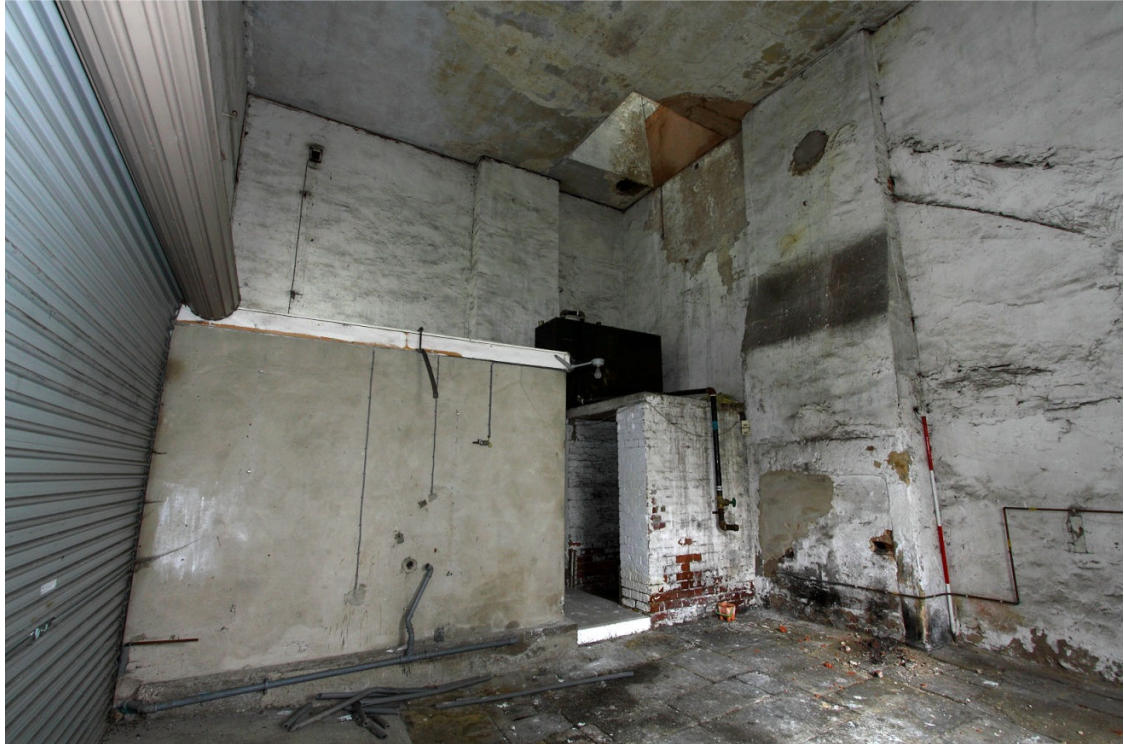
Plate 25 W and S walls of Brewhouse interior, looking SW. Note inserted garage door and bathroom to left. Square section wooden pipe with fitting below in upper left.

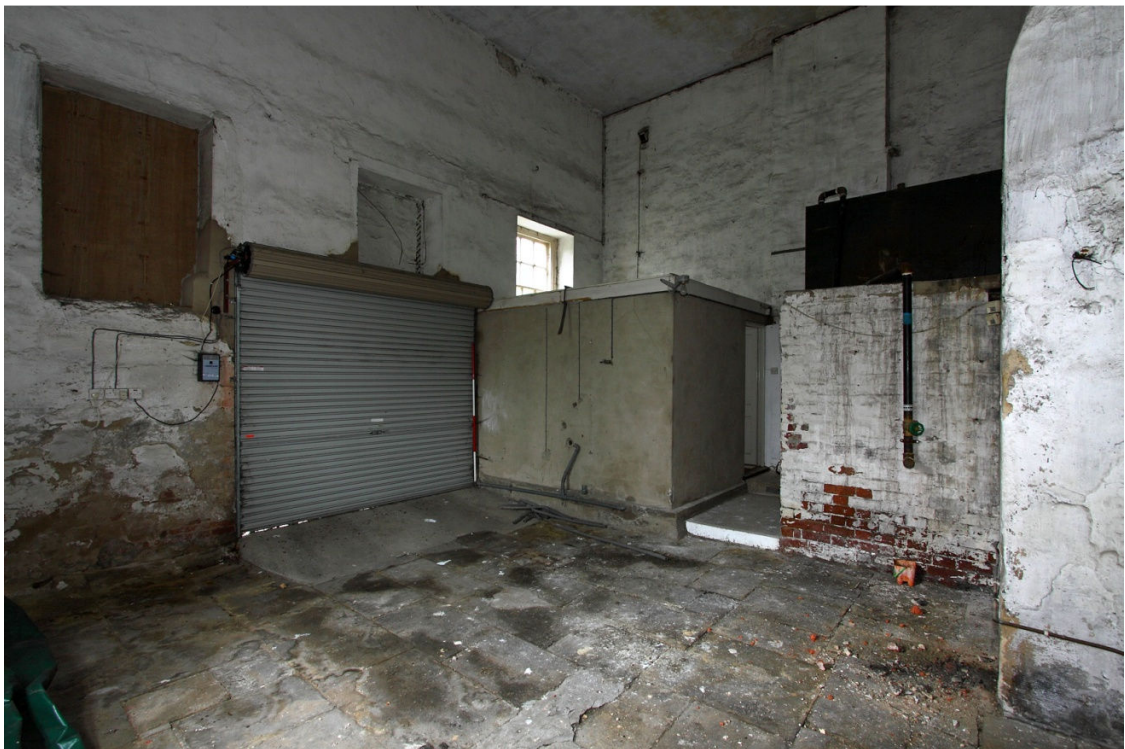
Plate 26 S and E walls of Brewhouse interior, looking SE. Note modern inserted garage door and bathroom.

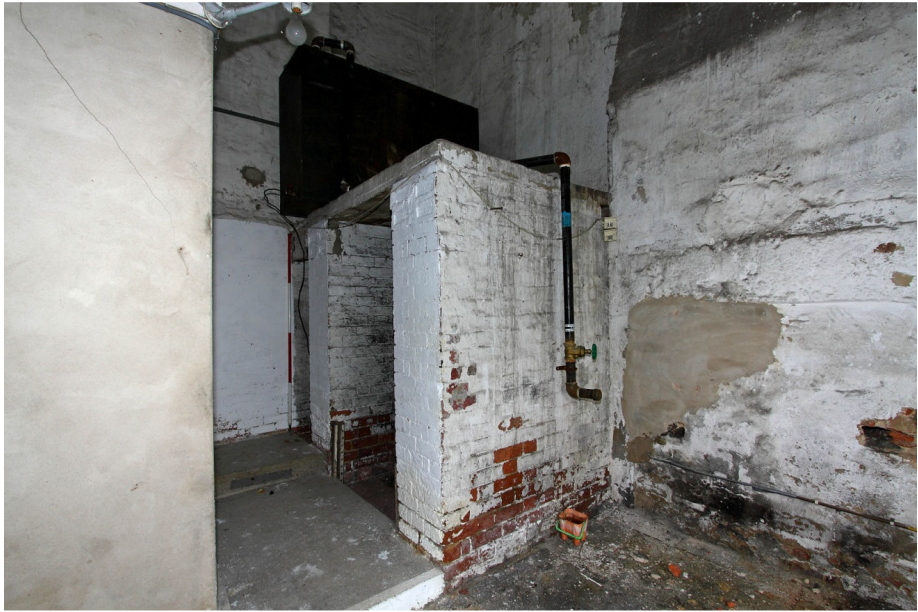
Plate 27 Fuel-store within Brewhouse interior, looking SW. Tank above is for storage of oil for Aga.

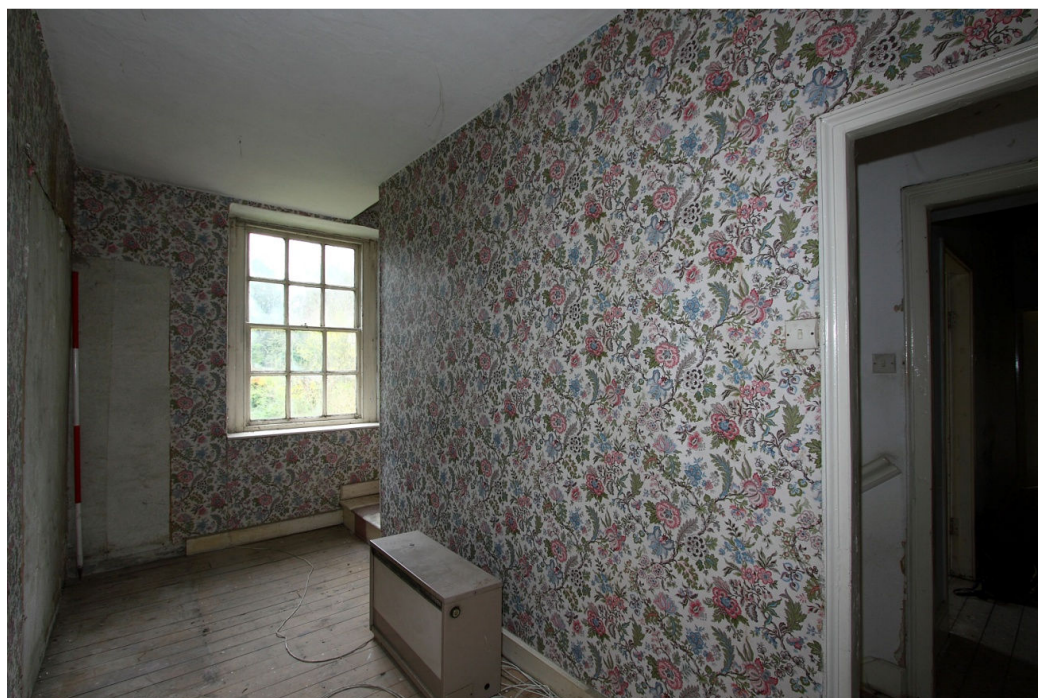
*Plate 28 First floor landing, looking W*

The head of the stairs from the ground floor lead directly to the rectangular landing area, with all first floor rooms being accessed via two corridors from this landing. This space is lit by one sash window to the west wall. 20<sup>th</sup> century skirting is affixed but there is no ceiling cornice. The narrow floorboards are of modern pine. A wooden staircase, fully boxed in with timber stud, rises from the north-west corner of the landing up to the attics. The lower three steps of the staircase turn through 90 degrees to a further straight flight of twelve steps that lead to the attics floor. At the foot of the straight flight there is a door of two panels. It is uncertain whether or not the extant staircase is original to the building.

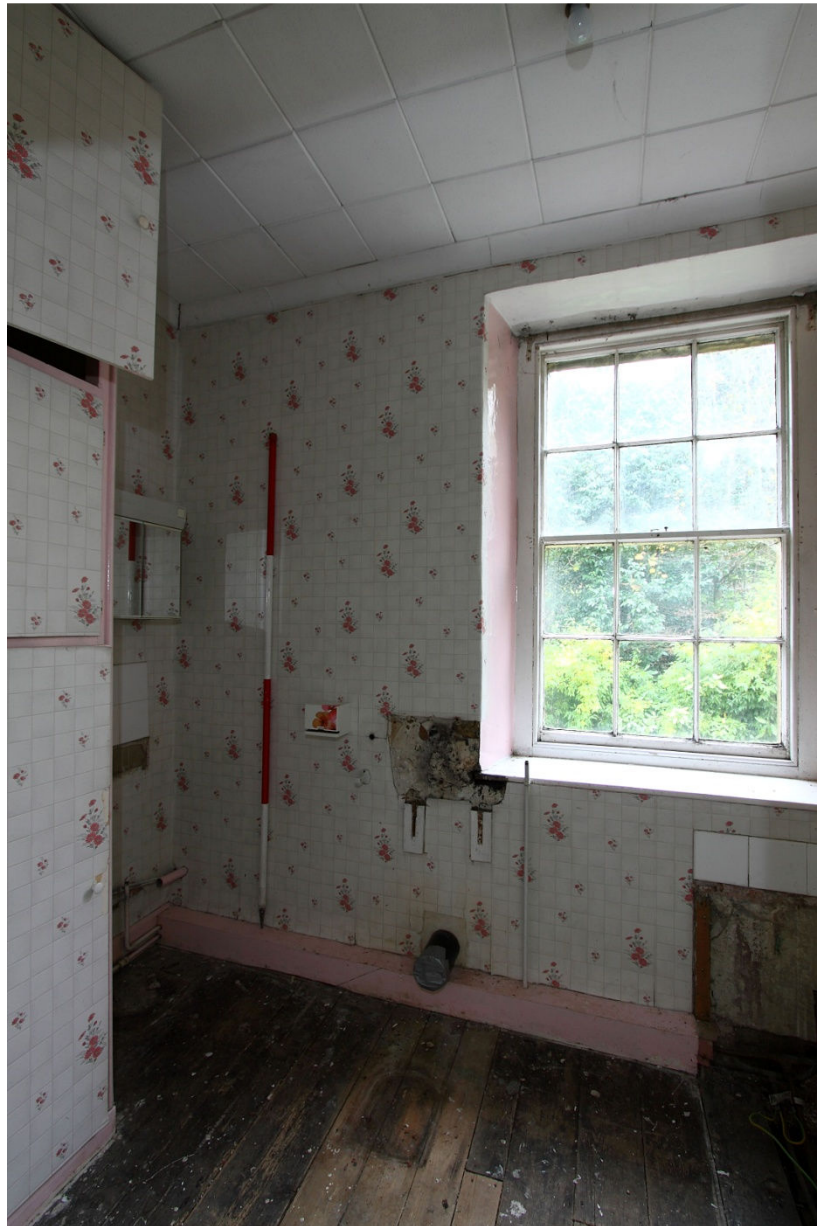
*Plate 29 Bathroom, looking S*

The bathroom is accessed via the narrow corridor that leads from the first floor landing to Bedroom 1. This small room has fittings for a w.c., bath and basin and a full height airing cupboard (hot water tank removed) to the north-east corner. The room is lit by a sash window to the south wall. The walls are papered, there is a simple wooden skirting, whilst the ceiling is covered with polystyrene tiles and there is a simple polystyrene cornice. Save for a few replacement pieces, the flooring is of wide pine boards which may be original to the building. The walls of the bathroom are of timber stud and it is almost certainly a 20<sup>th</sup> century creation hived off from the room that now forms Bedroom 1.

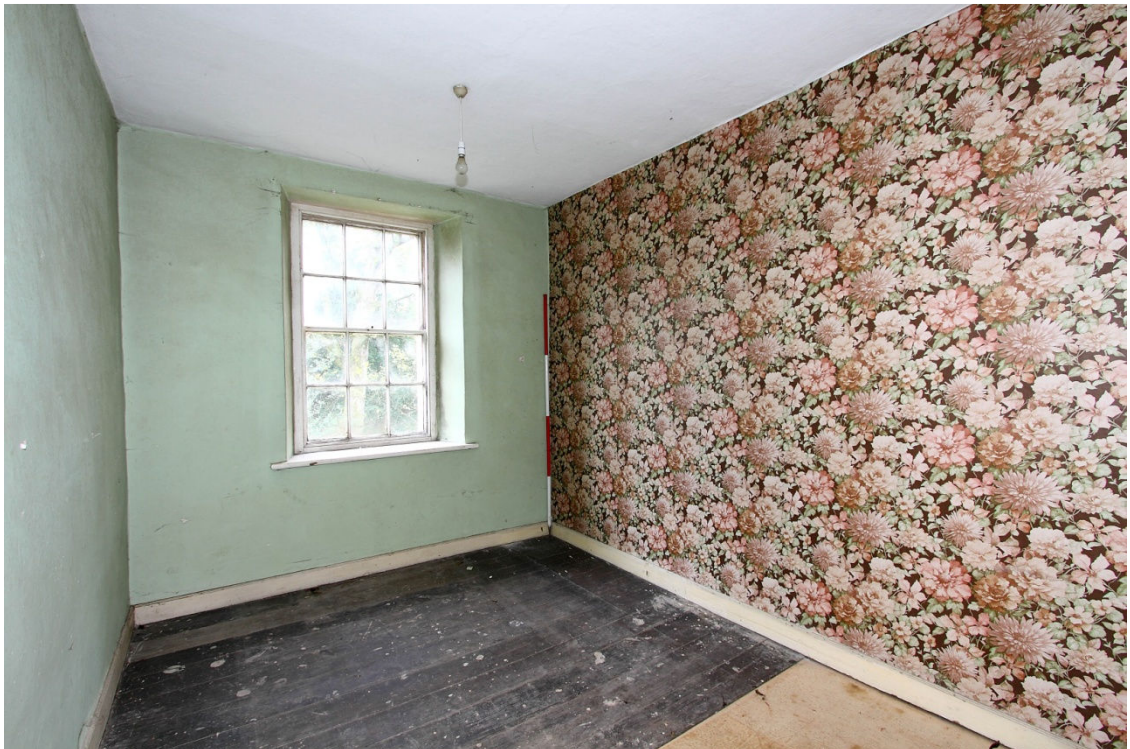
*Plate 30 Bedroom 1, looking WNW*

Bedroom 1 is accessed via the corridor from the first floor landing. Although the four panel door to this room (identical to those Bedrooms 2 and 3) is of probable 19<sup>th</sup> century date the door plain door frame is almost certainly later. The room is lit by a single sash window to the east wall. All walls, barring that of timber stud which separates it from the bathroom, are solid. The walls are papered, there are simple skirting boards but no ceiling cornice. Although patched up in places, the flooring is principally of old wide pine boards akin to those of the bathroom.

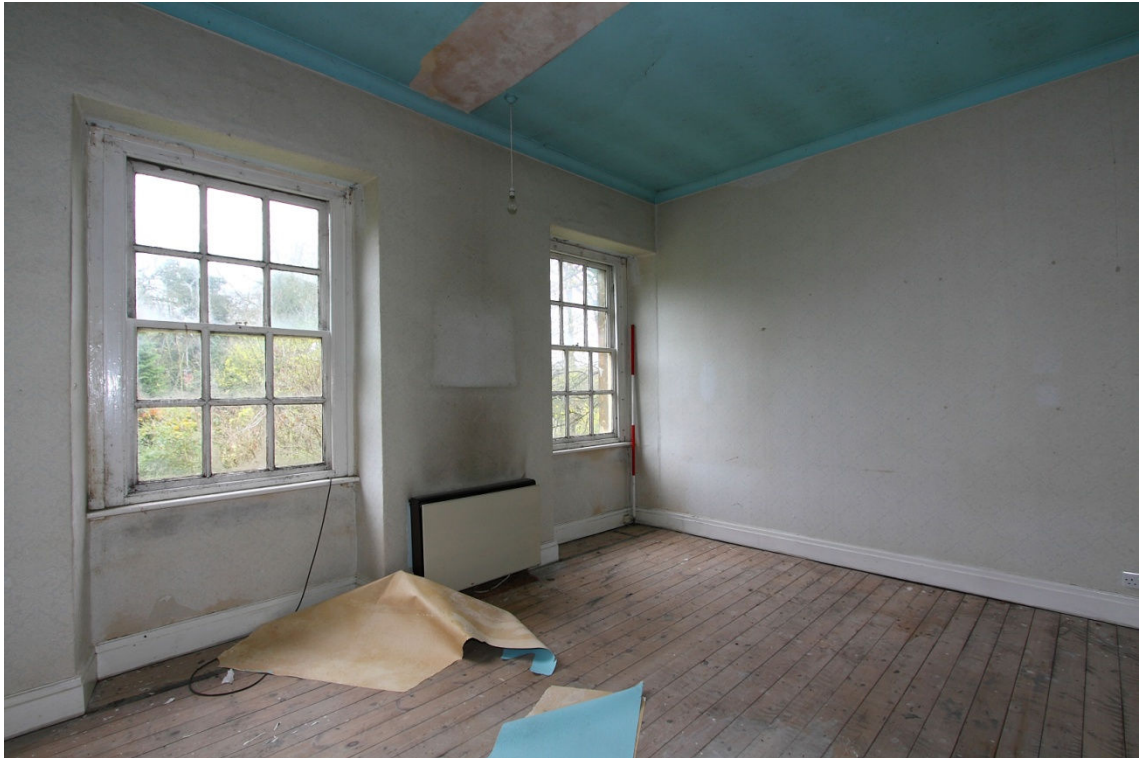
*Plate 31 Bedroom 2, looking SW*

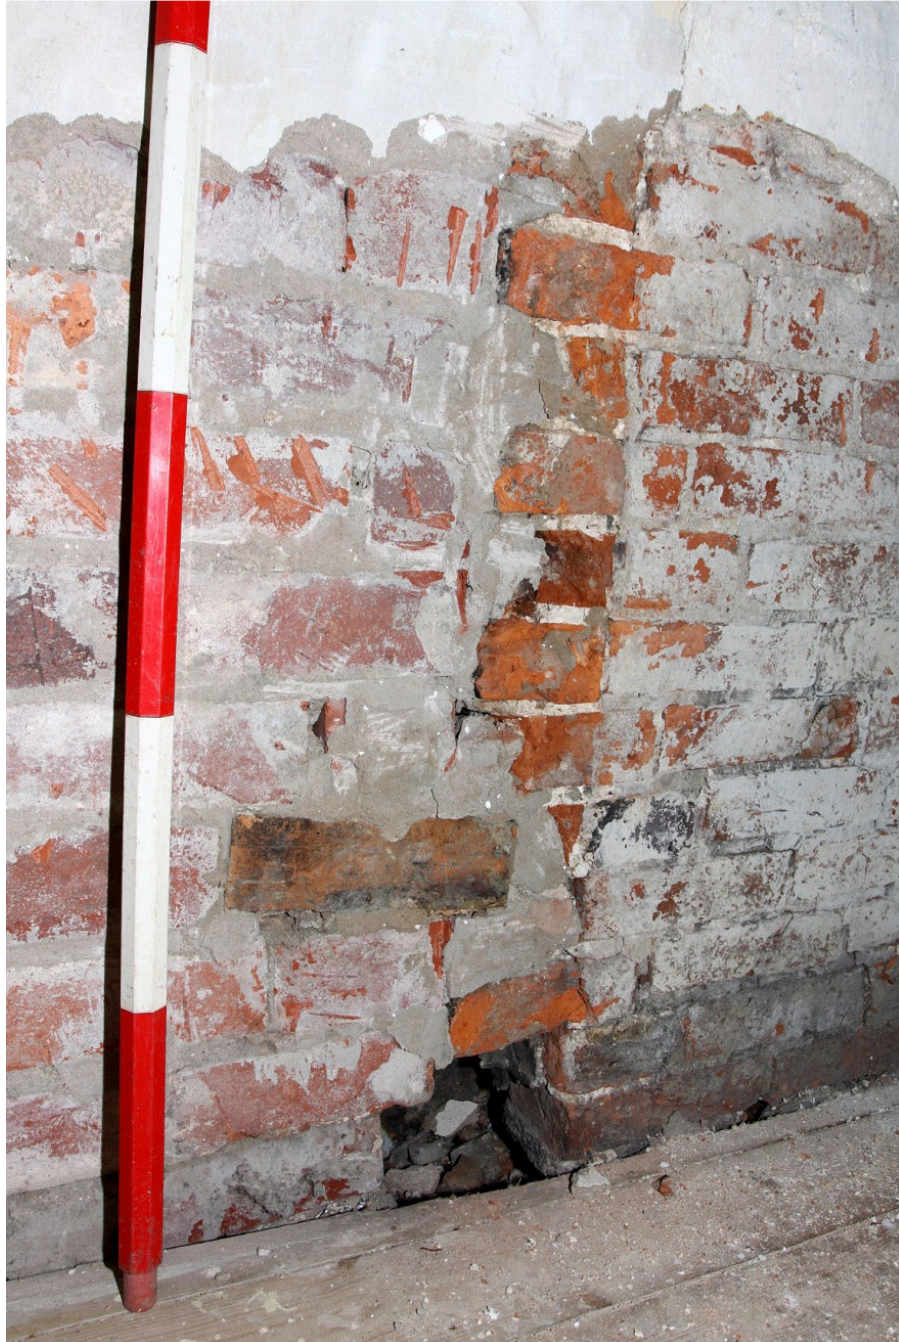
*Plate 32 Blocking of former fireplace in first floor passage, looking SE*

There is reason to believe that the large space formed by Bedrooms 2 and 3, together with the passage linking these, originally formed a single entity and that sub-division with timber stud partitions to create the extant arrangement is a later development. There are two principal reasons to suggest that this is so. Firstly, the dividing wall between Bedrooms 2 and 3 sits non-central and uncomfortably to the window arrangement of the western wall with a resultant loss of symmetry to both rooms. Secondly, and even more convincingly, the recent removal of an area of plaster to the eastern side of the corridor reveals evidence that suggests the former presence of a fireplace that would have fed into the large flue (Plate 32). This evidence takes the form of two vertical joints, some 1.95m apart, to the brickwork of the north – south wall. Infilling between these vertical joints is with 19<sup>th</sup>-earlier 20<sup>th</sup> century brickwork. A fireplace in this location would clearly have served to heat this putative large room and not a corridor.

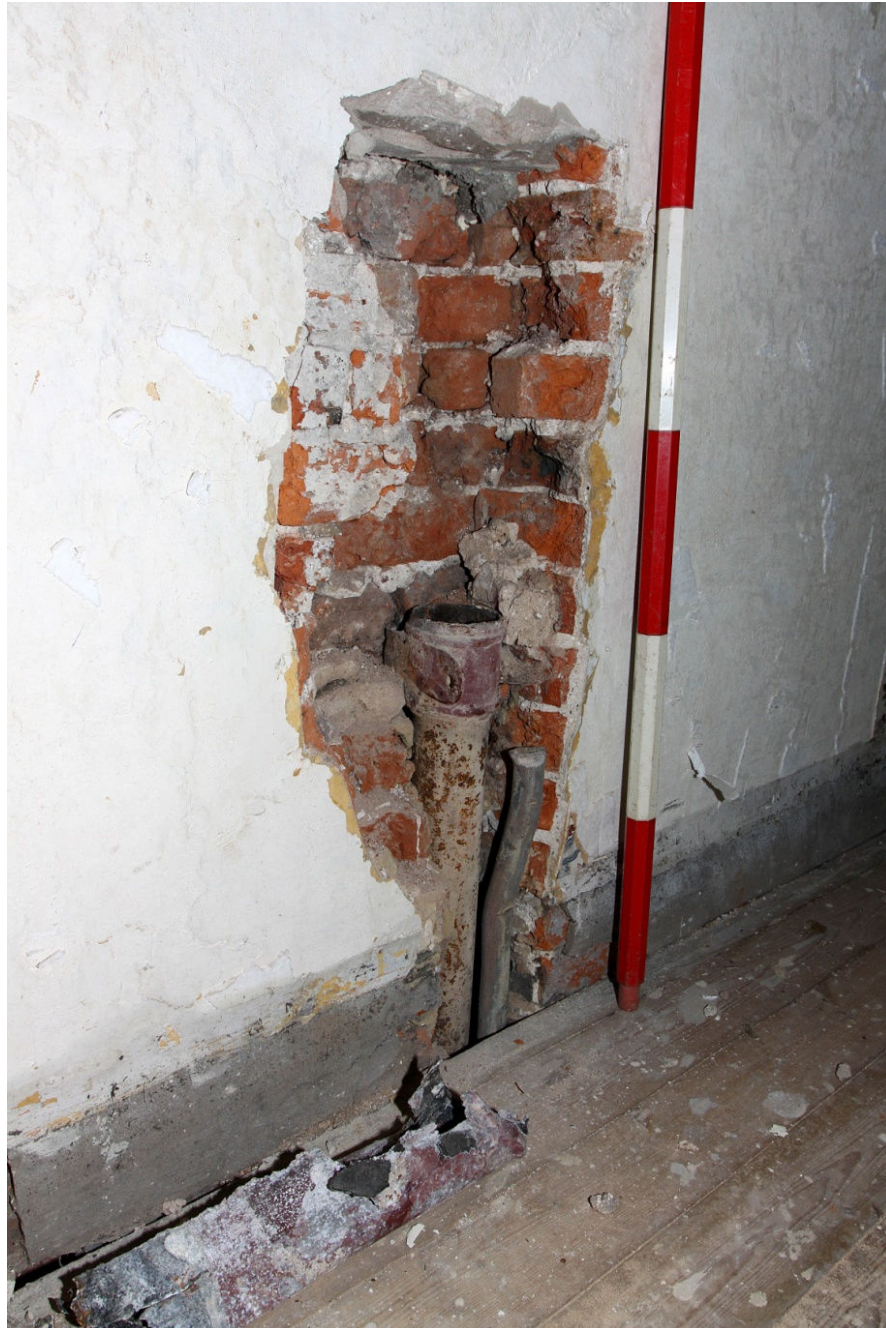
Plate 33 Pipe-work chased into wall in first floor passage, looking SE

It was also noted that to the south of the former fireplace, in a further area of recently removed plaster, that two vertically set metal pipes had been chased into the brickwork of the north – south wall (Plate 33). One of these was of cast iron drainpipe-type, the other of

smaller diameter lead. Examination of the brickwork above these exposed pipes indicated that they had never extended much above the level of the flooring of the first floor. As such, the cast iron pipe could never have extended to roof level as a drain. In all probability the lead pipe served as a water feed pipe and the large cast iron pipe as some sort of waste outflow. Like the suggested fireplace, these pipes clearly relate to an arrangement that precedes that of the extant layout. Whether or not a functional connection existed between the fireplace and the pipes is not known.

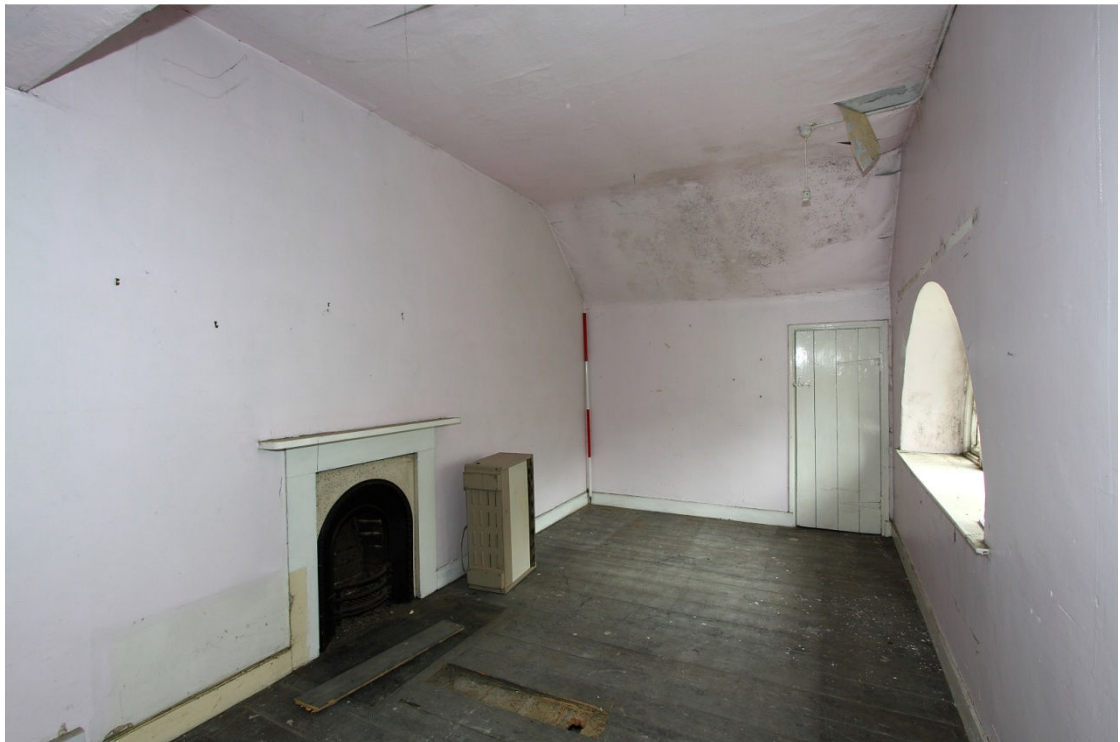
*Plate 34 Large, eastern attic room, looking E*

This room is accessed via a door of the same pattern as the small bedroom; the skirting is again identical to that of the small bedroom as is the round headed window to the south wall. The floorboards are wide, of pine, and seen to overlie a sub-floor of identically sized boards lain at 90 degrees. Such flooring treatment is generally regarded as quality work and may be regarded as indicative of the status of the building (Brunskill 2007, 130-131). A fireplace with stone jambs and lintel with cast iron grate and inset is set into the north wall of the room whilst a full room width boxed in storage area is present to the east side of the room. This storage area is accessed via a plank and batten door.

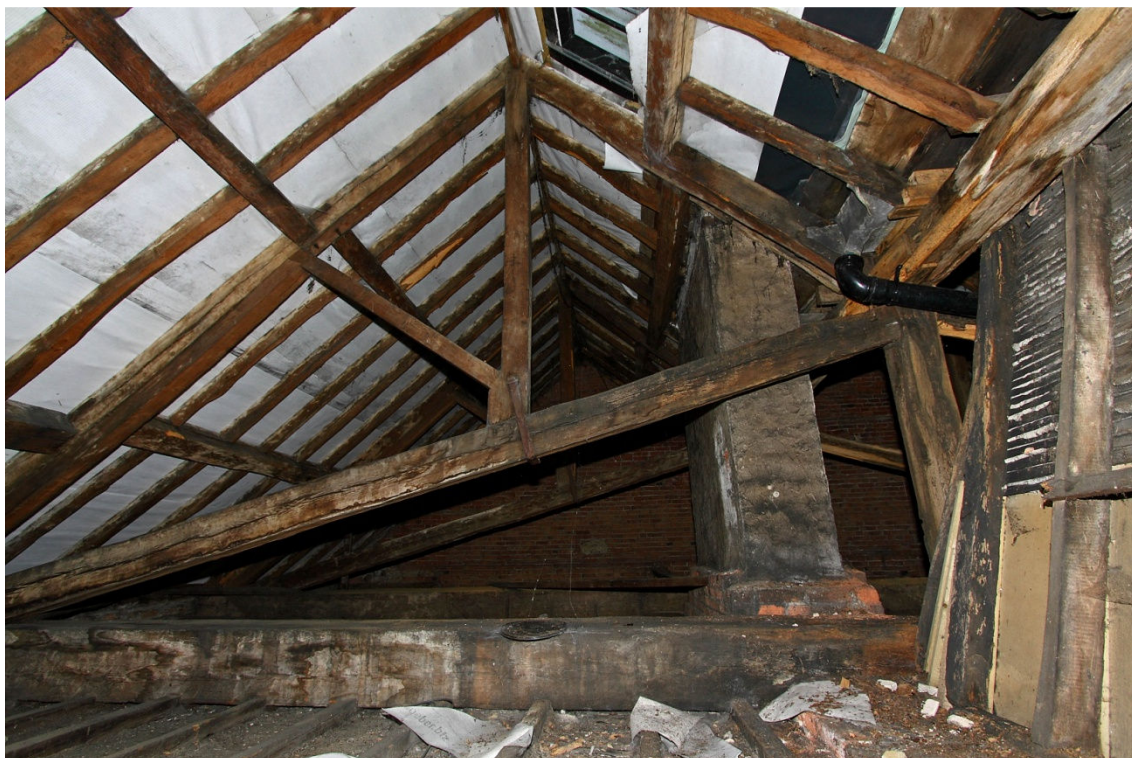
*Plate 35 View of roof timbers of W side of 'M' shaped roof, looking S. Note framework of brewhouse tapering hood to right, looking N.*

It was possible to peer into the roof space through a small rectangular hole that had been recently cut through the east – west brick wall close to the head of the staircase. It was not possible to enter this space however, and only part of the roof structure was visible. The roof form is known as a 'gabled 'M' shaped roof – effectively it is two parallel aligned gabled roofs separated by a narrow valley set at a height somewhat greater than that of the eaves. The valley itself is located immediately east of the internal north – south brick wall and sits at a level somewhat higher than that of the eaves. Within the roof space the internal north – south brick wall was seen to terminate just above first floor ceiling height whilst the large central chimney continues up, and beyond, roof level. The central and western sides of two roof trusses could be seen, one to the south of the large central chimney and one to its north. These appear to be the only trusses supporting this roof though obviously the north and south gable ends of the building are performing similar functions as is the internal east – west brick wall.

The lower member of each truss is formed of a tie beam of large proportions that appears to be seated into the tops of the walling to either eaves and gain support from the internal north – south between these. Extending vertically from the centre of each tie-beam are large posts, between which runs a large horizontal beam. These vertical posts and the beam are strengthened by large diagonal braces, one of which extends from either end of each tie-beam. Further vertical posts extend from a near central position from each of the large diagonal braces. These posts in turn support the principal rafters that provide the 'M' shape to the roof. The principal rafters are strengthened only to their outer sides by raking struts from the posts atop the diagonal braces. Two sets of butt-purlins are present to the outer sides of the trusses and one set to the inner. There are sets of five common rafters between each of the trusses.

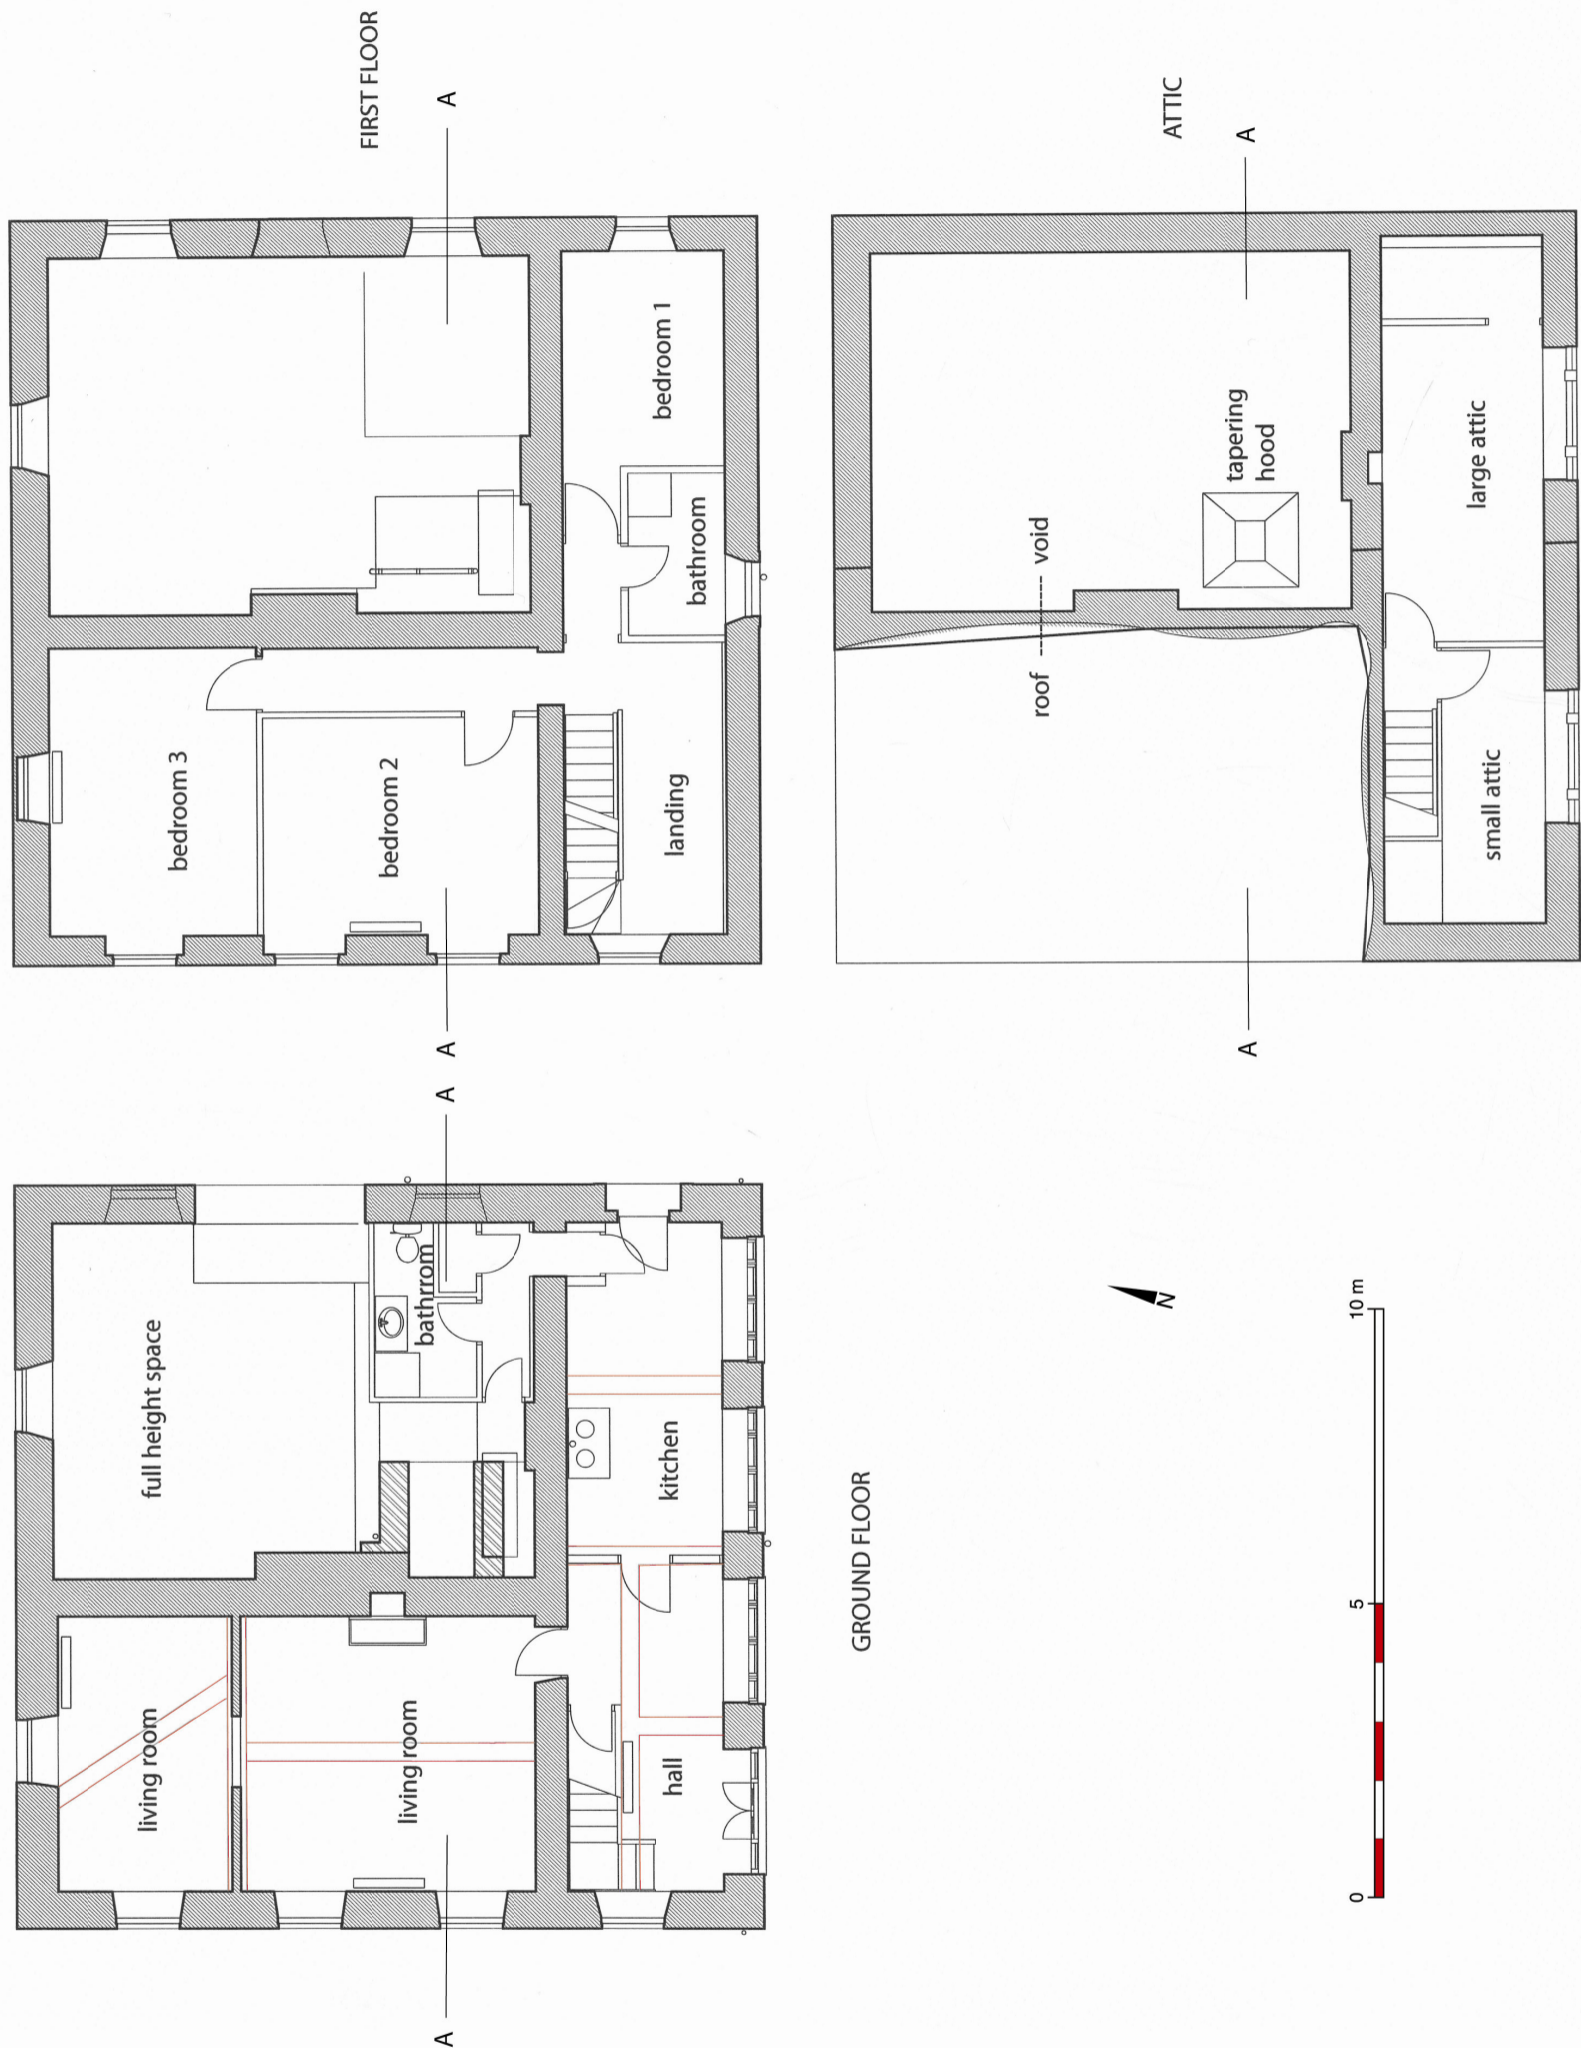
Figure 12 Floor plans of Brewhouse
