**STAYLEY HALL, HOWARD STREET,
STALYBRIDGE,
TAMESIDE**

WATCHING BRIEF REPORT

REPORT NUMBER 2013/50

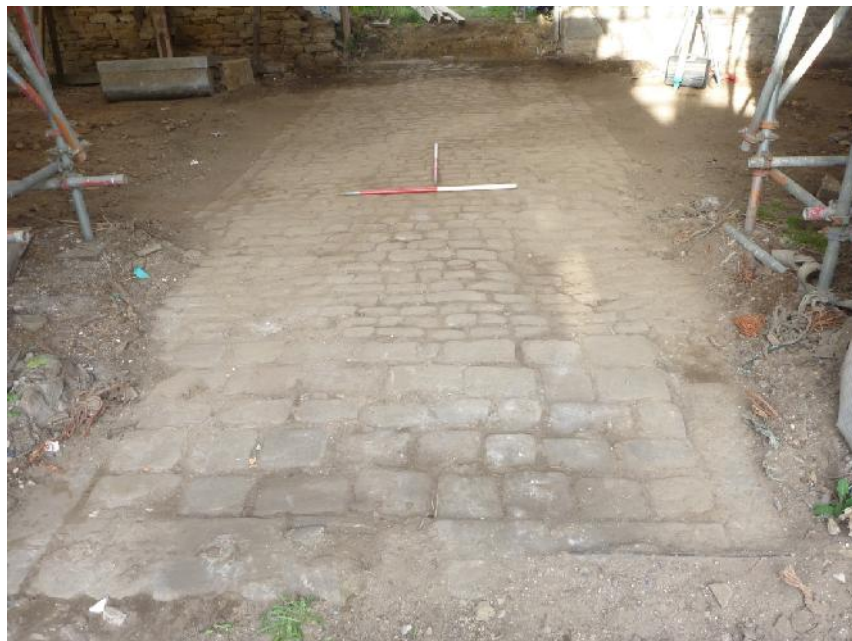
Plate 2 Building 5 track way. Looks north-north-west. 0.5m scale divisions

The track way (Figure 5, Plate 2) comprised 80 x 160mm setts and had been laid across the width of the barn to connect opposed 2.75m wide doorways, as well as provide a through access across the building.

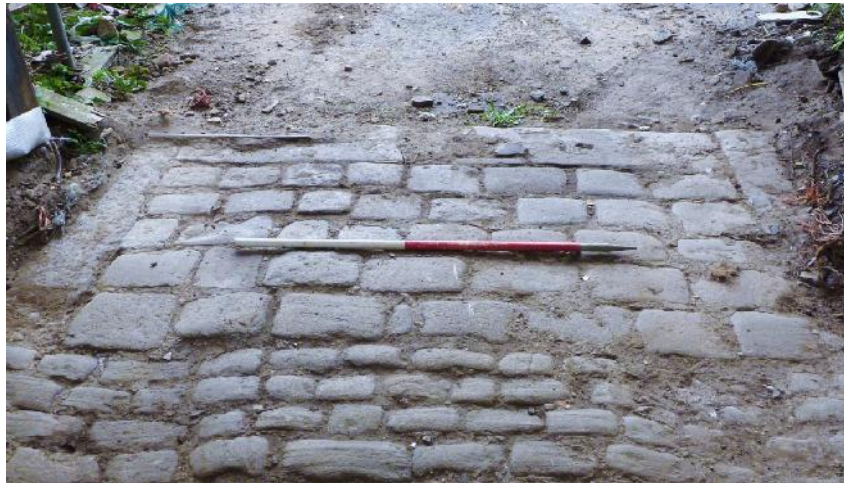
Plate 3 Detail showing larger setts and stone surround at southern entrance.

Note remains of iron door runner to top left. Looks south-south-east.

The edging comprised a single block, 1m long, up to 0.50m wide to east and west, whereas the southern side was bounded by two 0.30m wide blocks, one being 0.83m long and the other 0.91m long, each laid end to end to span the width of the doorway.

A short length of round iron bar (Plate 3), affixed to one of the edging stones in the southern entrance, showed that the barn door(s) latterly slid opened on runners. This was also most likely to have been the case at the northern entrance as a steep, up to 0.40m high, rise in the ground level outside the barn would have prevented hinged doors being opened outwards.

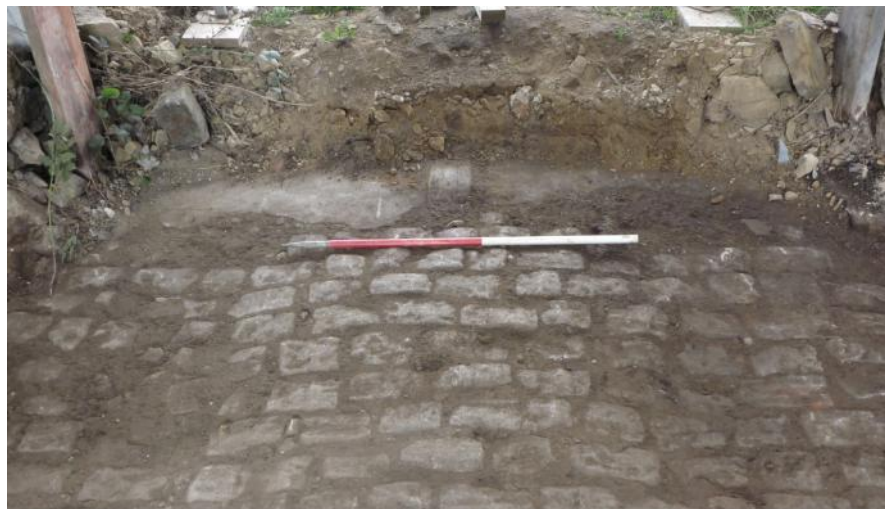
Plate 4 Northern doorway. Looks north-north-west.

Note parallel wheel ruts left and right of scale.

Despite not being fully excavated, enough of the floor within the northern door opening was exposed to show that it lacked the large stone edging and that the smaller setts continued beyond it (Plate 4).

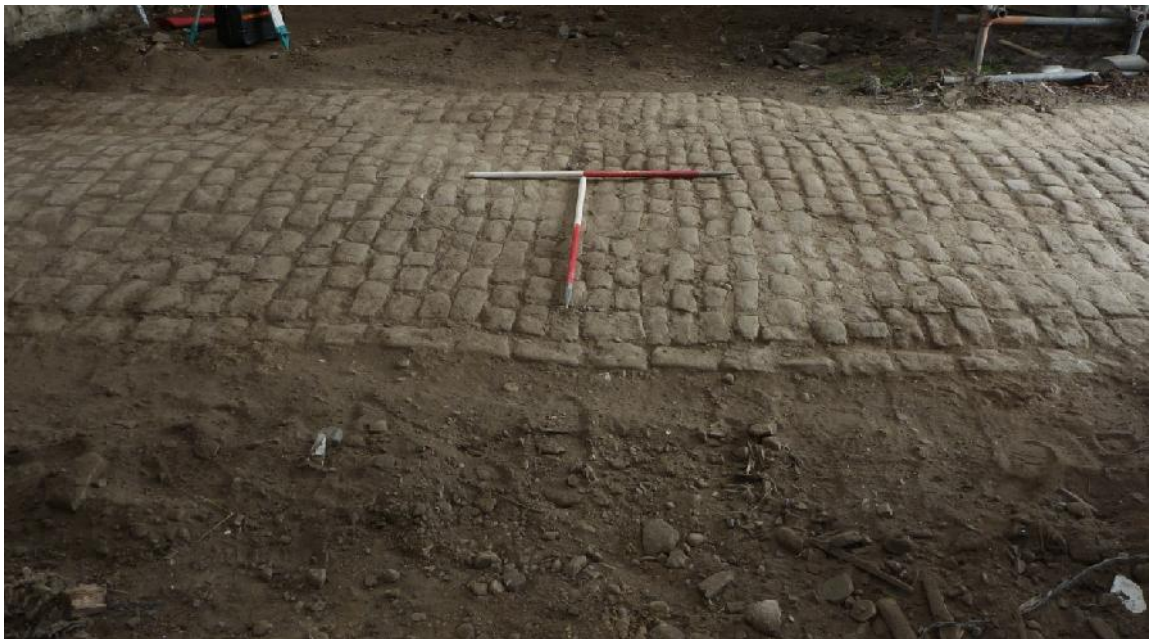
Plate 5 Record shot showing kerbstones along western edge (foreground) and buckled, rutted surface away from southern entrance. Looks east-south-east. 0.5m scale divisions.

The efficacy of the strengthening of the southern doorway was evidenced by its condition being significantly better than the well used, buckled and rutted state of the surface to the north of it (Plate 5).

The degradation of the surface was exacerbated by the lack of a firm bedding deposit. The individual setts were laid within a shallow bedding trench which, at up to 0.15m deep, had the same dimensions as the track way and was cut directly into the top of the natural sands. In some instances a soft lime mortar was used to infill between the setts, although a loose, medium – coarse grained dirty brown grey sand was the norm.

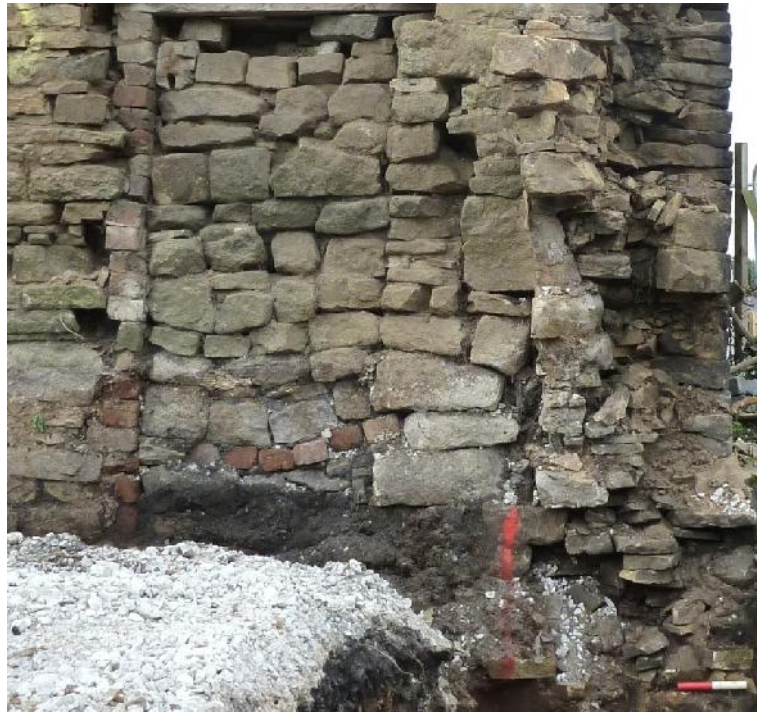
*Plate 6 Elevation showing remains of western wall of Building 6/7
at north-west corner of Building 7 (far right).
0.10m scale divisions.*

Building 6 (Figure 2), another former barn, was located c.6m to the south of building 5. It was a rectangular, north-north-west / south-south-east aligned building c. 25m long and 7m wide externally. The external walls of Building 6 were constructed in a similar manner to those of Building 5 but, at 0.60m wide, were slightly thicker. Building 7, a former cart shed and/or granary appeared to be of a contemporary construction. The southern end of the eastern wall of Building 6 was tied in with the northern wall of Building 7 and the western wall of both was continuous. (Figure 6, Plate 6).

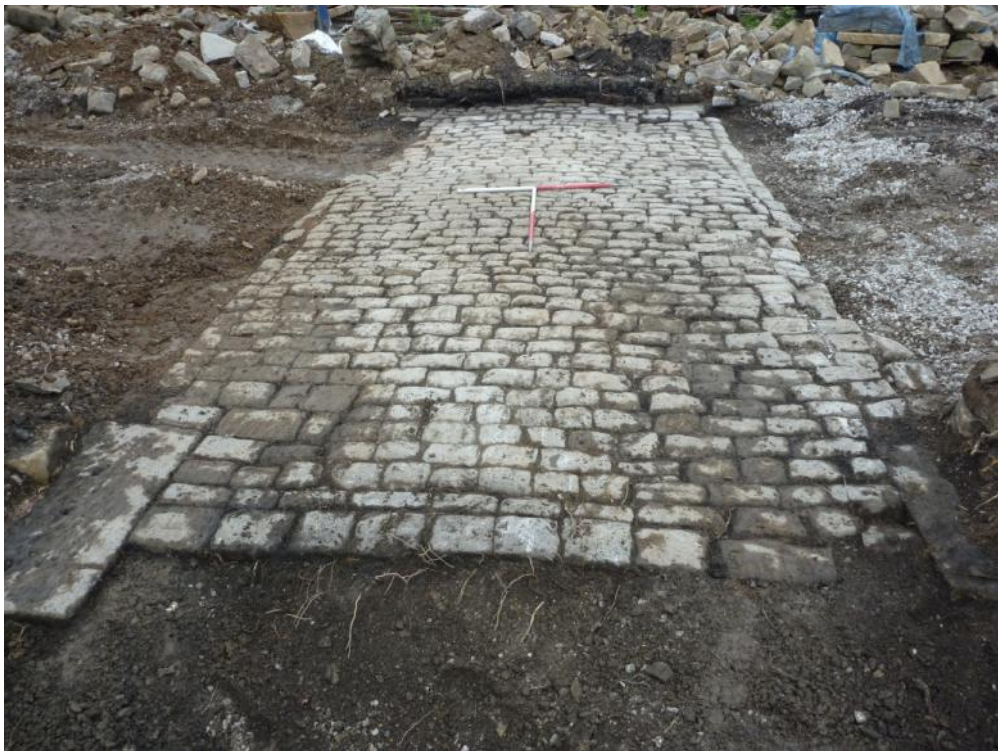
*Plate 9 Track way, Building 6 before new foundations cut. Western entrance
In foreground. 0.50m scale divisions.*

The build style used for the track way was similar to that observed in building 5, but in this case the larger sized setts used in its construction negated the need for strengthening at the entrances. In the east and west doorways, both ends were retained by large flat kerb stones, those in the eastern door way remained mostly hidden by later deposits. At the western doorway, however, the outer or western edging stones were absent and only northern and southern flanking kerbs remained (Plate 9)

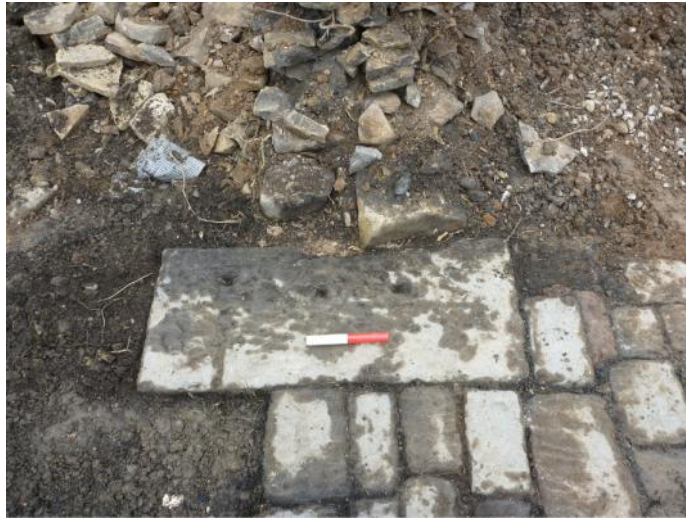
*Plate 10 Building 6, Detail showing arrangement of slot and holes in top of kerbstone at western entrance, north side of doorway.
Looks north. 0.10m scale divisions.*

Of these, only the northernmost of the kerbings survived to its full extent. This was 0.93m long, 0.41m wide and a slot and series of holes cut into the top of it suggested that it had anchored a bottom runner for a set of sliding doors (Plate 10). An in situ runner was

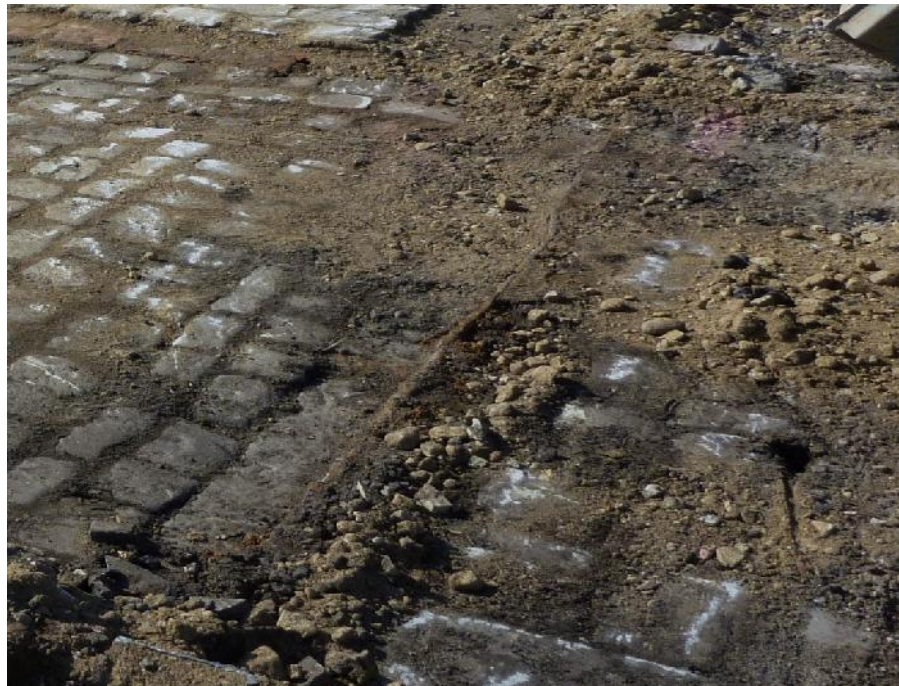
*Plate 11 Building 6, record shot of iron door runner
(bottom left – top right) after blocking removed. Looks south-east.*

observed beneath the blocking in the eastern entry. Sufficient time was only available for it to be recorded photographically (Plate 11).

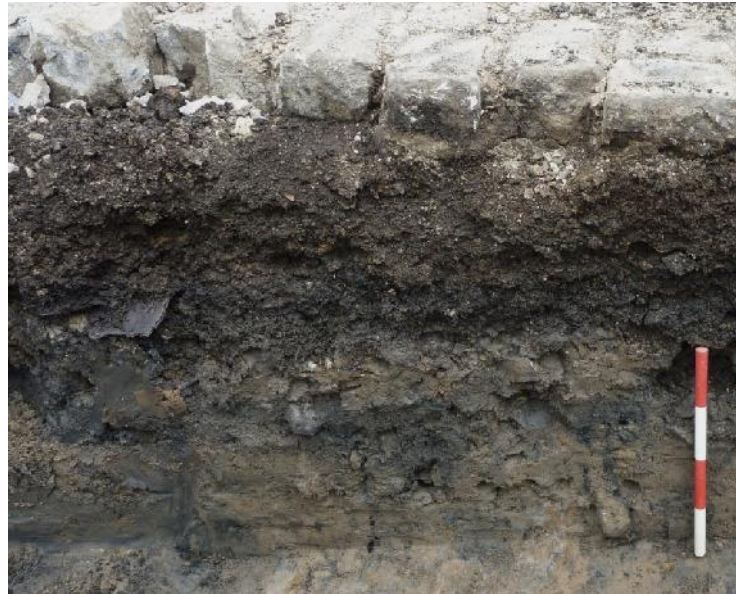
*Plate 12 West-south-west facing Section No. 7.
0.10m scale divisions.*

The presence of this cut suggested that the area may have been occupied by an earlier, un-surfaced midden or fold yard for livestock. This had probably become churned to such an extent through use that it necessitated digging down to firm ground before the stone sett surface could be laid. Initially the base of cut 30022 was consolidated with a deposit of compacted, dirty grey brown sand clay, small to medium pebbles and re-deposited natural (30023), with occasional small brick and slate fragments, up to 0.40m thick. The top of it was sealed beneath a deposit up to 0.28m thick of compacted mid grey and purple brown cinders (30024), which formed a bedding layer for the stone sett surface of the midden base (Plate 12).

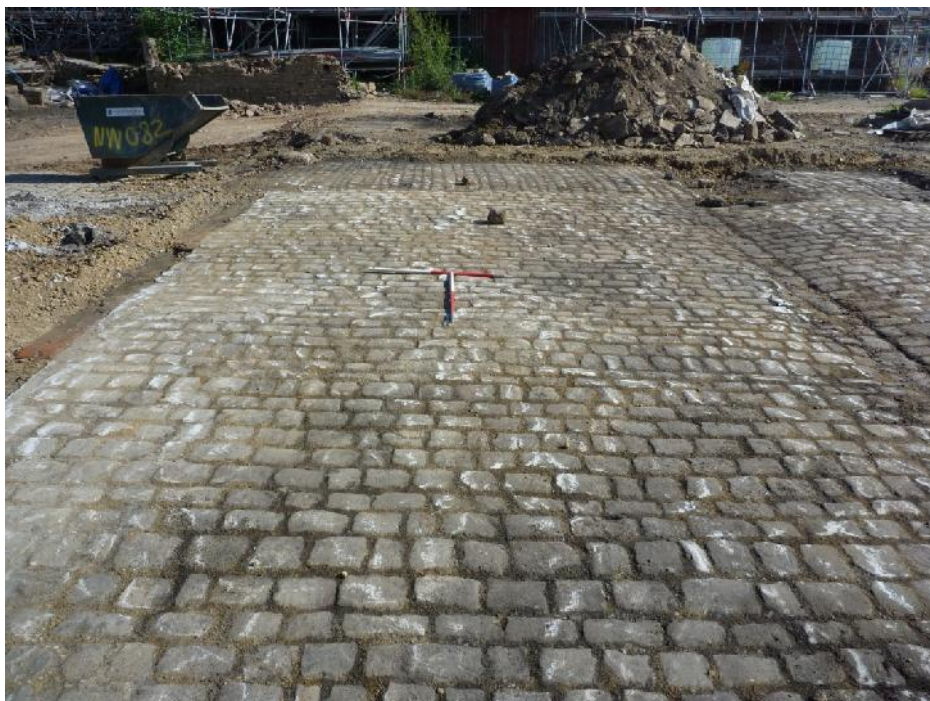
Plate 13 Shot of midden base showing extended track way leading from Building 6 (top left to right). Looks north-north-west. 0.50m scale divisions.

The construction of the midden base also involved widening the track-way by 0.80m towards the north, as well as extending it by at least 10m to the east (Plate 13), where it ran beyond the footprint of the new build. It was thought to have been contemporary with the midden as they both used a similar construction method (Plate 14).

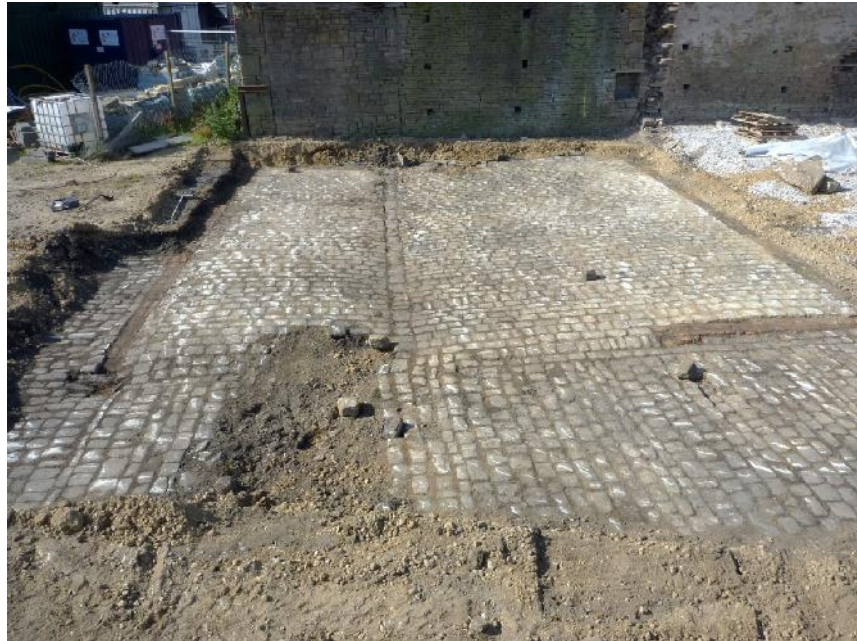
Plate 14 General view of midden base with track way extension in foreground. East end of Building 7 top centre. Damage in foreground of shot was noted in 2003 assessment. Looks south-south-east.

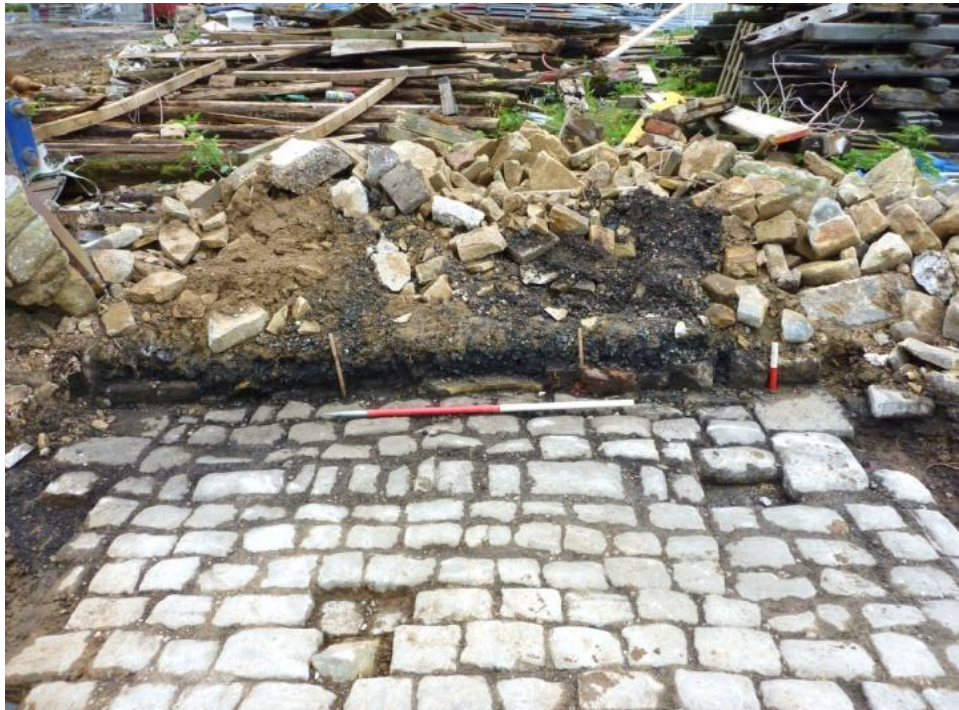
Plate 15 Last surviving course of blocking in east doorway (behind scales).

Post sockets? run from far bottom left (only part shown) to top right.

Looks east. 0.10 and 0.50m scale divisions.

The midden may have gone out of use when the eastern doorway of Building 6 was blocked by a brick and sandstone ashlar infill (Figure 8), probably in the first half of the 20th century. The doorway appeared to have been blocked in advance of the alteration and/or subdivision of the internal spaces of the barn. The only evidence for this was the survival of three square post sockets cut into the track way adjacent to the eastern doorway (Plate 15). The size of these varied between 150 x 130 x 100mm and 280 x 150 x 70mm and probably carried a series of uprights for divisions and/or supports for a second floor hay loft, tool or feed store. As the building had been mostly demolished before the watching brief commenced this will, however, remain far from certain. Most of the features above were further compromised by the cutting of the new foundations (Plate 16).

By the earlier 20th century, the midden appeared to have gone out of use, the eastern doorway of Building 6 had been blocked up and the internal space of it subdivided and/or adapted for a different use. This was only attested to by the survival of a single course of rough brick-work across the eastern doorway (Plate 16?) and three post sockets cut into the top of the in-building track way (Figure 8). Both of the above would have barred vehicles of any size from entering / exiting the building on this side. The Hall was abandoned as a dwelling by the 1940s and both it and the buildings surrounding it began a steady decline into a ruinous state by the last quarter of the 20th century.

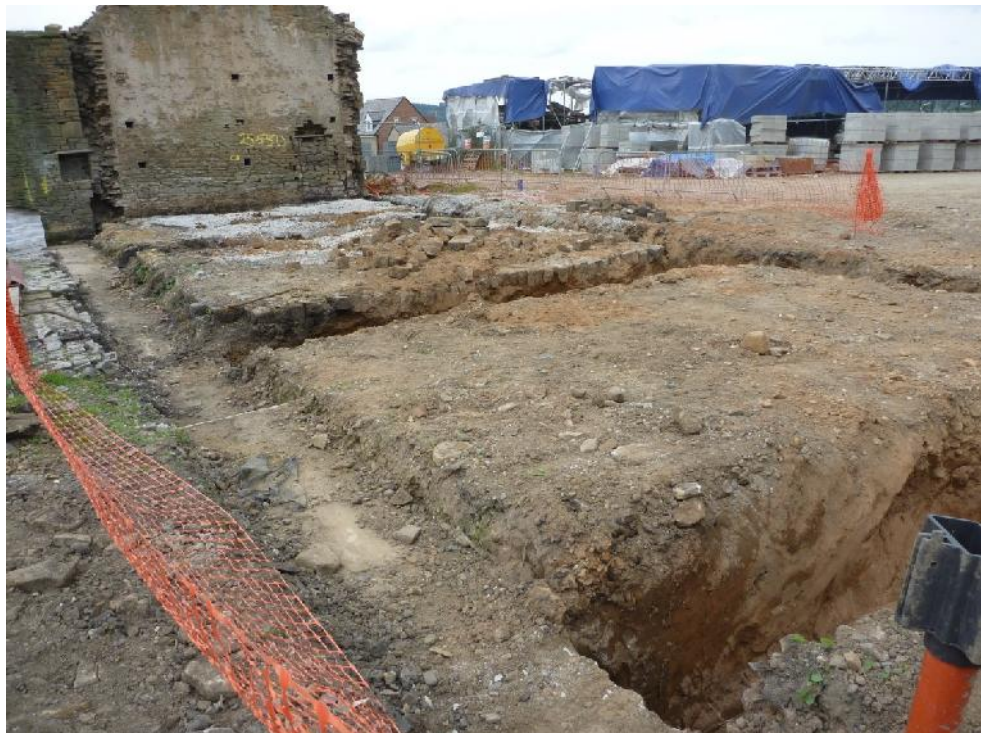
Plate 16 General view across Building 6 (right) showing part of midden base (diagonal far left) after foundations cut. Truncated sett track way runs diagonally across centre of shot. Looks south.

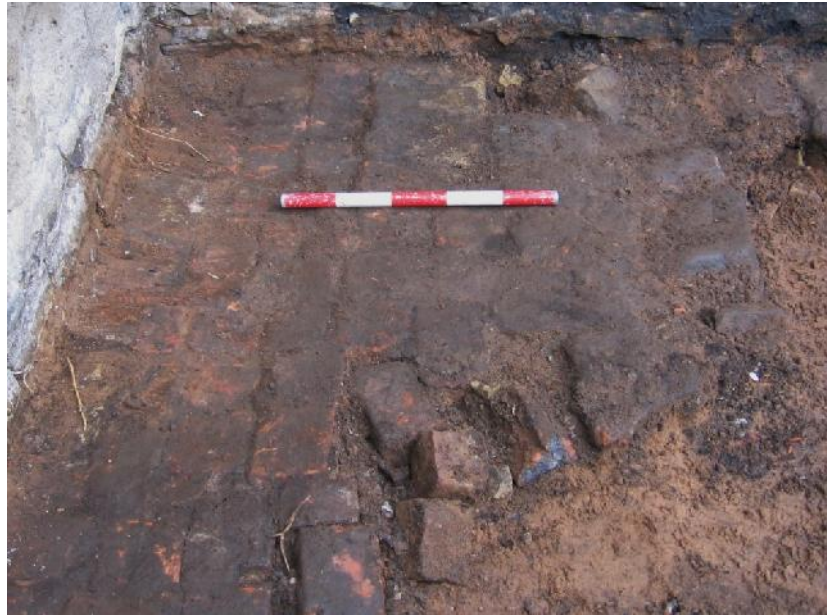
Plate 17 Detail showing brick floor (30032) in north-west corner Of Building 7. Looks north. 0.10m scale divisions.

Deposit 30028 was used as the bedding for a brick floor (30032). The 240 handmade 120 x 70mm bricks were laid wide face down and were tentatively dated to the first half of the 19th

century. These might have been sole survivors of the original floor surface in the western half of Building 7 (Plate 17).

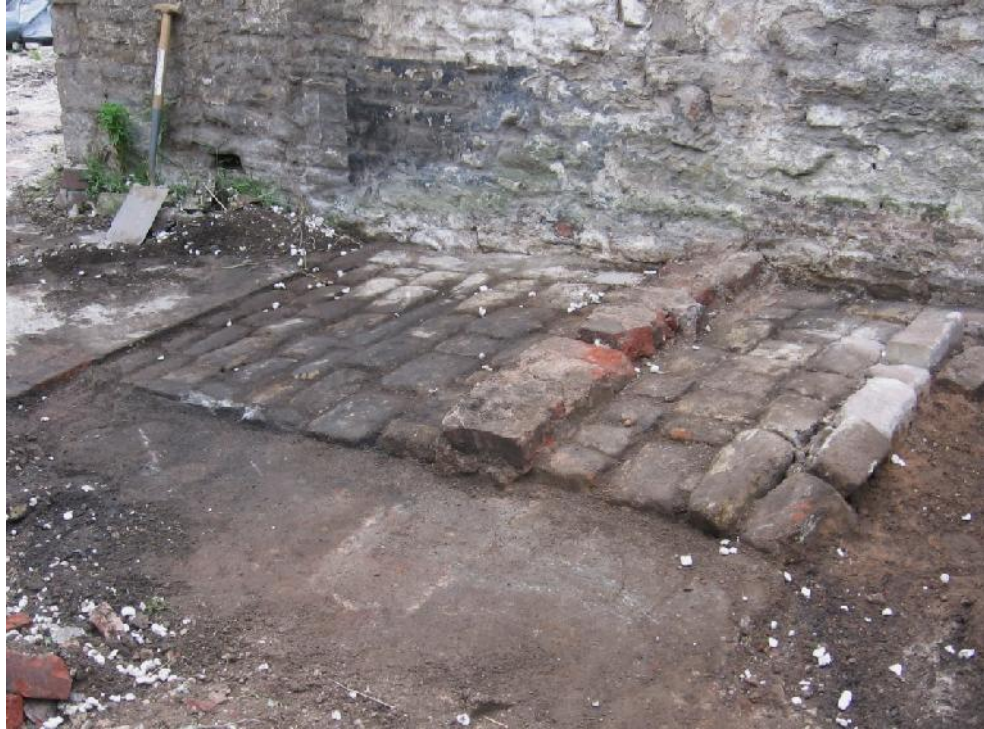
*Plate 18 Record shot showing Setts 30029 with Wall 30031 founded on top.
Later brick wall (30030) runs diagonally from centre left of shot.
Note scar in concrete just in front of wall 30031. Looks south.*

All that survived of the floors in the western half of the building was a 2.30m long, 1.30m wide patch of up to 220 x 130 x 120mm sized sandstone setts (30029; Figure 11, Plate 18). The setts most likely extended further towards the east, west and north but this could not be verified as they had been removed by later activity. All that could be said with any degree of certainty was that they were founded on top of deposit 30033, but were most likely contemporary with Floor 30032. It would appear that the sandstone setts had been chosen to tolerate much heavier use than the brick floor (30032). Their proximity to the main doorway suggests that they were specifically chosen to withstand the weight of carts and other sundry vehicles entering the eastern end the building.

In the mid – late 20th century, any setts surviving beyond surface 30029 were removed when a second, 3.5m long, 0.23m wide brick wall (30030) was constructed (Figure 11, Plate 18). This was aligned at 90° to the southern internal face of the building, hard against the eastern side of remaining setts 30029. The 215 machine made 102 x 75mm sized bricks were laid as two course width stretchers, at least one course deep, bonded with a hard pale grey / white cement mortar. Wall 30030 was itself sealed in by the last vestiges of concrete floor 30027, at least 0.15m thick.

A scar in the top of Surface 30027 (Plate 18), just to the north of Wall 30031, suggested that a further wall was constructed some 1.30m to the west and parallel with Wall 30030. It would seem highly likely that Wall 30031 had itself been incorporated into this new build. Why these two walls were constructed so close together is uncertain, although they may have served to support machinery such as a feed mill or, more likely, a fuel storage tank.

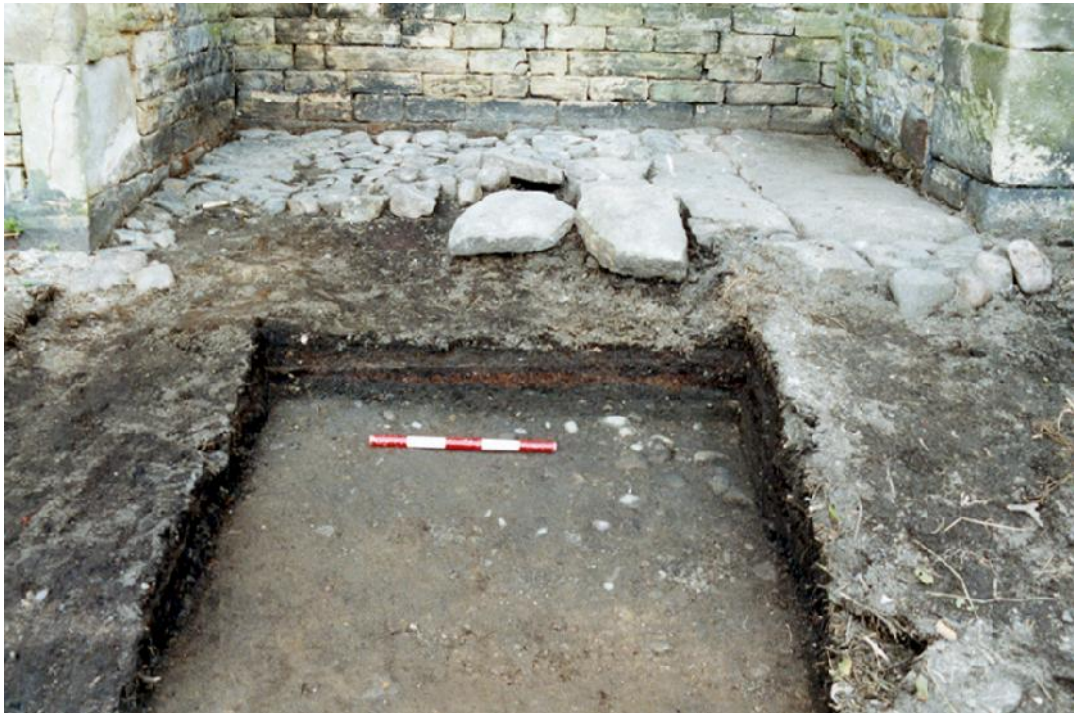
*Plate 19 2003 Trench 9 features before preservation by reburial. Looks north.
0.10m scale divisions.*

Trench 30 (Figure 2) was located hard against the southern façade of Stayley Hall, within the footprint of Trench 9 of the 2003 archaeological assessment (Plate 19). An in depth account of the findings for this trench can be found in the assessment report, hence the following text will only describe new features and deposits observed in 2012. The identifier Trench 30 was allocated for the 2012 watching brief works to avoid confusion with the results/finds arising from the 2003 excavations.

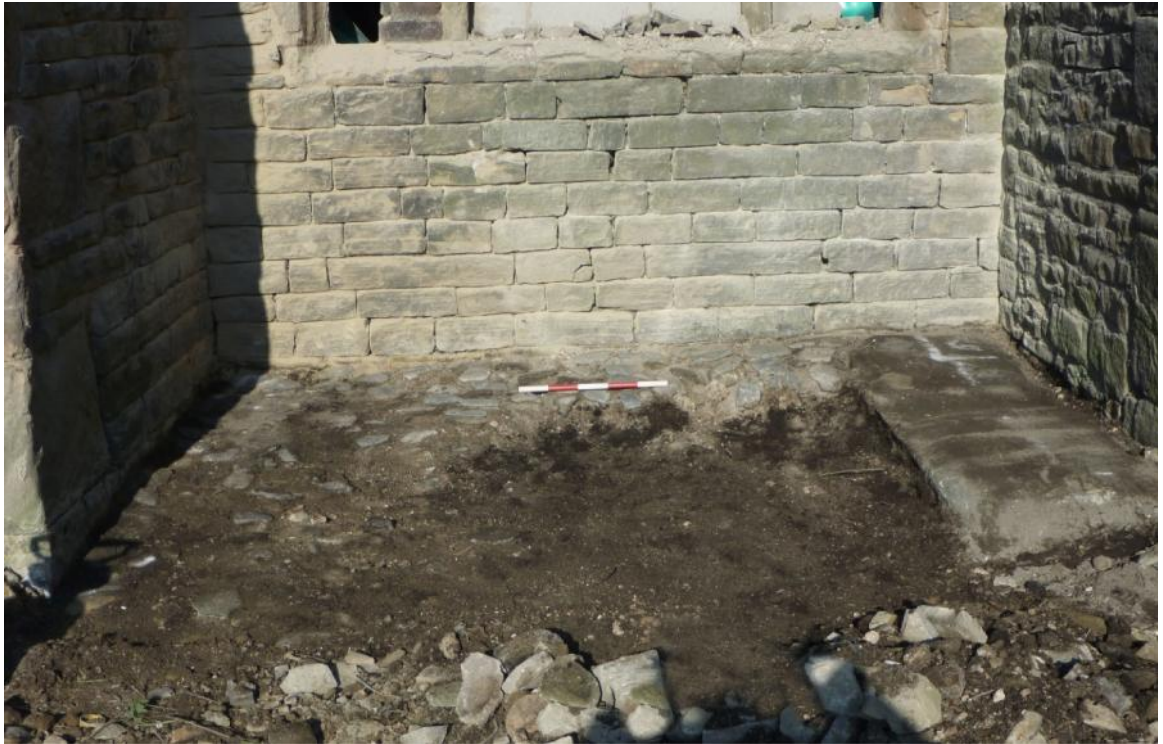
Plate 20 Trench 30 showing extent of damage suffered between 2003 and 2012. Looks north-west. 0.10m scale divisions.

When overburden was removed for the 2012 watching brief, it was apparent that the area had suffered damage in the intervening period (Plate 20). How or why this had occurred is not known to the archaeologist. What survived (Figure 12) was swept away by the excavation of the new surface water drains (Figure 2), removing all archaeological features down to the original foundation level of the Hall.

These were sealed beneath a 0.09m + thick deposit of compacted loose, dark greyish brown ash and cinder rich clay sand silt (30021) which formed a bedding deposit for a large, 2.10m long, 0.60m wide, 0.09m thick sand stone threshold (300019; Figure 12, Plate 20). The threshold was laid dry jointed hard up against the outer face of the hall. Once the threshold was in place, cobble surface 300020 (Figure 12) was laid up against it.

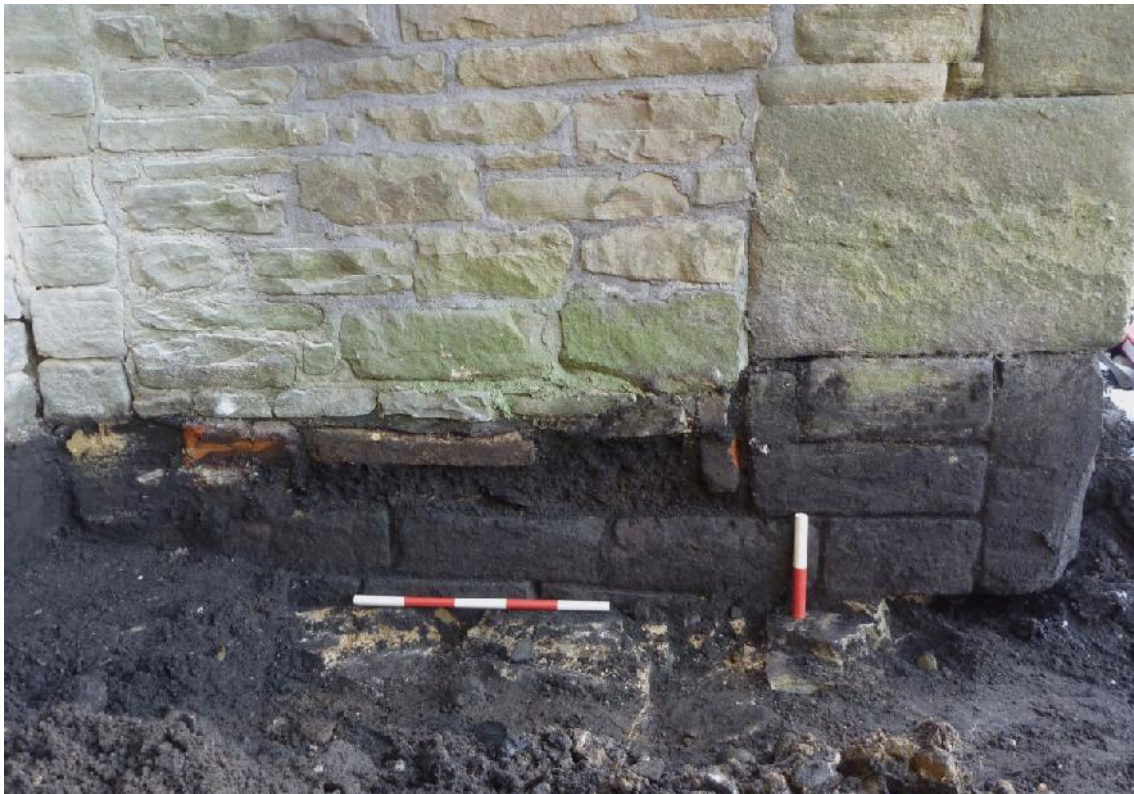
Plate 21 Section No. 16, elevation showing sequence of doorways and Hall foundations (below scales). Inserted ashlar blockwork can be seen vertical centre left to top left of shot Looks north-east. 0.10m scale divisions.

Removal of the threshold and levelling deposit 30021 revealed a sequence of adaptations to a former door way (Plate 21). The earliest of these ('Original Doorway', Figure 13) was 1.02m wide and had probably been constructed with the fabric of the Hall, when it was clad in stone in c.1600. This was then blocked up in an ad hoc fashion.

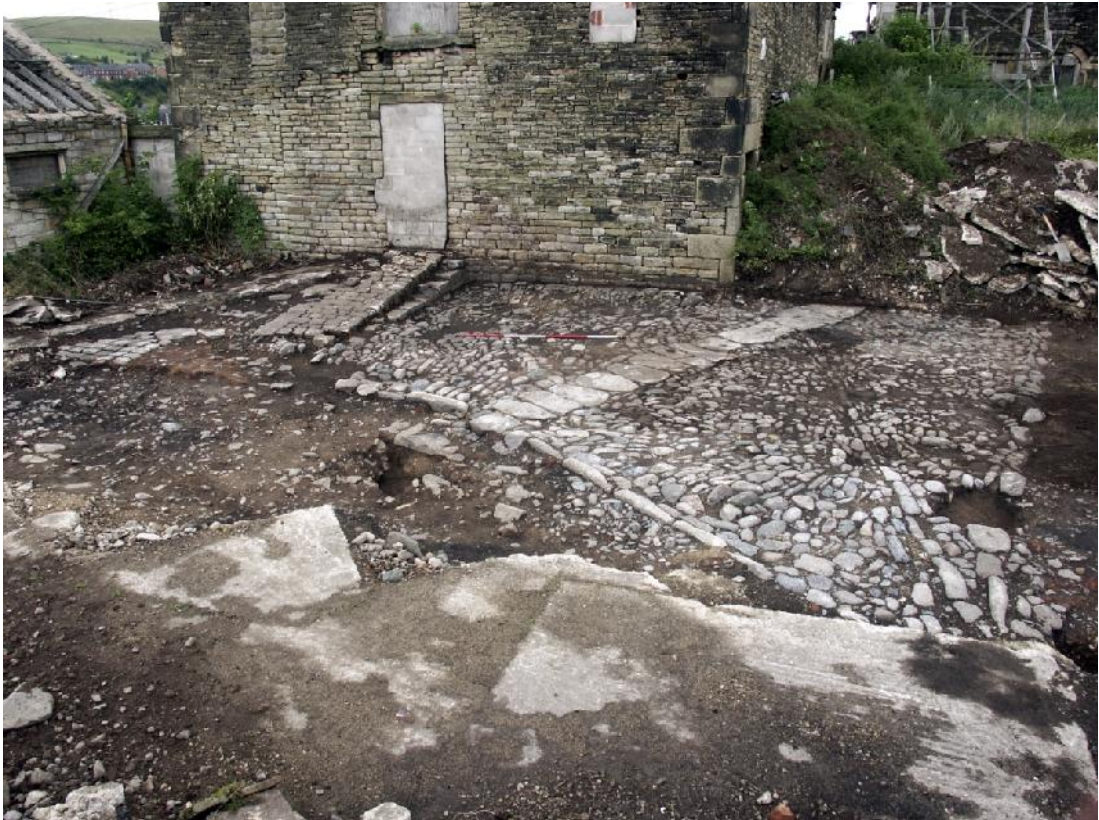
Plate 22 Decorative cobble surface in 2003 Trench 8 before being reburied for protection. Former cow house/stable (behind) demolished to make way for construction of 2012 Building 3 on almost identical footprint.

Looks north-west. 0.50m scale divisions.

Section No 3 was located some 2.5 m south-west of the south-south-west corner of Building 3 (Figure 2). This section (and No. 8, below) was selected to illustrate that the decorative cobble surface exposed in Trench 8 of the 2003 archaeological assessment (Plate 22) had been destroyed in the intervening period.

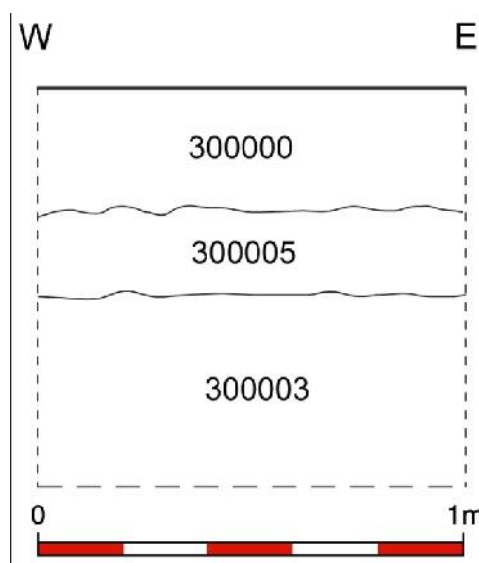
Figure 17 South facing Section No. 6

Section 6 was located within another foul water trench, some 10.3m to the south of Section No. 8. The trench was 0.65m wide and up to 0.93m deep. A 0.44m thick deposit of natural, loose, mid reddish brown sand and gravel (300003, Figure 17) was the earliest deposit present. It was observed at 0.49m BGL and continued beyond the base of excavation.

Directly above it was a 0.20m thick layer of modern disturbance comprising loose dark grey – black silt sand (300005) with occasional small modern plastic, brick and concrete fragments. This was overlain by a 0.29m thick layer of limestone hardcore (300000), which formed the modern ground surface.

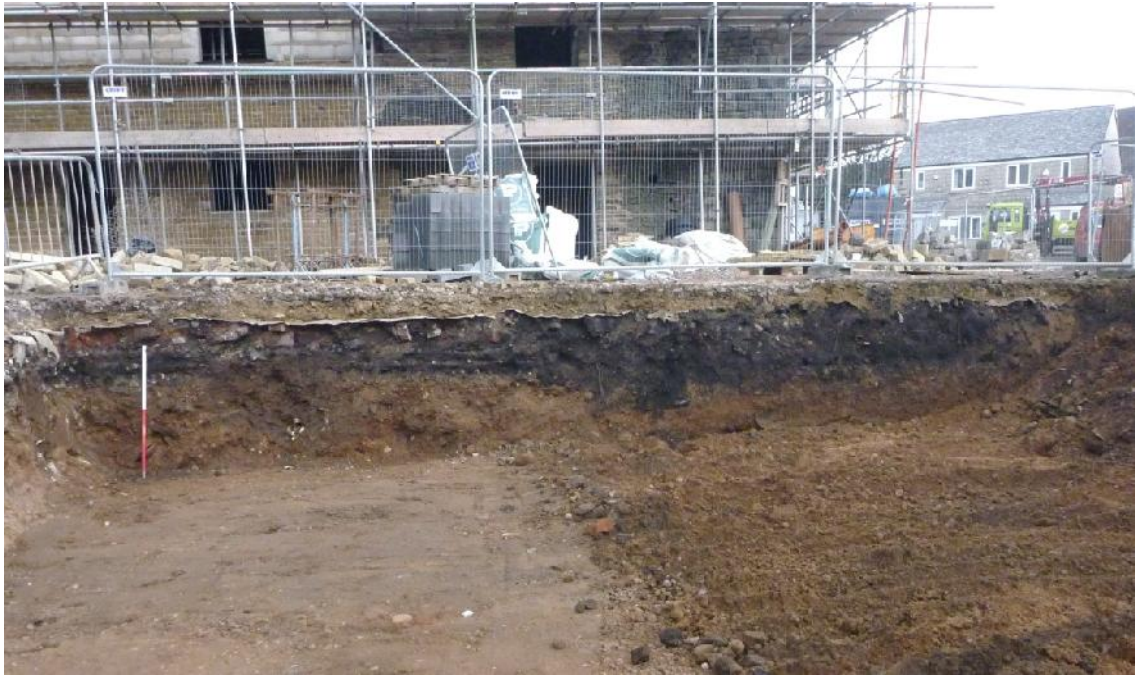
Plate 23 South-west facing section No. 14. 0.50m scale divisions.

Section No. 14 (Figure 19, Plate 23) was located on the eastern edge of the flood water attenuation tank construction trench. This was a large, 11.7m long, 9m wide, 1.40m deep, west-south-west / east-north-east aligned, rectangular cut located towards the centre of the development, close to its southern edge (Figure 2).

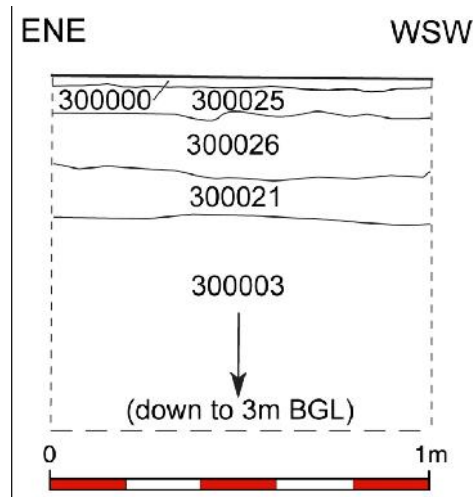
Figure 20 North-west facing Section No. 17

Section 17 was located within a deep surface water inspection chamber excavated south of the eastern wing of the hall (Figure 2, Plate 24).

This trench was c. 2.5m² and was excavated down to a finished depth of 3m BGL. In this trench the top of the pale brownish orange natural sands and gravels (300003) was observed at 0.41m BGL and they continued beyond the base of the trench. Overlying it was a levelling deposit of pale to mid brown sand and pebble gravel with occasional dark grey silt patches (300021), 0.11m thick. This was in turn sealed by a 0.18m thick deposit, comprising compacted loose dark grey – brown cinders and clinker (300026), below a 0.08m thick deposit of mid – dark brown clay silt sand (300025) with moderate small brick rubble and occasional limestone hardcore inclusions. The top of it was sealed by limestone hard core 300000 which, at 0.04m thick, formed the ground surface when the work was undertaken.

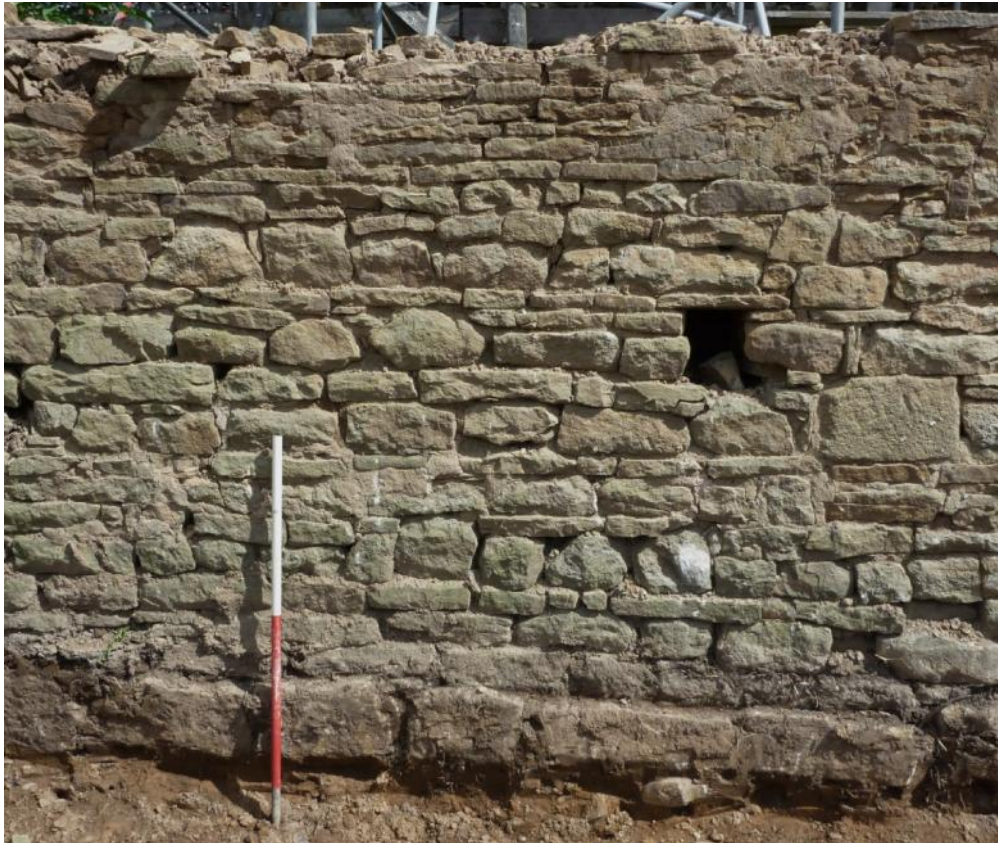
Plate 25 Part demolished northern wall of Building 6 showing elevated single course foundation above depth of internal floor reductions. 0.50m scale divisions

The track ways crossing buildings 5 and 6 were mostly destroyed by the conversion works. The removal of all of the other internal floors within these buildings in advance of the watching brief (Plate 25) renders dating their construction difficult.
