Glebe Farmhouse, Coleby Road, West Halton

**Glebe Farmhouse
Coleby Road
West Halton
North Lincolnshire**

**HISTORIC BUILDING RECORDING
(PHOTOGRAPHIC & DESCRIPTIVE RECORD)**

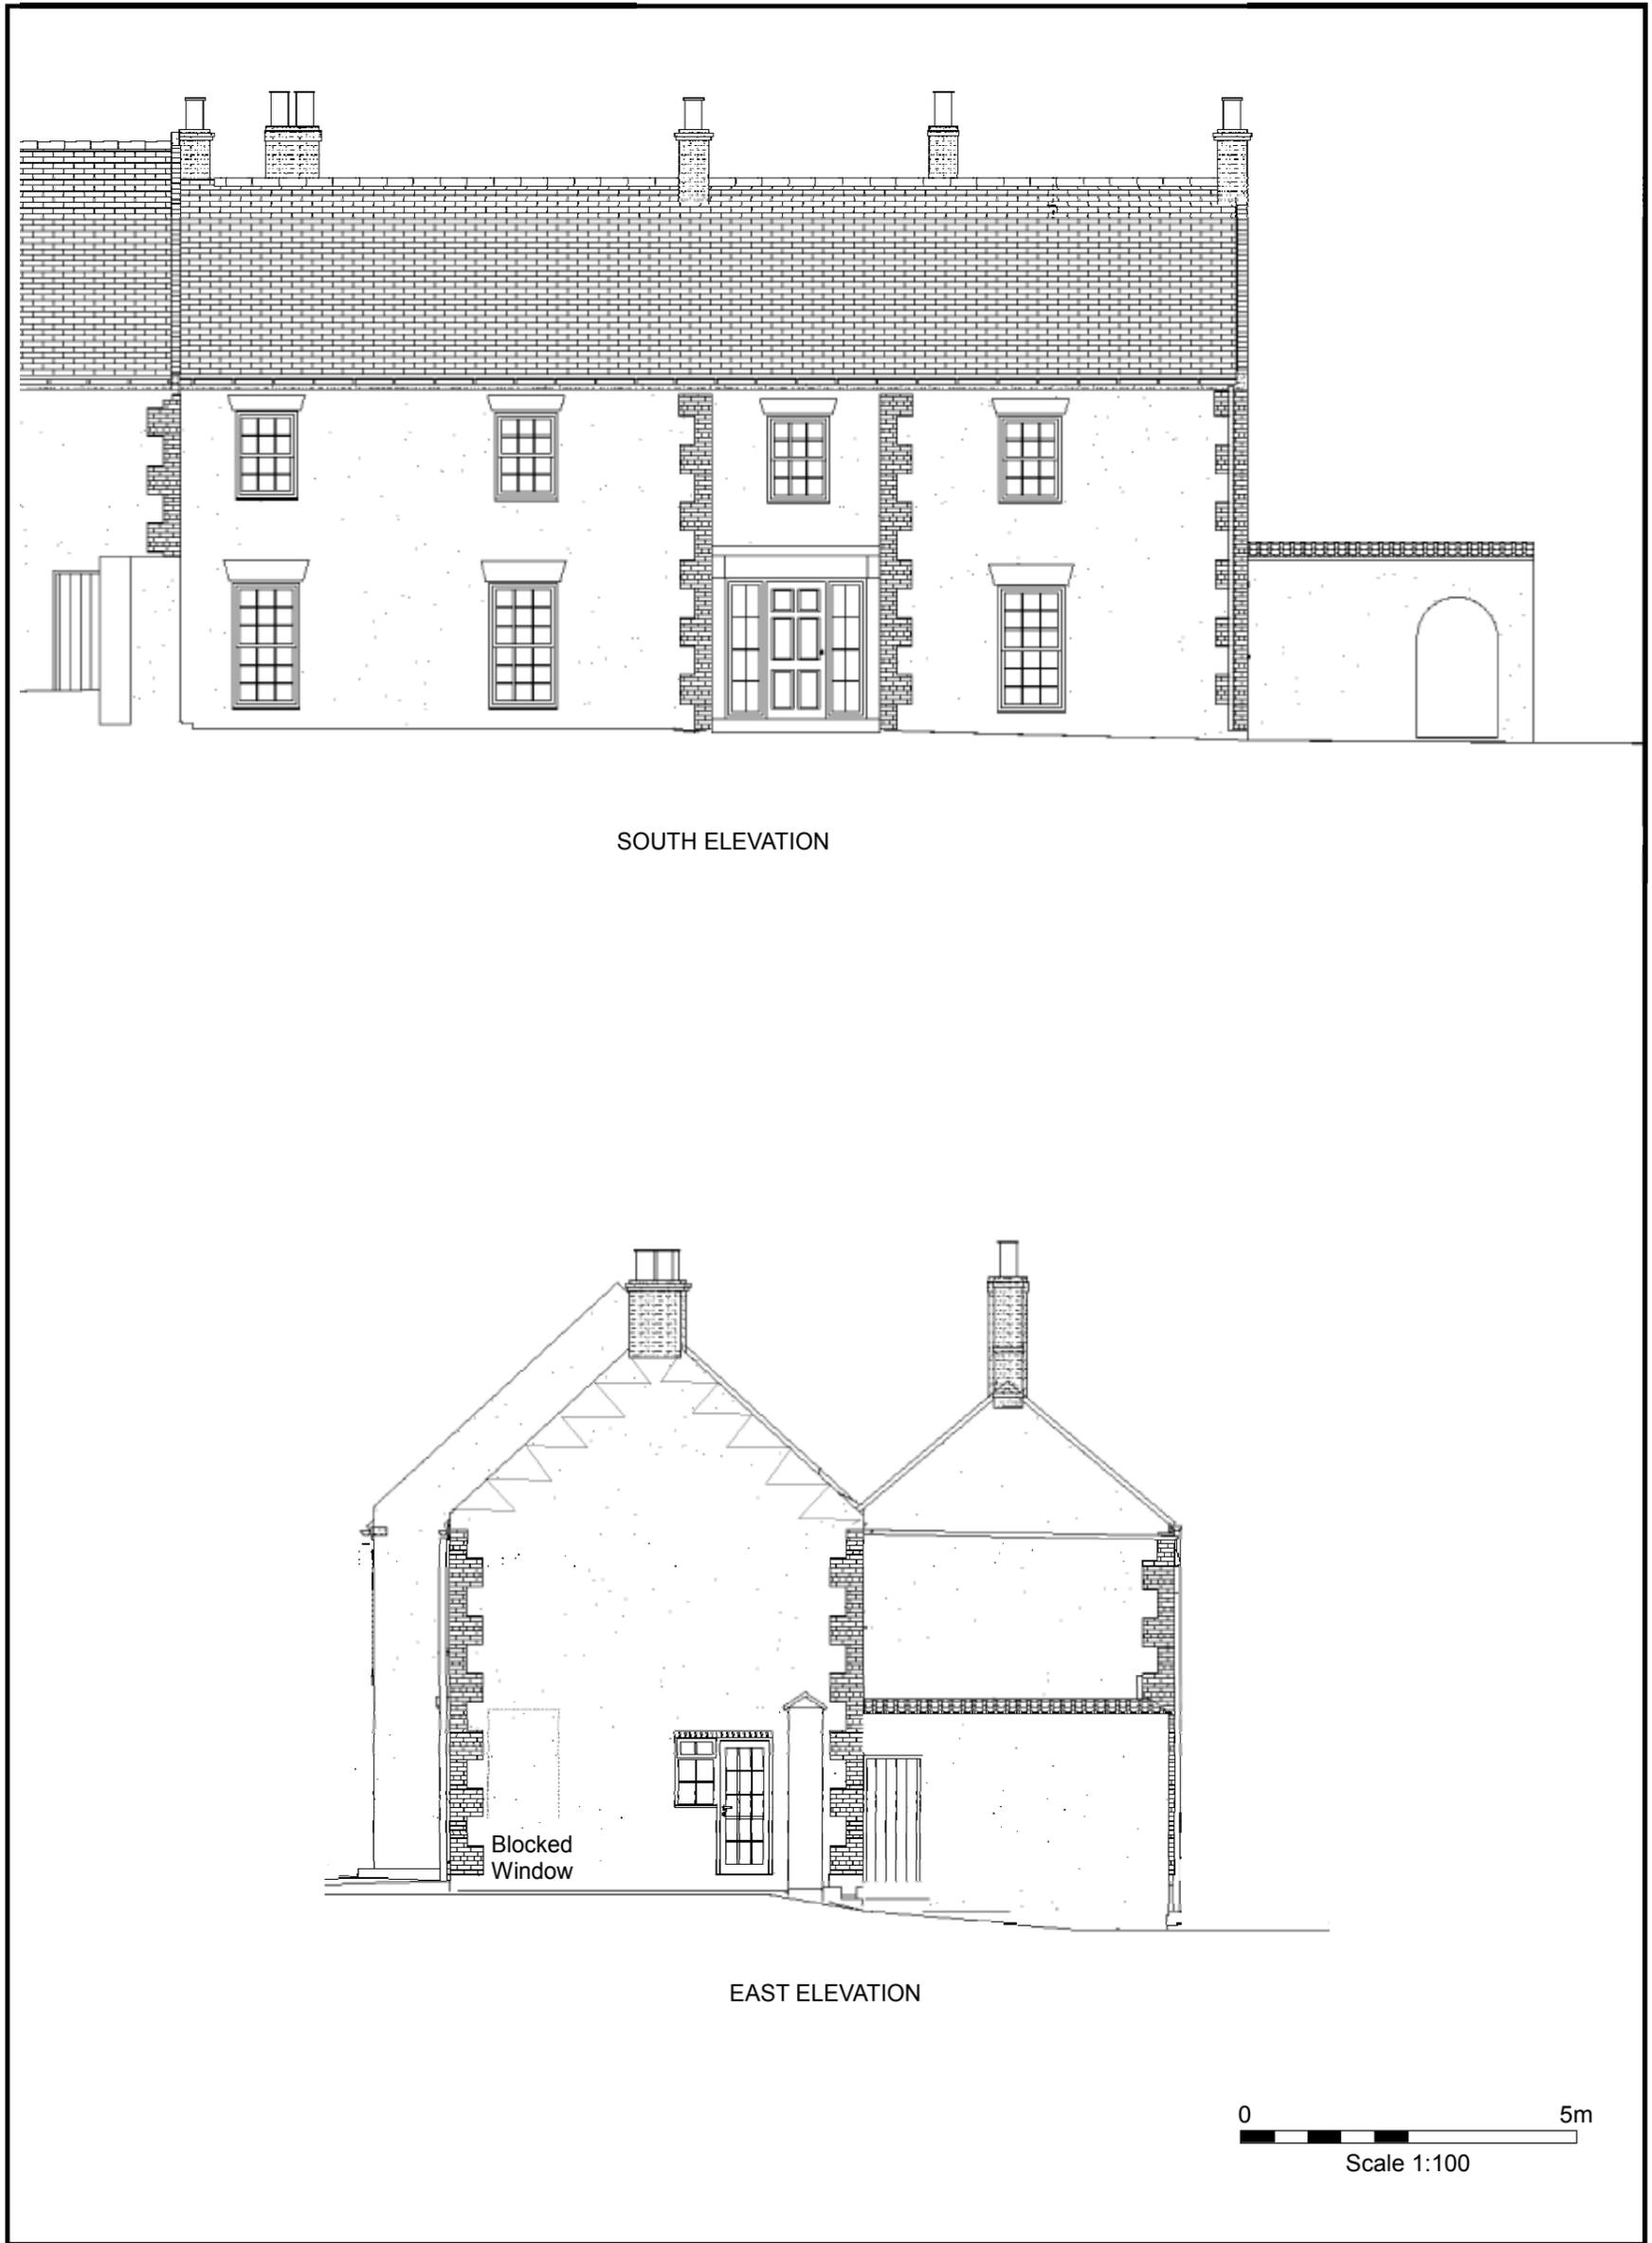
Figure 5. Glebe Farmhouse: South and East Elevations.

SOUTH ELEVATION

EAST ELEVATION

6.2 Farmhouse: Exterior Description (Figs. 3, 4, 5 & 6; Pls. 1-10)
