JOHN MOORE HERITAGE SERVICES

**BUILDING ASSESSMENT**  
**ON**  
**FRIZERS FARMHOUSE,**  
**SONNING EYE, OXFORDSHIRE**  
**NGR SU 75235 75966**

**JANUARY 2016**

**JMHS Project No:** 3386

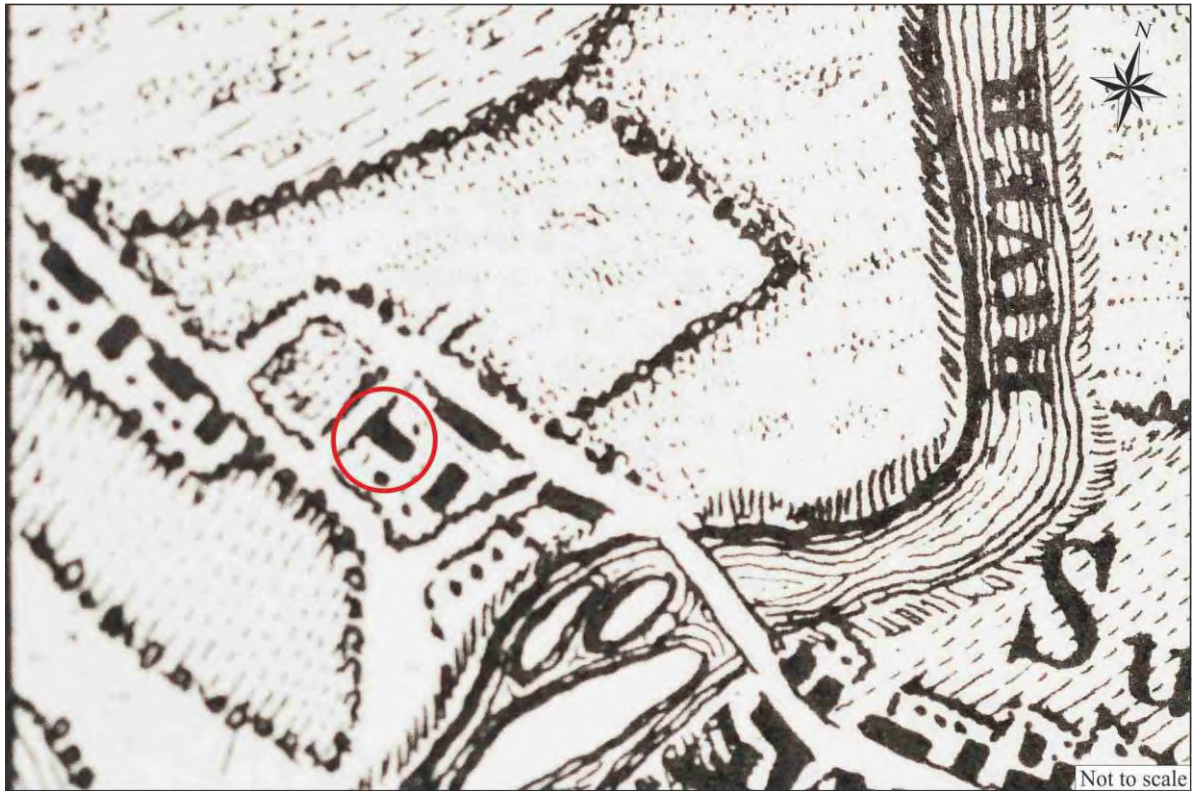
Figure 2: Rocque's map of 1761-2

The earliest map of the area is by Rocque of 1761-2 (T/M 128) which shows a building in the location of Frizer's Farmhouse that appears to be orientated northwest to southeast

(Fig 2). It is possible that this could mean that only the northeast part of the building existed with its orientation in this direction. Alternatively it could also mean that if the southeast extension was present at this date, due to the detail, Rocque may simply have oversimplified a main central range with two extensions.

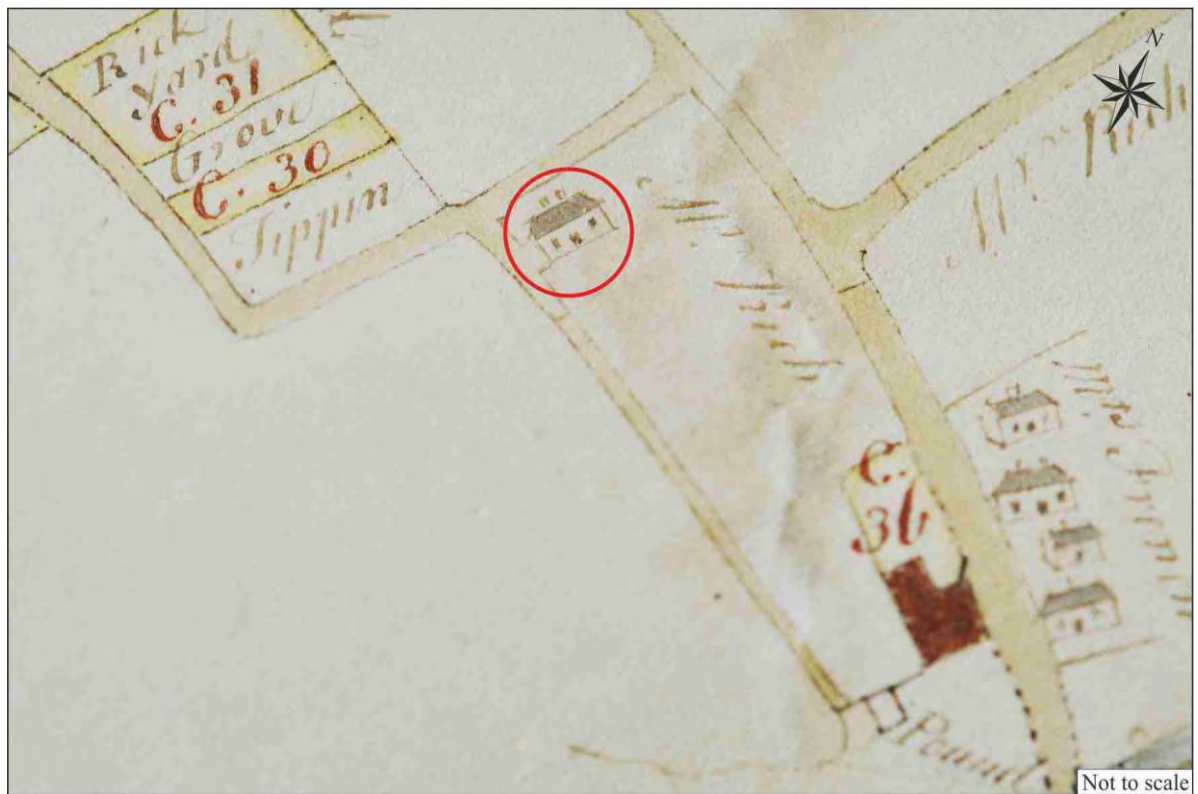
Figure 4: 1763 Estate map

The estate map of 1763 (D/EE P1) shows the road system around the farm as the same and the farmhouse in a pictorial form with two windows and a door, but two chimney stacks (Fig 4).

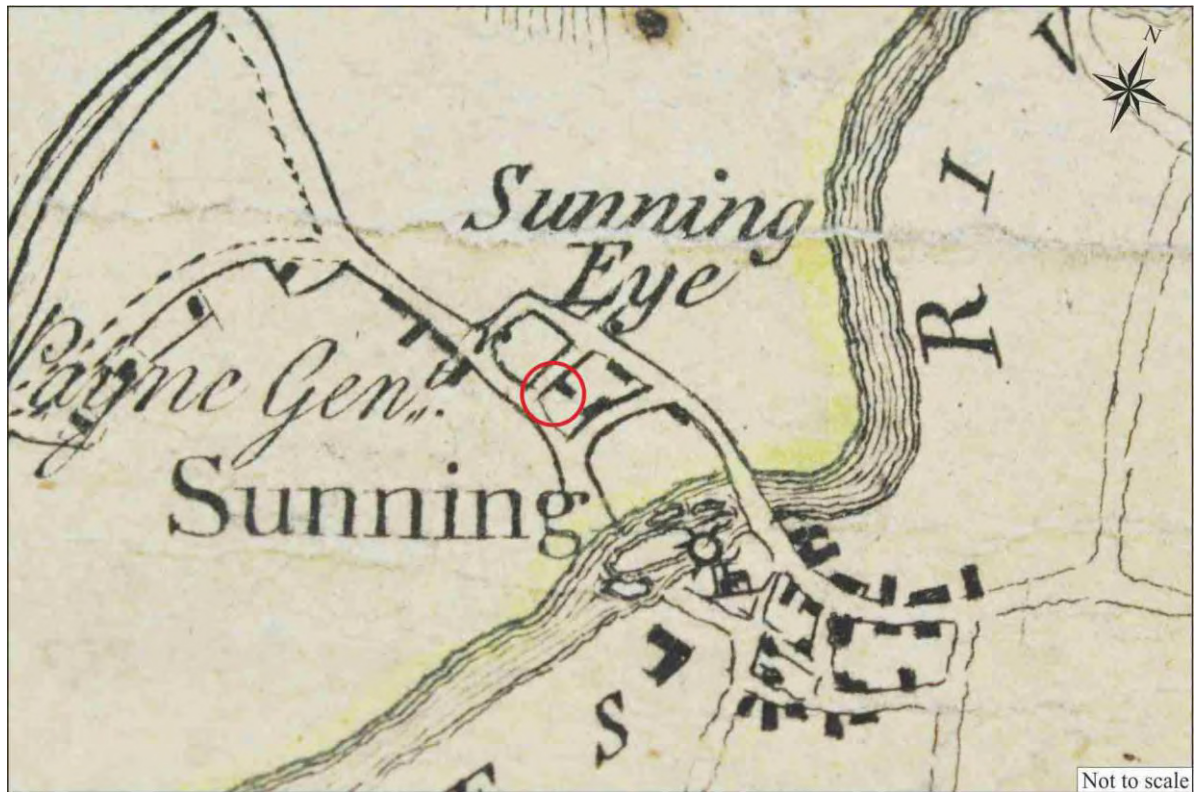
Figure 5: Jefferys's map of 1767

A county map from 1767 (CP/103/M/1), depicts the same as the 1763 map, but shows the building as rectangular structure with no details (Fig 5).

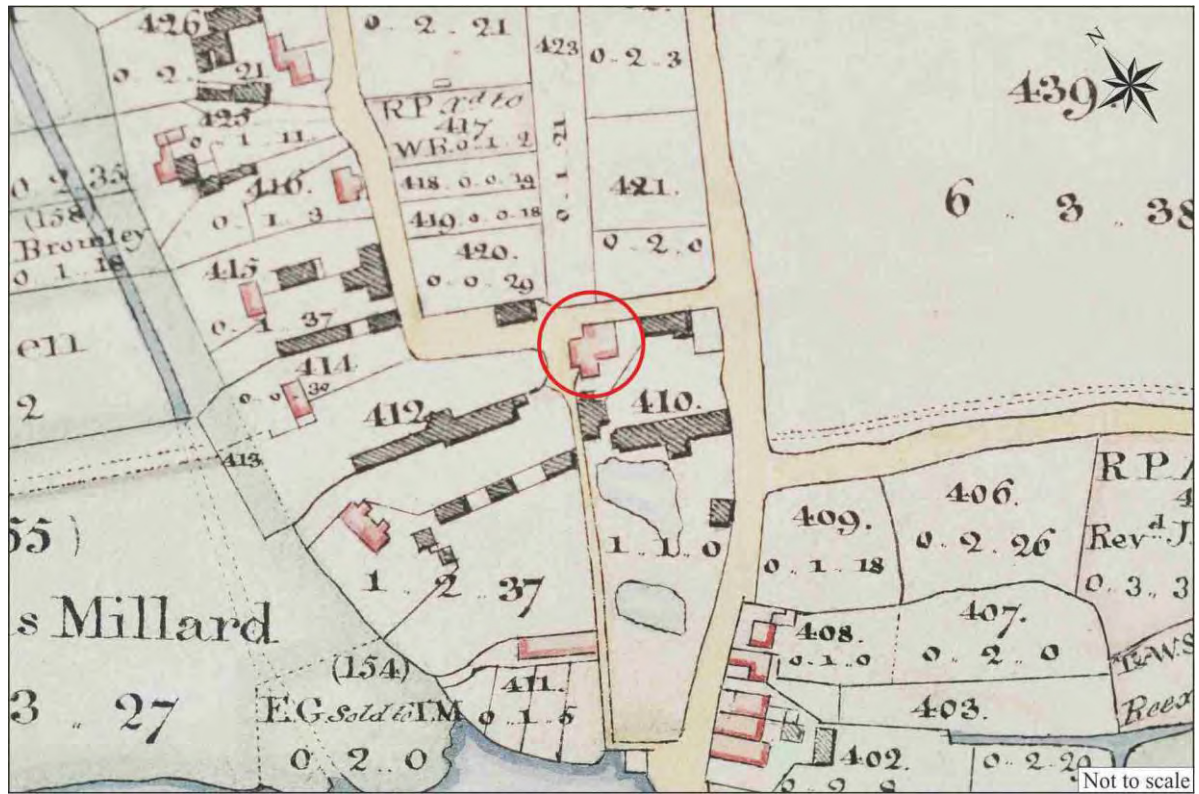
Figure 8: Map from c.1820

A map dated c.1820 (D/EE P4) shows the two storey and one and a half storey part of the building as being constructed. The map also shows a southeast extension from the building that in this case does not join the neighbouring barn (Fig 8). The barn is shown immediately to the south and the large barn on the southeast side of the courtyard. A further agricultural building is shown to the east. The plot is numbered 410 and this map appears to be either an identical replica or a map extremely similar to that of the Inclosure Map. A book (D/EE E11) dated 1825 appears to be a catalogue associated with this map. Plot 410 is reported as being a farm house, barns, stables, outbuildings and a yard. The property owner is noted as Robert Palmer and the occupier as a Thomas Frizer.

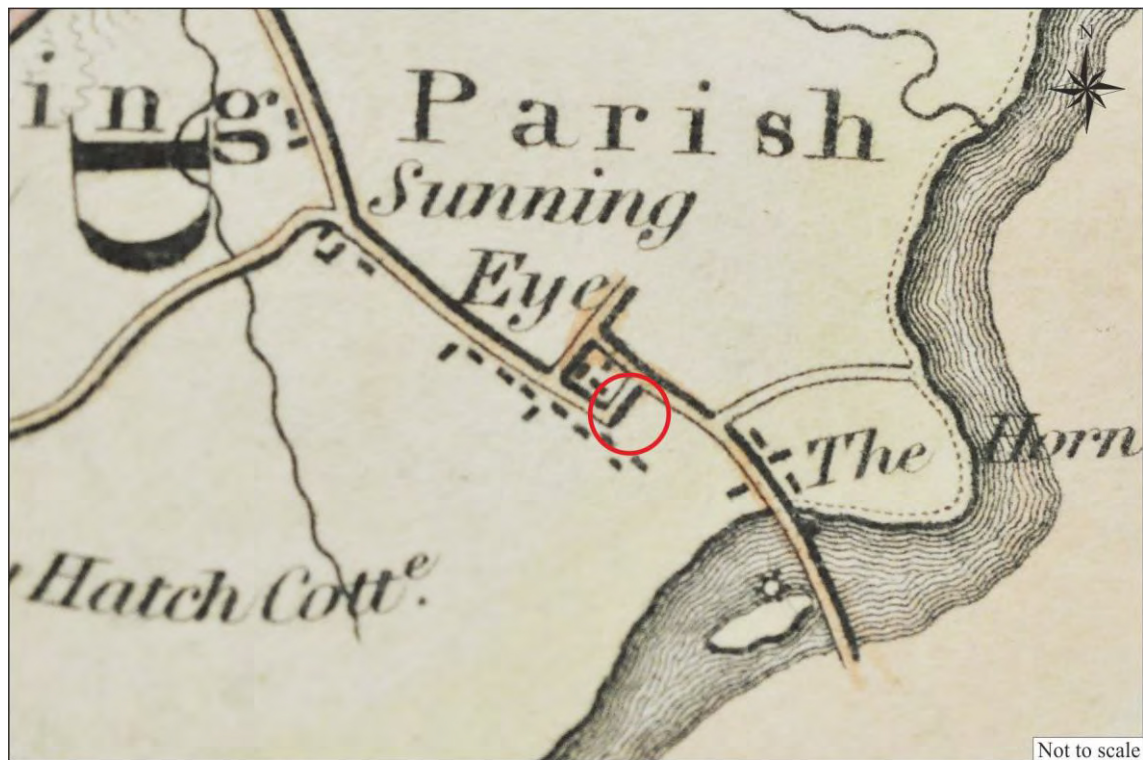
Figure 9: Bryant's map of 1824

A county map from 1824 (P345/M/1) appears to be problematic or erroneous (Fig 9). Buildings are shown in a large sub-square area of roads to the north of Frizers Farm. However, other maps show no or one building here, and it would seem likely that the Frizers Farm complex has been located in the wrong place.

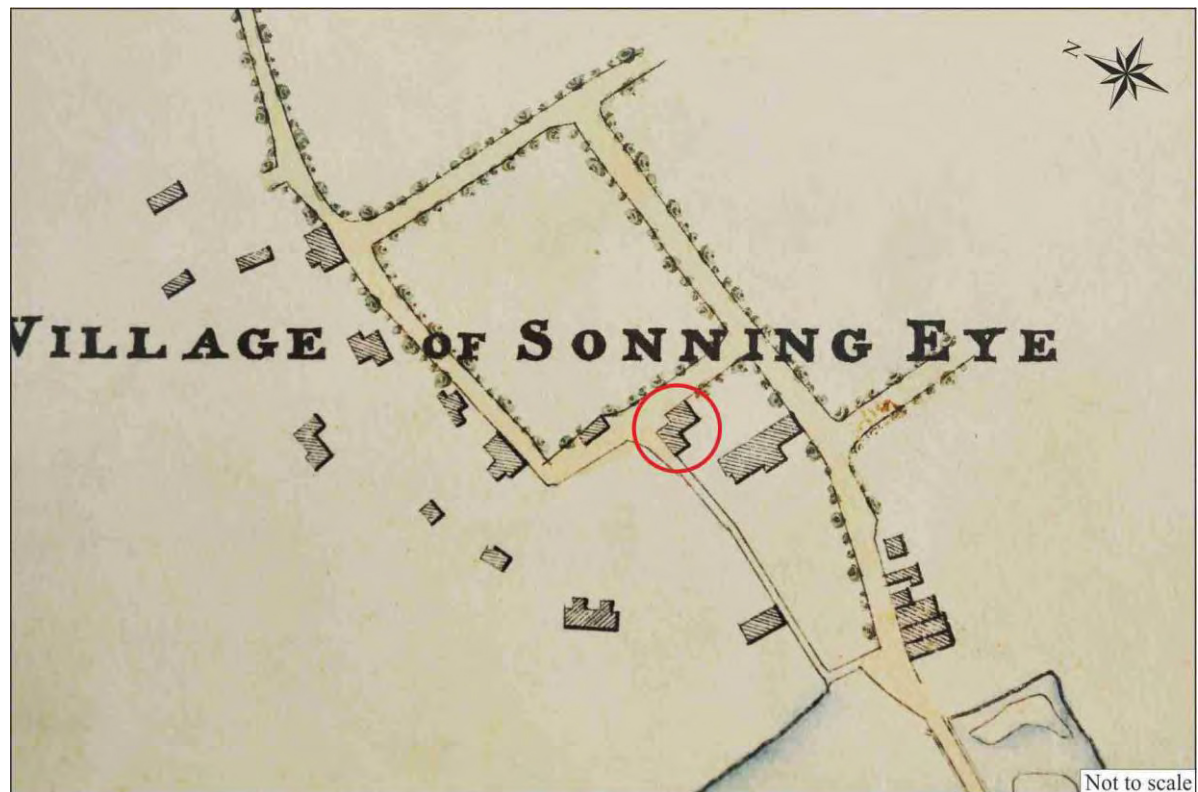
Figure 10: 1825 Estate map

An estate map of 1825 (D/EE P4) shows the structure in a shape that all of the two storey and one and a half storey structure of the building would have been in place (Fig 10). Extending from the southeast side of the structure there is an extension. The barn on the southeast side of the courtyard is shown.

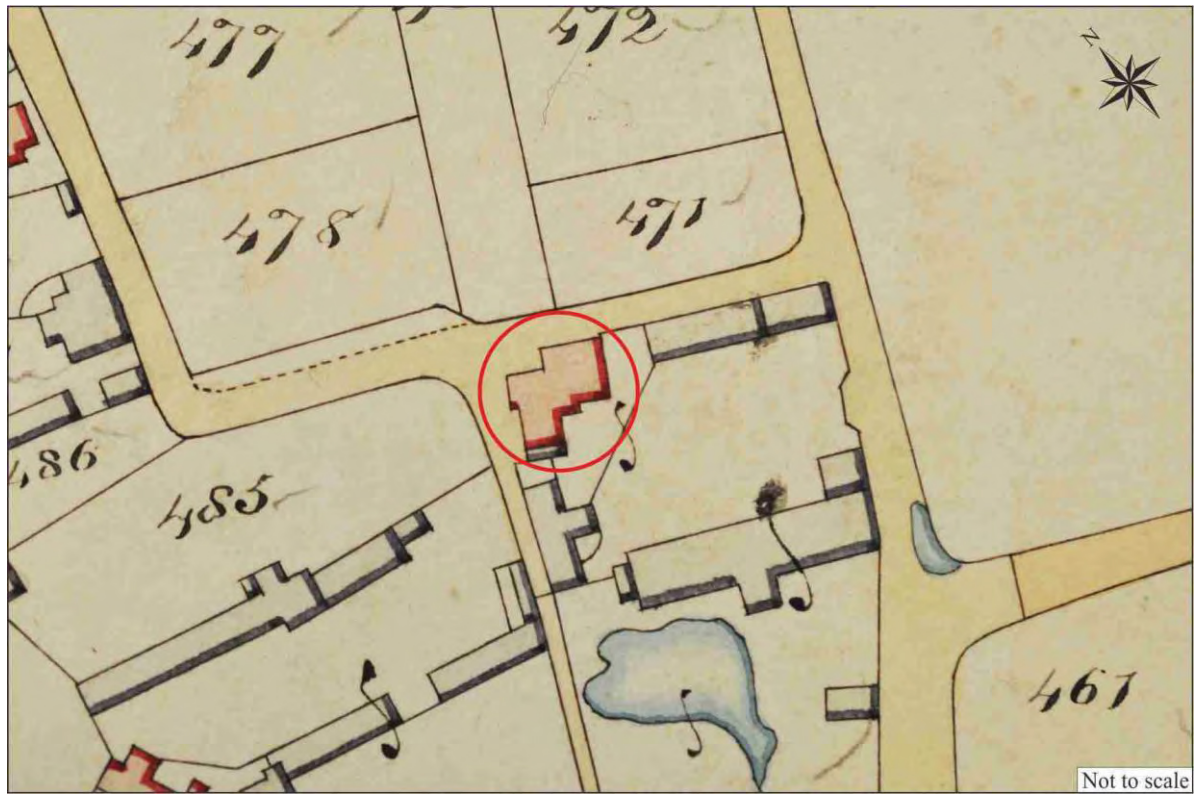
Figure 11: 1841 Tithe Map

The Tithe Map of 1841 (D/D1 113 D/1) shows the farmhouse as an irregular shaped structure with all of the two and one and a half storey part of the structure built (Fig 11). There is an extension of the building on the southeast side, extending towards the barn to the south. Between the barn and the farmhouse there is a structure or outbuilding that links both together. The line of the garden wall takes on a completely different form and it is only on the northwest side that the boundary conforms. The plot on the Tithe Map is numbered as 479, while the award notes that plots 460, 461, 471, 472, 479, and 500 are occupied by a Martha Frizer. Martha is presumably a relation of Thomas, either a widow or daughter, or less likely a more distant relation. Due to the way the document is microfiched it is difficult to ascertain who the owner is, but this is invariably a Palmer.

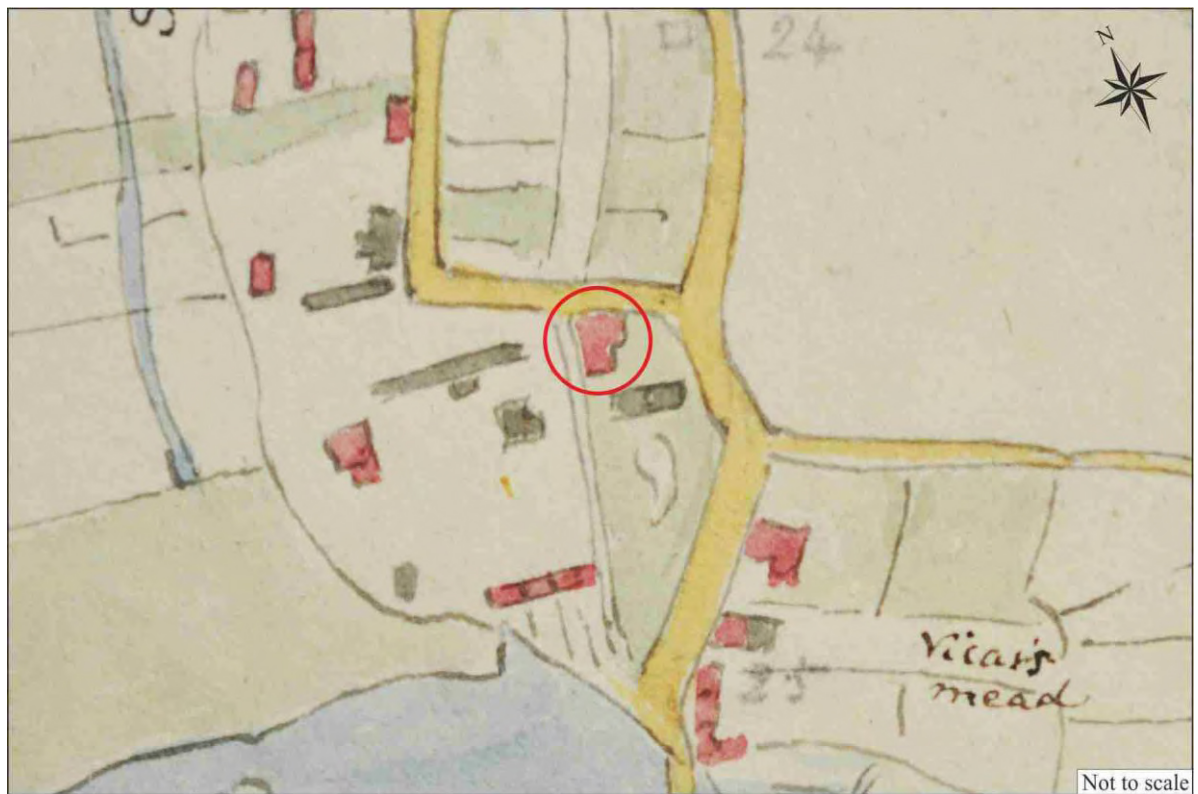
Figure 12: Map from 1845

The map of 1845 (D/EE P5) shows the main part of the house as existing (two storey and one and a half storey), it also contains the southeast extension of the structure (which is no longer extant) (Fig 12). This map for the first time shows the northwest corner of the building as being in-filled, which would suggest that this single storey part of the building was constructed at a date from 1841 to 1845.

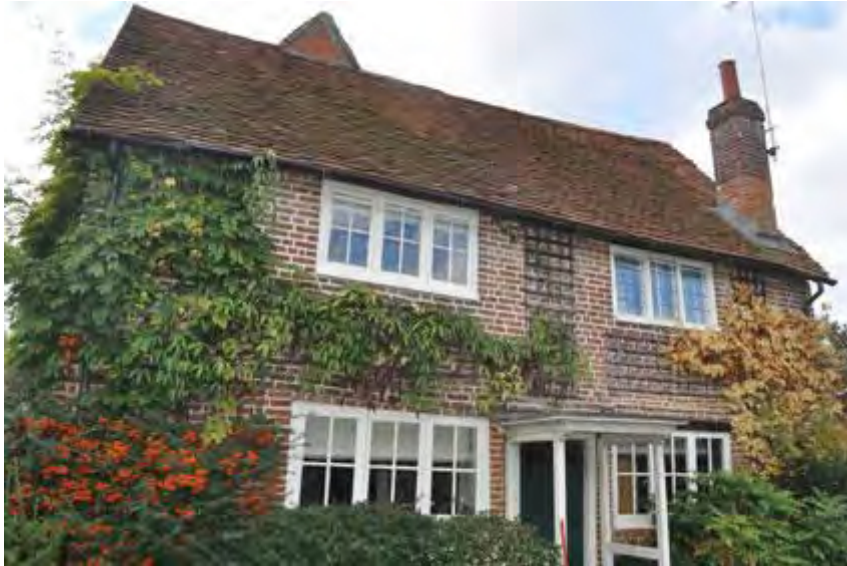
Plate 1: Northeast façade

The northeast façade is an elevation of brick, the majority of which measure approximately 220mm x 103mm x 50mm. The depth of brick would be consistent with a 16<sup>th</sup> to 17<sup>th</sup> century date. The bond is not a classic design and appears to be staggered and mixed to fit in with the window and door locations. This implies that the apertures are probably in their original locations.

The façade is of three bays of which the central bay is made of a panel door with a timber framed porch (plate 1). The porch hood is moulded with its upper side covered in lead. The porch extends so far to be cantilevered and thus has two H framed supports on either side. Discussions on lead flashing are noted in 1832 and 1875, so these porches could be 19<sup>th</sup> century additions or later (plate 2). The two flanking bays contain timber framed windows with two mullions on the ground and first floor. Three of the windows contain three units with four lights. The window on the right hand side on the first floor contains two mullions, like the others, but instead of the three units being divided into four lights,

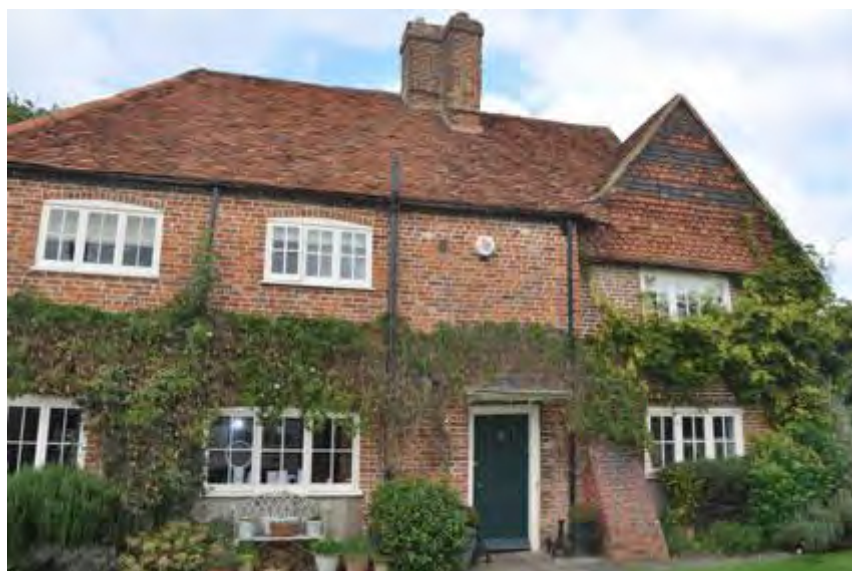
Plate 3: Southeast facade

The southeast façade contains four bays although the two southern bays run out of alignment (plate 3). On the right hand side of the elevation there is a gable end, which contains a single bay with a window on the ground floor and one on the first floor. The design of the windows is similar to that on the northeast elevation, mullioned, with three units with four lights. The gable above is tile hung; with the tiles either having square, rounded or wave ends. They are arranged in banks of three for an aesthetic effect. There is a later buttress on the left hand side of the gable constructed with bricks that measure 221mm x 110mm x 70mm approximately.

The rest of the elevation is staggered slightly forward and is constructed in brick of an irregular bond. The bricks are approximately 210mm x 100mm x 54-58mm, with most red but some are vitrified. Of the three bays that are located in this part of the façade, the right hand bay has a panel door on the ground floor. This has a cantilever porch above with no side supports and with lead sheeting on the upper side. The central and left hand bays contain windows with two mullions forming three units, each unit is divided into four lights. It is noticeable that the windows on the first floor are of a similar size to those in the east end gable and the northeast façade. However, those on the ground floor follow a similar design but are far larger and not aligned centrally with the windows above. The

area below the ground floor windows is rendered. The windows all have segmental headed arches above.

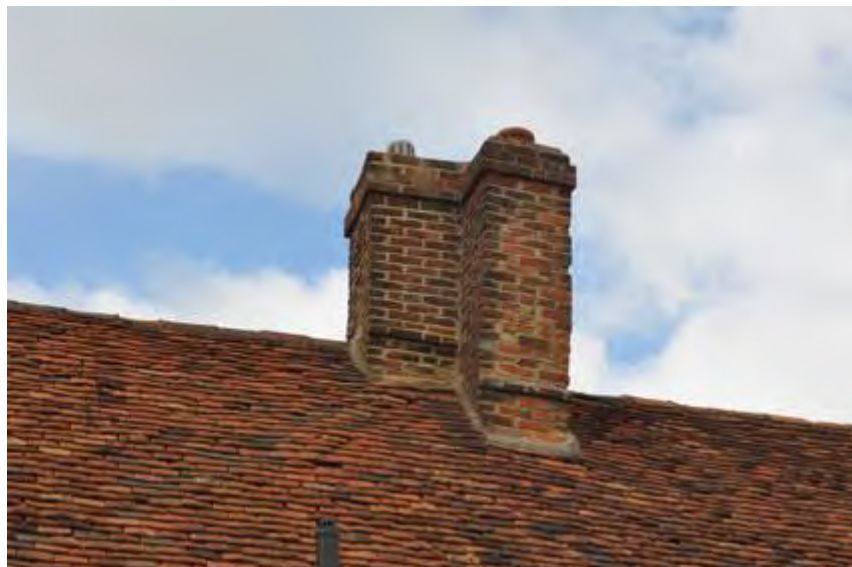
Plate 4: Chimneystack

Over this part of the building there is a red clay tile roof which is hipped on the left hand end and the roof extending over the pitch of the gable to the gablet of the northeast façade on the right hand side. Along the ridge line there is a chimneybreast of an L-shape with an upper and lower water tablet and a number of chimney pots (plate 4).

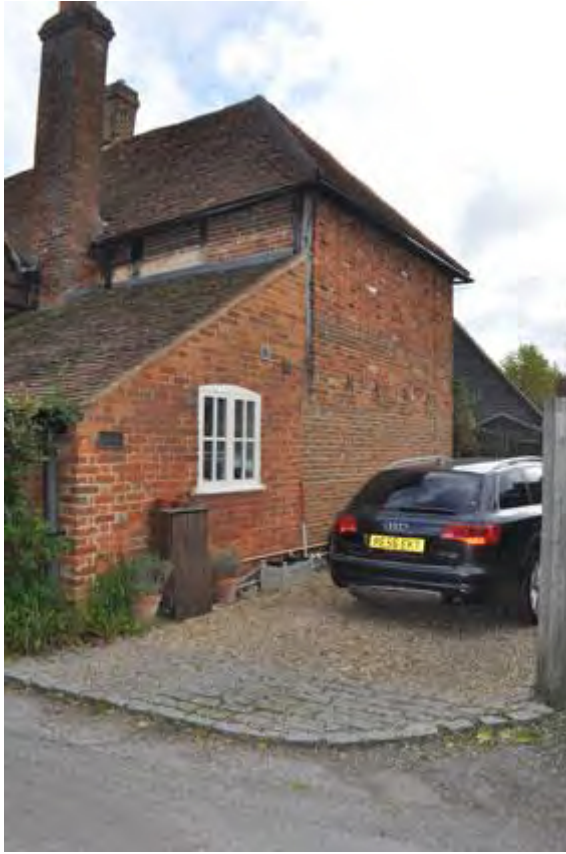
Plate 5: Southwest façade

The southwest façade (plate 5) contains two component parts. On the right hand side there is a plain brick wall containing bricks approximately 210mm x 100mm x 54-58mm. A number of the bricks are vitrified. On the left hand side of this end wall there is a timber post, which may need treatment with a preservative. Above the wall is a hipped gable end.

The left hand component of the wall contains the end of a single storey lean-to building. The wall is of brick that measure approximately 226mm x 107mm x 74mm. There is a single window with a segmental arch with single mullioned window with each unit divided into four lights.

Above the lean-to there is a half storey development with a gable end with a single window. The window is mullioned, but with each unit containing two lights. The gable is weather-boarded. To the right of this gable is a chimney with water table. Behind the gable the wall line rises again to a further clay tile roof.

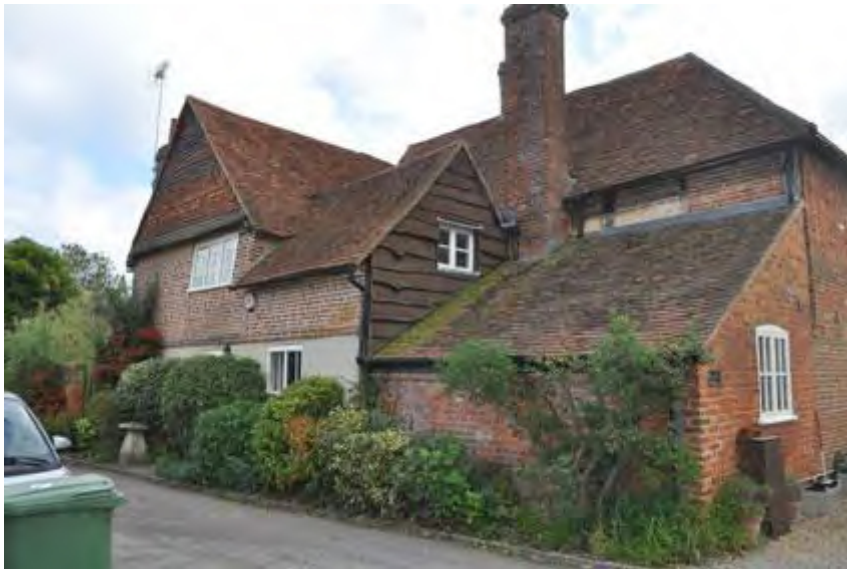
Plate 6: Northwest façade

The northwest façade (plate 6) contains a number of component parts. At the left hand end of the building is a gable end with a single bay set to the right hand side. On the ground floor is a modern door, probably in an old entrance, and above is a three unit mullioned window, with the windows containing twelve panes divided by lead tracery. In the gable there is a tile hung first floor and gable, which contains tiles with square, rounded or wave ends that form a pattern in the same way as the southeast gable. Over the left hand eaves

Above the single storey lean-to and the one and a half storey development there is a tall chimney stack with water tablet. To the rear of the chimney there is a two storey range. Part of a timber framed wall is visible to the left of the chimney. The timber framing contains part of a jowl post. This implies that it is part of a former gable end, which is shown on the 19<sup>th</sup> century maps. The two data sets thus confirm that there was a second range of structures orientated northwest to southeast. Above this is a red clay tile roof. Set on the ridge of this roof is a chimney with upper and lower water tablet.

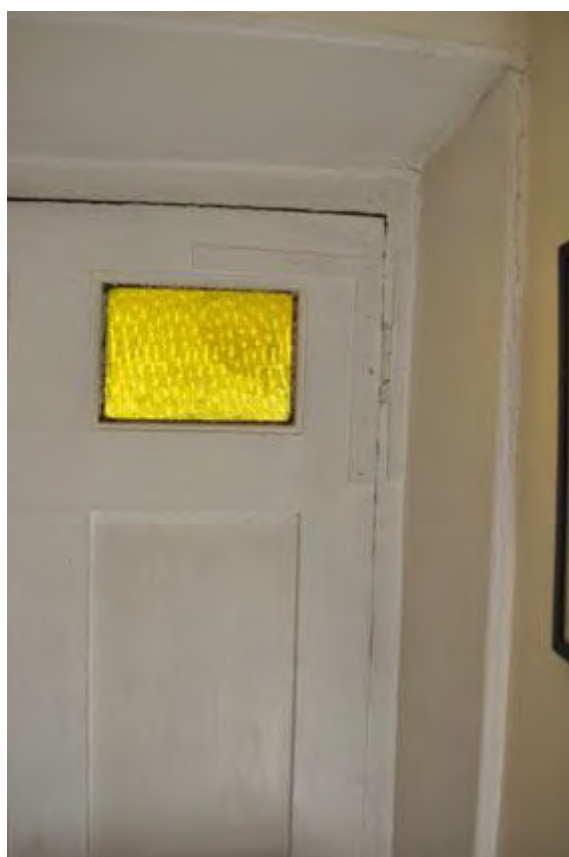
Plate 7: Front door with L-hinges

The main panel door in the northeast façade leads into room G1. This door contains six unequal panels of which the top two are glazed, and the fixtures contain two L-shaped hinges (plate 7). The panel door is similar to a dated example from Surrey dated 1712 (Alycock and Hall 1994, 18). The hinges are similar to examples from Gloucestershire dated 1707 (Alycock and Hall 1994, 25). On the northwest side of the room there is what appears to be the remains of a probable passage, which has been largely removed on the southeast side. The surround contains the remains of timber beams. On the northwest side of the former passage there is a further panel door reused, but in this case there are only

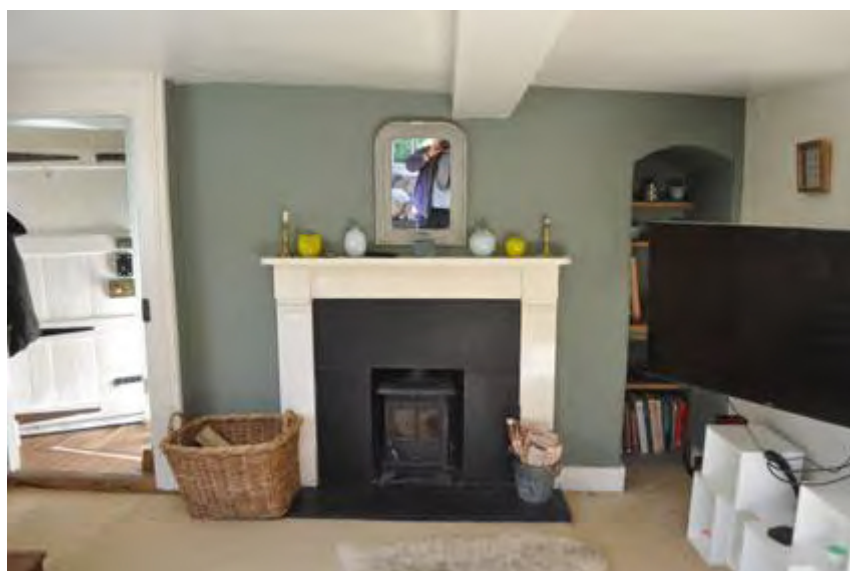
Plate 8: Fireplace room G1

two panels. At the southwest end of the former passage there was a further door leading to the stairwell. In the main part of the room G1 there is a mullioned window in the northeast wall, and also one in the southeast wall. Both mullioned windows have three units with four lights. Centrally in the southwest wall there is a fireplace (plate 8), probably of an 18<sup>th</sup> century date, which is flanked by an alcove on the right and a four panel door in a wall slightly staggered into the room. The door also has L-shaped hinges fitted (plate 9), which are similar to some dated from Gloucestershire of 1707 (Alycock and Hall 1994, 25); however, the screws are possibly later. The surrounding frame and wall is of timber. The ceiling contains a central beam running from above the fireplace to above the window in the northeast wall. The ceiling on the southeast side contains an area of panelling. The room appears to be an 18<sup>th</sup> or very early 19<sup>th</sup> century reworking of an earlier structure.

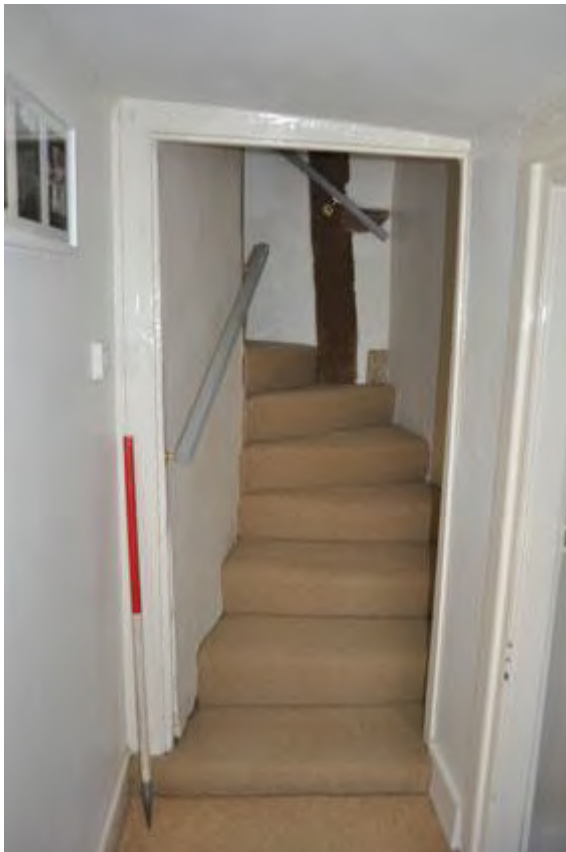
Plate 10: Stairwell G3

From room G1 a door leads into the stairwell G3 (plate 10). Here a spiral staircase is evident curving around a central timber. In the southwest wall there is evidence of a corner post. The northwest wall is staggered, but set in this wall are the remains of a plank door. This plank door has a handle similar to one from Suffolk dated 1718 (Alycock and Hall 1994, 26).

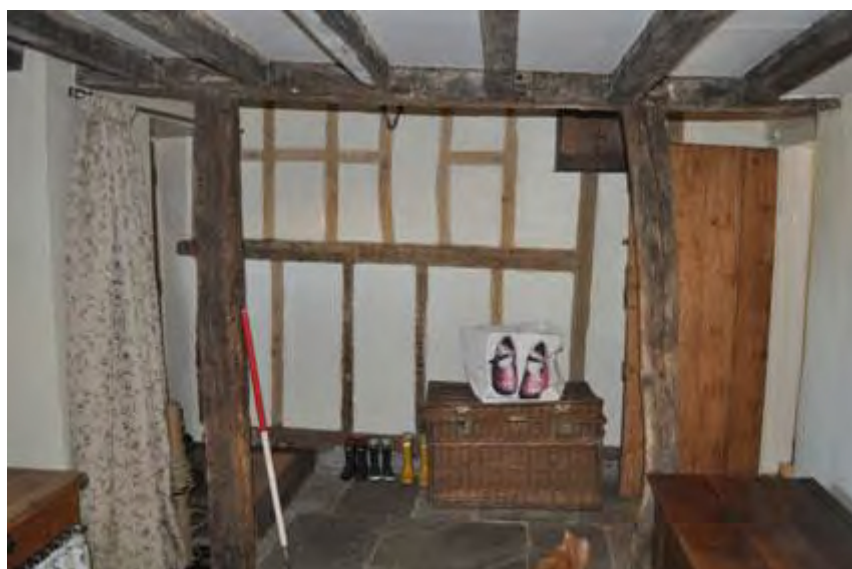
Plate 11: Room G4

The northwest plank door in room G3 leads into room G4. This room is now used as the entrance hall onto the street; however, it was originally the rear of the property. The northeast wall in this room is timber framed in a box design. Running parallel to this is a timber in the ceiling and two studs (plate 11). This is the remains of the exterior wall. The ceiling between the wall and the partial remains of the wall is slightly higher than the rest of the room and contains a number of joists. At the northwest end of this former passage there is a modern door. In the other part of the room there is a brick wall with a timber beam in the southeast wall. The bricks measure 195mm x 110mm x 70mm. The depth of these bricks is indicative of this wall being late 18<sup>th</sup> century at the earliest. To the right of this wall there is a plank door that is approached up three steps. In the southwest wall there is a relatively central plank door, and in the northwest wall a window.

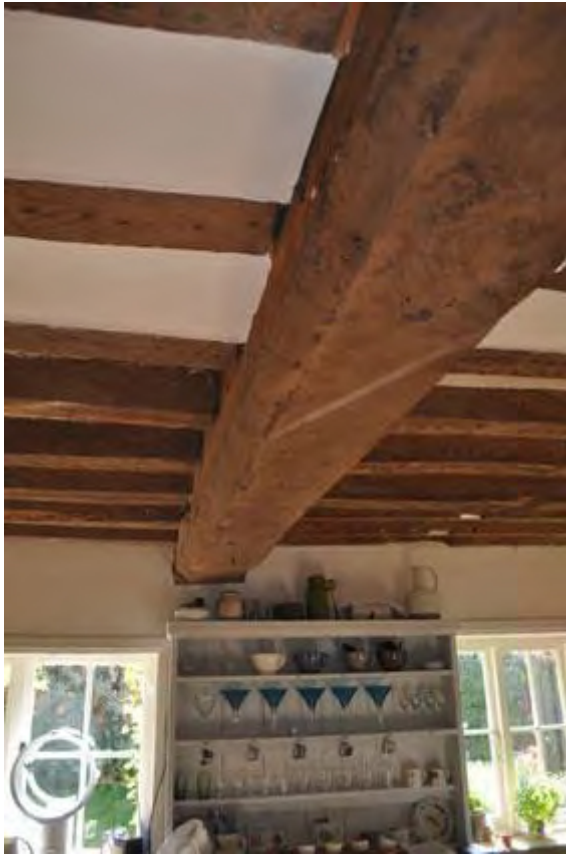
Plate 12: Beam room G6

The southeast door from the entrance hall leads up into the kitchen G6. The door handle resembles an example from Gloucestershire dated 1637 and one from Kent of 1645 (Alycock and Hall 1994, 26). In the northeast wall there is a range set within a brick semi-circular arch (plate 14). The bricks here are 220mm x 110mm and 70mm, with some of the dimensions similar to that of the wall around the stairwell as evident in room G4. To the left of the semi-circular arch there are a group of bricks low down in the wall, perhaps part of an earlier dwarf wall, that measure 220mm x 110mm x 45mm. These represent some of the narrowest and perhaps earliest bricks recognised in the structure. There is a plank door in the wall to the right of the semi-circular arch with a significant timber above, which does not align with the joists in the ceiling of room G6. The door handle resembles an example from Gloucestershire dated 1637 and one from Kent of 1645 (Alycock and Hall 1994, 26). In the southeast wall there are two mullioned windows of three units with four panes each (plate 13). The windows are larger than most in the structure and are probably considerably later than the others, possibly late 19<sup>th</sup> century at the earliest. The west wall is blank and there is a second door in the northwest wall that leads to room G7. In the ceiling located centrally there is a chamfered beam (plate 12) with stops at the southeast

end, but none visible on the northwest end. The stops are simple and comparable to a dated example from Devon of 1591 (Alycock and Hall 1994, 36); however a similar stop is recognised at Siddenhales Farm, Hockley Heath in Warwickshire where a 17<sup>th</sup> century date is suggested (Mercer 1975, 214). There are a series of joists either side.

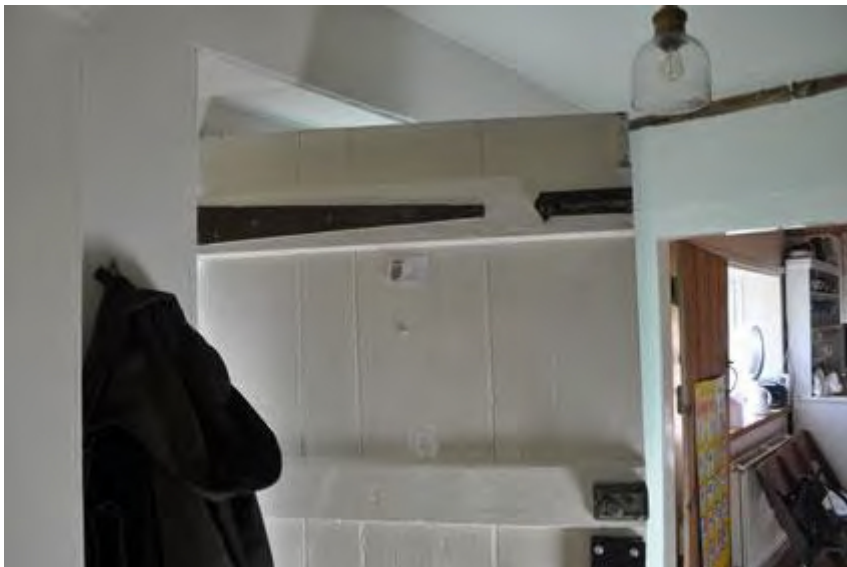
Plate 15: Door and hinges room G8

Room G8 is a small lobby passage and is entered from the eastern door of room G6. In the northeast wall there is a four panel door that leads back into room G1. In the southwest wall there is a plank door that leads back into the kitchen. In the southeast wall there is a panel door that is external and associated with the southeast façade (plate 15). This door has strap hinges with a base-plate similar to examples from Surrey of 1743 (Alycock and Hall 1994, 24).

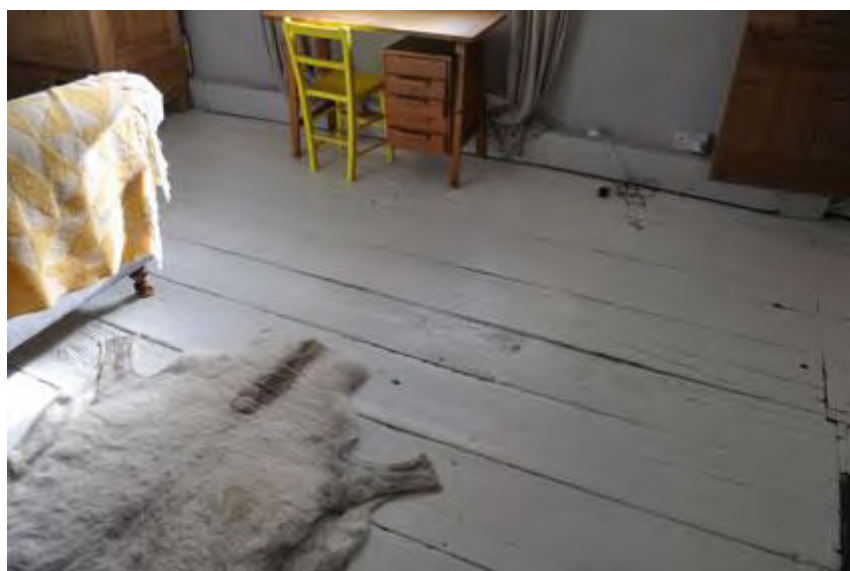
Plate 18: Wide floorboards room F2

The plank door in the east wall leads into room F2, a square or rectangular room with the one corner cut off creating a polygonal shape. In the northeast wall there is a mullioned window with three units containing four panes. There is a similar window in the southeast wall. In the southwest wall there is a fireplace and a plank door to the left. The angled wall looks like a latter insertion in what must have been an original two up and two down structure. The ceiling continues up into the wall space and evidence of trusses with a collar beam and struts are evident. The floor contains widely cut planks (plate 18), which implies they are at least early 19<sup>th</sup> century, but probably earlier.

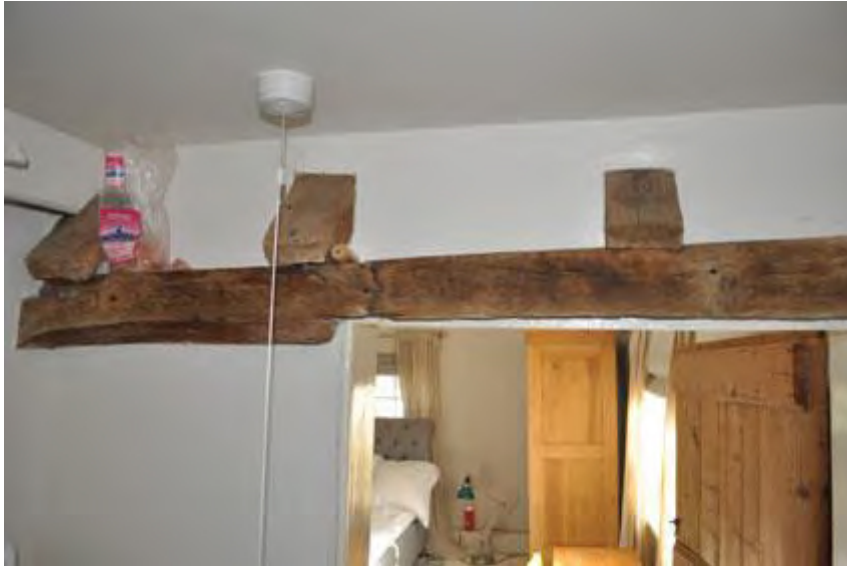
Plate 19: Wall plate in room F3

The southwest door from room F2 enters room F3 an en-suit bathroom. The room is L-shaped with no window. The most significant feature here is that the wall plate of the northeast roof structure (plate 19) can be seen to continue into this room creating two different roof levels. Rafters are attached to the wall plate. In the southwest wall there are the remains of timber framing (plate 20).

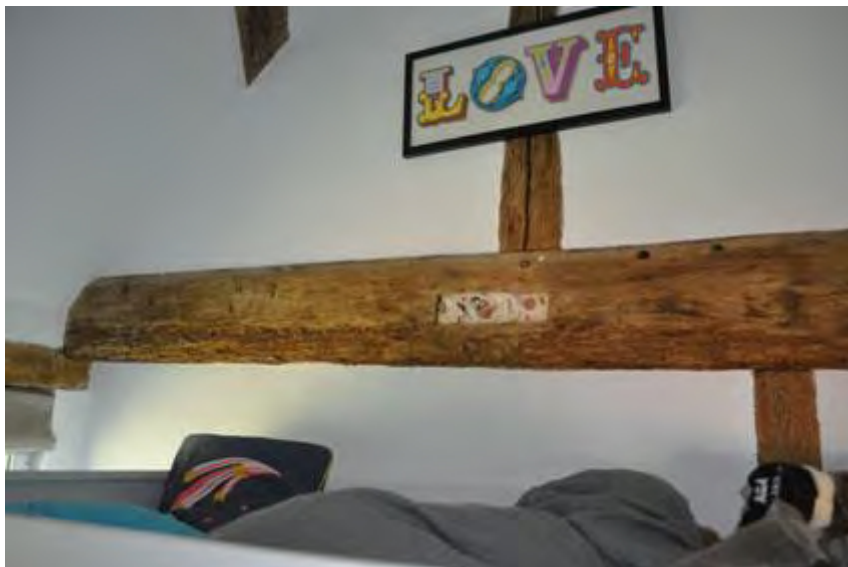
Plate 21: Part of truss room F4

From landing F1 a plank door enters room F4. In the northeast wall there is a mullioned window, with three units containing lead tracery creating 12 panes. In the northwest wall there is a similar window. The ceiling, like that in F2, continues up into the attic space revealing evidence of truss construction with collar beam and struts (plate 21). There is a further offset upright above the collar beam.

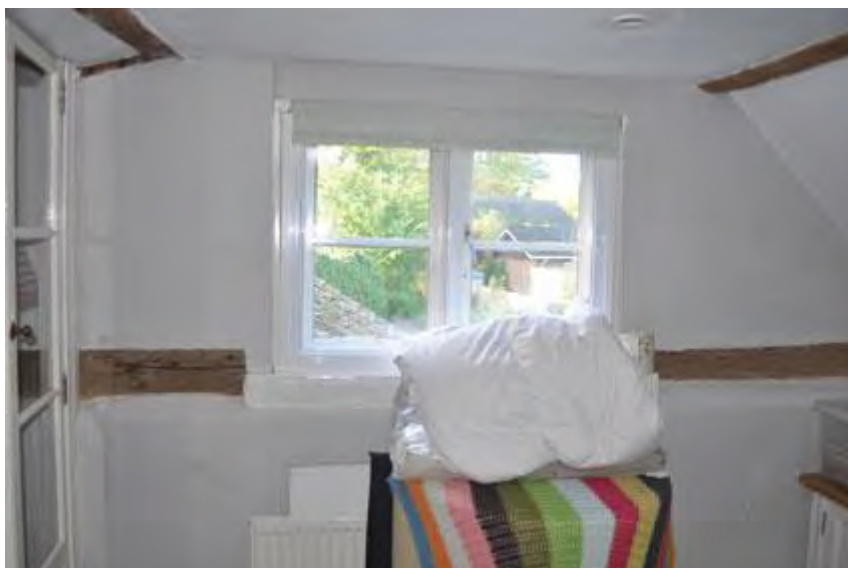
Plate 22: Room F5

The only other door of the triangular part of landing F1 is a plank door entering room F5 (plate 22). This room sits within a half storey addition with some timber framing in the ceiling. One of these on the southeast side appears to be part of an earlier wall plate, with the wall line underneath being re-arranged. In the southwest wall there is a mullioned window with each unit having two panes.

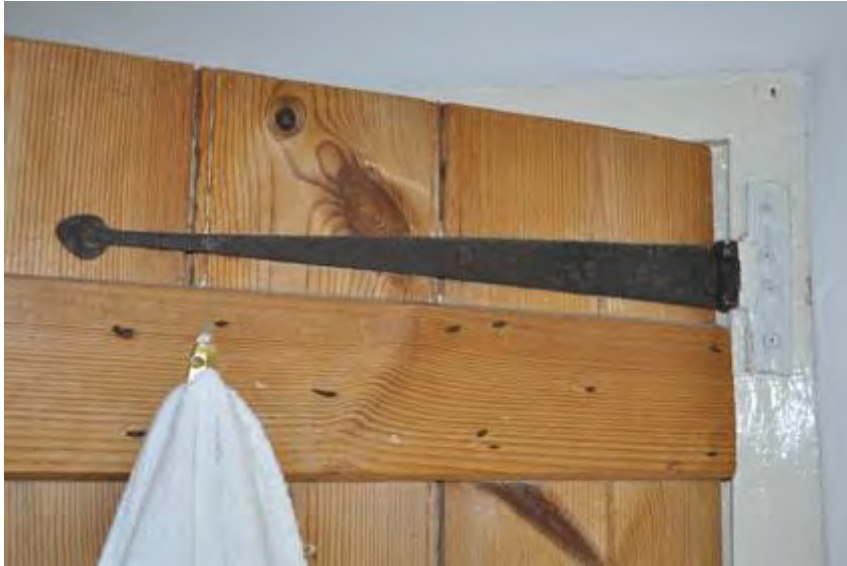
Plate 23: Early hinges room F8

The plank door in the southwest wall of room F6 leads into room F8. The plank door may be earlier than most due to the moulding between the planks, and the hinges (plate 23) are similar to examples from Wight dated 1727 and Gloucestershire from 1707 (Alycock and Hall 1994, 24). The screws in the hinge are not old. On the northeast wall there are built-in cupboards, behind which there are indications of a timber framed wall. In the southeast wall there is a mullioned window with three units each containing four panes. The ceiling beam contains chamfers and stops (plate 24); the stops are similar to those from Devon dated 1591 (Alycock and Hall 1994, 36).

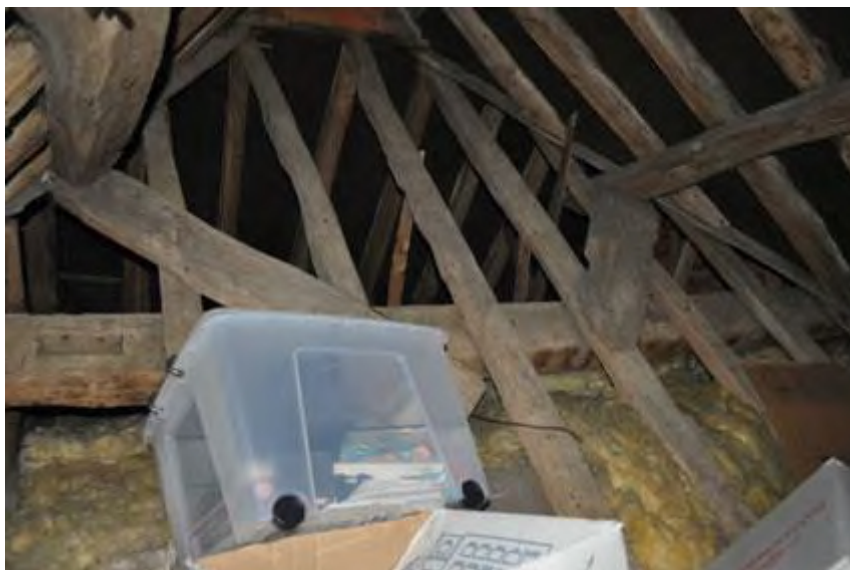
Plate 25: Timber frame of northeast range being built onto by later roof structure

The attic appears to contain three component parts. The earliest is located over the northeast part of the house and contains a frame of three trusses, rafters, purlins, braces and ridge beam (plate 25). Overlapping this is the roof orientated northeast to southwest. This has bracing timbers between the chimneybreast and the earlier roof. On the southwest side of the chimneybreast there is evidence of a box-framed truss, which may originally have been a gable (plate 26). This truss is located where the northwest wall line is staggered. The truss within the further extension appears to contain a collar beam only.
