**ARCHAEOLOGICAL INVESTIGATIONS**

**KELLOGG COLLEGE, 62/64 BANBURY ROAD,**

**OXFORD OX2 6PN**

**NOVEMBER 2016**

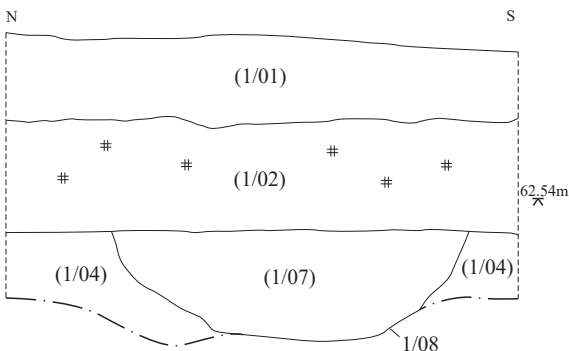
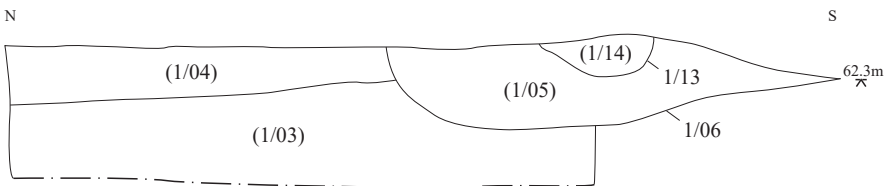
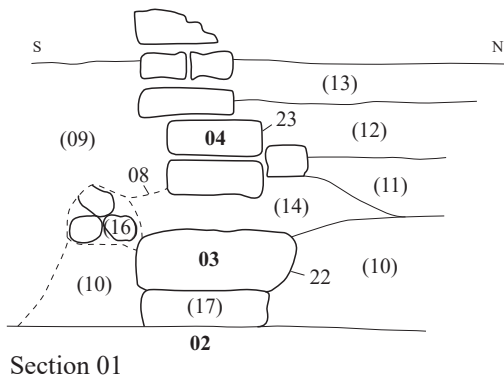
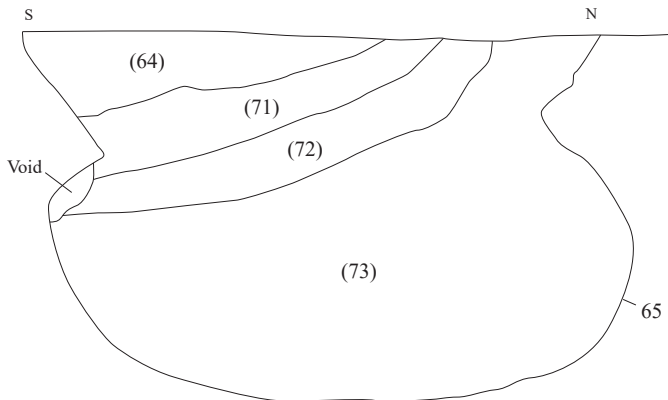
Figure 13: Sections

**Trench 1**  
**Section 1.1**

**Trench 1**  
**Section 1.2**

**Test pit 1 (2015)**

**Test pit 4 (2015)**

Feature 1/06 was an ill-defined ovoid, which was cut into the top of layer (1/04). The feature was recorded as being 1.26m by 0.94m and 0.2m deep (Fig. 13). The fill (1/05) was recorded as a firm mid-orange brown sand silt with stone inclusions. This feature was ephemeral in nature and had been truncated by later linear features and pit (1/10). This could be tree disturbance.

The southern wall of the garage was created by foundation cut 22 and was a linear feature made for wall 03. In the base of this foundation cut was deposit (17) a firm light grey brown mortar with frequent stone and gravel inclusions 0.1m deep (Fig. 13). This was bedding for masonry foundation 03 made of stones 400mm x 300mm x 180mm and was of rough largely unworked stones. The feature survived as one course orientated east to west and was mortared. This stone feature appeared to butt up to wall 02. This implies that there were probably two phases in the laying out of these stone features; initially the two boundary walls and then the later definition of internal features.

It is noticeable in section (Fig. 13, S01) that some of the brick walls of the garage were taken down and rebuilt, but this will not be elaborated on here.

Sub-circular cut 58 measured 0.7m by 0.5m by 0.23m with the sides sharply sloping with a flat base, which truncated context 26 (Fig. 13). The fill (59) was a firm dark red grey clay sand with brick, charcoal and stone inclusions. The fill contained brick and clay pipe of the 19<sup>th</sup> century. It was located centrally to the external west wall of the Coach House, and could be associated with construction.

Pit 65 was a sub-circular feature measuring 1.3m x 1.46m x 1m with irregular sides (Fig. 13). The lower fill (73) was a dark grey clay sand with stone inclusions. The fill contained 19<sup>th</sup> to 20<sup>th</sup> century pottery. Fill (72) was a firm light grey sand clay with stone inclusions. Fill (71) was a firm mid-grey sand clay with stone and coal inclusions. Upper fill (64) was a firm dark red grey sand clay with frequent stone inclusions. This deposit contained pottery of a 19<sup>th</sup> to 20<sup>th</sup> century date, besides residual Brill / Boarstall Ware of AD1200-1600. The latter is probably from earlier field manuring.
