JOHN MOORE HERITAGE SERVICES

HISTORIC (BUILDING) IMPACT ASSESSMENT

COLLEGE HOUSE, 18 EATON VILLAGE,

MAY 2019

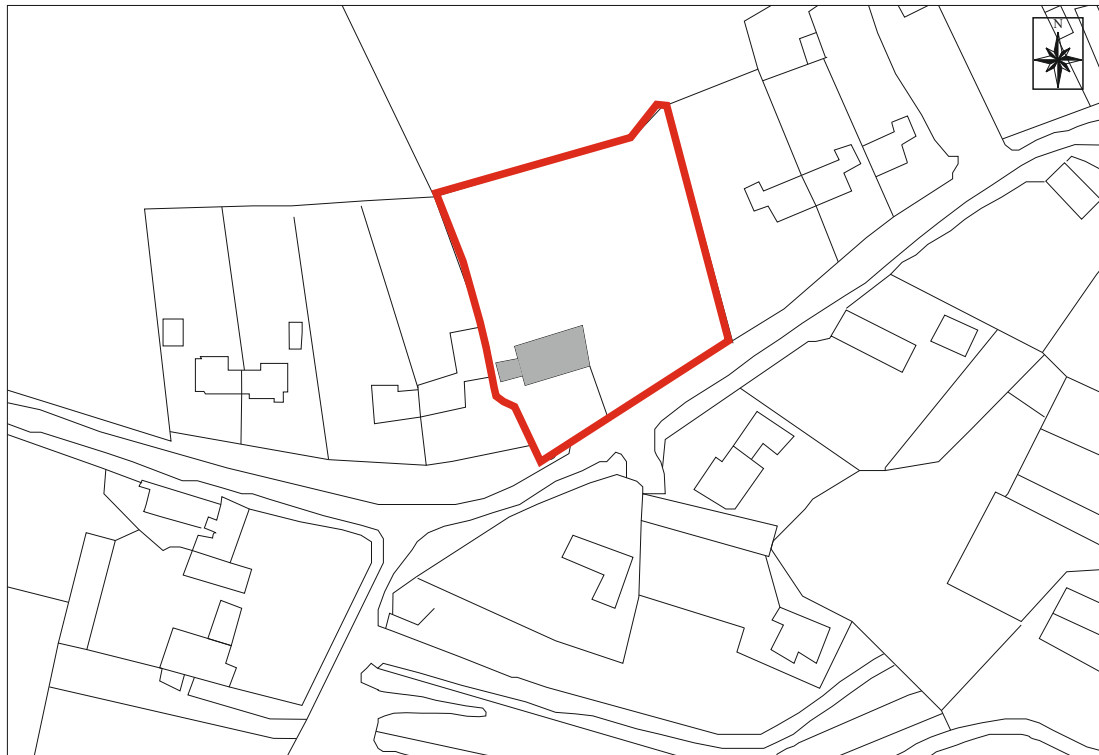
Figure 1: Site Location and Plan of College House

The proposed development site, College House, lies to the northeast of a forked junction of Bablock Hythe Road and a track leading to arable fields (Fig. 1). To the east, west, and south is a private dwelling, and to the north are arable fields and pasturelands. The entire site comprises approximately 0.28 hectares.

By the third edition Ordnance Survey Map of 1912 (Berks V.4: Fig.8) the NE farm building has disappeared, however, the dividing fence line is still remaining. The map clearly shows the NE and SW extension attached to the house. There is an additional small extension to the NNW. By the 1970 OS Map (not depicted), College House has formed the plan seen in Figure 1 with the NW extension reduced. The small NNW extension has been demolished.

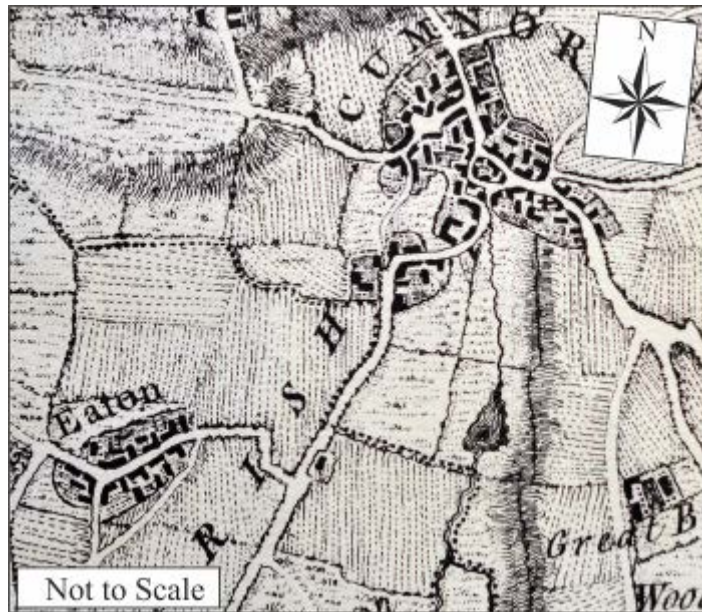
Figure 2 Rocque Map 1762 showing Eaton Village (T/M128)

Several maps have been discovered identifying the location of College House showing the development of the site from the 18th to the 20th century. It first appears in the Berkshire Survey Map by Roque of 1761 (T/M128), with the rectangular building situated on the site of College House (Figs. 2-3). This building likely corresponds with the Listed Building (EHLB 1048425) description "*early C17 end stack, now central ridge stack, of stone finished in brick. one- extended to 2-unit plan*" College House appears in the centre clustered around L-shaped buildings, which might not reflect the original spacing, but might be due to scale. This is sometimes the case with early maps.

College House can be seen in the Rocque map of 1761 (T/M128), as a rectangular building (Fig. 2). Although incorrectly positioned on the map, the northernmost rectangular building is likely to be College House, while the L-shaped building may be a (now demolished) associated farm building.

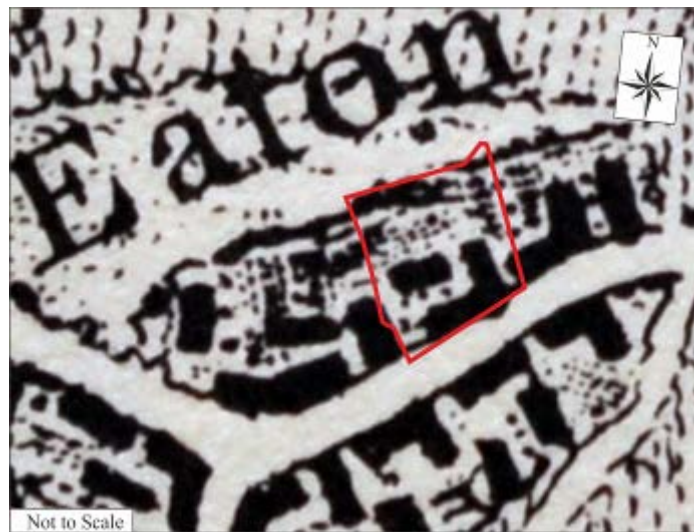
Figure 3 Detail of Rocque Map 1762 showing Eaton Village (T/M128).

It is likely that College House is the rectangular shape in Figure 3 with farm or outhouse buildings adjacent to it. The scale of Rocque's Map is too large to get the detail but it is possible that College House is depicted as a rectangular shape a little away from the main road with an "L" shaped building adjacent. In the Draft Enclosure Maps of 1828 (see Fig. 4, drawn at Scale 13.3inches=1mile) College House is listed as number 48 (in pencil). The building is an "L" shape, with a perpendicular outhouse building, and various small sheds and farm buildings surrounding it. To the northeast is a small pond. It is owned by a Richard Mollineux who also possesses other plots in the area.

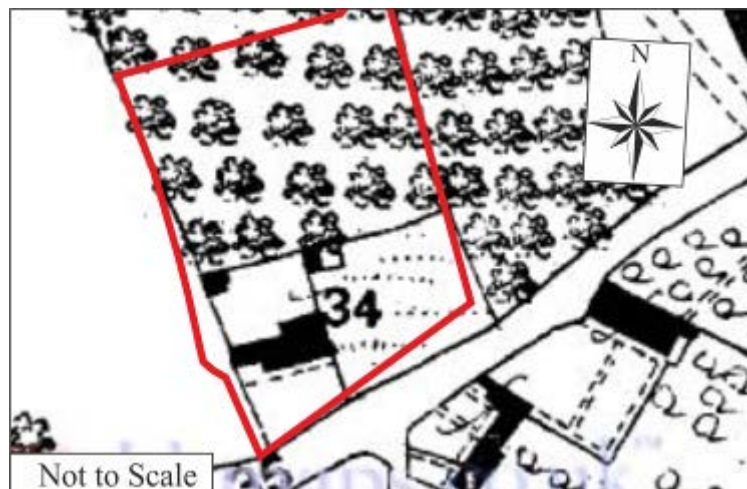
Figure 6 OS County Series 1876 Berkshire V.4 1:2500

The first edition of the Ordnance Survey Maps in 1876 (Berks V.4: Fig. 6) shows College House NW wing reduced and a SE extension added. Further changes see the removal of a lot of the sheds and outbuildings with just two buildings to the NW and N of College House remaining. The neighbouring plots to NE and SW continue to be fields. A similar situation is shown on the Ordnance Survey map of 1900 (Berks V.4: Fig. 7).

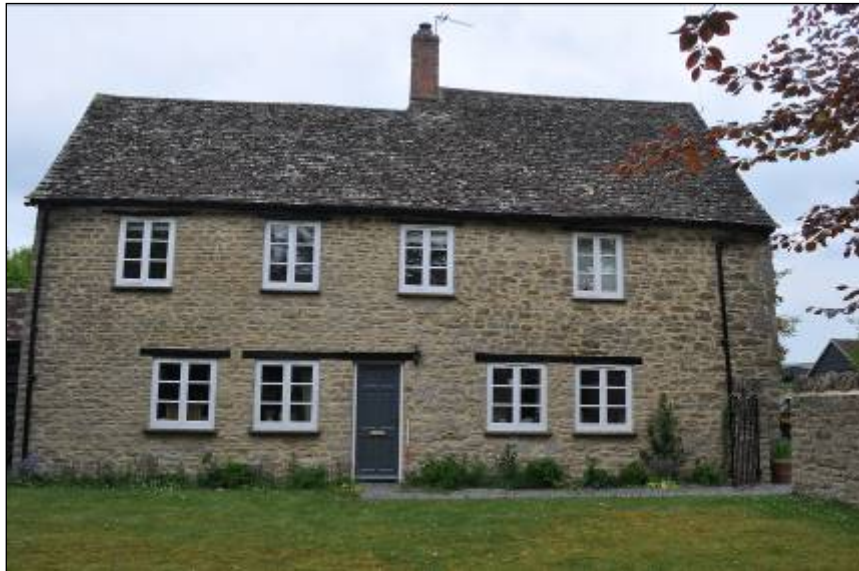
Plate 1 South Elevation of the front of College House

Comprising the front of the house, the Southern Elevation can be divided into three units (Plate 1). The two east units are two and a half storeyed structures of limestone with its mortar repointed in the 21st century with a limestone slate roof. The slate roof has one central internal chimney (part brick, part stone), which is located on an internal wall line that divides the two

College House is a two and a half-storeyed house in a broadly rectangular shape formed by two distinct units, with an extension to the rear and west forming a slight “L”. It is in the main largely faced with limestone (HE 2017b; 4). The main house (plates 1-2) has a pitch limestone slate roof with one central internal (part brick, part stone) chimney. From the chimney to the west the roof line is raised, possibly to accommodate the building of the stairwell. The current plan and elevations are illustrated in Figures 9 and 10.

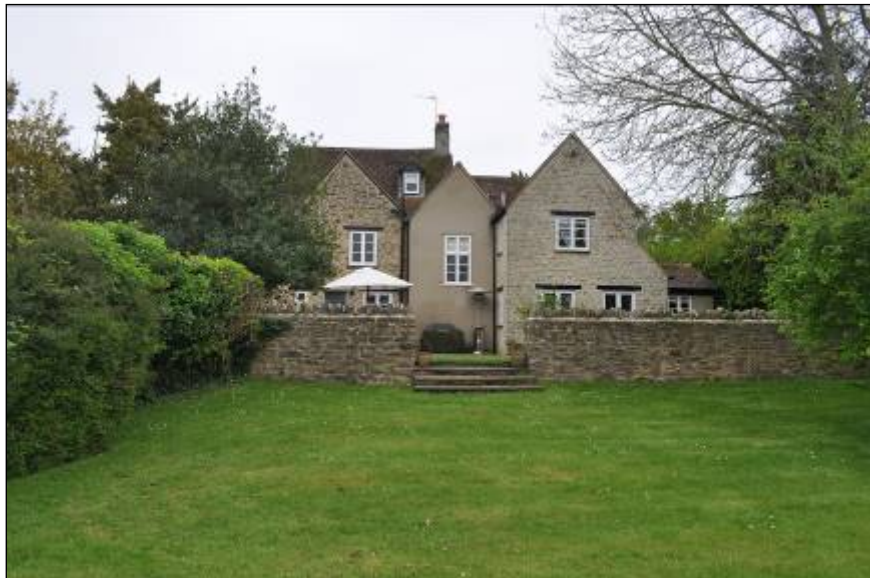
Plate 2 North Elevation showing the rear of College house and modern wall

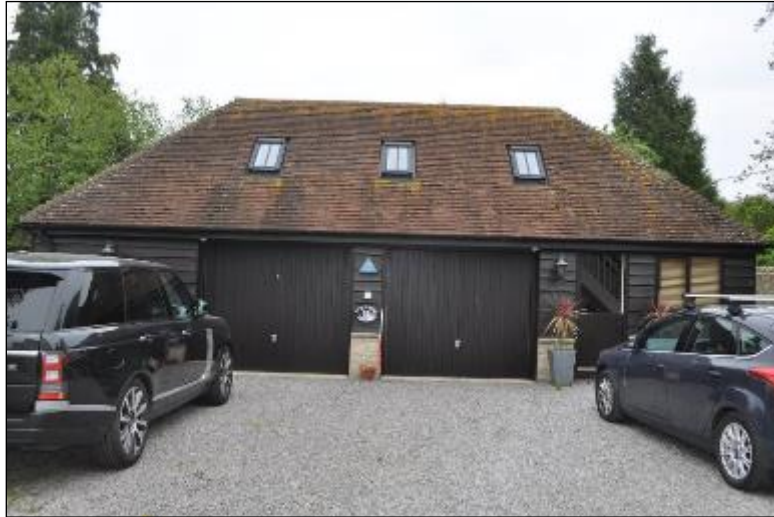
To the east of the house is a gravel driveway with a rectangular building comprising a modern garage and wood store of timber cladding and clay roof tiles with a brick plinth (Plate 3). To the north-east of College House is a square building comprising a modern stable block of dark timber cladding and clay roof tiles enclosed with a grass paddock and wooden fence surround.

Plate 3 The West Elevation of the Modern double garage, utility room and log store

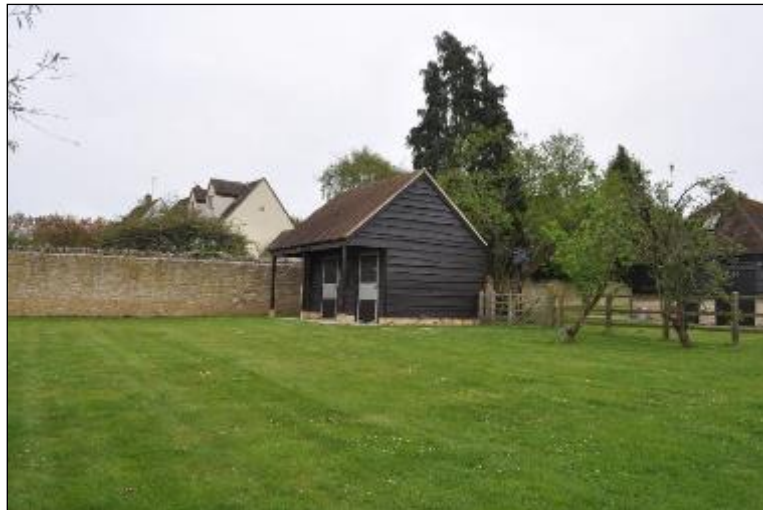
Plate 4 The North-East Elevations of the Modern Stables to the North-East of College House

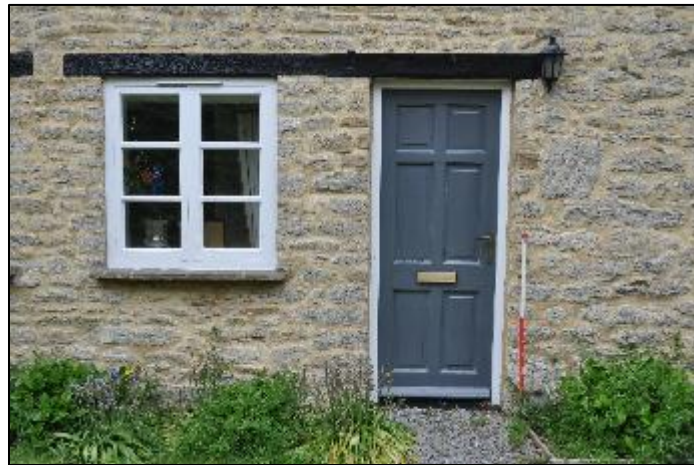
Plate 5 A Close up of the Main Entrance of Area 1 of the Southern Elevation

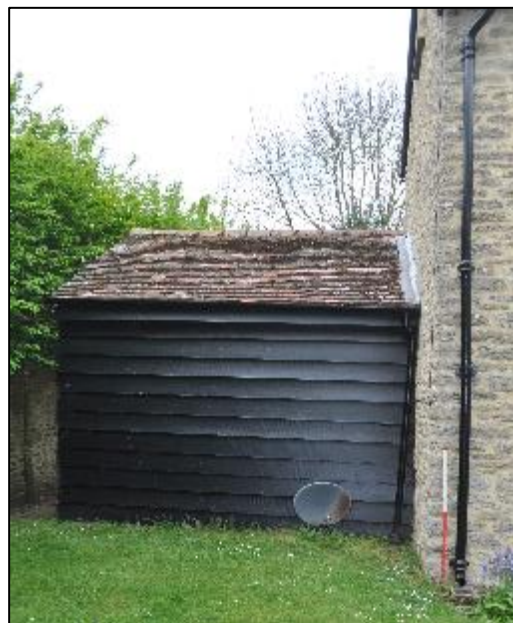
The smaller west unit is a modern single storeyed building of dark weatherboarding and clay roof tiles attached to the west of the Main Building. This is a modern kitchen wing (see Plate 6).

Plate 6: Area 2 of Southern Elevation comprising the modern kitchen wing attached to the Main House (Area 1)

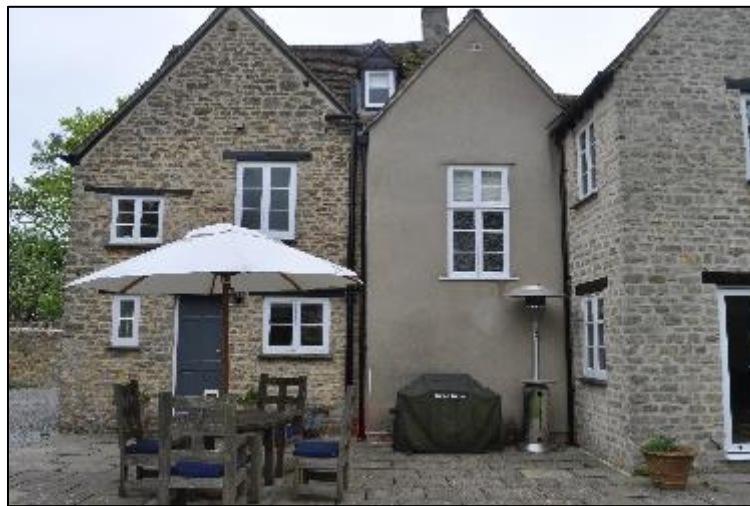
The North Elevation comprises the rear of the house and shows the various developments and additions to College House more clearly than E1 (see Plate 7). There are three wings to the house, each with gable ends, which will be described as Face Wing 1-3 for ease of reading. The two east to west roof lines evident on the front of the building stand above the rear gables.

Plate 7: Face Wings 1 & 2 and part of Face Wing 3 of the Northern Elevation

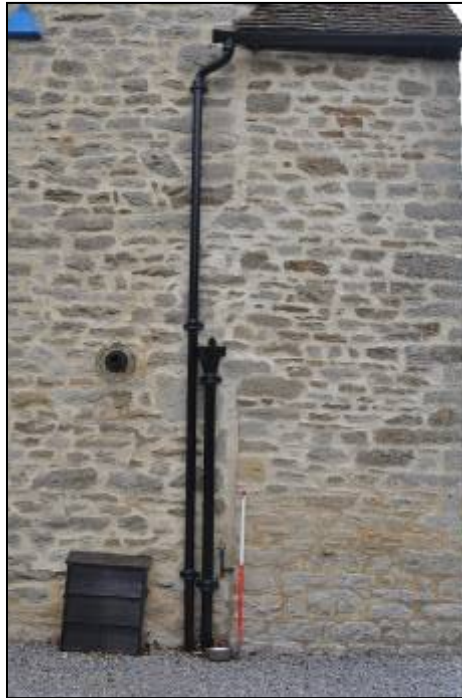
The Eastern Elevation comprises the eastern gable end of the main house where the roof line is taller than the western end of the house. In the eastern elevation, the two and a half storeys are clearly discernible. To the north abutting the eastern gable is the east wing with the butt joint clearly visible (see Plate 8). As noted in the southern elevation, the eastern elevation has been constructed using rough limestone blocks.

Plate 8 The butt joint is visible to the right of the drain pipe in E3: Eastern Elevation

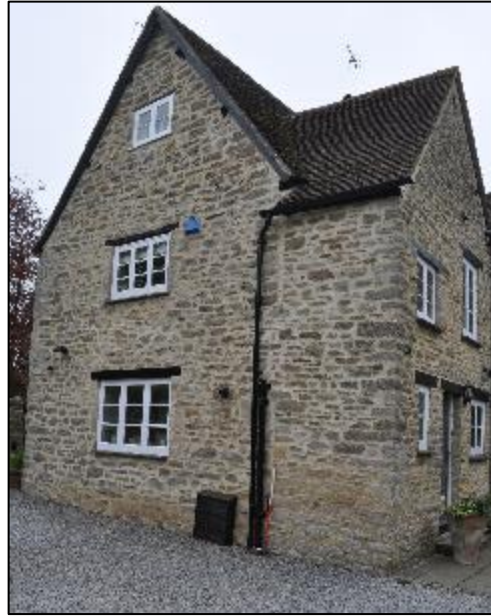
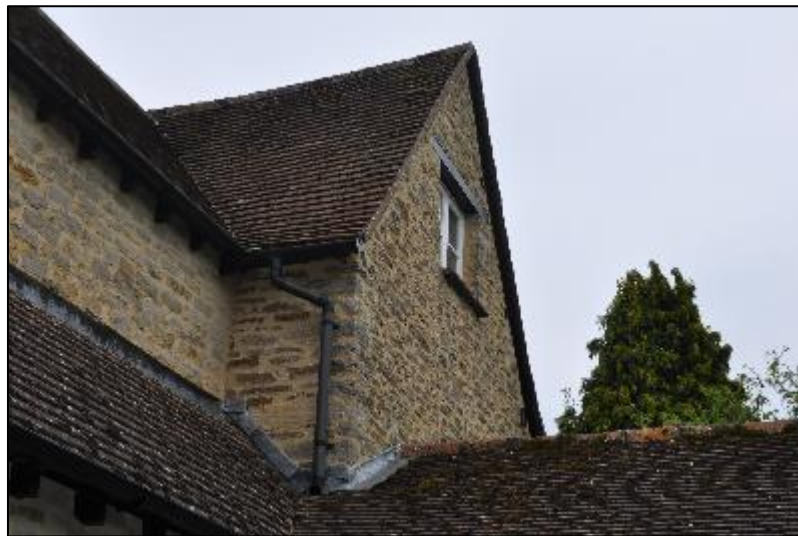
Unlike in the southern elevation, the windows are triple casement windows with wooden mullion painted white with 3x1, and the second floor a double casement window with 2x1 panes. All have a dark wooden lintel above and slate sill below. They are staggered in size, with the largest window at the ground floor, smallest on the second floor. This reflects the roof line (see Plate 9).

Plate 9 The corner of the Eastern Elevation and Northern Elevation showing the staggered windows (above) and butt joint link to the Face Wing 1

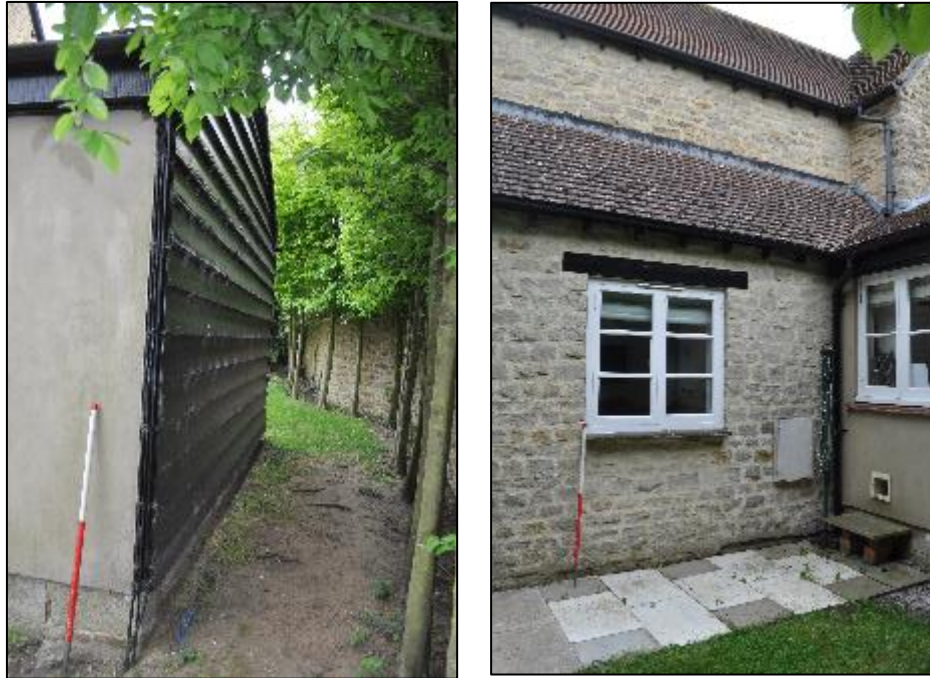
Due to restricted access, it proved a little difficult to illustrate the full extent of the Western Elevation in one image (see Plates 10 & 11). The western elevation contains the kitchen extension, and the side of the west wing with a lean-to (see E2) and the second floor of the Main House.

The western elevation also shows part of the main house, faced with variegated limestone blocks, and a clay tile roof. The second floor of the Main House contains a double casement window with wooden mullion painted white with 2x1. It has a dark wooden lintel above and slate sill below. This echoes the window seen in the opposite gable end of the Main House. The ground floor and first floor both likely contained casement windows (perhaps the ones re-purposed into Face Wing 2 or 3). Just below the roof line, the eaves have projecting wood spaced at regular intervals.

Plate 10 Selections of images to show the E4: Western Elevation. Above: The Second floor window. Right: The modern Face Wing 3 and Right: The Kitchen Extension

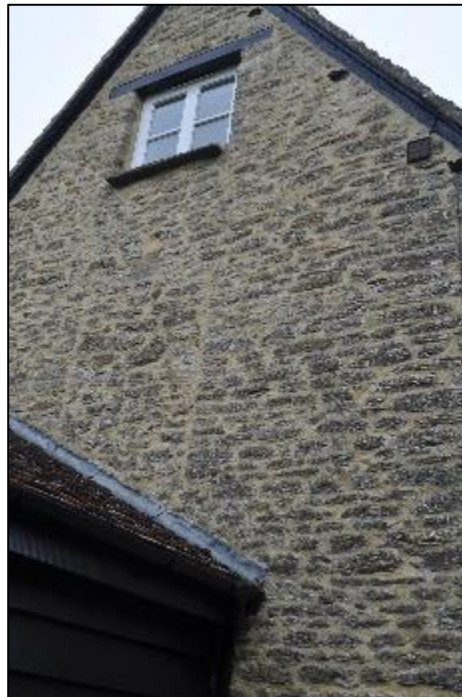
The Kitchen extension is faced with dark timber cladding on the western elevation and has a clay tile roof. The lean-to of the wing is faced with variegated limestone blocks and has a clay tile roof. It contains a casement window likely removed from the ground or first floor of the main house (see Plate 11). It is a double casement window with wooden mullion painted white with 3x1. It has a dark wooden lintel above and slate sill below. Just below the roof line, the eaves have a cornice row of projecting wood in a 'dentil' pattern.

Plate 11: The Second floor window of E4: The Western Elevation showing the two vertical joint lines where windows were likely removed.

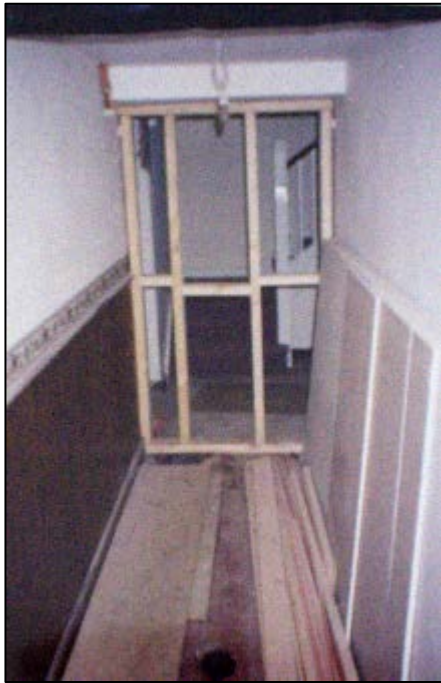
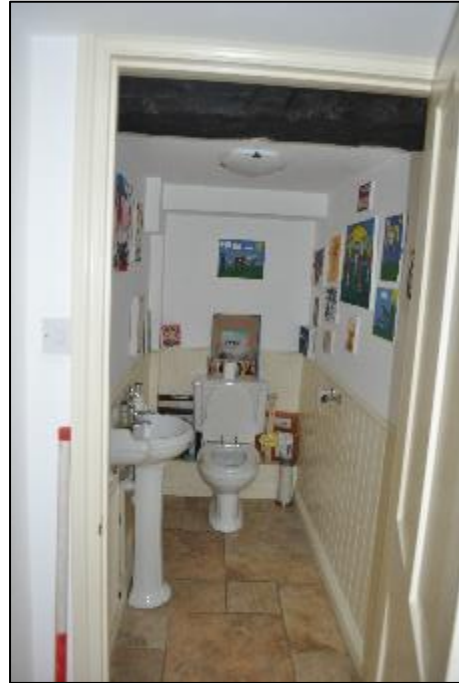
Room G2 had previously been part of a central passageway (altered in 1999 planning permission APT/9873/3/LB) leading through to staircase G6. A modern WC and a small sink with a modern door have now been installed. The ceiling still shows dark timber beam with slight chamfer and a barefaced dovetail. Just above the toilet is perhaps evidence for the original rear wall of the house with a further beam (perhaps replaced as a reinforced beam at some time when the rear stairwell was created).

Plate 12 Left: The hallway before it was blocked up to become WC (Image Courtesy of Mr Minoli). Right: WC G2 with exposed beam still extant

The hallway F5 is L-Shaped and has part of a chamfered beam in the ceiling. The beam previously noted in bathroom F4 links towards the interior chimney wall. This beam also follows a similar line to those seen on the ground floor that flows between G3, G2 and G8 (see Plates 12, 14, and 22). The northern wall contains a double casement window. On the western wall, a small cupboard F6 contains the boiler. The eastern wall contains a narrow entryway leading to antechamber F7, and up a small step further to bedroom F8. This contains a double-doored painted cupboard, painted white.

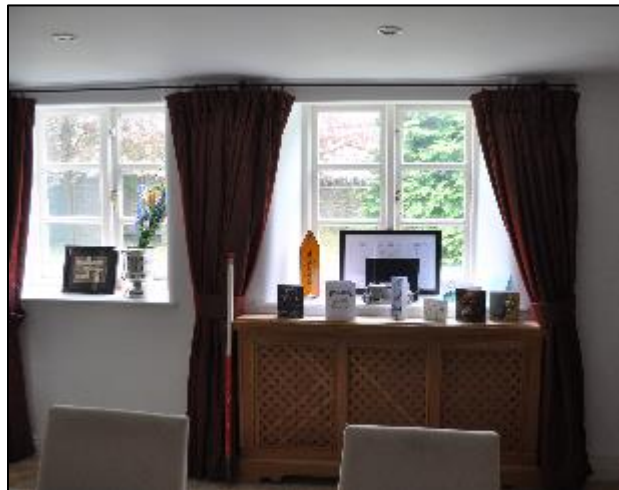
Plate 13 The two double casement windows in Dining Room G3

The Dining Room G3 is likely part of the original house. It contains two of the double casement windows 1x3 panes with modern brass slide window catches and window stays (see Plate 13). The floor is modern tile, the ceiling contains a dark exposed chamfered beam, likely a continuation of the one seen in G2. The joints are concealed.

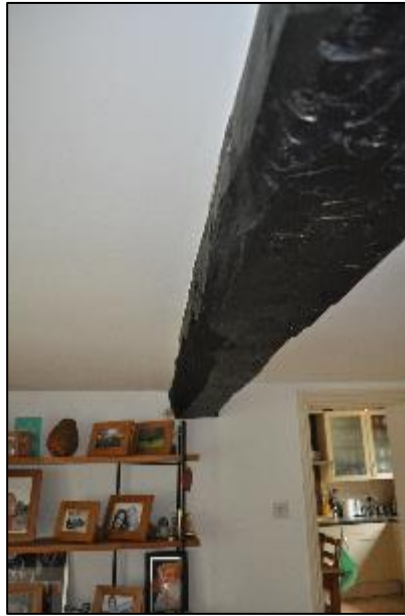
Plate 14 A Close up of the Chamfered dark timber beam in G3 leading towards kitchen G4

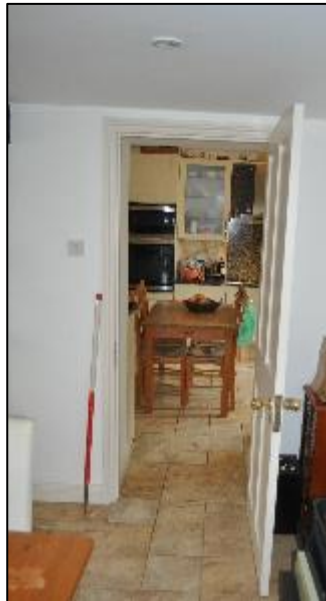
Plate 15 The doorway from G3 (Dining Room) into G4 (Kitchen).

Further west of the Dining Room G3 leads onto Kitchen G4. This is a modern construction, built initially prior to 1998 (plan noted in planning permission APT/9875/2/LB) and extended 1999/2000 (planning permission APT/9873/3/LB & APT/9875/5/LB).

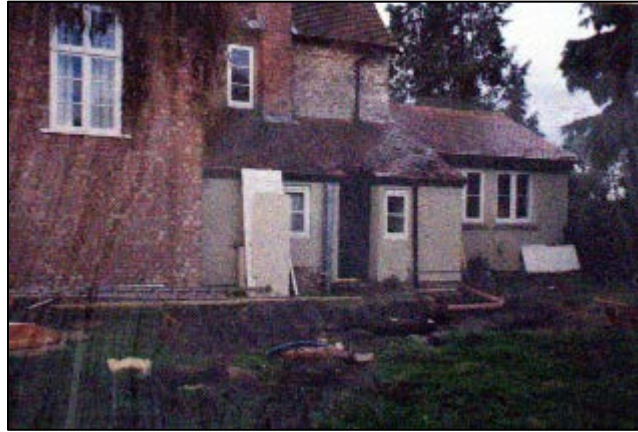
From earlier planning applications (APT/9875/2/LB), this room originally contained a lean-to with a central brick chimney which served a boiler. There were an additional utility room and cloakroom in this space (see Plate 16). There is a small step in G5 signifying where the previous cloakroom wall was located.

Plate 16 The Northern Extension c1999 prior to the demolition of a previous lean-to and boiler and the addition of Face Wing 3. Note that Face Wing 2 wall has yet to be rendered in cement at this point but the kitchen extension G3 has been built (Image Courtesy of Mr Minoli).

From the 20th century extension photographs and pre-planning application (APT/9875/2), it is noted that room G6 was already constructed in brick (see Plate 16), which was then rendered during the construction of room G5.

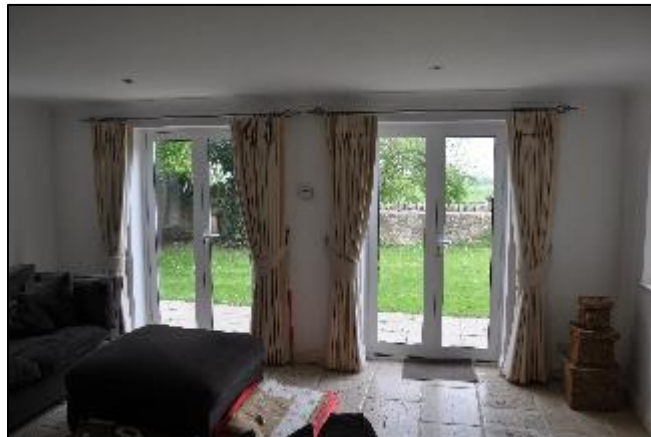
From Kitchen G4 the north eastern door leads to modern Sitting Room G5. The floor of G5 is modern tiles and the ceiling and walls are plastered and painted white. The northern wall contains two double doors of 1 pane leading out to the garden and patio (see Plate 17). The west wall has a double casement window and the east wall has a smaller double casement

Plate 17 The Interior of room G5 with patio doors and tile floor

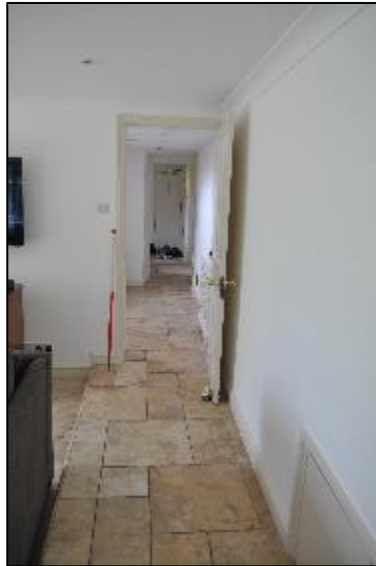
The eastern doorway of G5 leads into hall and Stairwell G6 (see Plate 18). The staircase is an open string, twisted and turned bannisters with pineapple finial, all painted white (Curl 2003, 206). The pineapple finial suggests that the stairwell is likely 19th century or evokes that style. Underneath the staircase is a small cupboard with a 4 panelled wooden door (see Plate 19). Above there are two stacked casement windows. The stairwell is carpeted. The floor is modern tiles and the ceiling and walls are plastered and painted white. On the southern wall, the blocked-up hallway can be noted as a recess in the wall (see Plate 20).

Plate 18 Looking towards G6 & G7 from G5. Note the step and the small cupboard to the right

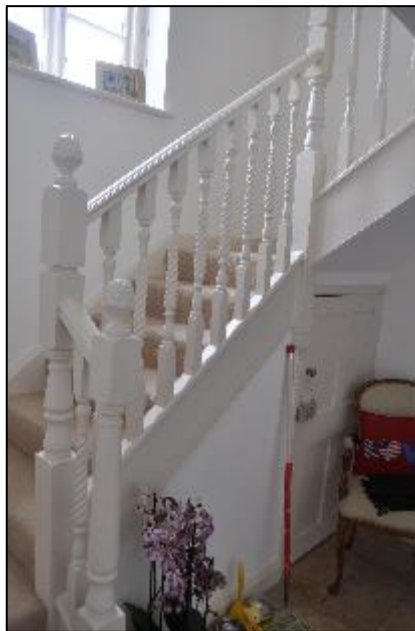
Plate 19 The staircase is an open string, with twisted and turned bannisters with pineapple finials, all painted white. Note the cupboard under the stairs. Scale 1m

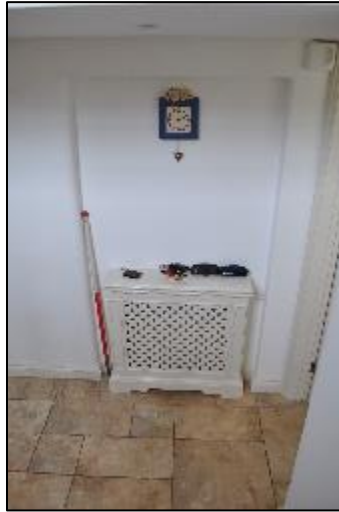
Plate 20 The blocked up hallway entrance that previously led to the main entrance G1 and now contains WC G2. Scale 1m

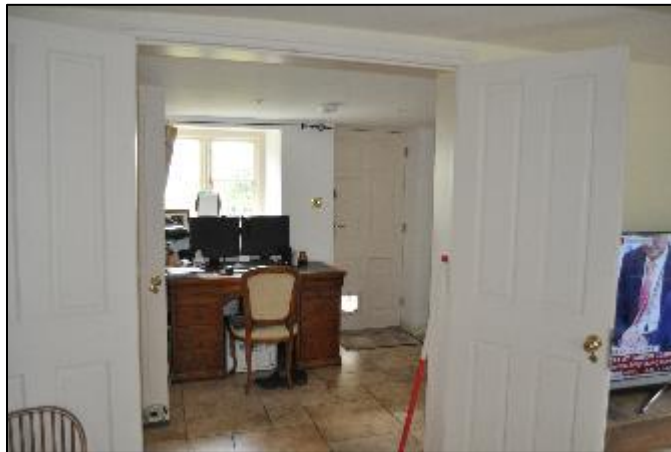
The eastern wall contains a doorway towards G7. The floor of G7 is modern tiles and the ceiling and walls are plastered and painted white. On the north wall of G7 is the rear entrance with a modern six panelled door painted white. Either side of the door are casement windows; to the west is a double casement window with brass slide, to the east is a single casement window. In the eastern wall are modern floor to ceiling cupboards. The southern wall contains two four panelled wooden doors that lead into sitting room G8.

Plate 21 The western casement window and rear entrance of G7 from G8. Scale 1m

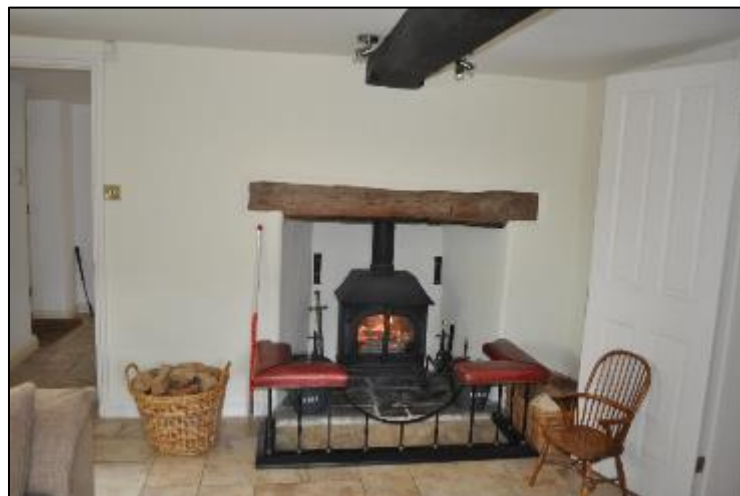
Plate 22 The Central Fireplace within sitting room G8. Scale 1m

Room G8 forms part of the original unit house. The floor is modern tiles and the ceiling and walls are plastered and painted white. One large exposed beam runs east-west across the ceiling of the room and appears to link up with the beam in WC G2 and Dining room G3 (see Plate 22). On the northern wall of G8 are double doors with four panels that lead into G7. The

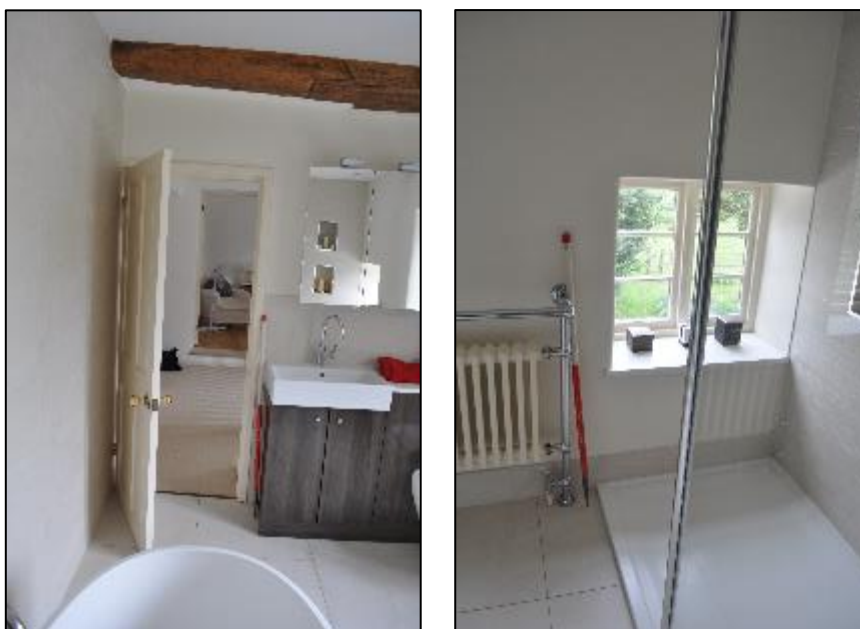
Plate 23 Views of the bathroom F2 showing (left) doorway into hall F1 showing crossbeam in the ceiling and modern sink, and (right) modern shower and casement window

The bathroom F2 contains modern 4-piece bathroom fixtures with a shower, toilet, bath and washbasin (see Plate 23). The floor is tiled and the ceiling is plastered and painted white. There is one large timber beam exposed running north-south which appears to link up with a beam in F6 to the south. The eastern wall contains recesses for storage.

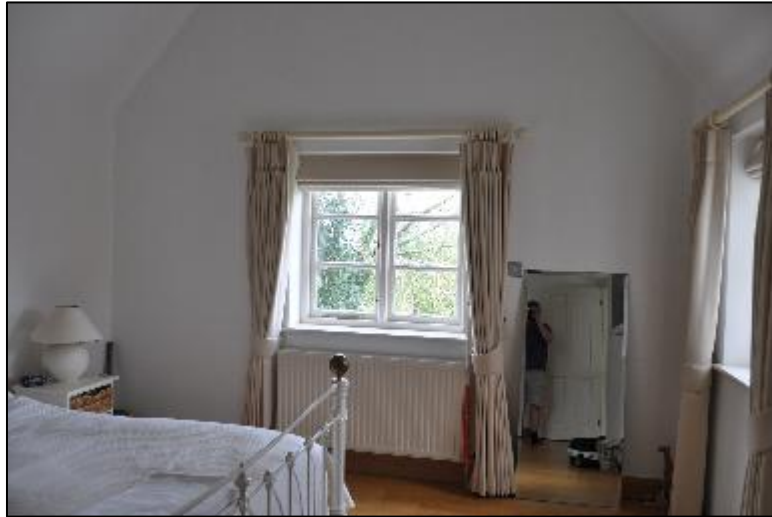
Plate 24: The modern master bedroom F3 showing the locations of the two casement windows

From F1 moving westward is a modern master bedroom F3 (built c1999 APT/9873/3). This is the first floor of the west wing. The floor is wood, the walls painted white and the ceiling is plastered and painted white following the gable roof (see plates 24 and 25).

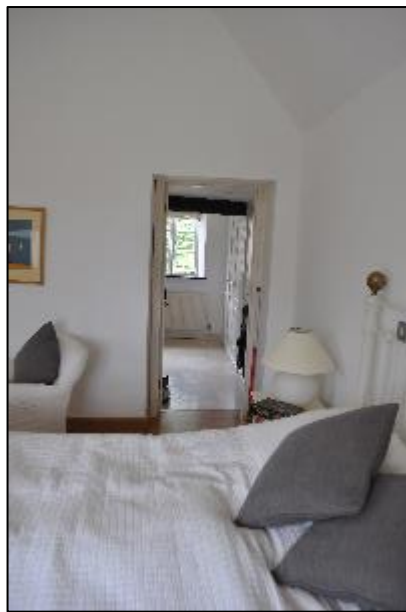
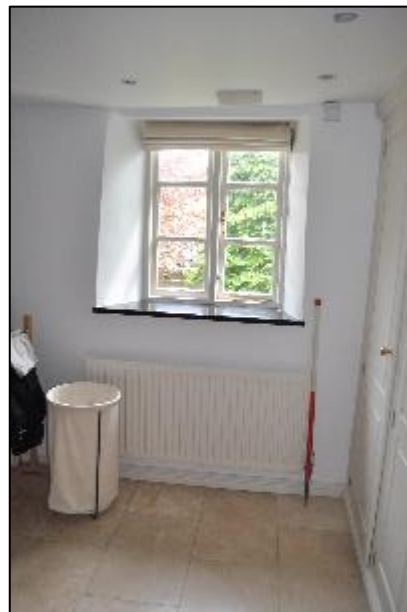
Plate 25: (Left) The view into the bathroom F4 of the Main House from the Master Bedroom (Face Wing 3) and (Right) the eastern casement window of the bathroom F4

The bathroom F4 contains modern 4-piece bathroom fixtures with a shower, toilet, bath and washbasin. Along the western wall is a series of built-in cupboards. The floor is tiled and the ceiling is plastered and painted white. The room contains two double casement windows. The eastern window contains modern colourful stain glass windows, the western window has a plain glass (Plate 26). The floor is tiled, the walls painted white and the ceiling is plastered white with a central chamfered wooden beam running east-west. This links to a beam in hallway F5.

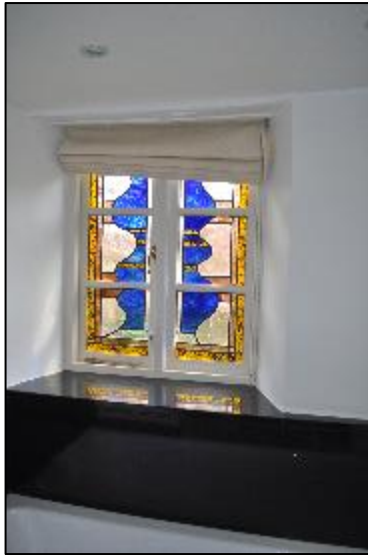
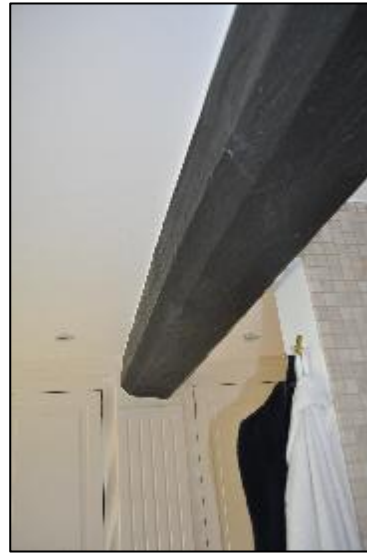
Plate 24 (Left): The modern stain glass window in the double casement window frame in bathroom F4. (Right): The chamfered ceiling beam running east-west in bathroom F4.

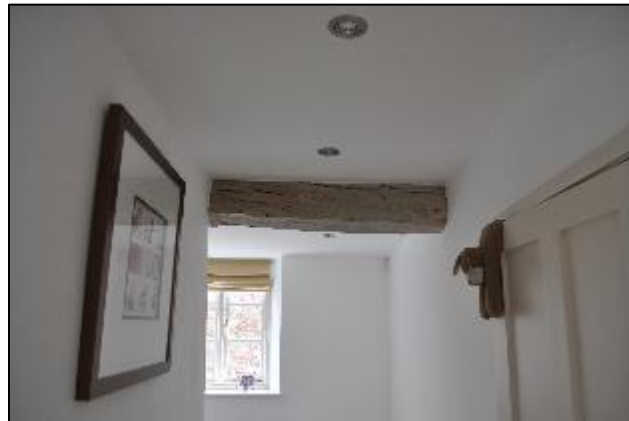
Plate 27: The chamfered beam in the ceiling of F5, which connects to the beam seen in F5 (Plate 26 above).

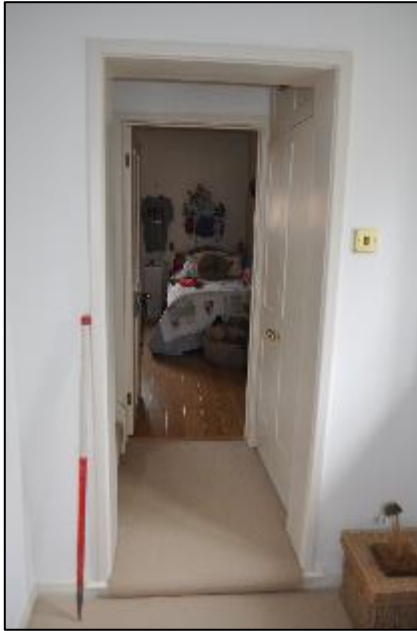
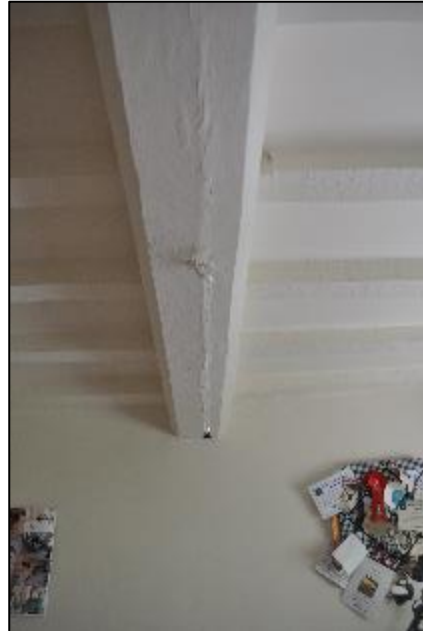
Plate 28 (Left): The Antechamber F7 leading up a small step from F5 and further into bedroom F8. Scale 1m. (Right) The chamfered beam and joists in the ceiling of F8.

Bedroom F8 contains a wooden floor, plastered walls painted white and a ceiling with an exposed chamfered beam and cross joists, all painted white. The chamfered beam appears to follow a similar line to that seen in bathroom F2, but at a slightly straighter angle (the beam in F8 appears to be more perpendicular to the wall, closer to 90° than the one seen in F2). The eastern wall of F8 contains a triple casement window, the southern wall a double casement window. The western wall contains a doorway into F7 and built-in cupboards (constructed c. 1999).

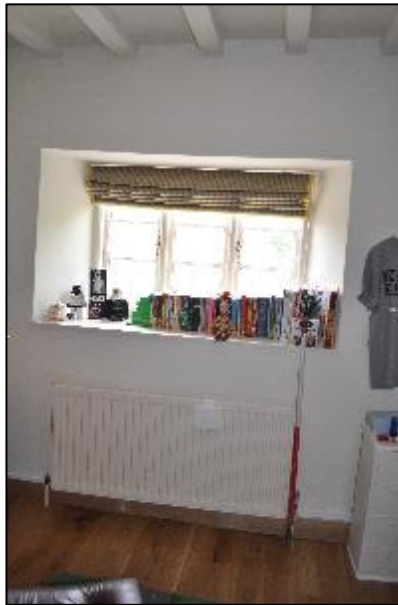
Plate 29: The Triple Casement Window in the eastern wall of bedroom F8

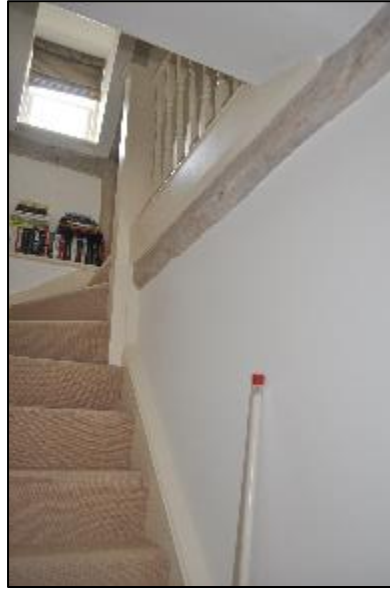
Plate 30: The staircase of S1 with an exposed wooden beam running north-south. Above the narrow window in the northern wall.

From antechamber, F7 is a stairwell leading to room S1. The staircase is an open string dogleg with winder and flat-topped handrail, turned bannisters and square finial. The staircase is painted white and the treads are covered with a beige carpet. Part of the top of the staircase and landing sits on a wooden beam running north-south (see Plate 30). From a small landing in S1 are two bedrooms, S2 to the west and S3 to the east.

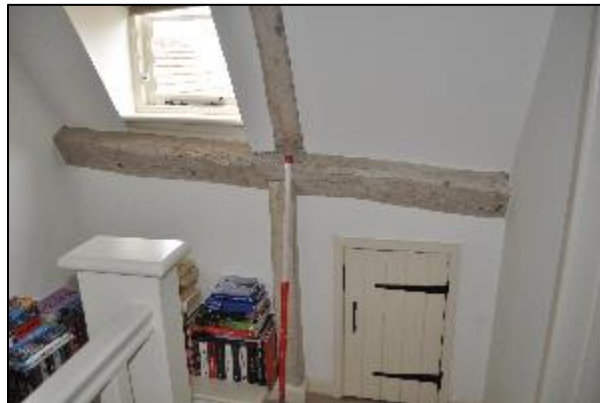
Plate 25 The single casement window and the exposed beams in the northern wall of S1.

The northern wall contains a small 1x2 paned single casement window and a wooden wall plate with two joists on edge exposed with splayed scarfs (see Plate 31). A small cupboard with two metal pintles and a small Norfolk handle. The eastern wall contains a doorway into bedroom S3. The southern wall contains a wooden wall plate with two joists on edge exposed with splayed scarfs, mirroring the northern wall.

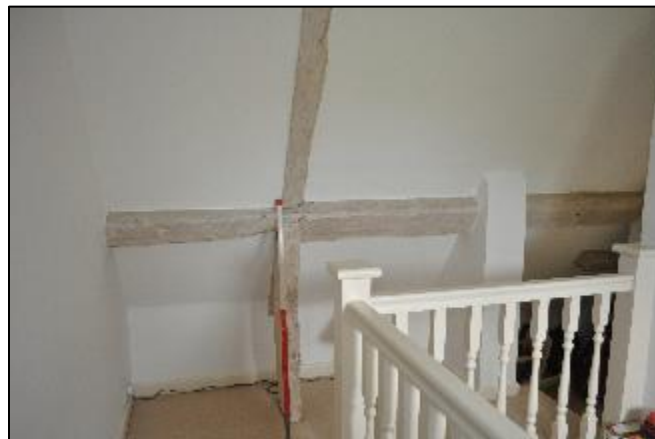
Plate 32: The exposed beams in S1 the southern wall.

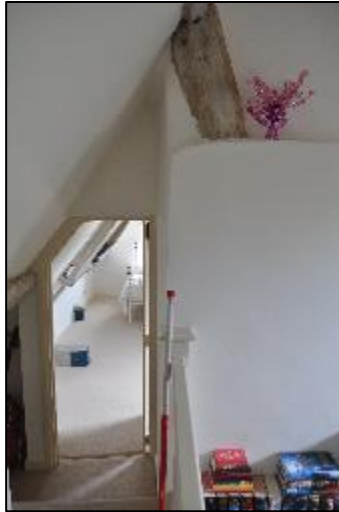
Plate 33: The Western wall of S1 looking towards the doorway into S2. An exposed brace beam can be seen above the chimney wall.

The western wall contains a narrow entryway with a rhomboid head into the bedroom S2. This is accessed via a single step down into the room. The access appears to have been created by cutting through a wall that previously linked to the internal chimney. An exposed beam, possibly a hammer brace is seen just above the chimney.

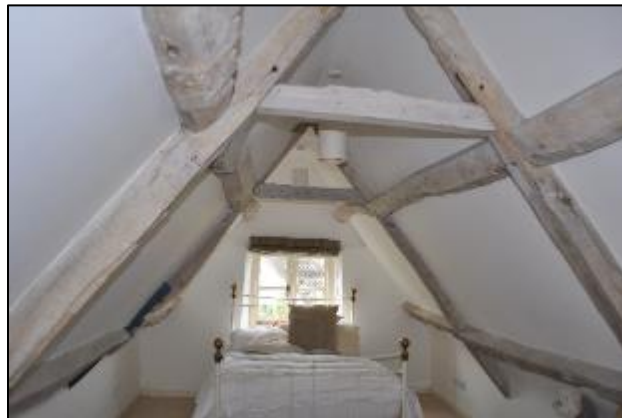
Plate 26 The Roof structure of room S2 looking west

Bedroom S2 contains further evidence of the roof structure with several beams exposed (see Plate 33 & 34). The upper struts and rafter trusses are still extant, but the lowermost struts have been removed, probably during the internal reconstructions in 1998/9 (see Plate 35). The west wall contains a double casement window, the north and south wall contains timber roof rafters and cross beams and two sawn-off struts. The northern wall also contains a modern Velux window. The eastern wall contains the doorway into landing S1. The floor is carpeted with beige carpet and the ceiling contains exposed beams, and plastered walls painted white.

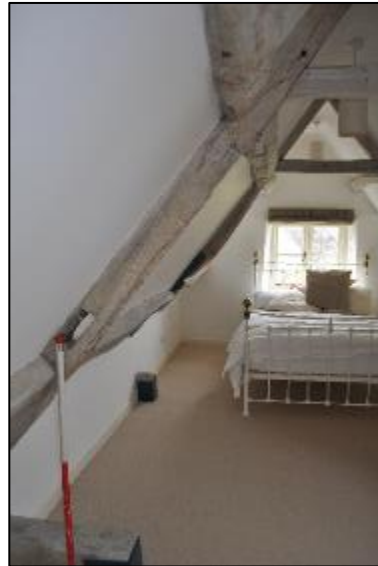
Plate 27 The two sawn-off beams on the ground level of room S2 looking west. Scale 1m

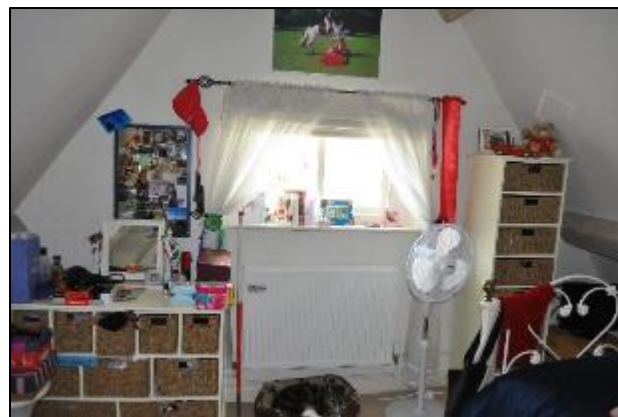
Plate 36: The double casement window in S3 looking east. Scale 1m

Bedroom S3 is off landing S1. The northern wall contains the doorway into S4 and a small cupboard (similar to the one in the landing S1 with dark metal pintle hinges). The eastern wall of S3 has a small double casement window (see Plates 36, 37, 38).

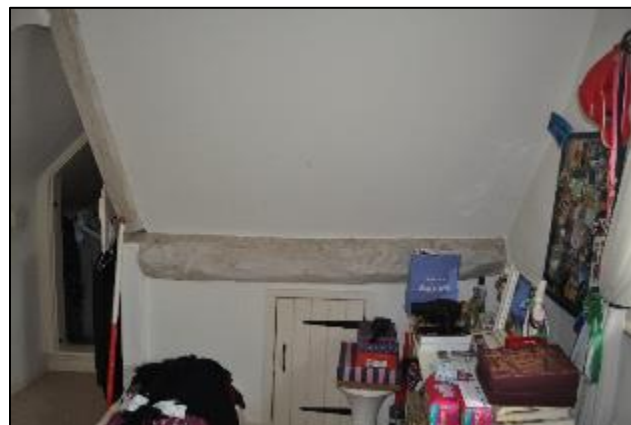
Plate 37: The doorway towards bathroom S4 and a small cupboard in S3. Scale 1m

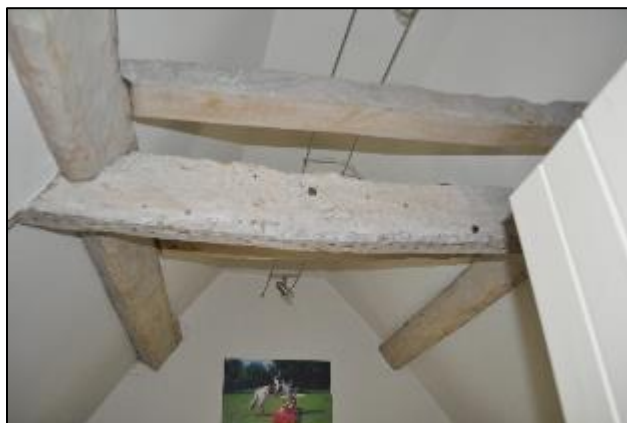
Plate 38: The exposed ceiling beams in S3

The western wall contains the doorway towards the landing S1. The floors are covered in beige carpet, the ceiling is plastered with two ridge collars, one below and one above the side joists (Plate 38).
