HISTORIC BUILDING RECORD

AWBERRY FARMHOUSE, BEENHAM,

BERKSHIRE

MARCH 2024

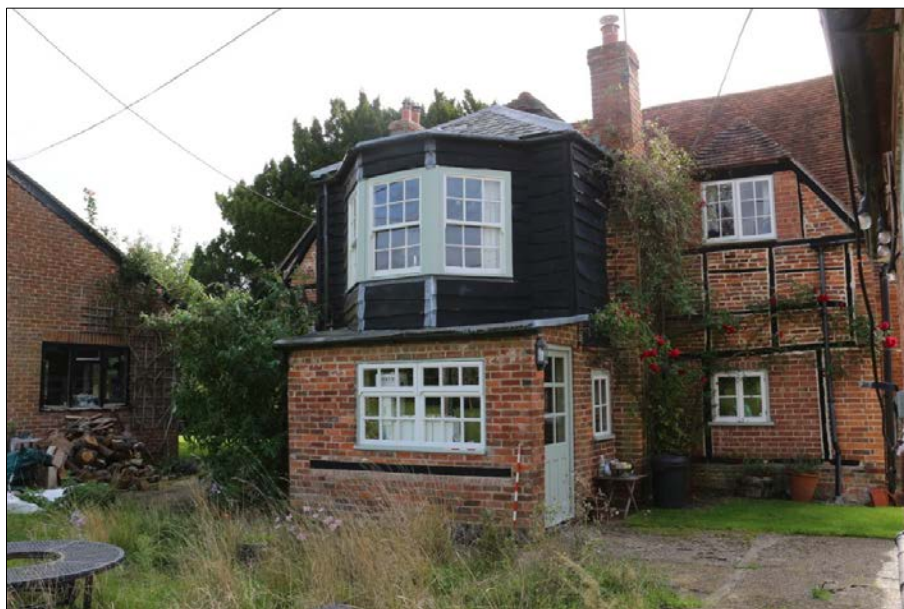
Plate 1. The study building (Scale: 1m)

The part of the building consented for demolition comprises a small multi-phase extension at the rear of the building. The extension is located centrally on the rear elevation and comprises three rooms: two ground floor rooms comprising a porch and kitchen; a first floor room in use as an office or store room at the time the survey.

The lower part of the elevation is brick built while the first storey is timber framed and weatherboarded with a central bay window. The north west and north eastern first floor elevations project from the timber framed structure above; both projections have a shallow single-pitch roof clad in metal sheeting. The roof of the timber framed first storey extension is hipped and clad in slate, with lead flashing.

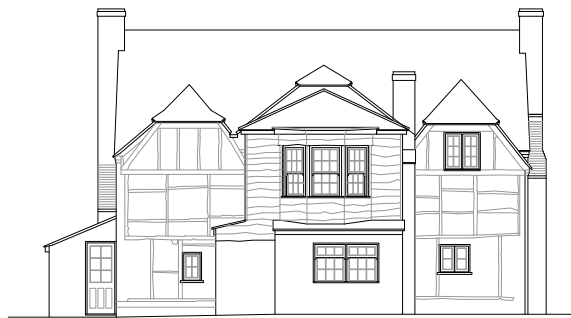
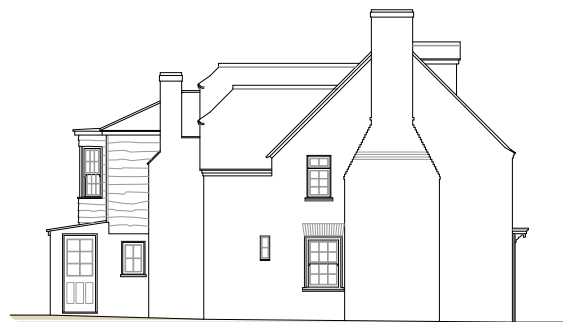
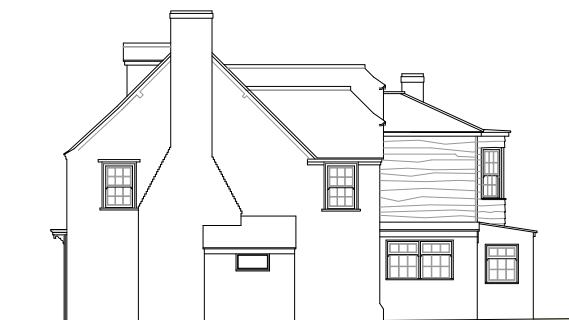
Figure 3:Elevations

North west elevation

South west elevation

North east elevation

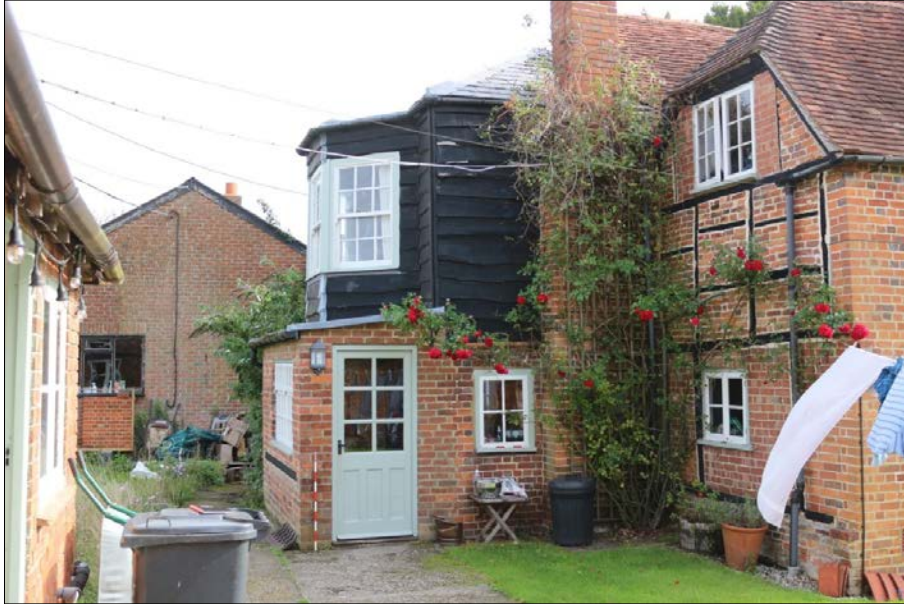
Plate 2. South west facing elevation

The south eastern end of the north west elevation is occupied by a brick-built chimney breast that butts against the north western elevation. To the north east the lower part of the elevation is brick built; two phases of construction are evident due to a variation in brick and brick bond.

Immediately north of the chimney is a small section of wall set in an English bond; the brick used in this section of the wall appears to correspond with that used in the chimney breast. A fixed single light wooden window of four panes is situated within this section of brickwork. Above this section of brickwork is the south west facing elevation of the first storey timber framed extension; here the elevation is blank and clad in treated weatherboarding.

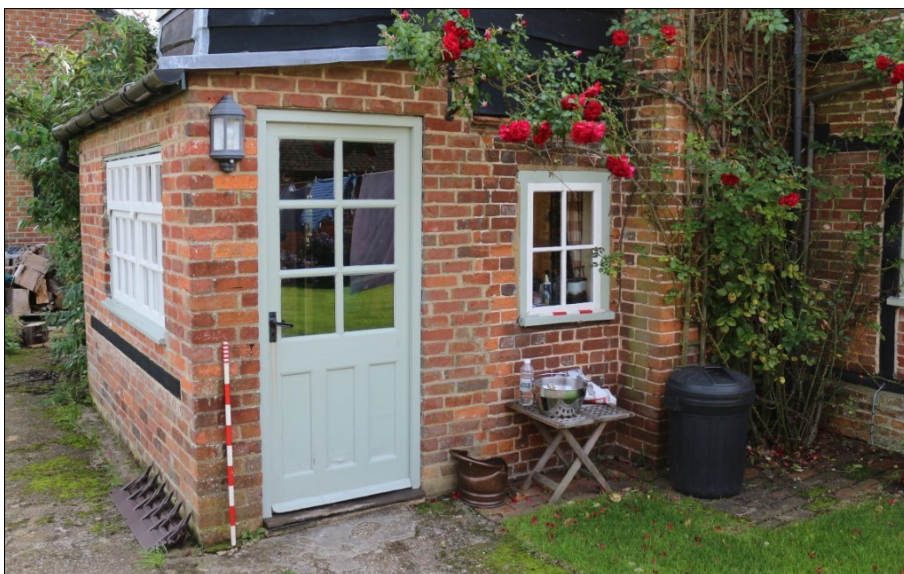
Plate 3. Lower part of the south west facing elevation,

To the north the lower part of the elevation is brick, set in a stretcher bond; this change in brickwork denotes the modern porch extension, built in *c.*2000. A modern panelled and glazed door is located centrally within this panel. On the first floor the bay window projects over the single-pitch roof of the extension.

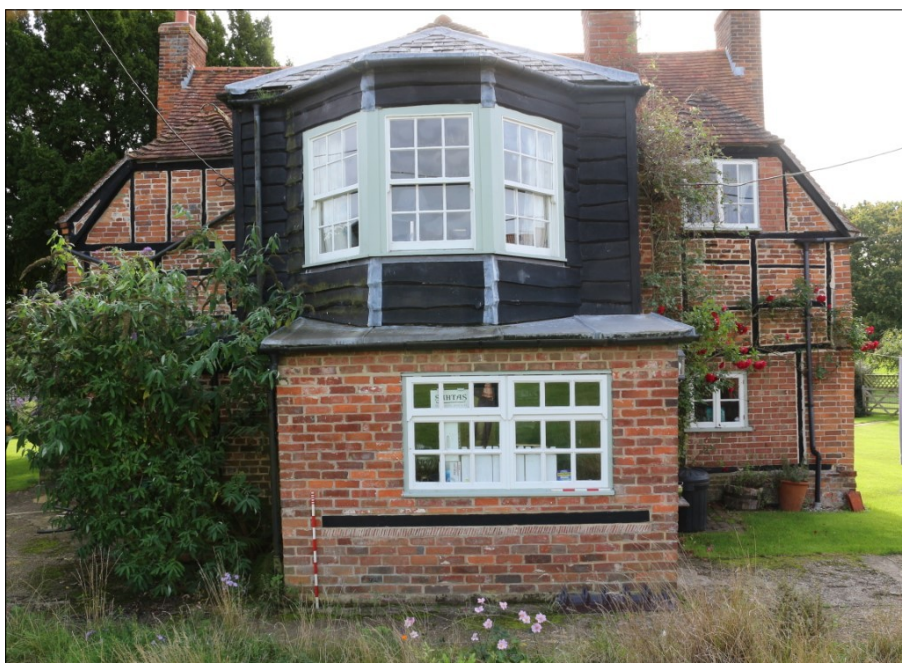
Plate 4. North west facing elevation

The larger part of the west facing elevation comprises the modern porch extension. This is built of brick set in a stretcher bond; a timber plate is set into the wall below a modern timber framed window. The window, which is set off-centre within the elevation, comprises two top-hung casements of three panes over two fixed lights of six panes. A plastic gutter runs the length of the extension, discharging into a downpipe on its northern side. To the north west, stepped back from the principal part of the elevation, is the brick-built side wall of kitchen, Room G1 (partially obscured by a plant in Plate 4).

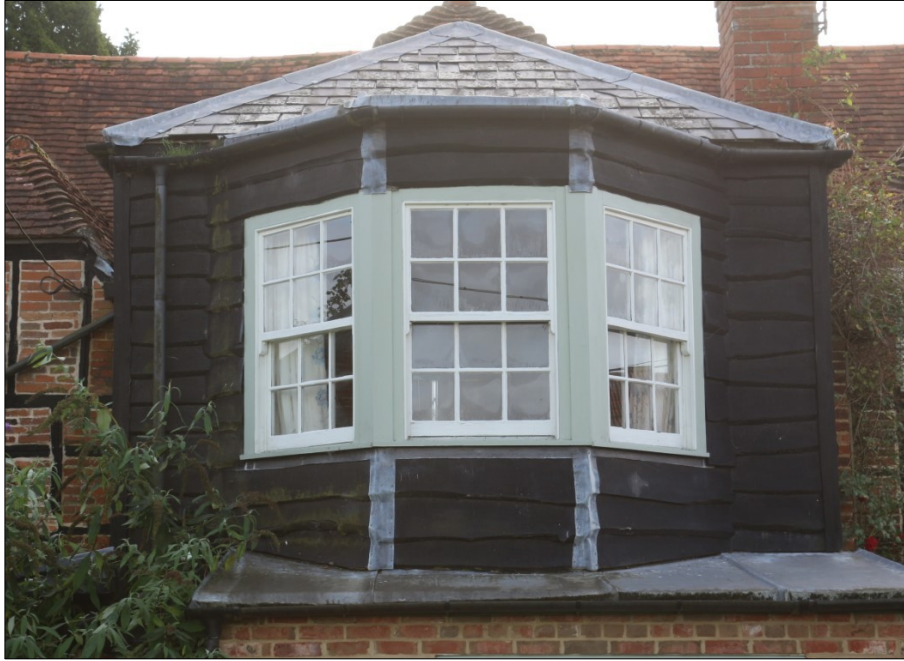
Plate 5. Bay window on the north west facing elevation

The upper storey is timber framed and clad in weatherboarding. Located centrally within the elevation is a canted bay window; The roof of the bay is clad in metal sheeting and a plastic gutter runs around the bay, leading into a downpipe on the north eastern side of the elevation. The bay is lit by three double hung sash windows; each light has six square panes and the frames have horns.

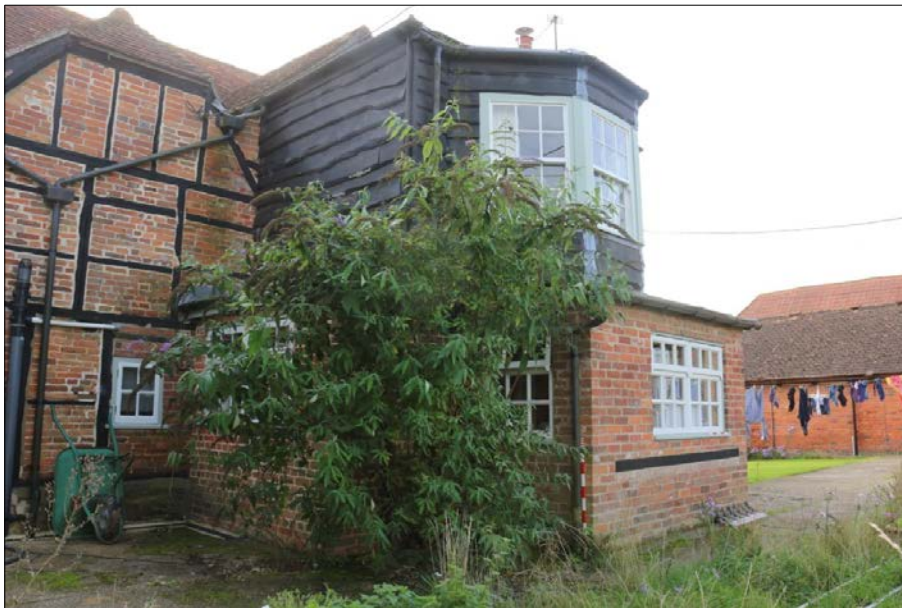
Plate 6. North east facing elevation

The north western end of the elevation comprises the north east side elevations of the modern porch extension, kitchen and overlying timber framed extension (Plate 6). A modern wooden framed window sits centrally within the side elevation of the modern porch extension; this is a top-hung casement of three panes over a fixed light of six panes (Plate 7).

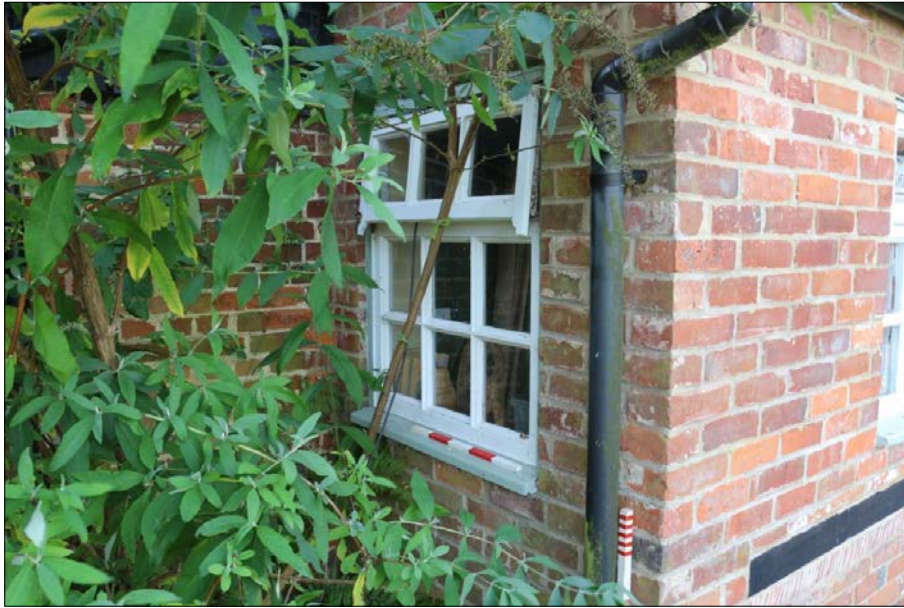
Plate 7. Window into G2 on the north east facing elevation

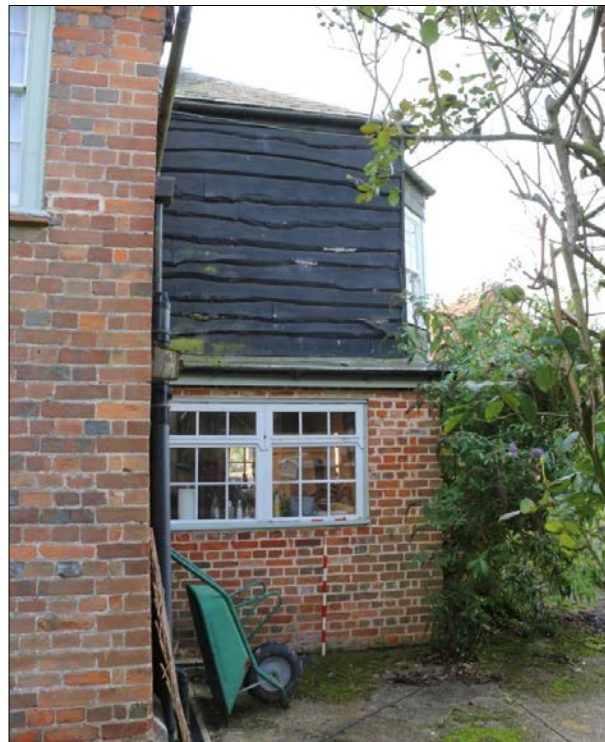
Plate 8. North east facing elevation

To the south east the lower part of the elevation is brick built, with brick set in an English bond; the available evidence indicates that this wall forms a small eastern extension of room G1 (Section 4.1). Set into the wall is a modern four light window comprising two top-hung casements of three panes over two fixed lights of six panes; this is the same as the window on the north west elevation. The side wall of the timber framed extension is situated above; this is clad in weatherboarding but is otherwise devoid of features.

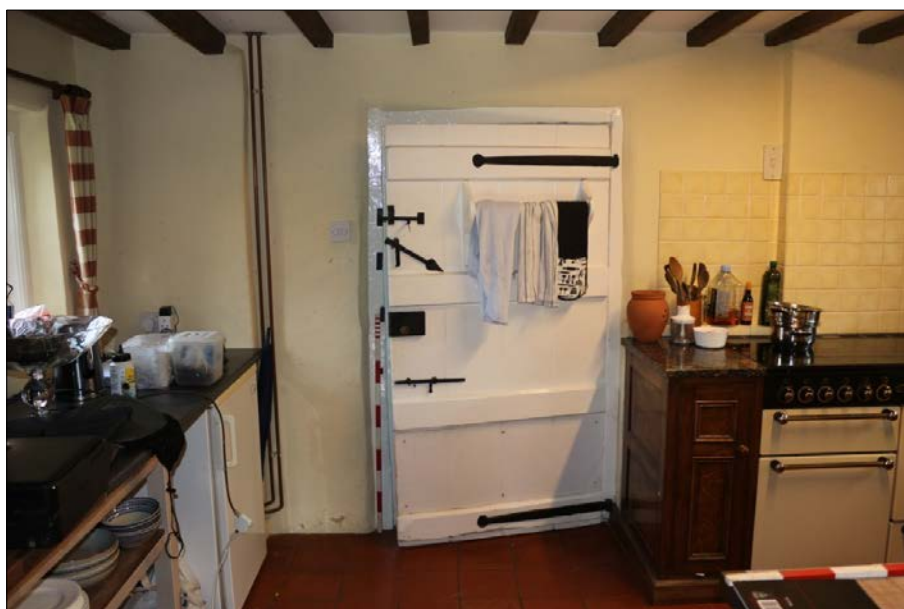
Plate 9. Historic plank door within Room G1

The north western wall contains a section of timber framed wall, visible in this room due to a difference in thickness compared to the brick walling that flanks it (the timber construction is more apparent in G2, where timber panelling remains extant). Situated within this part of the wall is the doorway to G2; this has a simple frame and contains a plank and batten door of probable 18th or 19th century date. The door exhibits a range of historic fittings, including round-end strap hinges, two iron latches, a lock case and a draw bolt.

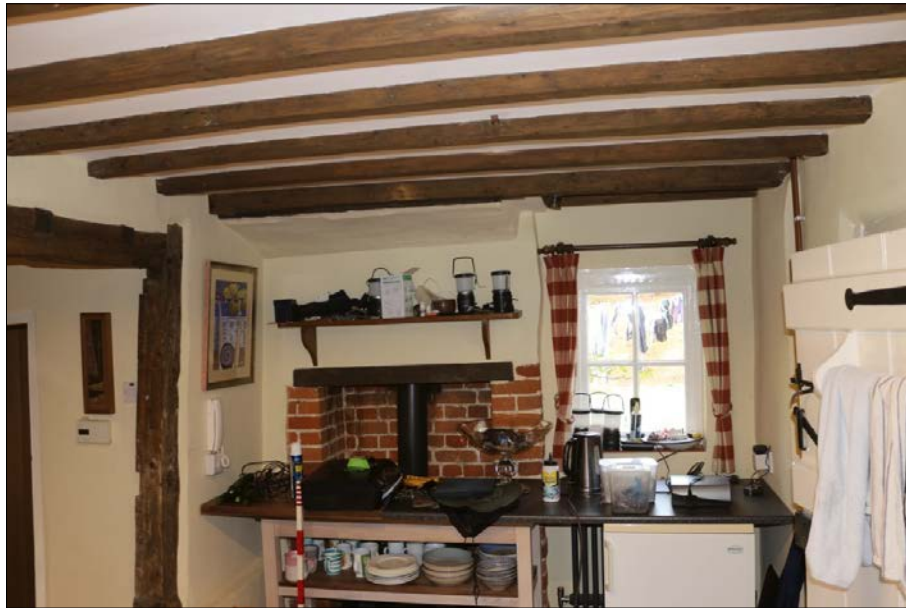
Plate 10. South west wall of Room G1 and ceiling/floor joists of F1

The south western wall contains a brick-built fireplace with modern timber lintel that contains a modern stove. A small fixed window is located to the north of the fireplace; this has ovolo-moulded glazing bars and a simple moulded surround. The south east wall would formerly have been the north western external wall of the building. The wall has an entrance into the main part of the house; this is partly framed by historic timbers, though these may be re-used from elsewhere as the entrance must have been created when the kitchen extension was added. On the western side of the entrance the brick-built plinth of the main building remains extant, though this has been removed along the rest of the wall. The north eastern wall contains a modern window, previously described above.

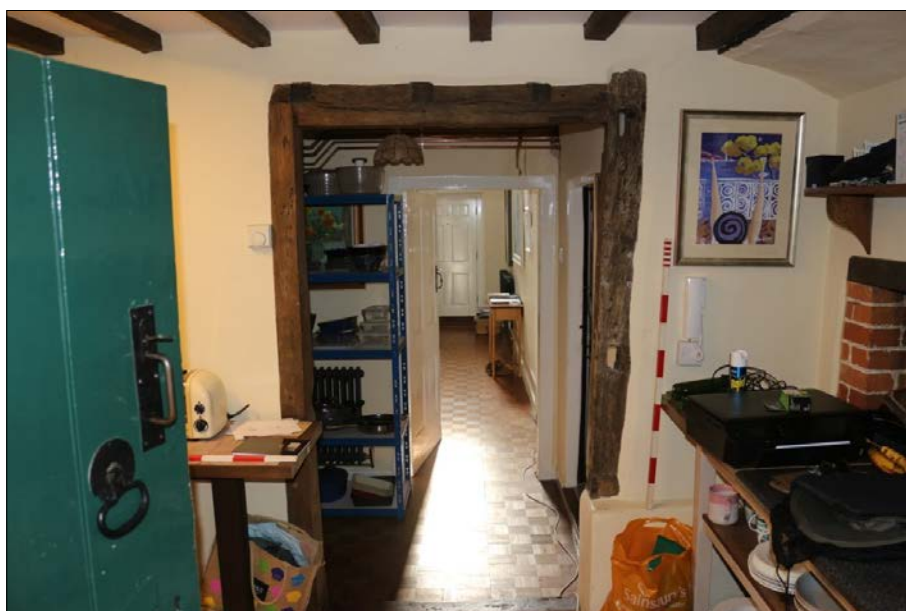
Plate 12. South eastern wall of Room G1; the scale bar is resting on the plinth

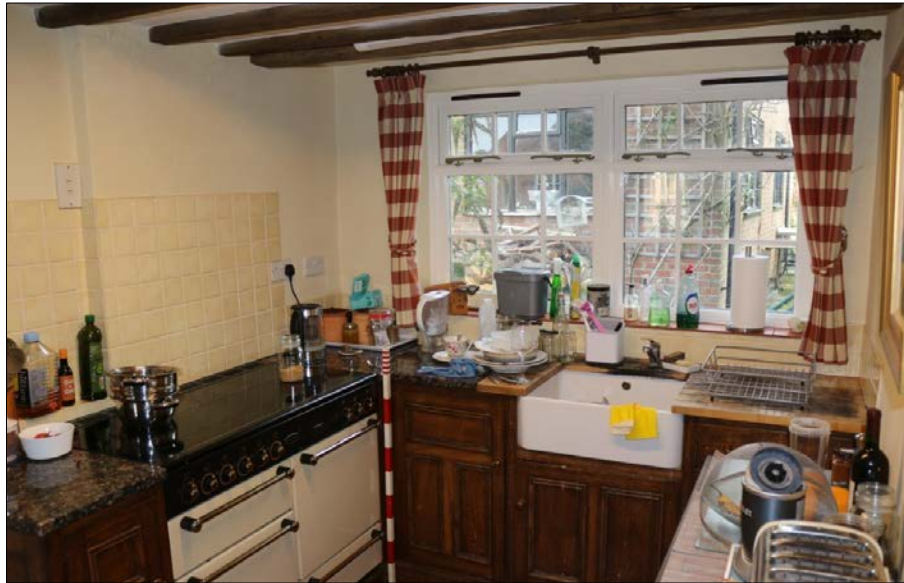
Plate 13. North eastern wall of Room G1

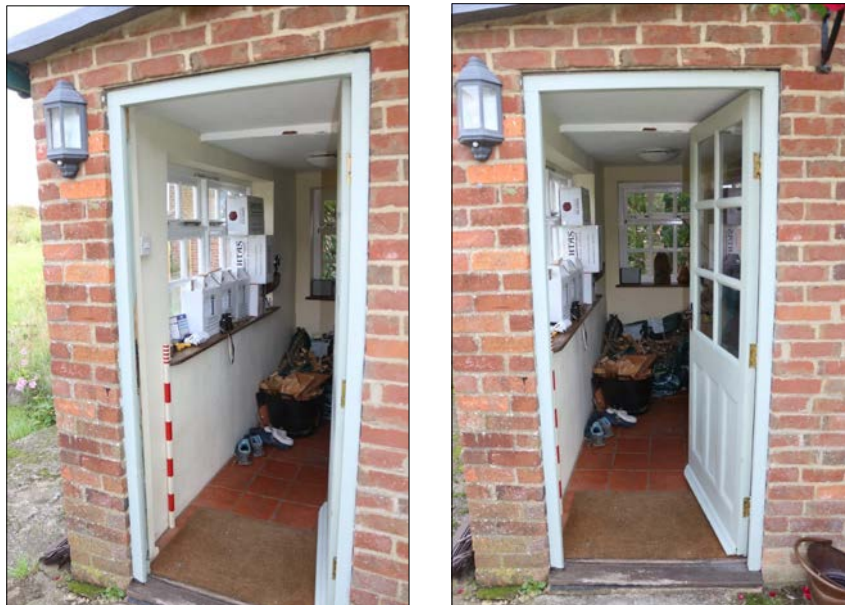
Plate 14. Room G2, as seen from outside the building

Room G2 is a modern porch extension. The room can be accessed from outside through a modern panel door located on the north west wall and from G1 through a historic plank and batten door on the south east wall.

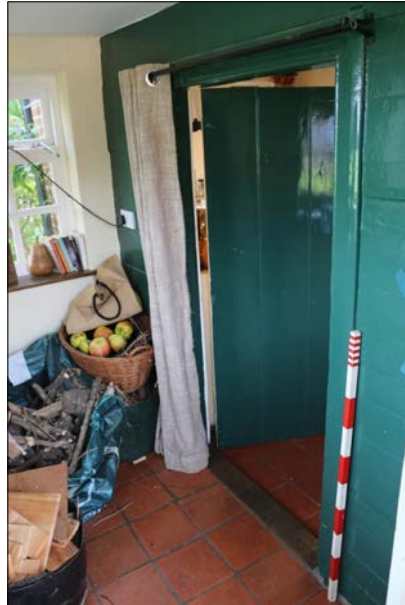
Plate 15. Room G2, timber clad south east wall

Both the north west and north east walls contain modern windows, previously described above. The south eastern wall is of timber framed construction, clad with simple timber panelling or weatherboarding set horizontally.

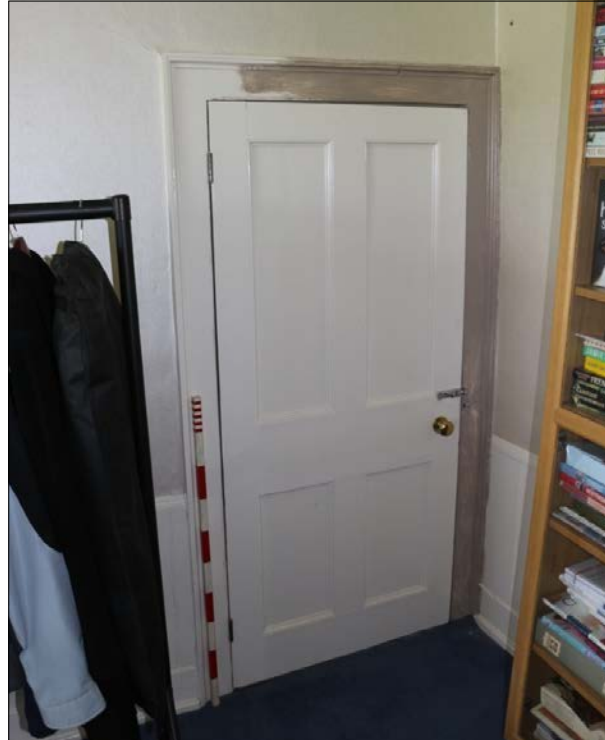
Plate 17. Room F1, four panel door to the bathroom

The room is accessed through a historic four panelled door of probable late 18th or early 19th century date (Hall 2007, p.44). The door sits within a moulded architrave. A matching door is present on the north eastern wall, providing access into a bathroom. In the south corner of the room a later stud partition forms a small cupboard; this is accessed through a modern (20th century) three panel door.

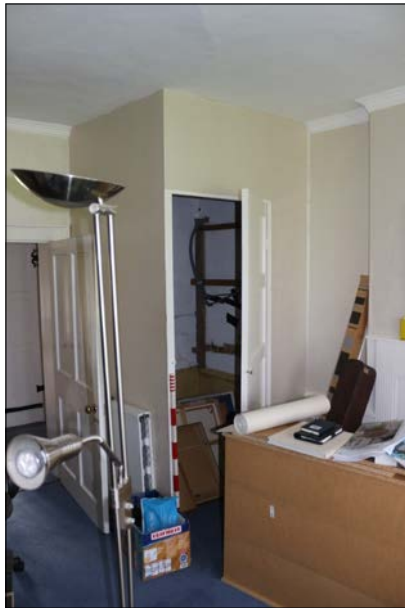
Plate 18. Room F1, cupboard and simple wainscot panel and dado rail within cupboard

A small airing cupboard was inserted into the southern corner of Room F1. Externally the weatherboarding and bay window of the first storey structure were replaced, with modern insulation fitted.

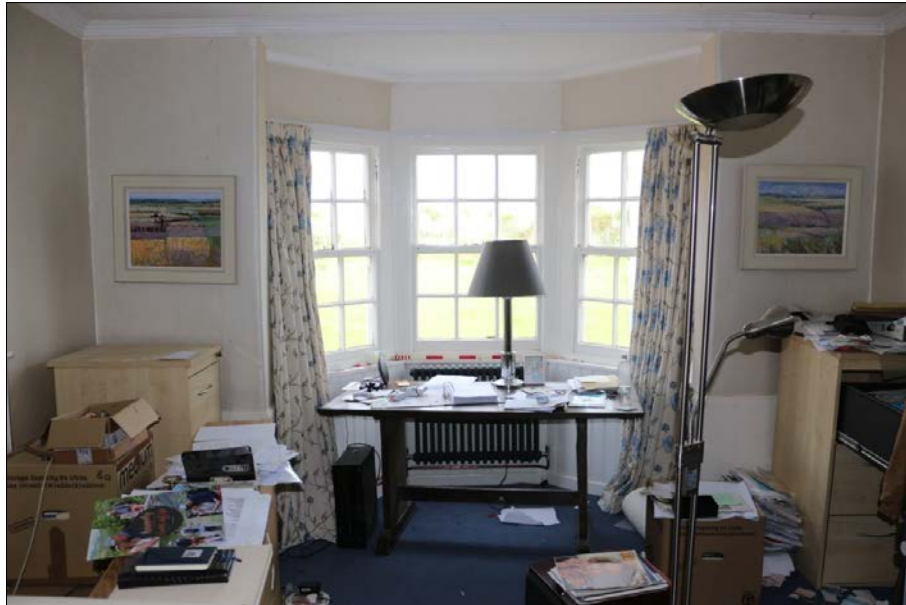
Plate 19. Room F1, bay window on north west wall

The north west wall contains the bay window. The sash windows themselves are of probable 20th century date. They have ovolo moulded glazing bars and brass fittings. The wooden panelling is present around the bay, but is different in form to that seen elsewhere in the room, being comprised of smaller planks.

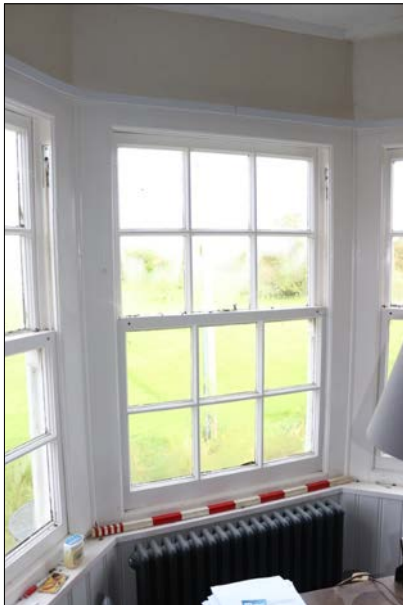
Plate 20. Room F1, sash window

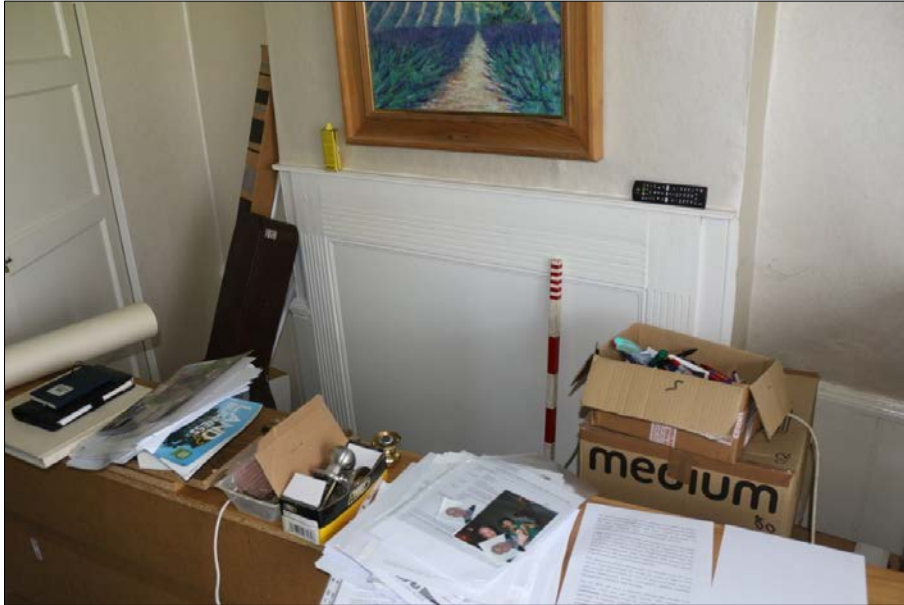
Plate 21. Room F1, fireplace surround

The south west wall contains a chimney breast and blocked fireplace; the fireplace surround has a low relief, with reeded decoration and simple mouldings. Based on the decoration this has a probable late 18th or 19th century date (Hall 2007, p.183).

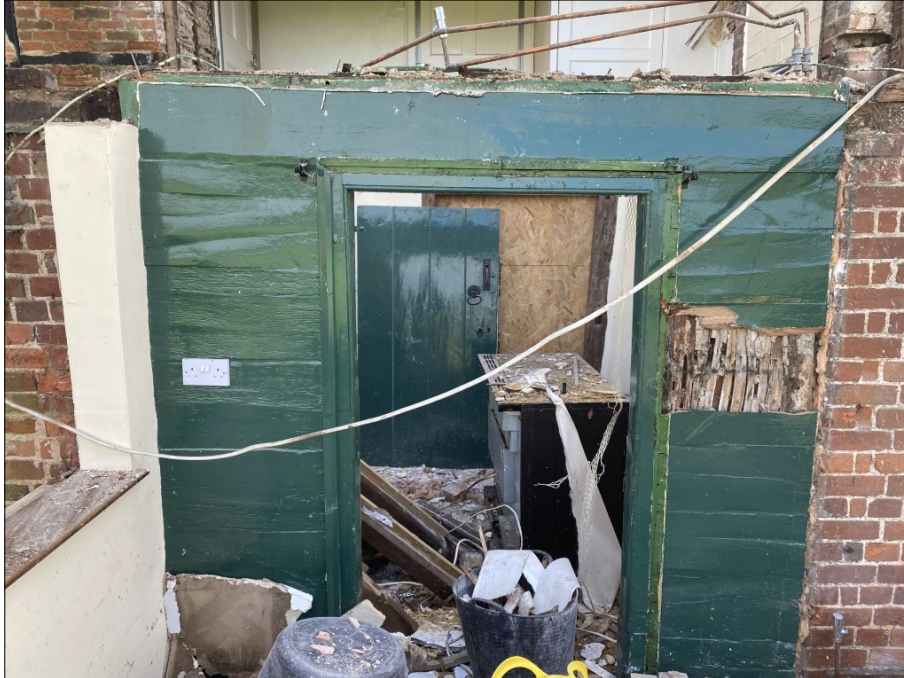
Plate 23. Rooms G1 and G2, timber panel

Three or potentially four phases of construction were evident during demolition of the building. The earliest phase comprised the brickwork of the south west and north west walls; as previously noted this was set in an English bond and appeared to be of the same brick as the chimney on the south west wall. The timber framed panel on the north west wall may be contemporary with this phase, or may be a later insertion

associated with a reworking of the overlying bay window, the position of which corresponded exactly with the panel. Demolition of the panel revealed a timber framed construction with lath and plaster on the interior side; the construction of the panel suggests a 19th century date. Later phases comprise the north east wall of G1 and porch G2, both of which date to the 20th century.

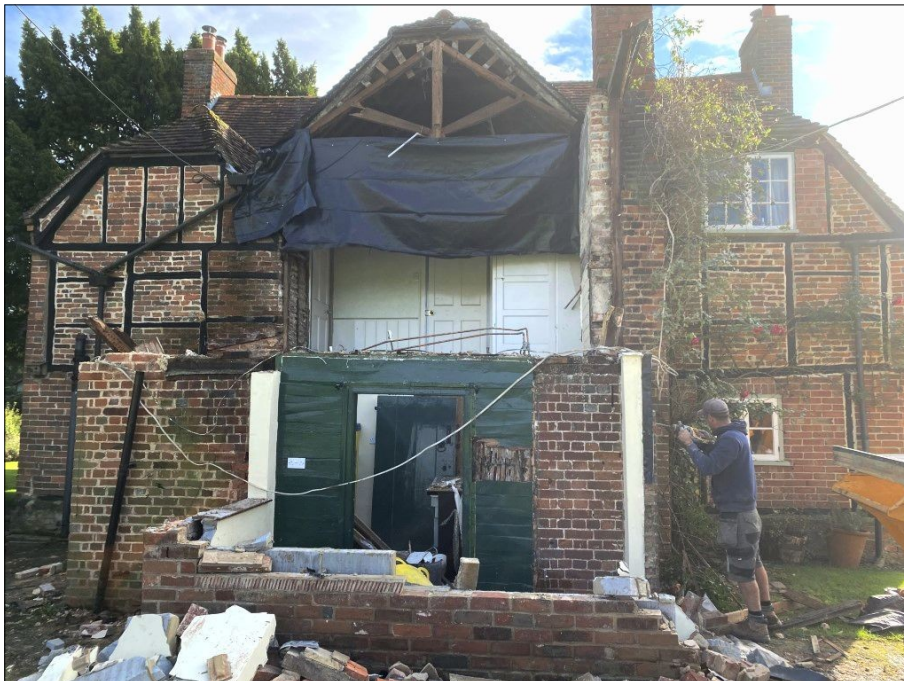
Plate 24. Demolition of lower floor structures

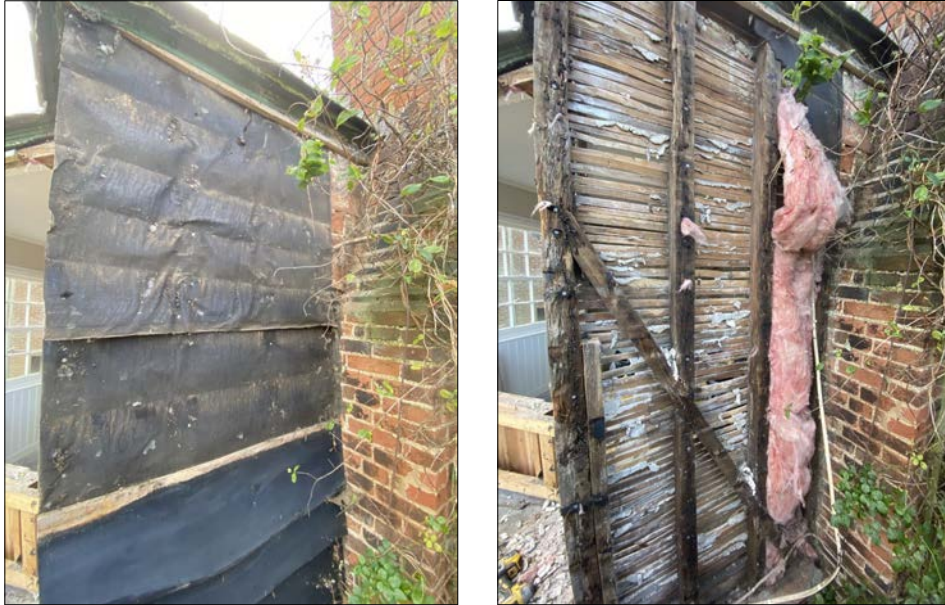
Plate 25. Removal of weatherboarding, membrane and fibre insulation

The principal construction of the first floor extension comprised studwork framing with occasional diagonal-braces. The studs were saw cut softwood, joined with nails

and set into wall plates. Evidence of recent refurbishment to the exterior of the structure was clear, with modern fibre insulation fitted between the studs, on top of which the weatherboarding, also modern, was fixed. Internally the walls were finished in lath and plaster. The lightweight construction of the structure is consistent with a 19th century date.

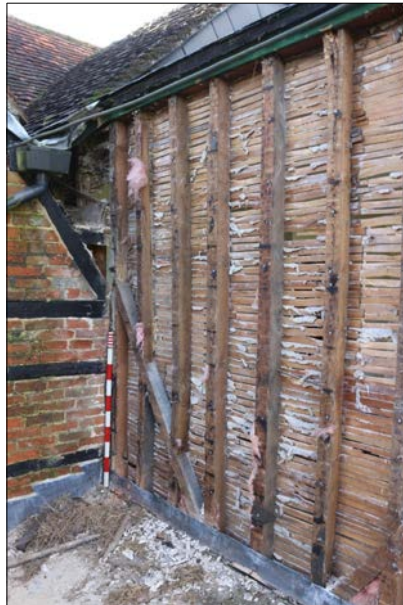
Plate 26. Framework of the north east wall, showing junction with the earlier structure

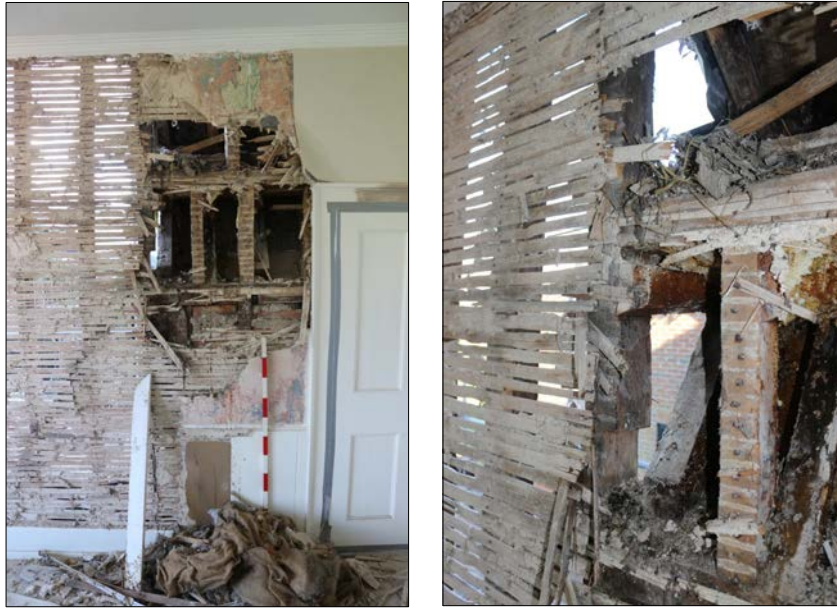
Plate 27. Intersection of the extension with the earlier building, as seen internally

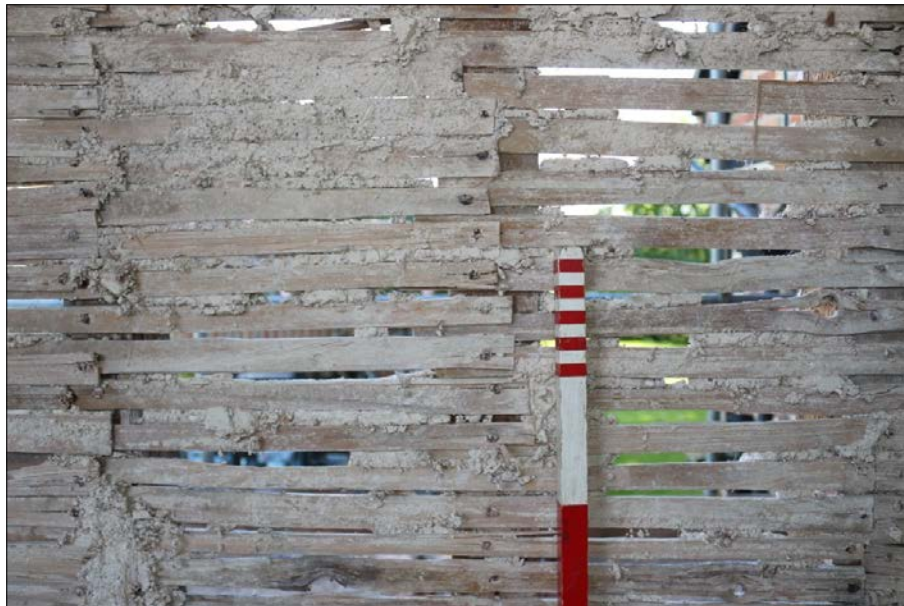
Plate 28. Room F1, Internal lath and plaster

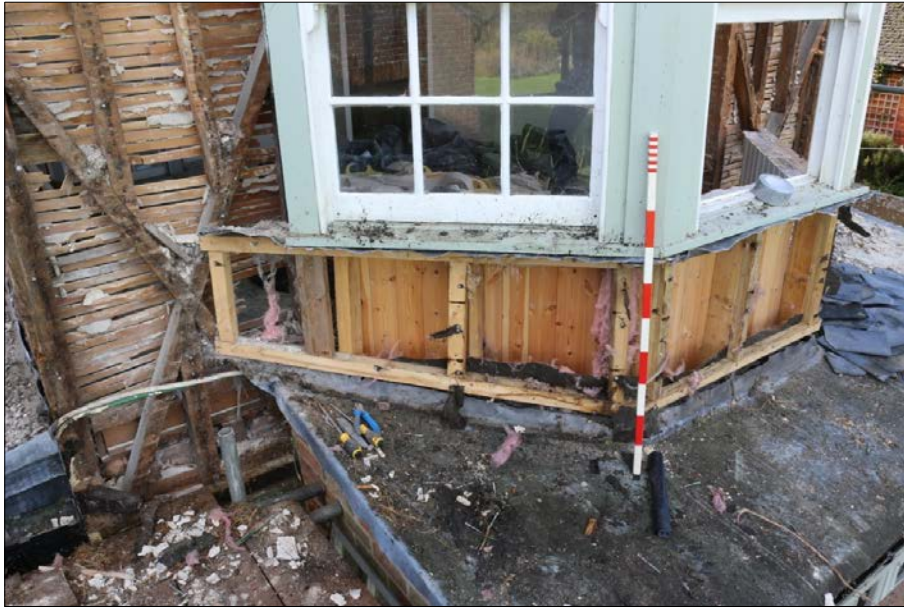
Plate 29. Modern framework of the bay window

Demolition revealed that the structure of the bay window was a modern addition. The bay was built from softwood studs, joined with nails and cross-head screws; internally the walls of the bay were finished in timber panelling that was also of a modern date, explaining the variation in panelling between the bay and the rest of the room.

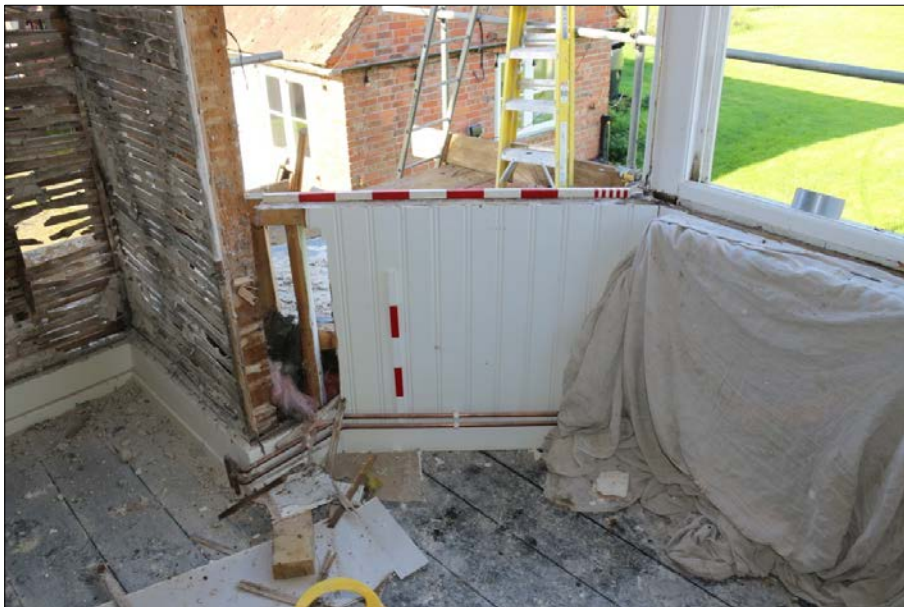
Plate 30. Modern timber panelling within the bay

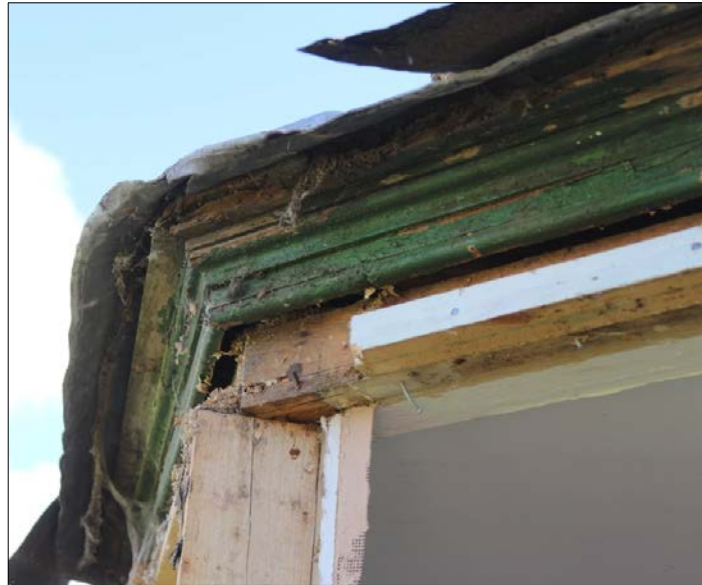
Plate 31. Earlier painted architrave at the top of the bay

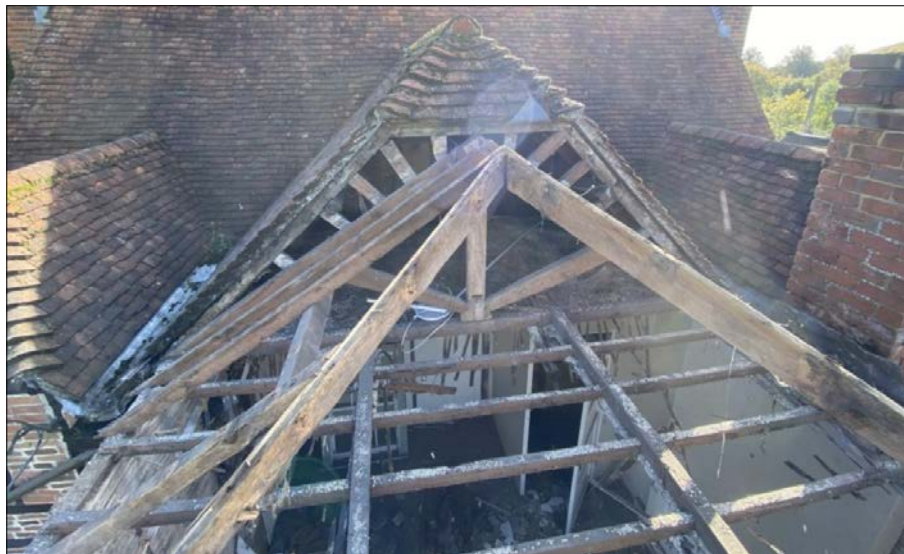
Plate 32. Roof structure of the timber framed extension

The hipped roof structure of the timber framed extension was of common rafter construction, with clasped purlins and a single king post truss located at the join between the half-hipped roof of the earlier building and the extension. The rafters of the hipped roof were secured using dragon beams and cross ties. Both the king post truss and corner and dragon tie beams are typical of late 18th or 19th century construction (Harris 1999, p.85-86).

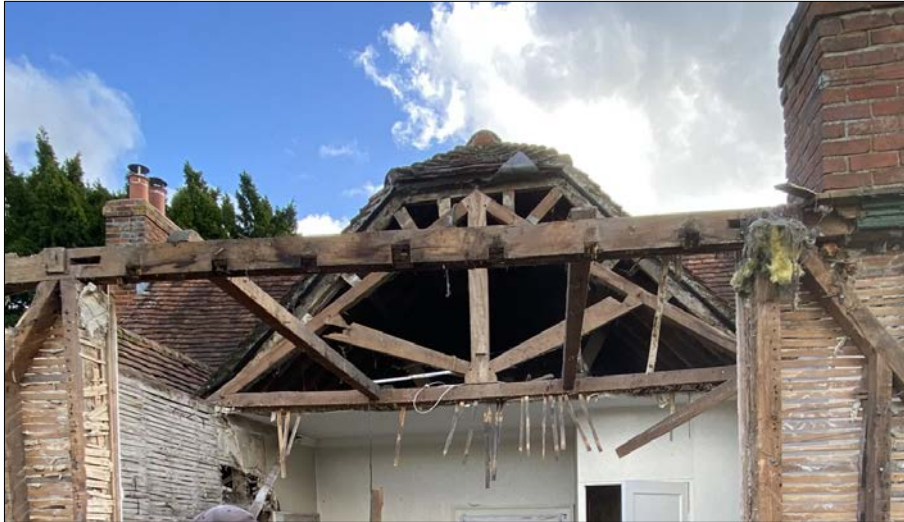
Plate 33. King post truss inserted within the gable of the earlier building's half-hipped roof

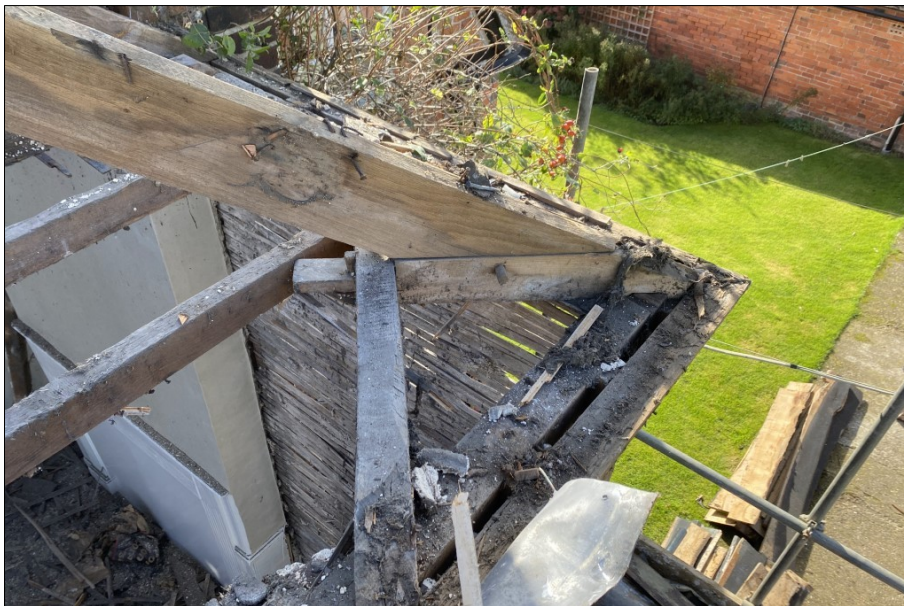
Plate 34. Corner and dragon tie-beam assembly supporting a hip rafter
