The structural development
of
NUNHIDE MANOR
SULHAM, BERKSHIRE

K A Rodwell
for
JOHN MOORE HERITAGE SERVICES

June 2009

THE STRUCTURAL DEVELOPMENT OF NUNHIDE MANOR

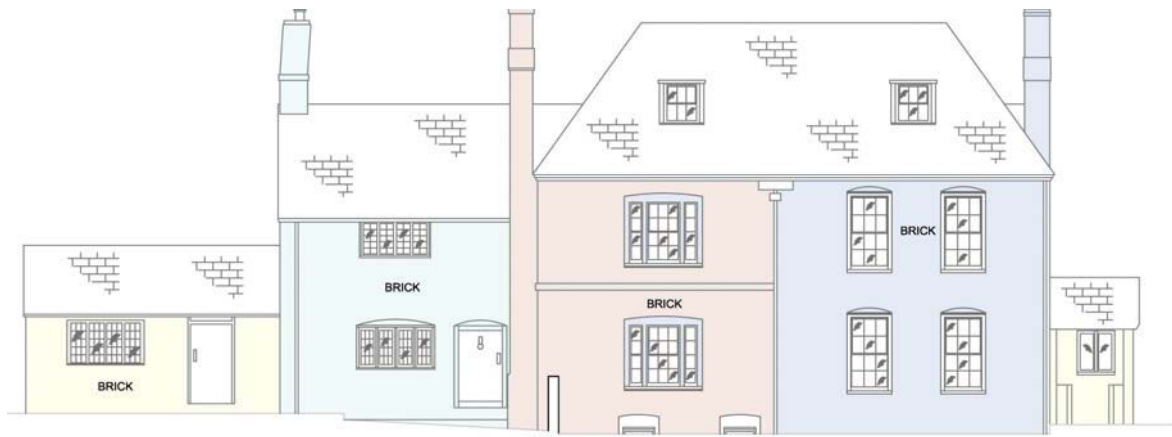
Farmhouse
Existing West Elevation

West

The house is built of brick with a hipped tiled roof and consists of a double-pile main range with a narrower lower service wing at the north end. The principal elevation faces west and has two distinct builds under a common roofline. The southern half is built of red brick in Flemish bond with wide lime mortar joints; it has a plinth and a dentilled eaves course. There are two pairs of twelve-light sash windows with segmentally arched heads and narrow glazing bars.

At the mid point of the wall there is a lead downpipe with the initials IE and the date 1698 on the hopper. This obscures a vertical straight joint; the brickwork to the south projects by c.50mm from the wall to the north which has a plinth largely faced in flint incorporating a cellar with two basement windows in brick light-wells. The body of this wall is also Flemish bond brickwork but they are thinner, the headers are vitrified and there is a three-course string at storey height. There is a single central triple-sash window on each floor, each of twelve lights flanked by four-pane side-lights with segmental heads; the wall below the first floor window is rebuilt. There are two rebuilt dormers in the roof and shouldered end stacks.

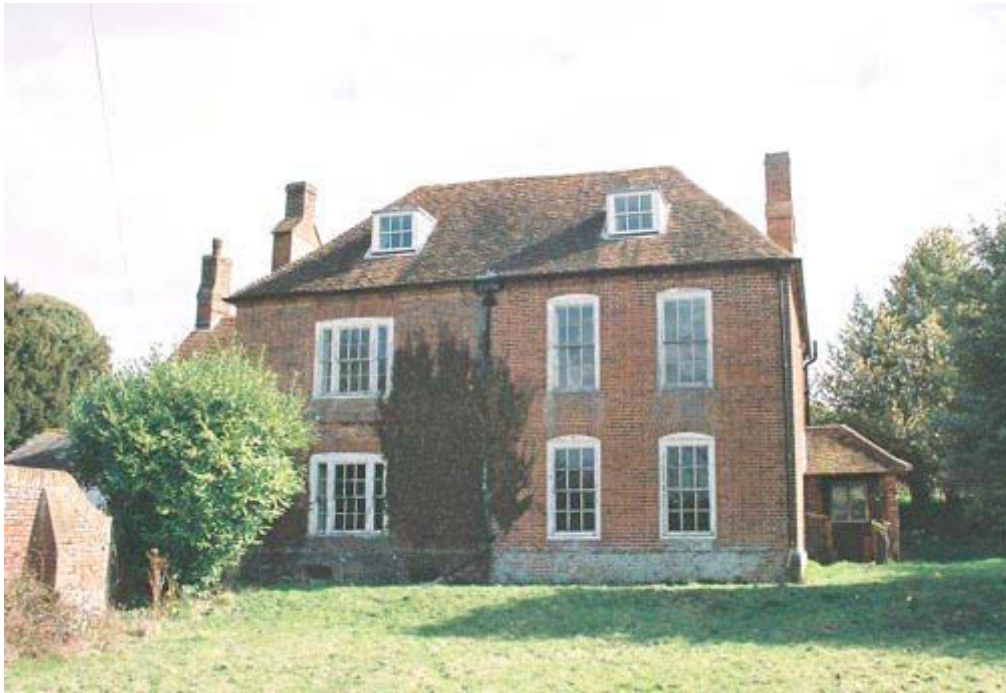
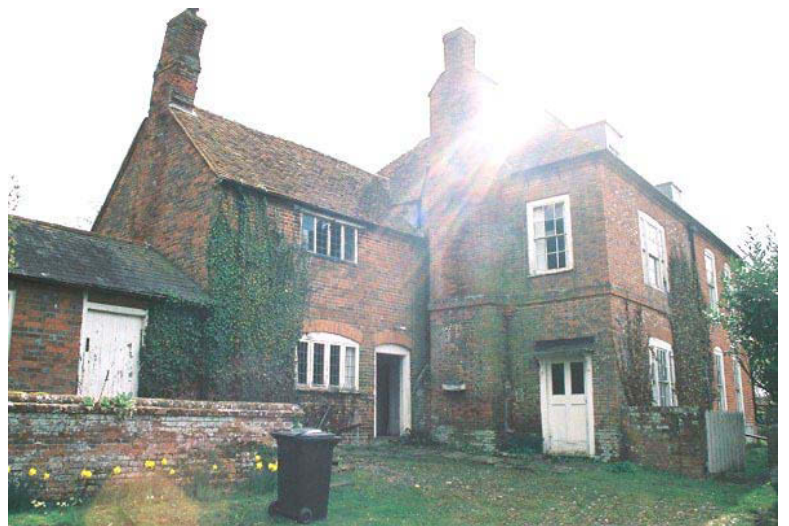
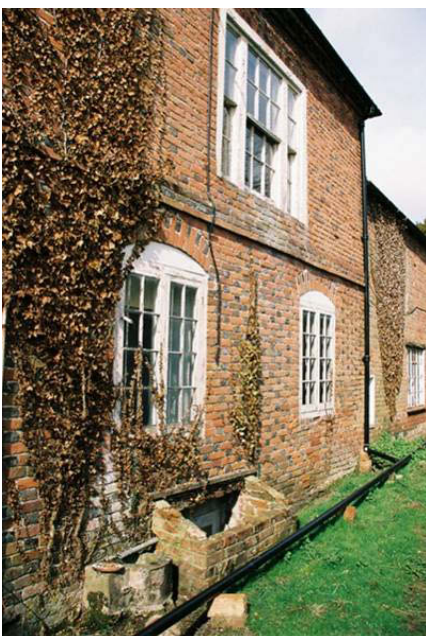
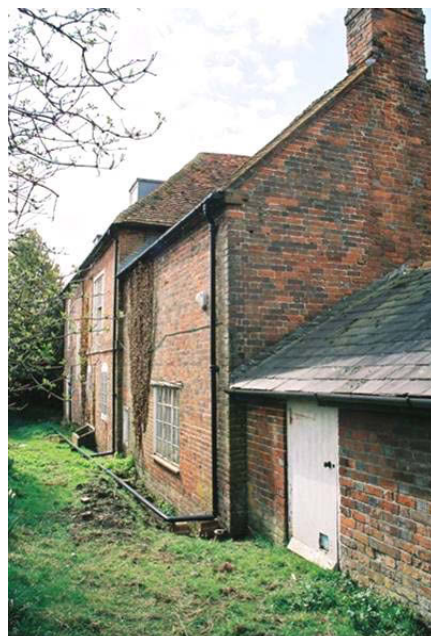
Fig 4

(clockwise from above)

West elevation; junction in builds behind
downpipe

East elevation from north

East elevation from south

Exterior (Figs 2-4)

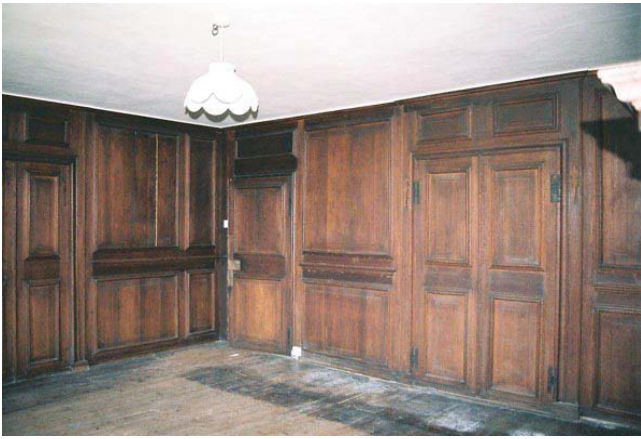
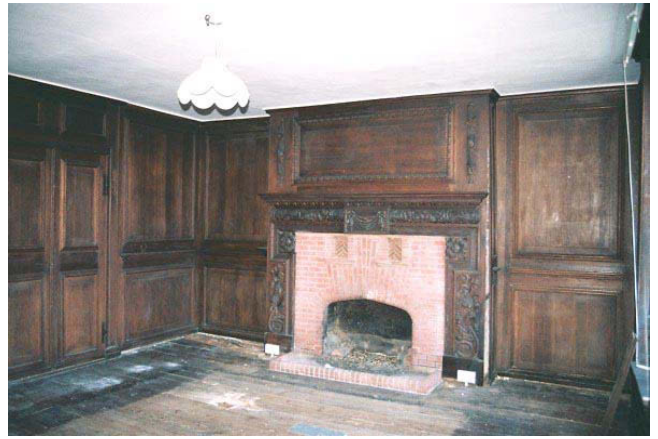
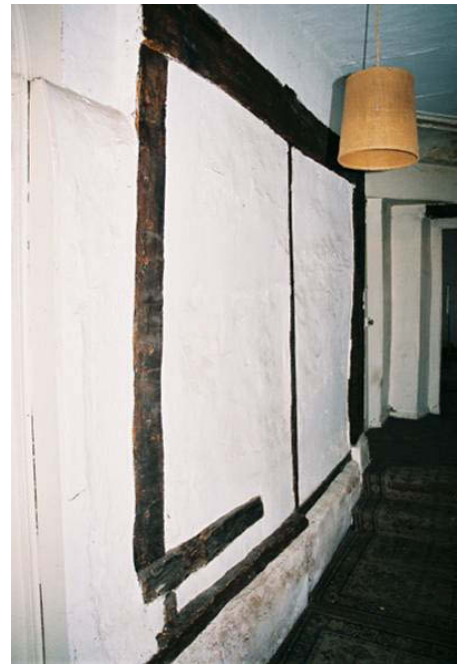
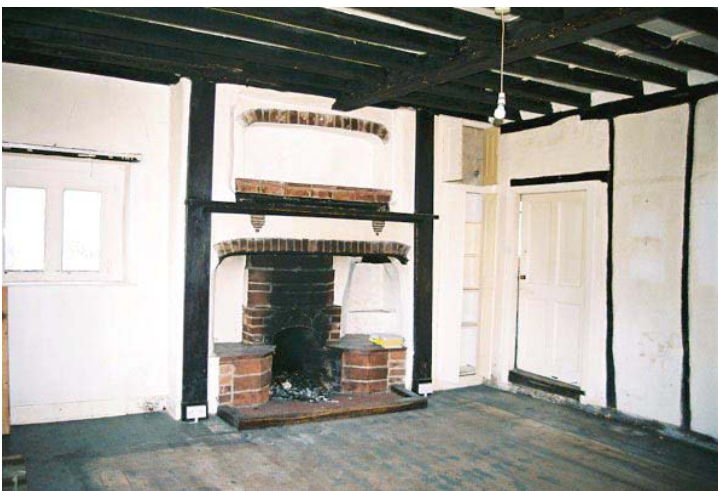
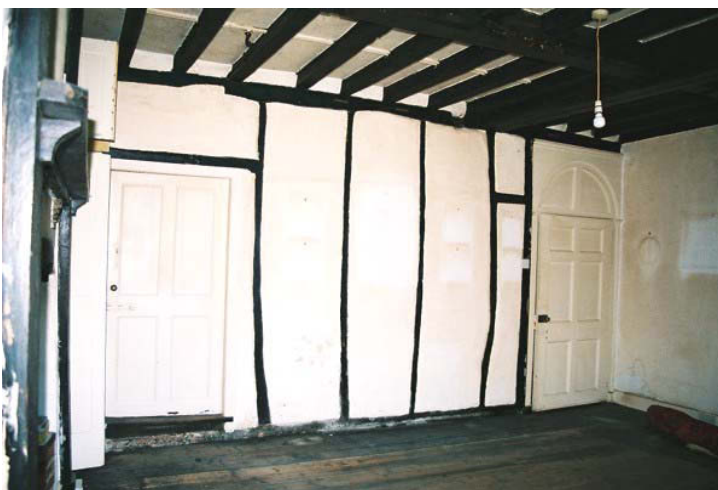
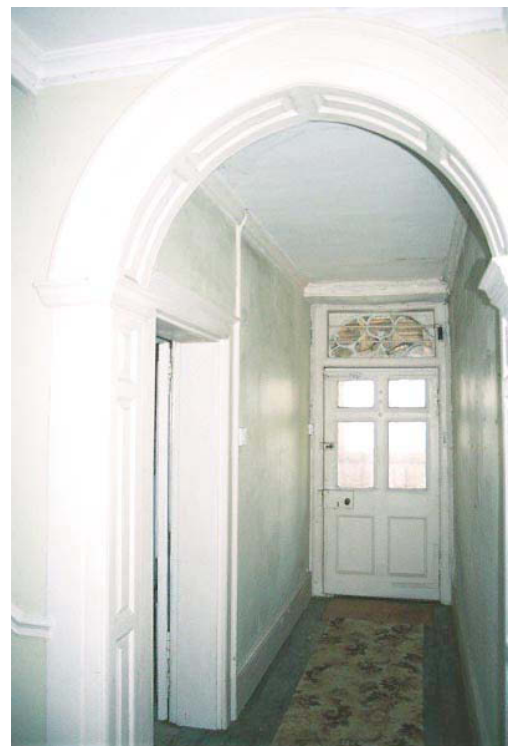
Fig 5

(clockwise from above)

Timber framing in NW reception room

Open fireplace in NW reception room, altered in early 20th cent

The main door to the north-west reception room is six-panelled with a pilastered architrave and an arched over-door. It is set in an exposed timber-framed partition with a cill beam and top rail and there is a second plainer door at the north end. The other three walls are plastered over brick and a patch has been stripped in the south-west corner to expose a void 50mm deep where the south wall is butted against the west wall. The west window appears inserted; it has shutters and the architrave projects 150mm from the wall face. The fireplace in the north wall was rebuilt in the earlier 20th century within an earlier opening to incorporate inglenook seats, a flat brick arch held on an iron bar and an alcove where there was formerly an oven. It is framed by applied timbers and there is an arched recess, probably old, above a high mantelshelf. To the west a door has been partially blocked to make a window and to the east there are cupboards; these are both 19th century features. The ceiling has a grid of exposed beams and joists; a number of these are replacements. The floor is 19th century boards.

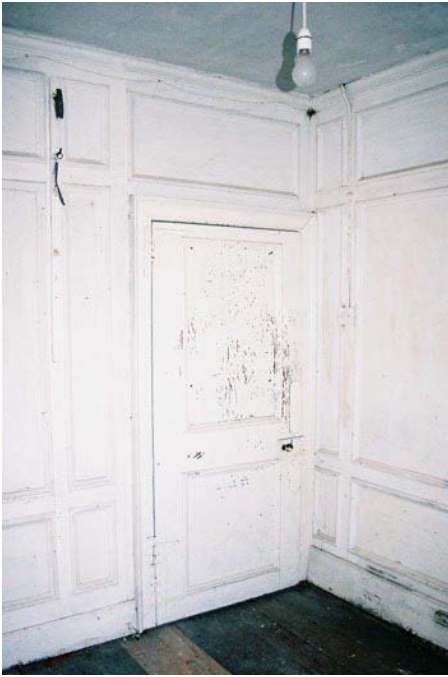
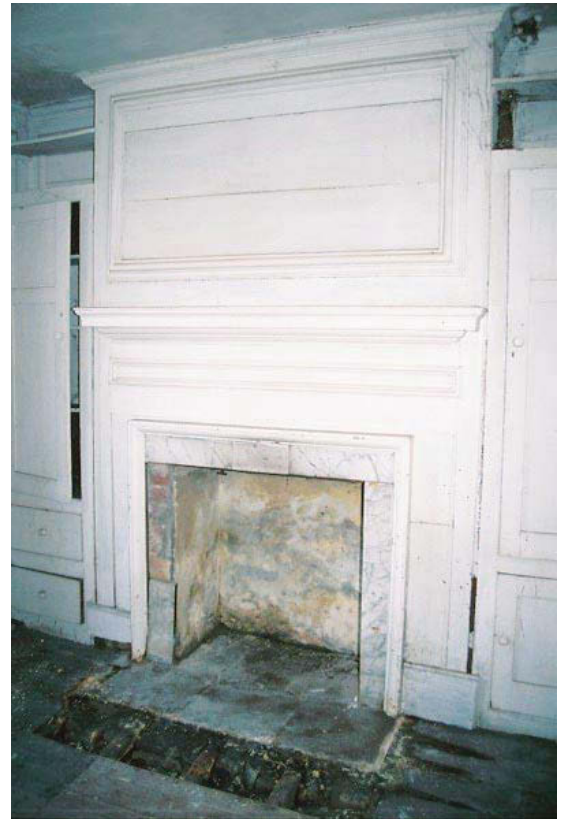
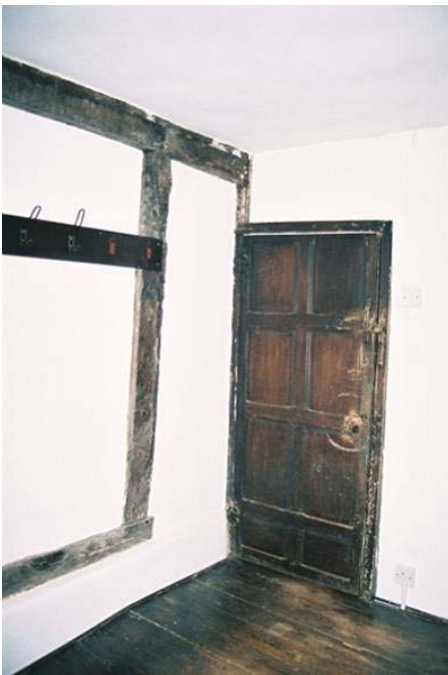
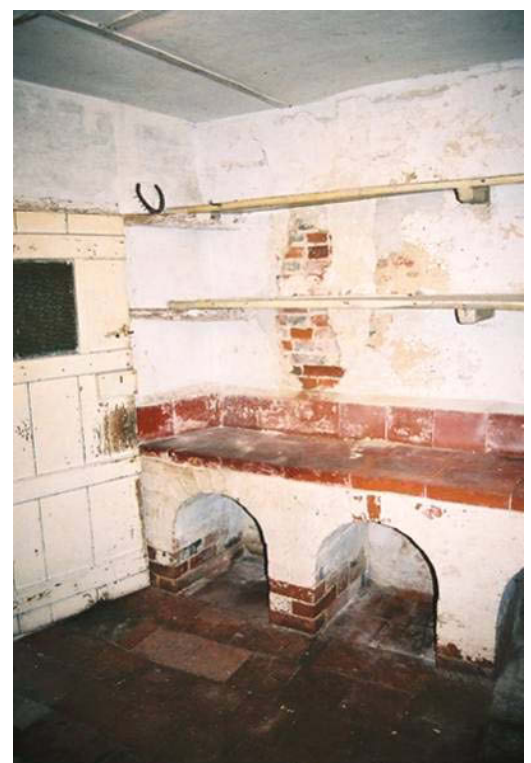
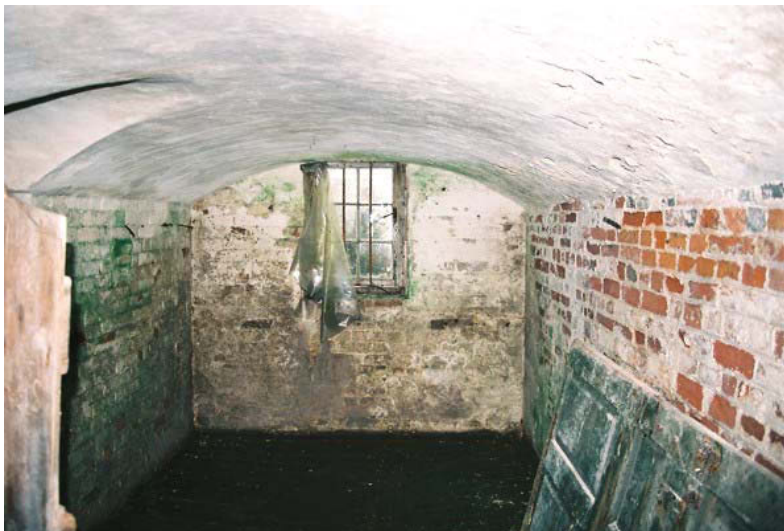
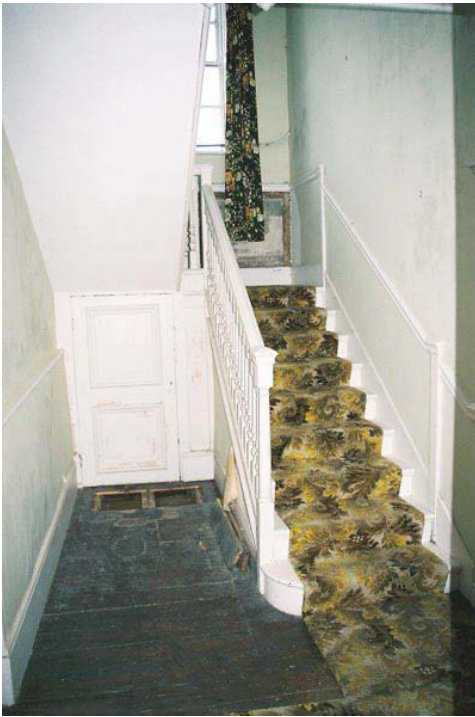
Fig 6

(clockwise from top right)

Timber-framing in cloakroom

SE reception room; early 18th century panelling

The south-east reception room is fully fitted out with raised and fielded panelling comprising skirting, dado, upper panel, frieze and cornice moulding. The door, window and fireplace are integrated into the scheme. The fireplace opening has white marble slips and a moulded mantelshelf with a raised panel above. Nineteenth century cupboards have been built into the recesses on either side over the original panelling which survives at the back. A paint scrape indicates that this panelling has had a succession of painted and grained finishes. The door is hung on mismatched L-hinges and has bolection mouldings on the reverse. The floor is 19th century boards affected by damp and the ceiling plain plaster, missing in places to expose 19th century joists.

North of the staircase hall and at a higher level is a cloakroom with a timber-framed south wall. This has a cill beam set on a dwarf wall and two posts; the western is tenoned into a rail below ceiling level; the eastern is full height and the rail is tenoned into it. The soffit of the rail has a series of dowels for wattles. There is a second rail, also morticed for a post in the north wall. The door is of 17th century panelled type but has been rehung as the narrow frieze zone is at the base; it has cockshead hinges and a wooden latch. In the adjoining passage the reverse of the framing to the north-west room is exposed. It is set on a dwarf wall and there is a full-height post at the north end.

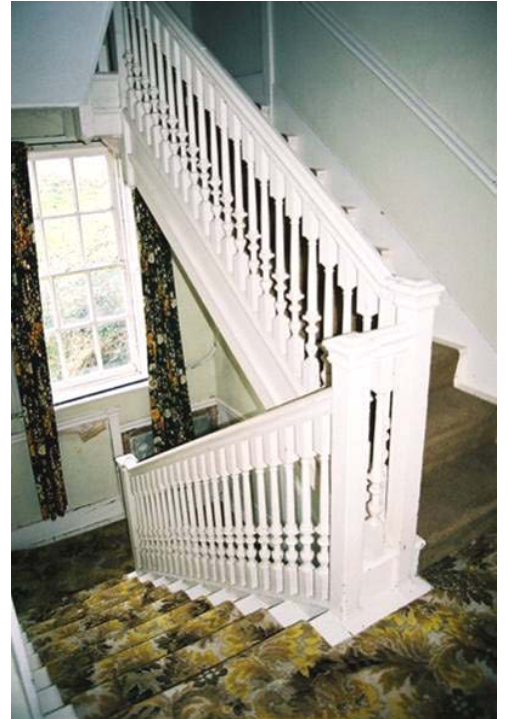
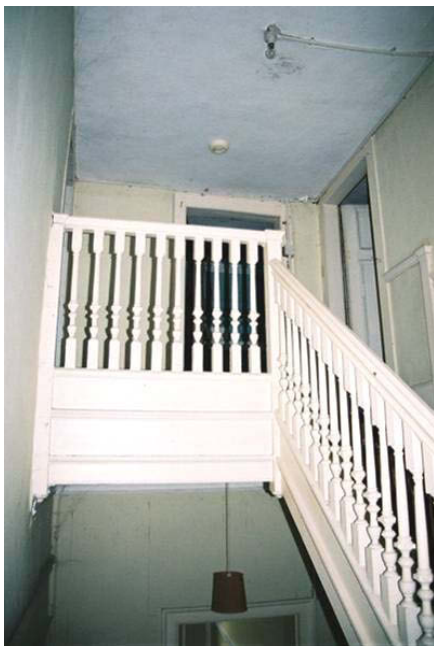
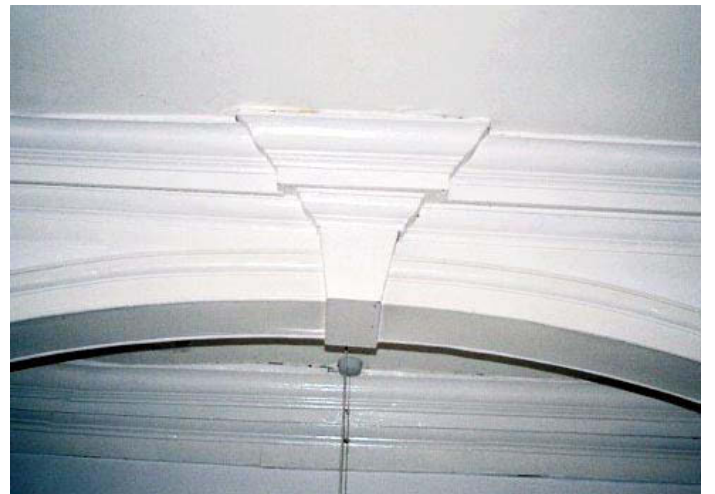
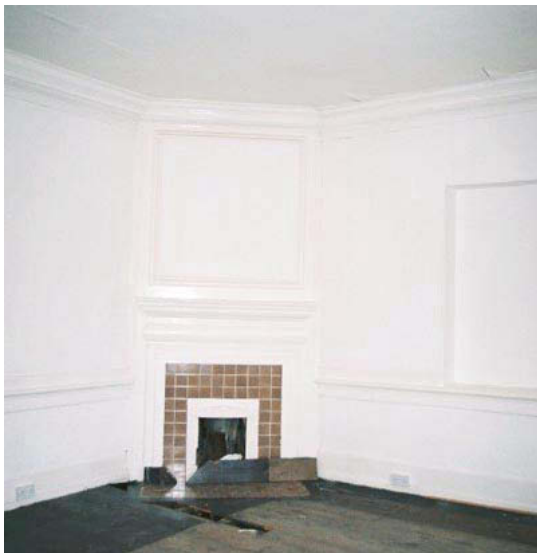
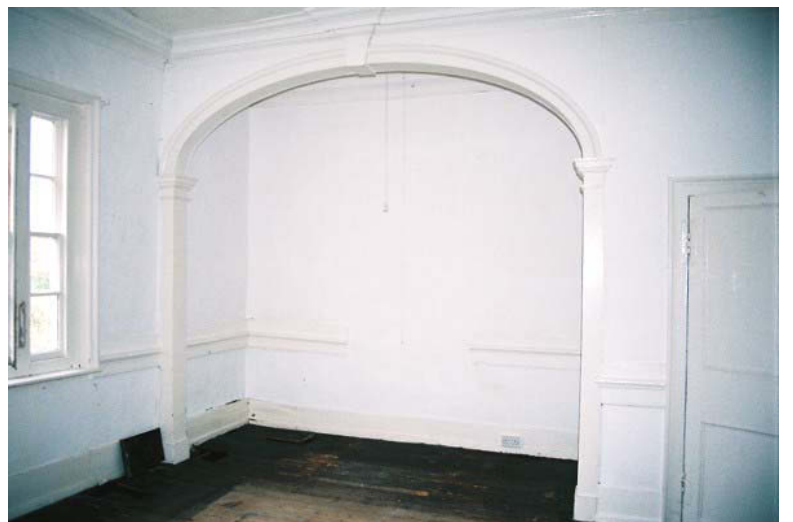
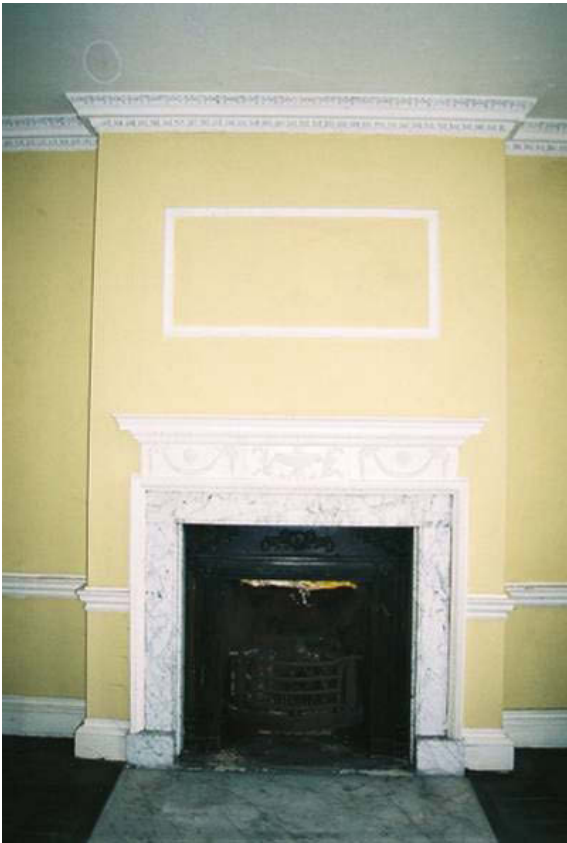
Fig 7
(clockwise from left)

Ground floor; early 18th cent staircase

NE bedroom: early 18th cent corner fireplace (C20 grate)

Staircase; top floor landing

The staircase at right angles to the passage is of 18th century dog-leg type with a closed string, toad's-back handrail, turned newels and turned vase-shaped balusters. There is a dado moulding on the wall side with pilasters on the half-landing and a contemporary two-panelled under-stair cupboard door.

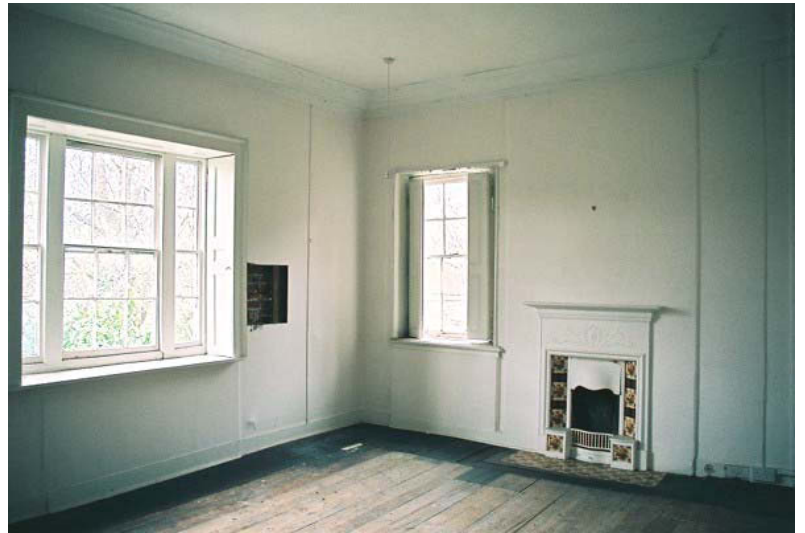
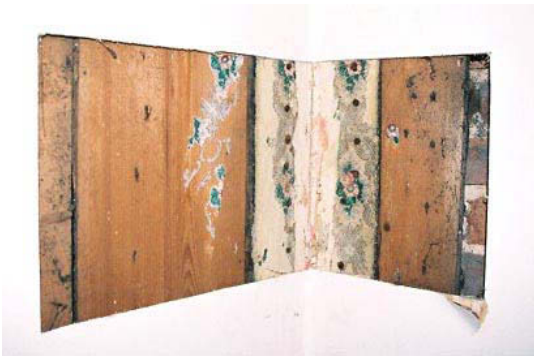
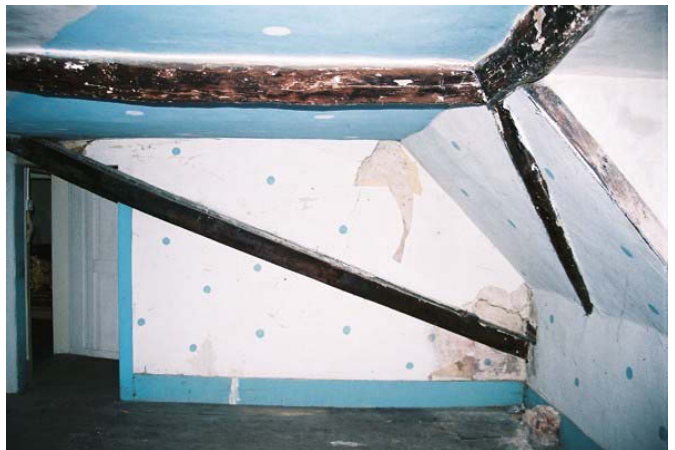
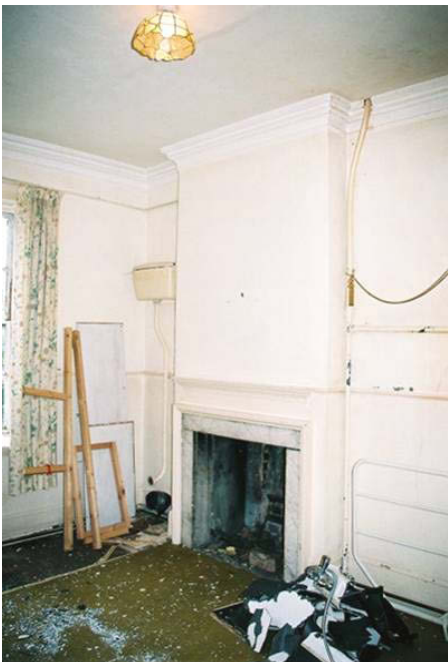
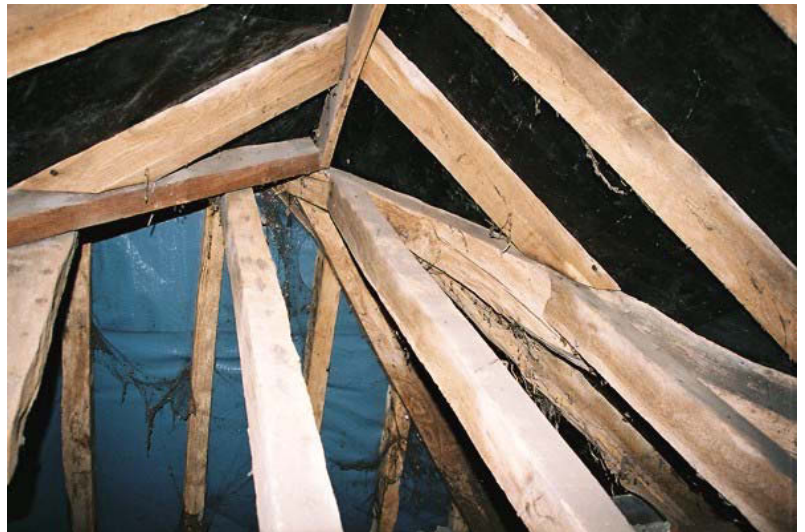
Fig 8

(clockwise from above)

North-west bedroom; old wallpaper behind hessian

Later 18th century fireplace in south-west bedroom
