ST THOMAS BECKET CHURCH, TUGBY, LEICESTERSHIRE
Archaeological monitoring of improvements
to drainage and internal facilities

Project title	St Thomas Becket Church, Tugby, Leicestershire					
Document title	Archaeological monitoring of improvements to drainage and internal facilities					
Report no.	17006					
Listed building no.	1326673					
Project code	TUG16					
Accession no.	TBA					
Local Authority	Leicestershire County Council, Melton District Council					
Parish	Tugby and Keythorpe					
Postcode	LE7 9WD					
NGR	486178 301014					
Distribution	Madeleine Wang, Project Leader: Tugby Tower Project; Michael Hawkes, Leicester Diocesan Archaeological Advisor; Leicestershire County Council HER					
Document comprises:	Doc. Control	Contents and Summary	Text	Figures	Photos	Appendix
	1 page	4 pages	13 pages	3 (3 pages)	48 (14 pages)	1 page

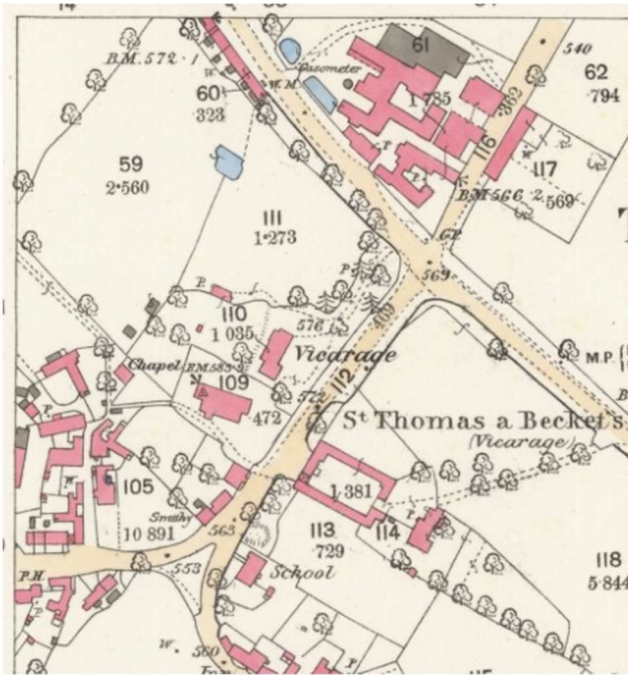
Figure 4: Comparisons of Ordnance Survey maps: 1886, 1904 and 1952

Extract from first edition 25" Ordnance Survey map 1886, showing the western boundary of the churchyard running from the Chapel Lane gateway

Extract from second edition 25" Ordnance Survey map 1904: note the realignment of the western boundary, so that it now encompasses an area to further west

Extract from 3rd Edition 6" Ordnance Survey map 1952: the present north-eastern extent of the churchyard is still shown as part of the vicarage garden. The most recent eastward extension of the churchyard also post-dates the survey for this map

The lack of burials in the south-west soakaway, coupled with the very small quantities of redeposited human bone was, at first sight, surprising. But this was explained by reference to historic mapping. The first edition 25-inch Ordnance Survey map, from 1886, shows that this area was right on the edge of the churchyard at that time, the boundary running from the entrance to Chapel Lane (Figure 4). By the 1904 second edition, this boundary had been squared off, extending the area of the churchyard, but the grave markers are likely to survive from most burials after this date.

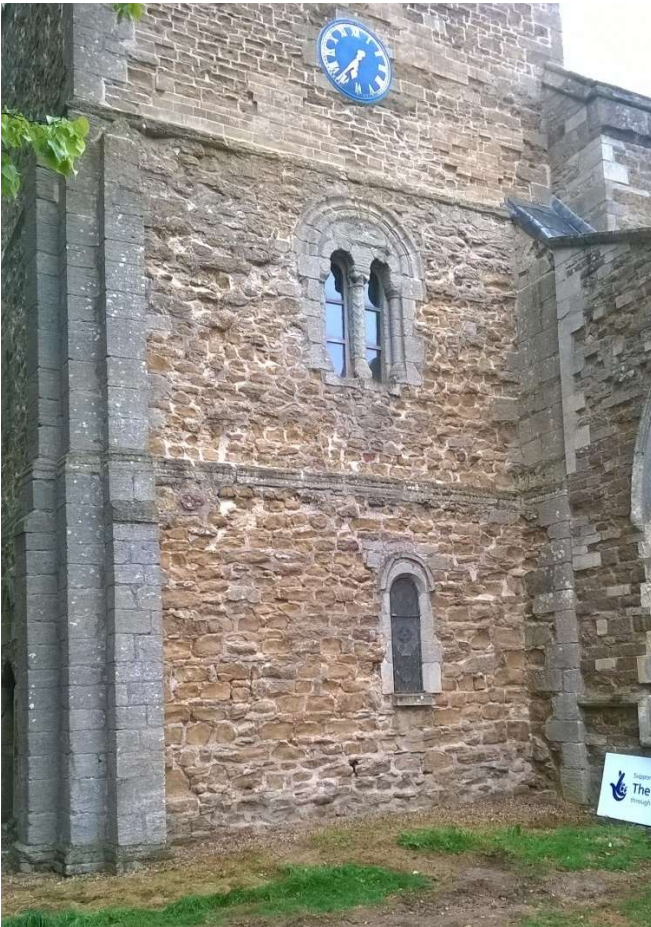
2: South face of the tower

The tower is the oldest part of the surviving building. The three lower stages are of ironstone rubble with dressed limestone quoins (Photos 2 and 3). The stages are articulated externally by string courses of flagstones. The lower stage of the tower was considered by Pevsner (1984) to possibly date from the late Anglo-Saxon period, in contrast to the three upper stages, which he thought post-conquest. The south-facing window in the lower stage has a rather crude round-headed arch externally (Photo 4). Its opening splays out through the considerable thickness of the walls, so that the internal arch of this window closely matches the arch of the west door. This

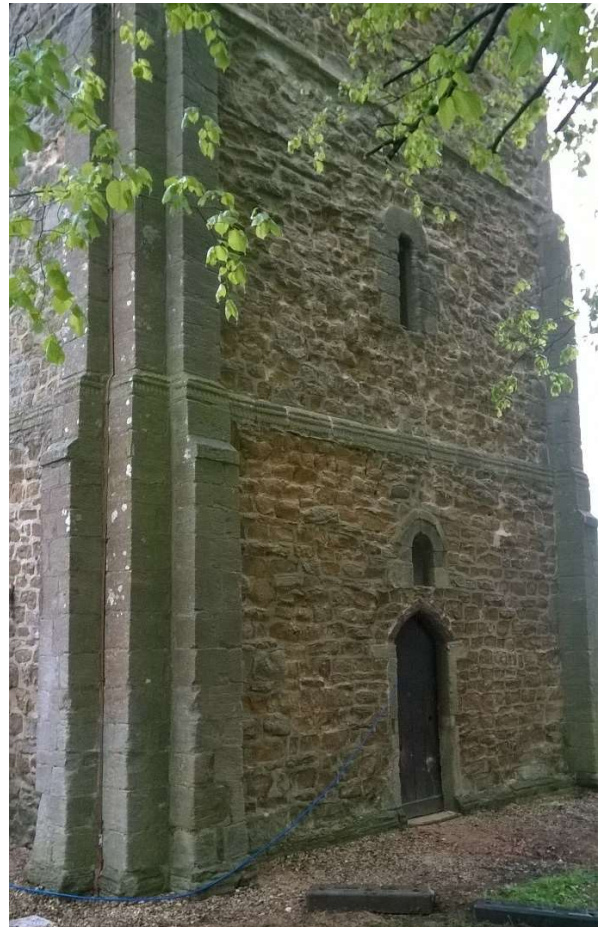
3: West face of the tower

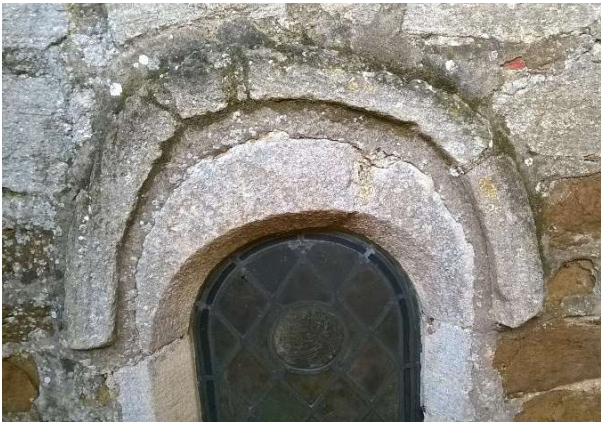
4: Hood-mould of window in lower storey south face of the tower

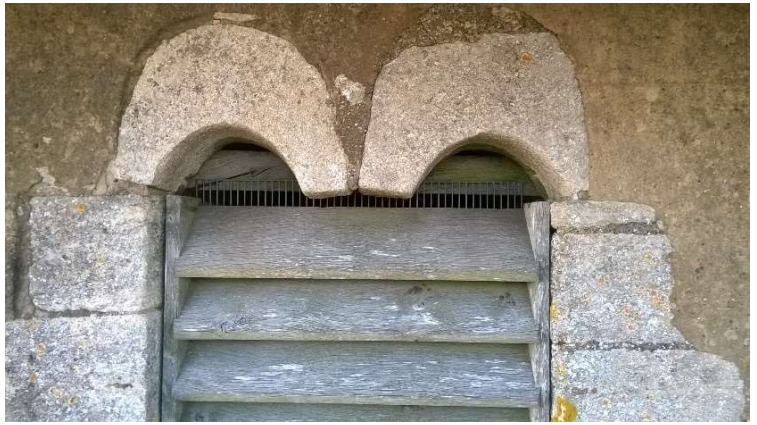
5: Detail of bell chamber opening: north face of the tower

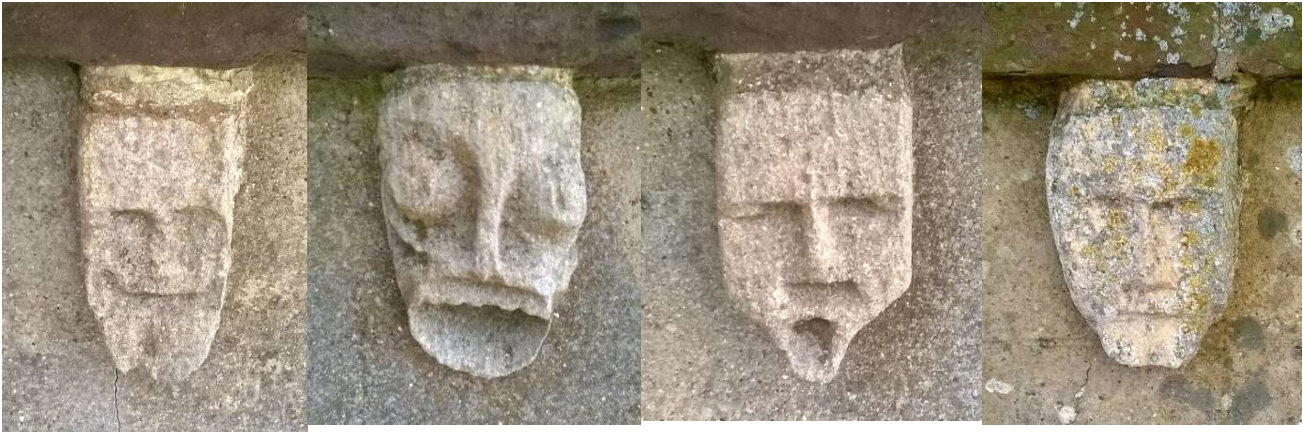
6: Selection of corbels from under the parapet of the tower roof

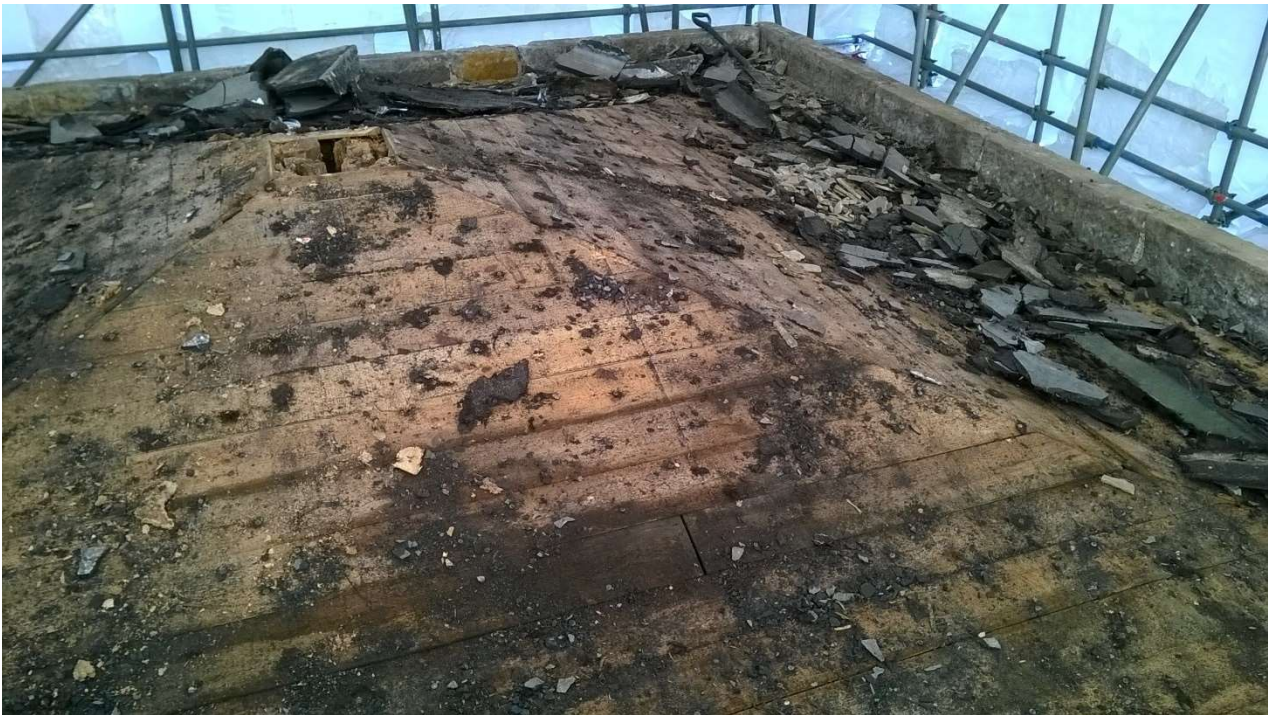
7: The tower roof during removal of the old asphalt layer

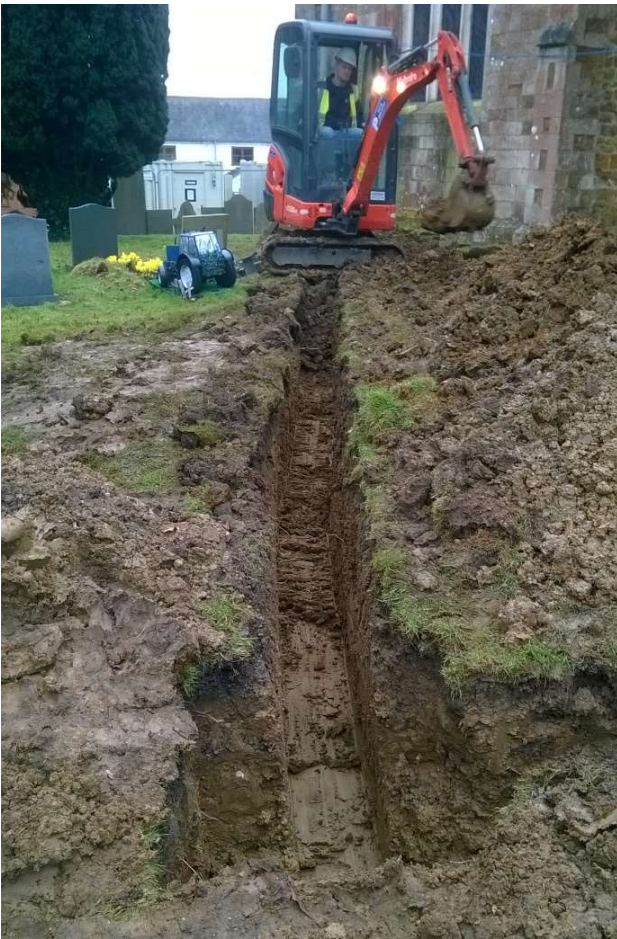
12: Excavating trench from north-east corner of chancel, looking east

- 12: Excavating trench from north-east corner of chancel
- 13: Northern soakaway pit, showing drain from north wall of nave, and drain crates in place
- 14: Skeleton from northern soakaway, showing remains of coffin timbers and staining

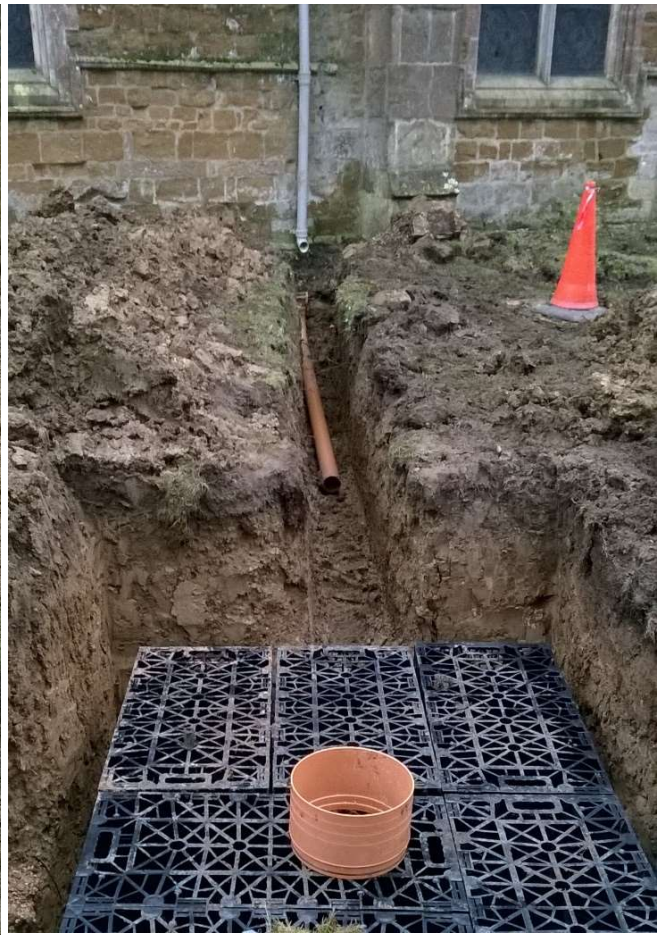
13: Northern soakaway pit, showing drain from north wall of nave, and drain crates in place looking south

Following earlier repairs to gutters, new drains were installed to conduct rainwater away from the building. Brick-lined gullies beneath downpipes were replaced with new grids above polypropylene silt traps: two on the north wall of the nave, and others on the north wall of the chancel (Photo 12), south-east corner of the chancel, either end of the aisle and the west side of the porch. Polypropylene 100mm-diameter drain pipes were laid, in trenches at least 400mm deep, to one of three soakaways. The soakaways were sited at least 5m away from the building, to the north, south-west and south-east of the church, and held arrays of 1000x500x400mm polypropylene drainage crates wrapped in double layers of Terram geotextile. The pits to take the crates were up to 200mm wider on each side than the crate arrays and were deep enough to allow at least 400mm of cover. The spaces around the crates were back-filled with pea-gravel.

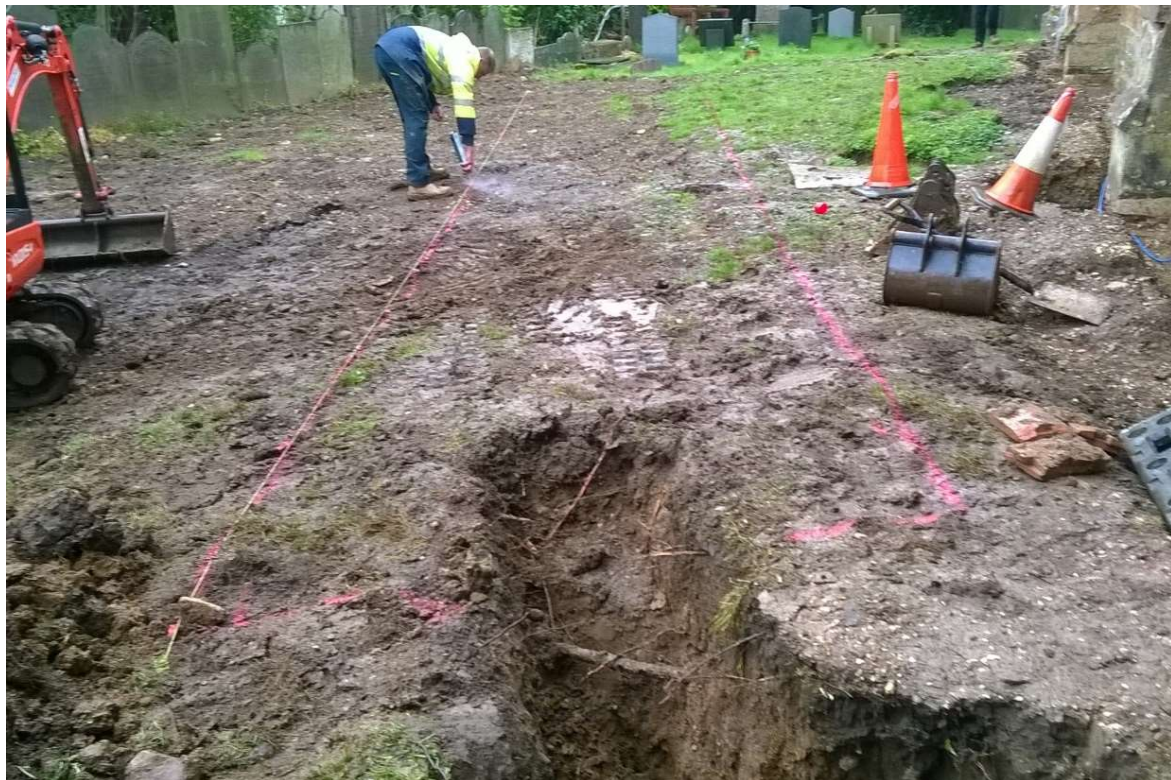
20: Marking out the extent of the trench arch drain, showing its location in the churchyard and the where the electricity cable to the end of the nave crosses at its west end, looking east

- 19: Teeth and jaw fragments from a child's skull, found in the entrance to trench arch drain
- 20: Marking out the extent of the trench arch drain, showing its location in the churchyard and the where the electricity cable to the end of the nave crosses at its west end

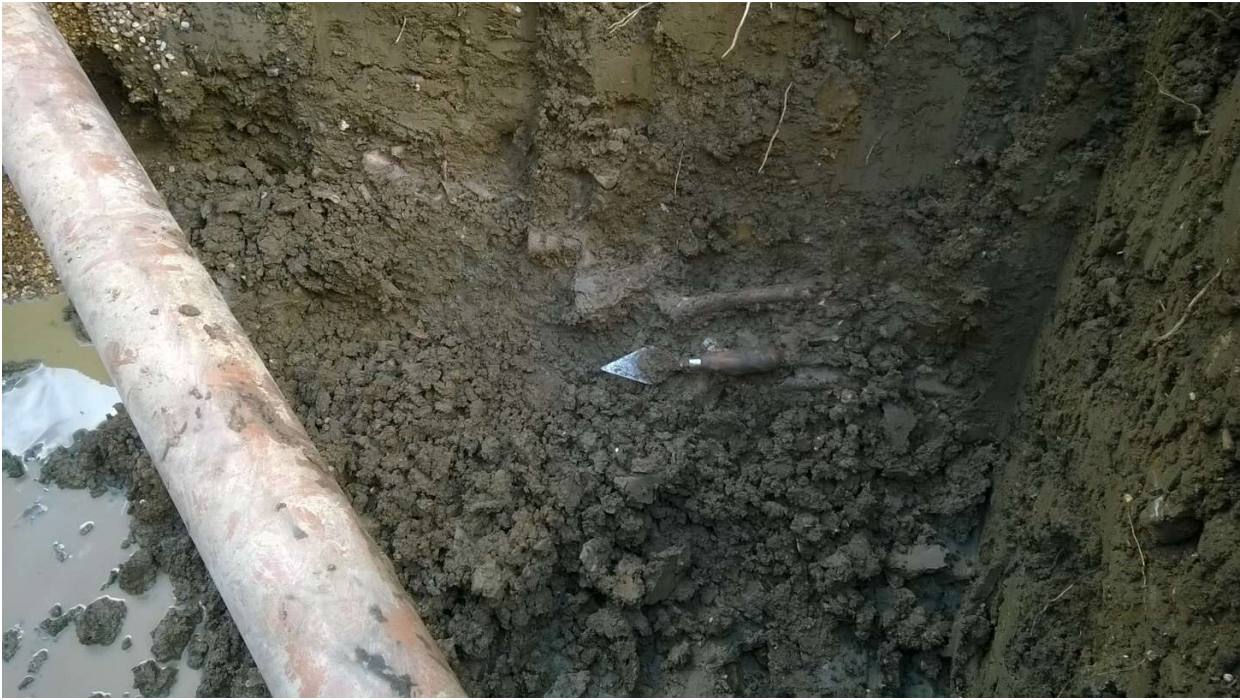
27: The eastern end of the trench arch drain, with juvenile skeleton, truncated above the lumbar vertebrae; also showing the drain from the east end of the chancel crossing towards the northern soakaway, looking north

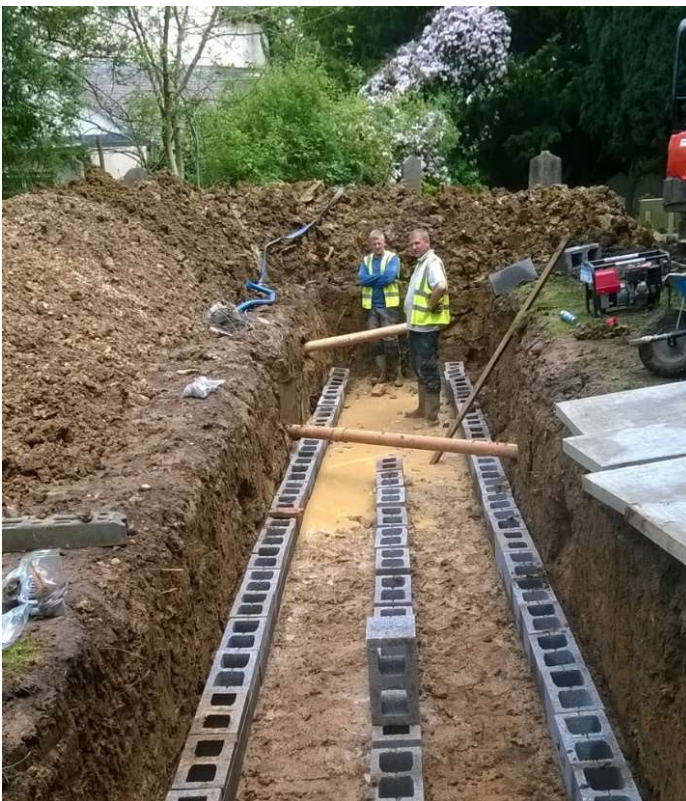
28: Installation of the trench arch drain. The three rows of hollow concrete blocks support a double row of paving slabs leaving a 200mm cavity into which the waste water drains discharge

- 28: Installation of the trench arch drain
- 29: Rim sherd of shell-tempered pottery, probably from 14th to 16th century, found directly beneath one of the skeletons in the trench arch drain

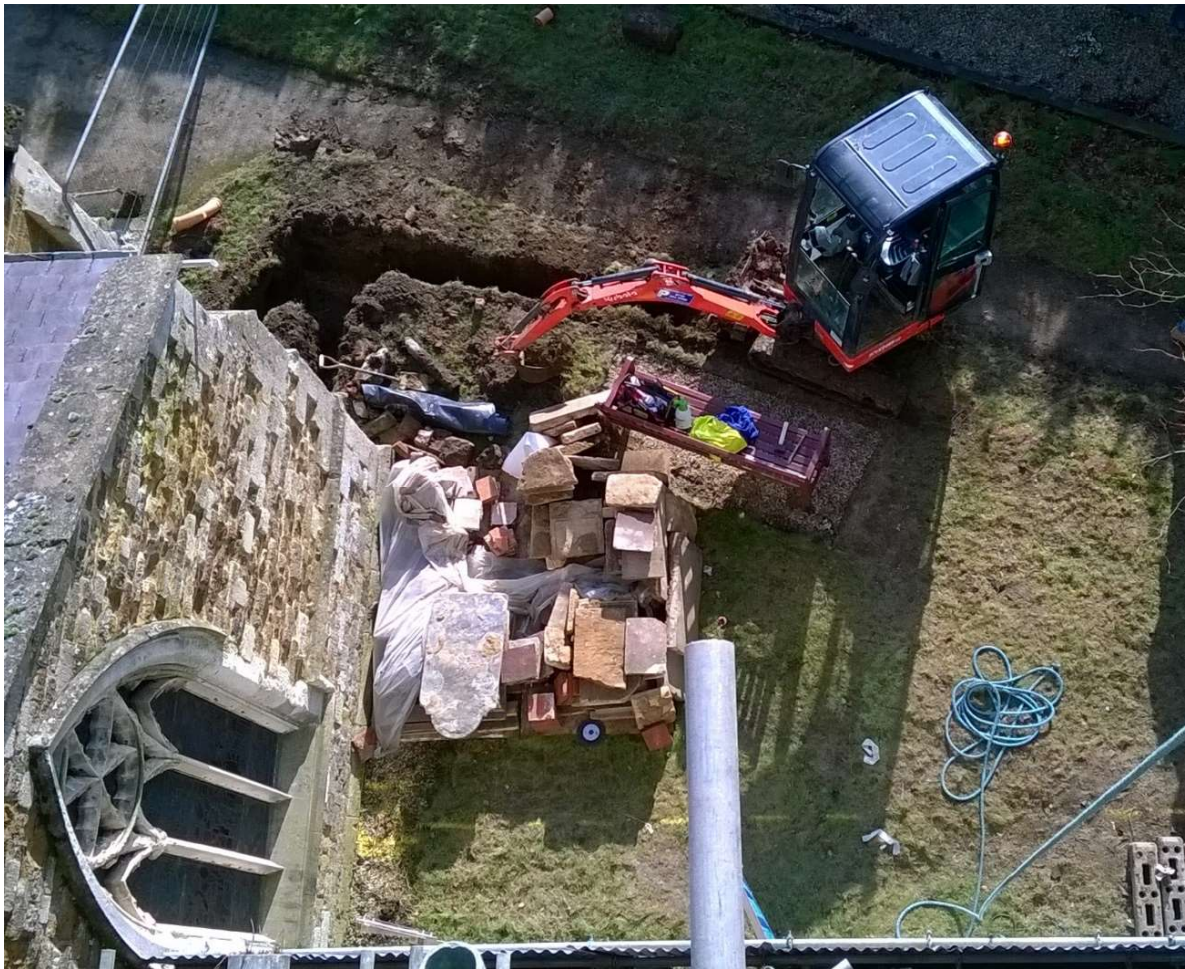
31: View from the tower of the trenches from the porch and the western end of the aisle

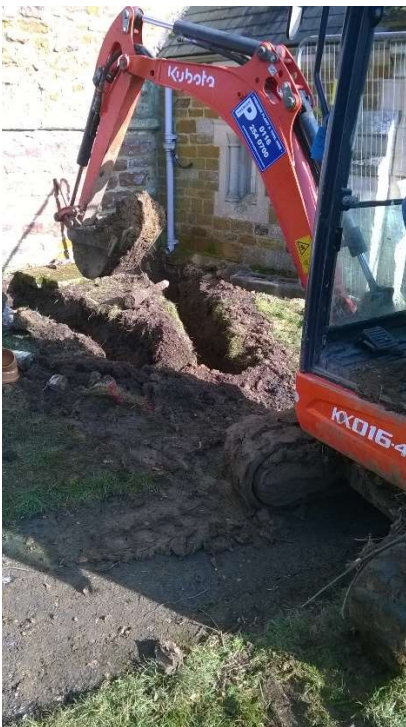
32: Trenches of drains from north-west corners of porch and aisle, looking north-east

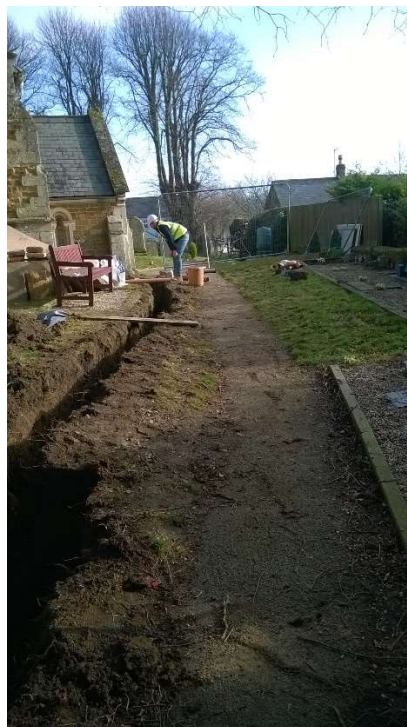
33: The drain to the south-west soakaway running along the north side of the path, looking east

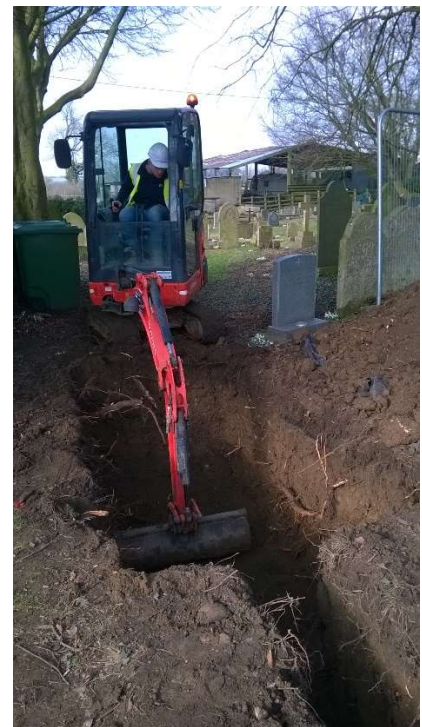
34: Excavating the south-west soakaway pit, between the path and headstones, looking west

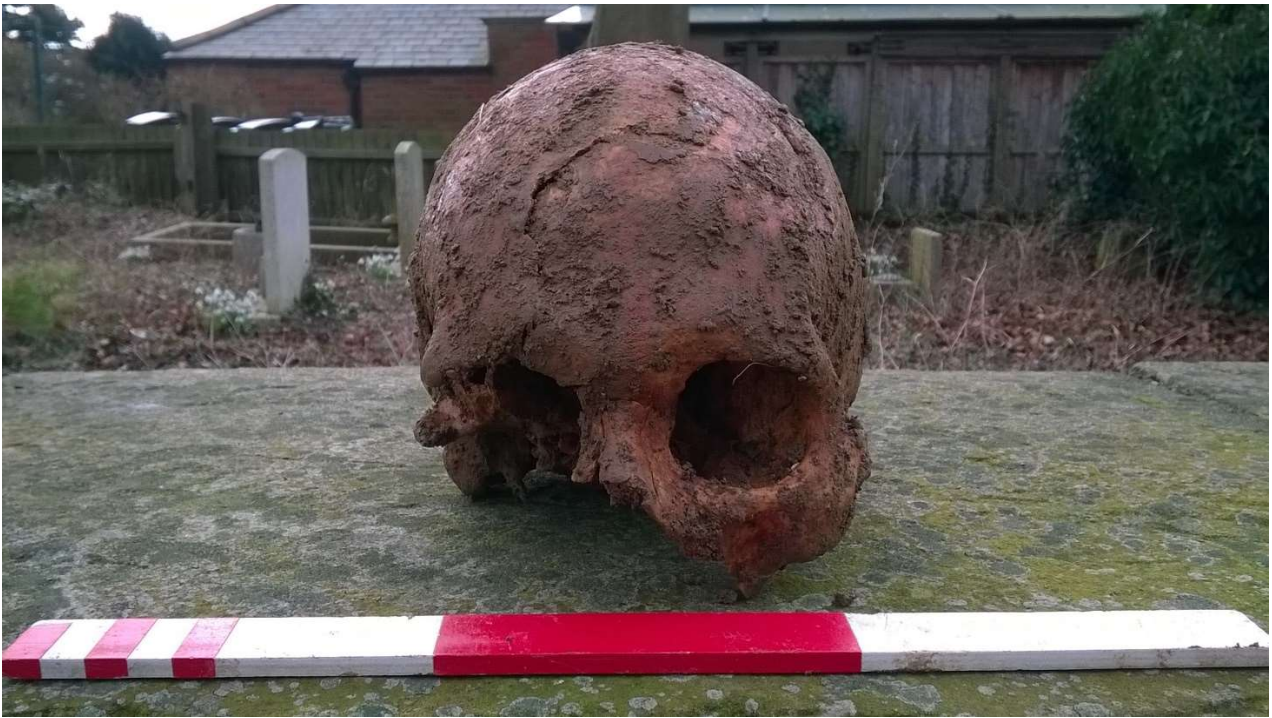
35: Redeposited skull retrieved from the drains to the south-eastern soakaway, close to the wall of the chancel aisle

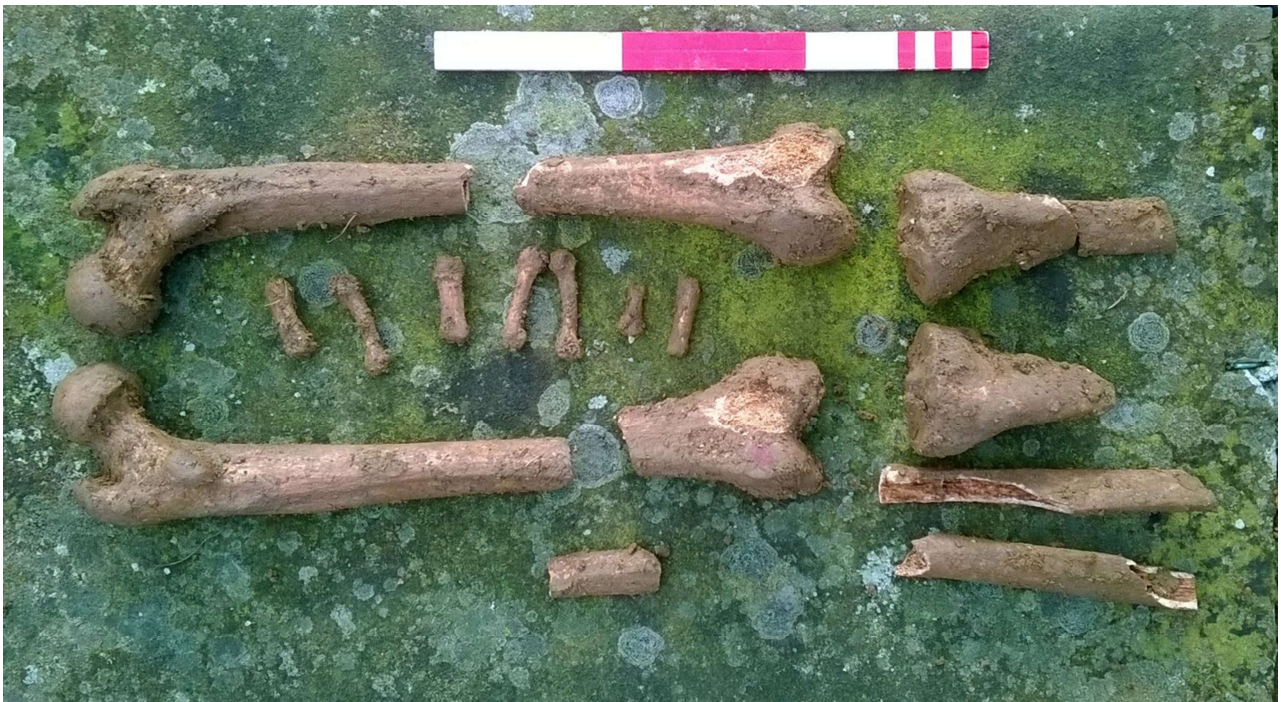
36: Articulated remains of truncated skeleton from the northern part of the south-eastern soakaway

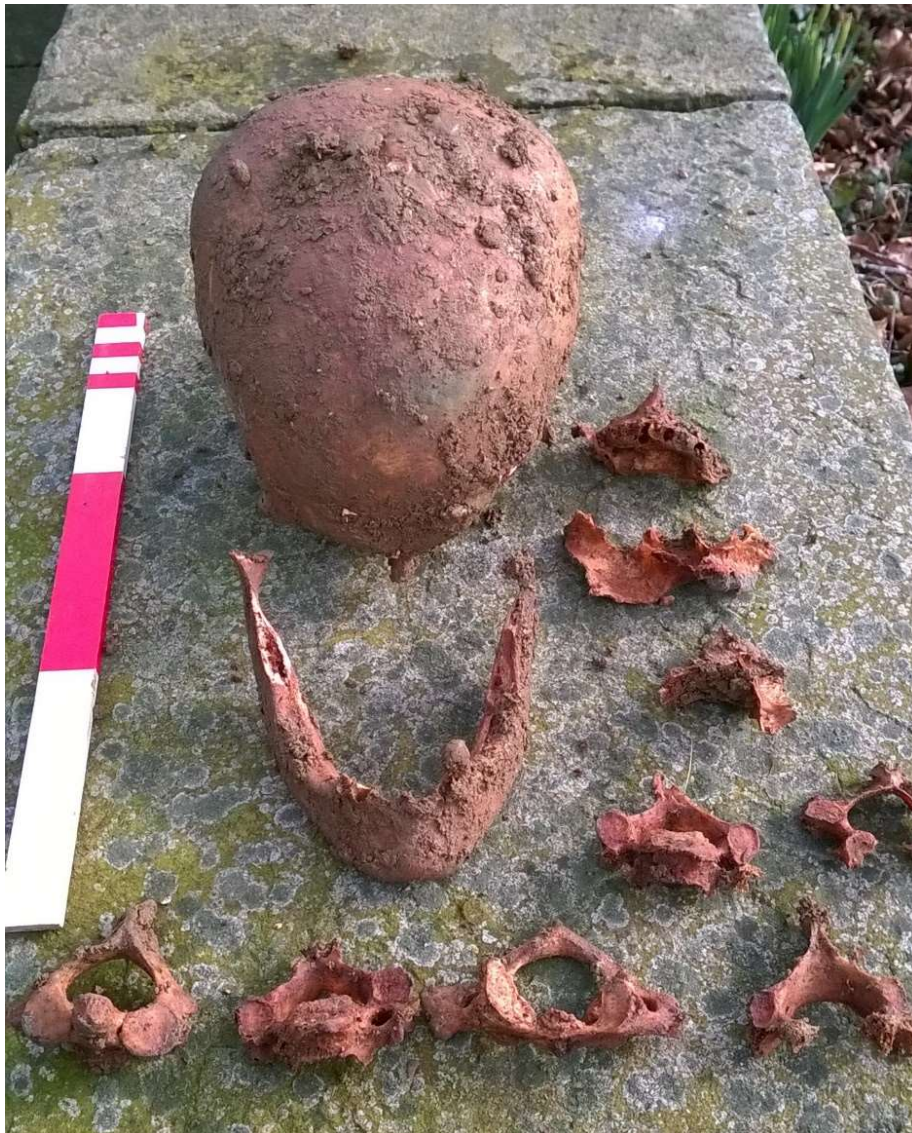
37: Skull and upper vertebrae from the south-eastern soakaway, close to the north-east corner. This skull is one of a number of bones which showed patches of green copper staining, probably from the corrosion of shroud pins

A high proportion of the earlier inhumations are likely to have been simple shroud burials, which were quite normal before the nineteenth century, but there was also ample evidence of coffin burials. Within the area of the northern soakaway, the deeper burial had small fragments of fairly coherent wood surviving, while others in the same area, as seen in the trench arch drain, had the remains of coffin timbers outlined by peaty deposits or soil stains. A number of the human bones showed green staining; in a couple of instances, from the south-eastern soakaway and the trench arch drain, the ghosts of shroud pins were clearly visible as flaky copper salt deposits.

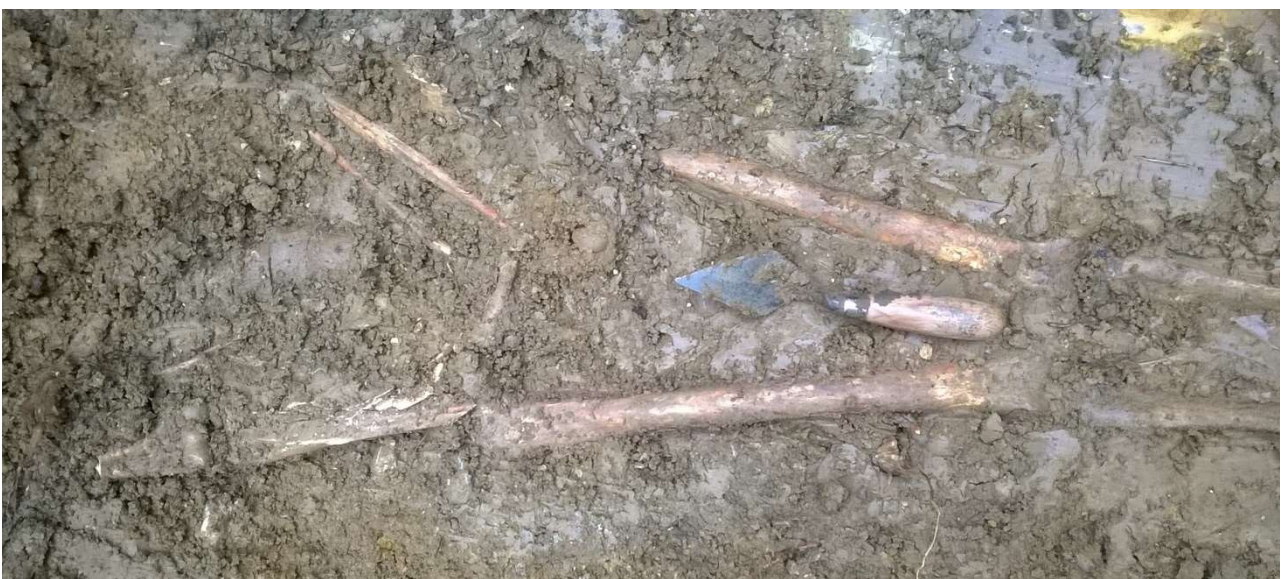
38 The deepest of the burials exposed in the south-eastern soakaway, this had been truncated by later graves from elbow to elbow across the upper body and across the lower legs, looking north

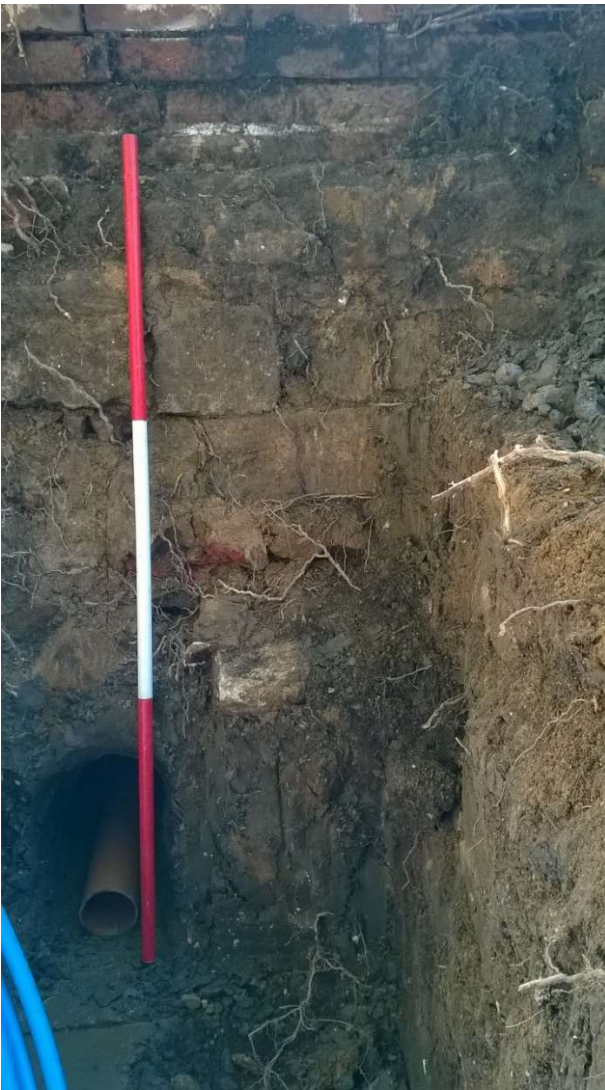
39: The back of the churchyard retaining wall, as seen in the pit to bring the waterpipe onto the site from the main on Main Street (scale = 1500mm)

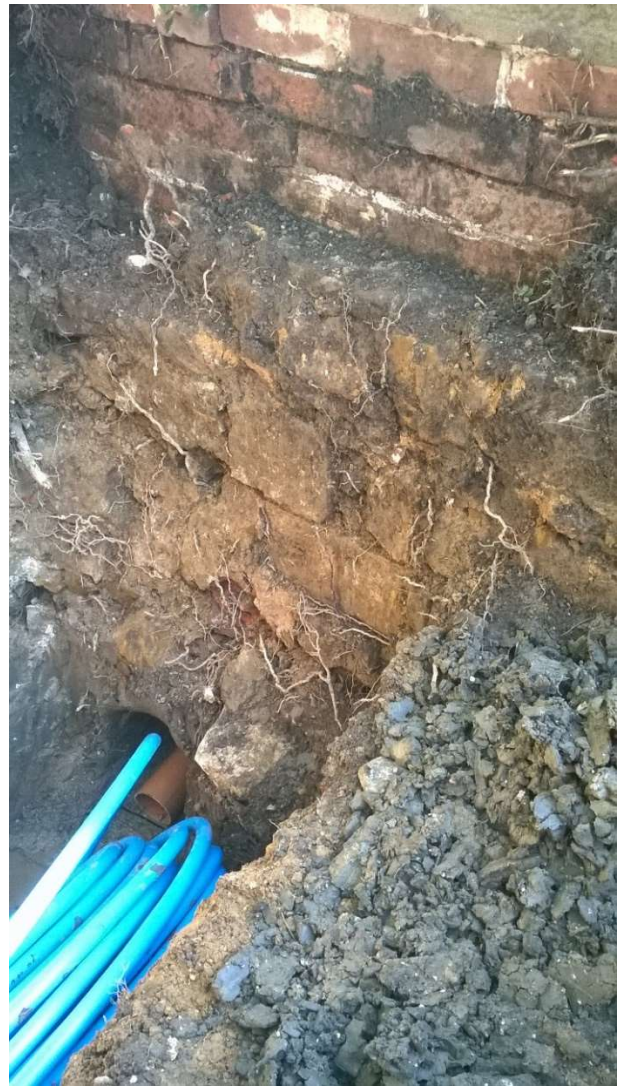
40: Another view of the back of the churchyard wall, showing how the brickwork was added to the front of the earlier stonework, looking north-east

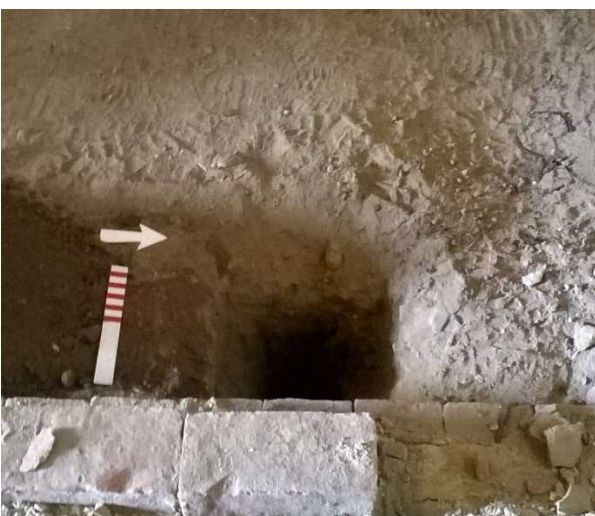
41: Posthole beneath floor of nave (scale = 200mm)

Opportunistic observations in the interior of the church, including the discovery of the unfilled posthole beneath the nave floor and the brick vault in front of the entrance to the tower, have made small, but interesting, contributions to the known history of the building. The posthole may be related to the former position of the font at this location or perhaps from scaffolding from an earlier phase of construction or repair.

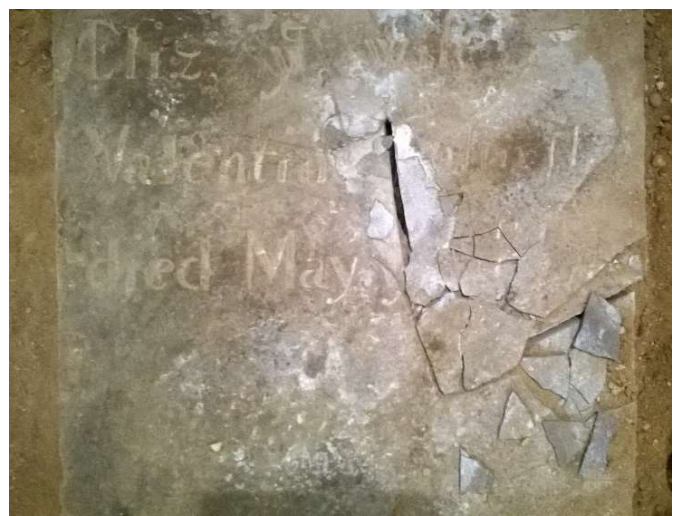
42: Inscription of grave slab that had been laid face down in flooring of nave: Eliz. wife of Valentine [??Collin]

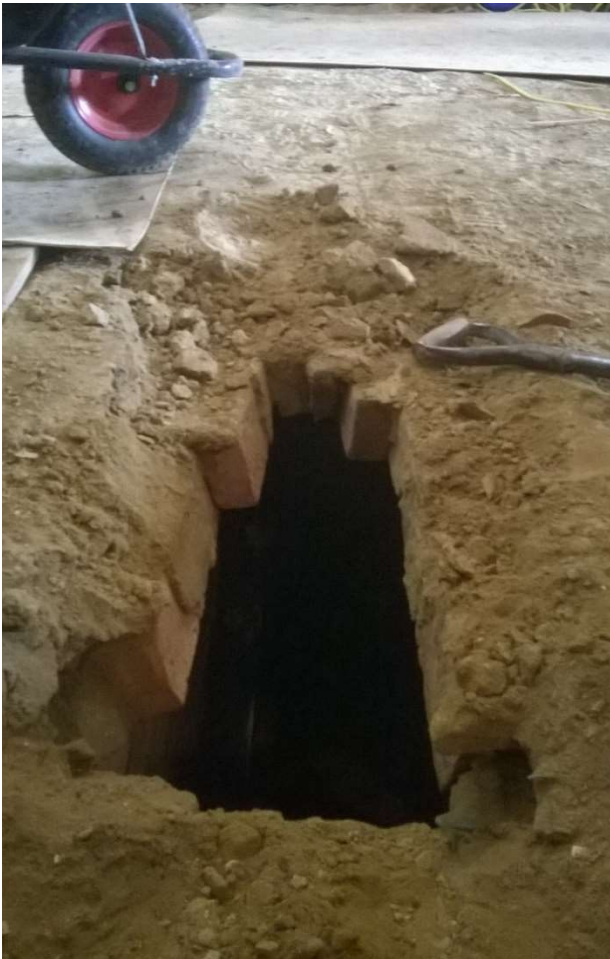
43: Brick vault beneath floor of nave, as first exposed, looking east

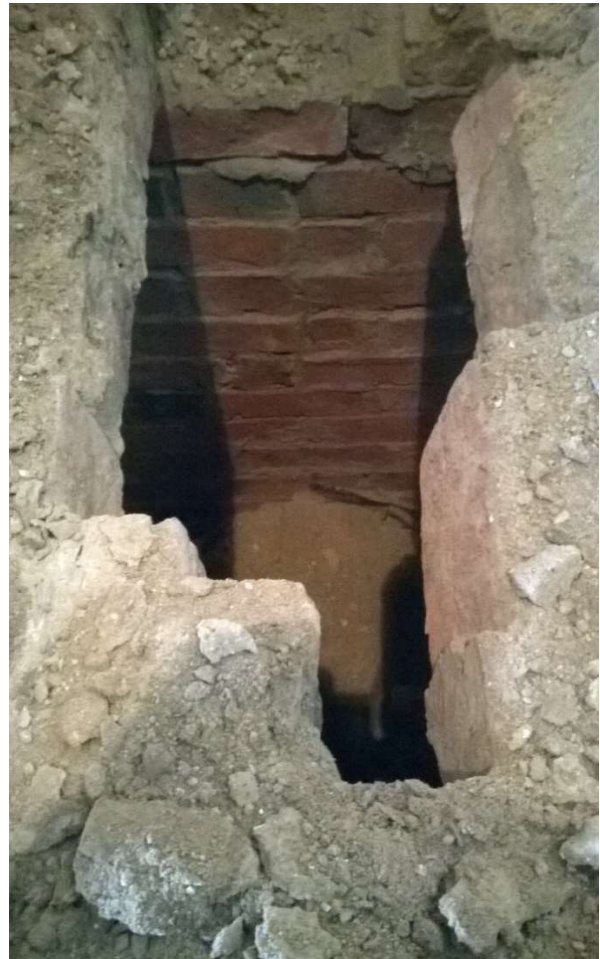
44: Brick vault, looking west, towards the entrance to the tower

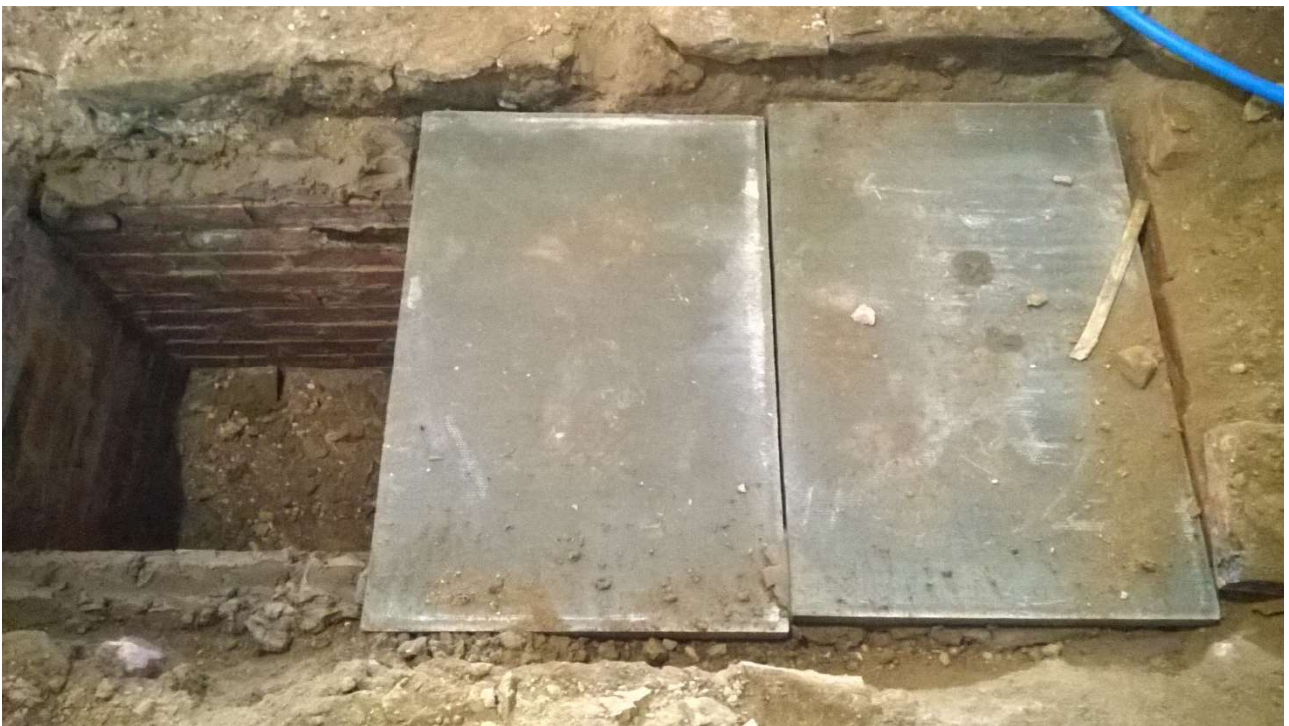
45: Brick vault during capping

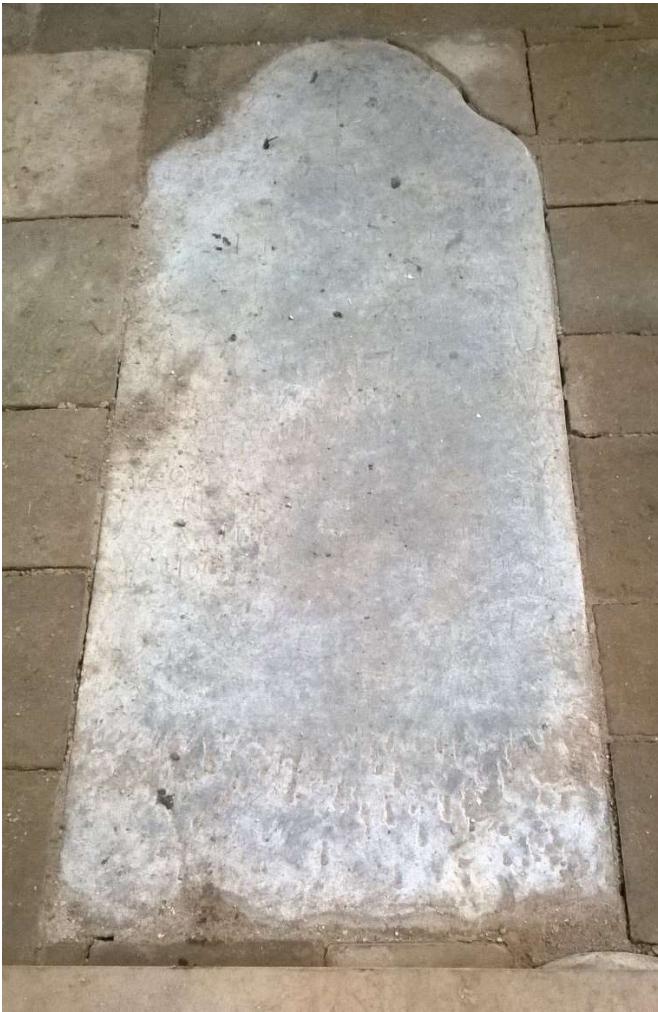
46: Brick vault sealed and with original grave slab replaced

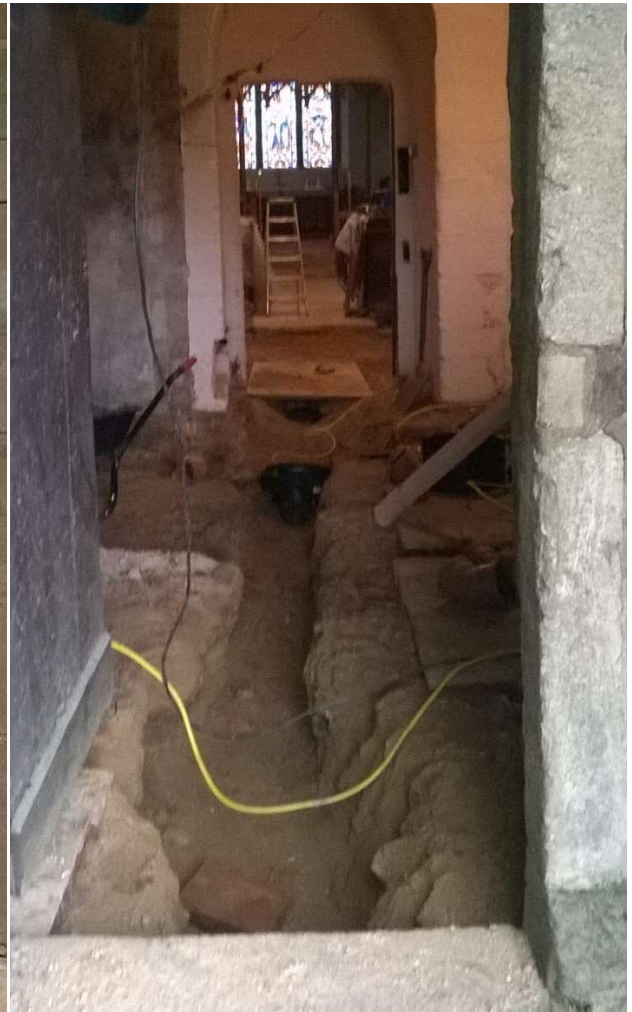
47: View of the tower through the west door, showing excavated service trenches

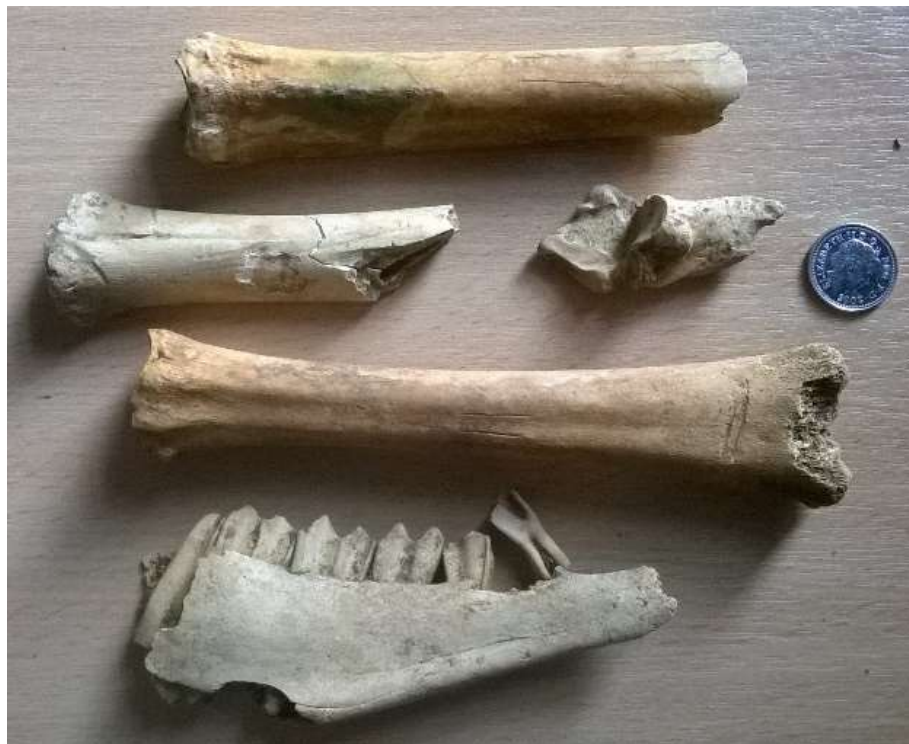
48: Butchered animal bones from water-pipe trench in north-east corner of churchyard
