ST JOHN THE BAPTIST CHURCH, SCAMPTON, LINCOLNSHIRE

Archive Report for:
Archaeological Monitoring (Watching Brief)

Project Code: SJS16

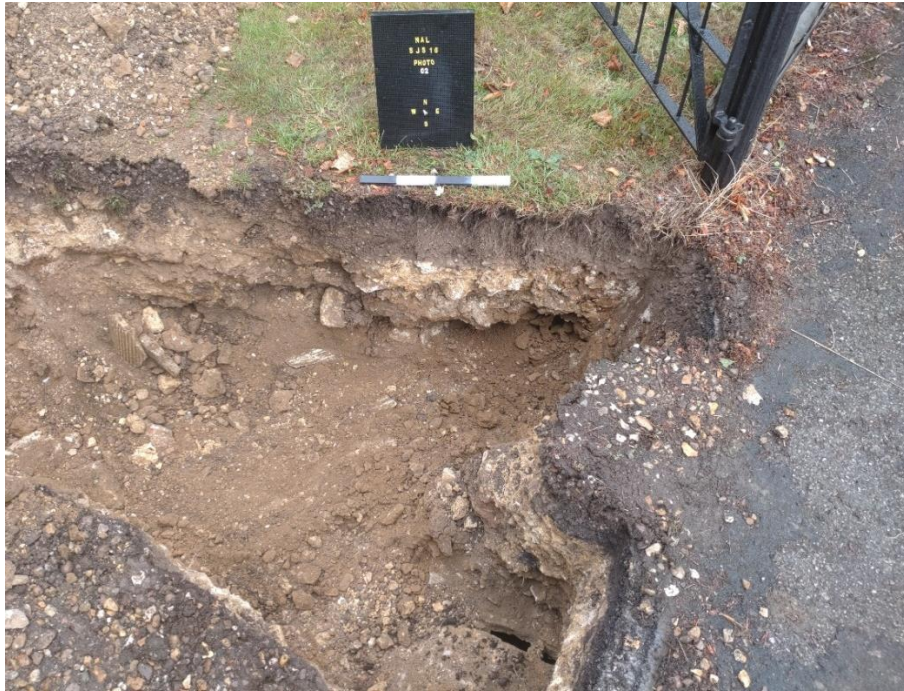
Photograph 1: Cut **04** containing stone topped culvert, facing northeast.

The removal of layers 05 and 07 approximately 1m west of the entrance to the churchyard exposed a 3m wide and 0.6m deep cut (04) for a stone topped culvert. Cut 04 was filled with a mixed loose light-brown sand (03) topped with concrete (photograph 1 – Figure 2). The top of the culvert was resealed as quickly as possible to avoid damage.

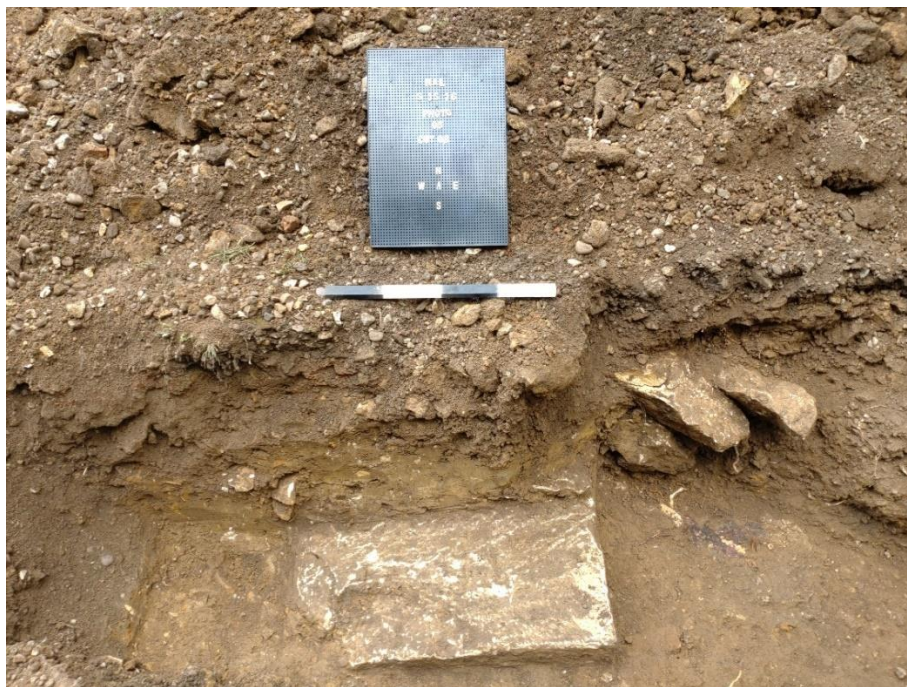
Photograph 2: Worked stone (RF1) found within cut **08**, facing north.

Cut **08** (photograph 2 – Figure 3) was recorded 6.5m to the south of the southeast corner of the church and continued the line of the wall forming the east end of the church. The cut was broadly north-south aligned and was 1.4m wide and 0.55m deep, with a concave profile and a flat base. The base of the cut was filled with a light-brownish-yellow clayey silt deposit (07) 0.1m thick. Above this layer was a single rectangular piece of worked Lincolnshire Limestone (RF1 - 675mm x 510mm x 160mm – Appendix 3). This was sealed by a mid-brown silty sand deposit (06) 0.55m thick.

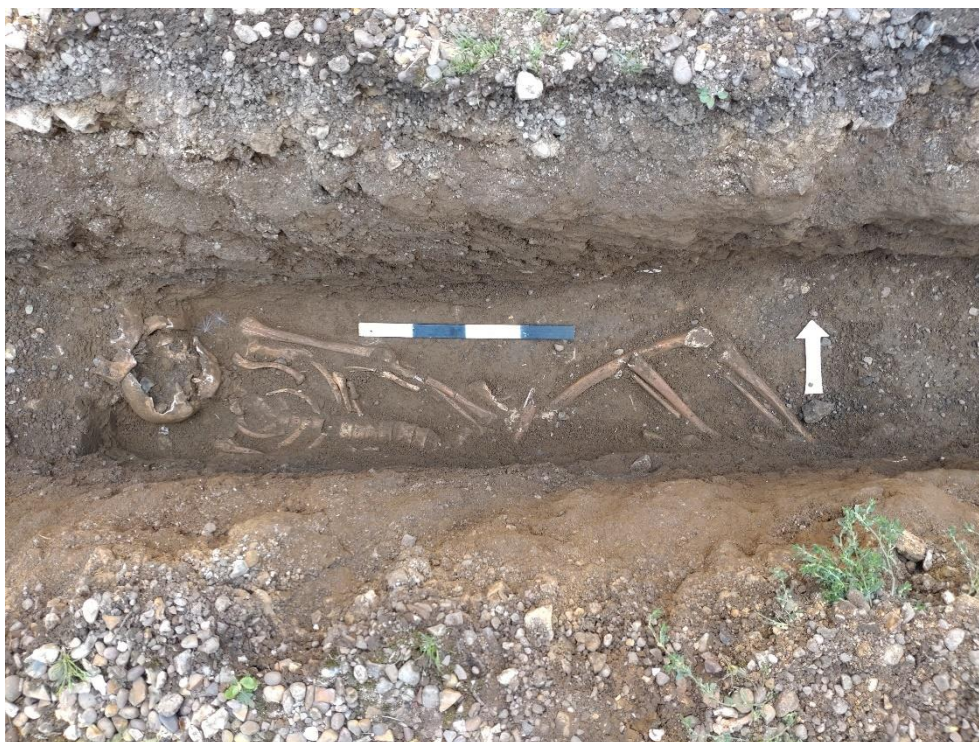
Photograph 3: Remains of Skeleton 1, facing north.

The service trench to the south of the church contained three burials (Figure 2) cut into cemetery soil layers 06 and 09. Skeleton 1 (Photograph 3 – Figure 3) comprised the remains of an adult and was located approximately 1.85m southeast of the church porch. It was found at a depth of 0.6m from the top of the trench (21.01m OD), at the base of a grave cut **11**. The grave was filled with a light-brown silty clay (10). The skeleton was possibly a young male and had evidence of a deformed right arm.

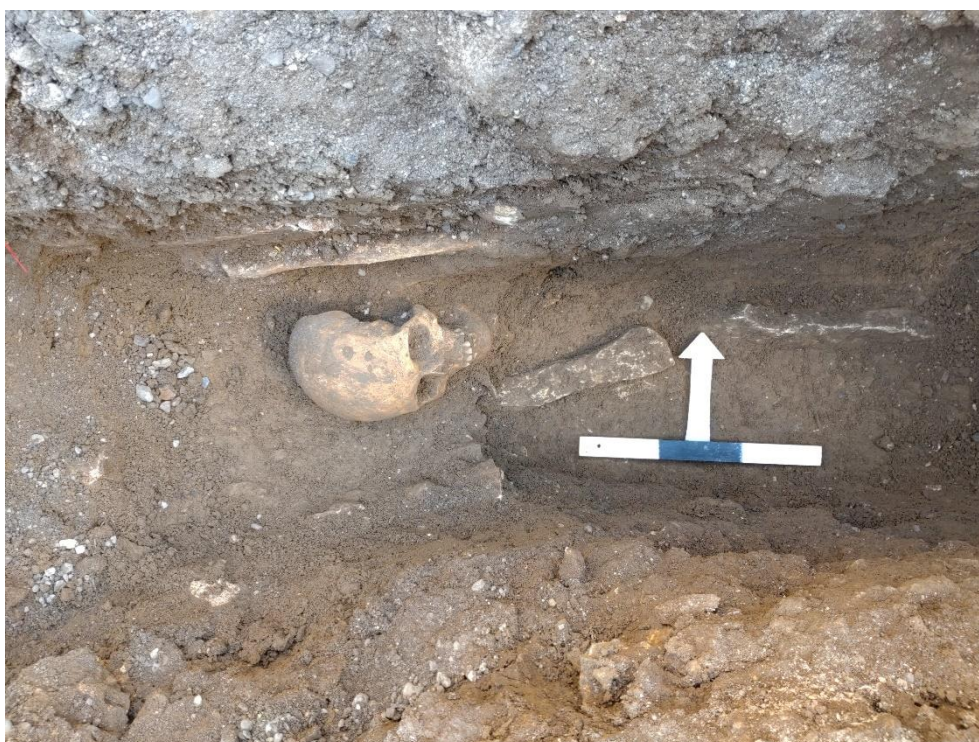
Photograph 4: Remains of Skeleton 2, facing north.

Skeleton 2 (Photograph 4 – Figure 3) comprised the remains of an adult that were located directly to the northwest of Skeleton 1. The lower portion of the skeleton below the clavicles had been truncated by the grave of Skeleton 1 (**11**). It was found at a depth of 0.65m from the top of the trench (20.96 OD), at the base of grave cut **13**. The grave was filled with a loose light-brown silty clay (12). The skeleton was that of an older adult and exhibited intense wear to the molars.

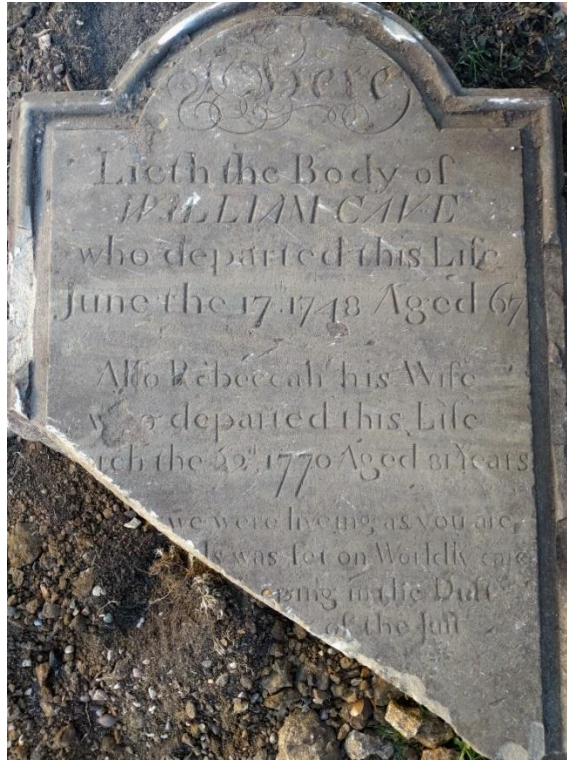
Photograph 5: Broken grave slab recovered from underneath layer 01.

In addition to the graves identified during the monitoring, a fragment of gravestone dated to 1748 was recovered from beneath layer 01 (Photograph 5). It was recorded by photography and then retained by the church.

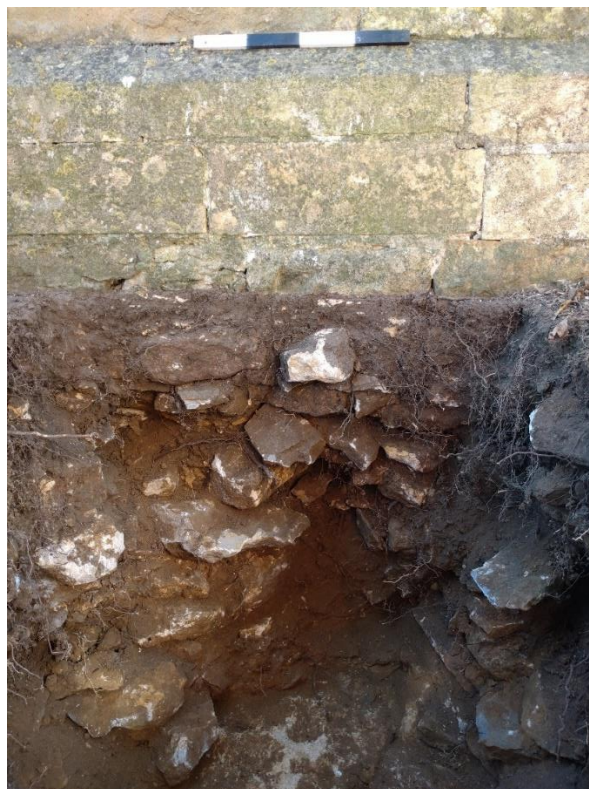
Photograph 6: Tower foundations 16 and 18, facing east.

Where the service trench met the west side of the tower, two masonry deposits (**16** and **18**) were recorded (Photograph 6 – Figure 3). The cut for the foundation (**19**) extended between 2-2.5m from the west side of the tower and was 0.7m deep with steep sides and a flat base. Masonry deposit **18** comprised regular rectangular worked unbonded slabs of limestone (500mm x 500m x 150m) laid flat on the base of the cut. Masonry deposit **18** was overlain by roughly hewn and coursed unbonded limestone slabs and rubble. These were sealed with a deposit of loose mid-brown silty clay (**17**) which filled the majority of cut **19**.

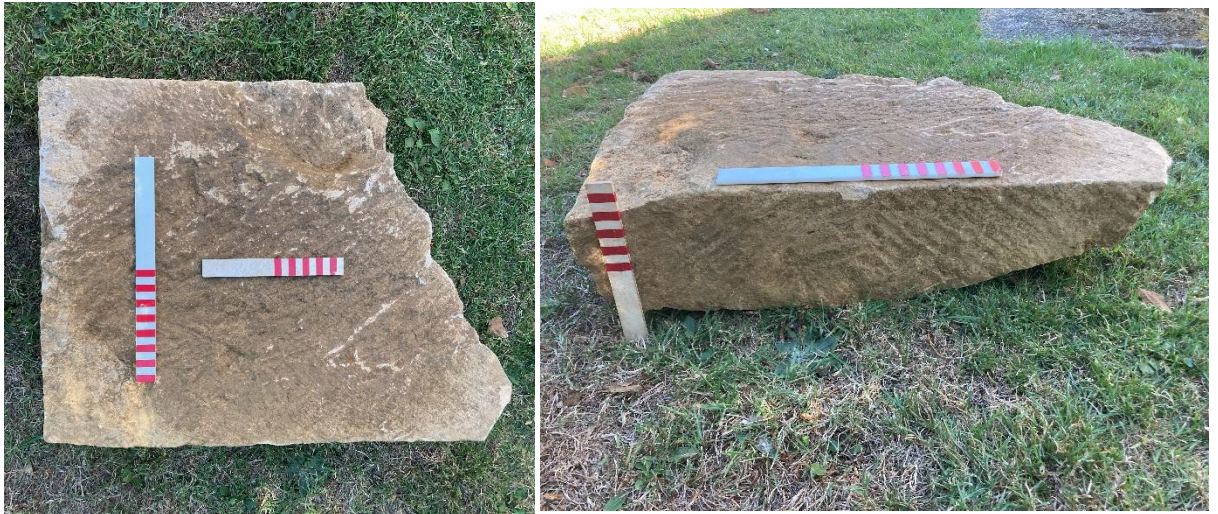
Figure 1 – Punch dressed ashlar block from context 08 of St John's Church, Scampton

The stone here assessed was fully recorded on site and it is currently held by the church. The item was given a unique number and recorded on an excel database, containing information regarding its context, type of element, basic description, type of material, overall dimensions, and an approximate date. A summary of the recording can be seen in table 1. The stone was photographed and is included as part of this report (Figure 1).

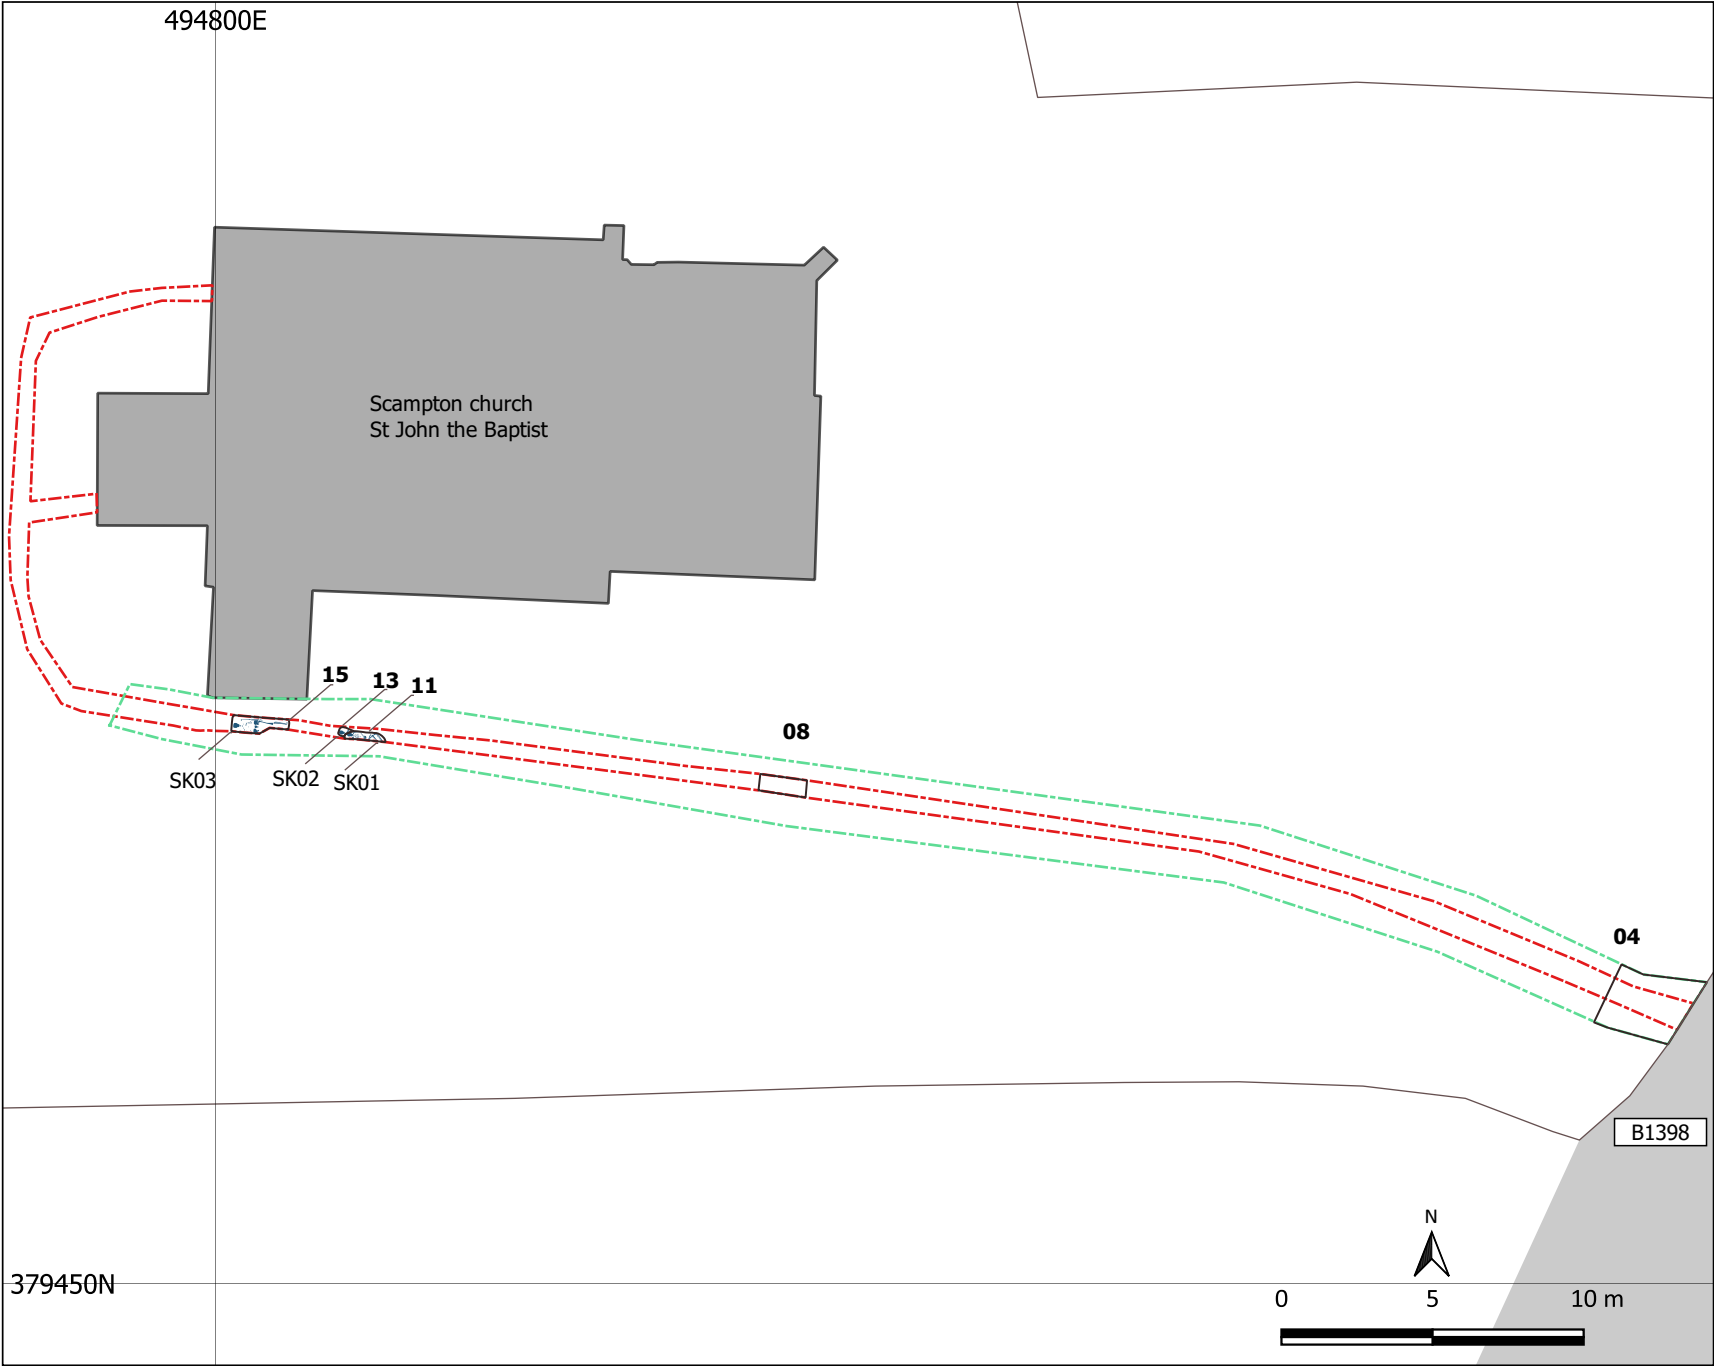
SJS16
 Figure 2 Location of Service Trench and Pathway
 Scale 1: 250 at A4

Scampton church
St John the Baptist

Fieldwork consisted of monitoring the excavation of a series of service trenches and a path to the south and west of the church (Figure 2). All work was undertaken in compliance with a Written Scheme of Investigation (WSI) that was prepared for the works (NAL 2022) and with the Grant of Faculty for the works (Appendix 2).
