FLOORBOARDS AND FOOTPRINTS -CONSTRUCTION OF THE FIRST FLOOR IN THE WEST FRONT AT CHATSWORTH

By OLIVER JESSOP

(The JESSOP Consultancy, 29 Dewar Drive, Millhouses, South Yorkshire, S7 2GQ)

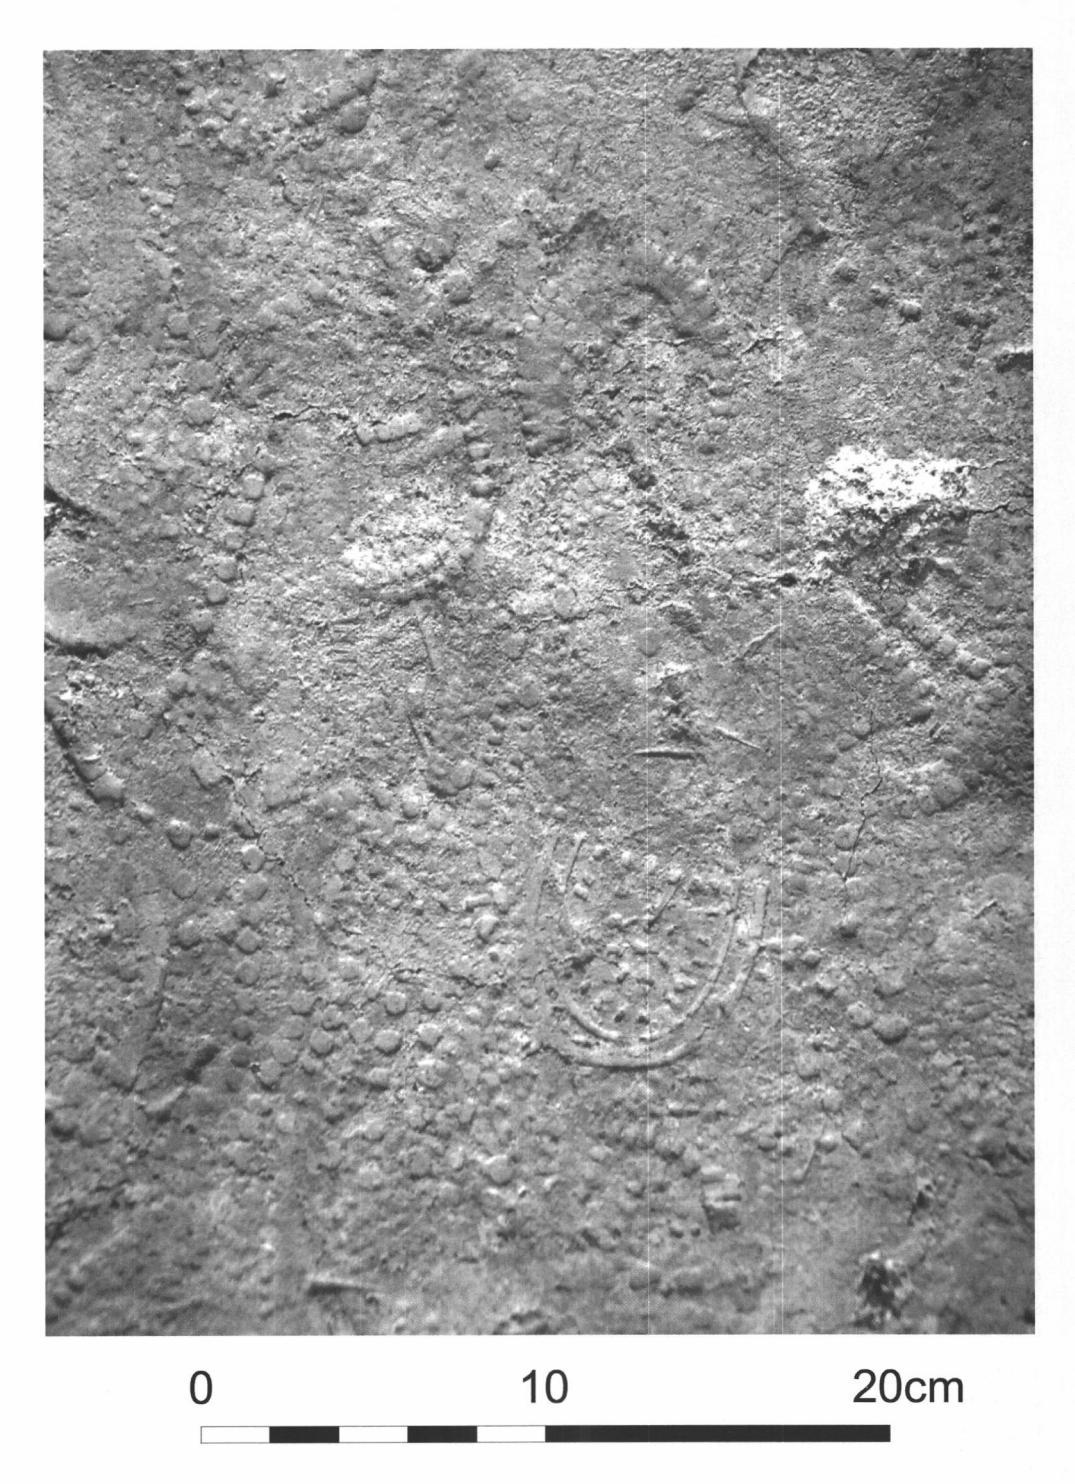
Plate 1: Footprint impressions discovered in the upper surface of the puggin on the first floor of the West Front.

During the archaeological recording, evidence for the craftsmen who worked on this phase of flooring alterations was identified in the form of pencilled initials on the underside of many of the floorboards, presumably representing a method of tracking the amount of work undertaken by each carpenter. In addition to this, footprints were identified as shallow impressions within the upper surface of the layer of puggin in many of the first floor rooms of the West Front (Plate 1). The footprints were completely random in their orientation, often surviving only as heel impressions. The principal characteristic of each print was the use of hob-nails that formed banded edges to each sole and around the heel. The shape of the nails varied from square, to rounded nails, some even covered the whole of the underside of the shoe. It was not possible to identify exactly how many different shoes were represented, however at least seven different impressions were noted, ranging in size from 20cm to 24cm in length. One sole was particular notable in having a stirrup, or horseshoe attachment around the heel, presumably offering a greater level of durability than those only shoed with nails.

The discovery of footprints of differing sizes from a variety of work boots and shoes, was an unexpected observation, however it is highly likely that more examples will survive in other buildings where layers of puggin lie undisturbed below floorboards. It can be suggested that whilst the puggin had clearly set, due to its thickness it must have taken a considerable time to cure, which may be inferred from the acceptance that it was firm enough for walking on whilst still soft, an activity clearly not regarded as being detrimental to its overall stability and durability. An alternative explanation for the prints is that they may represent a deliberate stage in the process of laying the puggin, where the surface was compacted to expel any trapped air pockets, or voids.

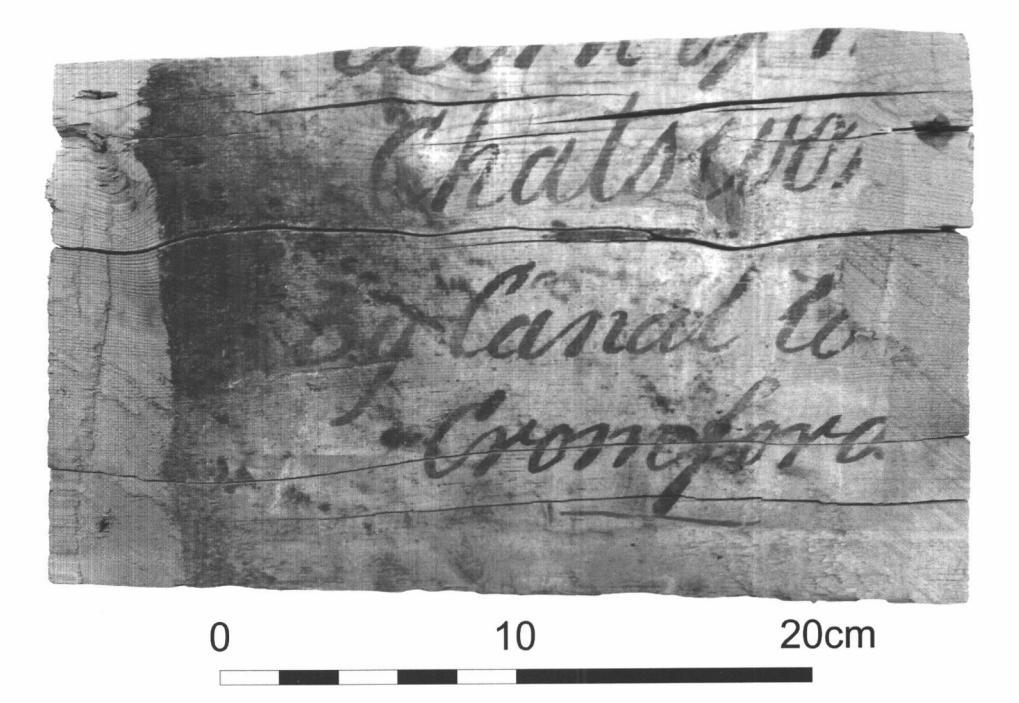
Plate 2: Reassembled fragment of softwood packing case used to transport materials from London to Chatsworth.

The archaeological recording has also established that narrow sections of planks, used to form the shallow troughs for the puggin, all appear to have been re-used. Many were sawn to length, then split with an axe to form narrow strips for insertion below the floorboards. Fragments of painted timber beading and moulded panels were recorded, along with eight pieces of plank with painted lettering (Plate 2), some of which could be reassembled together. Enough survived of these to reconstruct the original inscription: "...to clerk of works Chatsworth by Cromford Canal..." and "..No.145..". It can be inferred that in addition to the recycling of sections of timber panelling, and shutters, the workmen were using the softwood packing cases that had been shipped to the house along the Cromford Canal.

The floors also provide strong evidence that there was a culture of re-use and re-cycling, presumably to reduce the overall construction costs. The reverse and breaking up of packing cases, and sections of decorative moulded panels, are just two instances of this. The Chatsworth account books from the 1830s regularly list payments to Wheatcroft and Sons who, along with other enterprises (Glover 1829, 39), acted as wharf finger at Cromford Wharf, responsible for the transportation of materials along the Cromford Canal. They are frequently listed in the Chatsworth Accounts, for example on the 31st December 1832, they were paid £11.15.1 for 'freight by canal from London to Cromford'. Such an entry is perhaps not that striking, but it confirms the regular transportation of boxes to Chatsworth, an activity which is corrobrated by the discovery of the painted wording on the broken up packing cases re-used within the flooring.
