Petrological Examination of Stonework at Bourne Abbey Church, Bourne, Lincolnshire

Alan Vince

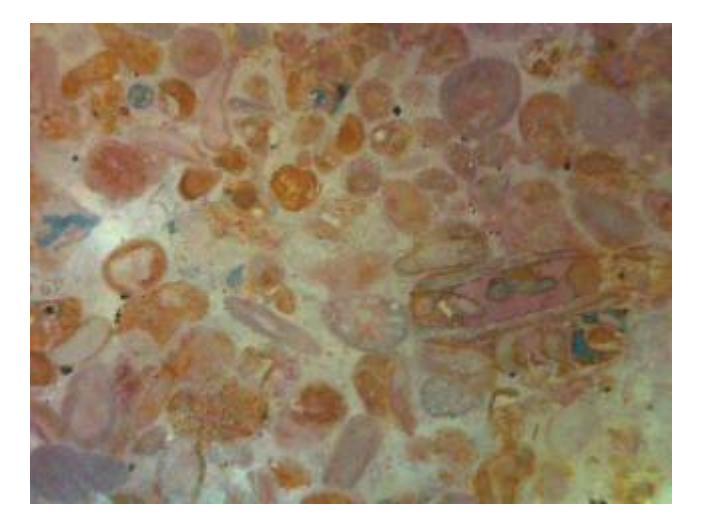
Figure 1

Rock 1: Samples 1-2, 4-8 and 10-11 are all very similar in appearance. They are all peloidal limestone with rare punctate brachiopod shells, sparse bivalve shells and sparse oolitic brown iron-rich pellets. Thin-sections were made of four examples (samples 1, 2, 8 and 10).

The following inclusions were visible in thin section:

- Pellets.
- Coral.
- Bivalve shell.
- Punctate brachiopod shell.
- Echinoid shell.
- The pellets and shell fragments are coated with micrite.
- The groundmass consists of sparry calcite, some ferroan and some non-ferroan.

The most likely source of Rock 1 is the upper part of the Lincolnshire Limestone (Kent 1980, 48-9). Rock 3 probably comes from a similar source, and is similar in the low amount of visible sparry calcite cement to stone from Ketton). Rock 2 is much finer-textured although still oolitic. Assuming the pre-13th century date assigned here is correct, the stone is likely to be either of local origin or perhaps brought to the site via water transport either from somewhere else on the fen edge or possibly further afield.

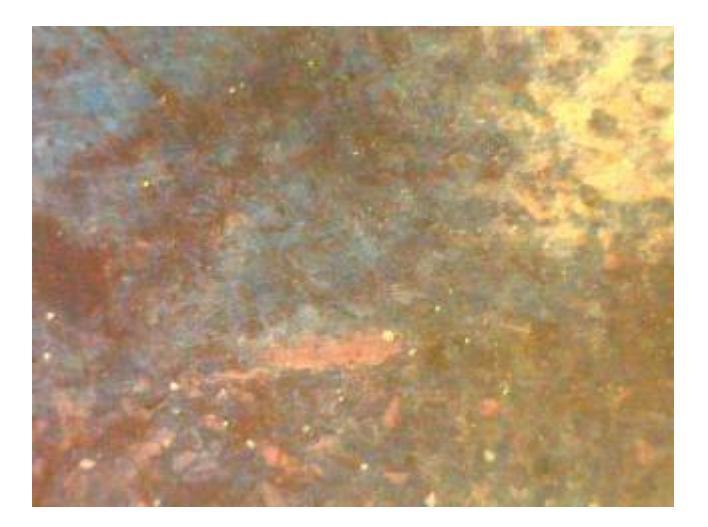
Figure 2

Rock 2: Sample 3 is much finer in texture than any of the other samples. It is suggested here that it comes from an earlier phase and was reused alongside roughly finished infill. None of the other stonework in the wall has such a fine texture, even the *in situ* carved stones (which all appear to be Rock 1).

The following inclusions were visible in thin section:

- Bivalve shell.
- Ostracod shell.
- Coral.
- The groundmass consists of sparry ferroan calcite.

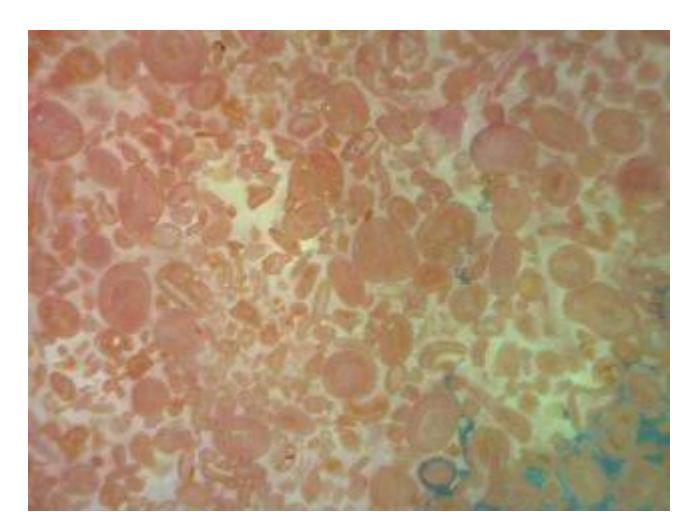
Figure 3

Rock 3: Sample 9 is if similar texture to the major group (Rock 1) but lacks the shell and ironrich oolitic grains. It is more similar visually to material used in definite 19th century work.

- Ooliths. Up to four layers of oolite built up over various cores, mostly biological in origin (e.g. shell). All grains less than 0.5mm across.
- Shell (completely altered to micrite), up to 0.5mm long.
- The groundmass consists of sparry non-ferroan calcite.

As far as the interpretation of the stratigraphic sequence in concerned, the important point is that rock 3 is limited to an area which forms a clear patch, different in block size and regularity from the remainder.

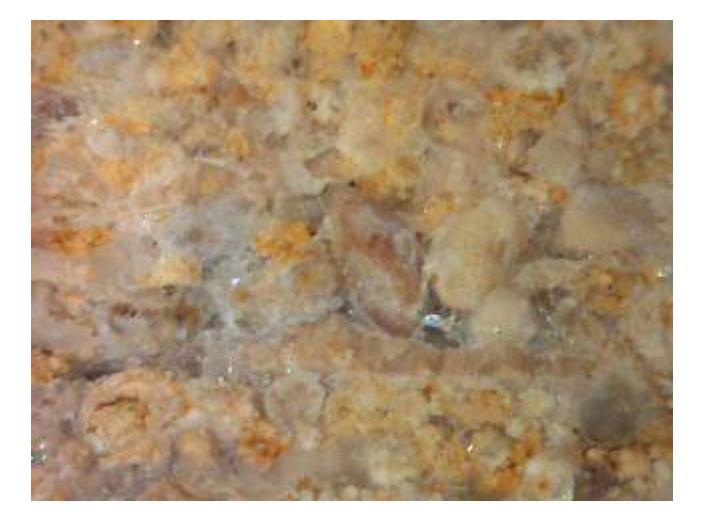
Figure 4 (sent for TS, sample V5154). Field of view for this and other macrophotos = c.3.4mm wide.

1. Taken from the right hand (i.e. more easterly) block of stonework below a chamfer course and block of coarse work running across wall.

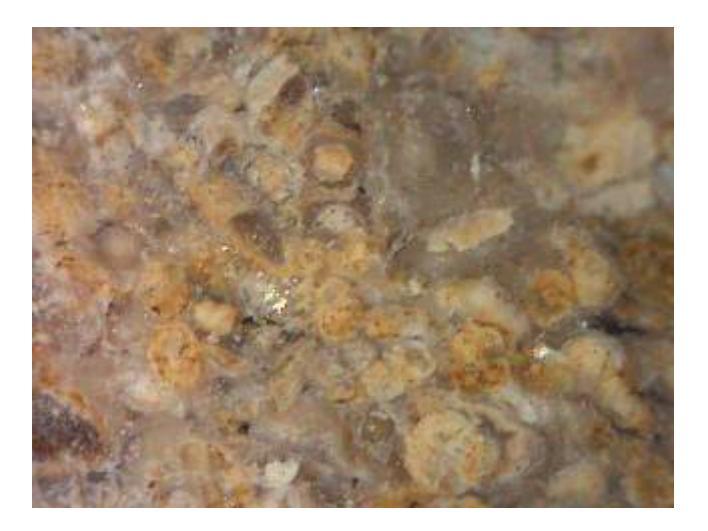
Figure 5 (sent for TS, sample V5155)

2. Taken from the left hand block of stonework below the chamfer course and block of coarse work.

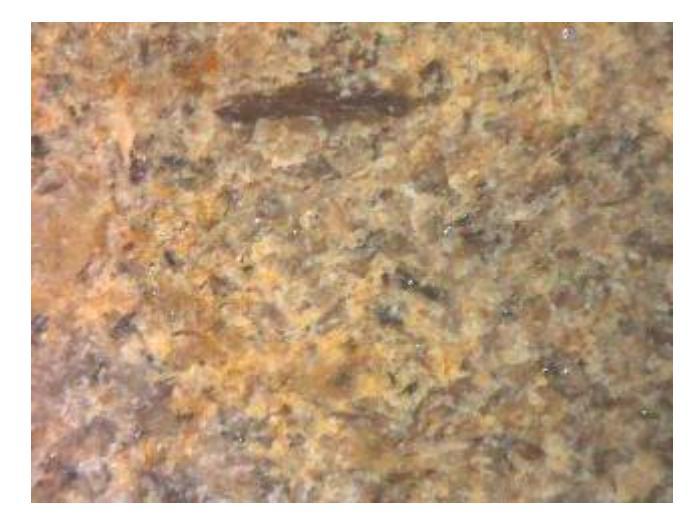
Figure 6 (sent for TS, sample V5156)

3. Taken from a block of stonework interpreted as the faced stonework forming the left hand side of a blocked doorway.

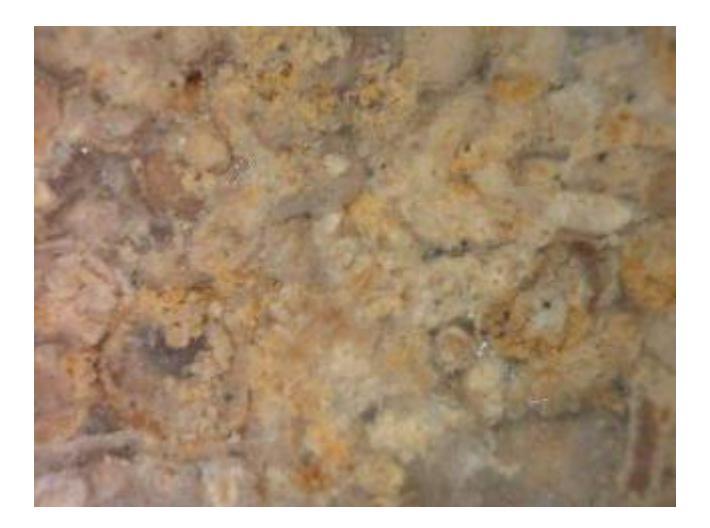
Figure 7

4. Taken from coarse work above samples 1 to 3 and below chamfer.

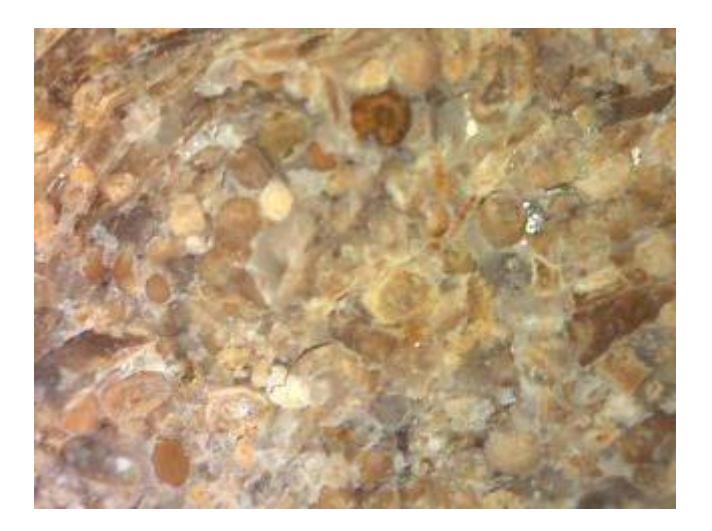
Figure 9 (sent for TS, sample V5157)

6. Taken from the block of masonry above the right hand part of the chamfer course and within the area of the supposed blocked doorway.

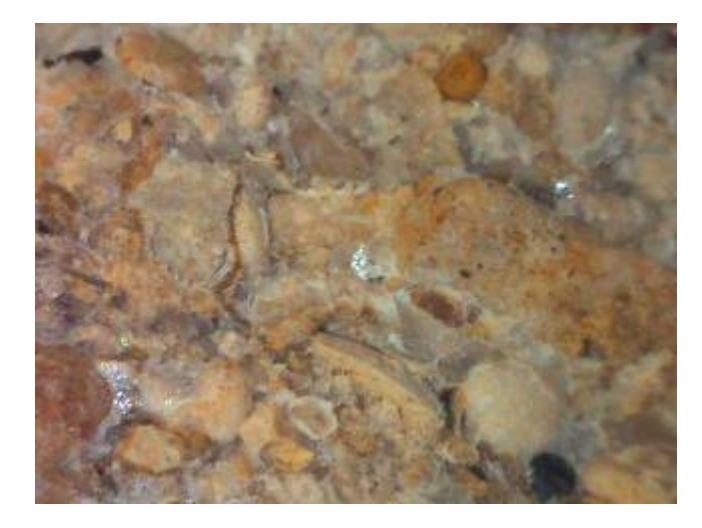
Figure 10

7. Taken from the upper part of the masonry block to the left, i.e. above sample 5 and below sample 9.

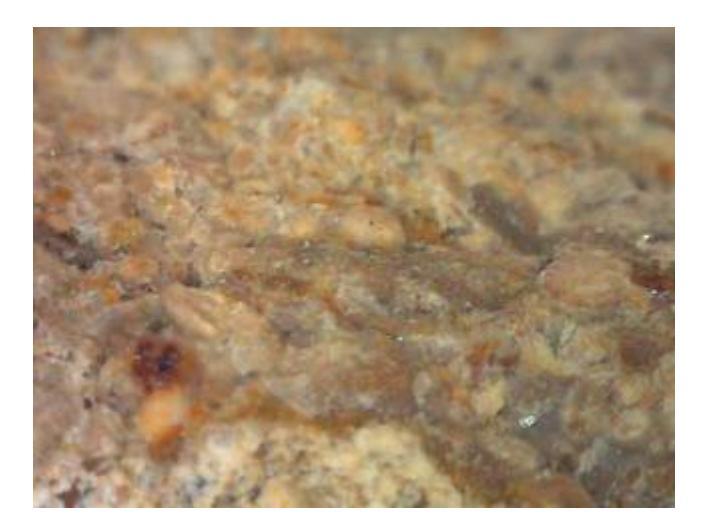
Figure 11

8. Taken from the upper part of the masonry block to the right, i.e. above sample 6 and below sample 11. Again, within the supposed area of door blocking.

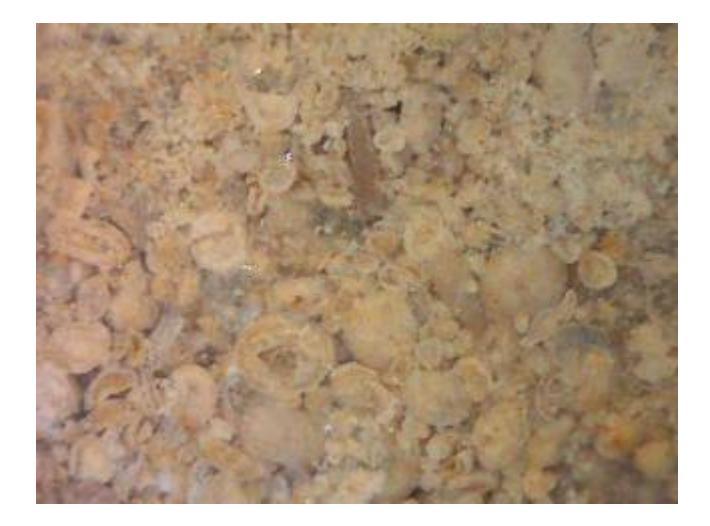
Figure 12 (sent for TS, sample V5158)

9. Taken from a patch of more regular-shaped stonework below the more westerly window and gallery opening. This appears to be a repair patch inserted into the wall, and cutting areas 8, 10 and 11.

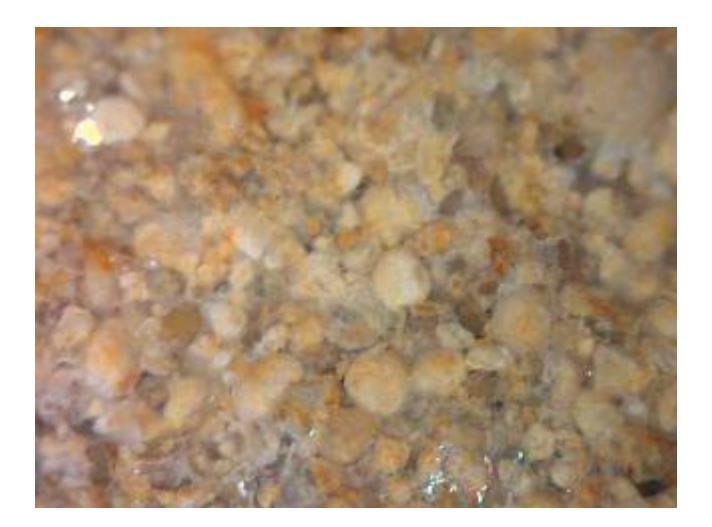
Figure 13

10. Taken from a patch of stonework to the left of the patch from which sample 9 was taken.

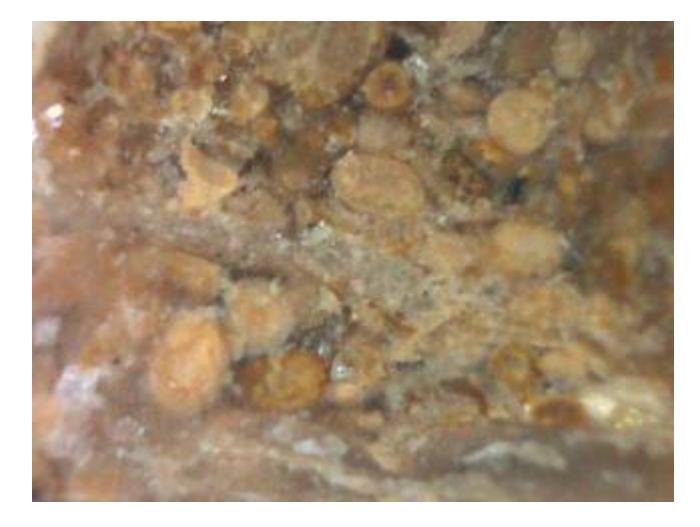
11. Taken from a patch of stonework to the right of the patch from which sample 9 was taken. This should be above any blocking.
