# Ingoldmells Sewage Treatment Works

# **Archaeological Watching Brief**

Site Code: ITW 99 LCNCC Museum Accn. No. 126.99 NGR: TF 5599 6762

LAS Report No. 399

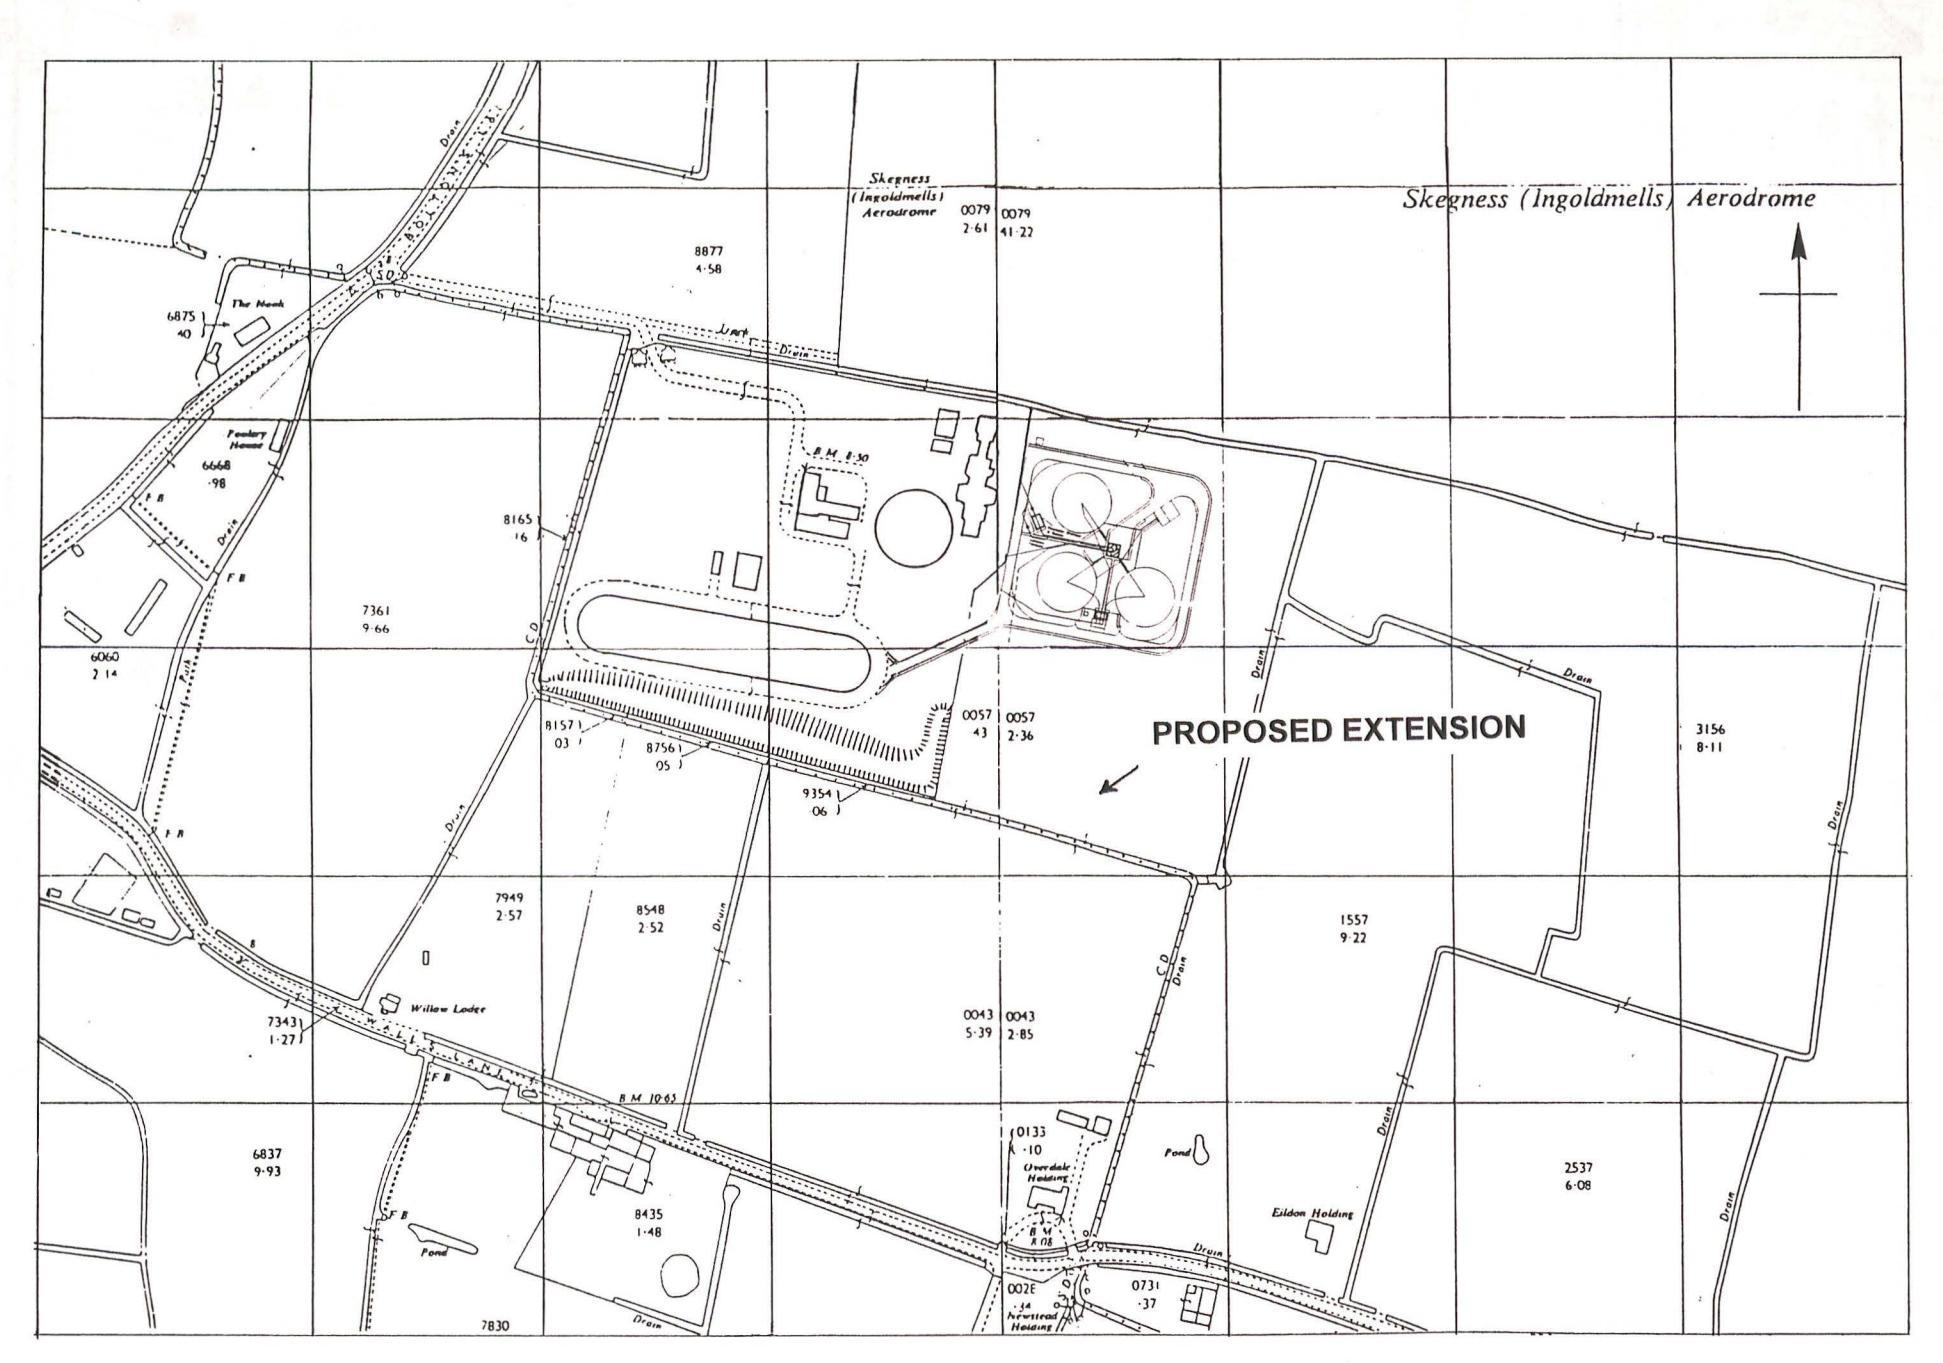
Fig. 2 Location and Layout of the Sewage Treatment Works (based on the Ordnance Survey 1:2,500 map. © Crown Copyright, reproduced with the permission of the Controller of HMSO. LAS Licence No. AL 50424A).

Intermittent monitoring of the NE part of the site by Wendy Booth continued until January 2000. The extent of briquetage (and peat) exposed by the works is indicated on Fig. 2. The exposed archaeological remains were restricted to the area of the SE cone, and land within 6m of its SW edge. Archaeological deposits extended beyond its NE and southern edges into ground which was not disturbed during monitoring visits.

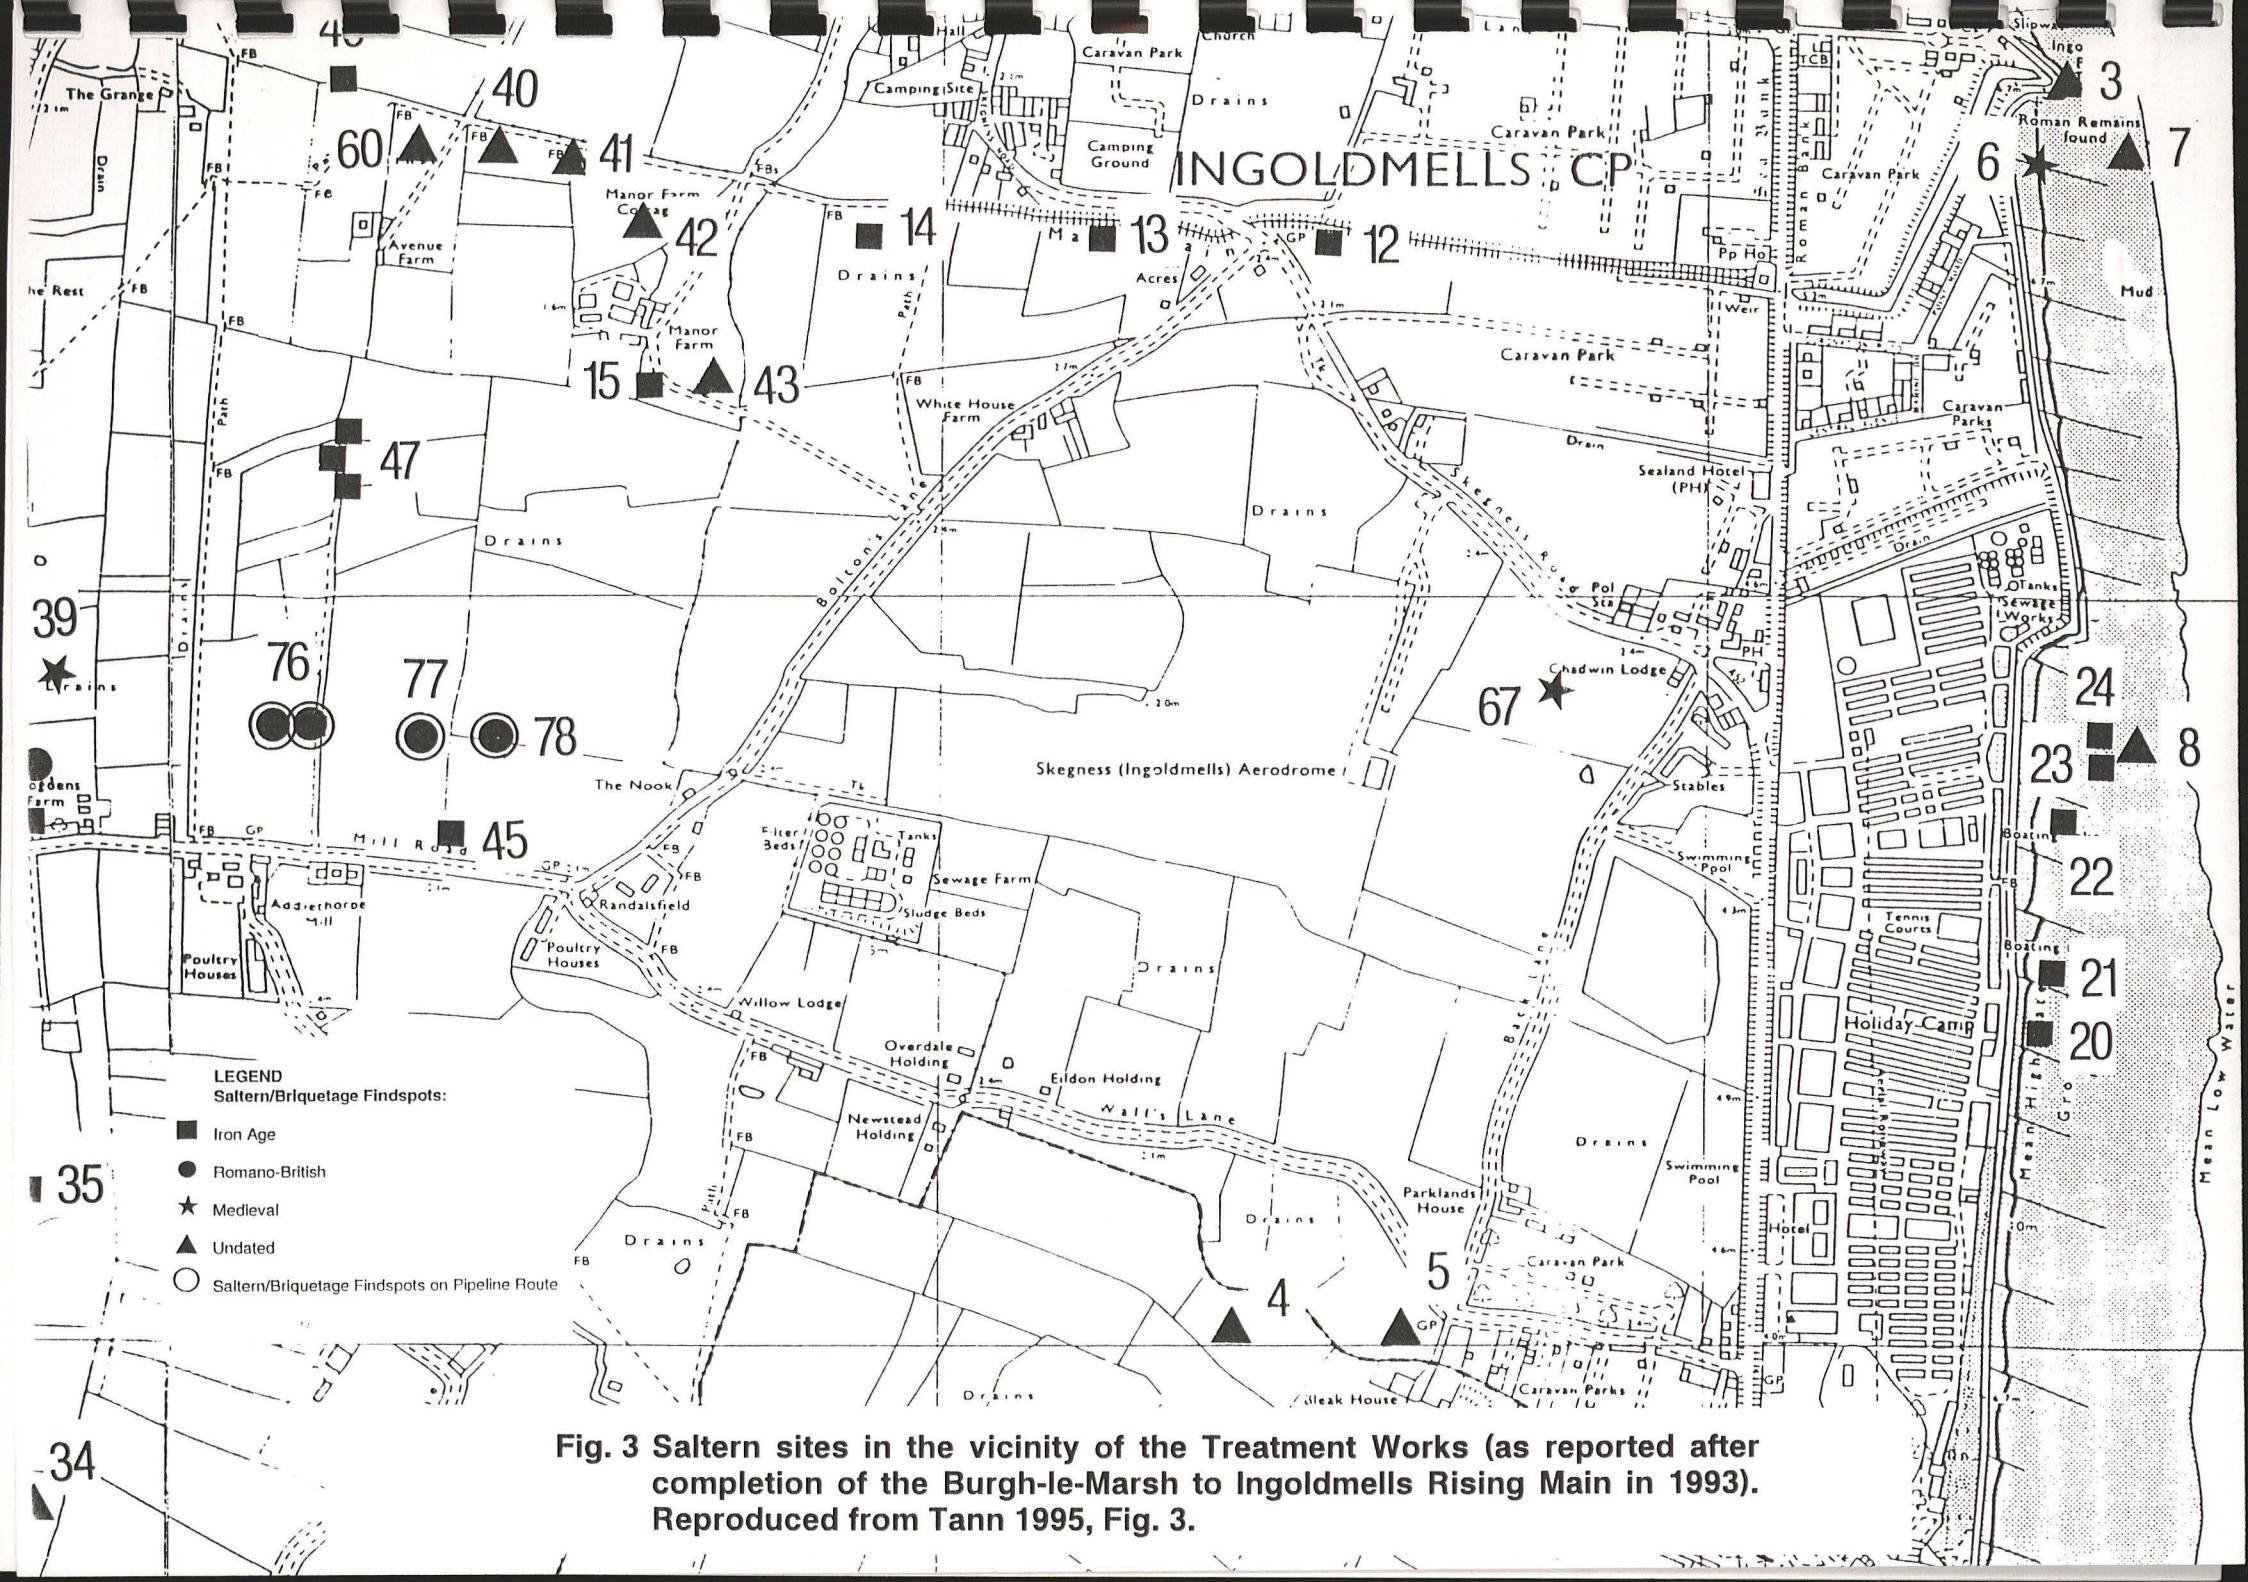
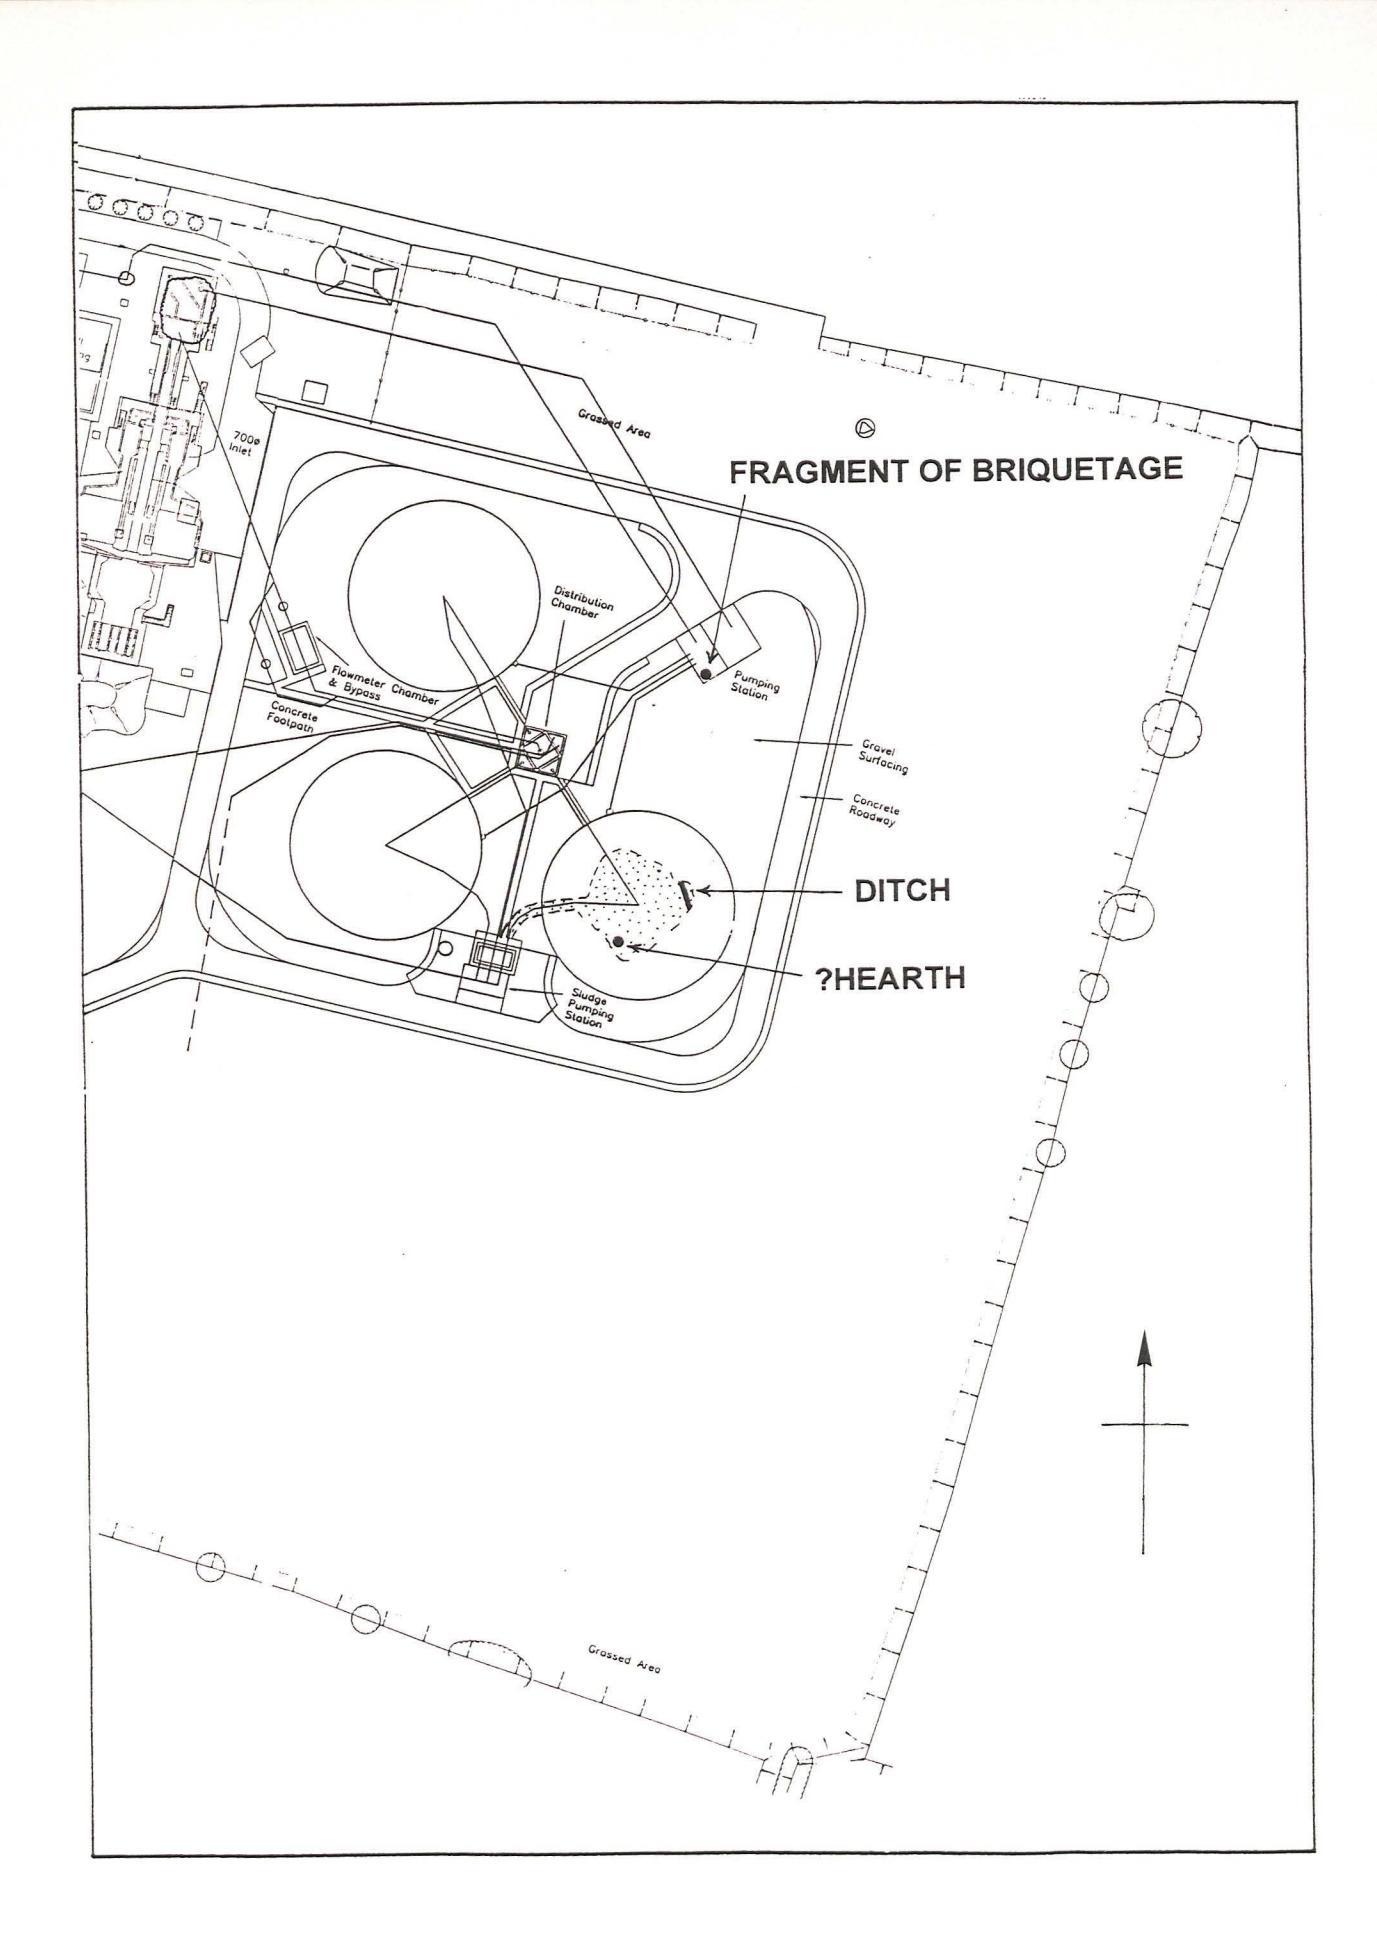
The pottery, since dated to the middle Iron Age, proved to be sherds from several vessels within the silt fill of a narrow gully or ditch (Fig. 4). The gully alignment was found to relate closely to the findspots of the previously collected pottery. A fortunate survival of all overlying deposits against a new pile (which had cut through the pottery-containing feature) enabled a full sequence to be established at one point (Fig. 5).

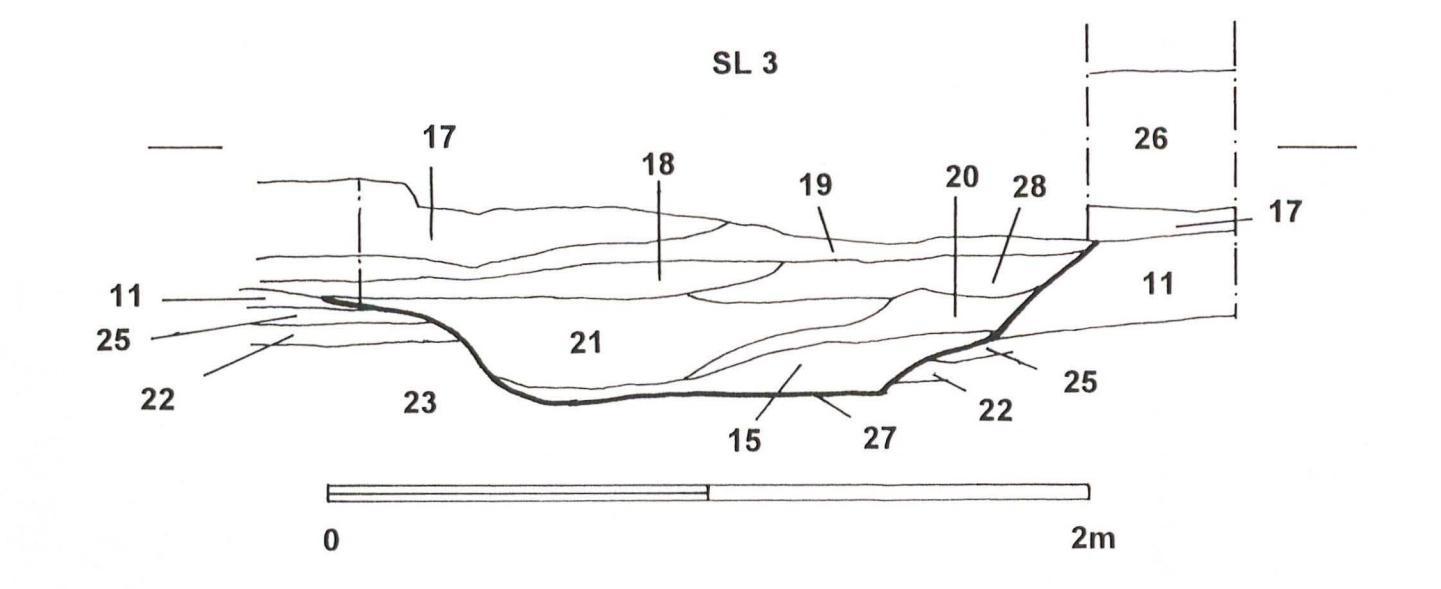
Fig. 5 Section across Middle Iron Age feature 27.

The sequence was:

topsoil (removed)

1.7m OD	0.35m stabilised slit
	0.05m grey/brown silt
	0.05m orange iron-panned silt
	0.2m grey/dark brown silt
1.05m OD	0.35m briquetage, burnt soil, lenses of blue/grey silt and dark brown silt
0.7m OD	0.03m black peat
0.67m OD	light blue/grey silt

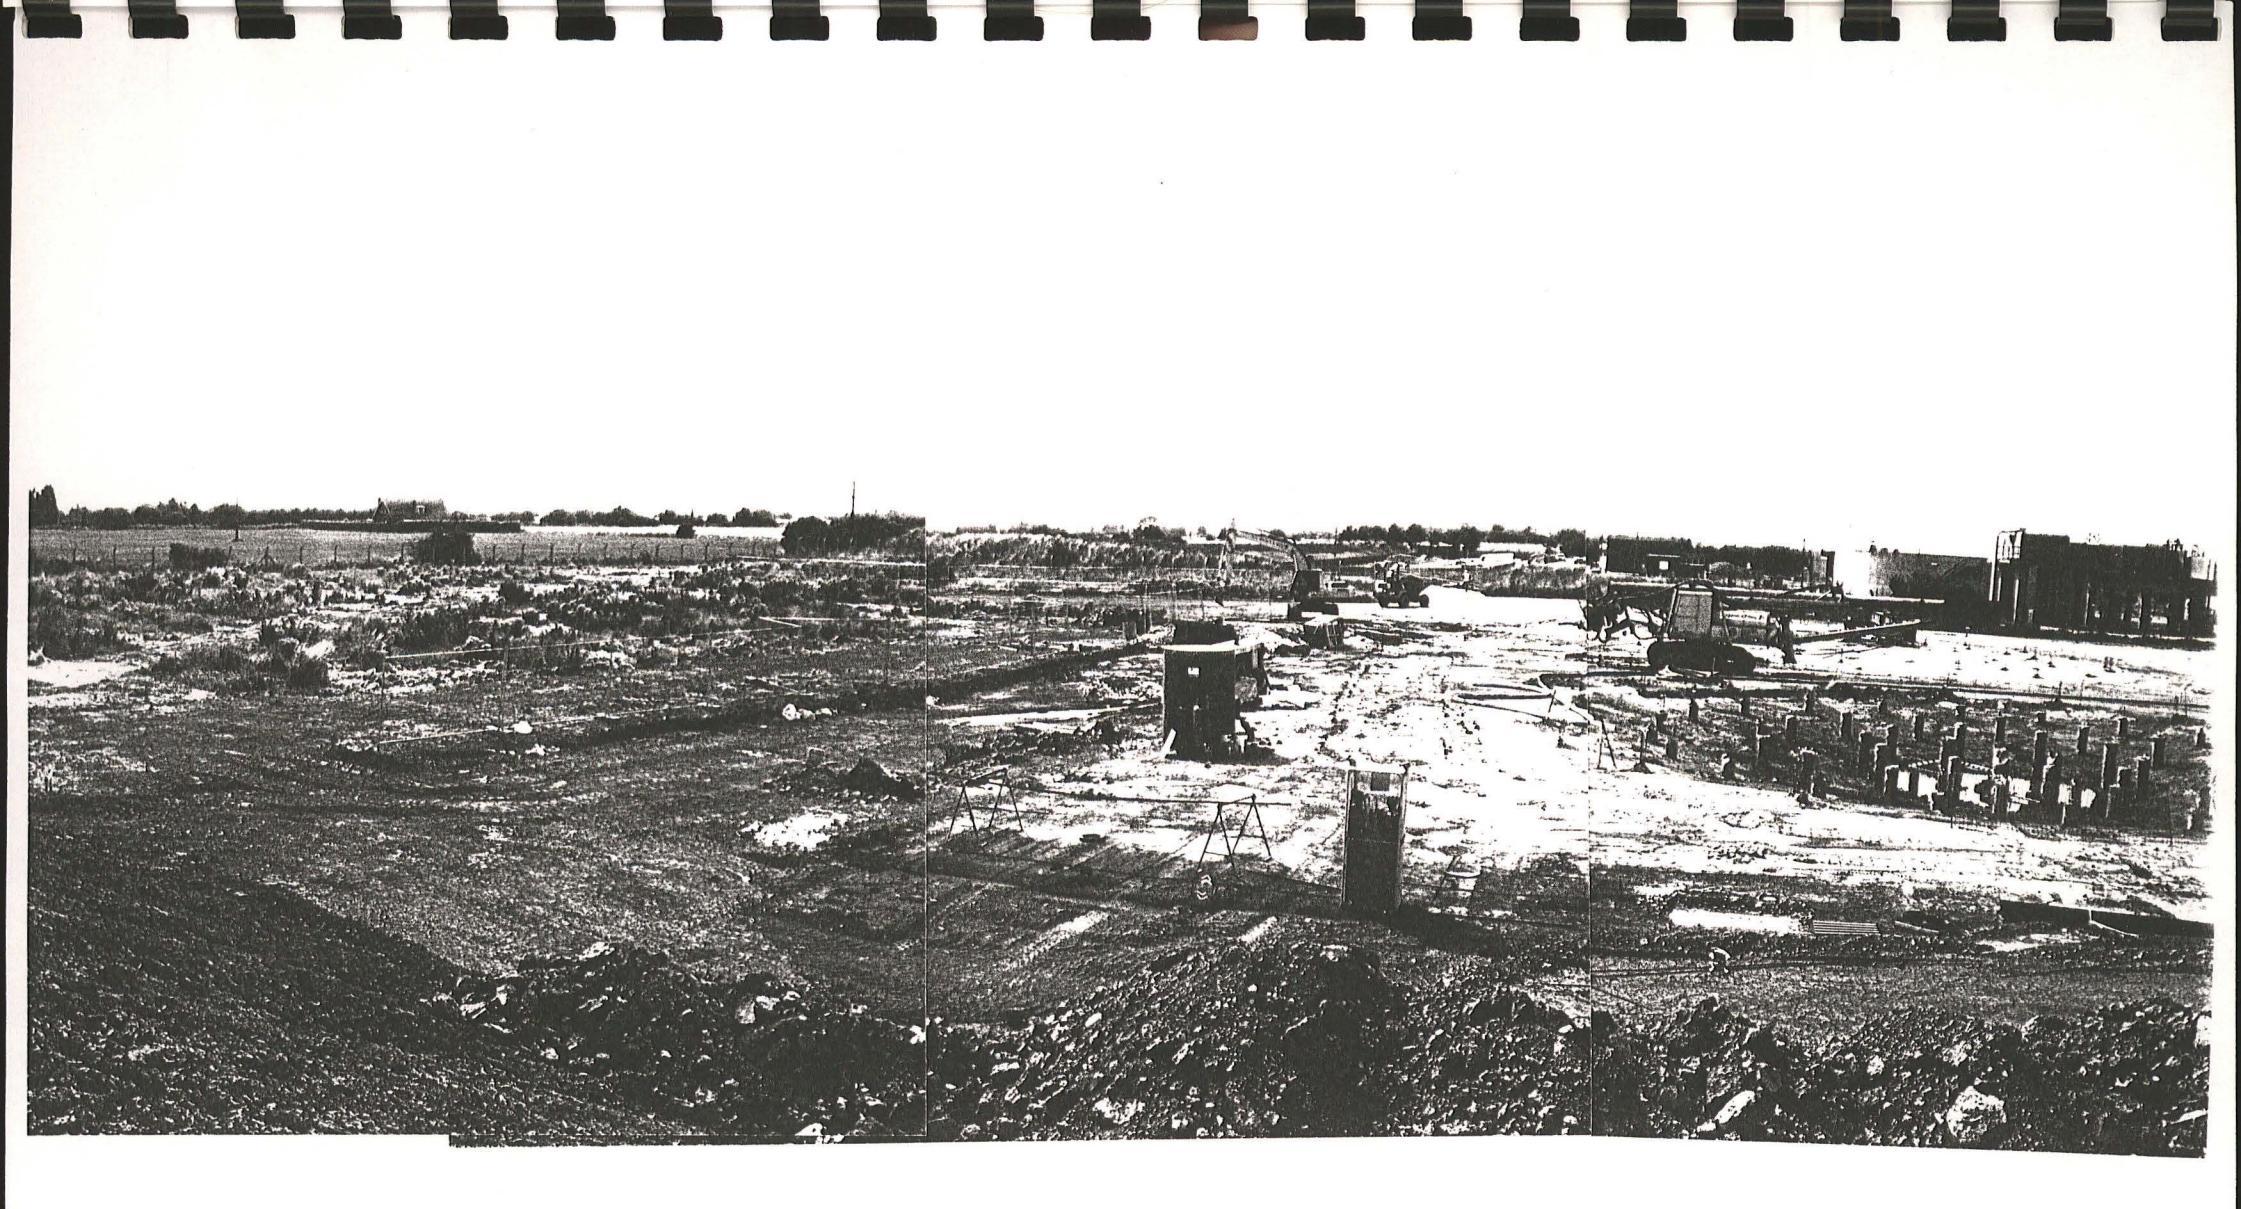
PI. 1 Location of the archaeological site and proposed Treatment Works extension (looking south).

An area south of the 1999 extension is now expected to be developed as part of the treatment works.

LAS considers that only a small part of the middle Iron Age saltern site has been disturbed by the 1999 treatment works extension. It does not extend to the west or NW, but may extend below the topsoil heap on the eastern side of the existing extension. The extent to the south has not been established. The finds have been processed, and environmental analysis has been arranged, but
