LINDSEY ARCHAEOLOGICAL SERVICES

New Vacuum Mains Sewerage Scheme Swaton, Lincs Archaeological Evaluation and Watching Brief NGR: TF 133 377 (centre) Site Code: SWTW 04 LCNCC Accn No. : 2004.228

LAS Report No. 830 May 2005

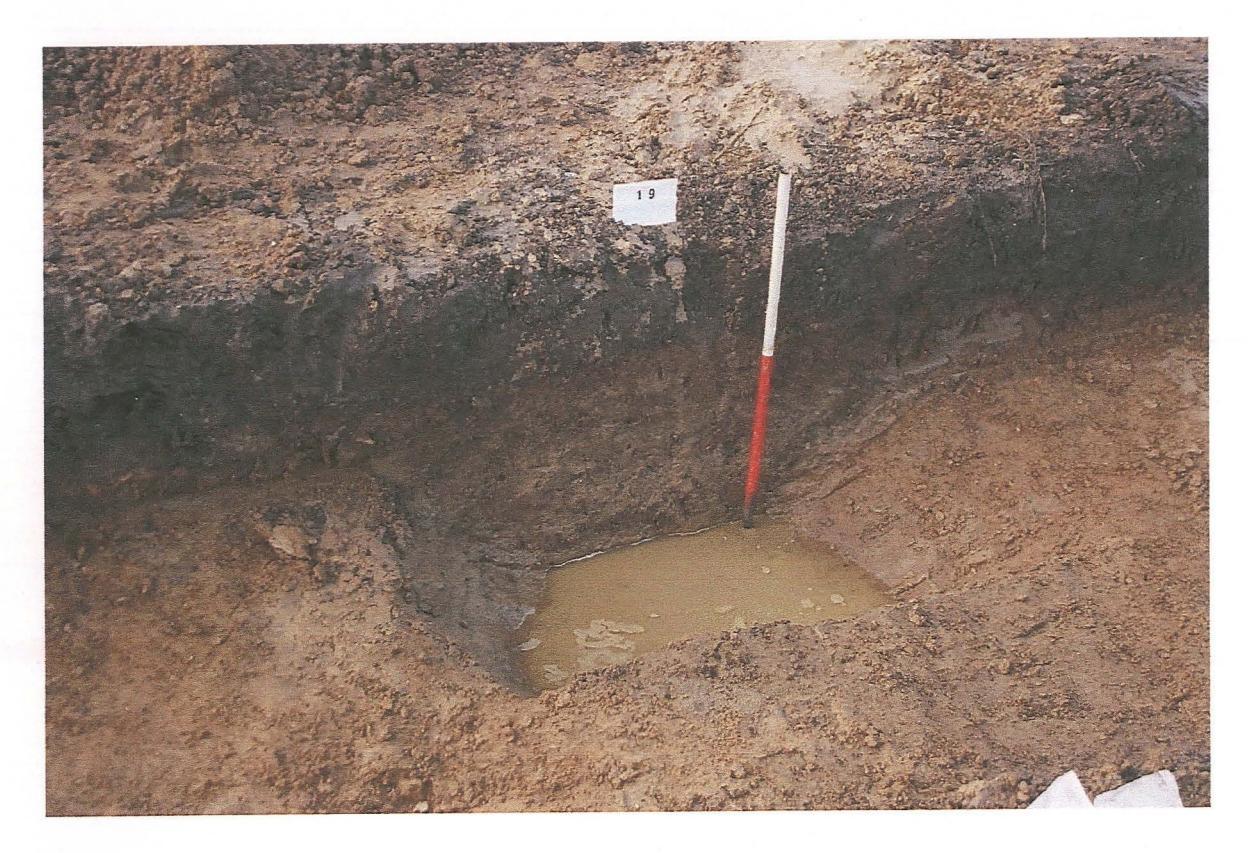
PI. 3 Trench 4 ditch 19, looking south (scale 1m).

A greyish yellow sandy silt **3** that filled a linear north-south aligned gently sloping cut **4** 2.40m in width and 0.42m in depth. This penetrated a layer of yellowish grey sandy silt **5**, that sealed light grey clayey silt **24** (which produced a ceramic date of 13th to 14th century), overlying mid grey sandy silt **25** within a north-south aligned linear cut **19** possessing a curved profile and base (Pl. 3). This feature measured 1.30m in width and 0.38m in depth and penetrated layer **2**, natural.

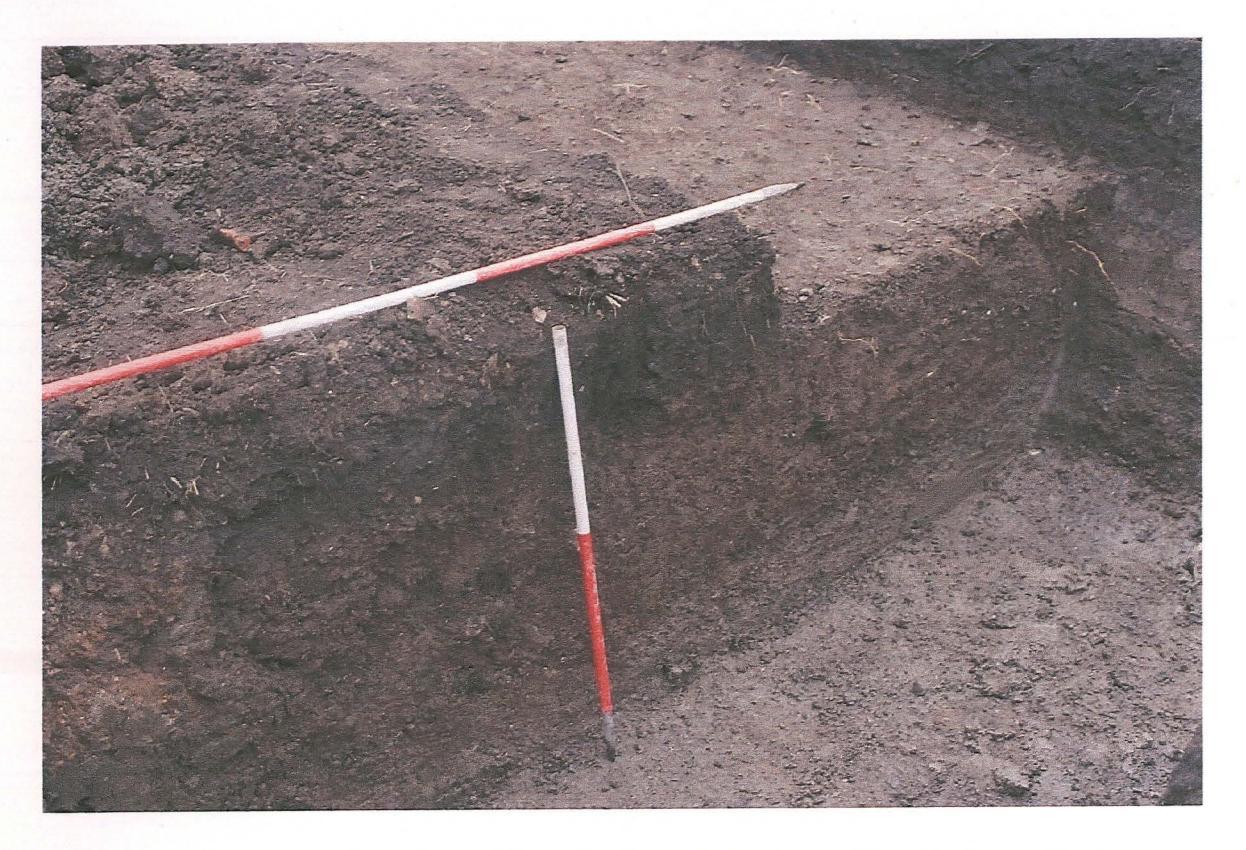
PI. 5 Trench 5 section through possible water channel, looking east (scales 2m and 1m).

A section was cut at 90° to the trench to investigate the large linear features (PI. 5). Beneath deposit **40** was a 0.42m deposit of mid green grey silty clay (**42**), a 0.24m deposit of light grey slightly gritty silt clay (**43**) which overlay yellow sandy gravel (**44**) (PI. 6). Layer **42** contained one sherd of $18^{th} - 19^{th}$ century pottery suggesting that all features above this level were modern and layer **43** produced a large fragment of a medieval limestone mortar (N. Field *pers. comm.*) and a fragment of post medieval to early modern brick.

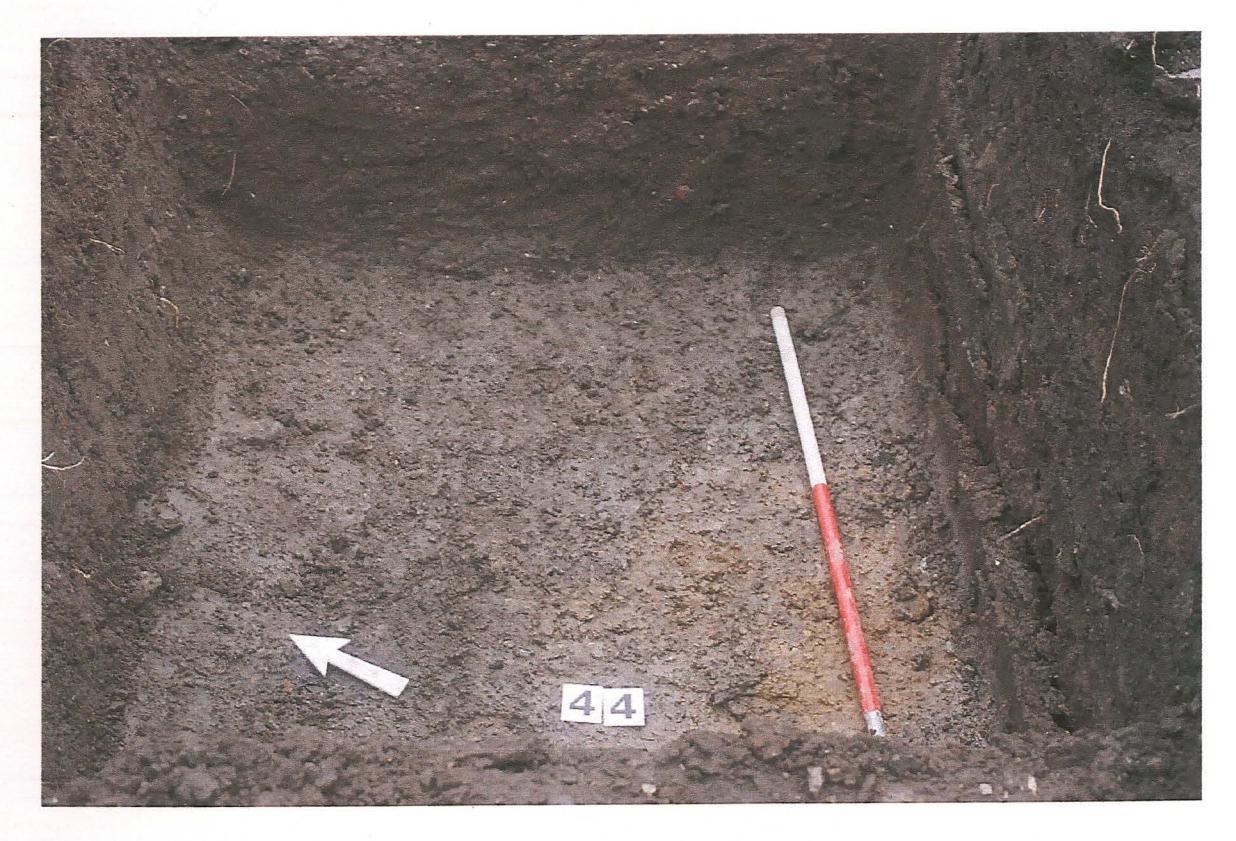
PI. 6 Trench 5 showing gravel deposit 44, looking west (scale 1m).
