Report No: 2014R067

Trengwainton Carn, Madron, Cornwall

Archaeological watching brief and recording

Trengwainton Carn, Madron, Cornwall-2009 to 2014

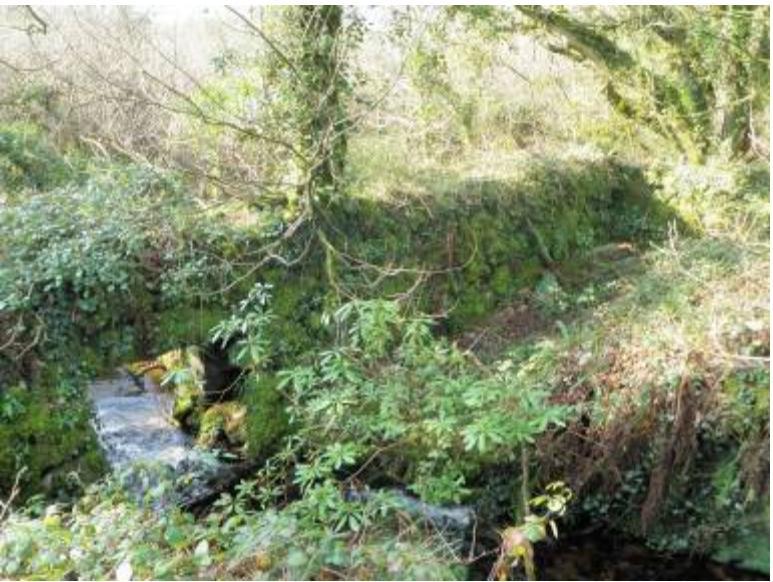
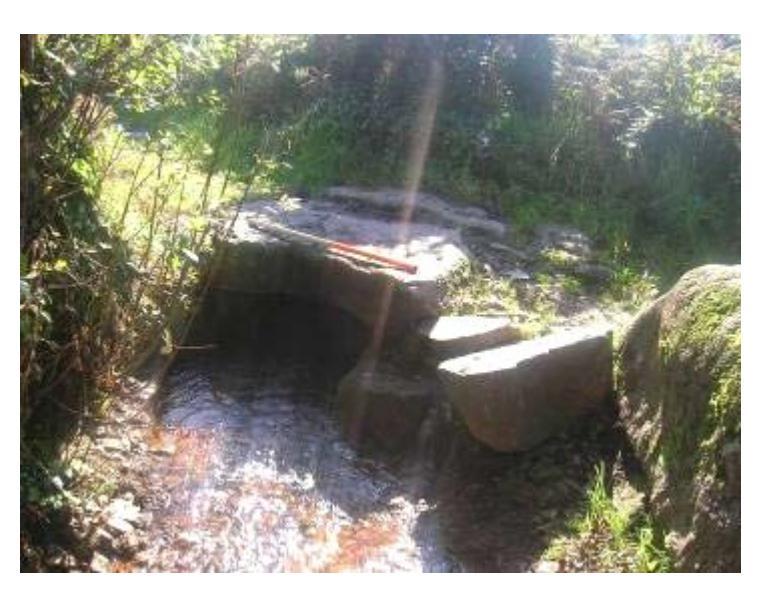
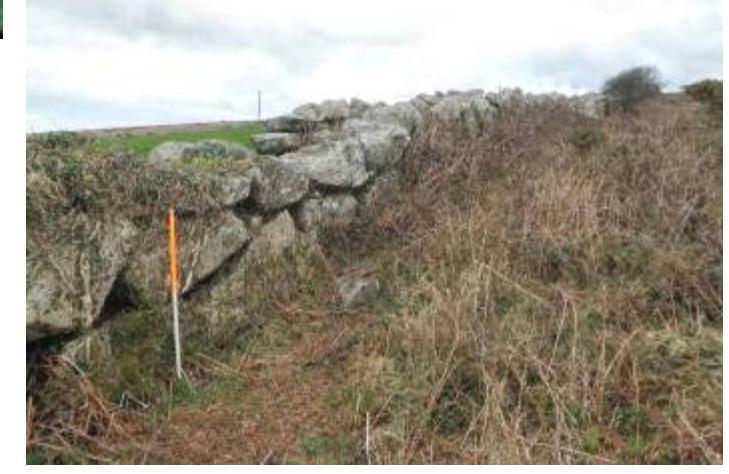
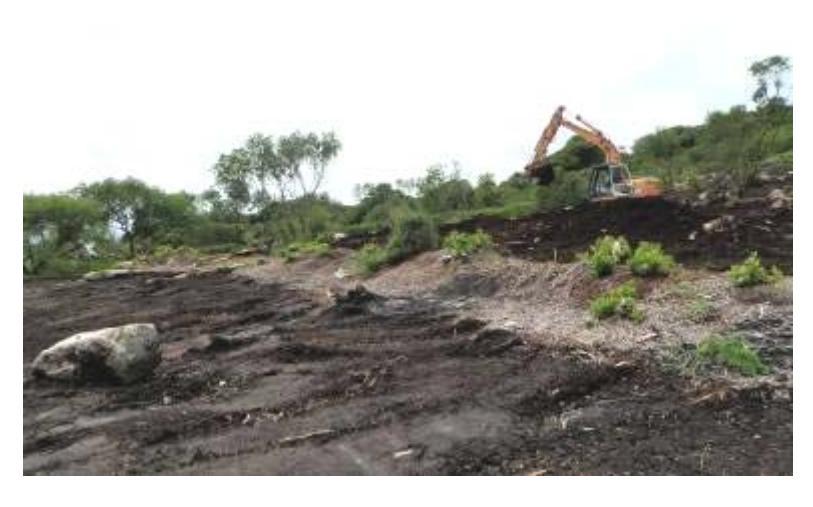
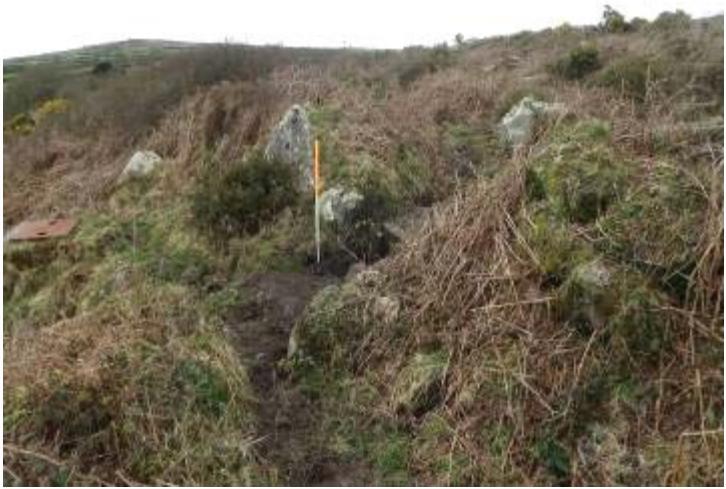
Fig 10 From top left clockwise: Stream Site 11 looking west from extreme northwest corner of F2; Site 3 footbridge; Boundary 8; pre-clearance west part of field system 14 (note manhole cover); and leaf litter clearance around the east part of field system 14 (avoiding damage to extant earth and stone banks).

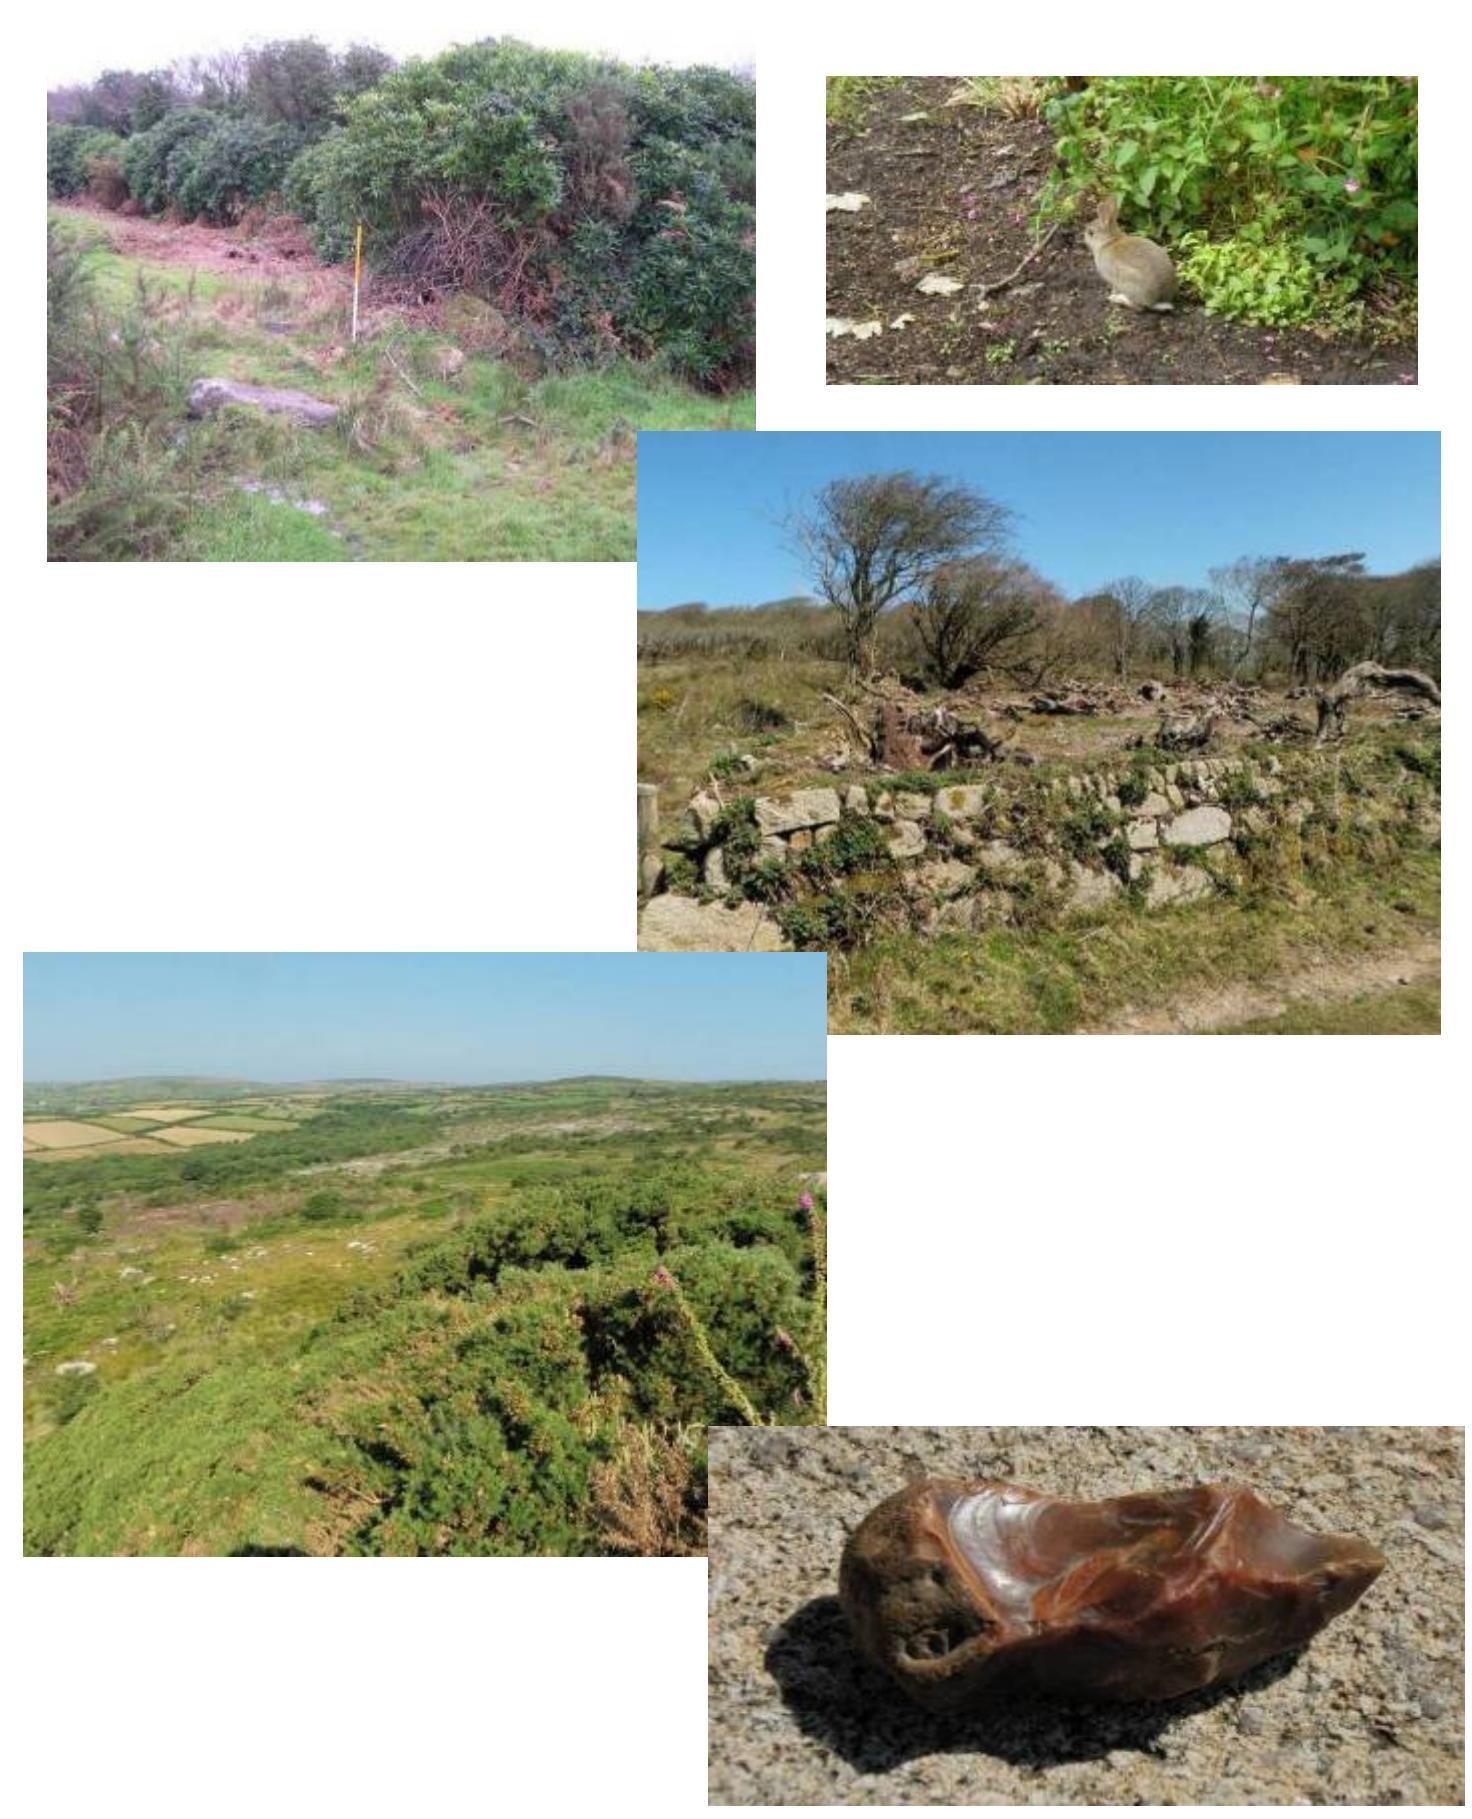
Fig 11 From top left clockwise: west end of northern Site 35 boundary; the return of wildlife after machining; looking across Boundary 6 from Church path site towards Area G; Mesolithic flint pick (85mm long); and looking from the top of Trengwainton Carn across Areas F1 and F2.

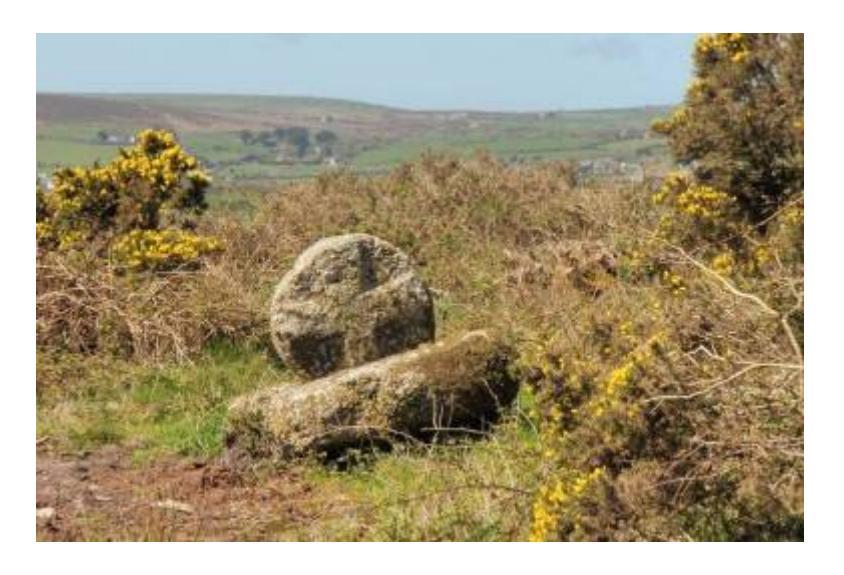
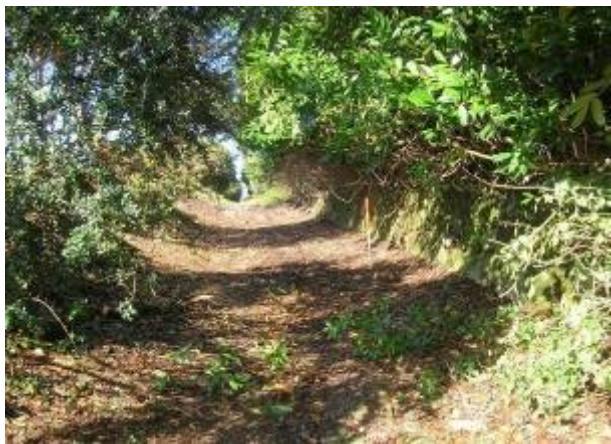
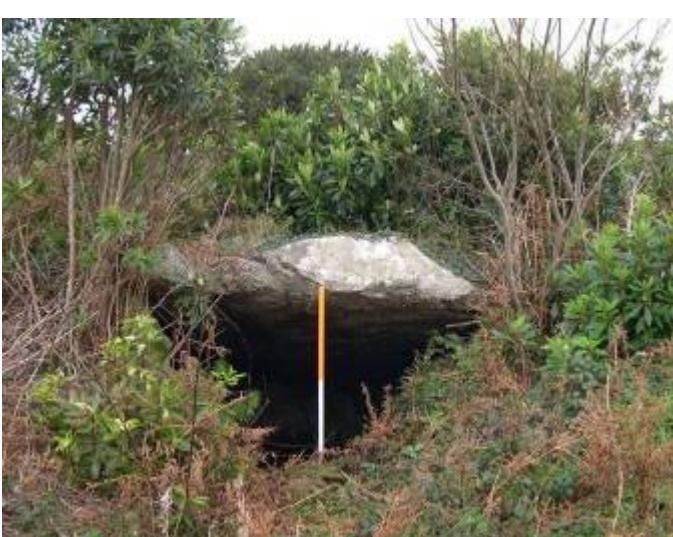
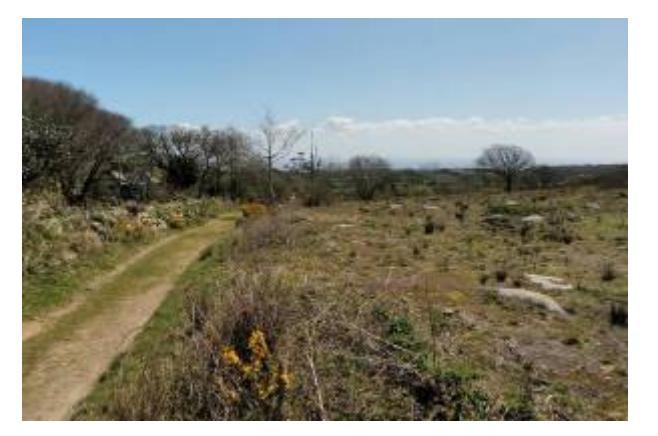
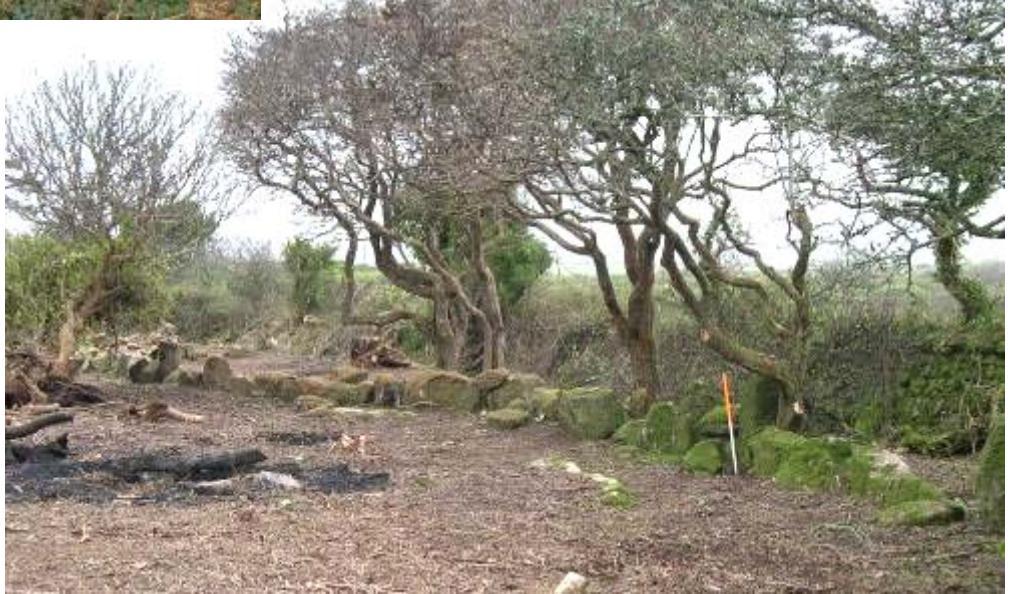
Fig 15 From top left clockwise: Scheduled Medieval cross Site 1; looking west along Church path Site 2 pre full clearance; looking east along Church path Site 2 post-clearance; late prehistoric orthostatic boundary Site 5 looking north; and the hull Site 12 prior to clearance.

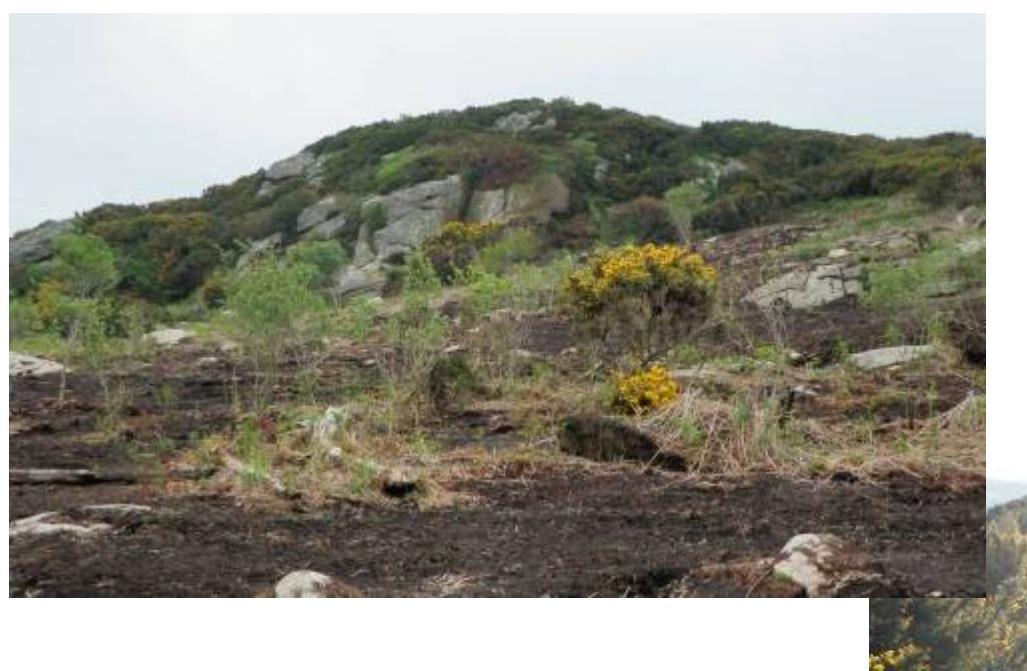
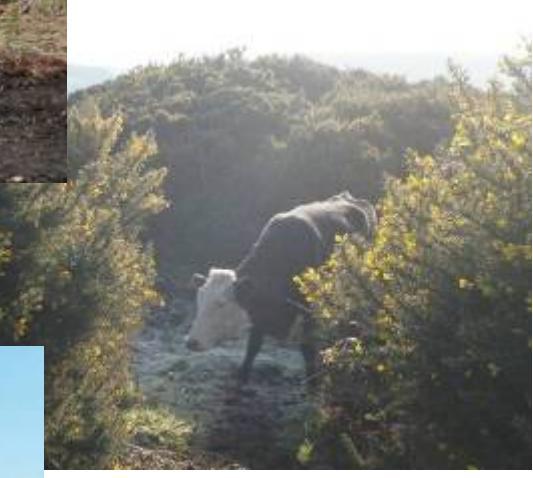
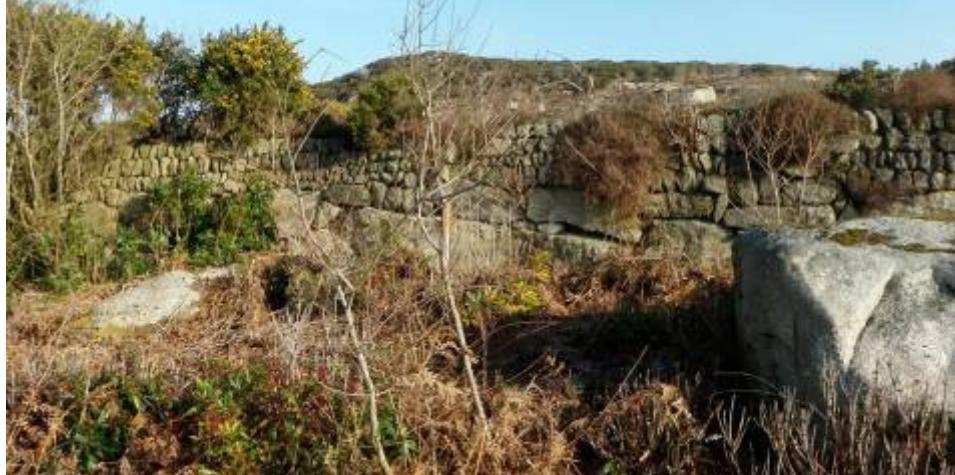
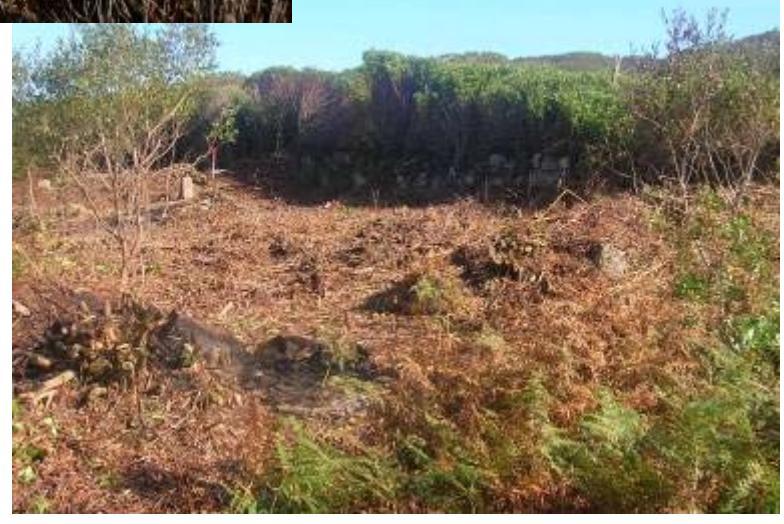
Fig 16 From top to bottom: Looking northeast towards Trengwainton Carn after leaf litter clearance; the successful re-introduction of cattle to the carn area; a particularly dramatic repaired section of boundary 3 with Area E and Trengwainton Carn behind; and square enclosure structure Site 8 from the south-west corner (note one of the two upright, drilled stones.

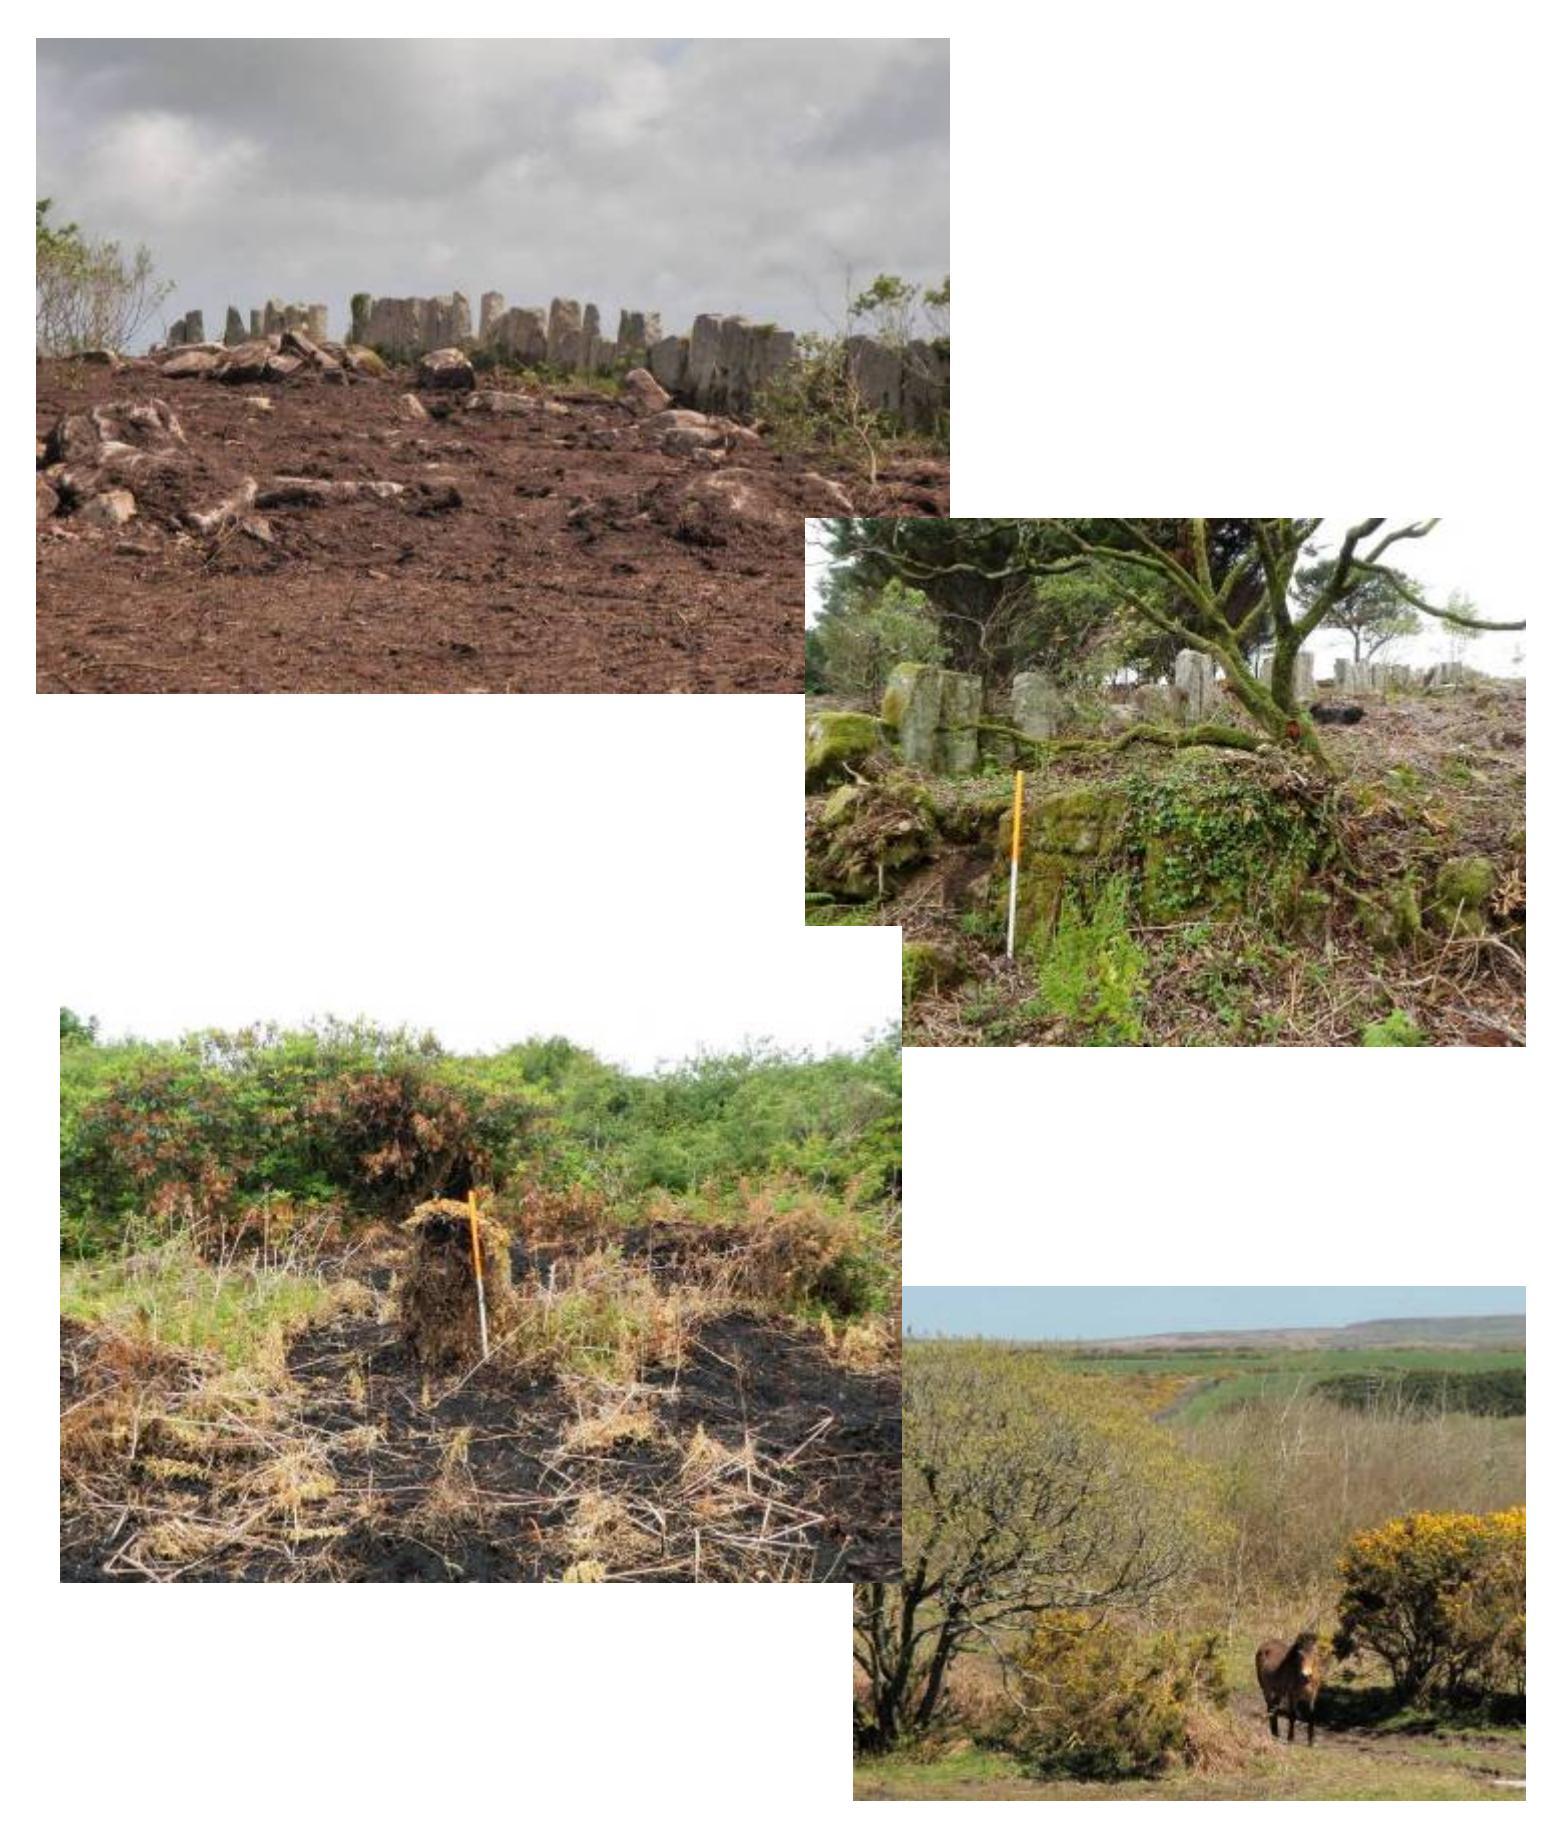
Fig 20 From top to bottom: orthostatic boundary 24; boundary 22 with later abutting boundary 24; northern terminal end/gate post of former boundary site 39; and a contented pony wandering in leaf litter cleared Area C amidst regenerating vegetation.

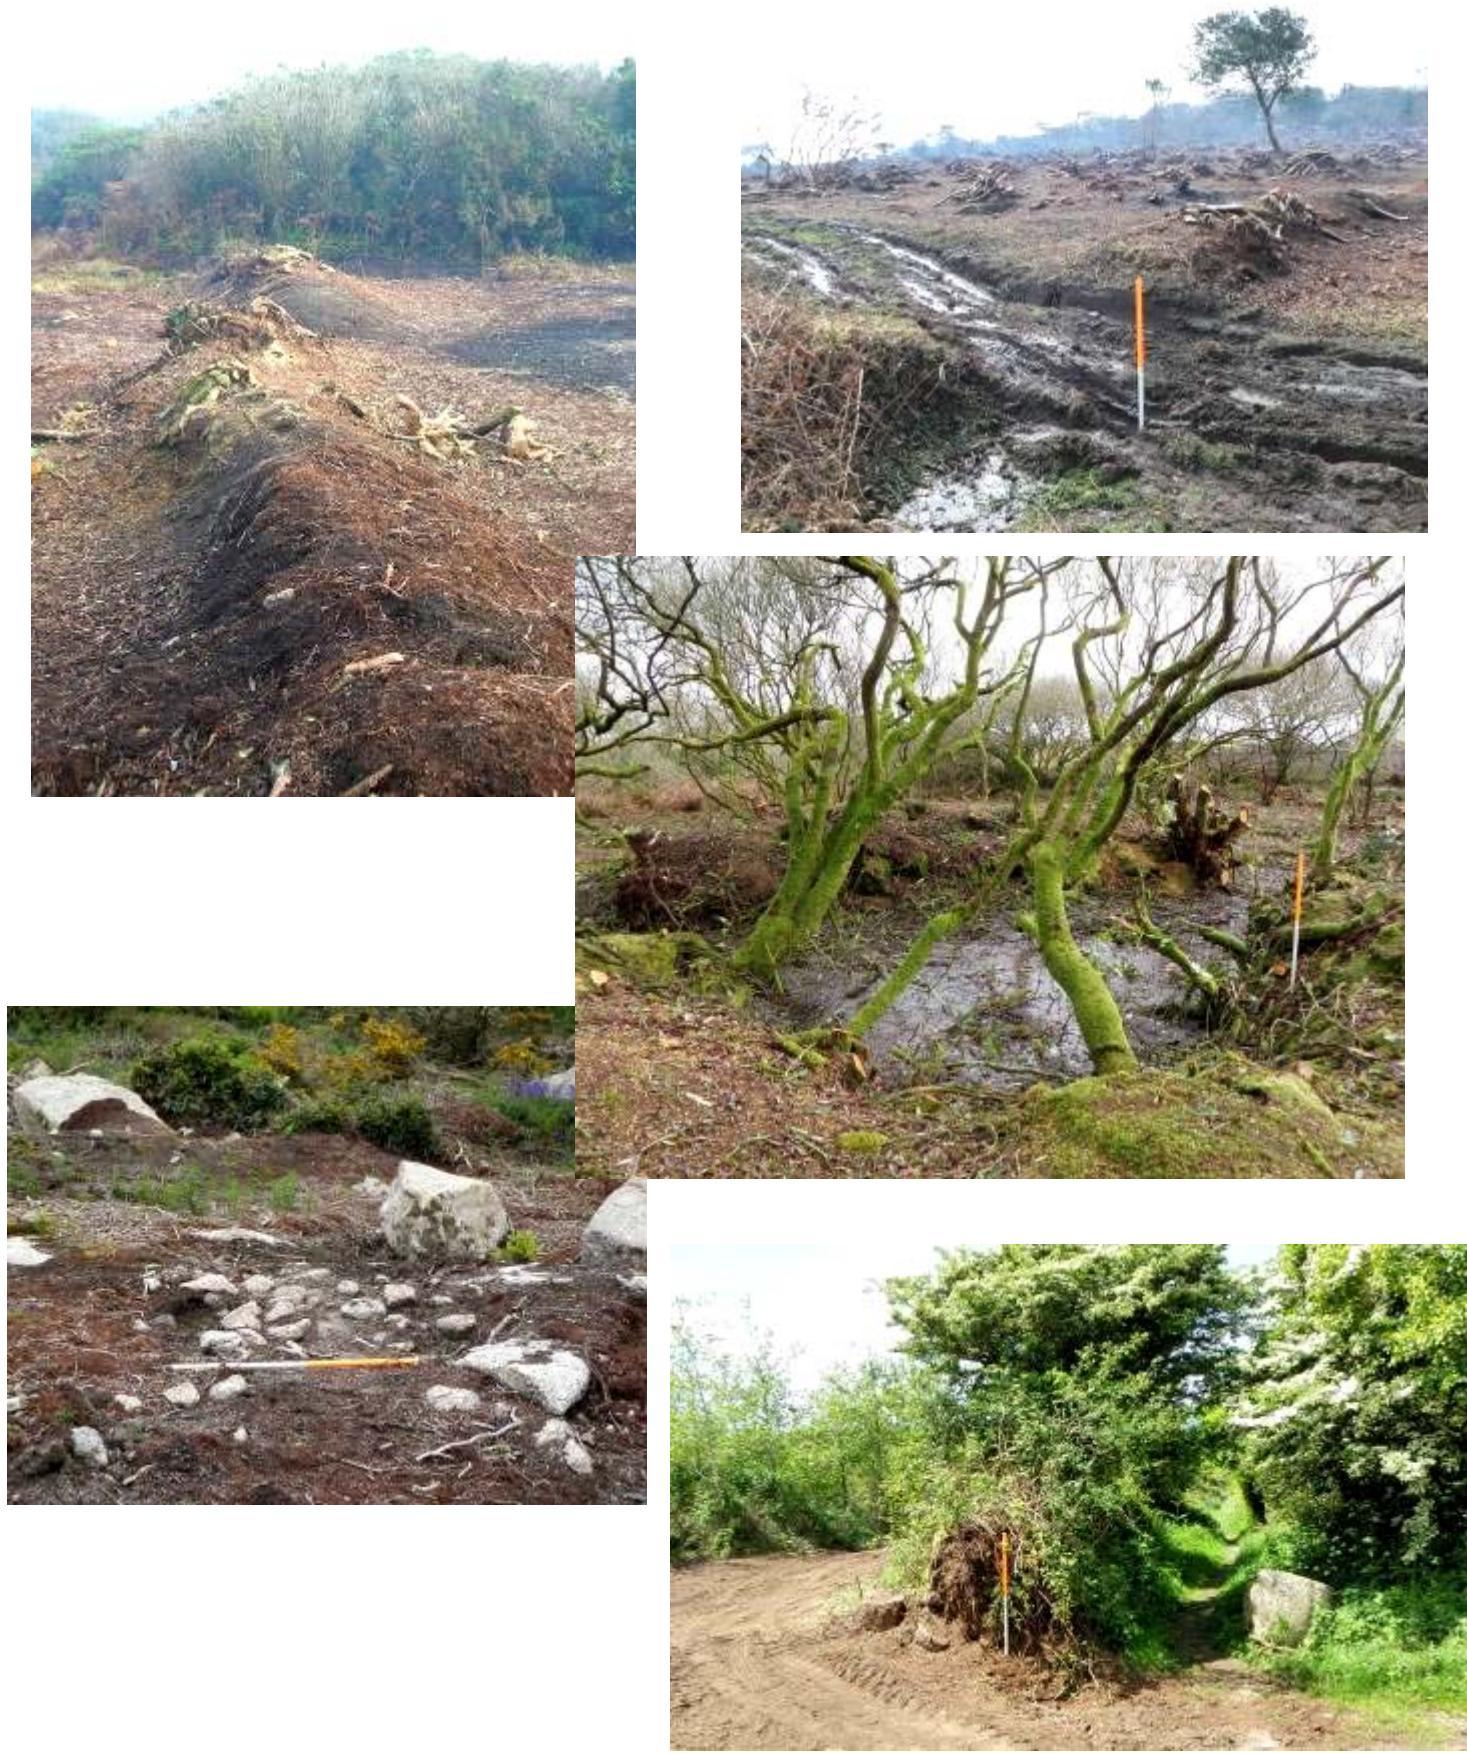
Fig 21 From top left to bottom right: looking north at part of field system site 22; looking west across vehicle damaged site 22 boundary 28; northernmost pit and dump site 44; one of the machine exposed clearance cairns in Area C; and looking north-west up green and narrow hollow way site 24 through the newly widened boundary 18 entrance in to Area C.

The removal of the remnant, poorly maintained and already severely damaged boundary site **B16** (marking the northern part of the eastern side of Area C), and the breaching of connected boundaries is most unfortunate. This was done during fencing designed to keep in the ponies planned for grazing the area. Boundaries affected include the extreme south-eastern end of **B15**, the south-eastern end of **B17** and the eastern end of **B27** (all of which have had previously small breaches widened mechanically). Boundary **B18**, running along the northern edge of the area has also had an original narrow entrance further enlarged to give access to medieval track/footpath **Site 24**. The extreme northern end of **B17** and **Site 47** in the north-eastern corner of Area C has been breached at its junction with **B18**, again as a result of fencing works.

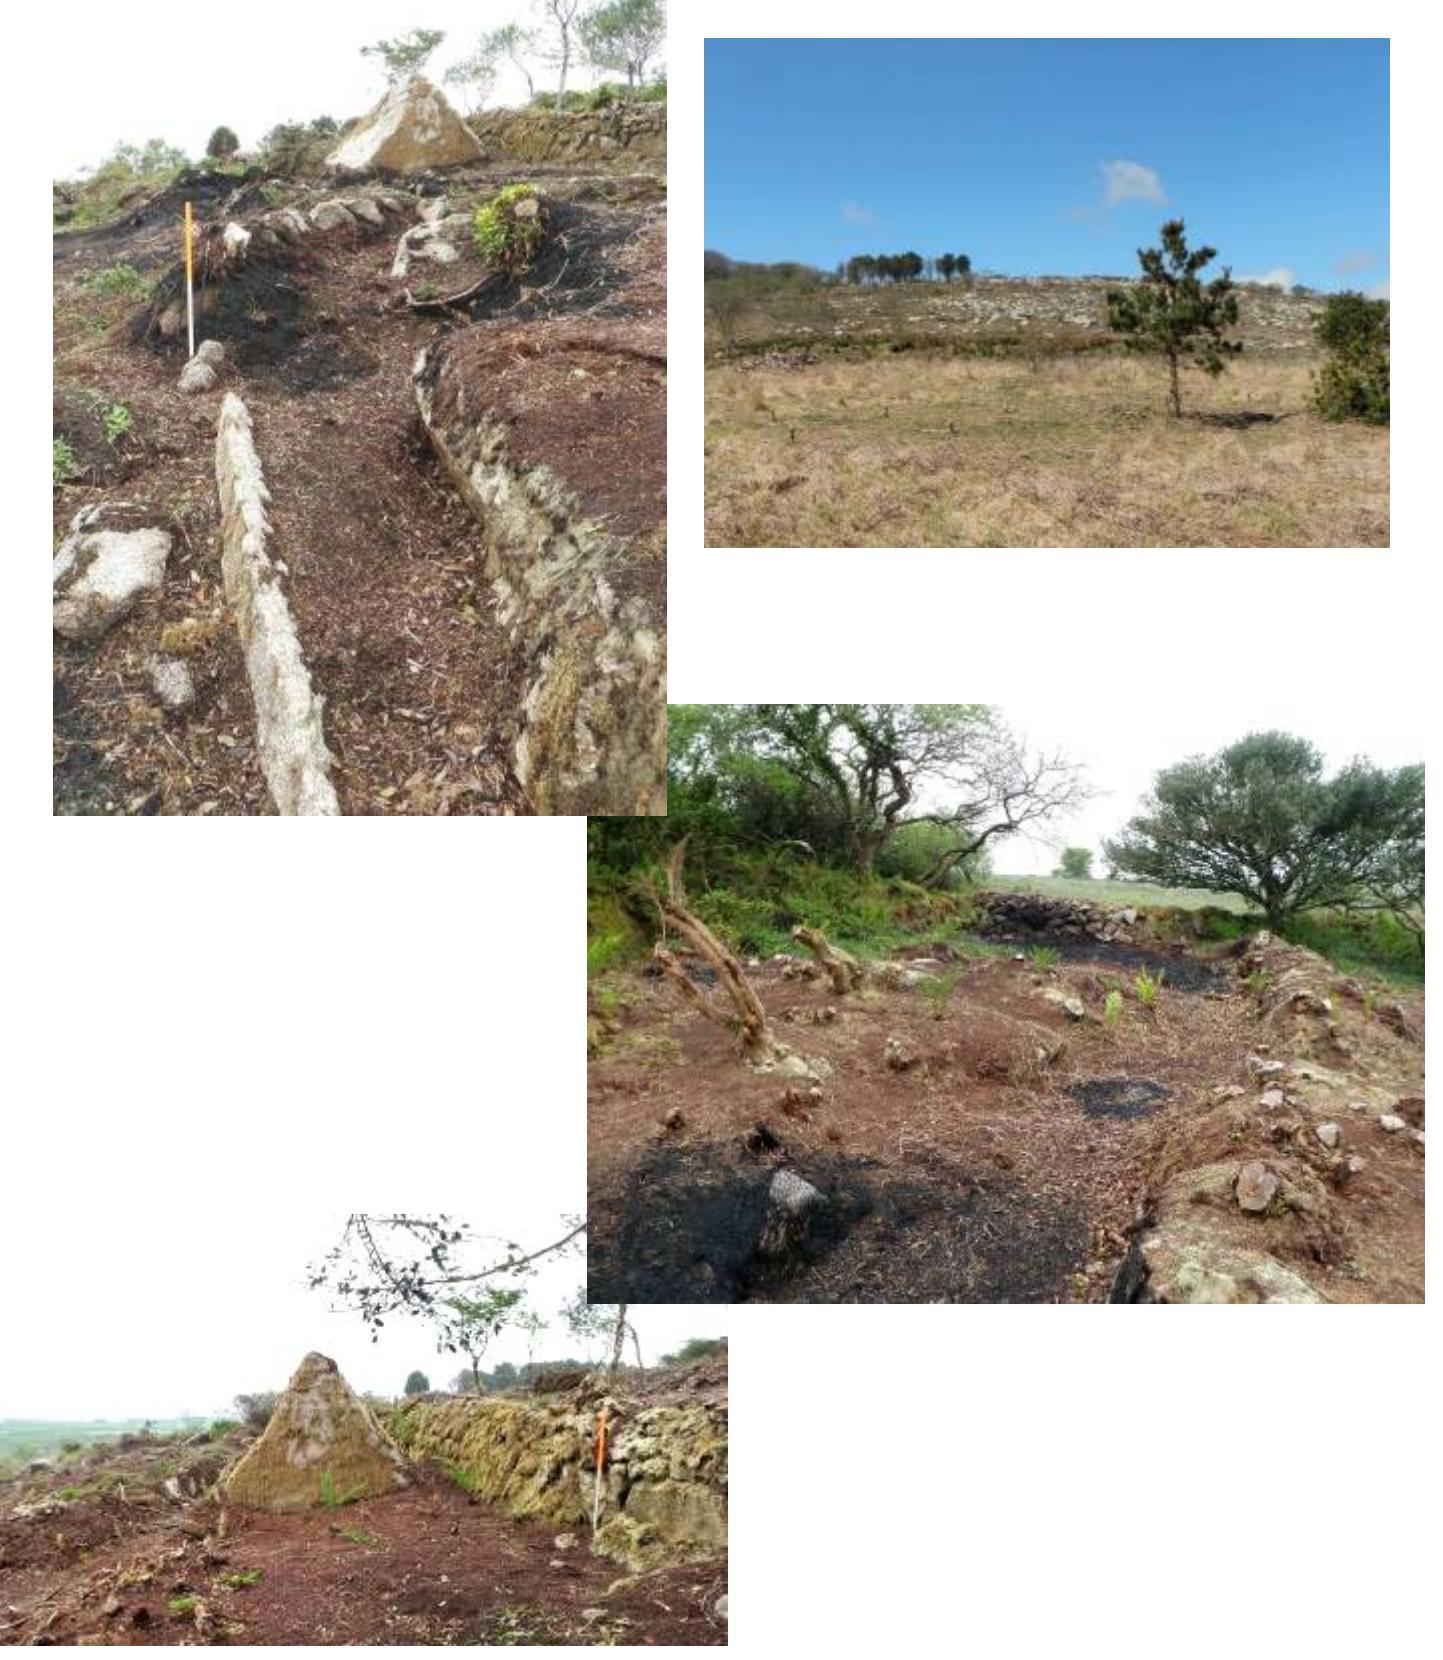
Fig 22 From top left to bottom right: looking south-west up a footpath linking the upper slopes of Area C with the access way/site 38; looking north-west from the southern part of Area C across one of the newly vegetated spoil dumps towards Trengwainton Hill; looking north between the two boundaries 29 (left) and 31 (and showing recent blockage of a former gateway leading in to land beyond the study area; and looking south at the 'pyramid' stone between boundaries 22 (right) and 23 within access way/site 38.

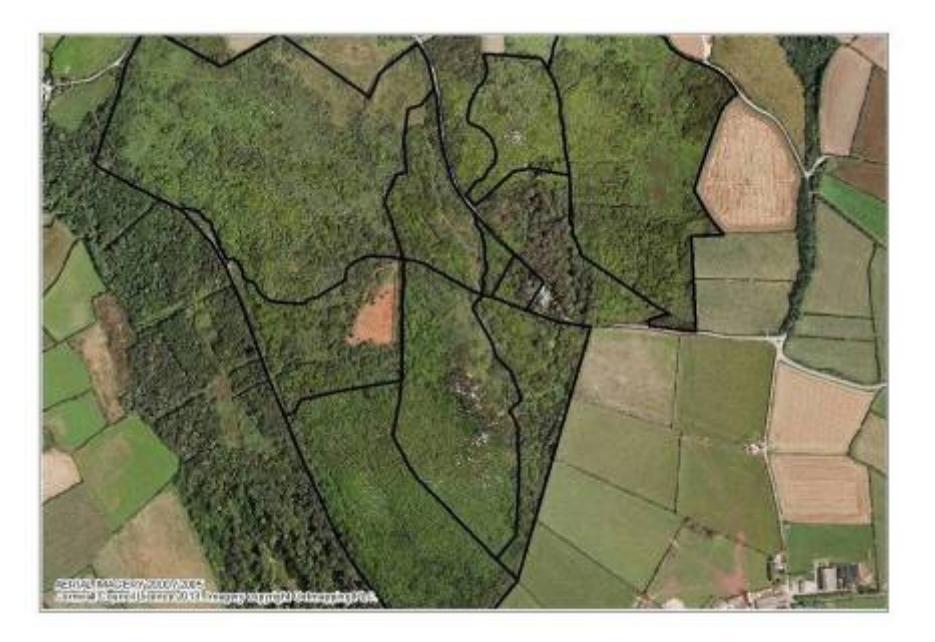
The effect of un-controlled Rhododendron growth on the study area was a major negative in terms of appearance close up, from Madron village, and as viewed from neighbouring hills and lower lying areas. It was also a major negative in terms of physical accessibility, preventing public access and preventing the re-introduction of livestock grazing. The ground beneath the dense Rhododendron cover was essentially 'dead', with severely limited light levels, a lack of water due to the 'thirsty' nature of Rhododendron, and a significantly reduced range of plant and animal wildlife. From an archaeological point of view the relatively extensive Rhododendron root systems were causing considerable damage, particularly to the boundaries (both the ephemeral and the more substantial ones), through stone displacement – destabilising both the stone and the often inner earth and stone cores and through the disturbance of earthen banks already susceptible to burrowing etc. The stability of the scheduled cross and the hull were also of concern. Unknown subsurface archaeological remains of medieval or earlier date

Fig 23 Aerial photograph taken in 2005 showing the study area lying beneath a swathe of out of control Rhododendron growth. Trengwainton Carn, Madron, Cornwall-2009 to 2014

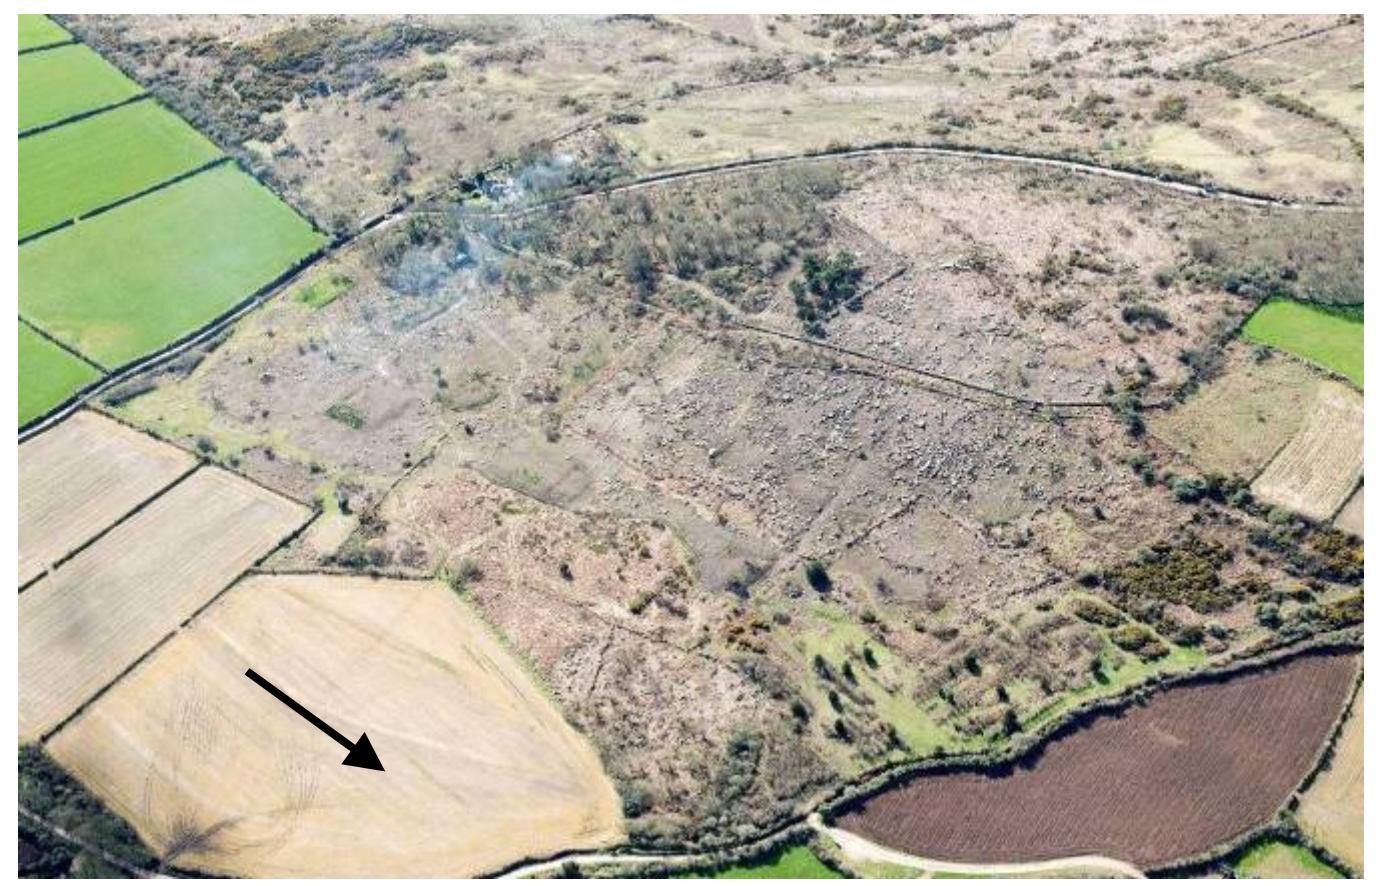
Fig 25 Aerial photograph taken in 2011 showing Areas B and C in the foreground. Arrow points north.

The following three aerial photographs – figures 25, 26 and 27 all show the very positive results of these clearance works (and should be compared with figure 23 when it was at its worst and figure 24, at a point prior to the uncontrolled spread of Rhododendron across the whole area.

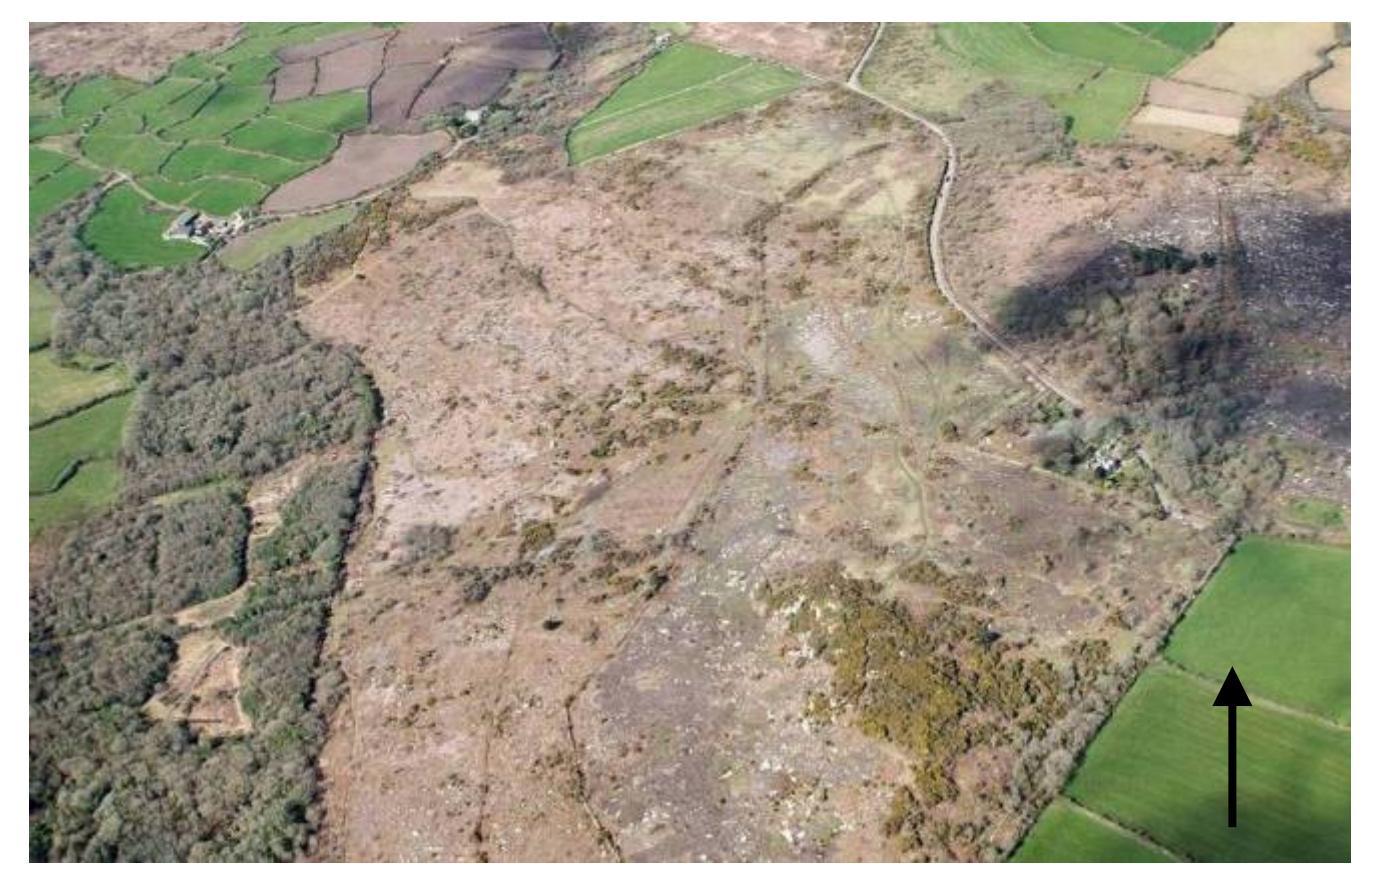
Fig 26 Aerial photograph taken in 2011 showing Areas F1, F2, D, E, G, A1 and A2 (with parts of B, C and A3). Arrow points north.

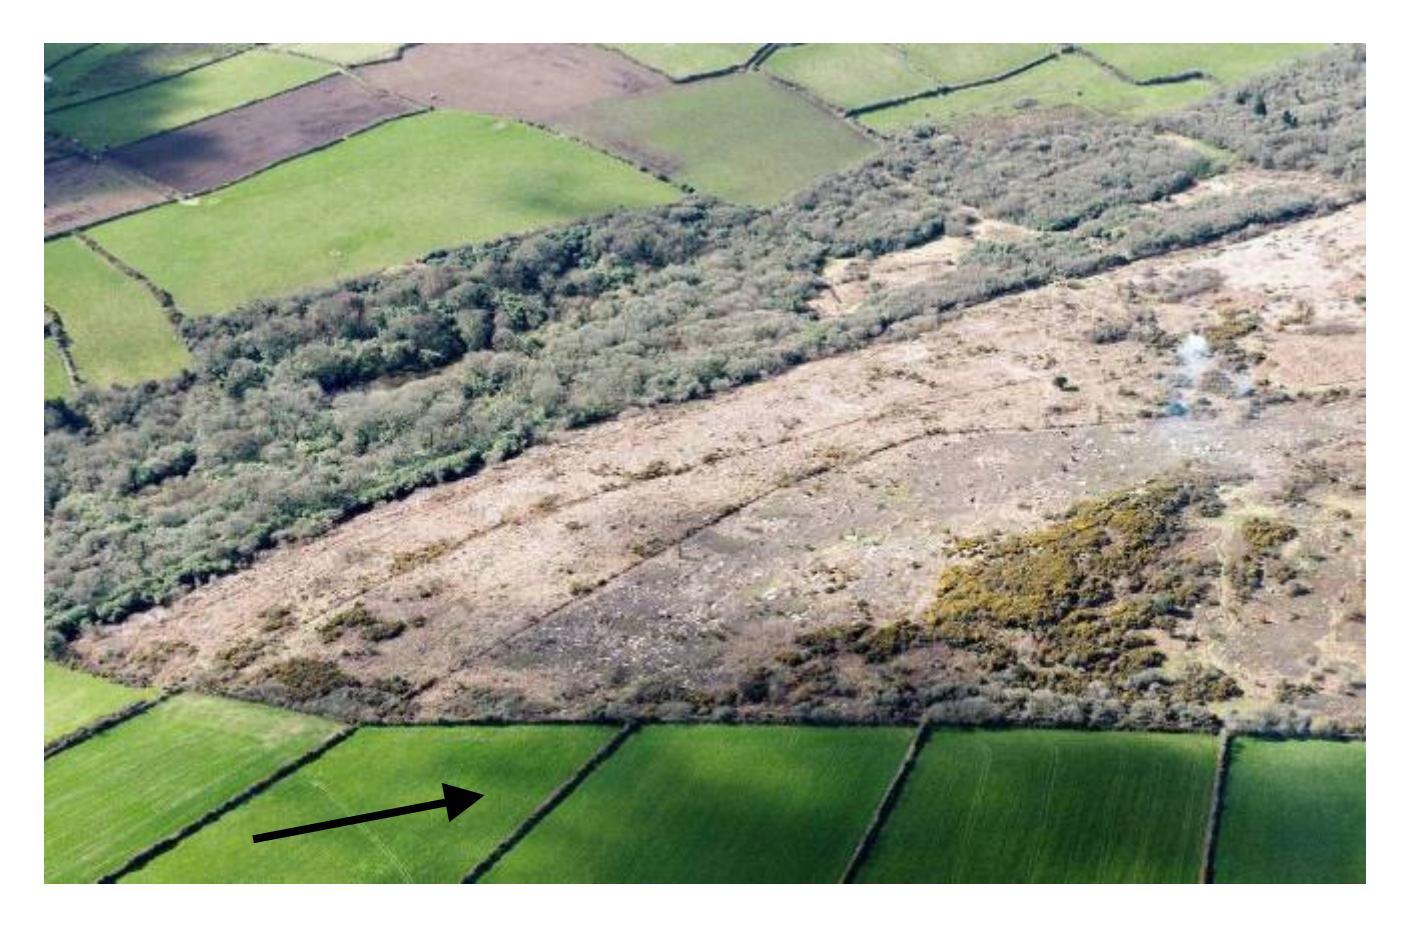
Fig 27 Aerial photograph taken in 2011 showing Area A3 and parts of A2 and E. Arrow points north.
