Report No: 2014R067

Trengwainton Carn, Madron, Cornwall

Archaeological watching brief and recording

Trengwainton Carn, Madron, Cornwall-2009 to 2014

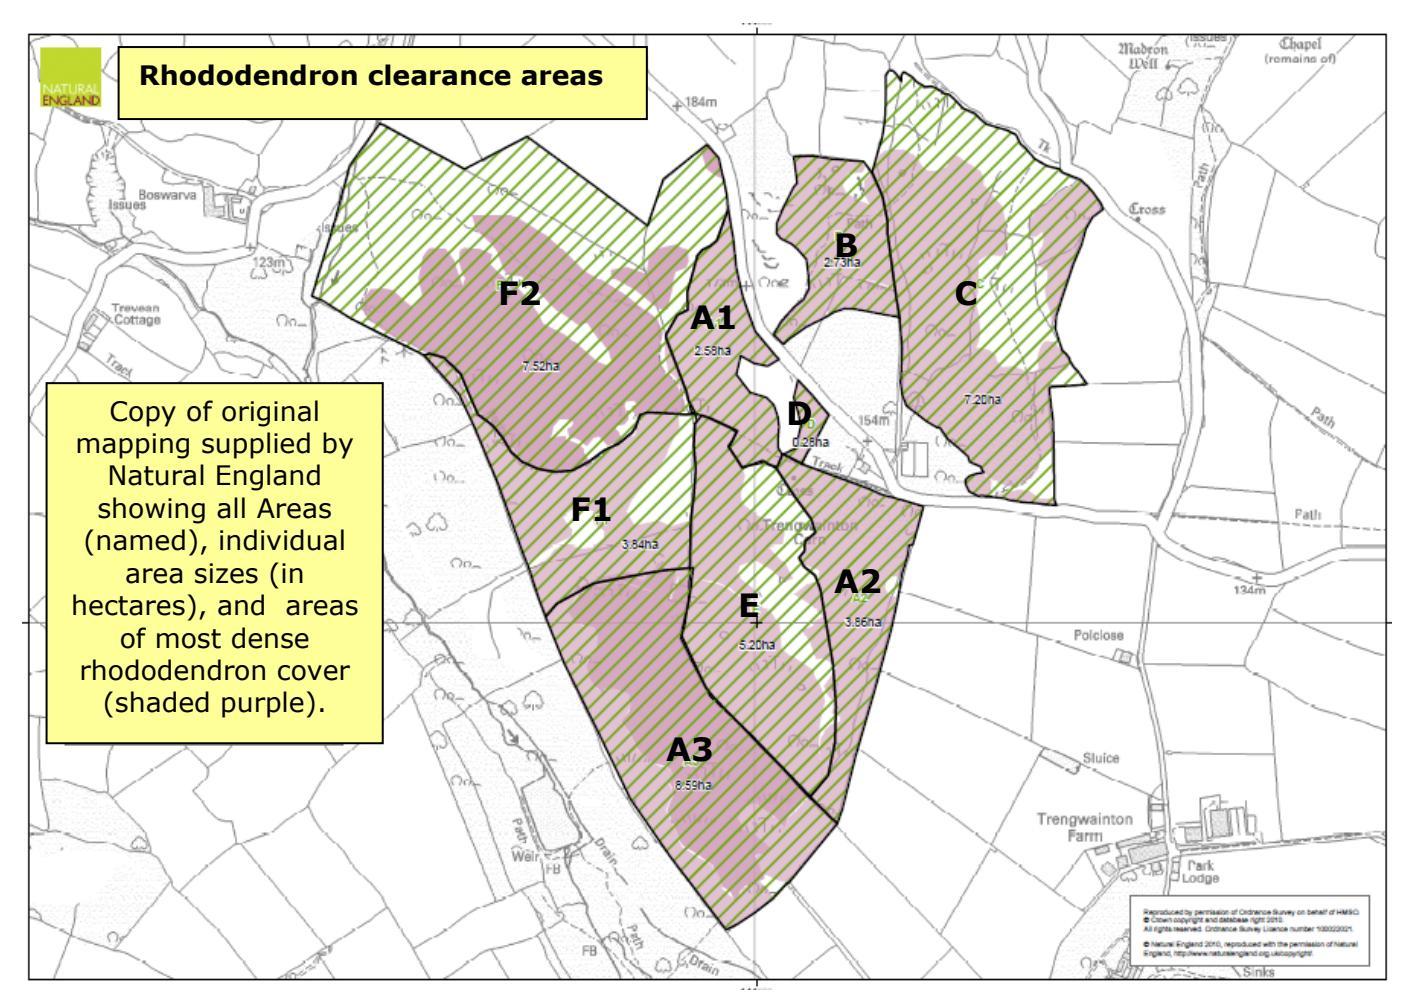
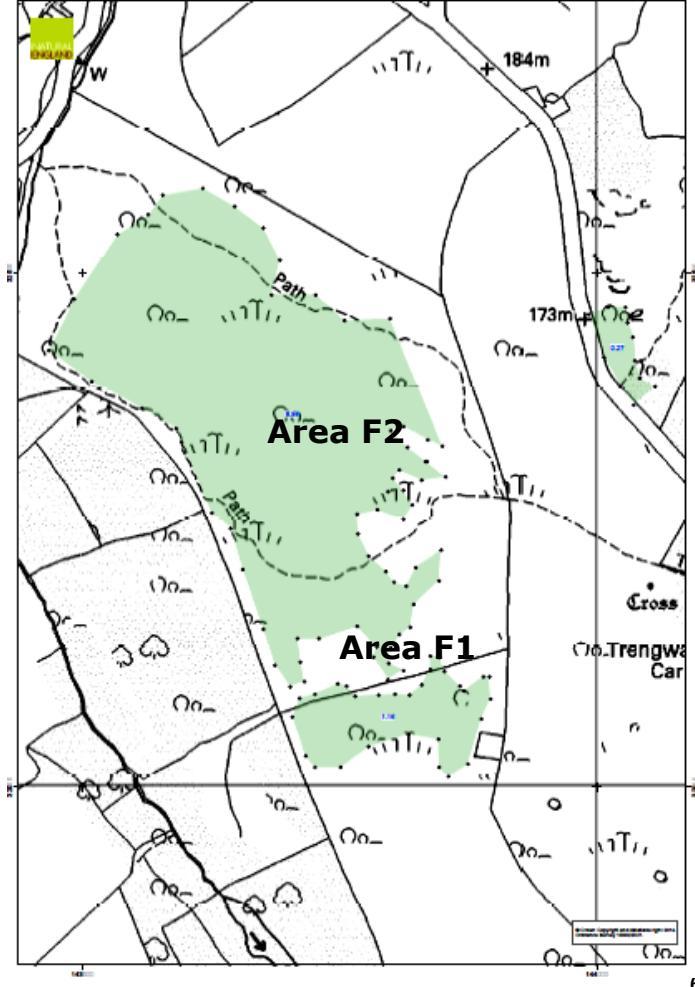
Fig 28 Top – The original Natural England plan for Rhododendron clearance works.

Bottom - The mechanically cleared areas within Area F1 and F2 (shown as green shading). Within these areas a very large number of small 1-2m high leaf litter dumps were created averaging 8-14m diameter.

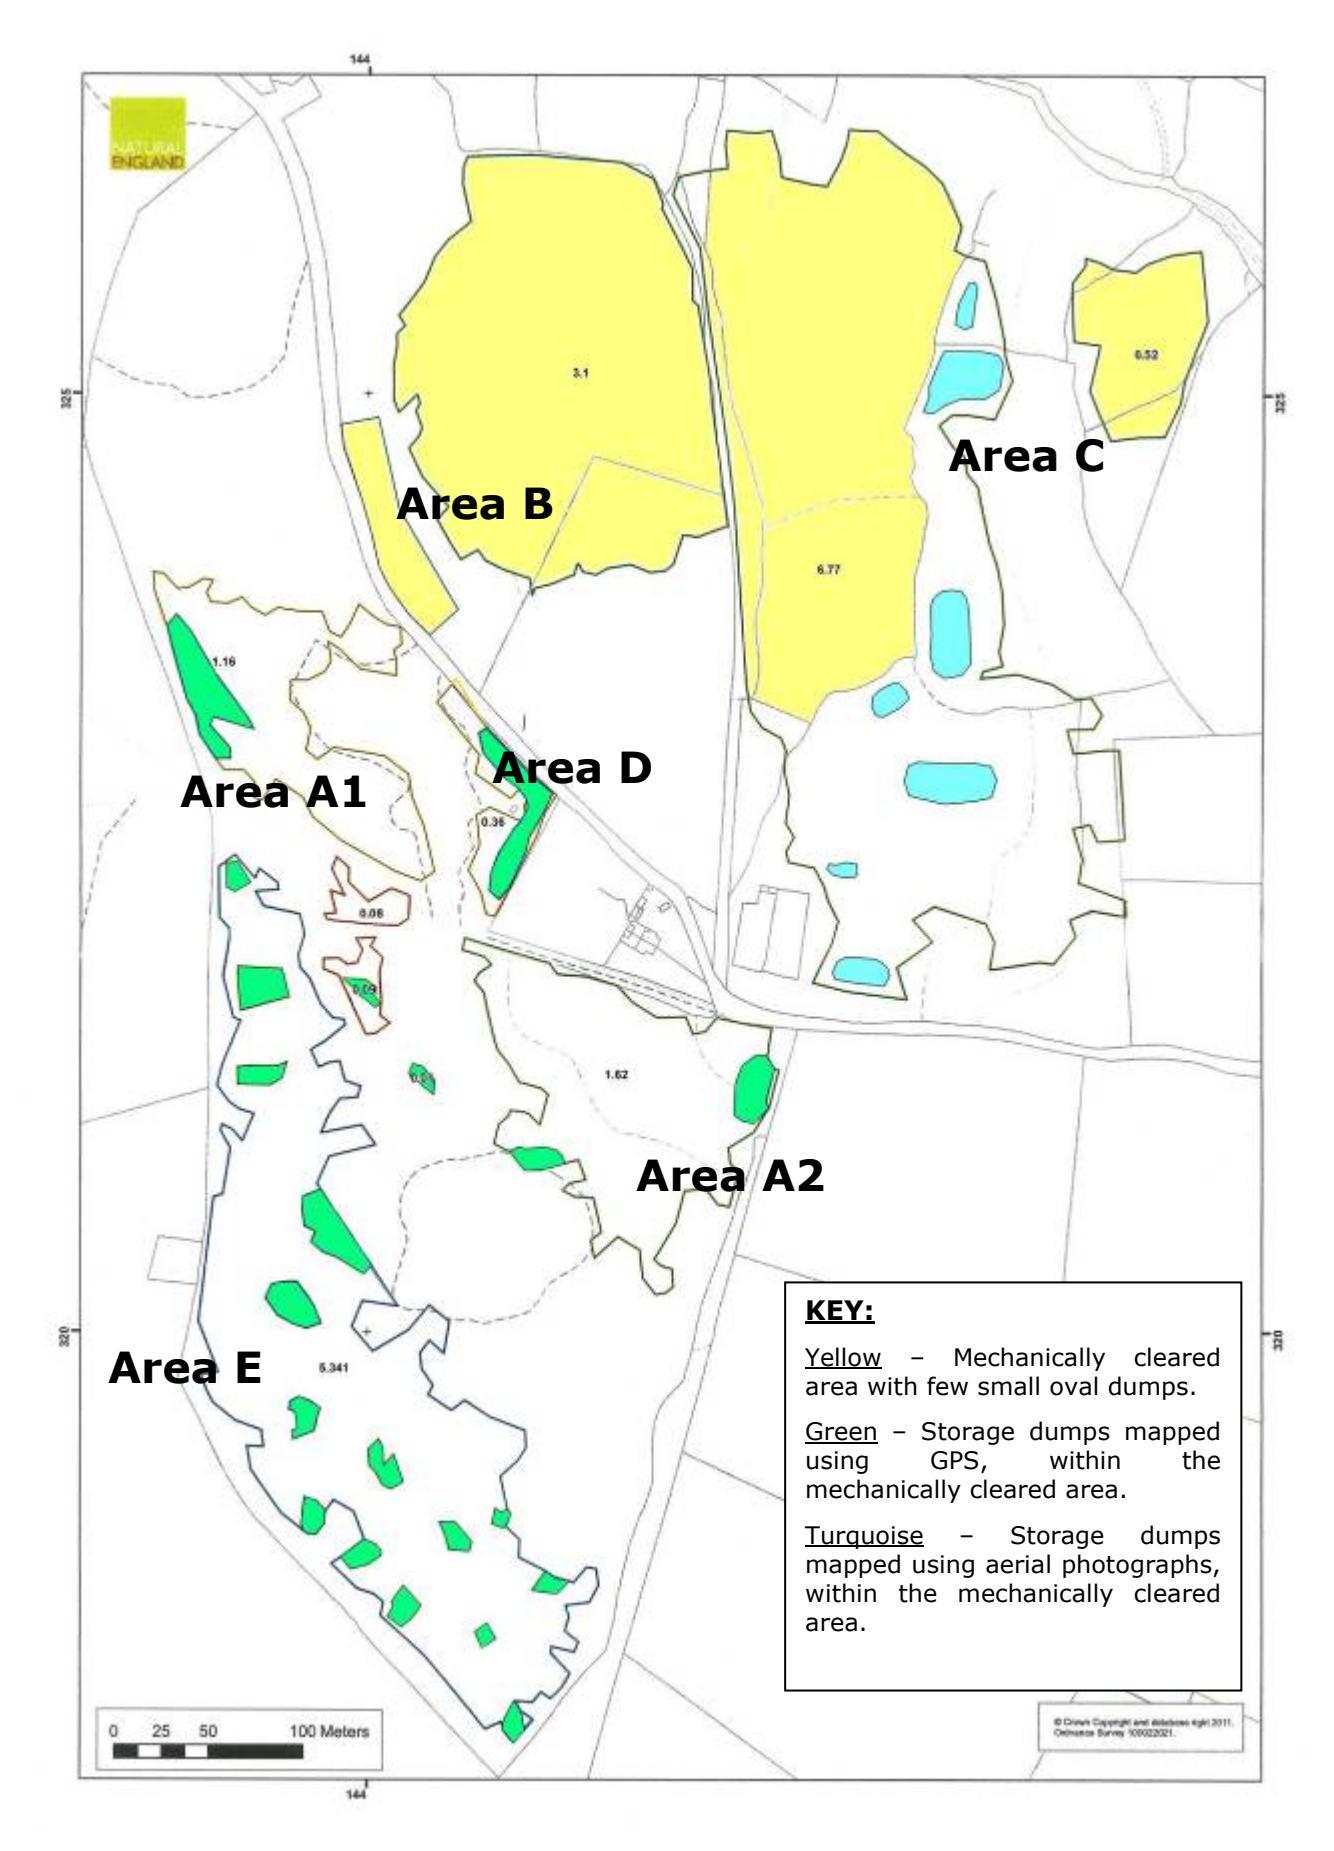
Fig 29 Combination map showing mechanically cleared areas and storage dumps within Areas A1, A2, B, C, D and E.
