Drakewalls Mine, Gunnislake, Cornwall Archaeological watching brief

Report No: 2018R025

Client	CORMAC Consultancy
Report Number	2018R025
Date	17 April 2018
Status	Final
Report authors	Ryan Smith and Adam Sharpe
Checked by	Dr Andy Jones
Approved by	Andrew Young

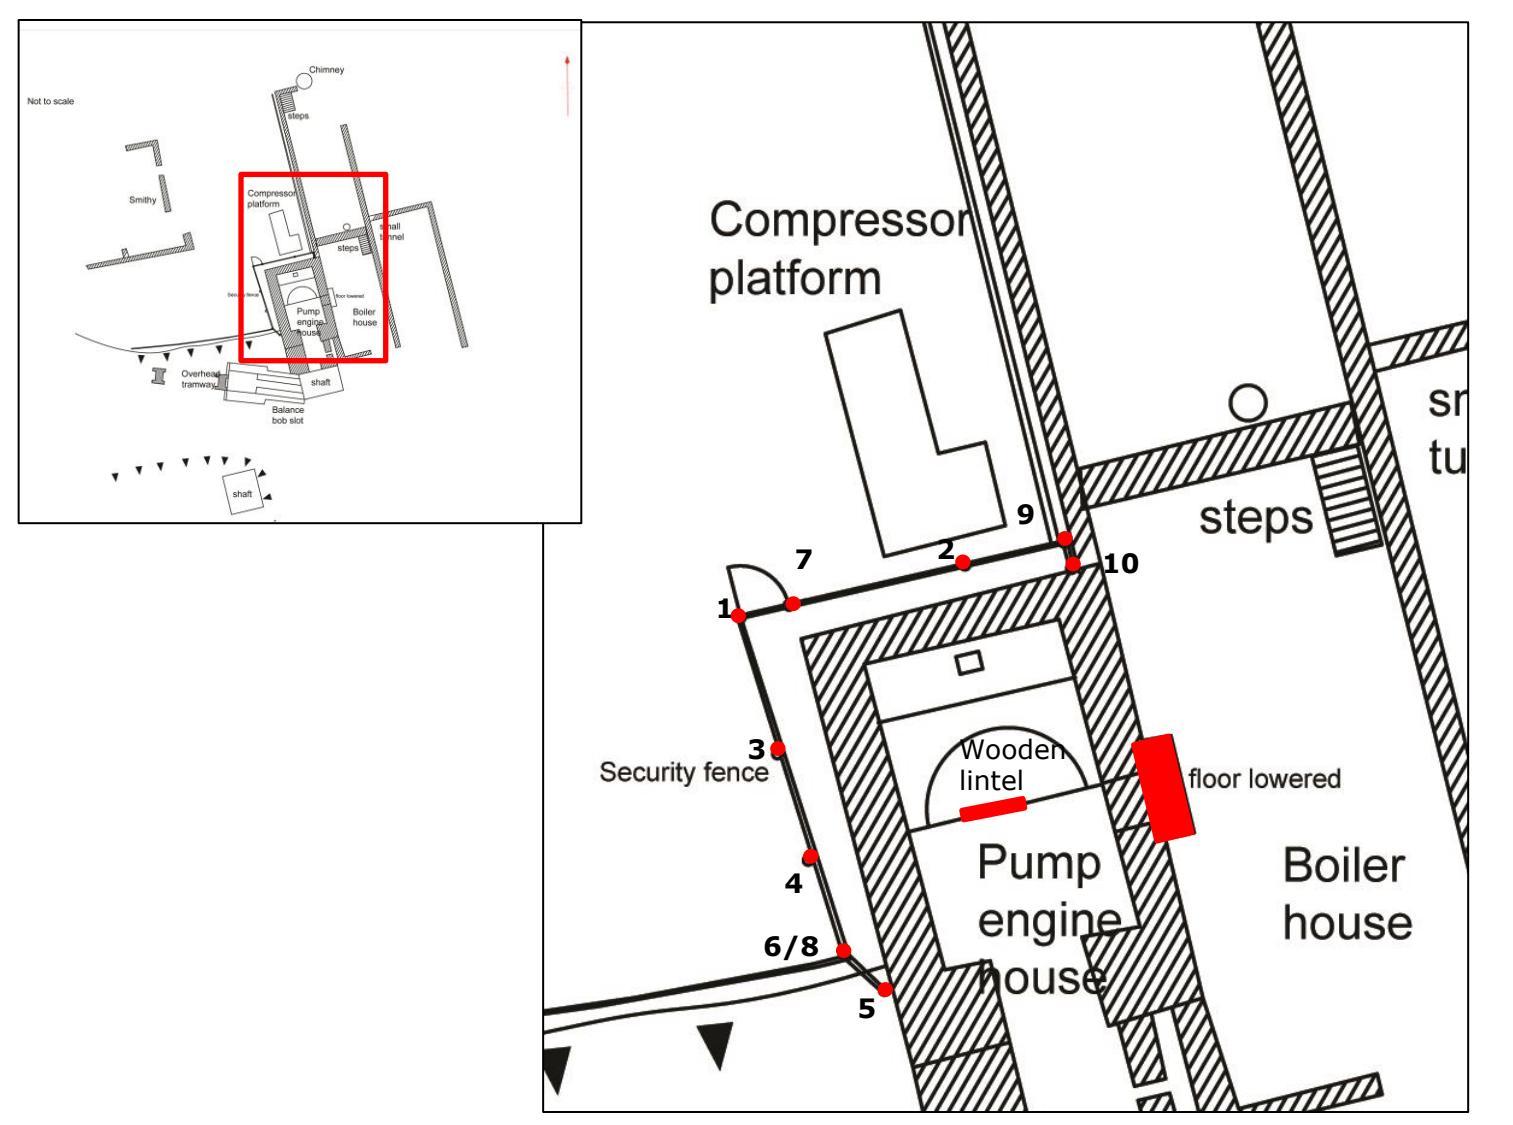
Figure 7: Location of postholes and the excavated area (shown in red).

Ten postholes (Figures 3 and 6) were excavated around the north and west perimeter of the engine house, seven of which were located one metre from the walls, the remaining three were excavated in closer proximity to them.

All pits were excavated by hand to a depth not exceeding 0.72m, but averaging 0.5m – 0.6m, dependant on location. No pit exceeded 0.3m in diameter. Once the post was installed into the pit, they were backfilled with a mix of Postcrete and water; once this had set the remaining space was backfilled with material removed from the posthole.

The corner post was set back by one metre from the corner of the north wall of the engine house. The topsoil (1001) was a dark deposit of decayed organics and vegetation, containing loose stones and some demolition rubble 0.2m deep. This overlaid deposit (1002), which was a yellowish brown clay soil containing some small fragments of stone; this appeared to be a natural subsoil but could be redeposited material. The posthole had a maximum depth of 0.72m

The topsoil was a dark deposit of decayed organics and vegetation with a depth of 0.15m; this overlaid (1003), a dark gritty sandy deposit made up of greyish stones, fragmented brick and decayed lime mortar. A large iron nut was recovered from this posthole.

The topsoil at this location was a dark deposit of decayed organics and vegetation, depth was 0.3m; this overlaid (1004), a dark yellowish-brown clay/soil mix which was loose and easy to excavate; it contained some smaller fragments of rubble. A small fragment of broken glass was observed within this deposit.

The topsoil was a dark deposit of decayed organics and vegetation with a depth of 0.15m; this overlaid (1005), a dark reddish clay/soil mix with small fragments of stone and brick, which appeared as a single deposit.

The topsoil (1006) was a reddish-brown loose clay/silt topped with vegetation and was 0.3m deep; below this was (1007), a darker greyish-black loose gritty soil containing some small fragments of stone. This posthole was excavated less than 0.2m from the wall of the engine house.

The topsoil here was a dark deposit of decayed organics and vegetation with a depth of 0.3m; this overlaid (1008), a yellowish-reddish brown clay/silt, incorporating fragments of stone and a single sherd of striped blue pottery and a lump of corroded iron which appears have been associated with the mine tramway.

The topsoil was a dark deposit of decayed organics and vegetation with a depth of 0.15m; this covered (1009), a layer of demolition rubble 0.2m deep incorporating fragments of granite, slate and other material associated with the engine house together with a gritty deposit which appears to be decayed lime mortar.

The topsoil was a dark deposit of decayed organics and vegetation, depth was 0.15m, this posthole was excavated alongside the retaining wall orientated northwest to south east. The lower fill (1010) was comprised of fragmented smaller pieces of stone and greyish grit associated with decayed lime ash cement.

The topsoil was a dark deposit of decayed organics and vegetation with a depth of 0.15m. This posthole was excavated near the junction of the retaining wall orientated northwest to southeast and the back wall of the engine house. The lower fill (1011)

comprised fragmented smaller pieces of stone and greyish grit deriving from decayed lime mortar.

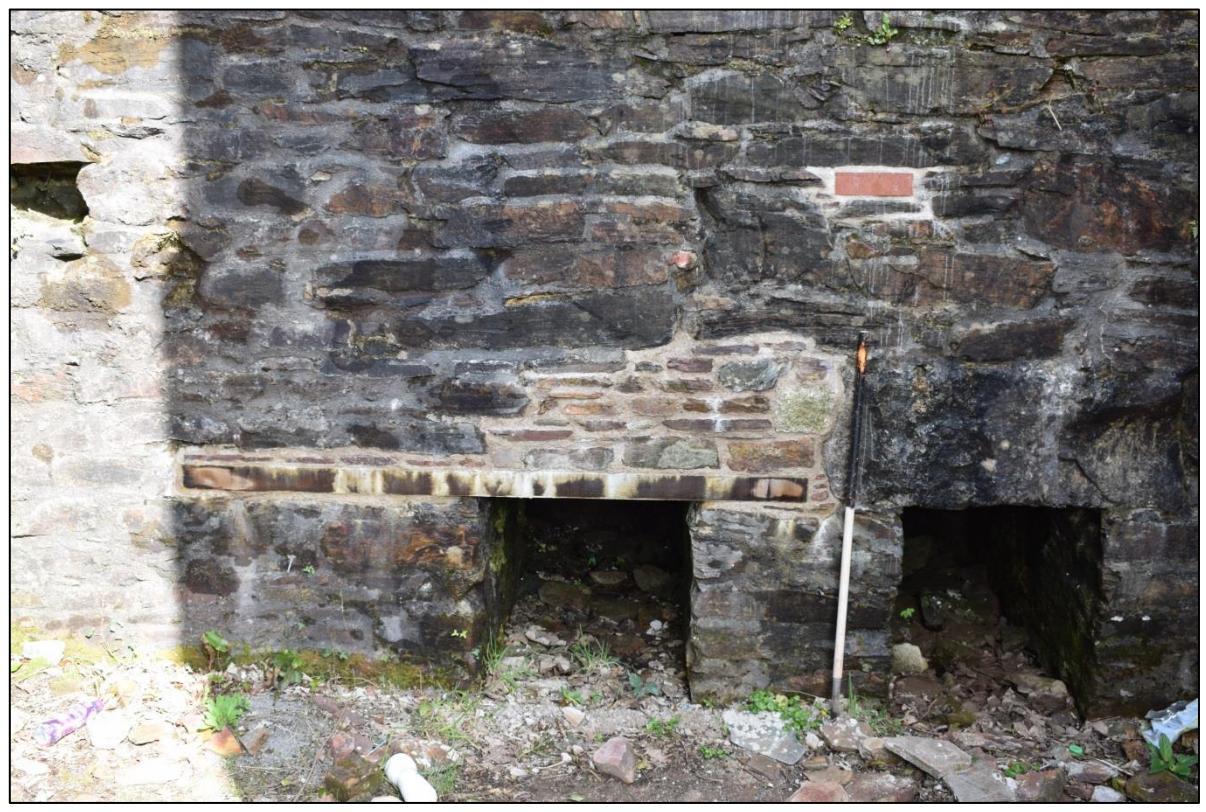
Figure 8: Lintel replacement and stone repairs carried out within the engine house interior.

In February 2018 CORMAC installed a new wooden lintel and repointed the interior wall of the main engine house (Figure 4).

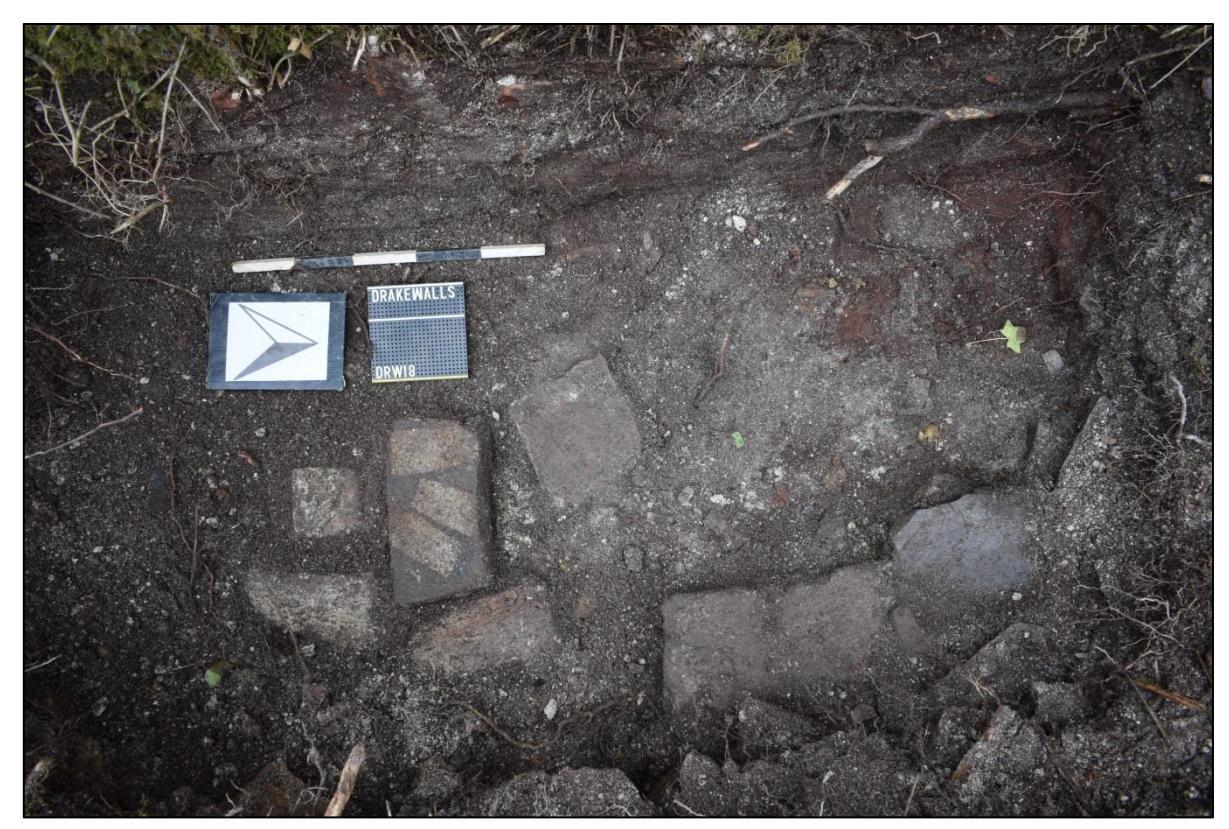
Figure 9: Possible wall remains associated with a side flue within the boiler house.

The brief for the boiler room floor was to lower the floor level underneath the wall opening so that it would be at least 2m from its cill over a length of one metre to each side of the wall opening; the edges of the excavated area were to be graded to gentle slopes.

Prior to excavation the cill of the wall opening was 1.6m above ground level, requiring a reduction in ground by 0.4m. Excavation revealed an area strewn with rubble (1012), but also part of a possible flue or drain; at 0.4m below the surrounding ground level several stones and bricks aligned north-south were revealed which appeared to have been bonded with lime mortar. The bricks [1013] appeared to represent the remains of a wall, possibly that bounding a boiler side flue, while to its south were several flat stones or purpose made tiles set in a bed of loose greyish gritty material which again appeared to be decayed lime mortar. To the north of the eastern end of the wall was an area of red silty clay (1014); an area 0.4m wide and 0.7m long was exposed at the northern edge of the excavation. Finds from this area were all of post-medieval/modern date and included the neck of a glass bottle, an iron bolt and a sherd of white glazed ceramic (see finds list in Appendix 2).

Landscaping of the some areas of the site such as within the buildings appears to have been more limited. The presence of a surviving brick floor and the low wall possibly relating to the Smithy to the north west of the engine house indicate that archaeological remains survive relatively undisturbed within this part of the site. Other buried features associated with the boiler house such as the boiler beds and flues may well therefore survive *in situ*.

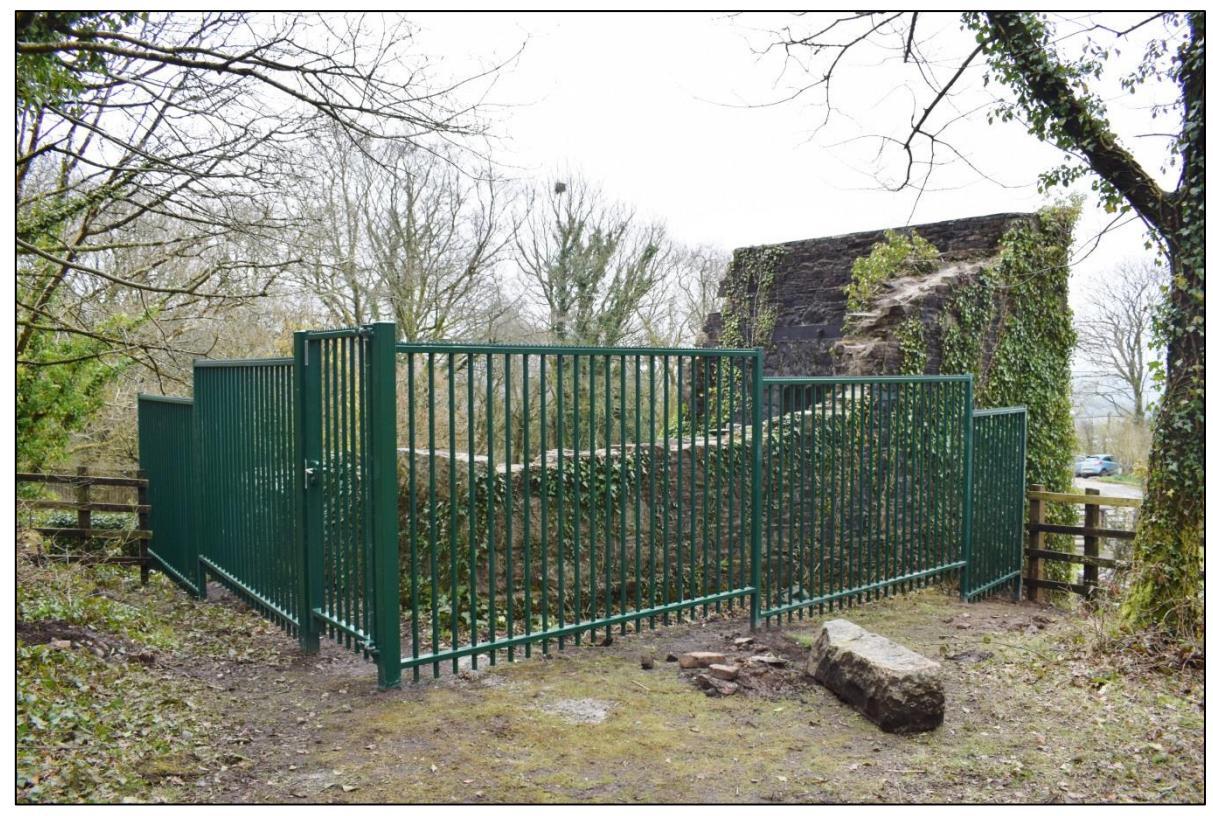
Figure 10: Security fence installed to the rear and side of the engine house.

- Preventing access onto the structure from the rear by installing permanent fencing.
- Preventing access into the structure via the eastern low level wall opening by lowering ground levels adjacent to this feature.
- Restricting access into the structure from the front by installing permanent fencing.
- Removing rubble from the interior of the building and disposing of this at an appropriate location.
- Installing a new wooden lintel within the interior of the building and undertaking minor patch repairs to the fabric of the building.
