Evaluation, building recording and watching brief at Warner Village Cinemas, 37-55 Friar Street, Worcester

Scheduled Ancient Monuments: Here and Worc 285f and 343d SMR references: HWCM 24905, WCM 100198 and WCM 100525

Project P1511 & P1541 Report 855 791

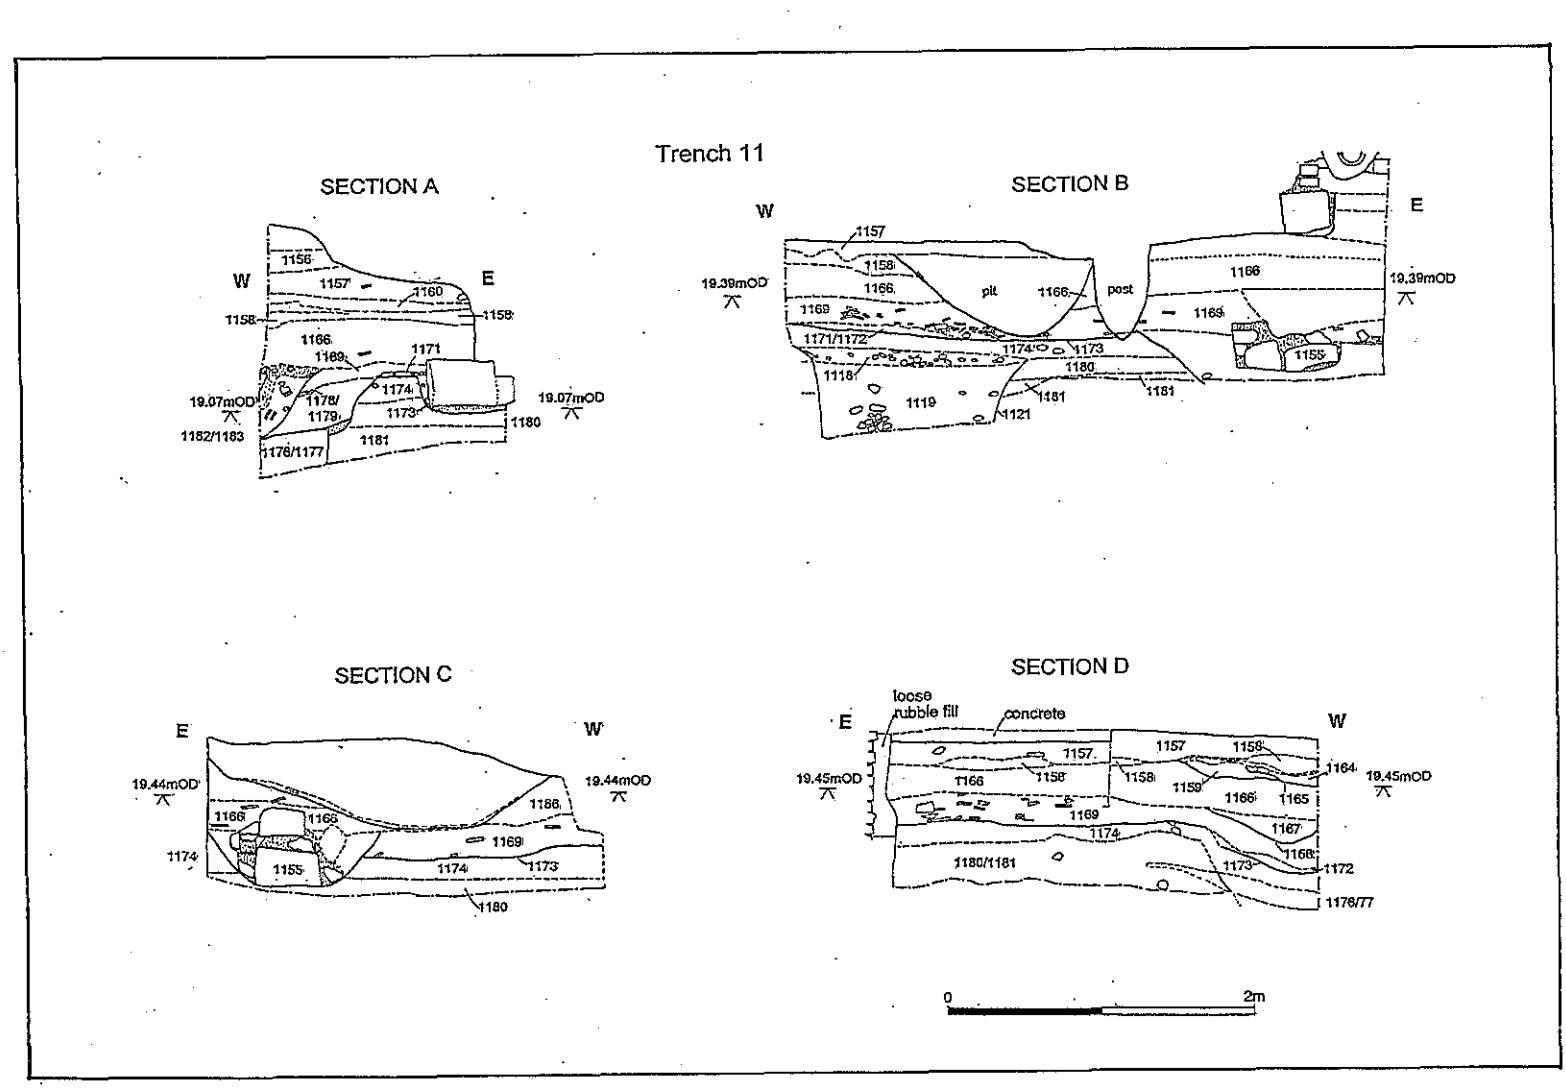
Figure 21: Area 1, Trench 11 sections (see Fig 18 for locations).

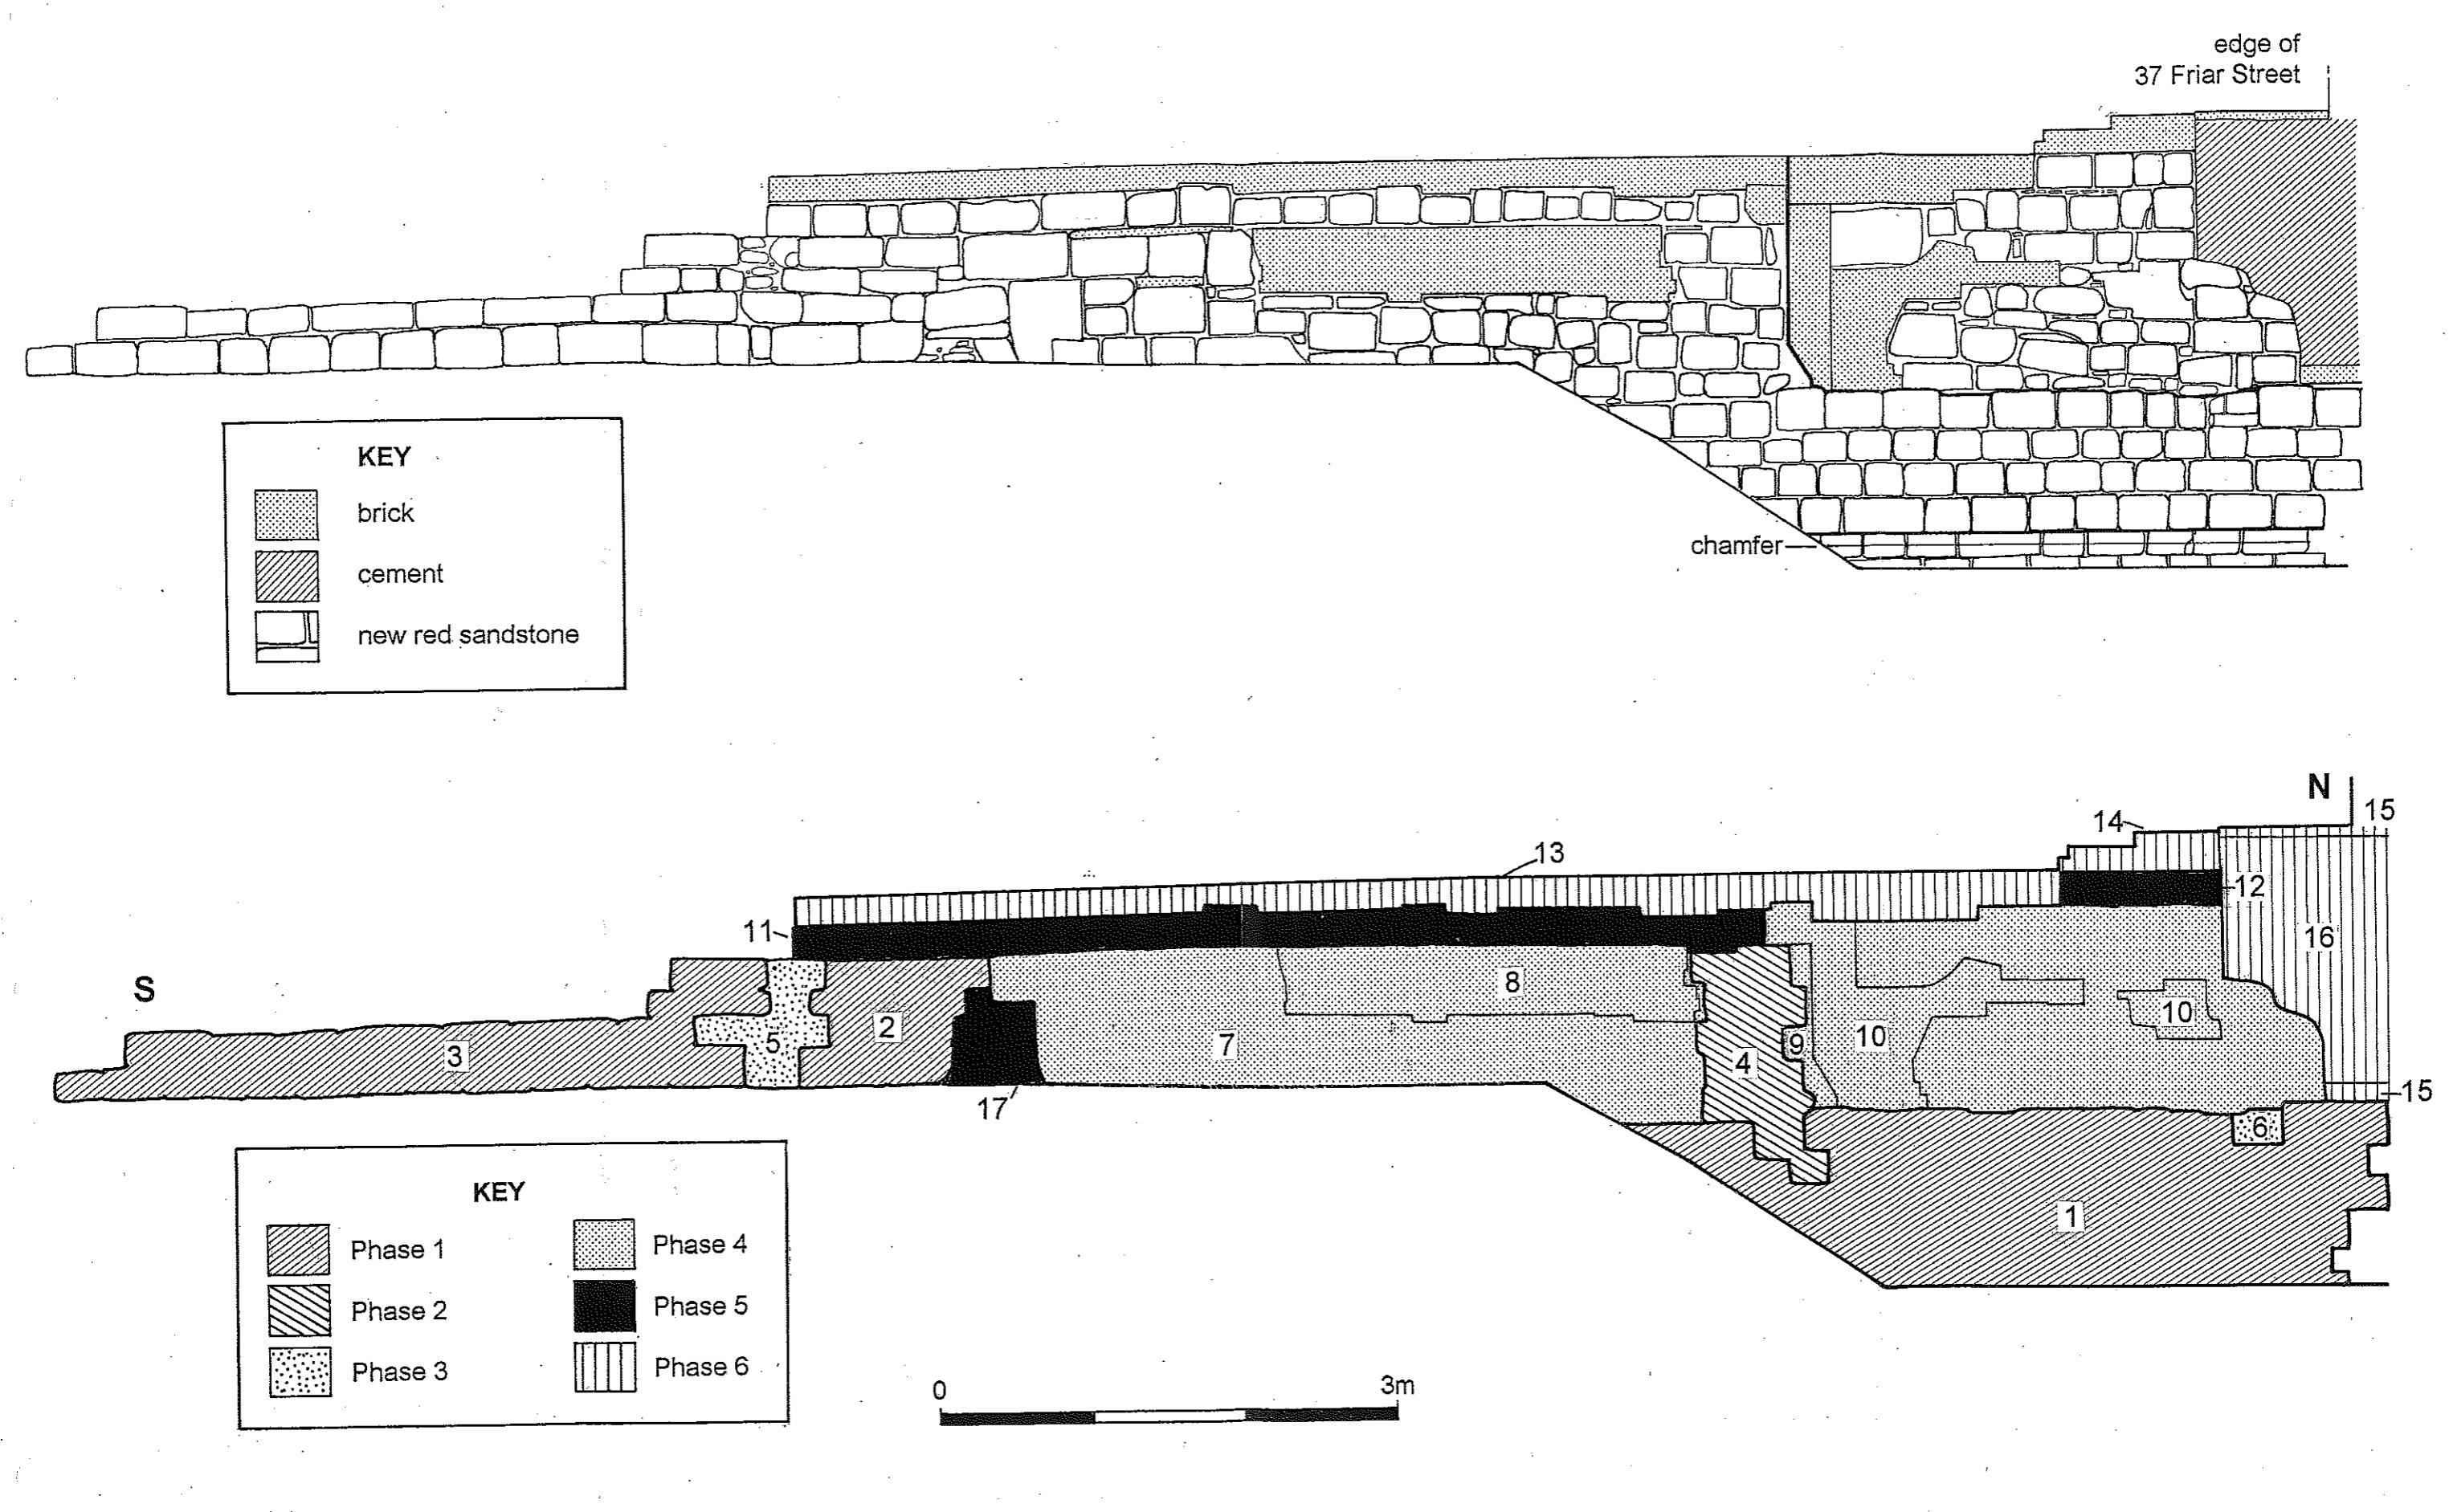
Figure 22: City Wall elevation.

EAST-FACING ELEVATION

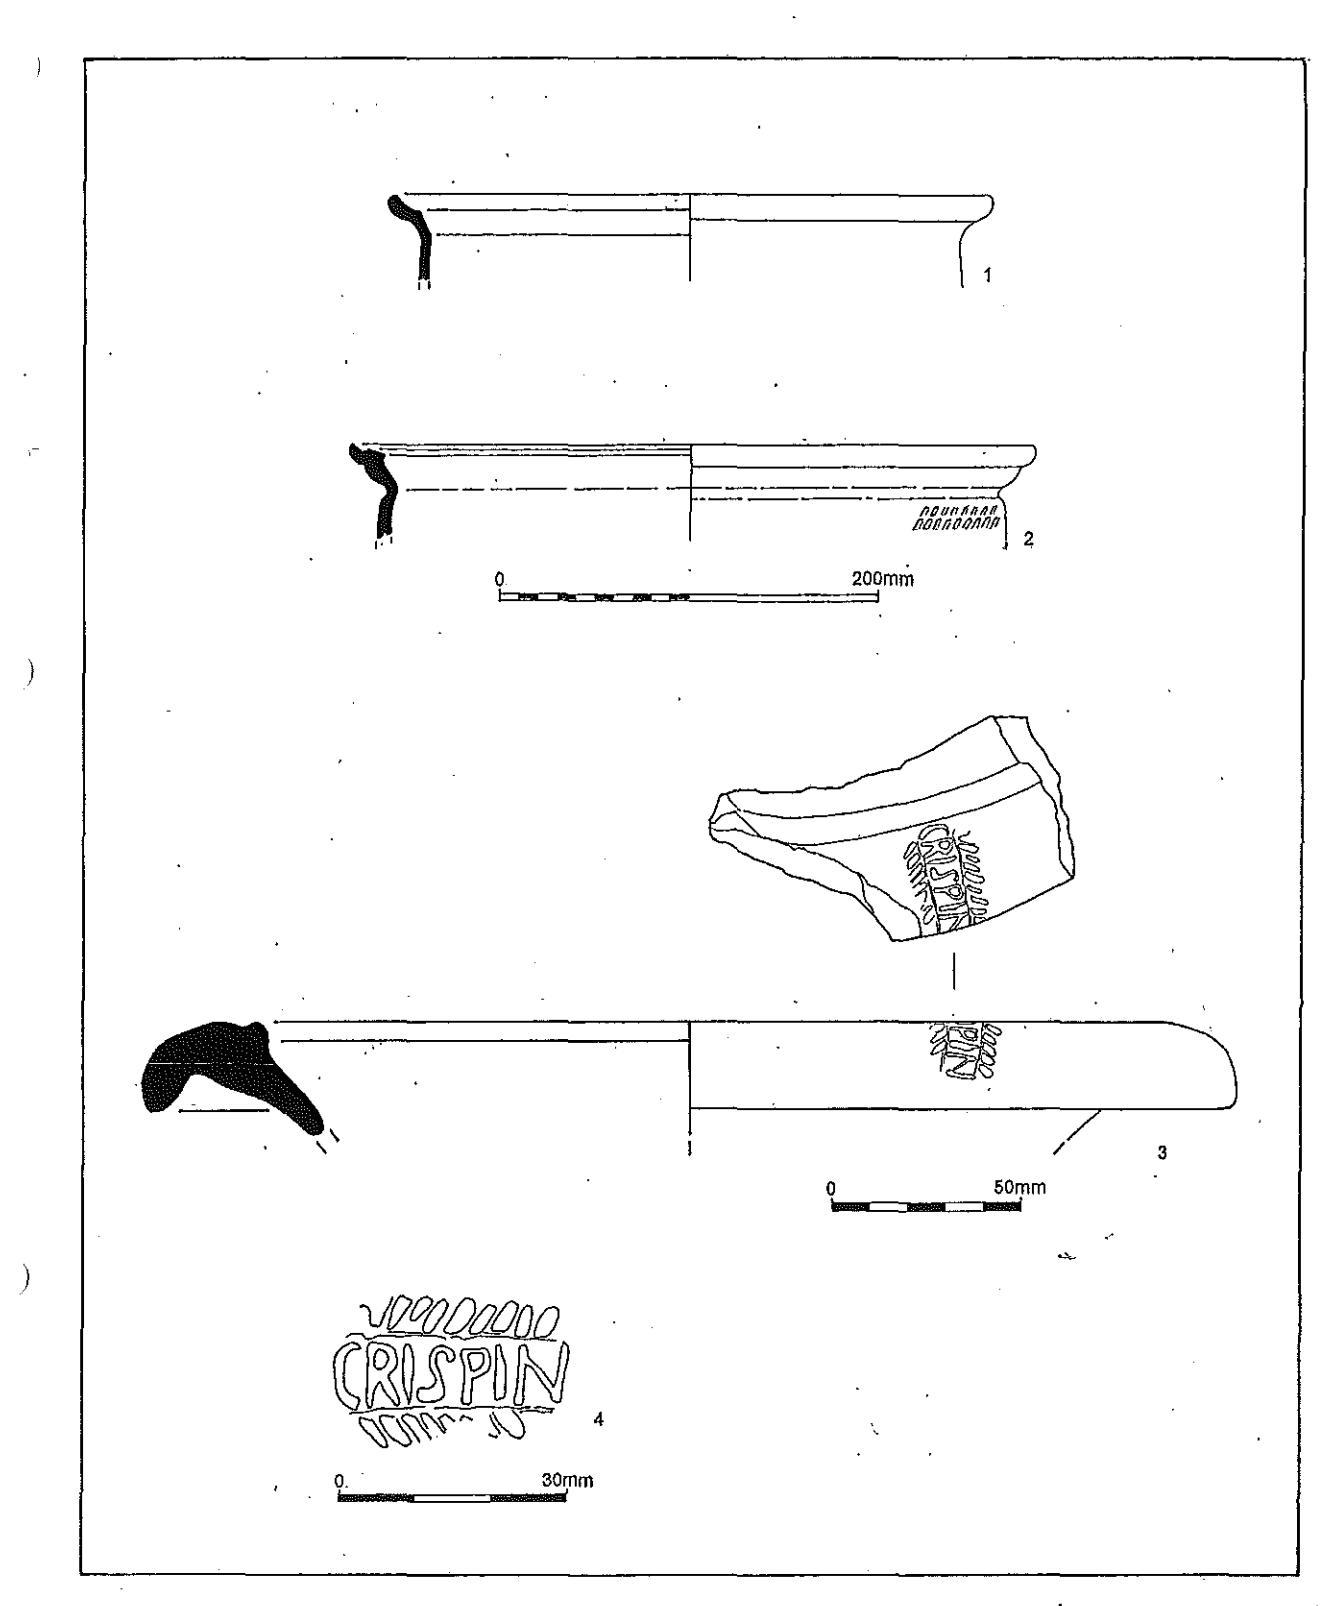
Figure 29: The pottery: 29.1, rim of cooking pot (fabric 64.4, context 1117); 29.2, rim of cooking pot (fabric 55, context 1288); 29.3, rim of mortarium displaying maker's stamp (context 1113); 29.4, detail of maker's stamp.

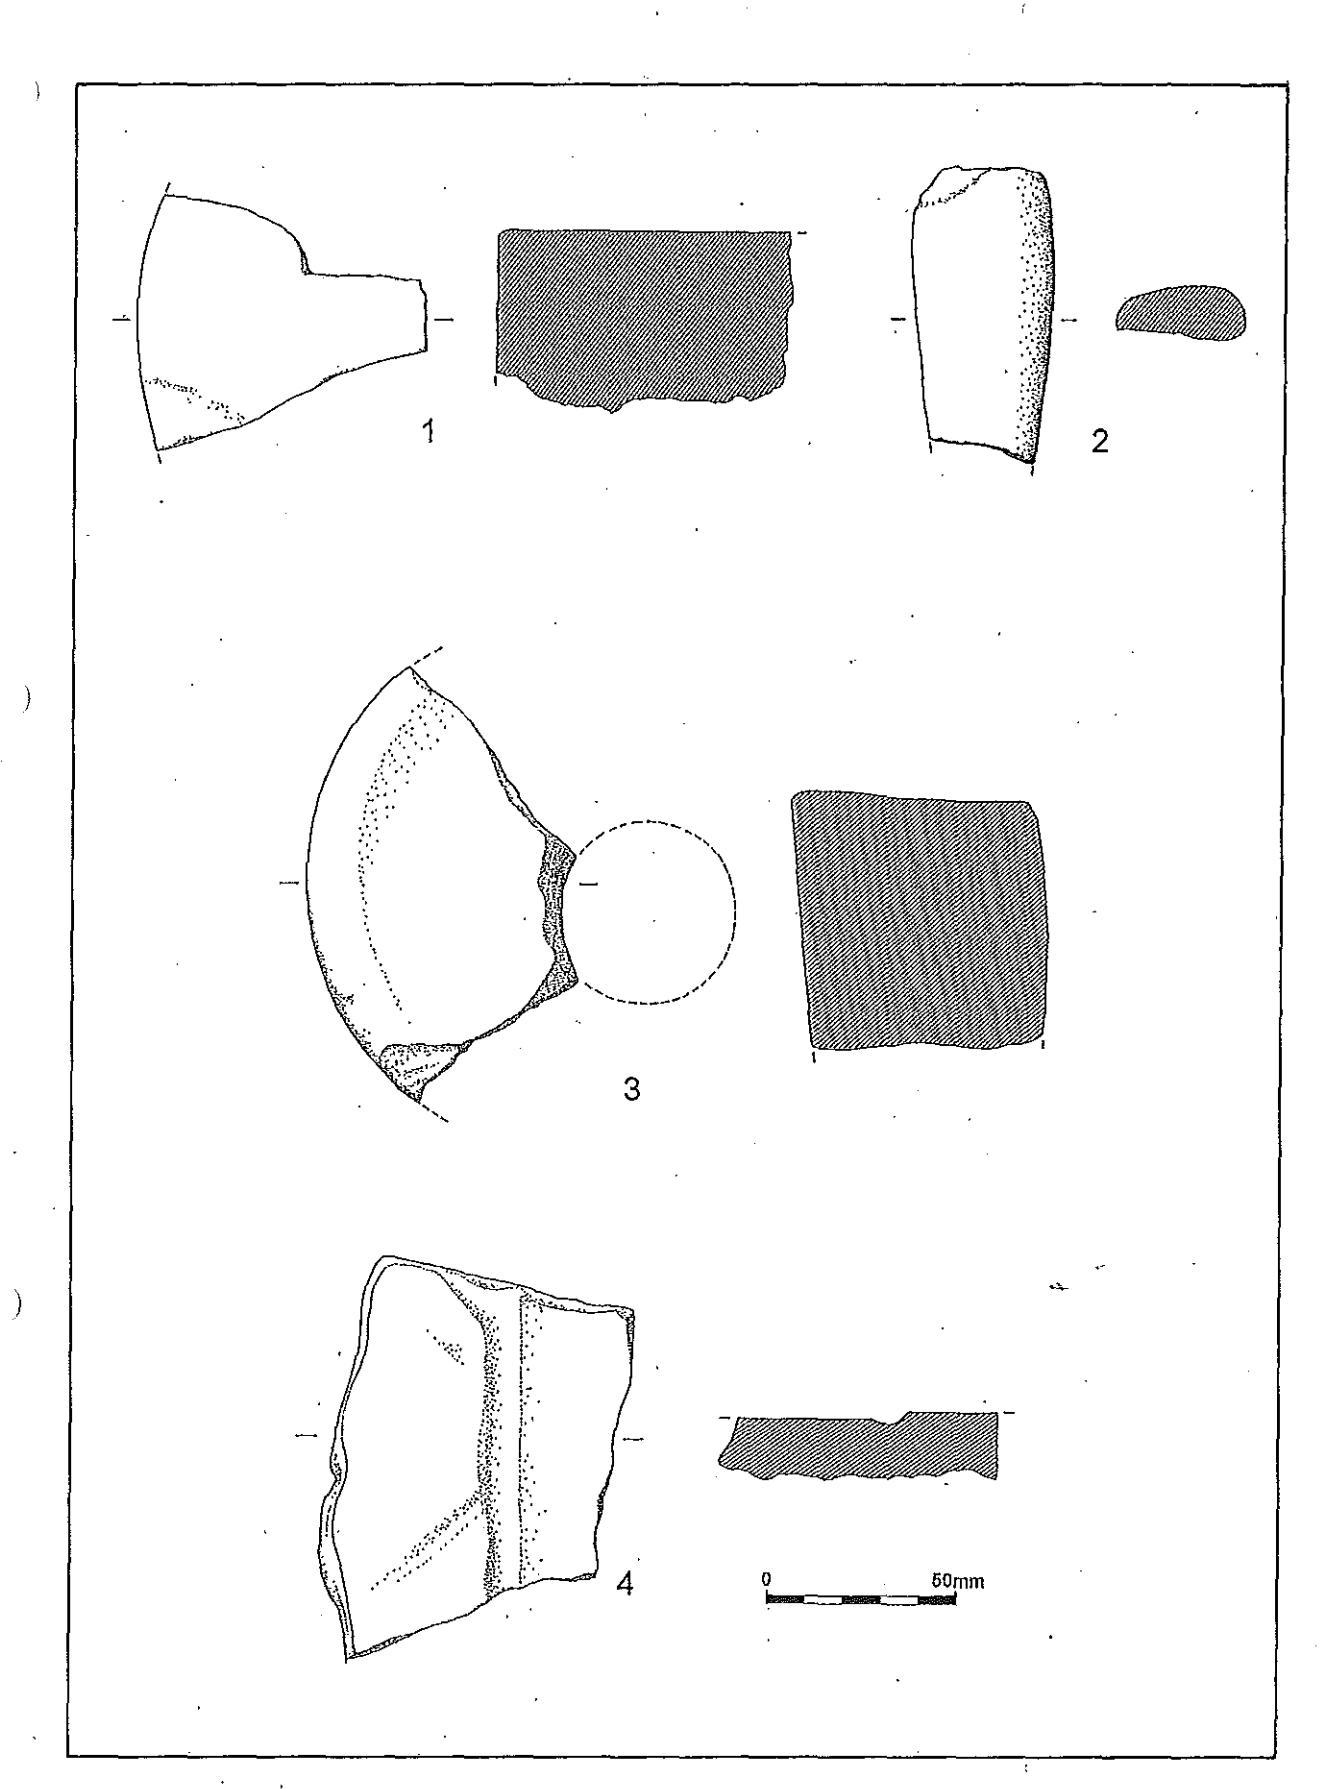
Figure 31: Worked stone: 31.1, fragment of a thick lias slab, originally circular; 31.2, fragment of Norwegian Rag whetstone; 31.3, fragment of a grindstone (grey micaceous sandstone); 31.4, lias slab used as a point sharpener.

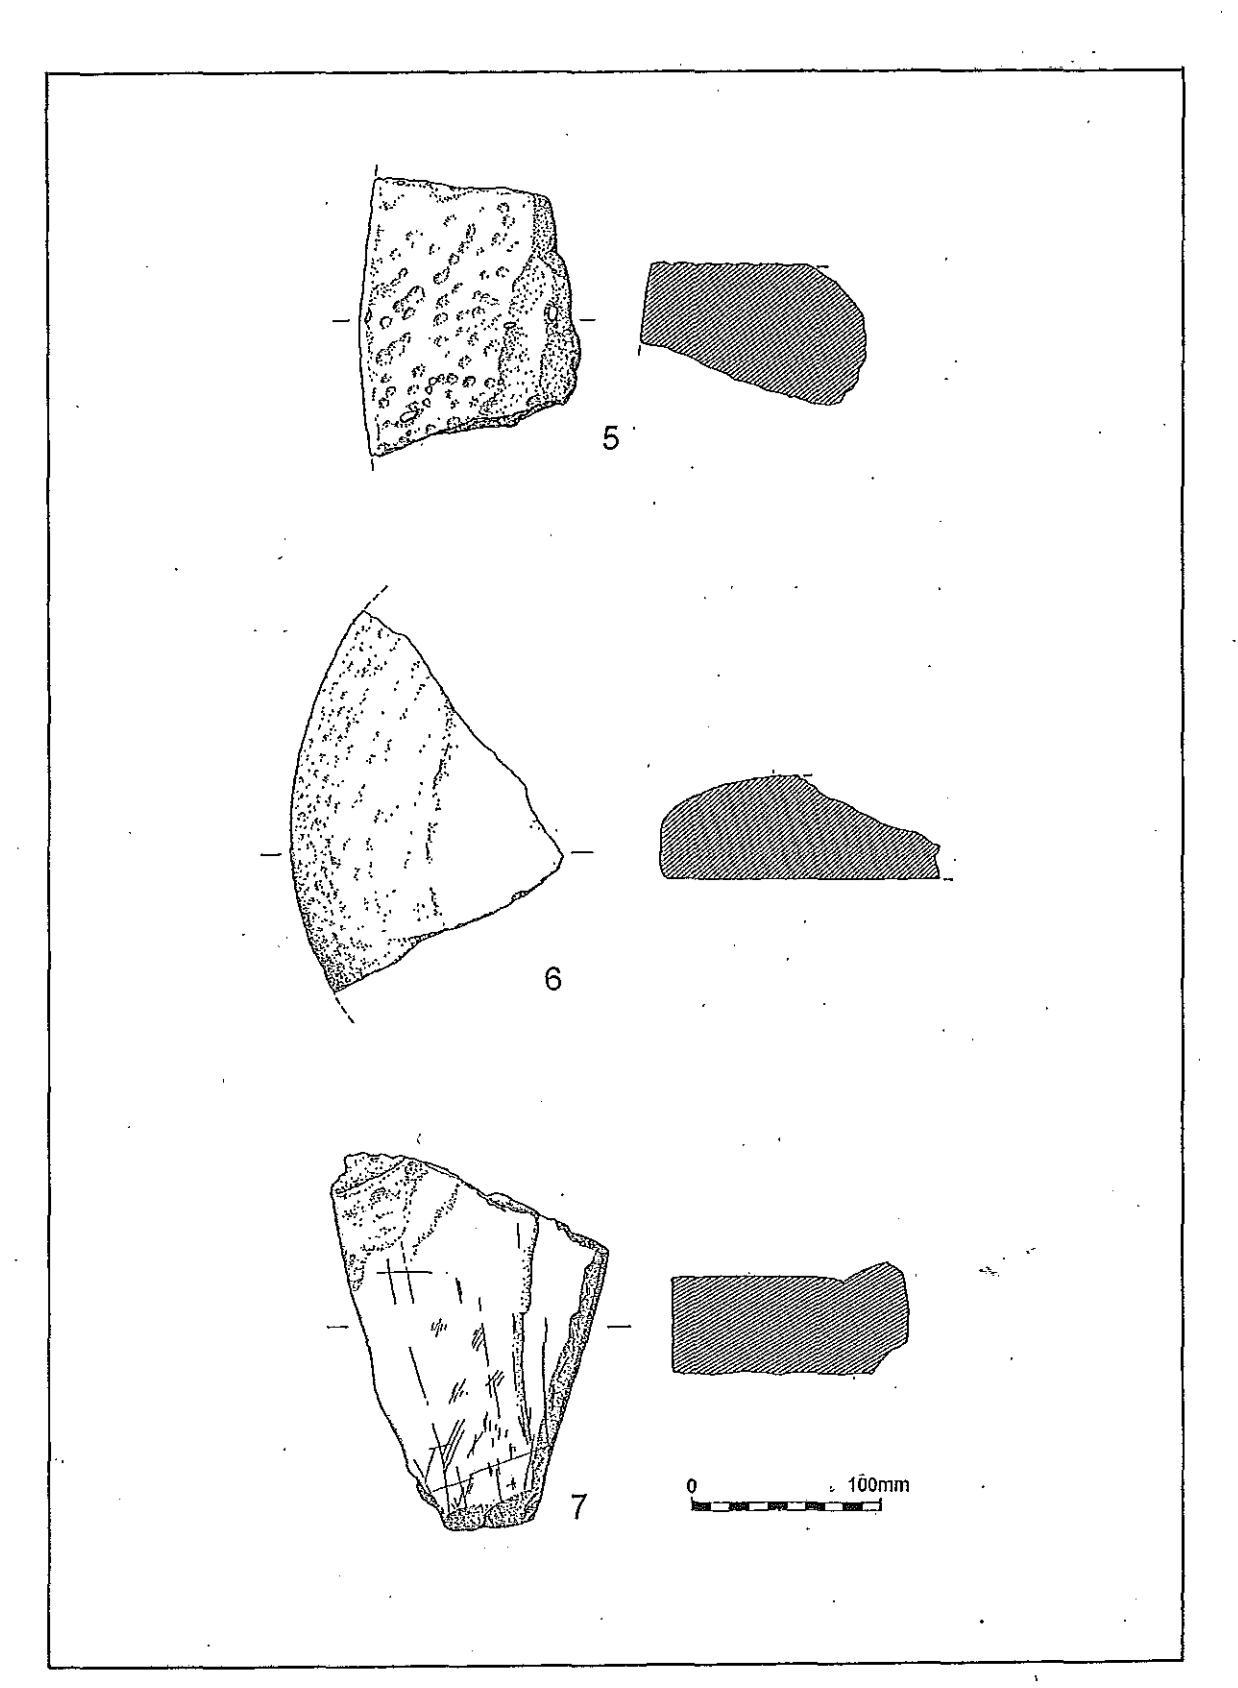
Figure 31 (continued): 31.5, fragment of burnt sandstone rotary quern; 31.6, fragment of red sandstone rotary quern; 31.7, slab of limestone used as a point sharpener.

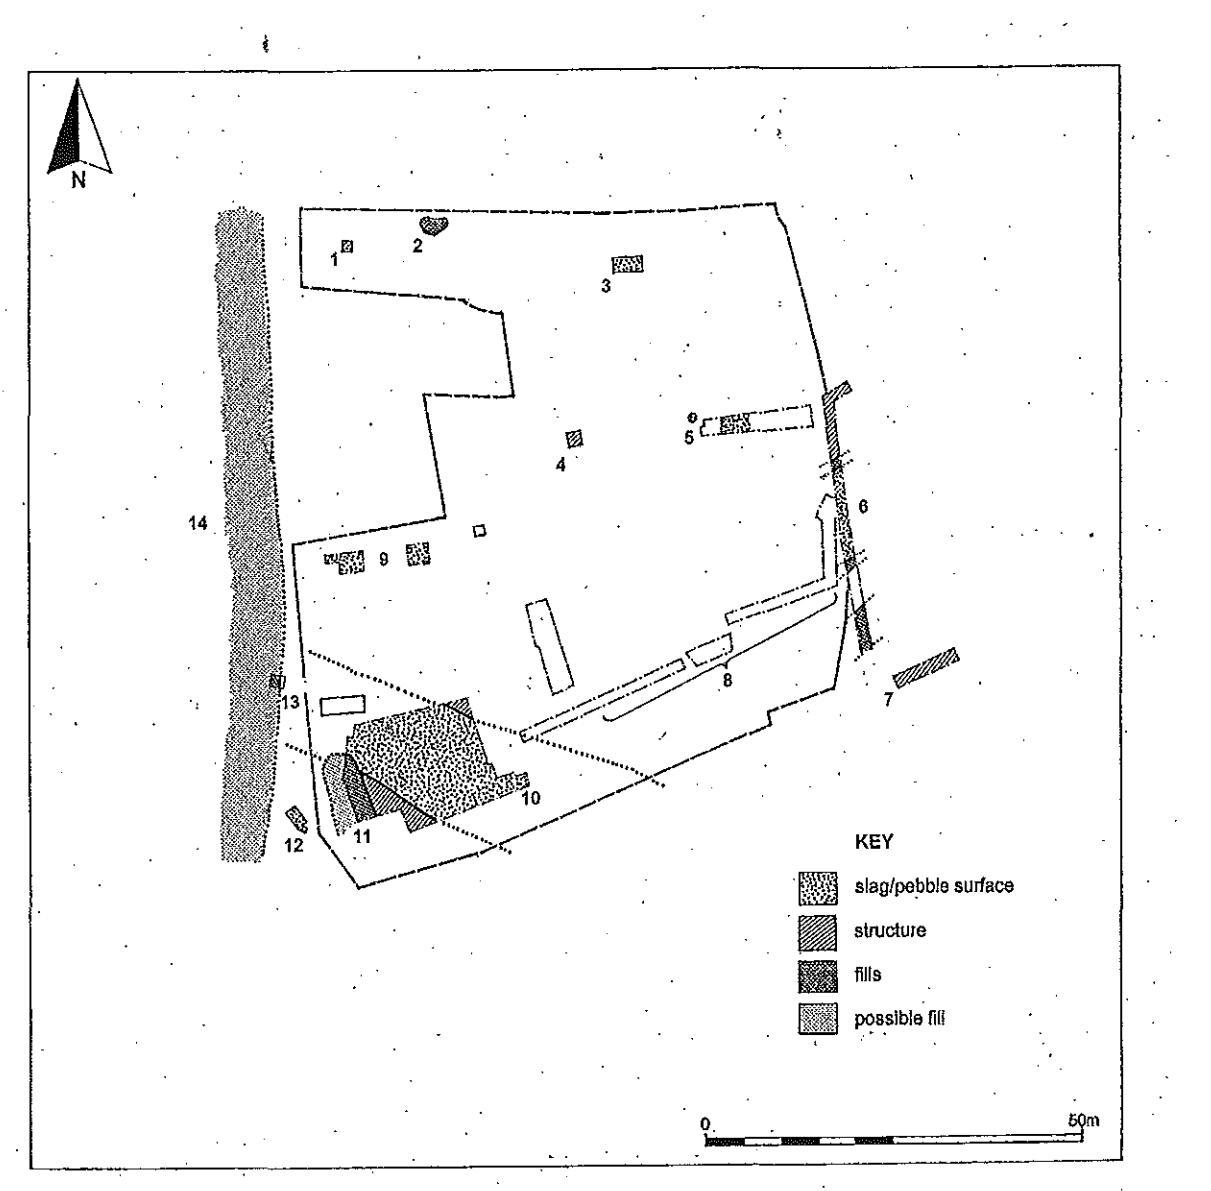
Figure 32: Summary of Roman deposits

- 1: 1st/2nd century pebble surface (Trench 5)
- 2: ?early Roman groundsurface overlain by dumped deposits (Trench 11)
- 3: 1st/2nd century pebble surface with ruts (Trench 2)

- 10: 1st L3rd/E4th century activity sequence of road surfaces with associated timber structures. Both industrial and domestic activities (Carver 1976-77)

- 11: Substantial 1st century ditch (Carver 1976-77)
- 12: Roman iron slag surface (Trench 17)
- 13: Substantial cut feature ?edge of ditch (Trench 18)
- 14: Projected alignment of Roman defensive ditch (Barker 1969 ditch "b")
