The recent archaeological watching brief conducted by Mr.K.J.Cale on behalf of Harrogate Borough Council at High Bridge, Knaresborough, confirmed that the present ground levels across this scheduled ancient monument had been largely formed by the deposition of recently imported sandy clays and hardcores, it is suspected that the majority of which were deposited during and following the major alterations to the bridge during the 1920's. These deposits have since been subjected to a high level of disturbance relating to the installation of an intense network of services that include major water and gas mains together with electricity and telecommunication cables and a complex surface water drainage pattern.

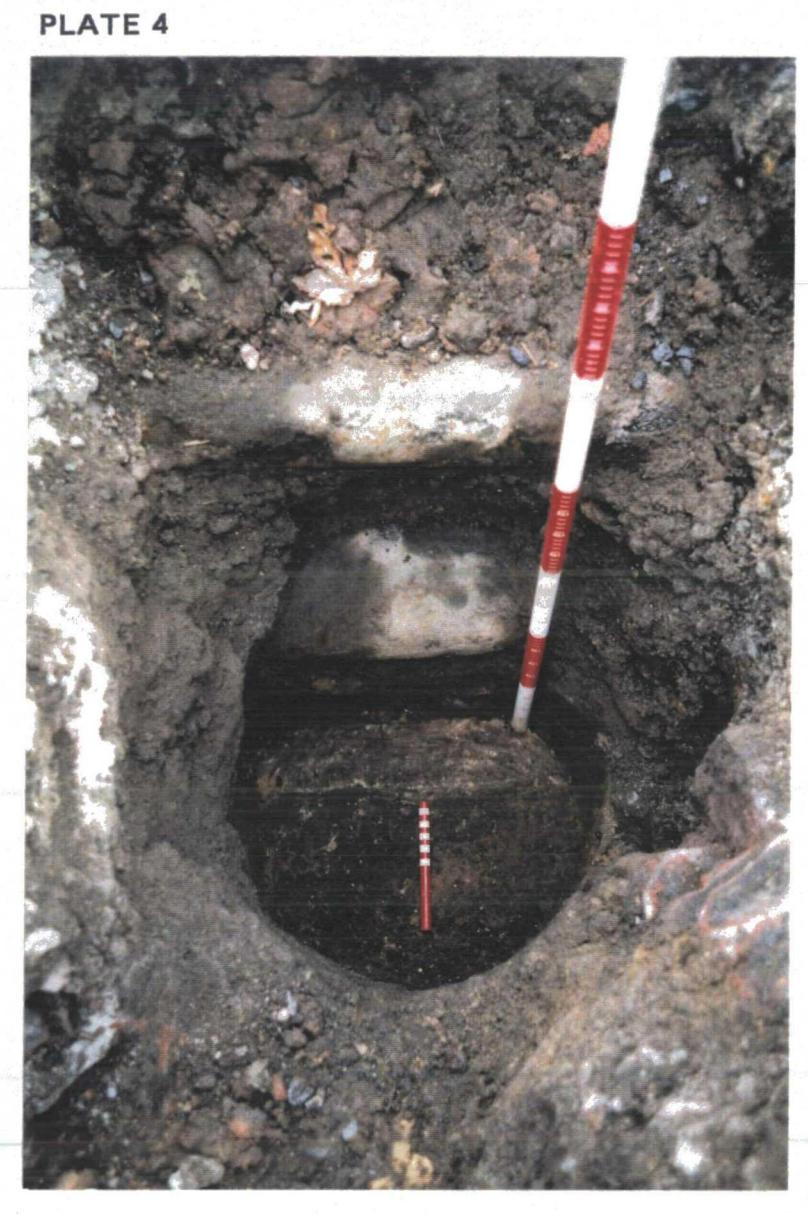
Feature A, dressed magnesian limestone masonry

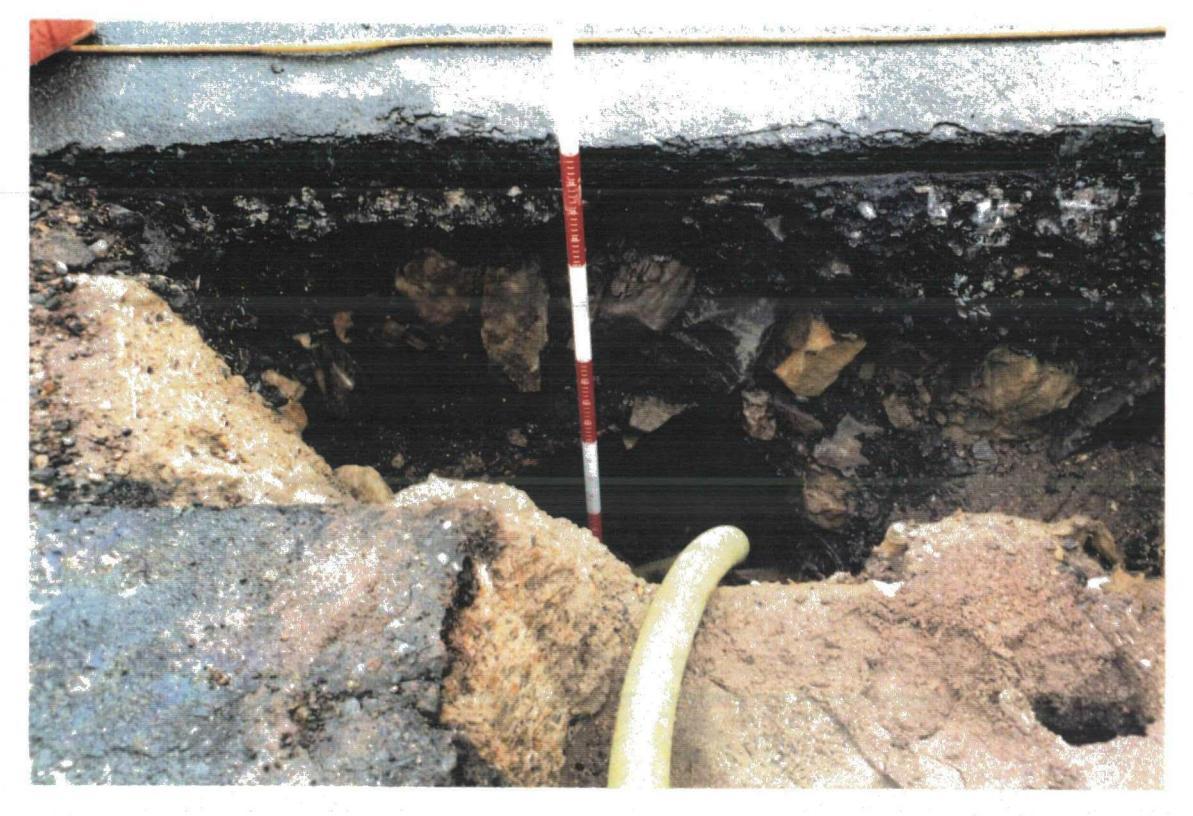
PLATE 6

an arrangement of sandstone setts, revealed in the west facing section of the exploratory sondage, area C. The setts were arranged end to end and bedded within tarmac scuffing's, and were butted to the buried west facing elevation of the 18th Century bridge. The setts had been subjected to a high level of settlement, this was compounded by more recent disturbance associated with the recent water action within sondage which had undermined this feature.

This former road surface was laid during the 1920's and associated with the most recent extension to the bridge.

Features C and D, the west facing elevation of the 18th Century bridge

the smoothly dressed sandstone masonry of the west facing elevation of the late 18th Century bridge were revealed during the excavation of area C. Three courses of masonry made up of dressed sandstone blocks each measuring 70 x 30cm in size were exposed in the west facing section of the elevation. Unfortunately the unstable nature of the sections of this sondage as a result of overnight water action meant that a detailed inspection of this fabric was unsafe. However it could be confirmed that the facing stones of the western elevation of the 18th Century bridge were not removed prior to the construction of the early 20th Century extension to the structure, but rather were left in situ and the hard core and clay infill of the new bridge were compacted against the elevation of the earlier structure.

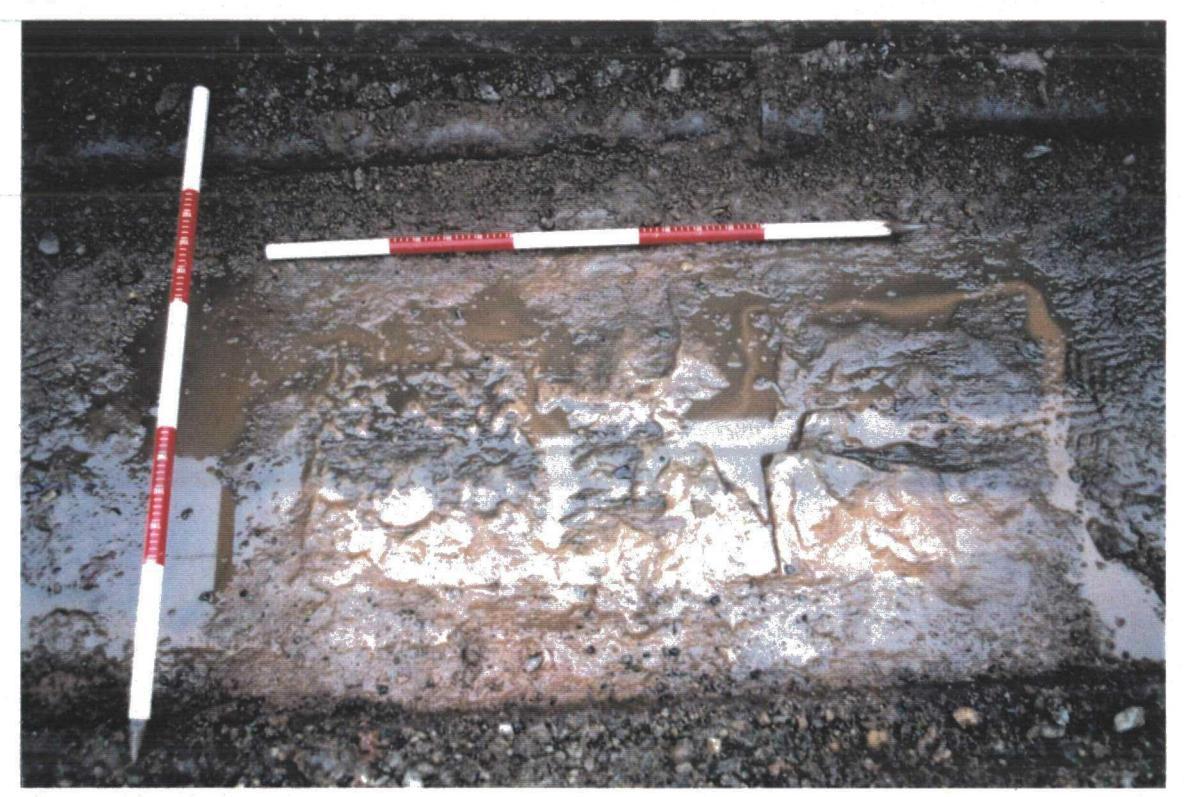
PLATE 7

Feature G, the apex of the northern arch of the bridge on it's eastern side, as revealed within Trench E

the apex of the northernmost arch on the eastern side of the bridge was revealed within the base of trench E. The masonry was exposed at 32cm beneath the existing kerbline and was found to be roughly dressed sandstone that matched with the type and finish of the eastern elevation of the bridge. The size of each stone measured 44×25 cm and unlike the apex of the arch identified on the western side of the bridge (drainage gully no.3) there was no evidence to indicate that the surface of the arch was sealed with bitumen.

It is suspected that this masonry dates to the early 20th Century and is part of the most recent eastern extension to the bridge.

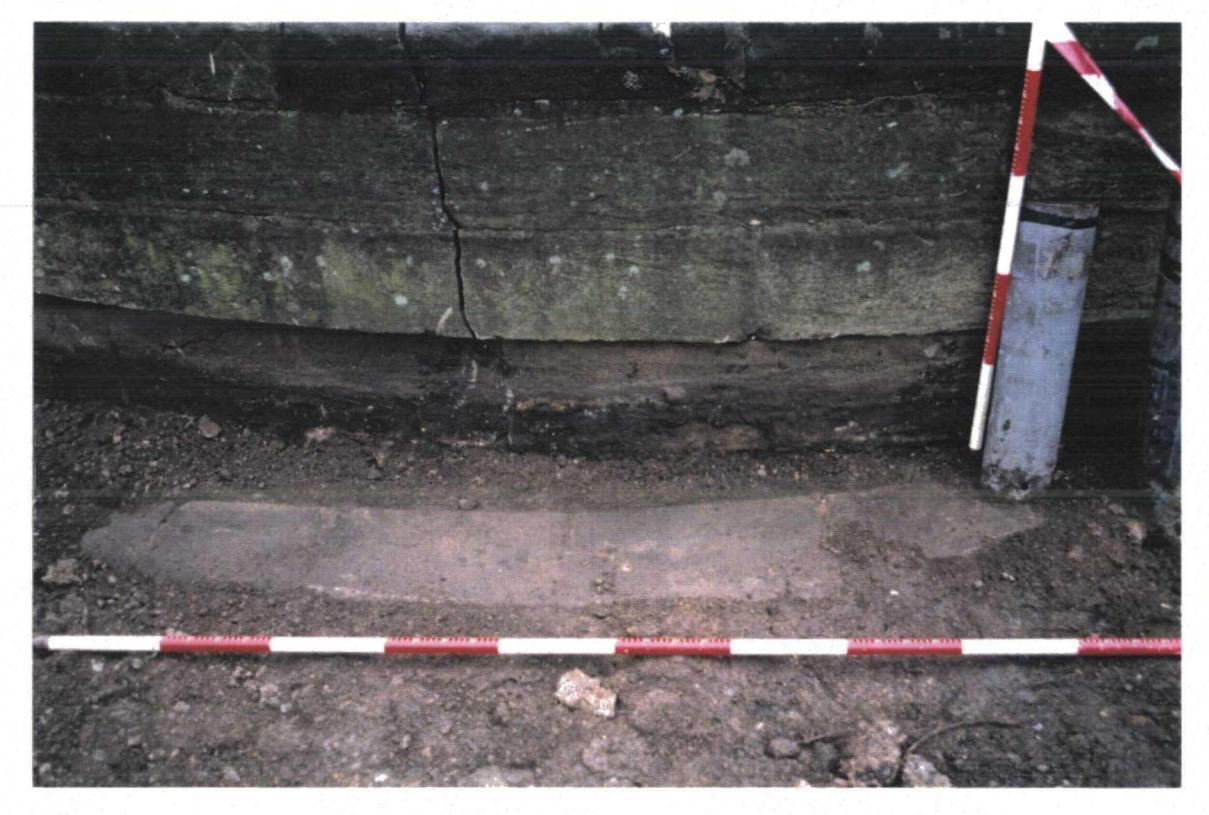
a total of four fragments of equally sized dressed sandstone blocks were identified at the northern extent of Trench E, and situated at the base of the existing parapet wall, the blocks were bedded level and arranged end to end forming a curvilinear kerb that had a different curvature to the extant parapet wall and existing kerb. The north eastern extent of this structure was not established as it was not revealed during these excavations, it's south western extent had been destroyed during the installation of electricity services.

The sandstone kerbline was heavily weathered indicating that the structure had prior to it becoming redundant been in use for some considerable length of time, it is possible that this feature is 19th Century in origin.

Feature E, a former kerbline on the northern side of the bridge, revealed within Trench E

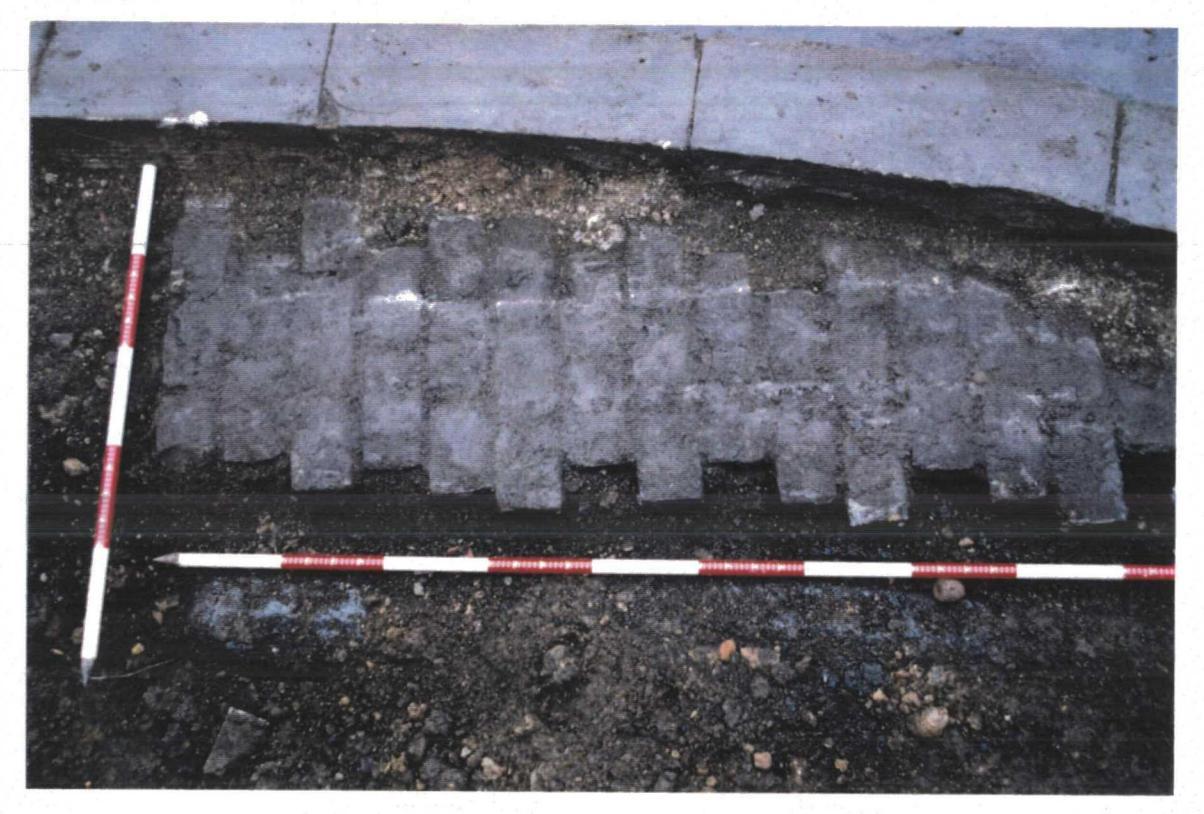
PLATE 9

an isolated and small area of granite setts that had survived in situ beneath the footpath at the northern extent of the bridge, the former road surface was exposed at 12cm below the existing kerbline within Trench E. The individual granite setts were bedded level within bitumen tar and the same adhesive substance had been poured between the joints of the setts.

This former road surface was found to be in a good state of preservation and it is understood that an identical surface was recently exposed during highway maintenance works at the Bond End junction to the north east. This would suggest that this surface was extensive and not only restricted to the bridge.

It is suspected that this feature is late 19th Century in origin.

Feature F, granite setts bedded within bitumen, a former road surface on the northern side of the bridge, revealed within Trench E
