SHREWSBURY BLACKFRIARS AND NURSES' HOME:

ARCHAEOLOGICAL EVALUATION

Simon Buteux

Birmingham University Field Archaeology Unit

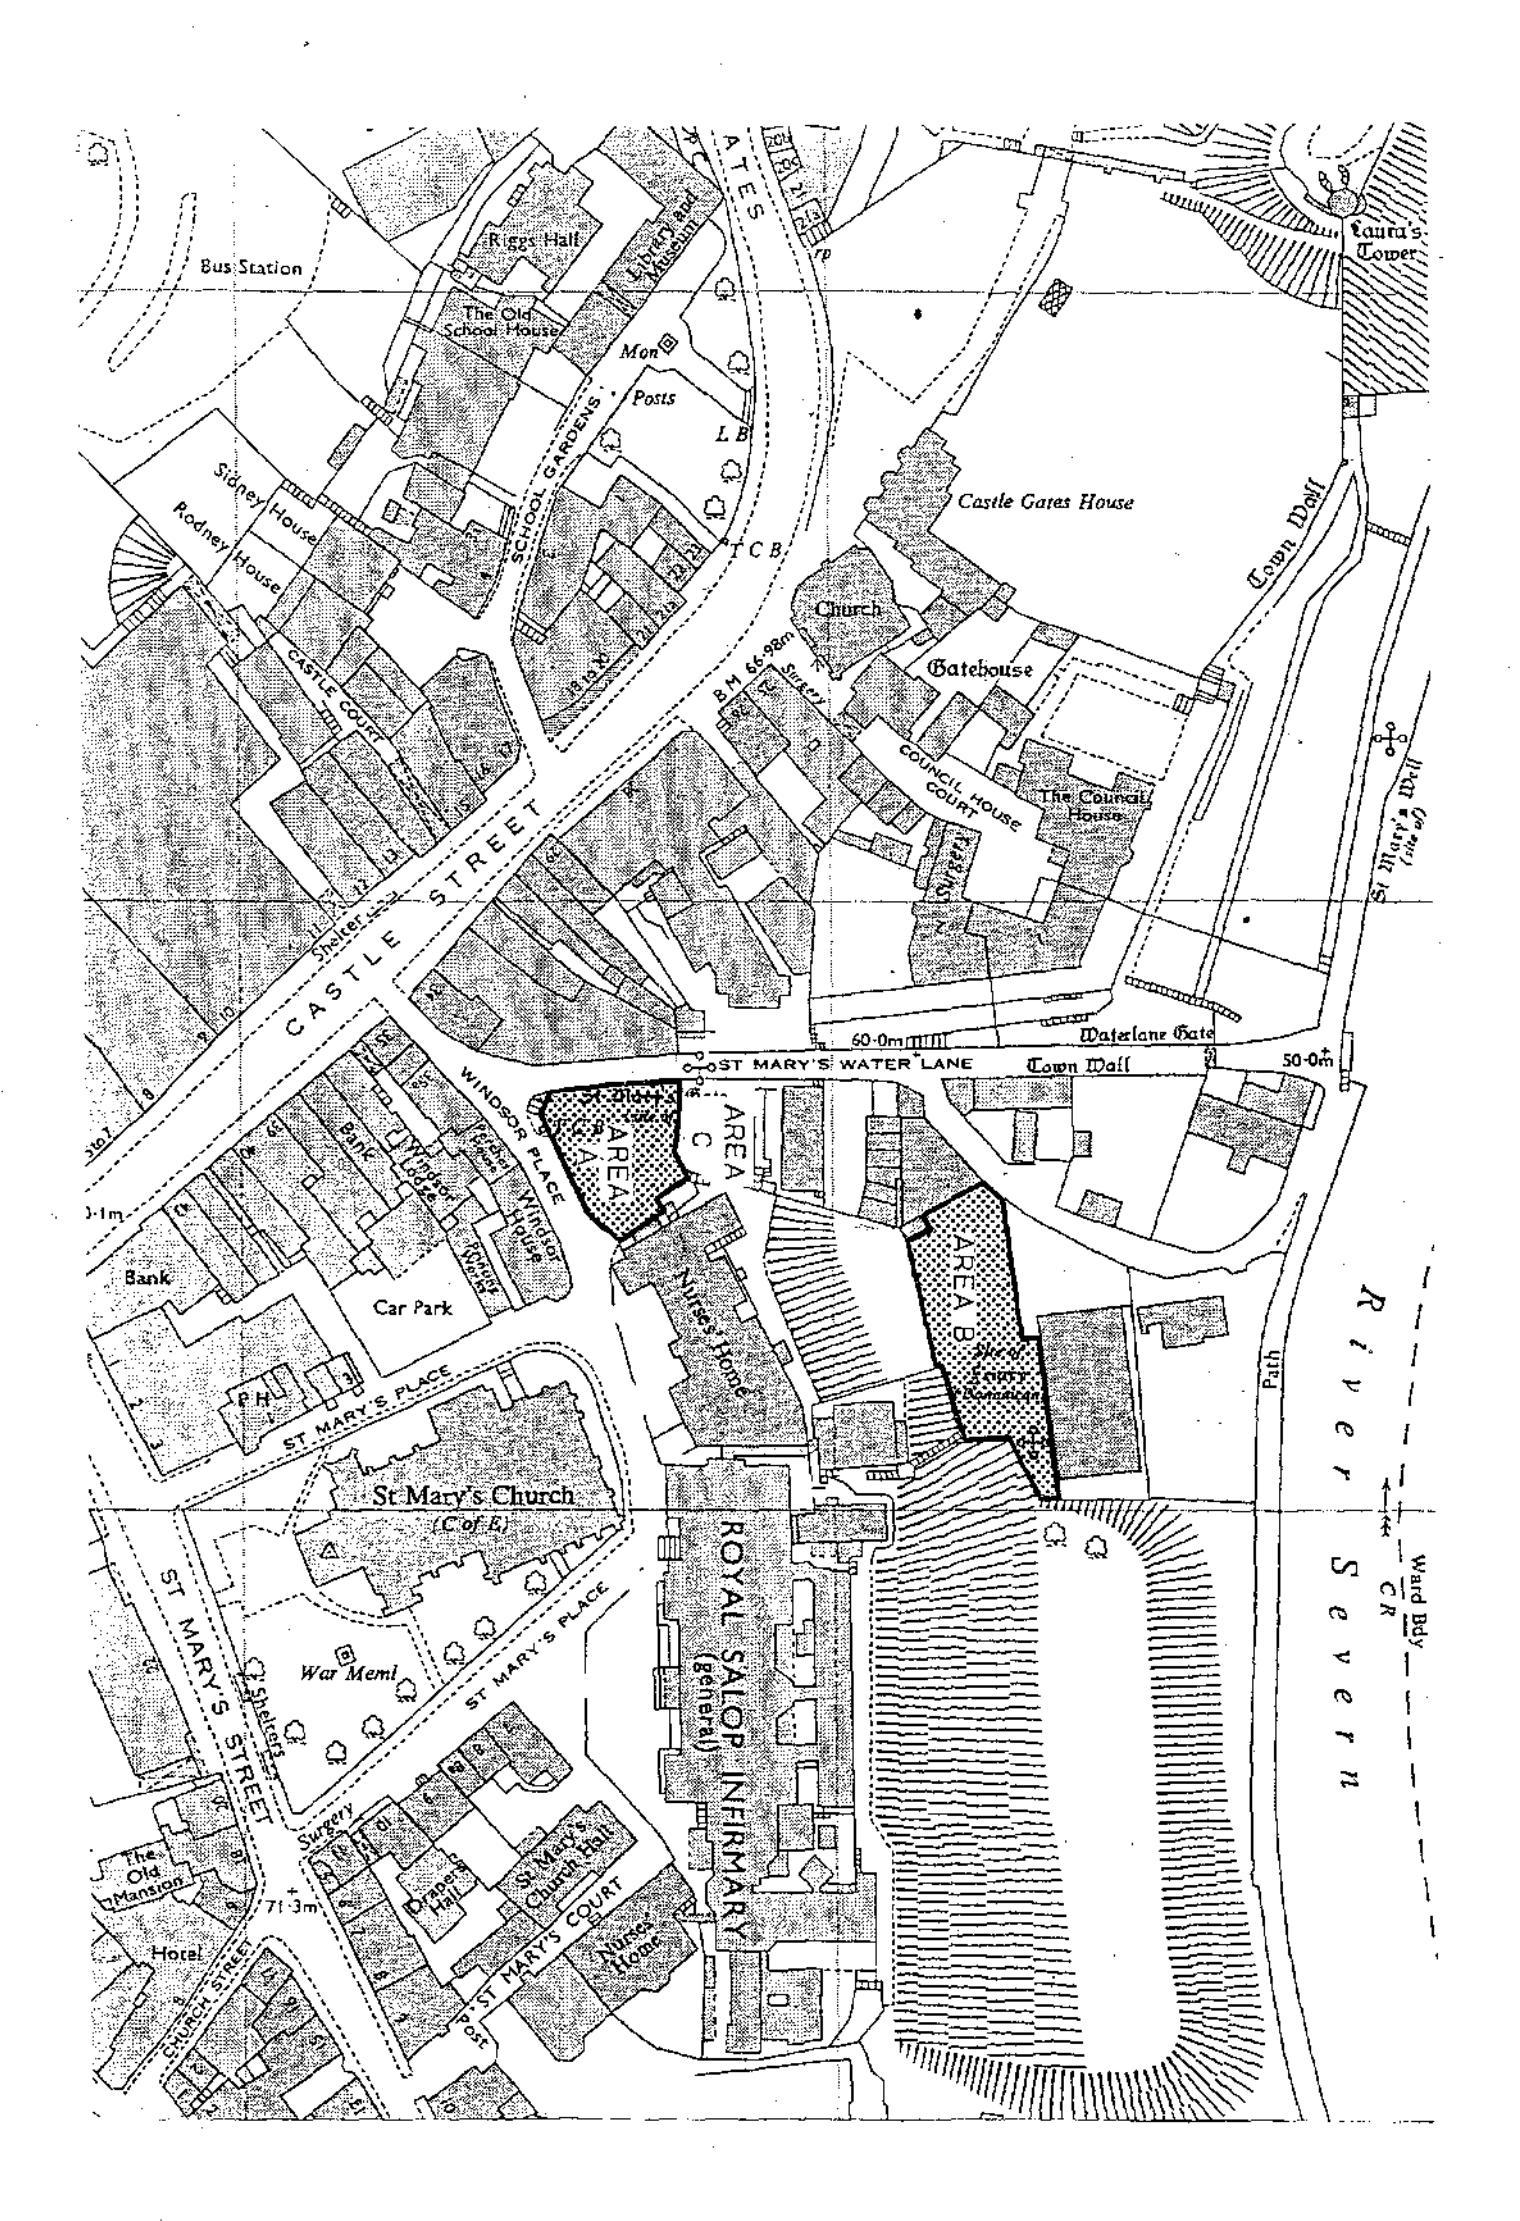
- 1. General location plan
- 2. Location of trial trenches
- 3. Site Profile
- 4. Trench A: Plan and section
- 5. Trench B: Plan and section
- 6. Trench C: Plan, section and elevation
- 7. Trench D: Plan and section
- 8. Trench E: Plan and section
