# King's Marsh & Pig Pail Sluice, Orford Ness Orford, Suffolk: Tidal surge repair works

ORF 139 Archaeological Monitoring and Historic Building Record SACIC Report No. 2015/057 Author: M. Sommers © SACIC

Historic Building Record and Archaeological Monitoring SACIC Report No. 2015/057 Author: M. Sommers Editor: J. Craven Report Date: November 2015

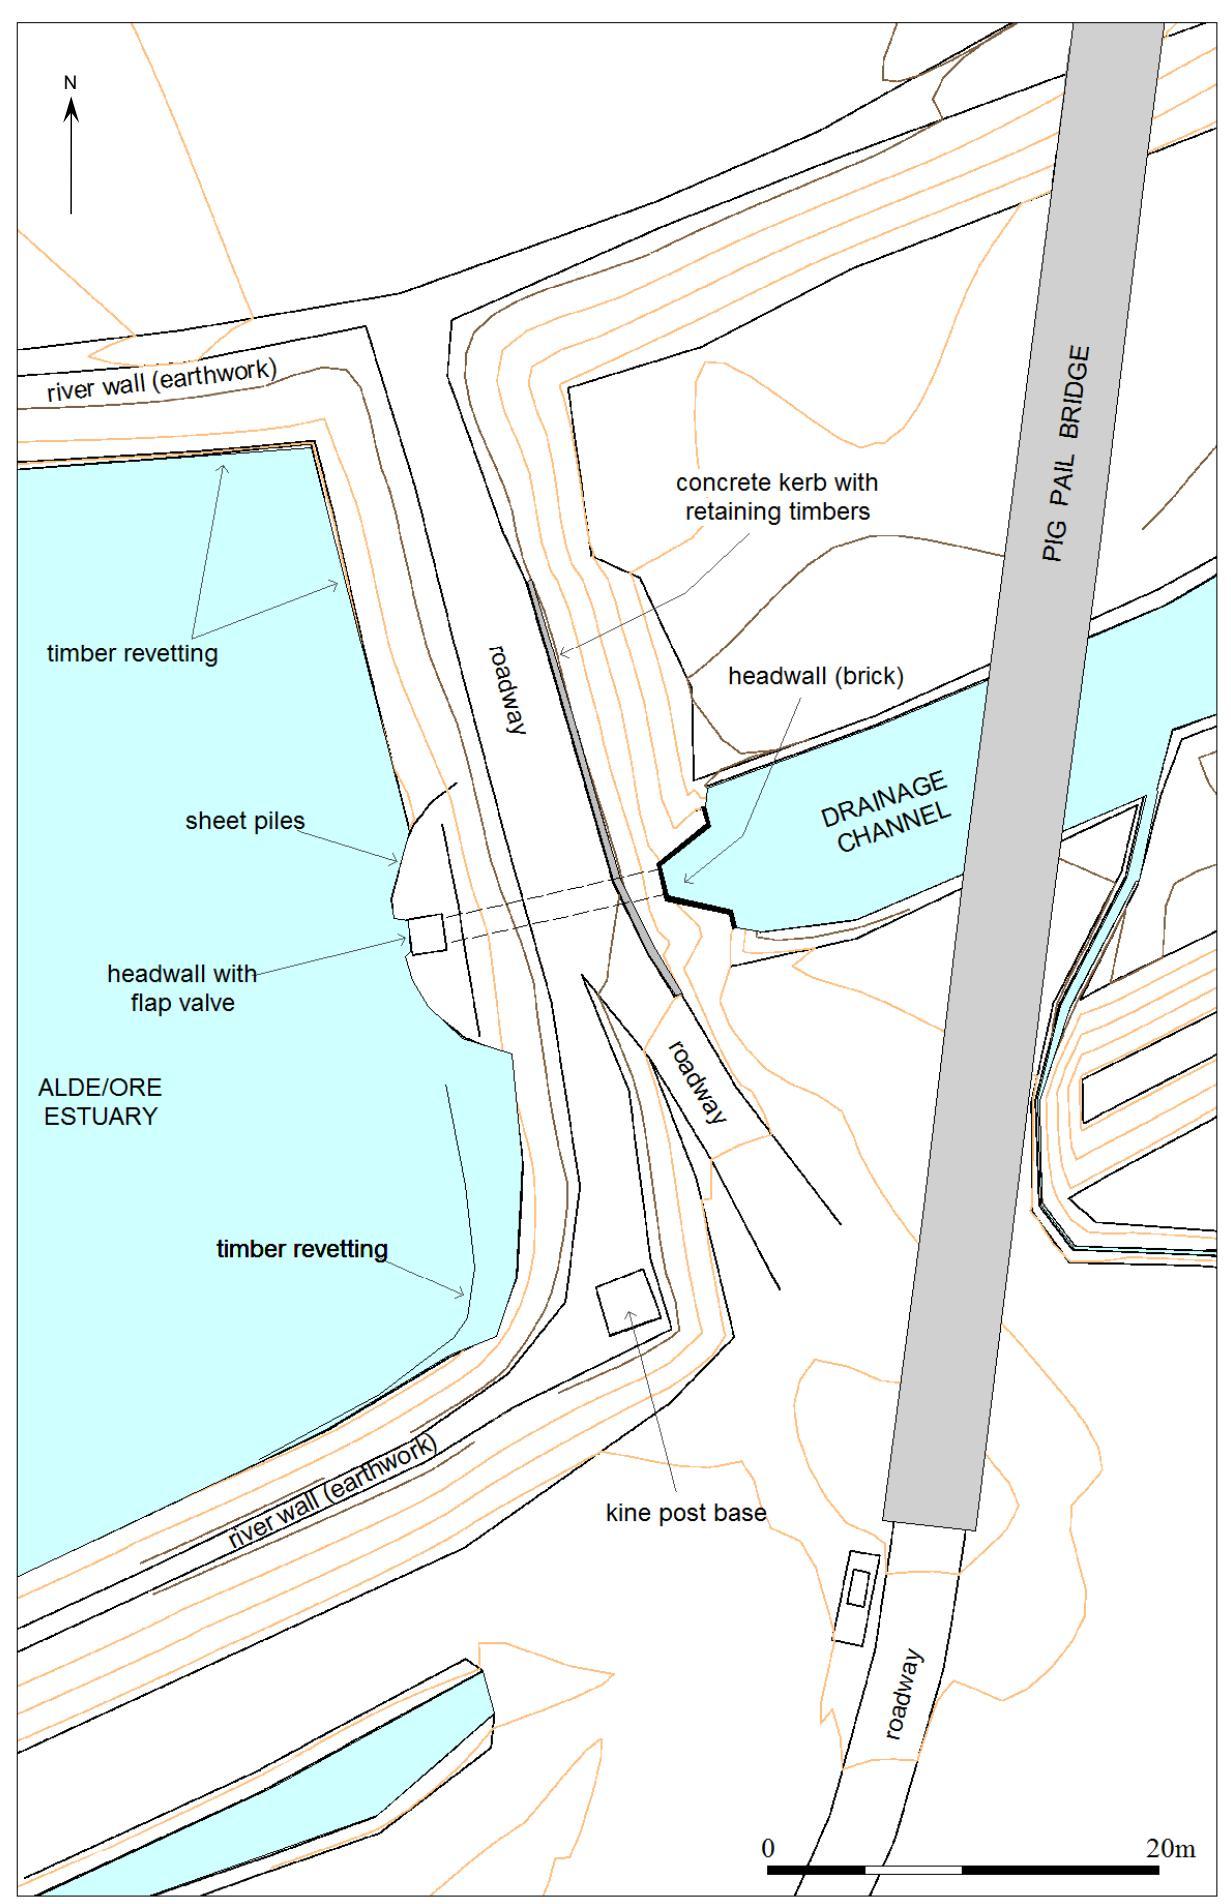
Figure 2. Plan of Pig Pail Sluice

The survey was undertaken on the 23rd July 2015 at approximately one to two hours after low tide. Figure 2 shows a plan of the sluice in relation to the surrounding features and Figure 3 comprises a series of more detailed plans, an elevation and a section along the line of the culvert. Plates 1 to 34 provide a number of views of the sluice and culvert.

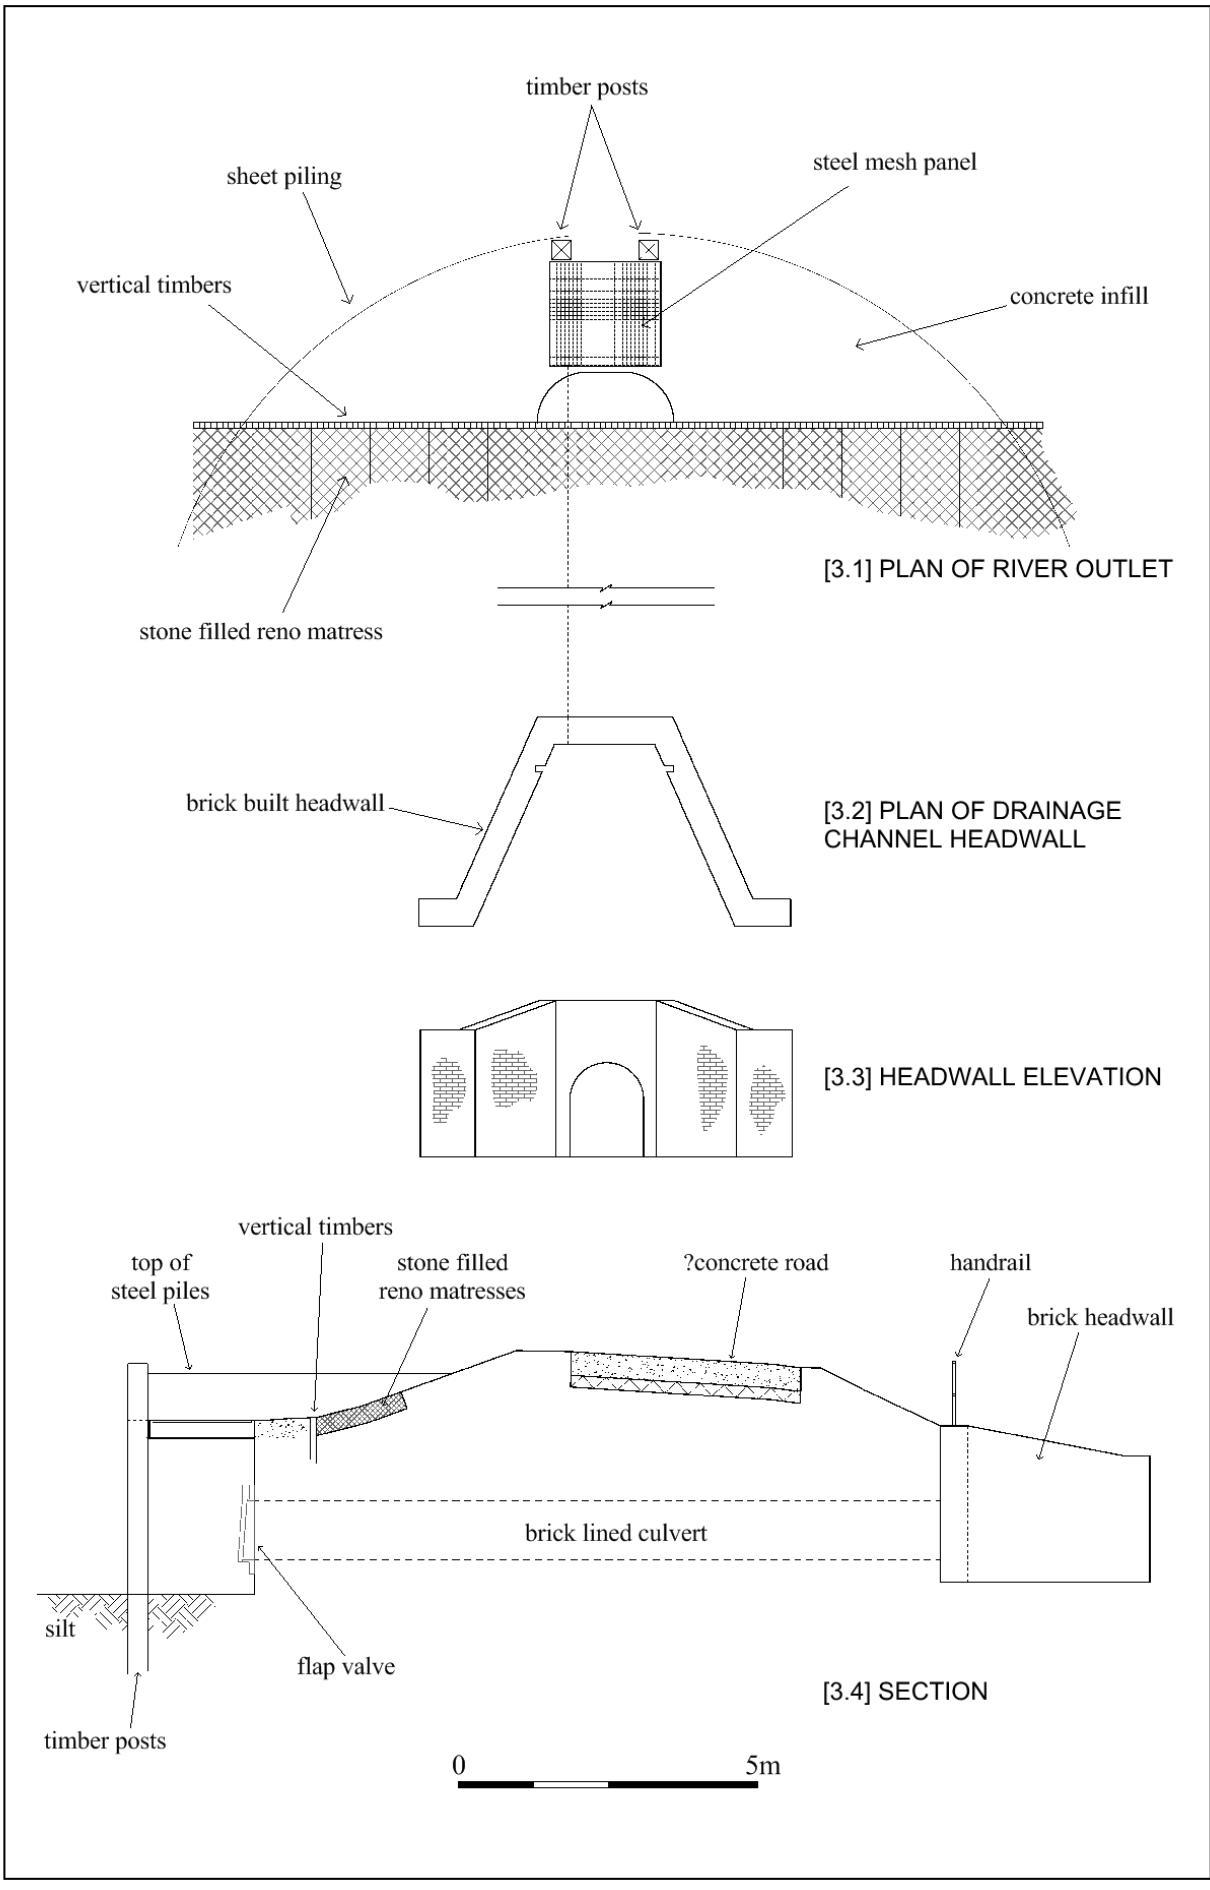
Figure 3. Pig Pail Sluice; detailed plans, elevation and section

The structure basically consisted of a masonry lined culvert aligned approximately eastwest beneath a roughly north-south earthwork embankment. A brick built headwall was present at the eastern, upstream end of the sluice and an outworks of sheet piling and concrete that enclosed a one-way flap valve on the downstream side. The purpose of the sluice was to allow water to drain from an unnamed channel at the northern end of the embanked area of marsh, known as King's Marshes, into a tidal stretch of the River Alde/Ore. The earthwork embankment, which comprises a section of the river wall running across an inlet on the southeast bank of the River Ore, and the one-way flap valve were in place to prevent the water re-entering the channel and flooding the adjacent land at high tide.

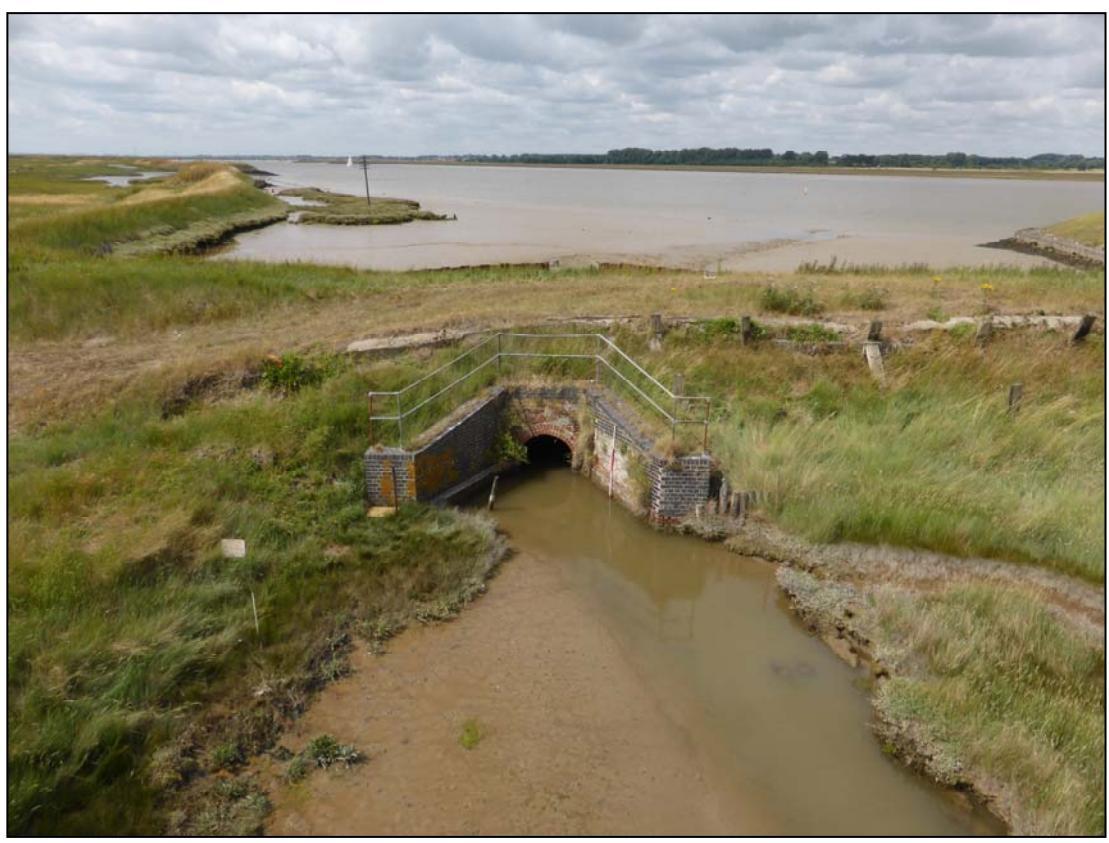
Plate 1. General view of Pig Pail Sluice from Pig Pail Bridge

The brick built headwall on the landward side of the culvert (plates 1 and 2). It acted to retain the earthwork in the vicinity of the culvert. It was probably originally built entirely of red brick although at some point large parts of the two flanking walls and the top of

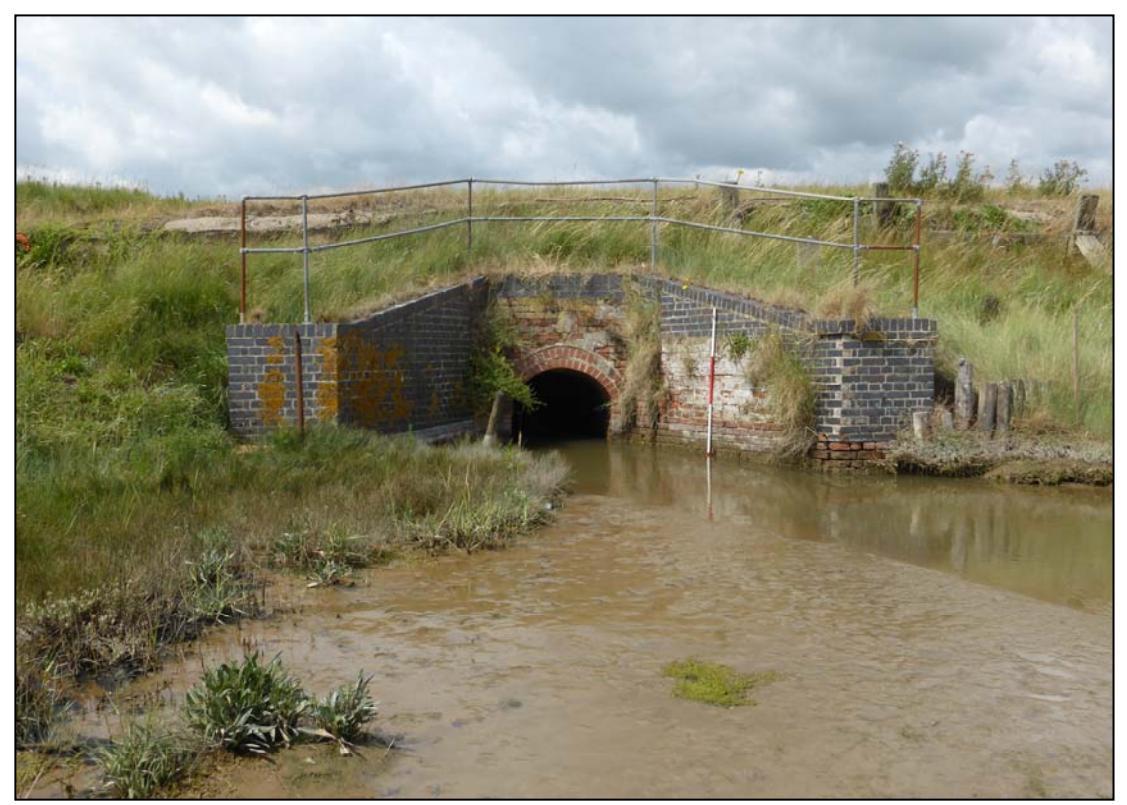
Plate 2. The brick headwall on eastern face

A handrail formed of two tubes running parallel with the top of the brickwork was secured via upright tubes and brackets to the top of the headwall (visible in plate 2). A single post was present within the water channel, close to southern flanking wall (visible in plates 3 and 4). It was angled towards the south but was presumably originally vertical; its purpose is unknown. Just to the east of the return on the end of the southern flanking wall was a vertical tube, of similar appearance to a scaffolding tube (plate 3), the top of which is heavily corroded; its purpose is unknown.

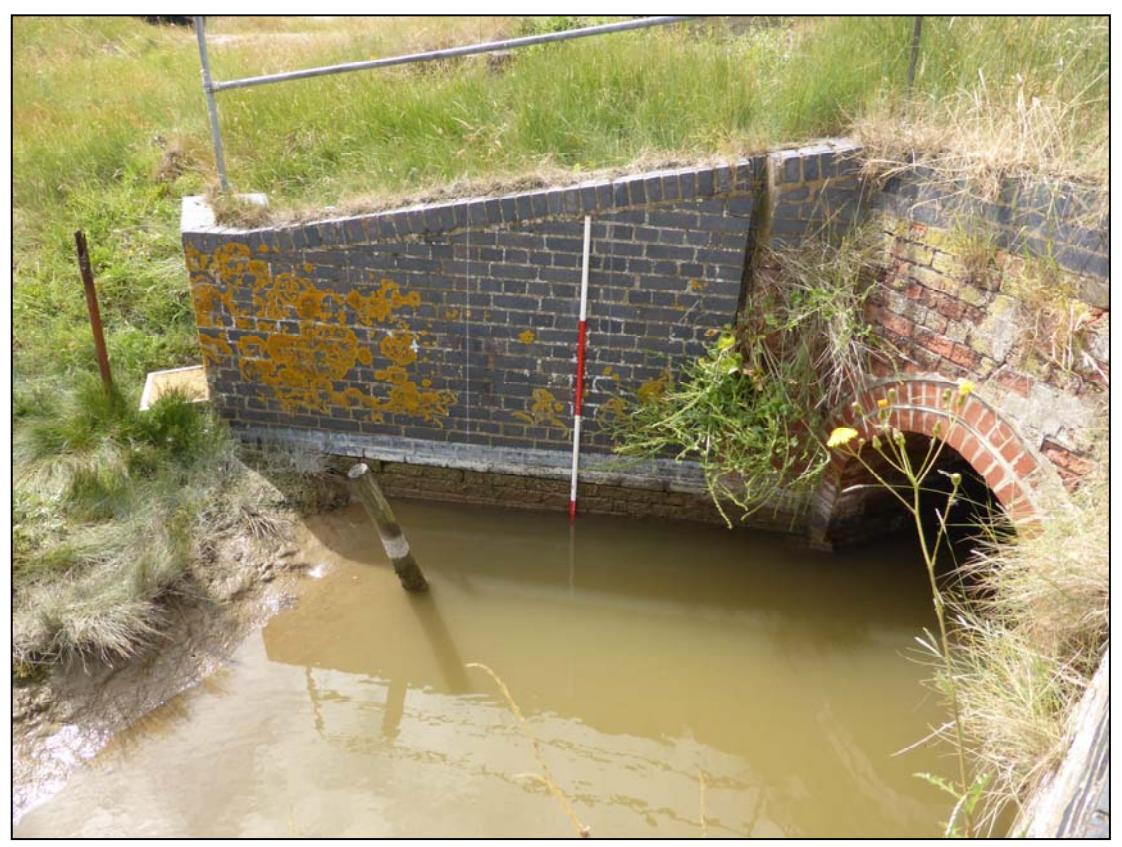
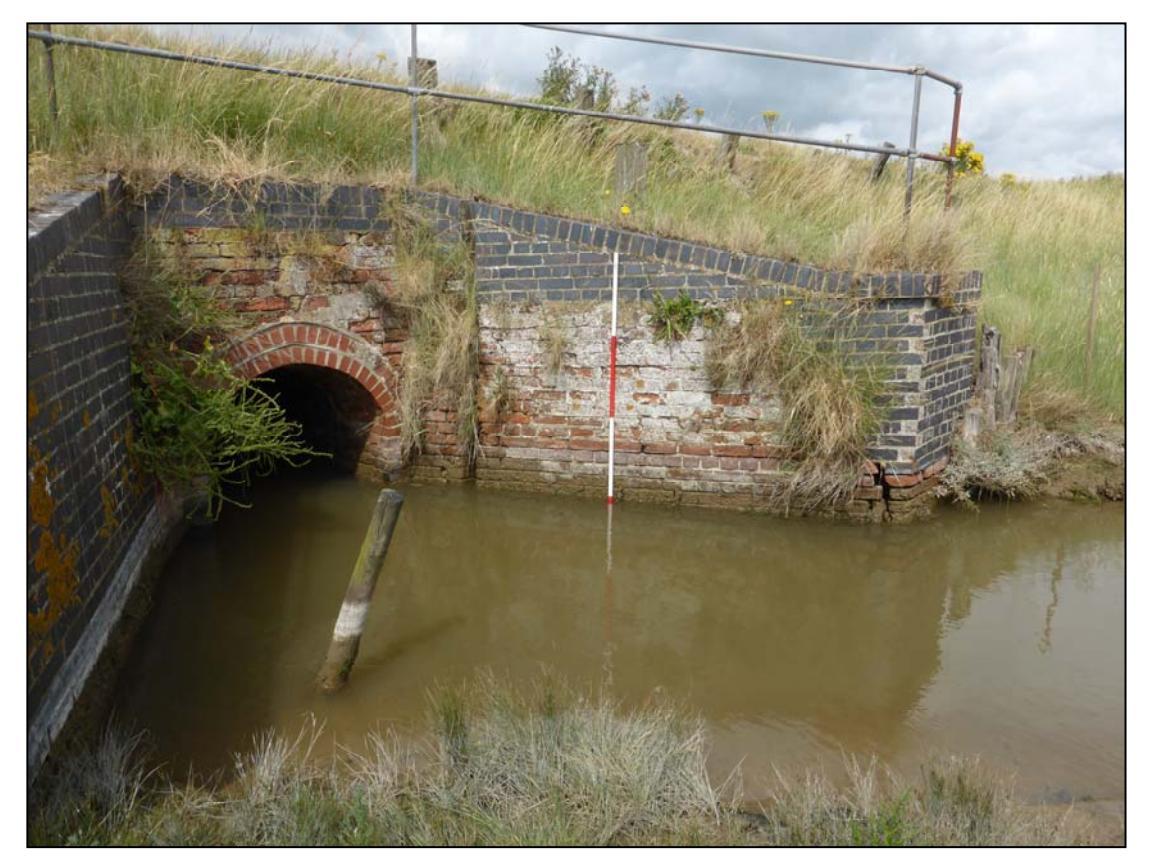
the central section had been rebuilt in hard blue engineering bricks cemented with a hard mortar (plates 3 and 4). The face of the culvert's arched vaulting had also been rebuilt but in a hard modern red brick, again with a hard mortar (plates 5 and 6). The remainder of the headwall appeared to be built of a soft red brick and cemented with what appeared to be a lime mortar, much of which had been washed out, except where limited repointing was evident, and this was likely to comprise the original fabric of the structure. The soft red brickwork was in very poor condition in places with cracking and dislodging of the structure evident, particularly at the base of the end of the northern flanking wall (plate 7). The sluice and culvert structure was not located in the centre of the earthwork but was off-set slightly to the south. A series of timber uprights were present to the north of the northern flanking wall (plate 8), which ran for a short distance and retained the toe of the earthwork.

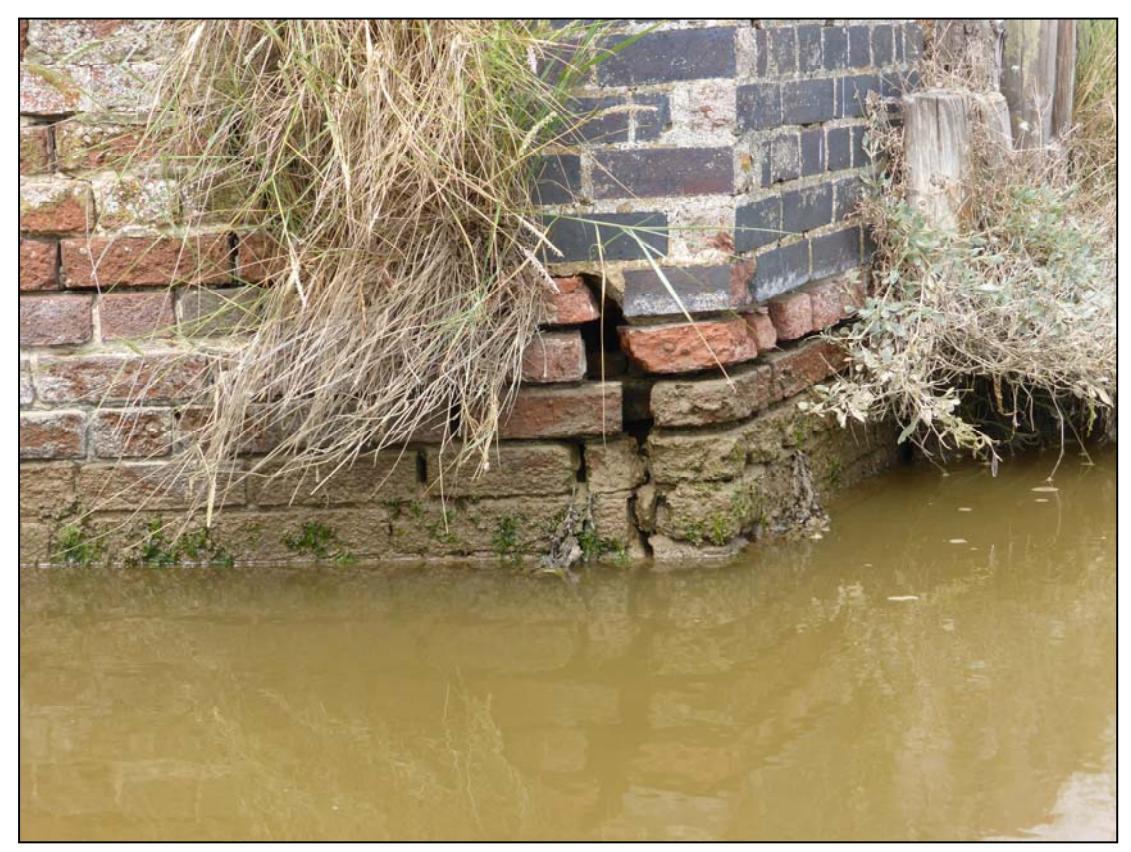
Plate 7. Eastern end of the northern flanking wall showing cracking and movement

An engineer's inspection of the sluice structure and the embankment through which it passed revealed that both were in poor condition and liable to fail. It could be clearly seen that the landward headwall was badly cracked, and that it was probably being undermined, and that the sheet piling on the river side was badly corroded. It was also noted that water permeated through the embankment in the vicinity of the culvert at high tide and it was to remedy these problems that the structure was to be removed and rebuilt.

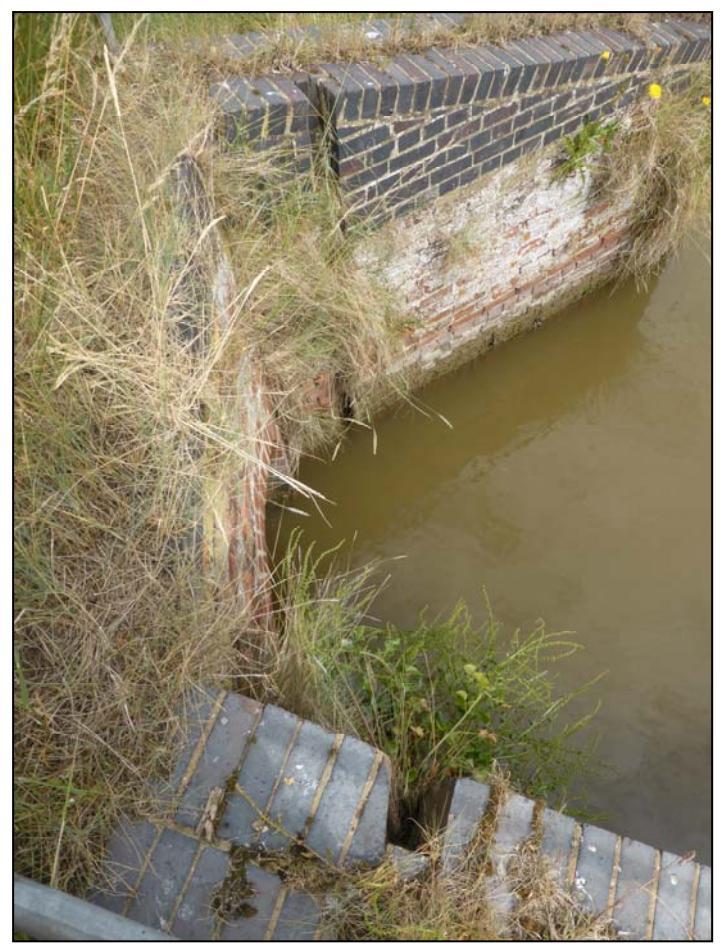
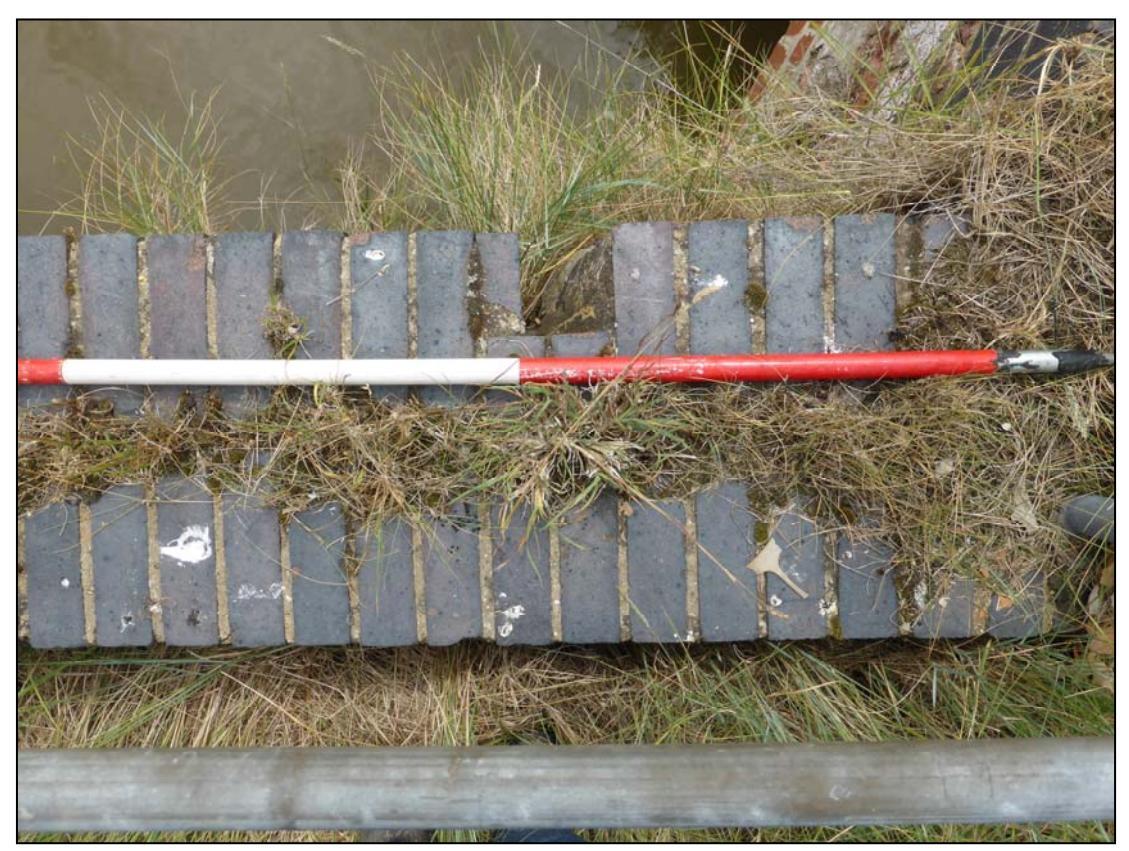
A pair of opposing vertical slots were present in the brickwork, one in each of the flanking walls (plates 9 and 10). These would have been for the insertion of boards or planks to block the drainage channel. The angle of the slots could suggest that planks were placed in pairs with one end of a plank braced against the flow of water in the channel by the other plank to form a V shaped dam. This would have presumably been put in place at high tide or on a falling tide to prevent water draining from the marsh in order to carry out repairs to the culvert and flap valve.

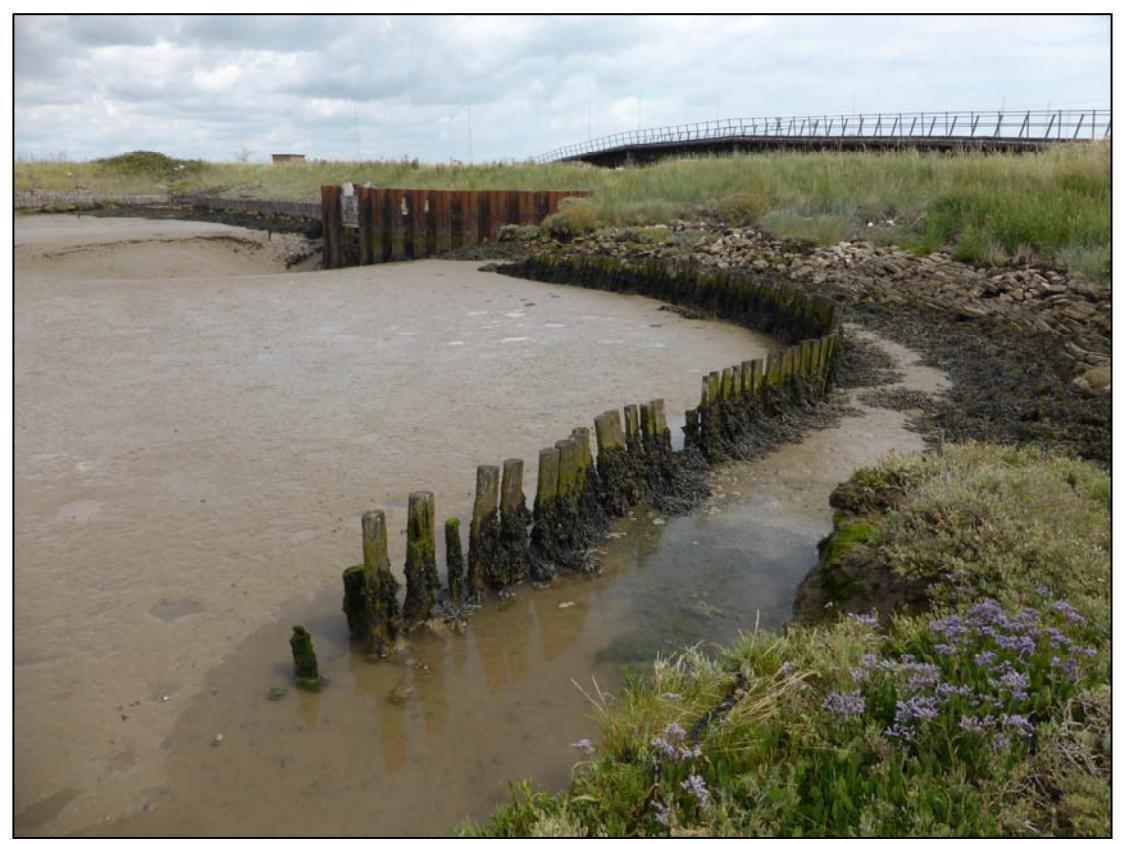
Plate 25. Timber revetting/defence to the south of the sluice (camera facing northeast)

comprised half-rounded timbers although they were in poor condition and erosion of the adjacent land had occurred leaving them as a free standing barrier along the river's edge (plate 25). The eroded embankment in this area is now protected by a facing of concrete blocks and slabs. These appeared to comprise recycled material which presumably originated from demolished structures on the ness. To the north of the sluice the timber uprights were of a rectangular section and formed a solid wall of timber which revetted the base of the embankment (plate 26). These defences continued along the northern edge of the inlet off the river and along the river bank to the north and appeared to be of a more recent construction than the timbers to the south.

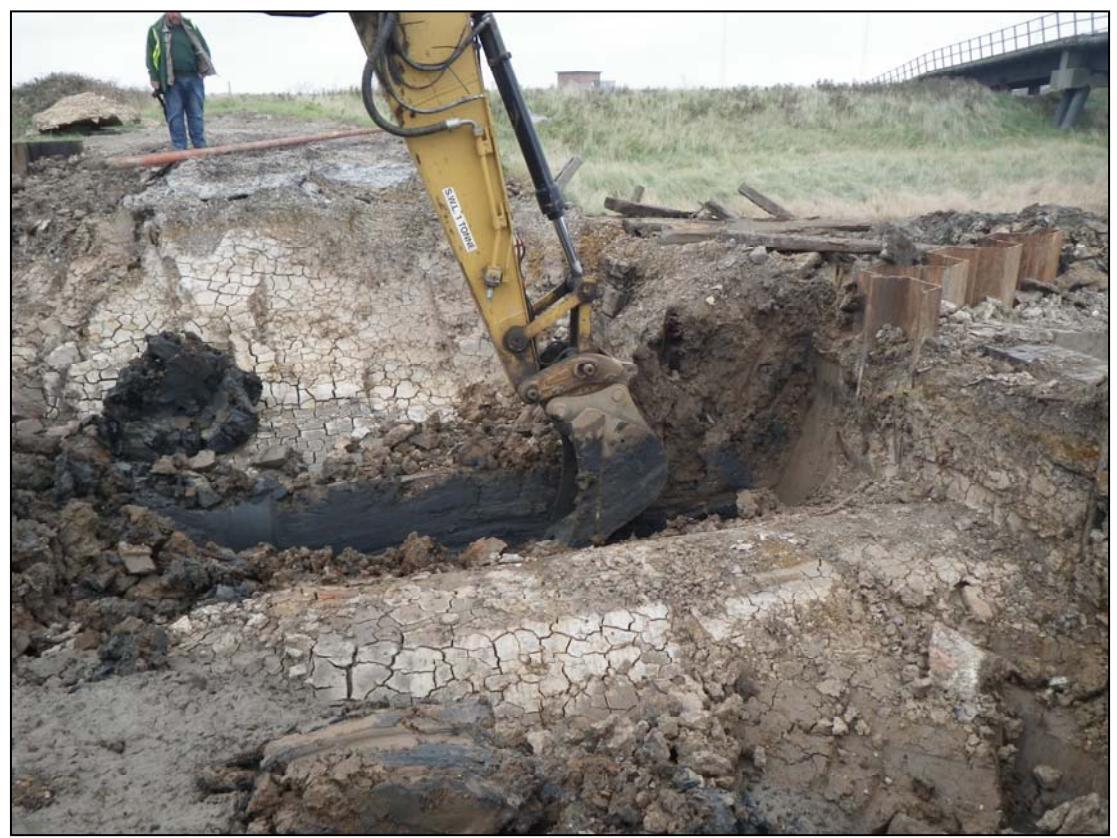
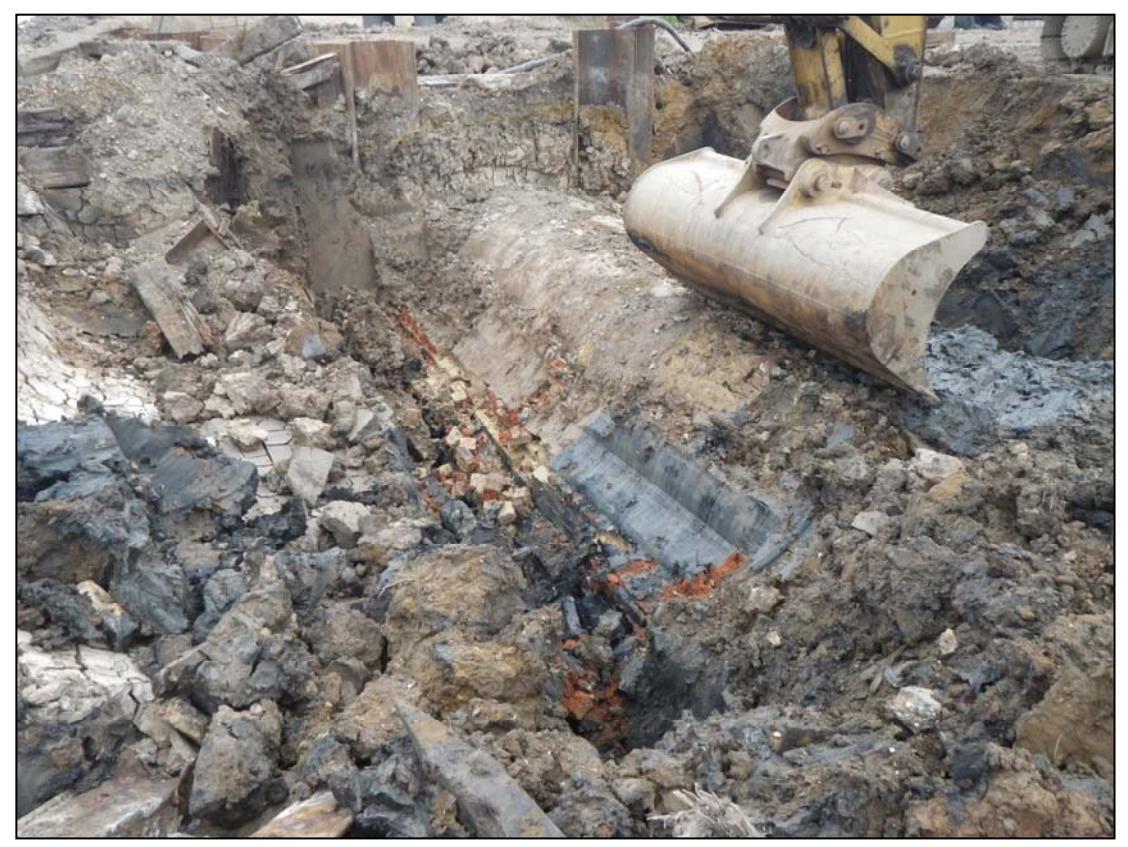
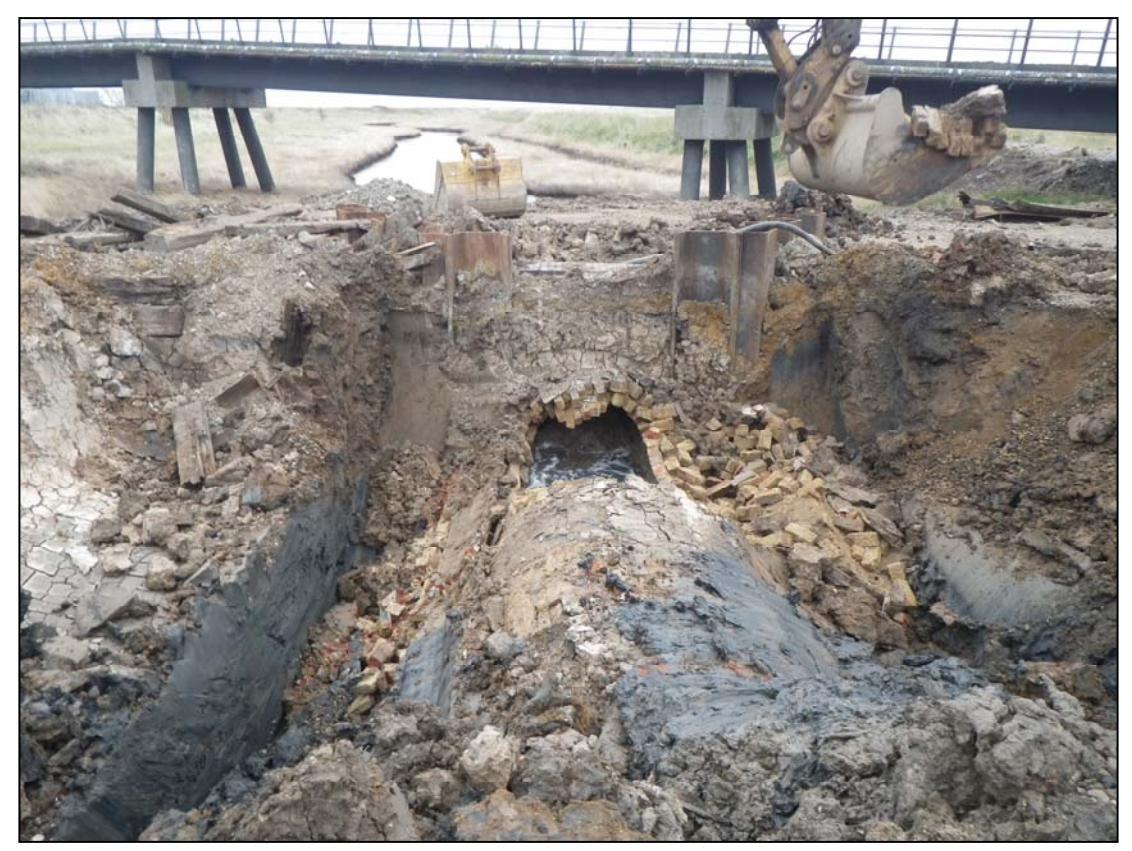
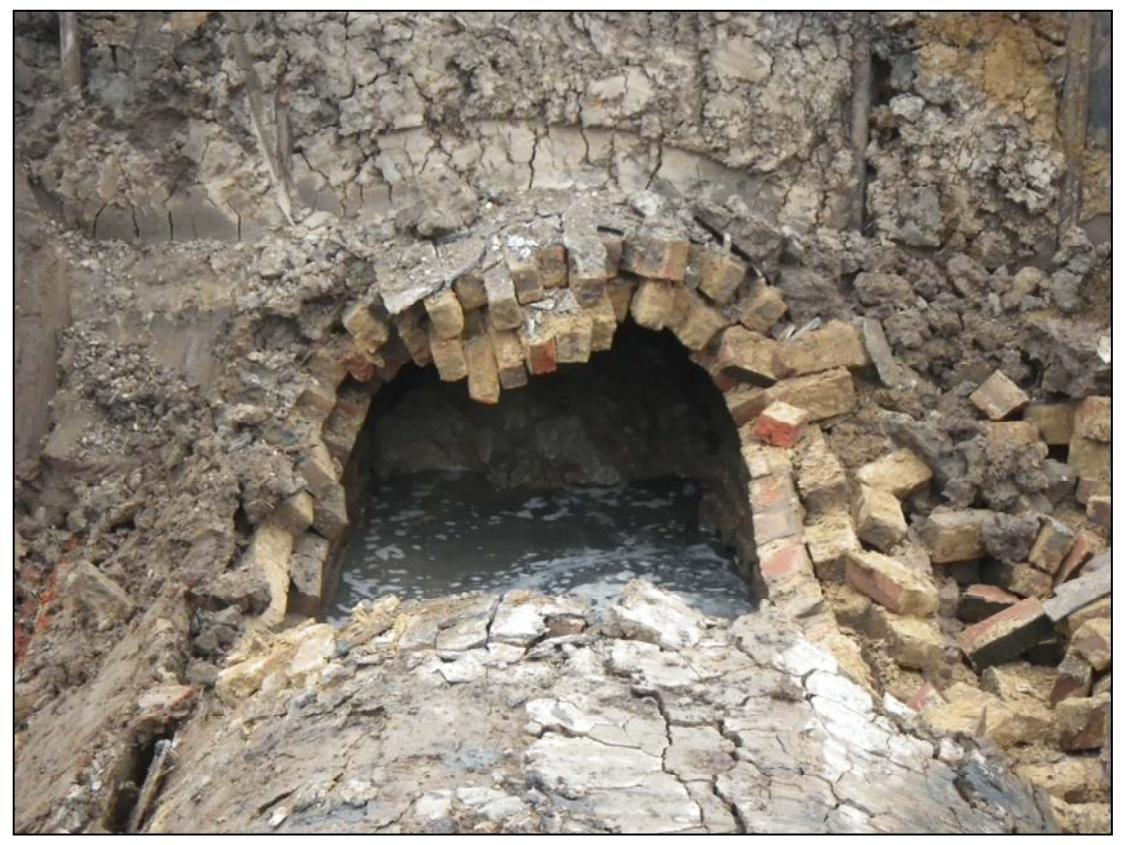
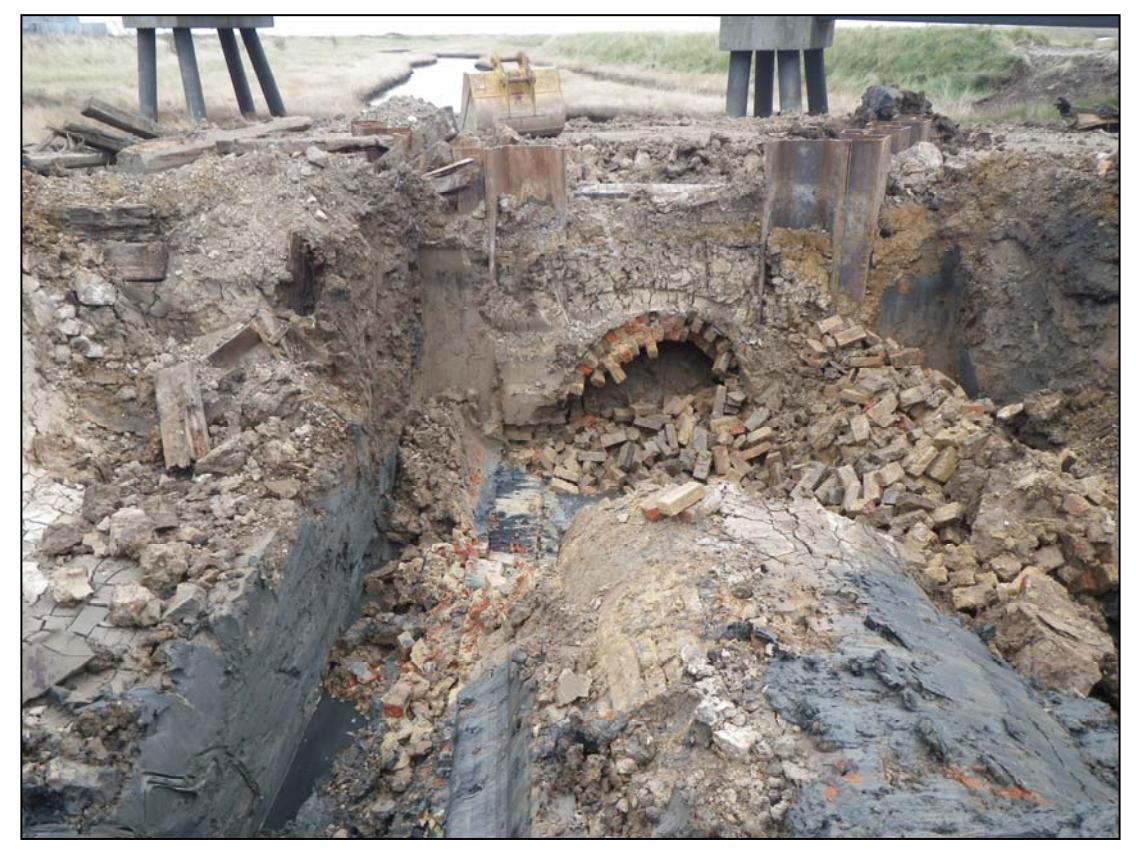
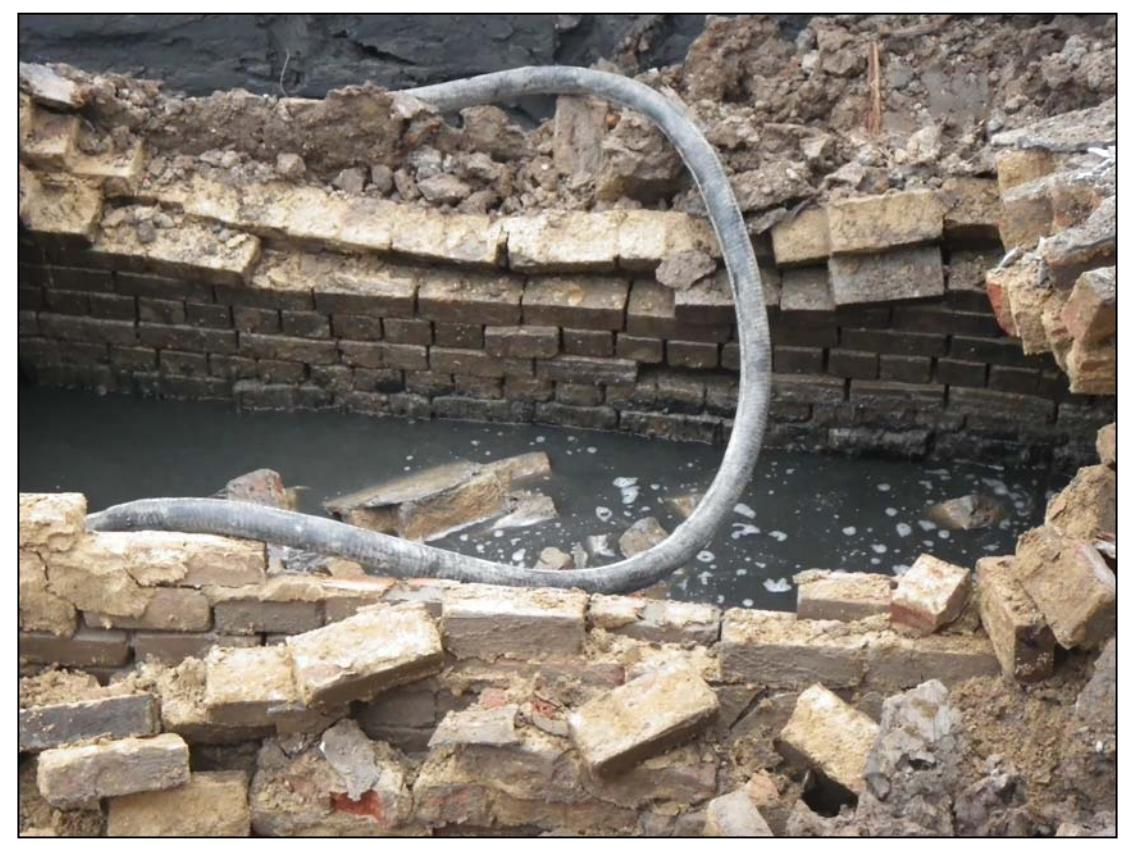
Removal of the culvert was archaeologically monitored in order to record additional evidence relative to its construction and observe for any earlier remains. The first stage was to excavate down to the top of the brick vaulted culvert (plate 27). The concrete roadway was broken through and part of the embankment was dug away using a mechanical excavator. The material forming the embankment comprised a yellowish to dark grey silty clay. The exposed length of culvert was formed of brick and covered with a thin skim of hard mortar (plate 28). Following its exposure the vault of the culvert was broken open (plate 29). This revealed that the culvert was constructed of two vertical walls, the width of four bricks (c.30cm) spanned by a semi-circular vault the width of two bricks (c.14cm) (plates 30 and 31). The bricks had been originally cemented with what appeared to be a lime mortar although much of this had been washed away from the brickwork that formed the inner face of the culvert (plate 32). The culvert was built upon a hard base formed of red brick that was at least two courses thick (plate 33). It was extremely solid suggesting the brickwork consisted of a number of courses or that it rested on an underlying foundation, such as a concrete raft or possibly timber piling. Other than the cutting of a narrow slot in the brickwork (plate 34), the base was left insitu.

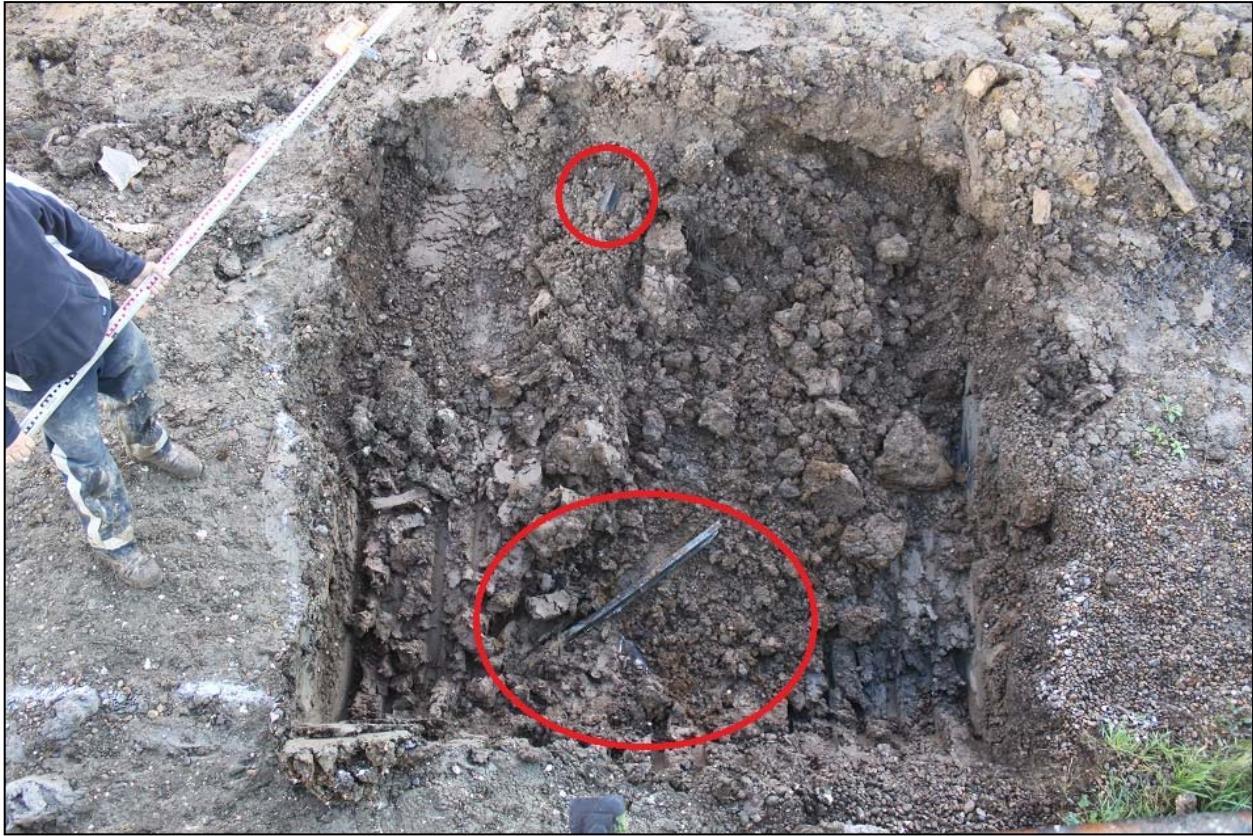
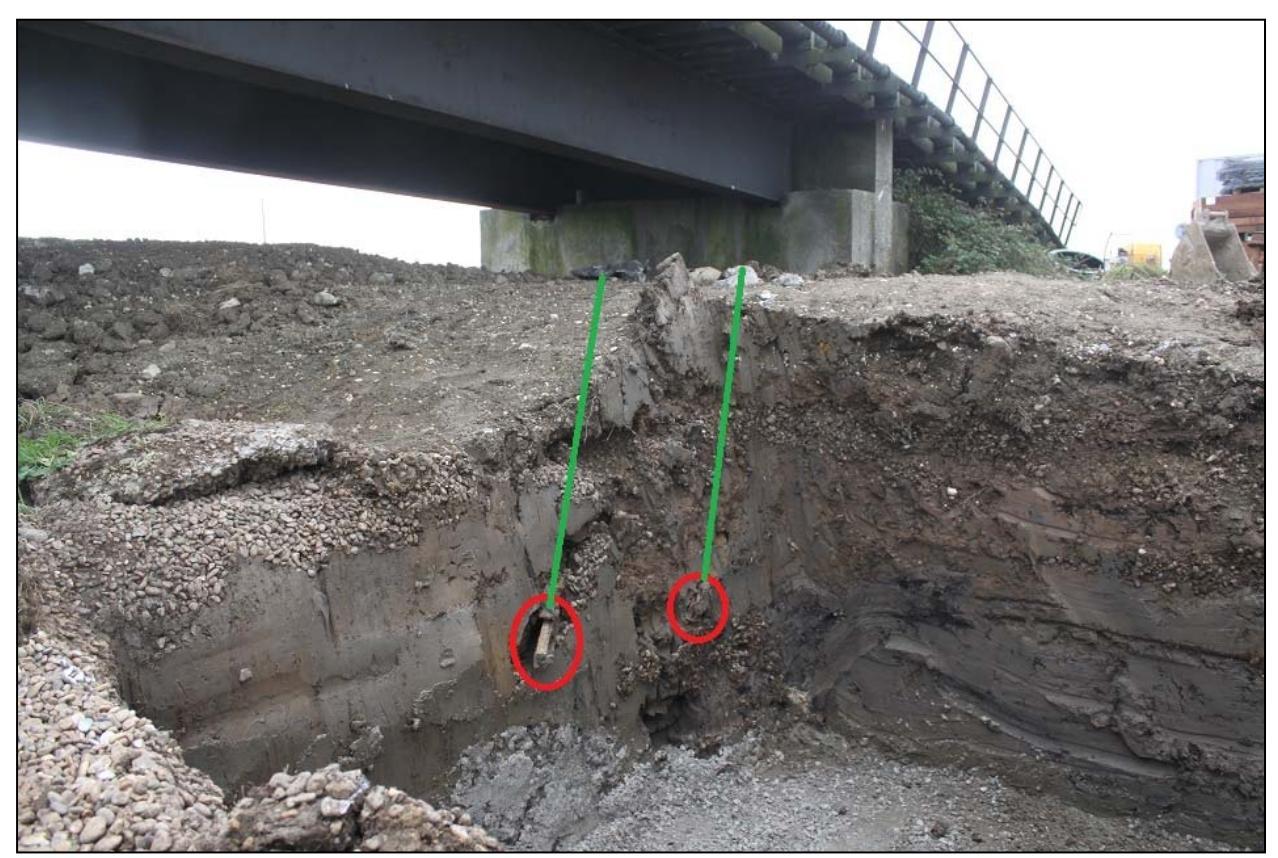
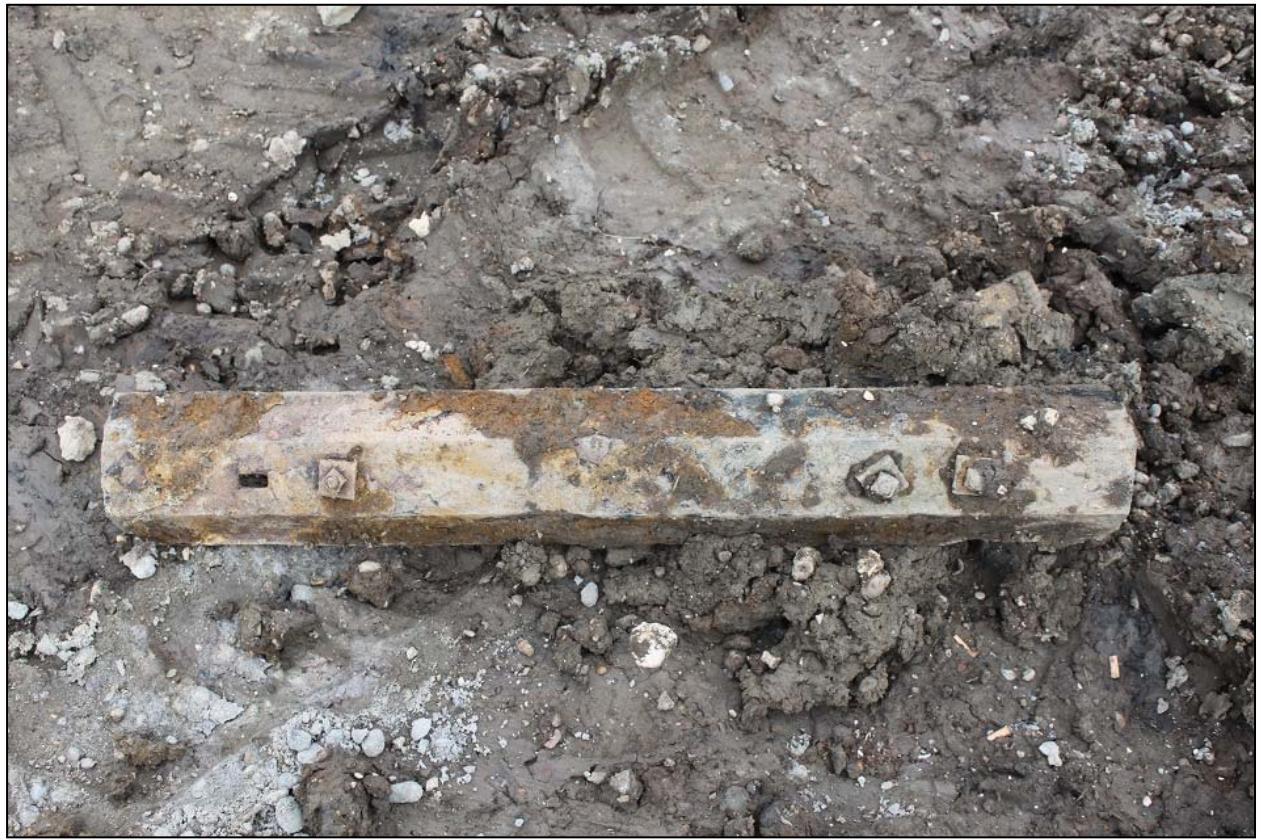
The track was not seen by the author but was recorded by Grant Lohoar, one of the National Trust Rangers, in early November 2015. He was of the opinion that it had just been dumped in this location or that it was possibly *in-situ* but may have been disturbed during the construction of Pig Pail Bridge. He suggests it was probably a remnant of the rail track that came down from Slaughden on the marsh/river side of the Ness, which was used to supply clay and materials for river wall repairs. It was possibly used during the construction on the Cobra Mist site, although the fact it seems to pass under the bridge and is interrupted by the piling for the bridge supports suggests that may be incorrect or, alternatively, that it may have been shortened when the bridge was built.

There are known lengths of railway track on the Ness, such as one that came down the beach side of the Ness to take shingle back up to Slaughden for beach recharge, which are occasionally exposed. It believed to have dated from the 1960/70s but it is possible this recently discovered section is a little earlier and possibly dates from the 1950's?
