### Chapter 8. Roman Road Survey

### 8.1 Summary

Excavation revealed what appears to be the agger of a road with ditches either side, dated by the high proportion of Romano-British finds recovered.

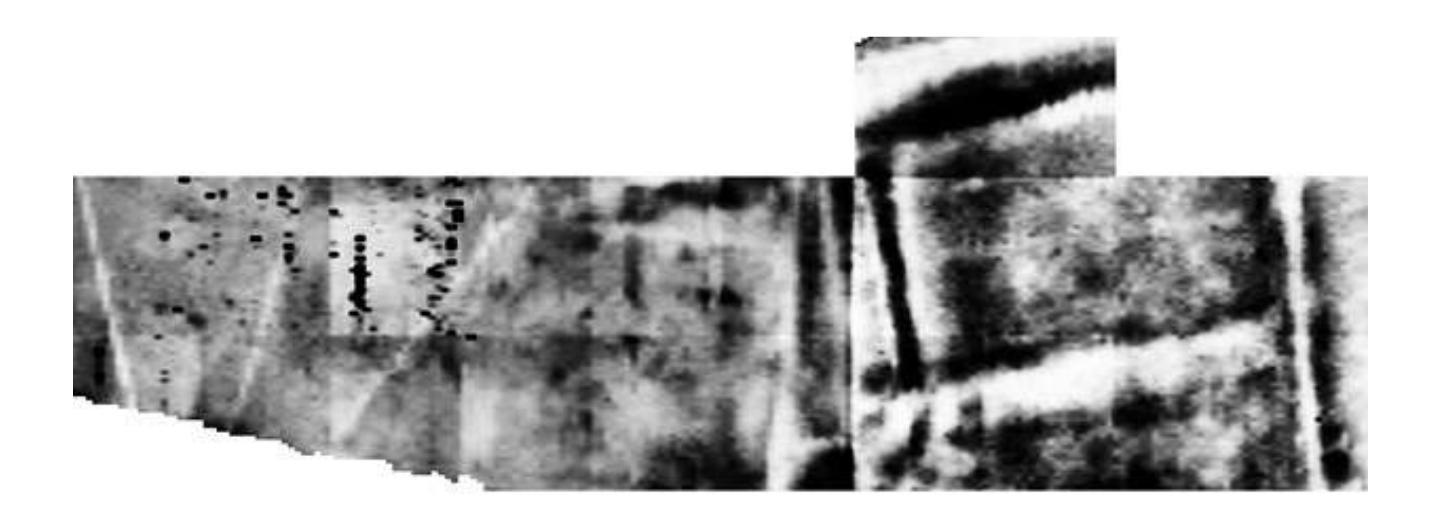
Figure 123. Resistance Survey from the Priory field site

The underlying geology of the Priory Field is greensand, which is not susceptible to magnetic variation, and so the magnetometry was ineffective. The twin probe resistivity survey showed features which matched the earthworks visible on the ground, and the line of the road, which now shows signs of wear and erosion.

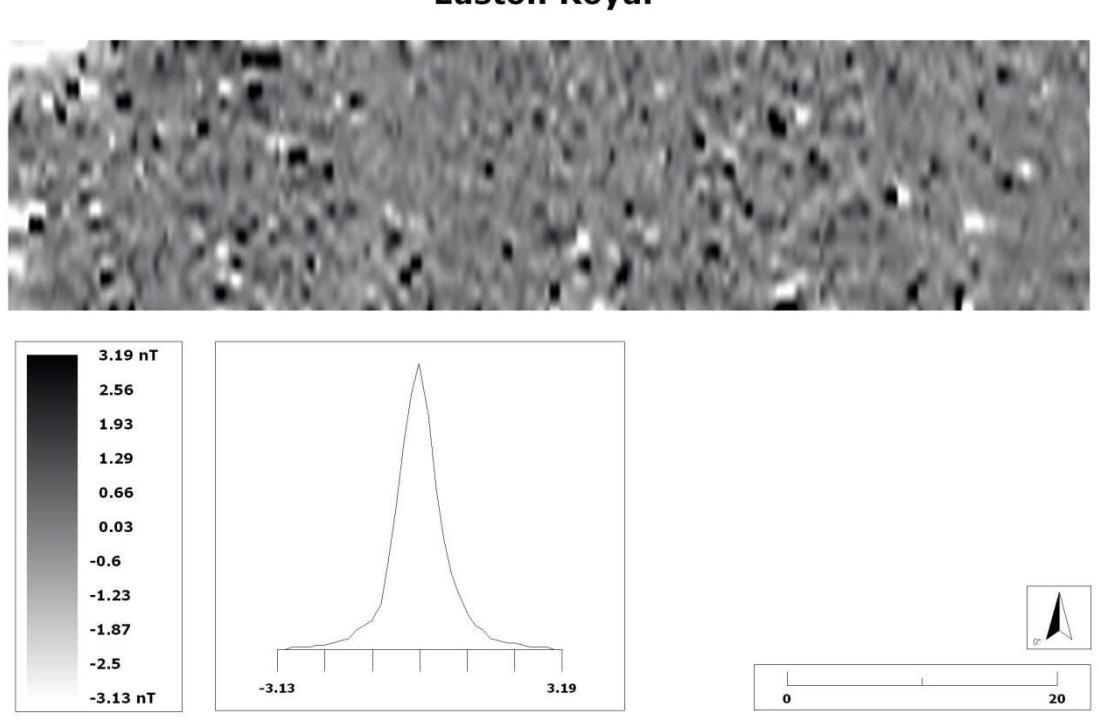
Figure 124. Magnetometer Survey from the Home farm site

A magnetometry survey of a small area 20 x 80 metres on the Home Farm site proved ineffective as the geology there is the same as in the Priory Field (Figure 124).

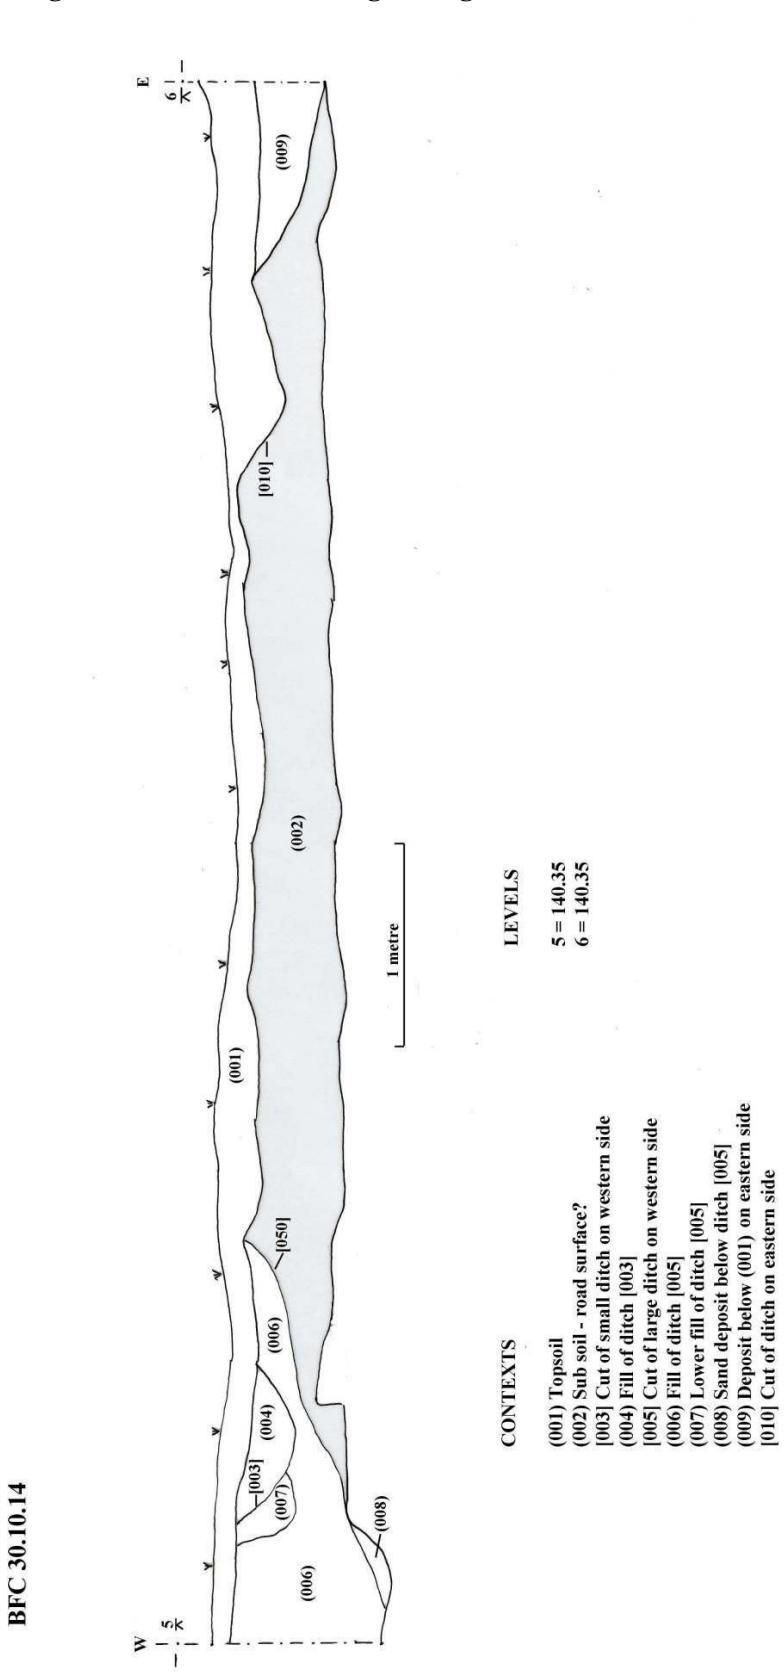
Figure 127. Section drawing through the Roman road

**EASTON ROYAL ROMAN ROAD**

SOUTH FACING SECTION

The topsoil (001) was a friable to firm, mid brown silty loam between 6 and 37 cm in depth. It contained 20 to 25% inclusions of angular stones up to 6cm in size. There were also roots, rotting vegetation and disturbance by vermin in this layer.

Directly below the topsoil was a greenish grey deposit (002). It was very compact and dense, consisting of greensand blocks, sarsen fragments and occasional flint and pebbles. The deposit was up to 0.5 metres deep and 6.5 metres wide, and was interpreted as the surface of the Roman road. The original underlying deposits had been levelled to provide a flat surface on which the material had been laid and compacted to form the road surface (Figure 127).

There was a small linear ditch [003] on the western side of the trench oriented north-south, half-moon in profile with sloping sides and a concave base. It measured 45cm wide by 24cm deep and contained a single fill (004) of firm, greyish brown, silty loam with no inclusions or finds. The purpose of this ditch is unclear, it is cut into the fills of a larger underlying ditch [005] and so post-dates it, and is possibly associated with the planting of the adjacenthedgerow.

The larger ditch [005] on the western side of the trench appears to be associated with the road. It is oriented north-south, assumed to be V-shaped in profile although its western limit was not reached as the adjacent boundary hedge and fence were constructed over it. The area exposed was 1.10metres wide by 55cm deep, but the original ditch probably had an overall width of 1.75 metres and a depthof 1.25 metres. The ditch contained three fills, the largest of which (006) was a friable to firm, mid greyish brown, silty/sandy loam with inclusions. These included small fragments of greensand and sarsen stones, and occasional pieces of fractured flint. Context (007) was a small deposit in the upper fill (006) of ditch [005] that could be associated with the smaller ditch [003], but with noticeable differences in the colour and make-up of the soils. These were friable, dark brown, silty clay withno inclusions and measured 15cm wide and 17cm deep. The primary fill (008) of ditch [005] was not fully excavated due to time constraints. This was possibly the bottom fill of the Romano/British ditch and was formed by natural erosion of the road surface into the adjacent ditch. The deposit was water- lain in character and comprised a firm, greenish grey mixture of silty sands with occasional fragments of greensand stone.

There were two distinct features on the east side of the trench. Feature (009) was an area which may have been the ditch on the eastern side of the road, the counterpart to ditch [005] on the west. However, the feature was not fully excavated and may have been caused by modern agricultural practices such as the use of a sub-soiler. It comprised a friable to firm, mid greyish brown, silty clay with inclusions of sand, and small fragments of greensand and sarsen stone. The feature was oriented north-south and was 55cm wide and up to 20cm deep.

There was a small ditch [010] on the eastern side of the road surface to the west of (009). It is oriented north-south and appears to mirror the small ditch [003] on the western side of the road. This ditch is 58 cm wide and 21 cm deep, and roughly half-moon shaped with sloping sides and a concave base. It contained a single fill which was the same as or very similar to the topsoil (001).

The evaluation trench showed the profile of a road with ditches on either side typical of Roman methods of construction. It appears to have been constructed of locally available materials, the surface being a compacted mixture of greensand blocks, sarsen stone, and flint and pebbles. The greensand blocks have degraded to small stones and sand over the years possibly because of wear and tear caused through use by animals and people, and by natural erosion.

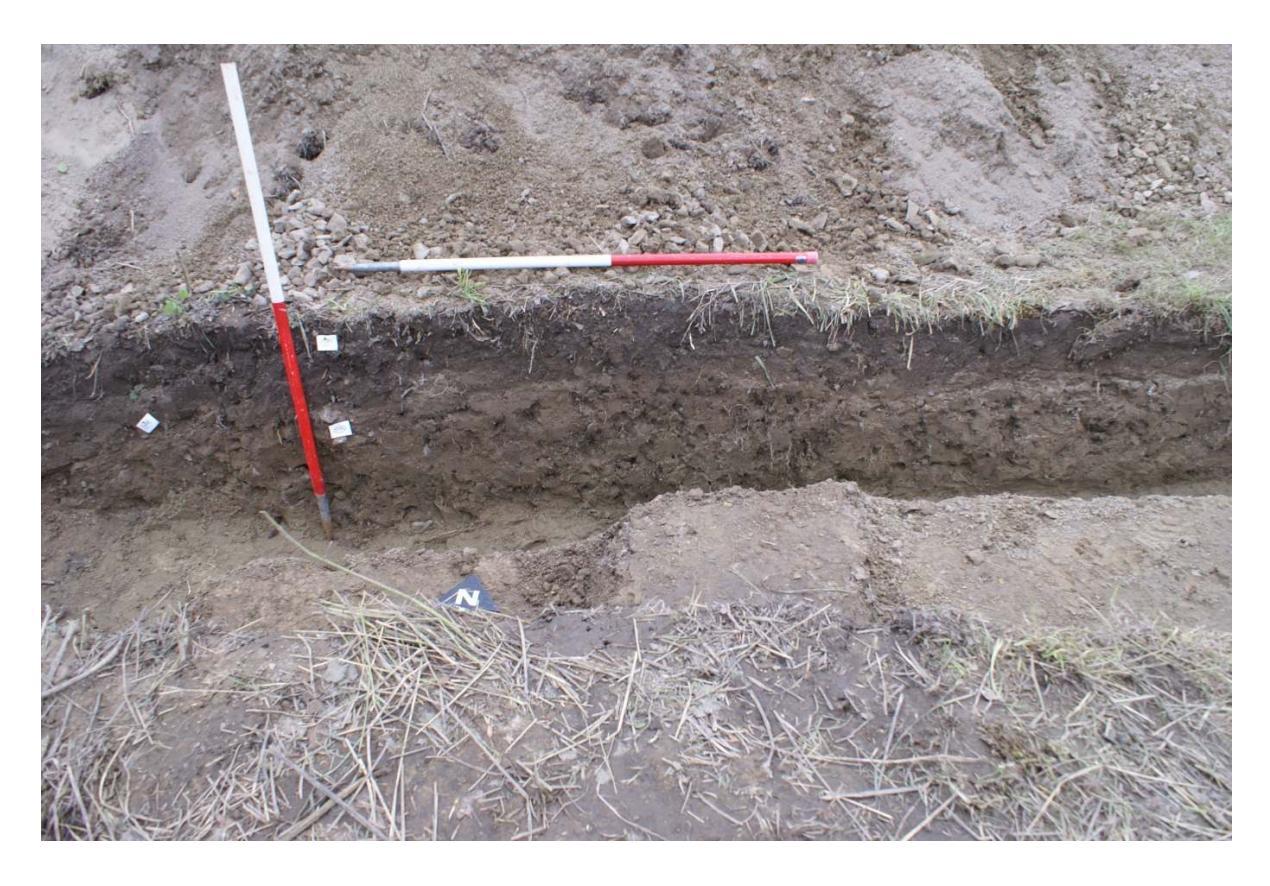
Figure 134. Photograph of the trench, showing the agger surface of the road.

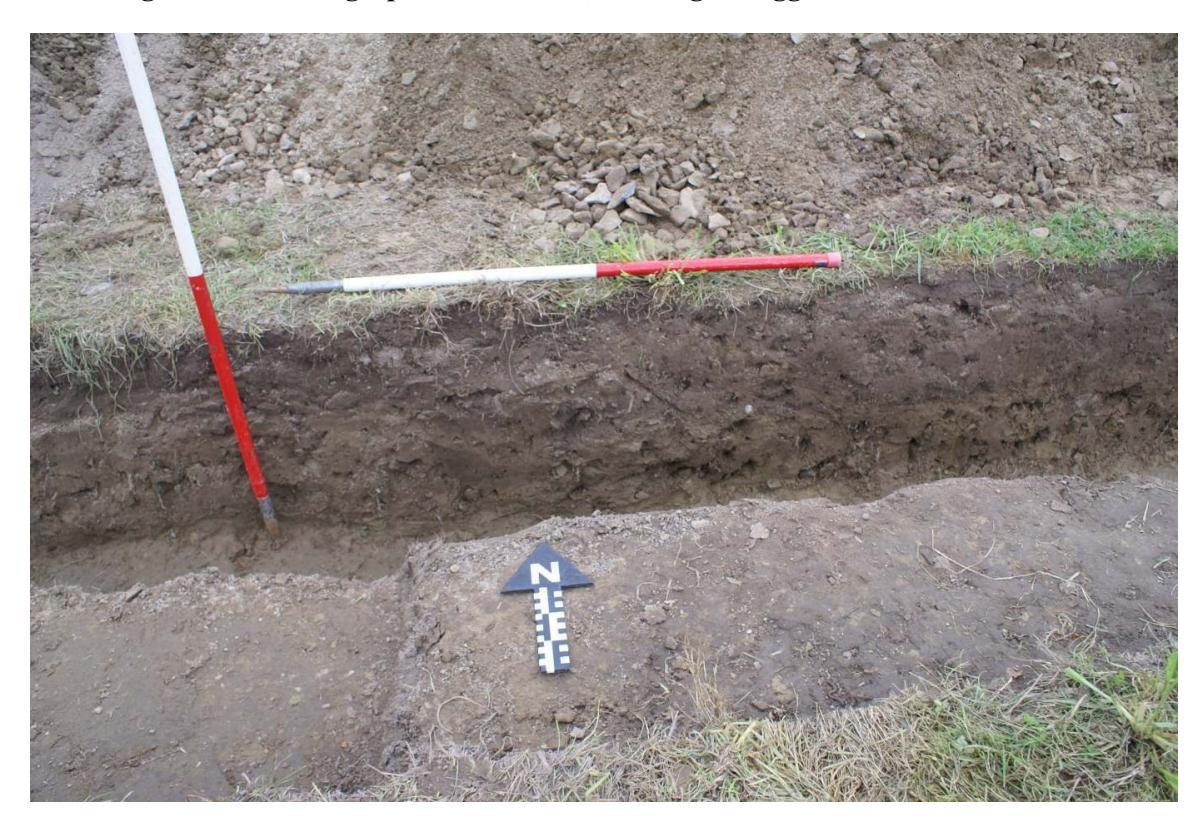
Figure 135. Photograph of the trench, showing the agger surface of the road.

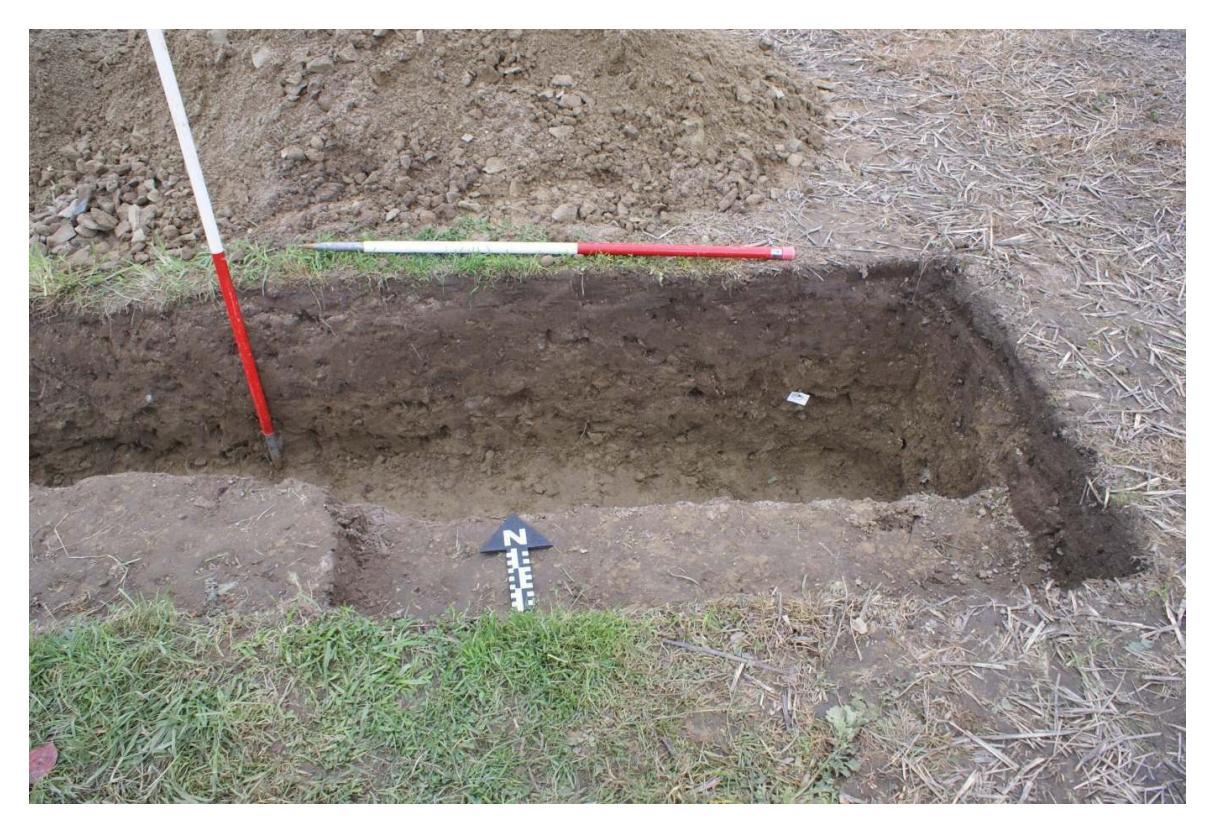
Figure 136. Photograph of the trench, showing the ditches on the eastern side of the trench.

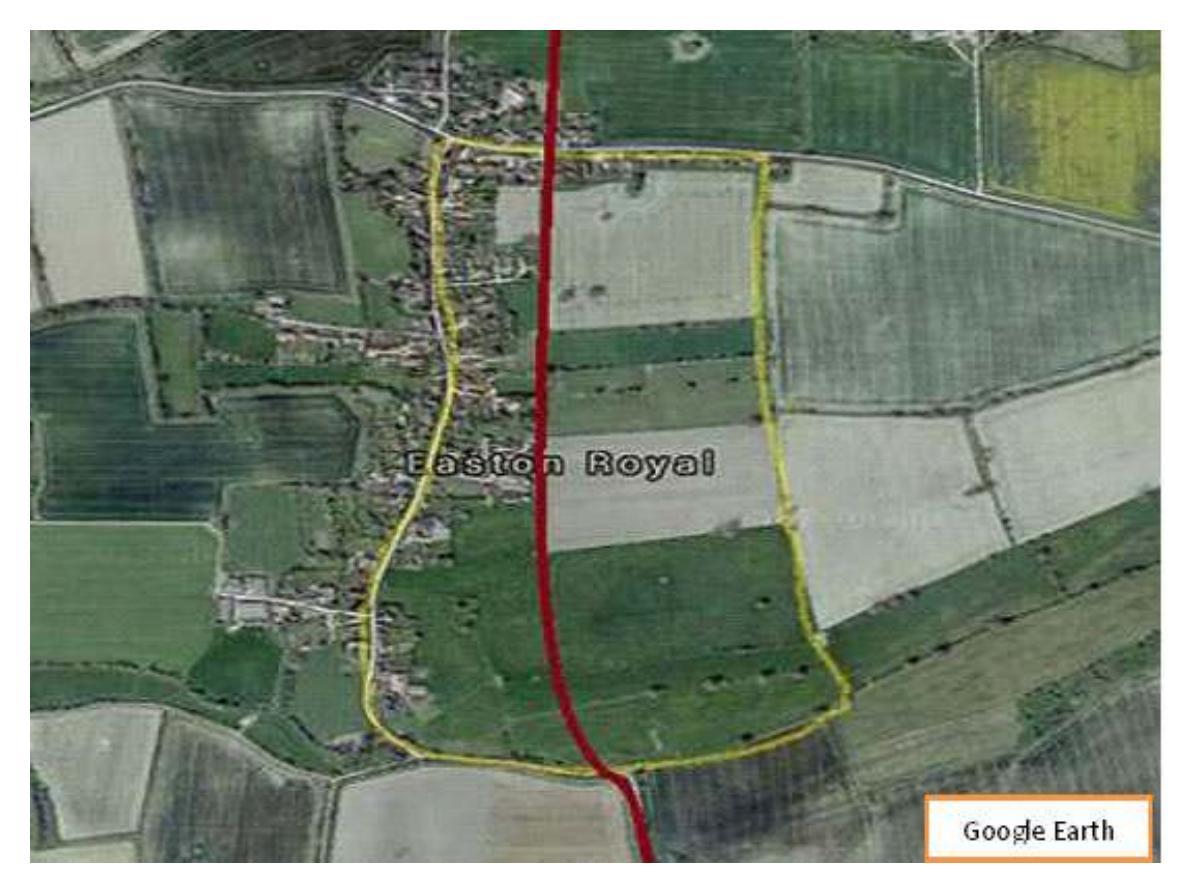
Figure 138. Aerial photograph of Easton Royal showing the predicted line of Roman road in red and the perimeter of the survey area in yellow .

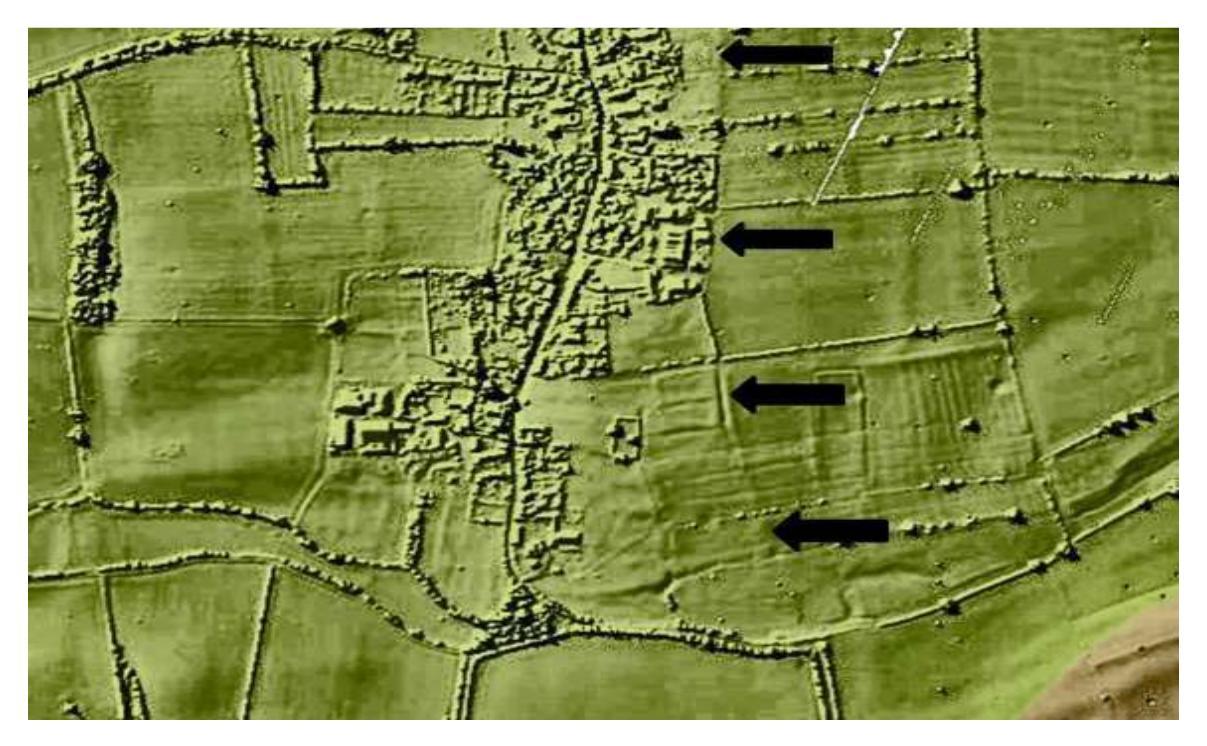
Figure 139. LiDAR aerial image of Easton showing line of the Roman road.

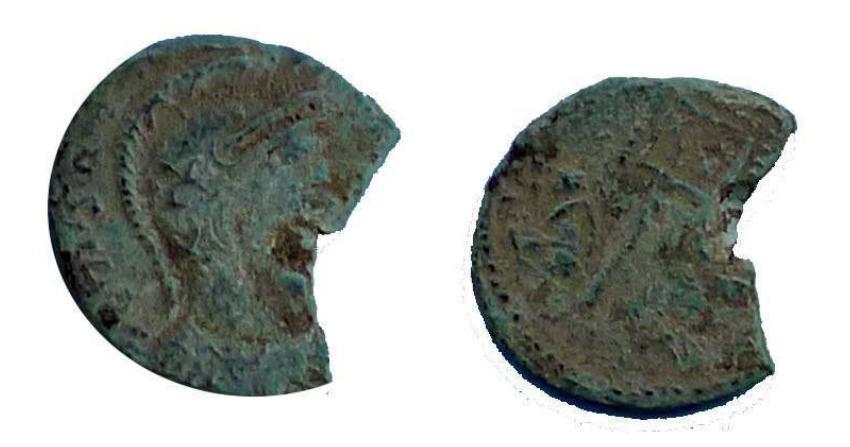
A copper alloy damaged coin was retrieved from (002), the obverse has a helmeted head facing right with the inscription "CONSTANTINUS AUG" and the reverse has two captives seated at the foot of a standard with the inscription "VIRTVS EXERCIT". The coin is dated AD309 – AD337 (Sear 1981, p316 3785).

### Figure 148. Photograph of Roman coin recovered from the agger surface of the road.

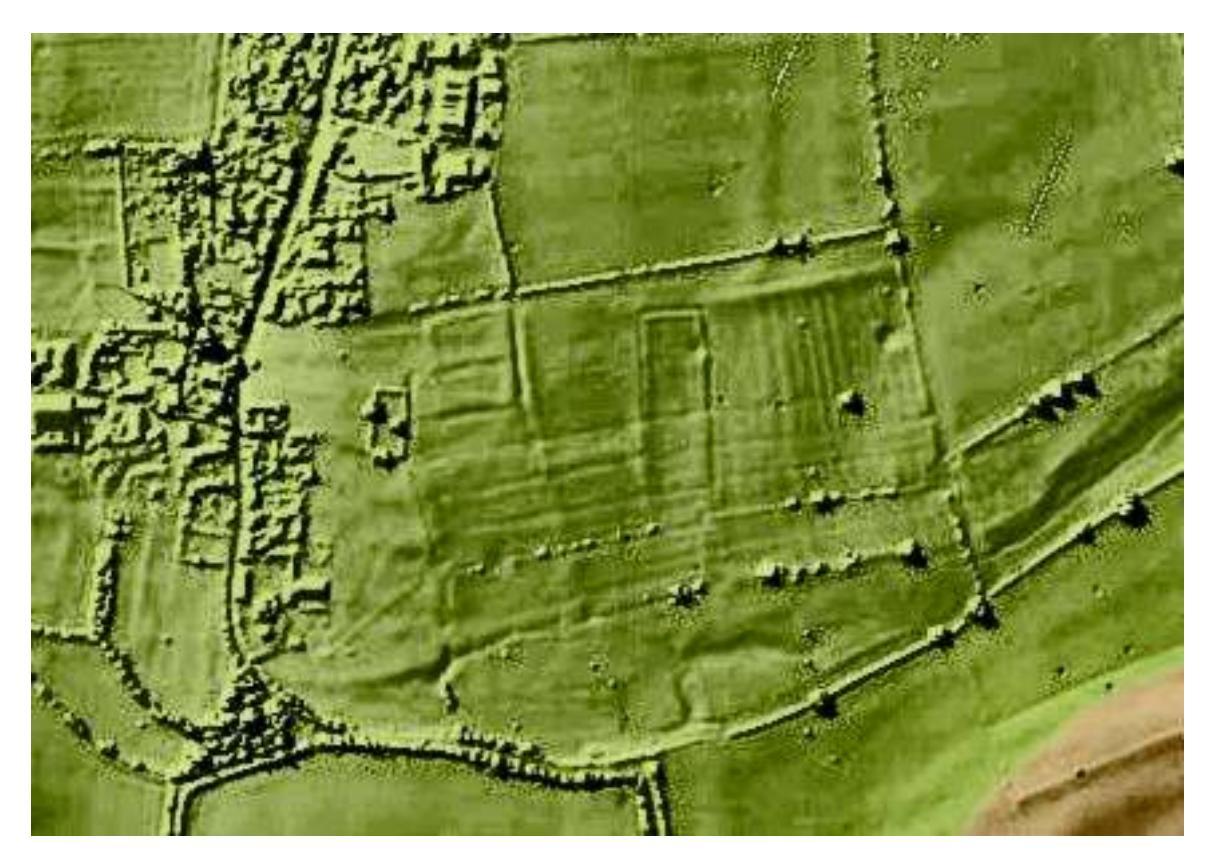
### Figure 162. LiDAR survey (north to top)

The earthworks recorded on air photography and LiDAR (Figure 162) are in close accordance with the features detected by the geophysical survey (Figure 163). The character of the features would suggest that the majority are of post-medieval date although this does not preclude the possibility that some *may* reflect the fossilisation of earlier landscape components.

The earthworks comprise a series of ditched enclosures, former ditched boundaries and features resulting from agricultural activities. Of the latter, most prominent is a block of ridge and furrow cultivation, probably medieval in date, aligned north-south with a substantial plough headland marking the northern limit. This lies on the eastern side of the study area. Immediately to the west of this is a large rectangular ditched and embanked enclosure, the north-west corner of which was also recorded by the geophysical survey (Figure 164, 9). The southern half of the enclosure and the corresponding area of ridge and furrow to the east appear to be overlain by a series regularly spaced east-west parallel ditches which are probably

post medieval plough land boundaries. The alignment of these features follows that of the present landscape boundary trends which are depicted on the 1814 Inclosure map and the Easton Estate map of 1846 (Bathe and Holley 2014, Appendix D).

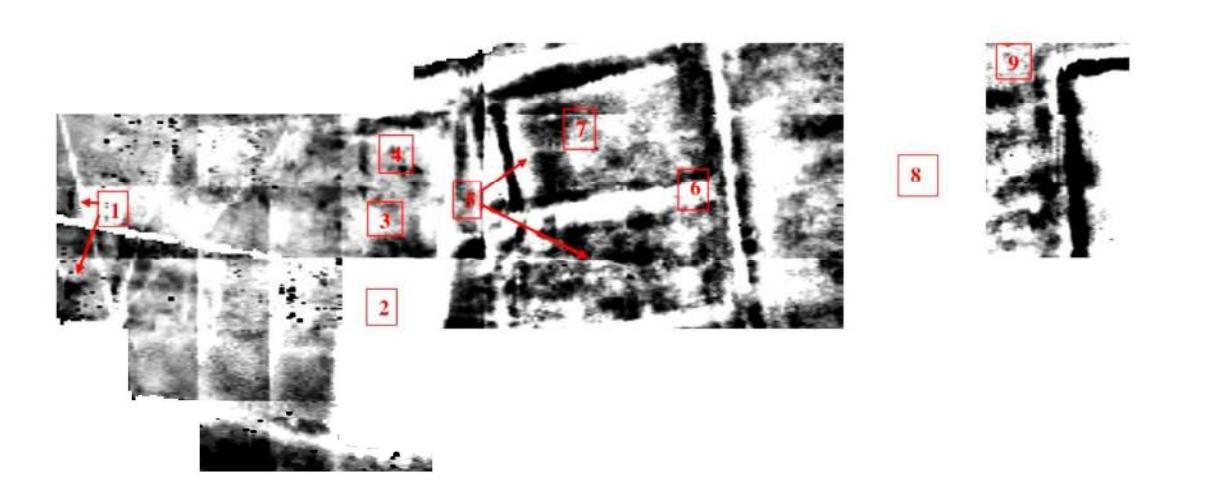
Figure 164. Annotated results of the geophysical survey (Oswin 2014, Fig. 3.3)

Further to the west is another subdivided enclosure of roughly square plan with traces of possible structures visible on the geophysics (Figure 164, 5, 6 and 7).
