Archaeology in Chester Cathedral 1995–97

by Simon Ward

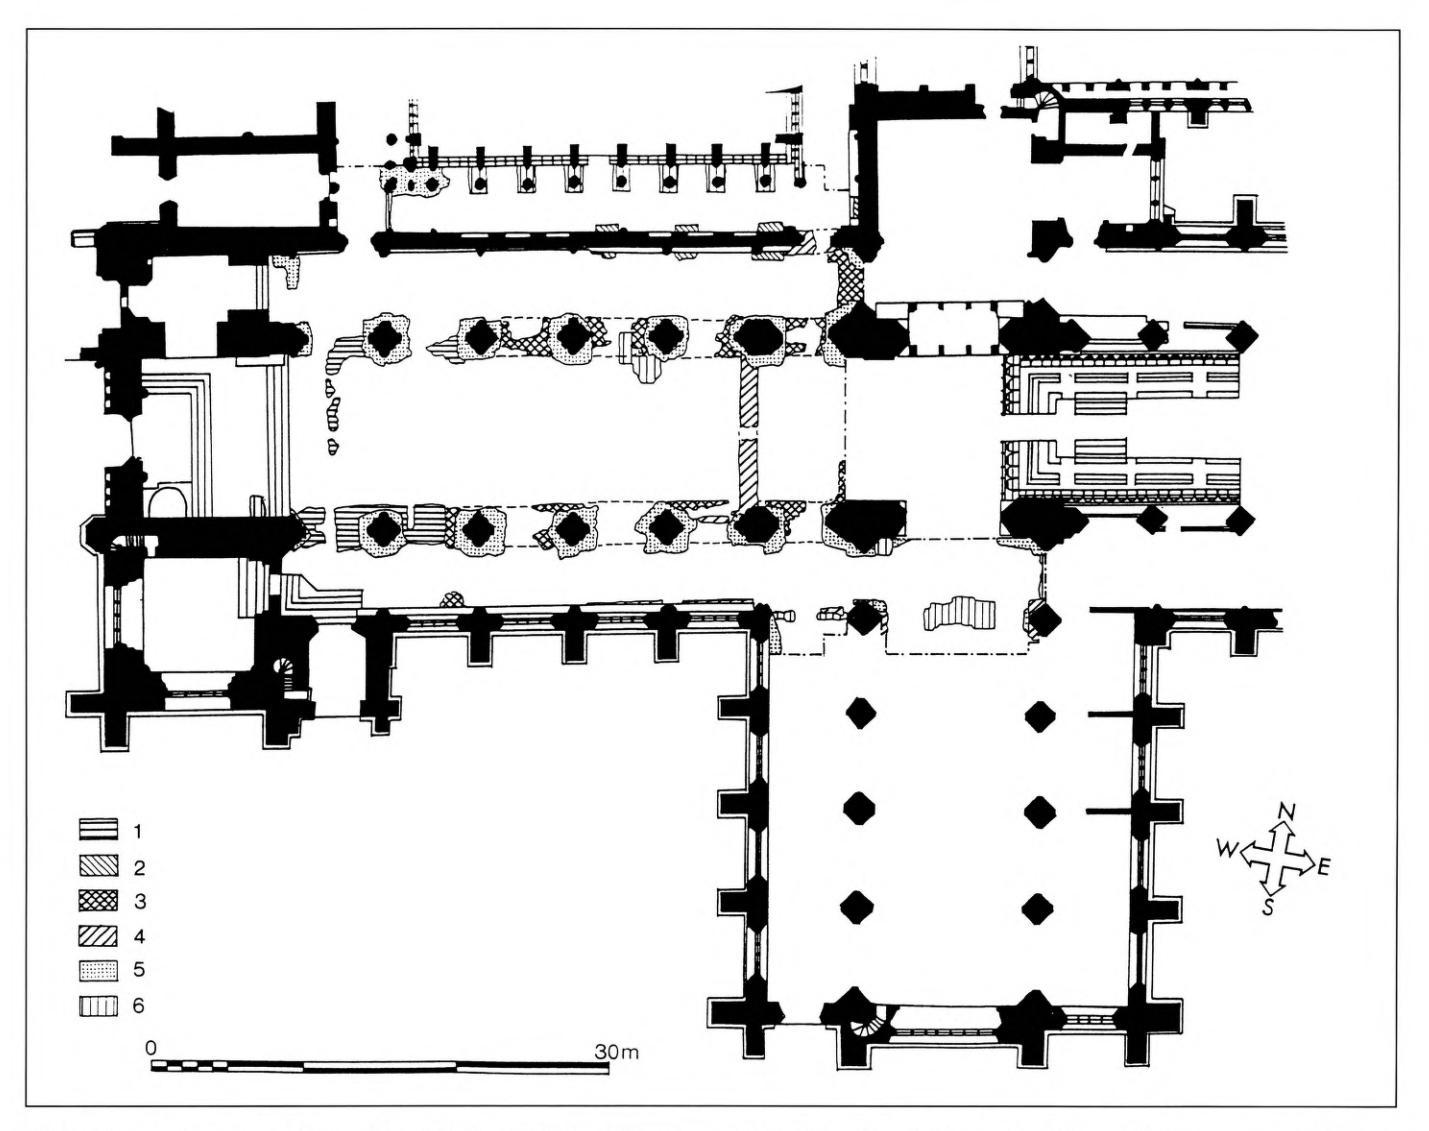
Fig 1 Excavated remains at Chester Cathedral. Key: (1) Phase 1, Saxon remains; (2) Phase 2, early Norman; (3) Phase 3, the Norman nave; (4) Phase 4, Norman or Early English; (5) Phase 5, the late-medieval rebuilding; (6) Phase 6, post-medieval (Illustration: Simon Ward)

Below the late medieval foundations lay earlier masonry. These remains appear to relate to more than one structural phase but their significance and relationships are not always clear (Fig 1). In the absence of artefactual

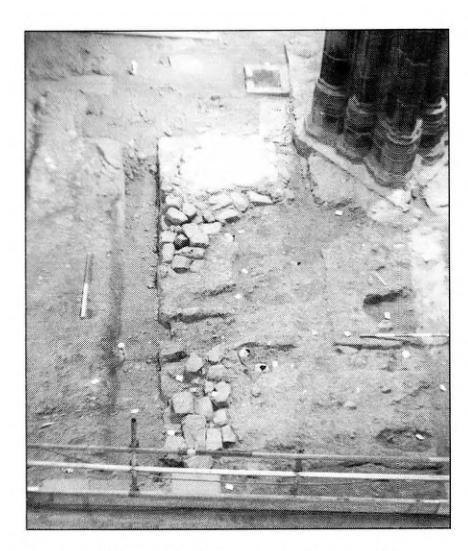
Fig 2 West end of the nave with possible Saxon foundations below the late medieval north arcade (Photo: Simon Ward)

The earliest structures, remains of foundations, were found beneath the arcades in the two westernmost bays of the nave. The southern one was more substantial and extended westwards to the western steps. The northern one terminated half way across bay 6. A rough return ran south from this termination but petered out half-way across the nave (Fig 2). These structures could well be part of the Saxon church extending westwards from the present building. Further short stretches of potentially Saxon masonry were also found under the north and south transepts. If the dating of these is correct, they must be from separate and not necessarily contemporary buildings.

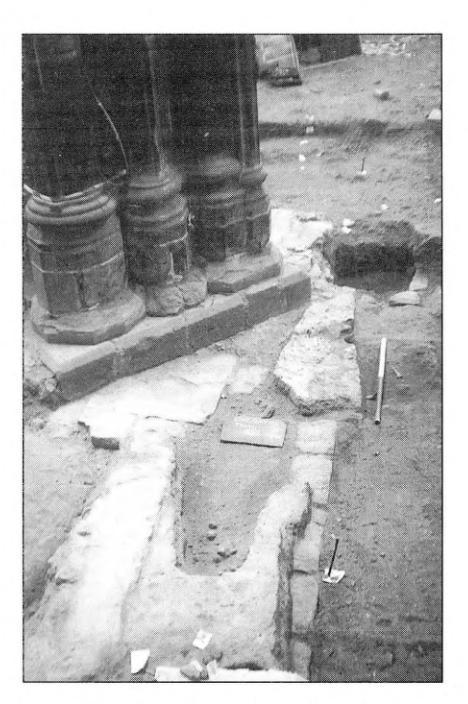
Fig 3 Pier 2 in the south arcade with chamfered base cutting remains of earlier mortar floor and Norman sleeper wall showing through beneath (Photo: Simon Ward)

a wall spanning the centre of the nave between the first piers. It was presumably the base of the original rood screen demarcating the east end of the nave. Patches of fine mortar floors (of which a sequence of at least three was recorded) survived against the west face of the wall (Fig 3). A further sandstone structure was set upon the mortar surface between piers 1 and 2 on the south. This may have been the base of the sedilia.
