# ARCHAEOLOGICAL EVALUATION REPORT

# Plum Pudding Hill, Upper Road, Baylham

## **BAY 040**

## A REPORT ON THE ARCHAEOLOGICAL EVALUATION, 2009

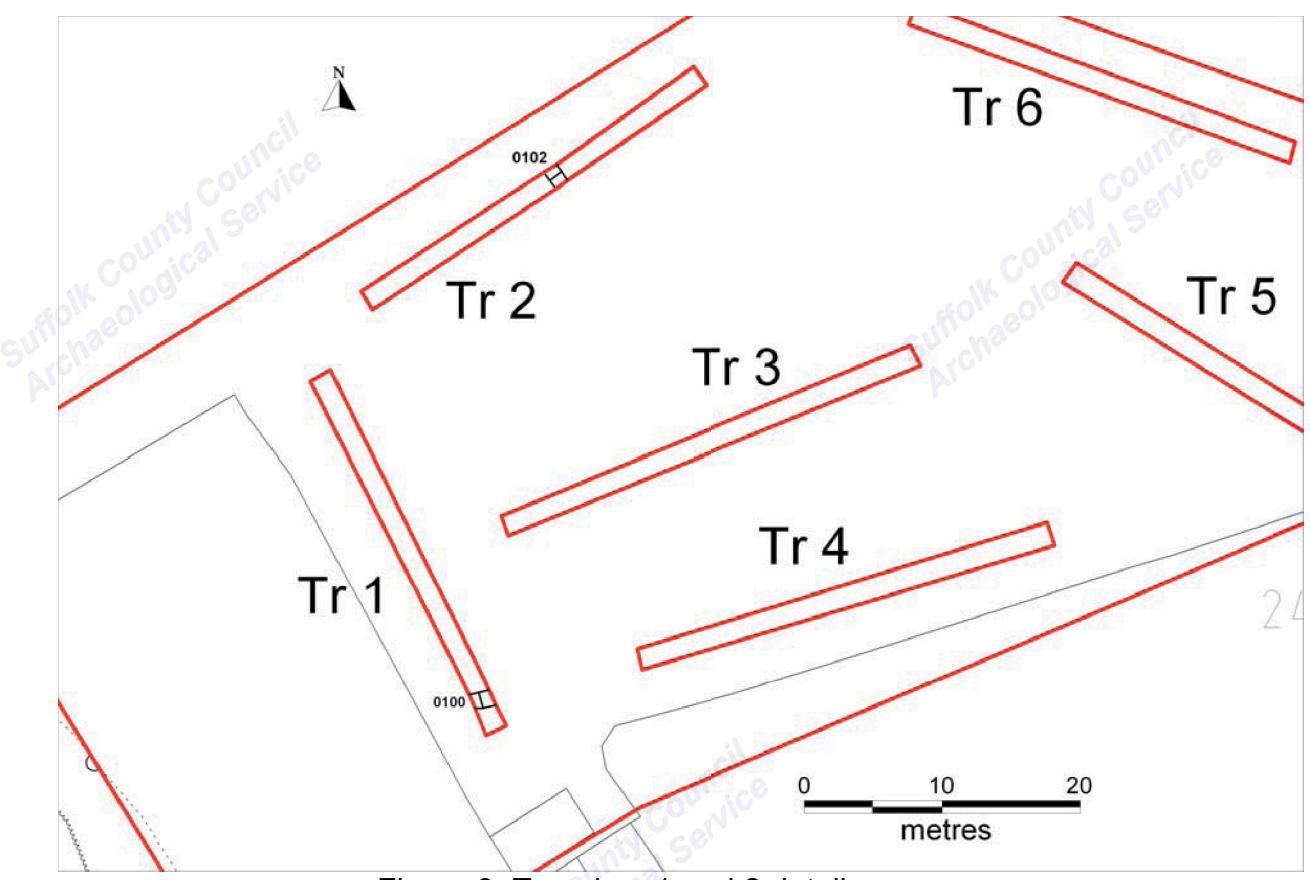
Figure 3. Trenches 1 and 2 detail © Crown Copyright, all rights reserved, Suffolk County Council Licence No. 100023395 2009

Trench 1 was located to investigate the area affected by the footings of the largest part of the extension to the existing building, running along the edge of the believed area of terracing activity where the tennis court was. The trench was 28m long, 1.6m wide and between c. 0.4-0.6m deep. A single archaeological feature was identified in the trench –ditch 0100 c. 0.8m wide, 0.35m deep and orientated approximately northeast-southwest, filled with a loose orangey/mid brown silty sand deposit with a moderate amount of small to medium sized stone inclusions. A sample was taken from this feature to increase the potential recovery of artefacts or ecofacts, although the nature of the deposit suggests that sample would be unlikely to provide either. In addition to this linear feature, a large natural channel was visible in the middle of the trench, believed to be a hillwash/water run-off deposit eroded through the chalk outcropping here. Figure 3 shows the principal features in Trenches 1 and 2.

It is believed that this ditch is not present further to the west (due to the previously mentioned terracing). It may extend further into the site but was not identified in other trenches.

moderate small to medium stone inclusions and patches. It was within this geology that the second feature, 0102, was found. This feature was recorded as a dubious linear feature, possibly a ditch, c. 0.55m wide by 0.3m deep, orientated approximately northeast-southwest (Fig. 3). In this case the following profile was recorded at its deepest point:

Two features of archaeological interest were noted during this evaluation, a single ditch in Trench 1 and a more dubious linear feature in Trench 2. After recording, both features were completely excavated in order to maximise any potential dating evidence, although in the event none was located. The lack of any continuation of the feature from Trench 2 into Trench 3 makes it more likely that this is not a real feature, and is most likely of natural origin.
