ARCHAEOLOGICAL MONITORING REPORT

Suffolk County Ser SCCAS REPORT No. 2008/79

Letheringham Hall, Letheringham **LRM 001**

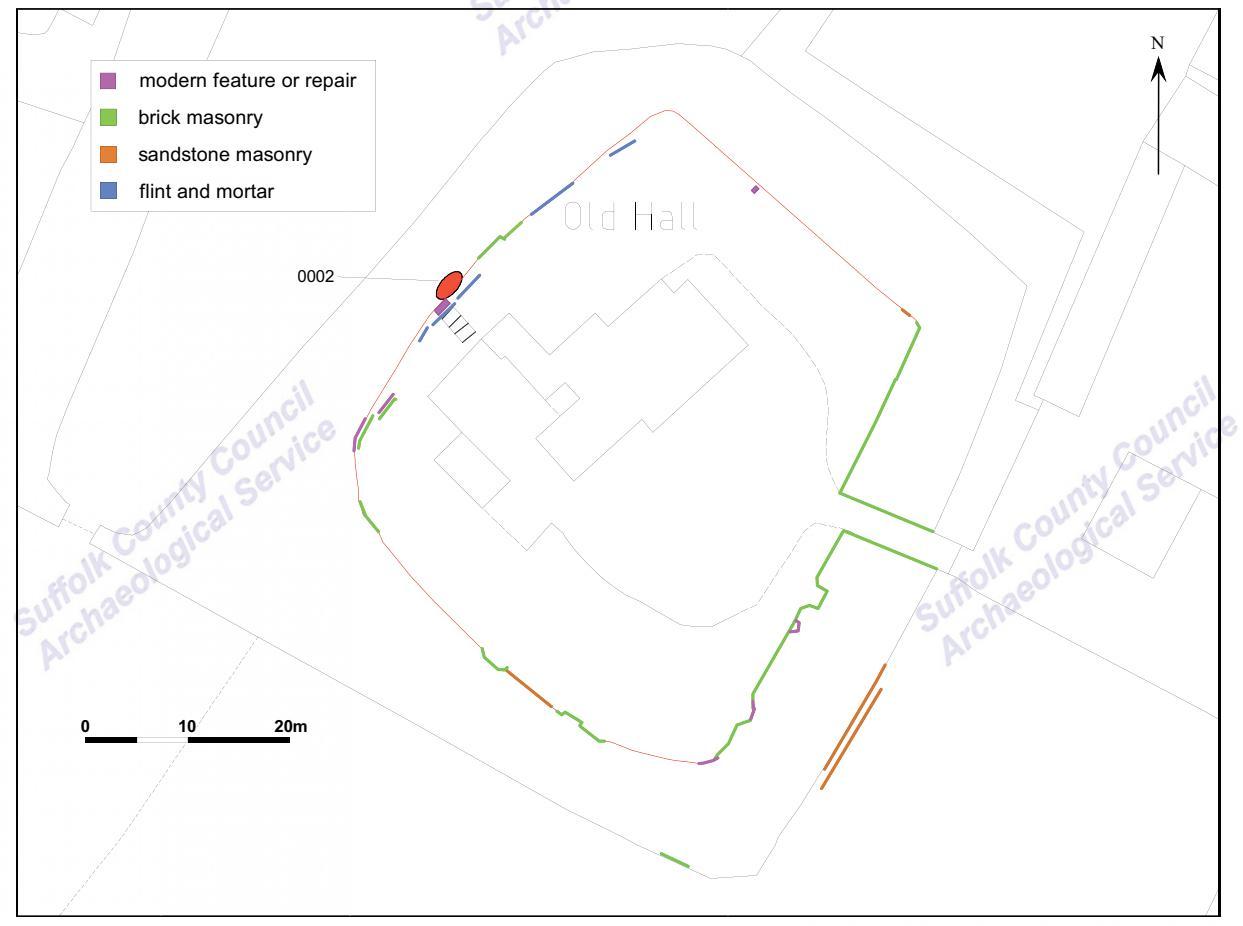
A small area of consolidated gravelly silts (0002) was recorded along the internal bank of the northern arm of the moat (Figure 3). It was situated below a fragments of flint and mortar revetting, but no relationship between the masonry and the deposit was determined. A large sherd from a late medieval vessel was recovered from 0002 which suggests that this deposit accumulated no earlier than this period and could be significantly later, incorporating the pot sherd as a residual find.

Various traces of revetting were observed around the internal, and to a lesser degree, the external banks of the moat. The locations and extent of the visible masonry fragments were recorded with the GPS and are shown on Figure 3. Three main fabric types were represented:

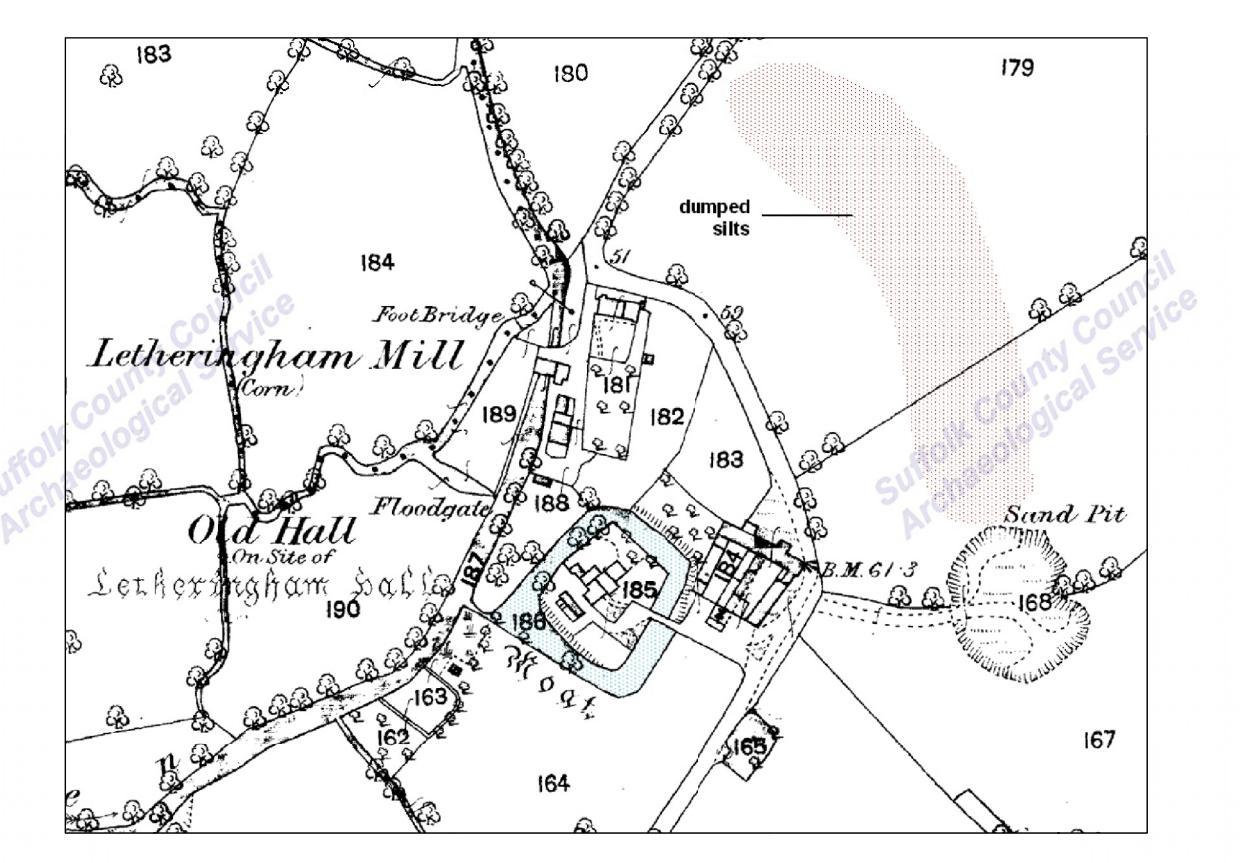
The silts removed from the moat profile were dumped in a disused extraction pit and once this was full, the remainder was spread over the fields surface (Figure 4). The silts were allowed to drain and weather for several weeks before they were subject to a visual inspection for any artefactual evidence and a metal detector survey by a local volunteer. In both cases, no pre-modern evidence was recovered.

Fig. 4. 1st edition OS map showing the disused sand pit east of Letheringham Hall, and the approximate area of silts spread over the field. The moat is shaded blue.

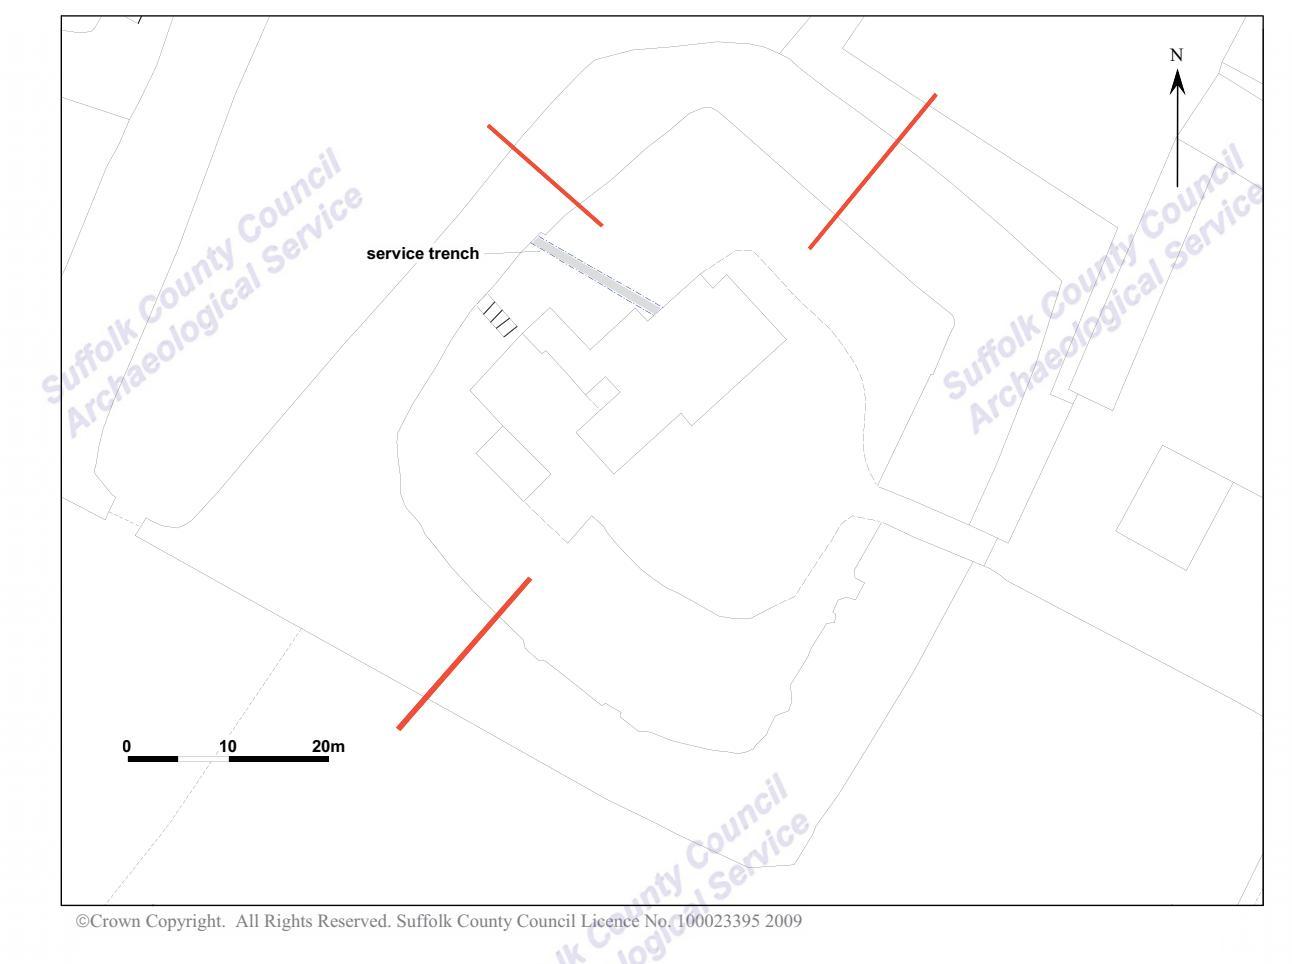
Figure 5. Location of excavated service trench and moat profiles

A shallow service trench cutting across the moat platform from the rear of the house to the moat edge was also monitored during the course of the project (Figure 5; Plates 14 & 15). The trench measured c.0.3m wide with an average depth of 0.35m, remaining within topsoil throughout. Finds recovered from the upcast spoil were all of modern origin, including china and brick fragments, none of which were retained.

Once the desilting was complete, the GPS was used to record profiles across three of the four moat arms (Figure 5) These are shown as Figures 6-8, with Figure 9 showing the north and south profiles in their correct relative positions. This was carried out in order to provide a representative record of the depth of the moat and its profile on completion of the works. The profiles also illustrate the difference in ground level between the exterior of the moat and the internal platform, which is on average 1.2m higher than the surrounding land.

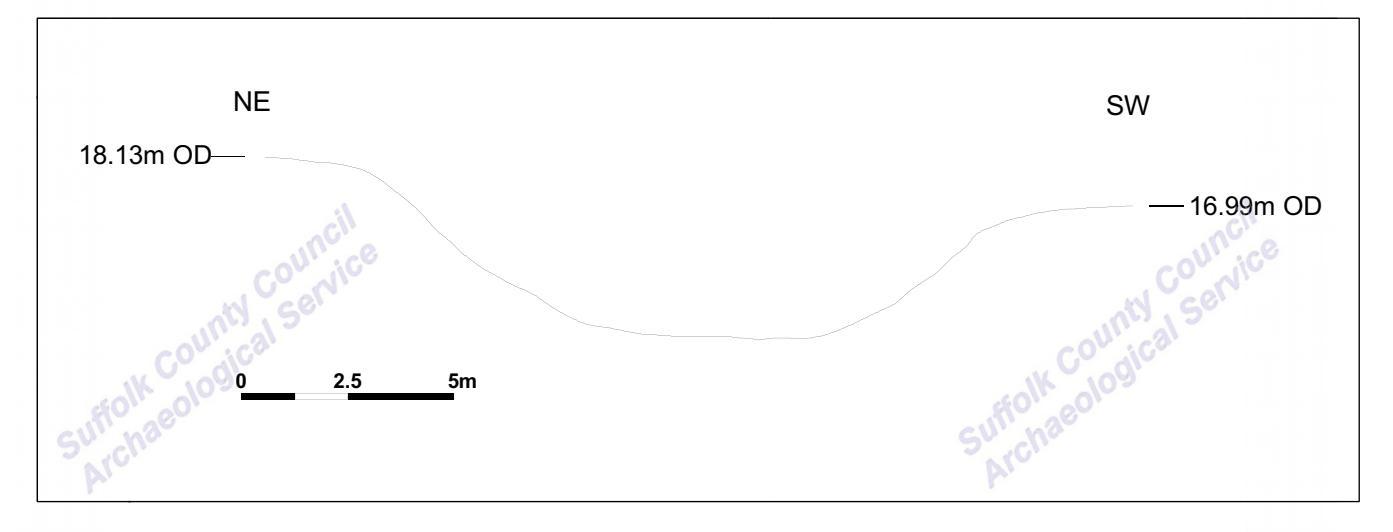
Figure 6. NE-SW profile across southern moat arm

The ditch profiles show that the internal platform is 1-1.5m higher than the surrounding ground level and was likely to have been raised during the original moat construction, using spoil from the excavated ditch.

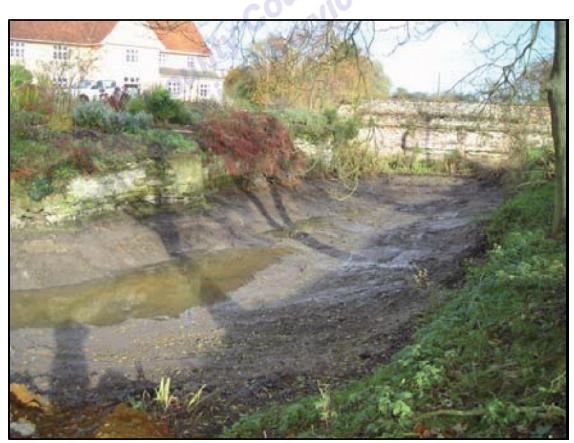
- Brick The causeway and part of the front face of the moat island are revetted with brickwork. This is believed to date from the sixteenth century but is eroded and has been much repaired. Remnants of pre-modern brickwork also exist at the rear of the island but their age is uncertain. Two brick built buttresses on the southern internal bank appear to be of quite early construction.

Plate 7. SE moat arm, looking NE towards causeway bridge and showing island revetting. After de-silting

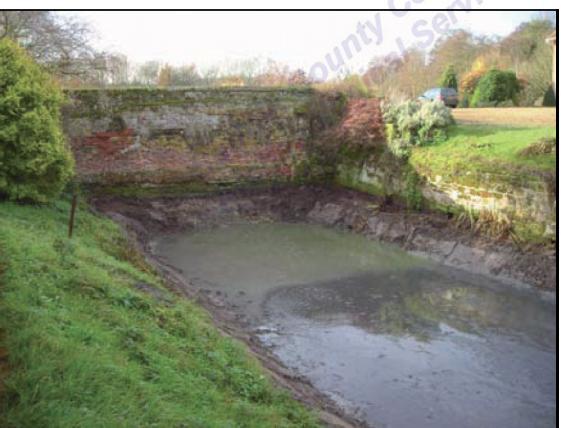
Plate 8. SE moat arm, looking SW towards causeway bridge and showing island revelling. After de-silting

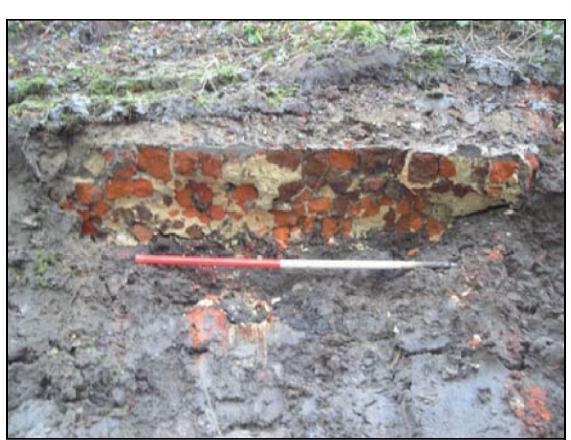
- *Flint and mortar* Fragments of undated, but pre-modern, brick were incorporated within its fabric. In places, surviving flint and mortar has been used as a base to build later brick structures off (Plates 10 & 11). There is no evidence to suggest the flint and mortar revetting is of recent origin but its date is unclear. Erosion appears to have undermined some of this masonry, causing it to break and slip down the bank (Plate 11).

Plate 11. Collapsed flint, mortar and later brick wall section within the internal face of the northern moat arm

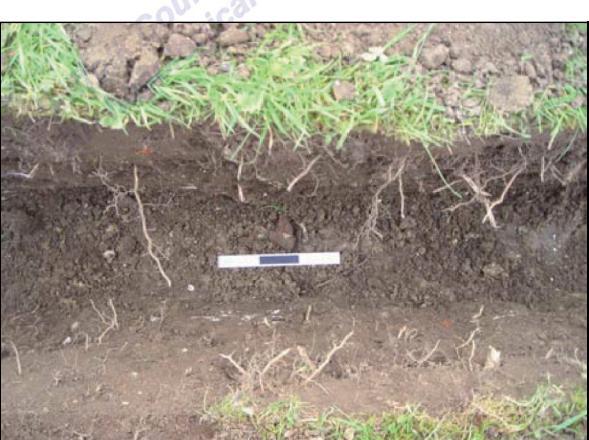
Plate 15. View of excavated service trench

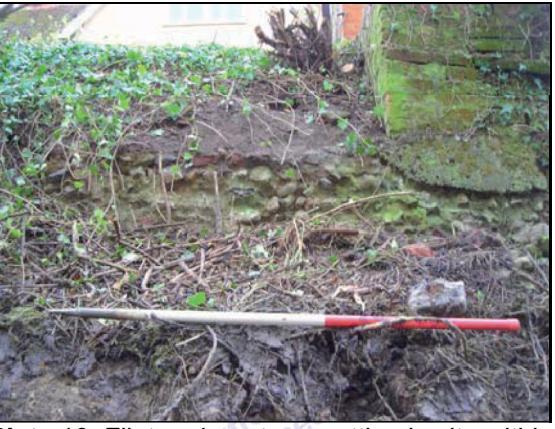
Plate 10. Flint and mortar revetting in situ within the internal face of the northern moat arm

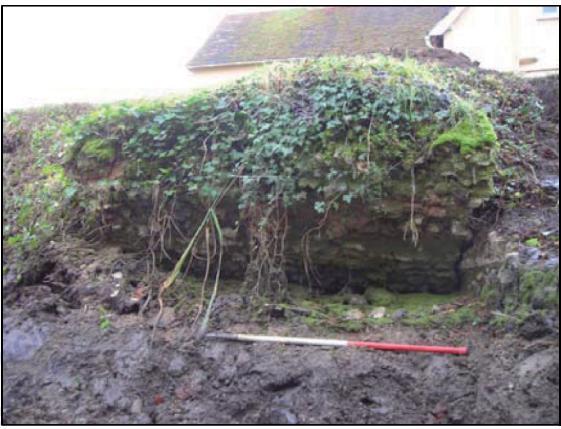
Plate 12. Fragment of flint and mortar wall in situ within the internal face of the northern moat arm

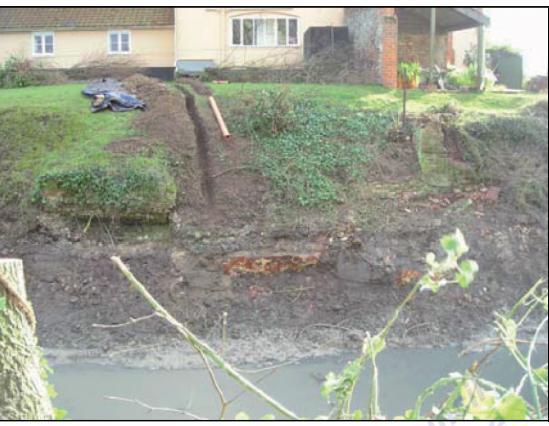
Plate 14. Location of the excavated service trench, looking SE
