# **ARCHAEOLOGICAL MONITORING REPORT**

A REPORT ON THE ARCHAEOLOGICAL MONITORING, 2003-4 (Planning app. no. F/2000/493)

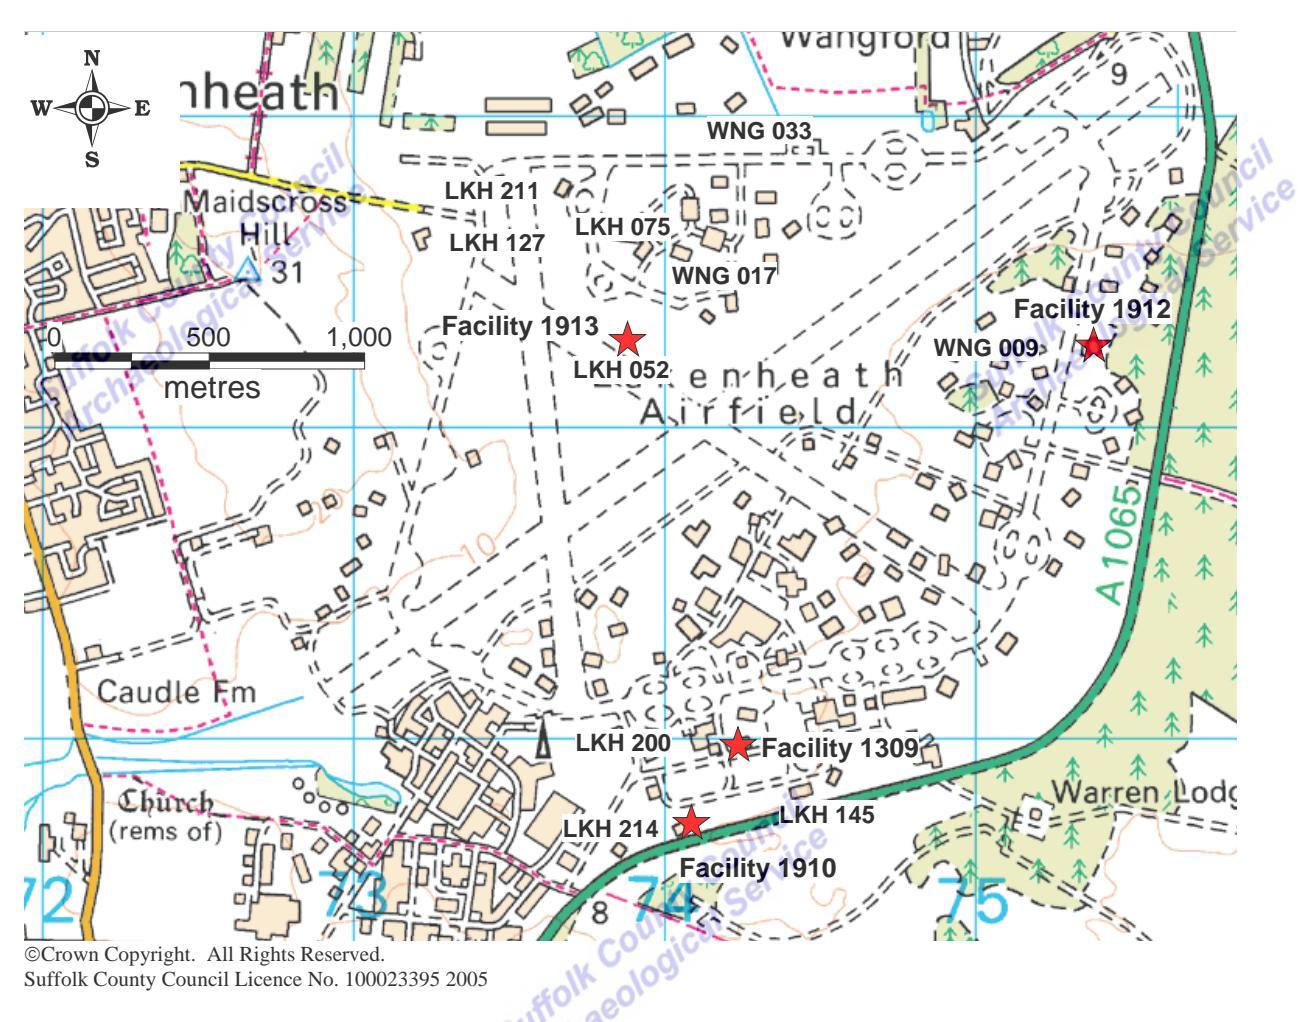
Figure 2 Construction sites in relation to nearby archaeological sites

Three visits were made to monitor the ground works for facility 1912 in May 2004 (Fig. 2). The building footprint and associated trenches were monitored. These showed c. 0.1m of thin sandy topsoil lying directly onto natural chalk with occasional orange-brown sandy patches. These patches were more frequent on the south side of the site, and the chalk cleaner on the north side, suggesting that the natural has been truncated to the north. In addition there were some patches of redeposited sand lying over truncated chalk in all areas of the site. Occasional brick flecks were visible at the interface between natural and topsoil and modern services could be seen Archaeo cutting the chalk, however there were no archaeological finds.

Two visits during construction of these facilities saw tank holes after excavation (Fig. 2). These showed predominantly disturbed ground with occasional patches of natural sand at c. 0.3m deep, with chalk at deeper levels (1.5m+).

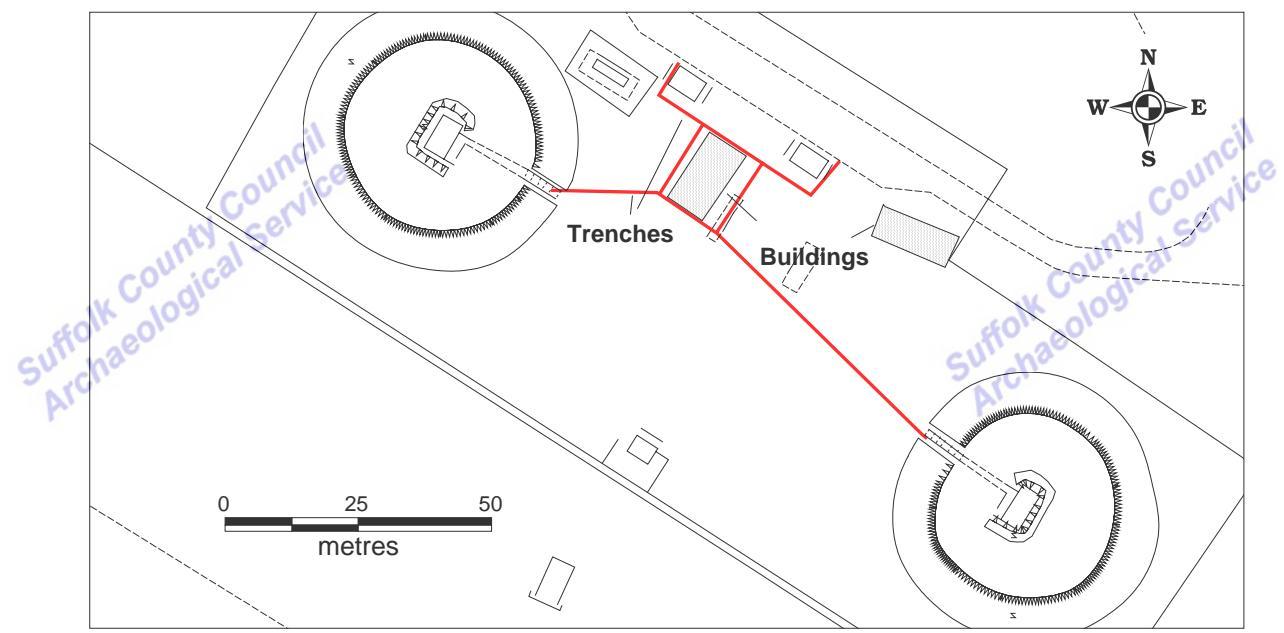
Two small buildings were being constructed (Fig. 3). Monitoring of the strip for the filter/separator building footprint showed that the north-eastern part of the site was totally disturbed to the depth of the strip, 1m (Fig. 4). The southern east-west section showed that the original ground surface had sloped quite steeply from east to west, with a black buried turf layer visible under 0.3m of redeposited material at the east end to 0.8m at the west end (Fig. 5). The buried turf (0.05m thick) lay over a layer of fine, purple-grey sand, between 0.2 and 0.3m deep. The footprint for the second, control, building was stripped to 0.65m below ground level. This showed dark grey-brown sand underlying thin topsoil across the whole site, the base of which was deeper than the stripped surface. Two hand-dug holes through this showed that it overlay a dense dark orange sand a further c.0.4m down (Fig. 5). These deposits are typical of low lying, moist landscapes and probably indicate that Wangford Fen originally extended to this point. The steep sloping ground is typical of the (now levelled) naturally undulating topography here.

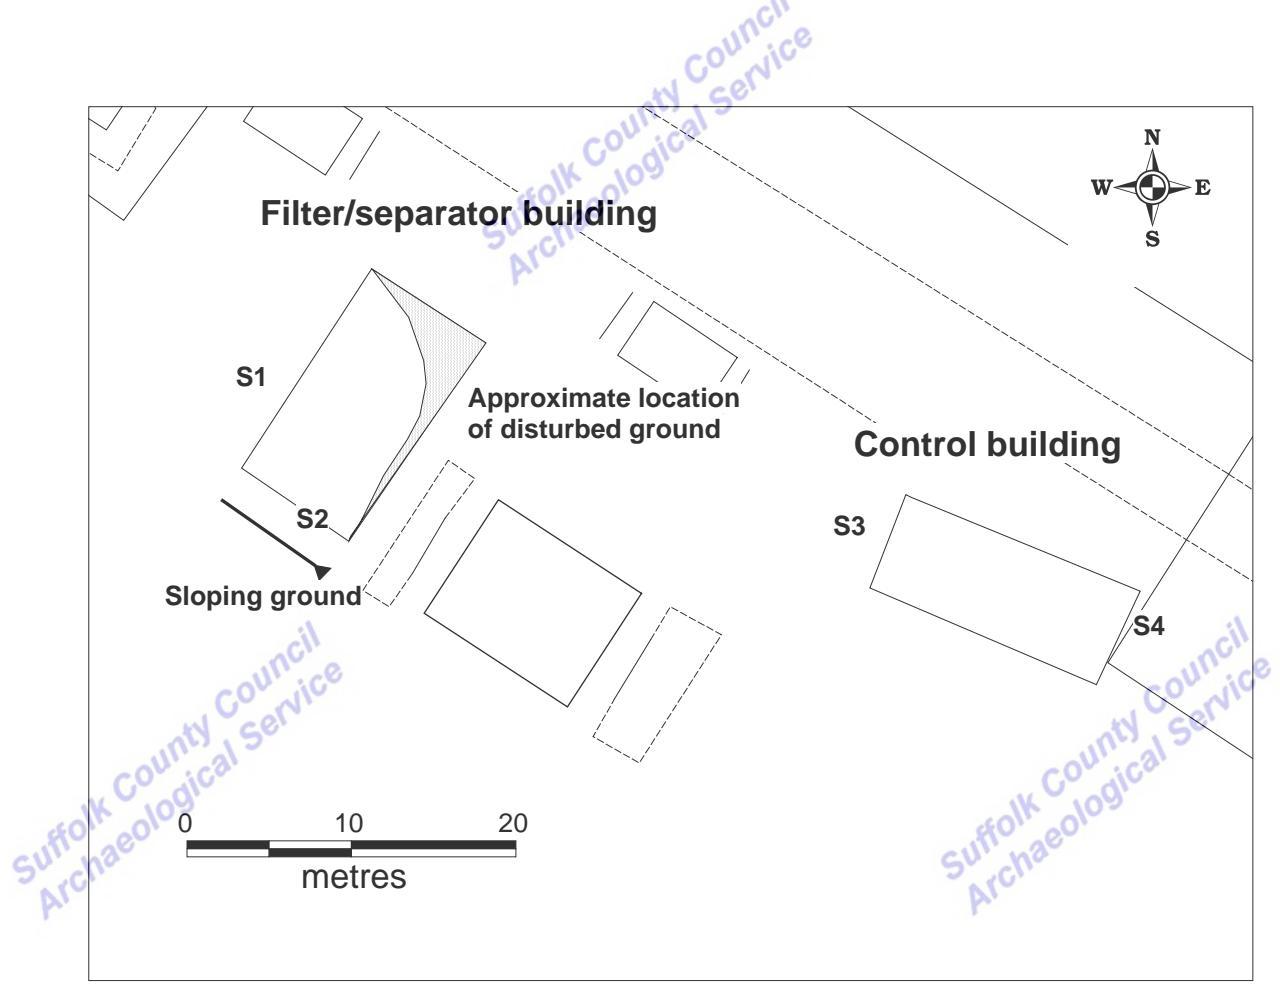
Figure 4

Facility 1913; detail

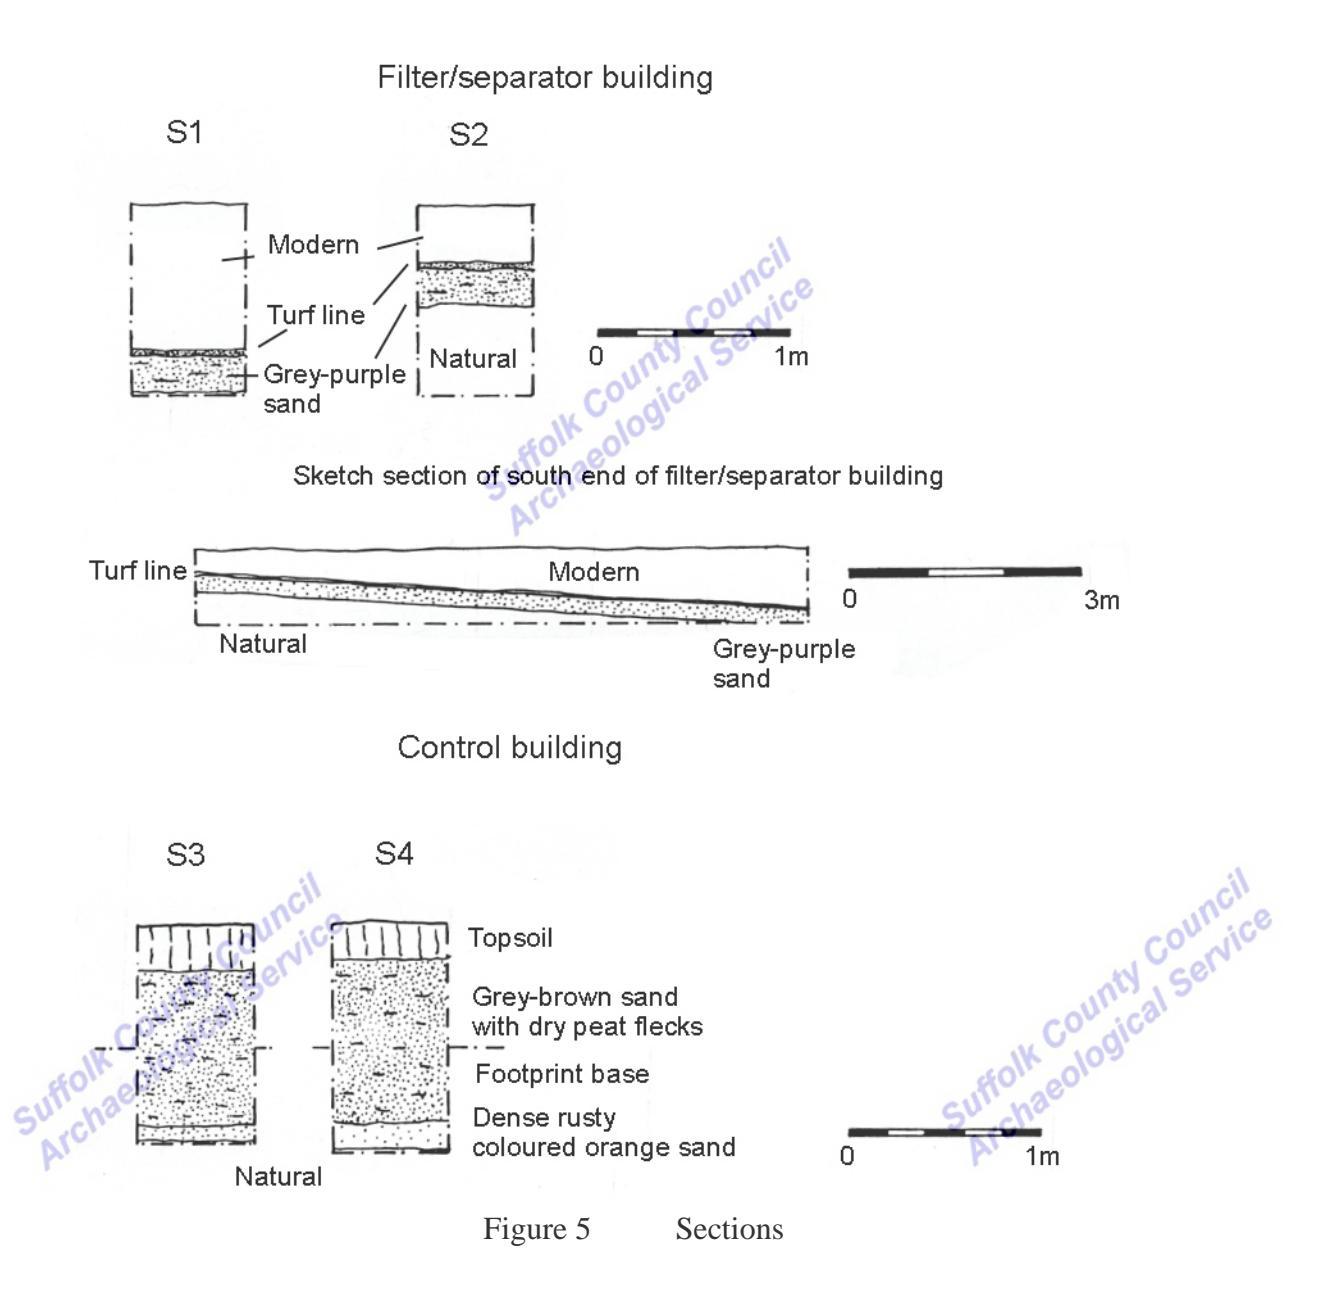
Monitoring of electric trenches to the buildings also showed similar soil profiles.
