ULAS Report No 2018-207 ©2018

Archaeological Monitoring and Recording

During Groundworks at

Skills Hub/College, Narrow Marsh, Nottingham

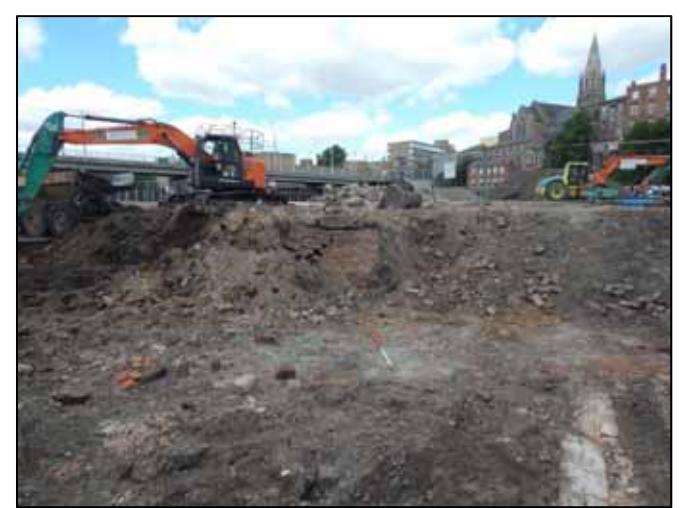
Figure 10 Ground reduction Zone 1 remnants of brick cellars

On the eastern side of Zone 1, brick and concrete pier foundations for railway viaduct arches were exposed at depths of between of 1.00m and 3.00m below the current ground level. Additionally, deposits of mixed aggregates and sand were found compacted around each viaduct pier foundation.

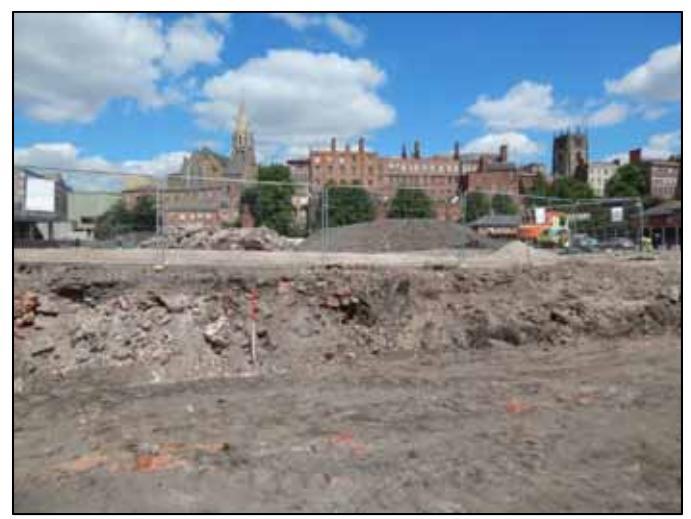
Figure 11 Ground reduction Zone 1 looking north

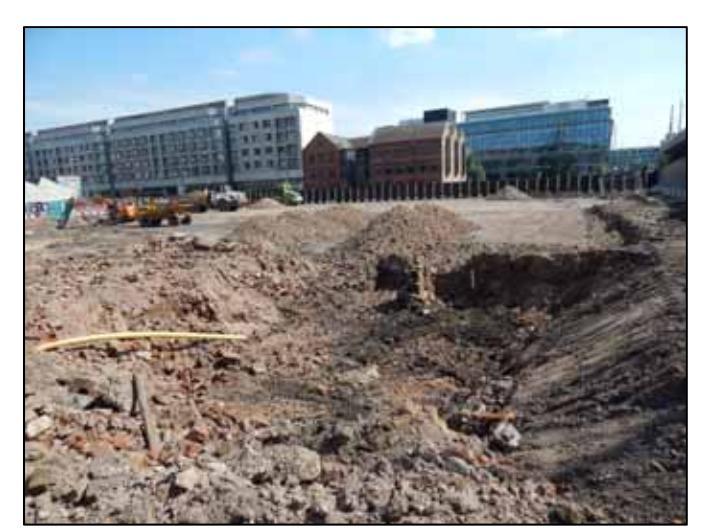
Figure 12 Ground reduction Zone 2 remnants of cellar foundations looking south

Excavations continued into Zone 2 and the overburden strip measured between 1.50m and 2.00m in depth. A homogeneous garden soil deposit continued to be found and was truncated in places by cellars. Overlying was a mixed 19th-century demolition layer that was heavily cut in places by brick cellars and by a disused service trenches. On the western side of the zone, modern overburden was compacted around substantial concrete foundations. During the removal of the concrete foundation a concrete basement or sump was revealed which measured at least 1.5m deep. Removal of the overburden deposits continued across the whole zone exposing more viaduct pier foundations on the eastern side. After overburden was removed the remaining garden soil deposits were reburied and sealed under a layer of re-engineered material that was placed back within the zone.

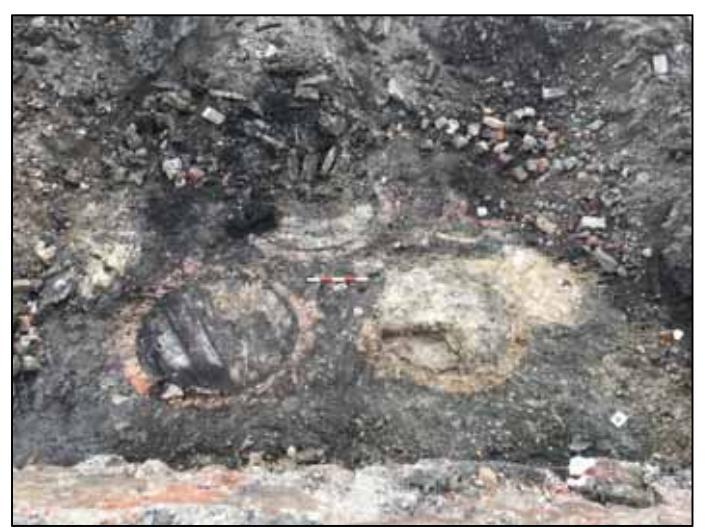
Figure 13 Clay lined pits in Zone 3

On the east side of the Zone 3 a group of circular post-medieval pits were partially exposed at the base of the excavations. The circular pits measured 1.5m in diameter and were lined with a combination of brick, clay and timber planks bonded with mortar and quick lime. The function of these pits was uncertain but they are perhaps associated with tanneries. The pits were found to be cutting the post-medieval garden soils and sealed under 19th-century demolition layers. These pits and the garden soil were subsequently reburied by re-engineered material that was placed back to help level the ground for the new building.

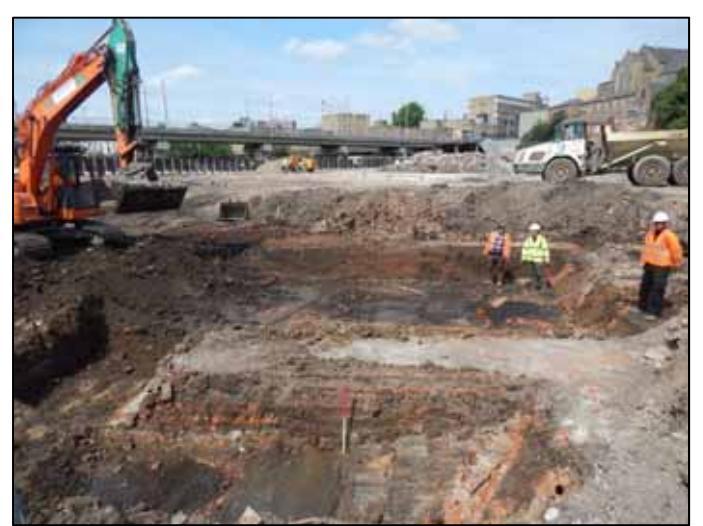
Figure 15 Top of viaduct brick and concrete foundations Zone 1 looking north-west

The top of these pier foundations were revealed during the remediation work in each zone (Figure 15). It was thought likely that these deep viaduct pier foundations had severely damaged or removed any potential archaeological deposits, but that they might leave islands of better-preserved deposits between them.

Once remediation ground work was complete in each zone, the top of the substantial brick and concrete pier foundations were exposed at depths of between of 1.00m and 3.00m below the ground level. These excavations had also revealed mixed overburden found compacted around each pier foundation base.

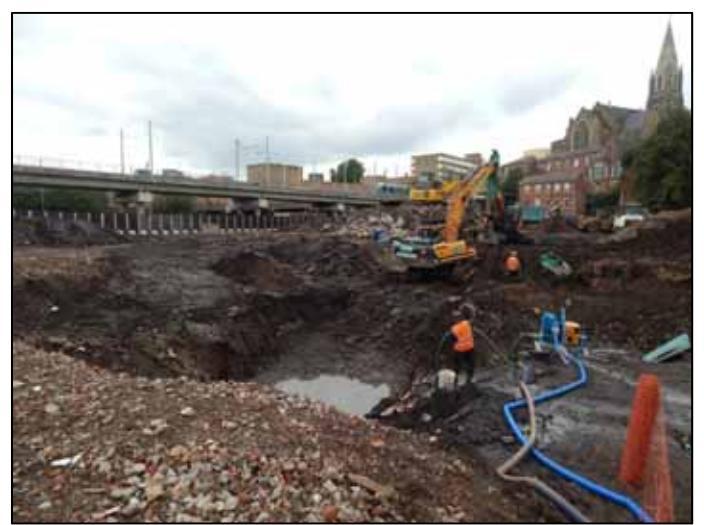
Figure 16 Removal of viaduct concrete foundations Zone 2

Excavations then continued remove the compacted overburden and foundation down to their base. The base of the foundations was reached at a combined depth of 5m below ground level and the footings resting on the natural sandstone. The excavations indicated that each individual pier foundation base was constructed in two parts. The first consisted of an foundation measuring 3.00m deep, but the foundations all rested on a second additional underpinning concrete foundation slab that was up to 2.00m thick. This underpinning foundation slab was found running the entire length of the viaduct trench linking each pier foundation and placed on the underlying sandstone geology.

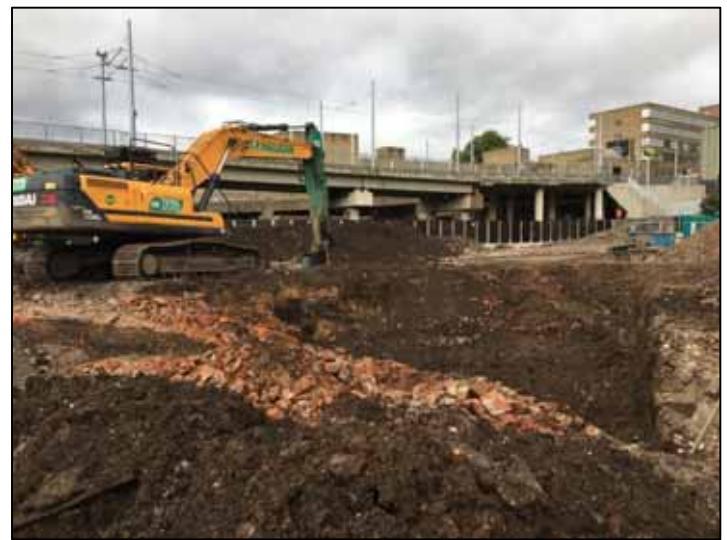
Figure 17 Ground reduction Zone 3

At depths of between 1.50m to 2.00m below ground level, post-medieval garden soils continued to be encountered at the base of the excavations in Zone 3. These deposits were revealed after removal of deposits of 19th-century demolition material which had been truncated in places by the 19th-20th century cellars. Towards the centre of the zone more viaduct pier foundations were uncovered. The cellars and viaduct foundations were sealed under a modern overburden that comprised demolition material and substantial concrete foundations associated with industrial buildings.
