Kilbraur Windfarm, Strath Brora, Highland

Archaeological watching brief on excavations for the site access track, turbine bases, borrow pit and other groundworks.

KILBRAUR WINDFARM, STRATH BRORA, HIGHLAND: RESULTS OF AN ARCHAEOLOGICAL WATCHING BRIEF

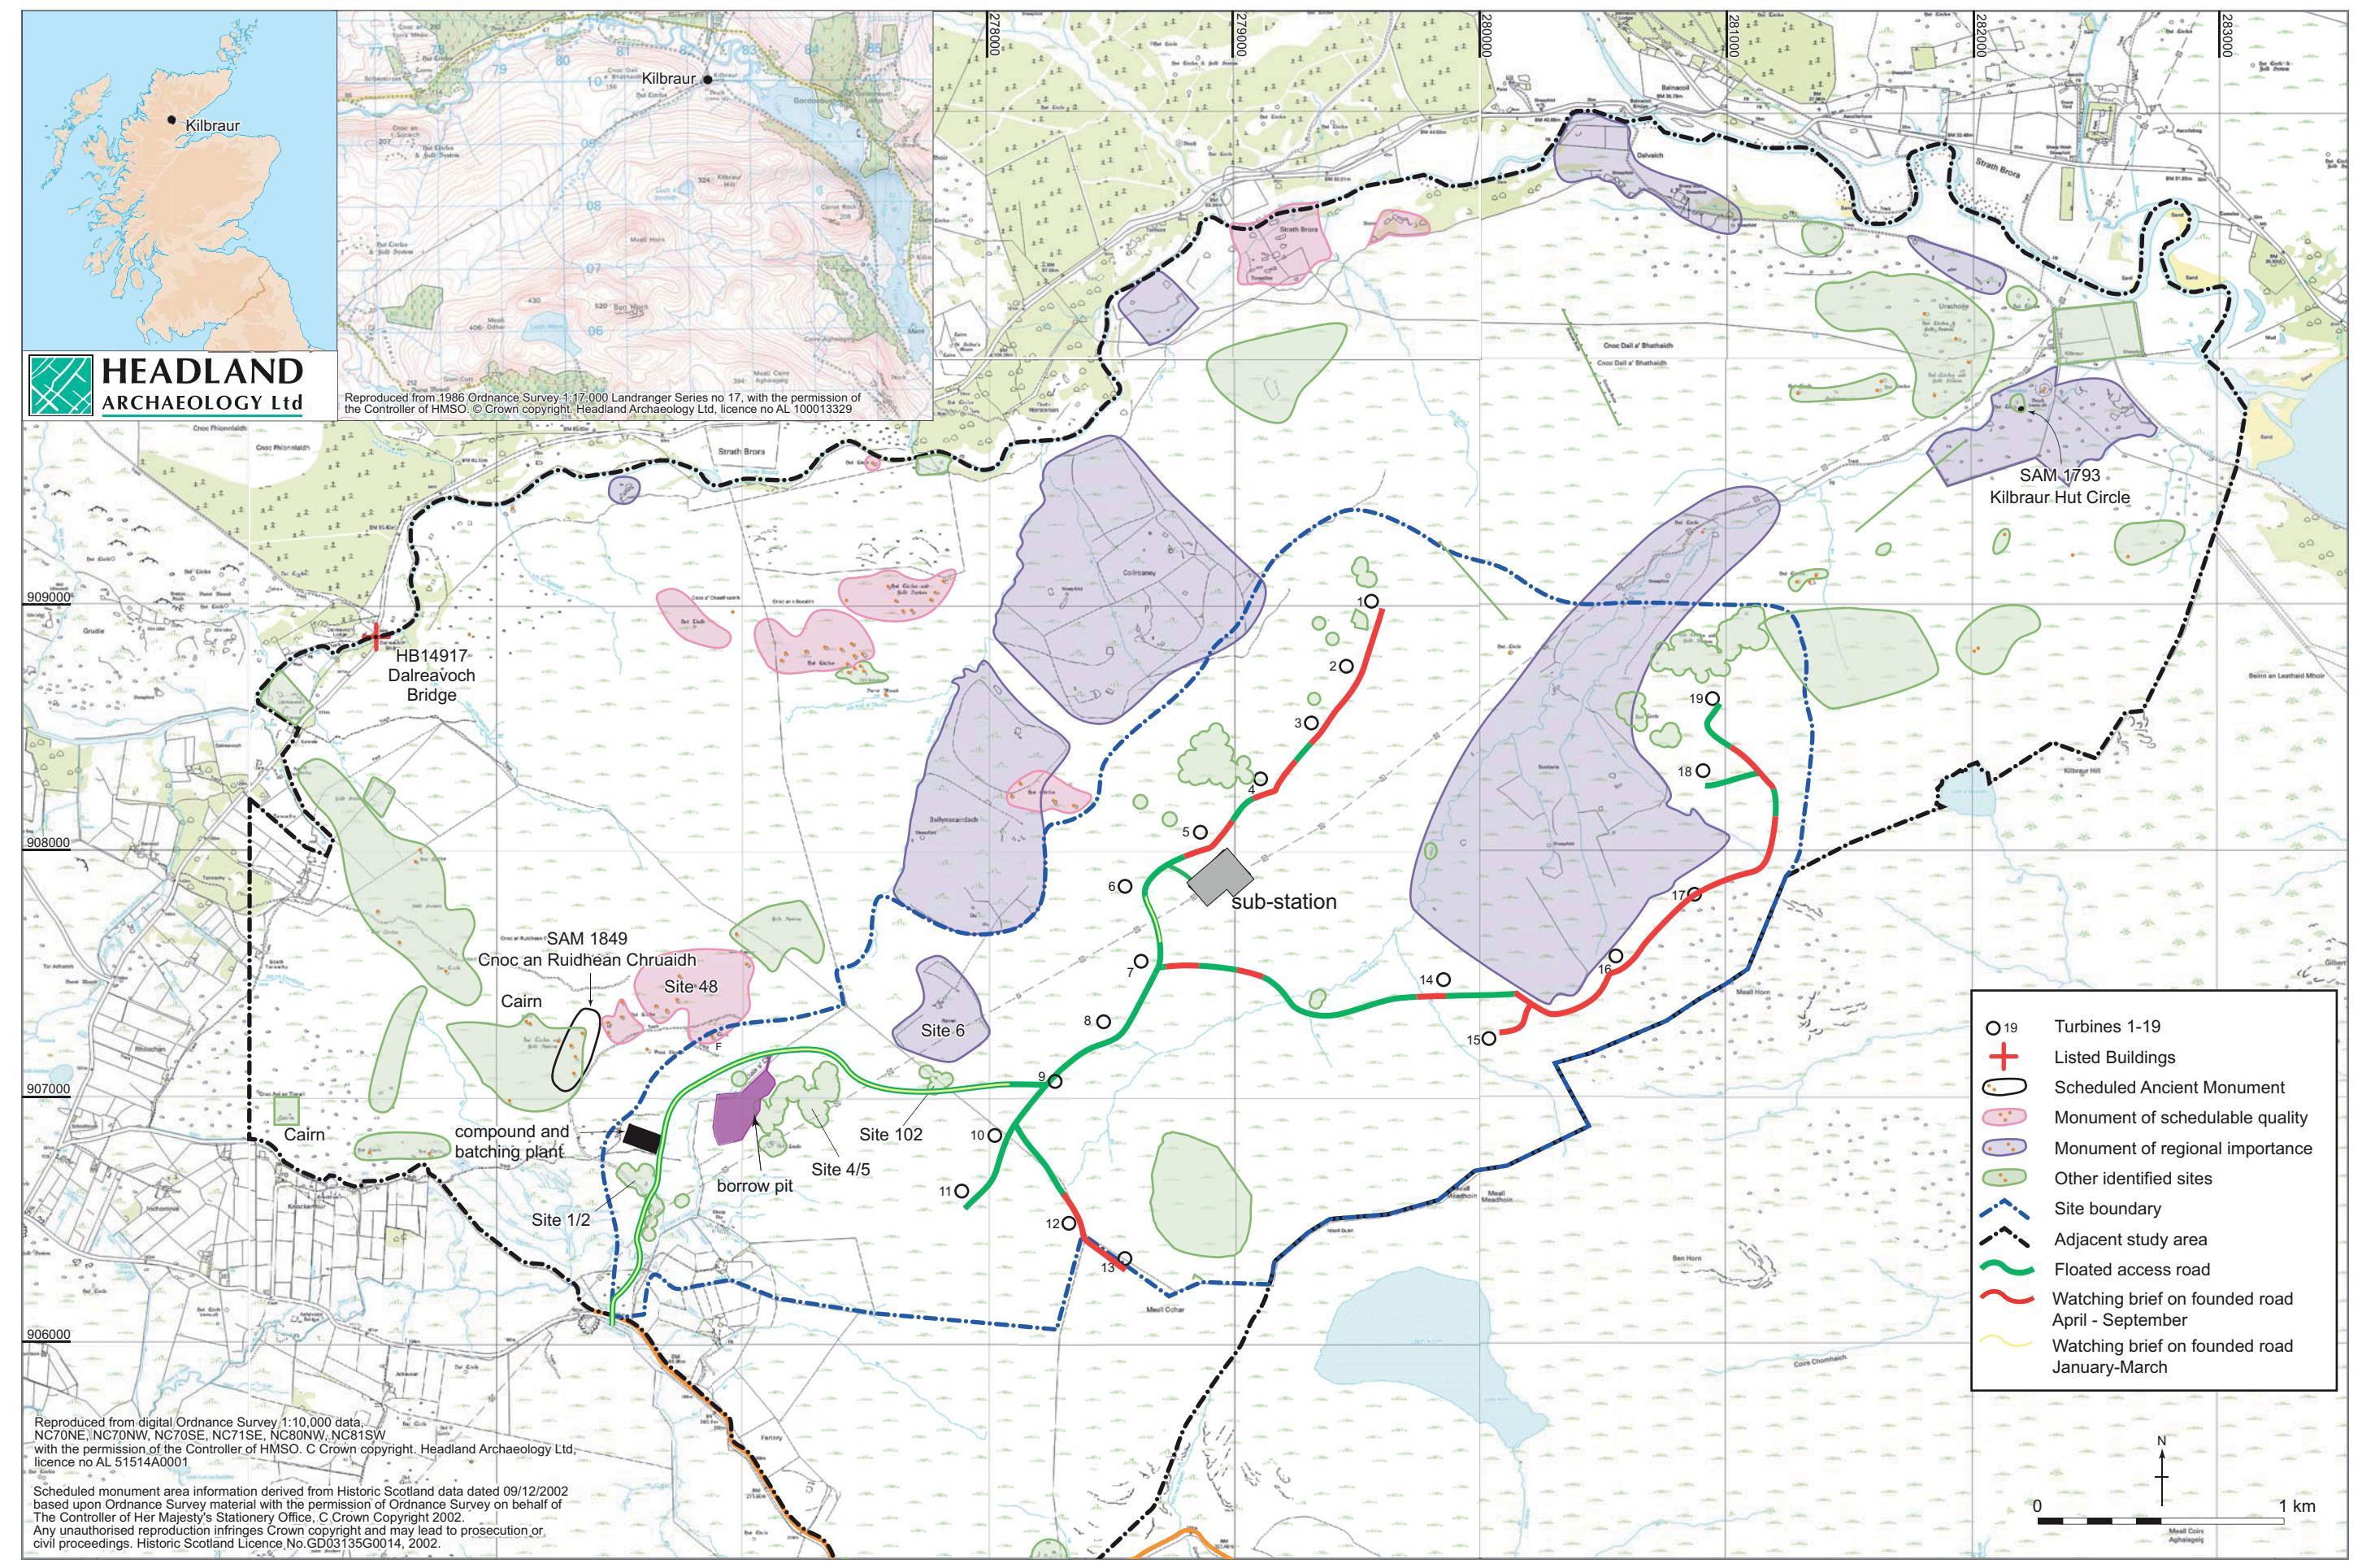
Figure 1: SBW02 - Area of watching brief on road April - September 2007

The onsite access track was constructed using a mixture of floating and founded road (*Figure 1*). The construction method of the road was generally decided by the depth of the peat with the road being floated, where practical, over the deeper deposits of peat. However in areas it was impossible to float the road, especially near the turbine bases and where the ground was steeply sloping, as these would have proved to be weak points in the track. Any

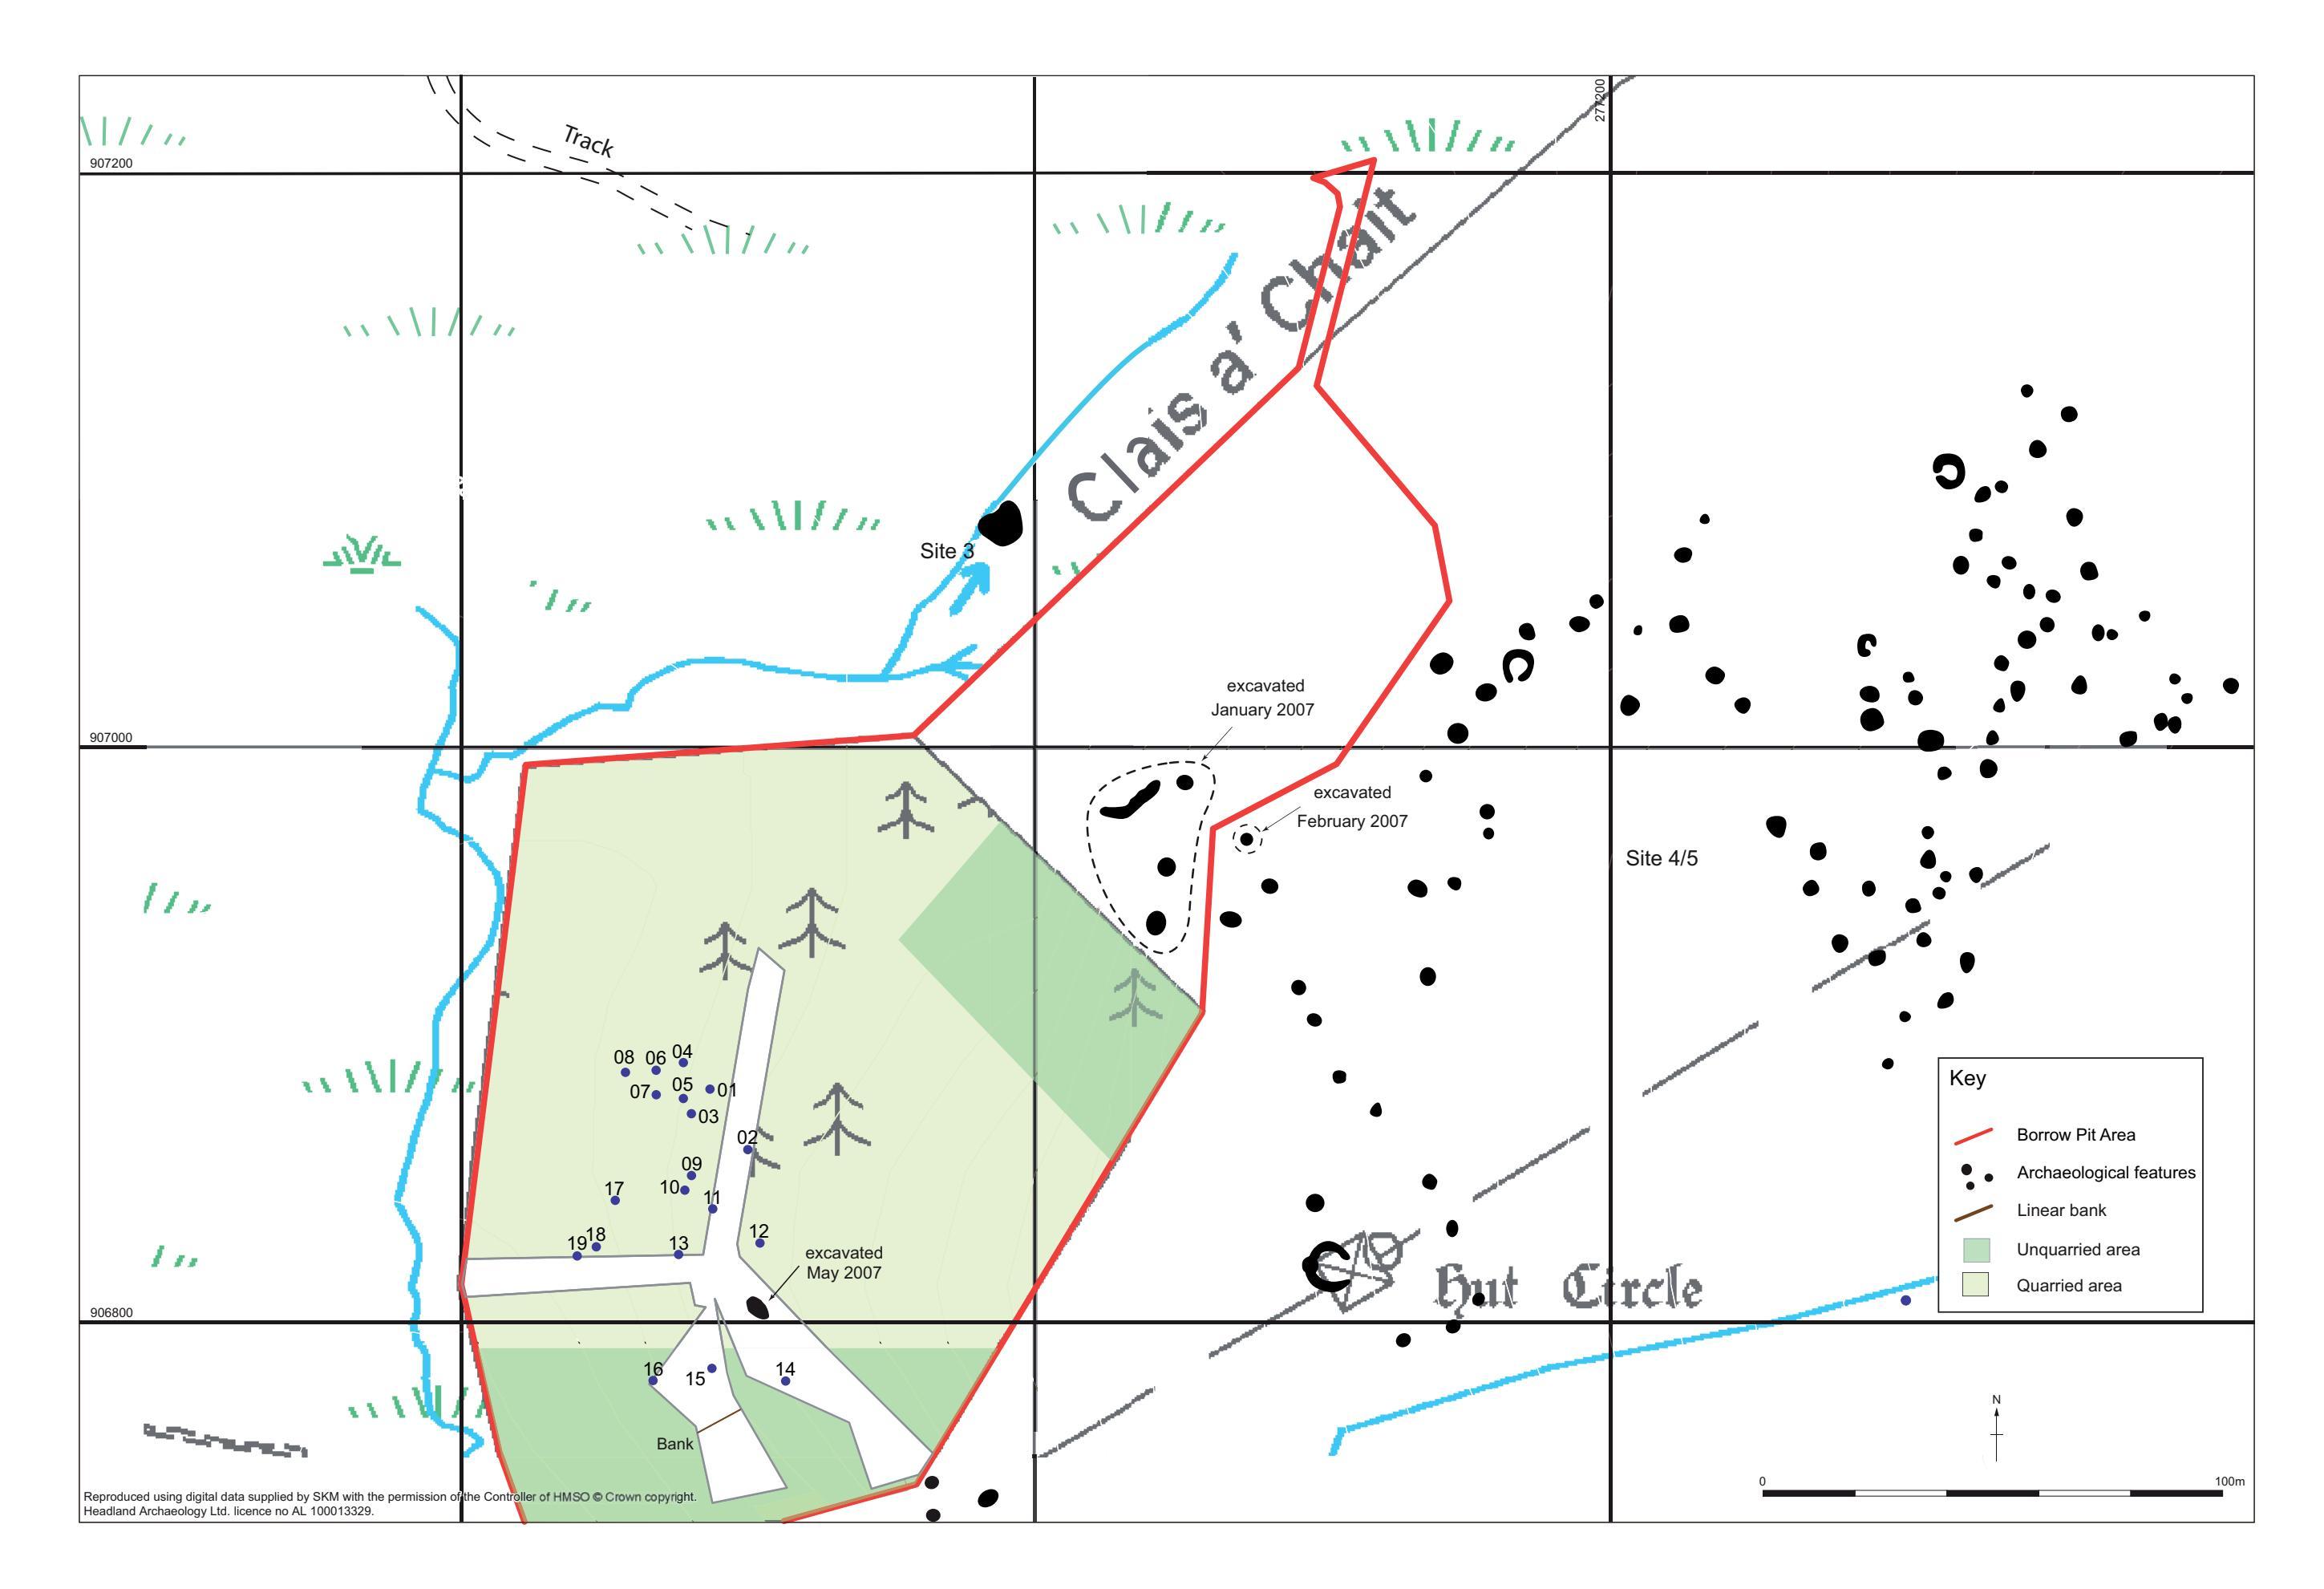
Figure 2: Location of cairns in borrow pit

Topsoil stripping continued in the borrow pit to expose a larger area for stone quarrying. This meant that the plantation to the south was to be excavated. Once the pine plantation was felled it became apparent that a number of upstanding features were preserved in this area (*Figure 2*).

The majority of these were cairns that had been damaged by forestry ploughing running from NW to SE leaving parallel 0.80m wide scars 2.5m apart across the whole hillside. The cairns were all similarly constructed of sub-angular to sub-rounded stones of mixed geology. The boulder interstices were filled with sandy silt that had been carried around through the stones by water and wind action after the cairn was constructed. The cairns were set directly on an orange brown sand and gravel subsoil, with no peat underlying the cairn. The size and shape of the cairns varied (*Table 1, Figures 3 to 21*).

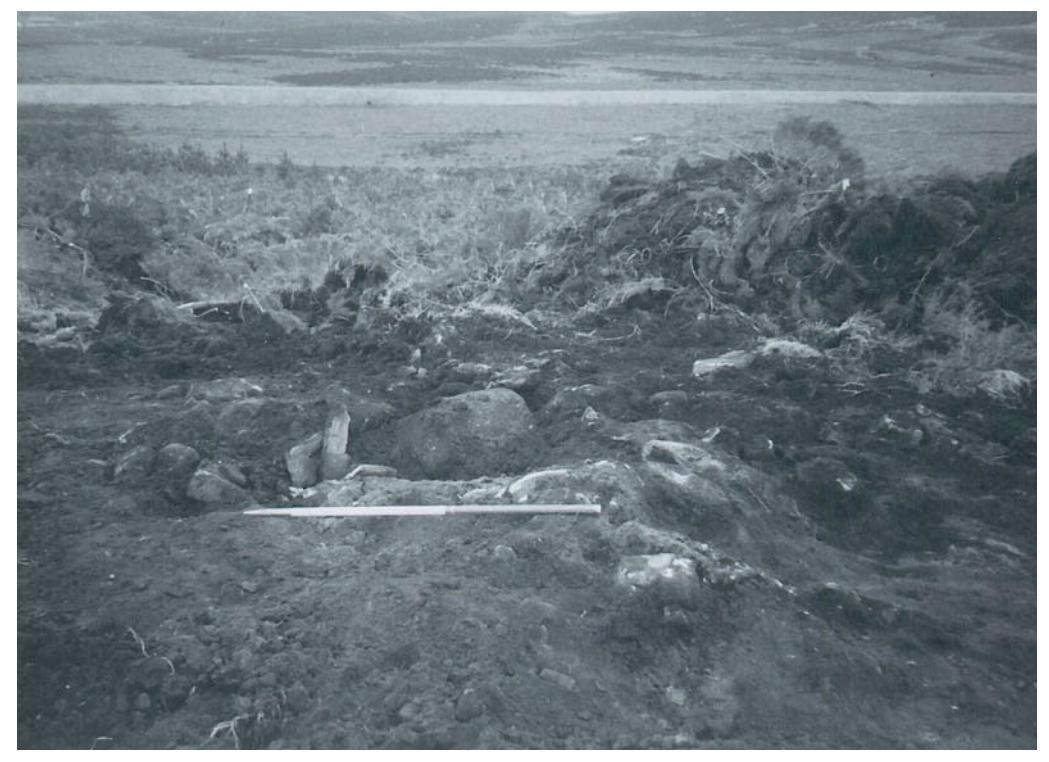
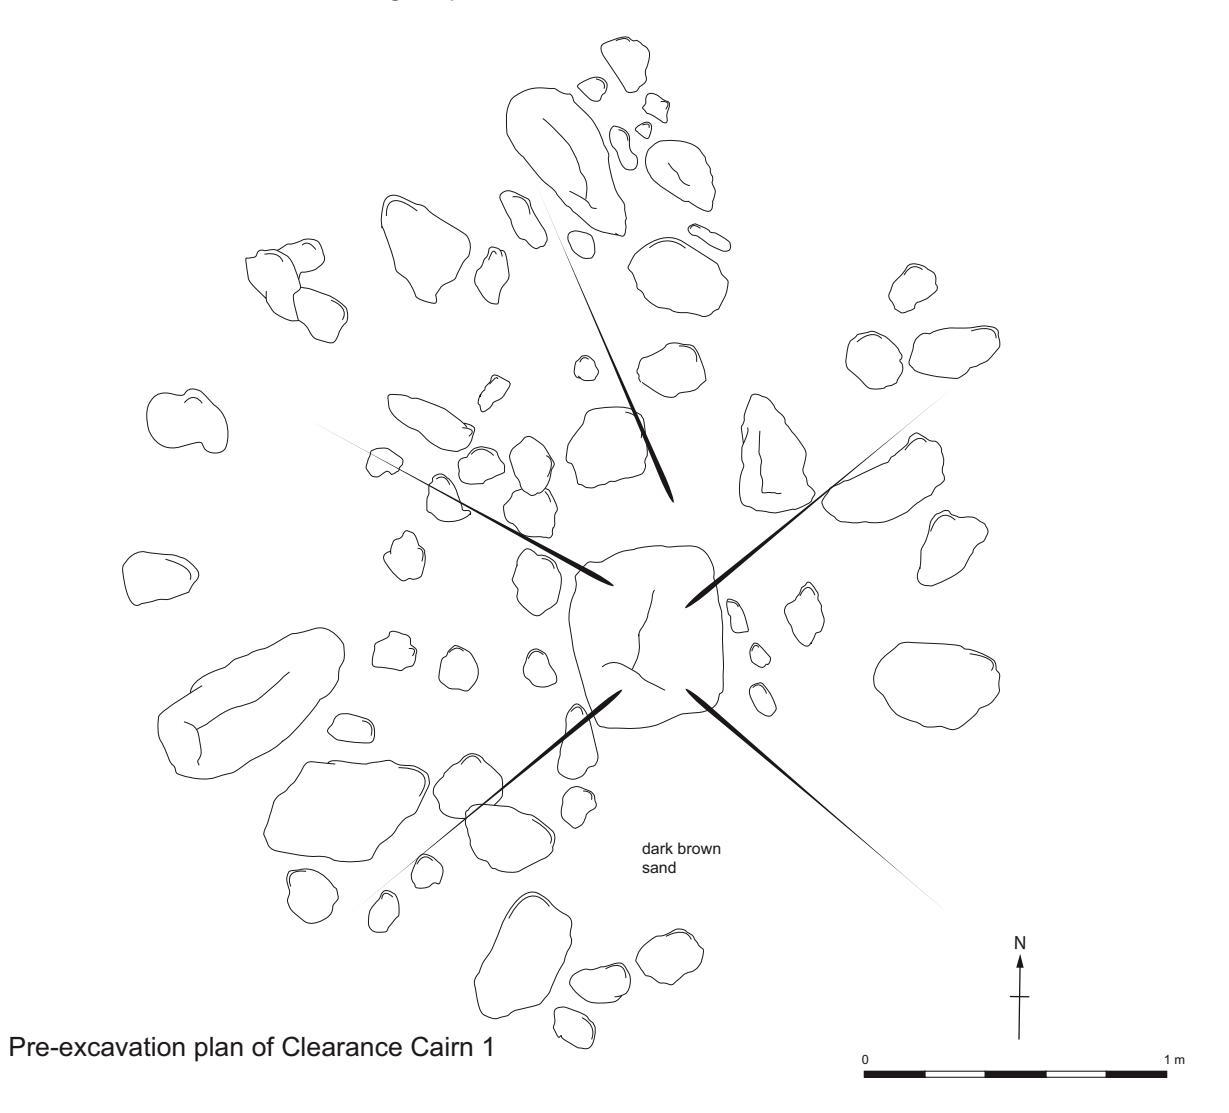
Clearance Cairn 1, looking W, pre-excavation

As Cairn 1 was badly damaged by the machine removal of the peat it was decided to record subsequent cairns in plan prior to excavation and then machine-excavate a section across them.

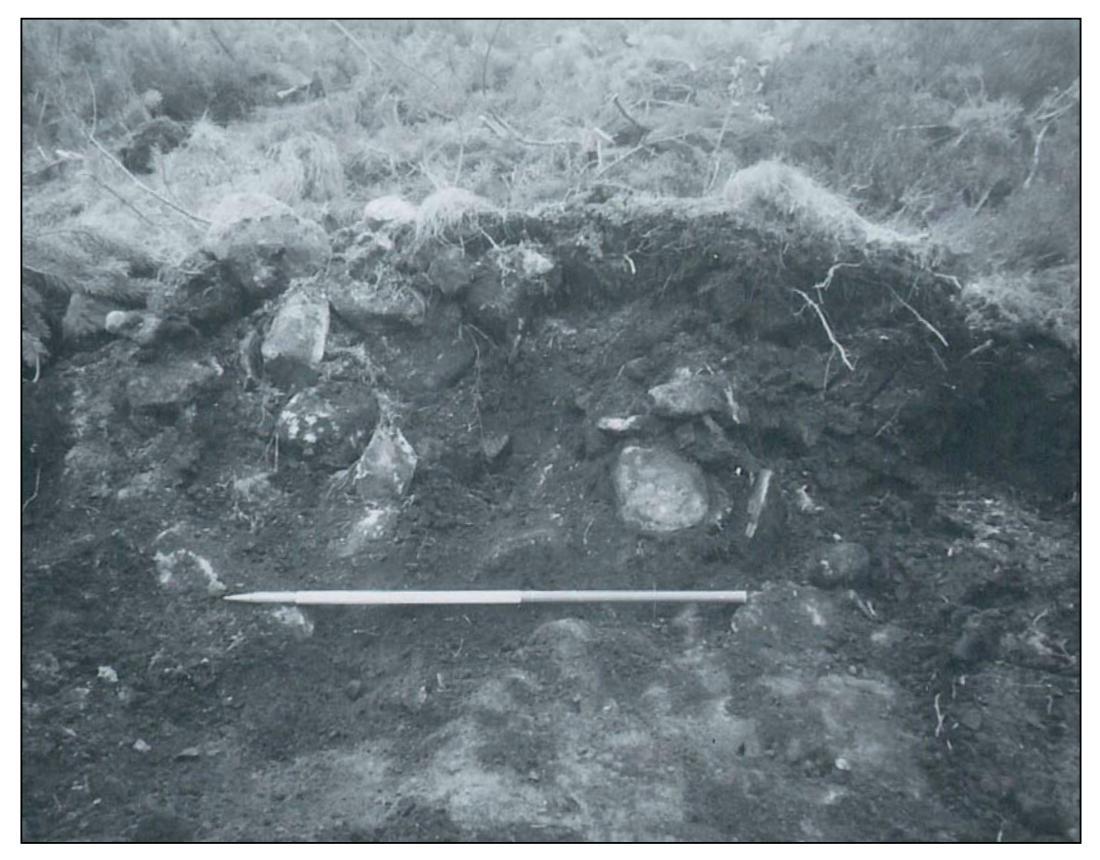
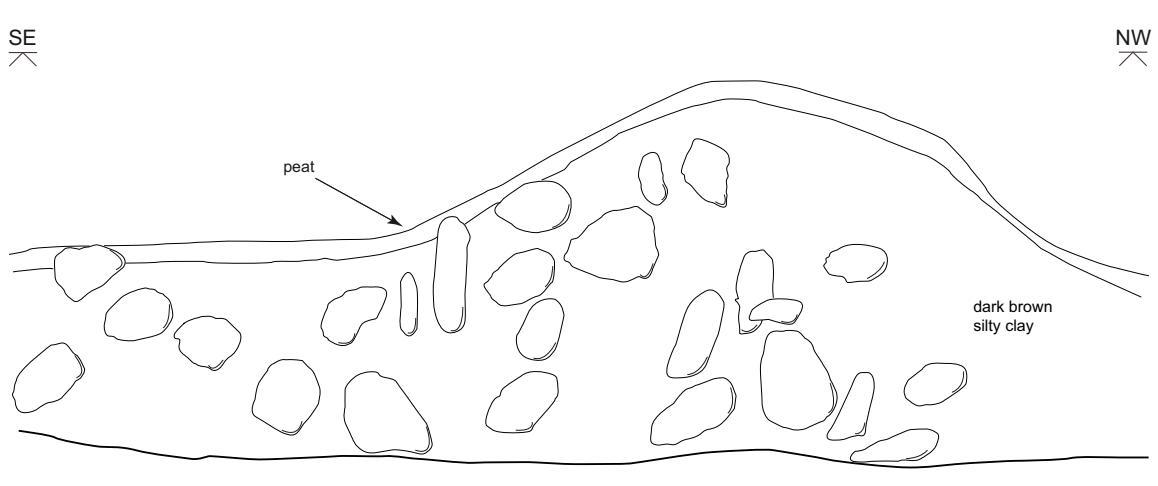
Section through Clearance Cairn 2, NE facing

Clearance Cairn 2, looking N

Natural - orange-brown coarse sand

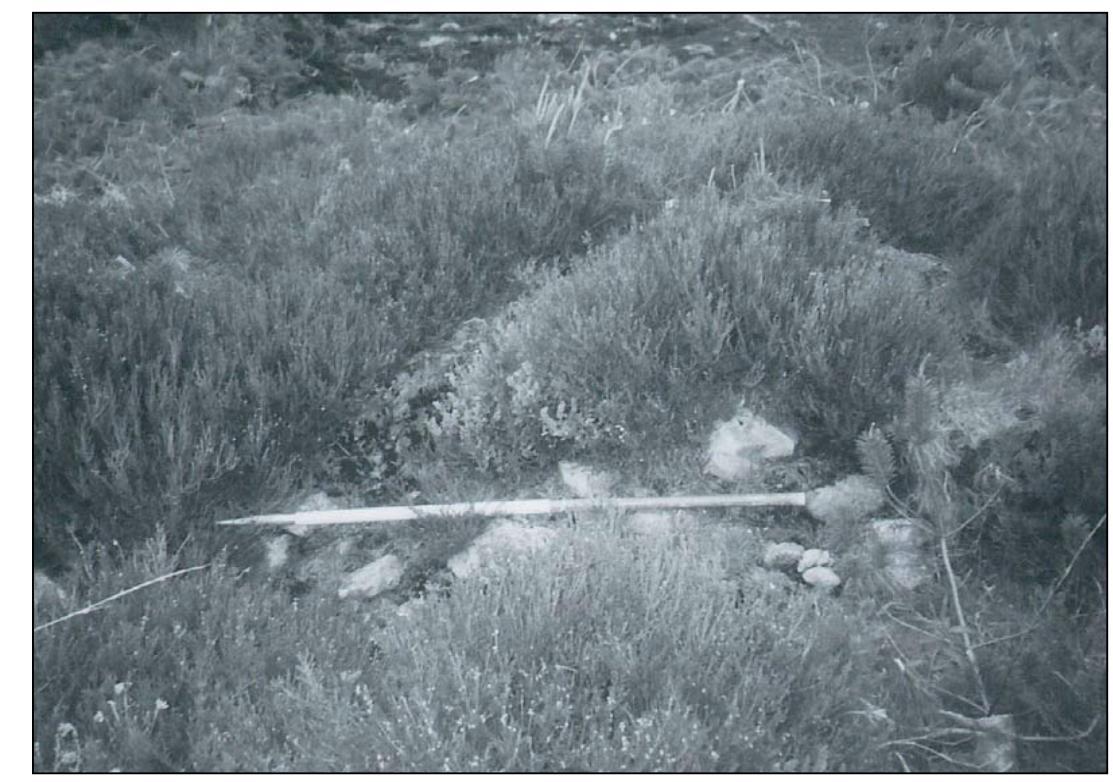
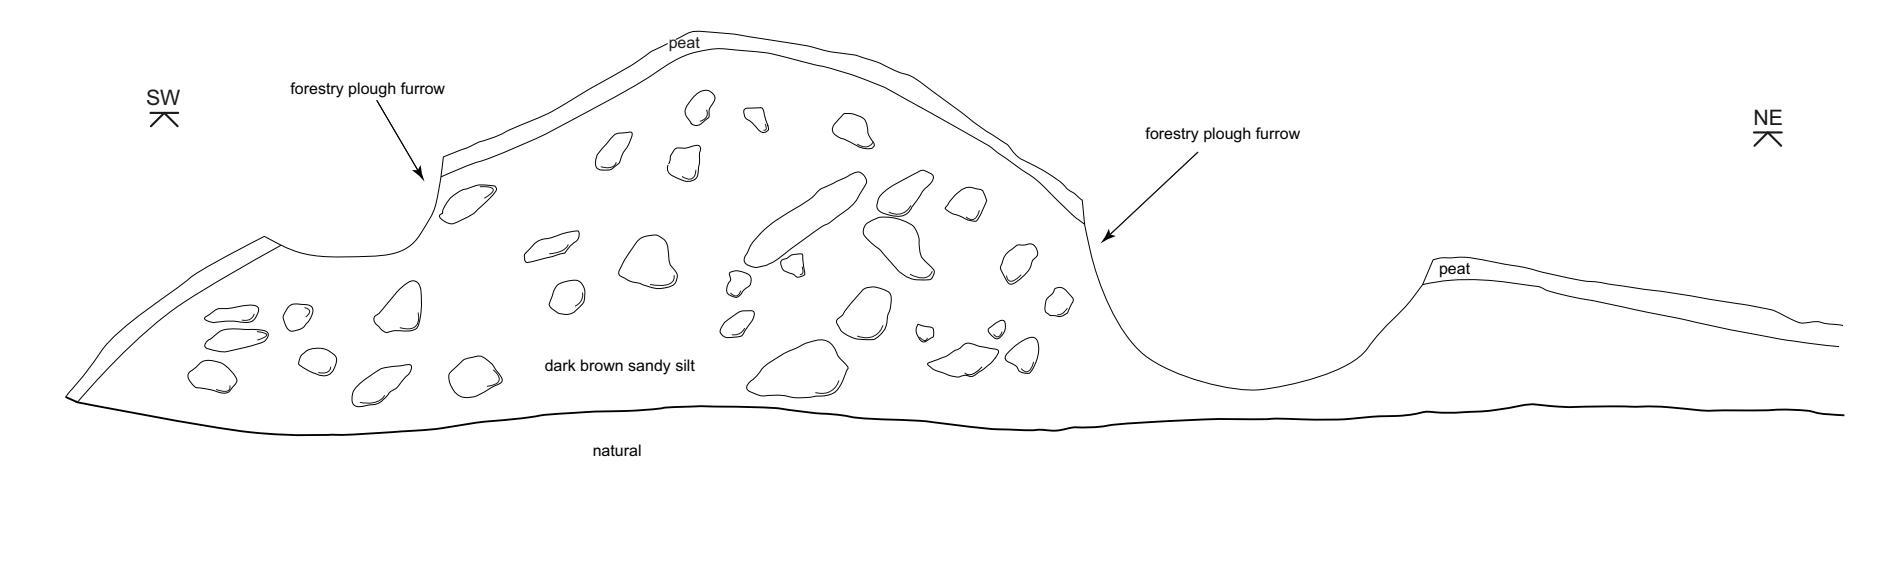
Figure 5: Clearance Cairn 3 plate, pre-excavation plan and SE facing section

Clearance Cairn 3, facing N

Pre-excavation plan of Clearance Cairn 3

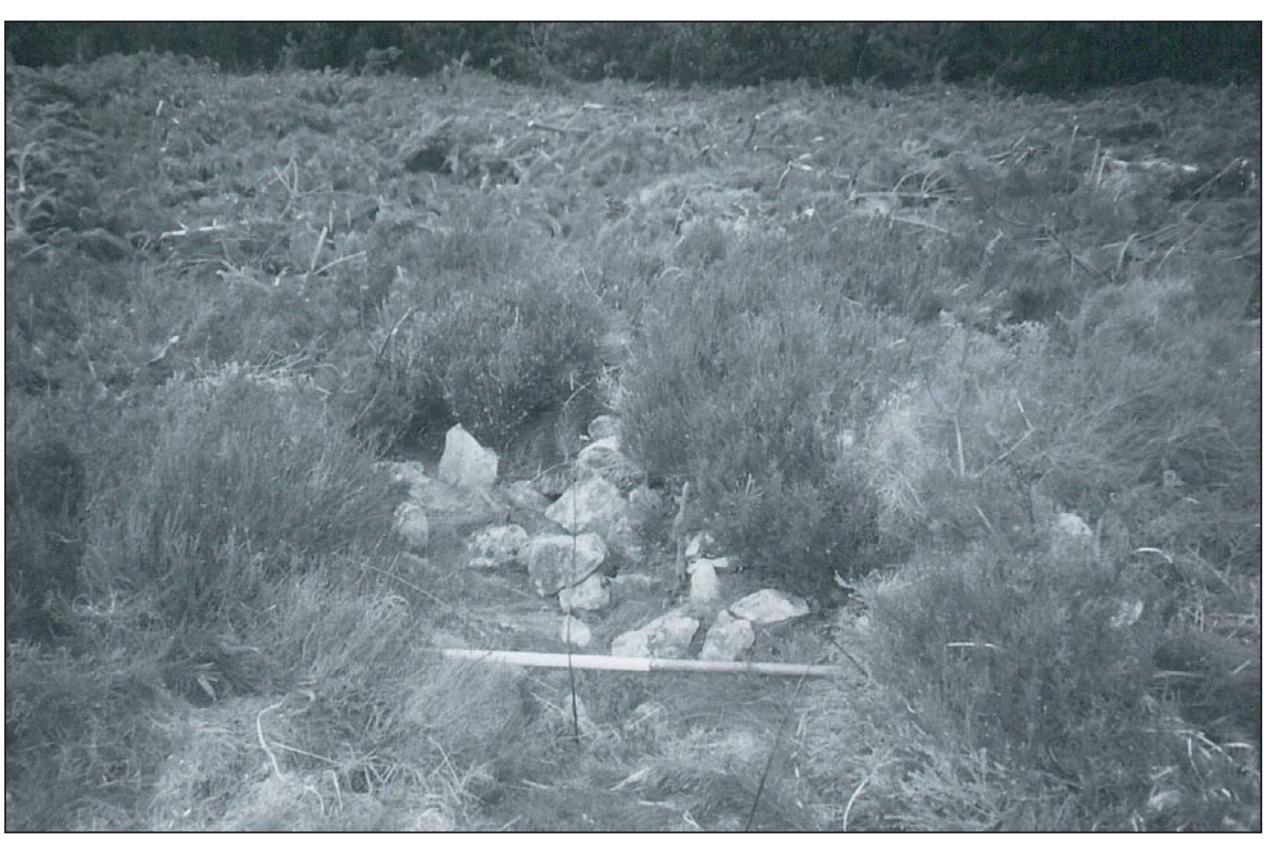
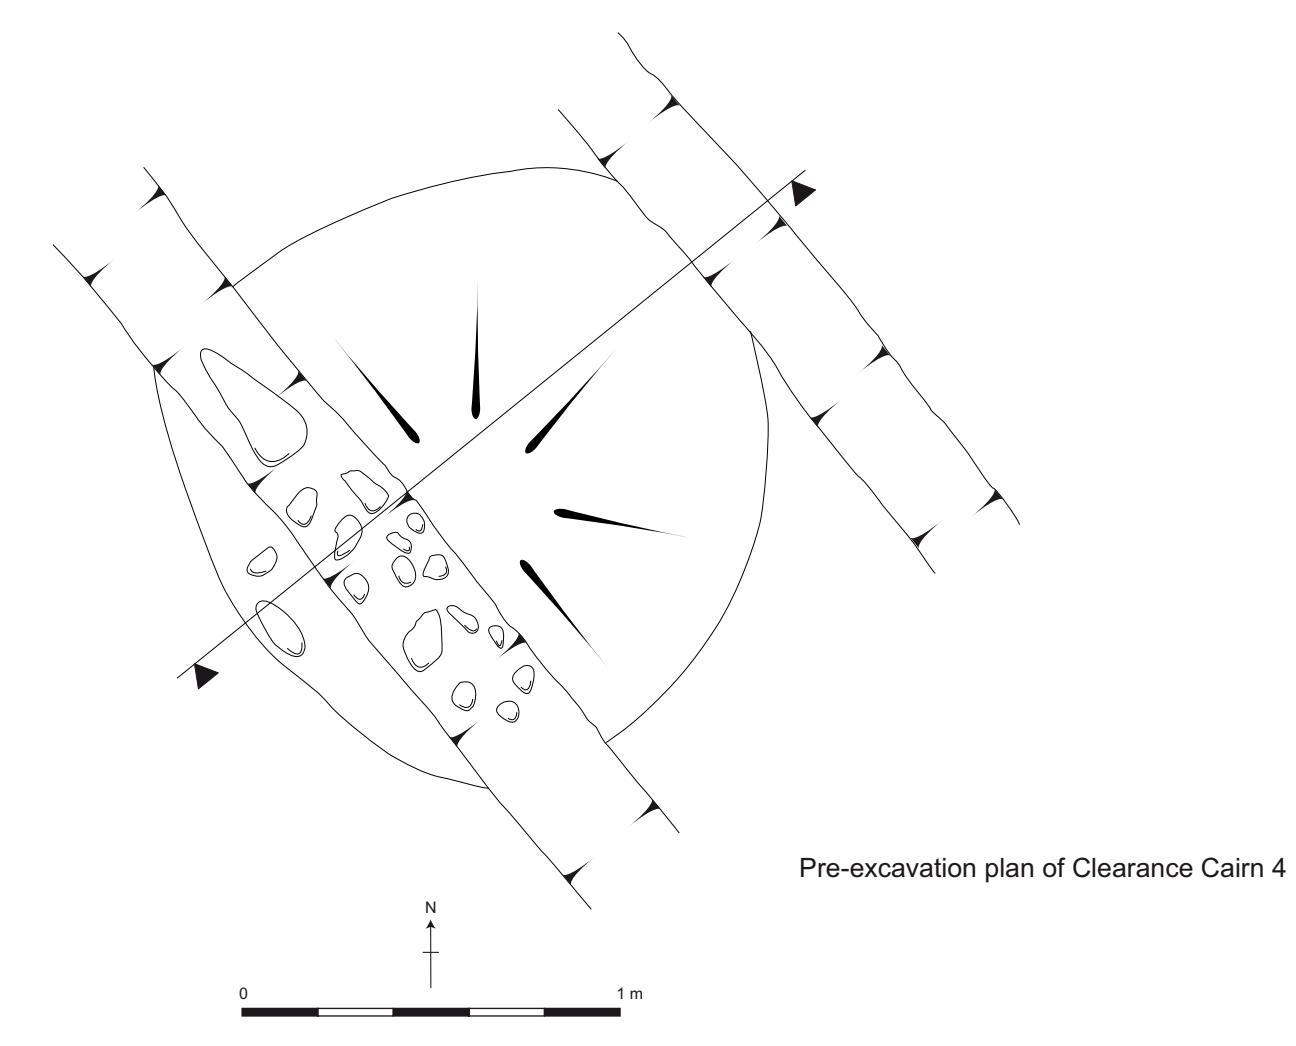
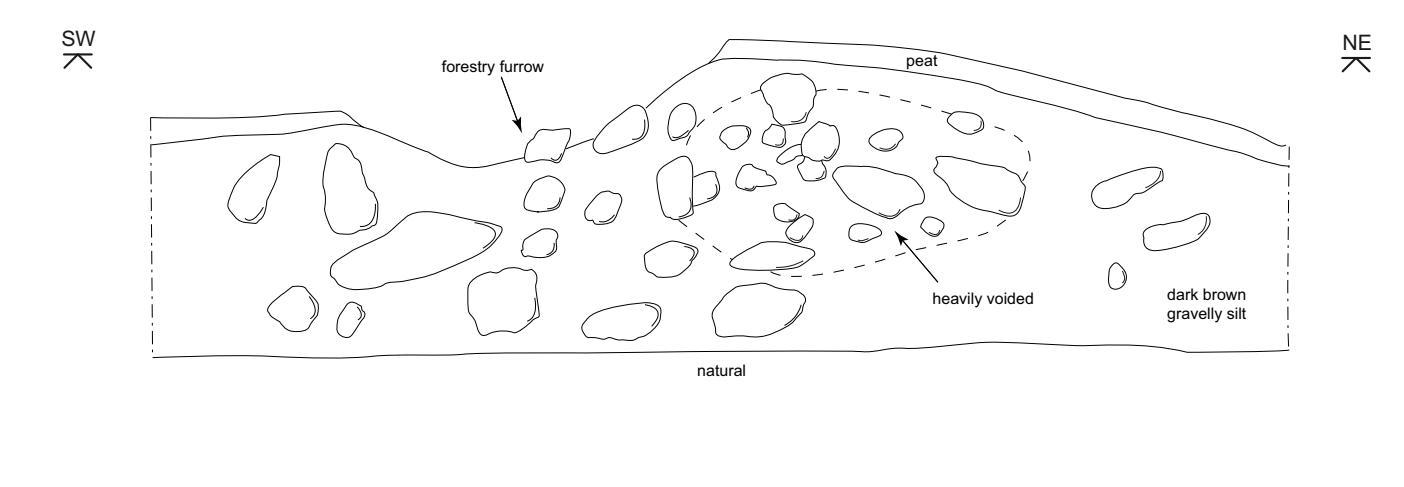
Figure 6: Clearance Cairn 4 plate, pre-excavation plan and SE facing section

Clearance Cairn 4, facing N

Section through Clearance Cairn 4, SE facing

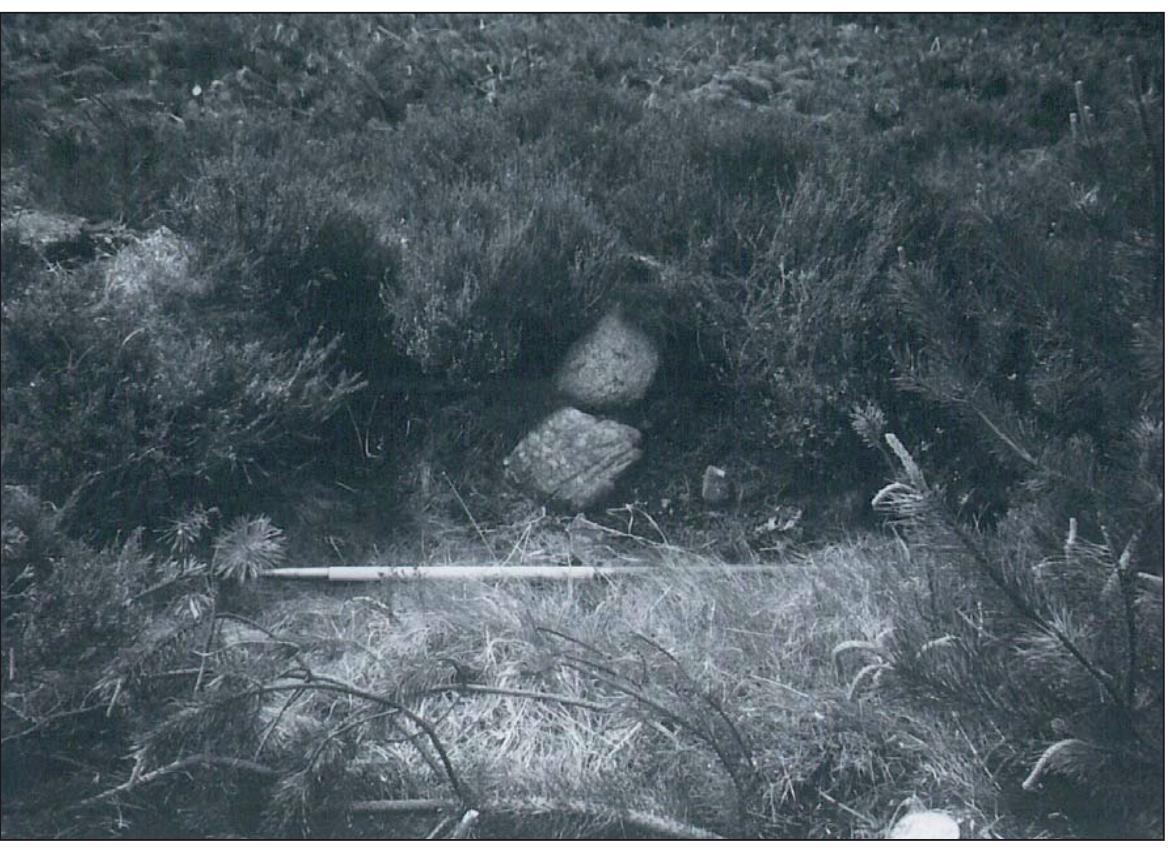
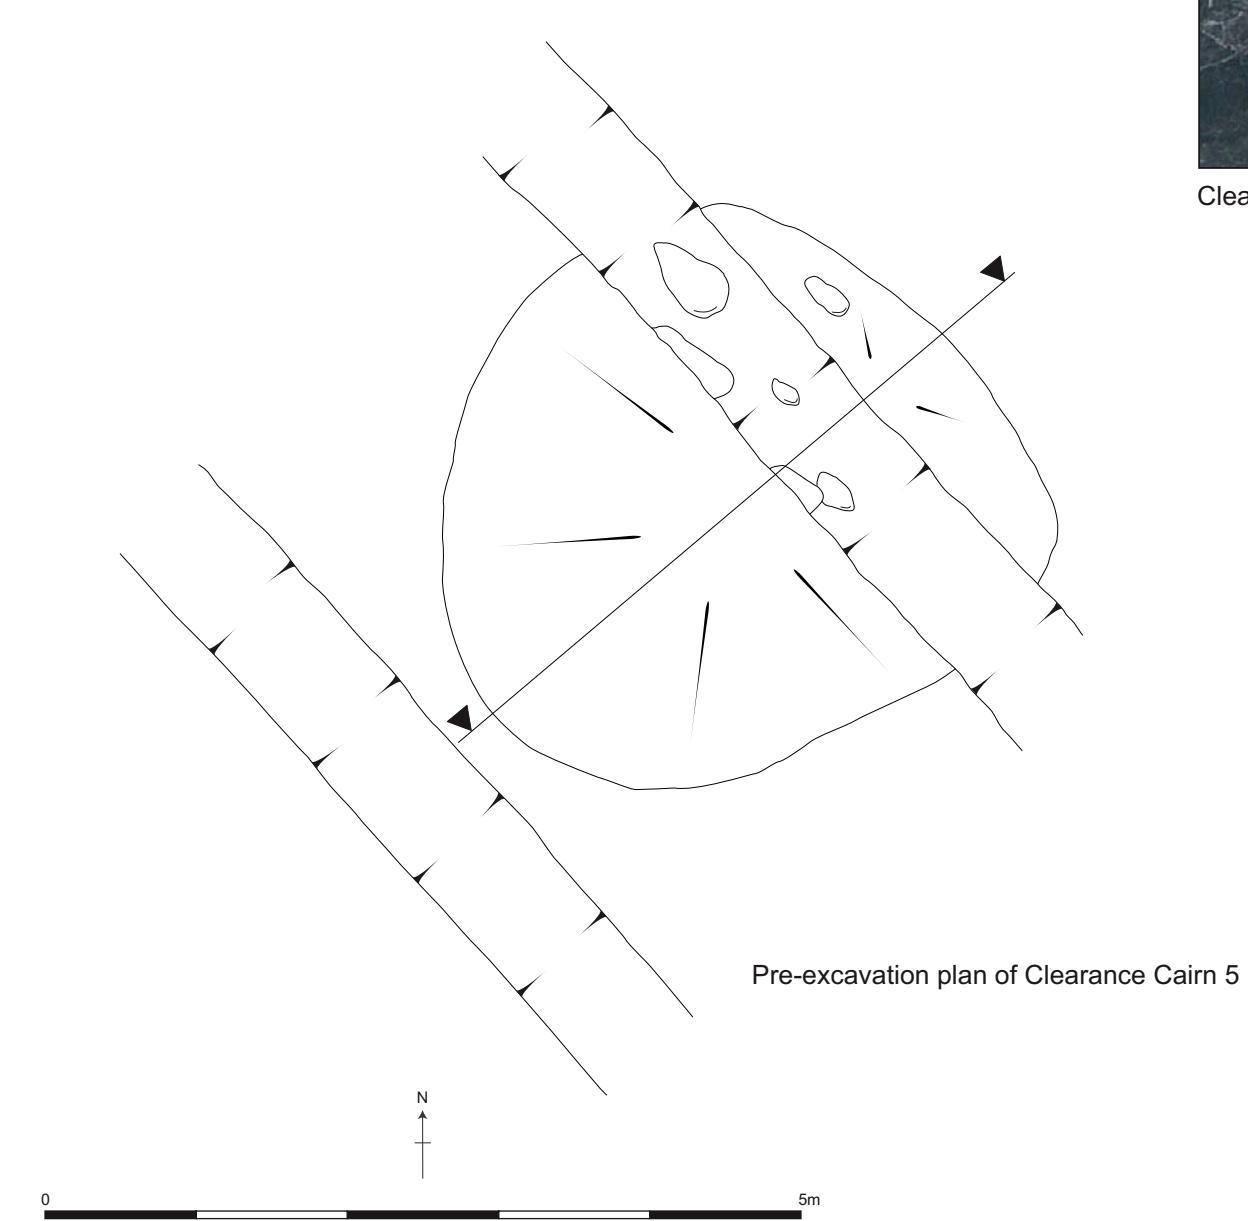
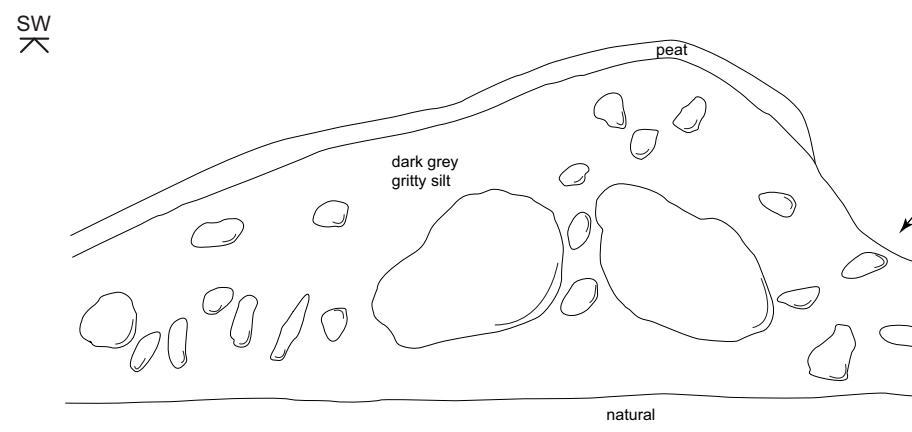
Clearance Cairn 5, S facing

Section through Clearance Cairn 5, SE facing

forestry plough furrow		
_		peat	
/ /	>

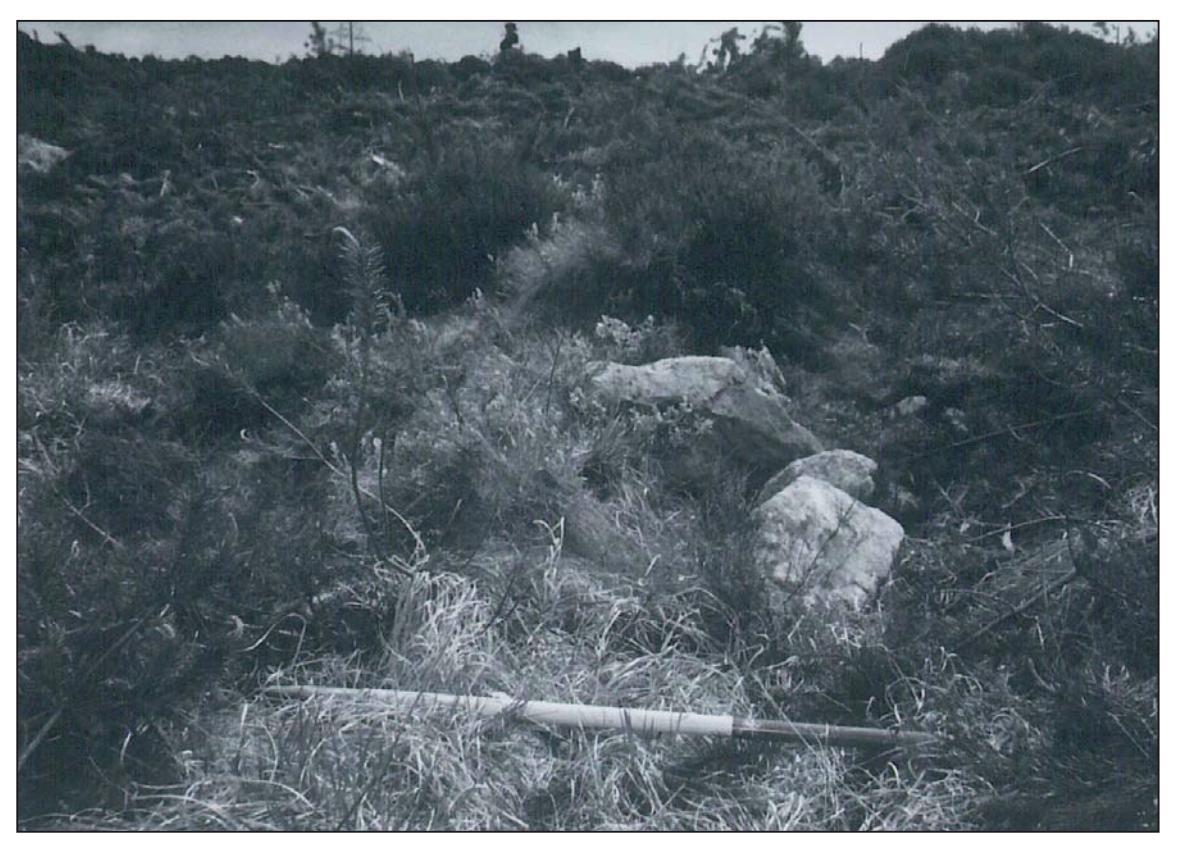
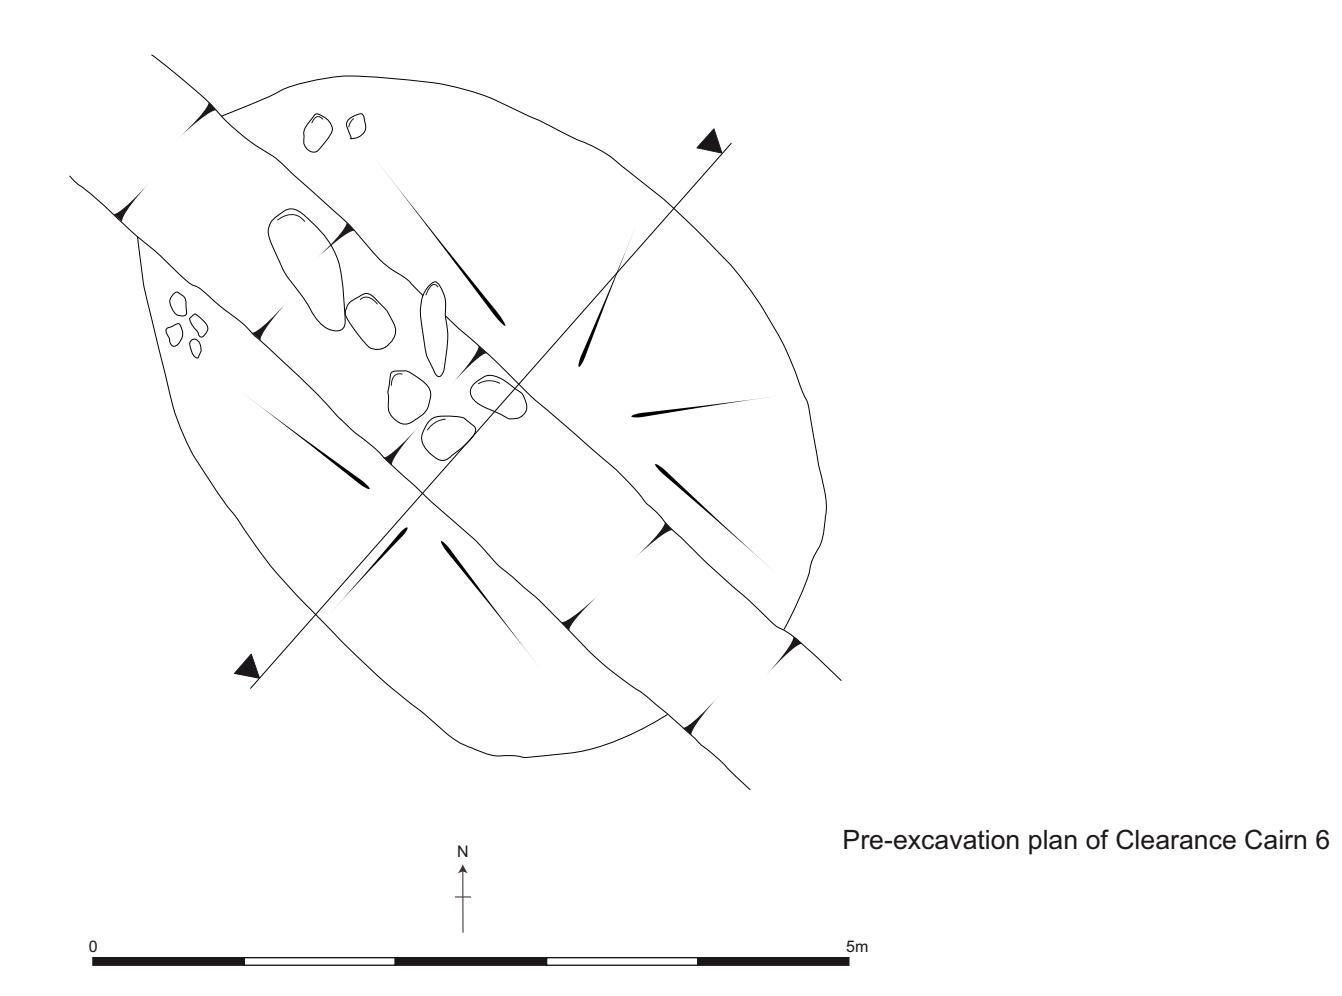
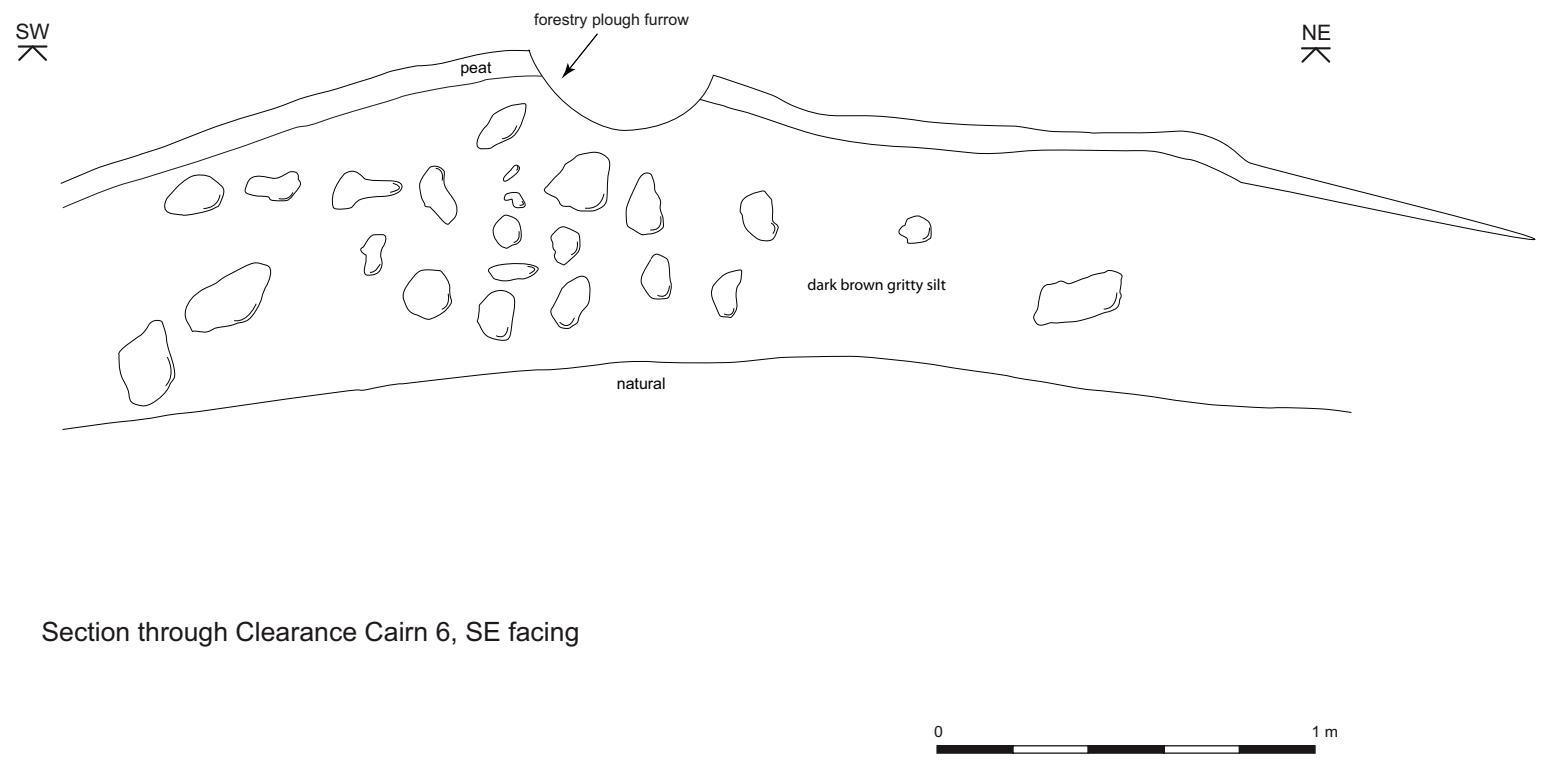
Figure 8: Clearance Cairn 6 plate, pre-excavation plan and SE facing section

Clearance Cairn 6, looking E
