Kilbraur Windfarm, Strath Brora, Highland

Archaeological watching brief on excavations for the site access track, turbine bases, borrow pit and other groundworks.

KILBRAUR WINDFARM, STRATH BRORA, HIGHLAND: RESULTS OF AN ARCHAEOLOGICAL WATCHING BRIEF

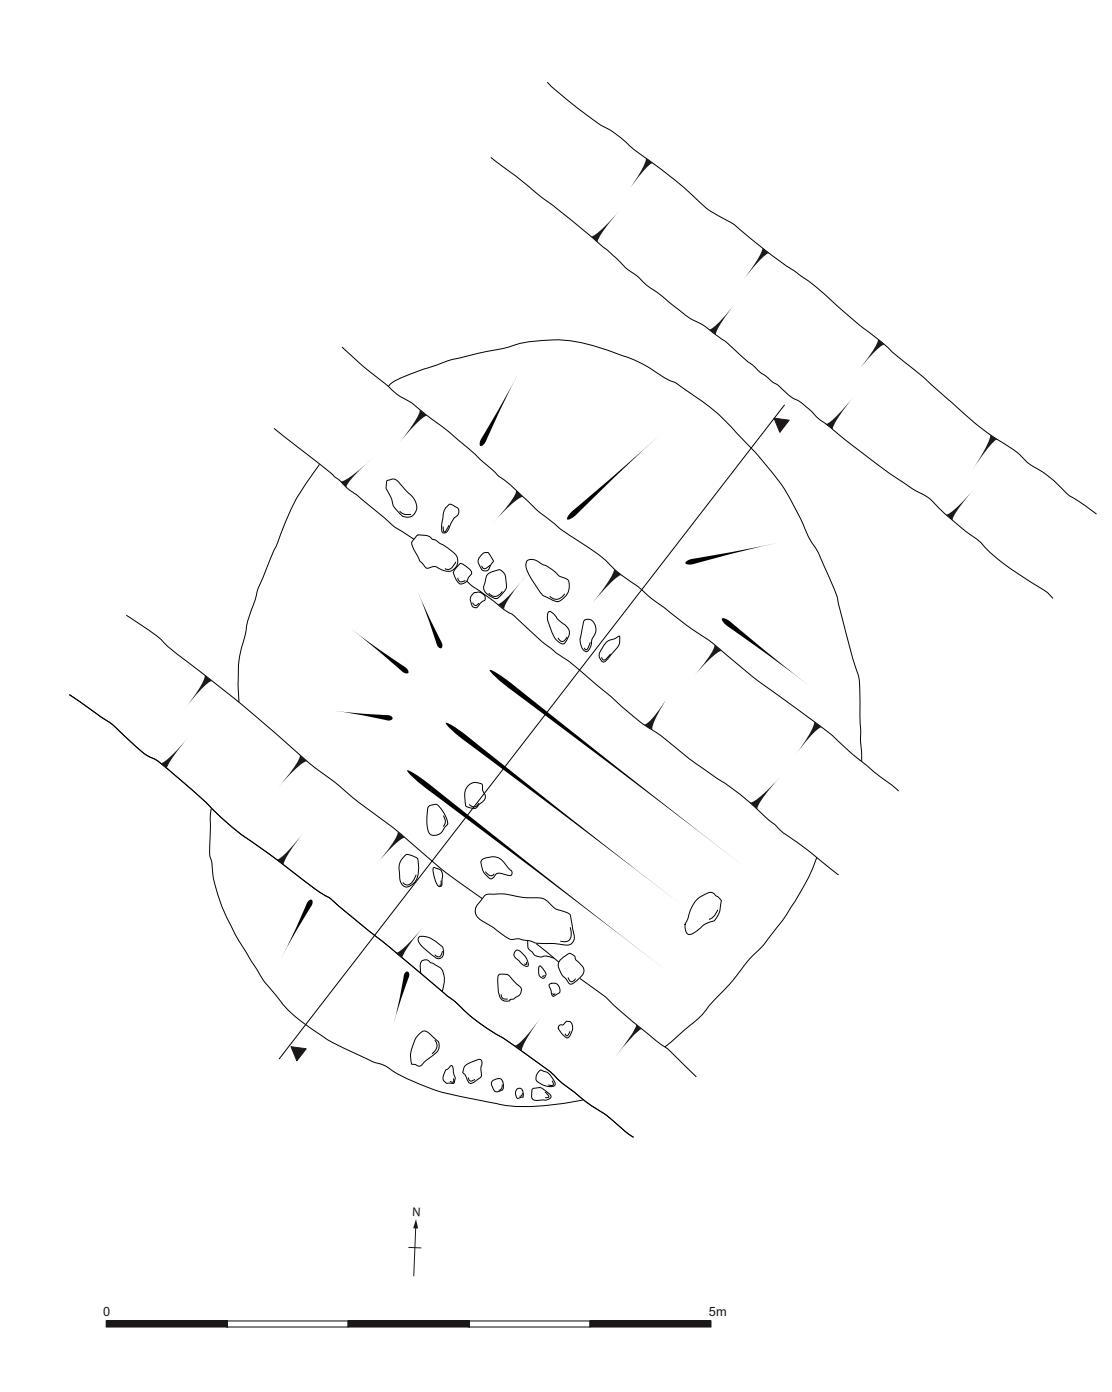
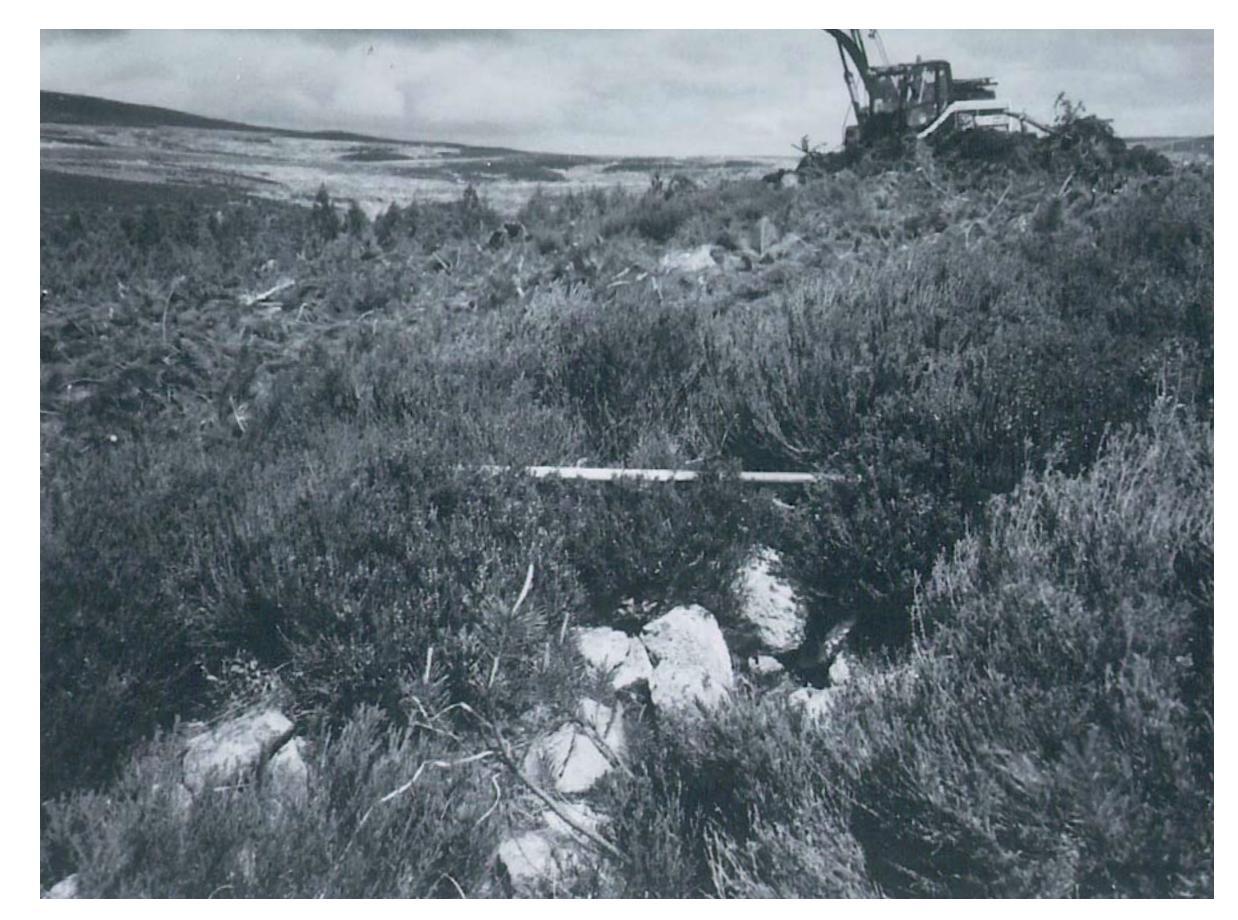
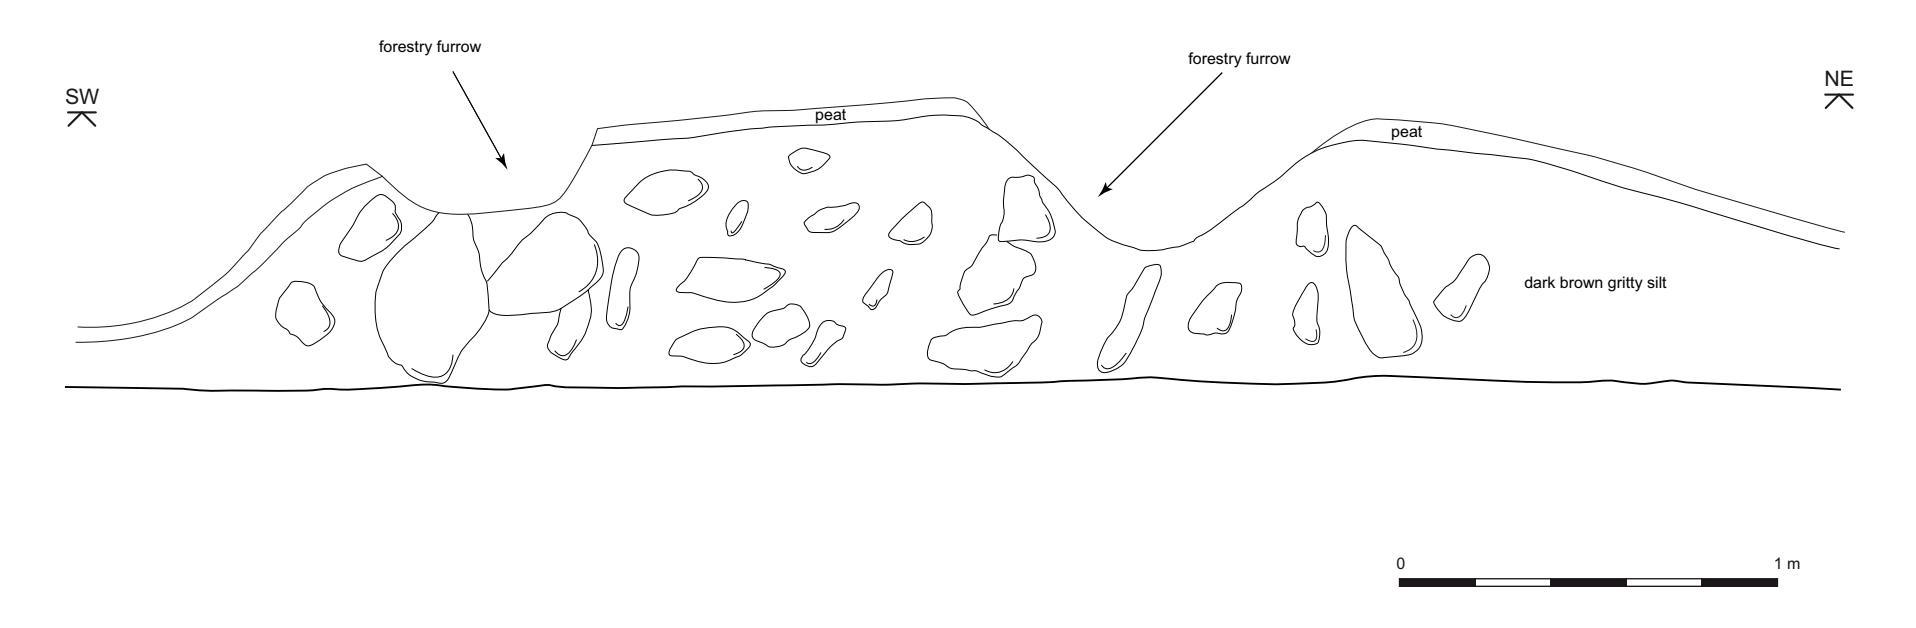
Figure 9: Clearance Cairn 7 plate, pre-excavation plan and SE facing section

```
Clearance Cairn 7, facing N
```

Pre-excavation plan of Clearance Cairn 7

Section through Clearance Cairn 7, SE facing

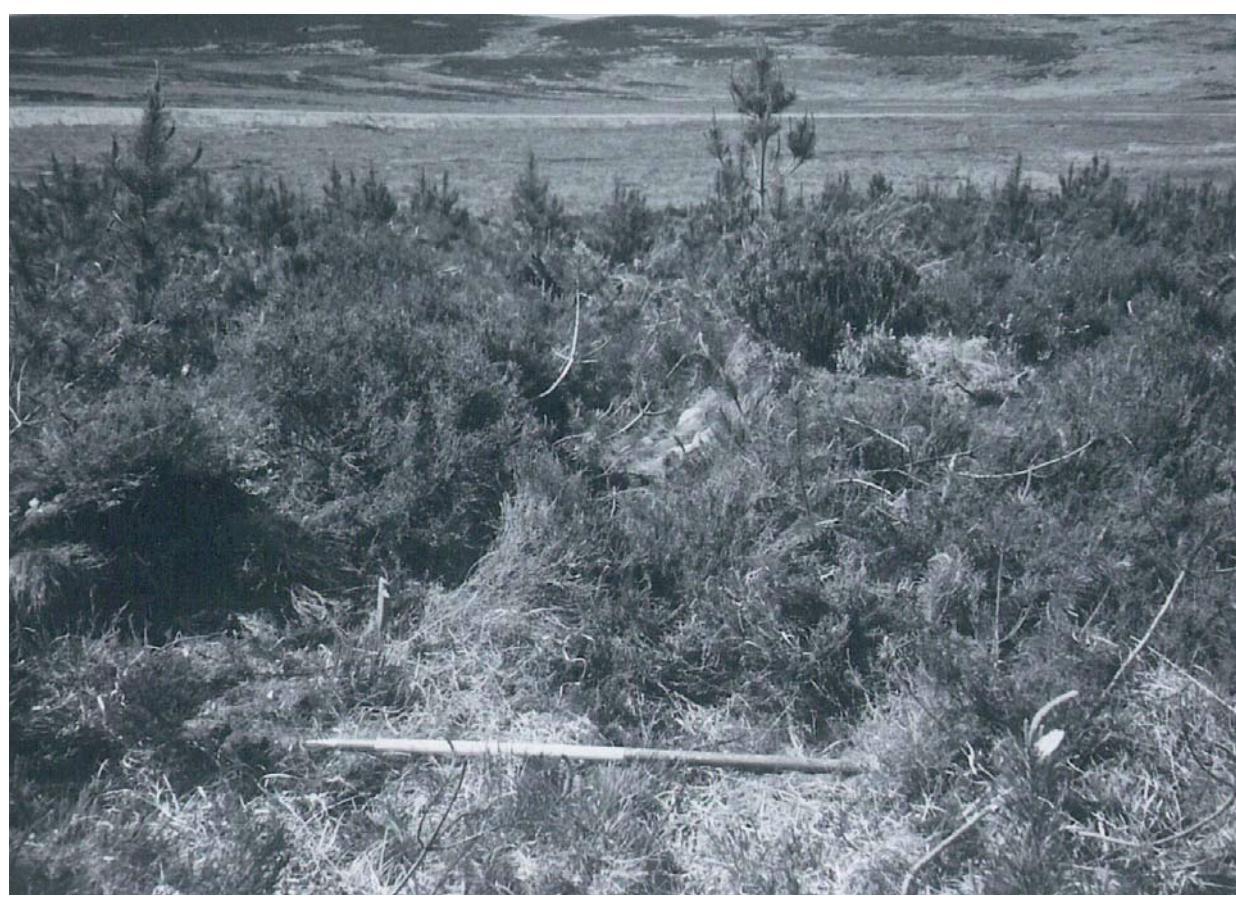
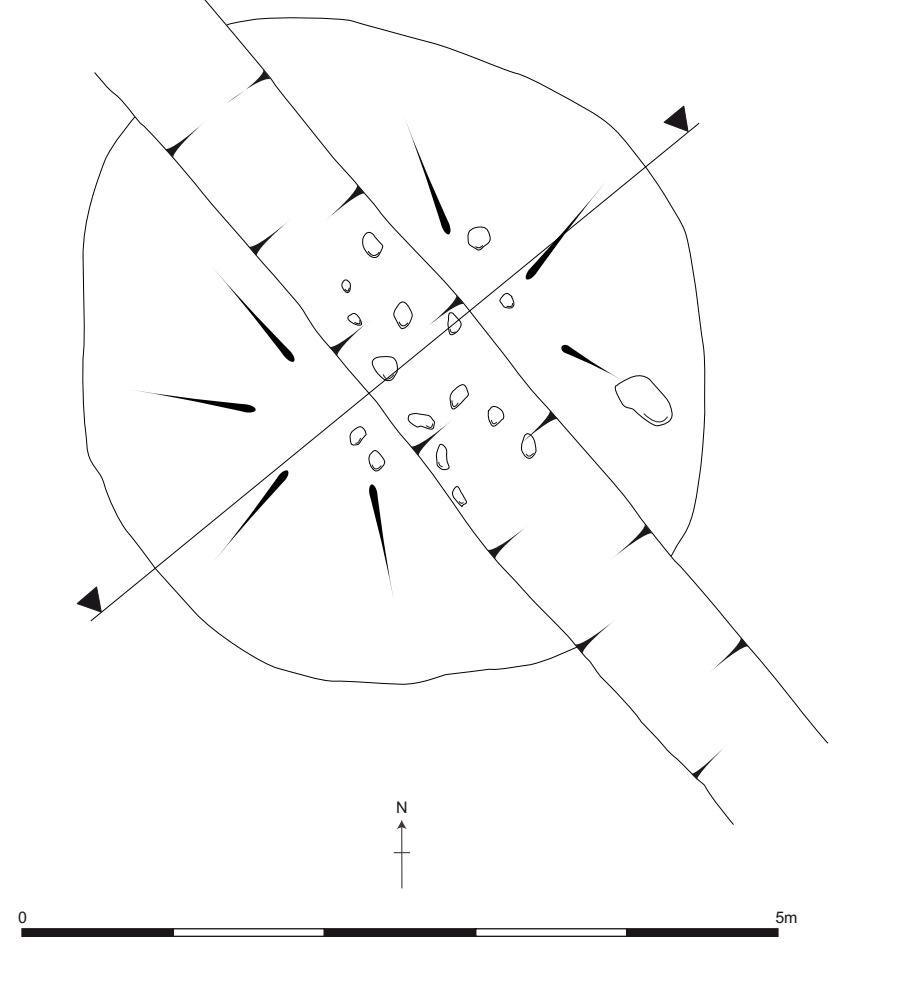
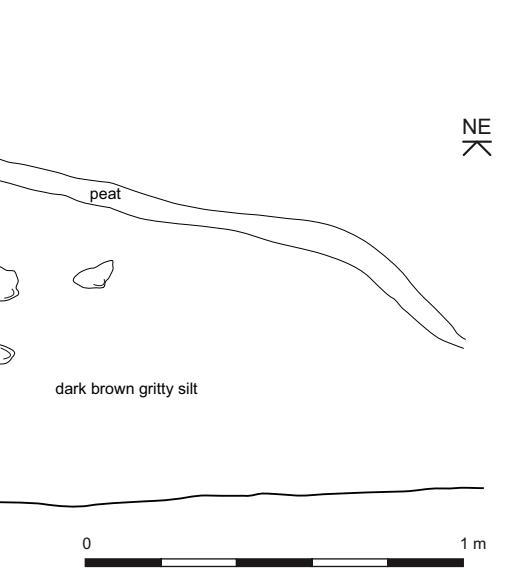
Figure 10: Clearance Cairn 8 plate, pre-excavation plan and SE facing section

sw \bigcirc natural

Section through Clearance Cairn 8, SE facing

Pre-excavation plan of Clearance Cairn 8

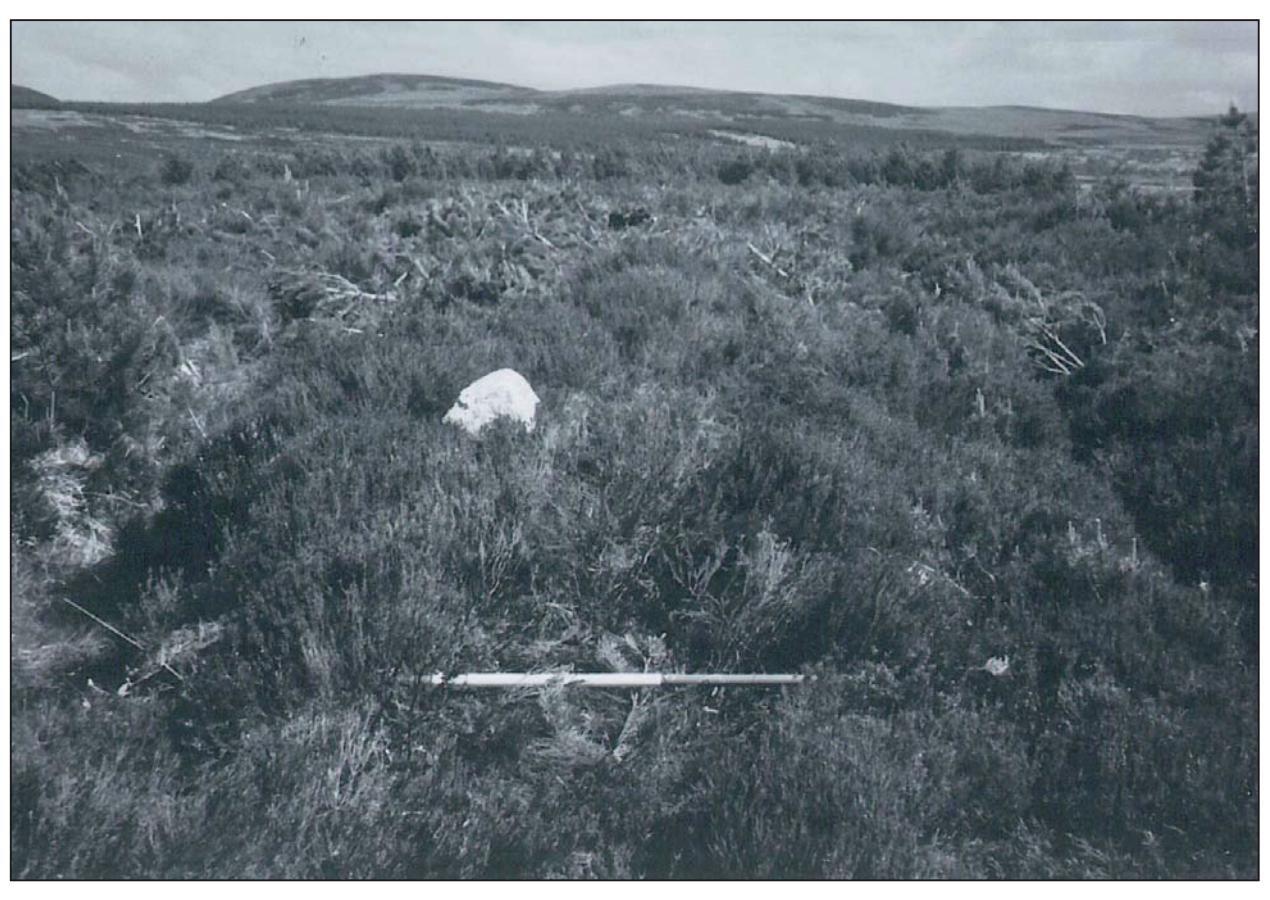
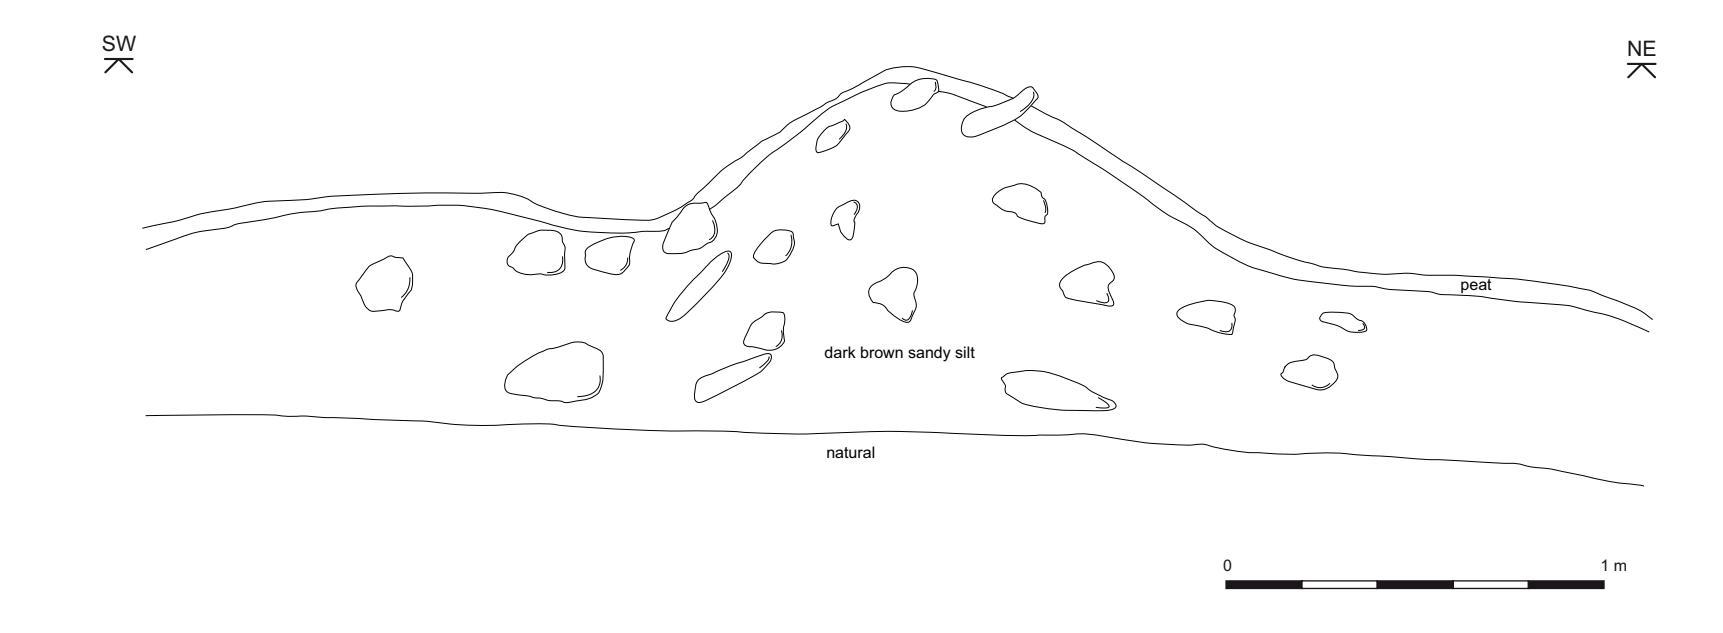
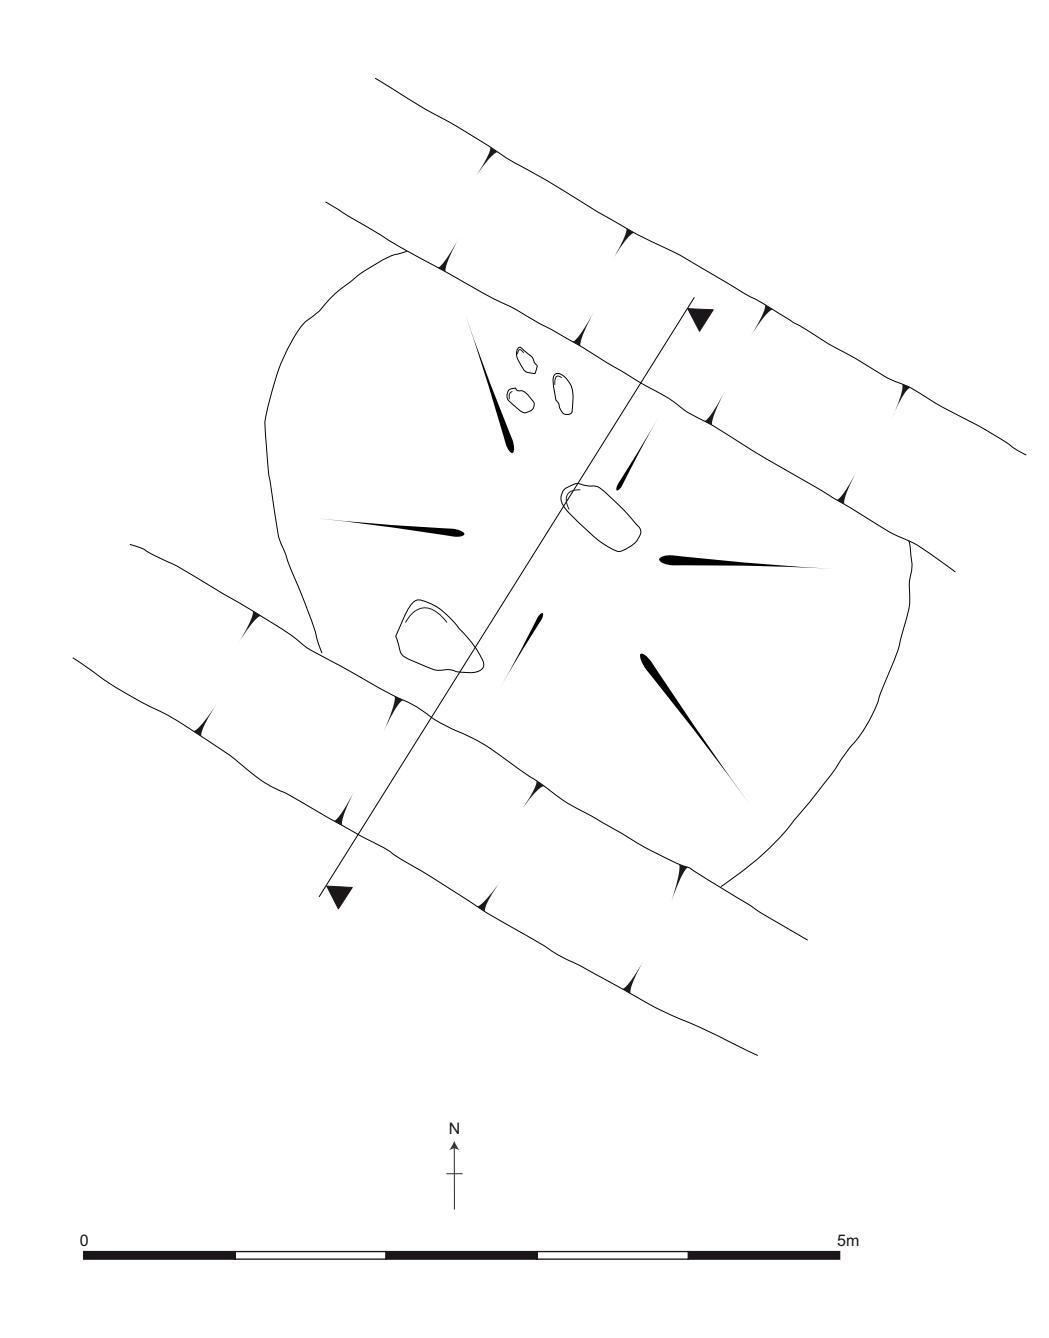
Figure 11: Clearance Cairn 9 plate, pre-excavation plan and NW facing section

Clearance Cairn 9, looking SE

Section through Clearance Cairn 9, NW facing

Pre-excavation plan of Clearance Cairn 9

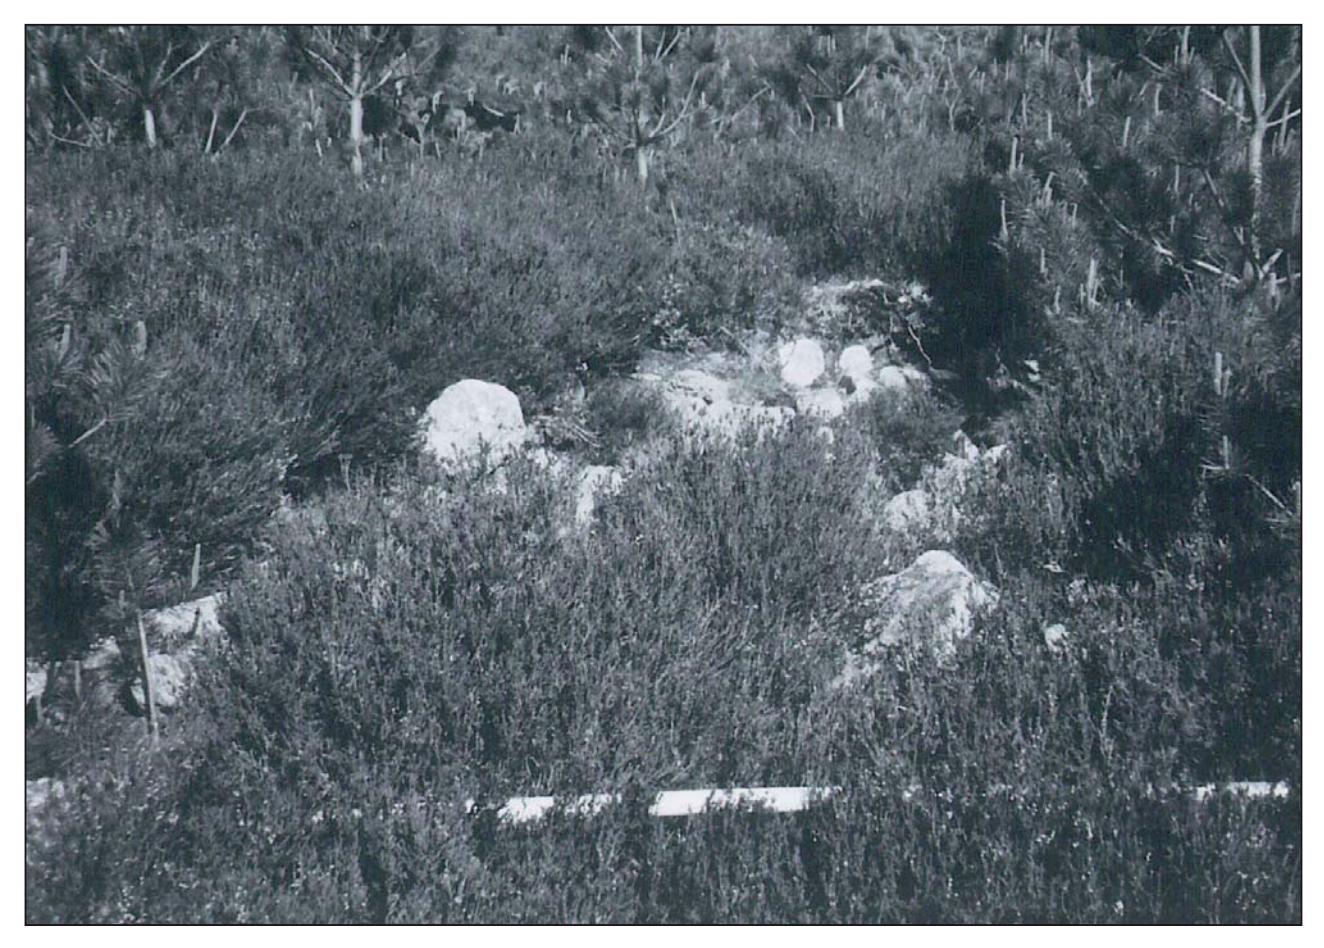
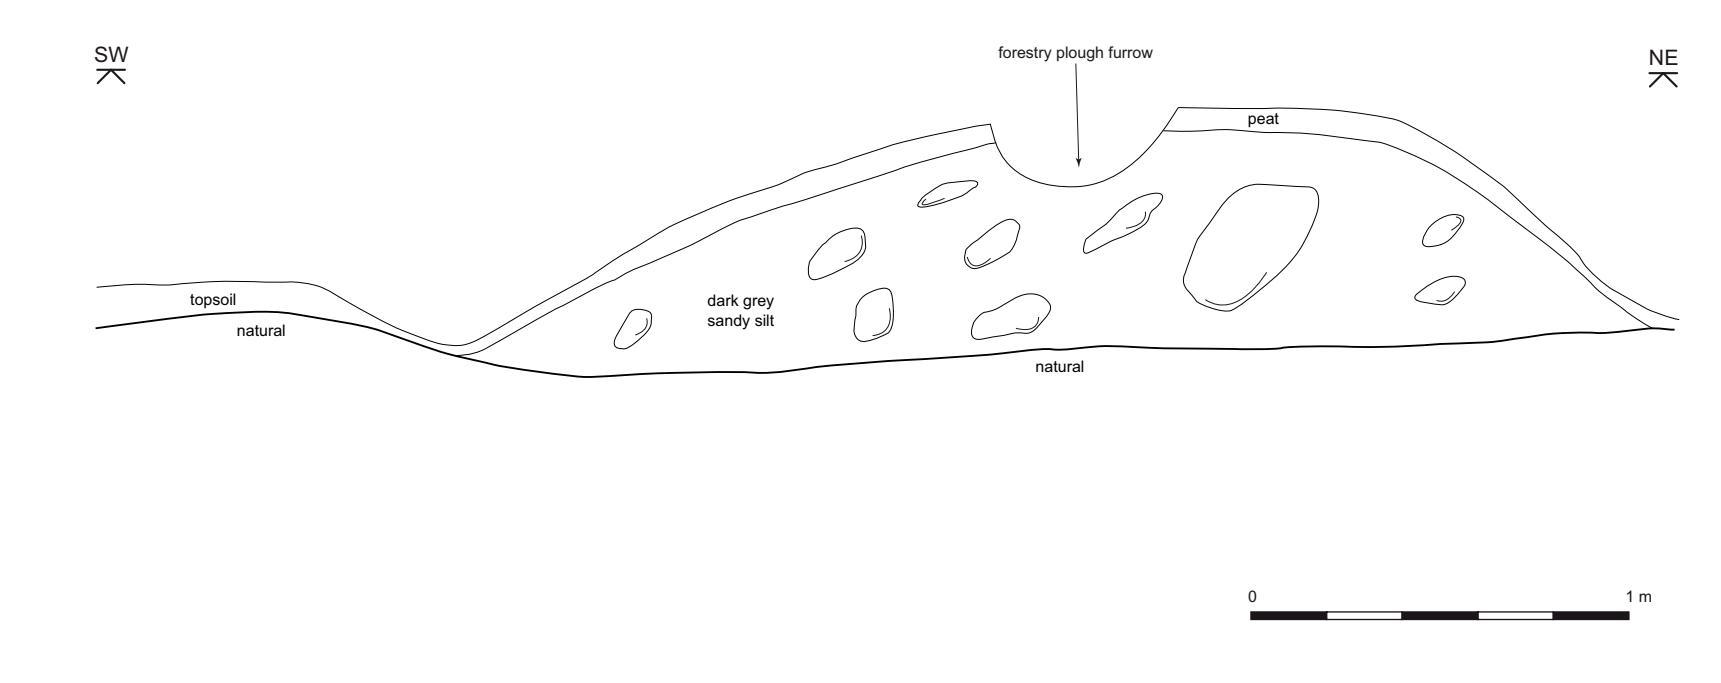
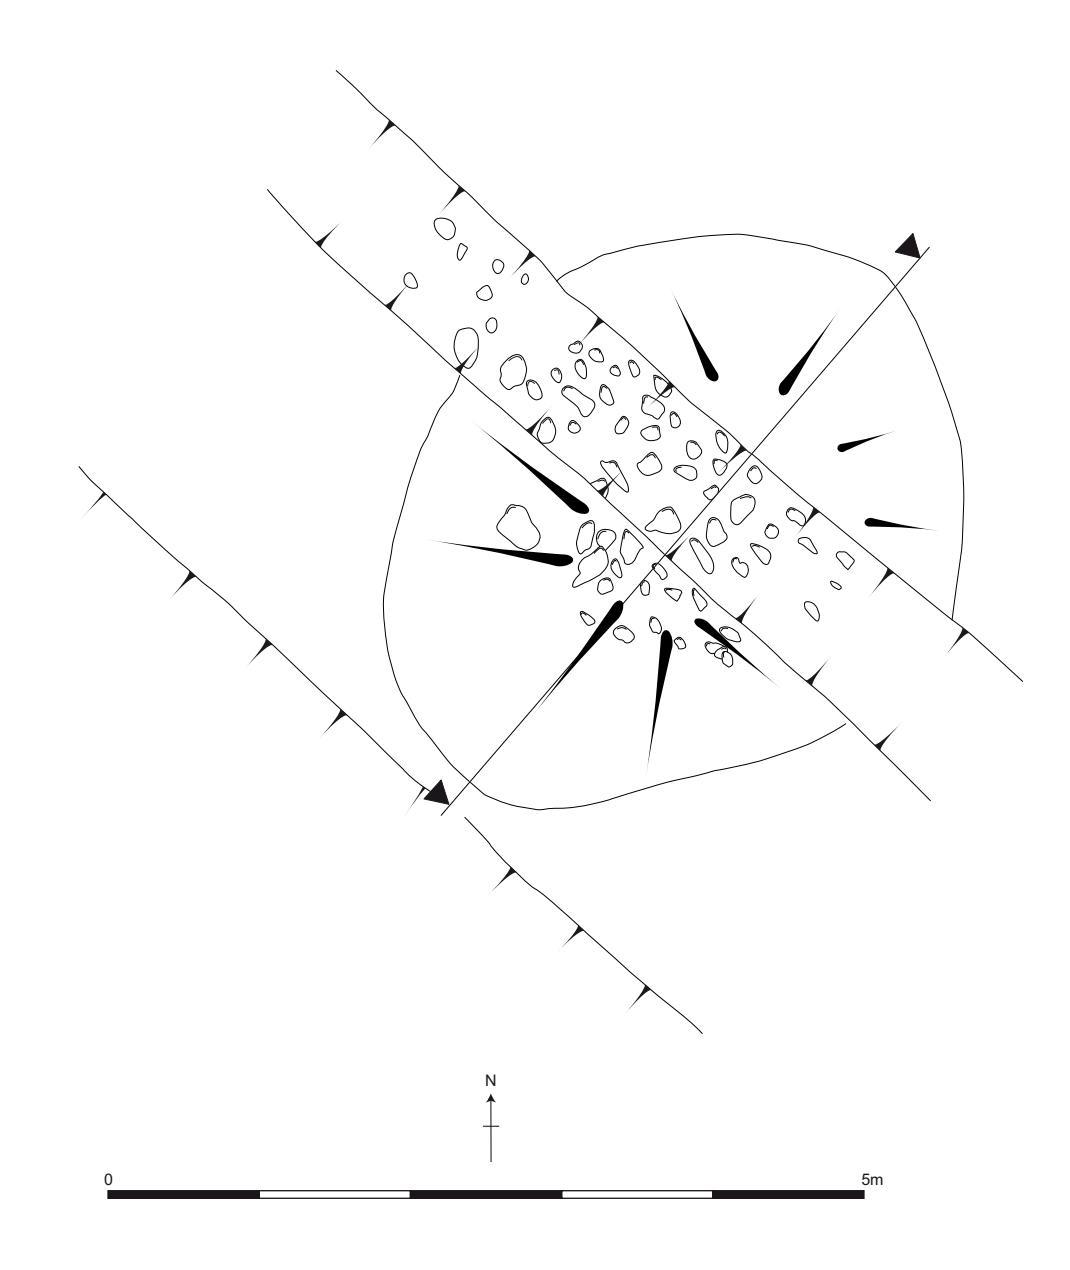
Figure 12: Clearance Cairn 10 plate, pre-excavation plan and SE facing section

Clearance Cairn 10, looking NE

Section through Clearance Cairn 10, SE facing

Pre-excavation plan of Clearance Cairn 10

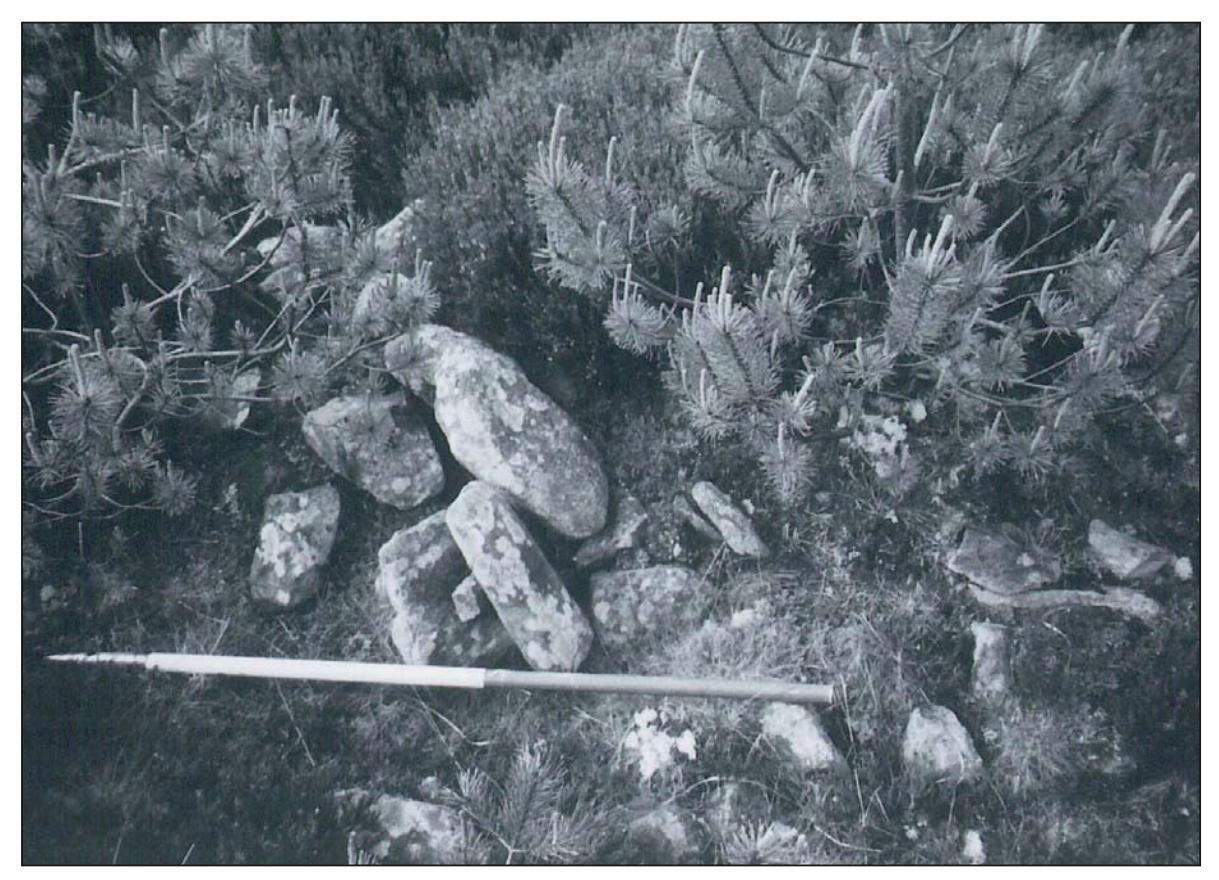
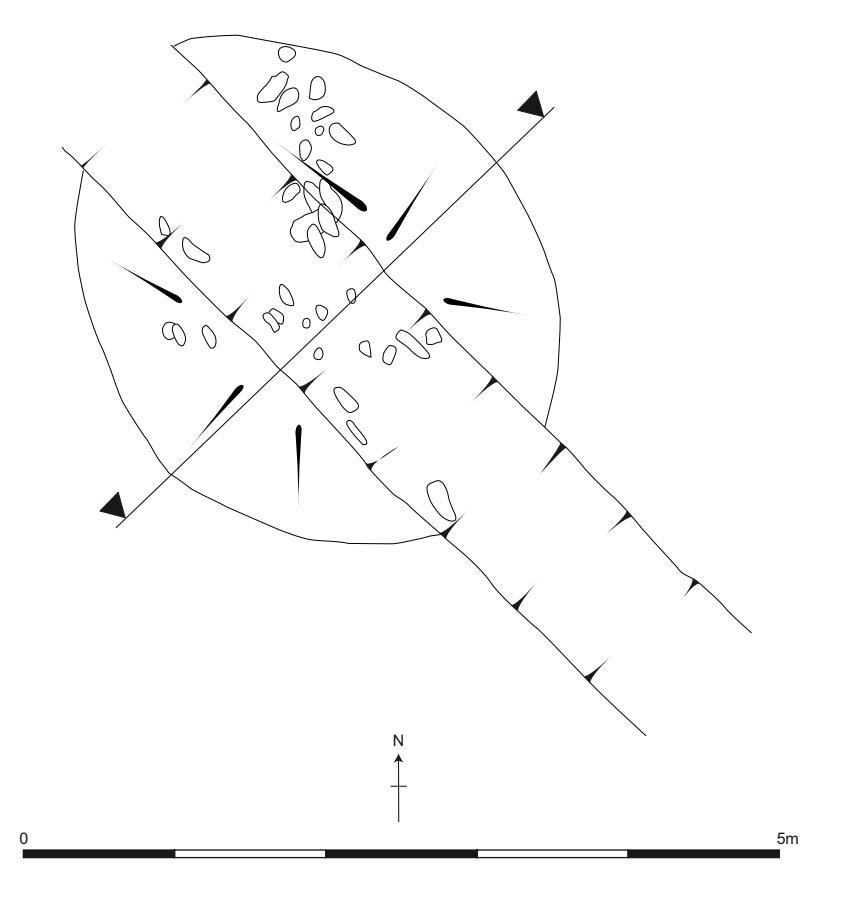
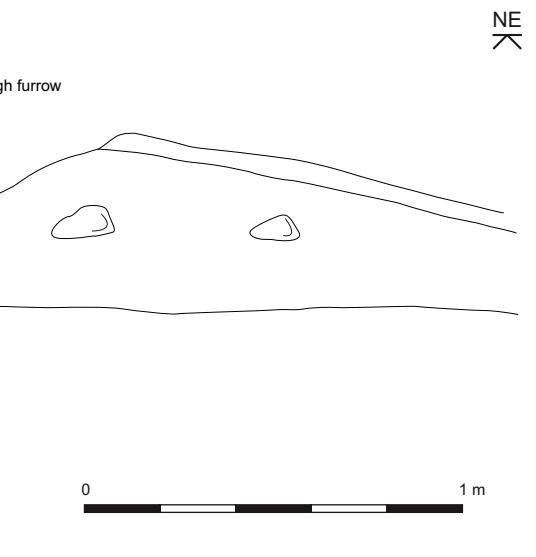
Figure 13: Clearance Cairn 11 plate, pre-excavation plan and SE facing section

Clearance Cairn 11, looking SE

sw 不 forestry plough furrow \bigcirc \bigcirc dark brown sandy silt natural

Pre-excavation plan of Clearance Cairn 11

Section through Clearance Cairn 11, SE facing

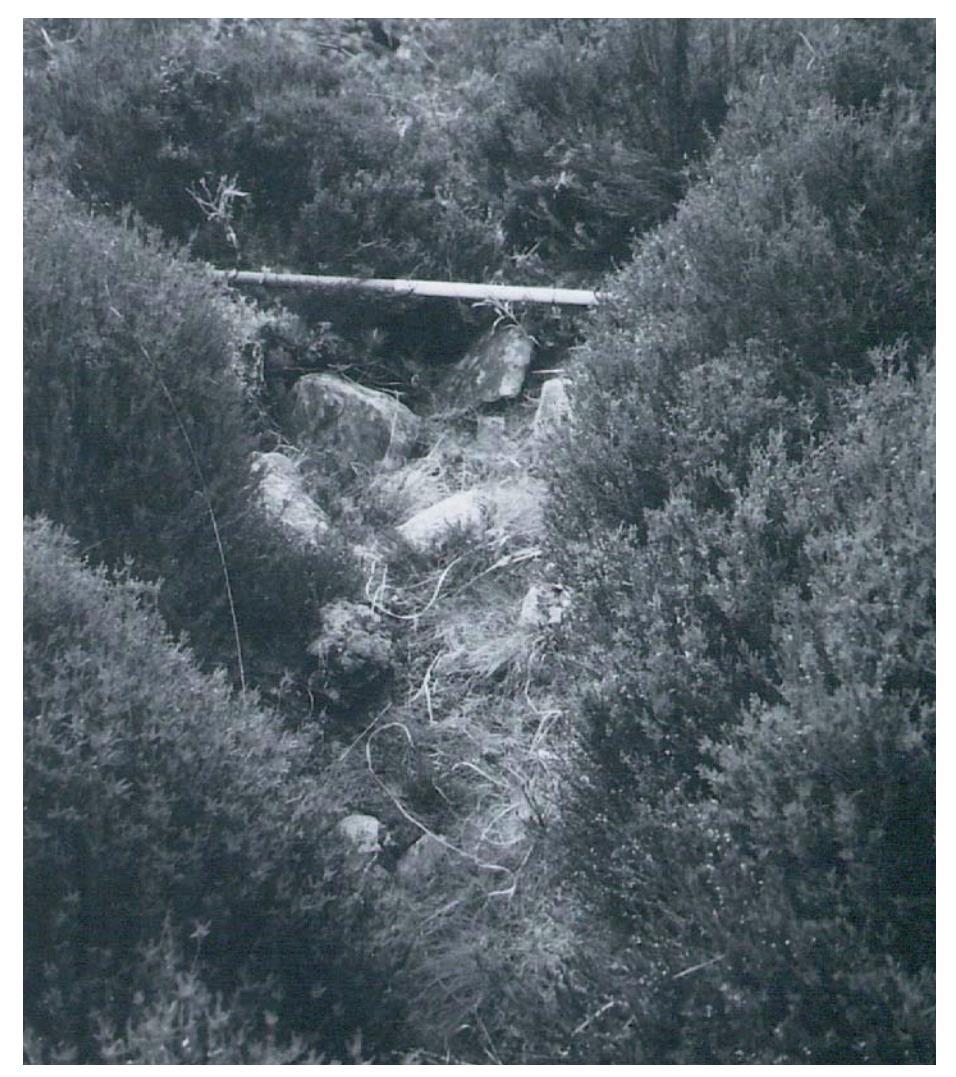
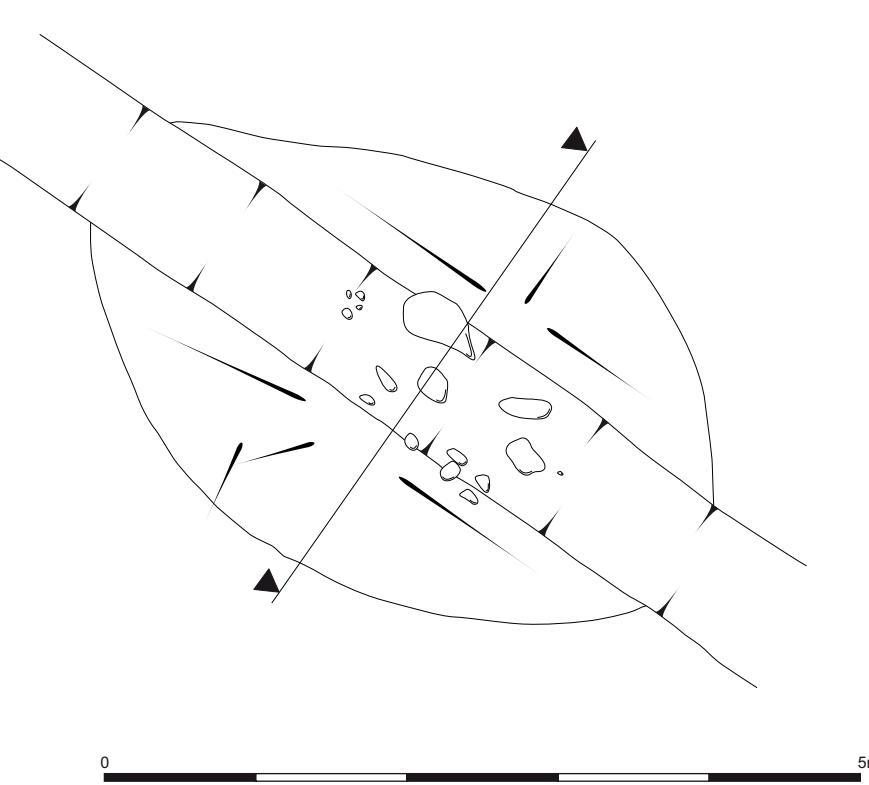
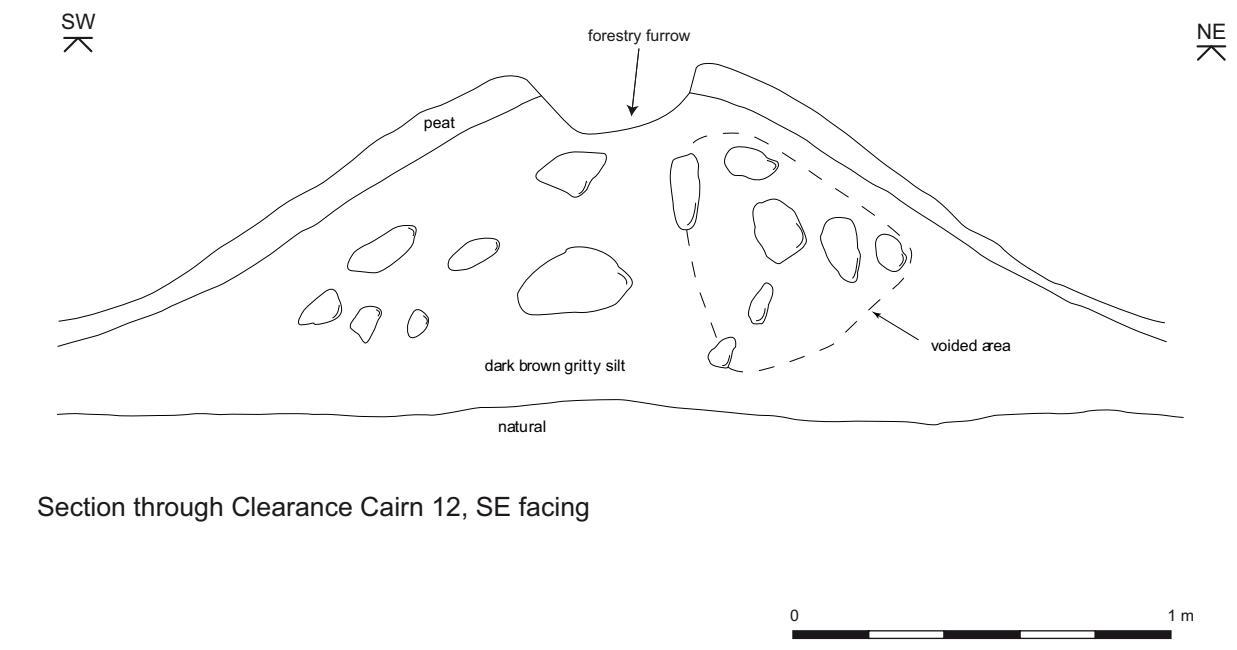
Figure 14: Clearance Cairn 12 plate, pre-excavation plan and SE facing section

Clearance Cairn 12, looking E

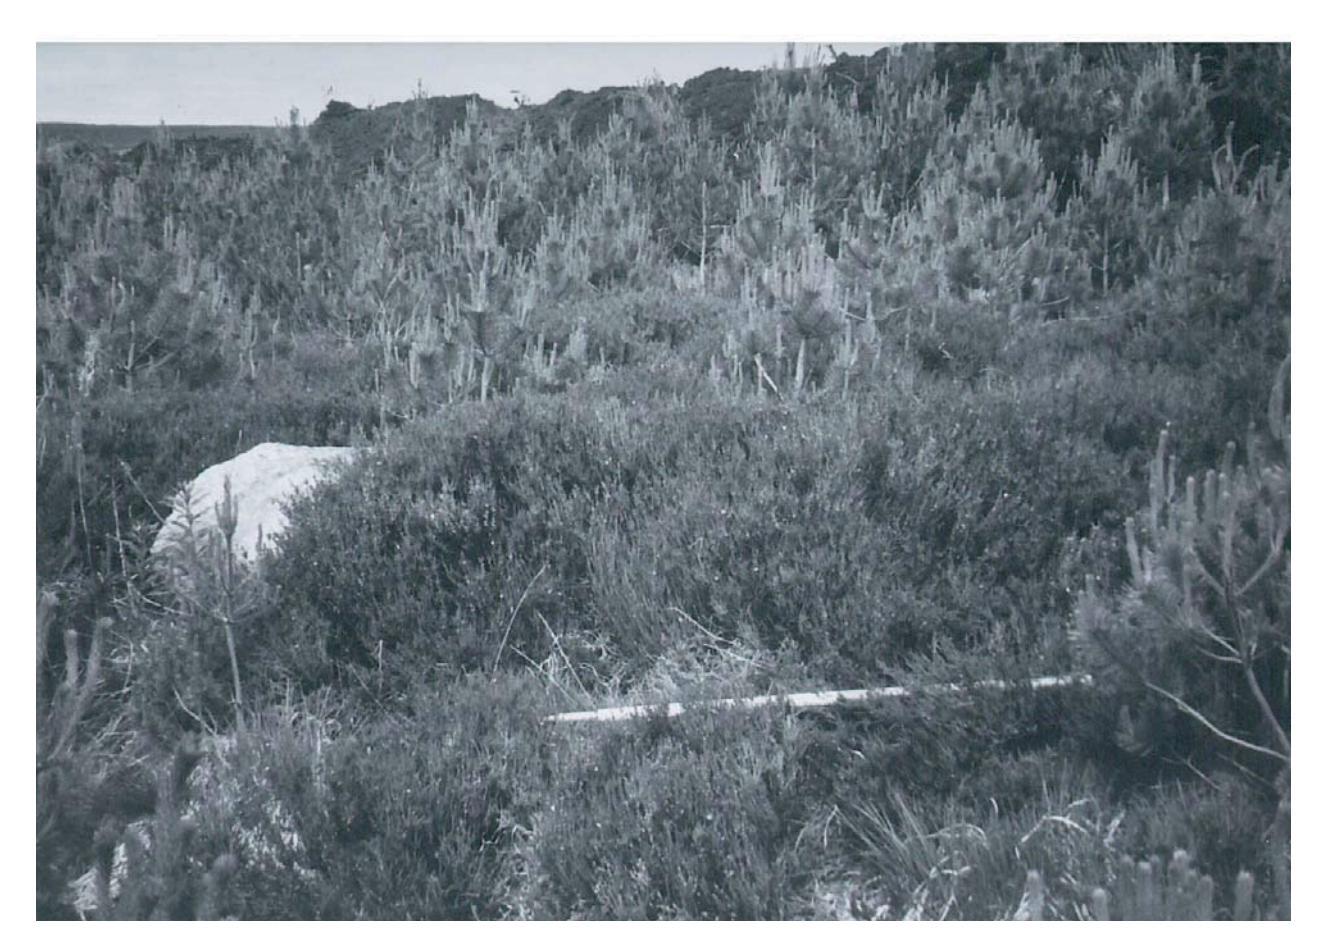
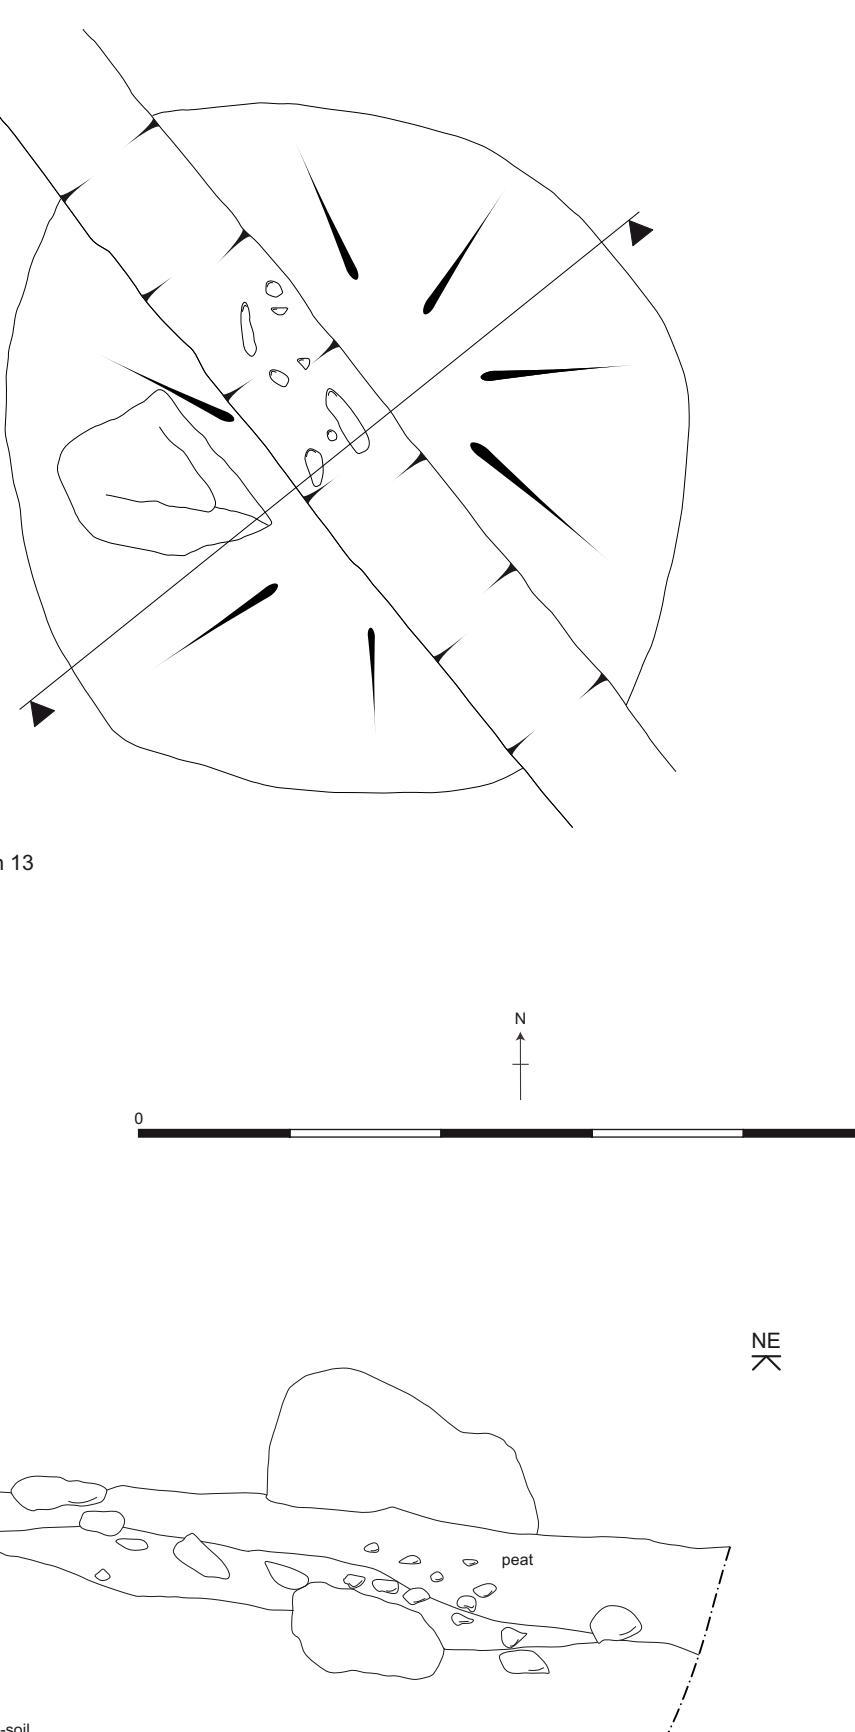
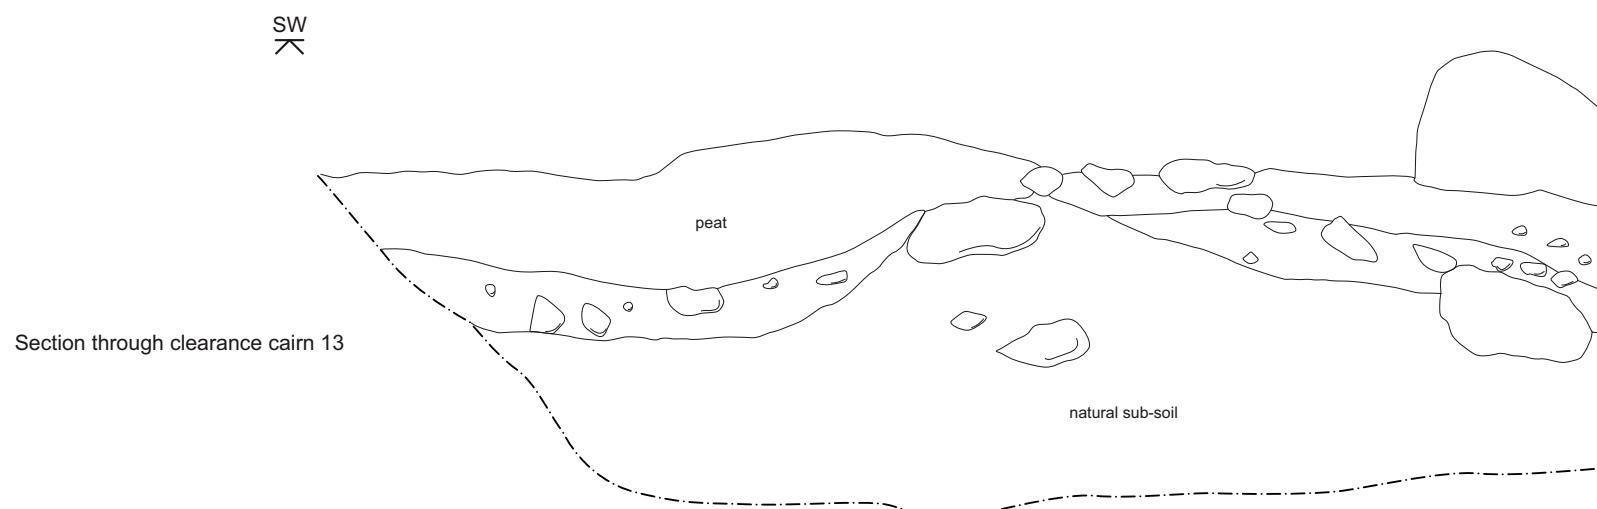
Figure 15: Cairn 13 plate, pre-ex plan and NW facing section

Pre-ex plan of clearance cairn 13

Clearance cairn 13, looking N
