Kilbraur Windfarm, Strath Brora, Highland

Archaeological watching brief on excavations for the site access track, turbine bases, borrow pit and other groundworks.

KILBRAUR WINDFARM, STRATH BRORA, HIGHLAND: RESULTS OF AN ARCHAEOLOGICAL WATCHING BRIEF

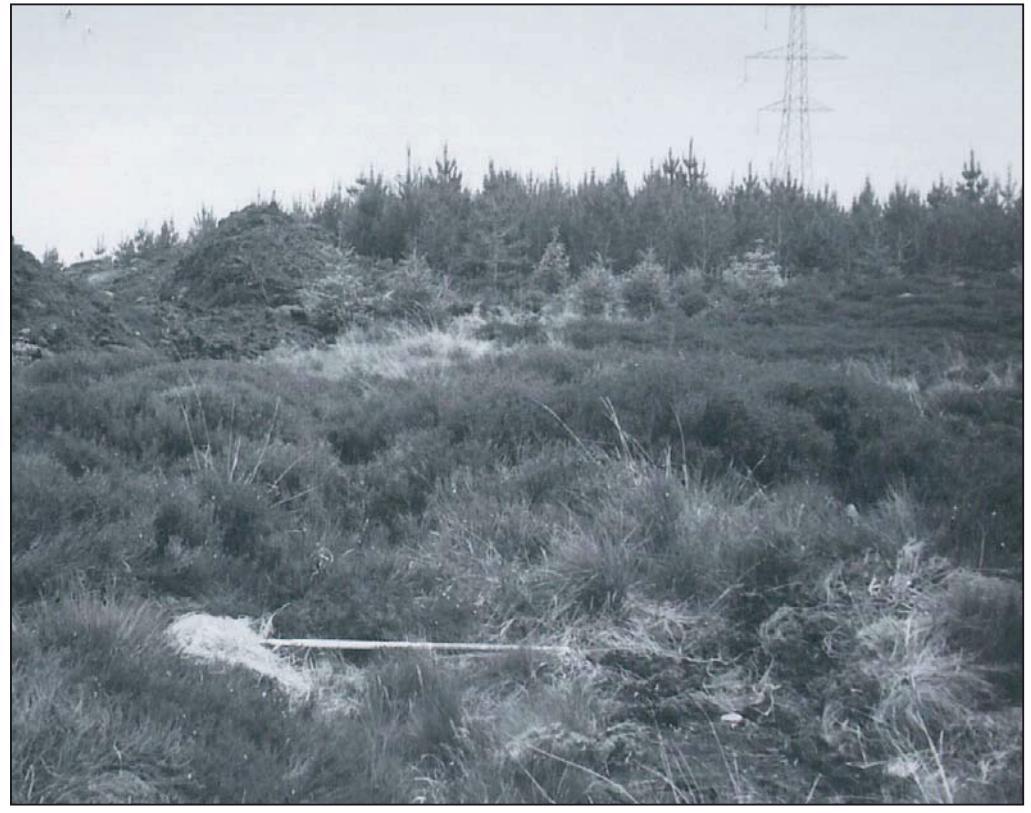
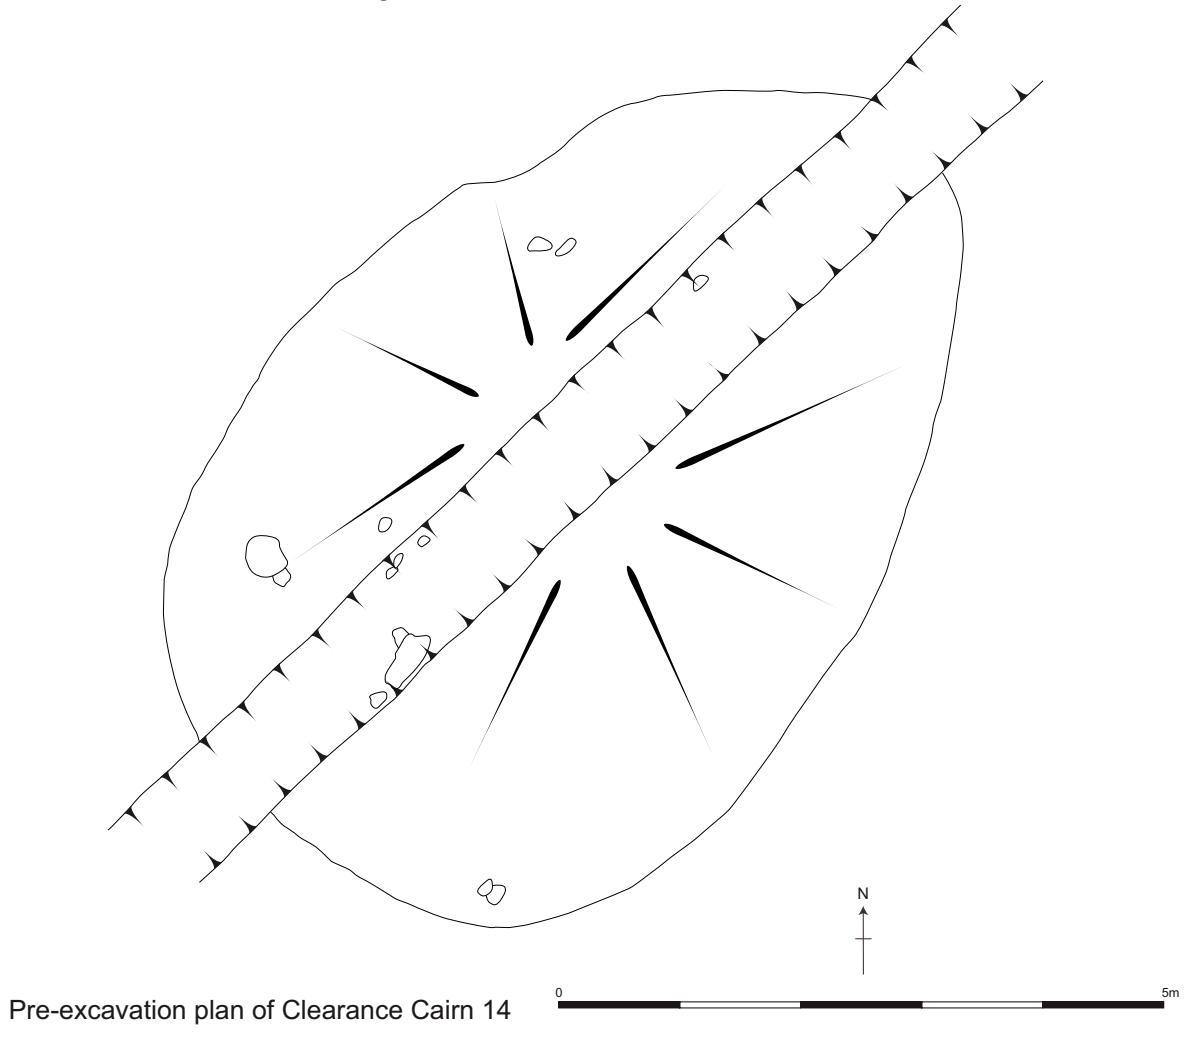
Figure 16: Plate and pre-excavation plan of Clearance Cairn 14

Clearance Cairn 14, looking NE

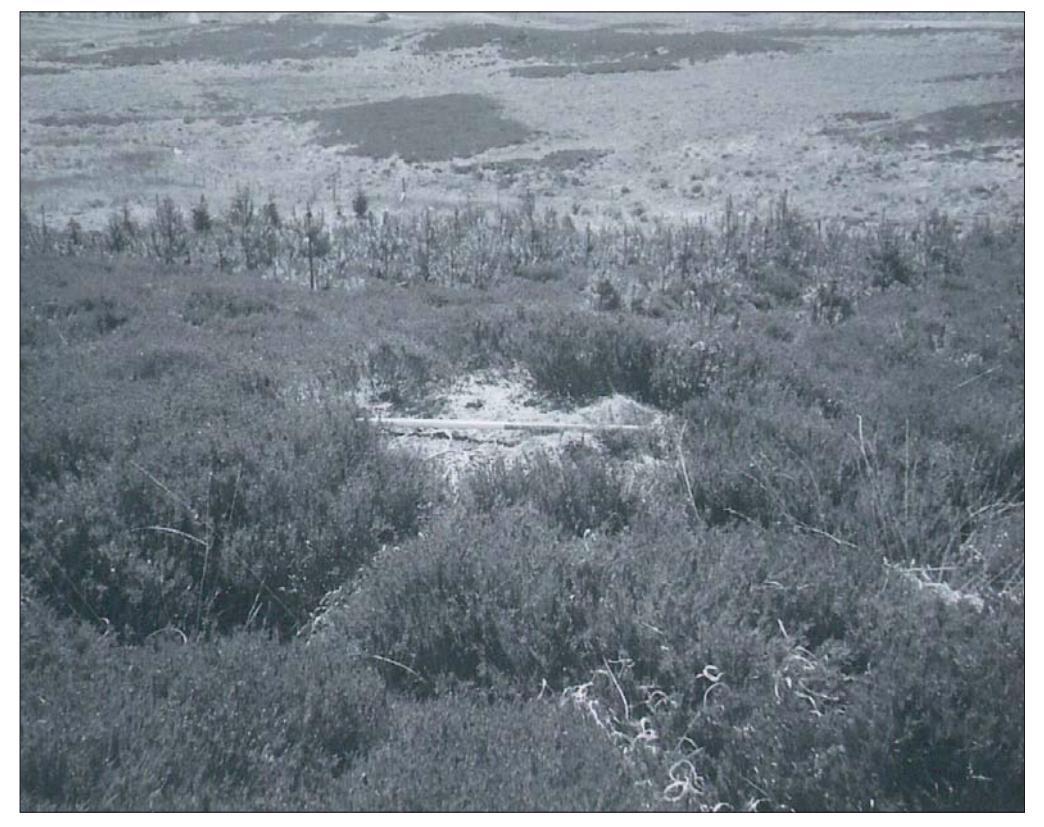
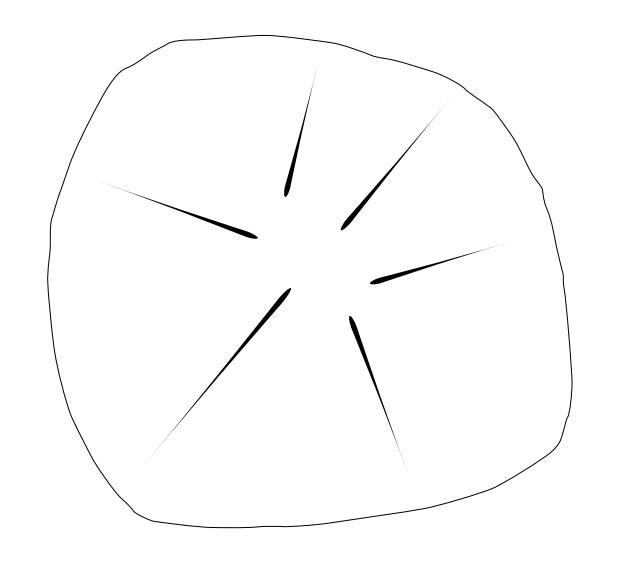
Figure 17: Clearance Cairn 15 plate and pre-excavation plan

Clearance Cairn 15, looking SW

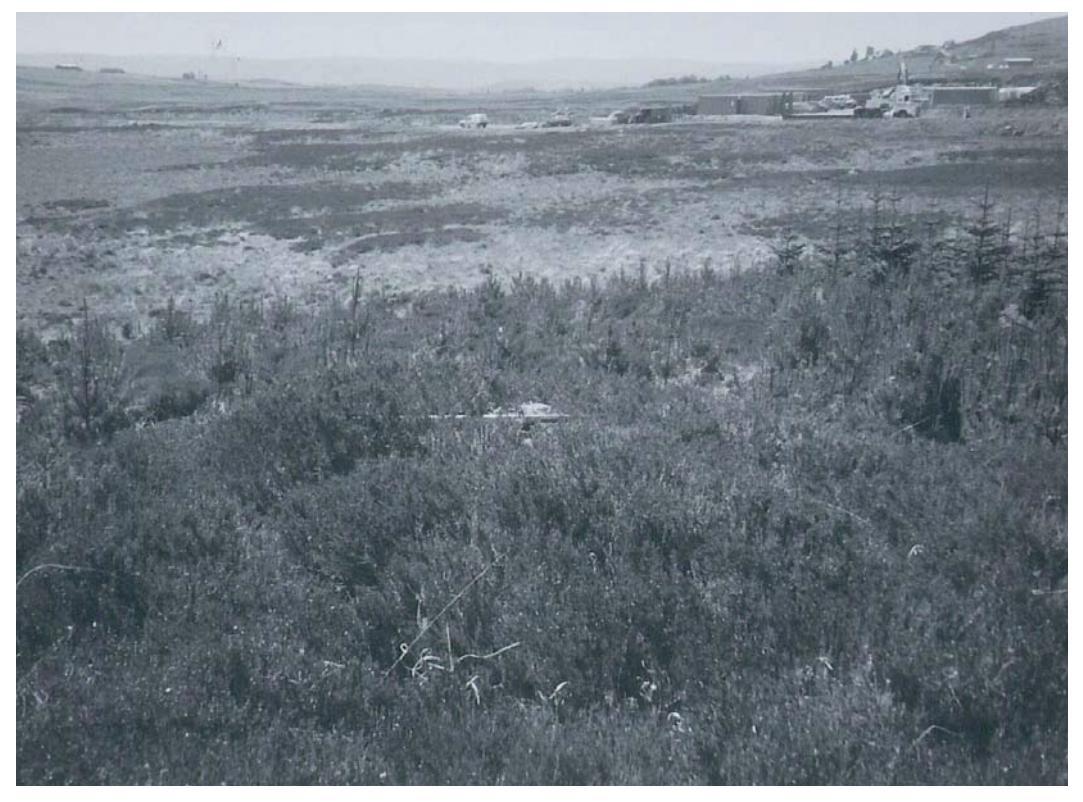
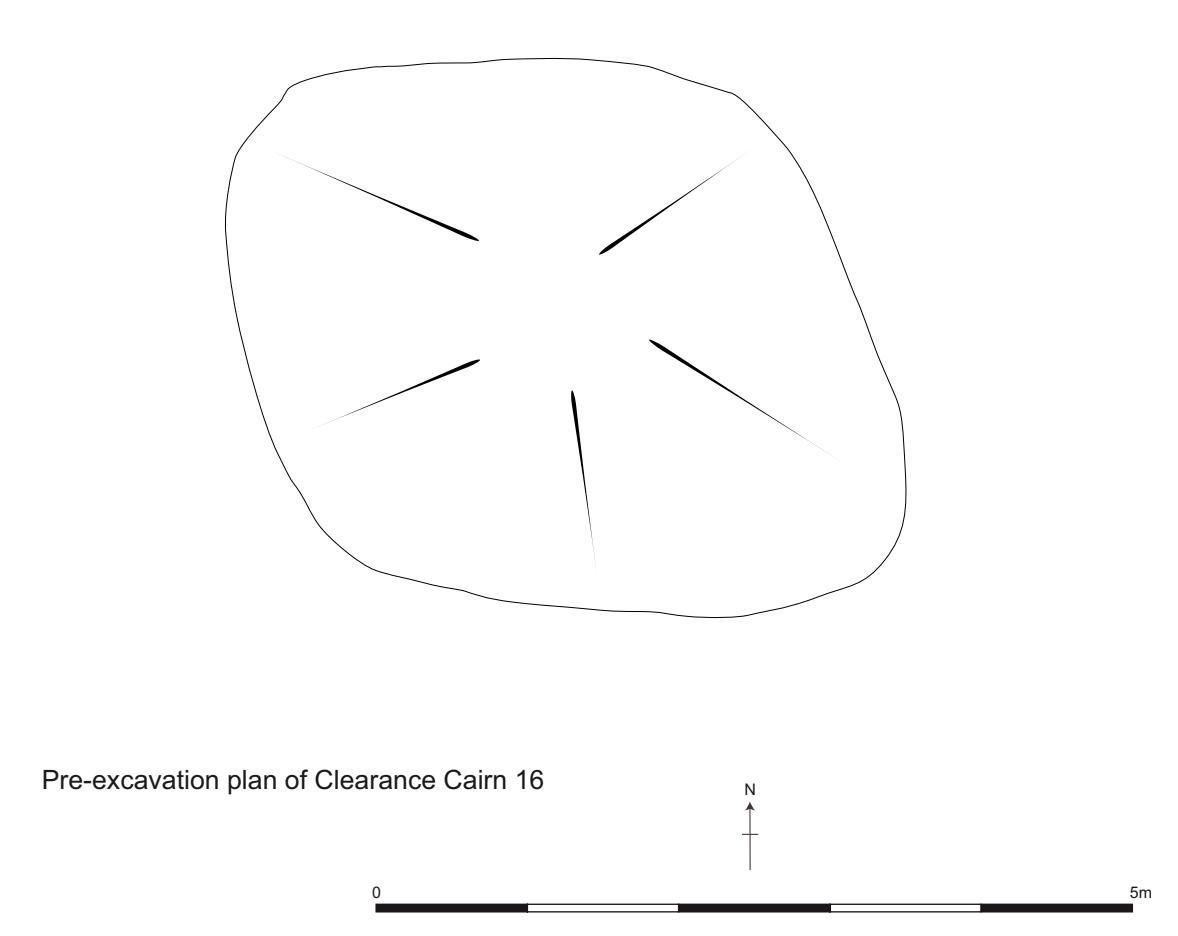
Figure 18: Clearance Cairn 16 plate and pre-excavation plan

Clearance Cairn 16, looking SW

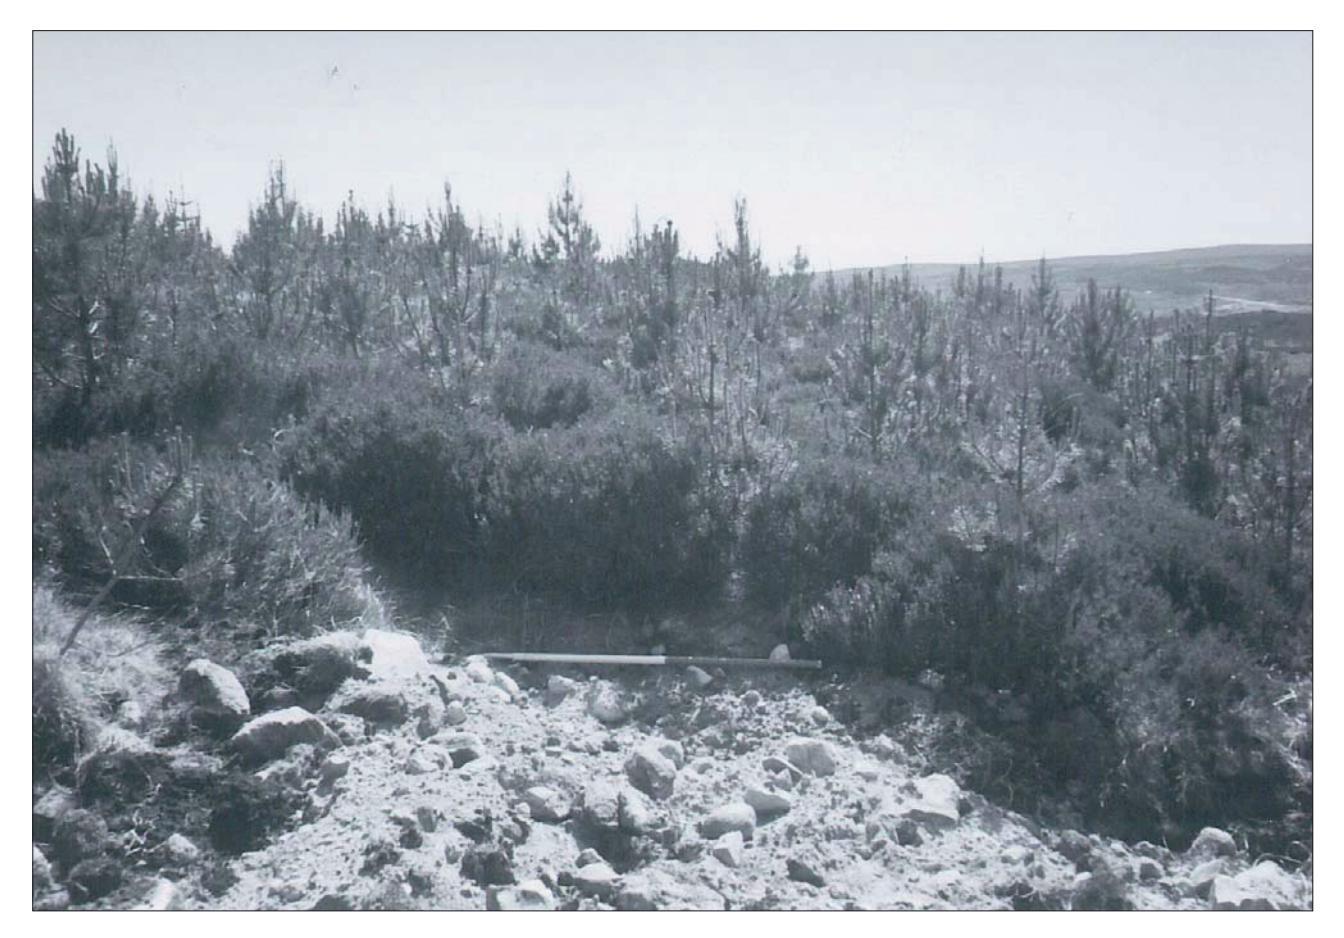
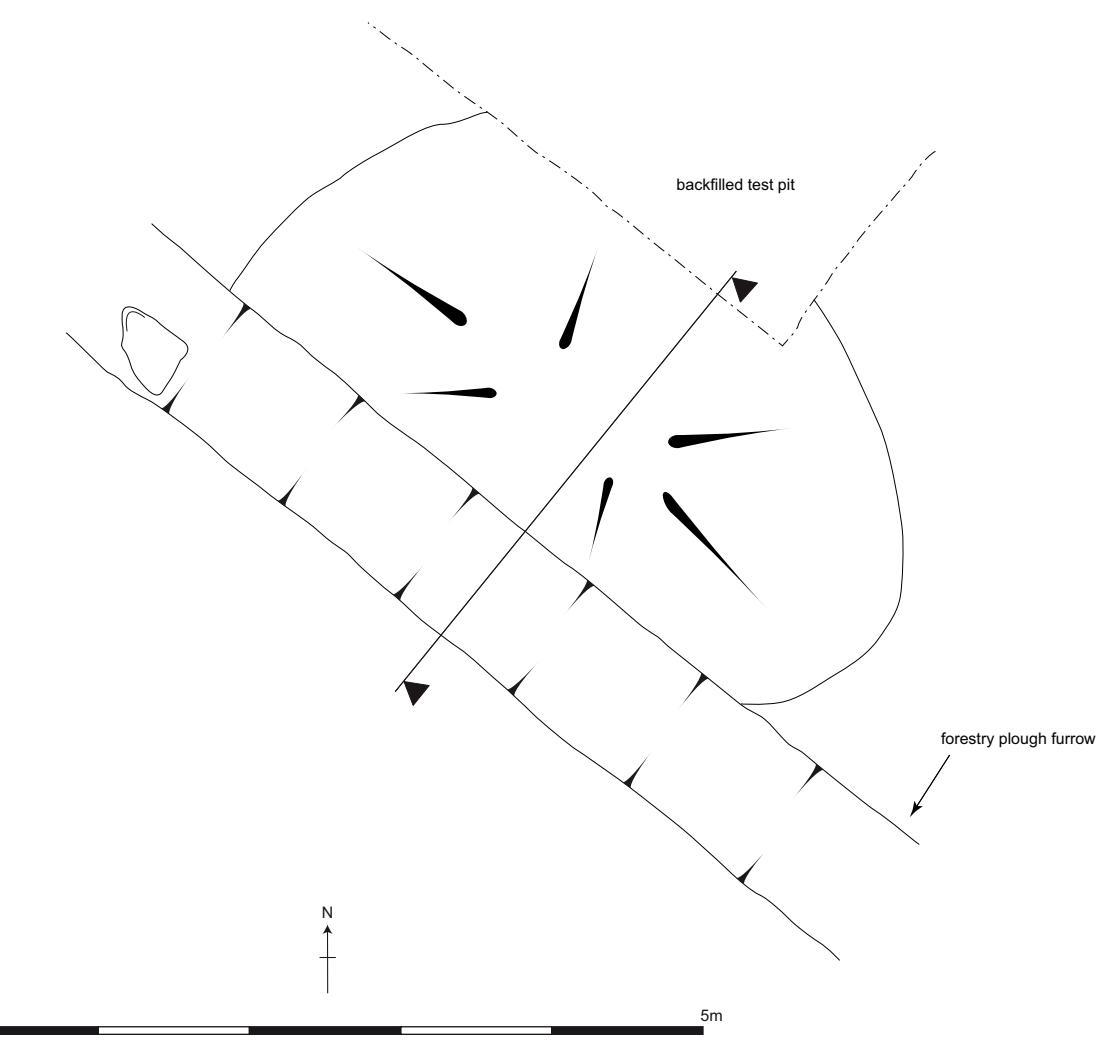
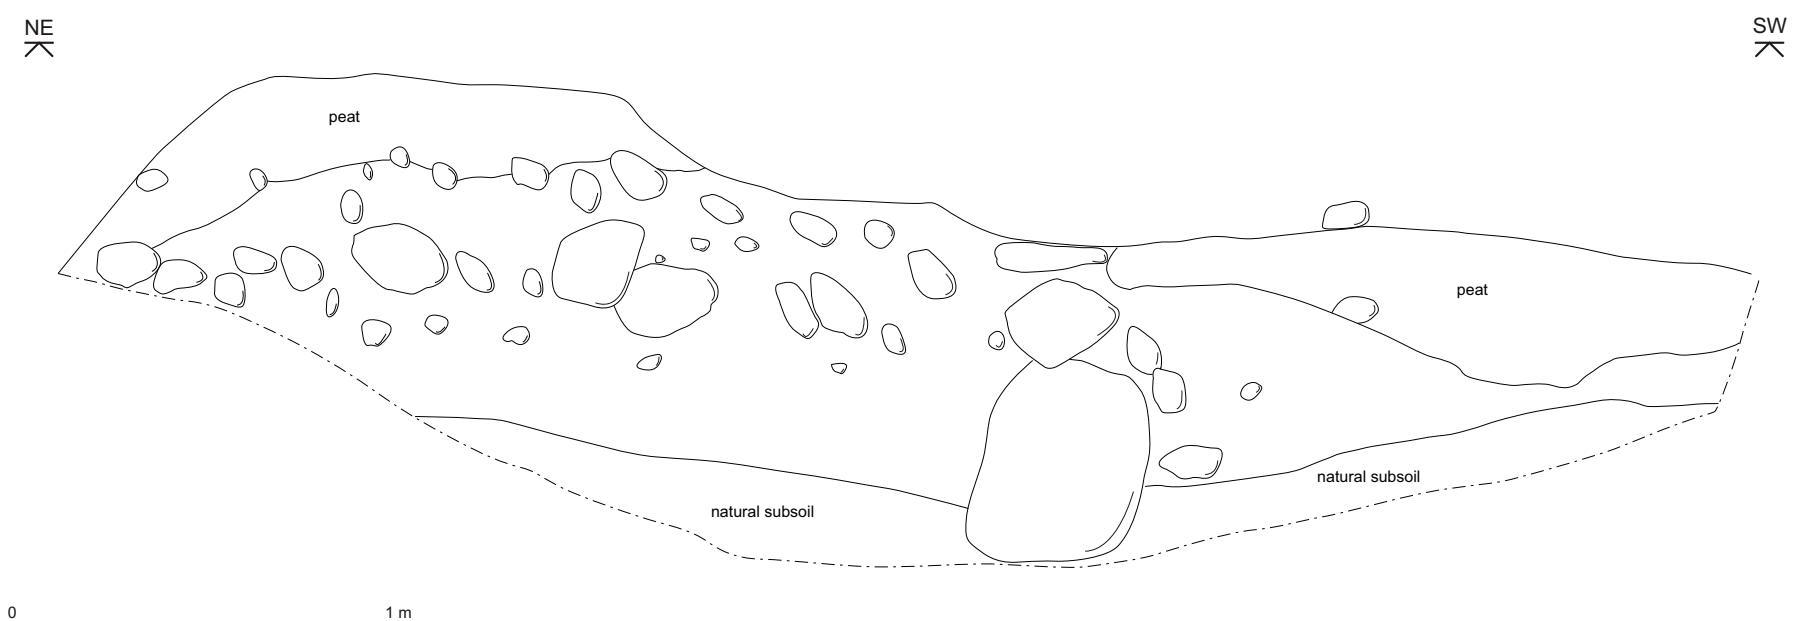
Clearance Cairn 17, looking S

Section through Clearance Cairn 17, NW facing

Pre-excavation plan of Clearance Cairn 17

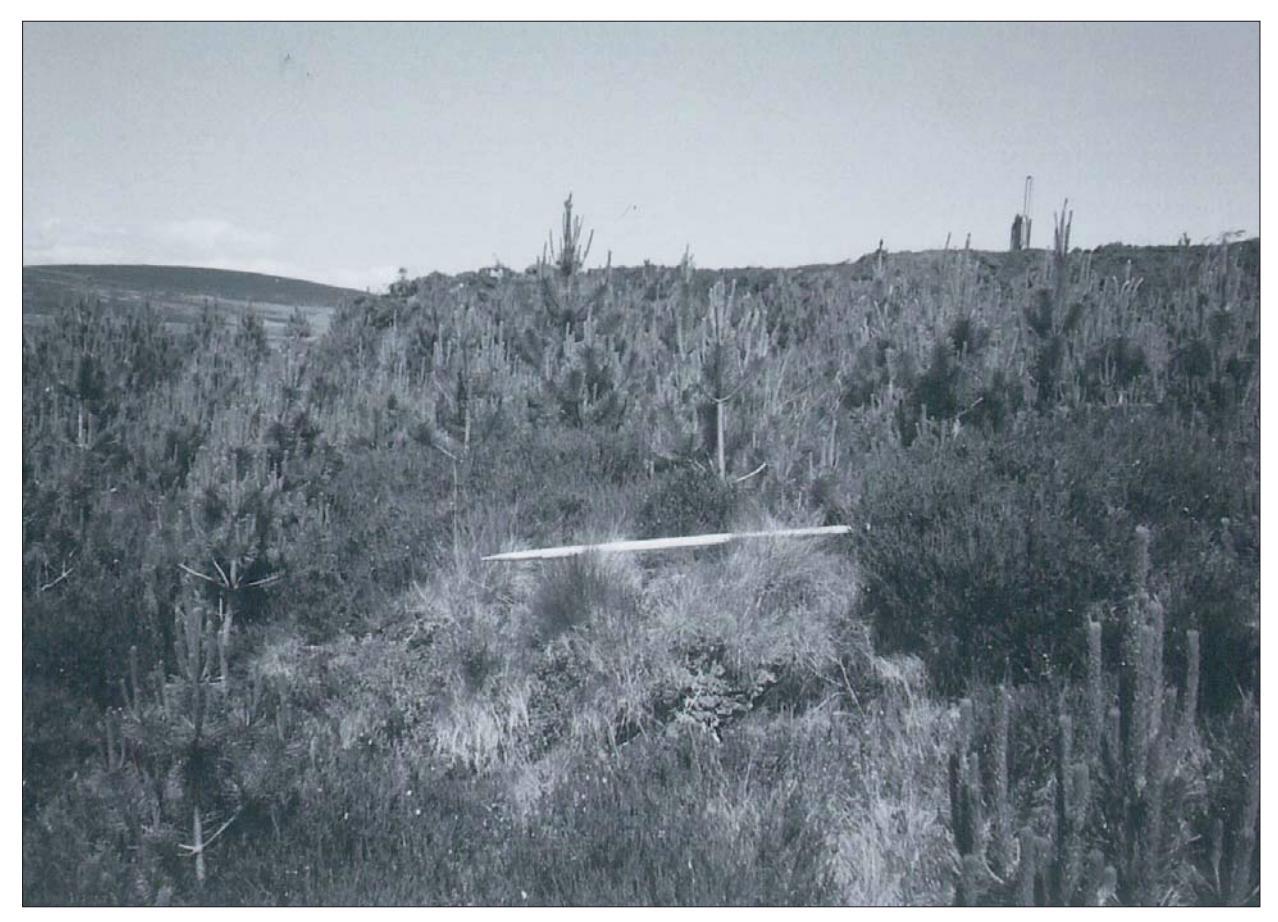
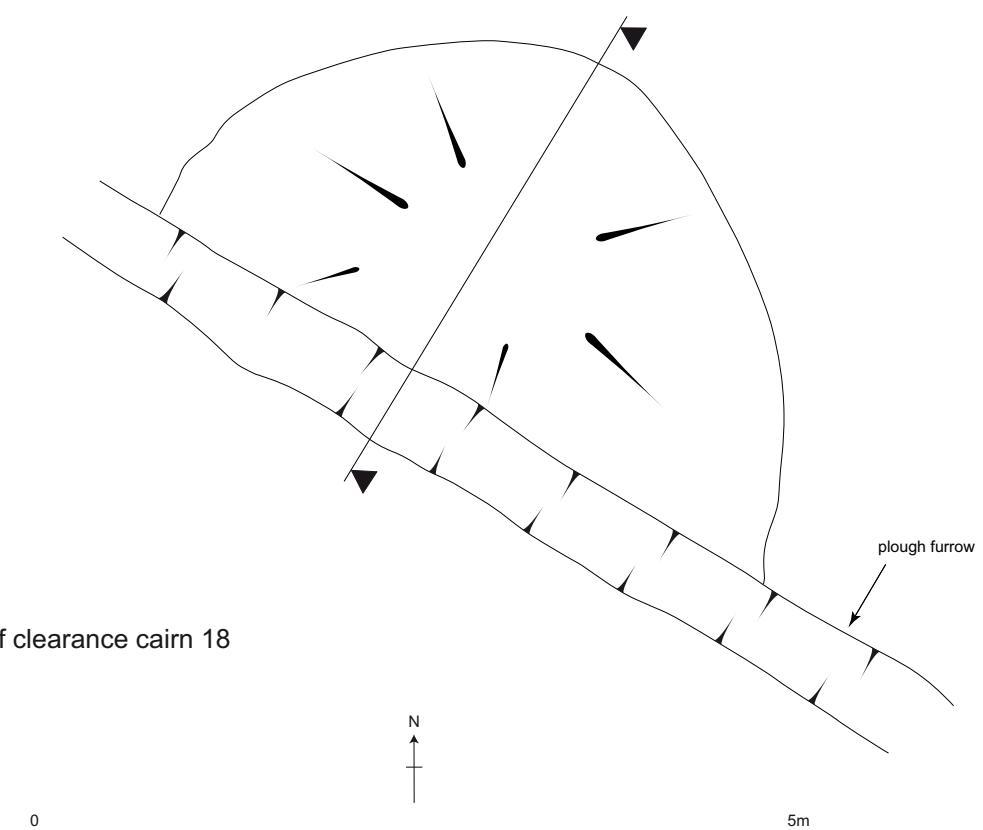
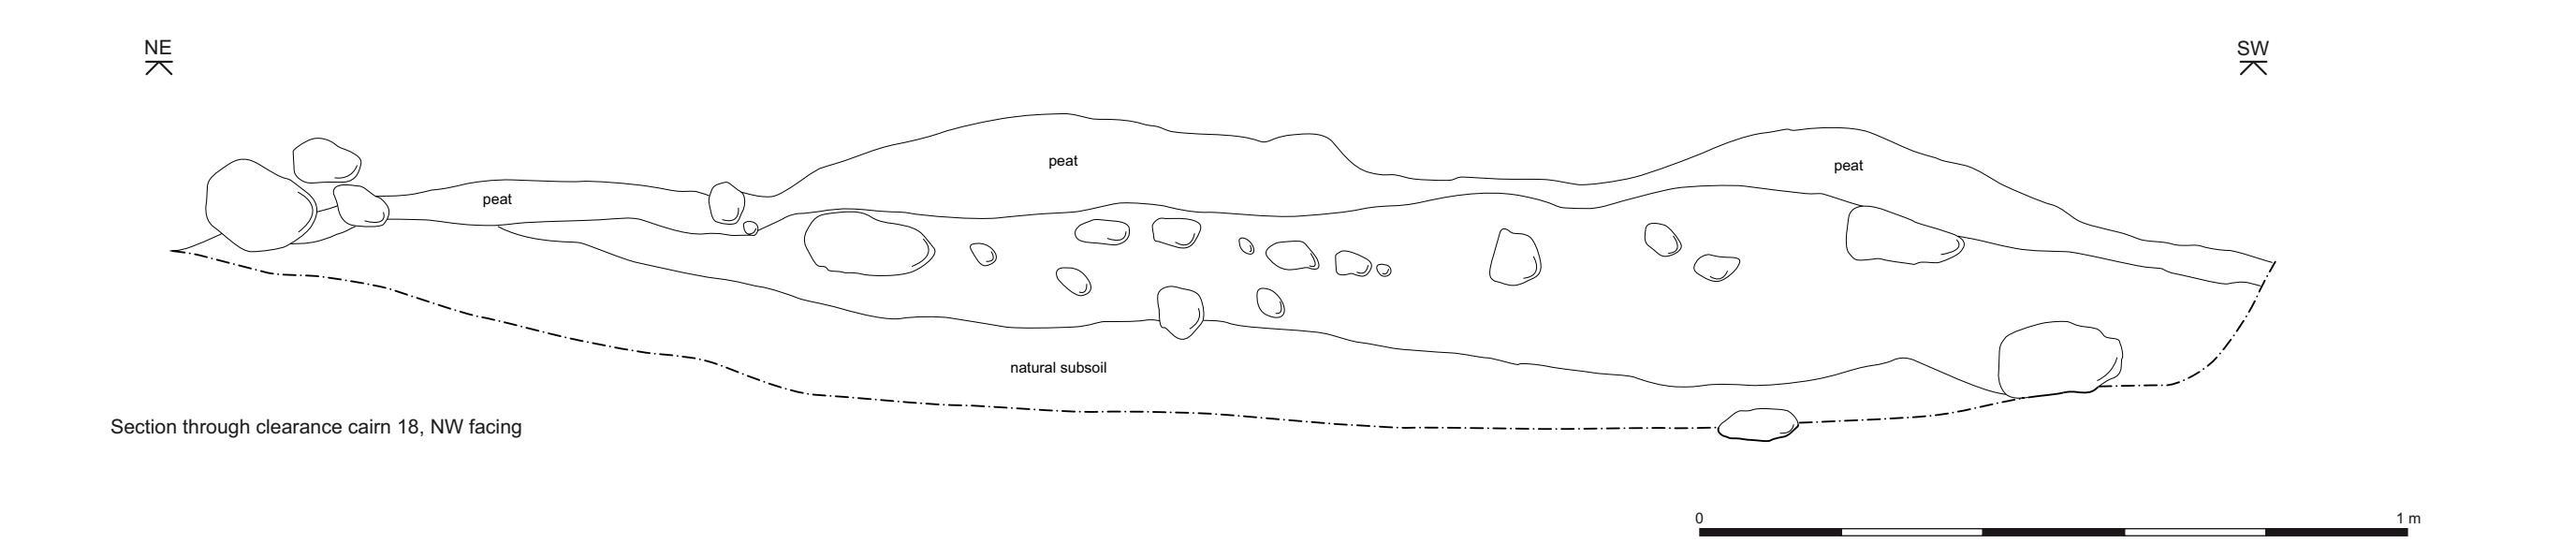
Figure 20: cairn 18 plate, pre-ex plan and NW facing section

Pre-ex plan of clearance cairn 18

Clearance cairn 18, looking NE

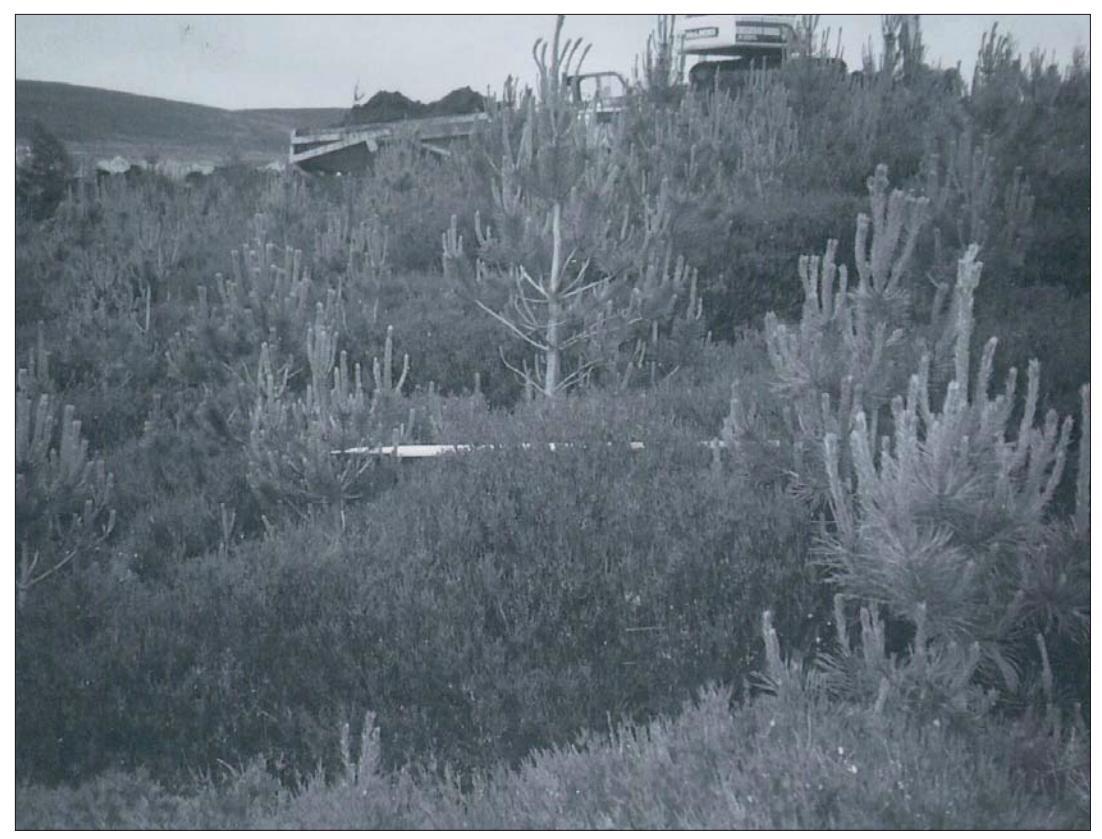
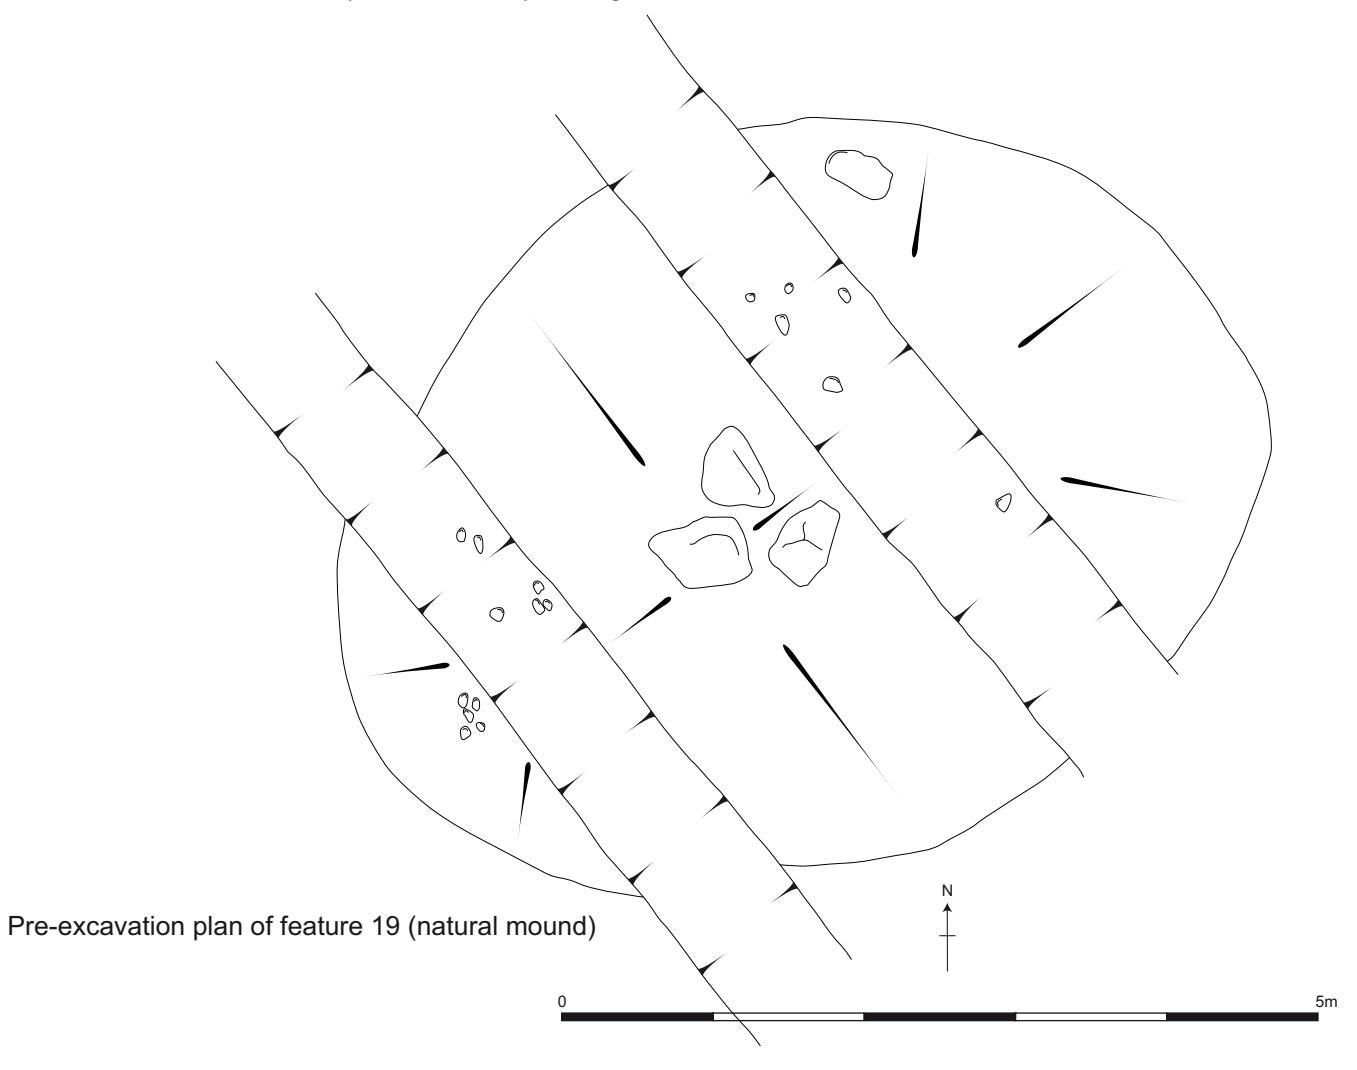
Figure 21: Feature 19 (natural mound) plate and pre-excavation plan

Feature 19 (natural mound) looking north

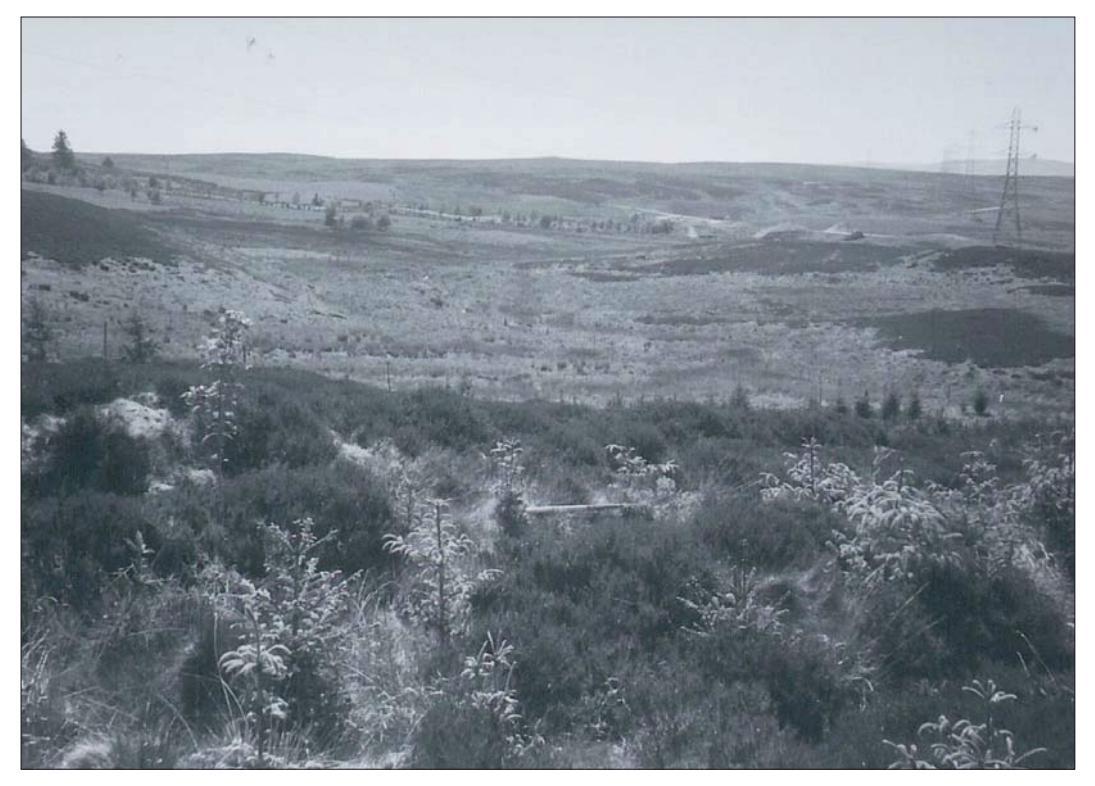
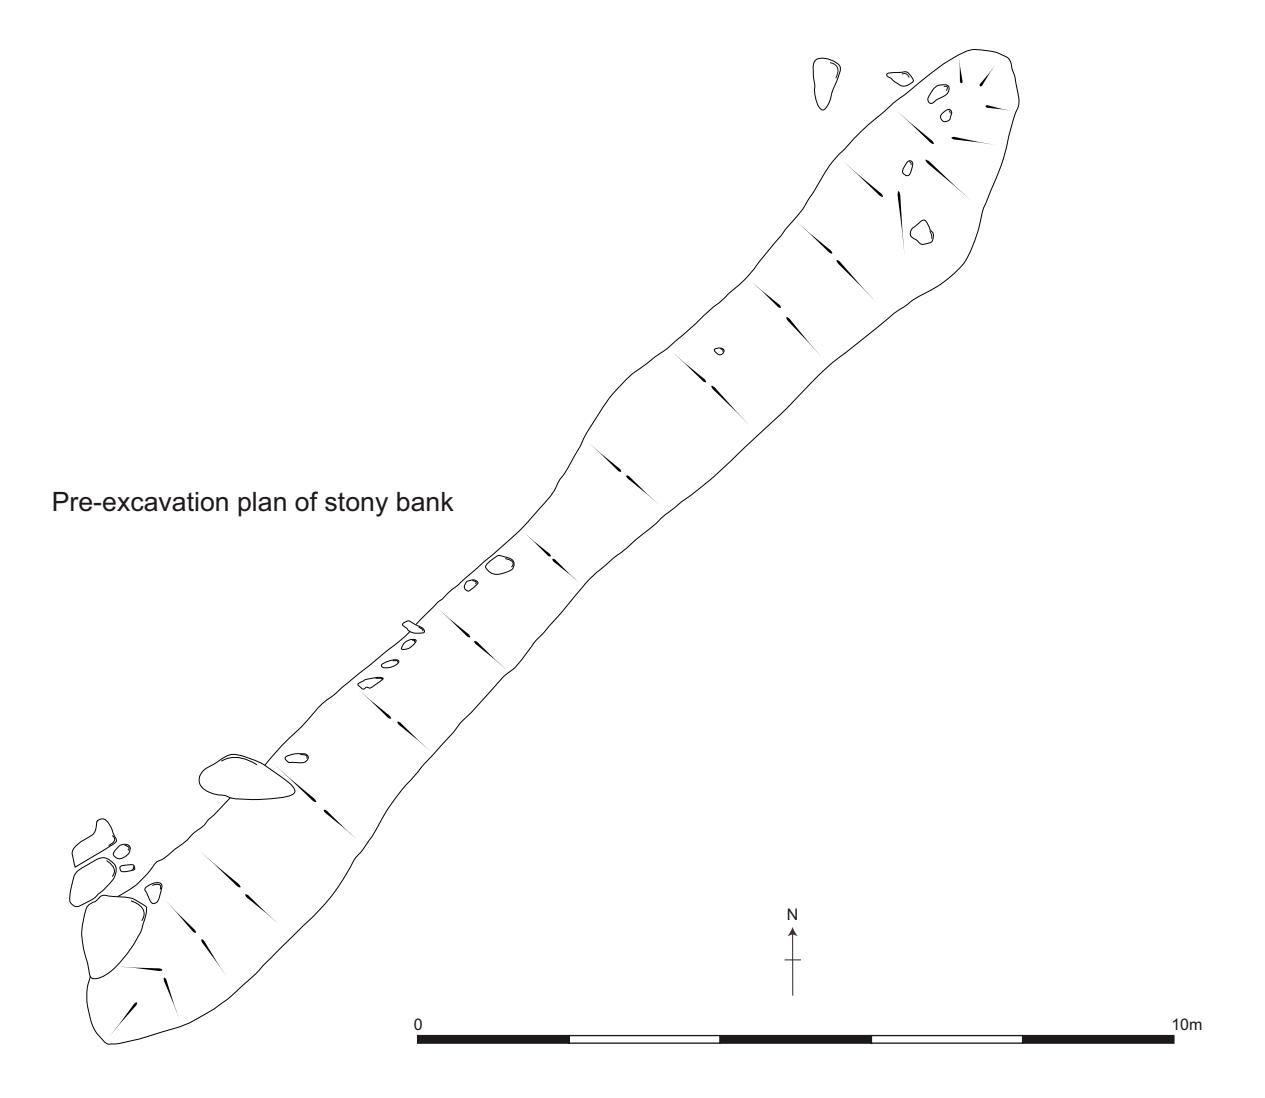
Figure 22: Stony bank plate and pre-excavation plan

There was also a fragment of stony bank located at NC 76888, 06774 (*Figure* 22). This ran NE-SW down the slope of the hill and measured 17.5m by 2.5m

wide (max) with a maximum height of 0.5m. This was not excavated as it was not to be affected by the quarrying.

Stony bank, facing S

The short stony bank found in the borrow pit appears to be the linear equivalent of a clearance cairn (Yates 1984).

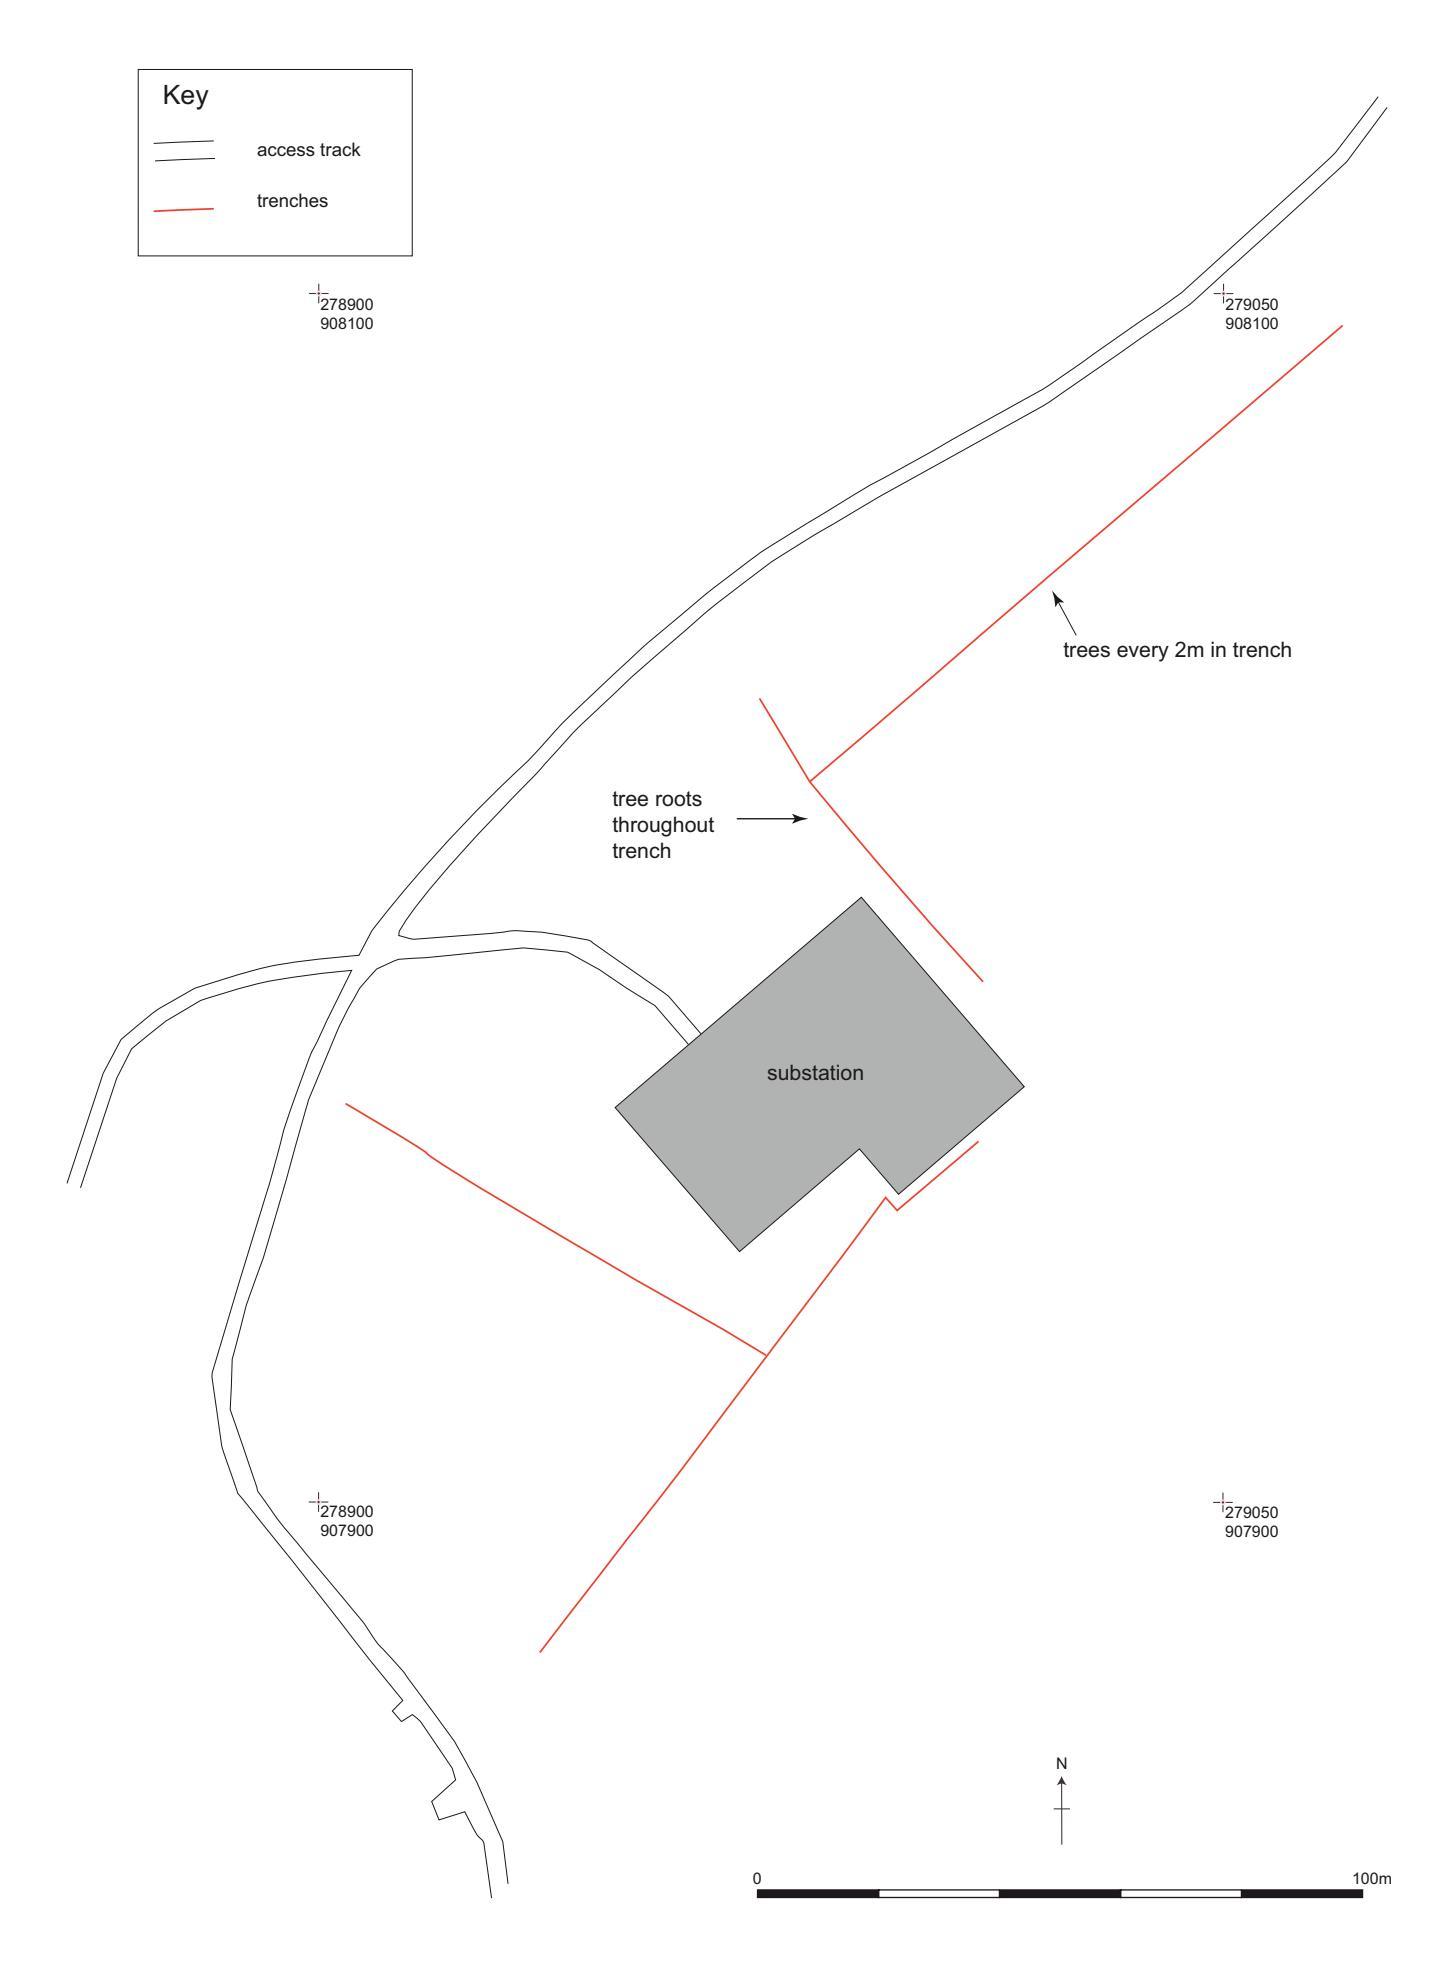
Figure 23: Location of substation earth grid trenches

Four trenches were excavated running from the sub-station in order to provide an earth grid (*Figure 23*). These trenches measured 0.7m wide and

were excavated to a depth of 0.9m with a total length of 675m. The trenches to the SW of the substation reached the natural subsoil. The trenches to the NE of the sub-station did not reach the natural subsoil as the depth of the peat was too great. These two trenches did however reach a layer of tree stumps preserved within the peat. These preserved trees were left in situ as the trench was not required to go any deeper. No archaeological features were observed in any of these trenches.
